AFWAL-TR-82-2119

RESTARTABLE HIGH POWER GAS GENERATOR

ROCKETDYNE DIVISION/ROCKWELL INTERNATIONAL
6633 CANOGA AVENUE
CANOGA PARK, CALIFORNIA 91304

FINAL REPORT FOR PERIOD MAY 1979 - AUGUST 1982

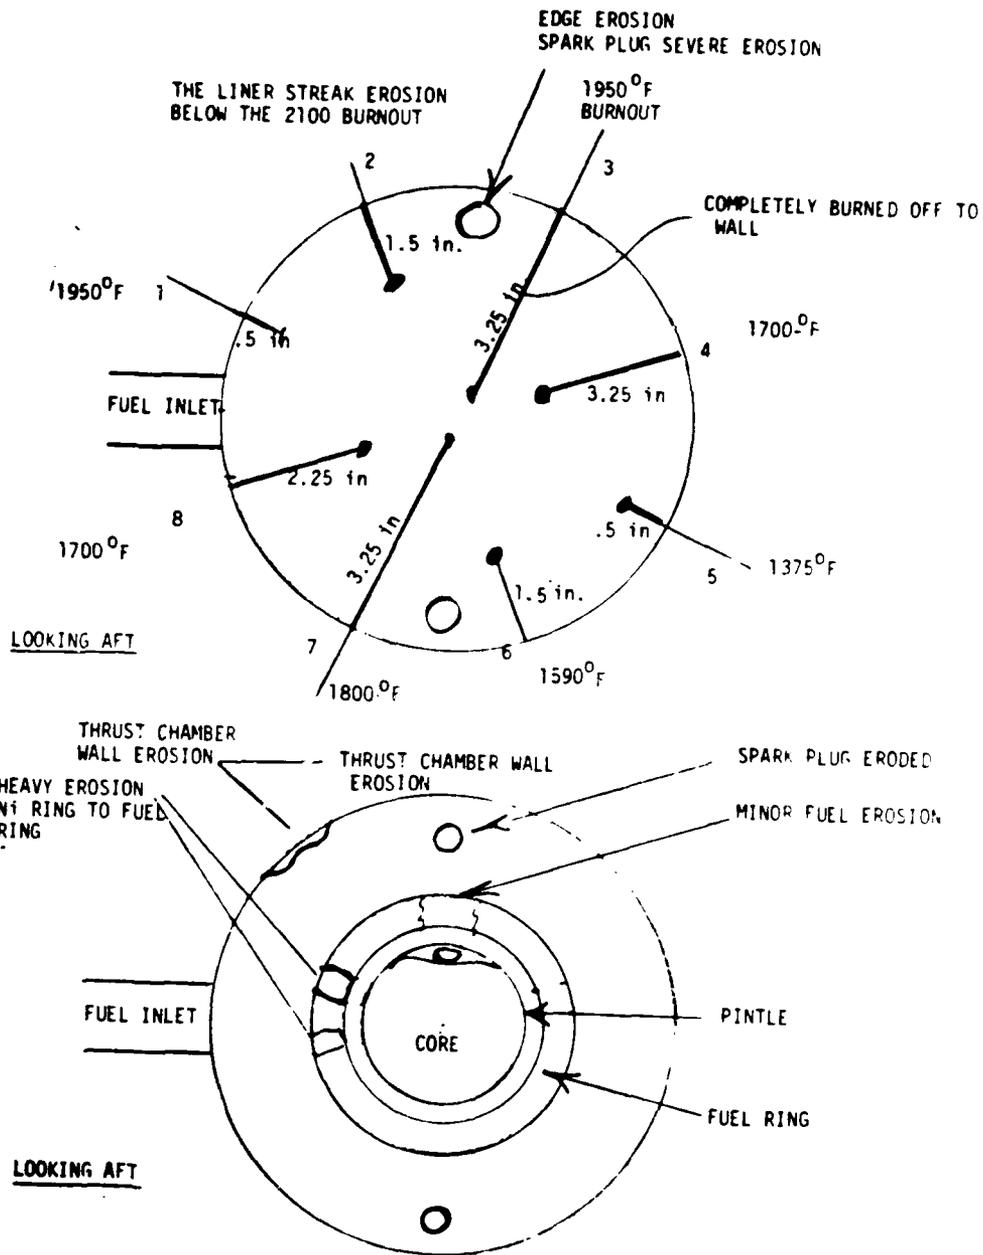
FIGURE 69. Hot Gas Temperature Measurement Locations
Relative to Injector Damage

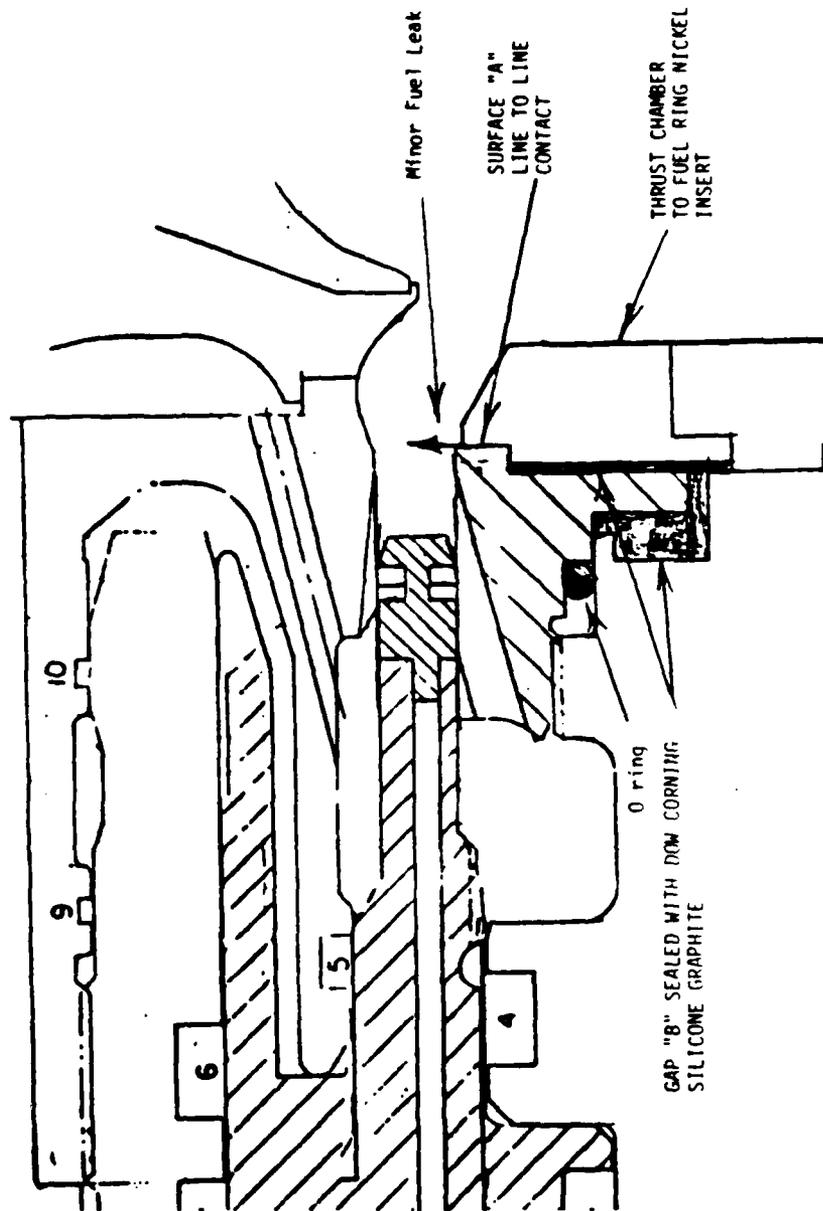
Figure 71. Injector to Combustor Interface

As previously stated, the small indications of combustion during the LOX lead have been noted only since incorporation of the new interface design. Since no

indications of core erosion had been noted during the performance of 13 tests accumulating 76 seconds of operation, it is felt that the core erosion is not a basic design concept problem, but a minor hardware assembly and pre-test checkout problem.

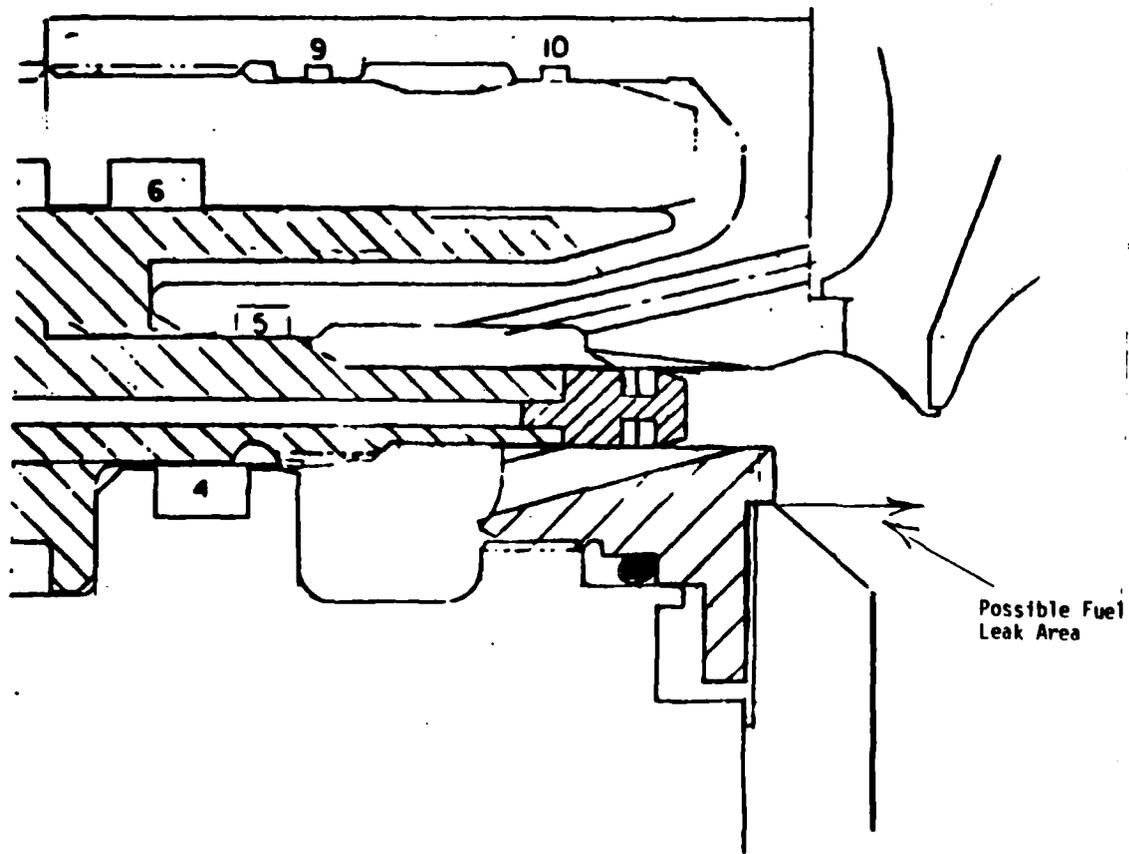
FIGURE 72. Original Injector to Thrust Chamber Interface

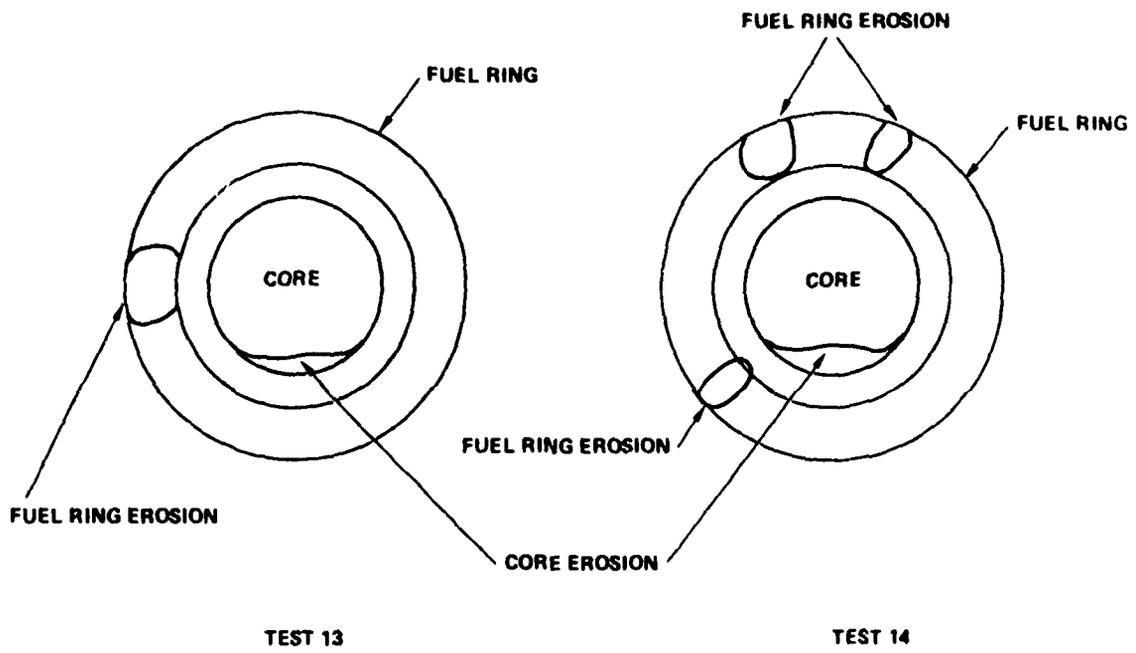
FIGURE 87
LOCATION OF INJECTOR EROSION

The previous tests indicating no core or fuel ring erosion other than to minor random fuel ring edge nibbling which was caused by lack of capability to transfer heat by the relatively low thermal conductivity 347 Cress.

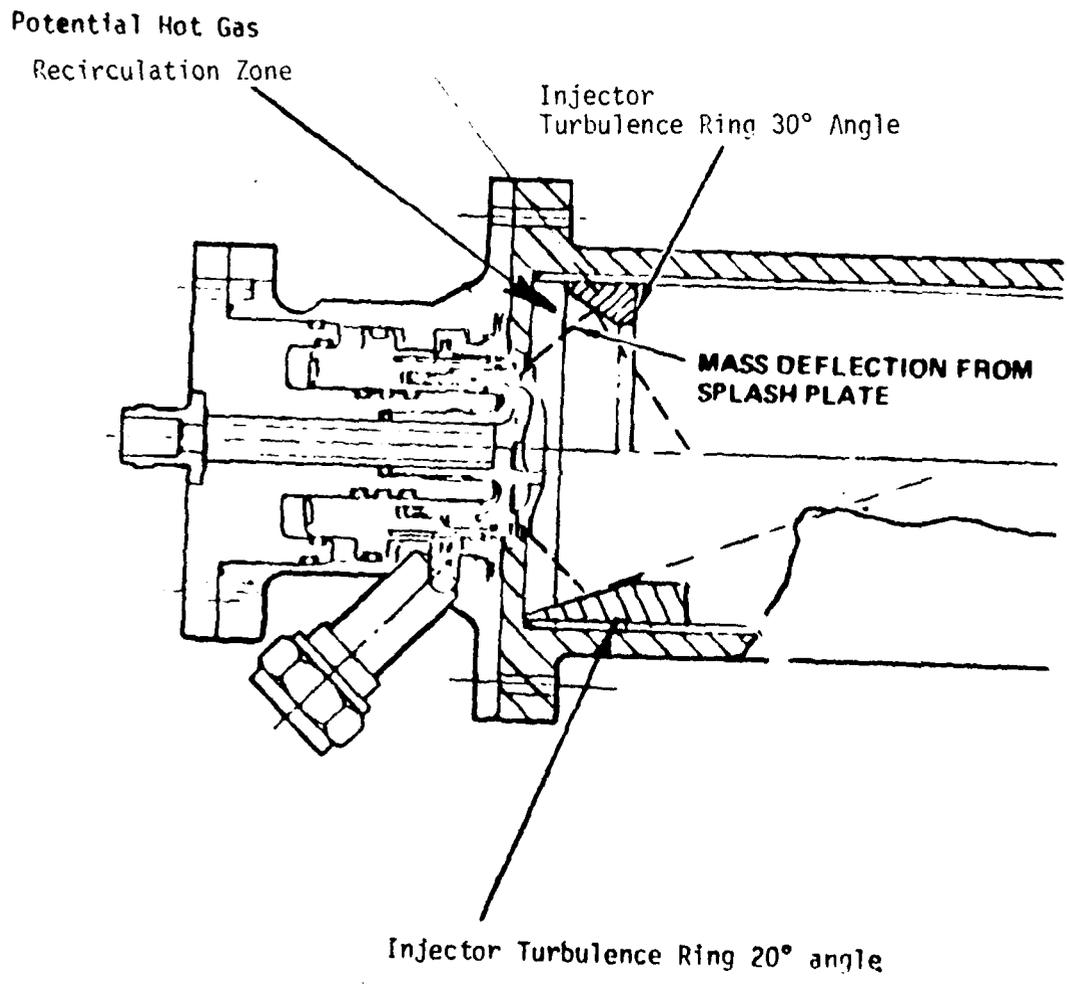
A more conservative configuration utilizing a 20 degree ramp angle which extends completely to the combustor wall diameter at the upstream end (Figure A-9) eliminates the "pocket" where recirculation was anticipated with the shorter ring and reduces the impingement angle of the injected mass on the ramp to a nominal 65 degrees. The cylindrical length of the reduced flow area section is also lengthened to one inch by this design to improve thermal integrity by increasing the mass of the ring.

Figure A-9- Turbulence Ring Configurations
