TECHNICAL REPORT

NO. 12728

ULTRASONIC INSPECTION FOR
ROADWHEEL BONDLINE QUALITY

Final Report

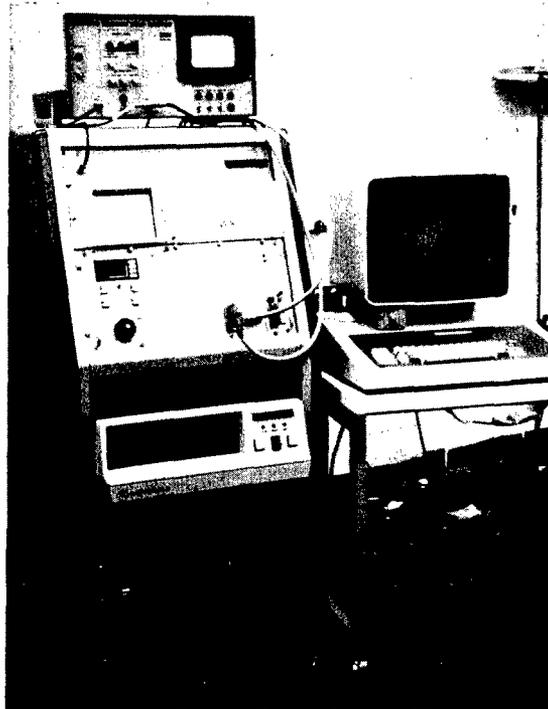
Figure 3 Ultrasonic Computer Data Analysis System

GARD has developed and is currently using a unique computer-aided data analyzer for various acoustic emission and ultrasonic investigations. It forms the basis for the ultrasonic roadwheel analysis performed on this program, and is shown in Figure 3. The system is composed of preprocessor, a microcomputer, and a floppy disk mass storage device. The preprocessor monitors amplified acoustic signals, converts it to ringdown counts, samples voltages being held in peak detectors tied to the outputs of eight frequency filter circuits, and presents the results to the microcomputer in a digital form. The microcomputer processes, stores, and displays the preprocessor results.

When the data are transferred from the preprocessor, they are organized into a format for storage to disk. This format is a collection of twelve computer words of "bytes" arranged in the following way. The first two bytes stored to or read from disk represent the number of computer-generated display sweeps which has elapsed since the previously recorded event. The next two bytes are a combination input composed of a 12-bit representation of the ringdown count and 4 bits representing the status of four flags used by the preprocessor logic. These flags and their significance are summarized in Figure 4. Each of the final eight bytes in the disk format is an 8-bit representation of the voltage sensed in one of the eight frequency bands analyzed. The ordering of these bytes in the format is 920 kHz, 675 kHz, 500 kHz, 370 kHz, 270 kHz, 200 kHz, 150 kHz, and 110 kHz.

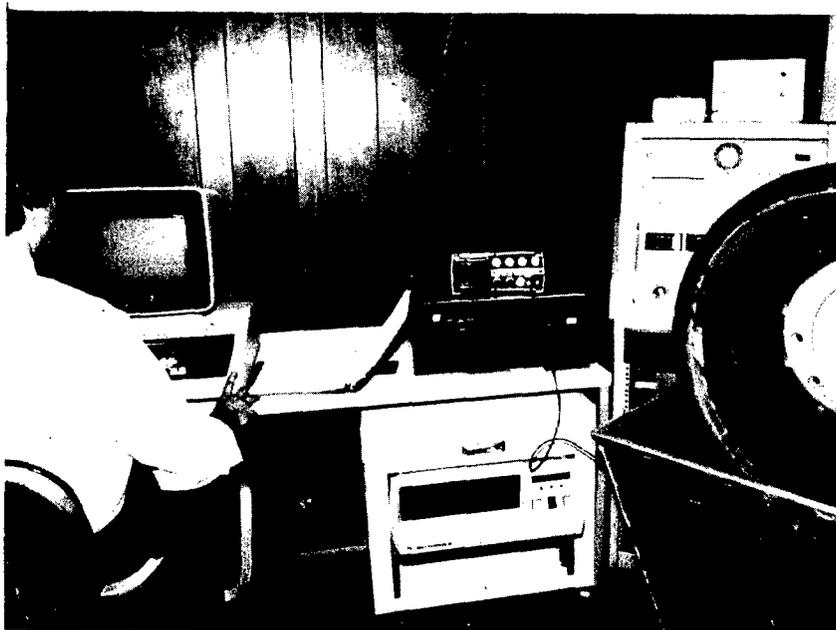
Figure 7 Roadwheel Computer Analysis System

Ten TACOM-provided roadwheels were inspected in the laboratory for test development and instrumentation checkout of the system described in Section 5.3. The System is shown in use in Figure 7.
