RECONNAISSANCE REPORT ON COASTAL EROSION AT FORT ORD
CALIFORNIA(U) COASTAL ENGINEERING RESEARCH CENTER
VICKSBURG MS O P SMITH DEC 83 CERC-MP-83-10

MISCELLANEOUS PAPER CERC-83-10

RECONNAISSANCE REPORT ON COASTAL EROSION AT FORT ORD, CALIFORNIA

December 1983
Final Report

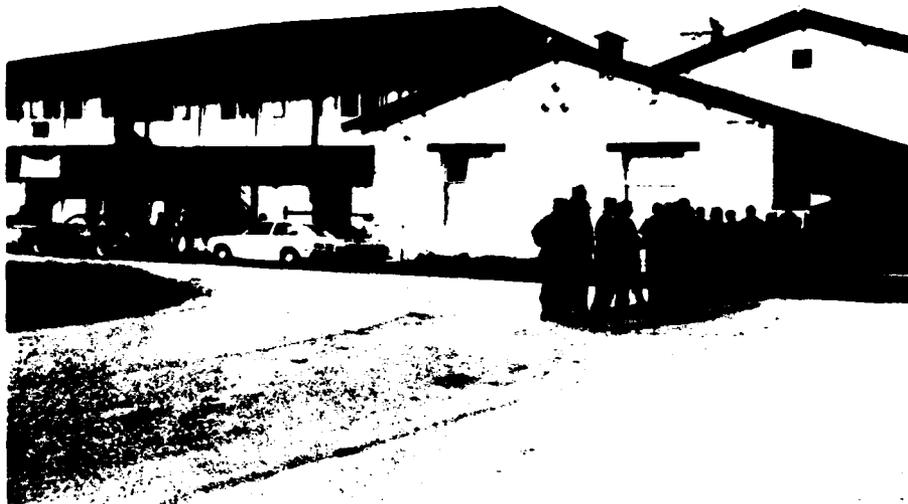
Figure 2. Stilwell Hall Recreational Center,
Fort Ord, California

7. Fort Ord became the home of the 7th Infantry Division in 1940, under the command of BG Joseph Stilwell. General Stilwell was primarily responsible for the 1941 construction at Fort Ord of Stilwell Hall Recreational Center. This distinctive Spanish style adobe-walled building encloses 51,882 sq ft and overlooks a spectacular view of Monterey Bay (see Figures 2 and 3). It is also known as "Soldiers Hall," since it was built for the use and with the contributions of enlisted men. Stilwell Hall was associated with the training and demobilization of large numbers of troops during World War II and the

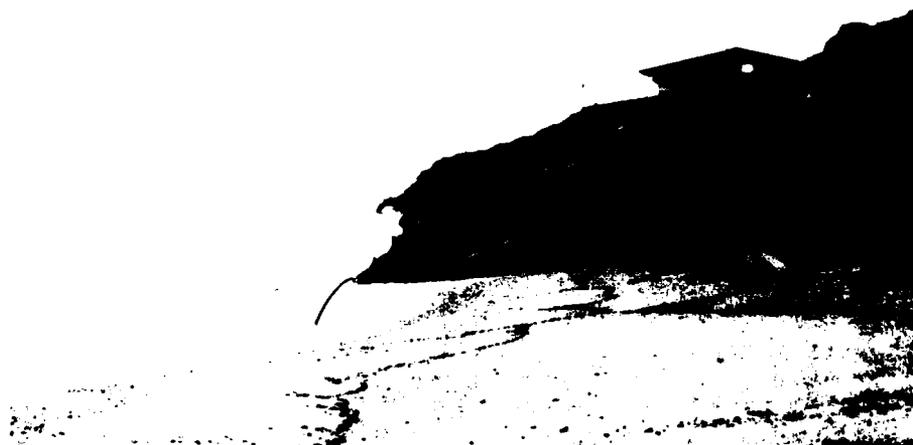
Figure 3. Shoreline at Stilwell Hall, Fort Ord, California

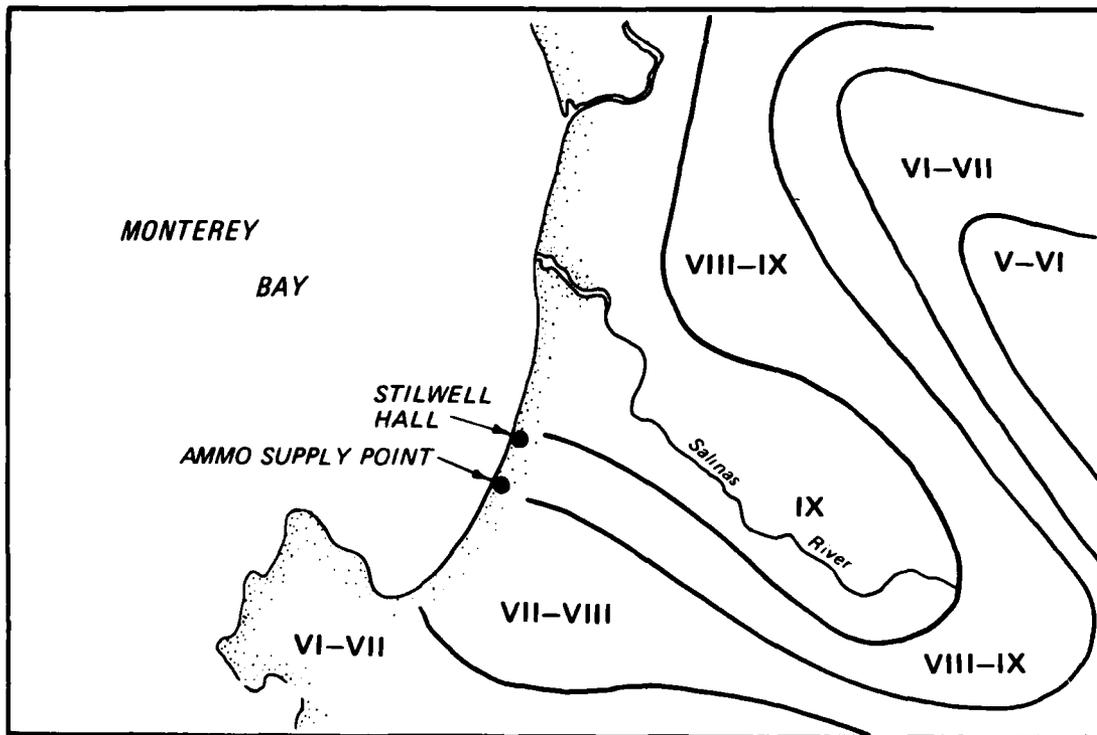
Figure 4. Seismic intensity zones for southern Monterey Bay, California (after Monterey County Planning Department 1980)

13. The seismicity of central California is well known, and the famous San Andreas Fault, 17 miles to the northeast, provides the principle hazard to Fort Ord. The Palo Colorado Fault, 14 miles to the southeast, also could cause significant earthquake damage (Resources Planning Consultants 1980). Figure 4 illustrates the seismic hazards of the vicinity, as interpreted by

the U. S. Geological Survey (USGS), in terms of "Rossi-Forel Ground-Shaking Intensity" zones derived from the 1906 San Francisco earthquake (Monterey County 1980). Table 1 defines the Rossi-Forel scale.

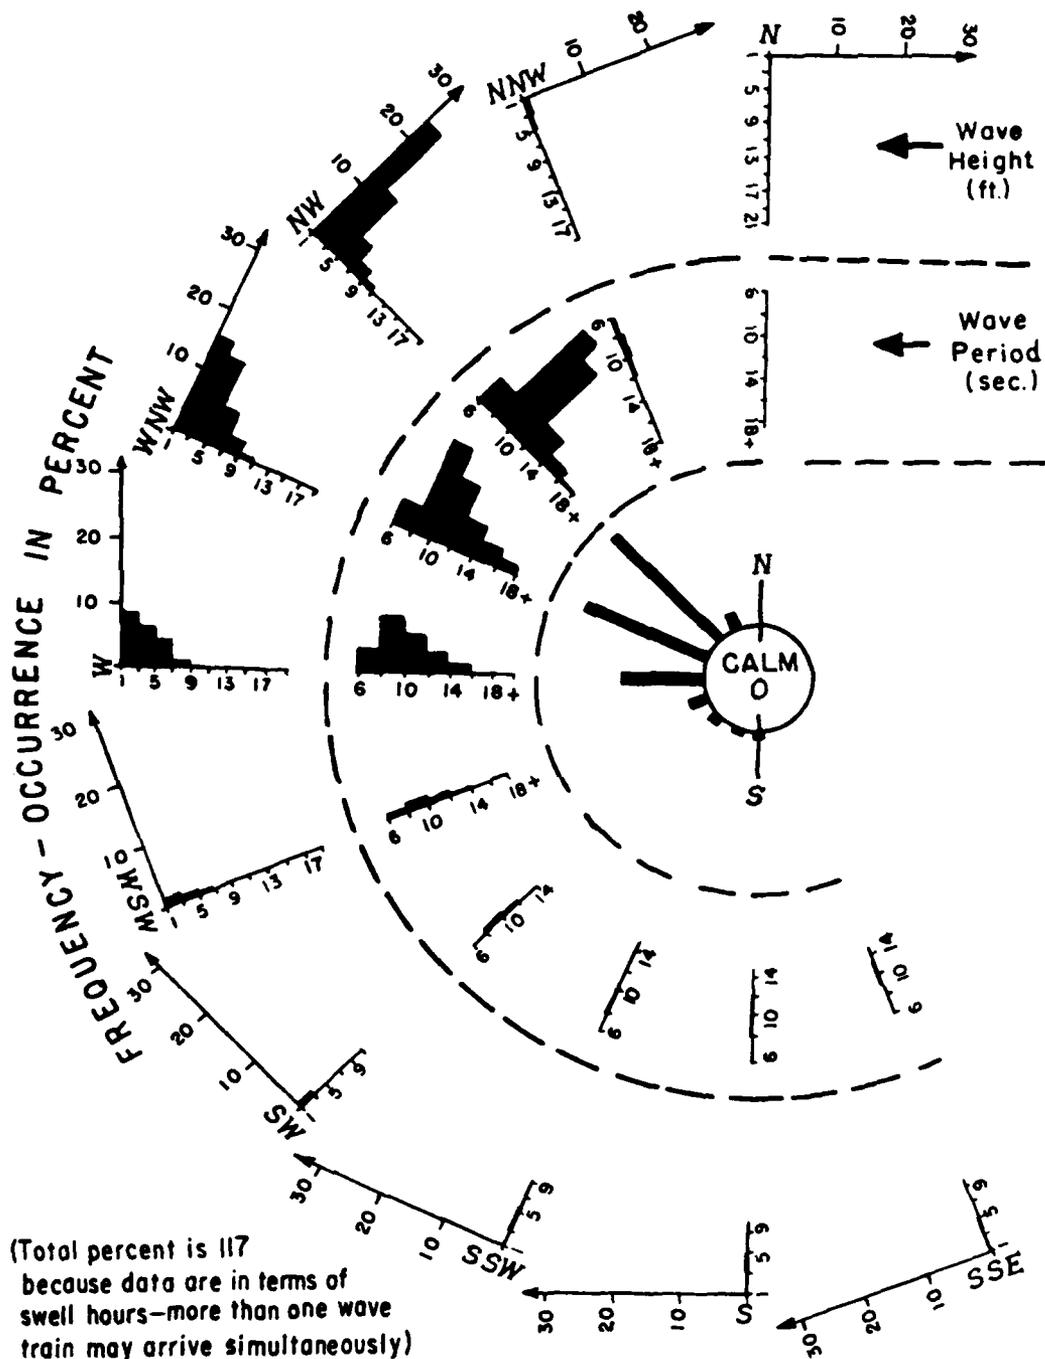
Figure 7. Average swell conditions offshore of central California (from Cherry 1964)

23. The wave climate of Monterey Bay is characterized by both Pacific Ocean swell (wave periods of roughly 8 seconds and greater) and locally generated wind waves. Swell is the most significant source of wave energy in the bay and is more directly related to shoreline development, according to Johnson (1956). Early spring and summer are typically characterized by swell from the northwest, while fall and winter bring swell from the west and southwest. Since swell is generated by very large-scale synoptic weather patterns, the statistics prepared by National Marine Consultants (1960) for a station 55 miles off San Francisco gives an indication of the directional frequency of occurrence of swell in this part of California, as shown in Figure 7.

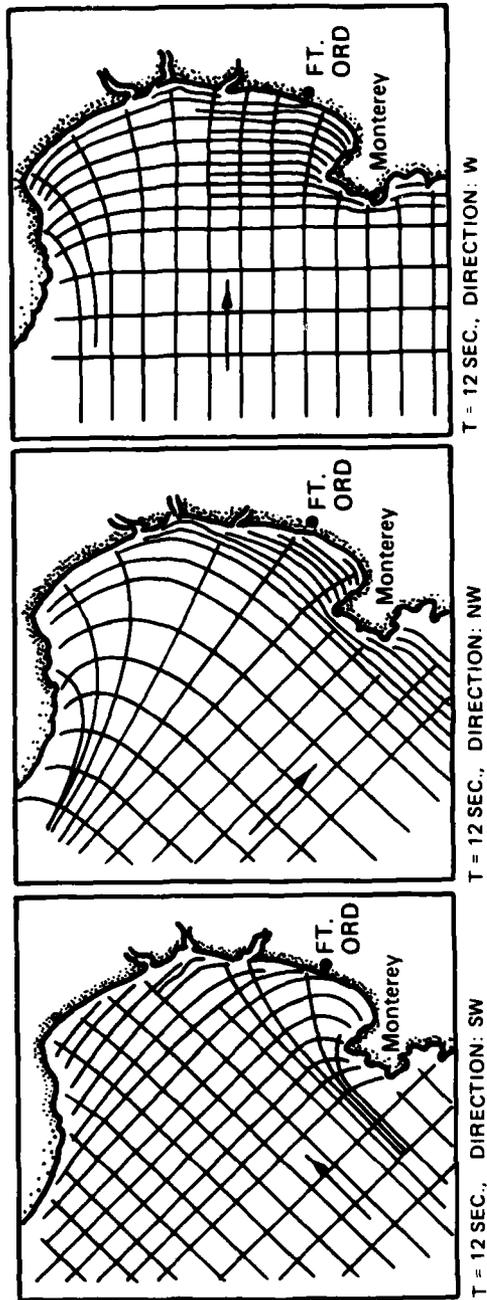
Figure 8. Wave refraction in Monterey Bay, California
(from Wiegel 1964)

24. The sheltering effect of the headlands of the bay is illustrated in Figure 8. This figure shows the typical refraction of swells from the southwest, northwest, and west. The less bending by refraction of wave orthogonals generally means less energy is lost to interaction with the sea bottom. The presence of the Monterey Submarine Canyon reduces the span over which these waves "feel" the bottom. The canyon has something of a lense effect for southern Monterey Bay near Fort Ord, causing wave energy to

converge in that area;* the straight orthogonals in Figure 8 for the northwest and west waves are an indication of this phenomenon. Storms west to northwest of Monterey Bay are known locally to have the worst consequences, and the Fort Ord coastline has been observed to have the highest breakers anywhere in Monterey Bay under these conditions.**

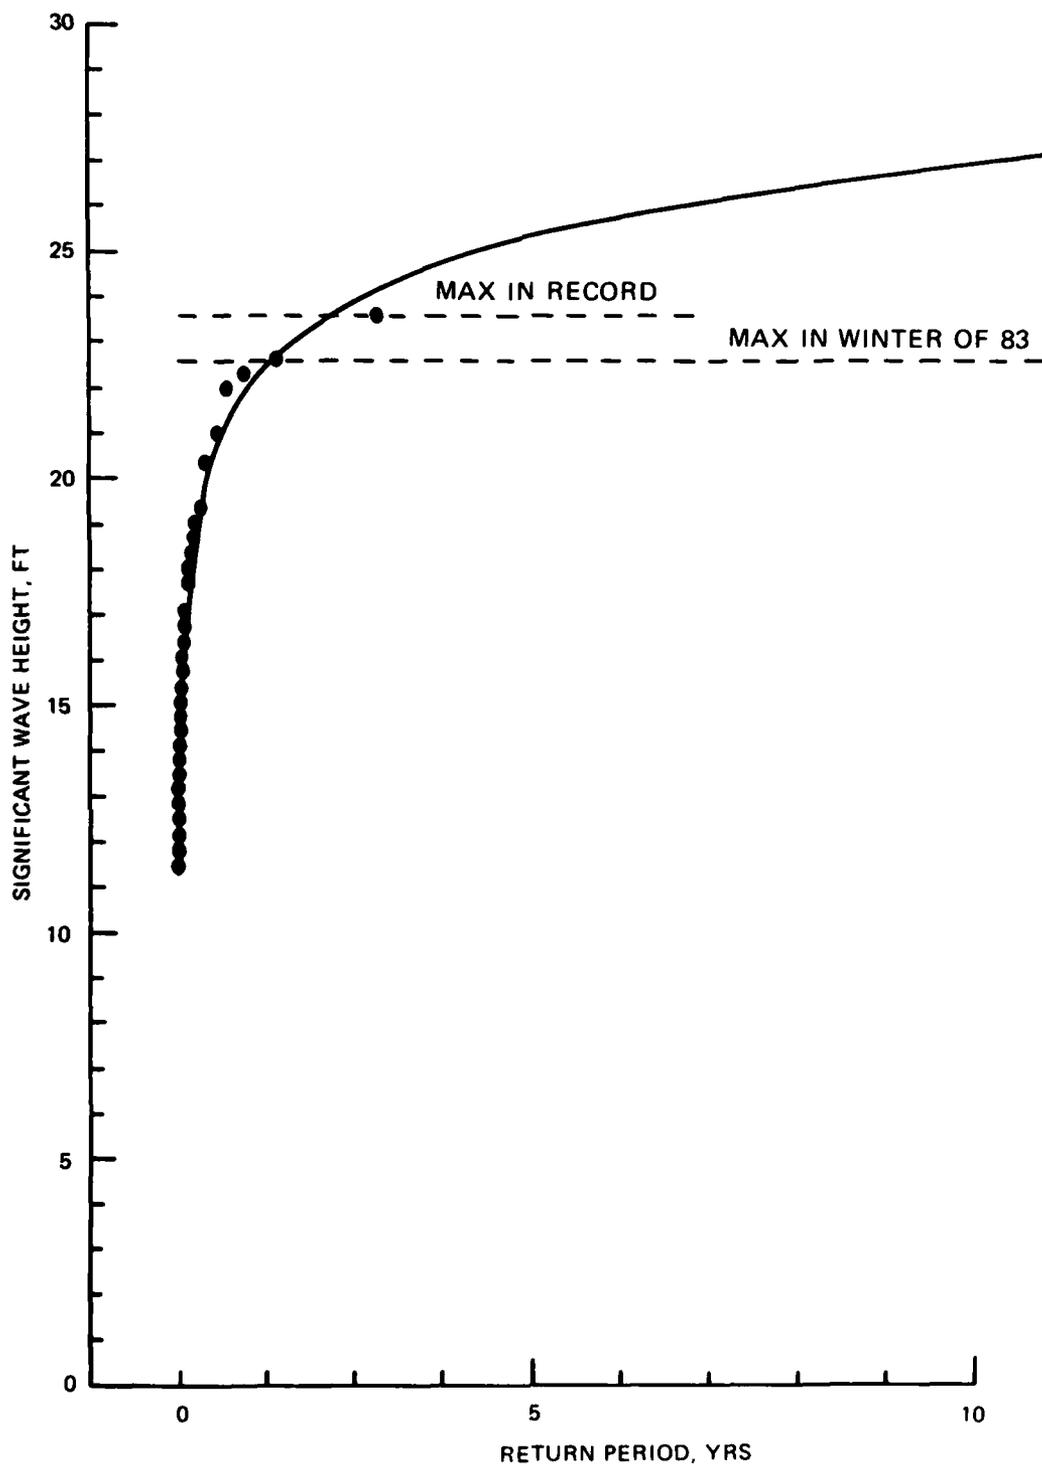
Figure 9. Statistical distribution of extreme significant wave heights measured in deep water off Monterey Bay, California (from Seymour 1983)

25. The U. S. Army Corps of Engineers and the State of California have maintained an expanding network of wave gages along the California coastline since 1976. A wave buoy has been in place in deep water off north Monterey Bay since October 1979, located approximately northwest of Fort Ord. A series of eight disastrous storms hit the California coastline during January through March 1983. The presence of these instruments has given engineers and scientists a unique opportunity to study the characteristics of extremely severe natural phenomena which caused the failure of many coastal structures. The severity of these storms was further affected by the El Nino climatic anomaly which caused a slowing of the California current and a general rise in sea level of about 8 in. Wave damages were aggravated by extreme astronomical tides which occurred coincidentally with some of these storms. Nearly all of the highest deepwater significant wave heights (to 24 ft) and many of the longest peak spectral periods (to 22 sec) were recorded at the north Monterey Bay buoy (Seymour 1983). The worst 1983 storm centers were located offshore such that waves must have been travelling to the southeast directly toward Fort Ord. Figure 9 shows the statistical (Weibull) distribution of the 10 percent highest significant wave heights recorded by the north Monterey Bay buoy from October 1979 to April 1983.

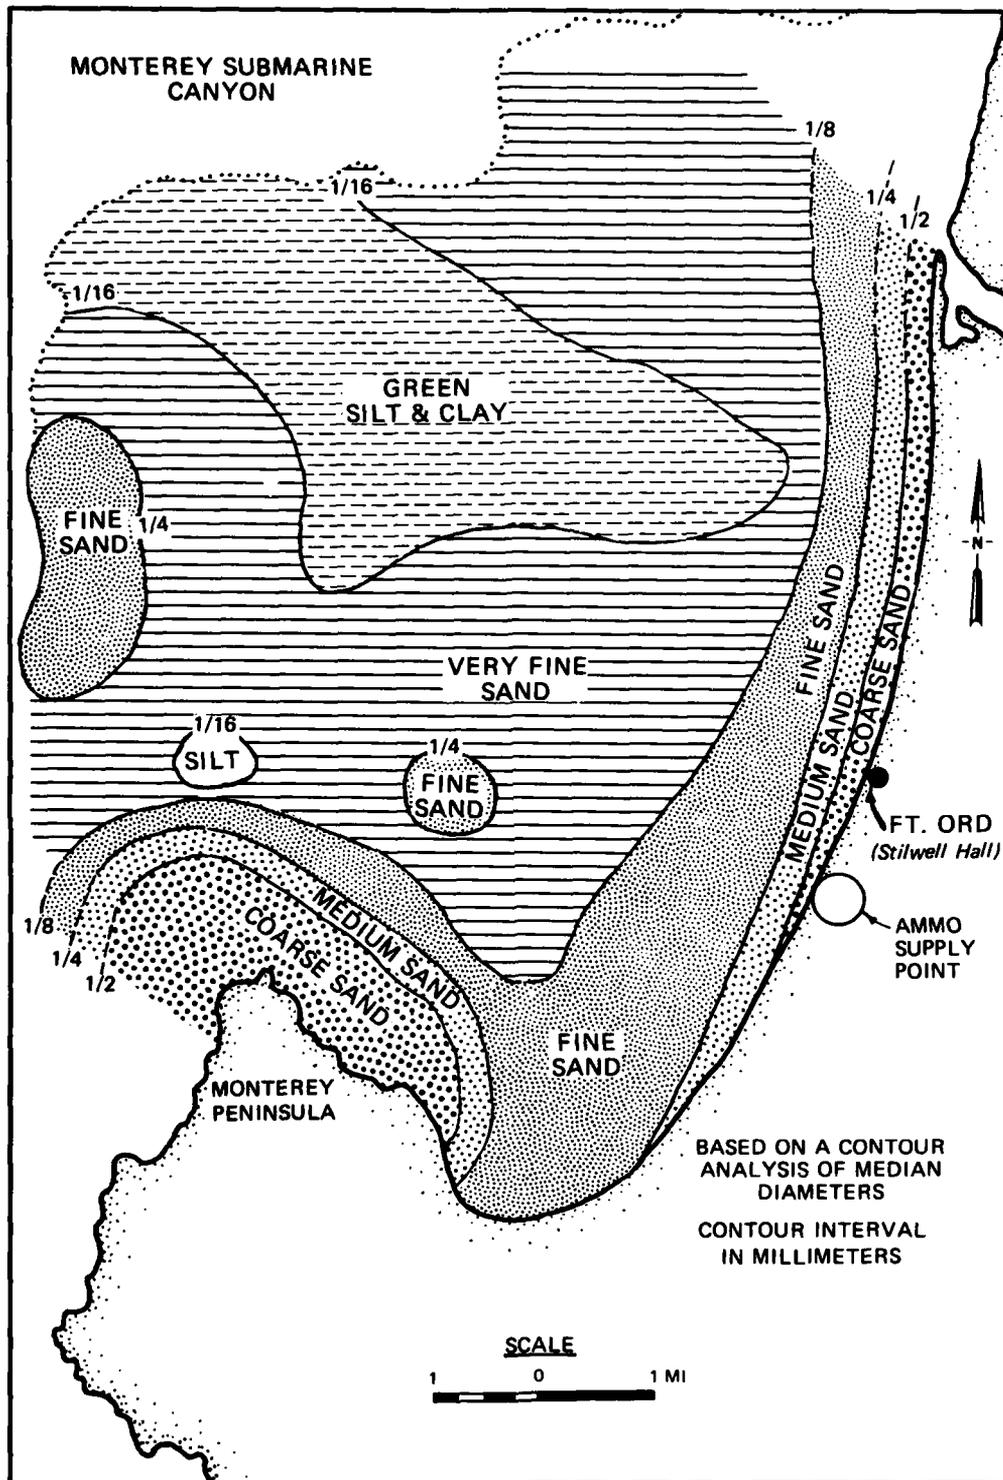
Figure 10. Sediment distribution in southern Monterey Bay, California (from Monteath 1965)

28. Sediments found near the shoreline, where wave effects on the bottom are strongest, tend to be more coarse as shown in Figure 10. Conversely, in the deeper parts of the bay the sea bottom is covered with fine material which settles after leaving the more turbulent nearshore areas. Grain size of sediments in Monterey Bay, particularly in the central portions to either side of the head of the canyon, tends to decrease uniformly with depth out to the edge of the Continental Shelf (Yancey 1969).

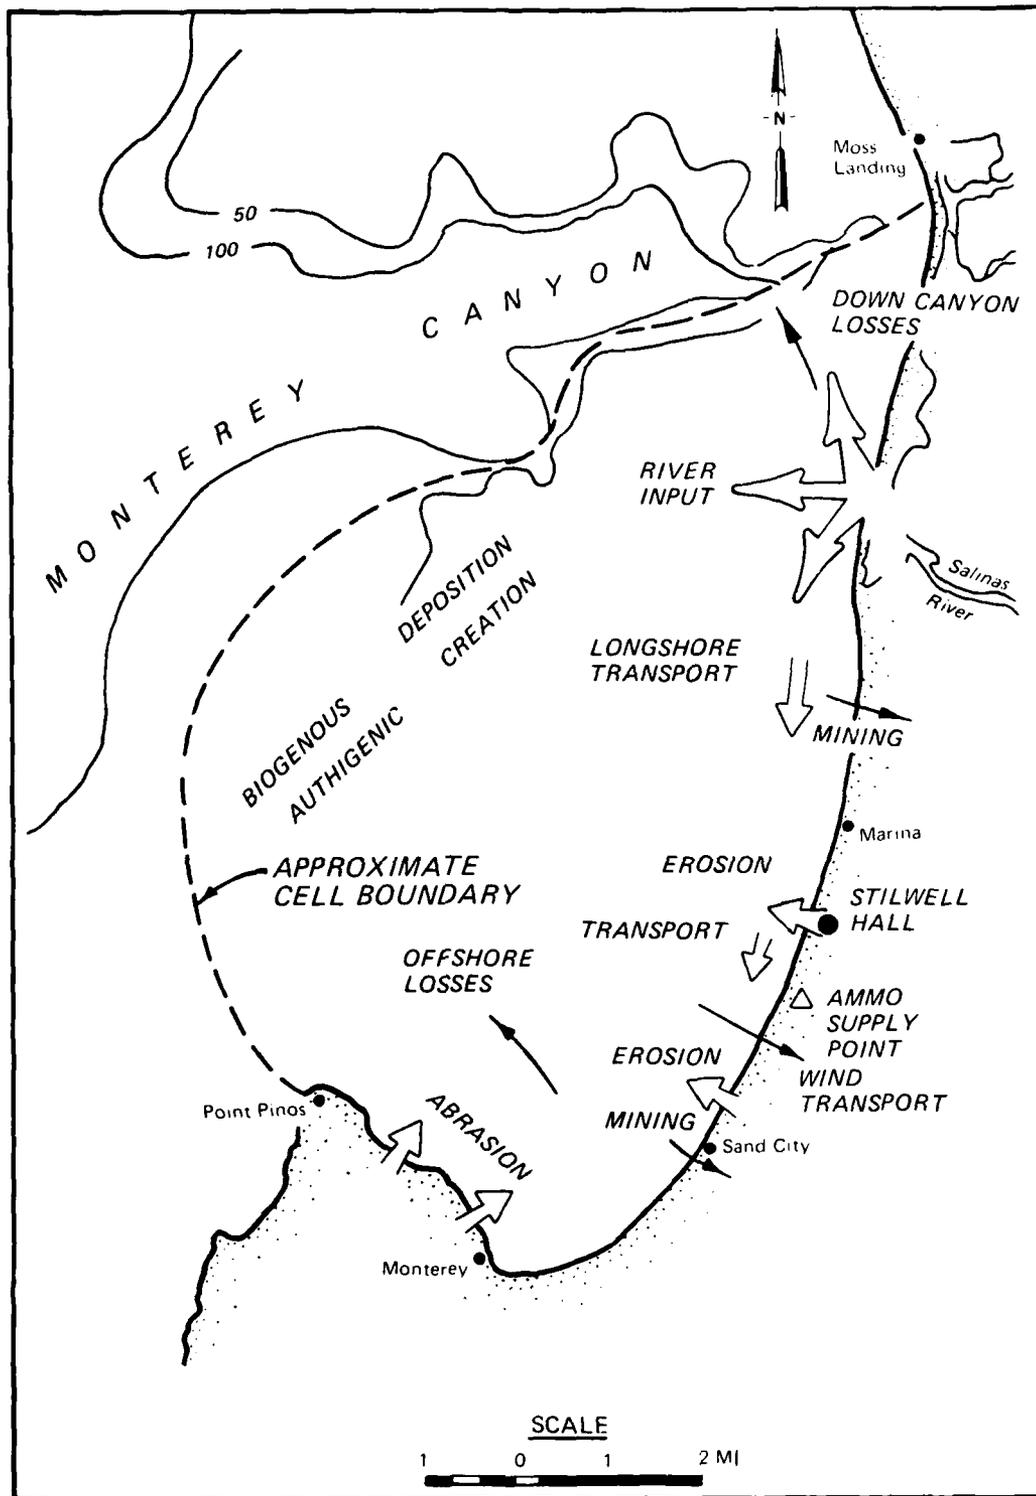
Figure 11. Sediment transport processes of southern Monterey Bay, California (from Dorman 1968)

33. The causes of erosion relate to long-term trends in the sediment budget for all of Monterey Bay, as well as to the gradual rise in sea level underway since the last glacial period (Monteath 1969). The Monterey Submarine Canyon is responsible for some sediment loss and, since its head is very near the shore at Moss Landing, tends to split the bay into two virtually independent halves for sediment budget purposes. The sediment budget and nearshore transport processes for Monterey Bay were studied in some detail by Dorman (1968) and Arnal, Dittmer, and Shumaker (1973). The various processes involved are illustrated in Figure 11.

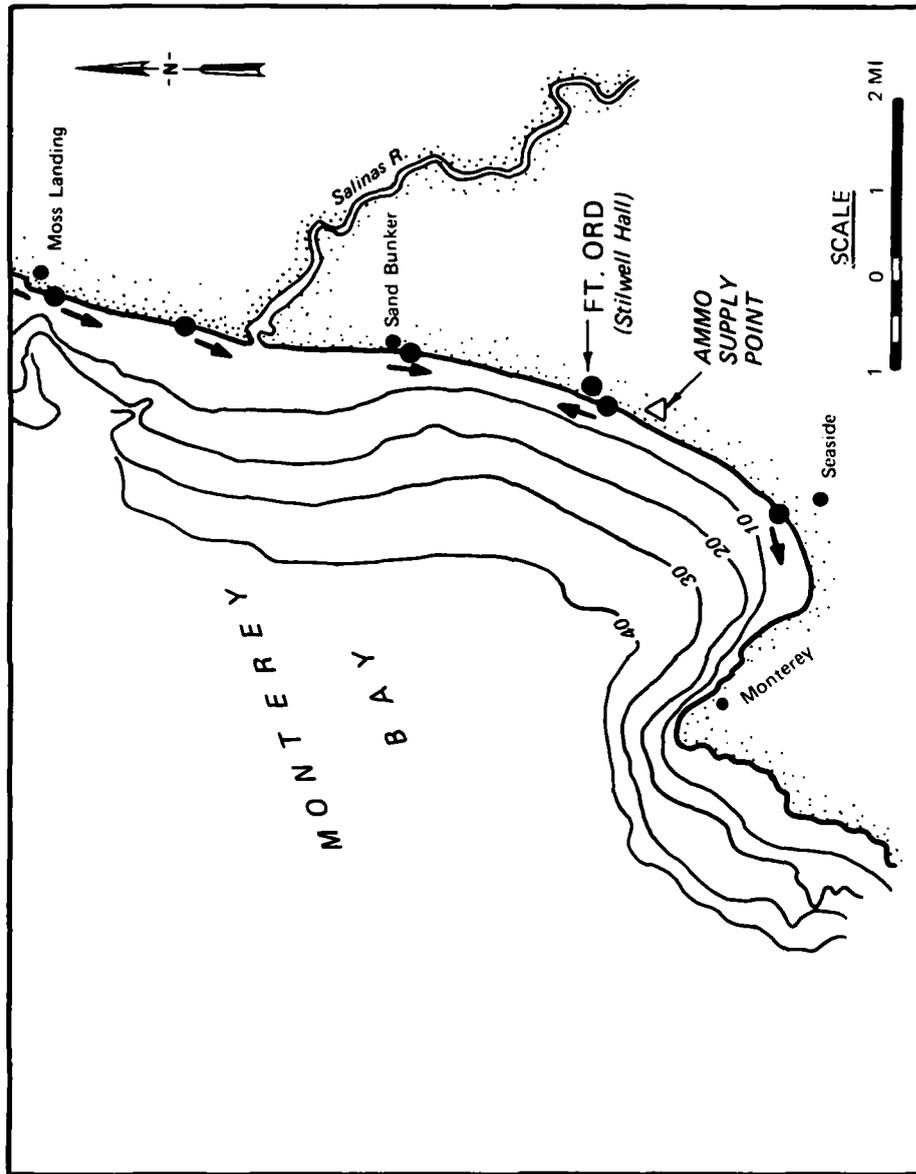
Figure 12. Longshore sediment transport directions predicted for Monterey Bay, California (after Arnal, Dittmer, and Shumaker 1973)

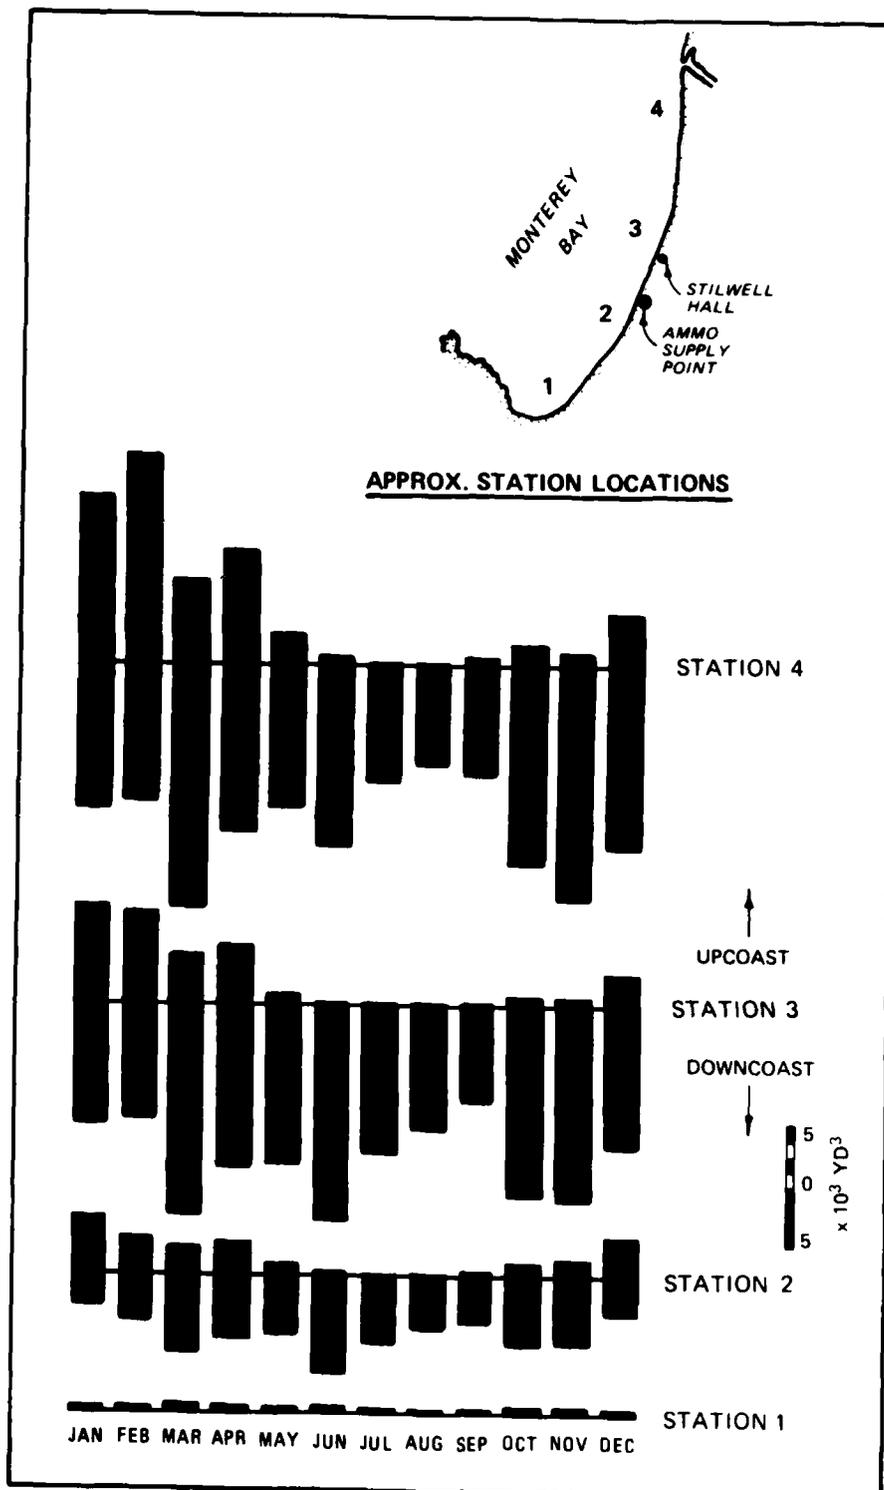
Figure 13. Longshore sediment transport rates predicted for Monterey Bay, California (after Dorman 1968)

of 191,000 cu yd per year was computed by Arnal, Dittmer, and Shumaker (1973). Average monthly rates computed by Dorman (1968) are shown in Figure 13. These two investigations did agree that the magnitude of long-shore transport drops off near Fort Ord and that wave-induced onshore-offshore sediment transport is probably more significant in this immediate vicinity.

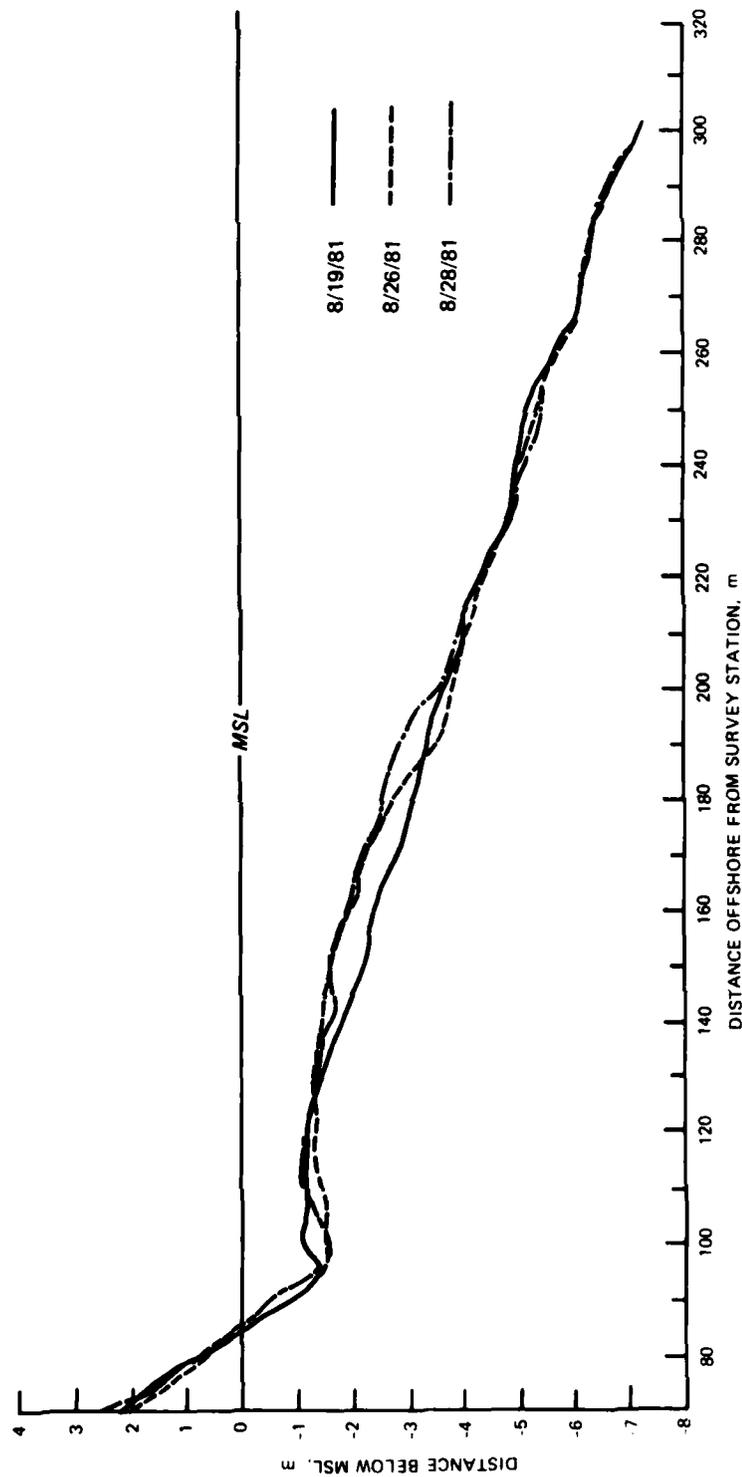
Figure 14. Nearshore profiles measured near Stilwell Hall, Fort Ord, California (unpublished data courtesy of A. Sallenger, Jr., USGS, Monterey, Calif.)

of 1 vertical to 10 horizontal (1:10) are normally considered steep beaches. The beach slopes measured by Dittmer (1972) just north of Fort Ord were 1:7 to 1:11, and slopes of 1:6 were consistently measured by the USGS just a few hundred feet south of Stilwell Hall, as shown in the beach profiles of Figure 14.

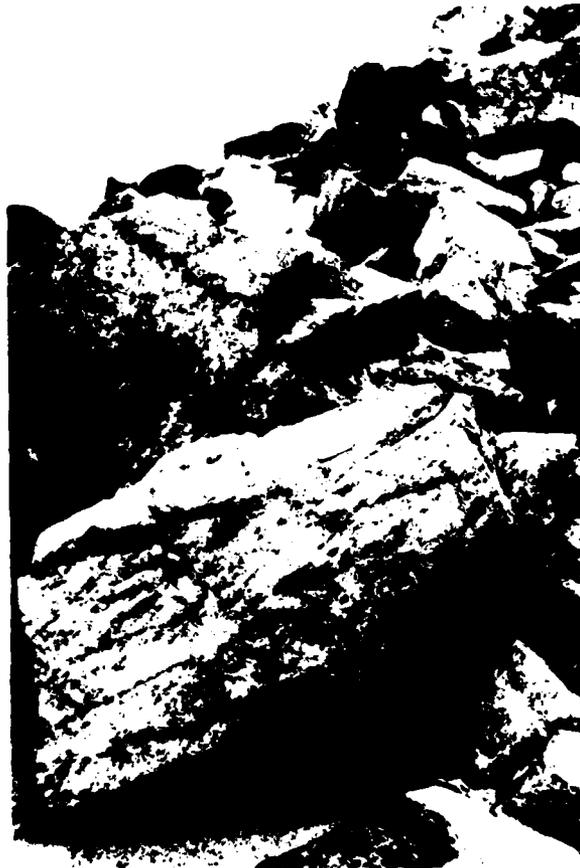
Figure 15. Armor rocks of the existing revetment at Stilwell Hall, Fort Ord, California (August 1983)

determined. The existing revetment at Stilwell Hall was apparently last maintained around 1972 with the placement of additional quarried rock (granite). Figure 15 is a photograph of a 4- by 8-in. notepad placed on one stone of the existing revetment.

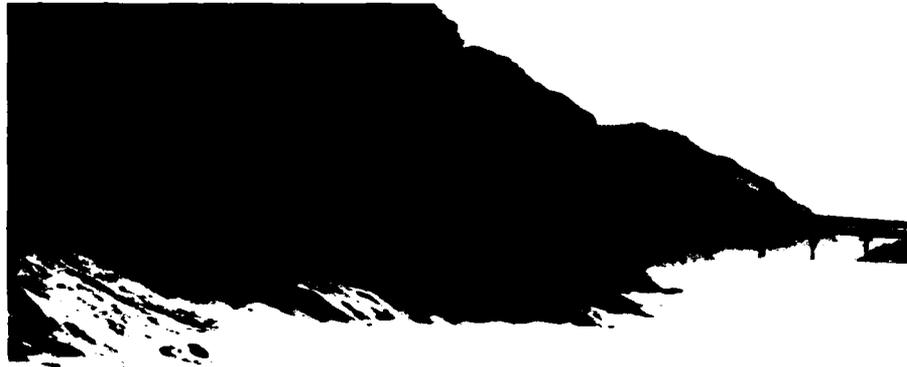
Figure 17. Waves striking the base of dunes below Stilwell Hall, Fort Ord, California (January 1983)

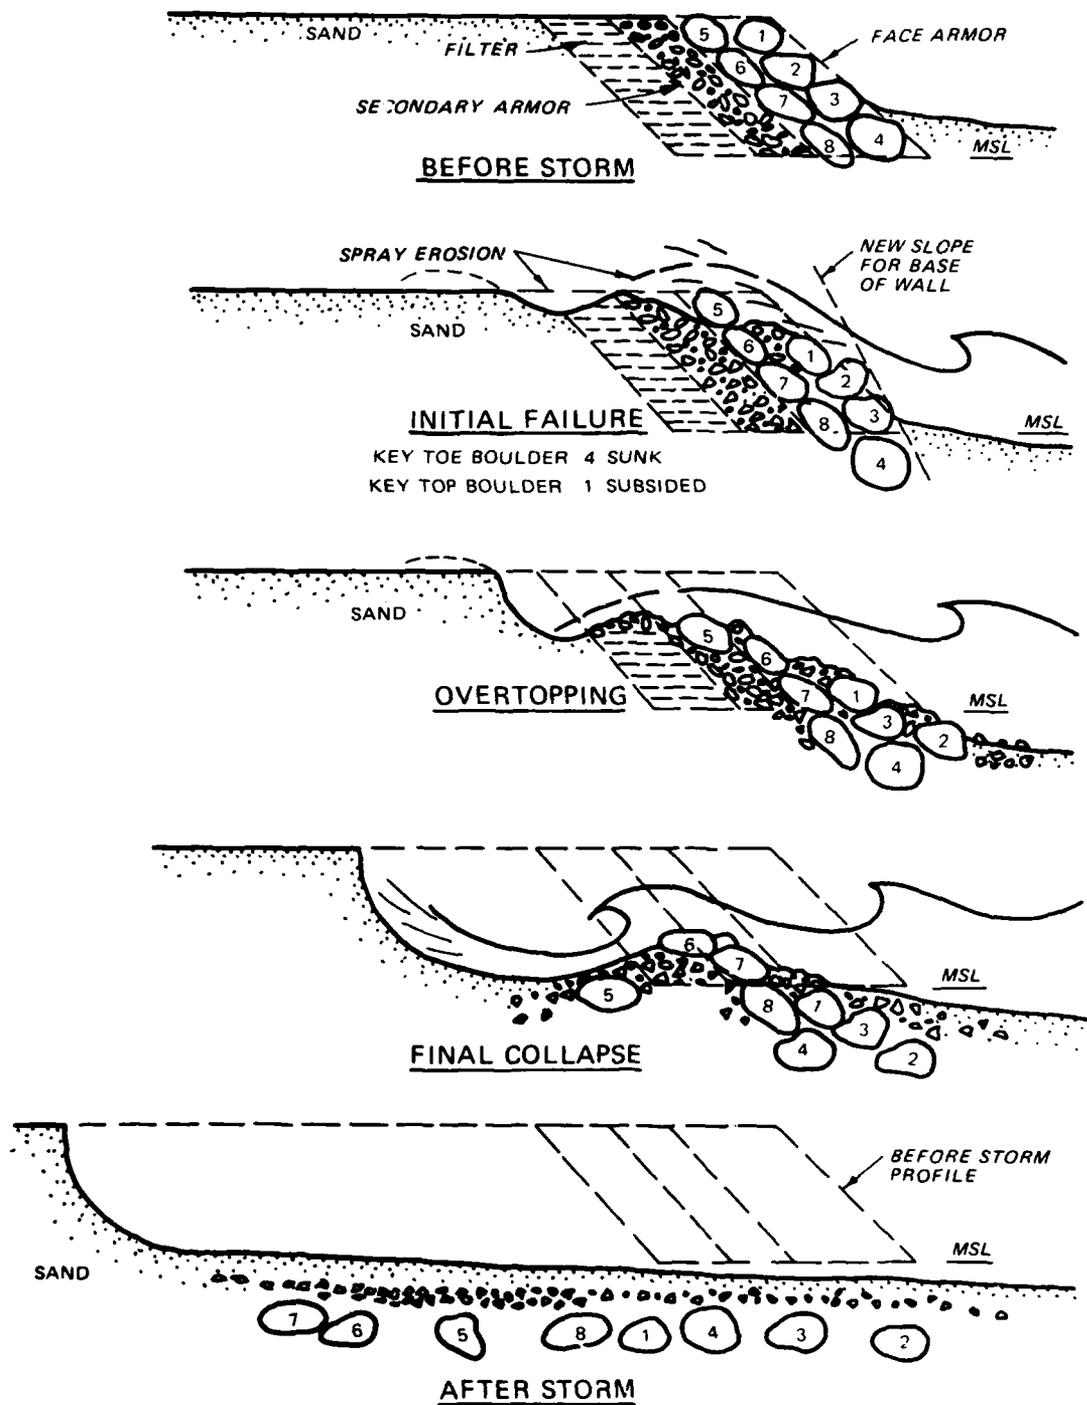
Figure 19. Typical failure sequence of a rubble revetment (after Smith and Chapman 1983)

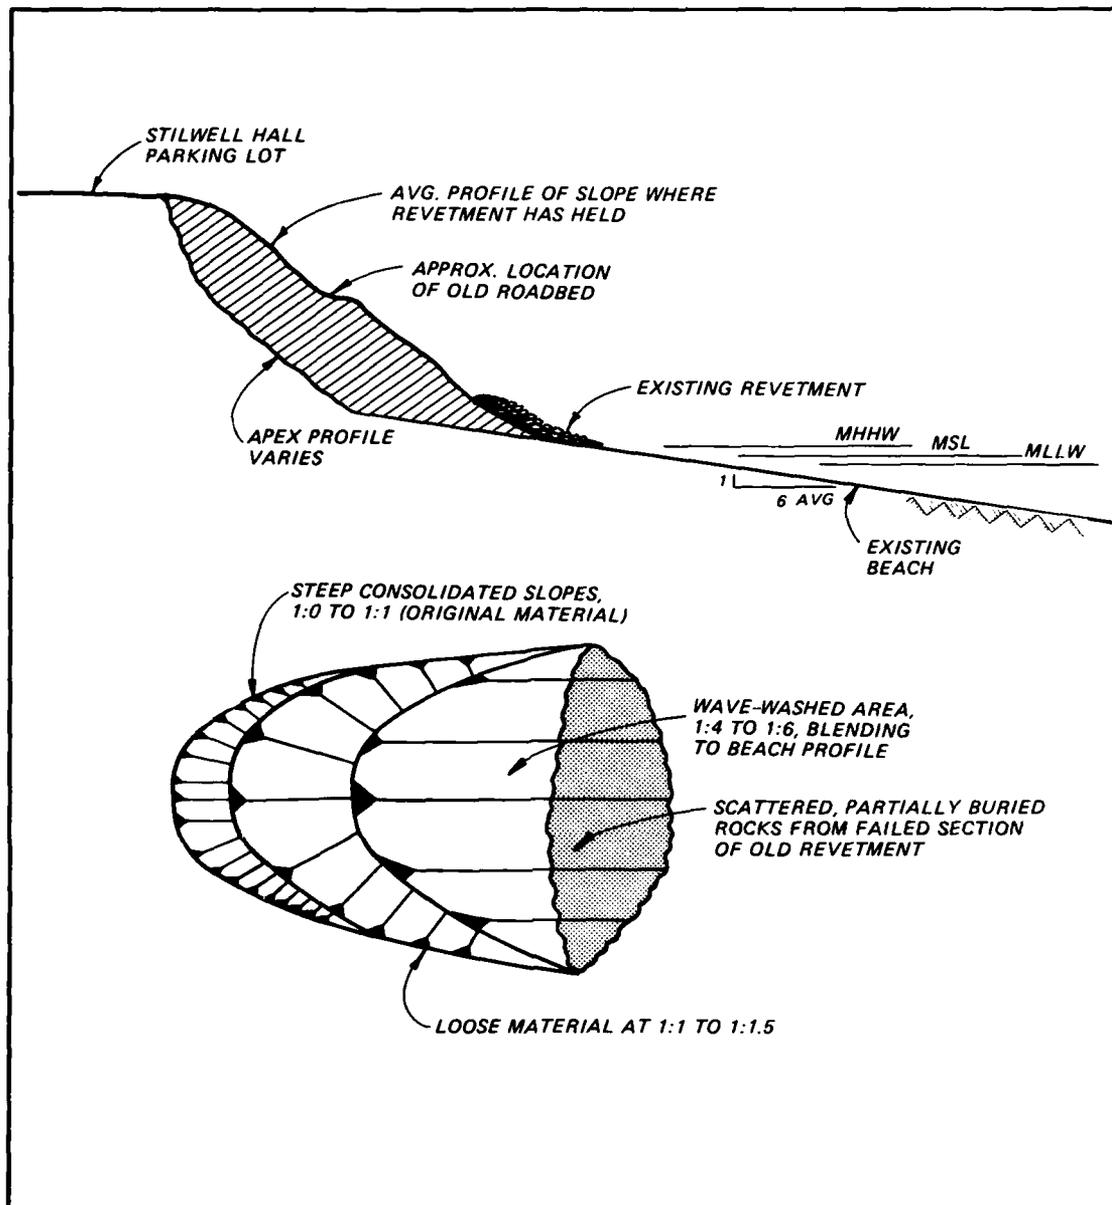
Figure 21. Profile and plan appearance of scallops observed on seaward face of dunes at Stilwell Hall, Fort Ord, California (August 1983)

43. The major scallops at Stilwell Hall were four in number and were observed to coincide with sections where the existing rubble revetment had completely failed. This revetment, while partially effective during normal winter conditions, had been completely inundated by the 1983 storms. Revetments of this type are commonly known to fail because scour both at the toe and behind the crest ultimately results in a complete collapse (Smith and Chapman 1983), as illustrated in Figure 19. This is apparently what happened at Stilwell Hall. Figure 20 shows an August 1983 view of a failed portion of the revetment with a surviving section beyond. The typical plan and profile of the scallops at Stilwell Hall are shown schematically in Figure 21.

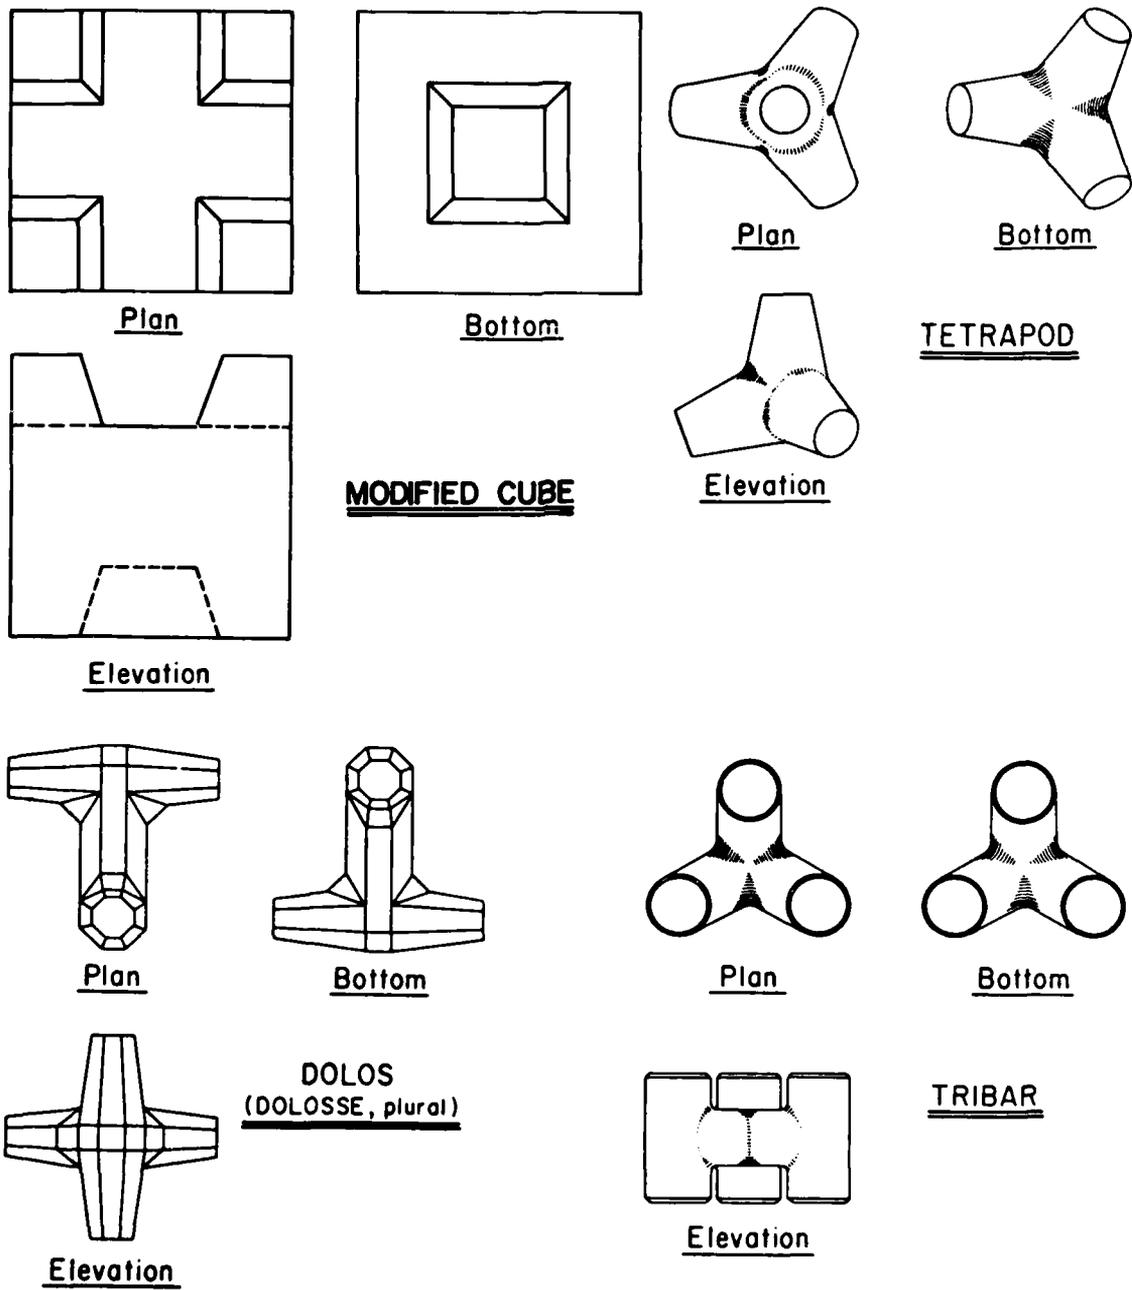
Figure 22. Concrete armor units

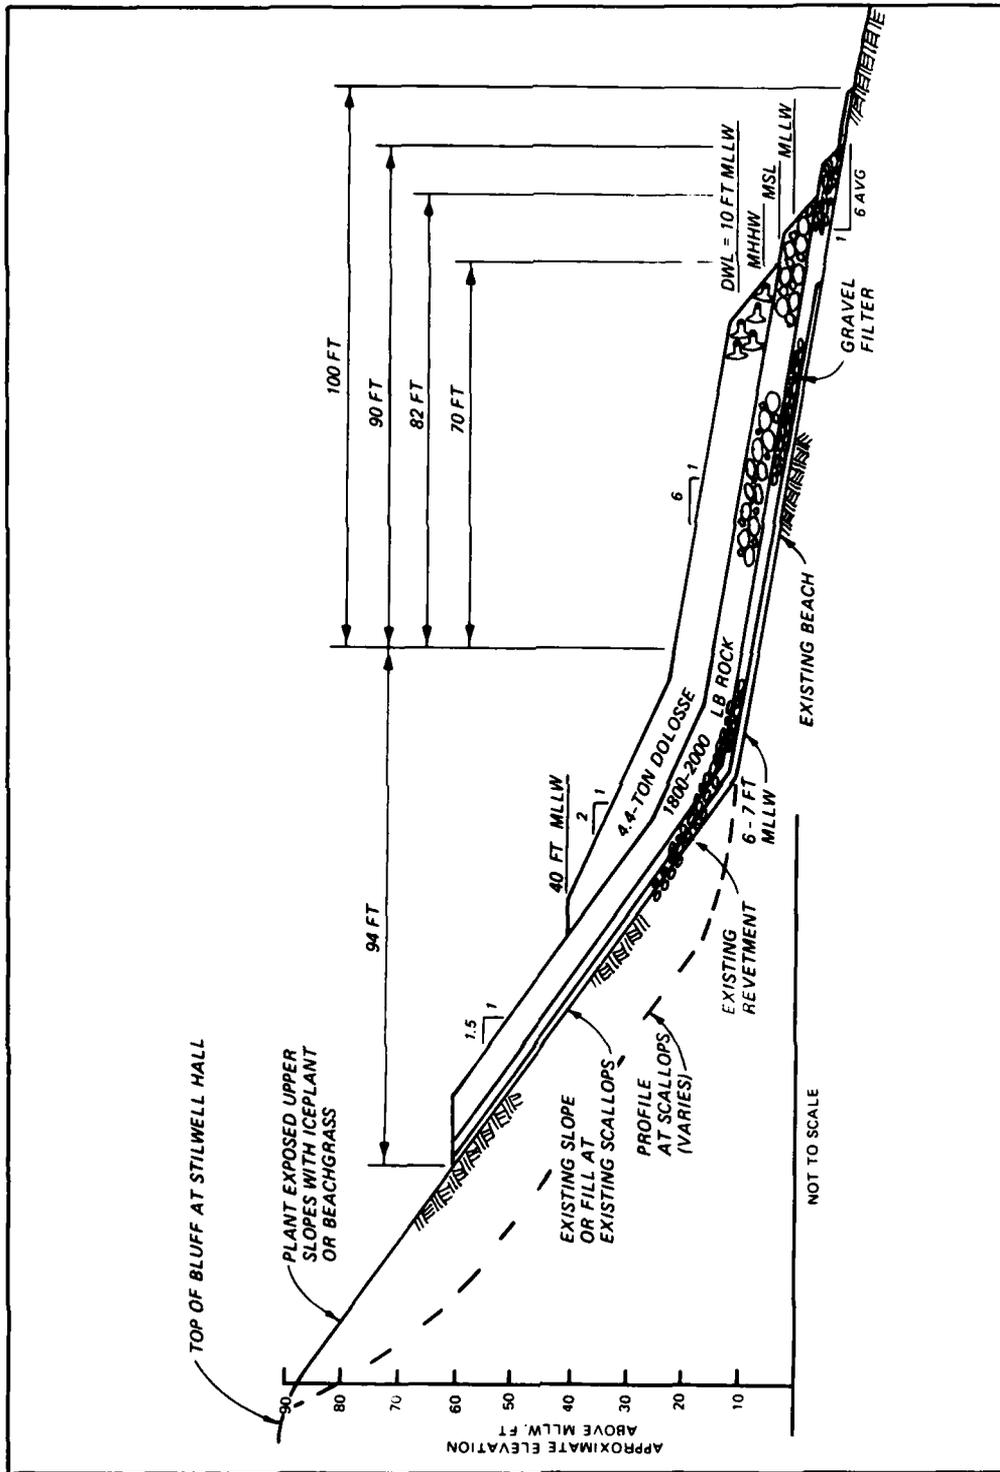
Figure 23. Profile of proposed rubble slope revetment at Stilwell Hall, Fort Ord, California

68. The cross section finally chosen for the purpose of estimating quantities is shown in Figure 23. A plan view showing the main trunk and the wings which tie the structure into the natural slopes at either end is presented in Figure 24. This drawing also shows the projected shoreline retreat with the structure at a rate of 6 to 7 ft per year, to illustrate the need for an extension of the revetment wings in about 30 years. Maintenance at roughly 10-year intervals would also be required to redress the revetment slopes and repair minor flanking.

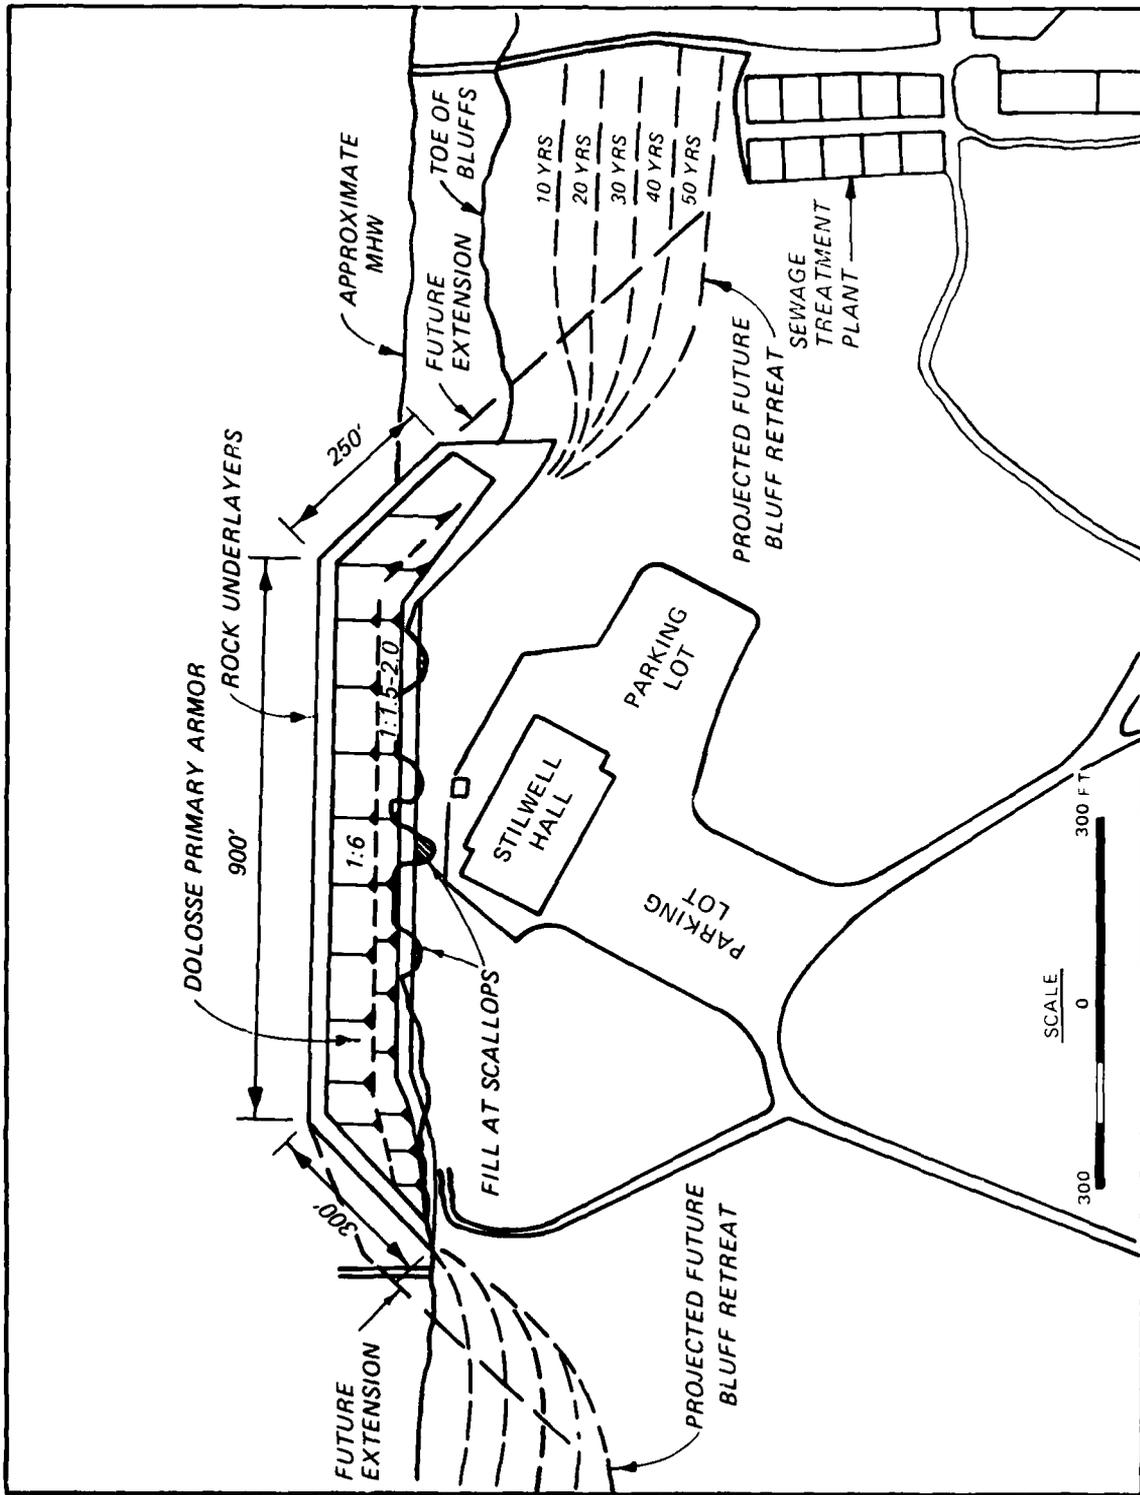
Figure 24. Plan view of proposed rubble slope revetment at Stilwell Hall, Fort Ord, California
