RECONNAISSANCE REPORT ON COASTAL EROSION AT FORT ORD
CALIFORNIA(U) COASTAL ENGINEERING RESEARCH CENTER
VICKSBURG MS O P SMITH DEC 83 CERC-MP-83-10

MISCELLANEOUS PAPER CERC-83-10

RECONNAISSANCE REPORT ON COASTAL EROSION AT FORT ORD, CALIFORNIA

December 1983
Final Report

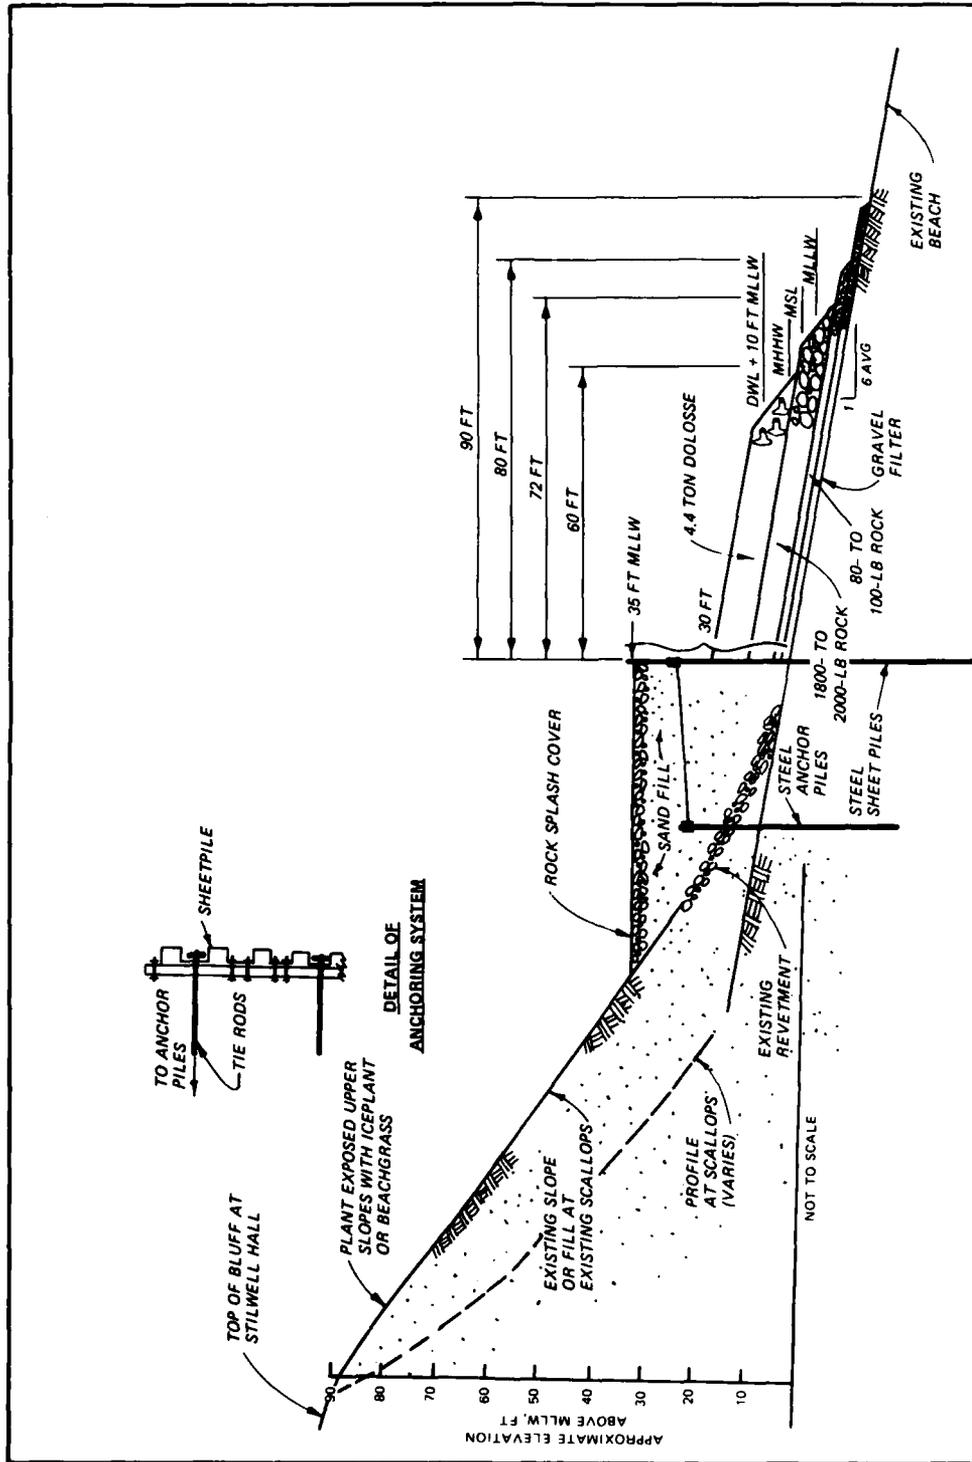
Figure 25. Profile of proposed sheetpile bulkhead at Stilwell Hall, Fort Ord, California

69. After a number of trial cross sections were formulated and attempts made to compute wave forces in the specified conditions, the composite bulkhead revetment structure shown in Figure 25 was chosen to estimate material quantities. Detailed structural computations were not performed since the wave forces could not be satisfactorily estimated. Conservative estimates of

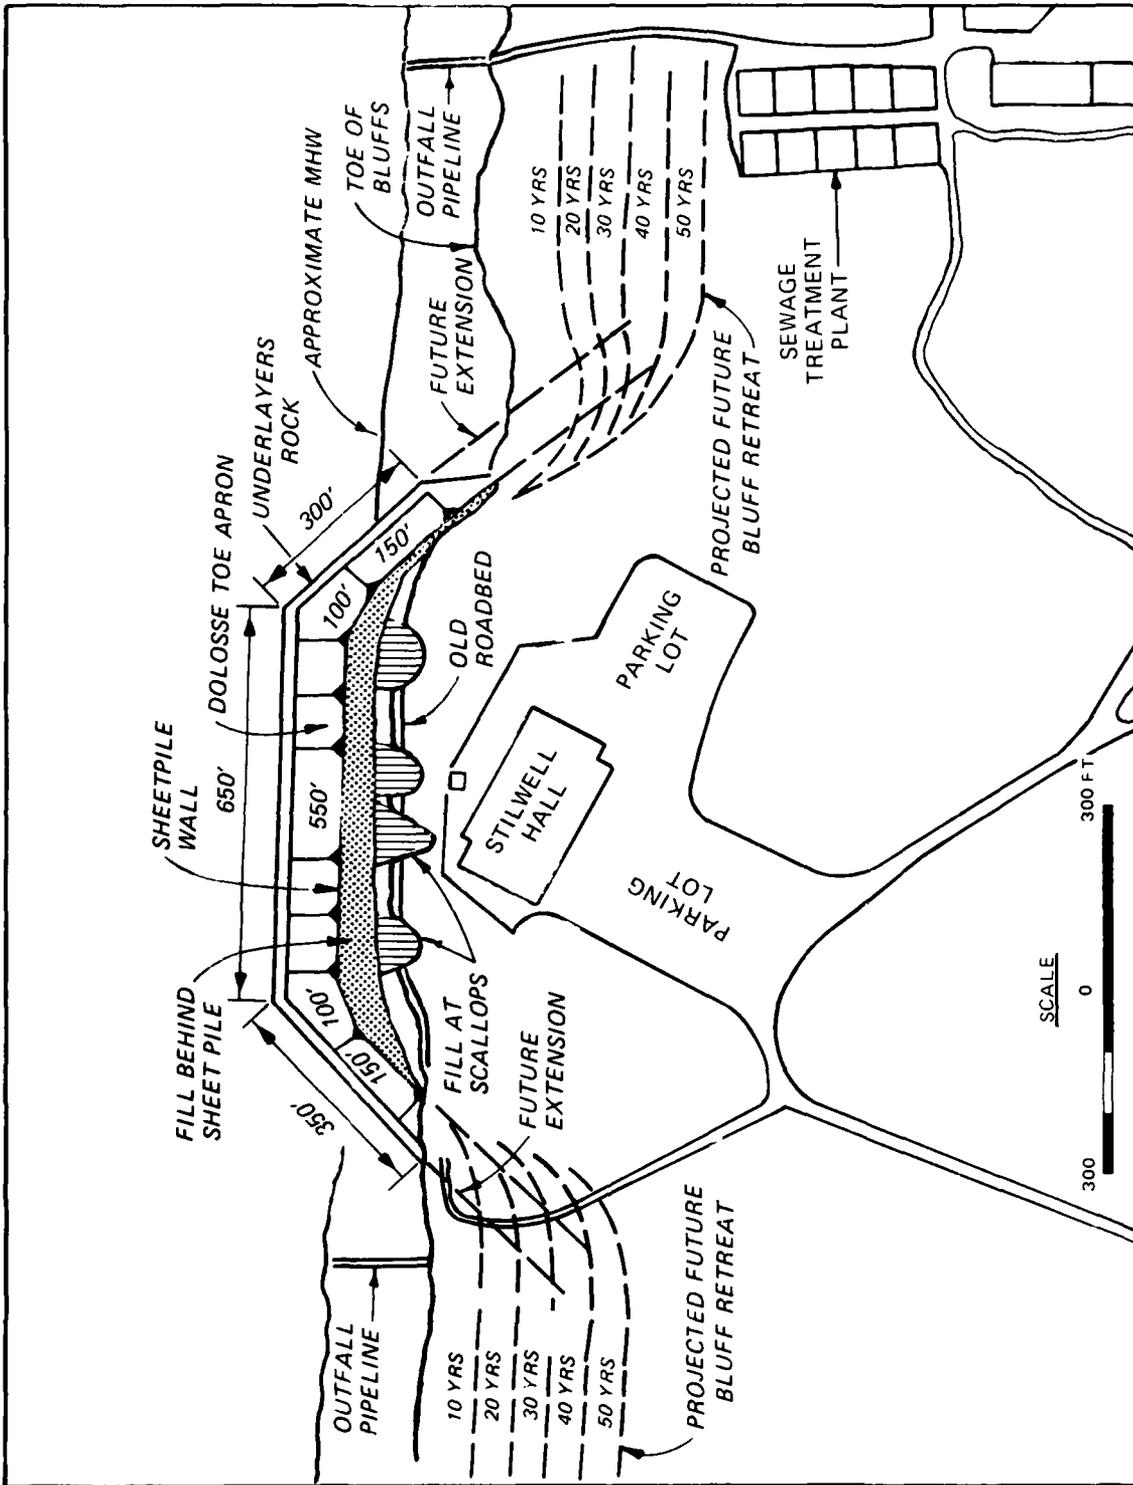
Figure 26. Plan view of proposed sheetpile bulkhead at Stilwell Hall, Fort Ord, California
