TECHNICAL REPORT SL-83-7

TESTS AND EVALUATION OF UPGRADED FLAT-PLATE AND WAFFLE-SLAB FLOOR SYSTEMS

Stanley C. Woodson, Mark K. McVay

U. S. Army Engineer Waterways Experiment Station
P. O. Box 631, Vicksburg, Miss. 39180

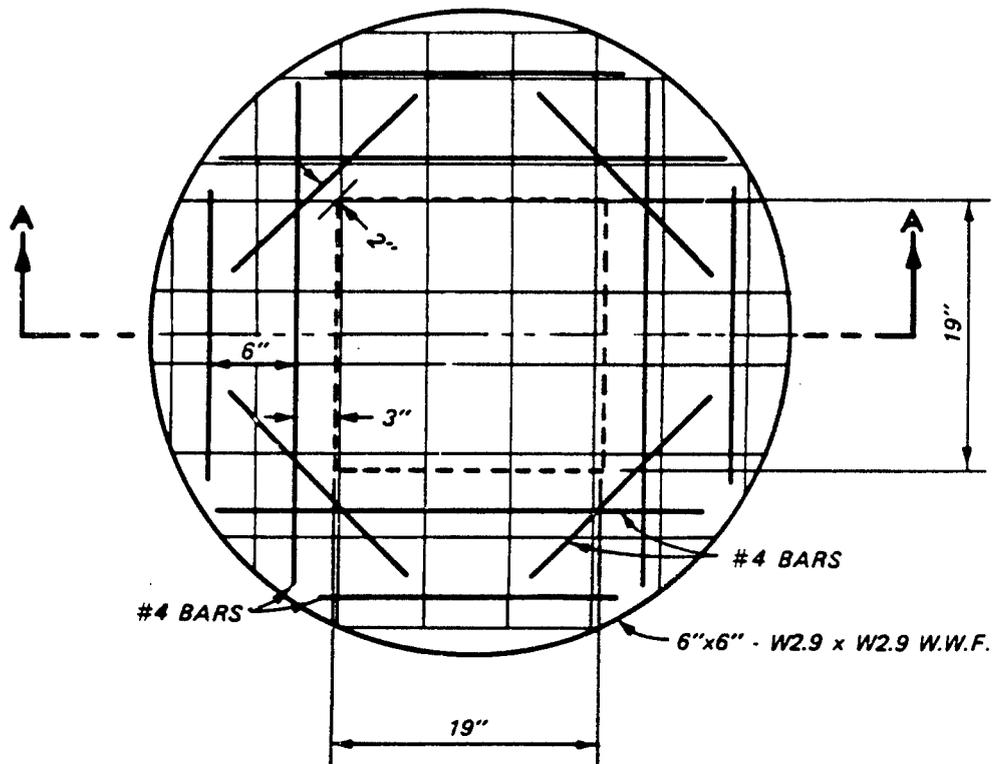
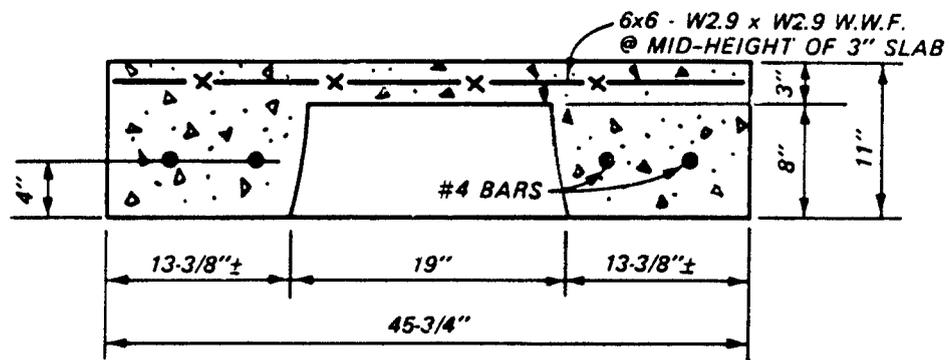
Figure 2.1 19- by 19- by 3-inch waffle-slab panel.

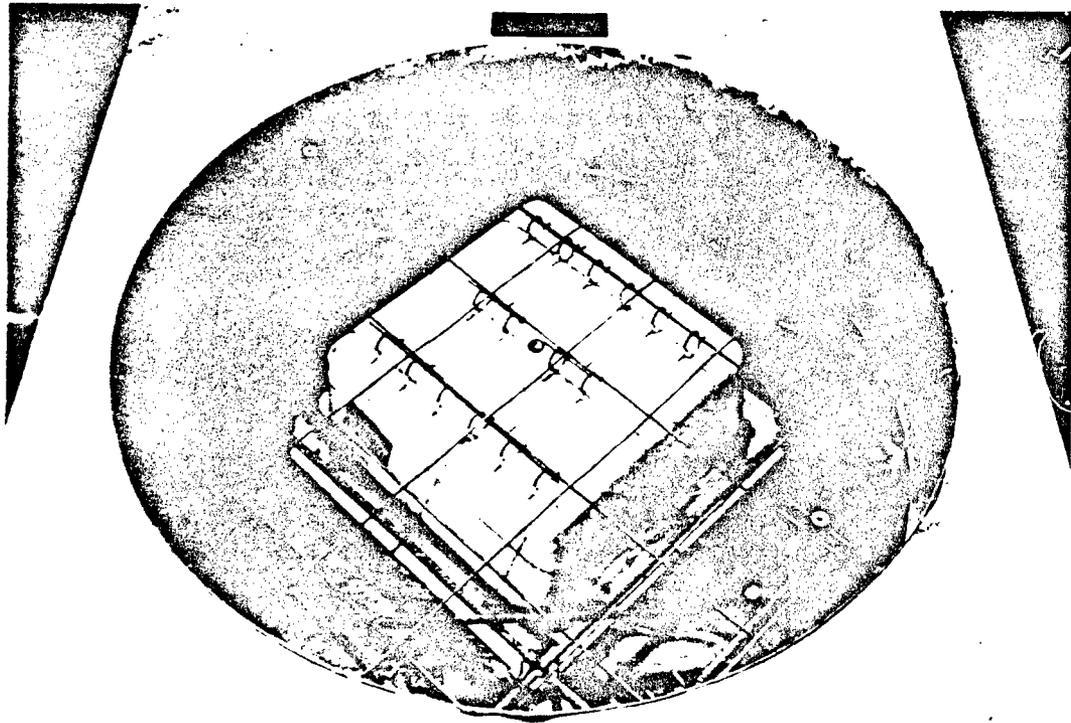
Figure 2.2 19- by 19- by 3-inch waffle-slab panel
formwork and reinforcing steel.

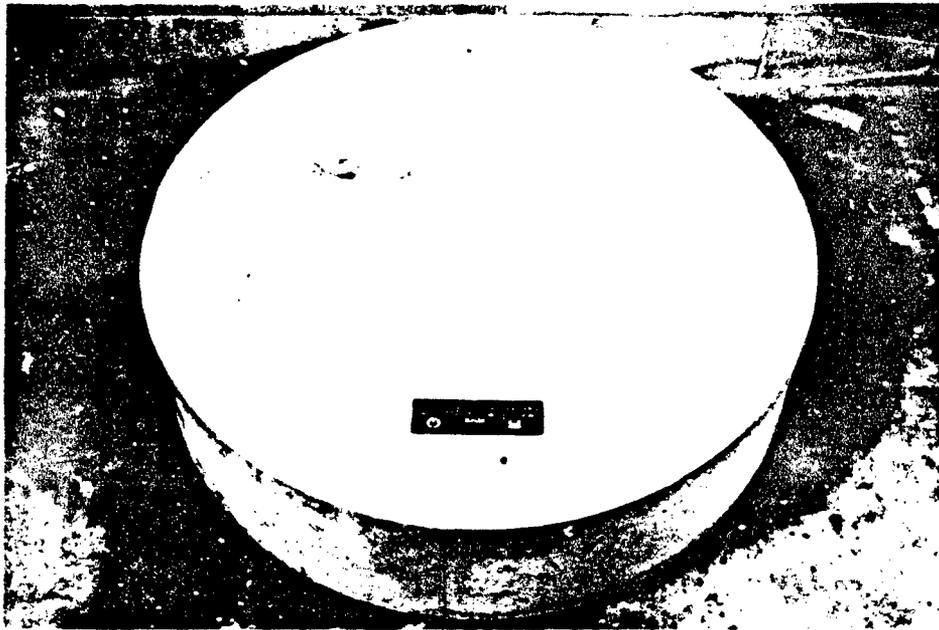
Figure 2.3 Completed 19- by 19- by 3-inch waffle-slab panel.

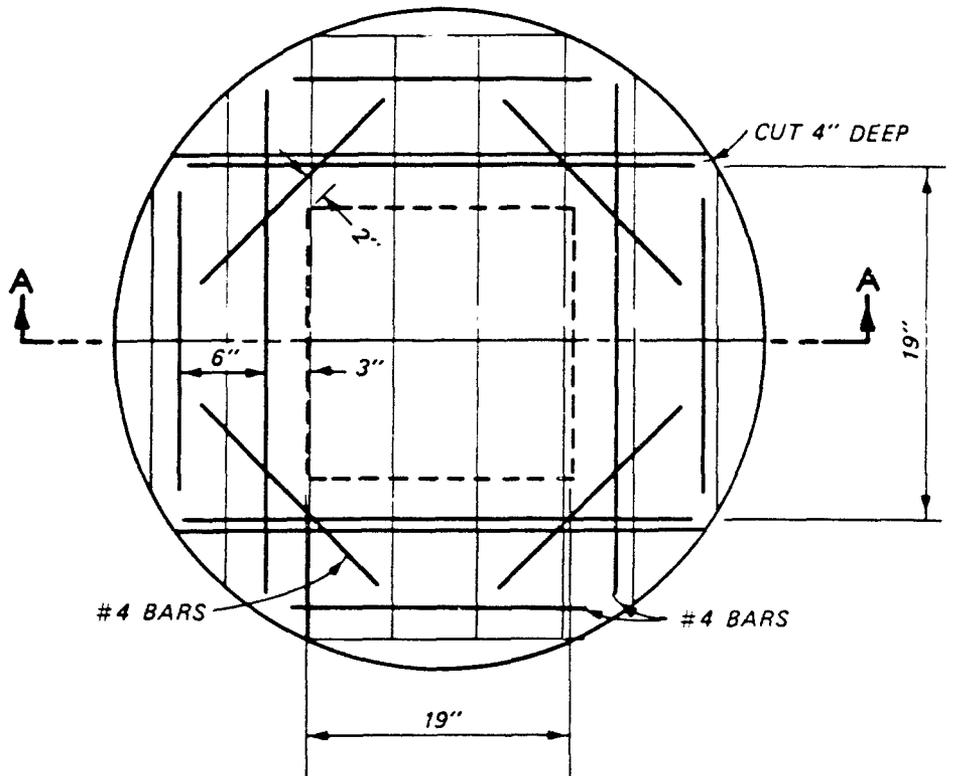
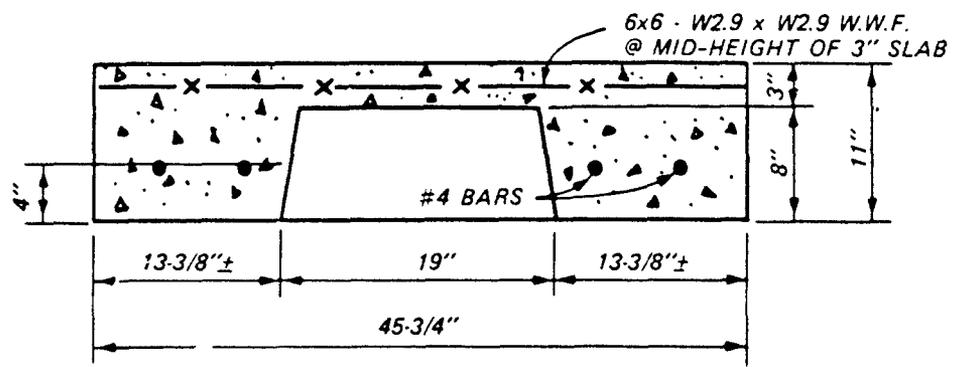
Figure 2.4 19- by 3-inch one-way slab.

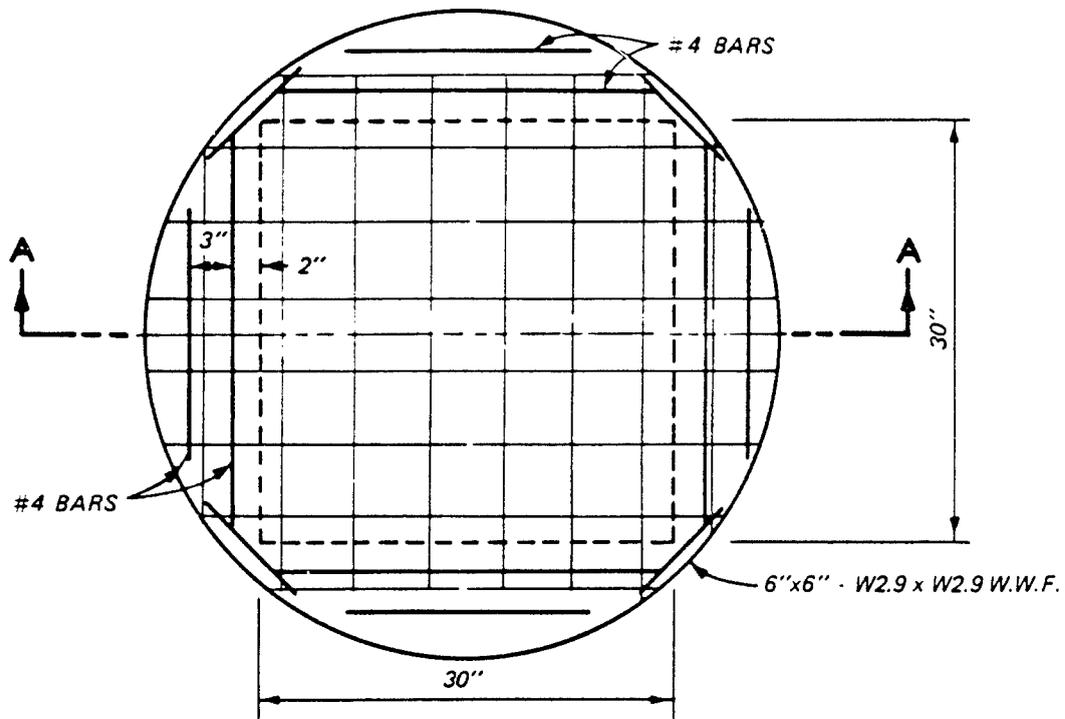
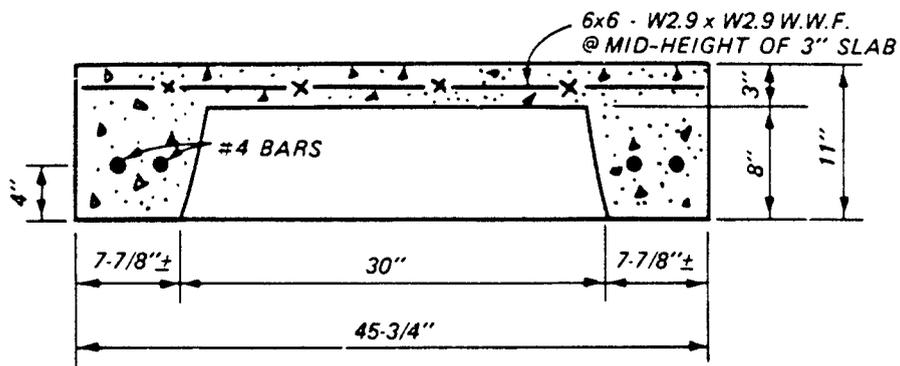
Figure 2.6 30- by 30- by 3-inch waffle-slab panel.

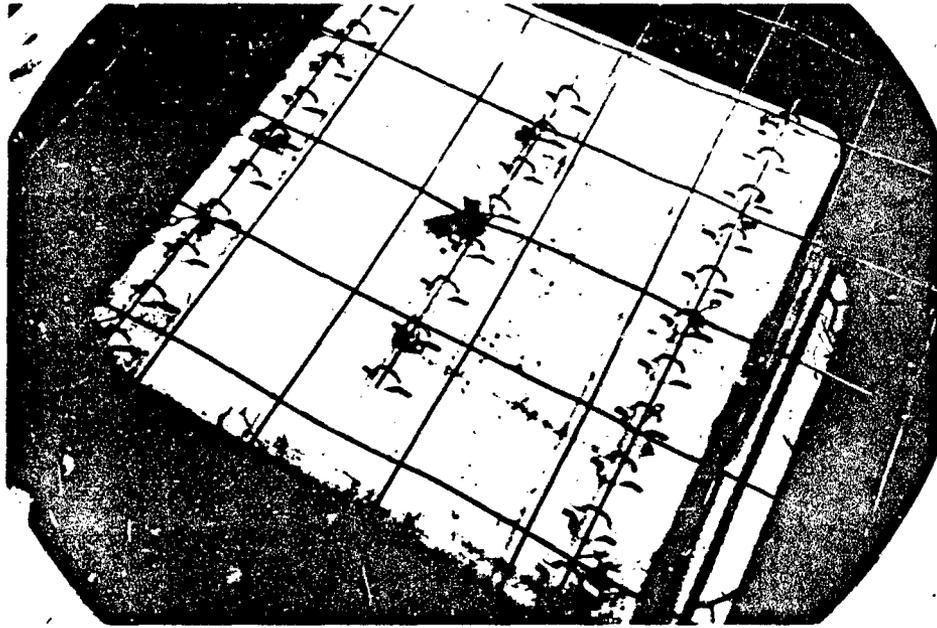
Figure 2.7 30- by 30- by 3-inch waffle-slab panel formwork and reinforcing steel.

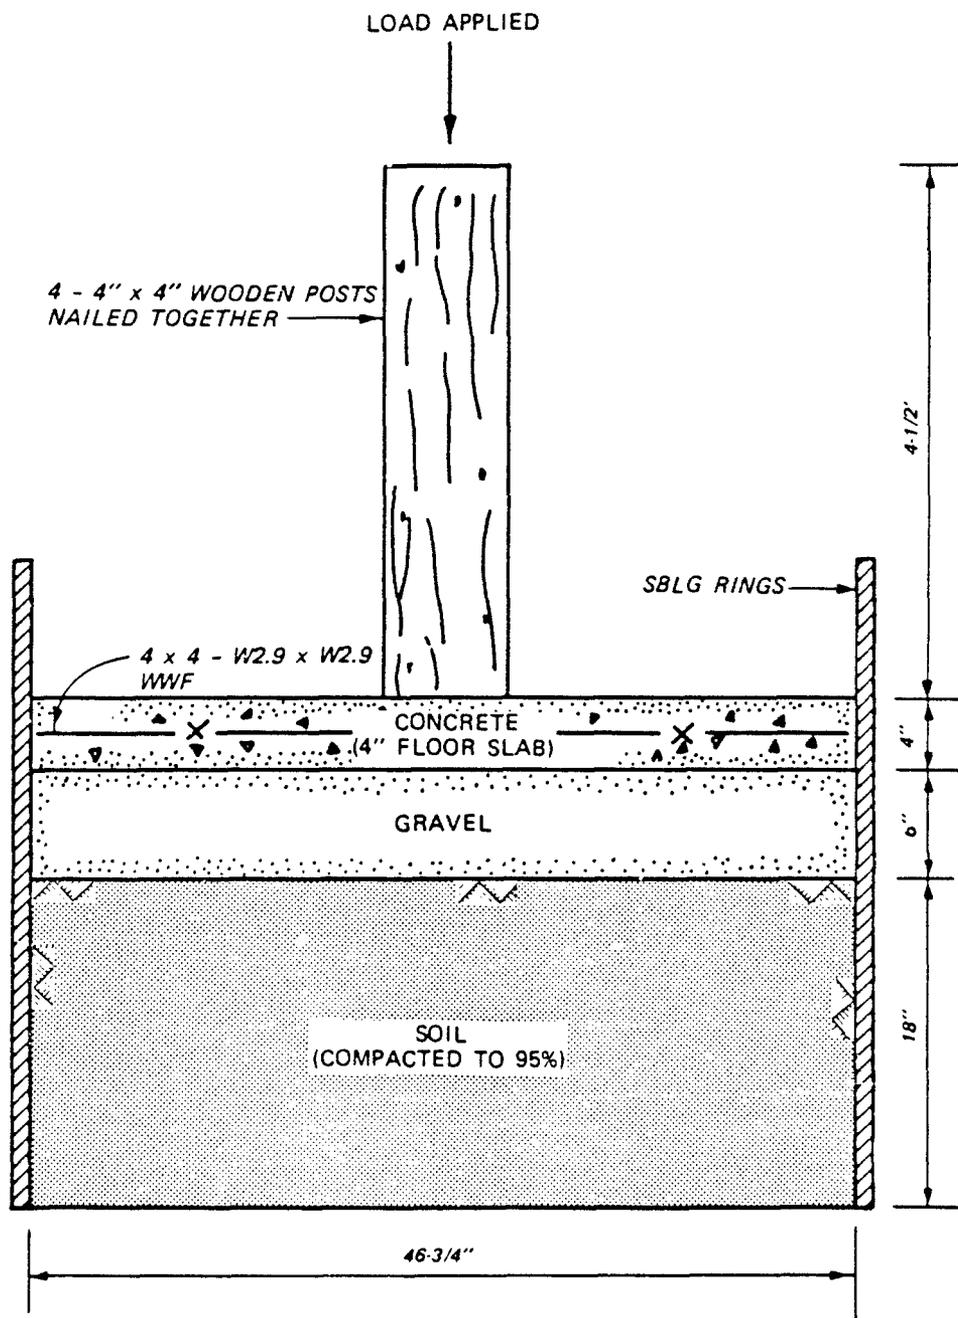
Figure 2.9 Punching strength of a 4-inch-thick slab on grade.

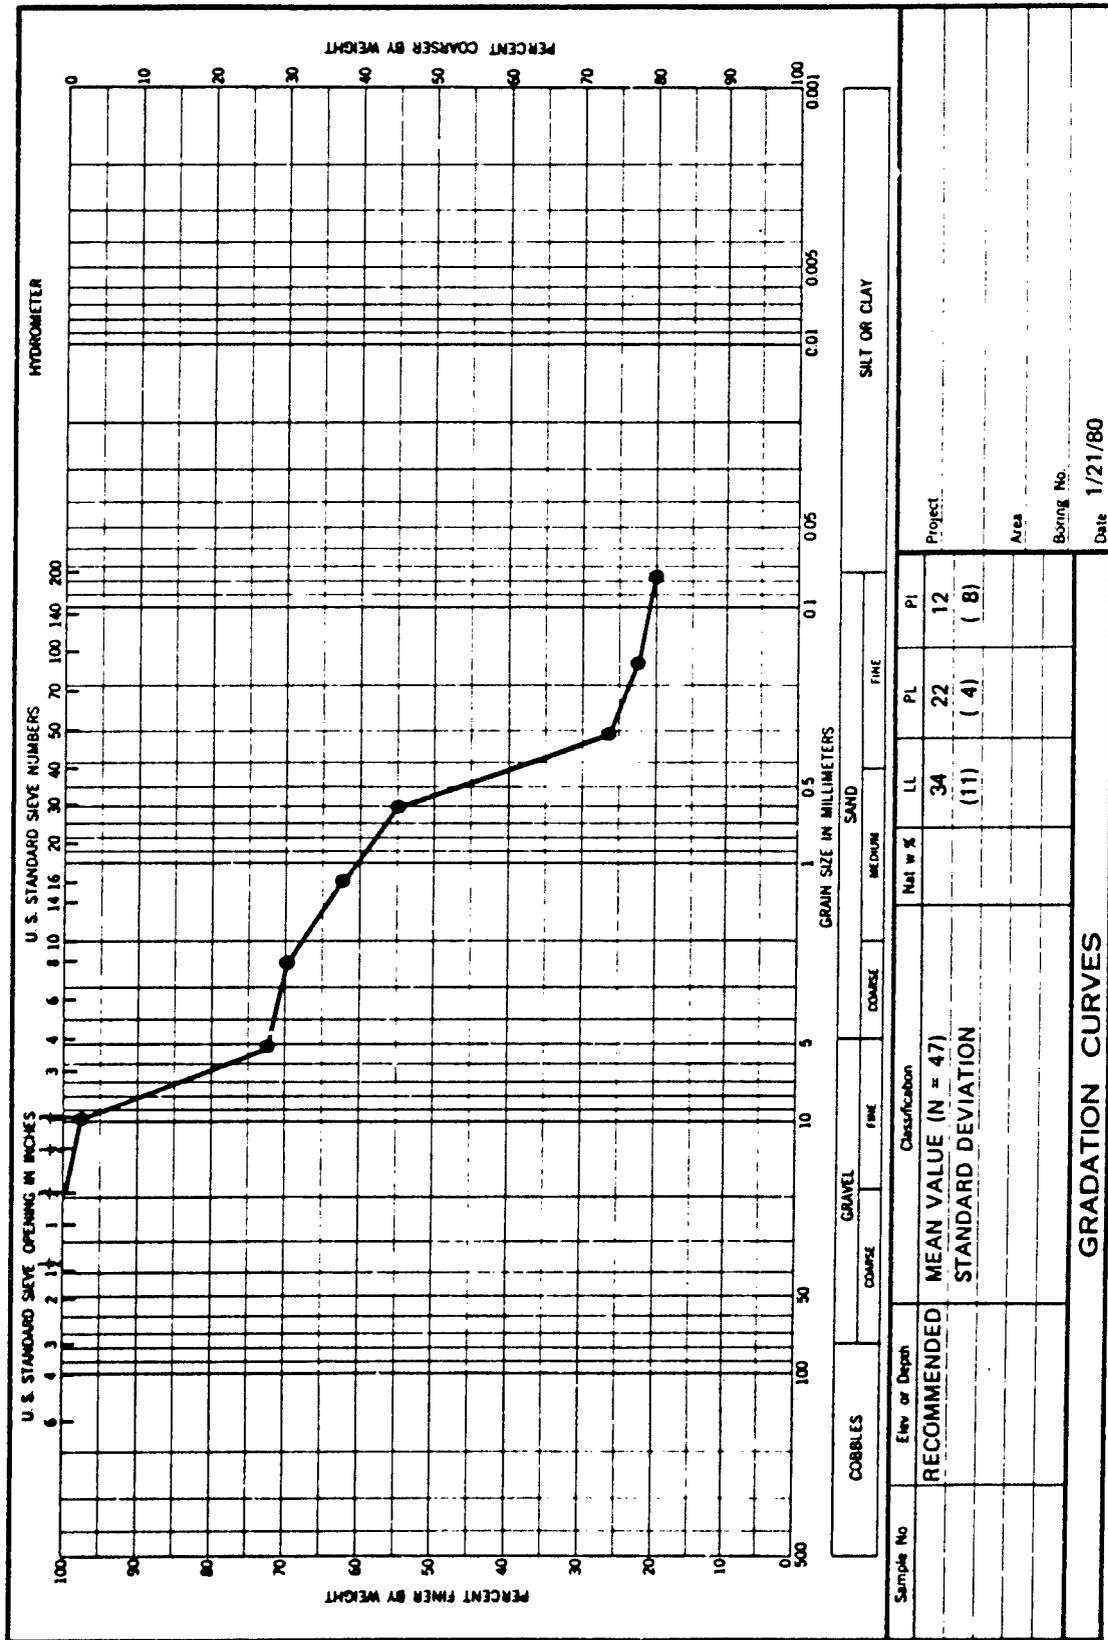
Figure 2.10 Gradation curve of soil used in test specimens.

A gradation curve and a compaction curve for the gravelly sand soil are shown in Figures 2.10 and 2.11, respectively. The soil was placed in 5-1/2-inch loose lifts and compacted to 4-1/2-inch lifts with four passes of a pneumatic tamper at 100 psi to achieve 95 percent maximum density. One dry density reading and one moisture content measurement were taken at the 9-inch compacted depth in both of the test specimens. The soil in both test specimens had identical dry densities and water contents of 129 lb/ft³ and 6.8 percent, respectively. Uniaxial strain tests were conducted on the soil and the results are shown in Figure 2.12. The gravel was washed river gravel,

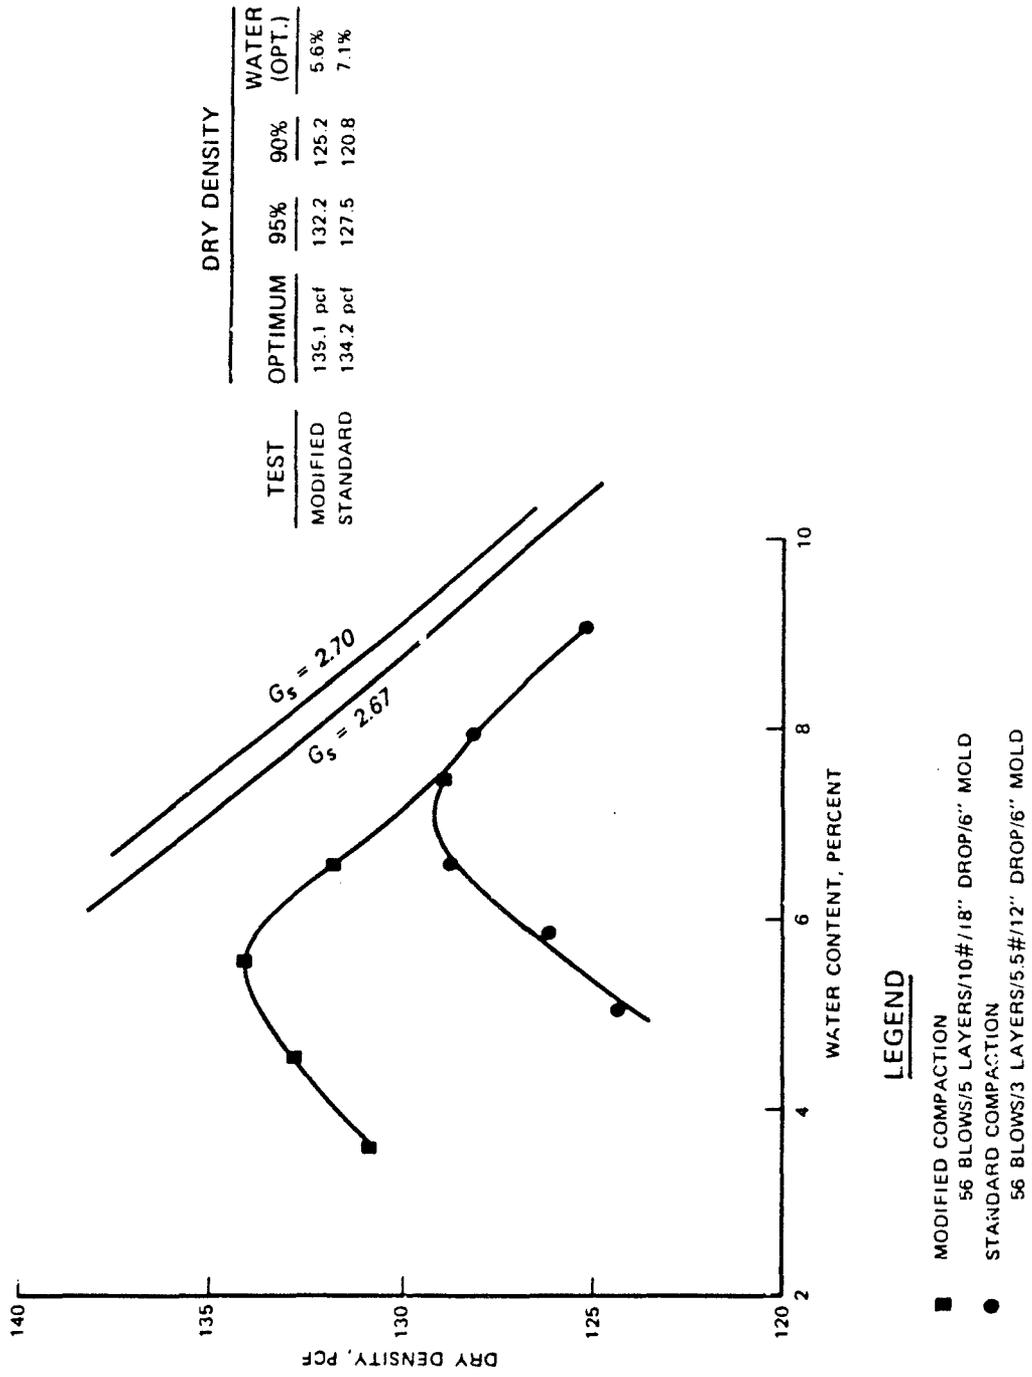
Figure 2.11 Compaction test results for soil in test specimens.

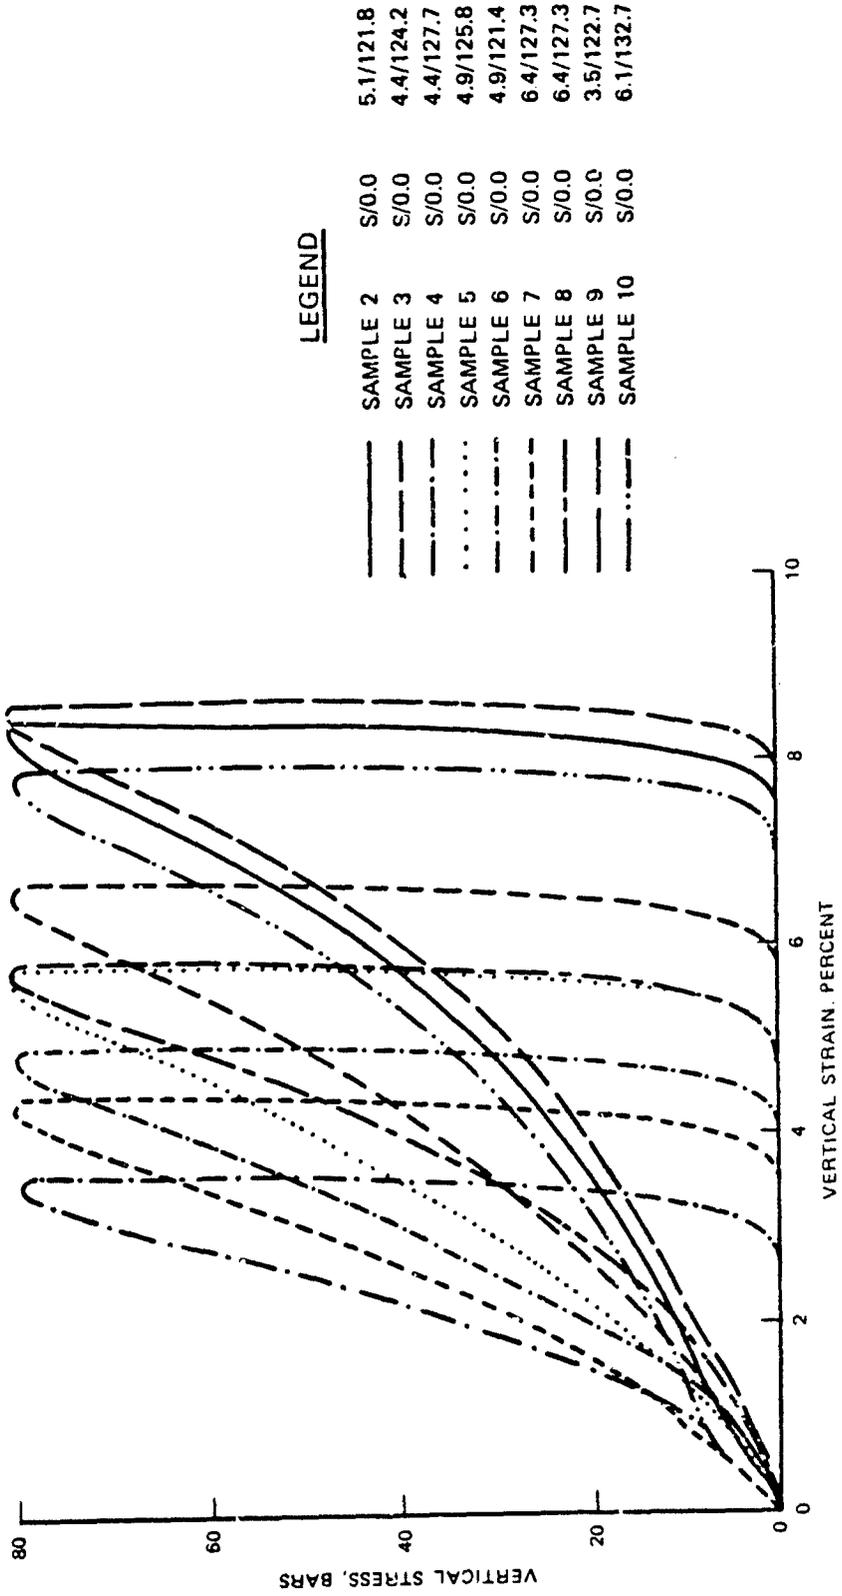
Figure 2.12 Uniaxial strain test results for soil in test specimens.

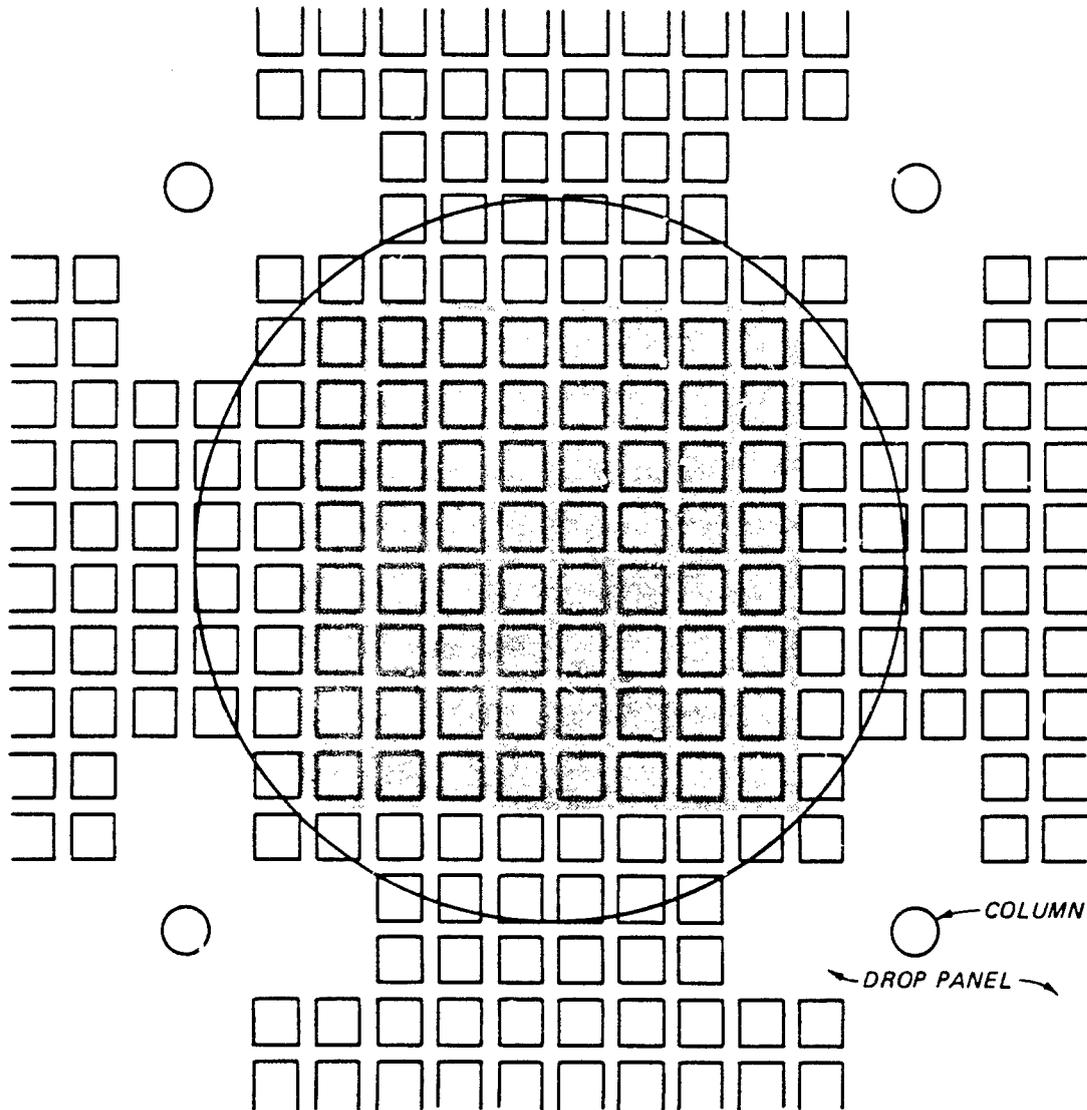
NOTE: TEST SPECIMEN REPRESENTED BY SHADED AREA.
 REMAINING AREA INSIDE CIRCLE TRANSFORMED
 TO RIGID SUPPORT.

Figure 2.16 Center portion of waffle slab.

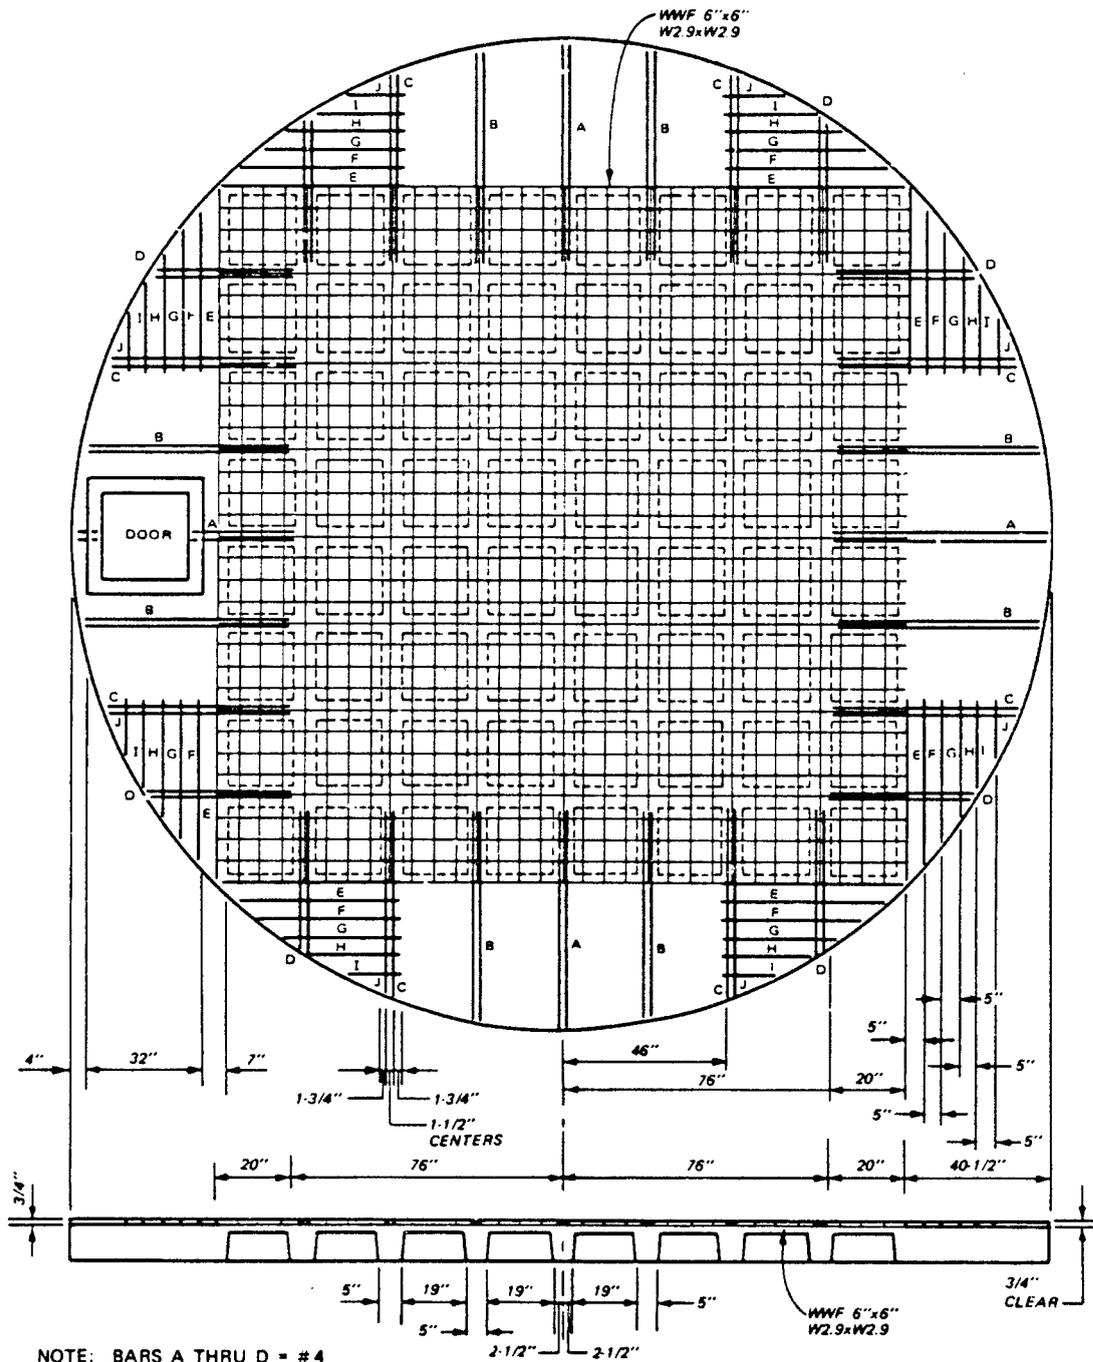
Figure 2.18 Waffle-slab top reinforcing steel.

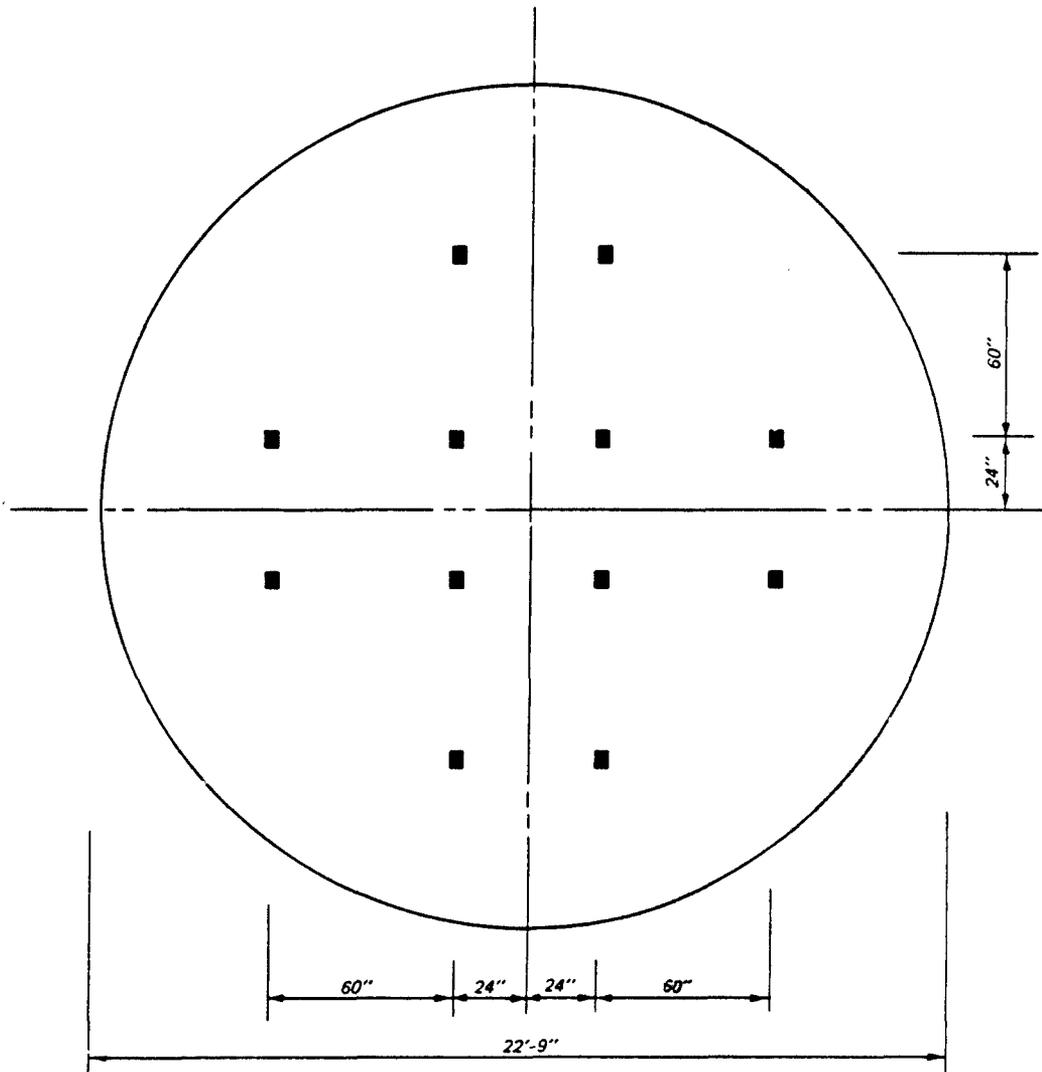
Figure 2.23 Center portion of a 22-foot-square flat plate.

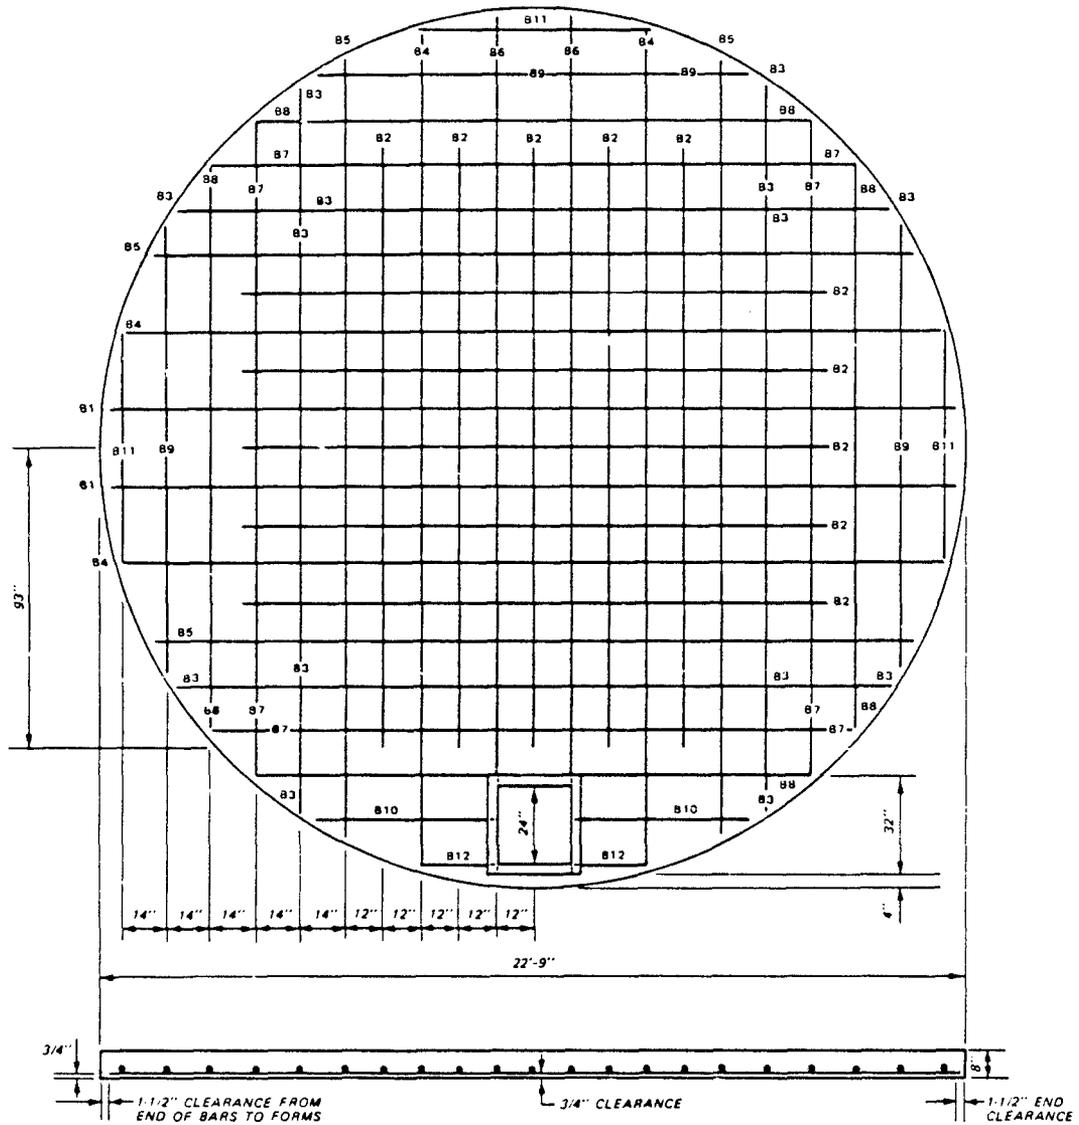
NOTE. B1,B2,B4,B5, & B6 = #4 BARS.
 B3,B7 THROUGH B12 = #5 BARS.
 USE 3/4" CHAIRS.

Figure 2.24 Flat-plate bottom reinforcing steel.

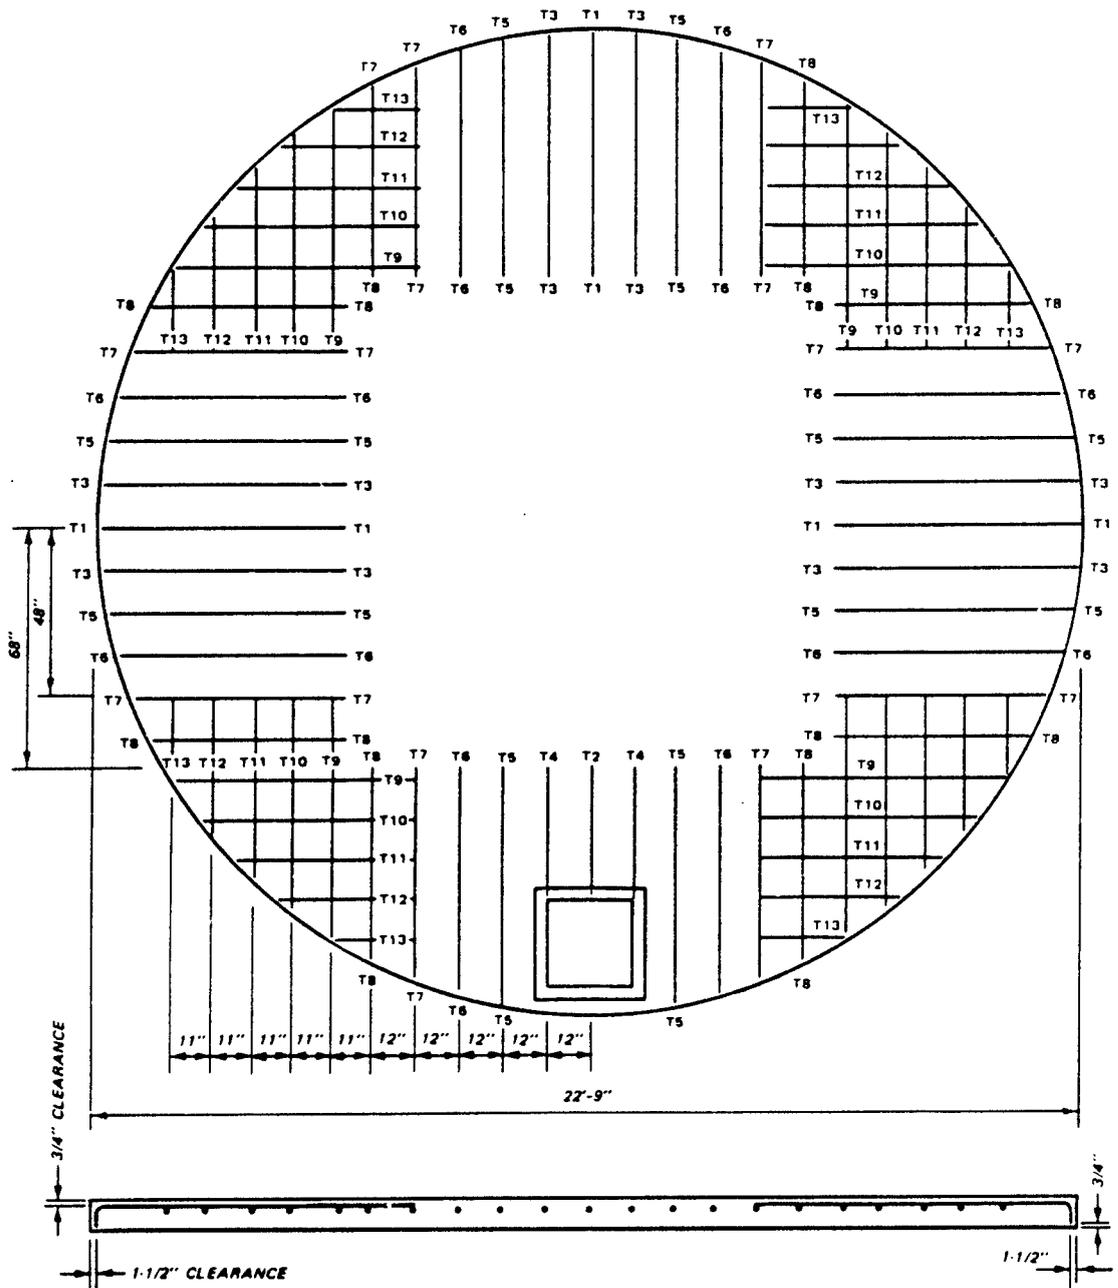
NOTE: T1 THRU T8 = #4 BARS.
 T9 THRU T13 = #7 BARS.

Figure 2.25 Flat-plate top reinforcing steel.

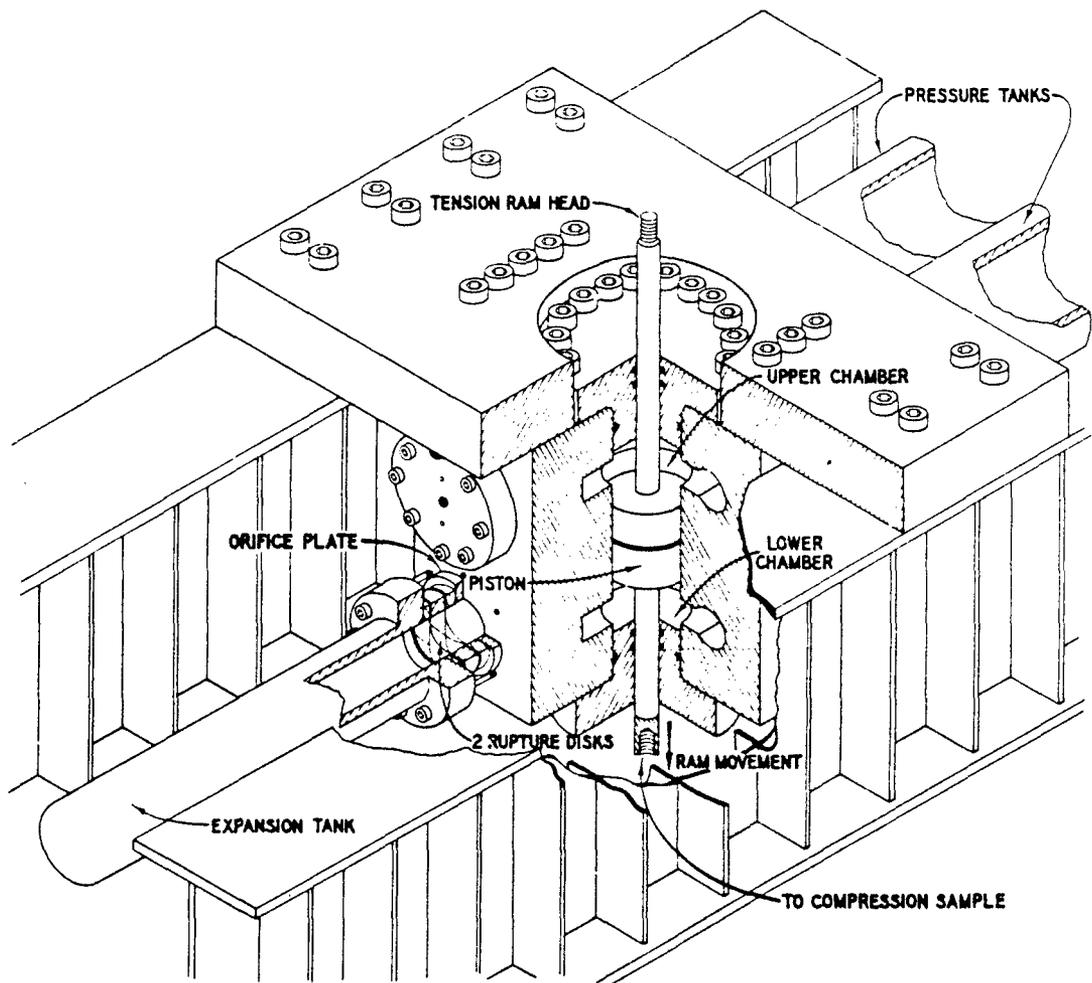
1. PEAK DYNAMIC LOAD: 200,000 LB IN LESS THAN 2 MSEC.
2. RISE TIME: 1 TO 200 MSEC.
3. HOLD TIME: 0 TO 200 MSEC.
4. DELAY TIME: 15 TO 500 MSEC.

1. DETERMINATION OF DYNAMIC STRESS-STRAIN PROPERTIES OF CONSTRUCTION MATERIALS.
2. DYNAMIC TEST OF STRUCTURAL ELEMENTS:
 - a. BEAMS UP TO 18 FEET IN LENGTH.
 - b. COLUMNS UP TO 8 FEET IN LENGTH.
 - c. TENSILE SPECIMENS UP TO 3 FEET IN LENGTH.
 - d. STRUCTURAL CONNECTIONS AND FRAMES.

Figure 2.28 200-kip loading device.

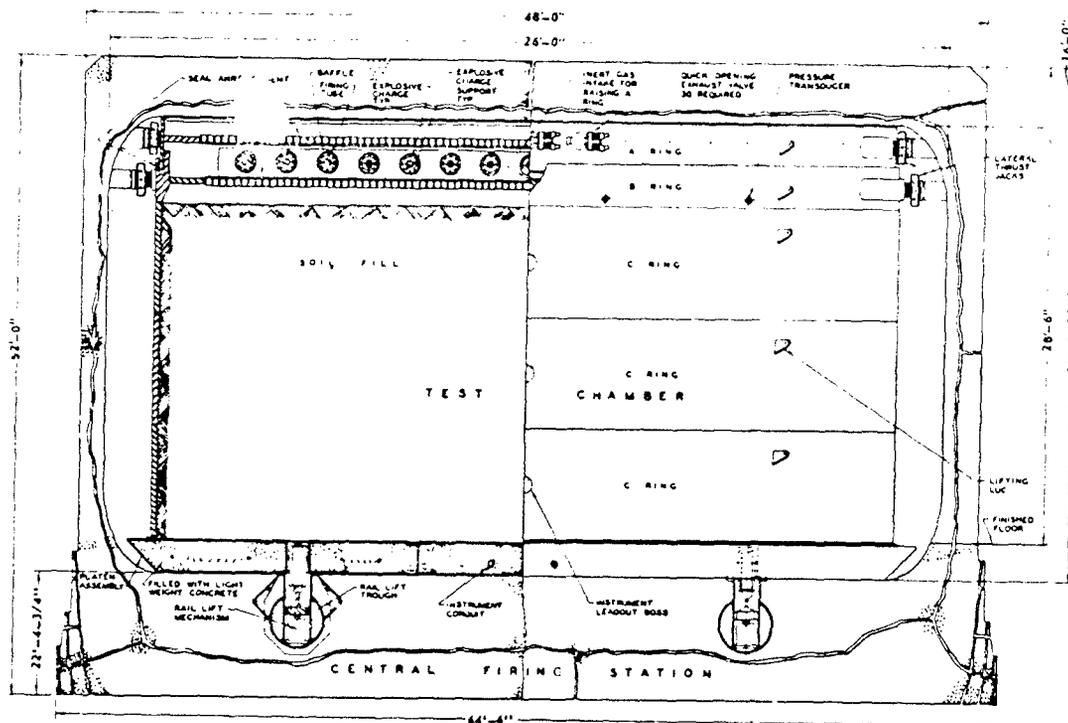
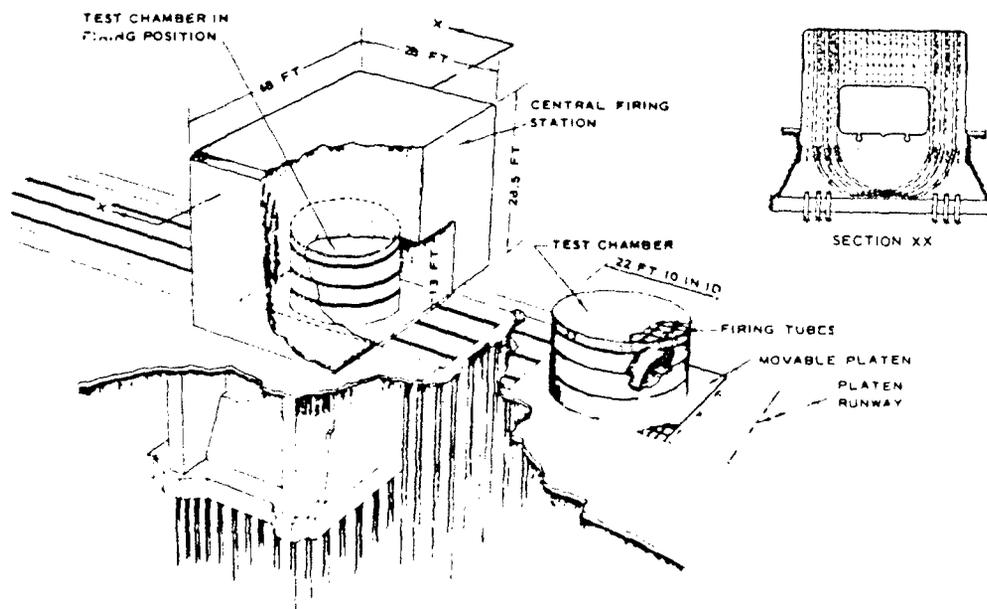
a. Half section of the LBLG.

b. Cutaway view of the LBLG.

Figure 2.29 Large blast load generator (LBLG).

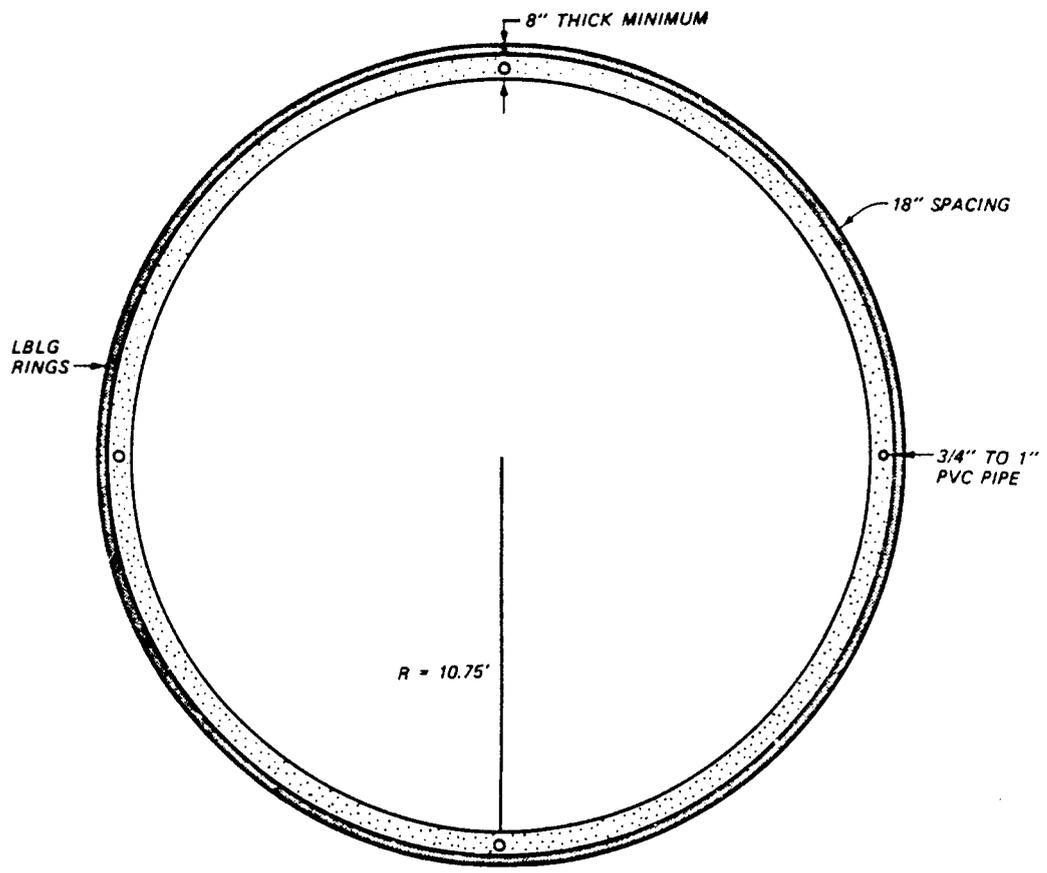
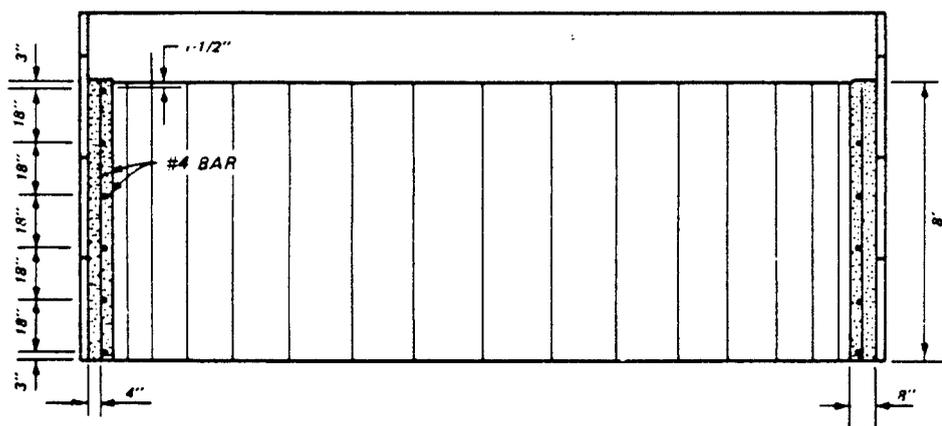
NOTE: 48-#4 BAR-94-1/2" LONG

Figure 2.35 Concrete support ring inside the LBLG.

center portion of the 22-foot-square flat plate were all tested in the LBLG. An 8-inch-thick concrete ring was cast along the inside of the LBLG rings to support the test specimens; see Figure 2.35. Several 1/4-inch-thick spacers were placed on top of the concrete support ring, preceding a test specimen being lowered upon it. Then the 1/4-inch crack between the specimen and the support ring was filled by allowing high-strength grout to flow downward between the side of the specimen and the LBLG ring, and laterally into the 1/4-inch space. The placement of grout was continued until the grout began to fill the space between the specimen and the LBLG ring. When the grout's surface was approximately 1 inch above the bottom edge of the 11-inch-thick slab, the grouting procedure was discontinued.
