TECHNICAL REPORT SL-83-7

TESTS AND EVALUATION OF UPGRADED FLAT-PLATE AND WAFFLE-SLAB FLOOR SYSTEMS

Stanley C. Woodson, Mark K. McVay

U. S. Army Engineer Waterways Experiment Station
P. O. Box 631, Vicksburg, Miss. 39180

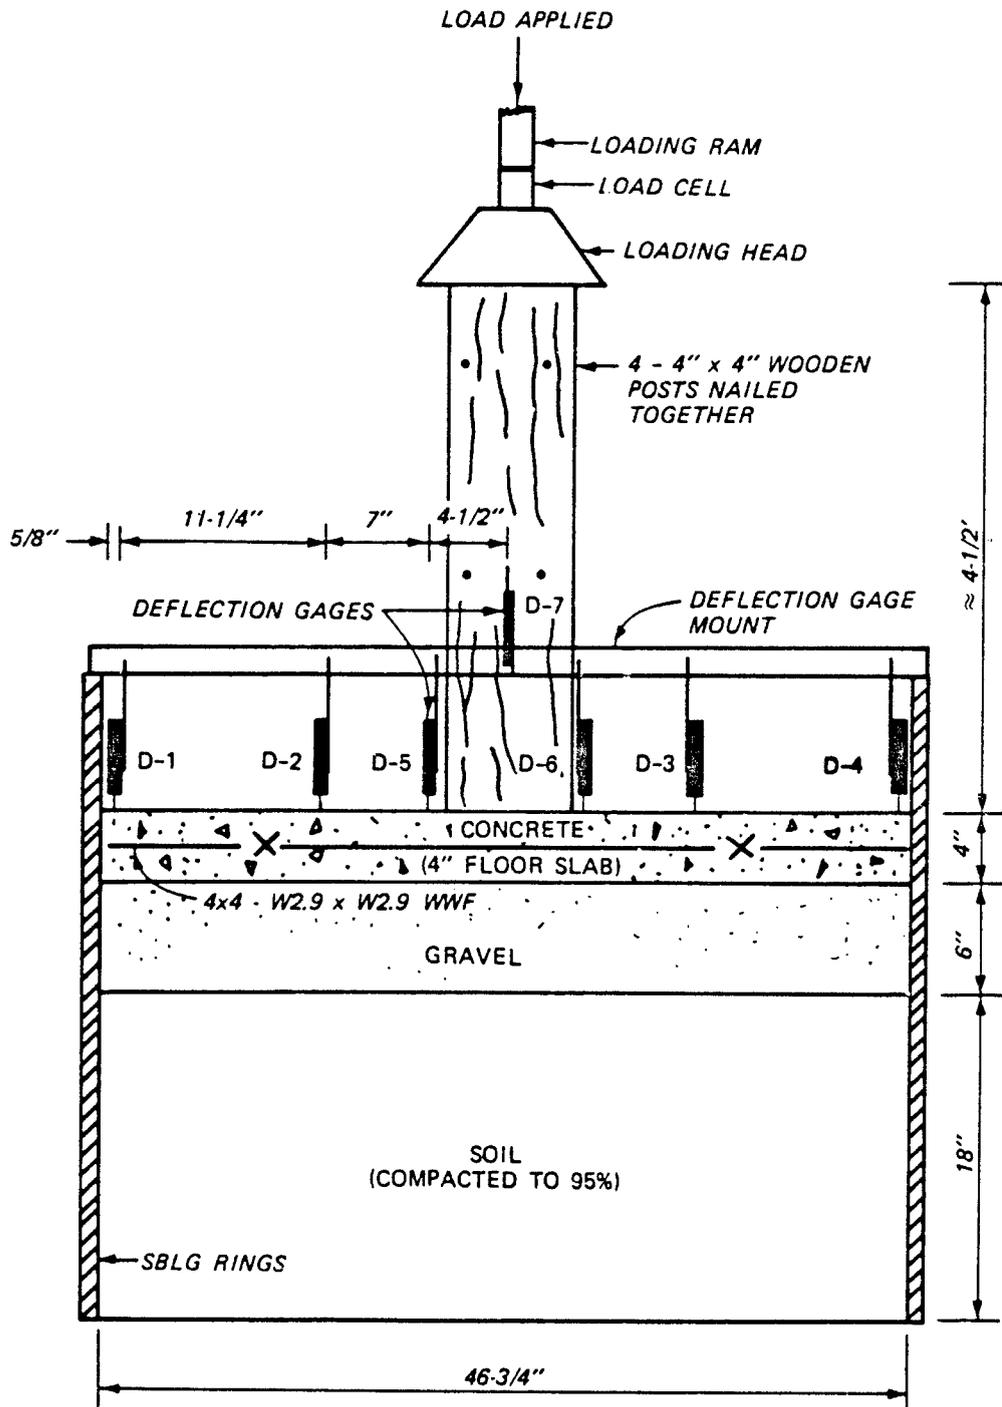
Figure 2.38 Instrumentation of slabs on grade.

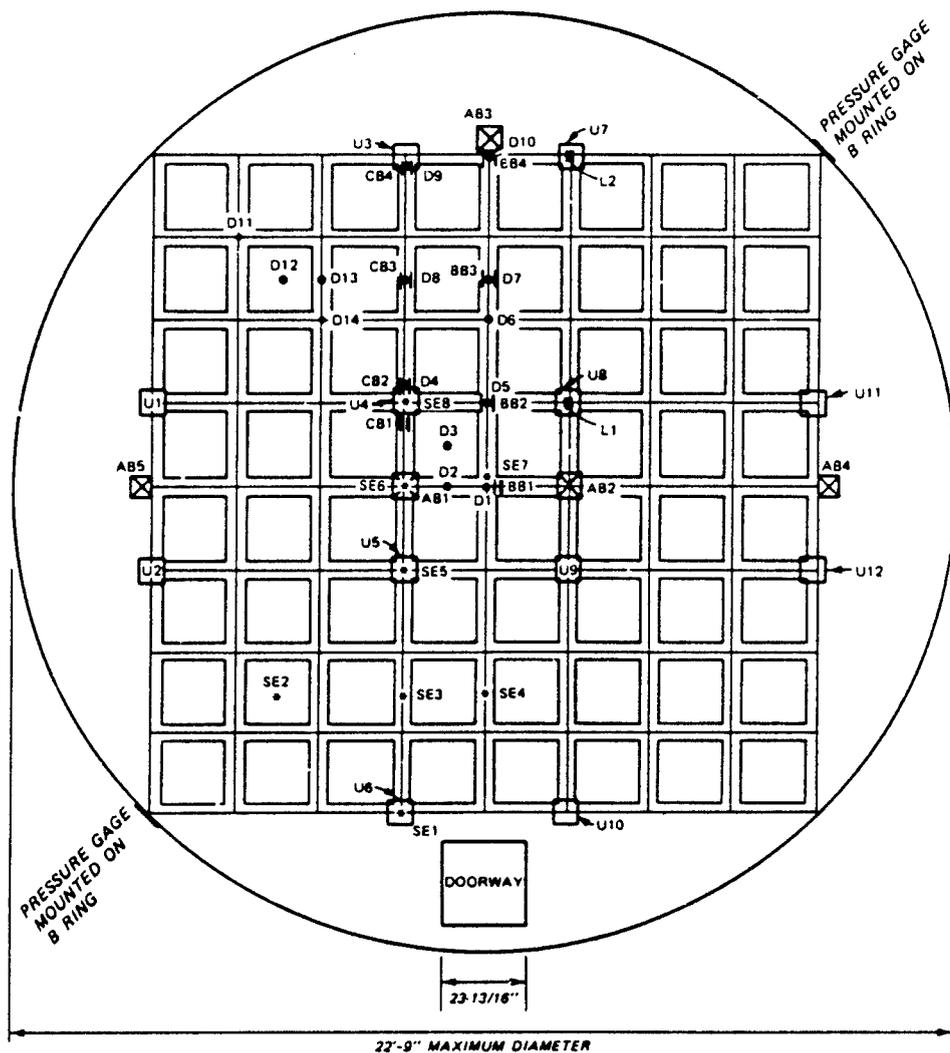
- ⊗ AIRBLAST (DYNAMIC TEST ONLY)
- DEFLECTION GAGE
- LOAD CELL
- SOIL STRESS GAGE
- || STRAIN GAGE PAIR
- UPGRADING POST

Figure 2.39 Instrumentation of center portion of a waffle slab.

Figure 2.39 shows the instrumentation layout for the waffle-slab specimens. As noted in Figure 2.39, the instrumentation of the dynamically tested slab differed from that of the statically tested slab by requiring five airblast gages to measure airblast pressures applied to the structure; otherwise, the two slabs were instrumented identically with various types of transducers strategically located on and within the specimen. Excluding the airblast gages, a total of 42 transducers were used per specimen.

The dynamic loading produced minor structural damage to the upgraded slab system. Upgrading post U9 fell to the floor of the test chamber (refer to Figure 2.39). The applied load caused the upgrading post to compress the wooden wedges beneath the post, resulting in the loss of surface contact between the upgrading post and the waffle slab. Upgrading post U5 experienced some surface contact loss with the waffle slab, resulting in a tilt of the post before contact was regained. Figure 3.13 shows upgrading post U9 on the test chamber's floor with post U5 in the background.

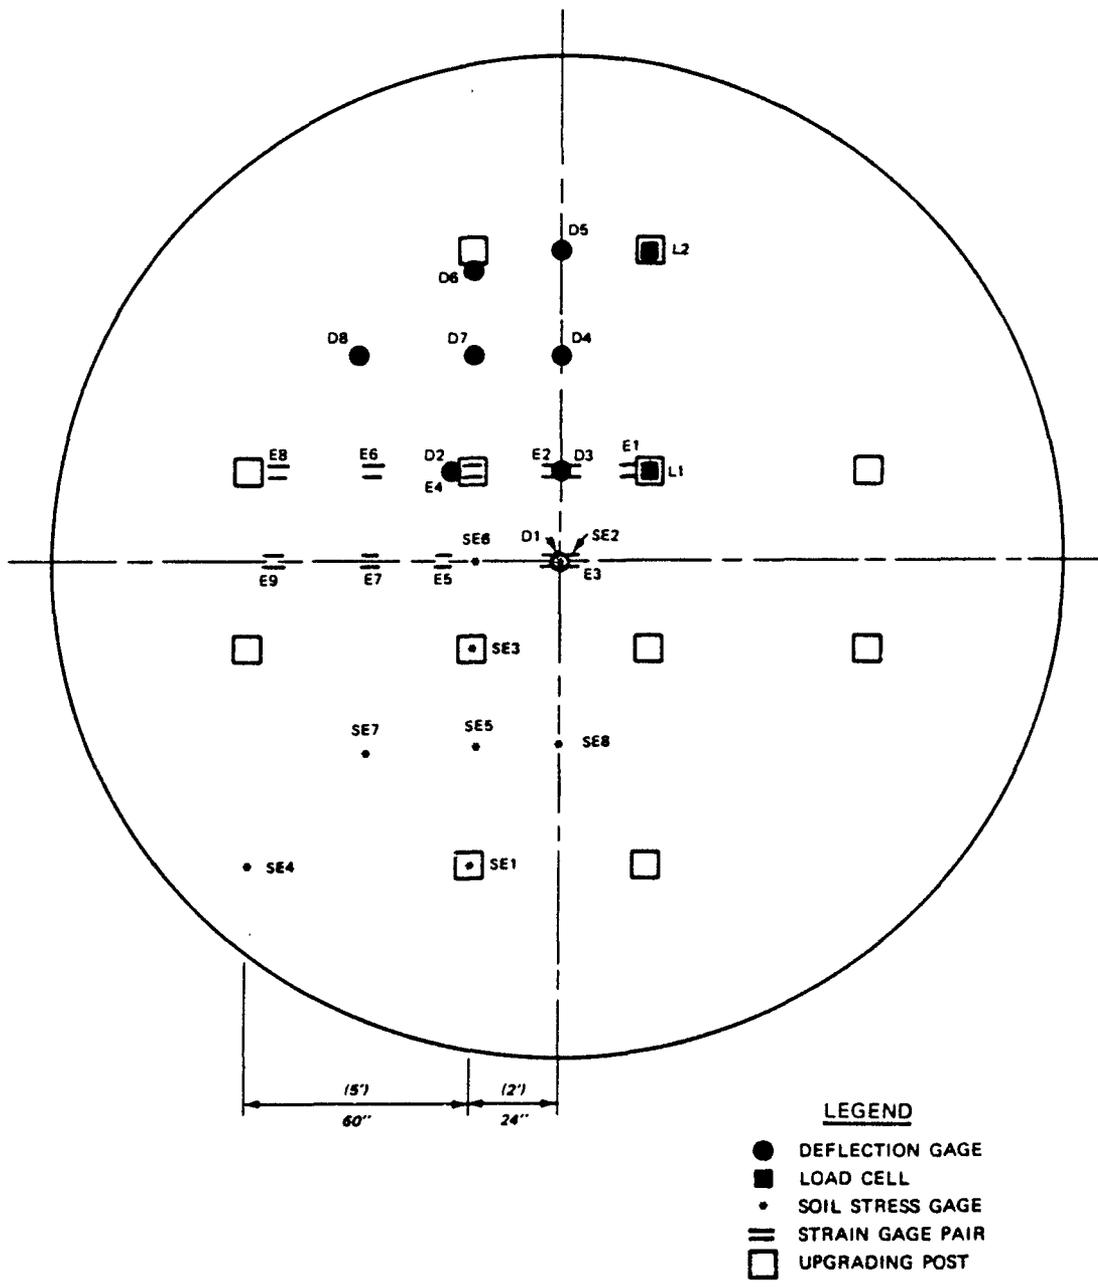
Figure 2.41 Instrumentation of center portion of a flat plate.

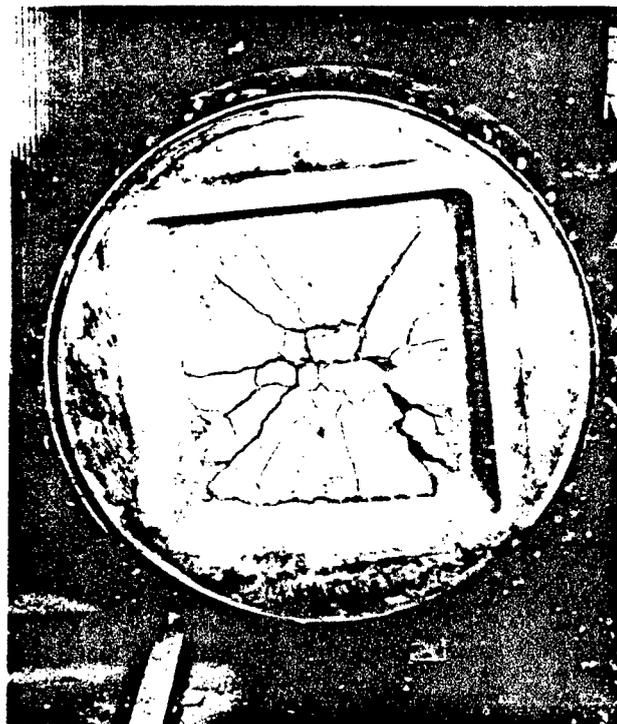
Figure 3.4 Posttest bottomside view of 30- by 30- by 3-inch waffle-slab panel.

The applied pressure supported by the specimen was continually increased until it approached an approximate value of 347 psi. A sudden decrease in the applied pressure then occurred. Figure 3.4 is a posttest view of the panel showing the ruptured area with initiation of a 45-degree shear plane angle along the panel's inside perimeter.

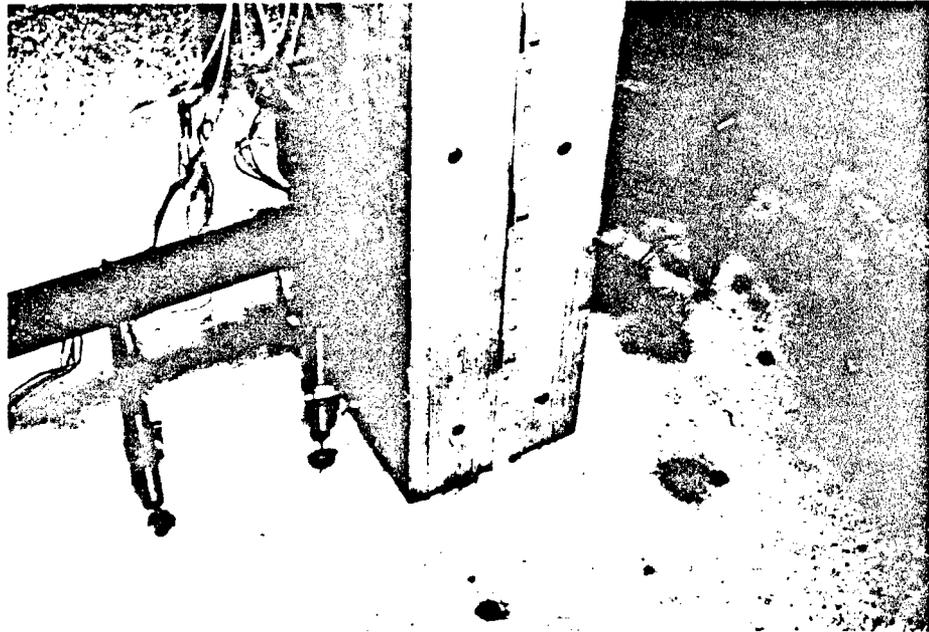
Figure 3.5 Wooden column punched into 4-inch-thick slab on grade due to static loading.

A peak dynamic load of approximately 135 kips was transferred to the slab on grade by the 7- by 7-inch wooden post. This load caused the wooden post to punch into the slab and induce shearing of a conical section beneath the post in a manner similar to the punching of the statically tested slab on grade. However, the vast difference in loading rates for the two slabs creates a need for further discussion.

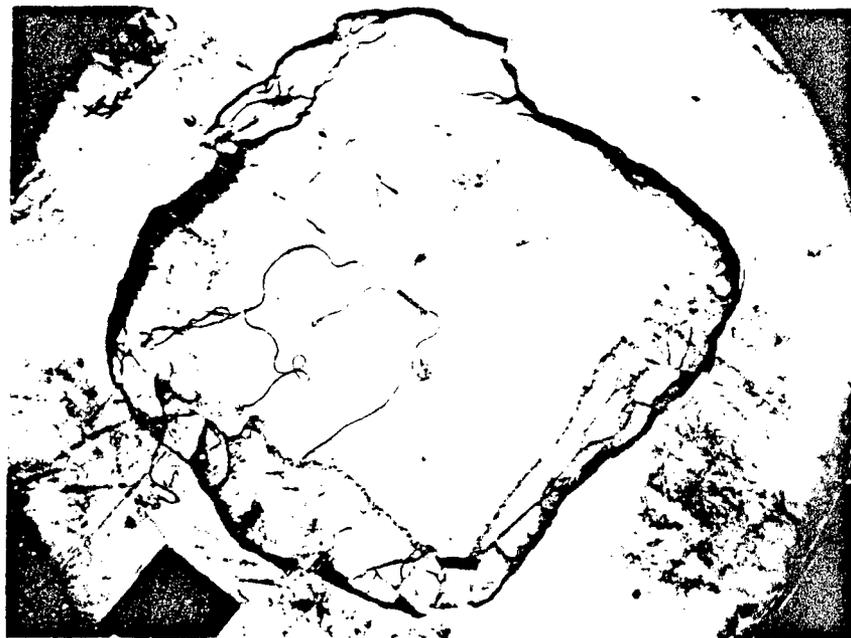
Figure 3.8 Statically tested waffle slab in test chamber.

The slab model as it appeared after removal of the sealing membrane and sand cover is shown in Figure 3.8. The shearing of the slab along the waffled boundary was responsible for most of the model slab's displacement as shown in Figure 3.9. The sheared slab did not collapse to the test chamber's floor due to the immediate relief from loading pressure when the sealing membrane ruptured. Therefore, the model slab remained supported only by reinforcement steel along the waffle boundary as shown in Figure 3.10. Figure 3.11 shows the model's buckled composite wooden upgrading posts on the test chamber's floor, unable to help support the posttest slab.

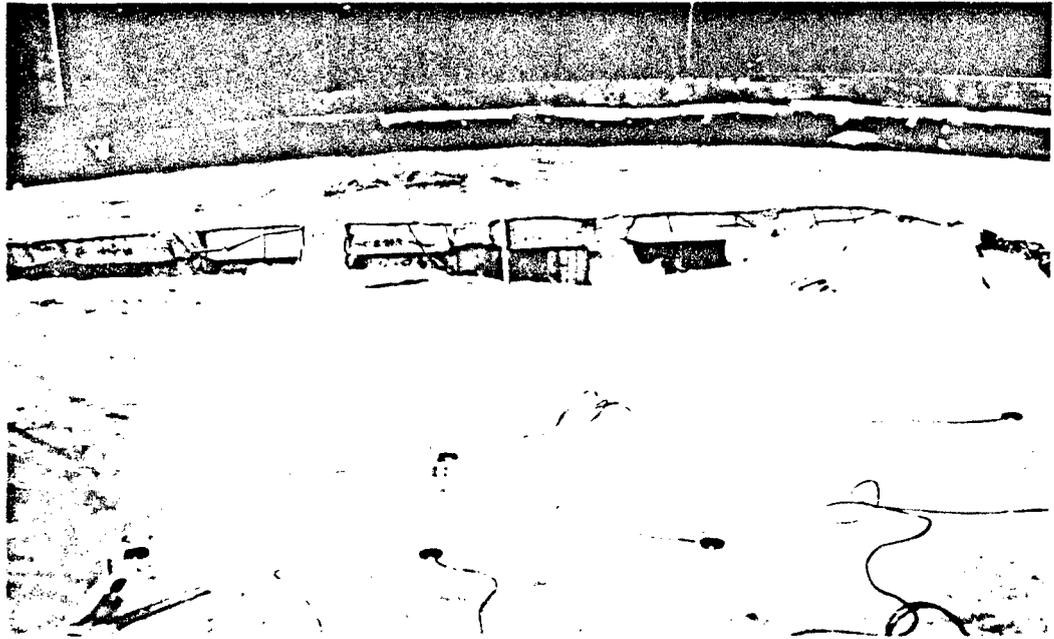
Figure 3.9 Sheared waffle boundary of statically tested waffle-slab center portion.

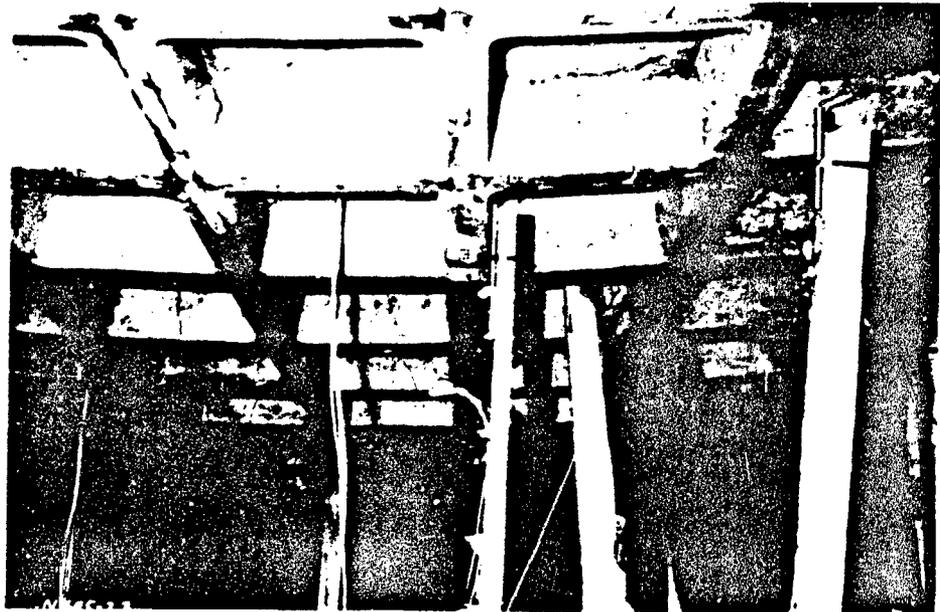
Figure 3.12 Posttest bottomside view of statically tested waffle slab.

Apparent flexural deflection and flexural cracks of the waffle slab are visible in Figure 3.12.

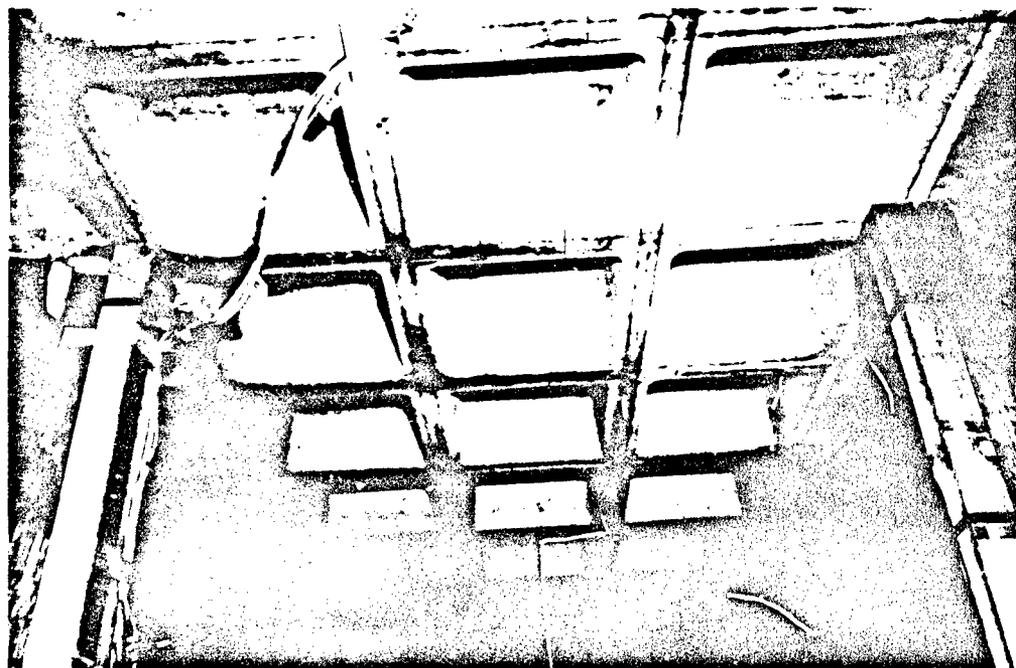
Figure 3.14 Hairline cracks of first dynamic waffle-slab test.

Noticeable hairline cracks in the slab were located in one region of the specimen. The cracks formed along one row of the waffle-slab's panels during the test as shown in Figure 3.14. The waffle-slab edge parallel to the row of cracked panels, as shown in Figure 3.14, is located next to the specimen's entryway hatch. In reference to Figure 2.37, the waffle-slab's southwest corner panel also experienced cracking as shown in Figure 3.15. The described cracks were darkened with a black marker to make them more visible in their respective photographs.

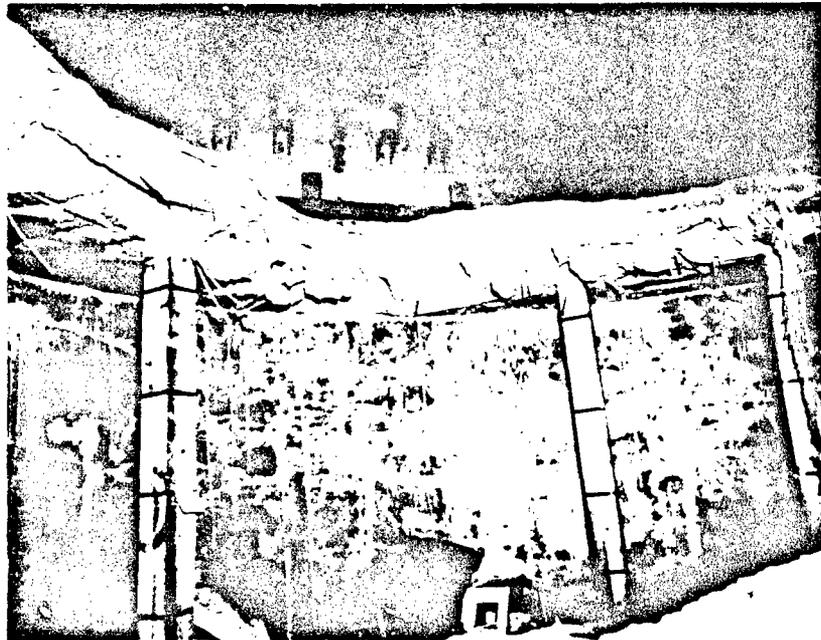
Figure 3.18 Sheared waffle slab after second dynamic test.

The waffle slab sheared along its perimeter at an approximate angle of 45 degrees as shown in the slab corner view in Figure 3.18. Some of the wooden upgrading columns located along the slab's waffle perimeter remained in position after the test, although spalling occurred on surrounding concrete.
