SSI 8306-5

INDUSTRIAL HARDENING AND POPULATION BLAST SHELTER TESTS AT THE DIRECT COURSE EVENT

FINAL REPORT

FEDERAL EMERGENCY MANAGEMENT AGENCY
WASHINGTON, D.C. 20472

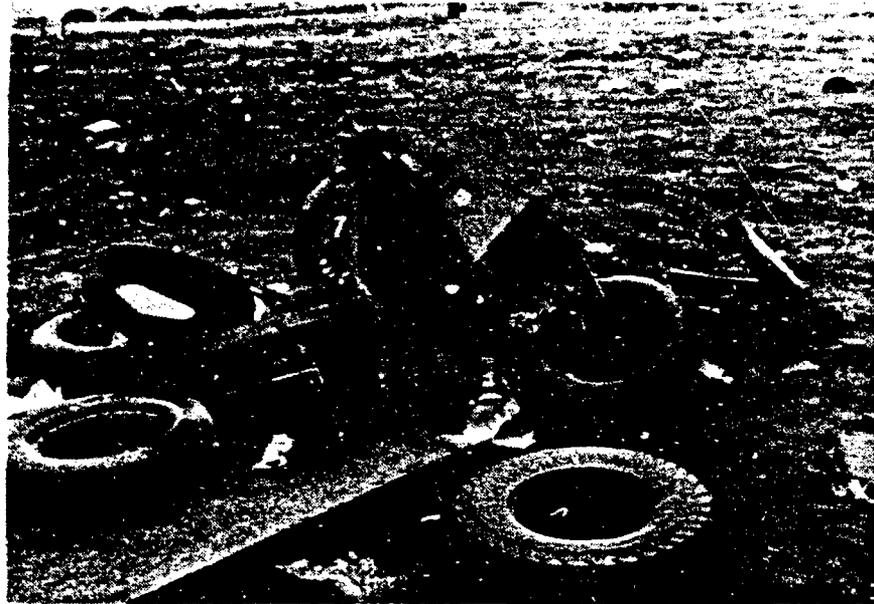
Fig. 2-4. Posttest Photographs of Experiment 4100-A.

It had been estimated that this cluster, with a horizontal dynamic pressure impulse of $I_q = 0.3$ psi-s, would translate approximately 3 ft, and not overturn, if the array maintained its integrity.* The displacement observed was 6 ft (corresponding to an $I_q = 0.42$), and the array came apart to the extent that the first row of equipment was lifted over the second row (compare Figure 2-3 with Figure 2-2) when the banding ceased to hold the array together because the light sheet metal portion of the equipment deformed. Posttest examination of the equipment indicated that, although the legs of the bandsaws were damaged beyond repair, many of the saws themselves were still operable. The posttest condition of each of the items is listed below along with the actual repair time to put them into running condition.

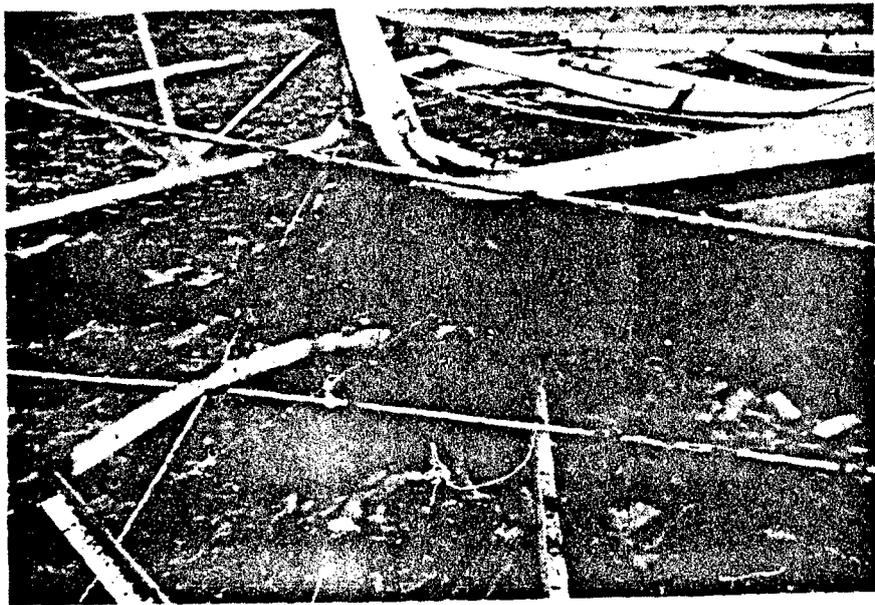
Fig. 2-10. Posttest Photographs of Experiment 4110.

The overpressure received at the building was 27 psi. The structure collapsed as shown in Figure 2-9. The cluster displaced approximately the same distance as those exposed in the open, but unfortunately this put it under one of the major structural members of the collapsing building. The resulting mess is shown in Figures 2-10 and 2-11. In spite of the apparent heavy damage, three of the saws were easily repairable. The posttest condition of each of the items along with the repair time is presented below.

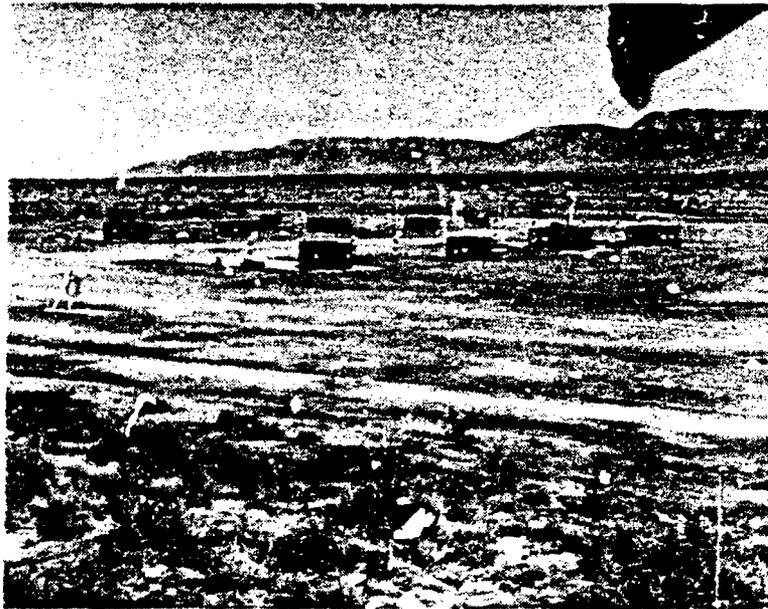
Fig. 2-12. Pretest Photograph of Experiment 4115.

The estimated peak overpressure from the BRL northern instrumentation line was 44.31 psi. (The corresponding dynamic pressures at this location is not known.) As noted above, WES measurements made in front of this experiment indicate that the pressures may have been significantly higher, on the order of 20% to 30% higher. The damage to the arrays was extensive; at this overpressure all of the arrays broke up, and the individual drums were then subjected to the dynamic pressure as individual objects (negating the cluster concept over a major portion of the pulse). Breakup of the arrays occurred for two reasons: because some drum lids came off and let the drums deform as the fluids ejected, and because the seatbelt webbing ruptured where the drums did not deform. High-speed photography from farther down range show drums lofted as high as 30 to 50 feet in the air. For example, at the seven-barrel array on the concrete pad (4115-A), the seatbelt webbing ruptured

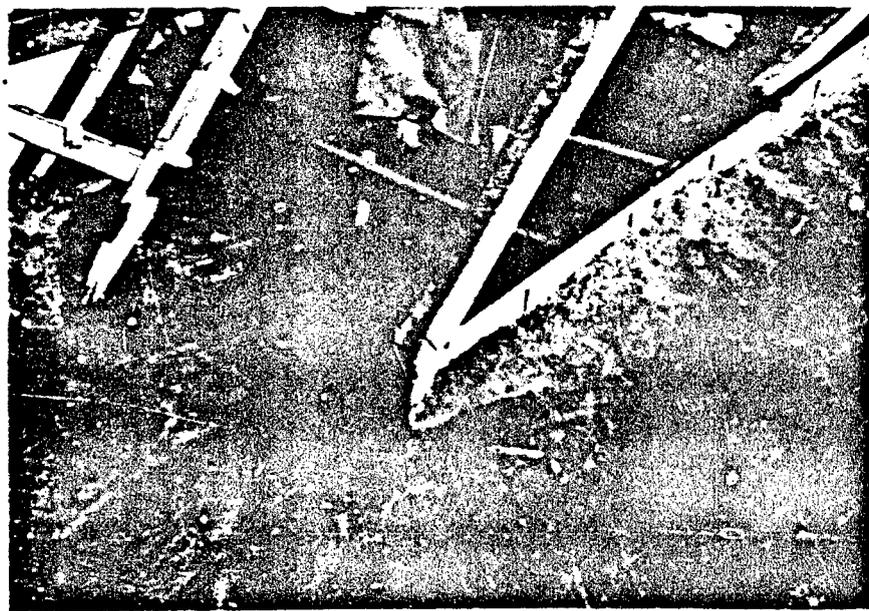
Fig. 3-15. Posttest Photographs of Column Line ③ of the Steel Frame Building, Experiment 4140.

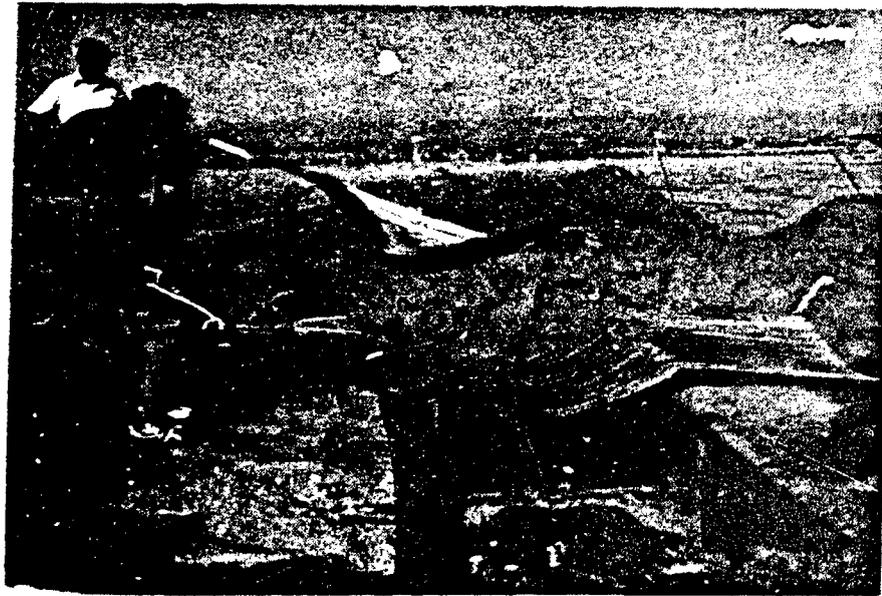
Fig. 5-12. Posttest Photograph of Corrugated Steel Closure.

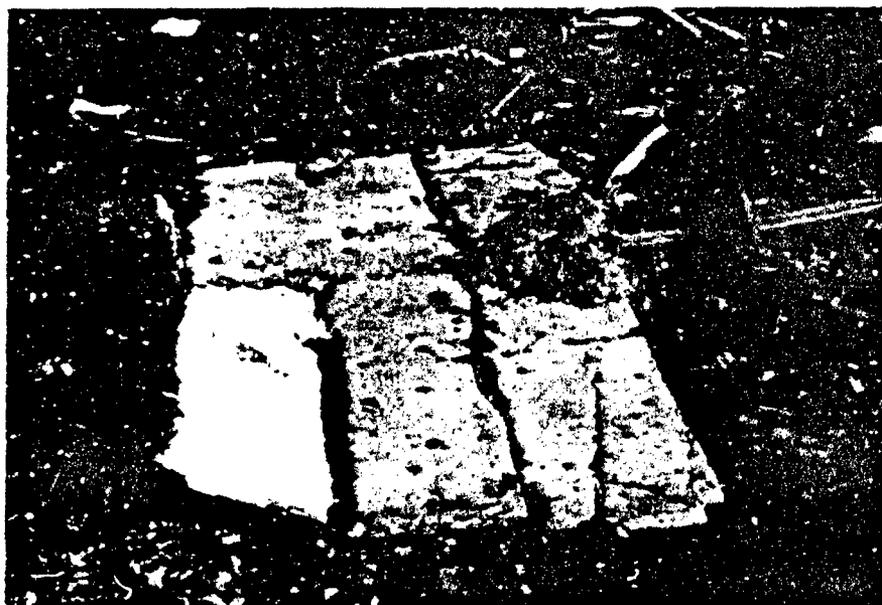
Fig. B-10. Steel Building Debris at 706 Feet.

Distance Along Radial From Front of Bldg.	Distance From Radial	Description
707 ft	Right 156 ft	SF, 4 ft X 8 ft (see Figure B-10)
717 ft	Right 23 ft	CF, 6 in. X 6 in.
750 ft	Right 55 ft	CW (C-8), 4 in. X 10 in.
	Left 190 ft	CW, 6 in. X 10 in.
780 ft	Left 178 ft	CW, 6 in. X 8 in.
790 ft	Left 168 ft	SF, 16 in. X 32 in.
800 ft	Right 228 ft	SF, 16 in. X 24 in.
875 ft	Left 120 ft	SW (S-3), 8 in. X 8 in. (see Figure B-11)

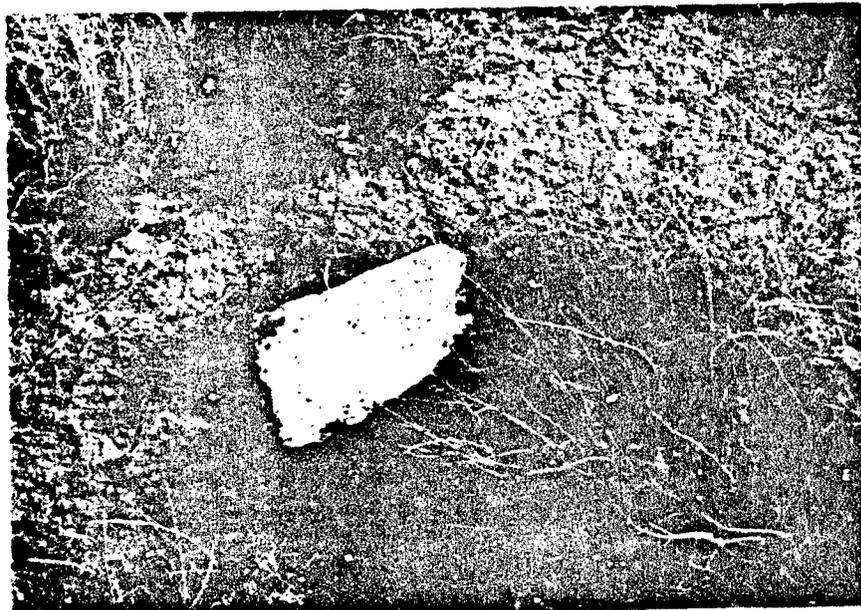
Fig. B-11. Steel Building Wall Fragment at 875 Feet.
