**US Army Corps  
of Engineers**  
Construction Engineering  
Research Laboratory

Technical Report M-351  
July 1984

**EVALUATION OF THE PAVEMENT CONDITION INDEX  
FOR USE ON POROUS FRICTION SURFACES**

by  
Starr D. Kohn  
Mohamed Y. Shahin

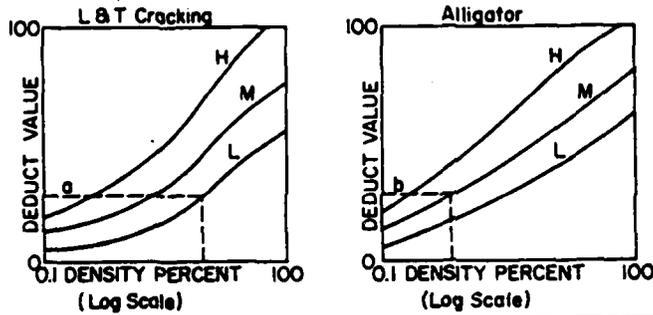
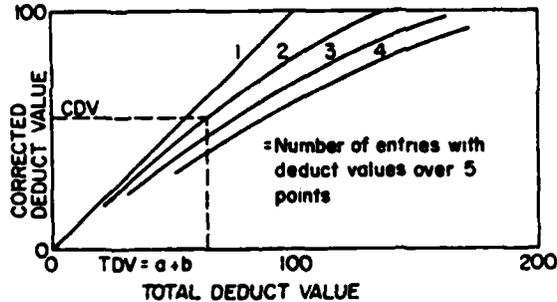
Figure 1. Steps for determining PCI of a pavement feature.

STEP 1. DIVIDE PAVEMENT FEATURE INTO SAMPLE UNITS.

STEP 2. INSPECT SAMPLE UNITS: DETERMINE DISTRESS TYPES AND SEVERITY LEVELS AND MEASURE DENSITY.

STEP 3. DETERMINE DEDUCT VALUES

STEP 4. COMPUTE TOTAL DEDUCT VALUE (TDV)  $a + b$

STEP 5. ADJUST TOTAL DEDUCT VALUE

STEP 6. COMPUTE PAVEMENT CONDITION INDEX (PCI) =  $100 - CDV$  FOR EACH SAMPLE UNIT INSPECTED.

STEP 7. COMPUTE PCI OF ENTIRE FEATURE (AVERAGE PCI'S OF SAMPLE UNITS).

The PCI is a numerical indicator of the pavement's structural integrity and surface operational condition; the index ranges from 0 to 100, with 100 indicating excellent condition. The index is a function of the type, quantity, and severity of observable distress in the pavement surface. Figure 1 summarizes the steps for calculating the PCI for a given pavement feature.

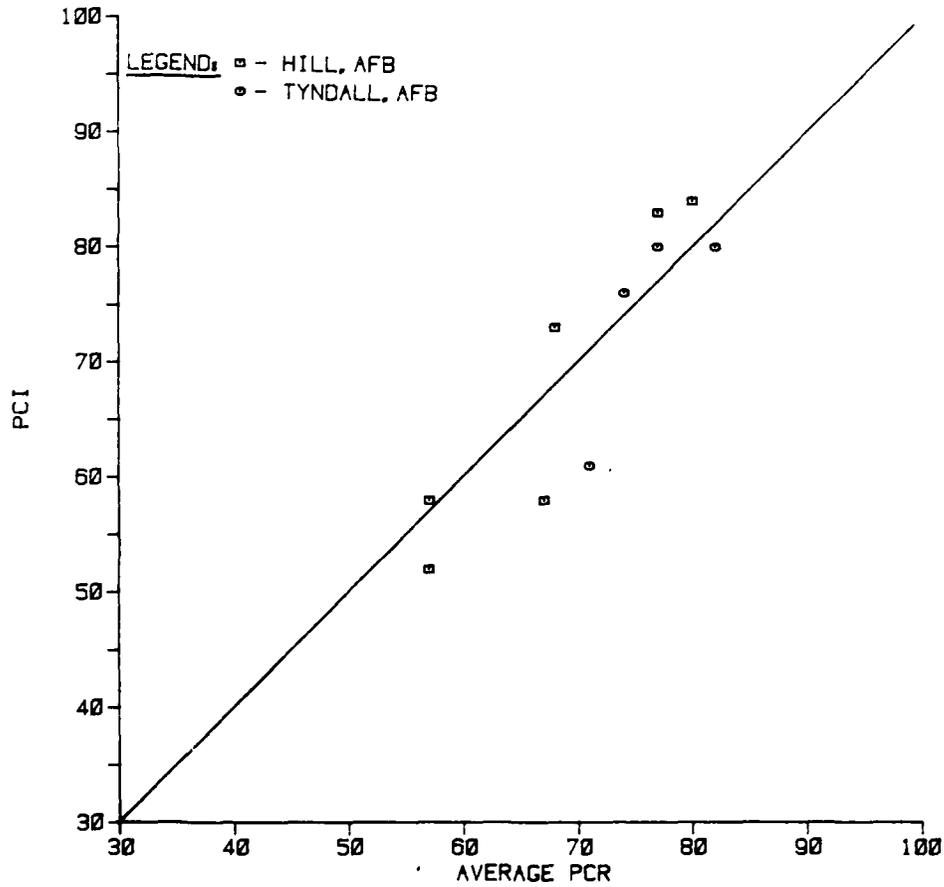
**Figure 3. PCI vs. PCR for United States air bases.**

The first condition surveys were performed at Hill and Tyndall Air Force Bases. Table 1 summarizes the PCR and PCI ratings; Figure 3 is a plot of the average PCR compared to the calculated PCI.

As shown in Figure 3, there is generally close agreement between PCR and PCI for these sample units, the largest differences being 10 points at Tyndall and

9 points at Hill. At Tyndall, the maximum difference occurred in a sample unit which contained a depression, some jet blast, medium reflection cracks, patching, and medium raveling. It appears that the raters may have overlooked some of the medium raveling, because the pavement surface was damp from rain. At Hill, the maximum difference was a sample unit in an area where there was some alligator cracking; a review of the rating forms indicated that the raters did not recognize the amount of alligator cracks present and subsequently gave higher values.

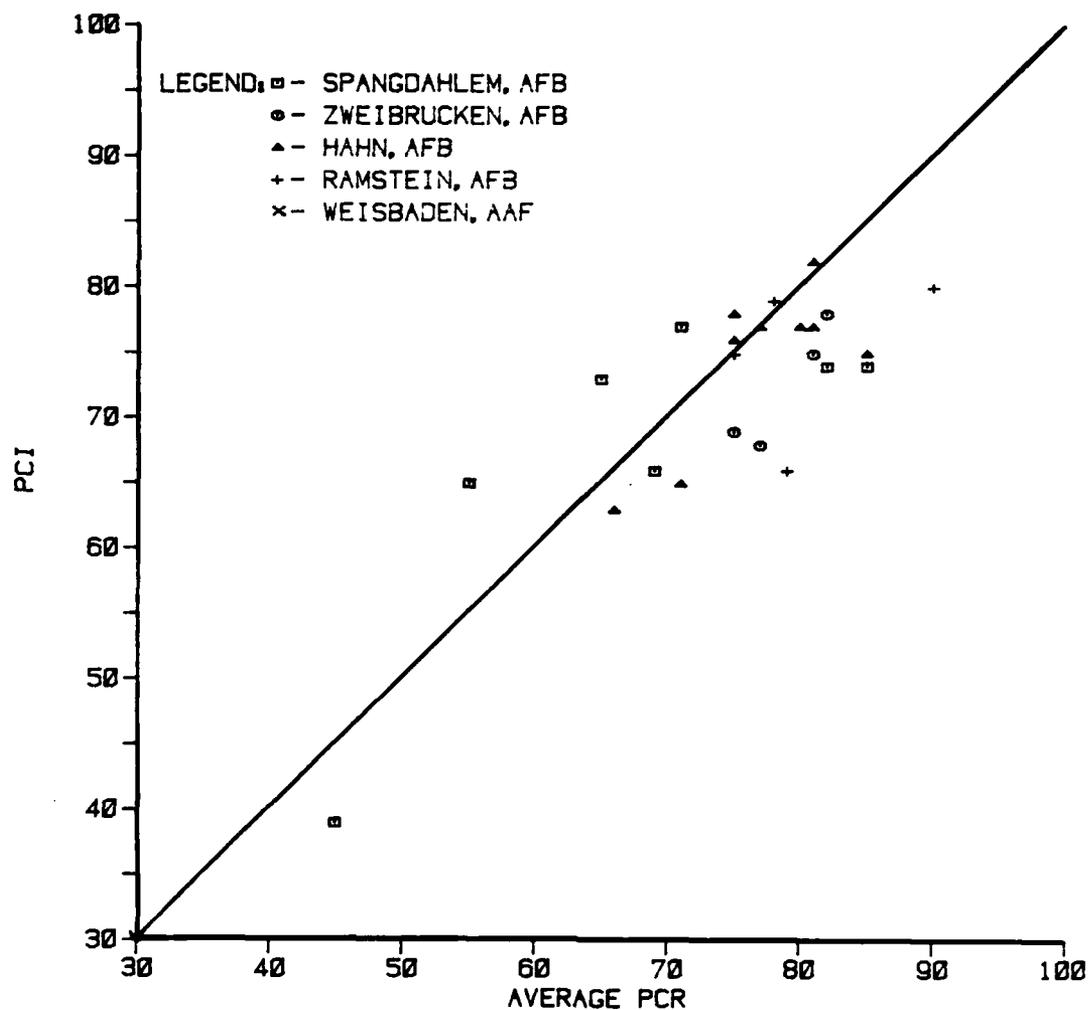
Figure 4. PCI vs. PCR for German air bases.

Table 2 and Figure 4 summarize the ratings for the bases surveyed in Germany. As shown in the table, the calculated PCI is generally lower than the average PCR. Also, five of the 24 samples showed differences of at

least 10 points. In reviewing these sample units, it appeared that the raters were generally underestimating the amount of medium raveling present. This distress was hard to measure in the field due to its erratic occurrence over relatively small areas of the sample. Also, the distress was being measured under a new definition for the severity levels, which had been established based on the first field survey.

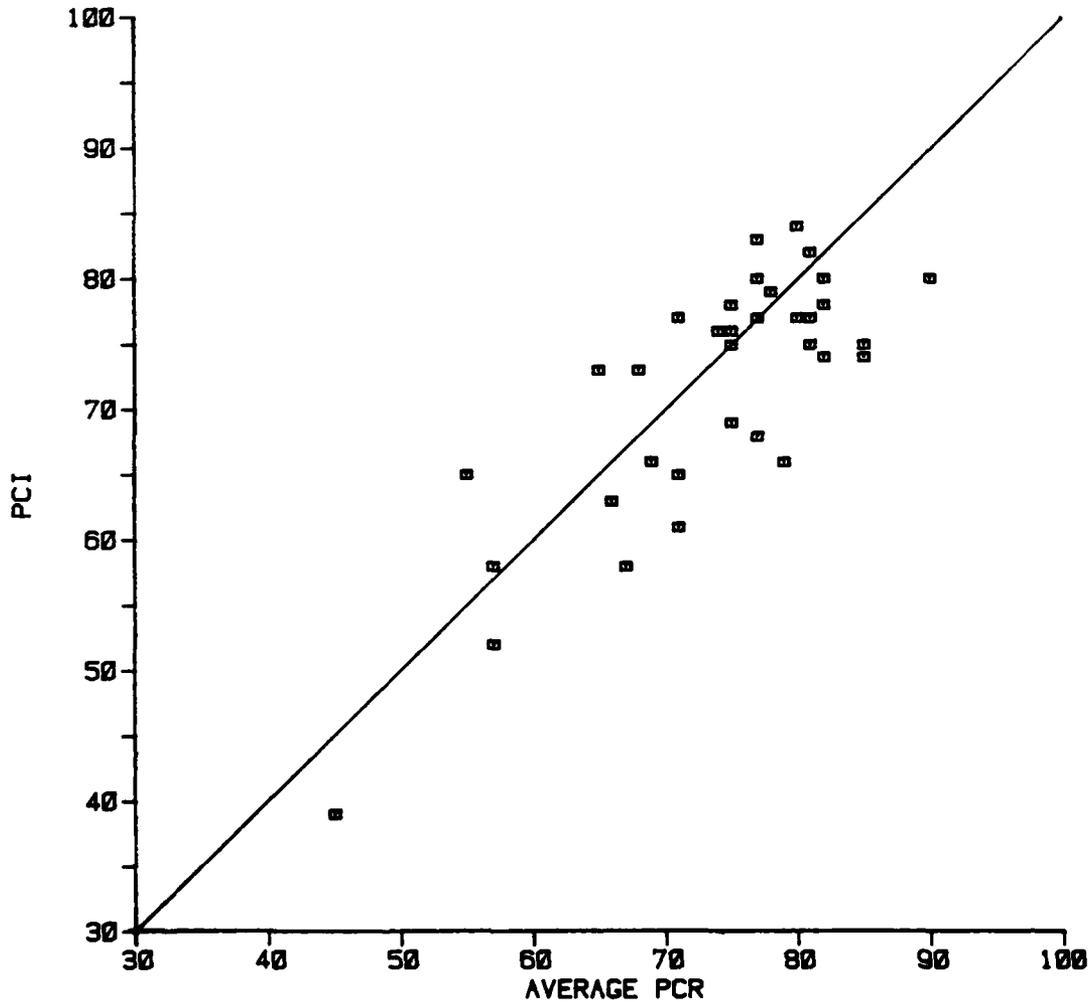
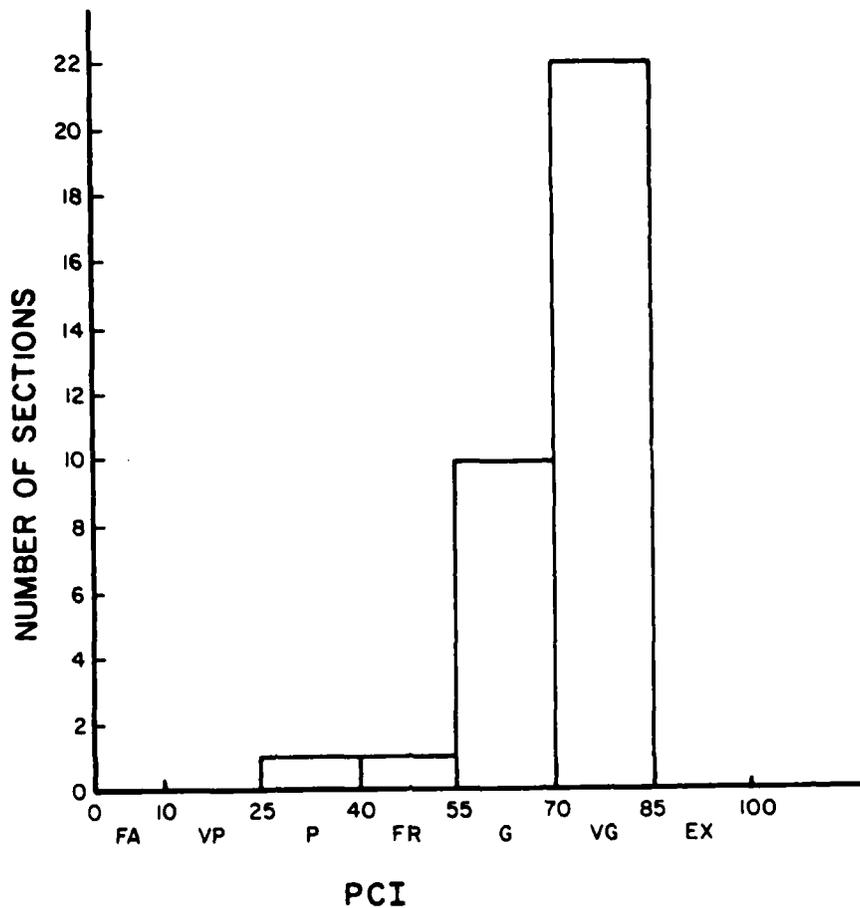
Figure 6. Distribution of sample unit PCIs.

Figure 5 compares the PCR and PCI values for the total data set. As shown, the average PCR correlates well with the calculated PCI. The average absolute difference of PCI and PCR ( $PCI - PCR$ ) is 5.4 points for the entire data set. Figure 6 shows a distribution of the PCIs for the sample units. Most of the sample units are in the range of 55 to 85, indicating that the pavement is in good to very good condition. The overall average PCI of all sample units is 72.
