DESIGN OF ALTERNATE LAUNCH AND RECOVERY SURFACES FOR
ENVIRONMENTAL EFFECTS(U) ARMY ENGINEER WATERWAYS
EXPERIMENT STATION VICKSBURG MS GEOTE.

DESIGN OF ALTERNATE LAUNCH AND RECOVERY SURFACES FOR ENVIRONMENTAL EFFECTS

U.S. ARMY ENGINEER WATERWAYS EXPERIMENT STATION
GEOTECHNICAL LABORATORY
P.O. BOX 631, VICKSBURG, MS 39180

JULY 1984

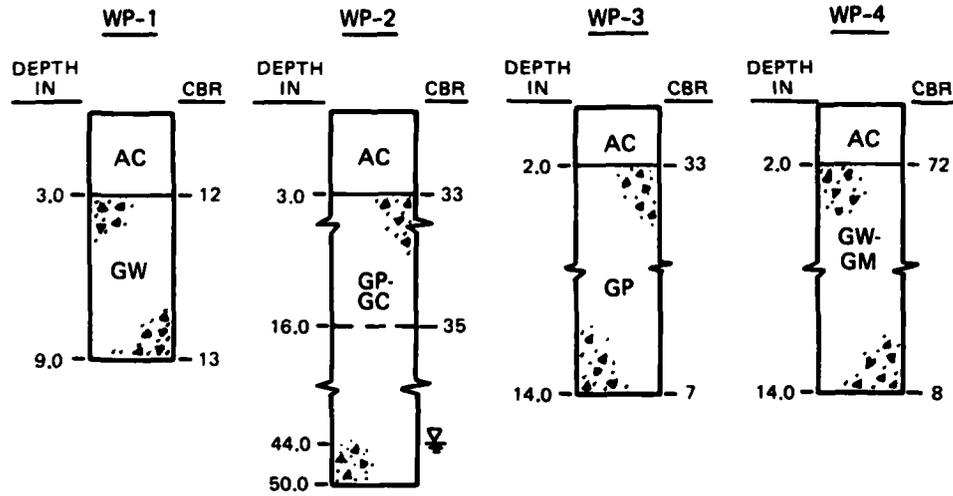
<u>PASSES TO 1-IN RUT</u>			
	39	400	60	100
	<u>PASSES TO 3-IN RUT</u>			
	44	643	90	162
	<u>SKIDS TO FAILURE</u>			
	1	6*	6	35
	<u>TURNS TO FAILURE</u>			
	11	75*	28	75*
	* NO FAILURE

Figure B-33. Structure and Traffic Test Results of Wright-Patterson AFB Pavements

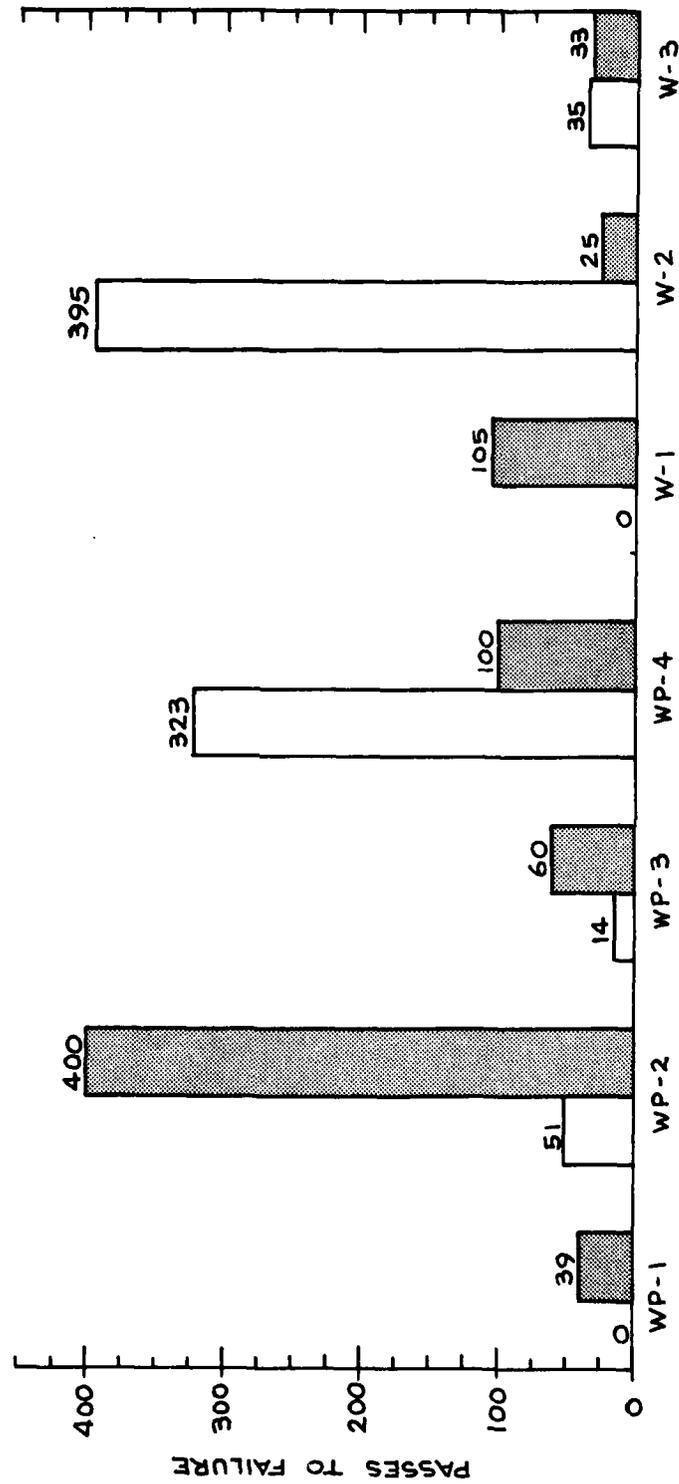
Figure B-35. Comparison of Predicted Passes to Failure from In-Place Measured CBRs to Traffic Results

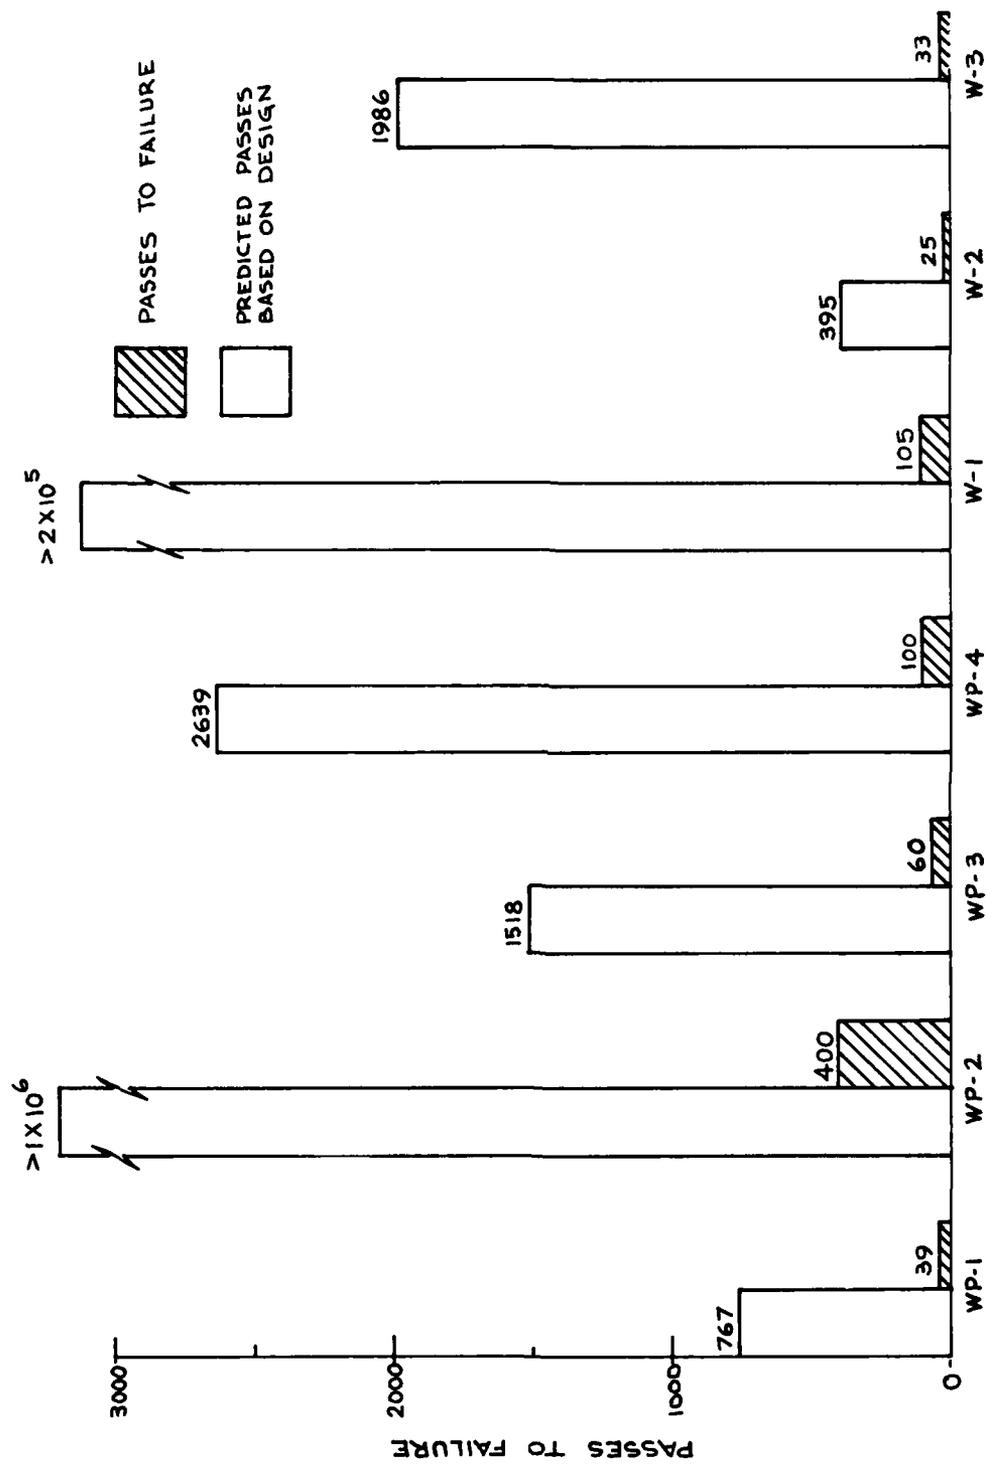
Figure B-36. Comparison of Design Passes to Failure to Traffic Results

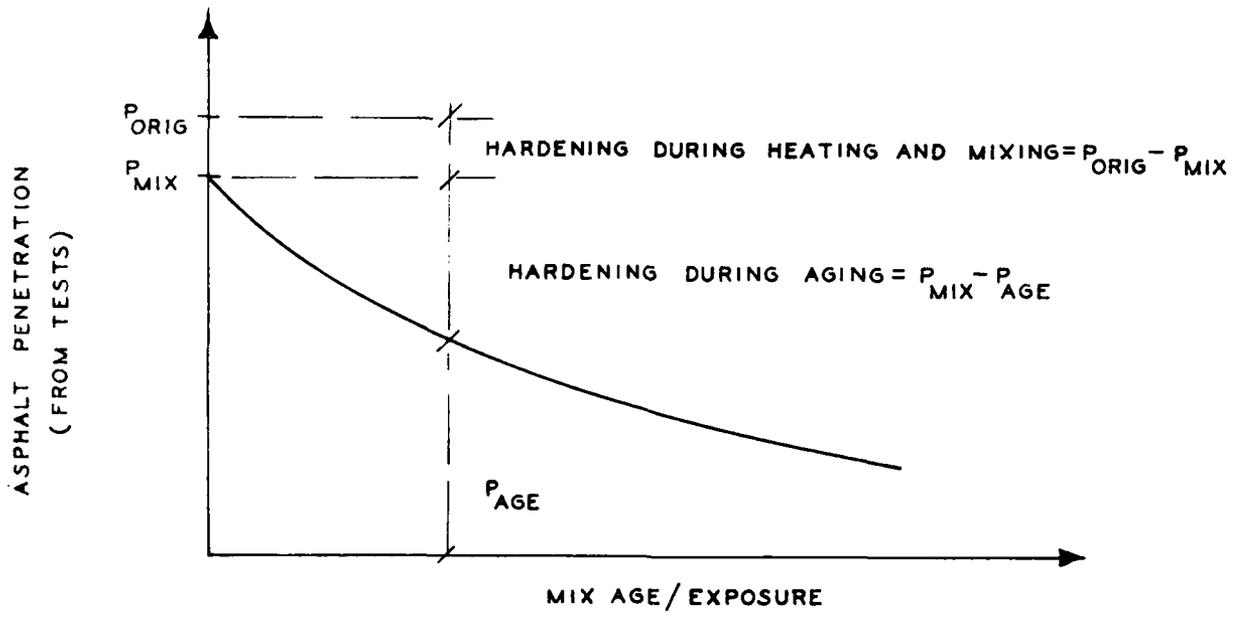
Figure B-37. Asphalt Hardening as a Result of Age

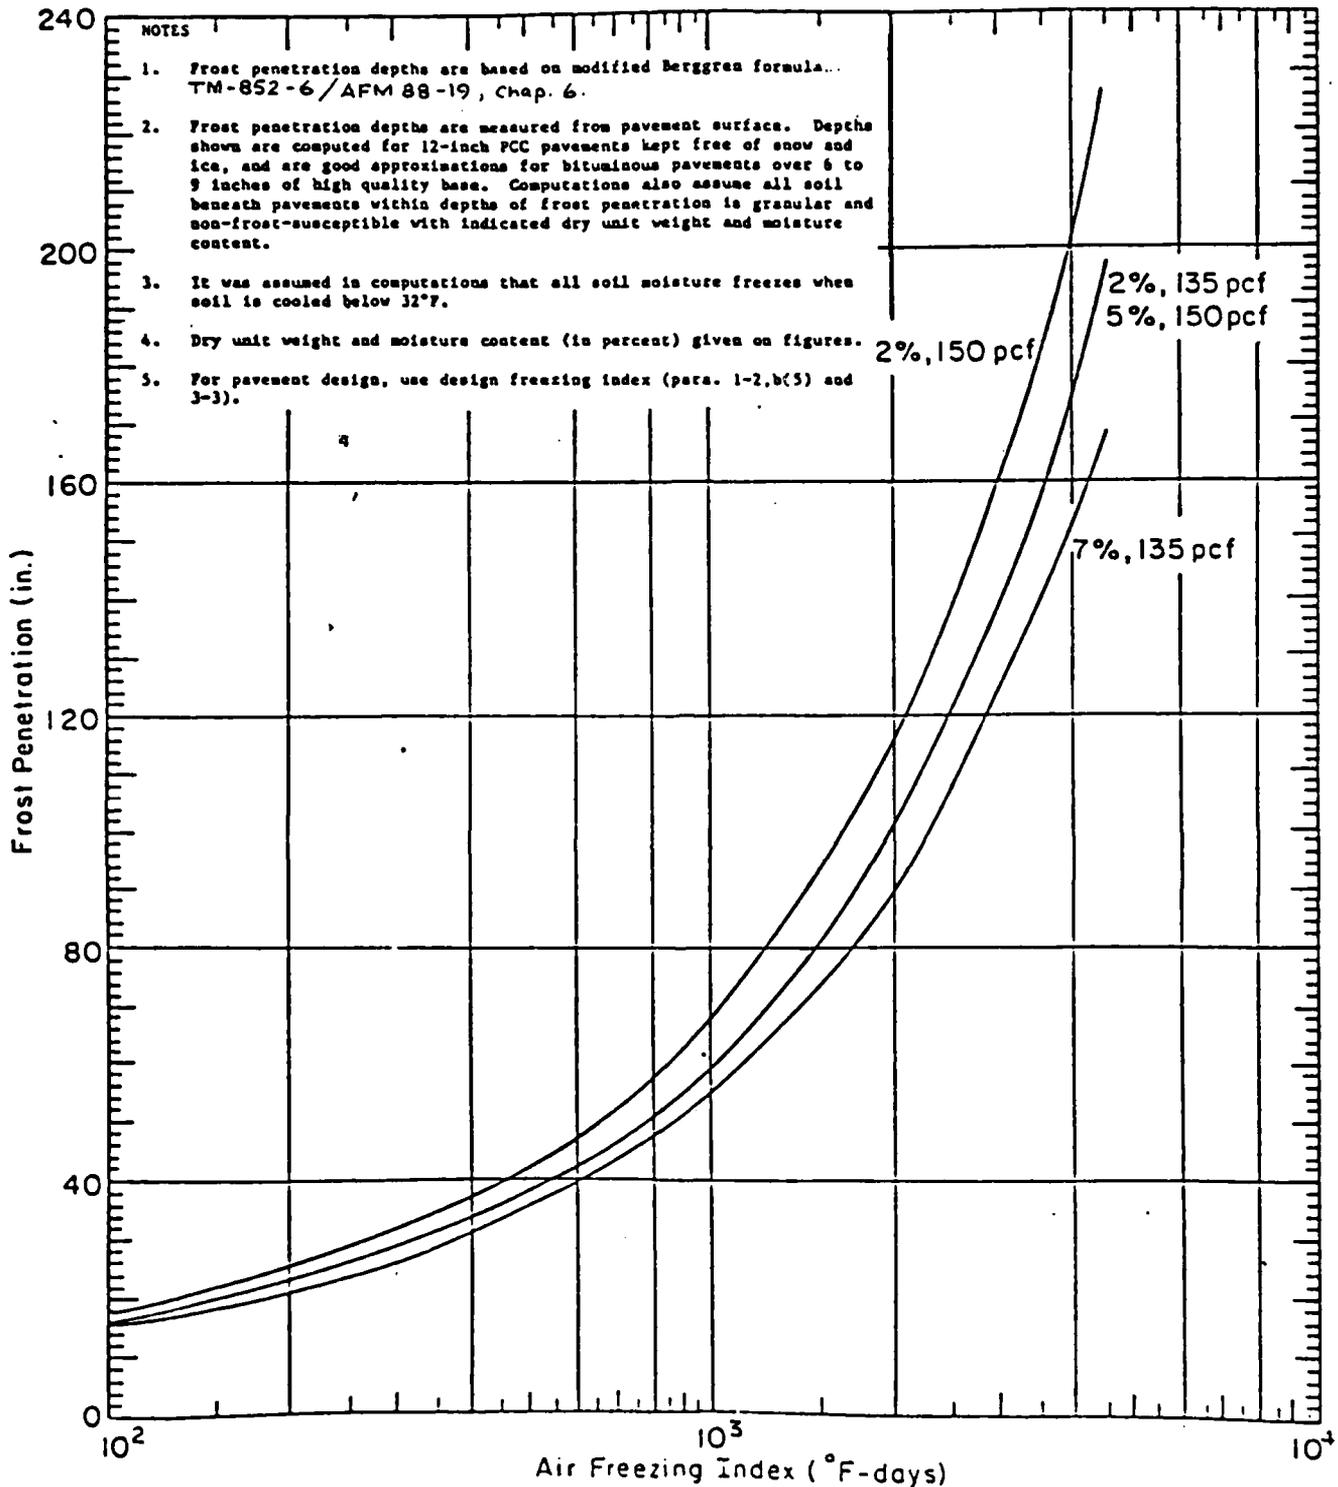
Figure B-45. Frost Penetration Beneath Pavements for Base Materials Having Densities of 150 and 135 pcf

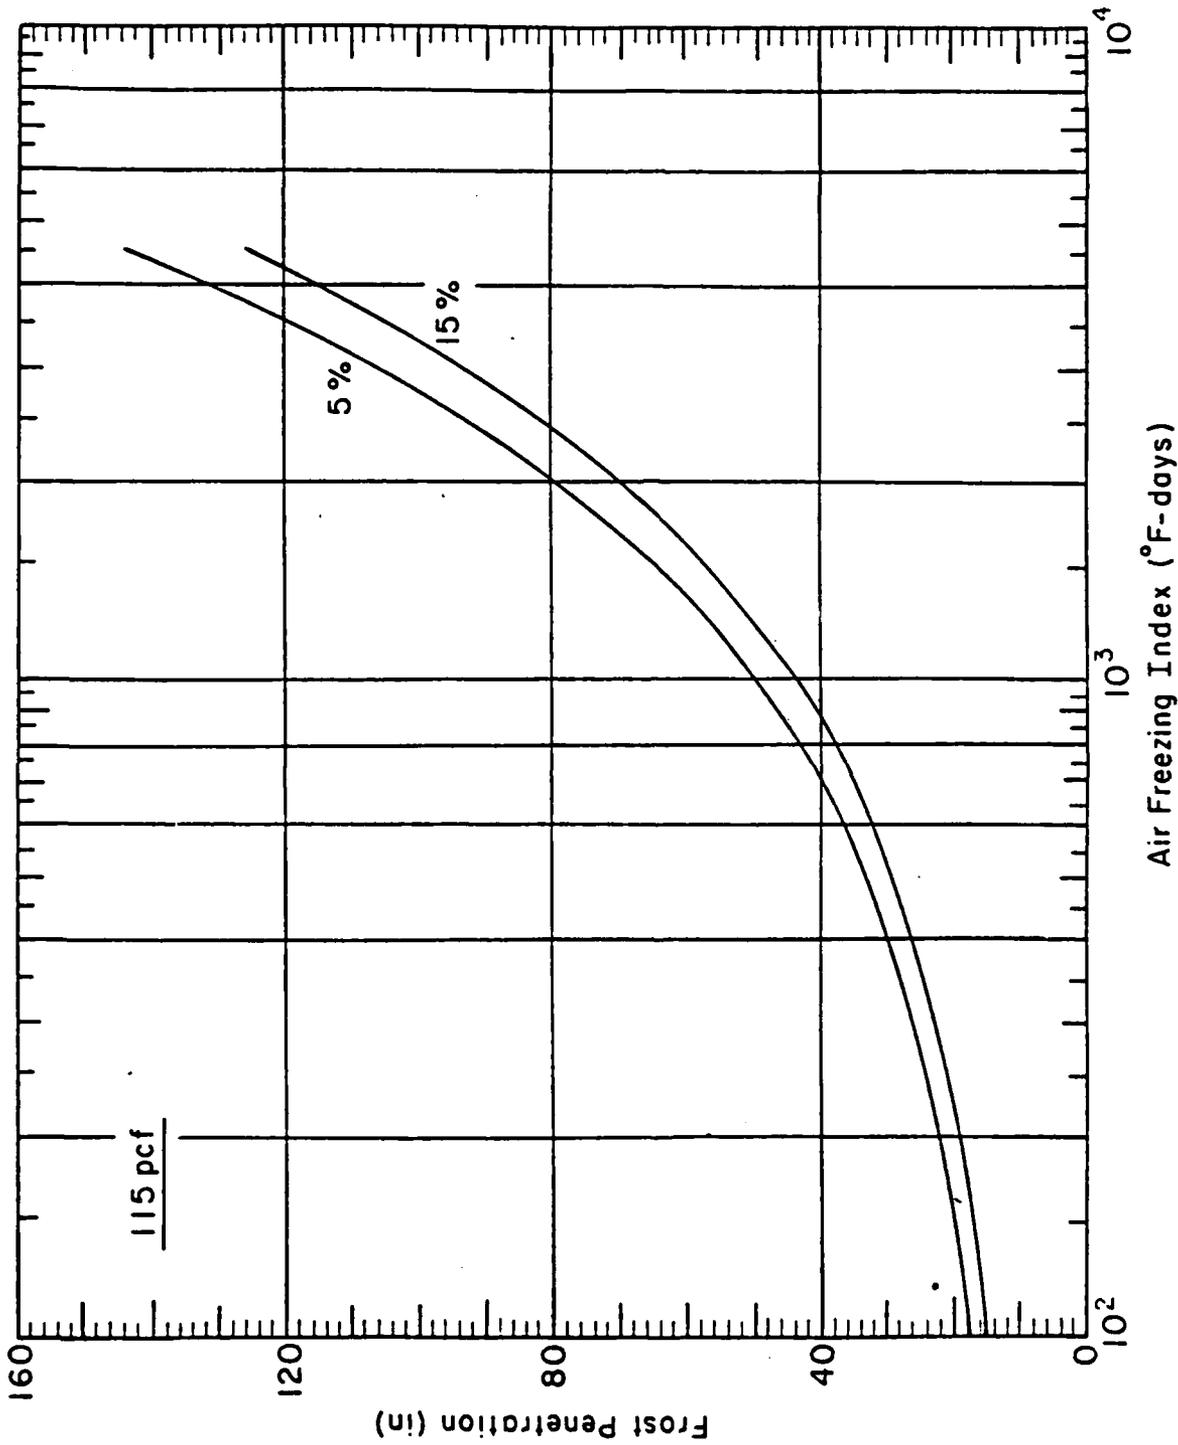
Figure B-46. Frost Penetration Beneath Pavements for Base Materials Having a Density of 115 pcf

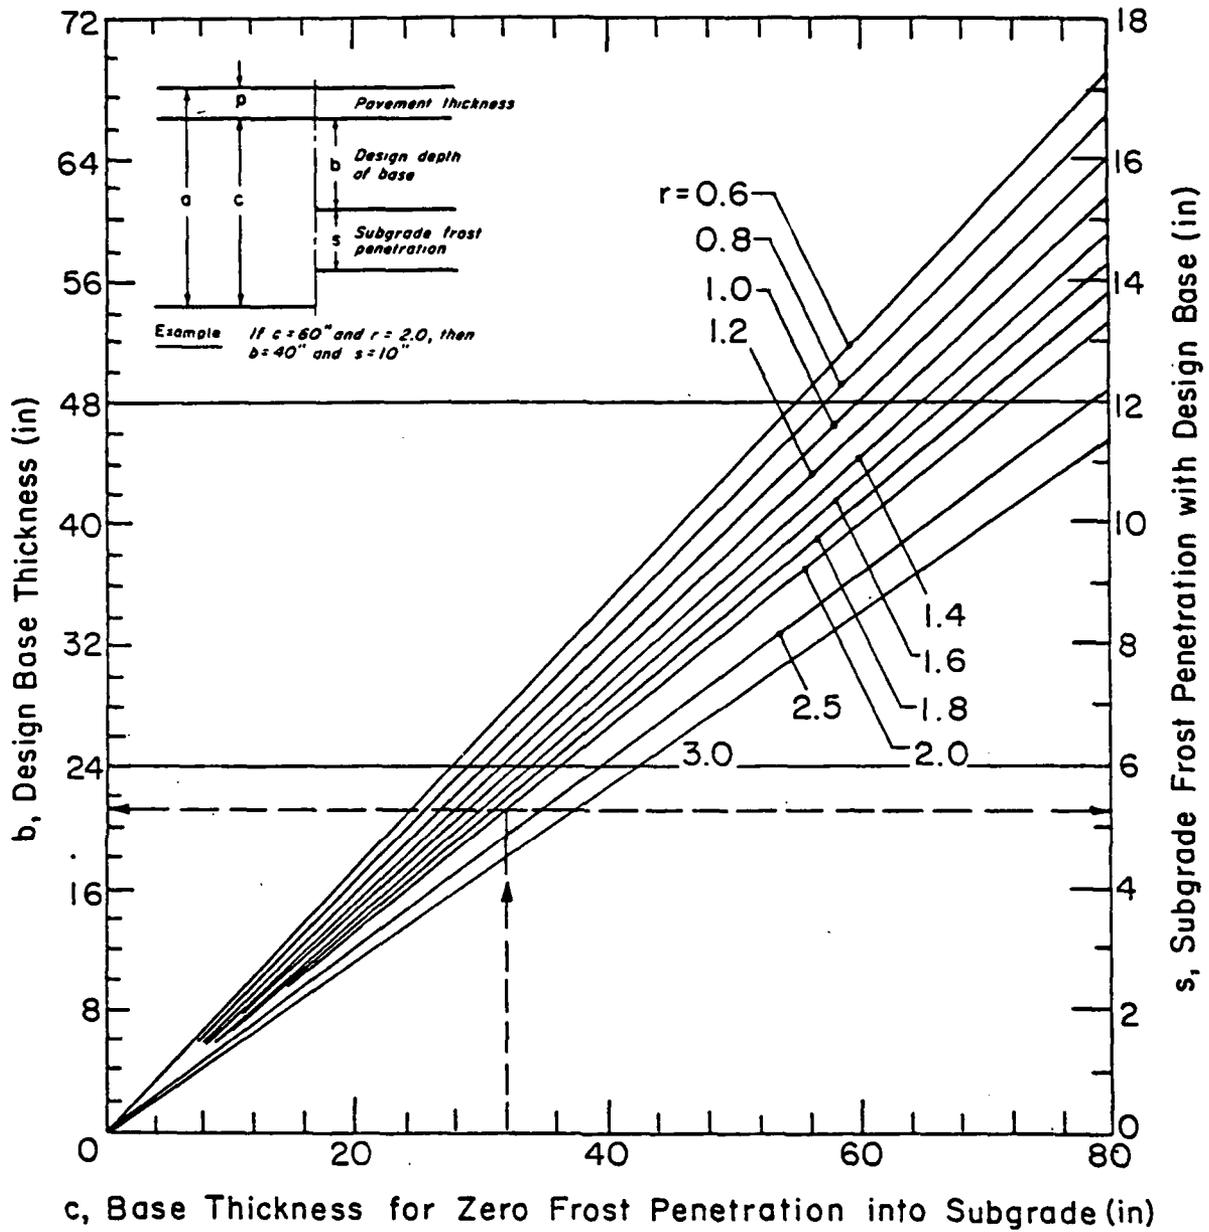
- a = Combined thickness of pavement and non-frost-susceptible base for zero frost penetration into subgrade.
- $c = \frac{a}{r}$
- w_b = Water content of base.
- w_s = Water content of subgrade.
- $r = \frac{w_s}{w_b}$ Not to exceed 2.0 for type A and B areas on airfields and 3.0 for the other pavements.

Figure B-47. Design Depth of Non-Frost-Susceptible Base for Limited Subgrade Frost Penetration

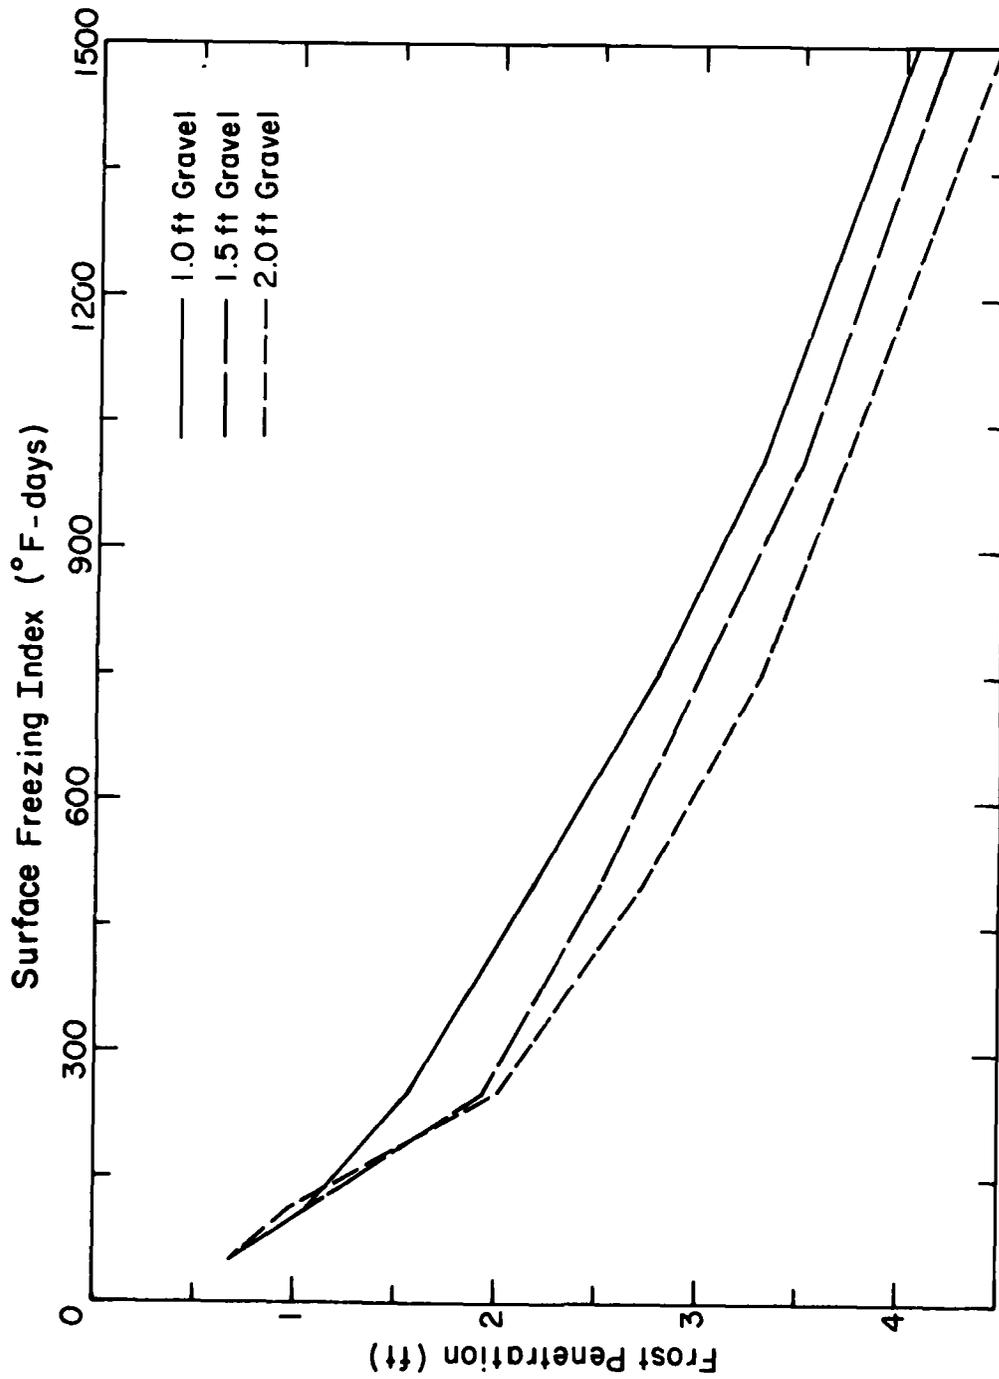
Figure B-48. Frost Penetration Beneath 3-inch Thick AC Pavements with Various Thicknesses of Gravel Base at 130 pcf and 5 Percent Moisture Content and Subgrade at 95 pcf and 18 Percent Moisture.

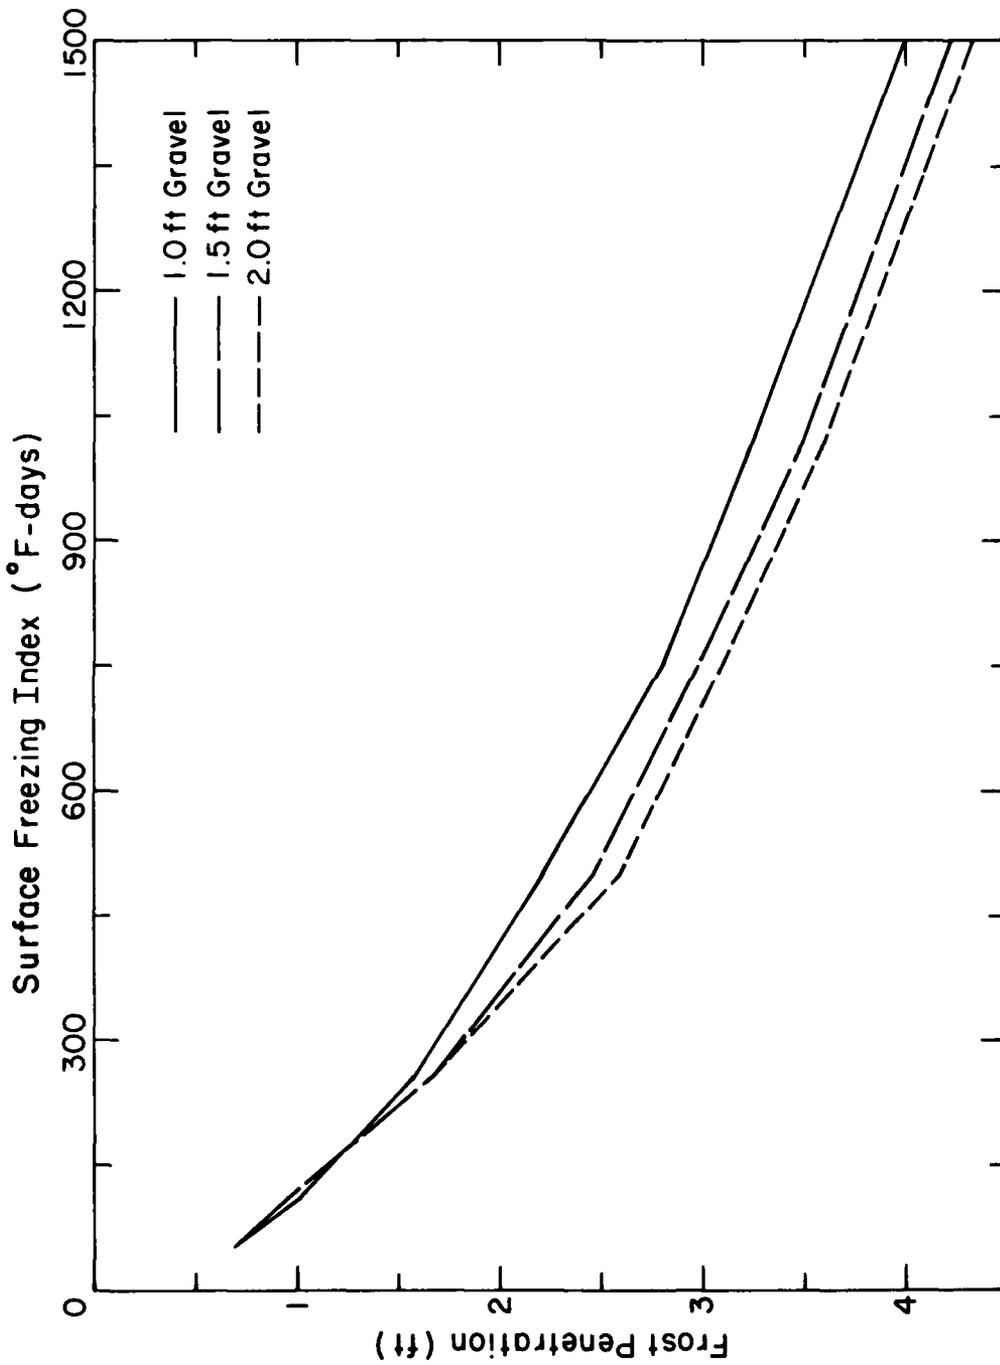
Figure B-49. Frost Penetration Beneath 3-inch Thick AC Pavements with Various Thicknesses of Gravel Base at 115 pcf and 8 Percent Moisture Content and Subgrade at 95 pcf and 18 Percent Moisture

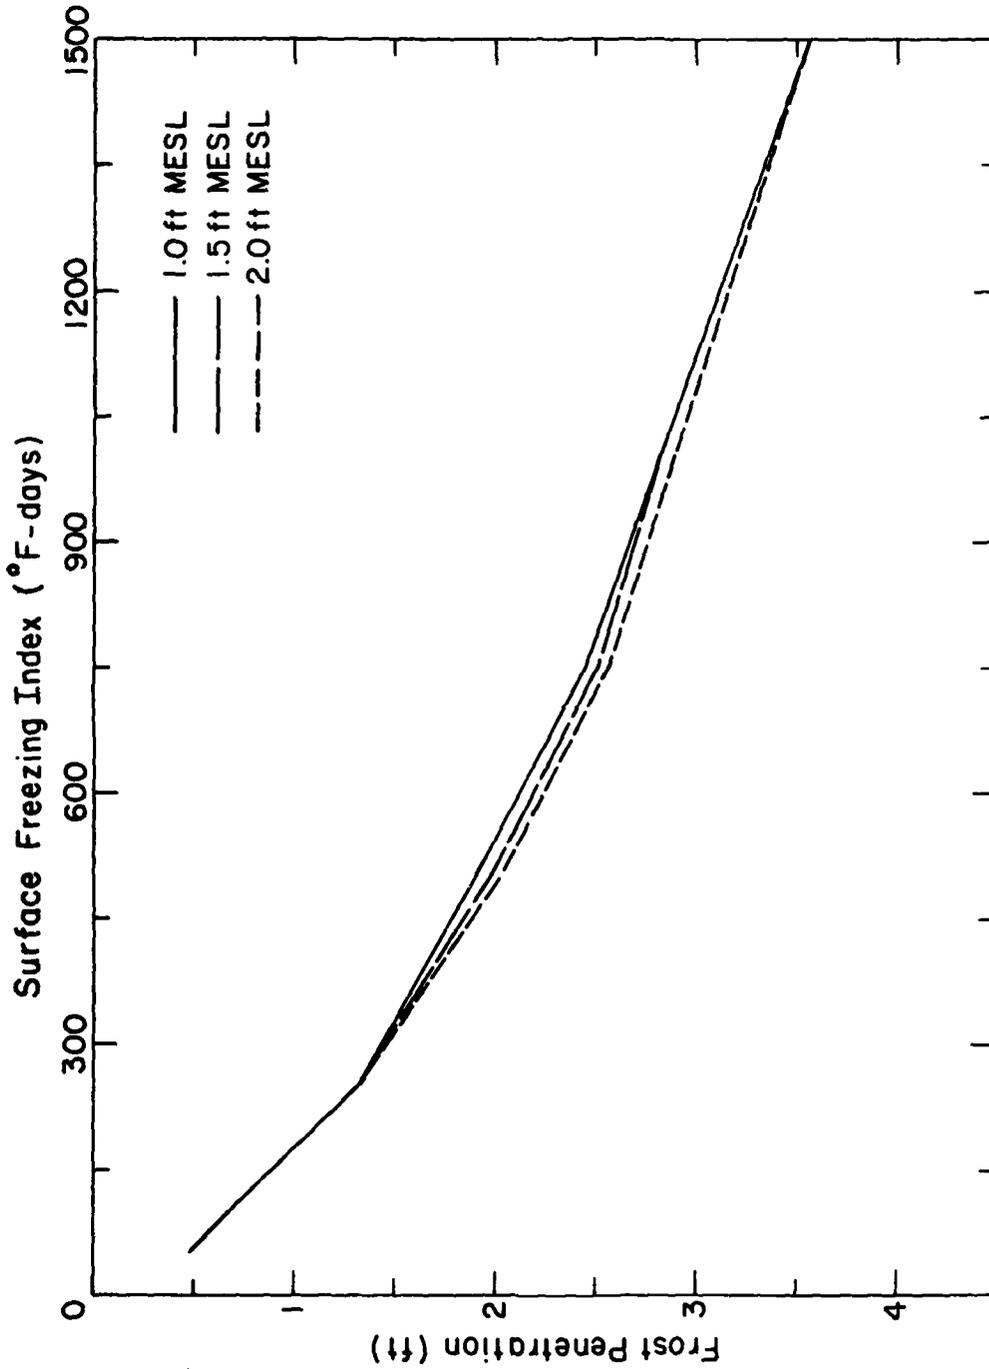
Figure B-50. Frost Penetration Beneath 3-inch Thick AC Pavements with Various Thicknesses of MESL (100 pcf at 12 Percent Moisture Content) Over a Subgrade at 95 pcf and 18 Percent Moisture Content

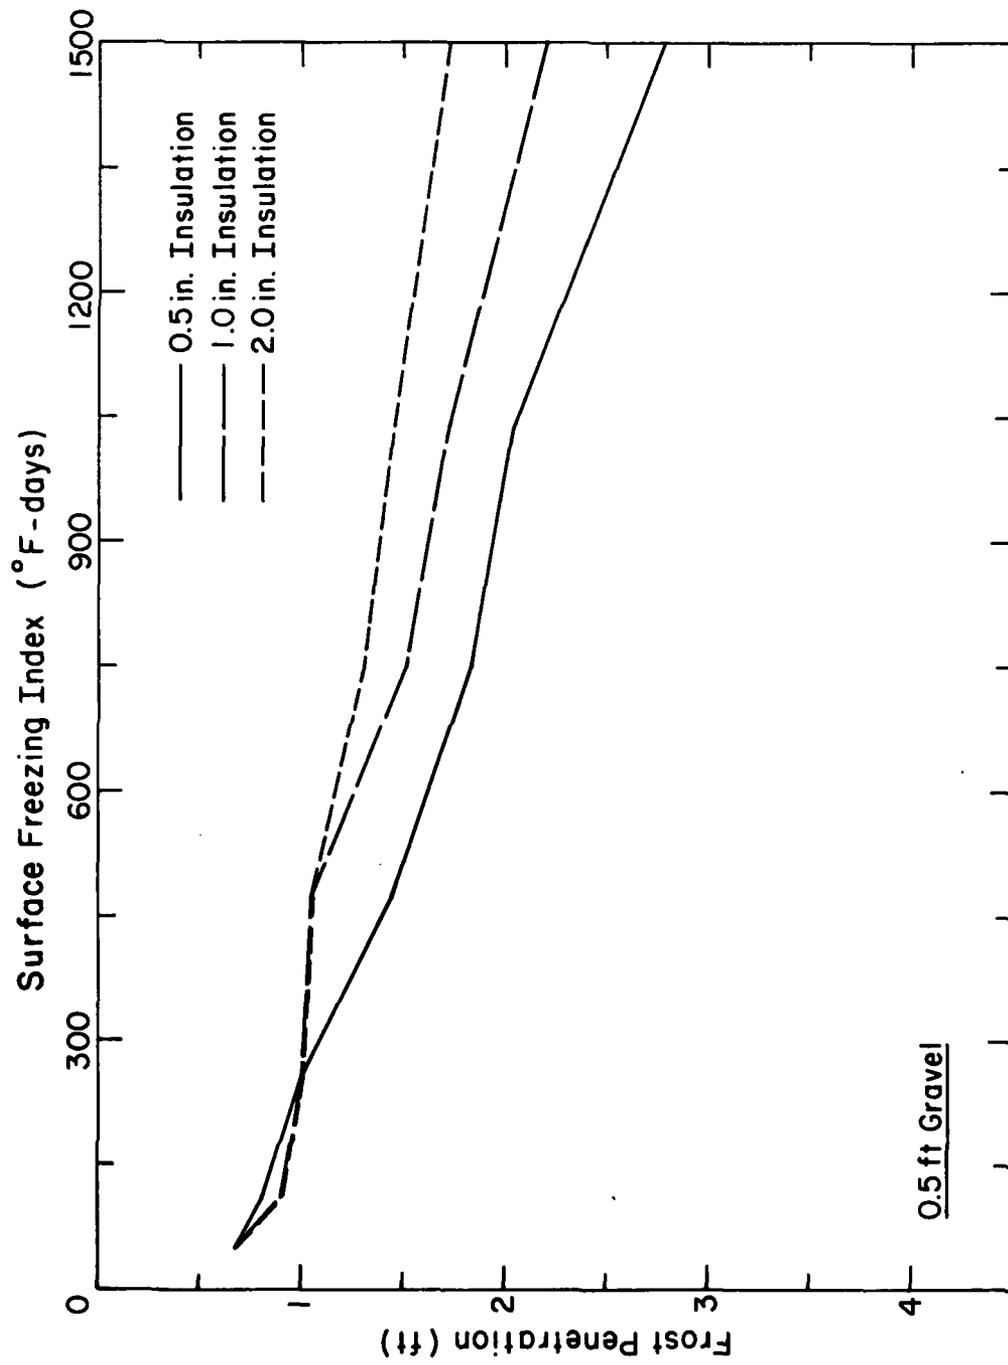
Figure B-51. Frost Penetration Beneath 3-inch Thick AC Pavements with 0.5 foot of Gravel (115 pcf at 8 Percent Moisture Content) and Extruded Polystyrene Insulation Over a Subgrade at 95 pcf and 18 Percent Moisture Content

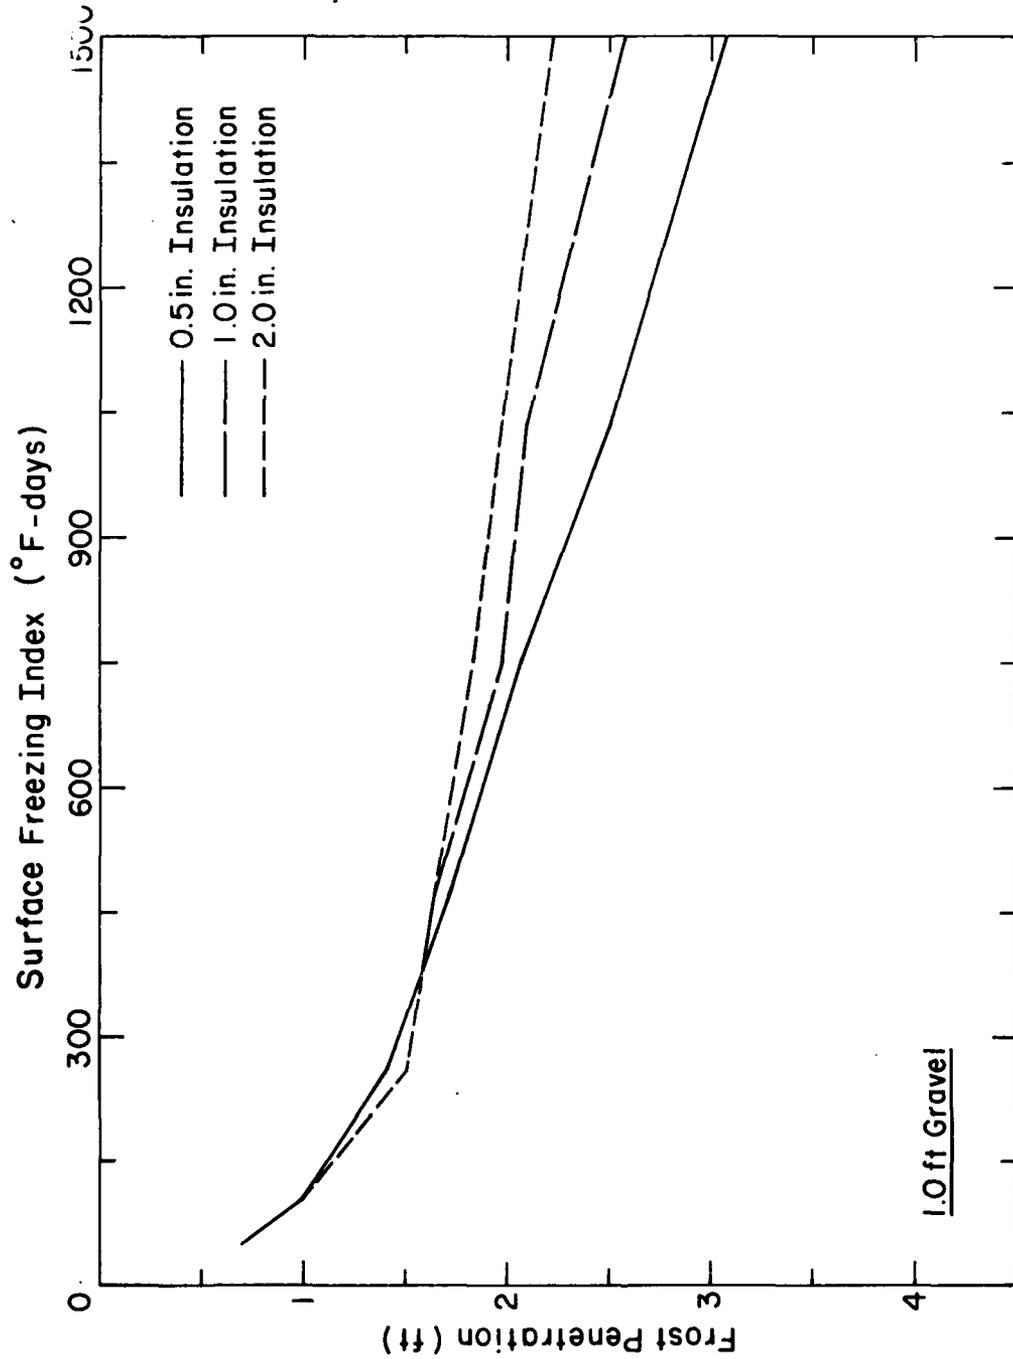
Figure B-52. Frost Penetration Beneath 3-inch Thick AC Pavements with 1 foot of gravel (115 pcf at 8 Percent Moisture Content) and Extruded Polystyrene Insulation Over a Subgrade at 95 pcf and 18 Percent Moisture Content

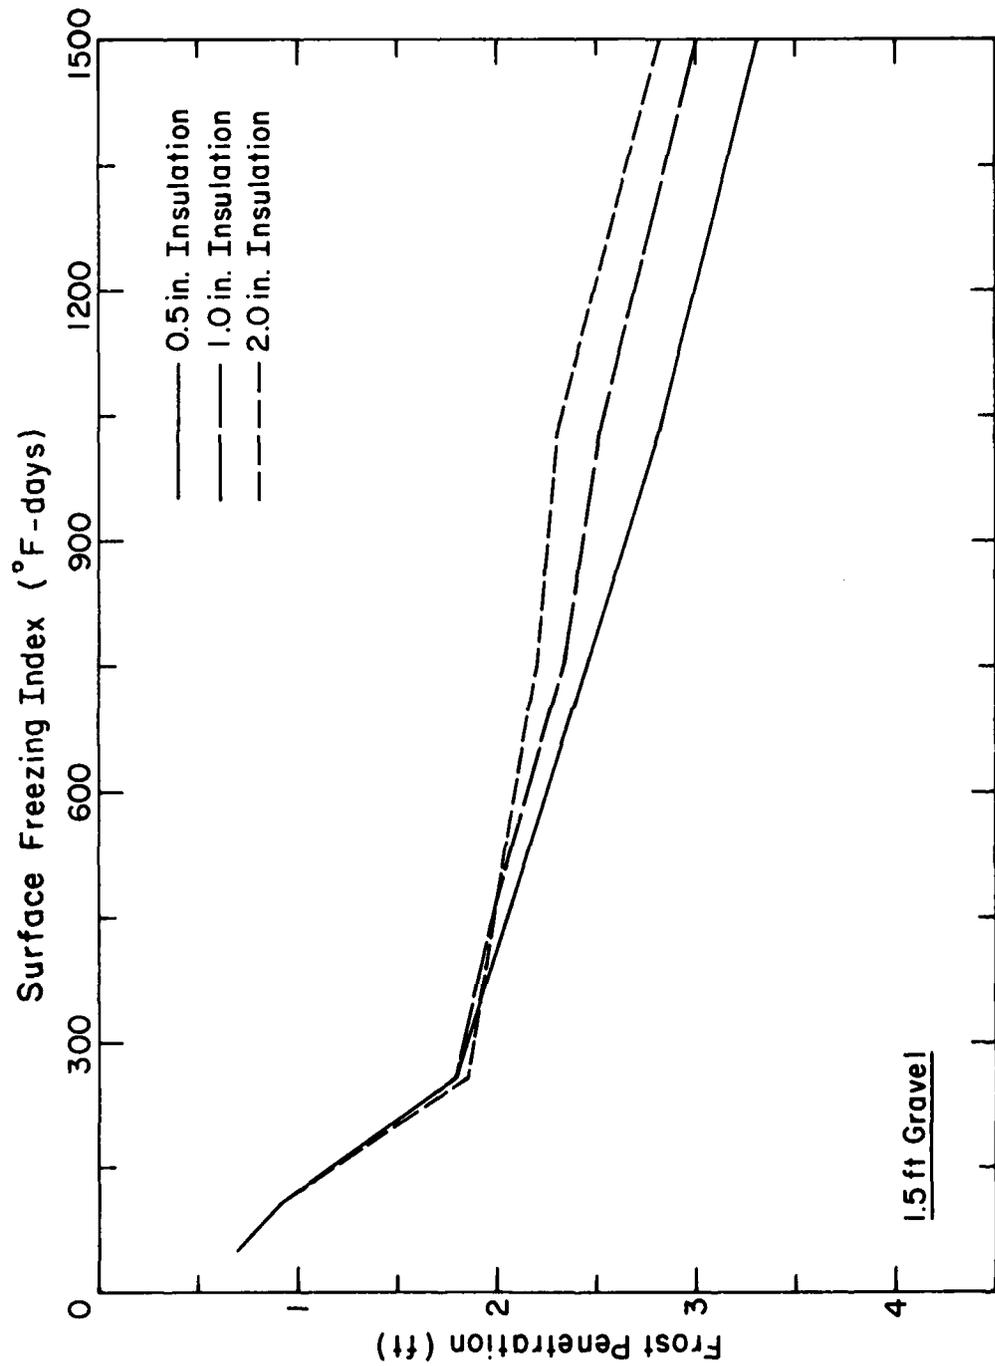
Figure B-53. Frost Penetration Beneath 3-inch Thick AC Pavements with 1.5 feet of gravel (115 pcf at 8 Percent Moisture Content) and Extruded Polystyrene Insulation Over a Subgrade at 95 pcf and 18 Percent Moisture Content

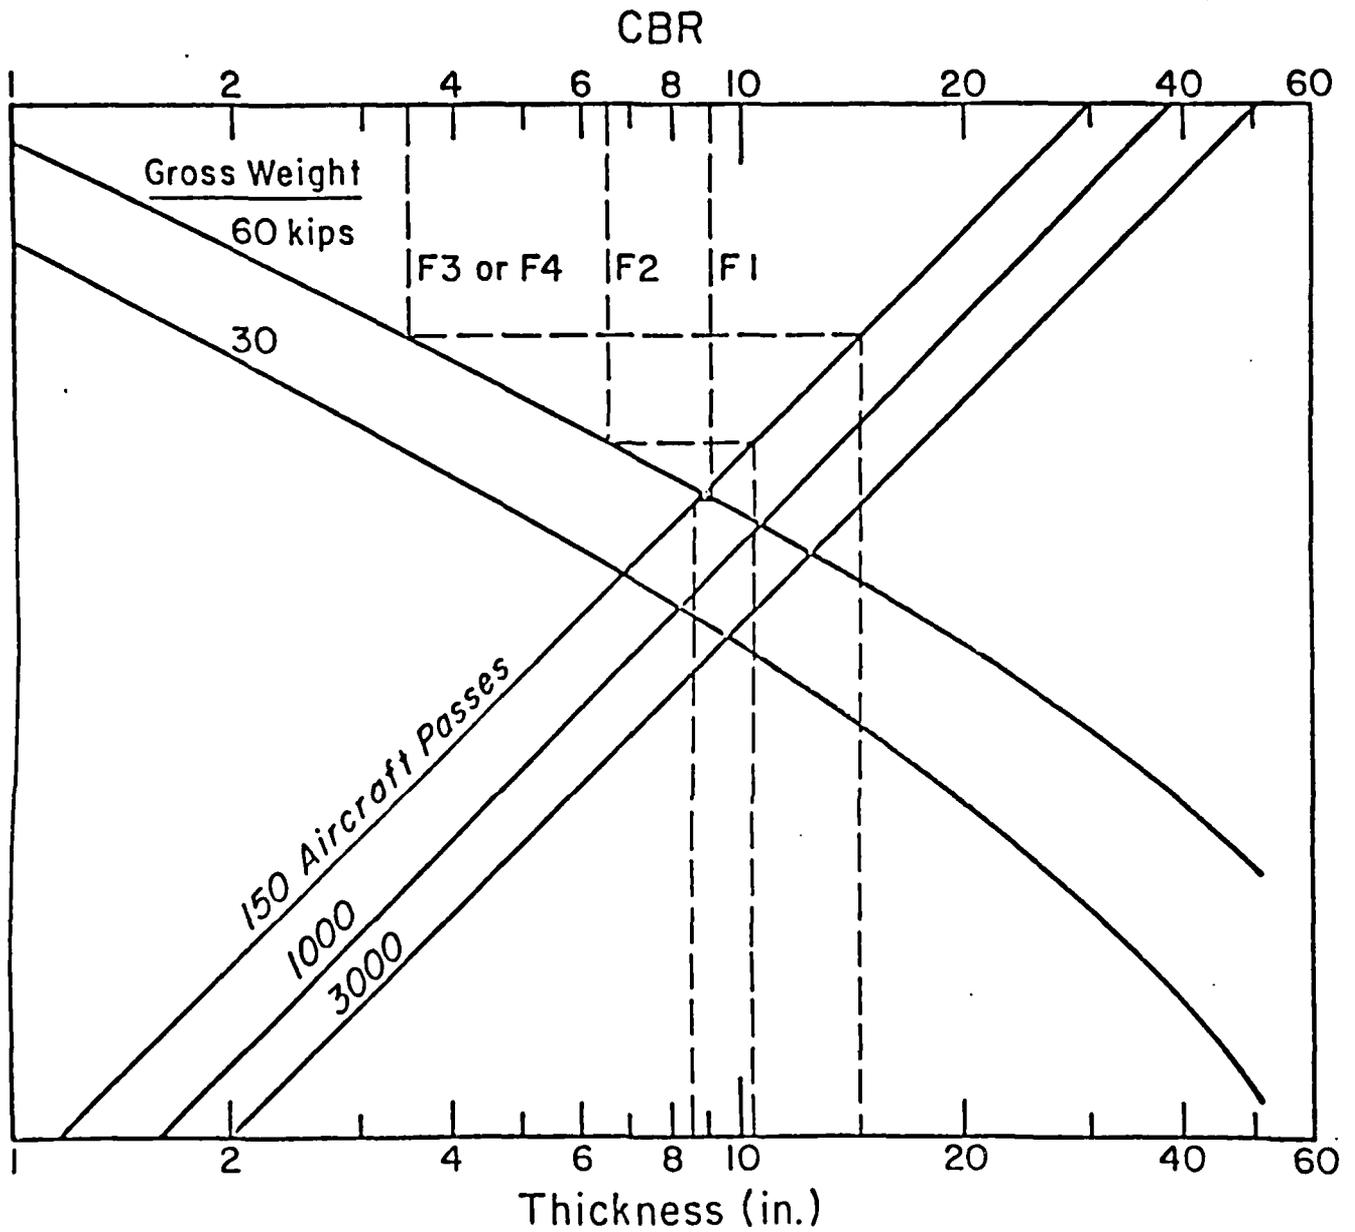
Figure B-54. Flexible Pavement Design Curves for ALRS Pavements

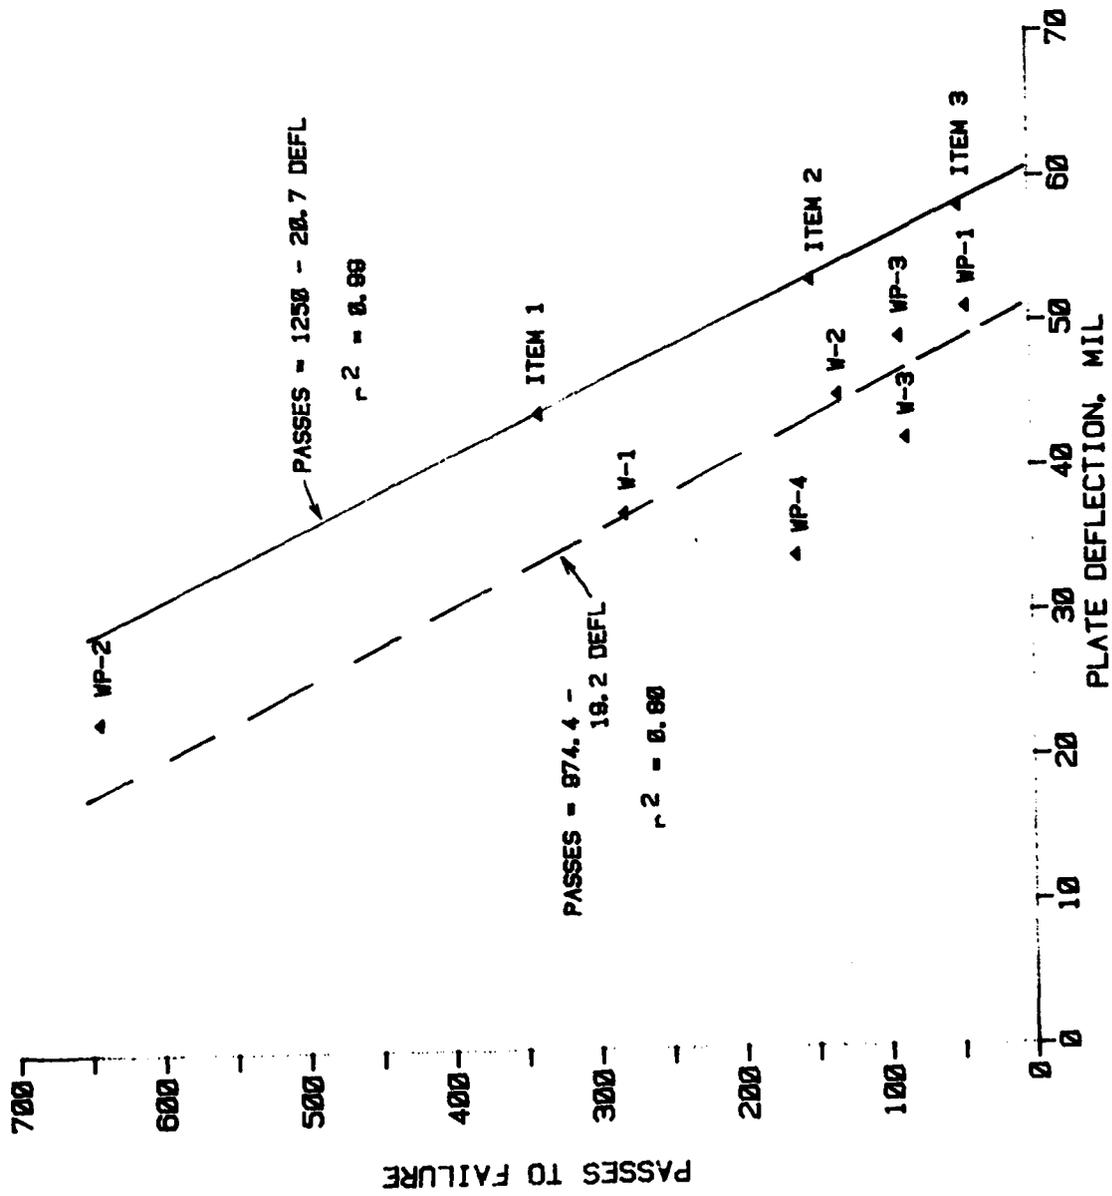
Figure B-56. Falling-Weight Deflectometer Deflections Compared to Passes to Failure

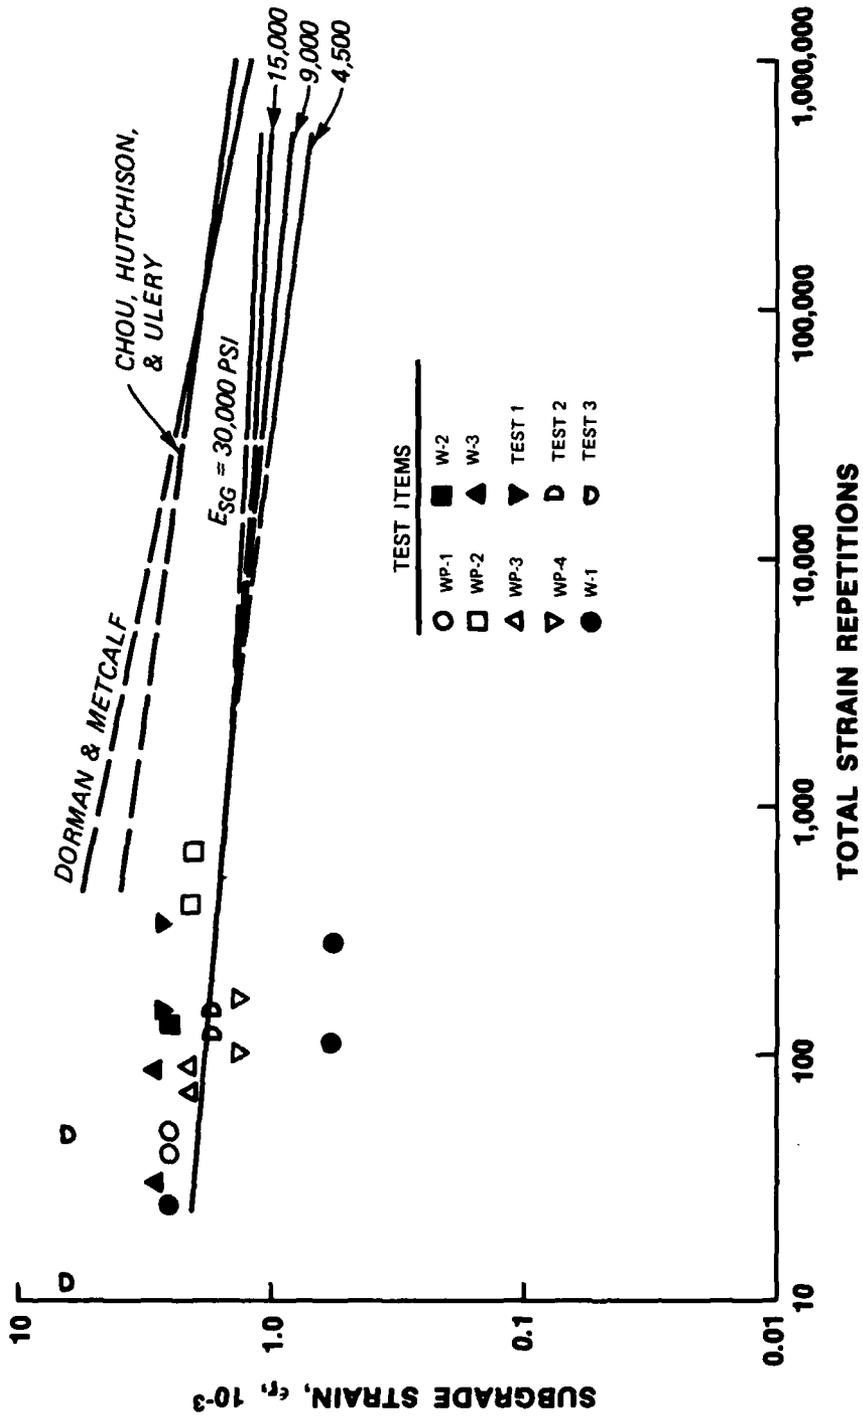
Figure B-57. Limiting Vertical Strain in the Subgrade
