DESIGN OF ALTERNATE LAUNCH AND RECOVERY SURFACES FOR
ENVIRONMENTAL EFFECTS(U) ARMY ENGINEER WATERWAYS
EXPERIMENT STATION VICKSBURG MS GEOTE.

DESIGN OF ALTERNATE LAUNCH AND RECOVERY SURFACES FOR ENVIRONMENTAL EFFECTS

U.S. ARMY ENGINEER WATERWAYS EXPERIMENT STATION
GEOTECHNICAL LABORATORY
P.O. BOX 631, VICKSBURG, MS 39180

JULY 1984

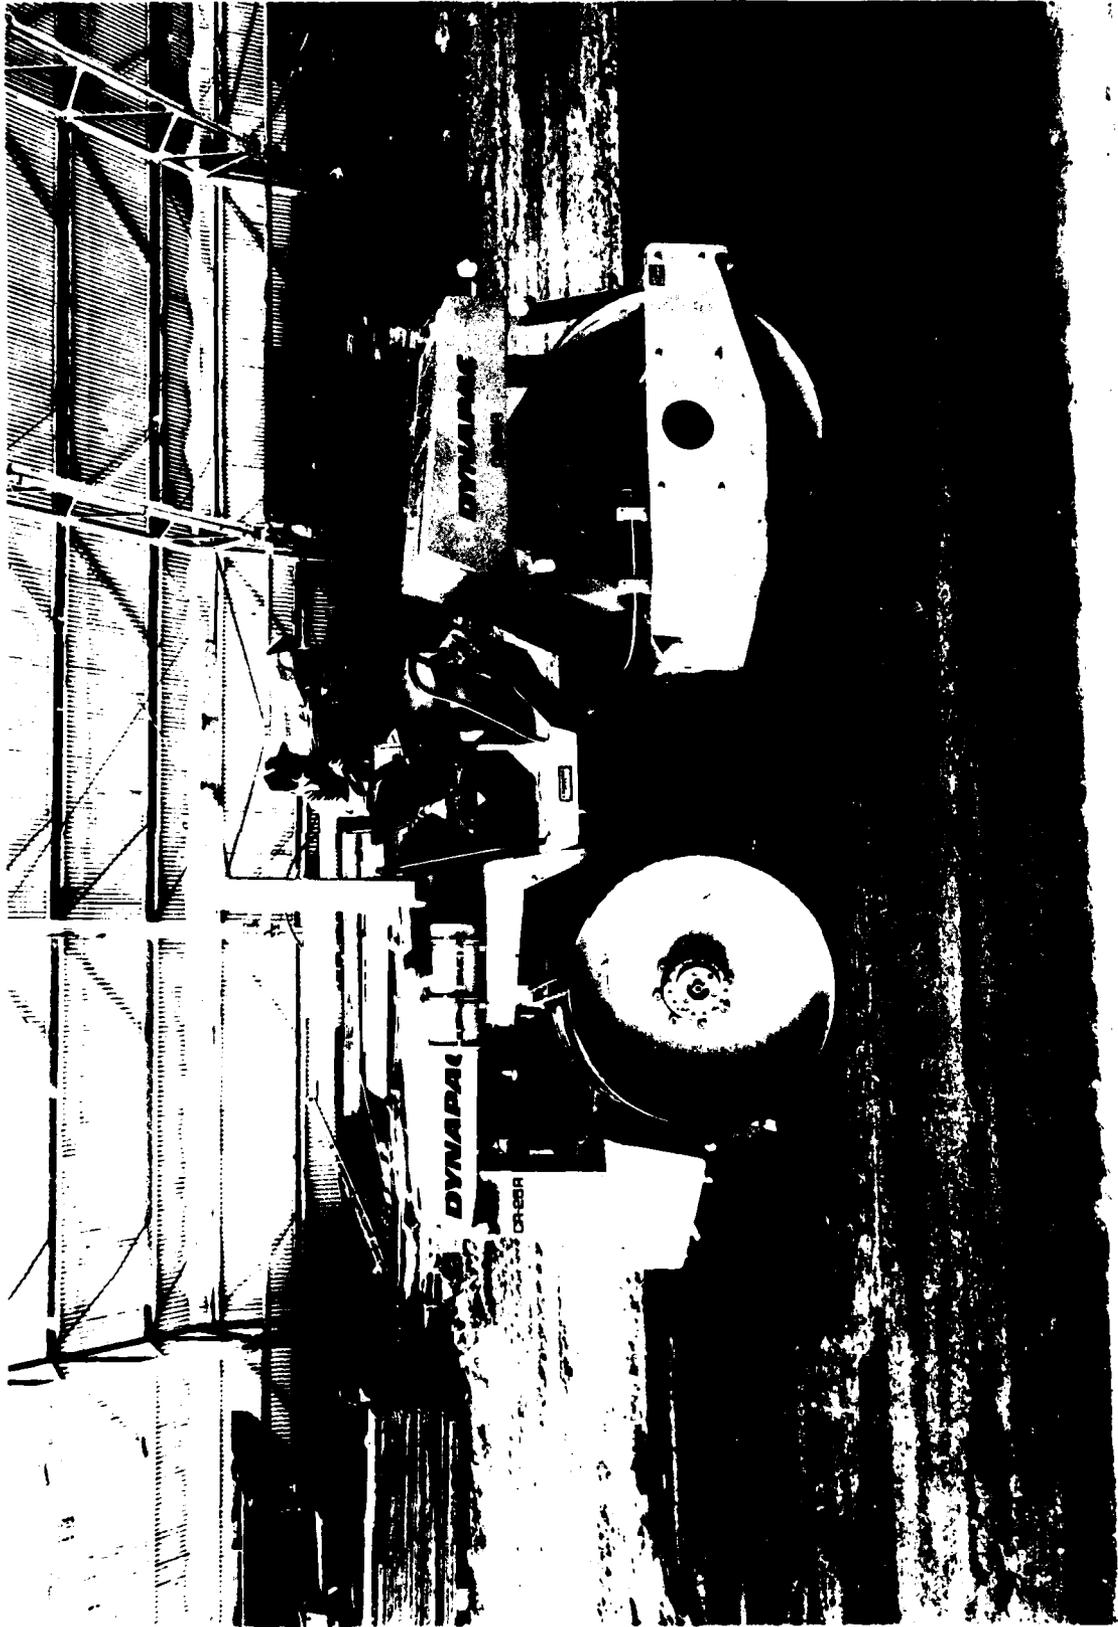
PHOTO C-4. Compacting Asphalt with Vibratory Roller

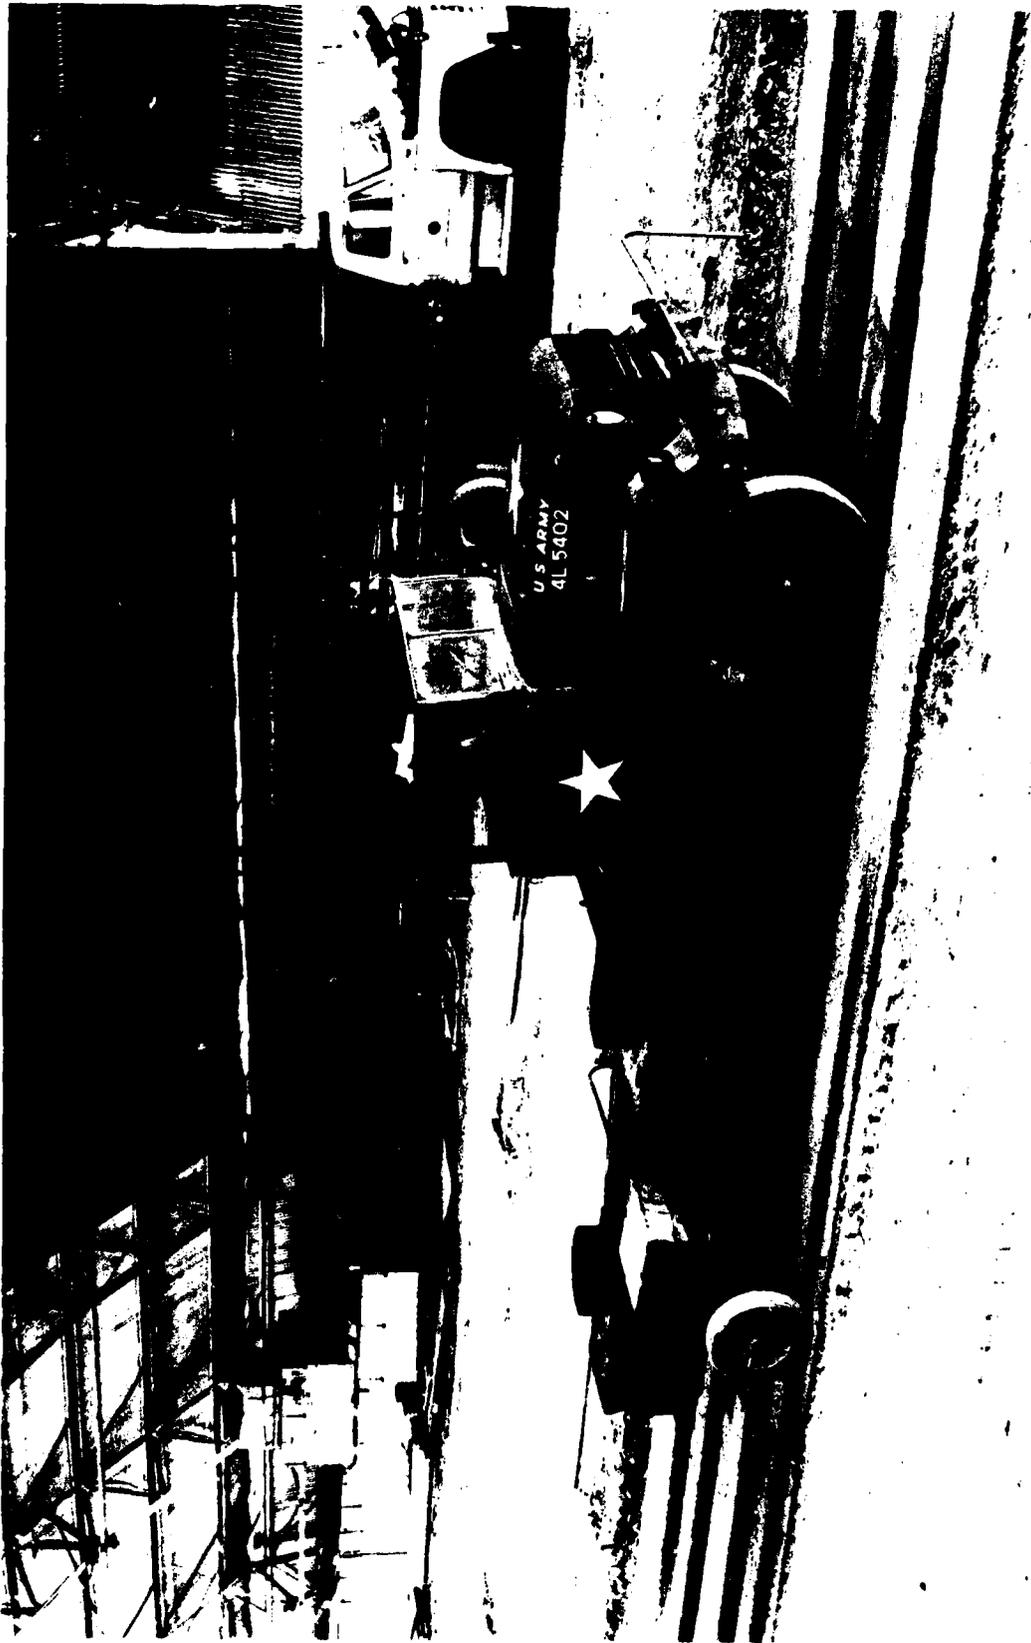
PHOTO C-7. F-4 Aircraft Load Cart

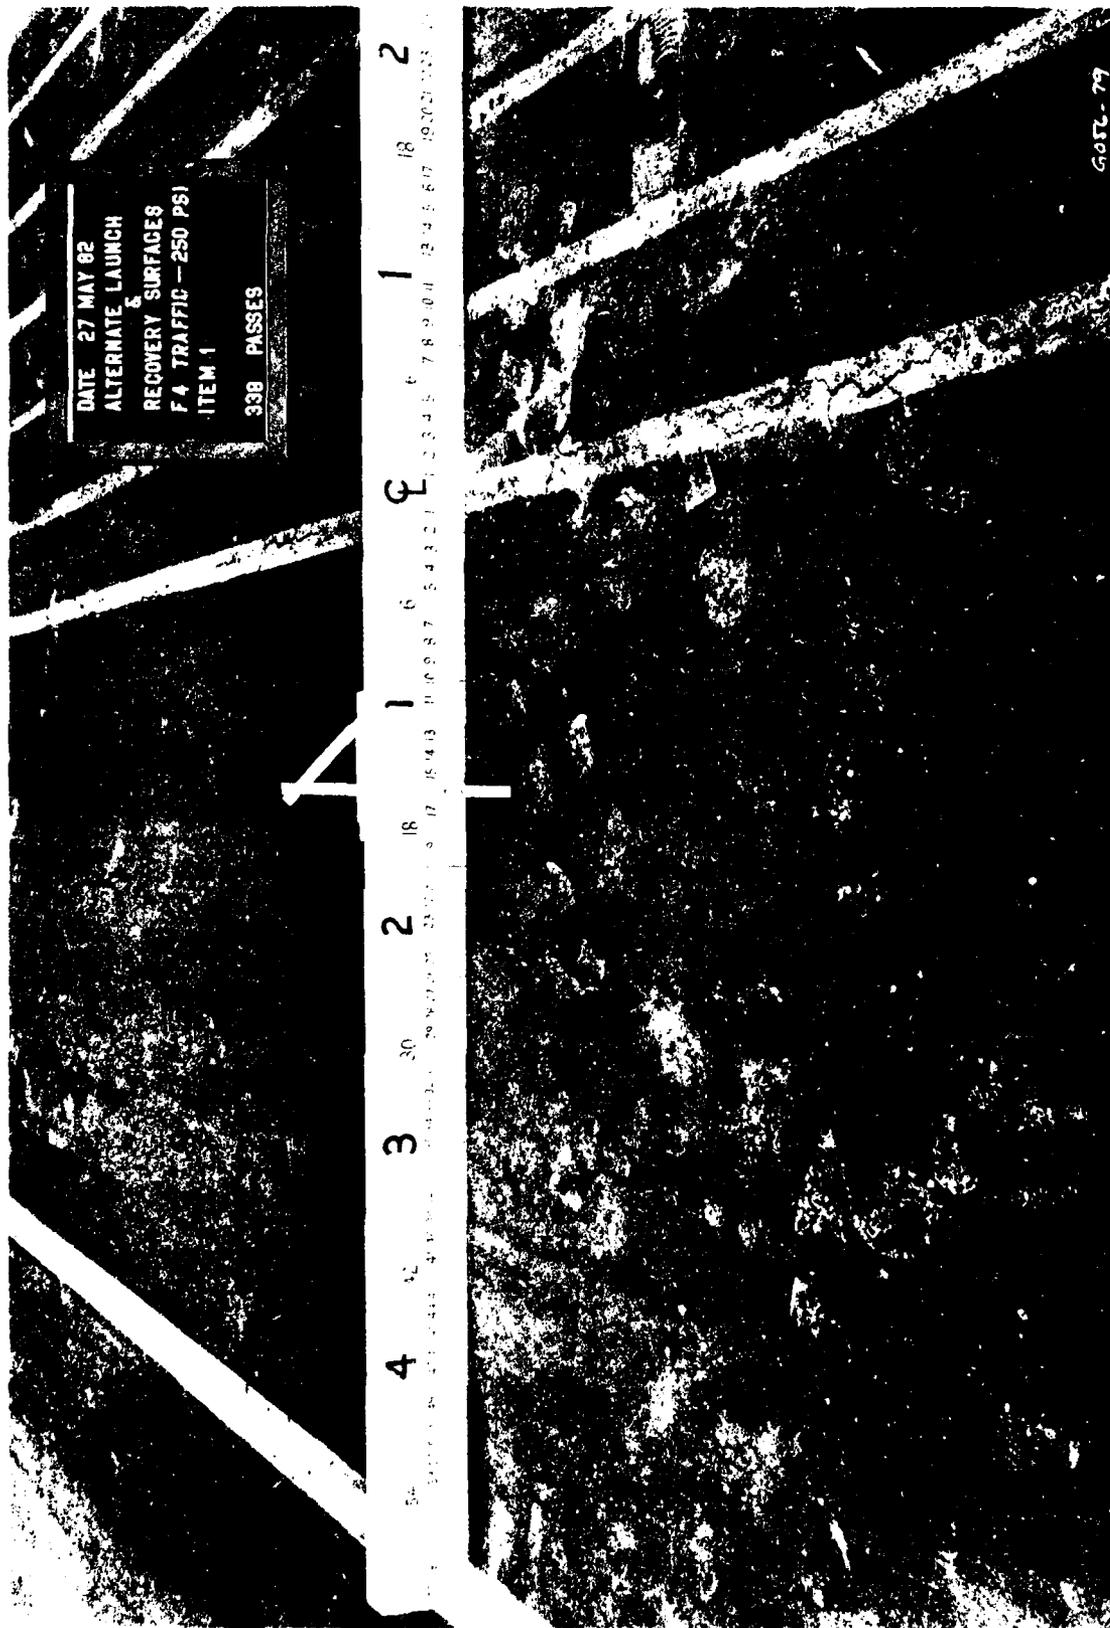
PHOTO C-8. Failure of 2-inch Asphalt (Item 1) Under Distributed Traffic

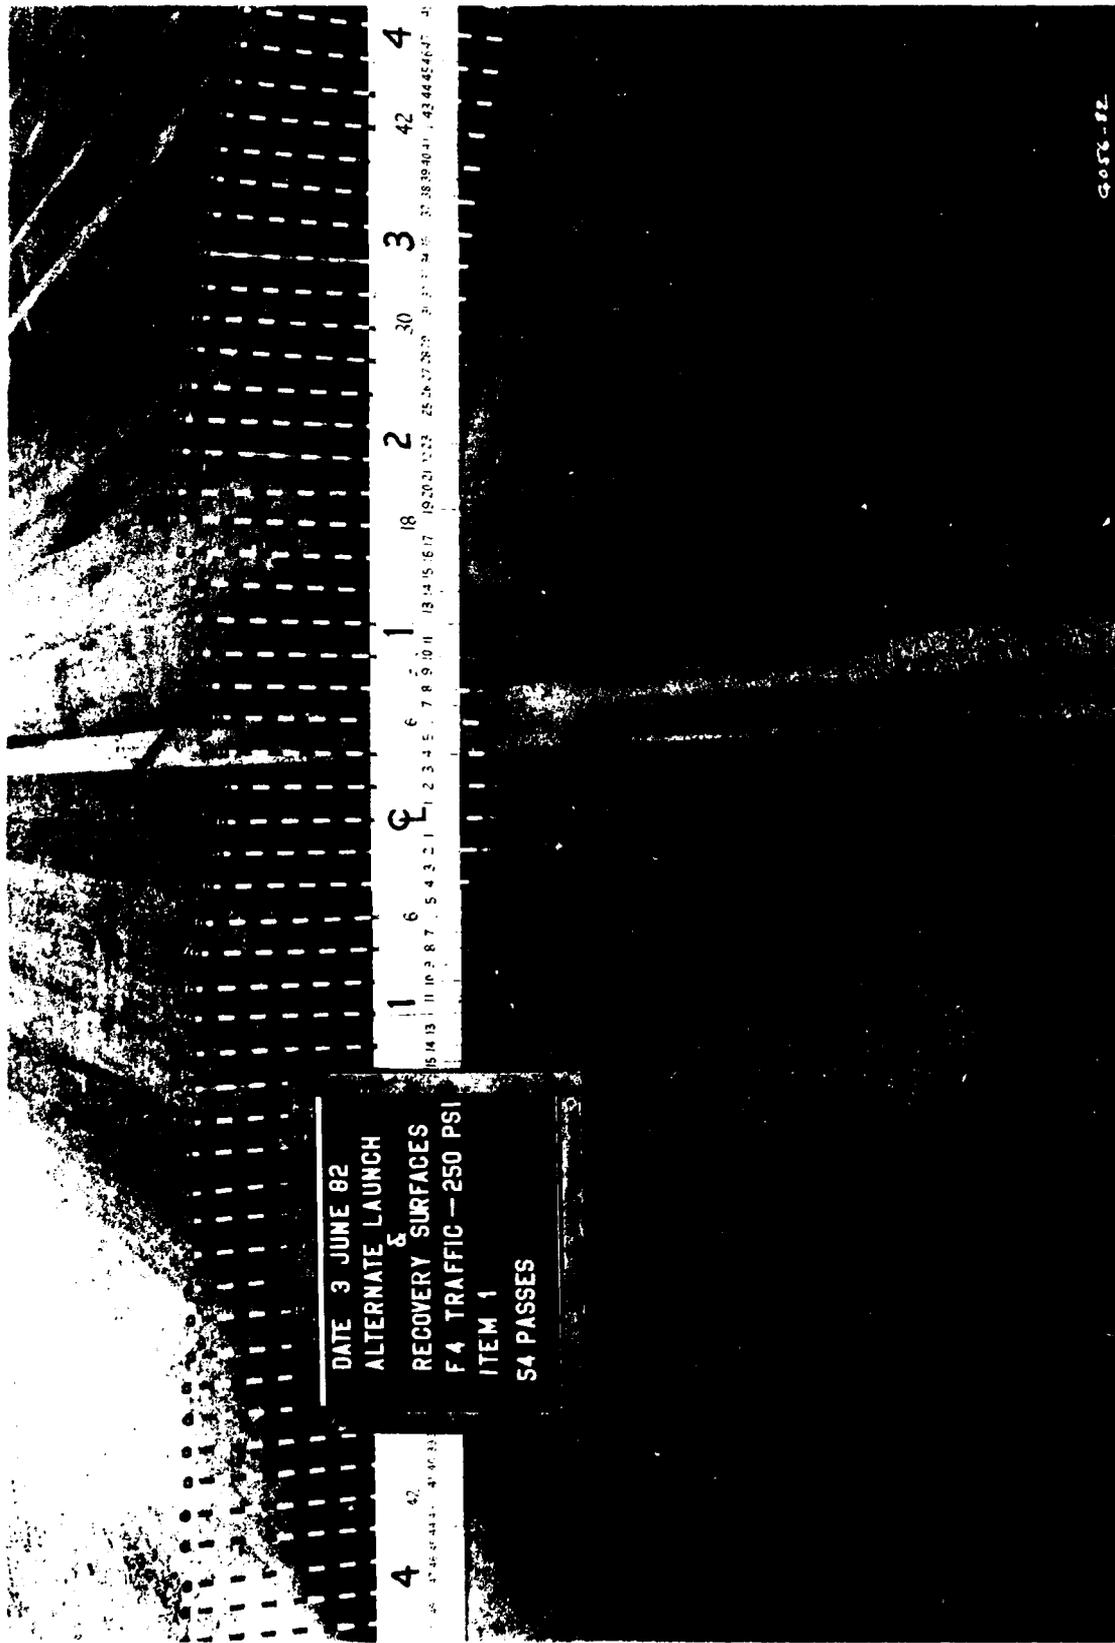
DATE 3 JUNE 82
 ALTERNATE LAUNCH
 &
 RECOVERY SURFACES
 F 4 TRAFFIC - 250 PSI
 ITEM 1
 54 PASSES

PHOTO C-9. Failure of 2-inch Asphalt (Item 1) Under Channelized Traffic

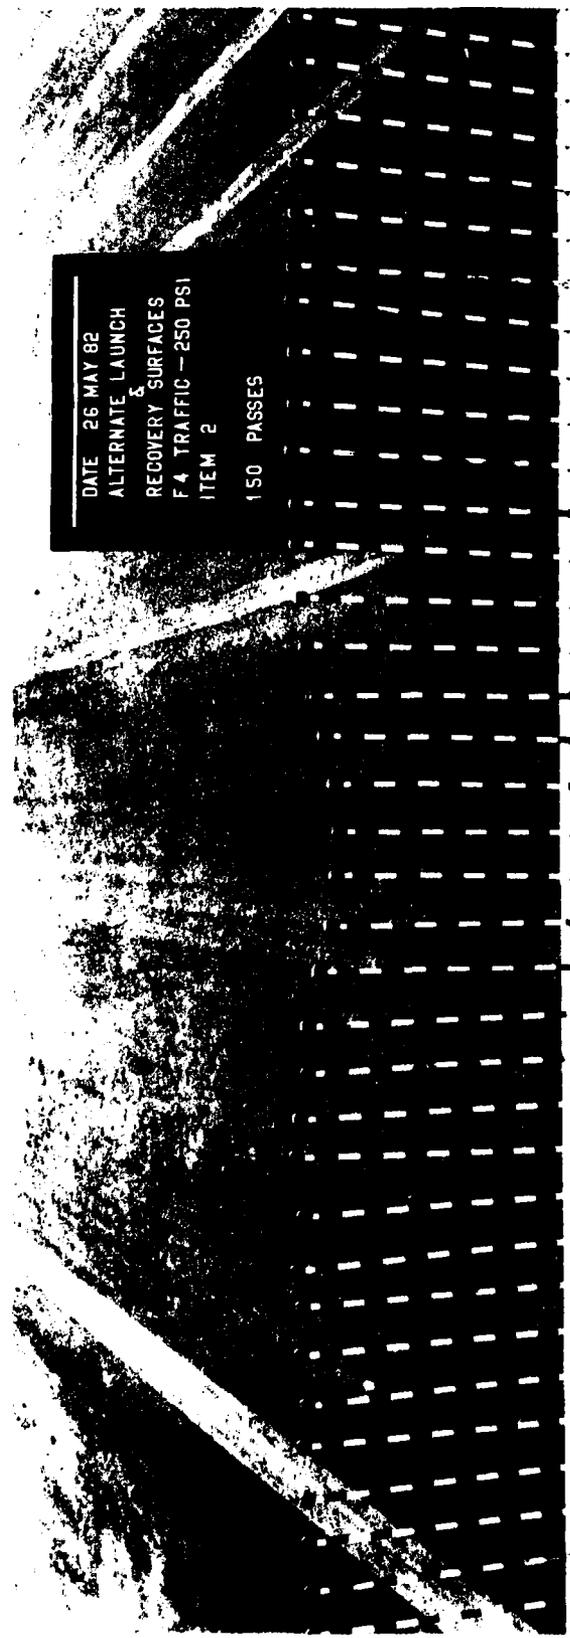
DATE 26 MAY 82
 ALTERNATE LAUNCH
 &
 RECOVERY SURFACES
 F4 TRAFFIC - 250 PSI
 ITEM 2
 150 PASSES

PHOTO C-11. Failure of 1-inch Asphalt (Item 2) Under Distributed Traffic

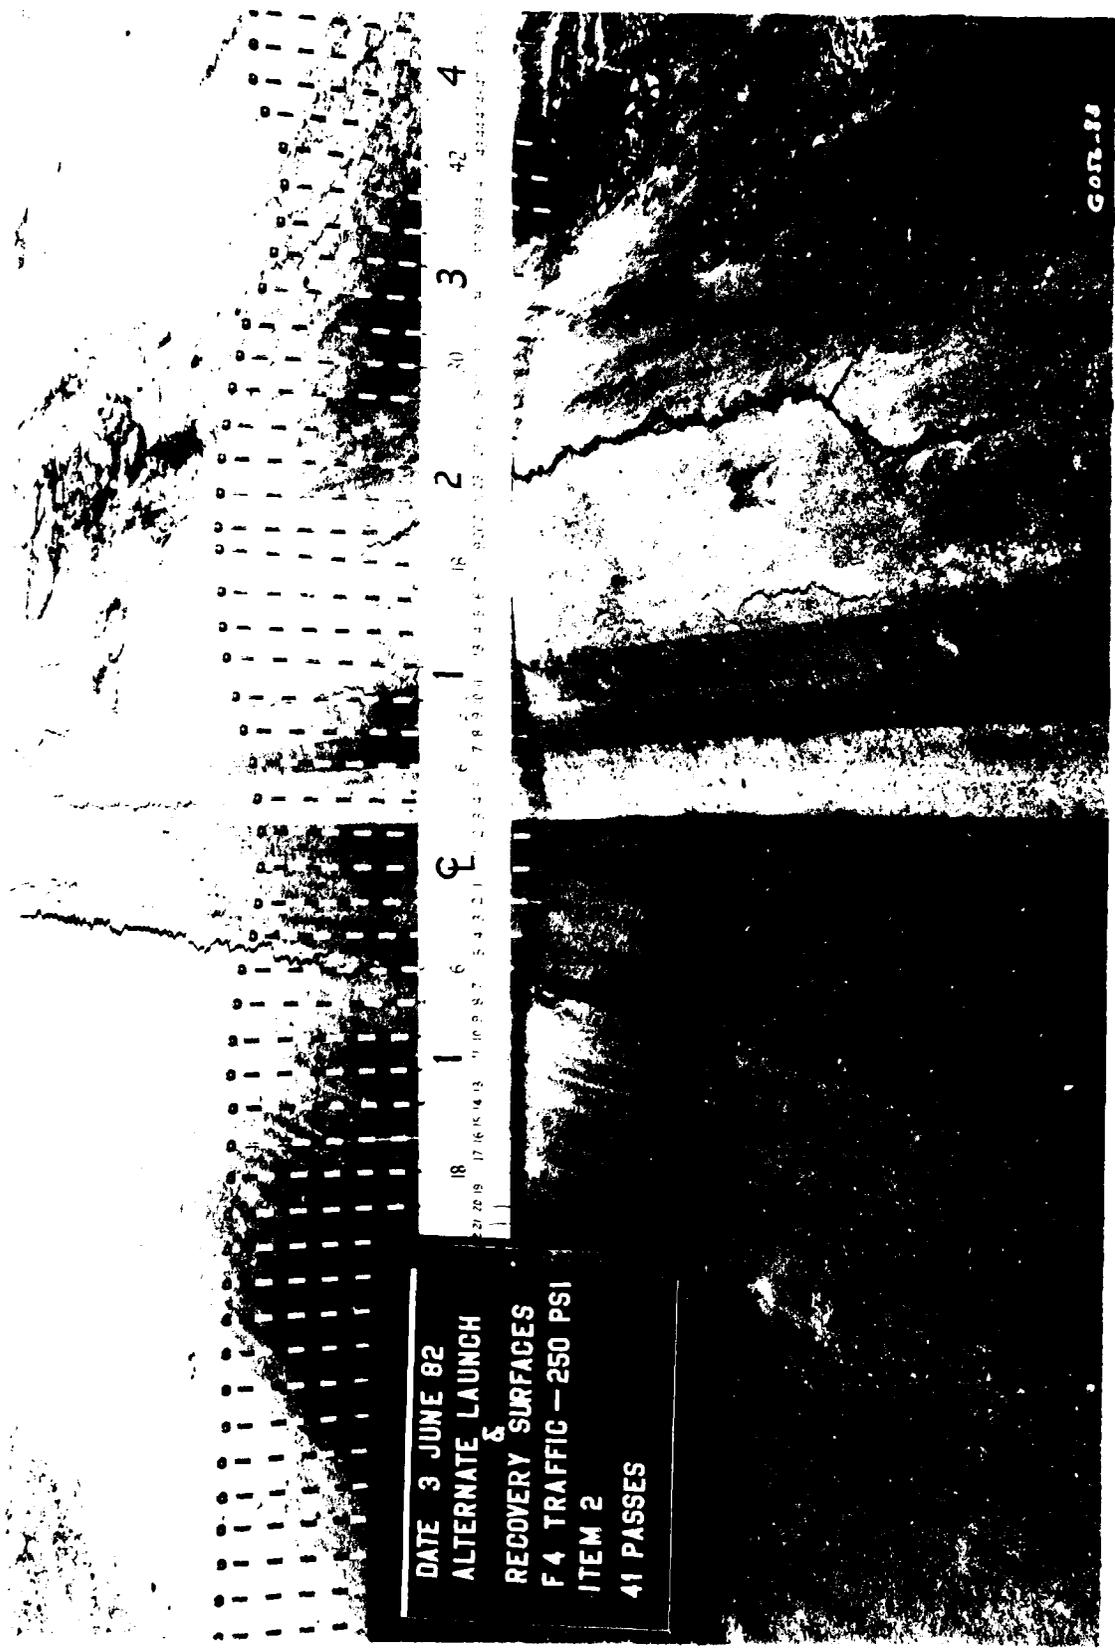
DATE 3 JUNE 82
ALTERNATE LAUNCH
&
RECOVERY SURFACES
F 4 TRAFFIC - 250 PSI
ITEM 2
41 PASSES

PHOTO C-12. Failure of 1-inch Asphalt (Item 2) Under Channelized Traffic

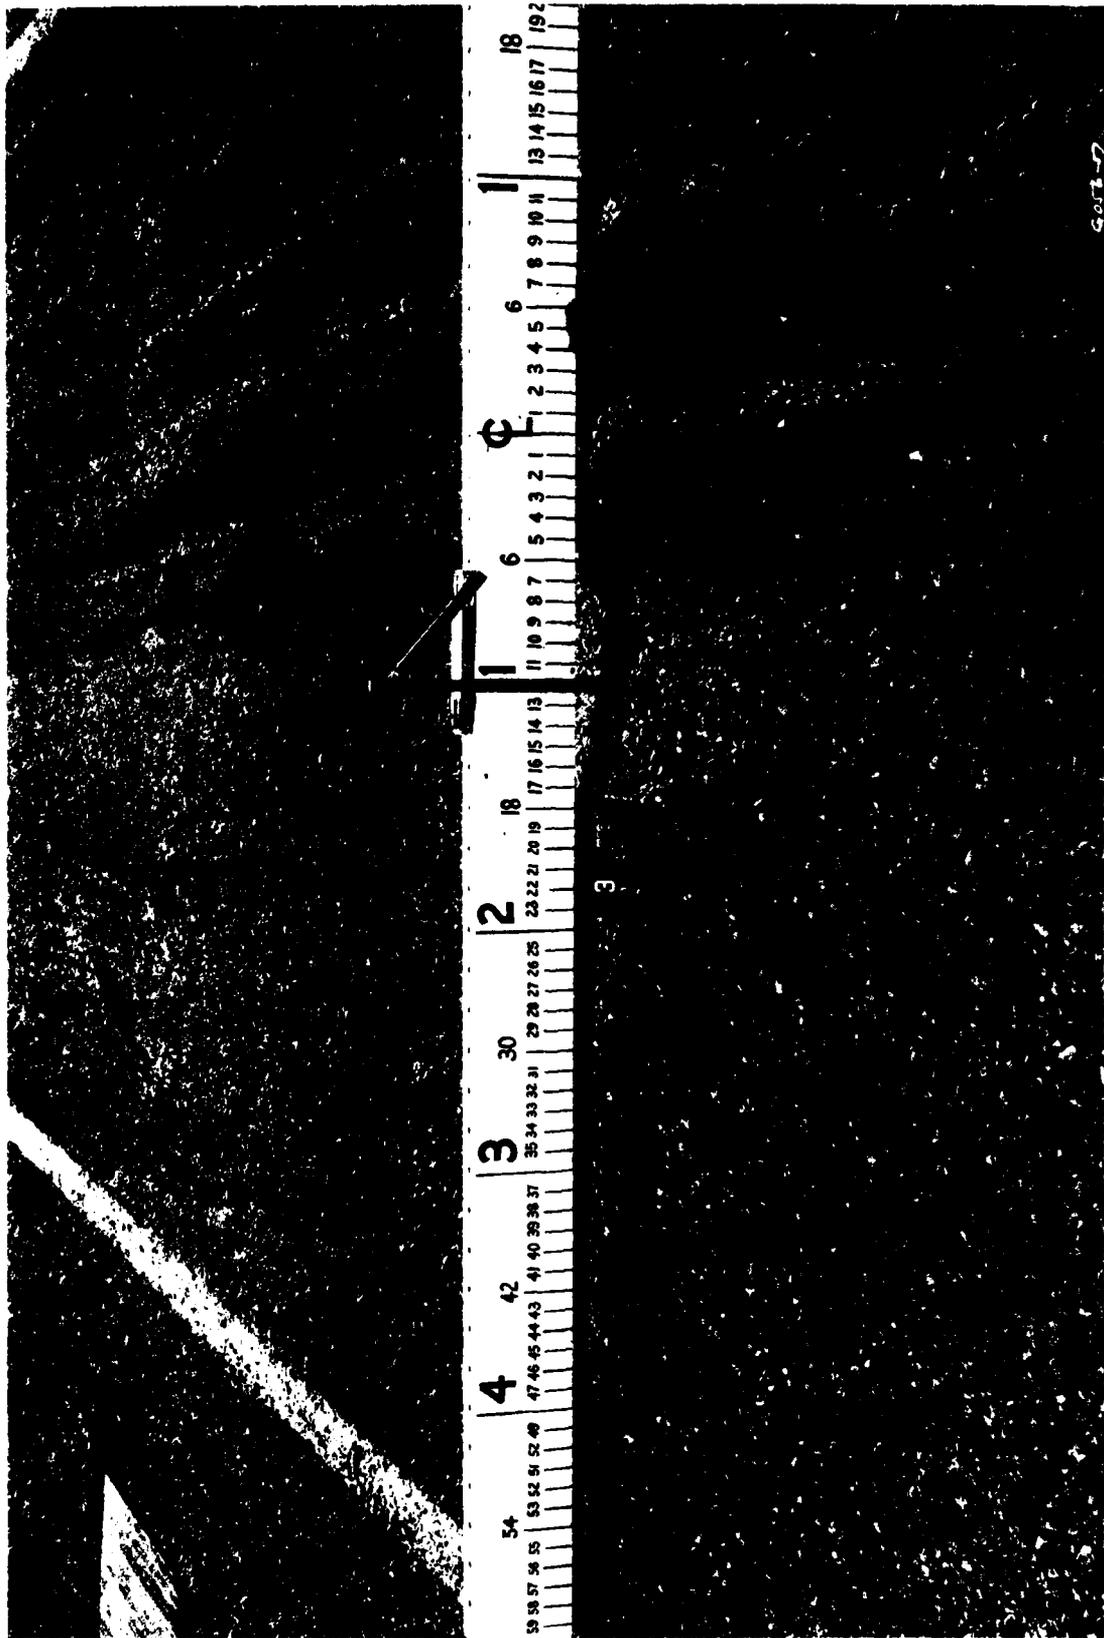
PHOTO C-14. Failure of DBST (Item 3) Under Distributed Traffic (48 Passes)

In all wheel load tests, the surface treatment cracked significantly as deformations occurred in the underlying base course. The cracking and breaking up of the surface treatment indicated that it would not be adequate for a long-term ALRS surfacing.

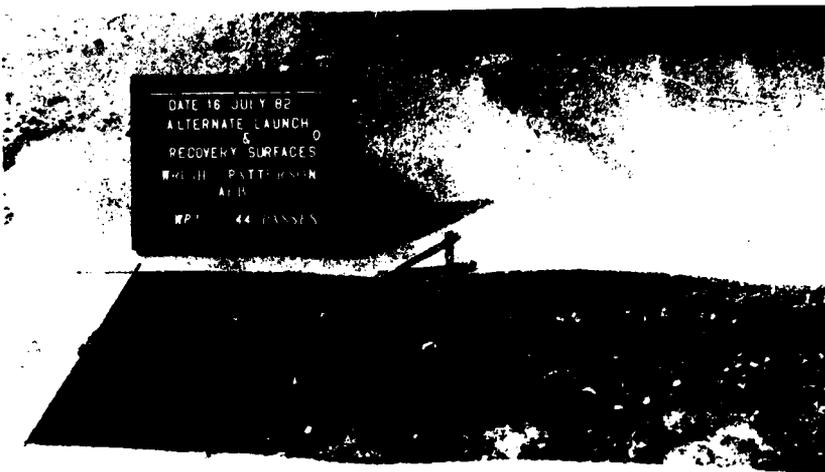
PHOTO C-17. Typical View of Test Trench After Removal of Pavement Surface

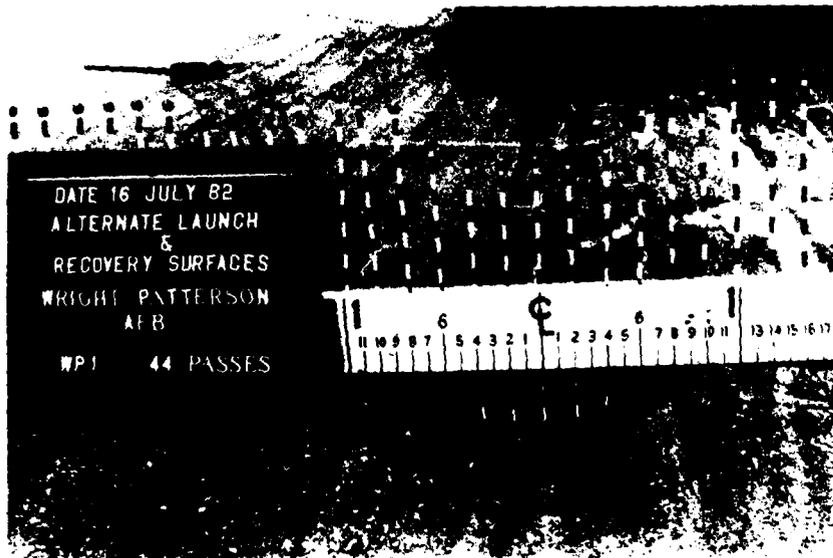
PHOTO C-20. Closeup of Measurement Showing Maximum Deformation at Failure

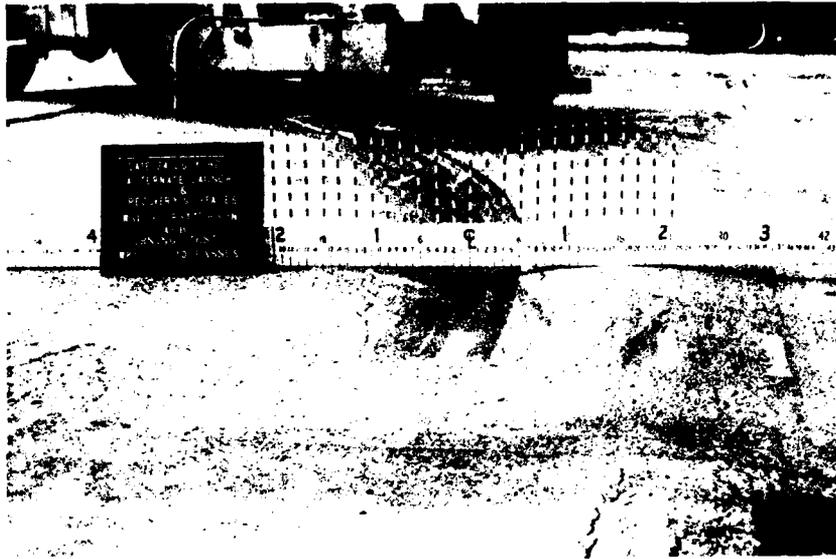
PHOTO C-21. View Showing 2-inch Rut Depth After 10 Passes of the Turning Test

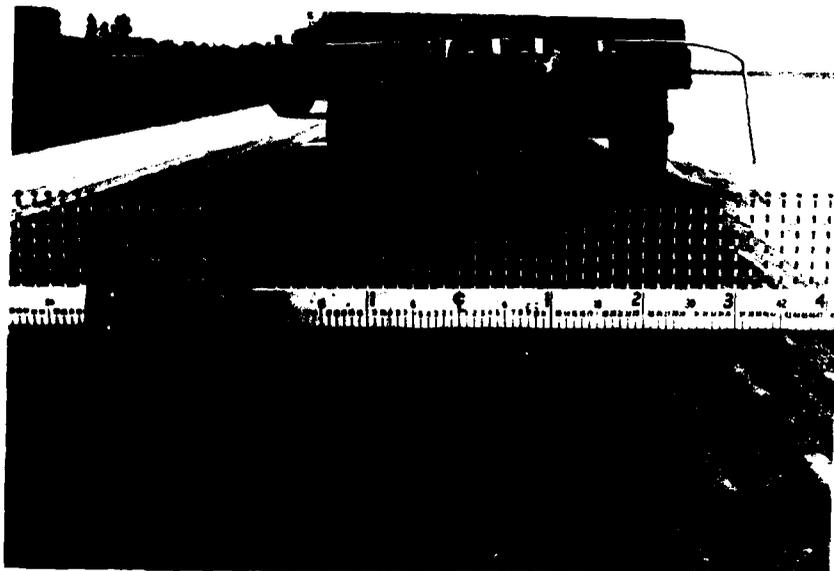
PHOTO C-24. WP-2 Test Feature After 240 Passes

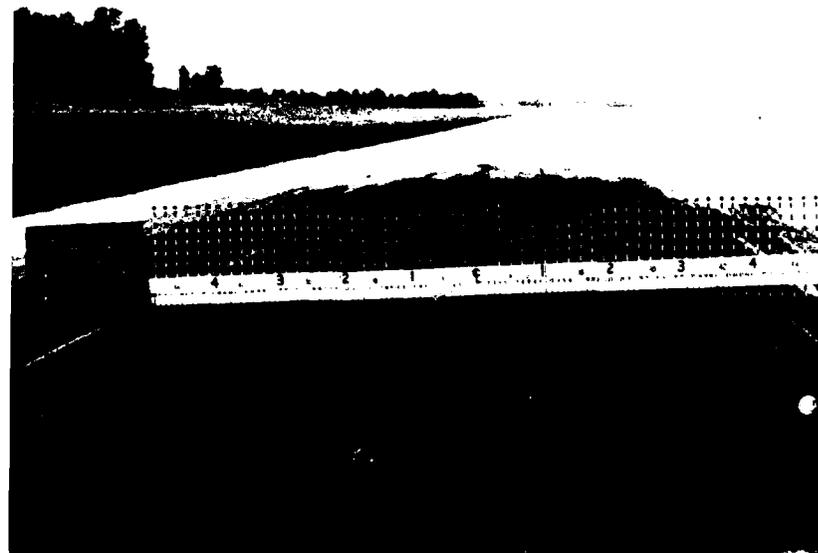
PHOTO C-26. Failure of Test Features WP-2, Rut Depth in Excess of 3 Inches

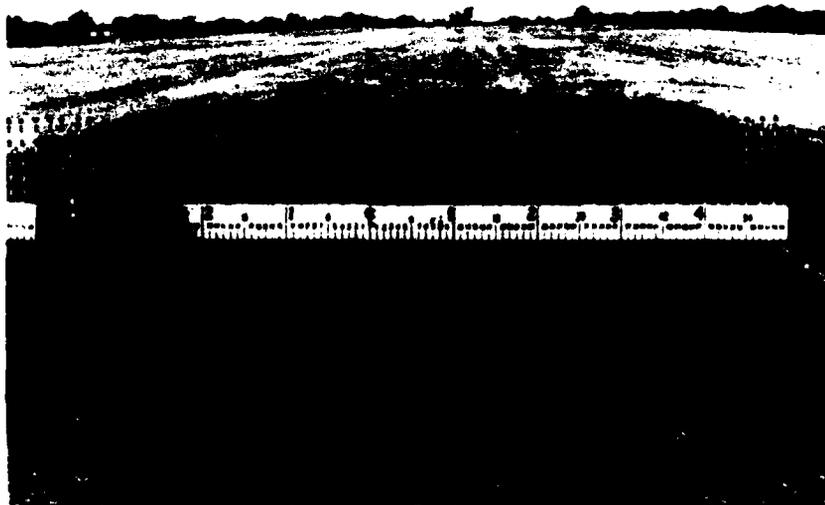
PHOTO C-38. Failed Condition of the W-1 Feature; Rut Depth in Excess of 3 Inches

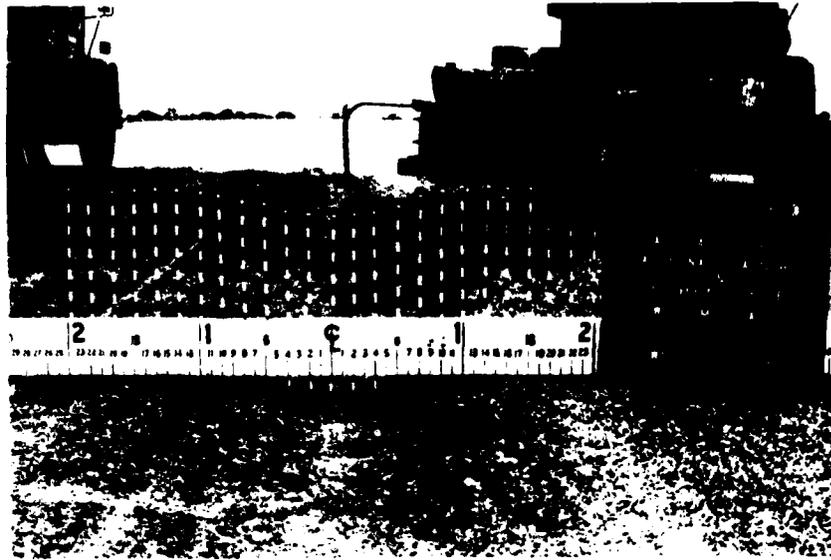
PHOTO C-39. View of Turning Test Area After Completing 75 Passes

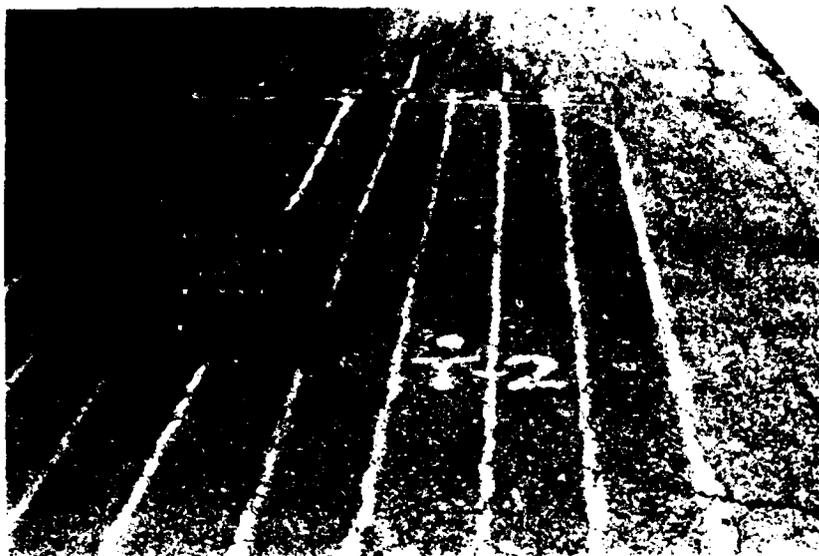
PHOTO C-45. View of Turning Test Area Before Traffic

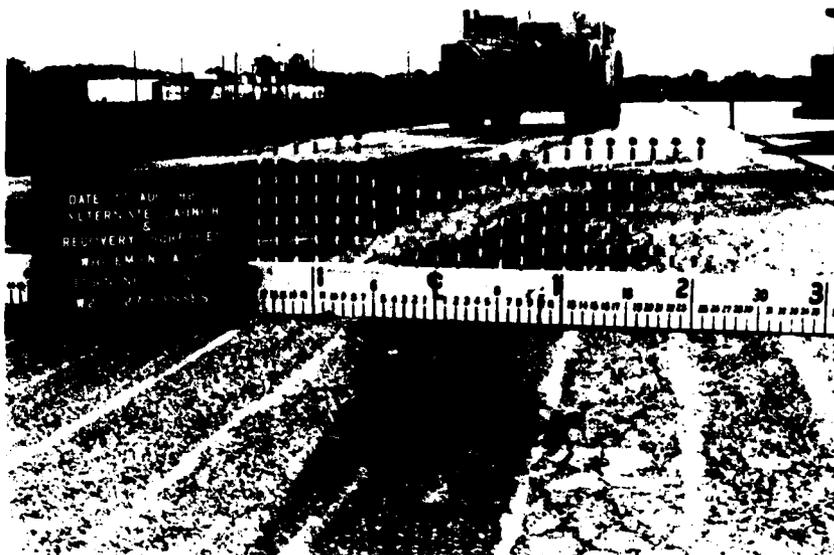
PHOTO C-47. View of Turning Test Area After Failure
