A HISTORY OF FULL-SCALE TESTING OF AIRCRAFT STRUCTURES AT THE NATIONAL AERONAUTICAL ESTABLISHMENT

R.L. Hewitt

National Aeronautical Establishment

AERONAUTICAL NOTE
NAE-AN-24
NRC NO. 24089

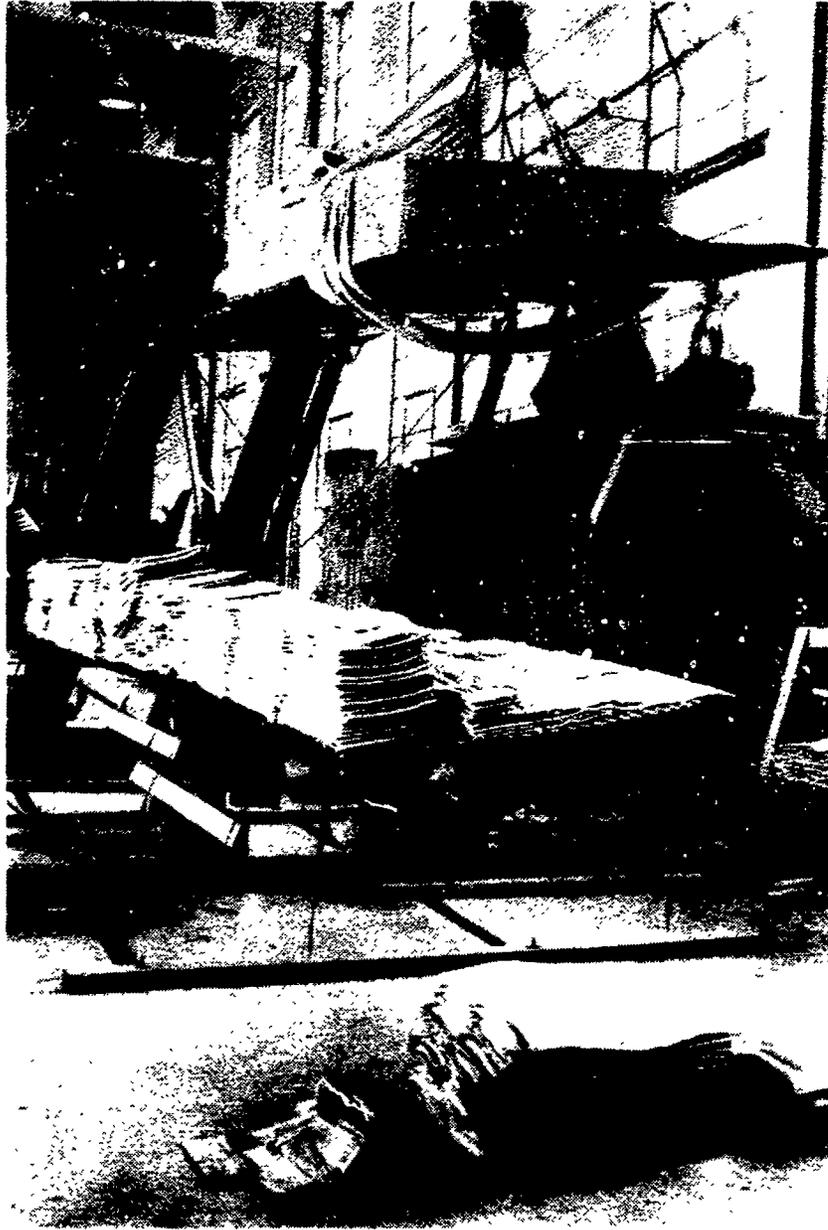
FIG. 2: PROOF LOAD TEST ON AN 800-HOUR TIGER MOTH WING

They were rigged in the inverted position in a test stand as shown in Figures 1 and 2 with root end fittings provided to apply the correct type of reaction. Slot and balancing loads were provided by loading platforms and a system of wooden levers (early whiffletrees) while a box on the lower wing was located to provide strut reactions. Short slats spanned the rib intervals and transmitted shot bag loads directly to the rib trusses. A frame supported by hydraulic jacks provided an abutment for the structure to rest on during loading operations, while a sling was loosely looped around the lower wing as a precautionary measure. Deflections along the leading and trailing edges were measured by a mechanical "strain gauge" reading to 0.001 ft. All wings were loaded to 120% of ultimate load without collapse and it was concluded that there was no evidence of deterioration with age or failure in the glued joints.

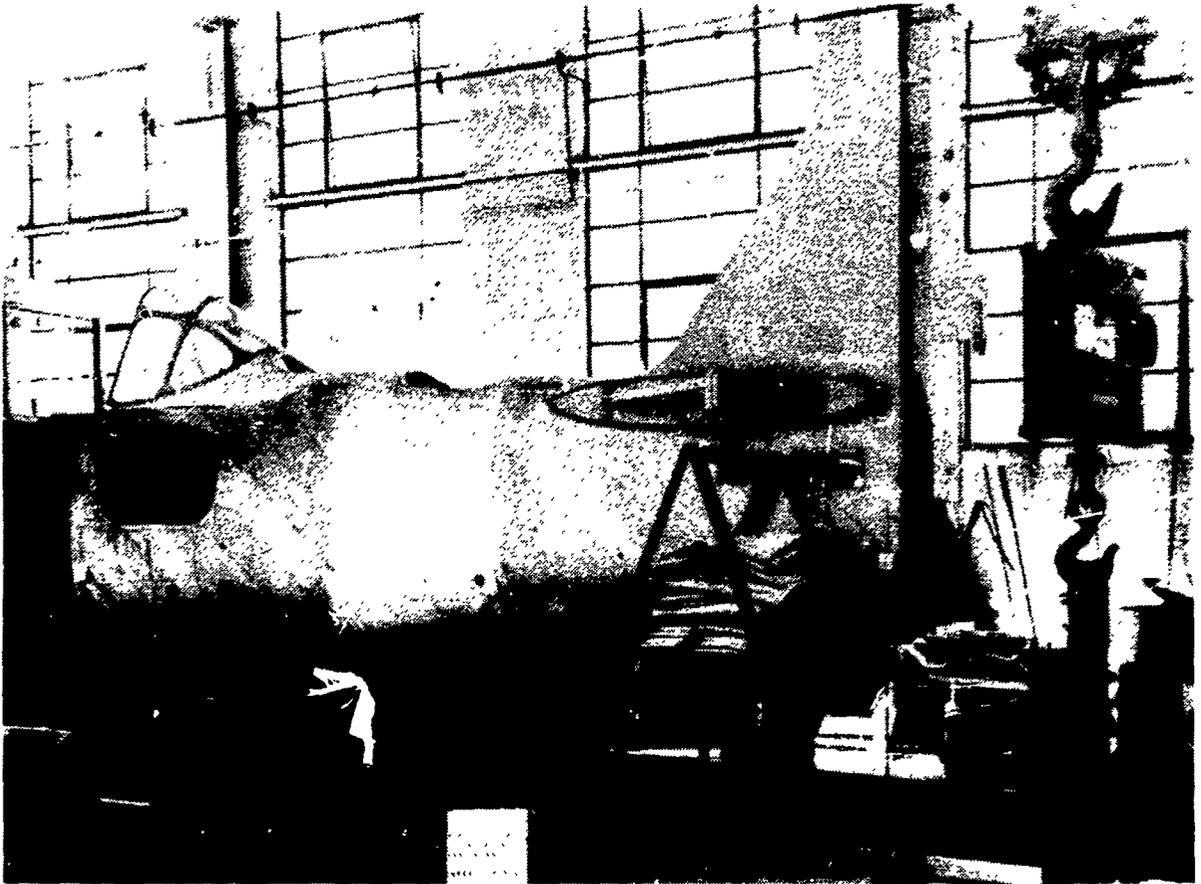
**FIG. 6: MOULDED PLYWOOD HARVARD FUSELAGE UNDER ULTIMATE DESIGN LOAD
FOR A SPECIAL TAILWHEEL CONDITION AFTER REPAIR**

positions (Figure 7) for various loading conditions and loads applied by means of lead weights and lead shot bags for down loads and by a hand hoist, scale balance and a steel beam for up loads. Deflections were measured with a surveyors level and "strain gauges". All the design loads were successfully carried except for a "special tailwheel condition B" which resulted in a failure of the lower skin fibres at 100% design load, Figure 8, due to a stress concentration at the sharp corner of the flare cut-out and lack of continuity of the short stiffeners which carried the flare tube brackets. After repair and modification the design load was successfully carried.

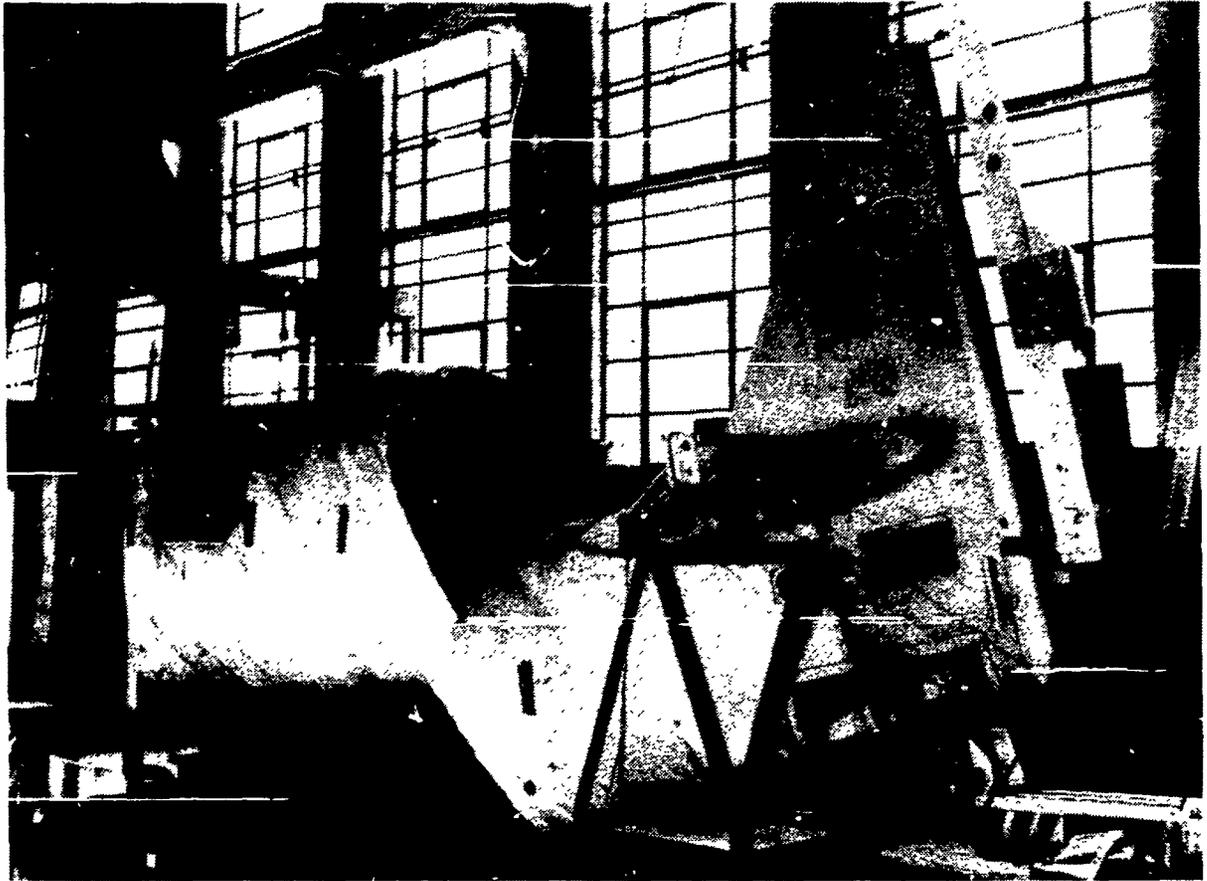
**FIG. 8: FAILURE OF MOULDED PLYWOOD HARVARD FUSELAGE UNDER
A SPECIAL TAILWHEEL CONDITION**

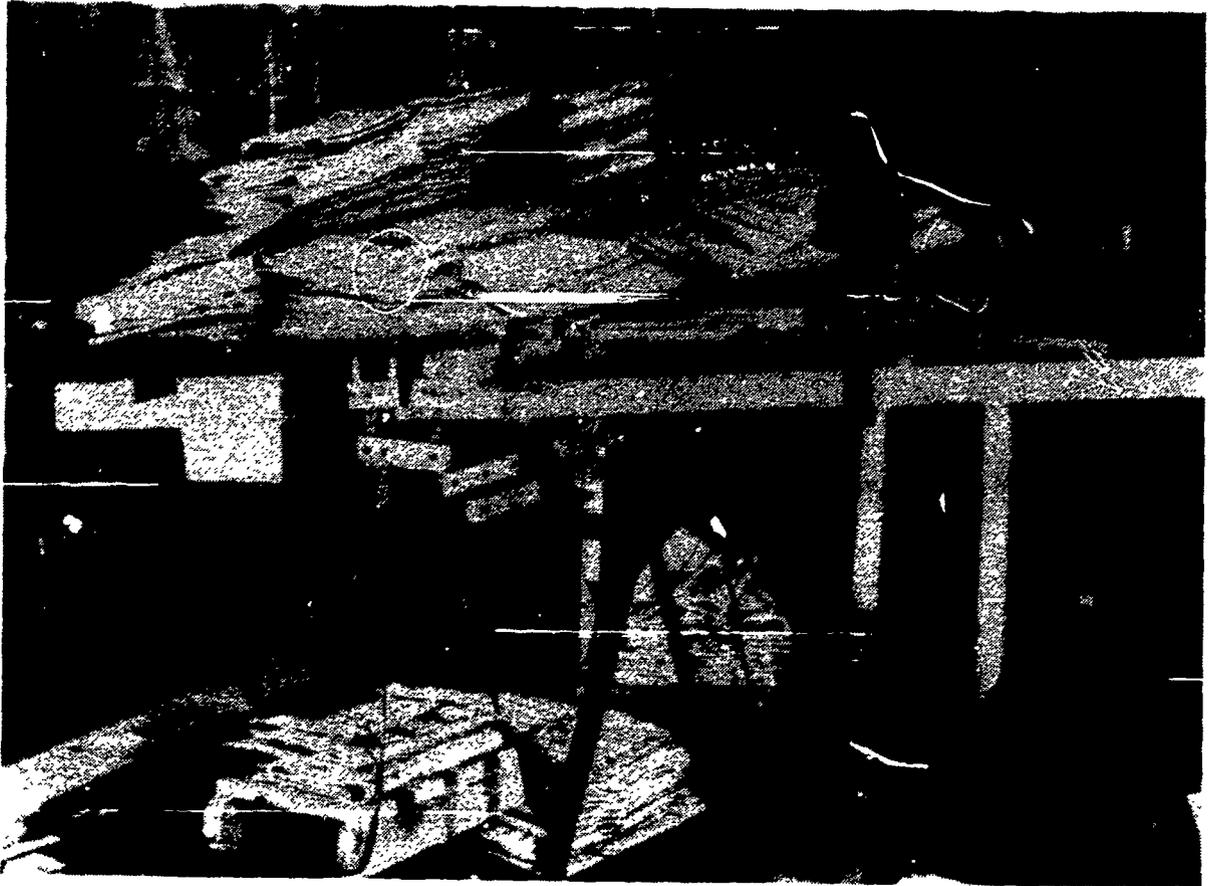
FIG. 9: STATIC TEST OF MOULDED PLYWOOD HARVARD STABILIZER

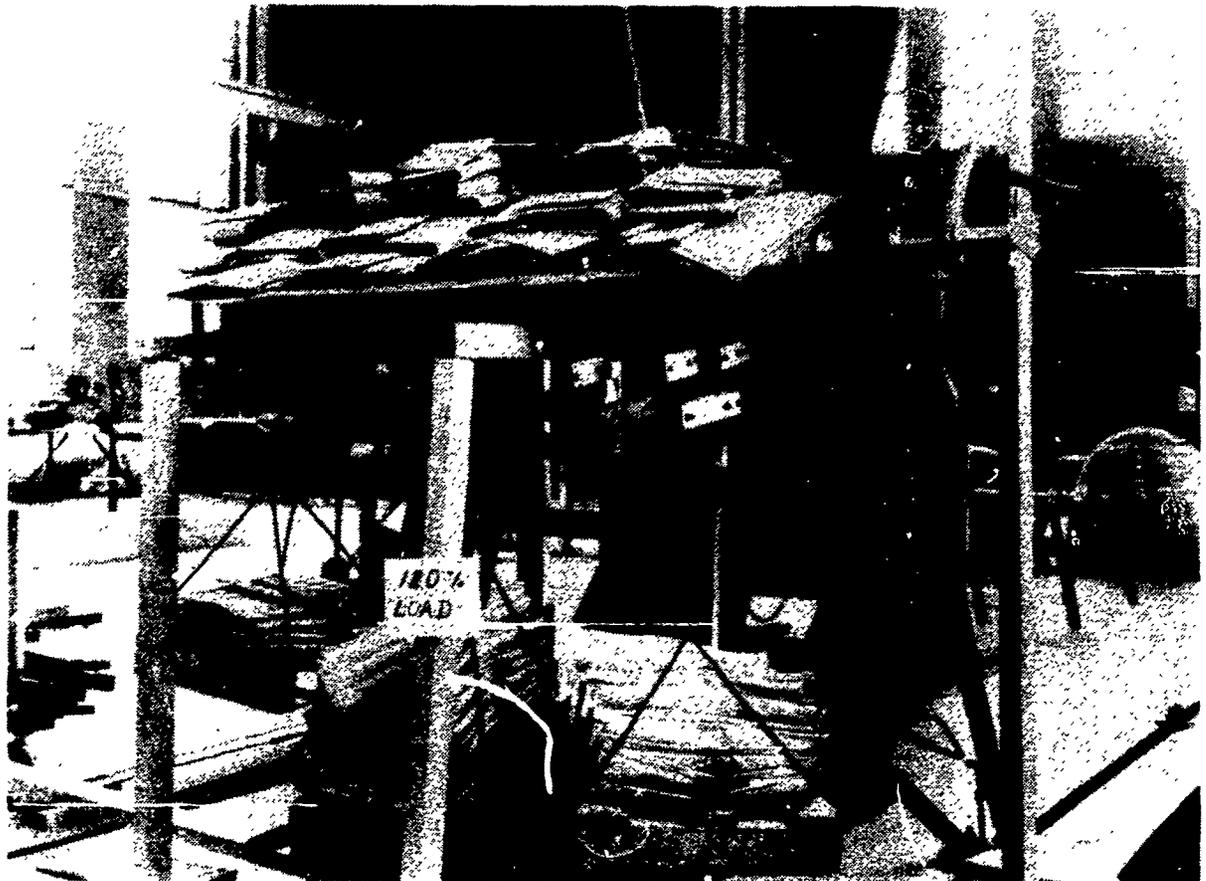
FIG. 10: STATIC TEST OF MOULDED PLYWOOD HARVARD ELEVATOR

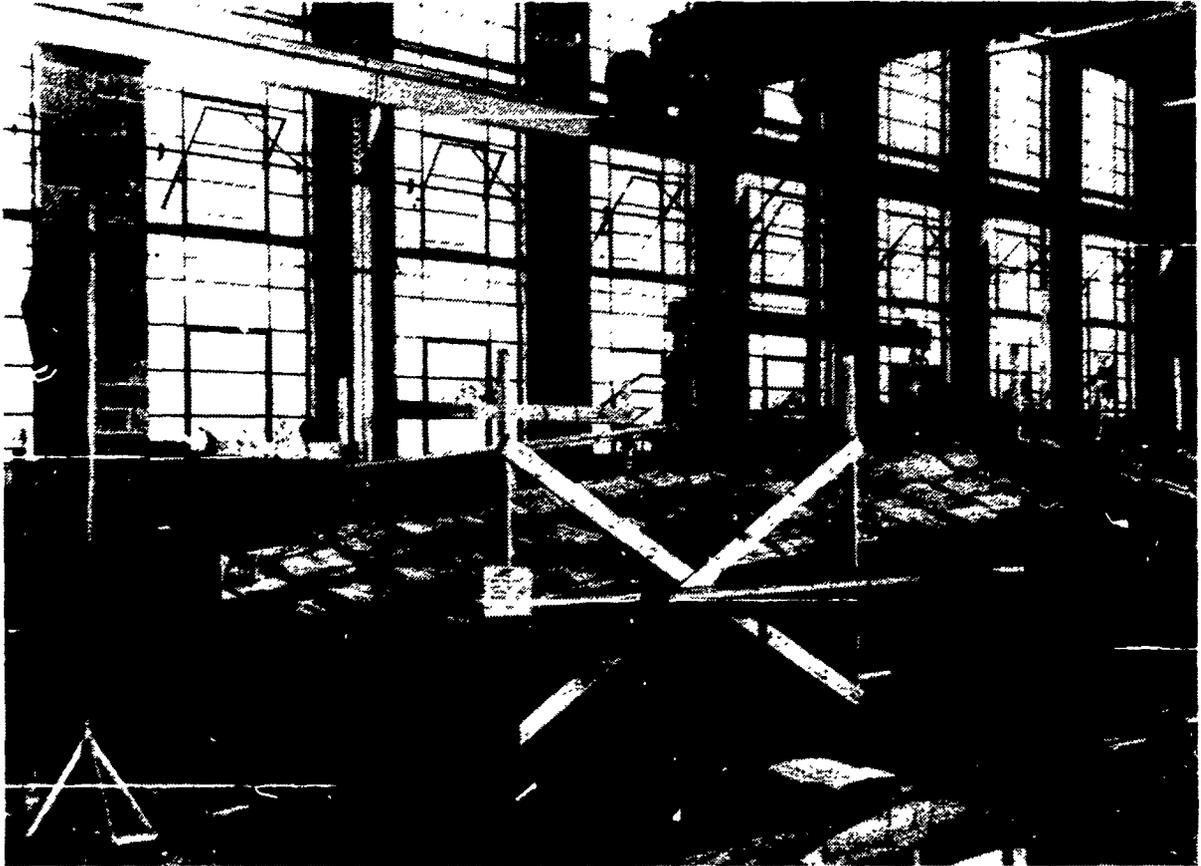
**FIG. 12: ANSON MAINPLANE UNDER LOAD SHOWING WHIFFLETREE
FOR APPLYING ENGINE AND UNDERCARRIAGE LOADS**

In 1943 static tests were conducted on four Anson mainplanes for the Department of National Defence for Air⁽⁶⁾ to determine the reduction in strength resulting from glue deterioration in the spars of two condemned Anson I mainplanes and to determine the strength of a new Canadian built mainplane for use in the Anson V aircraft. The 56.5 ft mainplane was loaded in the inverted position using slats and shot bags in the normal way as shown in Figure 11 while engine and undercarriage loads were provided by a crane reaction through a whiffletree arrangement shown in Figure 12. Deflections were measured by the same mechanical "strain gauges" referred to above, although in this report they are called "tape strain gauges", while dial gauges were used to monitor the deflection of the test stand. The condemned mainplanes, one classed as in "very bad condition" (and labelled "write-off") and one in "fairly bad condition" failed at 75% and 90% respectively of the design loading while the new mainplane failed at 95% design load. It was concluded after observing the failures that while the glue in the old spars (a cold setting urea formaldehyde) had deteriorated to some extent, the mainplanes had not failed as a result of this deterioration, but had failed like the new one at the centre section of the tension spar where a 5/8 inch bolt hole reduced the section. As a result of this observation, a further condemned mainplane in a similar condition to the previous two was modified by the addition of a 5/8 inch birch lamination in the critical area. This modified wing failed at 105% of the design load at a different location.

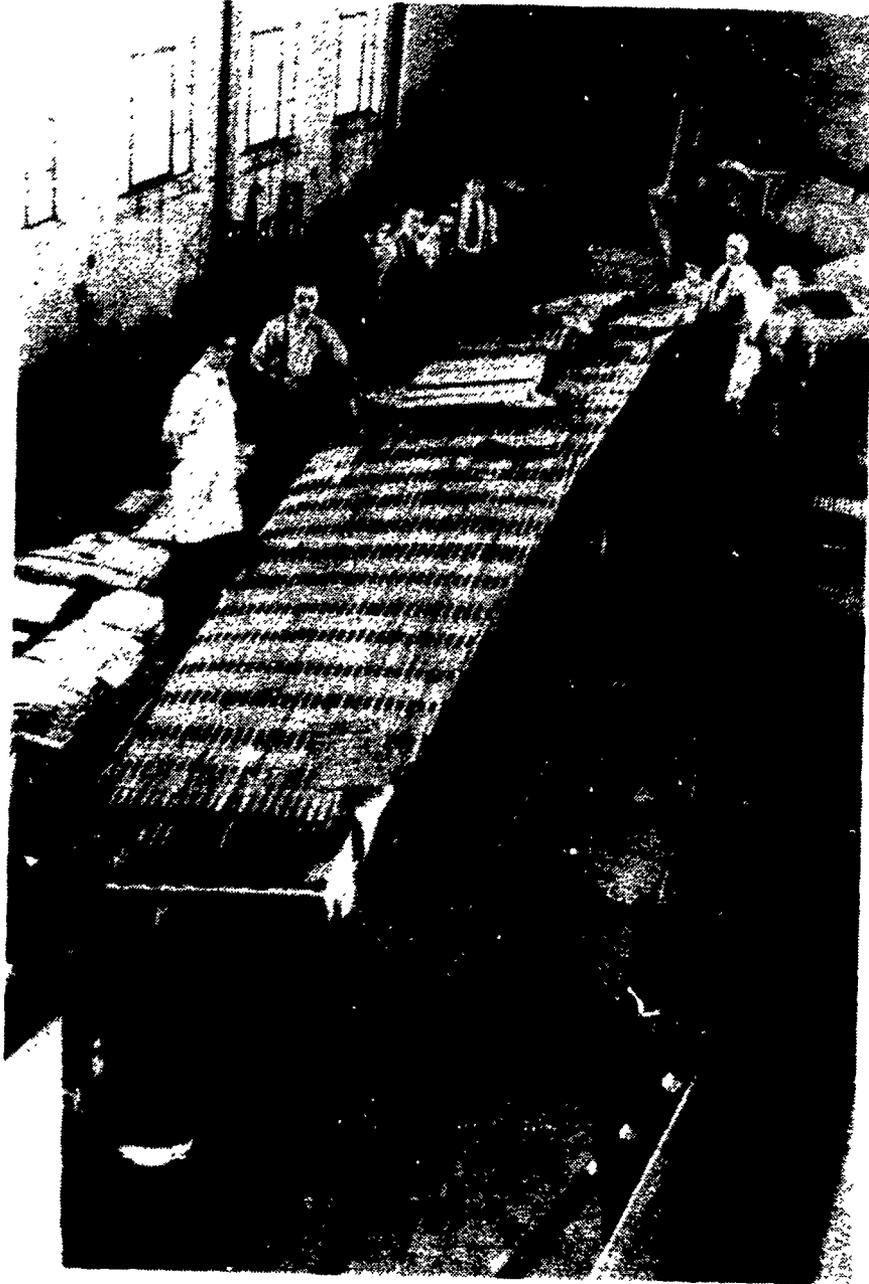
FIG. 15: TEST SET-UP FOR CORNELL WING

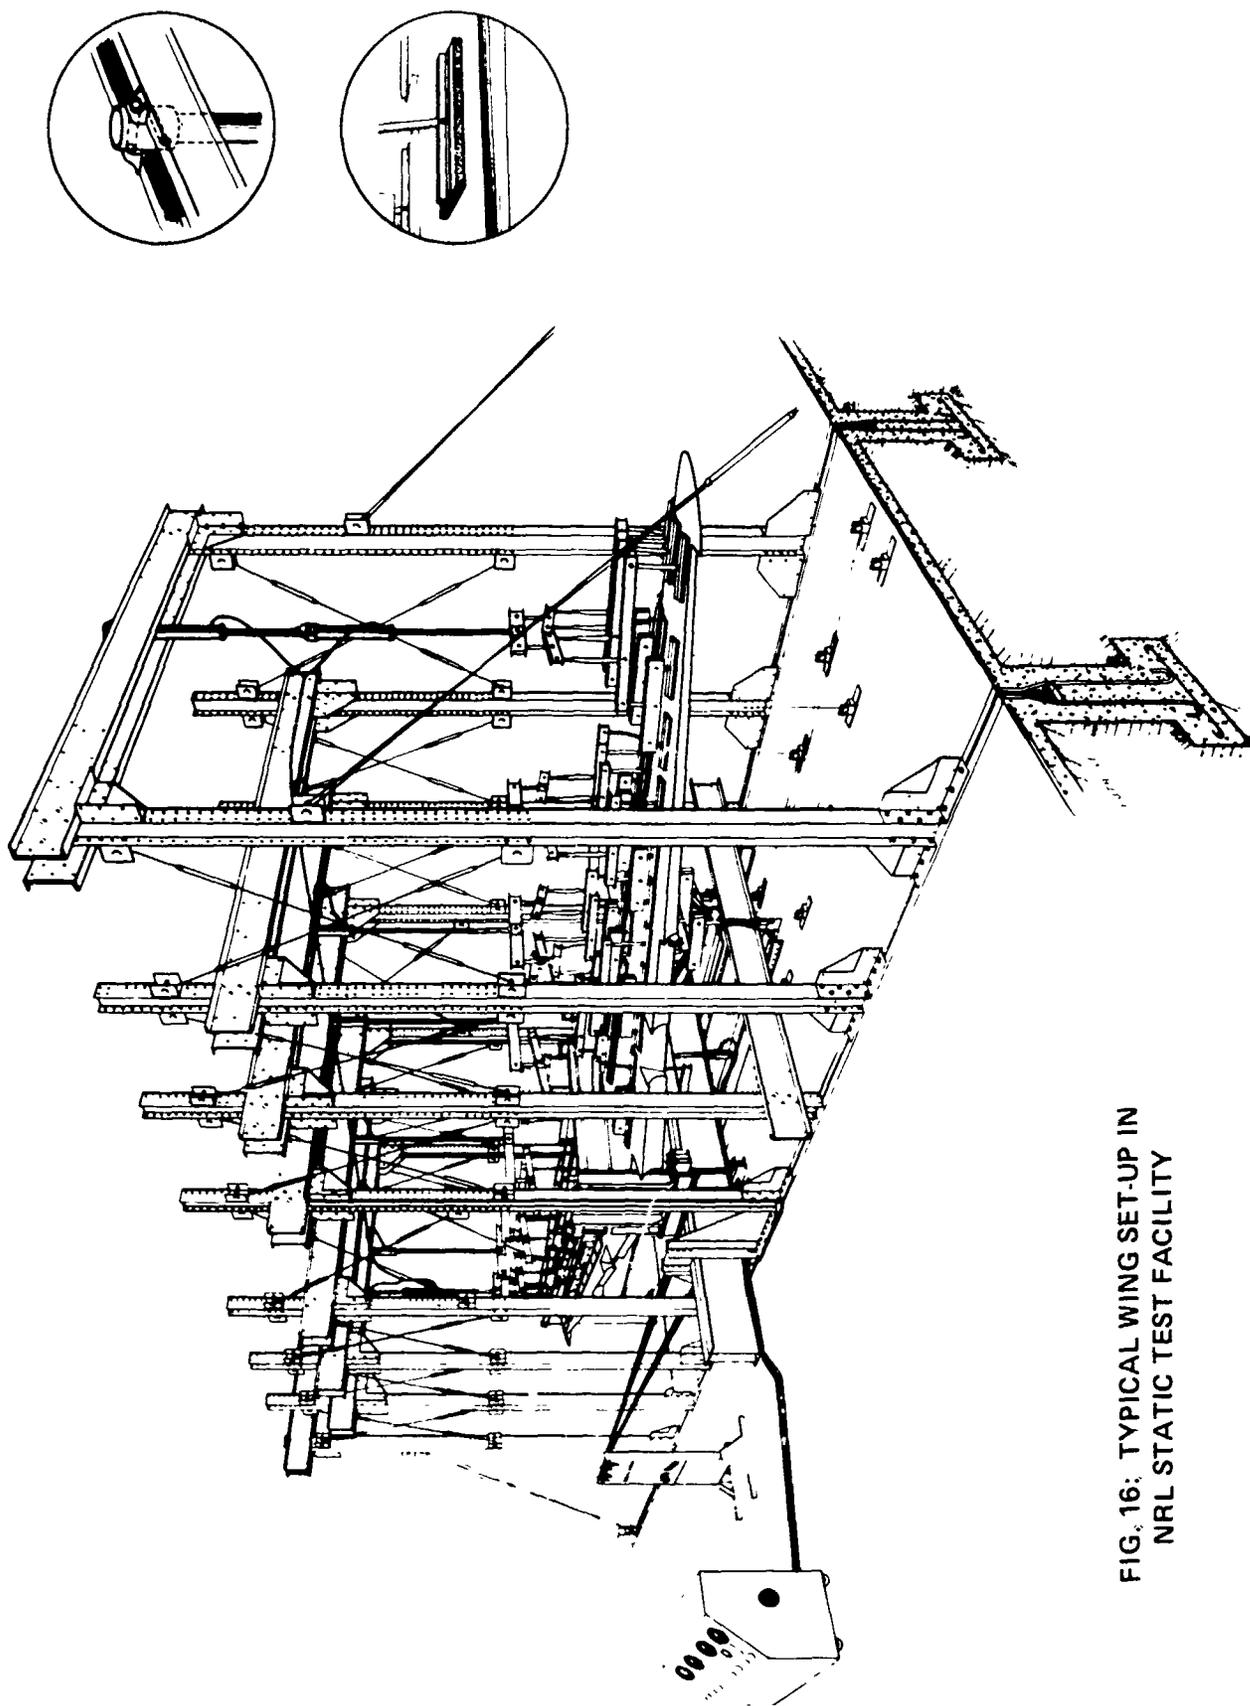
FIG. 16: TYPICAL WING SET-UP IN
NRL STATIC TEST FACILITY

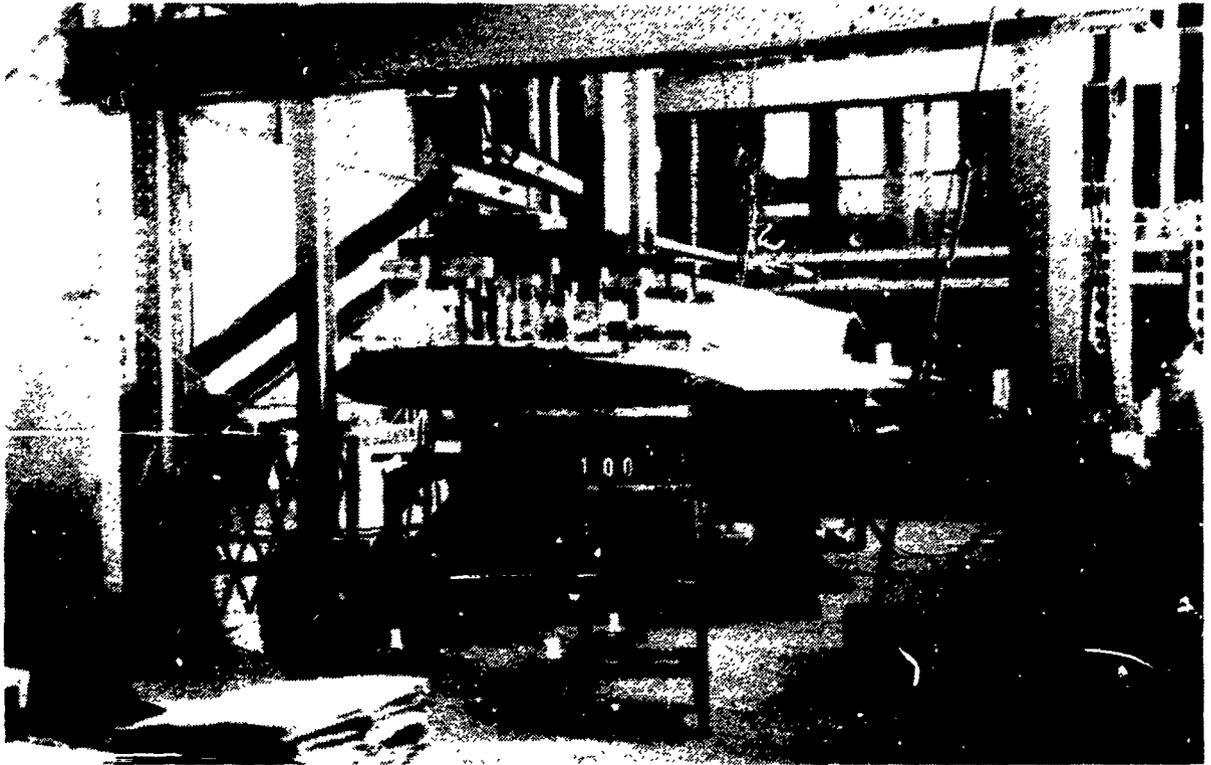
FIG. 18: TEST OF C-102 DERWENT FIN

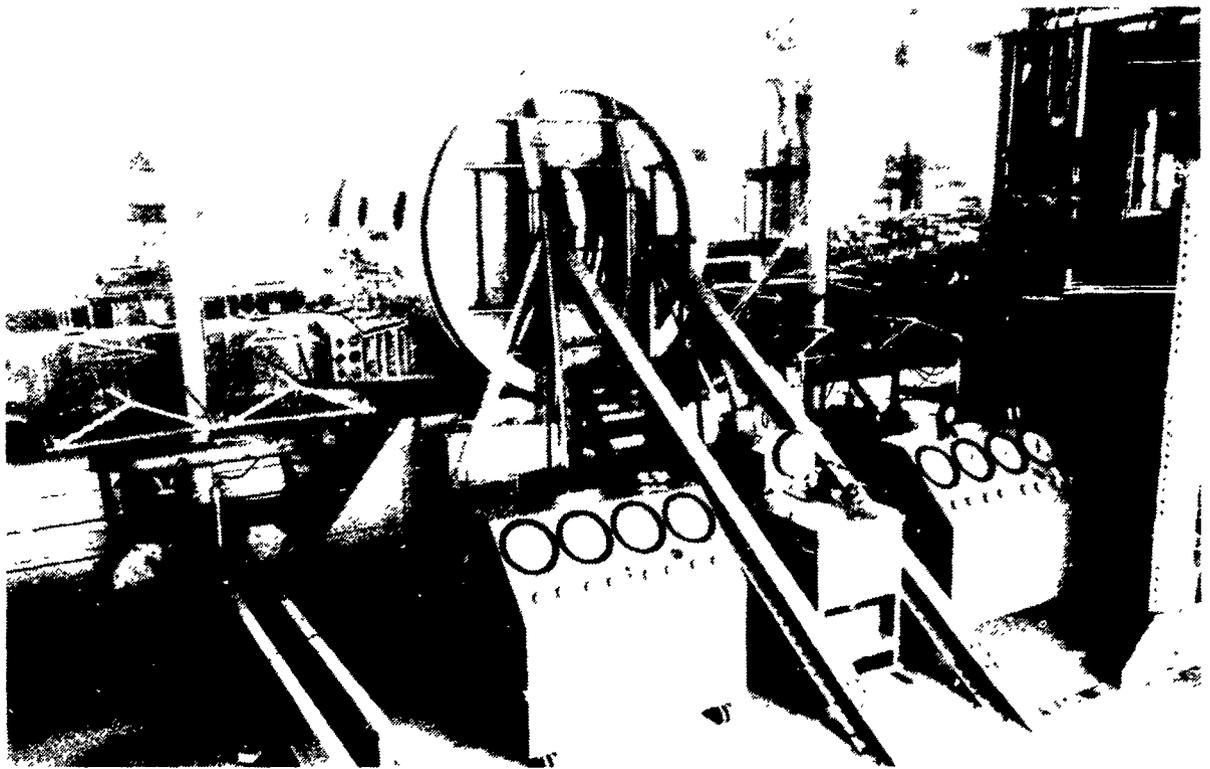
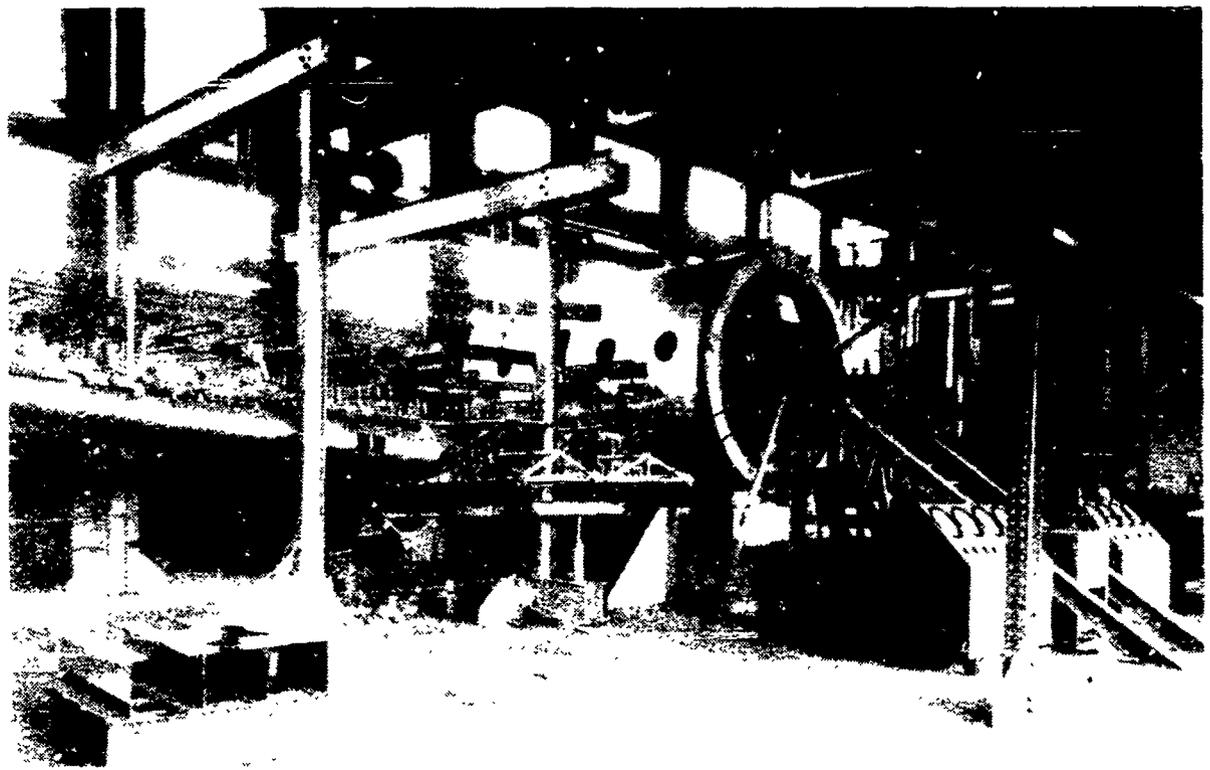
FIG. 20: TEST SET-UP FOR C-102 DERWENT MAINPLANE AND CENTRE FUSELAGE

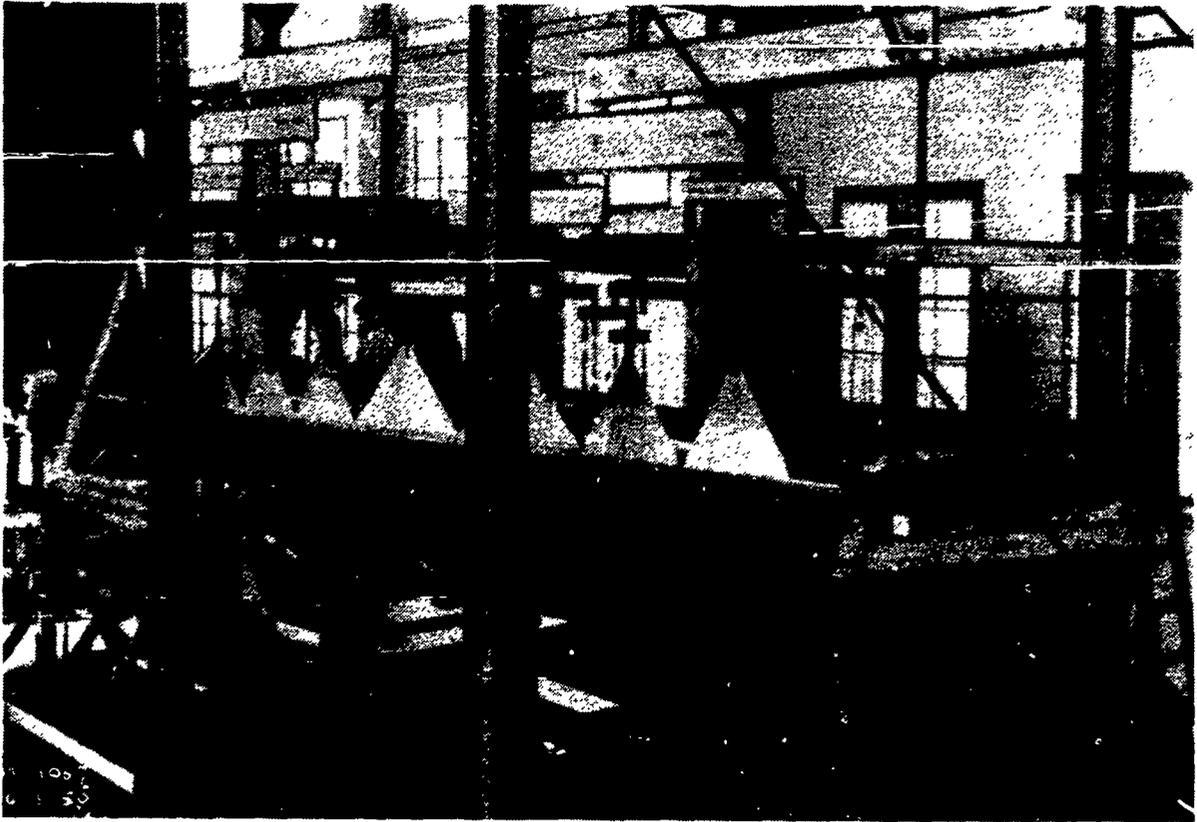
FIG. 23: TEST SET-UP FOR C-100 OUTER WING SHOWING RIVETED ATTACHMENTS TO LEADING EDGE

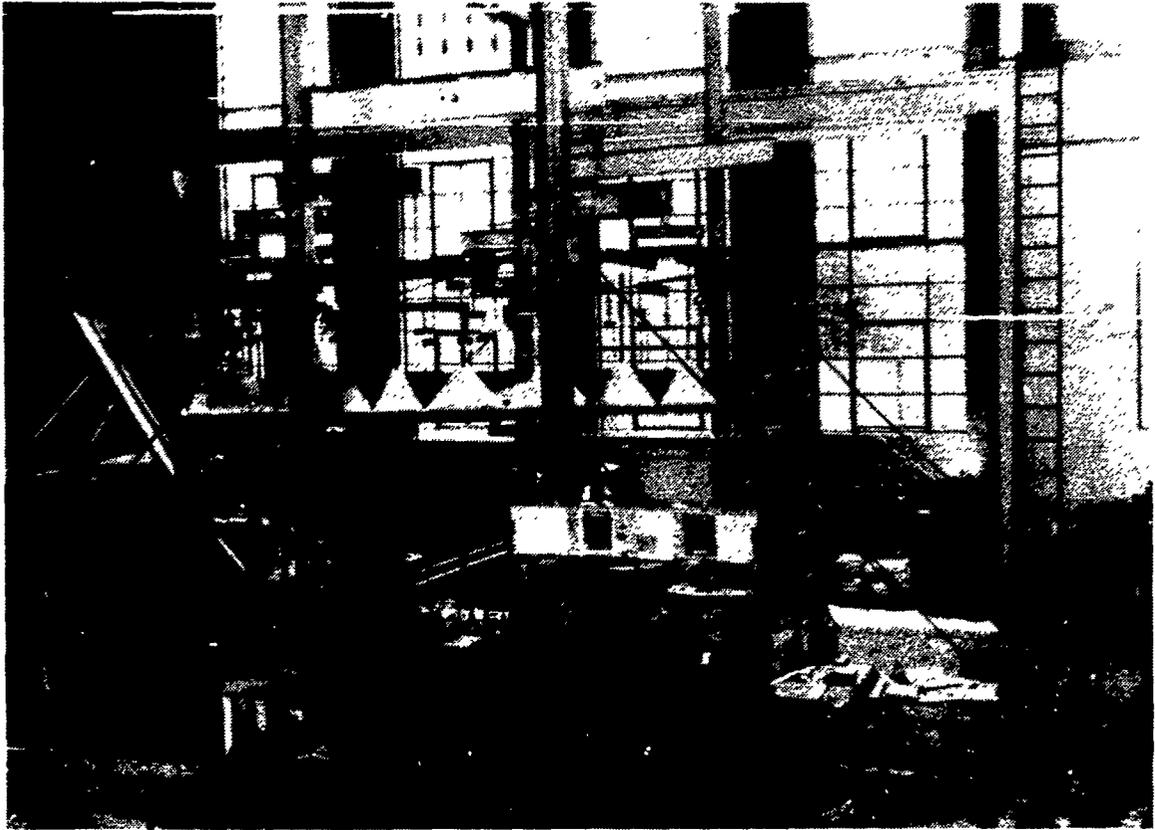
FIG. 26: AUTOMATED REPEATED LIMIT LOAD TEST ON C-100 MARK 3 OUTER WING

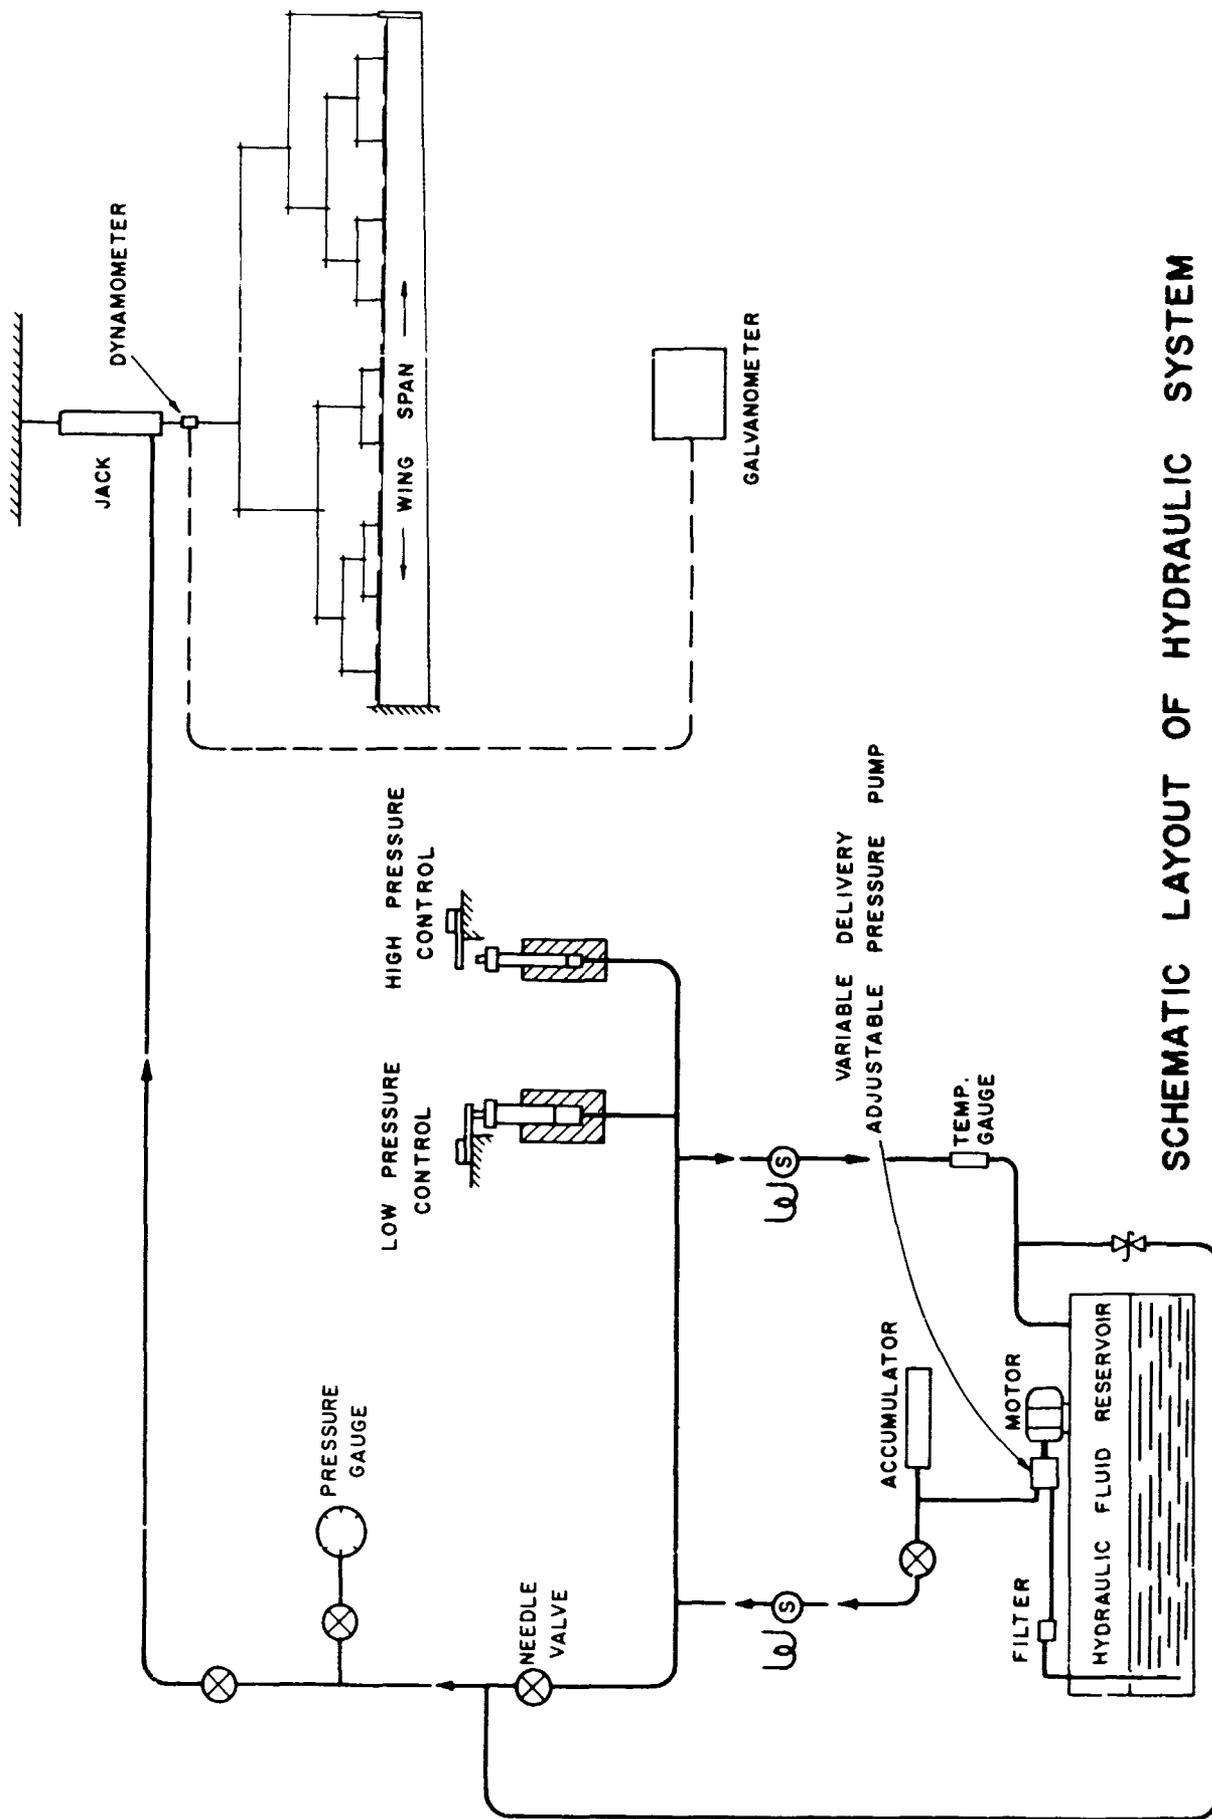
SCHEMATIC LAYOUT OF HYDRAULIC SYSTEM

FIG. 27: AUTOMATIC LOADING SYSTEM FOR REPEATED LOAD TESTS

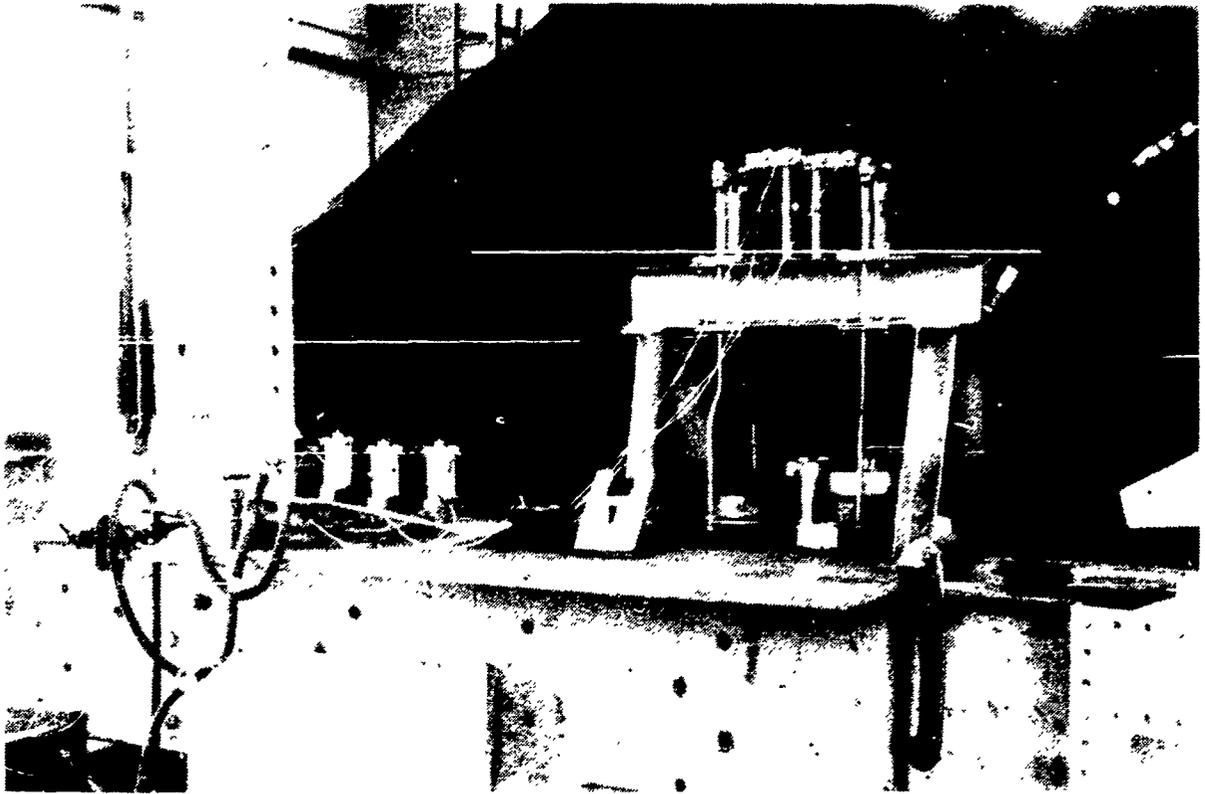
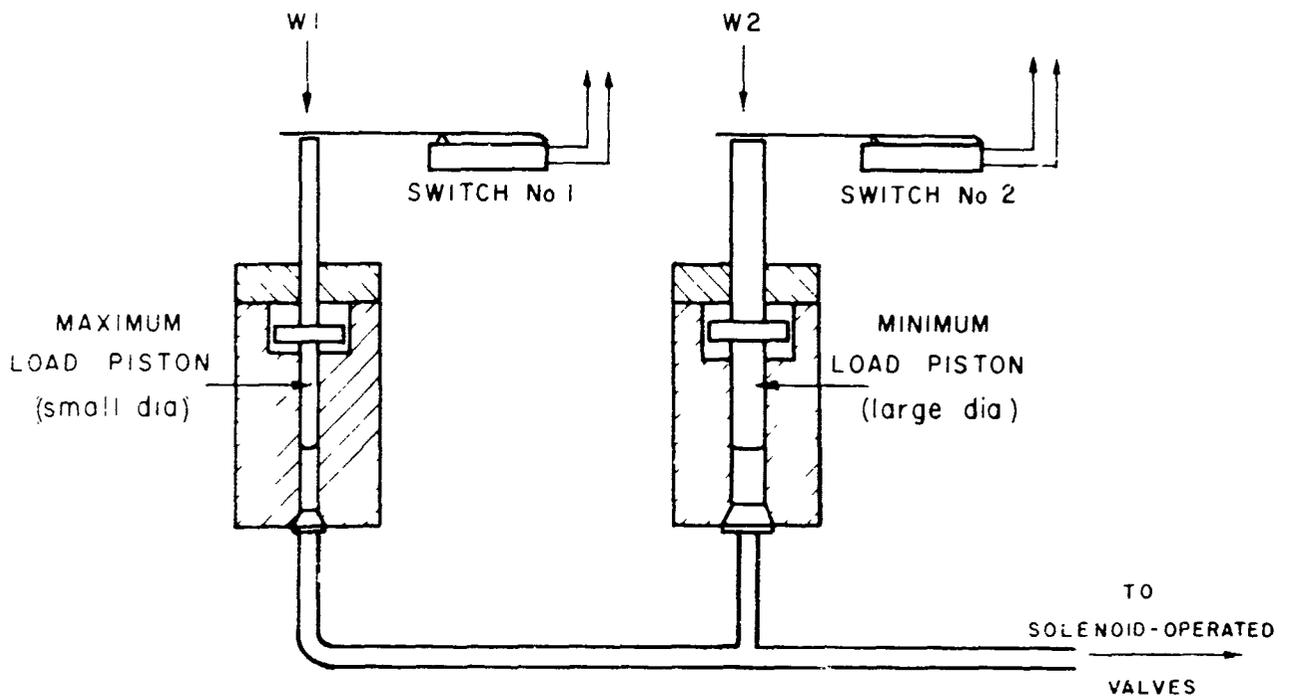
FIG. 28: PHOTOGRAPH AND SCHEMATIC OF REPEATED LOAD BALANCING SYSTEM

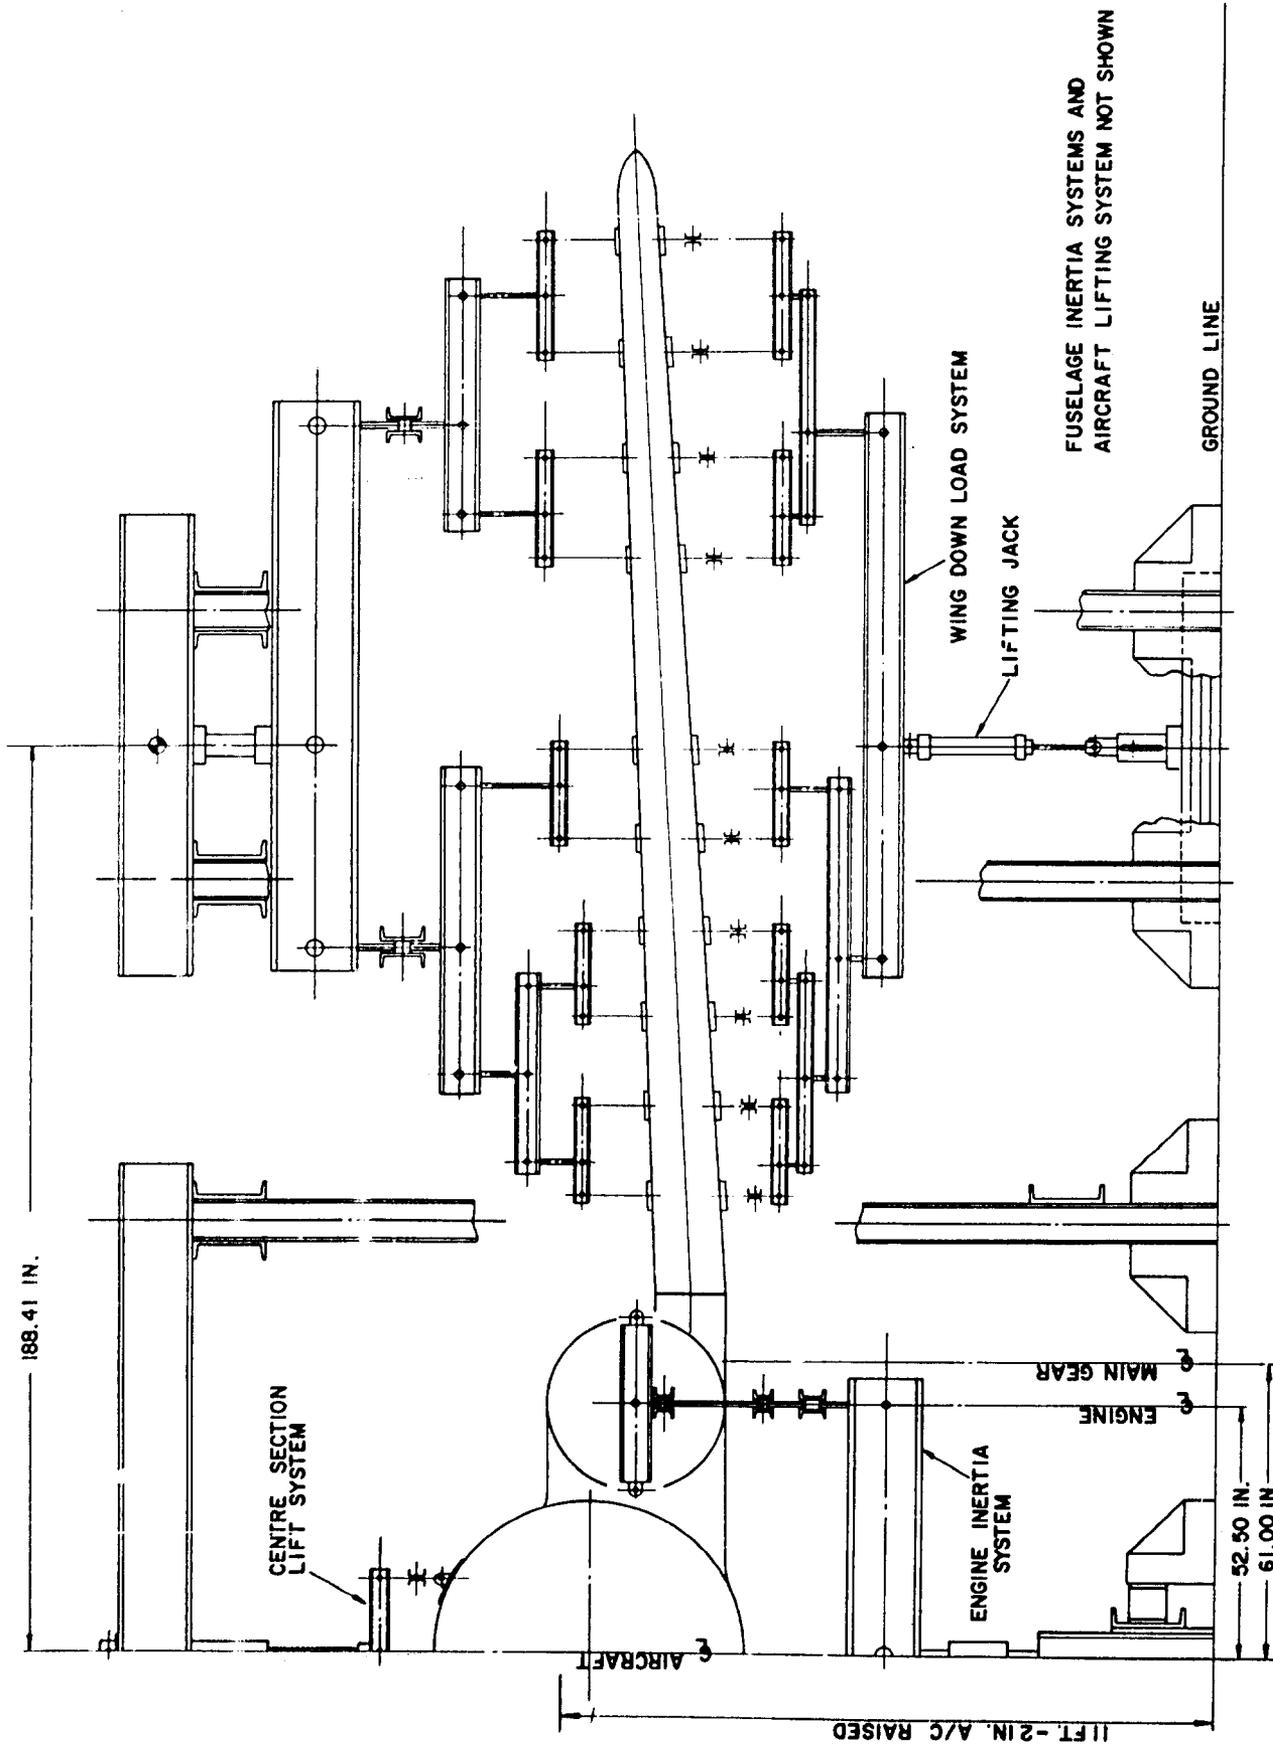
FIG. 30: C-100 WING-FUSELAGE TEST ARRANGEMENT - FRONT ELEVATION

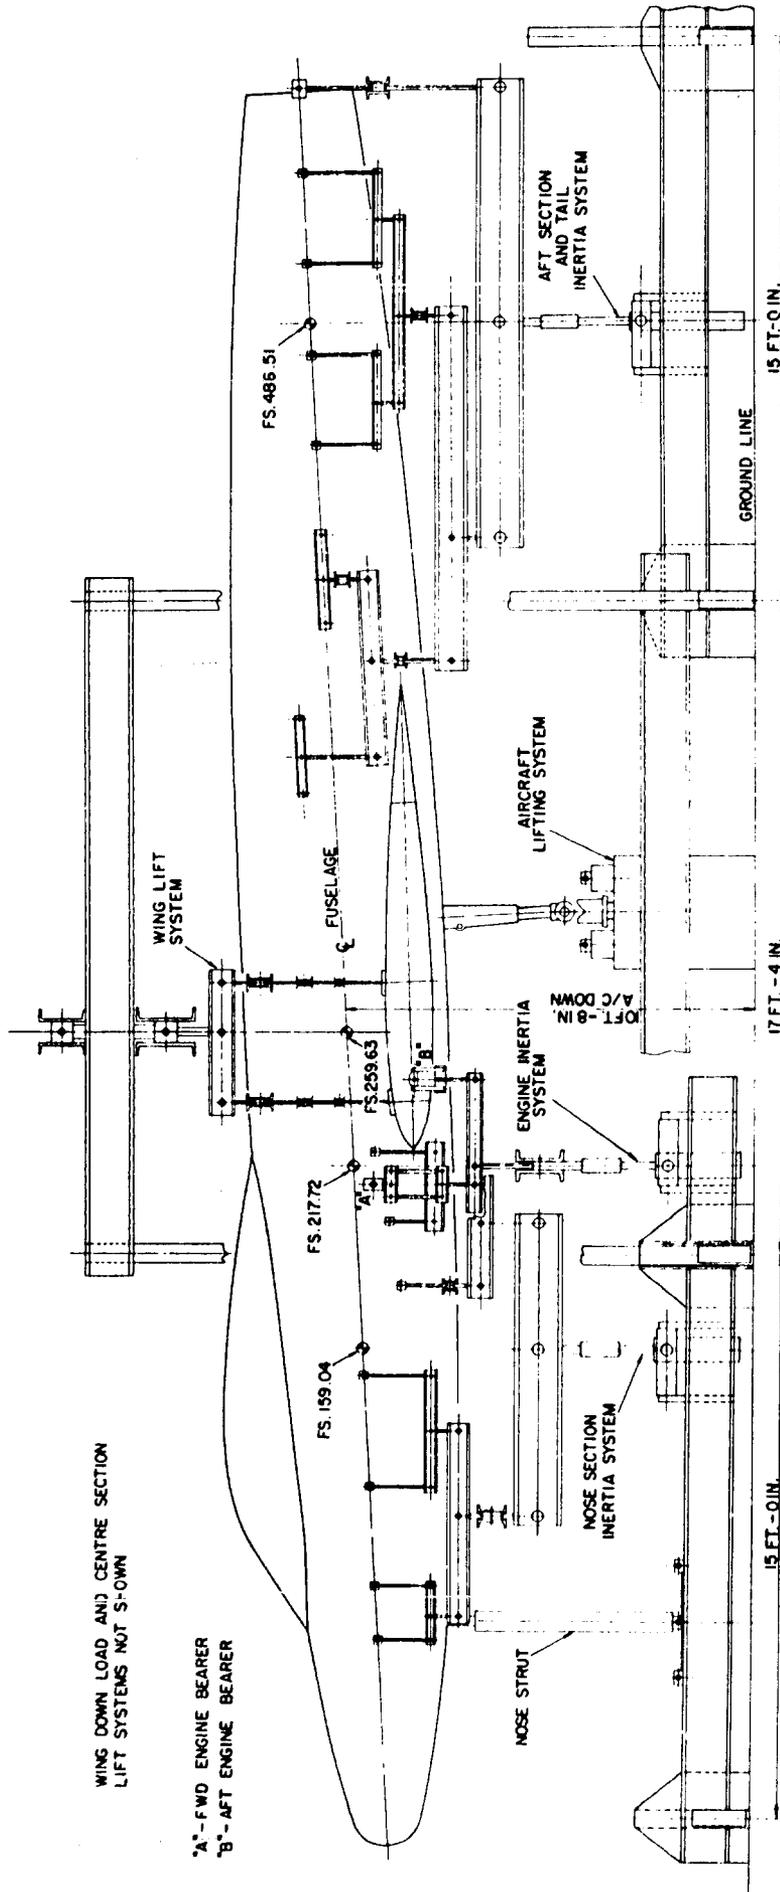
FIG. 31: C-100 WING-FUSELAGE TEST ARRANGEMENT - SIDE ELEVATION
