A HISTORY OF FULL-SCALE TESTING OF AIRCRAFT STRUCTURES AT THE NATIONAL AERONAUTICAL ESTABLISHMENT

R.L. Hewitt

National Aeronautical Establishment

AERONAUTICAL NOTE
NAE-AN-24
NRC NO. 24089

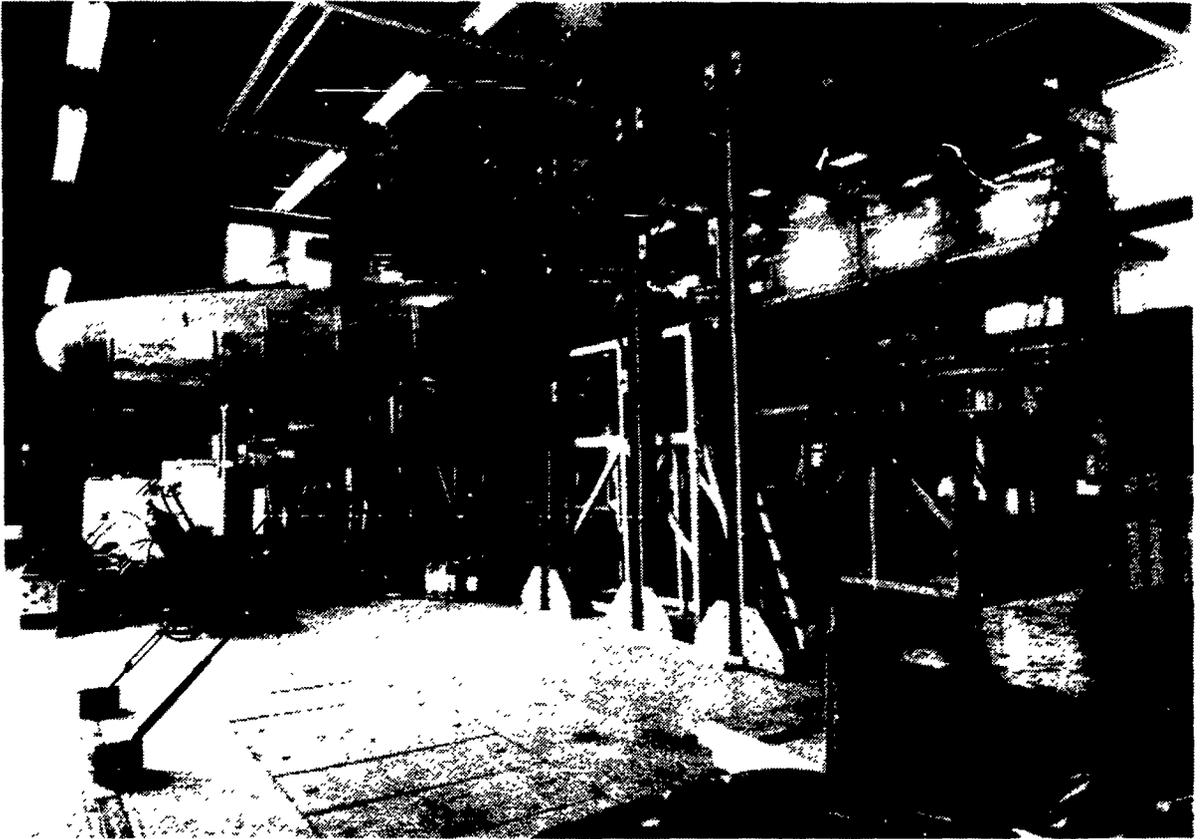
FIG. 32: C-100 WING-FUSELAGE FATIGUE TEST ARRANGEMENT

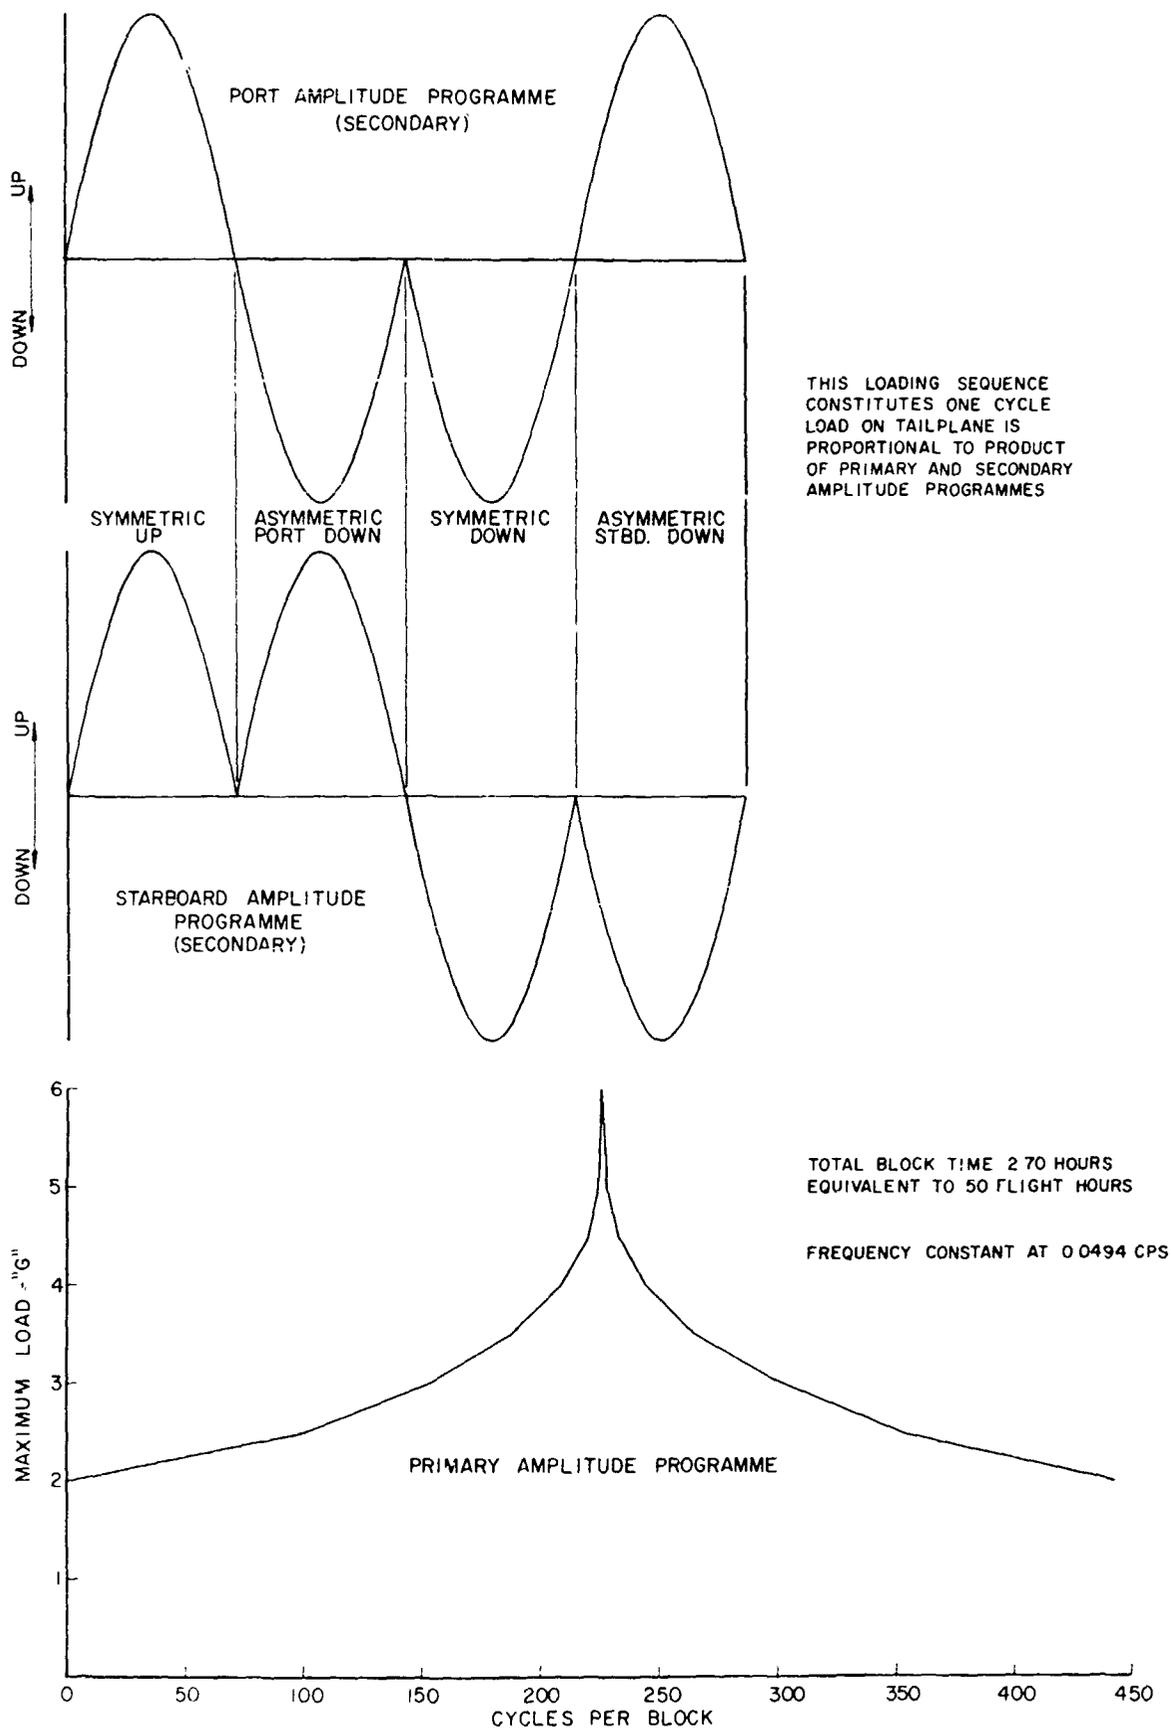
FIG. 33: TEST LOAD HISTORY FOR C-100 TAILPLANE

The test load history derived from this spectrum was applied in a programmed scheme in which the load level was progressively increased and decreased in a continuous manner in repeated blocks to give the correct distribution of load level and frequency. Constant amplitude testing at the most damaging level (from a Miner analysis) was rejected as being only able to show the mode of failure pertinent to the selected load level. In addition, the interpretation of the test would also be dependent on the validity of the cumulative damage hypothesis used. Random load application according to the load and frequency distribution was rejected both because of its complexity at that time and because of a concern over interpretation of a test result which might be influenced by the particular random sequence used in the test.

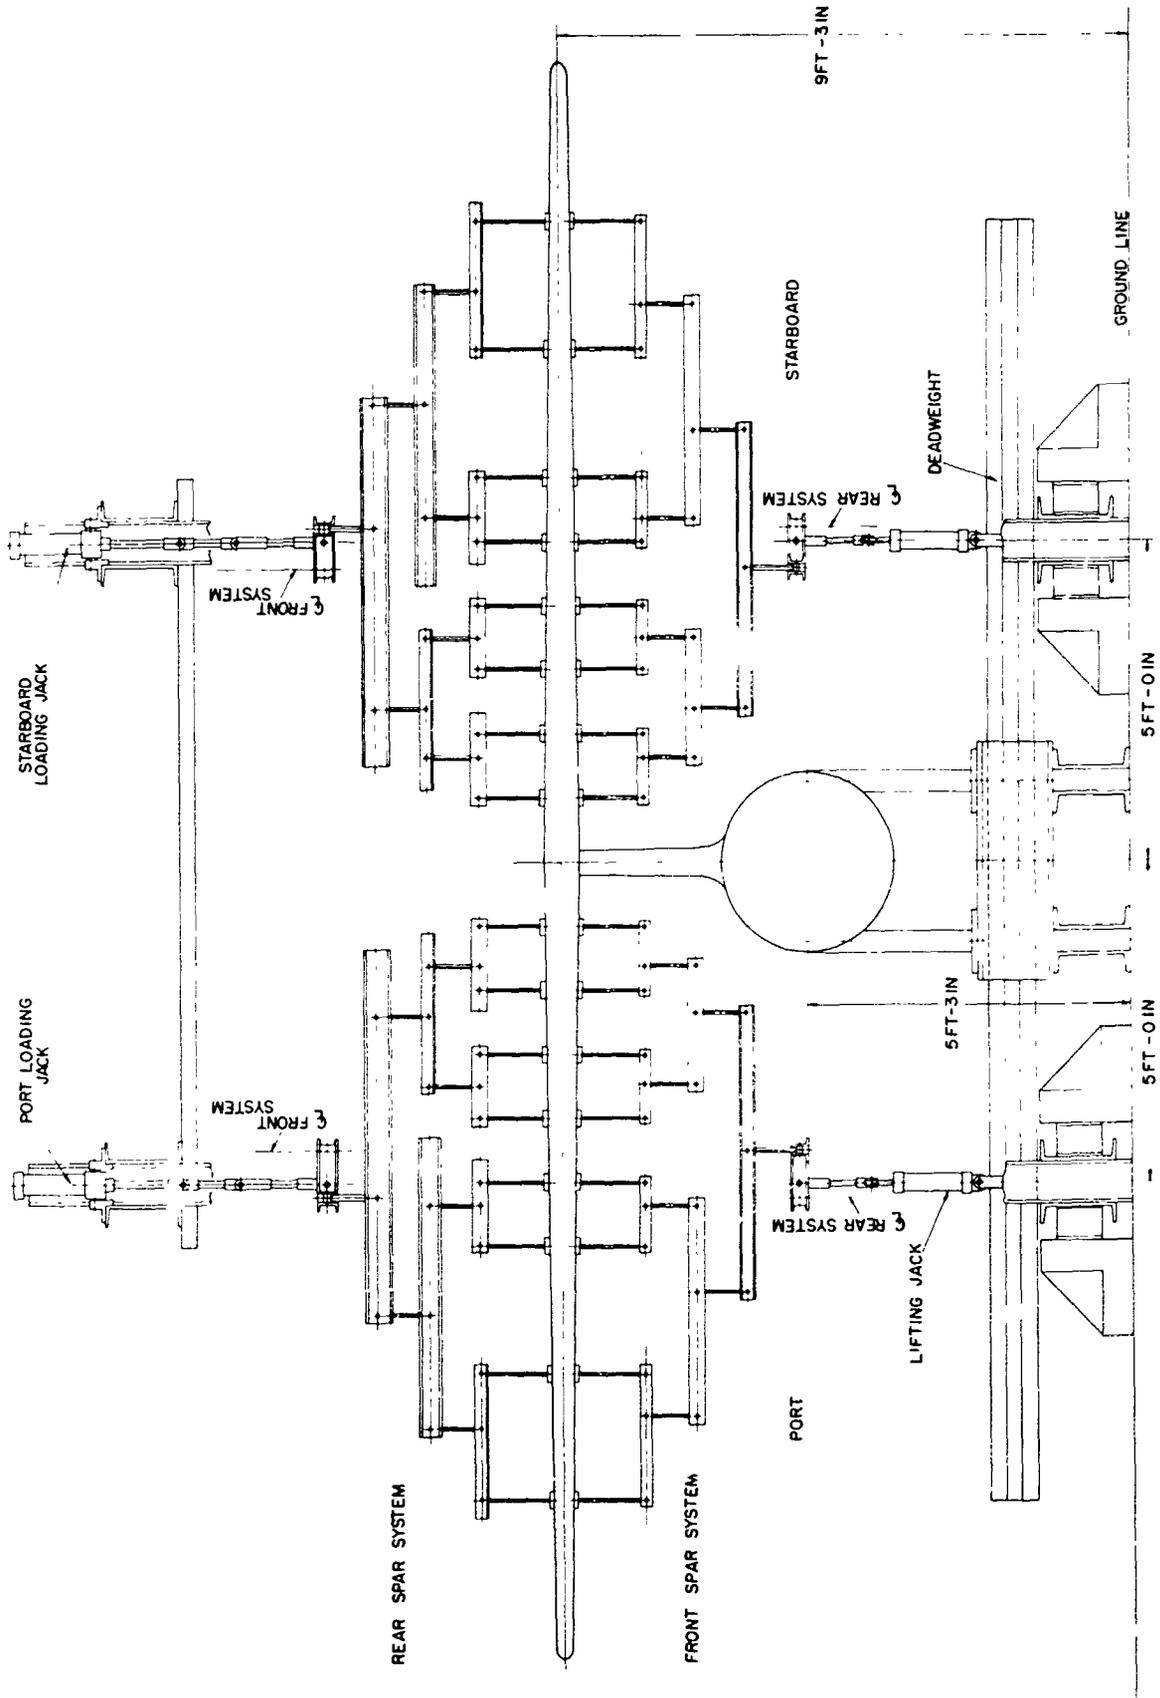
FIG. 34: C-100 TAIL UNIT TEST ARRANGEMENT - REAR ELEVATION

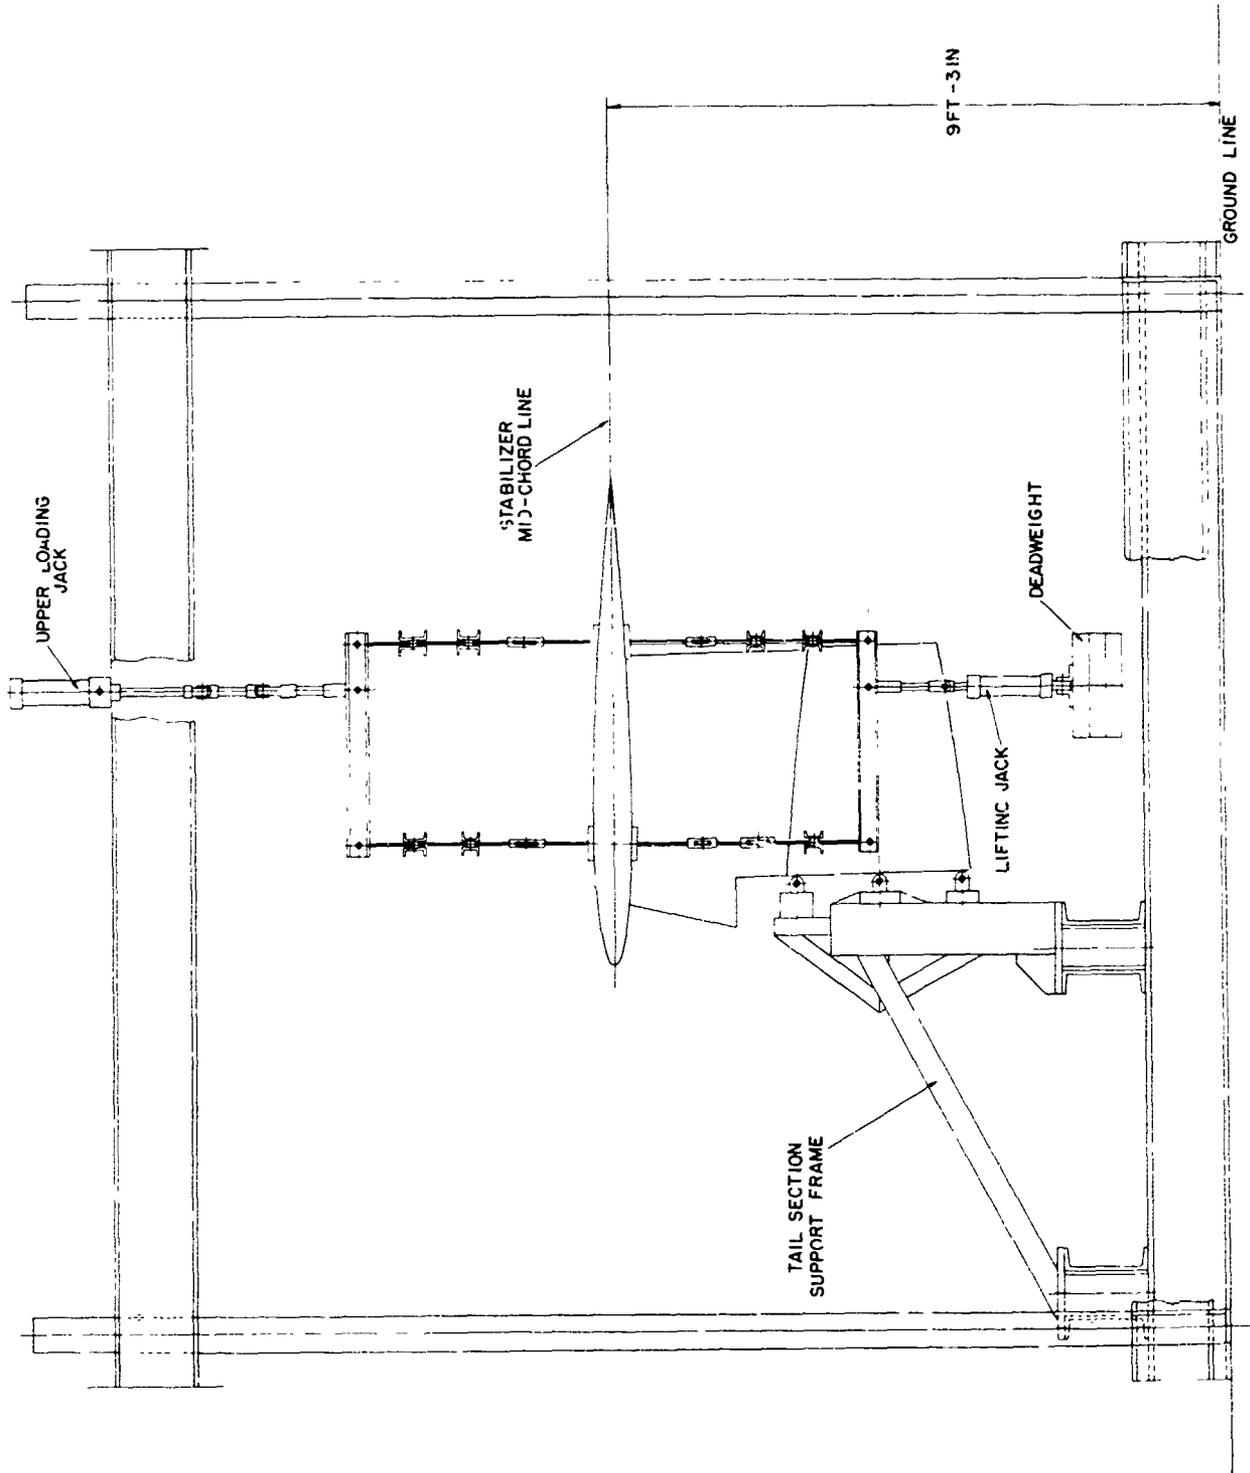
FIG. 35: C-100 TAIL UNIT TEST ARRANGEMENT - SIDE ELEVATION

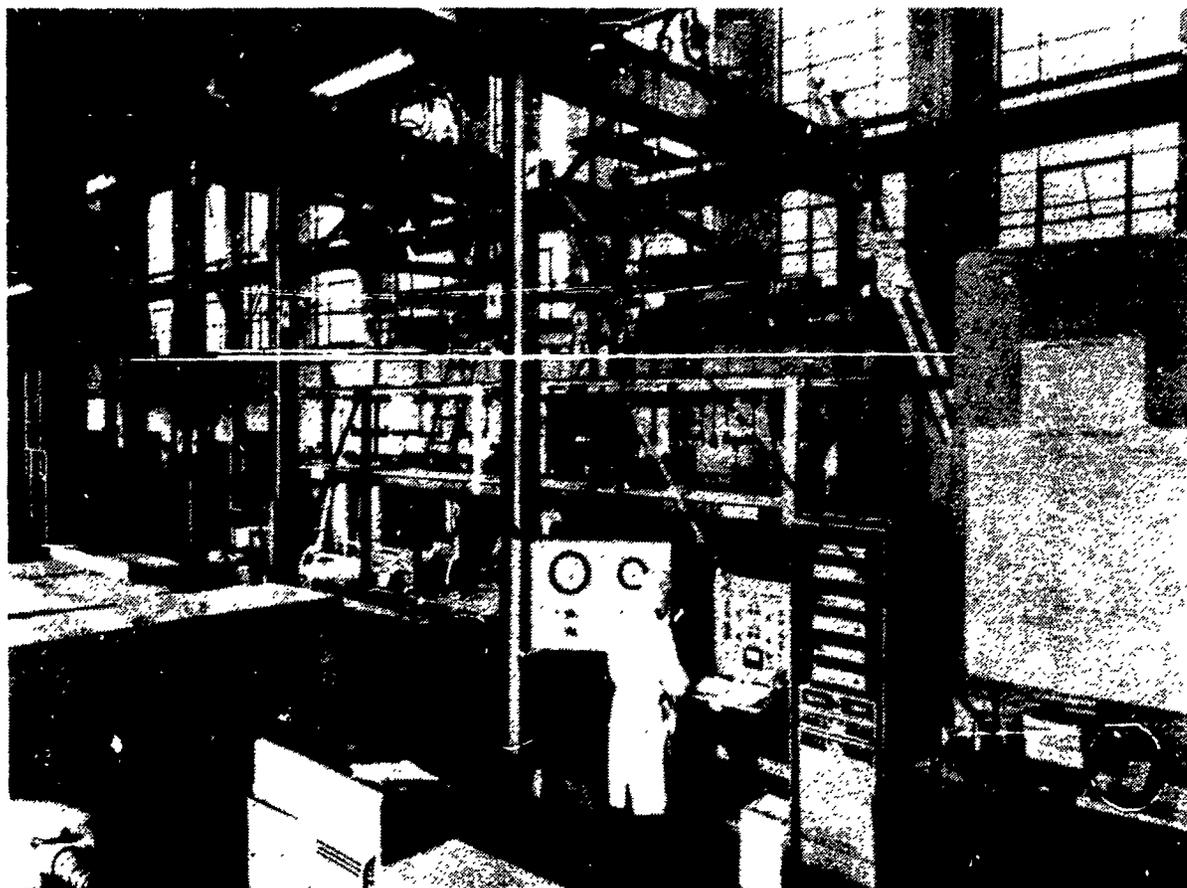
FIG. 36: C-100 TAIL UNIT FATIGUE TEST ARRANGEMENT

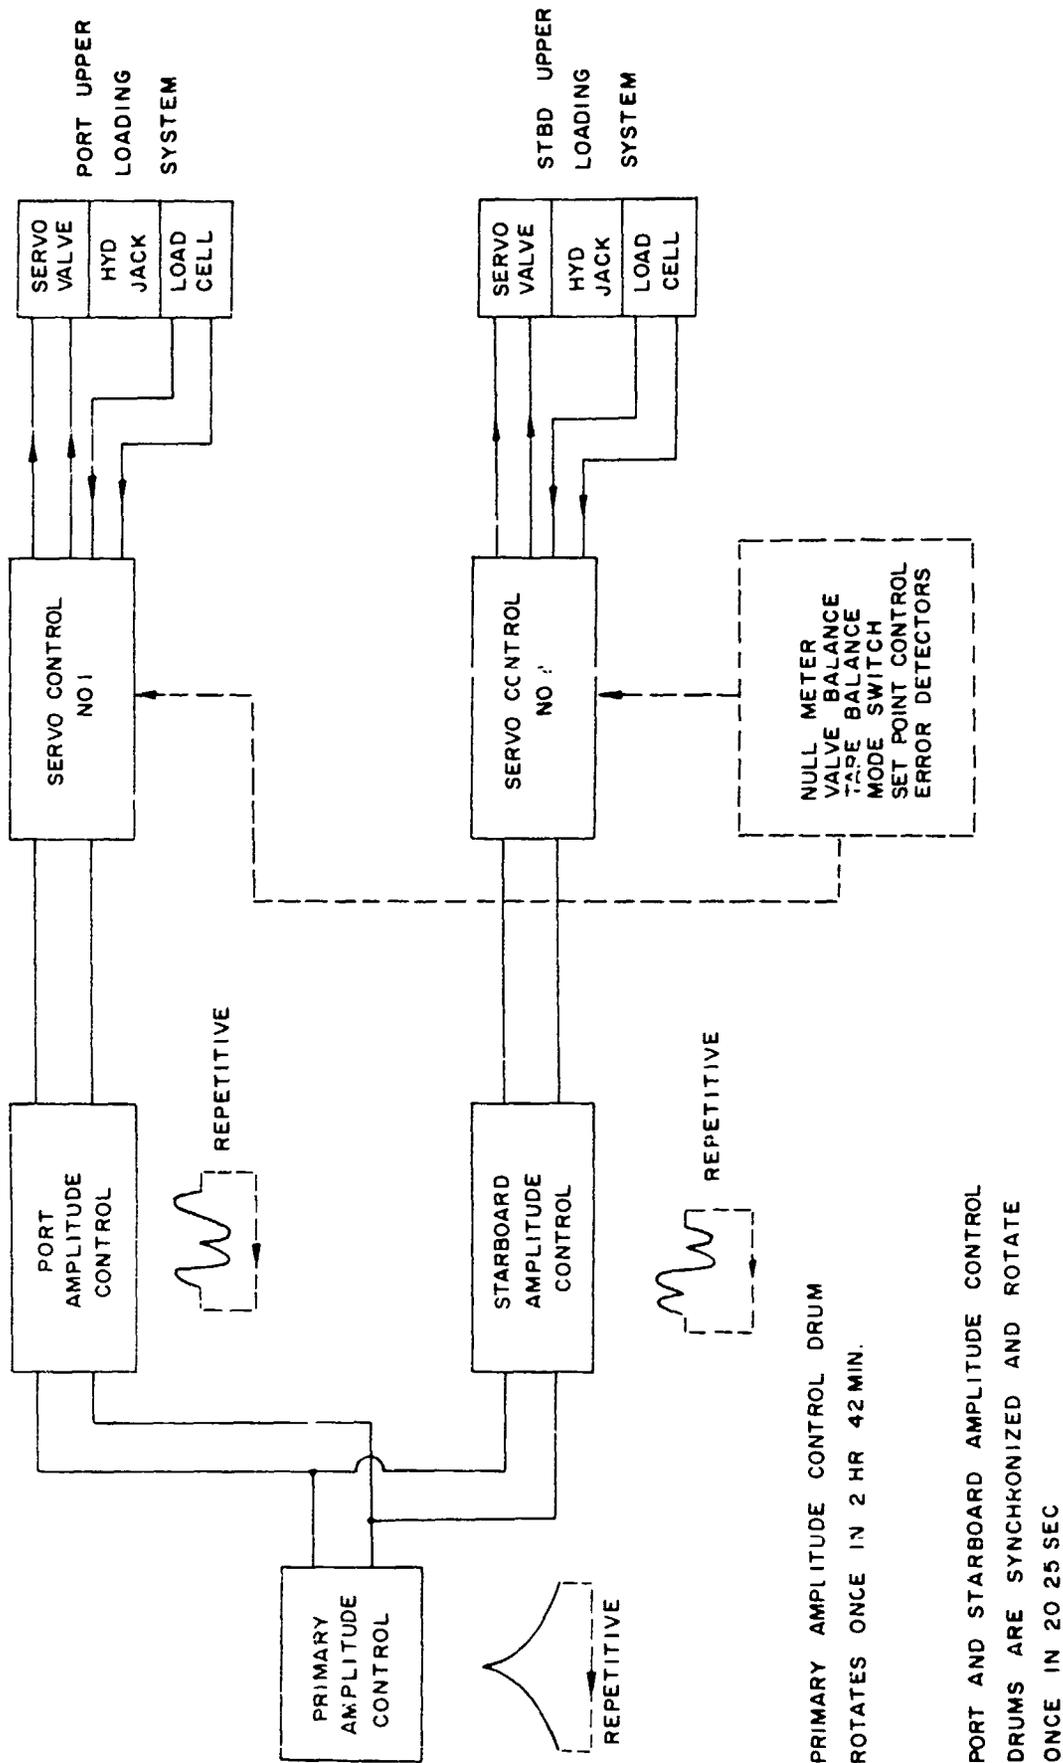
FIG. 37: BLOCK DIAGRAM OF LOAD CONTROL SYSTEM FOR C-100 TAILPLANE TESTS

The load control system consisted of four basic units, a function generator, regulated d.c. reference voltage and discriminator, and programmable frequency control and amplitude control potentiometers. Programs were etched on conductive paper, the etched line dividing the surface into two electrically isolated areas. The paper was attached to a rotating drum and an electrostatic probe connected to a potentiometer followed the line to give an output proportional to the position of the line. The function generator generated a sine wave function in which the base frequency was varied by the control potentiometer so that the small cycles could be applied faster than the large ones. This output was then modified by a bias voltage to shift the mean to the desired level and then further modified by the amplitude control potentiometers which resulted in an output amplitude corresponding to the desired load history. This output was then divided by proportioning attenuators so that the signal being fed into each of the three servo-controllers was in direct proportion to the load requirements of each system. The load applied to the centre section lift system was maintained at a constant value throughout the test by a set-point adjustment of the corresponding servo control unit. The frequency was such that a complete 50 hour load block consisting of 454 cycles was applied in 2-1/4 hours.

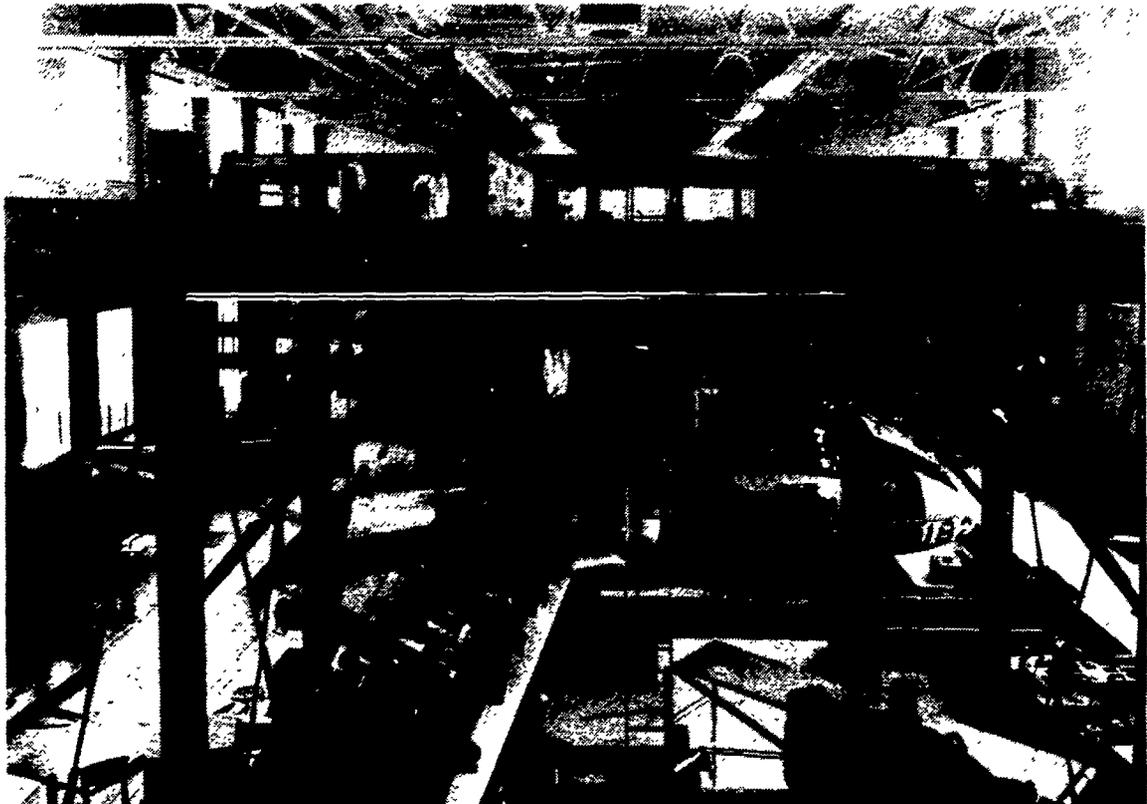
FIG. 38: VIEW OF TUTOR FATIGUE TEST SHOWING WING LOADING SYSTEM

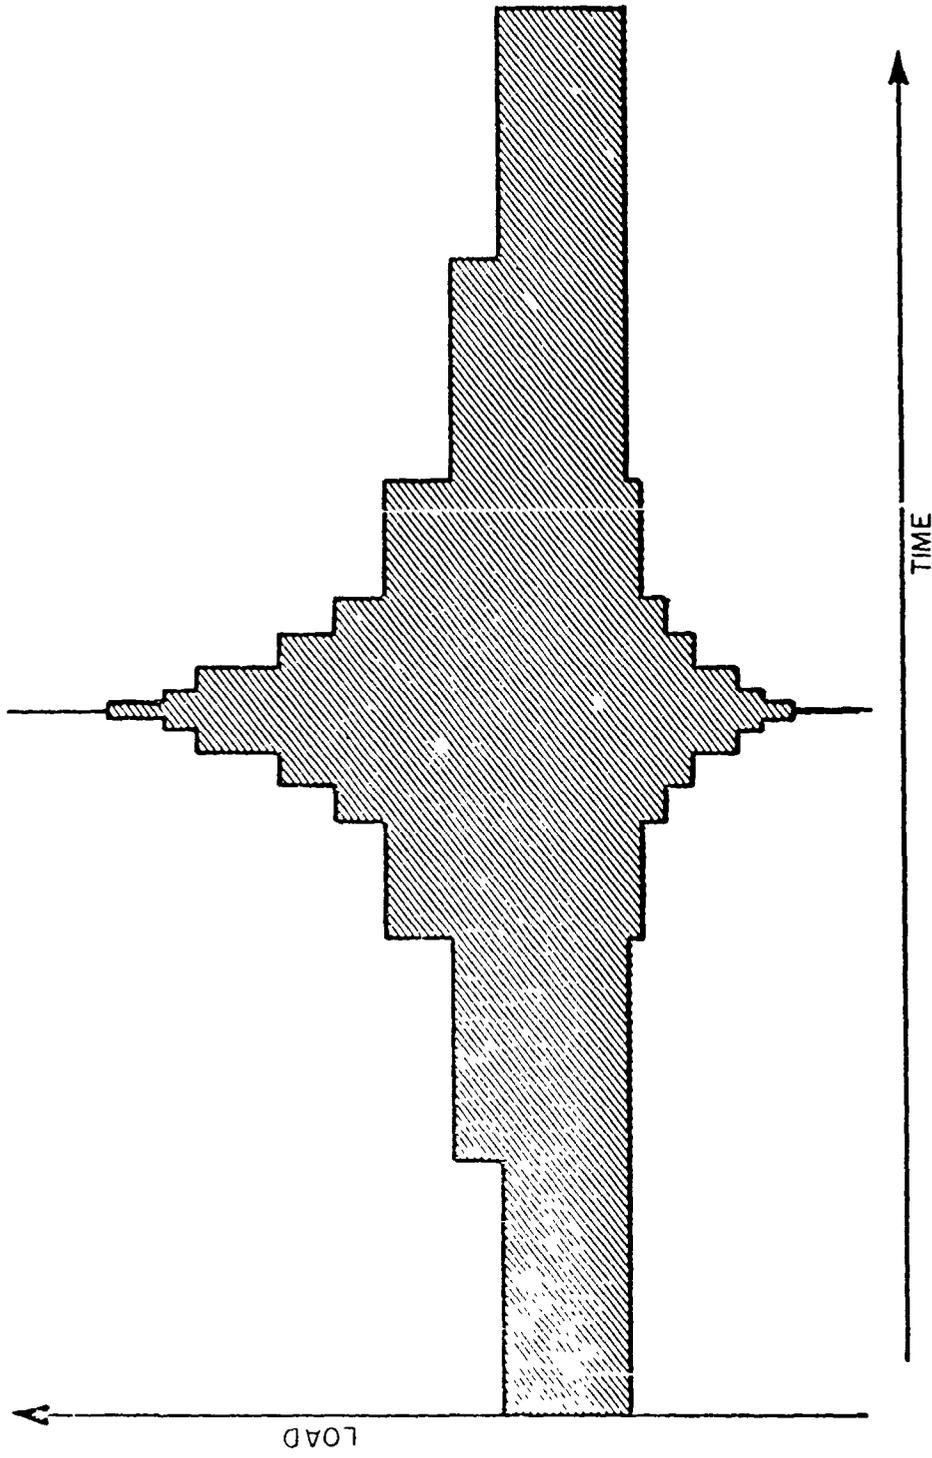
FIG. 41: NINE LEVEL LOW-HIGH-LOW LOADING SEQUENCE USED IN TUTOR FATIGUE TEST (TRAINER ROLE)

The derived spectrum for the test^(4.4) was based on counting accelerometer data from the more severe of two training bases. The loads were applied in a programmed sequence of progressively increasing and then decreasing loads of the same general form as for the CF-100 test, with each positive load cycle being followed by the negative equivalent that had the same frequency of occurrence. Since it was considered that a minimum of 30 load blocks should be applied before failure to avoid block sizing effects, and cracks had been observed as low as at 800 hours, a block size of 10 hours was chosen. Since during a typical 10 hour block only peak loads corresponding to 5.4 and -0.55g were encountered, the missing more severe loads were applied manually at the end of a group of five 10 hour blocks, so that all loads that were present in the load spectrum were applied during the course of 1000 equivalent test hours. The truncation level was set at a level that was exceeded 100 times per flight hour, which resulted in 1000 cycles per 10 equivalent flight hours compared with the 145 applied by the manufacturer.

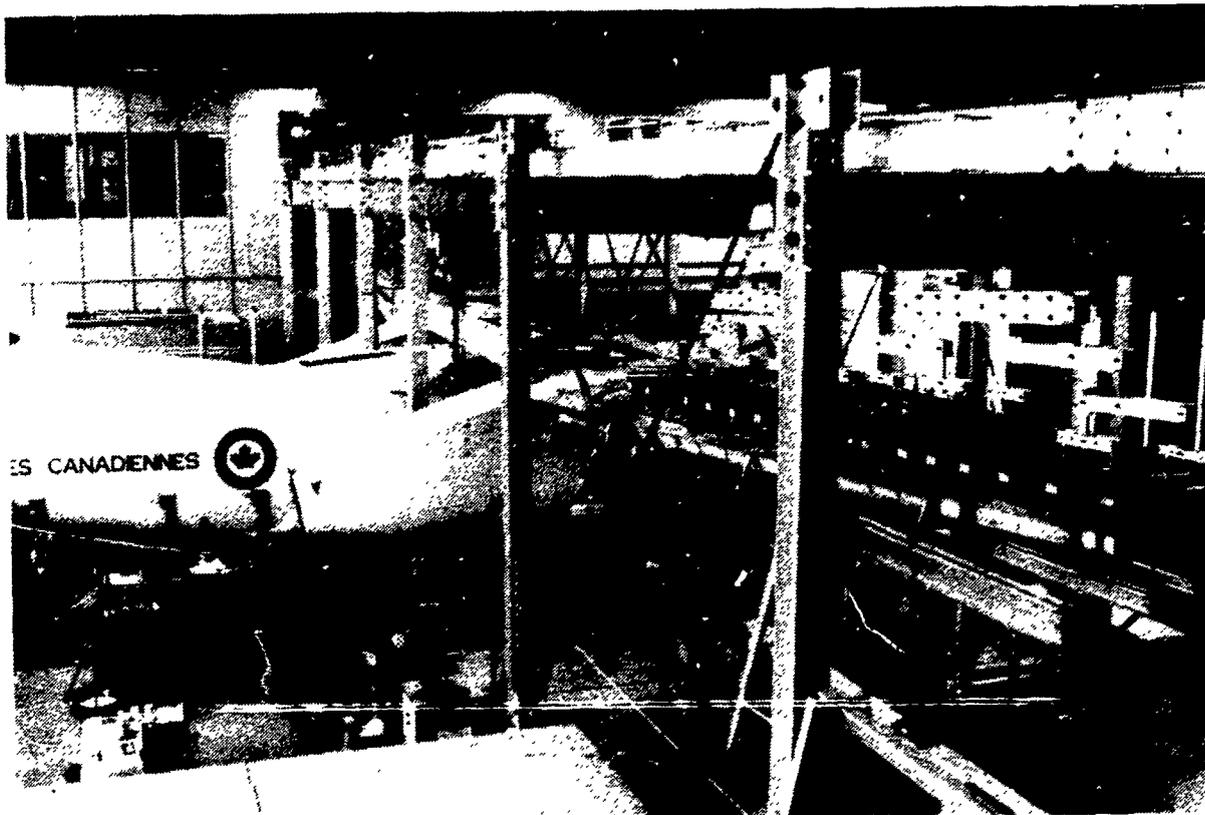
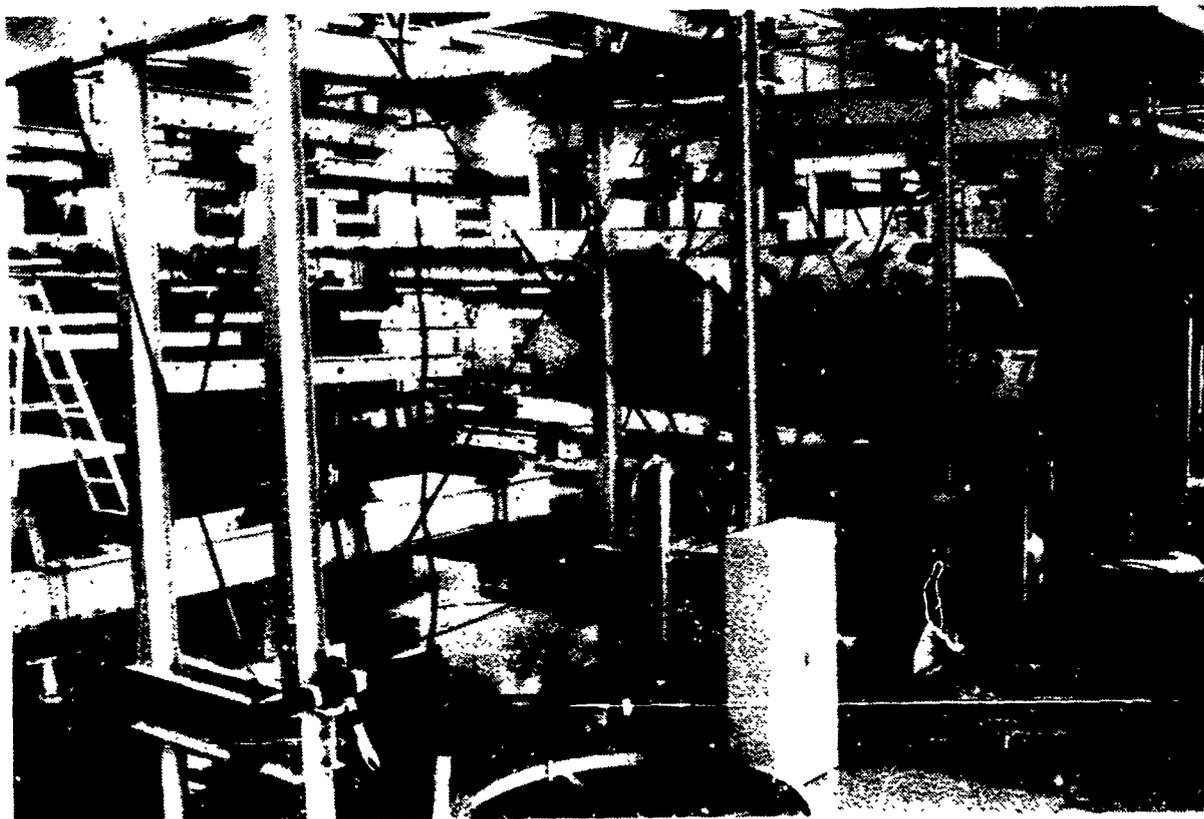
FIG. 42: TRACKER WING FATIGUE TEST SET-UP

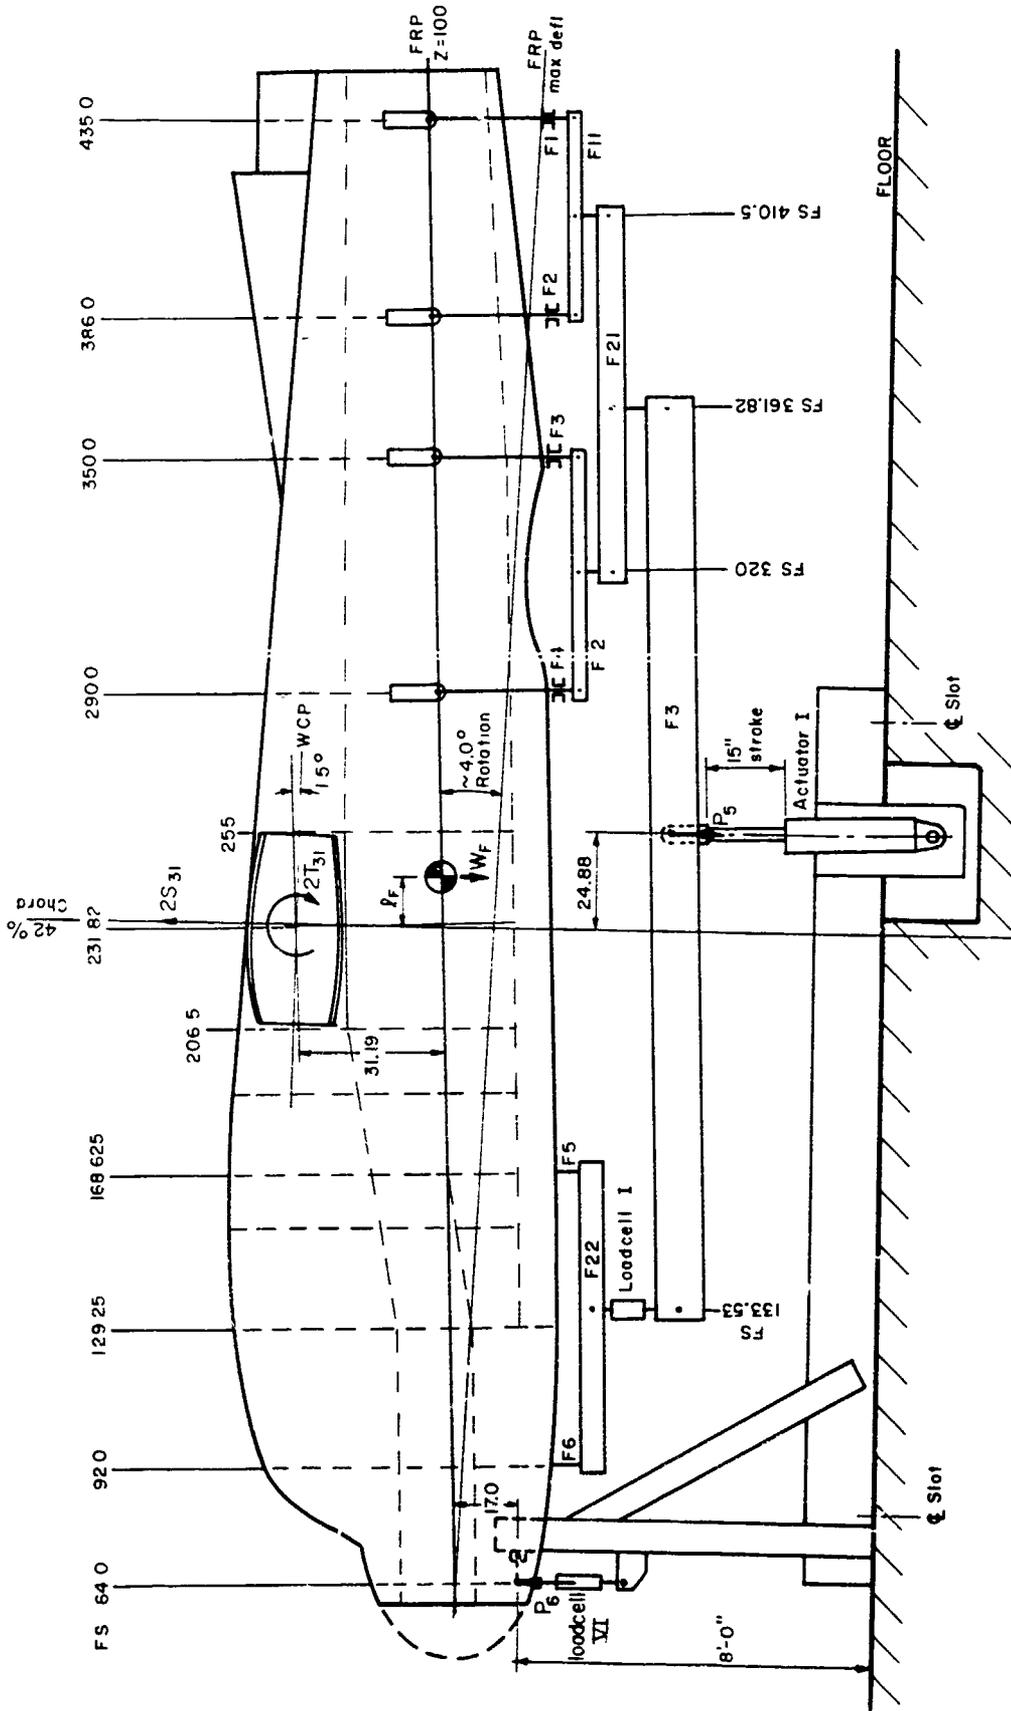
FIG. 43: UNDER FUSELAGE WHIFFLETREE SYSTEM

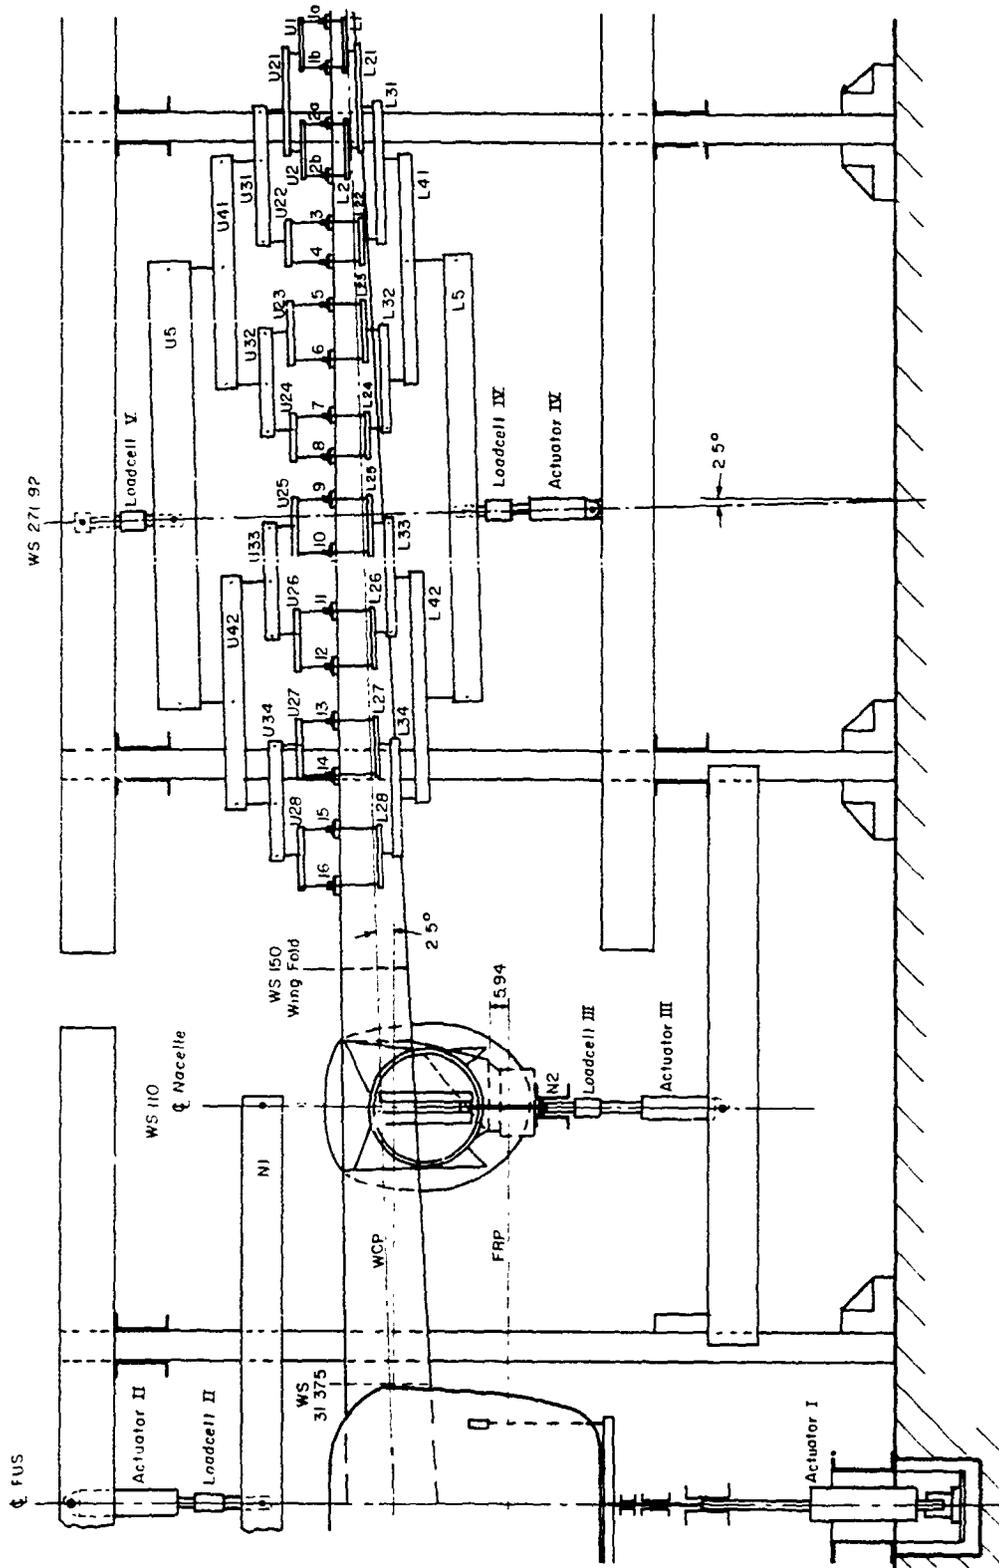
FIG. 44: TRACKER WING LOADING SYSTEM

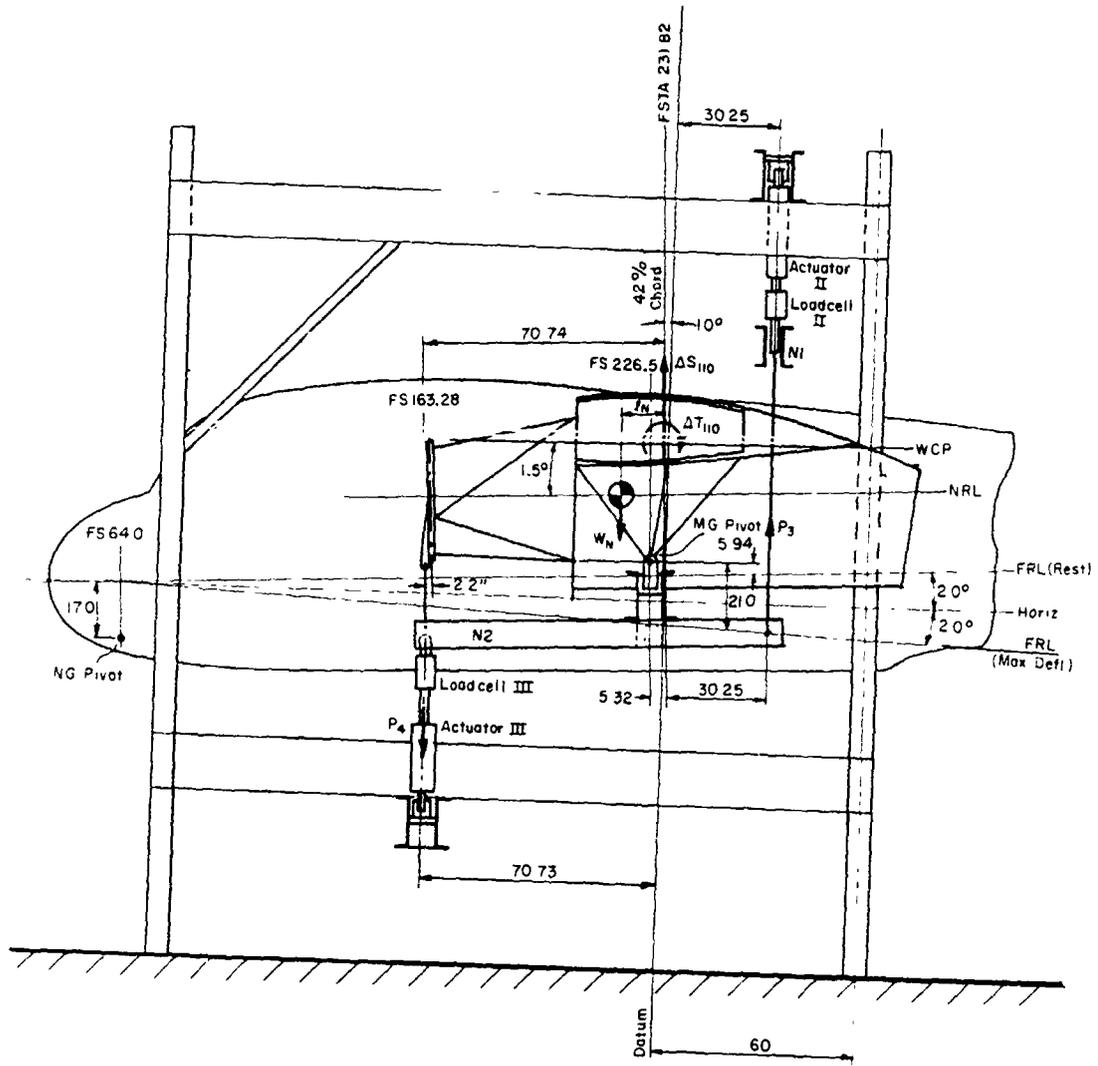
FIG. 45: NACELLE LOADING SYSTEM

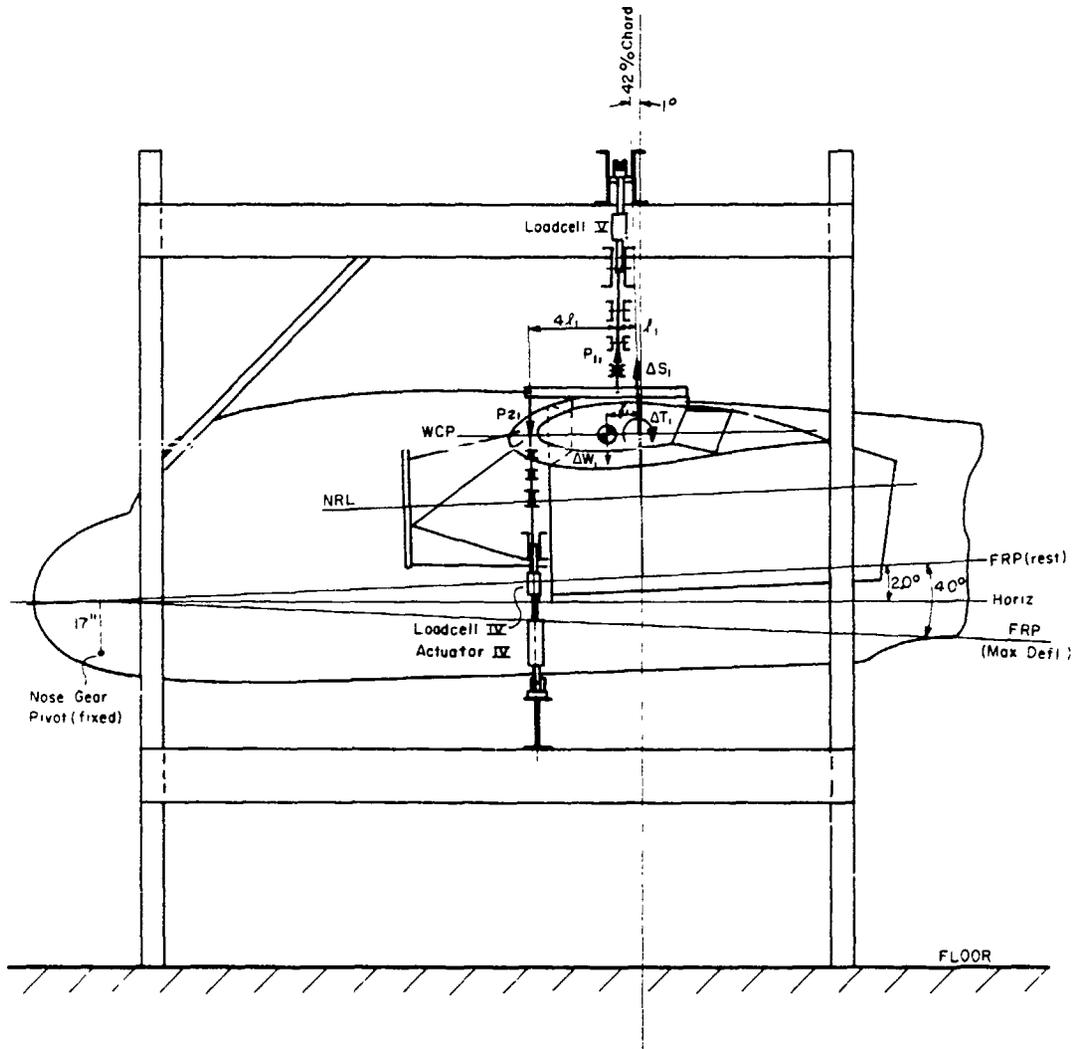
FIG. 46: OUTER WING LOADING SYSTEM
