**INVESTIGATION OF COMPARATIVE MOSQUITO BREEDING IN**  
**DREDGED MATERIAL DISPOSAL SITES USED IN THE**  
**MAINTENANCE DREDGING OF THE ATLANTIC**  
**INTRA-COASTAL WATERWAY IN**  
**SOUTH CAROLINA**

by  
Joseph Vorgetts, Jr., M.S.  
and  
Wm. Bruce Ezell, Jr., Ph.D.  
Department of Biology  
The Citadel  
Charleston, South Carolina

Contract No. DACW 60-76-C0032  
Final Report  
U.S. Army Corps of Engineers  
Charleston District  
P.O. Box 919, Charleston,  
South Carolina 29402

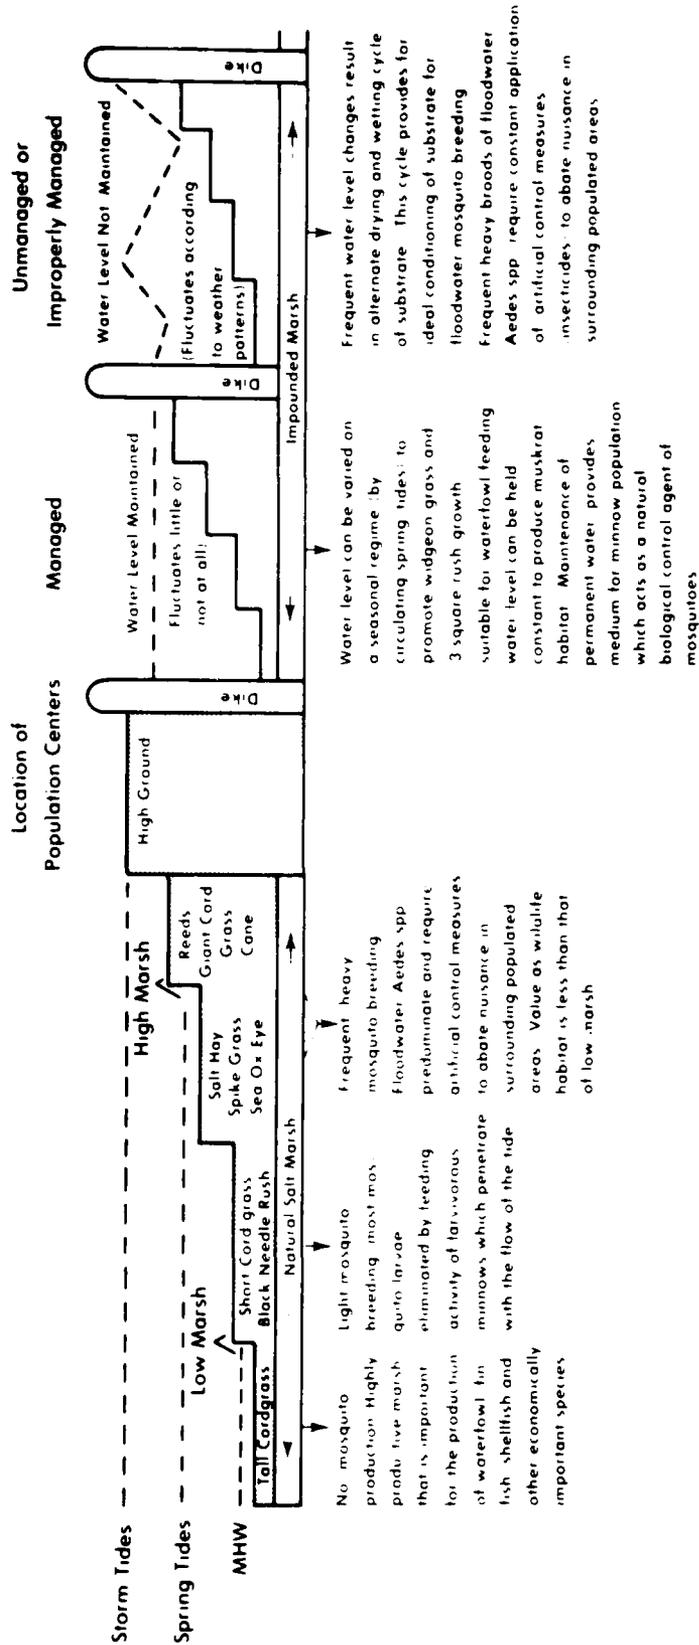
Figure 1 The Relationship of Mosquito Breeding to Wetland Habitats in Coastal South Carolina

31. The relationship of marsh elevation to floodwater mosquito breeding is illustrated in Figure 1. Diked dredged material disposal areas correspond to the category of "unmanaged, impounded marsh" in the illustration. Mosquito breeding associated with diked disposal sites is usually confined to a number of identifiable subhabitats within and immediately outside the dikes. These subhabitats are illustrated in Figure 2 and described in the following paragraphs. More detailed

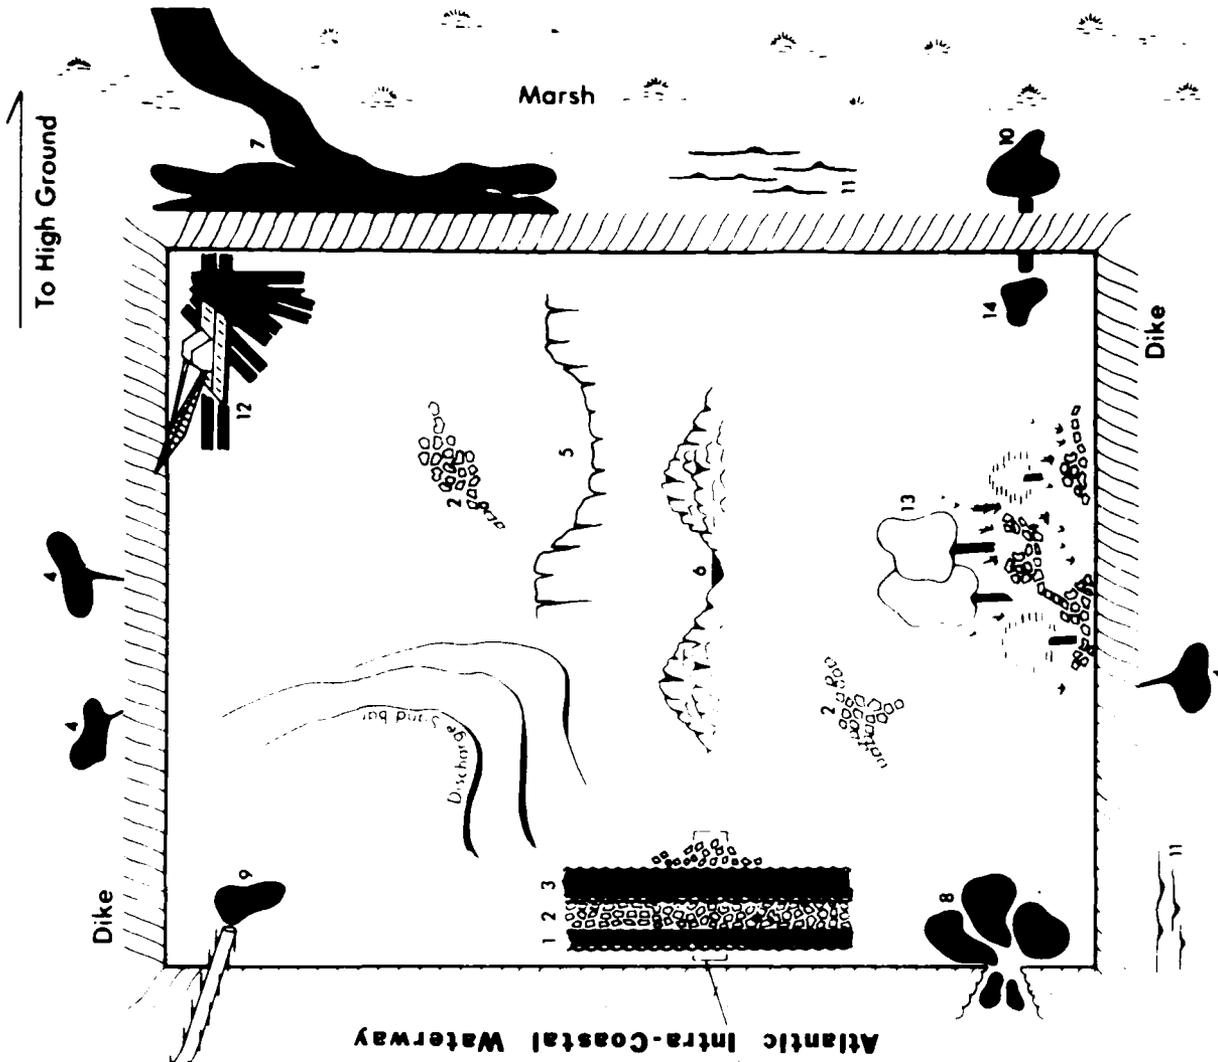
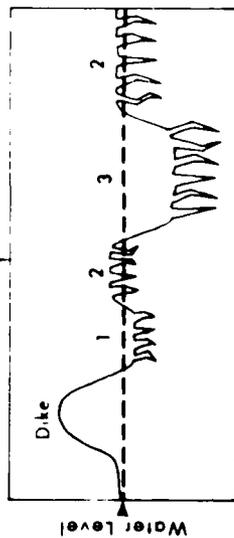
Figure 2 Composite Diagram of Possible Mosquito Breeding Habitats Associated with Dredged Material Disposal Areas (after Ezell, 1978)

1. Dike swale
2. Fissured soil (generalized breeding) Subject to rainfall.
3. Swales from previous borrow pit
4. Seepage outside dike
5. Depression sites
6. Swales between hummock sites
7. Blockage of tidal drainage (outside disposal area)
8. Dike failure with resultant ponding (high tides and rain)
9. Discharge sites inside dike
10. Outfall site pools (outside dike)
11. Localized breeding outside dike
12. Surface distortion due to equipment operation
13. Protective volunteer vegetation
14. Sump site (inside outfall pipe)

36. Blockage of tidal drainage\* (item 7, Figure 2): This condition results when dredged material disposal sites are interposed within natural tidal drainage patterns. This results in the interruption and/or redirection of small tidal creeks which drain the marsh. If redirection is complete, no mosquito breeding problem is produced. However, partial or complete interruption of drainage patterns results in the creation of a shallow pond or large puddle at the perimeter of the disposal site.

41. Seepage (item 4, Figure 2): Following a disposal operation, surface water gradually percolates into the substrate. In some disposal sites, subsurface horizons of the dredged material substrate apparently are nearly impervious to surface water. This situation results in a perched water table. As a result, horizontal percolation of water occurs which is manifested by seepage at the base of the dike around the outside perimeter of the disposal area. Other factors may also influence this effect (e.g., the close proximity of the borrow pit to the dike and improper dike construction) and the relative importance of each of these factors has not yet been established (see Part V for a more detailed discussion of dredged material substrate characteristics). Such seepage may result in the formation of pools along the outer perimeter of the dike, which represent a frequent source of mosquito production. Formation of such breeding areas is especially enhanced if the dike interrupts the natural marsh drainage pattern and/or is juxtaposed with upland areas.

42. Depression and hummock sites\* (items 5 and 6, Figure 2): These conditions result when depressions associated with the natural

43. Dike failures (item 8, Figure 2): This situation may result when seepage at the base of a dike (paragraph 41) undermines some portion of the dike around a disposal site. Erosion caused by runoff from rainfall and by the effect of wave and tidal action which occurs in the AIWW, may also result in dike failure. Wave and tidal effects can be magnified by situating the disposal site too close to the AIWW. Dike failure may eventually occur even when several meters of marsh or other substrate are situated between the Waterway and a disposal site if the energy of wave and tidal action is sufficient to gradually erode the substrate which was previously acting as a buffer. An important aspect influencing this effect is the force of waves created by the wakes of passing boats (this problem is particularly acute for disposal sites located in the vicinity of McClellanville, South Carolina; see individual site descriptions for additional details). When a dike is breached in the manner described above, the disposal site frequently becomes prone to flooding caused by spring and storm tides, but not to the flooding caused by the ebb and flow of daily tides. Thus, the site is easily flooded, but not flushed by tidal action. As a result, dike failure provides an excellent means for flooding some of the mosquito breeding subhabitats described in this section. Thus, dike failures tend to enhance and augment mosquito breeding conditions that are already present.

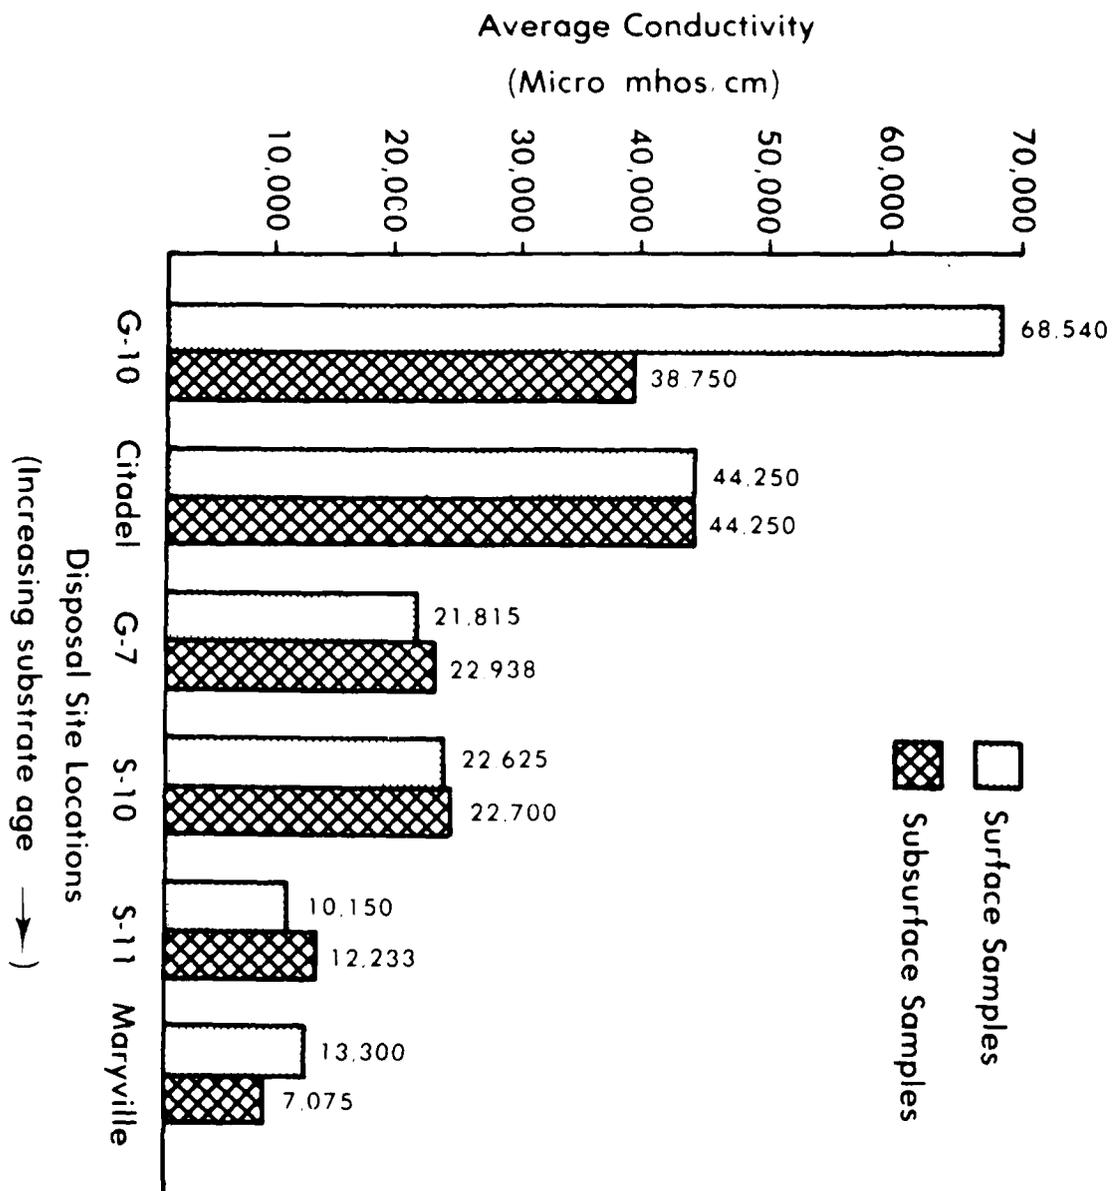
Figure 4 The Average Surface and Subsurface Conductivity of Dredged Soil from Six South Carolina Disposal Areas

s: surface sample                      ss: subsurface sample

60. Acidity and conductivity: Both of these parameters exhibited variations which appeared to be closely associated with the age of the substrate of each disposal area sampled. As expected, an inverse relationship was observed between conductivity values and increasing time following deposition of dredged material. This effect is illustrated graphically in Figure 4. The values shown in the histogram of Figure 4 represent the averages of all surface and all subsurface conductiveness (reported in Tables 2-7) recorded for each disposal area sampled. A similar time-related decline in conductivity was reported by Ezell (1978) for disposal areas in the vicinity of Charleston Harbor. The results of the Ezell (1978) study were combined with the results reported in Tables 2-7. These data were used to construct a histogram for the average conductivity of dredged soil less than one year old, one-five years old and more than five years old (Figure 5). Much of the observed conductivity apparently results from seawater salts deposited in disposal sites as dissolved salts in the mixture of particulate matter and water which makes up dredged material. Conductivity values for some sampling sites exceeded that of seawater which probably represents the precipitation and concentration of salts at the substrate surface as surface water evaporated following a disposal operation. The decline in the salinity of older substrates apparently reflects the translocation of surface salts to deeper strata

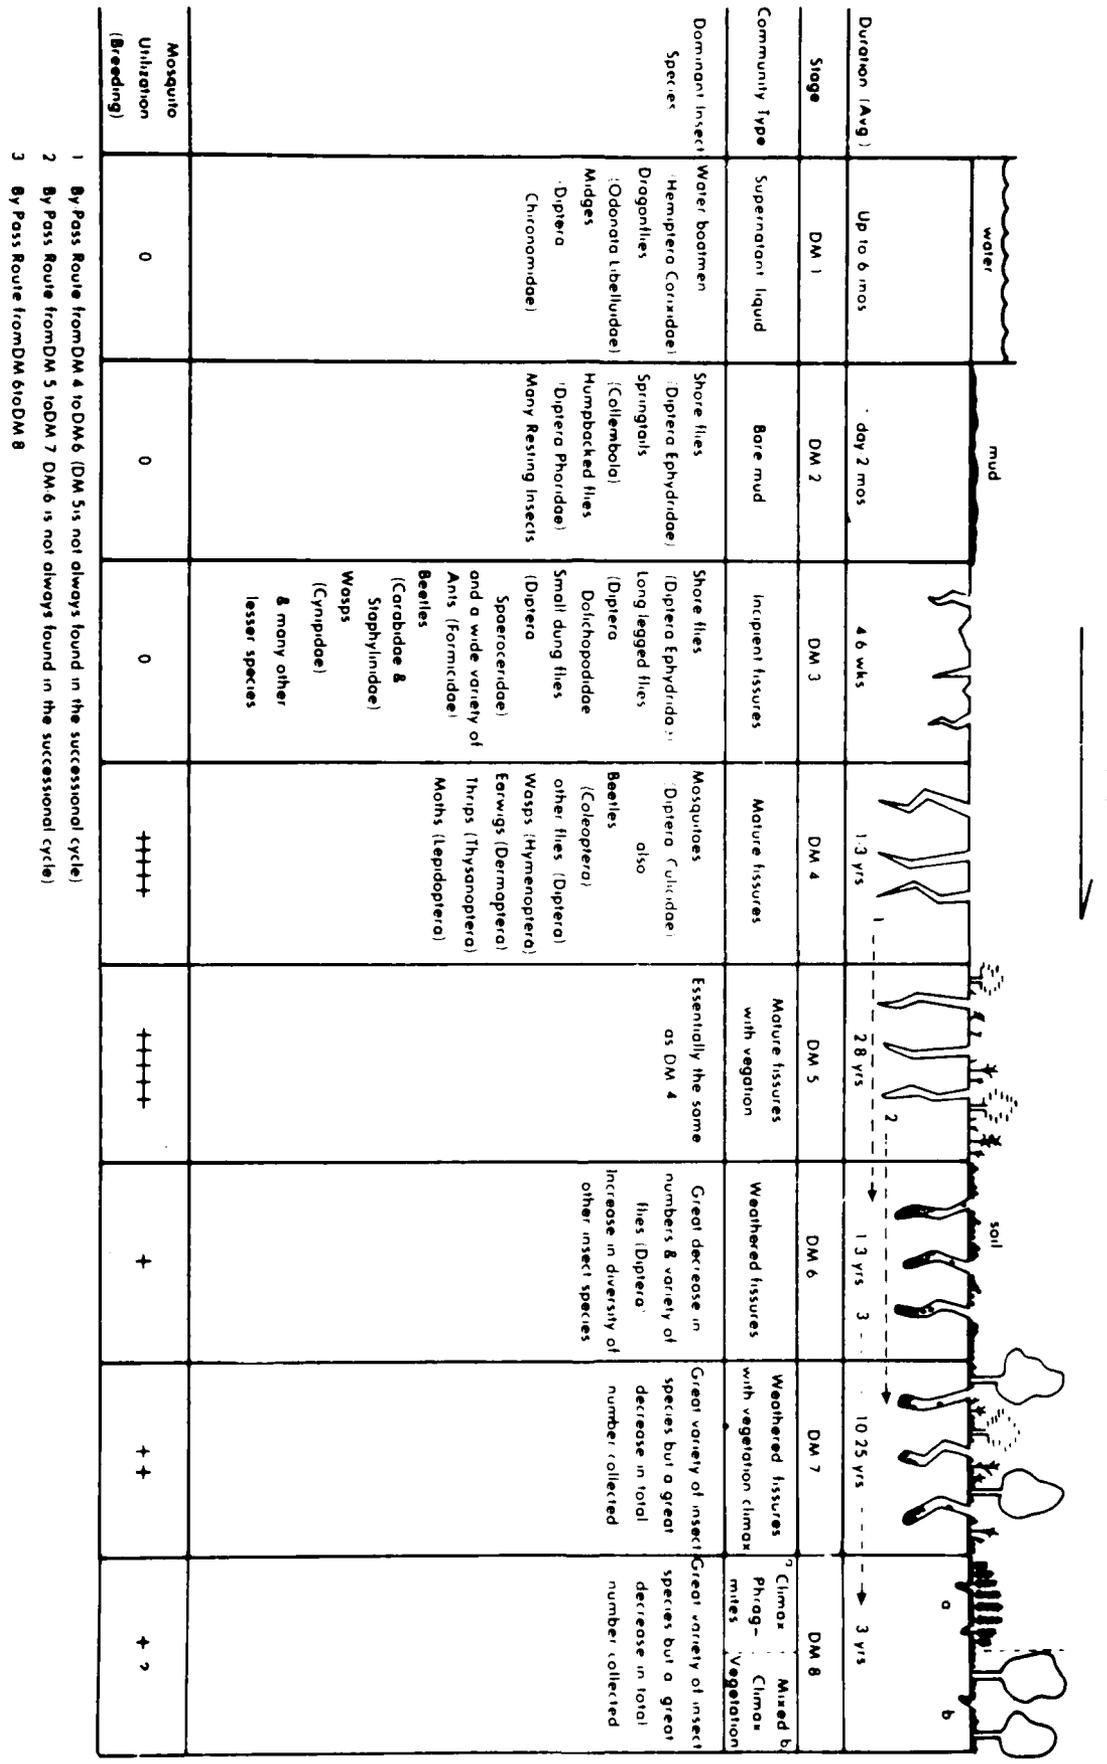
Figure 6 Summary Diagram of Insect Habitats Based upon Dredged Soil Weathering Conditions (after Ezell 1978)

- 1 By Pass Route from DM 4 to DM 6 (DM 5 is not always found in the successional cycle)
- 2 By Pass Route from DM 5 to DM 7 (DM 6 is not always found in the successional cycle)
- 3 By Pass Route from DM 6 to DM 8

63. That the presence of fissures in dredged material disposal areas is probably the best single indicator of mosquito breeding was previously mentioned in this report. The fissured stage and conditions prior to and following fissure formation have been classified according to physical substrate characteristics and the floral and faunal species composition inhabiting the substrate (Ezell, 1978). This classification system is especially useful for applied mosquito control operators because the stages are easily identified in the field and the stages most likely to support mosquito production have been described. A total of eight stages bearing the abbreviation DM (for dredged material) were identified by Ezell (1978). A descriptive summary of these stages follows. A summary diagram of these stages is provided in Figure 6.

65. DM-2 (bare mud): This is a transitional stage characterized by an unbroken mud flat. It is not significant as a mosquito producer. This stage precedes the formation of mosquito producing stages by about six-eight weeks. Thus, it is a good indicator of the approximate time of onset of mosquito breeding within a site.

66. DM-3 (incipient fissure formation): This is also a transitional stage resulting from further drying of the mud flat characteristic of DM-2. It is always marked by the presence of shallow, tenuous fissures. It may also be marked by the presence of the white, siliceous remains of diatoms stranded on the surface of the mud when supernatant water evaporated. These deposits frequently persist through subsequent stages. This stage rarely lasts longer than six weeks and no mosquito breeding is associated with it. However, Ezell (1978) found that overall arthropod diversity was highest in this stage.

67. DM-4 (mature fissures): In this stage, the differential rate of drying at surface and subsurface strata is manifested by a greater rate of shrinkage near the surface. As dehydration continues, deep fissures form (10-60cm and occasionally more in depth). When viewed from above, the fissured surface of dredged material appears as a mosaic of blocks (see Figure 7). Such fissures form ideal mosquito breeding microhabitats because rainfall is trapped at the bottom of them. The duration of this stage is approximately 1-3 years. If the duration is short, fissures may fill before pioneering vegetation has had sufficient time to become established. In this case, the DM-4 stage advances directly to the DM-6 stage.

68. DM-5 (vegetated fissures): When the DM-4 stage persists for more than a year and/or when seed sources are in close proximity to or inside a disposal site, a dense stand of vegetation may become established on the fissured surface (see Figure 8). *This condition appears to be the most favorable situation for mosquito production in a disposal site* (and perhaps anywhere in the coastal environment). The vegetative layer has several roles in relation to mosquito production: (1) it reduces air circulation and insolation within the fissures and this reduces evaporation of water within fissures. This stabilizes the mosquito breeding microhabitat. The extent of the possible offsetting effect of transpiration is not known. (2) It provides a more protected habitat which provides for greater survival of adult mosquitoes—especially for emerging adults. (3) It contributes to the fulfillment of the energy needs of adult mosquitoes by providing

69. DM-6 (weathered fissures) and DM-7 (weathered fissures with vegetation): DM-6 conditions normally follow the DM-4 stage if weathering of fissures is rapid. DM-7 conditions result when weathering of fissures is slow and is further retarded by the tendency of vegetation to maintain the fissured substrate. The DM-4 to DM-5 to DM-7 sequence usually represents a series of conditions which support heavy and sometimes nearly continuous mosquito breeding for many years. The DM-4 to DM-6 succession usually results in less intense mosquito production which is maintained for a shorter duration of time. Nevertheless, even in this latter case, mosquito breeding is nearly always sufficiently severe to require control measures.

70. DM-8 (climax stage): This stage is represented by the development of tall woody shrubs and trees with a closed canopy. Although usually less intense, mosquito breeding may persist during this stage especially if the DM-4 to DM-5 to DM-7 successional sequence has preceded it. Another type of climax stand is the grassy monoculture produced by *Spartina patens*. This condition is a climax in the loosest sense of the term because no other vegetational species are usually observed to precede its development. Once the monoculture of *S. patens* is established, it appears to persist indefinitely. This species is probably most accurately viewed as a persistent ruderal. When a new dredging operation results in destruction of a phragmites stand, this species is able to rapidly reestablish itself by the production of new stems which penetrate through the new layer of overlaying dredged material.

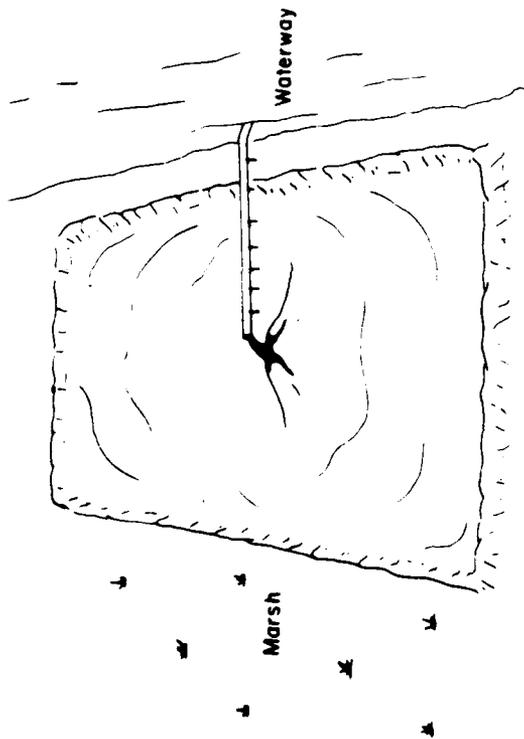
A

Initial Operation : Discharge Pipe near center of disposal area

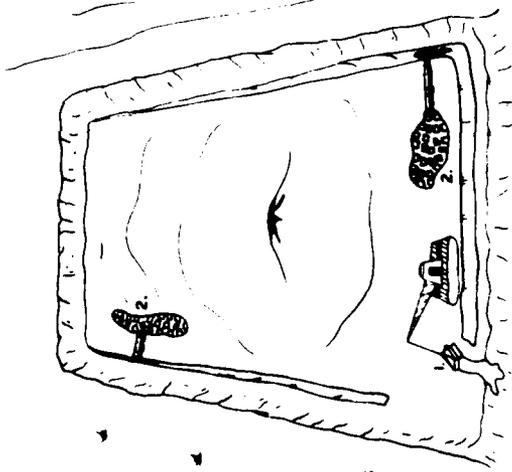
C

1. Dredge material from RIM ditch is used to reinforce original dike
2. Specific breeding locations must be isolated
3. Culverts and/or tide gates established to insure tidal flow
4. Collateral ditches may be needed to drain specific individual breeding locations

RIM Ditch Operation
