NASA
Technical Memorandum 86881

Experimental and Analytical Study of Ceramic-Coated Turbine-Tip Shroud Seals for Small Turbine Engines

January 1985

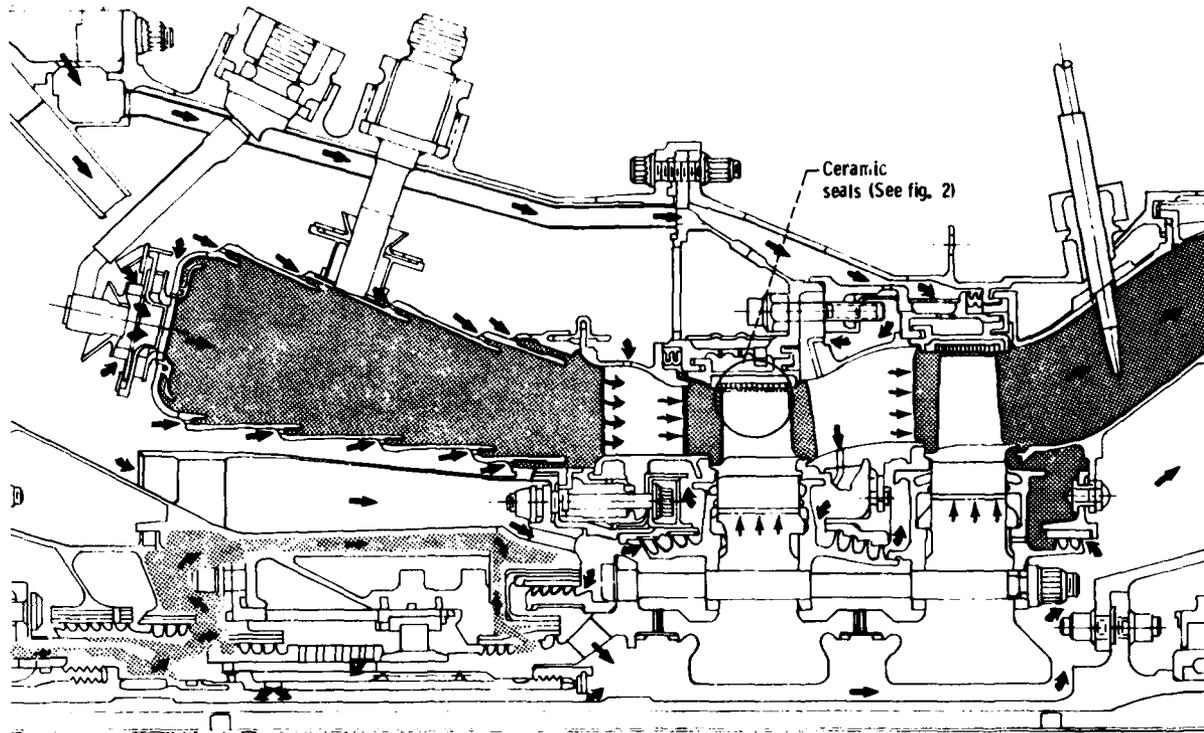
Figure 1. - Engine hot section schematic.

The ceramic shrouds were installed as six circumferential segments in a small (4.5-kg/sec (10-lb/sec) airflow class) turboshaft engine as the first-stage high-pressure turbine tip shroud (fig. 1). The advanced-design engine used for this investigation is currently in production for military and commercial applications. It is a front-drive, turboshaft engine with an integral particle separator, a single-spool gas generator section consisting of a five-stage axial, a single-stage centrifugal flow compressor; a through-flow annular combustor; a two-stage axial-flow gas generator (high pressure) turbine; and a free two-stage axial-flow power turbine. The engine testing was done in a ground level test facility, at the NASA Lewis Research Center using Jet A fuel. Trace elements of certain metals such as vanadium pentoxide rapidly degrade ceramic coatings. An analysis of the fuel found insignificant amounts of these elements.

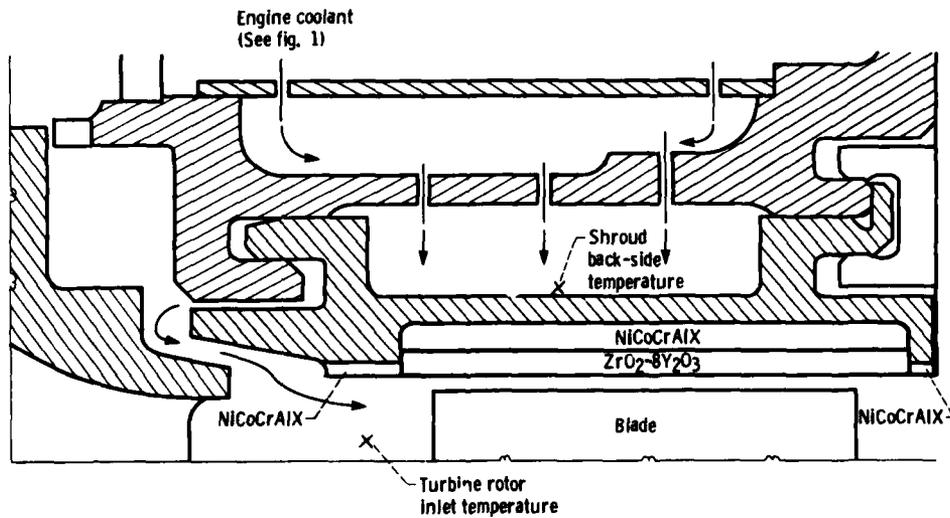
Figure 2. - Schematic of ceramic seal.

A schematic illustration showing a cross section through a typical turbine tip shroud segment is shown in figure 2. Of importance in this figure is the substrate, Haynes-25, part of the BOM configuration, the NiCoCrAlX bond coat (1.0 mm (0.040 in) nominal thickness), and the 8-wt % yttria-stabilized zirconia (also 1.0 mm (0.040 in) nominal thickness). The preparation and application procedures for the substrate, bond coat, and ceramic are described in the section "Seal Fabrication." A photograph of the six shroud segments after application of the ceramic is shown in figure 3.

analysis. In figure 2 the details of the ceramic gas-path seal are illustrated. The Haynes-25 substrate surface was prepared by cleaning and grit blasting. The NiCoCrAlX was then plasma sprayed onto the substrate in a low-pressure environment to a nominal thickness of 1.0 mm (0.040 in).

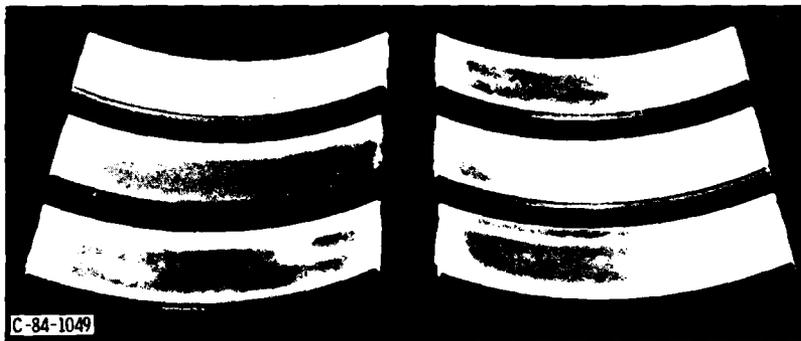
Figure 3. - Shroud segments after plasma spraying.

A photograph of the shrouds before installation in the engine is shown in figure 3. Photographs of a shroud after removal from the engine are shown in figure 12. Visual inspection reports after 4, 210, and 739 cycles are contained in appendix B. Comments on the condition of the shrouds after completion of testing are contained in ANALYSIS OF A MATERIALS SECTION, which is to follow.

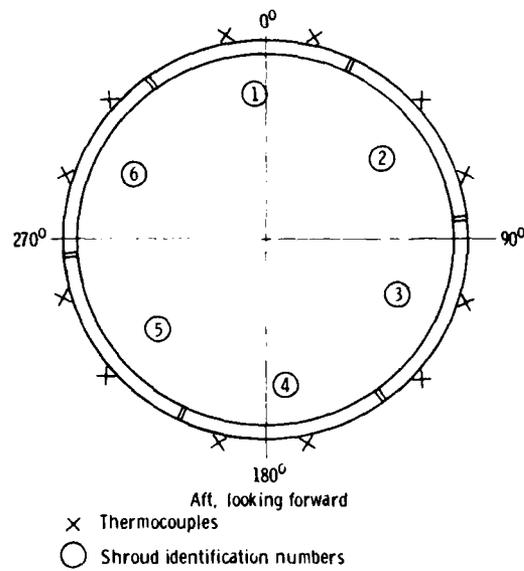
Figure 4. - Position of thermocouples on turbine tip shrouds.

The shrouds were impingement cooled on their back sides using compressor discharge air (see fig. 2). Two thermocouples were attached to the back of each segment (fig. 4). The number of thermocouples was limited (1) by the number of leads that could be fed through the structure containing the impingement cooling holes without significantly altering the cooling pattern and (2) by the number of thermocouples leads that could pass through two ports in the combustor outer wall housing to connect to the facility data system.

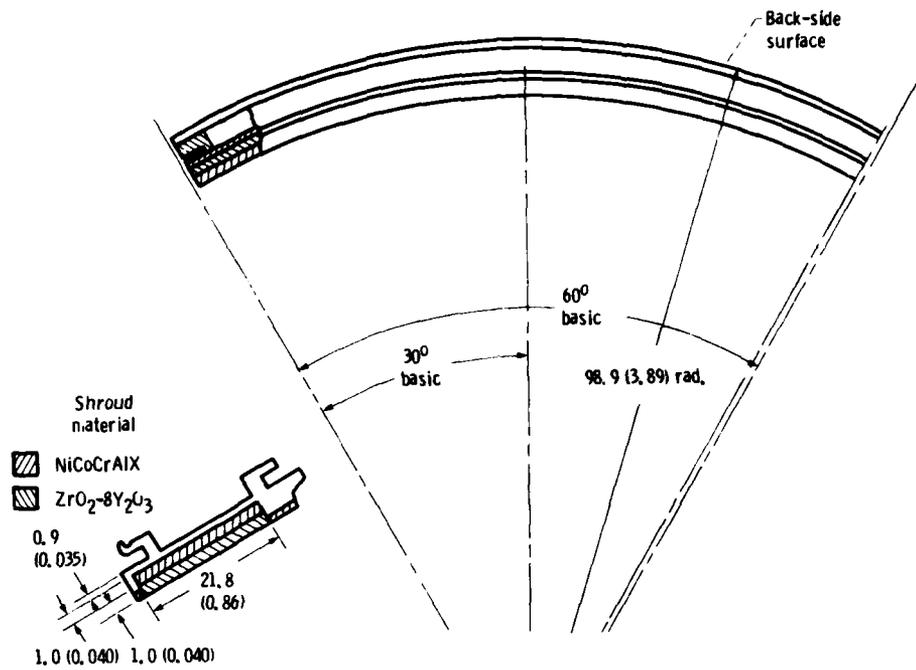
Figure 5. - Shroud general geometric parameters. (Dimensions are in millimeters (inches).)

The general geometric parameters are shown in figure 5. The importance of concave curvature in reducing spallation will become more apparent in the

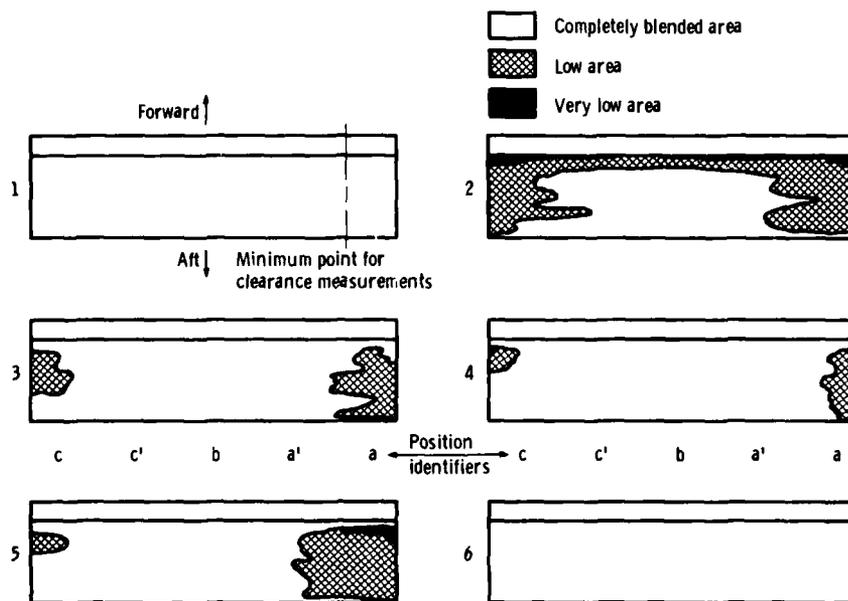
Figure 6. - Schematic of ceramic shroud thicknesses as installed in engine after final grinding.

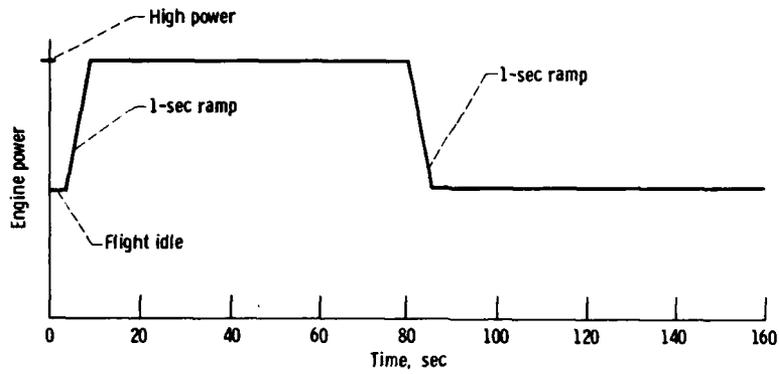
Figure 7. - Typical engine transient cycle.

The test operations cycle was represented by 80 sec of operation at high power followed by 80 sec at flight idle power with 1-sec ramps between the two power levels (see fig. 7). The substrate temperature reached equilibrium during the heatup (flight idle to high power acceleration) but did not quite attain equilibrium during the cooldown (high power to flight idle deceleration). Plots of engine speed indicate an overshoot in speed for both heatup and cooldown (fig. 8). These excursions were considered in the calculated gas temperature, but were not detected in the substrate temperature histories as will be discussed under RESULTS AND DISCUSSION.

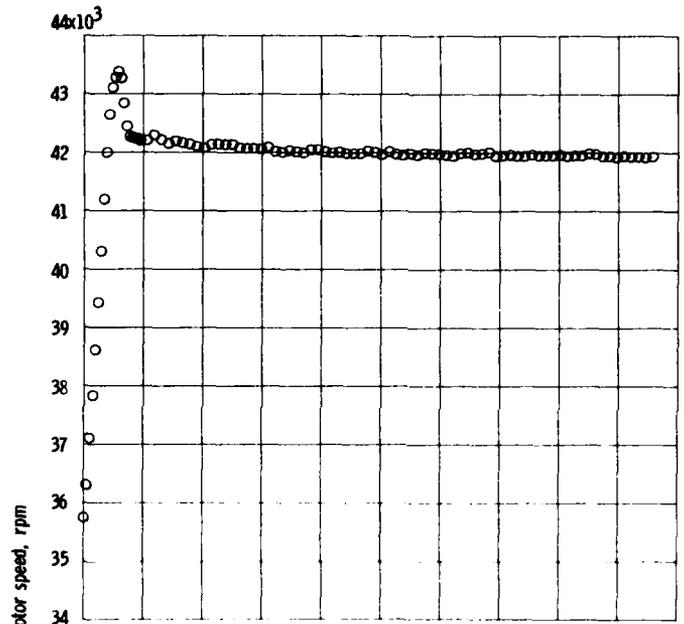
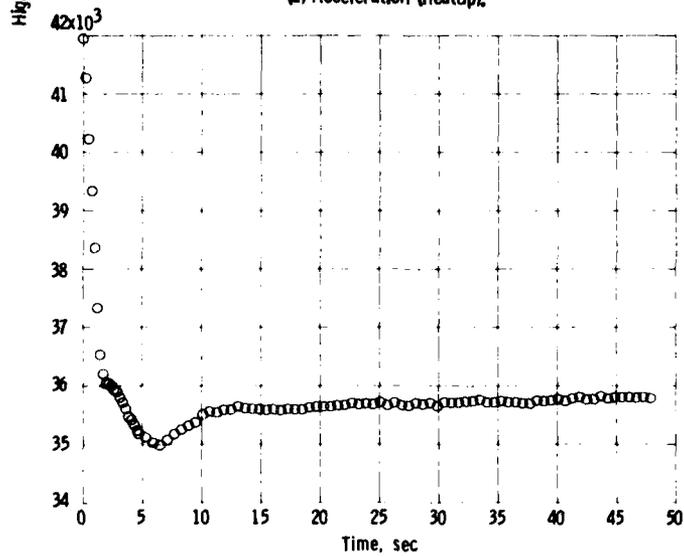
(a) Acceleration (heatup).

(b) Deceleration (cooldown).

Figure 8. - High rotor speed variation with time.

turbine temperature or high rotor speed were reached during the speed overshoots shown in figure 8. Even with this restriction, gas path temperatures over 1205 °C (2200 °F) were reached during high power operation.

The engine was operated through 1001 cycles from idle power to high power and back to idle with the ceramic shrouds installed. Counting all the engine time from shroud installation to removal this amounted to 57.8 engine hr. This included initial engine-facility shakedown tests and daily engine-instrumentation health checks. A typical engine acceleration from idle to high power is shown in figure 8(a). The corresponding gas-path temperature and the average of 12 thermocouple readings for the shroud back-side temperature are shown in figure 9(a). Similarly, the engine high-rotor speed and average gas-path and shroud temperatures for deceleration are shown in figures 8(b) and 9(b).

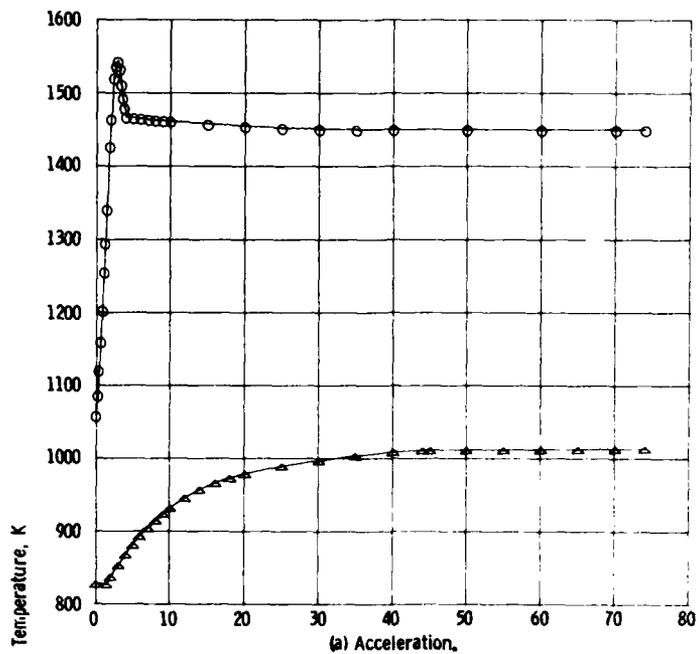
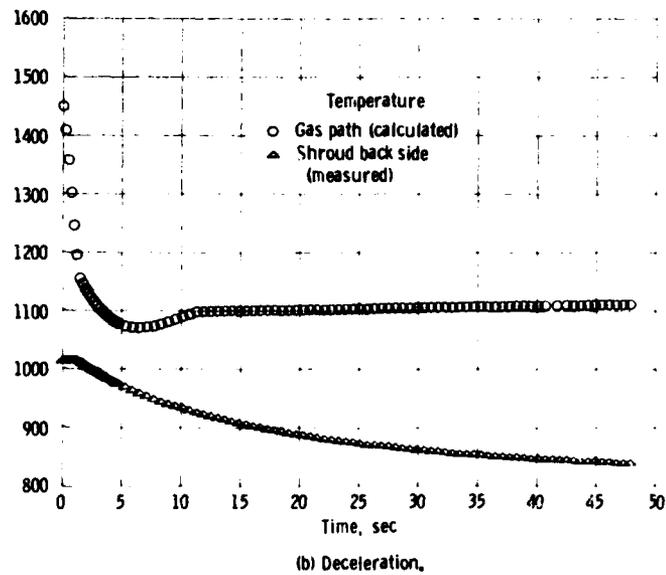
Figure 9. - Average shroud back-side temperature and gas-path temperature variation with time.

The numerically computed temperature profiles through the substrate, bond coat, and ceramic for engine acceleration and deceleration are shown in figure 11. Figure 9 shows that for acceleration an equilibrium condition was reached in ~40 sec, while for deceleration equilibrium was not quite reached during the cycle. The method used to calculate these profiles is contained in appendix A.

The time and temperature histories (fig. 9) were used as input to ADINAT. The base cycle of 80 sec of heating and 80 sec of cooling was followed for one cycle. The properties were interpolated using the time-step Euler backward implicit scheme.

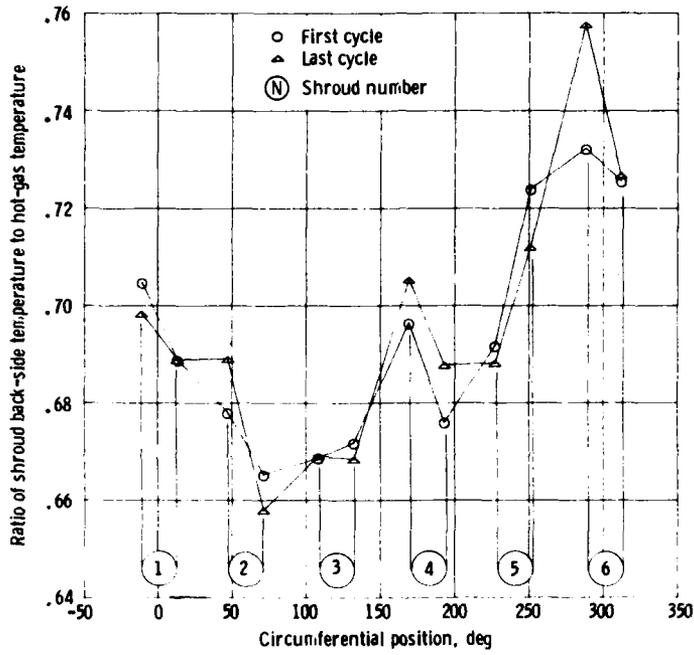
Figure 10. - Normalized shroud back-side temperatures at high power for first and last (1001) cycles.

Normalized steady-state shroud back-side temperature after the first and the last (1001) cycles are shown in figure 10. As can be seen in this figure, thermocouples on shroud 6 are somewhat out of agreement with the trend established by the other thermocouples. However, the thermocouples showed no visual or electrical signs of distress under posttest inspection. Possible explanations for this situation include cooling hole blockage, which limited flow to the backside of this shroud, excess coolant bleeds to the hot-gas path, thinner than normal ceramic coating, combustor temperature profile variation, or shroud-to-blade clearance variation from nominal. This problem has not been resolved.

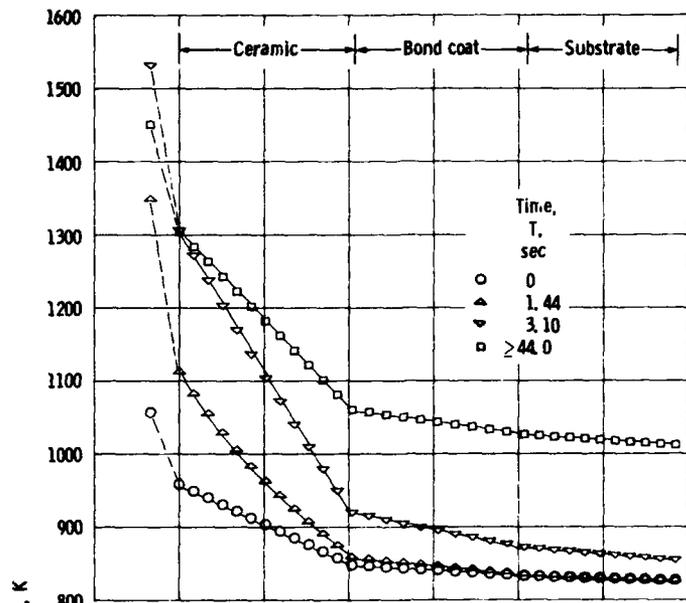
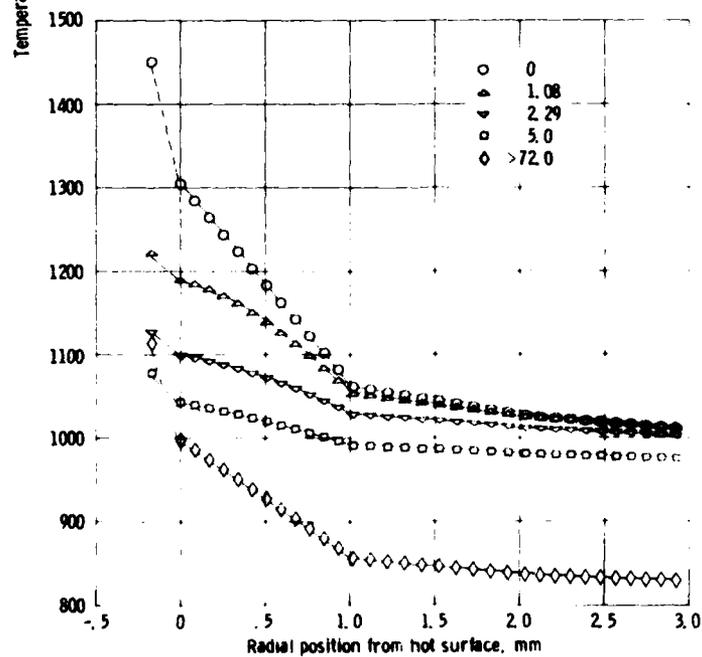
(a) Acceleration.

(b) Deceleration.

Figure 11. - Variation of shroud temperature profile with time.

Typical thermal profiles through the shroud are illustrated in figure 11 for the thermomechanical heatup and cooldown parts of the cycle. In contrast

to burner rig tests, these profiles indicate a near-zero heat flux for a short time during cooldown; as such, the cooling is more uniform.

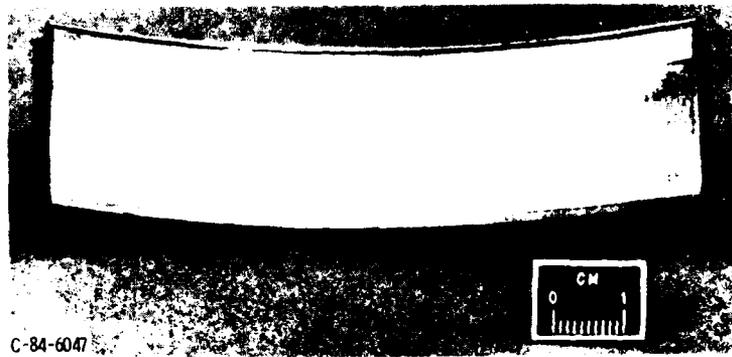
(a) Hot-gas side.

(b) Backside.

Figure 12. - Shroud segment after 1001 cycles.

In this evaluation, one shroud (shroud 6) and a typical cross section were metallographically examined. The front and back surfaces of a typical shroud are shown in figure 12, which indicates a reasonably smooth surface without visible defects. Some slight erosion was evident, along with a small amount of 8-wt % yttria-stabilized zirconia ceramic darkening. Macroscopic observations (figs. 17 and 18) (at 32x) showed cracking in the bond coat region along the trailing edge (fig. 18(a)), which extends back into the ceramic flow path surface. Some ceramic cracking was also evident along the leading edge (fig. 17(b)), along with some surface microfracturing (fig. 17(a)). The right end of the shroud showed both vertical and bond-line cracking (fig. 18(b)).

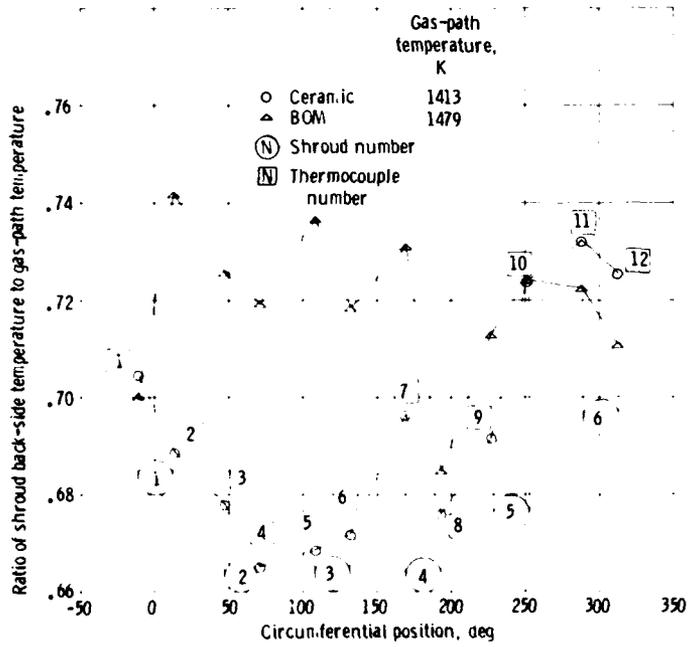
Figure 13. - Comparison of ceramic and bill of material (BOM) shroud back-side temperatures at high power after one cycle.

A comparison of the shroud back-side temperatures for the ceramic and the BOM shrouds after the first cycle for both are shown in figure 13. While on the whole the ceramic temperatures were significantly lower, the opposite was true for such as thermocouples 1, 10, 11, and 12. This lends some credence to the previous hypotheses as to the higher than nominal temperatures in the vicinity of shroud 6. Excluding these thermocouples the difference between the ceramic and the BOM shrouds was approximately 78 °C (140 °F) on the average. The numerically computed radial gradients through the BOM shrouds for an engine acceleration and deceleration are shown in figure 14. A comparison of these radial gradients with those of the ceramic material (fig. 11) shows that the temperatures through the ceramic are lower, testifying to its insulating ability over that of the BOM material.

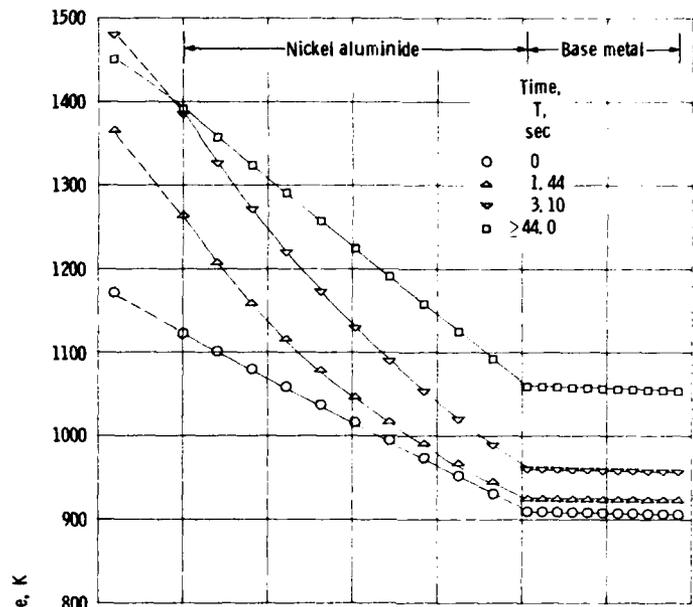
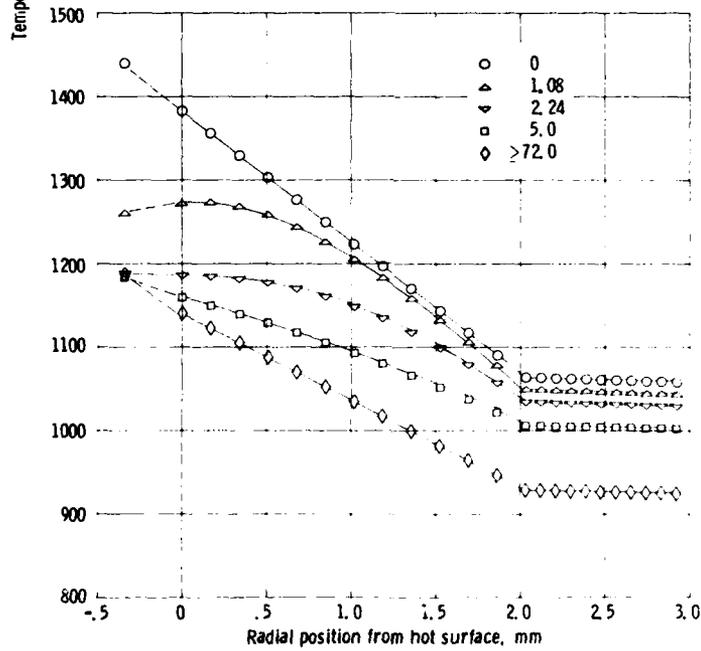
Figure 14 - Variation of bill of material shroud temperature profile with time.

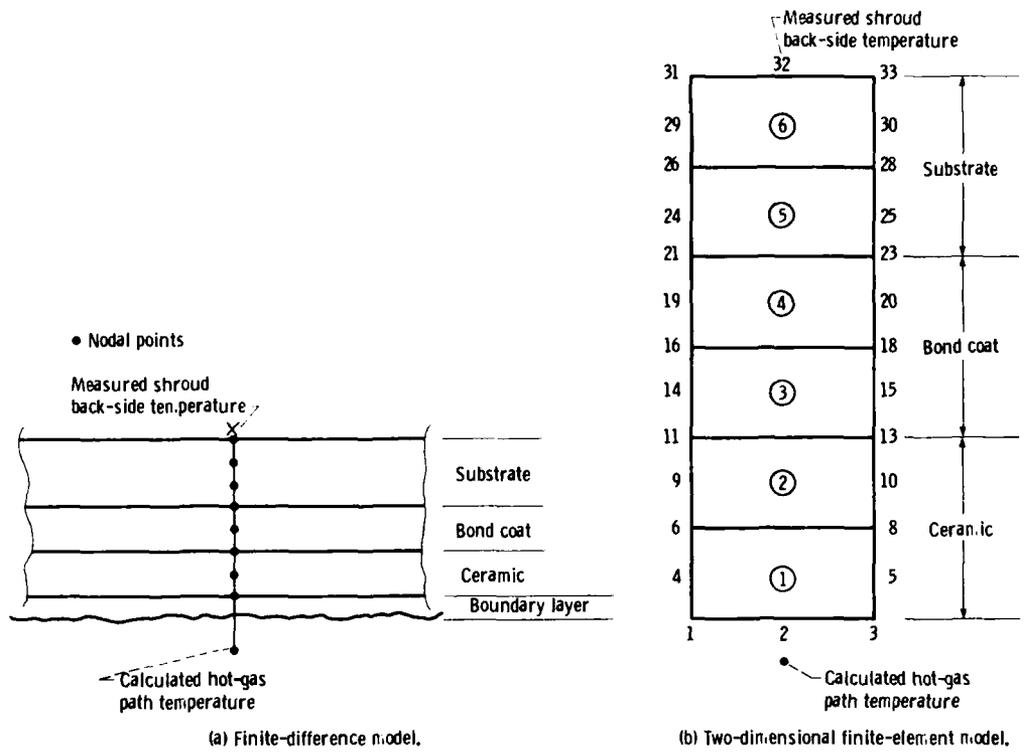
Figure 15. - Models used for heat-transfer calculations.

The models used are illustrated in figure 15. A variable number of elements were used per layer of material, ceramic, bond coat, and substrate for the one-dimensional model (fig. 15(a)). The 6-element (two-dimensional) model with 33 nodal points used an 8-node serendipity element (fig. 15(b)) with 4-Gaussian quadrature points per element situated approximately at 1/3 of the distance from the boundaries. Although a one-dimensional conduction model could have been used for heat transfer, the two-dimensional model was used to be compatible with the thermostress program, ADINA (ref. 4).

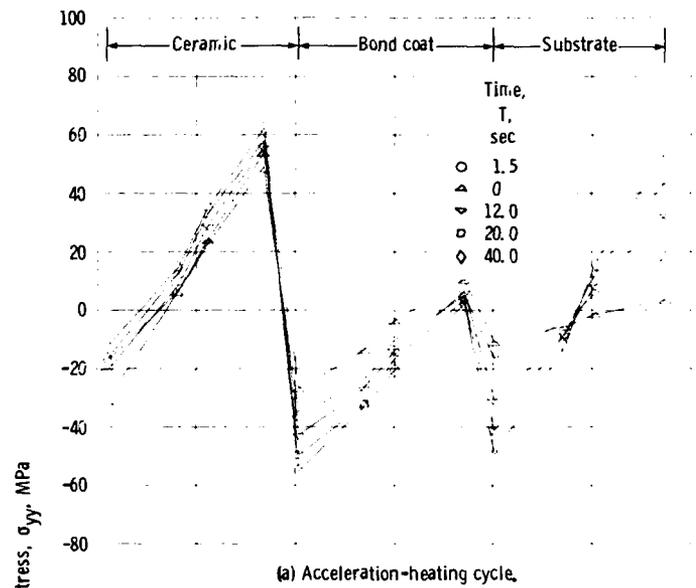
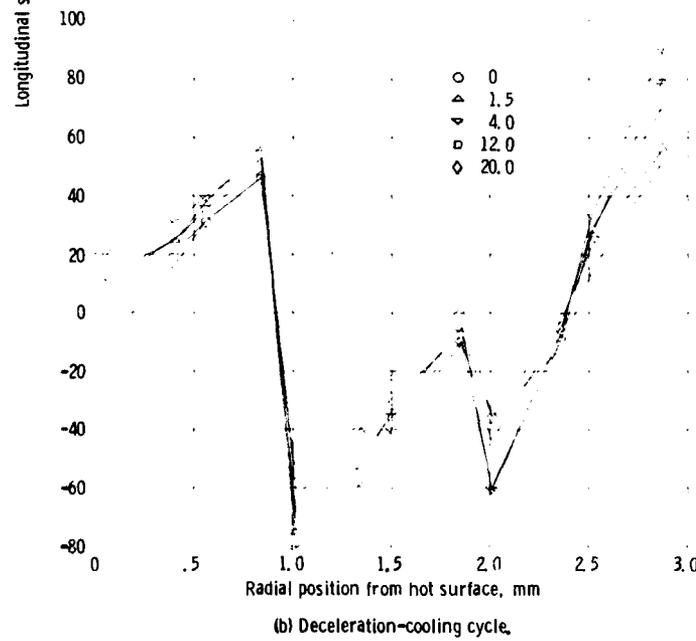
Figure 16. - Shroud longitudinal stress.

Using the thermal profiles generated by ADINAT, the radial, shear, circumferential, and longitudinal stresses within the shroud were computed. The longitudinal stresses are illustrated in figure 16 for the heatup and cooldown portions of the test cycle.

For this inelastic behavior case, radial and shear stresses are small, with the radial stresses negligibly small. The significant stresses for this case are the longitudinal and circumferential stresses, which are similar in magnitude. The longitudinal stresses are illustrated in figure 16 for the heatup and cooldown portions of the test. The longitudinal stresses are tensile at the surface during the cooldown portion of the cycle. These produce surface microcracking. Also, the stresses at the ceramic side of the bond coat and ceramic interface are always tensile, a condition leading to microcracking but not necessarily to material failure.

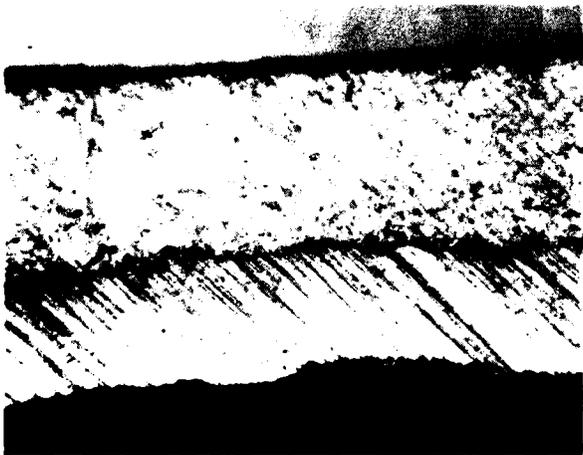
(a) Ceramic and frame crack trailing edge.

(b) Right end bond line and vertical crack.

Figure 18. - Micrographs of ceramic shroud section - trailing edge and right end.

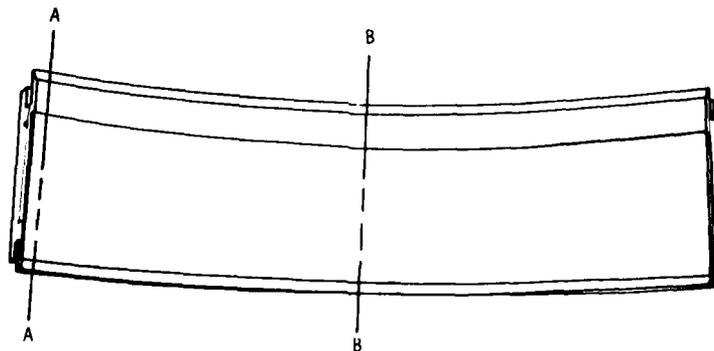
Figure 21. - Metallographic sectioning locations.

Pretest and posttest microstructures of the plasma sprayed coatings (yttria-stabilized zirconia and NiCoCrAlX) on the engine shroud segments were examined. (Section locations are given in fig. 21.)

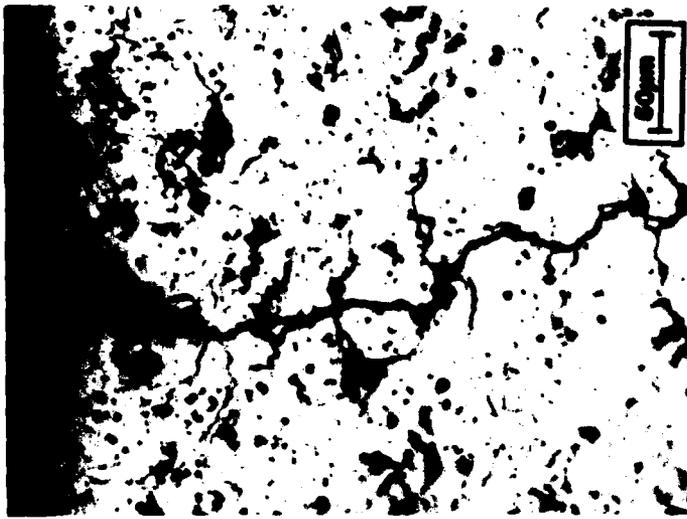
(b) Posttest microstructure; cross section A-A.
Figure 22. - Continued.

(c) Posttest microstructure; cross section B-B.

Examination of posttest ceramic coating microstructure (figs. 22(b) and (c)) revealed extensive segmentation, commonly called mud-flat cracking, and some local areas of lateral cracking and large porosity. Apparently, densification of the ceramic occurred. Caution must be exercised here, however, as observed microstructures are very dependent on metallographic polishing methods. The metallic bond layer exhibited considerable porosity, predominately due to pullout during metallographic polishing which was optimized to reveal the ceramic microstructure. The extensive porosity noted next to the leading and trailing edges was due to the geometry of the part not having been optimized for plasma spray coating. No evidence of any significant oxidation or β -phase (NiAl) depletion on the NiCoCrAlX bond layer was noted. Variations in the thickness of the metallic and ceramic layers found in sections AA and BB are due to impression of the process.
