THE EFFECT OF STRESS AND HOT CORROSION
ON NICKEL-BASE SUPERALLOYS

THESIS

Presented to the Faculty of the School of Engineering
of the Air Force Institute of Technology
Air University
In Partial Fulfillment of the
Requirements for the Degree of
Master of Science in Aeronautical Engineering

March 1985

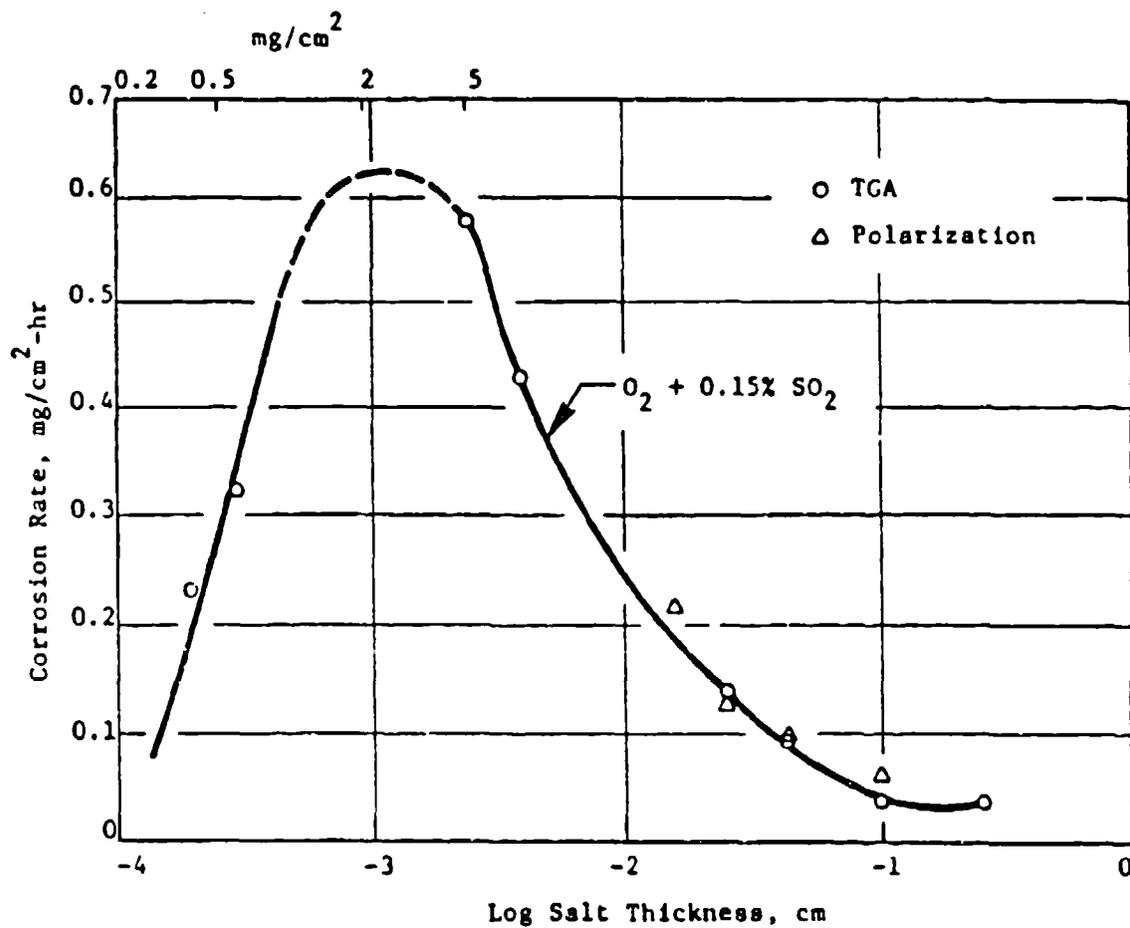
Figure 1 shows the effect of salt thickness on hot corrosion rates for a nickel-base superalloy as reported by Fang and Shores.⁽¹³⁾ The figure clearly shows that the most severe corrosive condition was not complete immersion but at a Na_2SO_4 salt coverage of approximately 2.5 mg/cm^2 (in an $\text{O}_2 + 0.15\% \text{ SO}_2$ gas environment). Although Fang and Shores

FIG. 1. Effect of salt thickness on hot corrosion rates (ref. 13).

A set of five René 77 pins were coated with varying amounts of salt ranging from a coverage of approximately 0.5 mg/cm^2 to 10.0 mg/cm^2 . Attempts were made to coat pins with thicker salt layers, but approximately 10 mg/cm^2 proved to be the maximum coverage achievable with the spraying technique used in this study. The salt composition used was 90% Na_2SO_4 / 10% NaCl . Figure 35 shows the pins after 72 hours at a temperature of 1652°F (900°C). It is very apparent from visual examination that salt thickness affects the degree of hot corrosion attack. Note that at the greater salt thicknesses, the oxide which formed was no longer adherent as seen on previous specimens. Figure 36 shows the weight change of the René 77 pins as a function of salt thickness. This graph shows a maximum corrosion attack at a salt coverage of approximately 7.5 mg/cm^2 . These data show a similar trend to that found by Fang and Shores as shown in Figure 1 of this report.

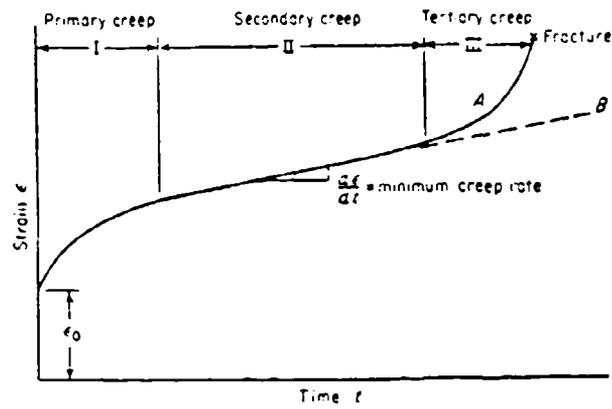
Figure 2 is a schematic of a typical creep curve. The creep curve is divided into three stages. The first stage of creep is known as

FIG. 2. Typical creep curve showing the three stages of creep.
 Curve A, constant load test; curve B, constant stress test.

primary creep and is a region of decreasing creep rate in which the creep resistance of the material increases due to the specimen deformation. The strain represented by ϵ_0 occurs instantaneously upon loading the specimen. Most of this strain is elastic and is recoverable upon unloading. The second stage of creep, known as secondary creep or steady-state creep, is a region of essentially constant creep rate which results from a balance between the processes of strain hardening and recovery. The slope of this linear region is the minimum creep rate for the material and is often given in material property data. The third stage of the creep curve is called tertiary creep and occurs when there is significant intergranular sliding and cracking and internal void formation. There is frequently a reduction in cross-sectional area due to necking during tertiary creep, and the creep rate increases rapidly with time until fracture occurs. The three stages of creep vary with changes in stress and temperature and in many cases, are not well defined.

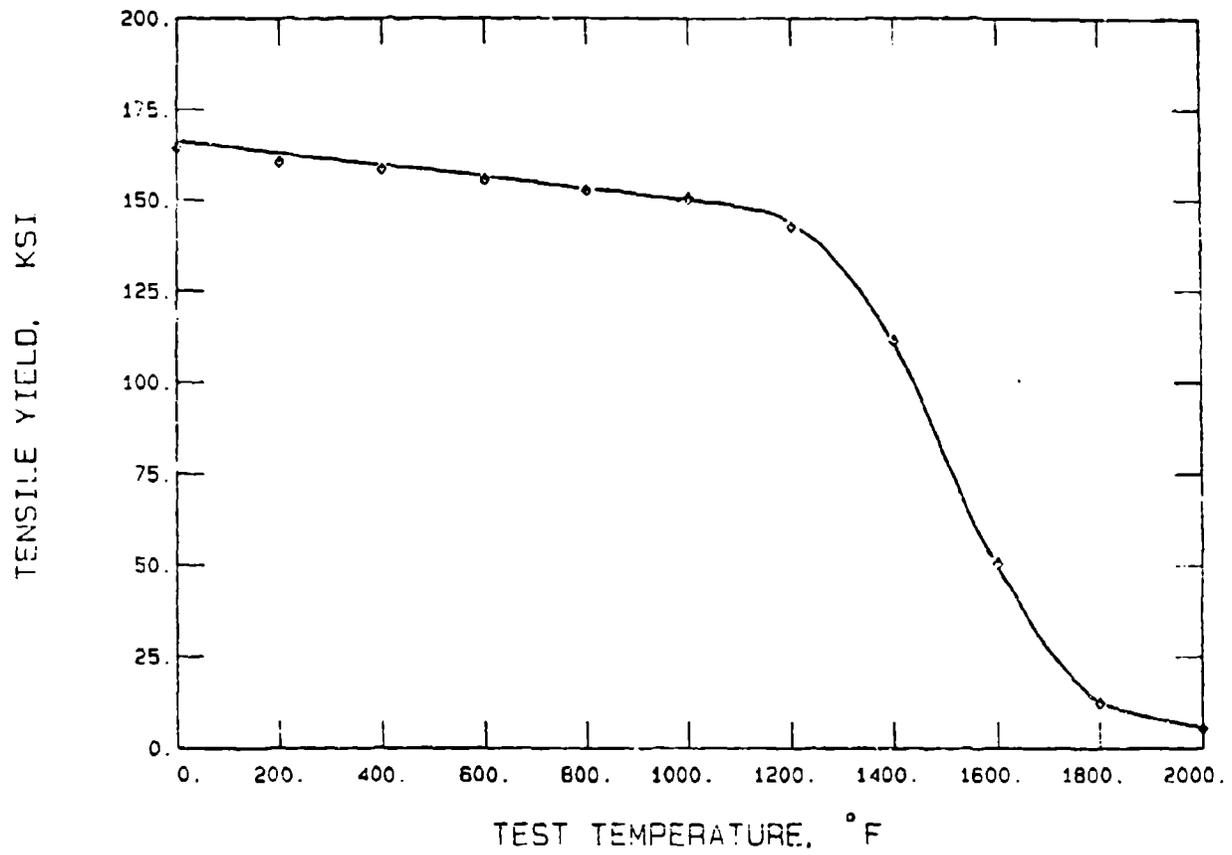
FIG. 3. Effect of temperature on the yield strength of IN 718 (ref. 15).

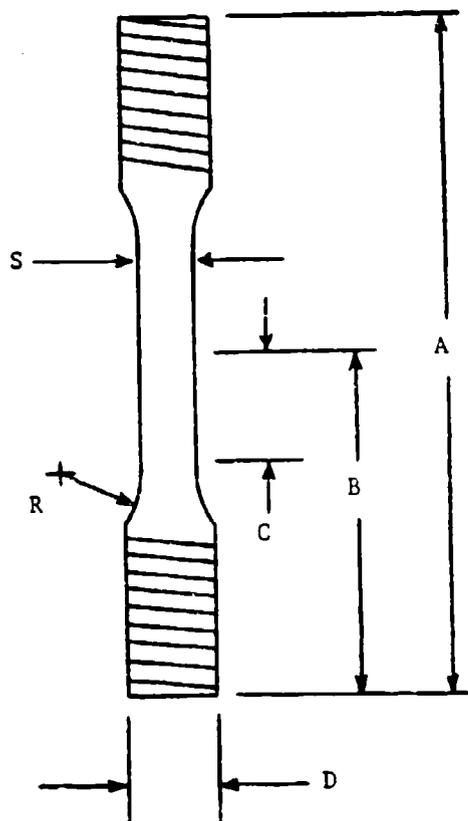
A	4.00
B	2.00
C	0.625
D	0.50
R	0.50
S	0.25

dimensions in inches

FIG. 4. Inconel 718 round bar tensile specimen.

would occur in a relatively short test time. Studying an alloy whose material properties limit its use in applications where hot corrosion occurs "magnifies" the hot corrosion process and the deformation mechanisms which take place. The smooth round bar tensile specimens were machined from the plate transverse to the rolling direction and have a gage length of 1.25 inches and a diameter of either 0.25 inches or 0.125 inches. Overall dimensions of the test specimens are shown in Figure 4.

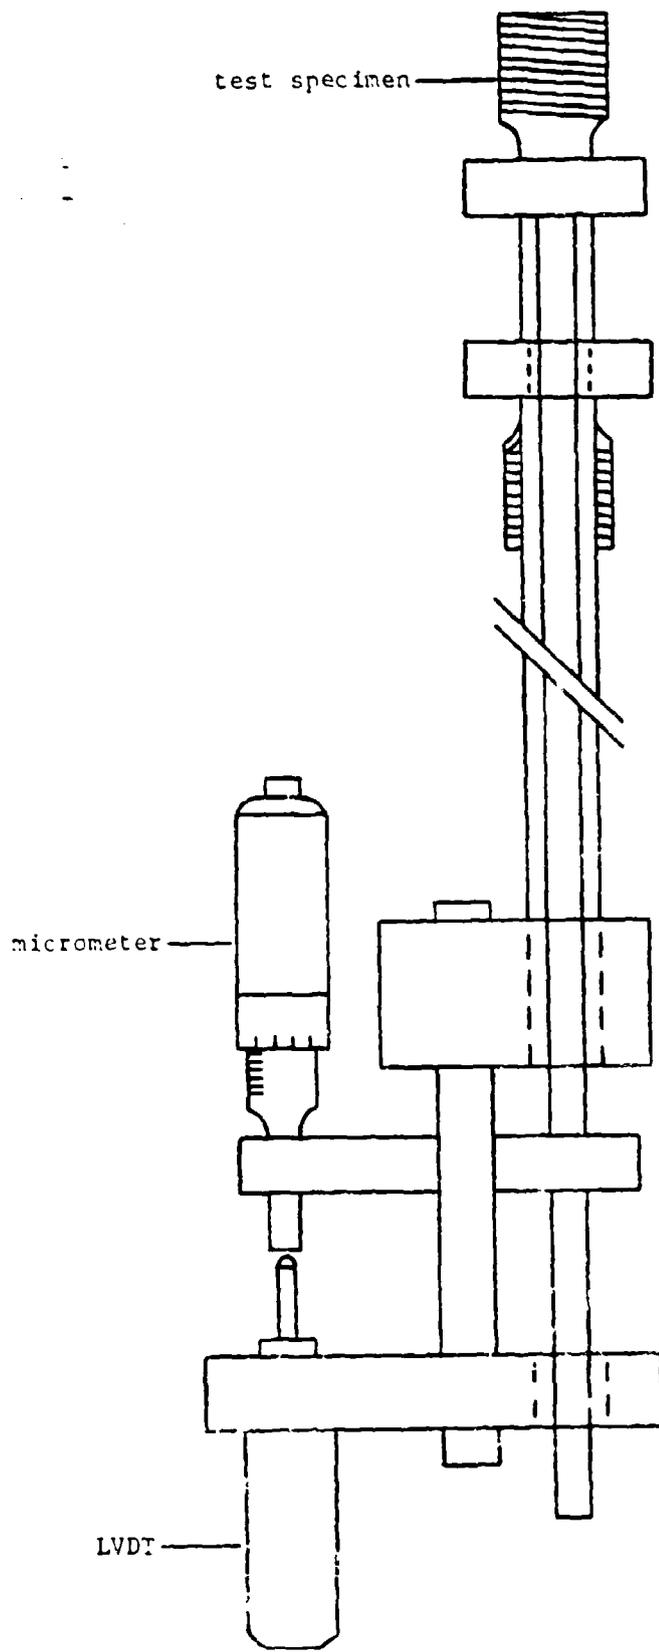
The creep elongation measurements were recorded using a specially designed extensometer consisting of two rods in two concentric tubes. The extensometer tubes extended along the load train of the creep frame and down through the bottom of the tube furnace. The axial deflection was measured using a Daytronic LVDT (linear variable differential transducer) located at the lower end of the rod-in-tube assembly outside the furnace. A schematic of the extensometer assembly is shown in Figure 6. The micrometer was used to calibrate the LVDT output prior to each test.

FIG. 6. Schematic of extensometer assembly.

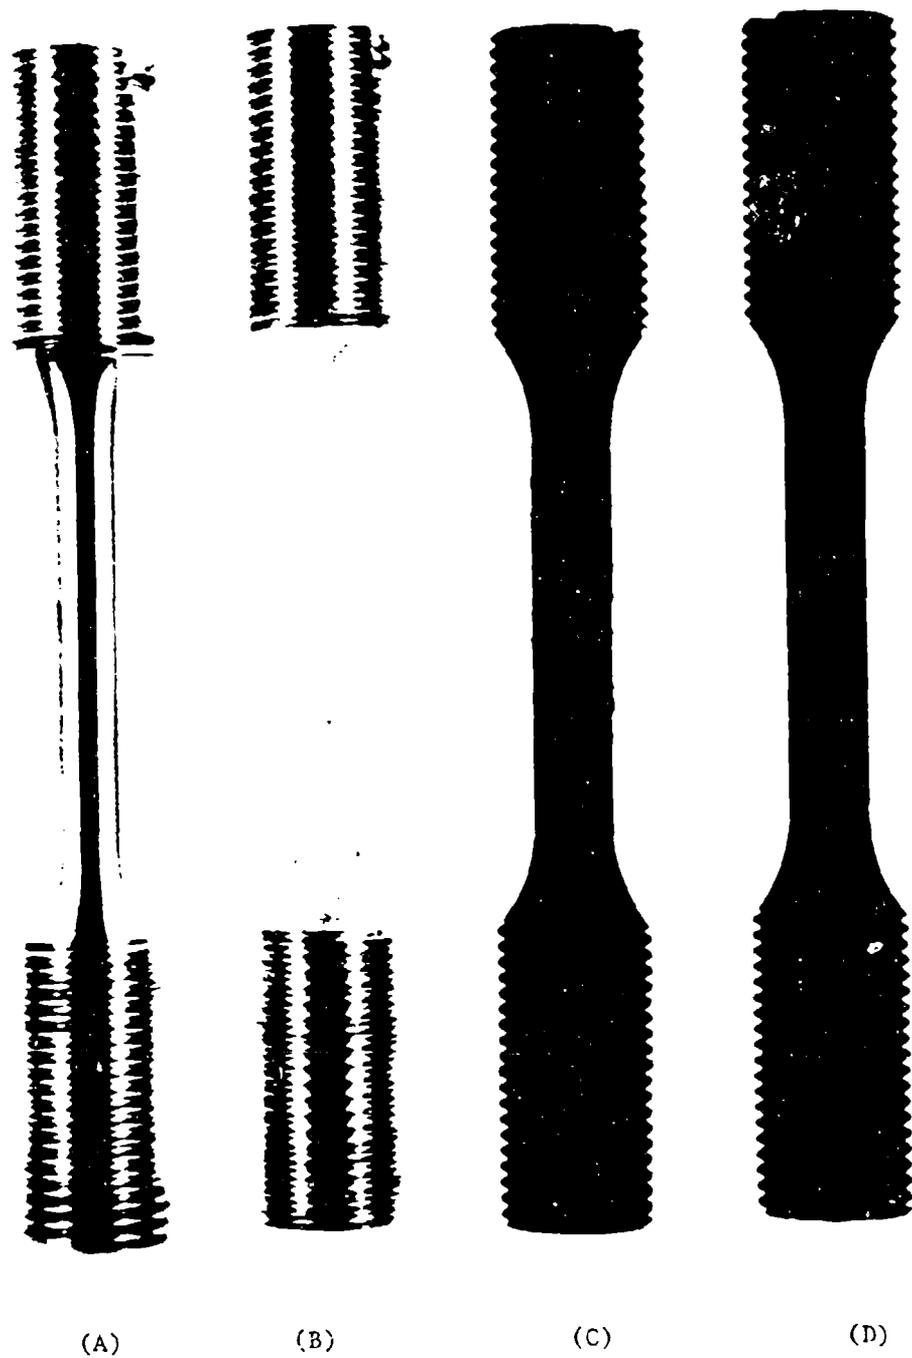
FIG. 7. Inconel 718 specimens (A) as received; (B) after salt coating; (C) after hot corrosion attack; and (D) after oxidation.

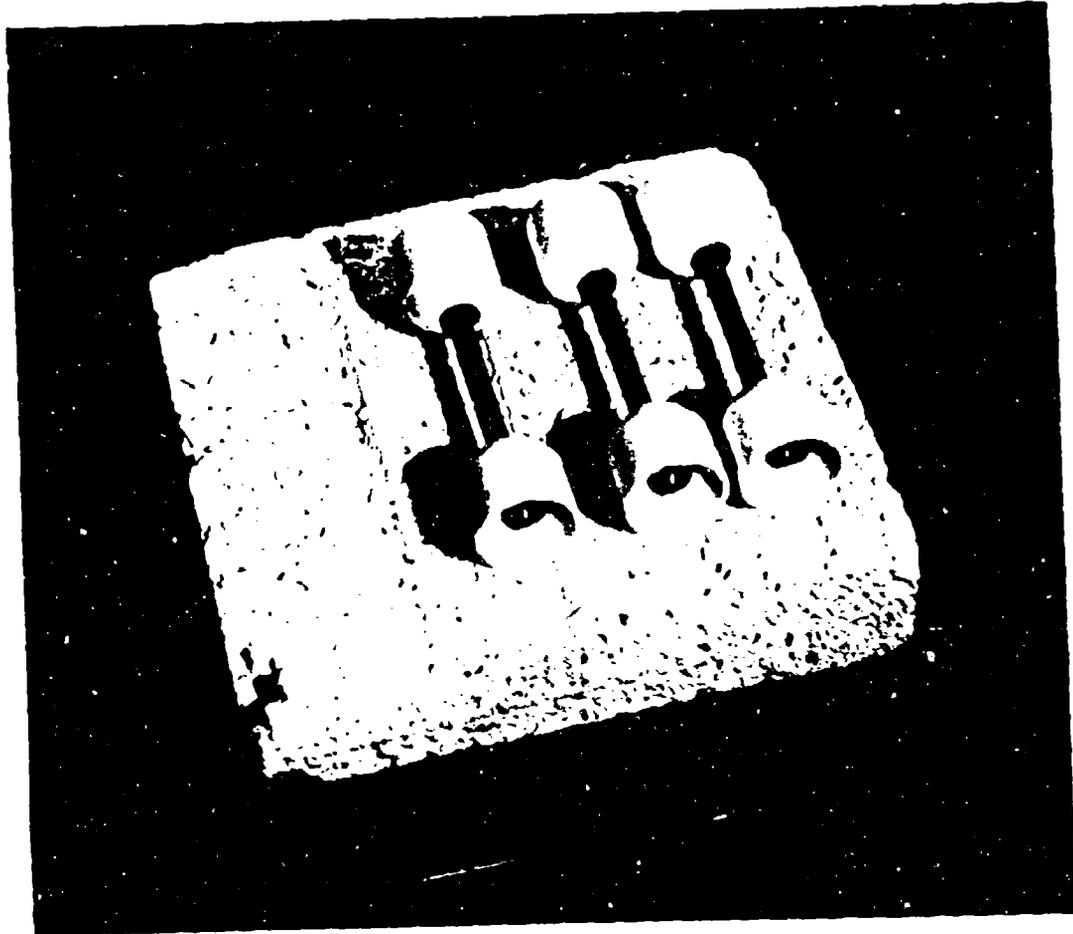
FIG. 8. René 77 and René 80 pin placement for testing.

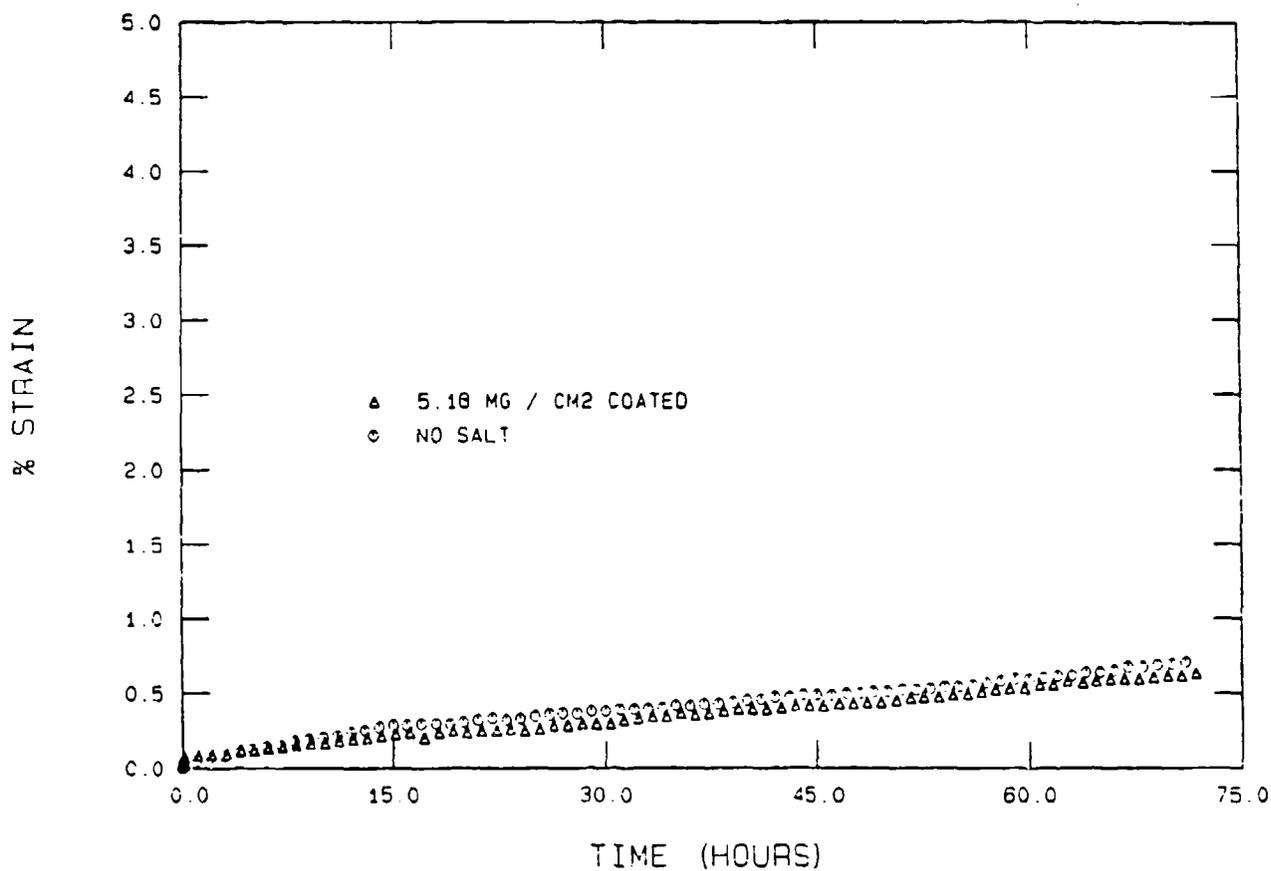
FIG. 9. Creep curves for IN 718 at a stress level of 10 Ksi.

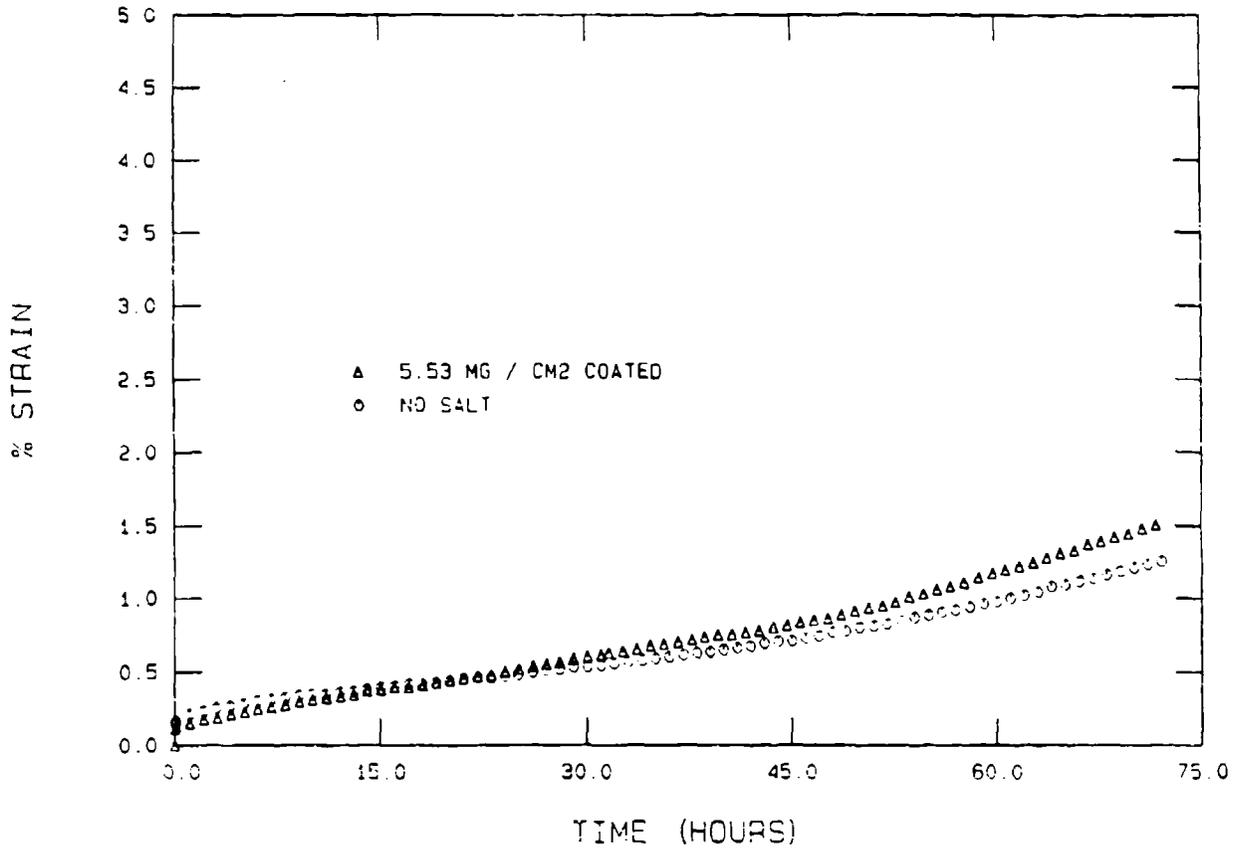
FIG. 10. Creep curves for IN 718 at a stress level of 15 Ksi.

72 hours while the uncoated specimen had a strain of 1.25% in 72 hours.

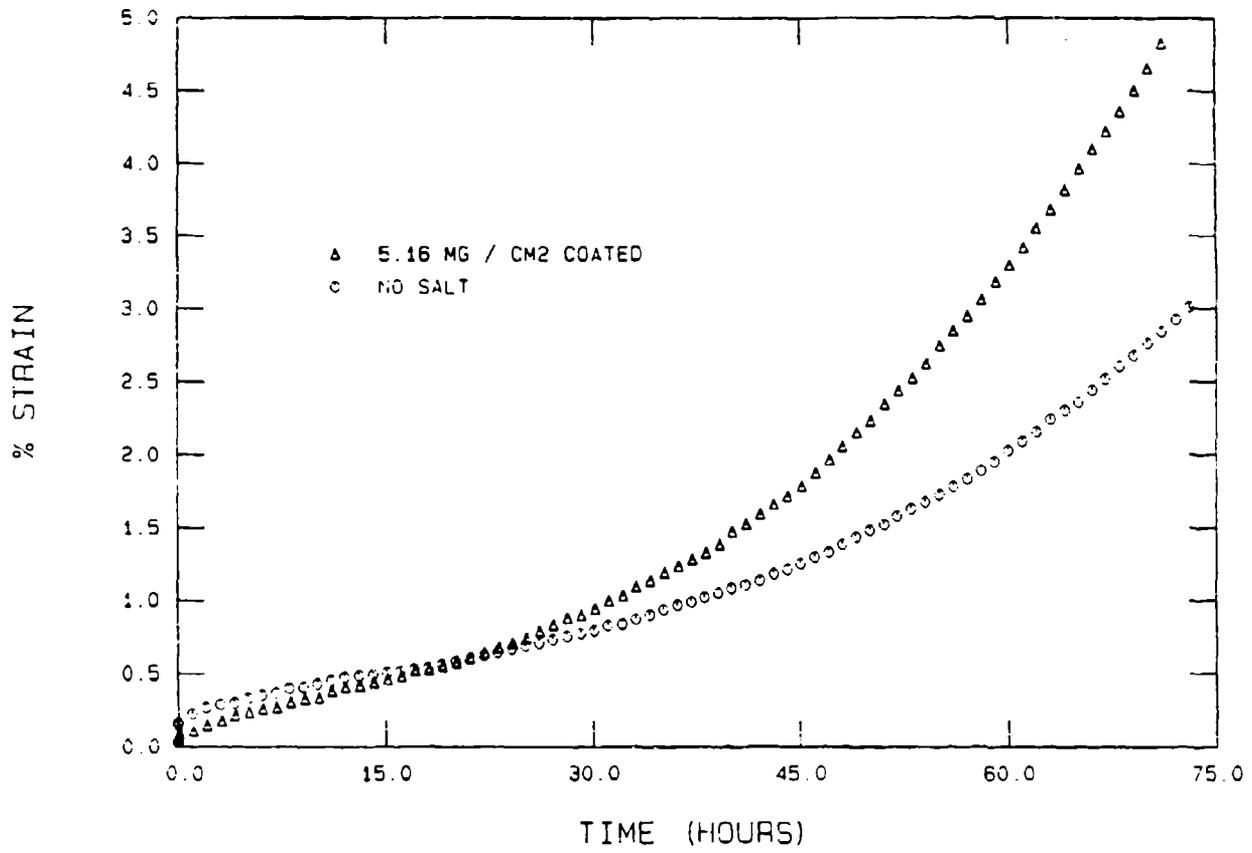
FIG. 11. Creep curves for IN 718 at a stress level of 20 Ksi.

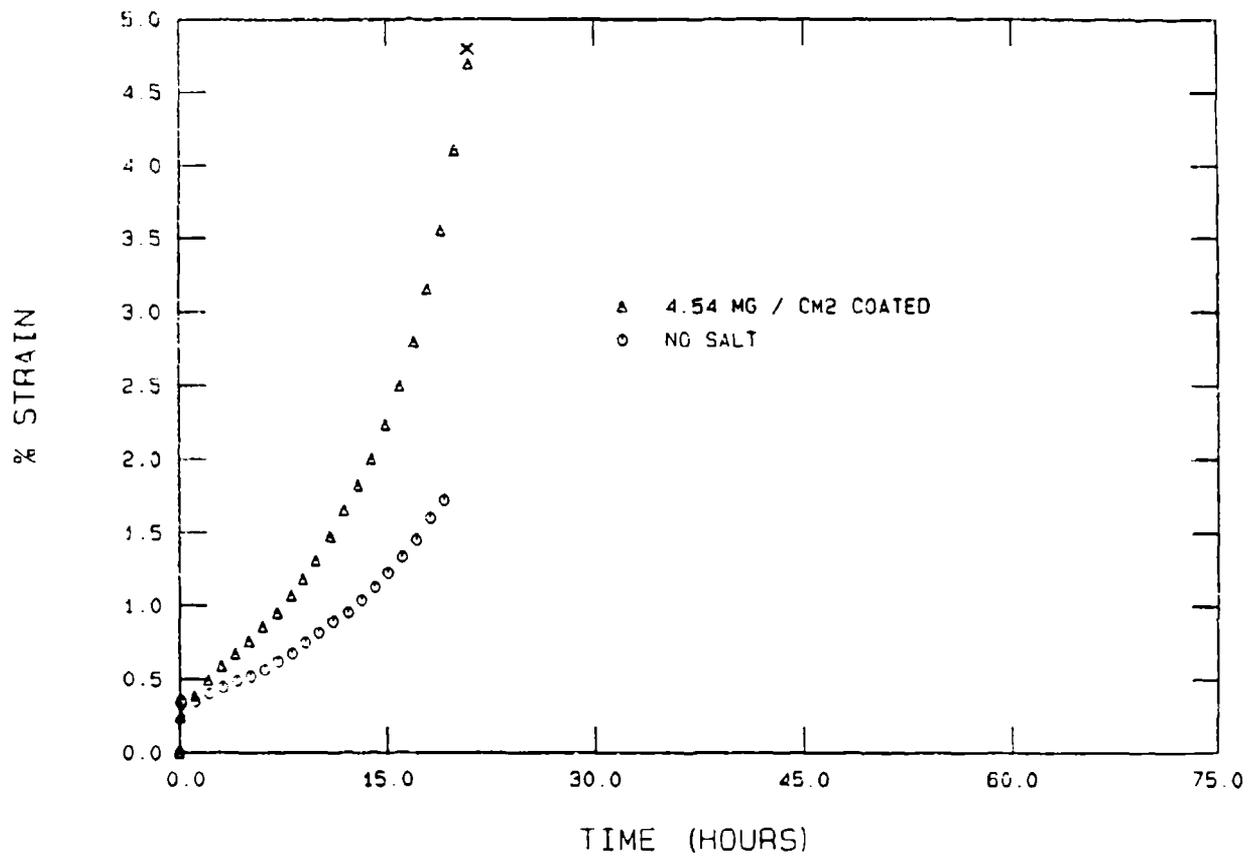
FIG. 12. Creep curves for IN 718 at a stress level of 30 Ksi.

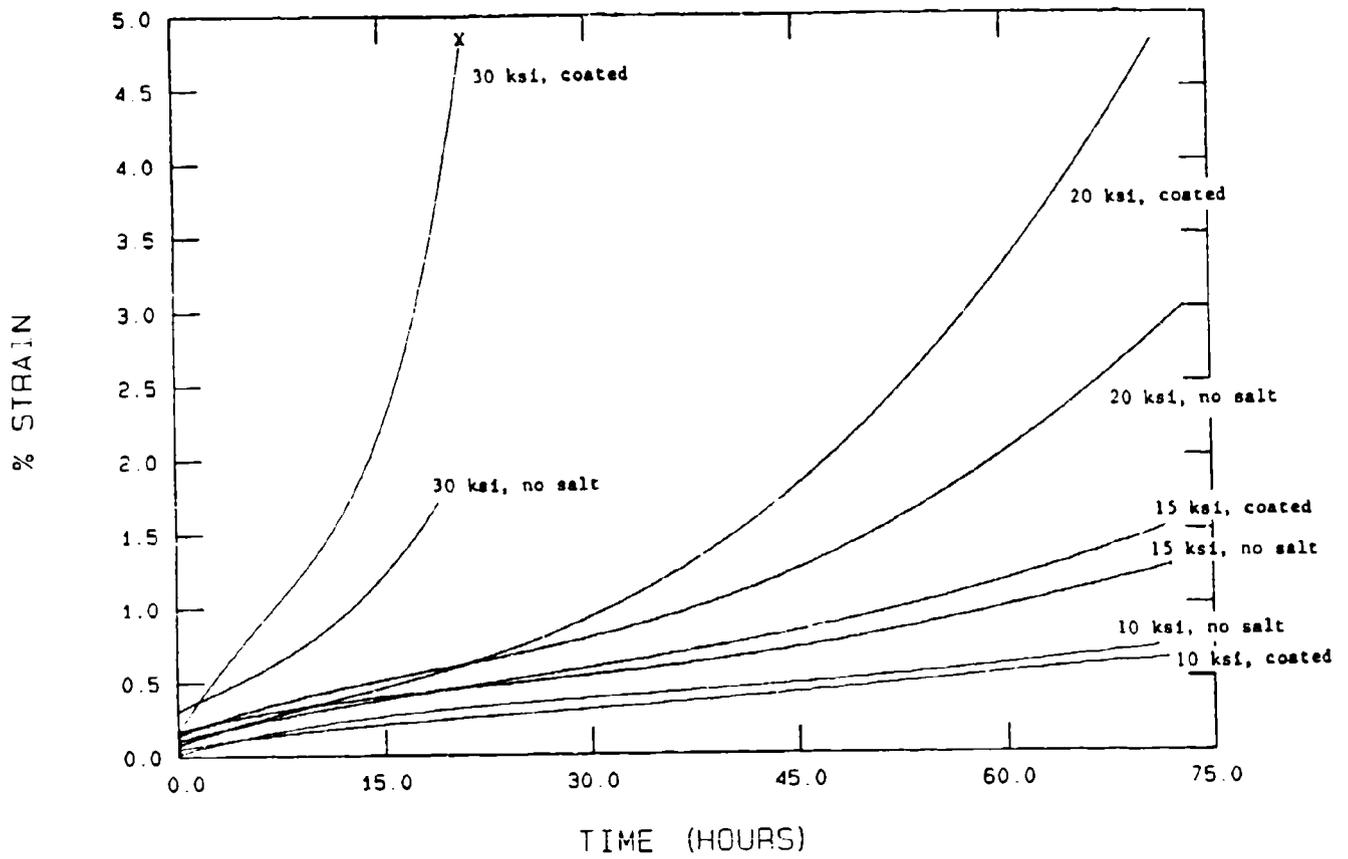
FIG. 13. Effect of molten salt of the creep behavior of IN 718.

tested at 20 Ksi and 30 Ksi experienced predominantly tertiary creep from the onset, and the effect of the molten salt was most severe for these test conditions. At the lower stress levels, the effect of the molten salt was markedly less. At 15 Ksi there was little influence on the creep behavior by the salt environment up to approximately 45 hours. At 10 Ksi there was virtually no effect on the creep behavior due to the presence of molten salt. These specimens underwent primarily steady-state creep throughout the length of testing. There seemed to be no effect of the molten salt environment during steady-state creep, and a significant loss of creep resistance occurred only during the third stage of creep.

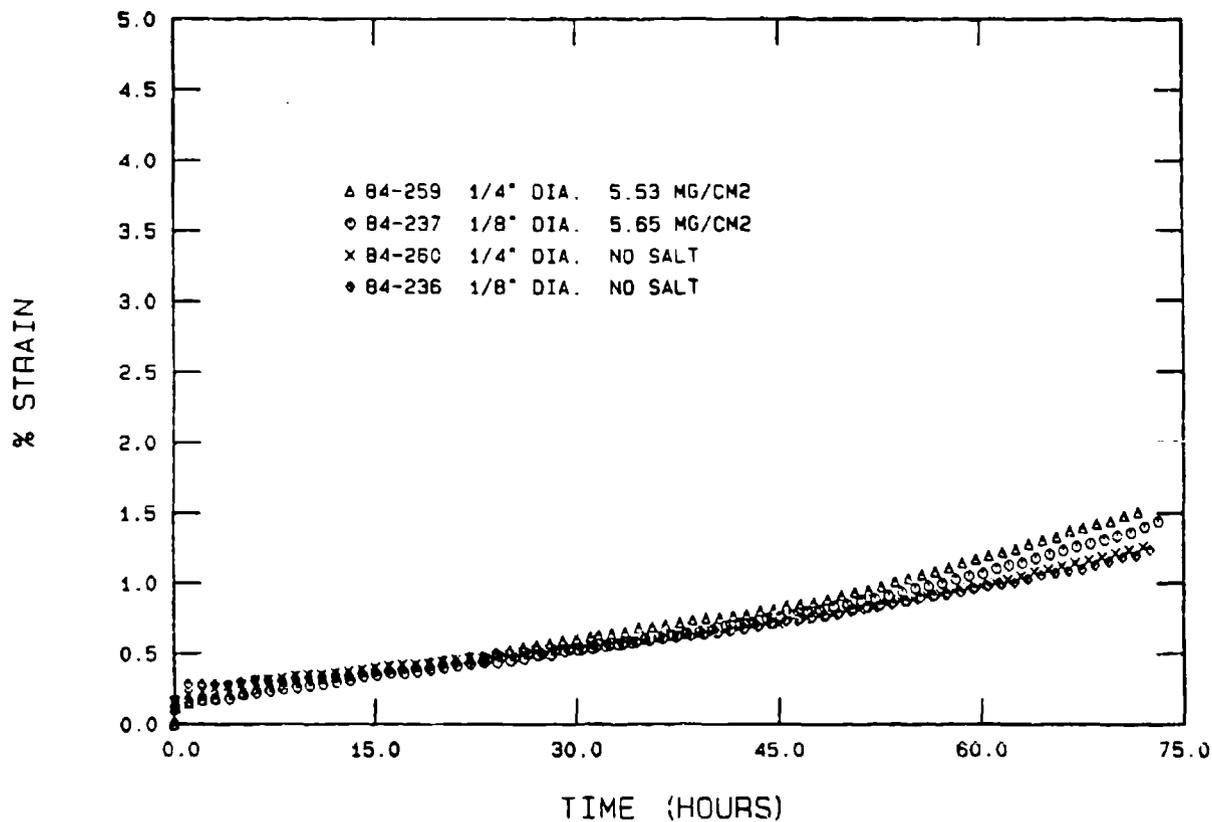
FIG. 14. Effect of reduced diameter on creep at 15 Ksi.

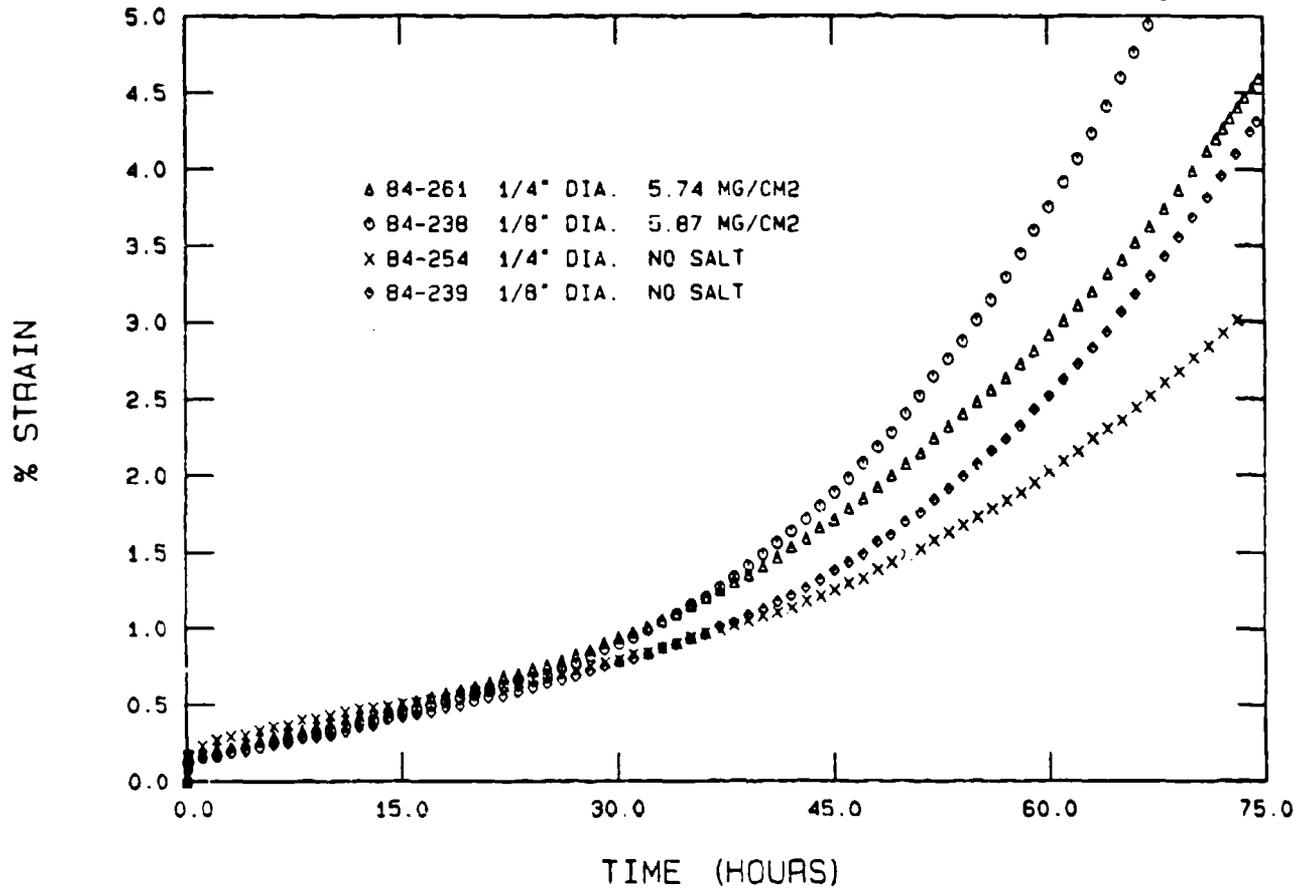
FIG. 15. Effect of reduced diameter on creep at 20 Ksi.

diameter specimens tested at the same stress level for both the salt coated and uncoated specimens. In both cases, the percent strain in 72 hours was approximately 1.7% greater for the salt coated specimens than for the uncoated specimens of corresponding diameter. The molten salt environment and laboratory air environment reduced the creep resistance of the 0.125-inch diameter specimens which experienced predominantly tertiary creep during testing.

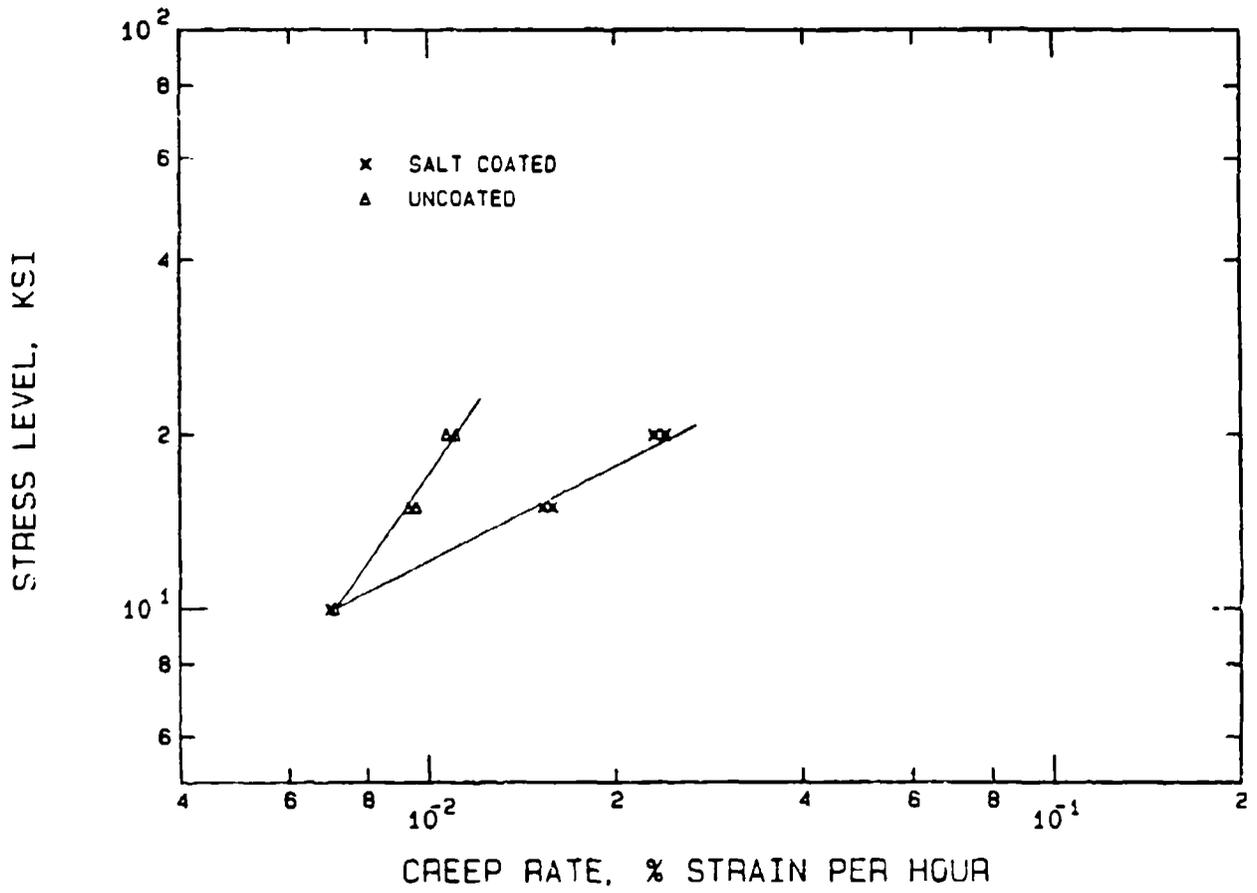
FIG. 16. Effect of stress level on the minimum creep rate for IN 718.

The difference in the strain rate coefficients indicates that different creep mechanisms occurred for the salt coated specimens versus the uncoated specimens. However, it was difficult to determine exactly the minimum creep rate for specimens which did not exhibit a well-defined steady-state creep region, and the actual value of stress corresponding to that point in the test where the minimum creep rate occurred was unknown. As a result, the slopes of the straight lines in Figure 16 are not exact, and the statement that the creep mechanisms are different for coated and uncoated specimens cannot be made without some scepticism.

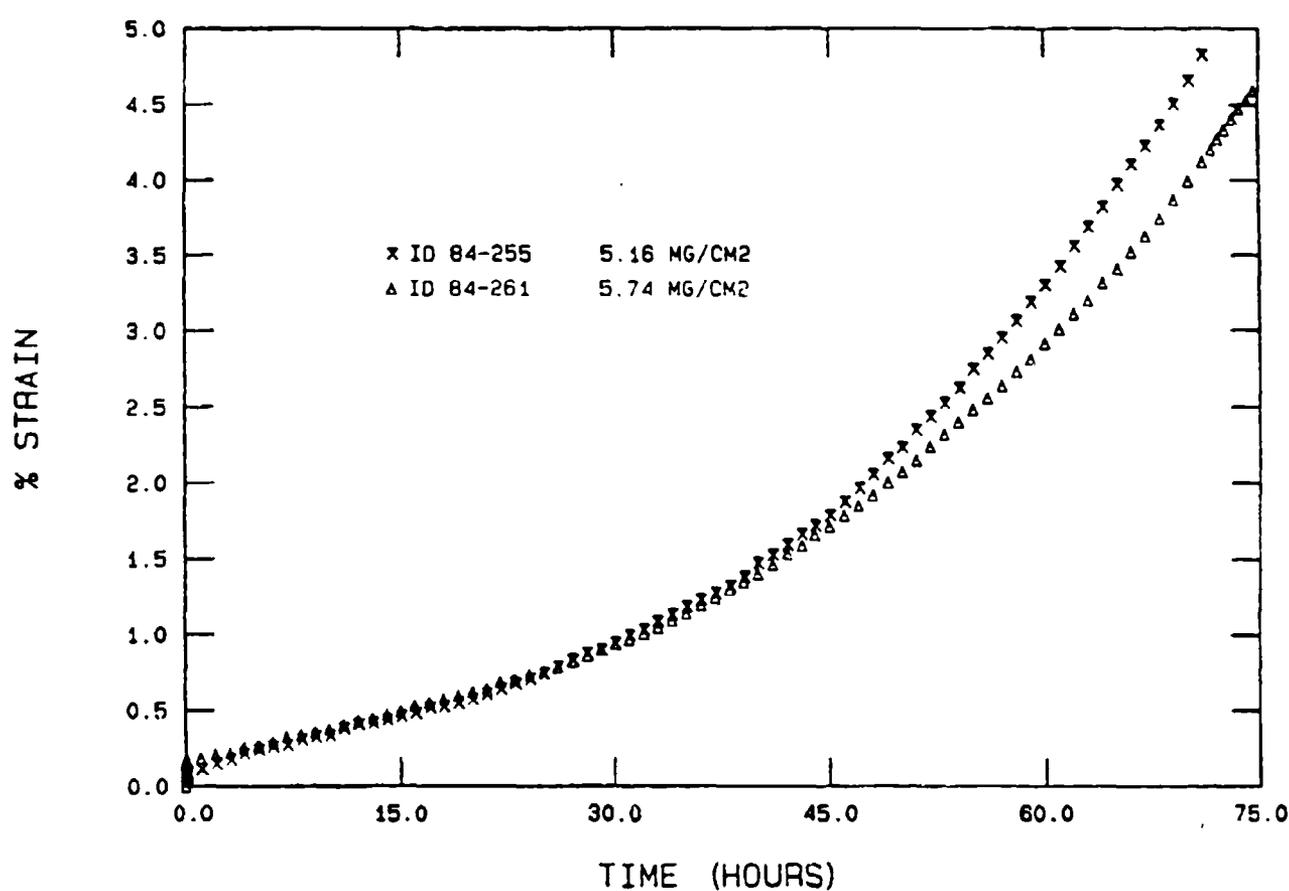
FIG. 17. Duplicate creep test at a stress level of 20 Ksi.

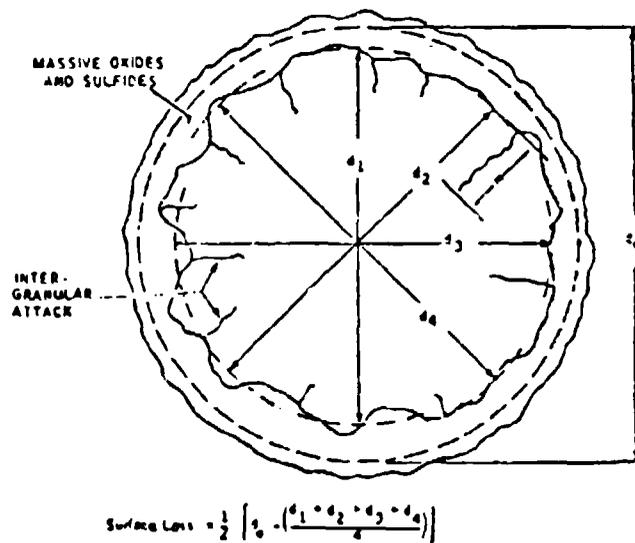
FIG. 19. Method for determining the depth of hot corrosion attack.

photomicrographs is the interface between the surface oxide layer (Zone I) and the underlying region of intertwined oxide and metal (Zone II). The depth of corrosion attack appears to be greater for the 15 Ksi stress level than for the 20 Ksi stress level. This illustrates that although the overall depth of penetration of the hot corrosion attack increased with increasing stress level as shown in Figure 20, localized regions did exist where the depth of corrosion attack was greater than the average value calculated as shown in Figure 19.

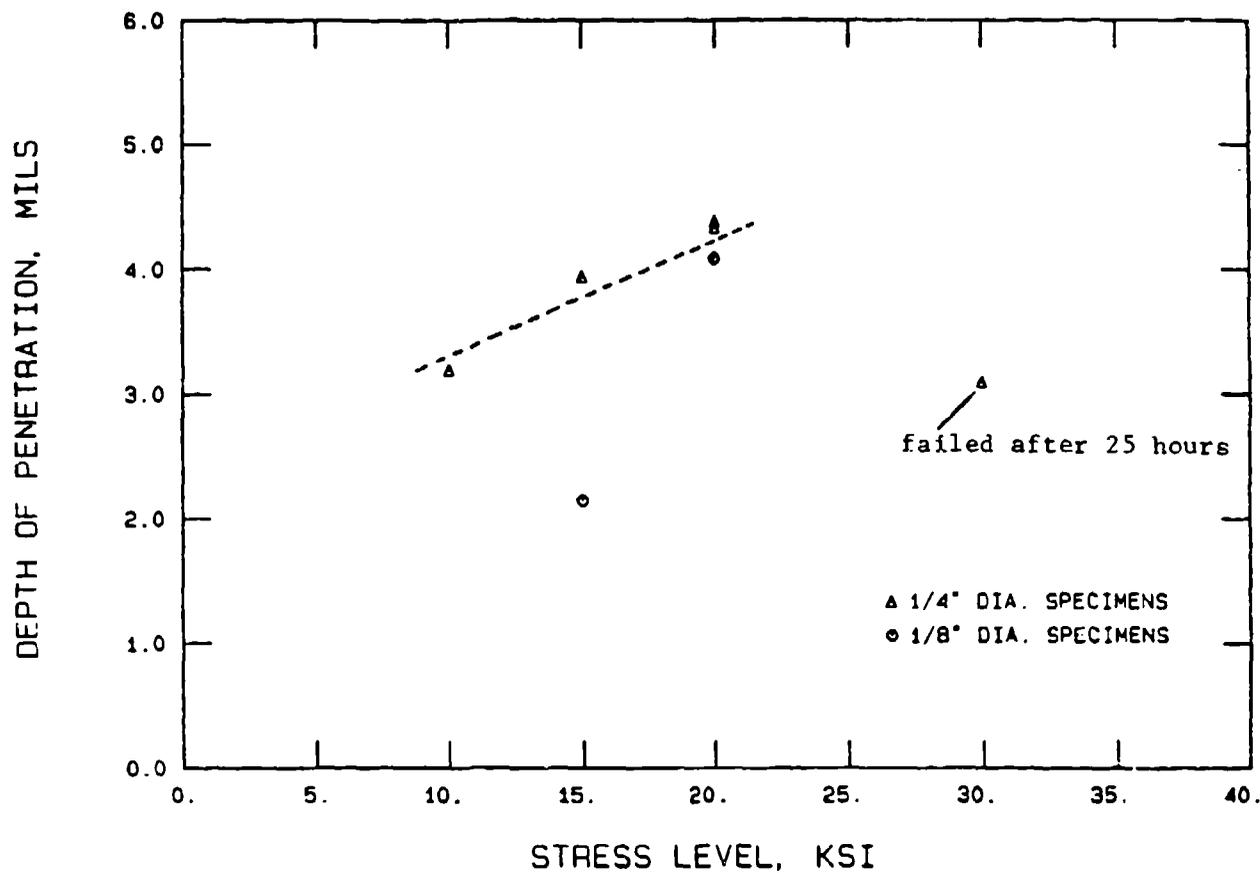
Figure 20 shows the depth of penetration of the corrosion attack versus stress level for salt coated specimens. The depth of corrosion attack increased with increasing stress level. The measurement made of the specimen tested at 30 Ksi gave a depth of penetration of only 3.1 mils. This was due to the shortened test time which did not allow the corrosion attack to occur as in specimens tested for the full 72 hours. It is also interesting to examine the effect of specimen diameter on the depth of penetration. As noted earlier, the creep tests conducted at a

FIG. 20. Effect of stress level on the depth of hot corrosion attack.

stress level of 15 Ksi exhibited virtually identical creep curves for specimens of both 0.25 inches in diameter and 0.125 inches in diameter. Figure 20 shows, for this case, that the depth of penetration for the 0.125-inch diameter specimen was less than that for the 0.25-inch diameter specimen. This was due to the test-to-test variability in the amount of corrosion attack that is typical of mechanisms of a localized nature even though test conditions were the same. The depth of penetration for the 0.25-inch diameter specimen was approximately 3.95 mils which results in 6.14% of the original cross-sectional area of the round bar specimen being affected by corrosion attack. The depth of penetration for the 0.125-inch diameter specimen was 2.15 mils, and thus 6.61% of the original cross-sectional area of the round bar specimen was affected by corrosion attack. These specimens which underwent nearly the same percentage of corrosion attack exhibited virtually identical creep behavior. At a stress level of 20 Ksi, the depth of the hot corrosion attack for specimens of both diameters was approximately 4.28 mils. As a result, the reduced diameter specimen suffered a greater loss of creep resistance due to the molten salt than did the 0.25-inch diameter specimen. For the 0.125-inch diameter specimen, 13.23% of the original cross-sectional area was attacked by corrosion, while only 6.73% of the original cross-section of the 0.25-inch diameter specimen was affected by corrosion attack. Although based on only a few number of specimens, it appears that the degree of environmental degradation of the creep resistance by molten salt is related to the ratio of the cross-sectional area affected by corrosion attack to the original cross-sectional area of the specimen.

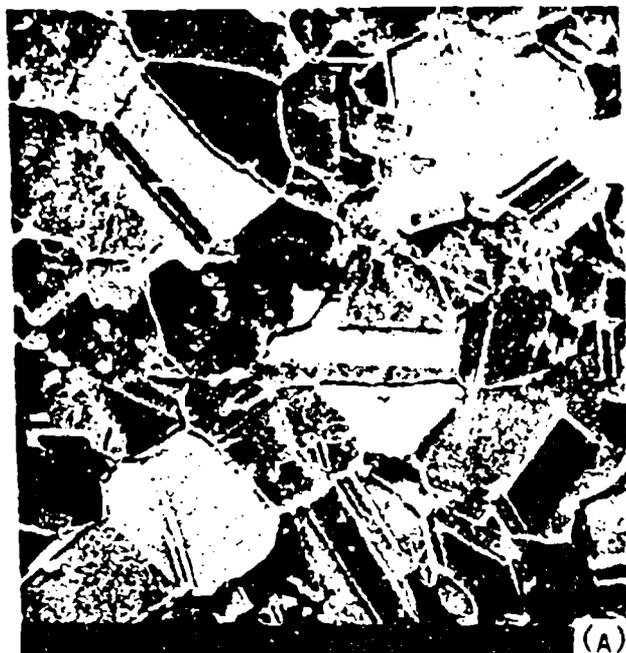
FIG. 21. SCANNING ELECTRON MICROGRAPHS (1000x) SHOWING MICROSTRUCTURE OF IN 718 (A) IN FULLY HEAT TREATED CO'NDITION AND (B) AFTER CREEP TESTING AT 20 ksi FOR 72 HOURS AT 1472°F

approximately 3.0% strain in 320 hours. Metallographic examination revealed that the specimens contained only moderate amounts of transformed orthorhombic Ni_3Cb phase, primarily at the grain boundaries. Thus, even after 320 hours at 1400°F and at 35 Ksi, the amount of orthorhombic Ni_3Cb was considerably less than that seen in this study. The uncoated specimen tested in this study at 1472°F at 30 Ksi underwent 1.75% strain in just 25 hours. The results of Khobaib's work and those of this study indicate that the presence of the orthorhombic Ni_3Cb phase contributes to significant reduction of the creep resistance of IN 718. The reduction in yield strength of IN 718 from a test temperature of 1400°F to 1472°F also contributes to the reduced creep resistance.

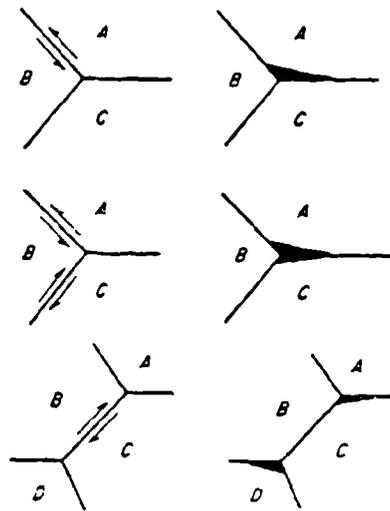
FIG. 24. Schematic drawings of grain boundary sliding and intergranular cracking.

grain boundaries. In addition, no carbides are present at the grain boundaries in this depleted zone because it appears that as the chromium content in the alloy is lowered by sulfur and oxygen, the carbides, mainly Cr_{23}C_6 , dissolve. Without the particles to pin the grain boundaries and inhibit the relative motion of the grain boundaries, sliding can occur with relative ease.
