THE EFFECT OF STRESS AND HOT CORROSION
ON NICKEL-BASE SUPERALLOYS

THESIS

Presented to the Faculty of the School of Engineering
of the Air Force Institute of Technology
Air University
In Partial Fulfillment of the
Requirements for the Degree of
Master of Science in Aeronautical Engineering

March 1985

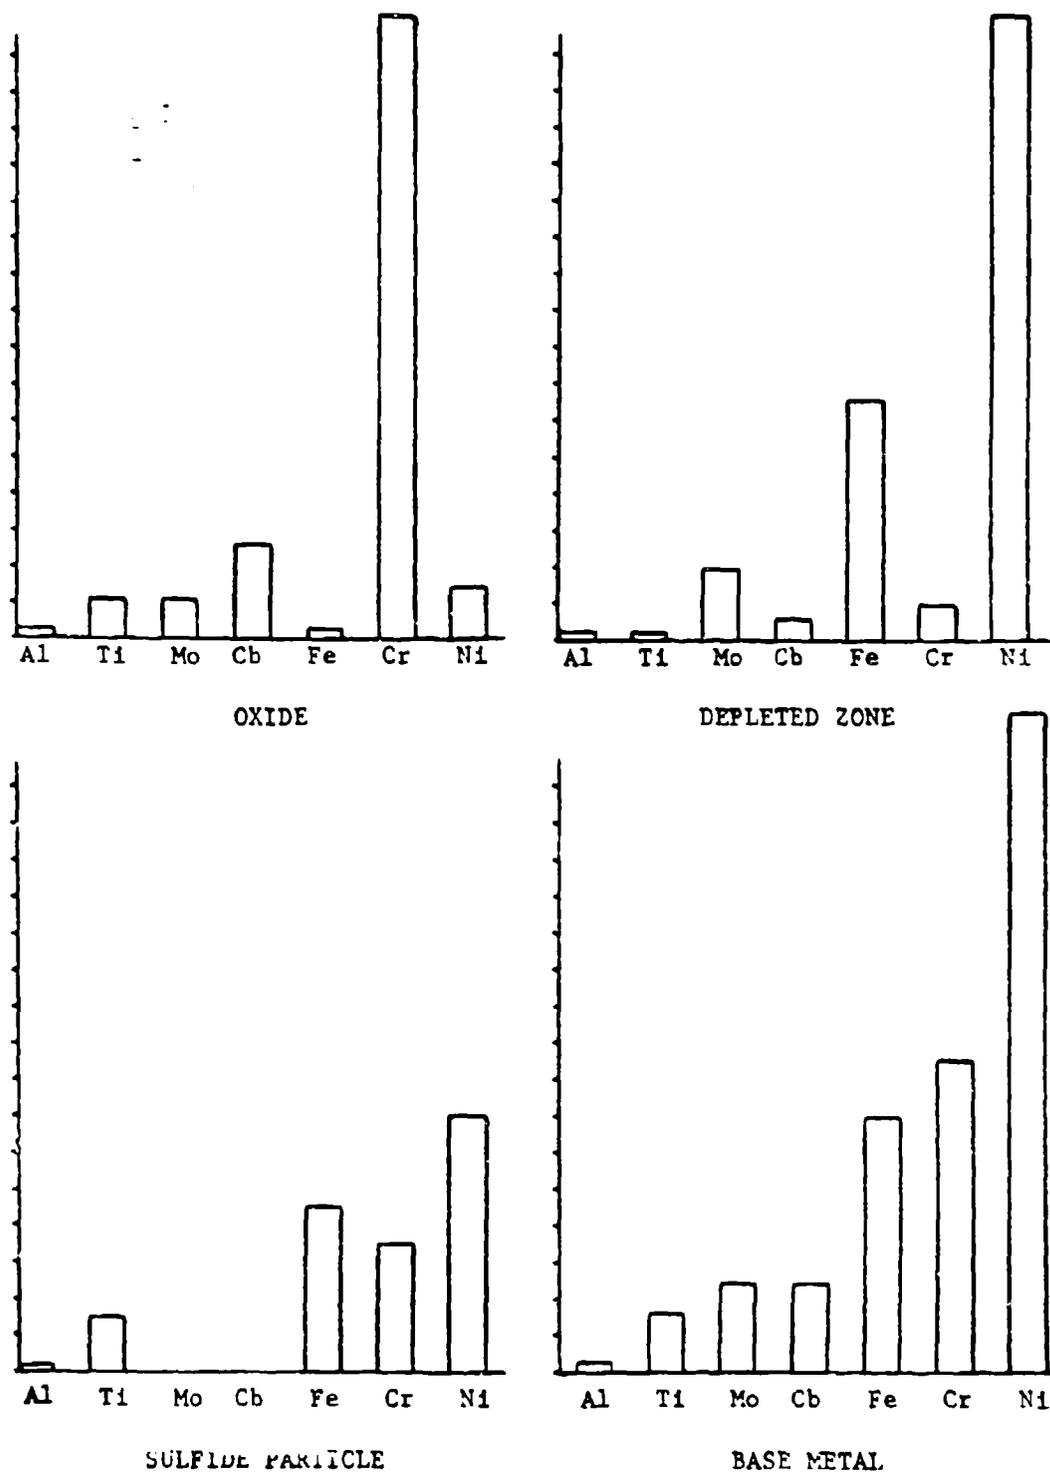
An elemental analysis of the corrosion products was conducted using X-ray energy spectroscopy. The results are summarized graphically in Figures 26 and 27. The oxide formed on the surface of the IN 718 specimens was rich in chromium which is to be expected because of the high chromium content of the alloy. Cr_2O_3 is the thermodynamically stable oxide compound for chromium. Much of the titanium and columbium in the alloy also formed oxide compounds. Thermodynamic data suggest that TiO and CbO are most likely the compounds formed. In addition, nickel was found in the oxide layer presumably as the compound NiO . Chromium and titanium were also found in the sulfide particles. Although Figure 26 shows the sulfide containing significant nickel and iron, this is misleading. The sulfide particles were very small and surrounded by metal depleted of alloying elements. The X-ray analysis of a small sulfide particle undoubtedly detected the presence of nickel and iron from the surrounding depleted metal. Note that in the depleted zone, nickel and iron are the main constituents. It is likely that there is indeed some nickel and iron in the sulfide particles, but chromium and titanium appear to be the stronger sulfide formers. The amount of molybdenum and columbium in the sulfide particles could not be determined using X-ray energy spectroscopy since the strong sulfur peak of the energy spectrum masked the presence of molybdenum and columbium. Due to the formation of the oxide layer and internal sulfides, the depleted zone of metal was void of most of the chromium, titanium, and

FIG. 26. Elemental analysis of the hot corrosion products for IN 718.

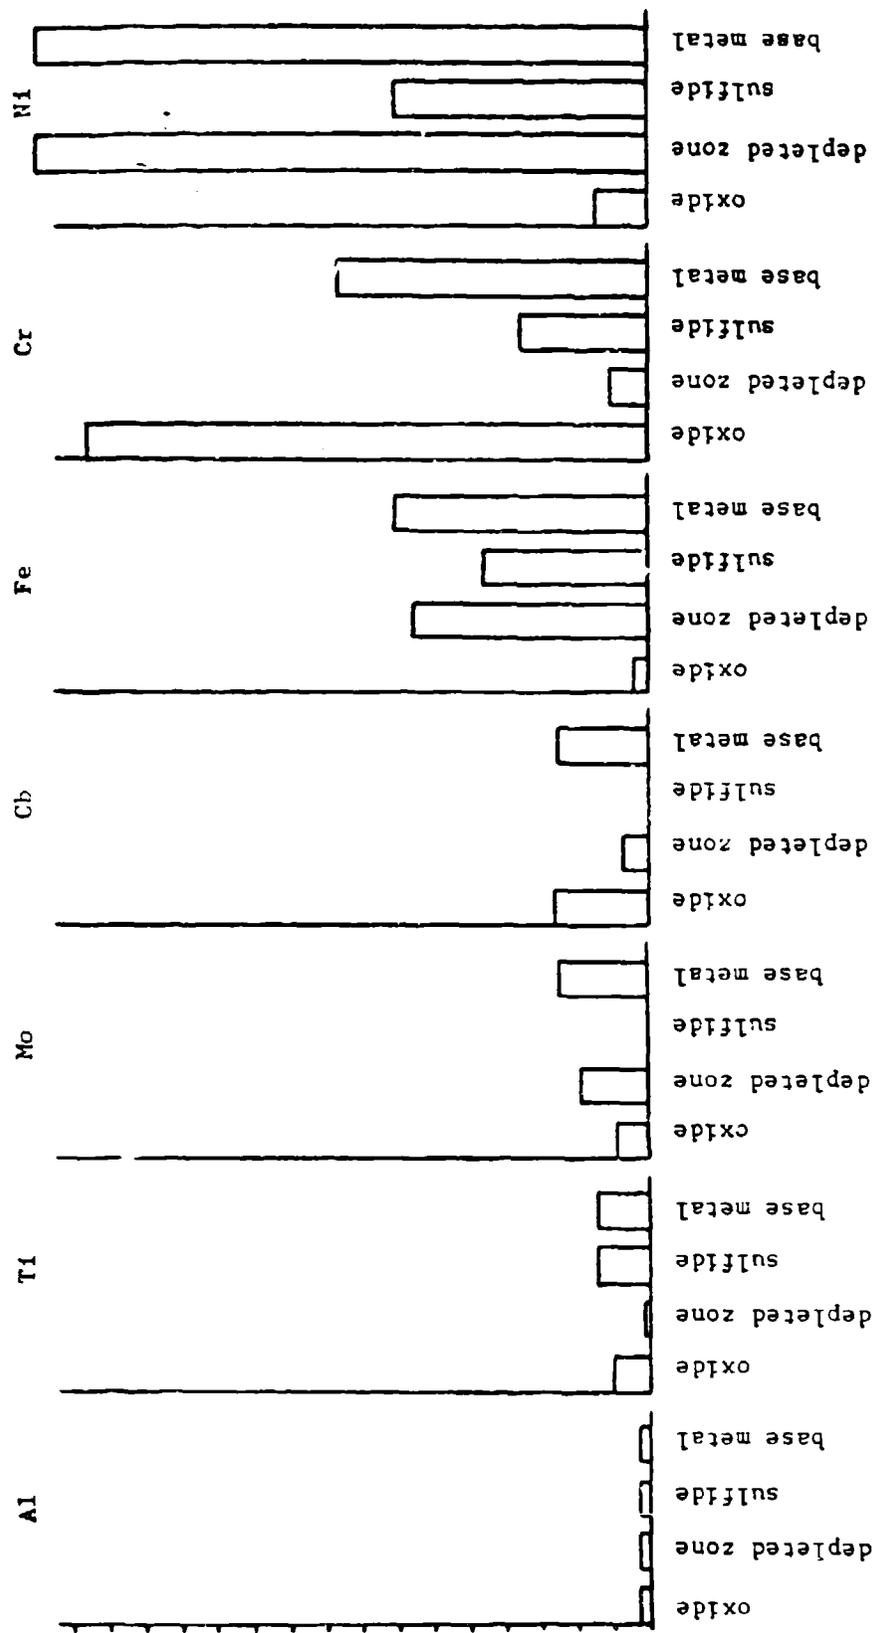
FIG. 27. Elemental analysis of the hot corrosion products for IN 718.

columbium. This left a depleted zone rich in nickel, iron, and molybdenum. The aluminum in the alloy appeared to be uniformly distributed throughout the corrosion products.

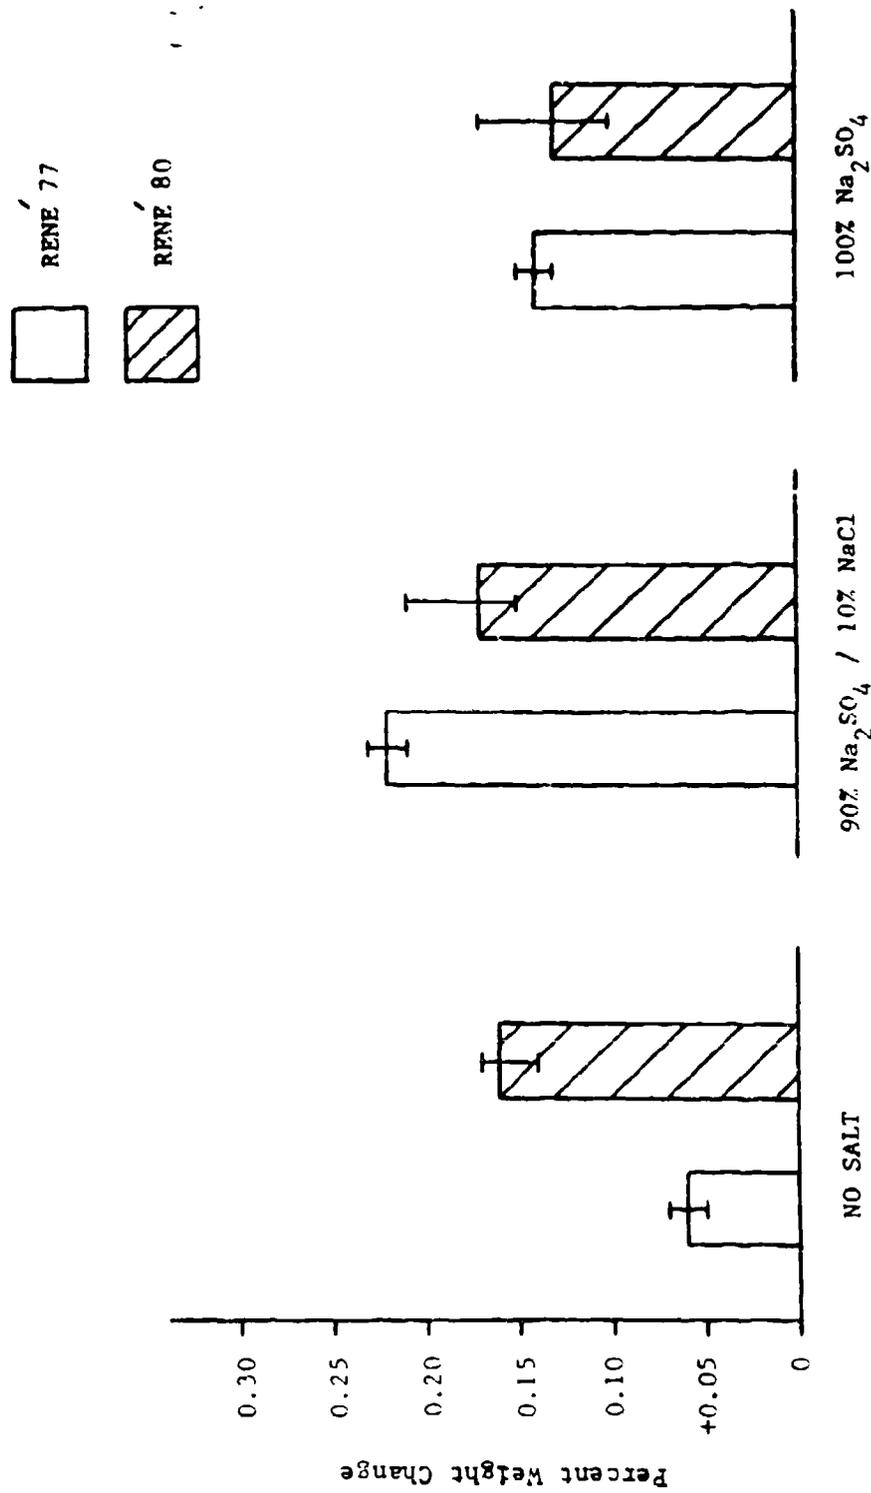
Small cylindrical pins of René 77 and René 80 were tested to examine the oxidation and hot corrosion resistance in an unstressed condition at 1672°F (900°C) for 72 hours. Figure 28 shows the weight change of uncoated and salt coated pins for both alloys. Each bar of Figure 28 represents the average of three pins tested under the same conditions. The data show several trends. Based on weight-change measurements, the René 77 was more oxidation resistant than the René 80. However, the René 80 was superior to the René 77 in hot corrosion resistance. In addition, the data show that the 90% Na_2SO_4 / 10% NaCl salt was slightly more corrosive than the pure 100% Na_2SO_4 .

FIG. 28. Weight change of salt coated specimens after 72 hours at 1652°F.

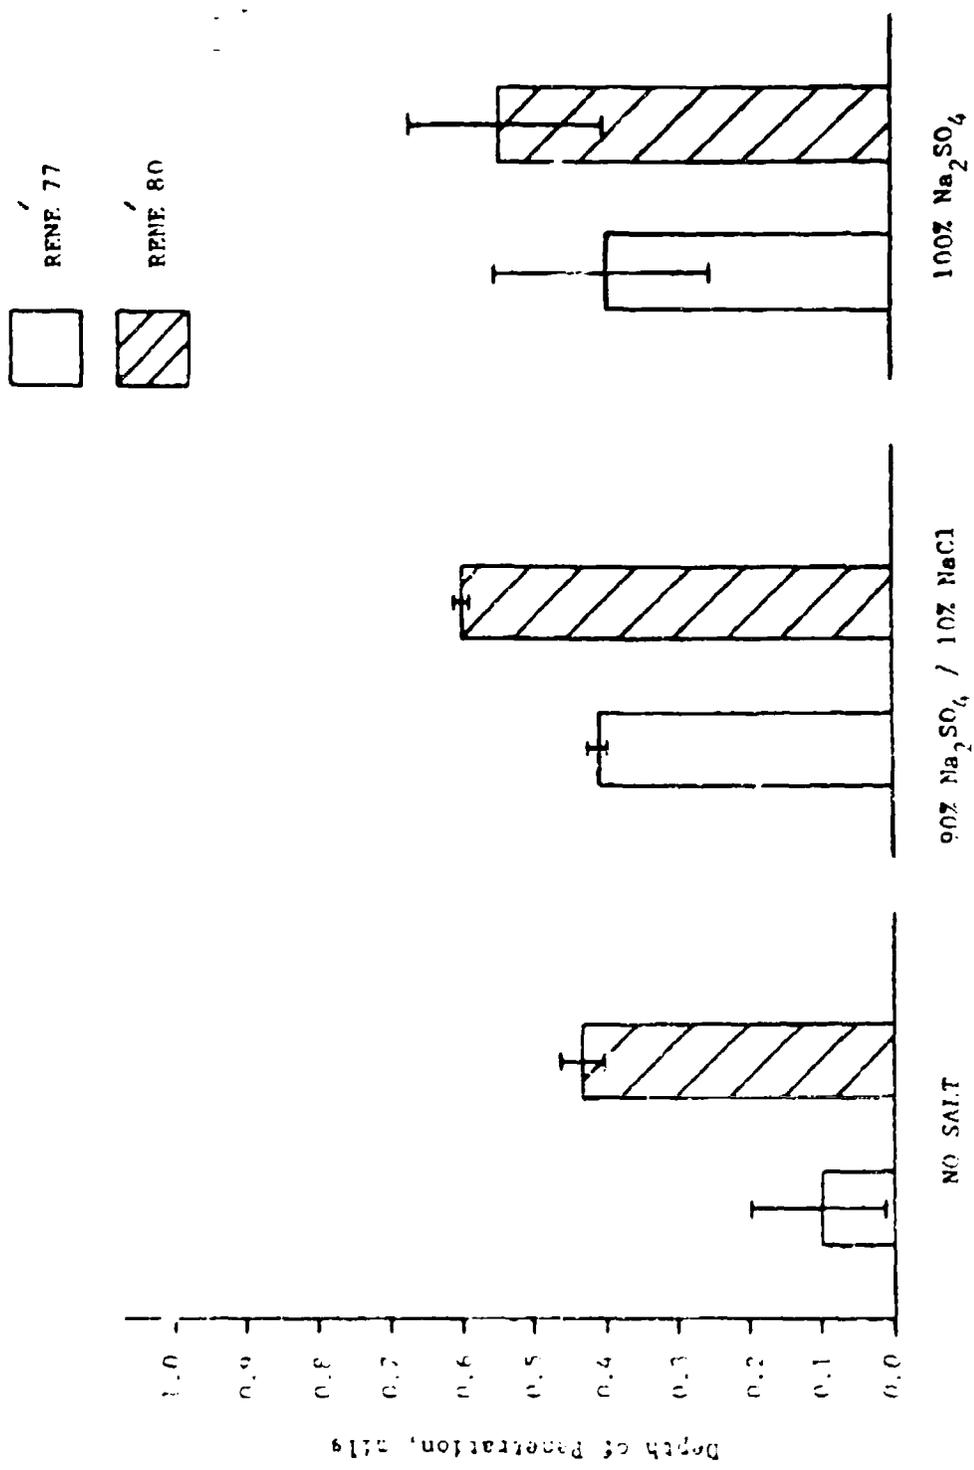
Figure 29 shows the depth of corrosion attack measured on a cross-section as previously described for IN 718. The depth of oxidation attack was considerably less in the René 77 pins than in the René 80 pins. The René 77 was less susceptible to oxidation attack than was the René 80. This agrees with the results of the weight-change measurements. However, in a molten salt environment, René 80 suffered a deeper corrosion attack than did René 77 even though the weight change in René 80 was less than that of the René 77. Also note that the depth of penetration of the hot corrosion attack was approximately equal for both salt compositions.

FIG. 29. Depth of hot corrosion attack of salt coated specimens after 72 hours at 1652°F.

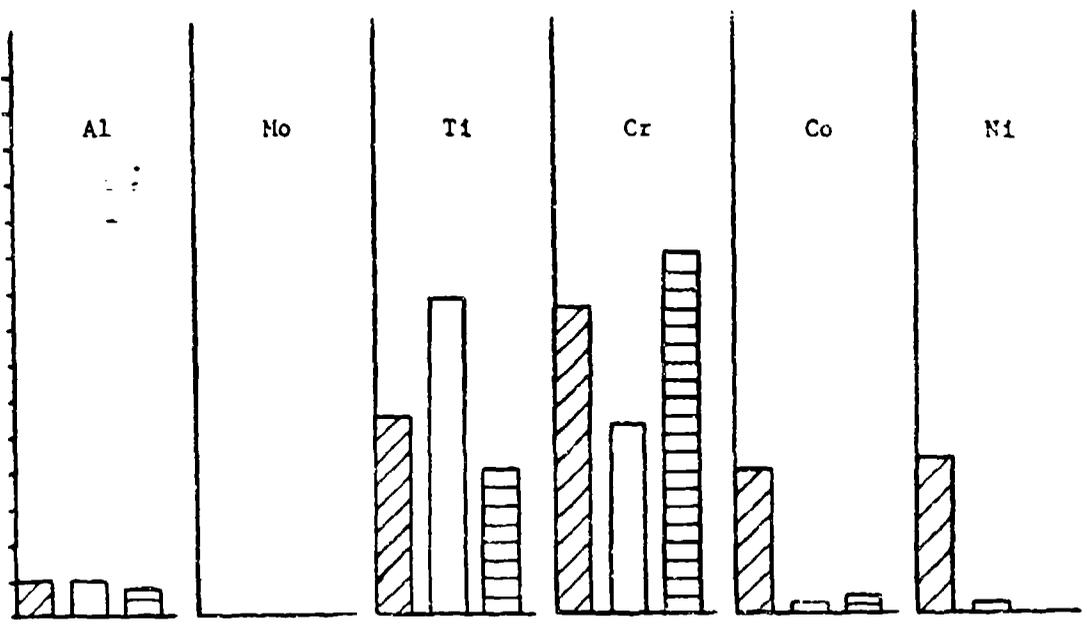
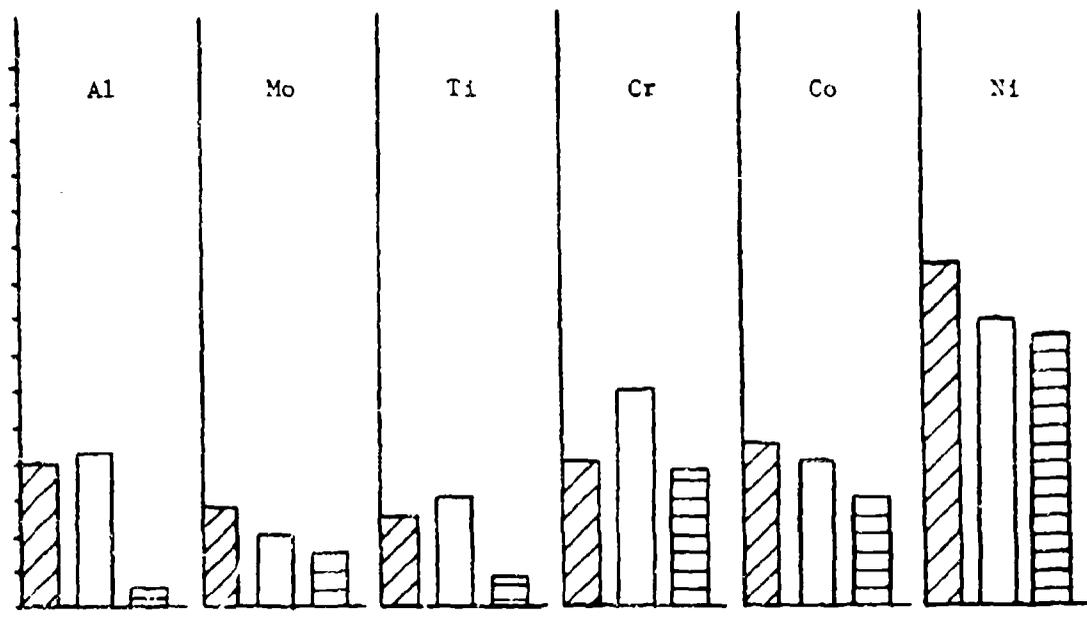
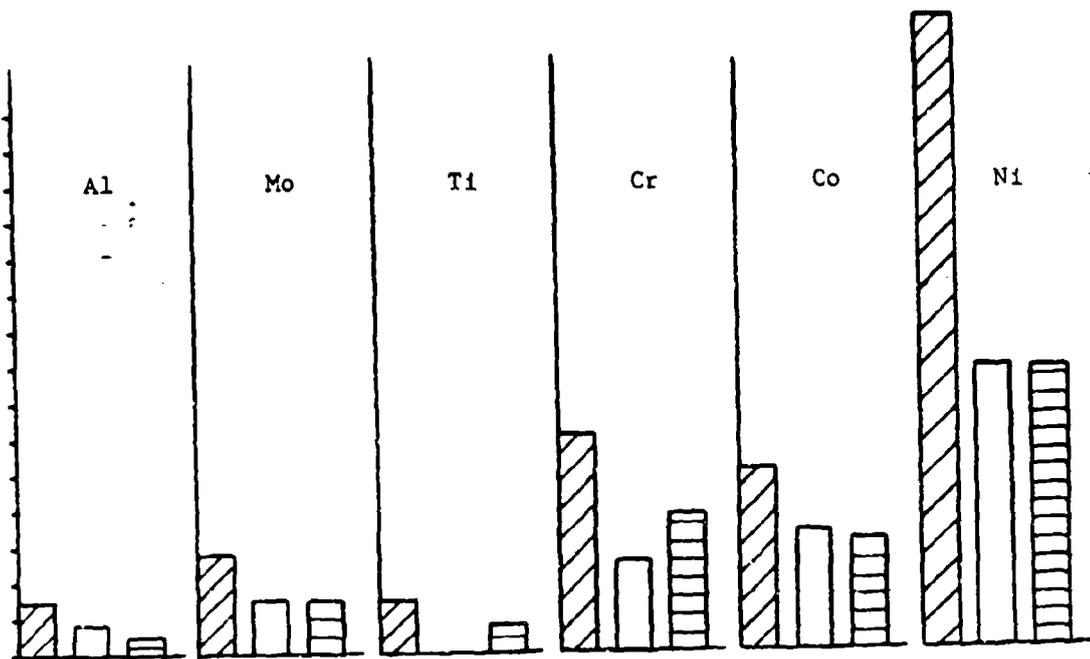
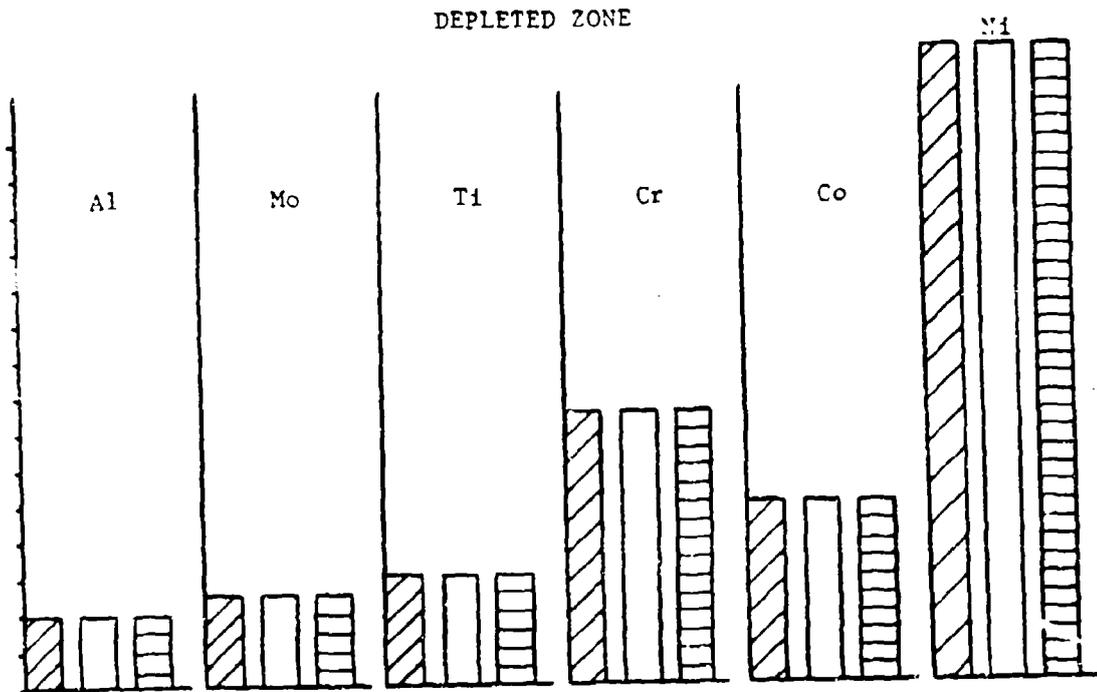
In both the René 77 and René 80 pins, the oxide composition was similar. The surface oxide was rich in chromium and titanium. For the pins coated with a salt of 90% Na_2SO_4 / 10% NaCl , the oxide was richer in chromium than in titanium. However, when the pins were tested with a 100% Na_2SO_4 salt coat, the oxide formed contained more titanium than

FIG. 32. Elemental analysis of the hot corrosion products for Rene 77.

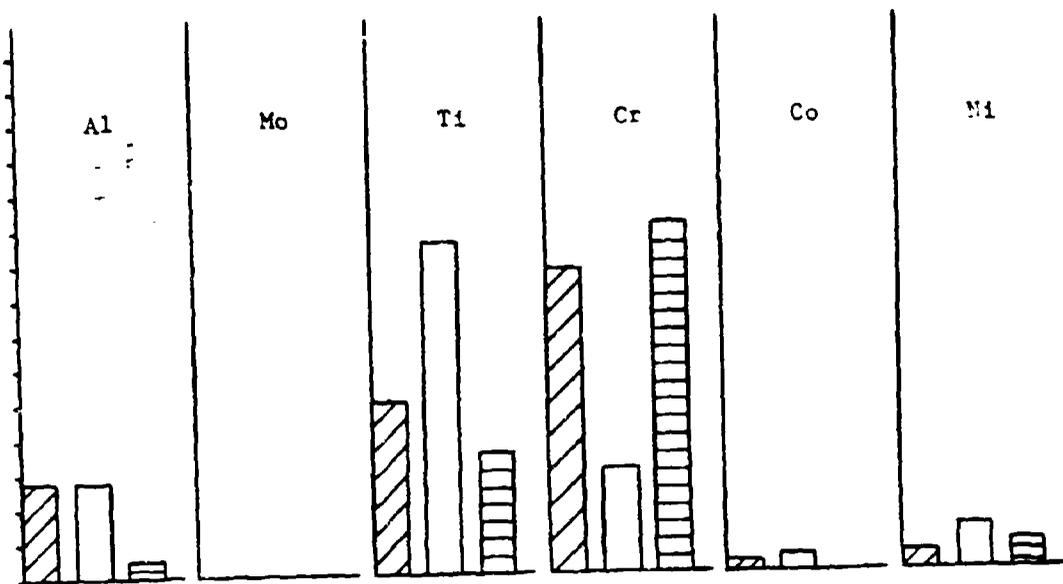
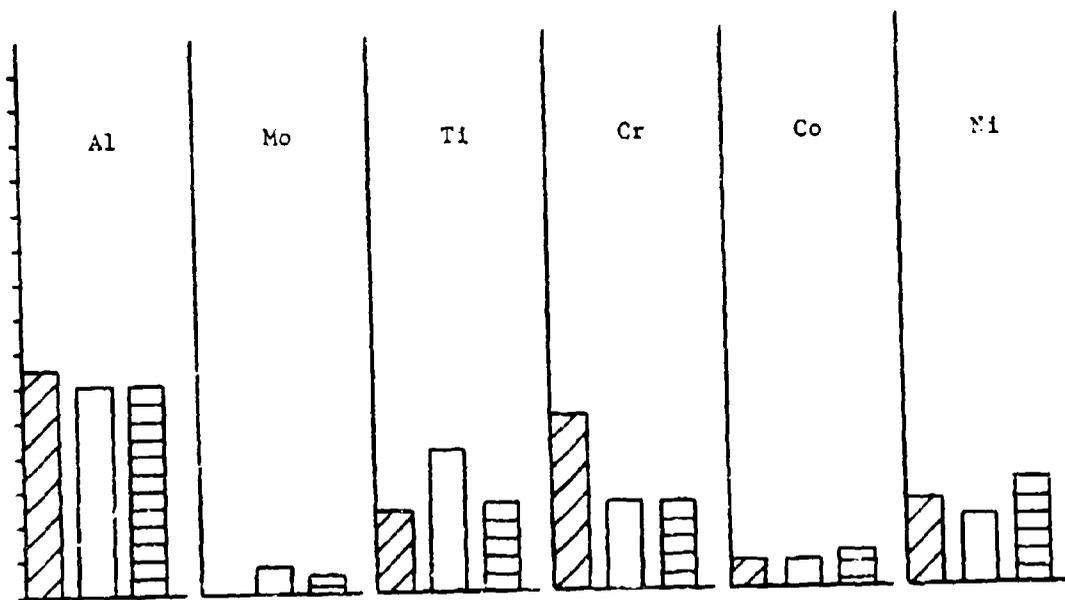
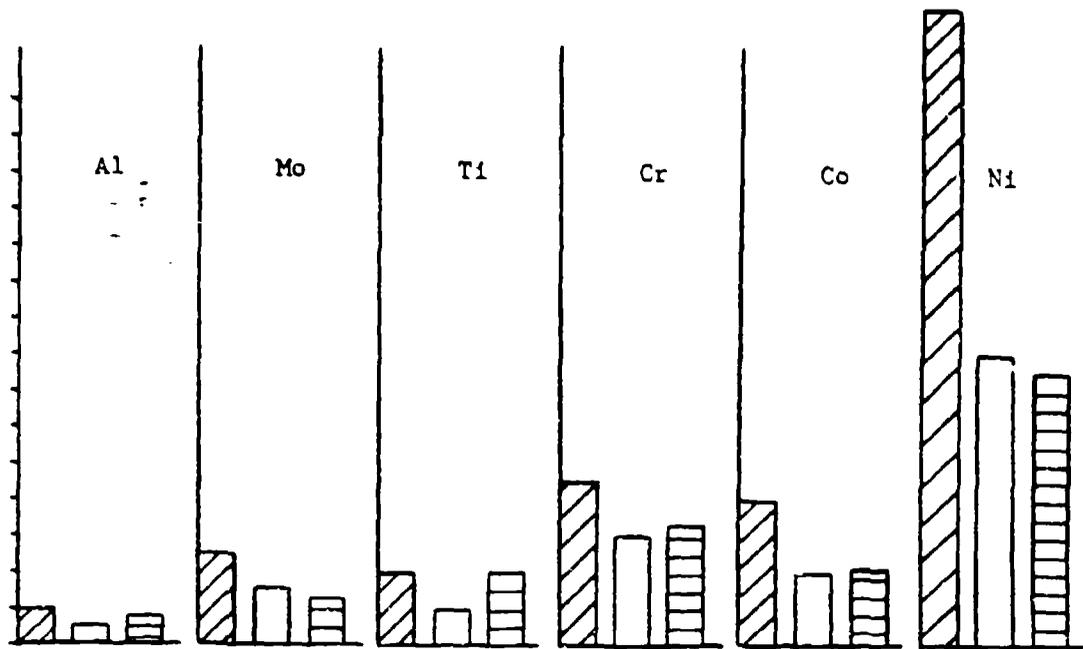
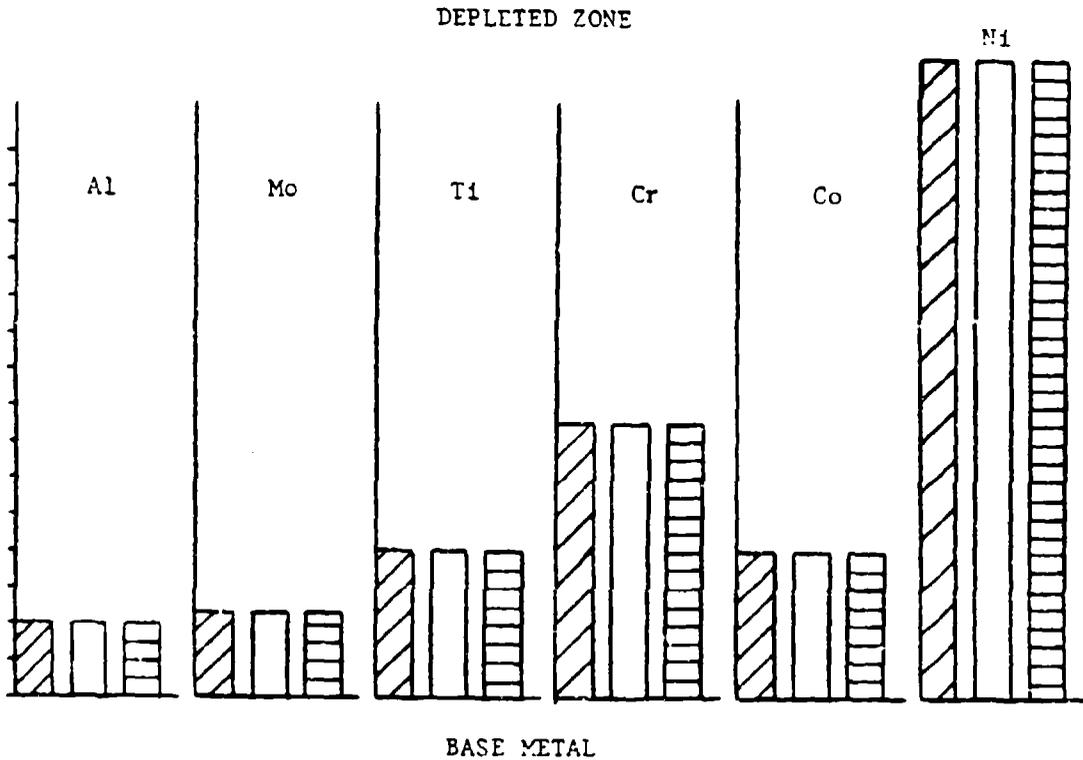
FIG. 33. Elemental analysis of the hot corrosion products for Rene 80.

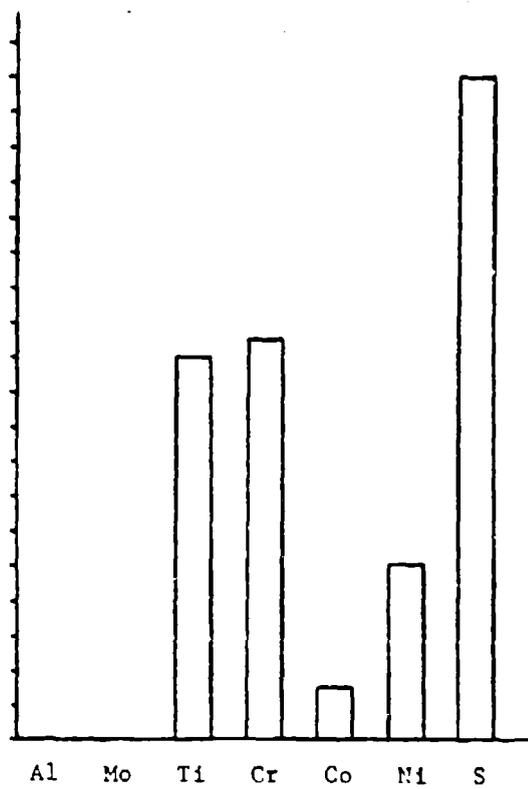
Figure 34 shows the composition of the sulfide particles found in Zone II of both René 77 and René 80 after hot corrosion attack. The sulfides were rich in chromium and titanium. Because the strong sulfur peak in the X-ray energy spectrum masked the presence of aluminum and molybdenum, the presence of these elements in the sulfide particles could not be determined.

FIG. 34. Elemental analysis of sulfide particles found in René 77 and René 80 after hot corrosion attack.

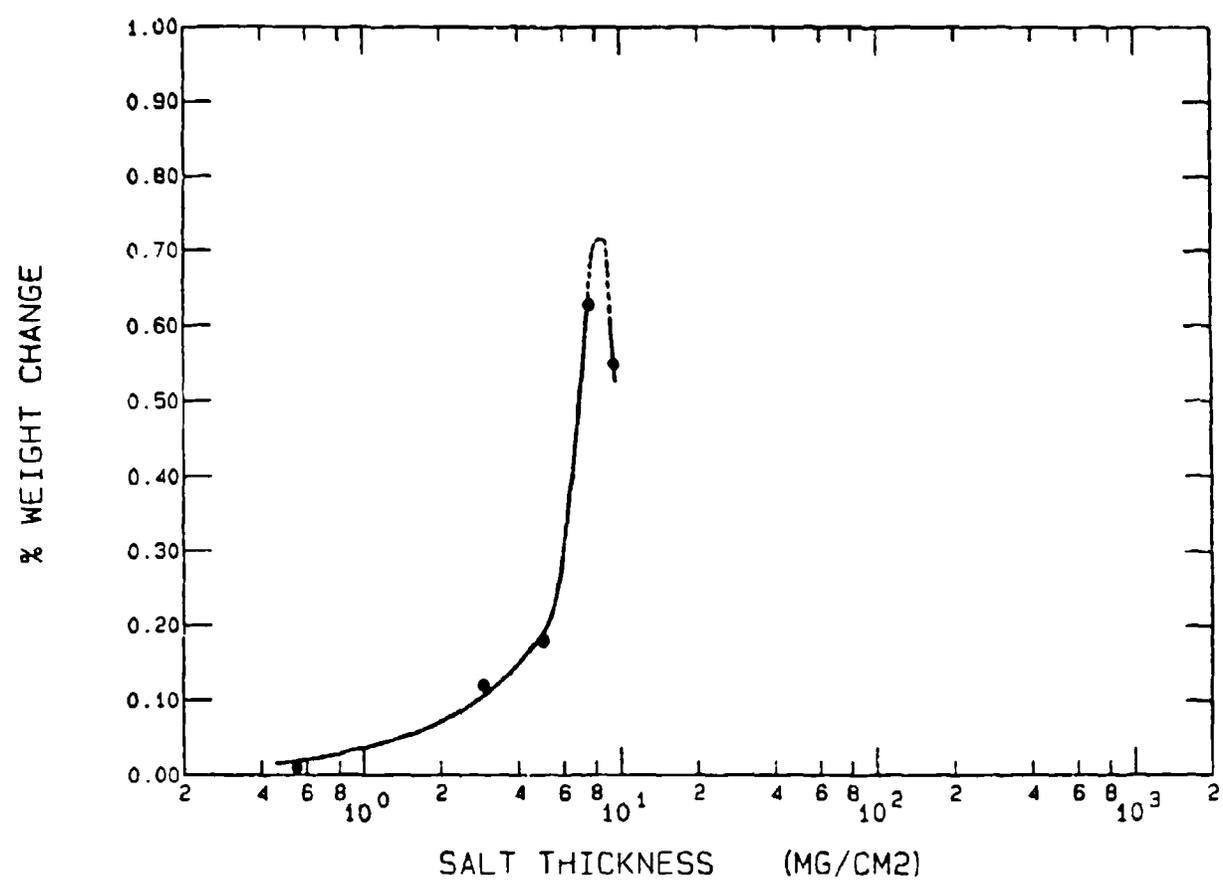
A set of five René 77 pins were coated with varying amounts of salt ranging from a coverage of approximately 0.5 mg/cm^2 to 10.0 mg/cm^2 . Attempts were made to coat pins with thicker salt layers, but approximately 10 mg/cm^2 proved to be the maximum coverage achievable with the spraying technique used in this study. The salt composition used was 90% Na_2SO_4 / 10% NaCl . Figure 35 shows the pins after 72 hours at a temperature of 1652°F (900°C). It is very apparent from visual examination that salt thickness affects the degree of hot corrosion attack. Note that at the greater salt thicknesses, the oxide which formed was no longer adherent as seen on previous specimens. Figure 36 shows the weight change of the René 77 pins as a function of salt thickness. This graph shows a maximum corrosion attack at a salt coverage of approximately 7.5 mg/cm^2 . These data show a similar trend to that found by Fang and Shores as shown in Figure 1 of this report.

FIG. 36. Effect of salt thickness on the hot corrosion attack of René 77.
