CRREL REPORT 85-7

Measuring thermal performance of building envelopes

Nine case studies

Stephen N. Flanders

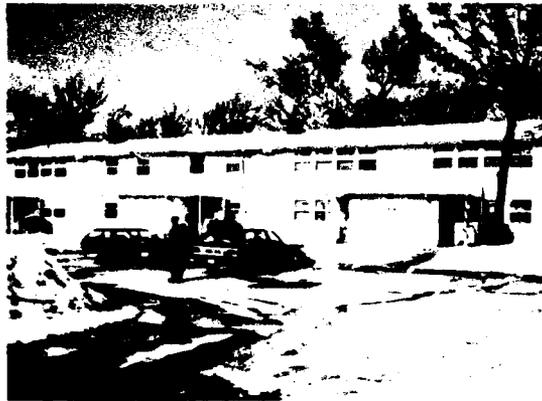
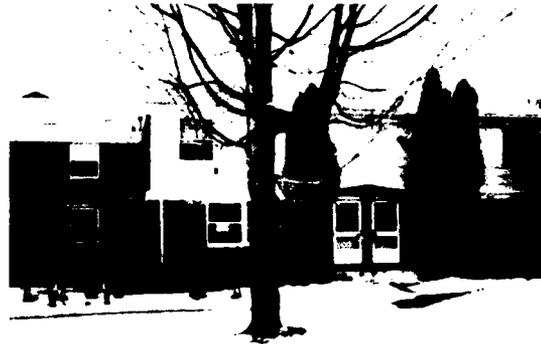
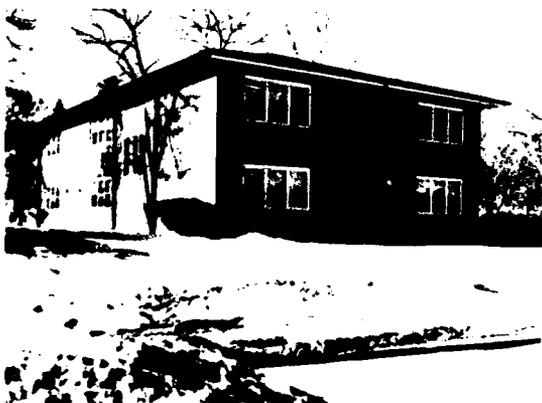
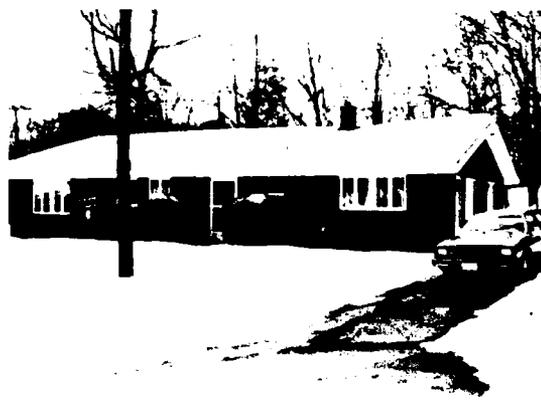
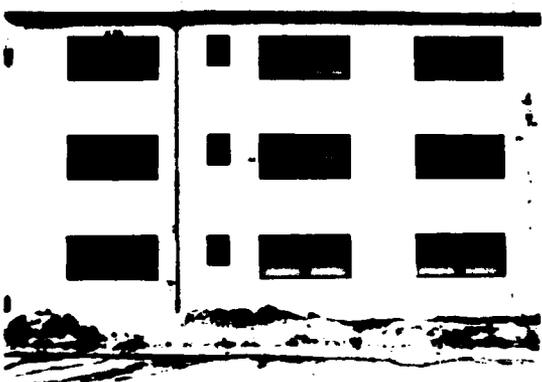
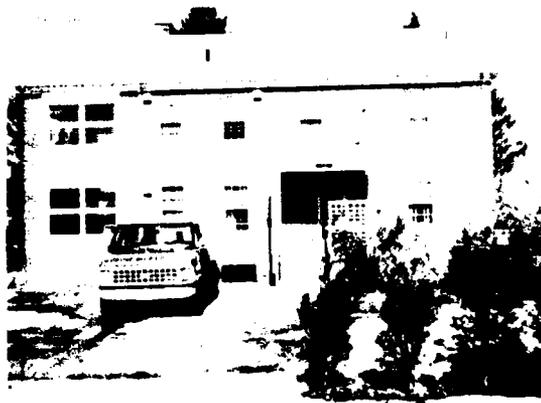
a. Capehart family housing.

b. Wherry family housing.

c. MCA bachelor officers' quarters.

d. MCA family housing unit.

e. Masonry block visiting officers' quarters.

f. Brick colonial officers' dwelling.

Figure 1. Examples of the building types studied at Ft. Devens.

Figure 1 shows typical examples of each building type. For convenience some types are referred

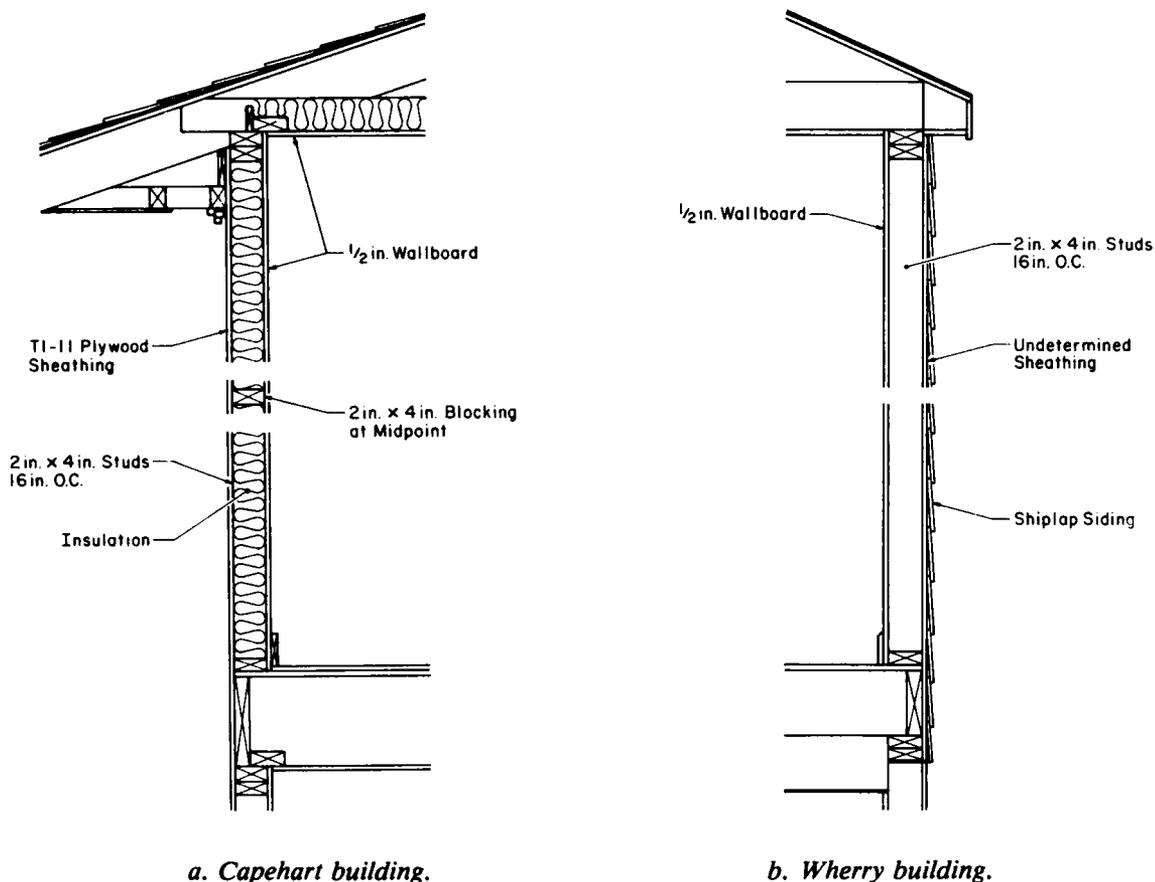
Figure 2. Typical cross sections of frame buildings at Ft. Devens, according to as-built drawings and external inspection.

The as-built drawings (Fig. 2) for Capehart construction indicate 2 in. of fiberglass batt insulation in a 3.5-in. stud space. This renders an estimated thermal resistance of $R = 8.2$. If the stud space were completely full of fiberglass insulation, then the R-value would be 13. A $\frac{1}{4}$ -in. inspection hole drilled at two places in building 933 revealed a 1-in. double layer of gypsum wallboard, a 1-in. air

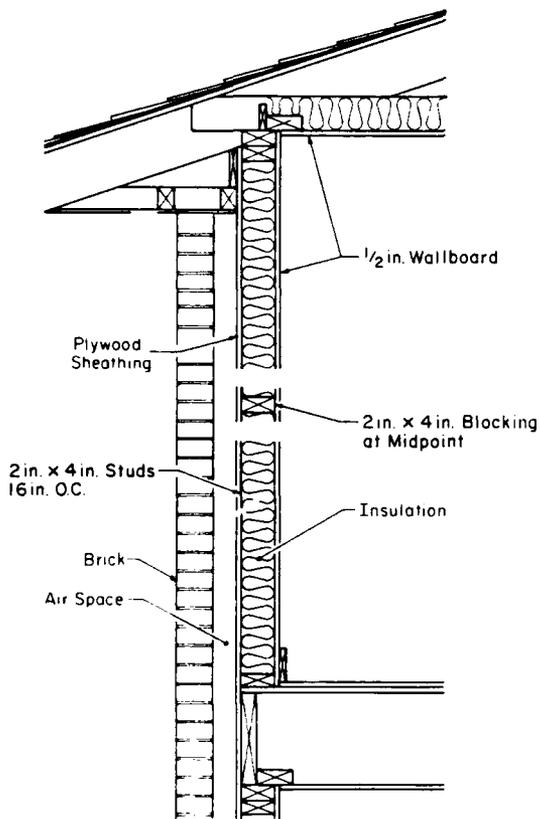
Figure 3. Typical cross section of MCA buildings at Ft. Devens, according to as-built drawings.

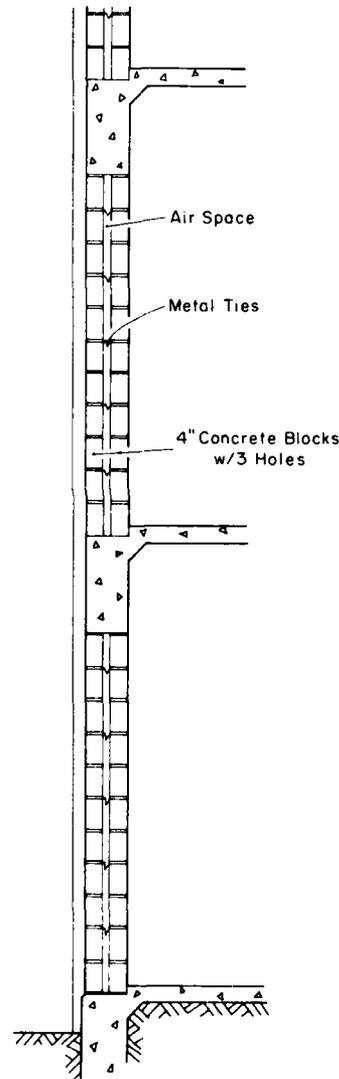
a. Concrete block building.

Figure 4. Typical cross sections of masonry buildings at Ft. Devens, according to as-built drawings.

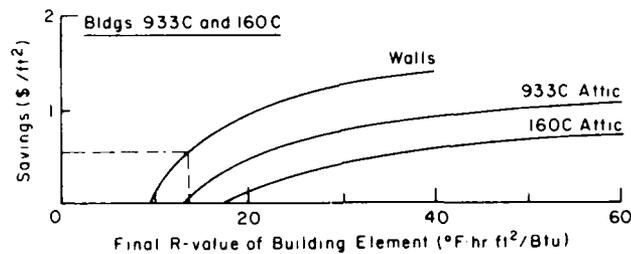
Figure 13. Fifteen-year present worth energy savings potential for adding insulation to two Capehart buildings as a function of the final R-value.

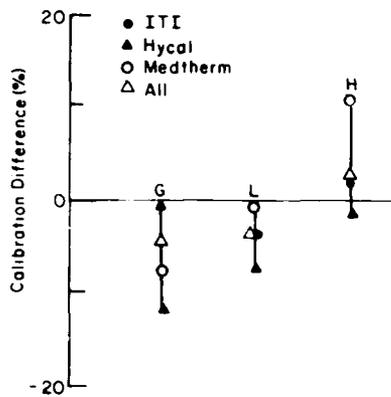
Figure 12. Average difference in calibration between a reference set of calibration runs and the test condition for all treatments of each sensor type. G = gypsum wallboard; L = polystyrene foam with a low R-value; H = polystyrene foam with a high R-value.

Figure 12 demonstrates that for all sensors and all treatments there was little difference between the calibration of sensors on sheetrock and on foam. There was a greater effect from having the second layer of foam. This result is suspect, however, because this condition was not part of the procedure that randomized the tearing down and setting up of experimental variables. Appendix D describes this study in greater detail.

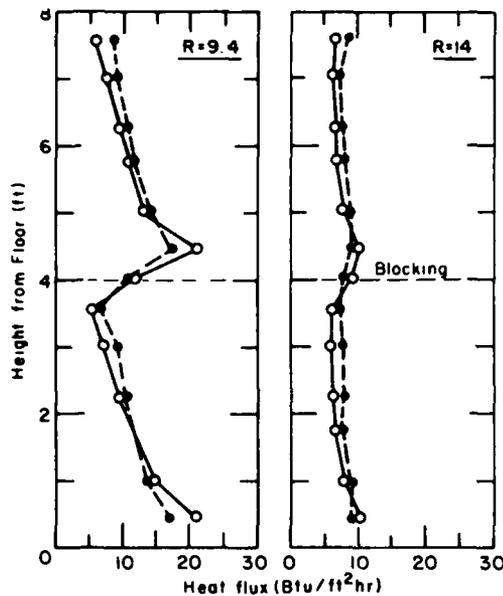
Figure 11. Heat flux through laboratory test wall sections. In the case on the left a single, vertical foil curtain creates two air spaces within the stud cavity. In the case on the right the wall contains a 2-in. mineral wool batt with an air space on the cold side. The open circles represent heat flux through the stud spaces, and the closed circles represent flux through the studs. Reproduced by permission of National Research Council of Canada.

has a primarily convective heat transfer mechanism, the resulting curve (Fig. 11a) would have the characteristics of Figures 10a and b. Where insulation is a dominant factor, curves correspond to Figure 11b.

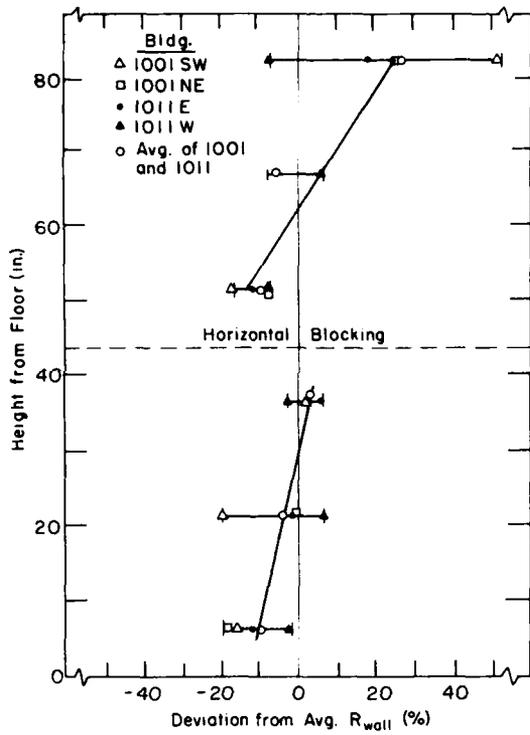
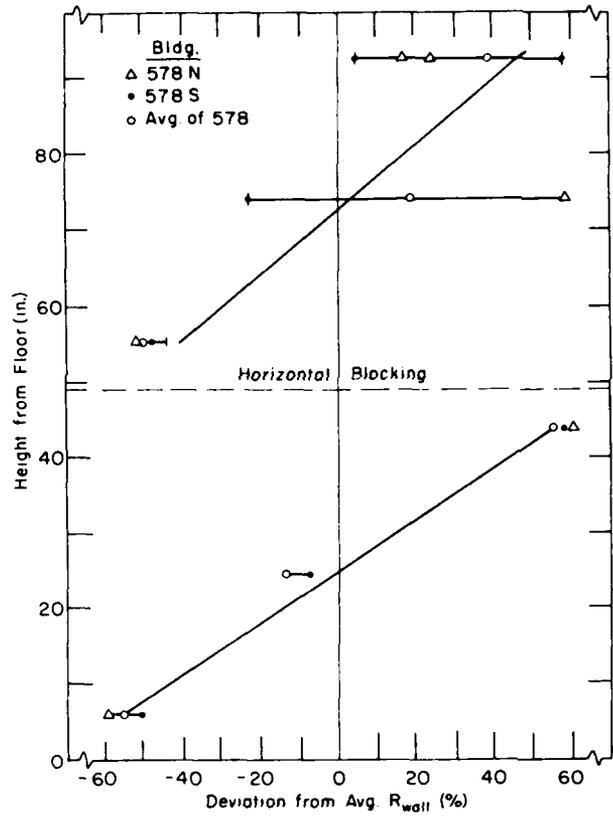
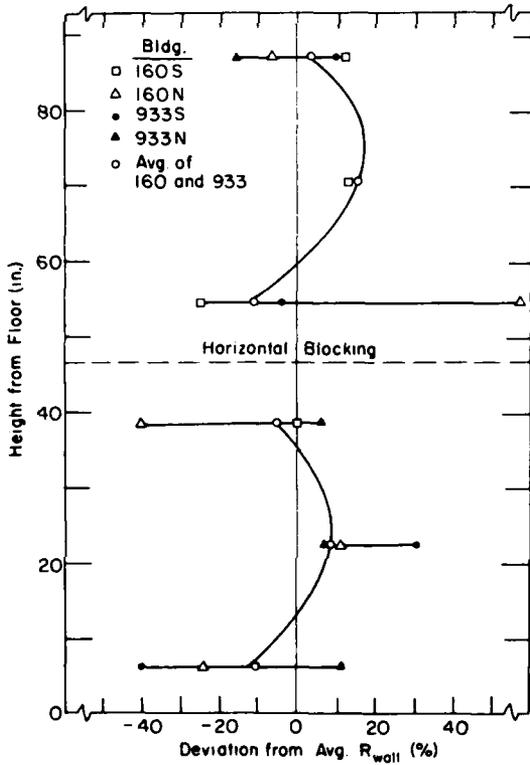
a. Wherry housing (buildings 1001 and 1011).

b. MCA housing (building 578).

c. Capehart construction (buildings 160 and 933).

Figure 10. Percentage deviation of each R_{wall} from the average R_{wall} for each wall, plotted against height on the wall.

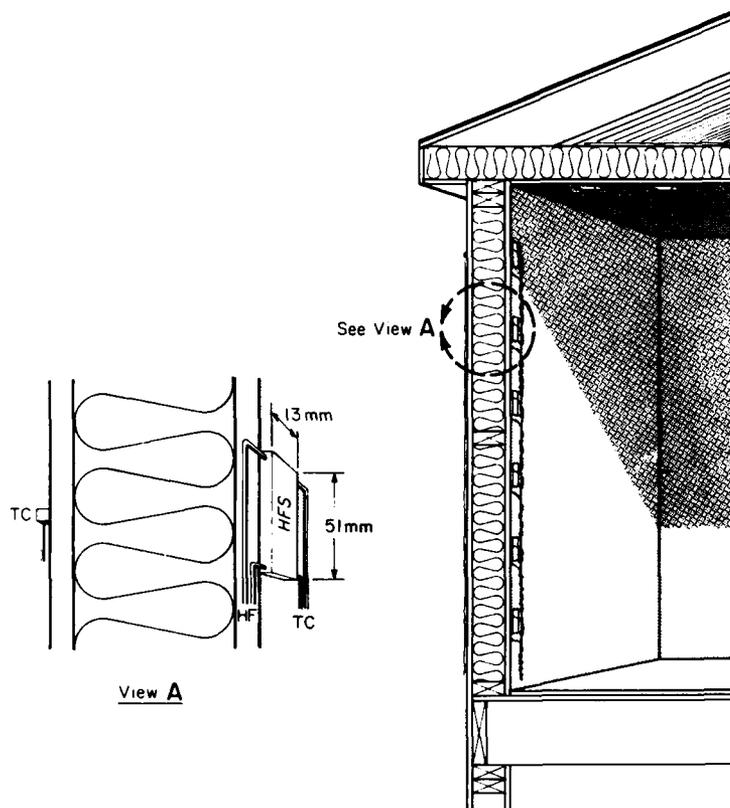
Figure 6. Overall placement of temperature sensors on inside and outside surfaces and an HFS inside.

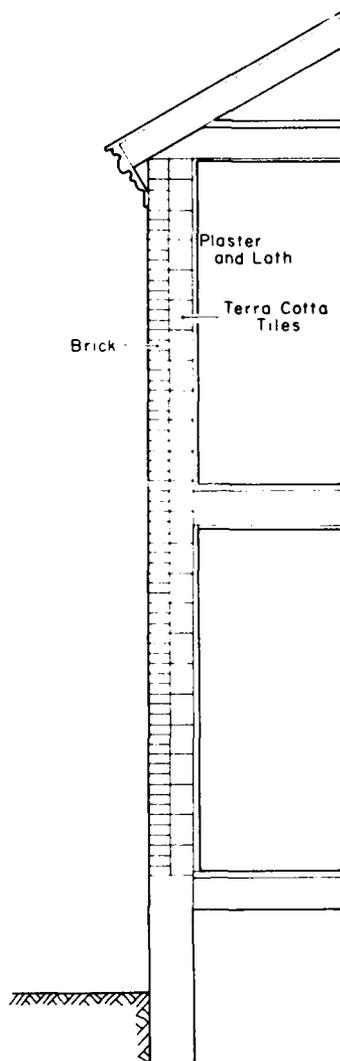
b. Colonial brick building.

Figure 4 (cont'd). Typical cross sections of masonry buildings at Ft. Devens, according to as-built drawings.

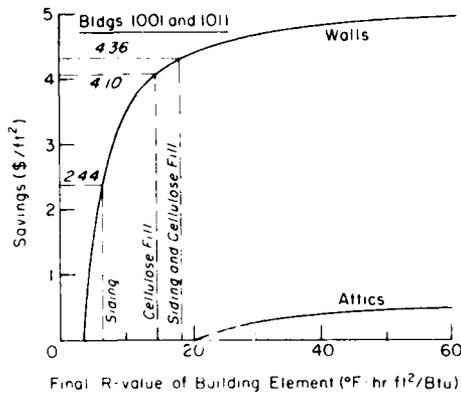
Figure 14. Fifteen-year present worth energy savings potential for adding insulation to two Wherry family housing buildings as a function of the final R-value.

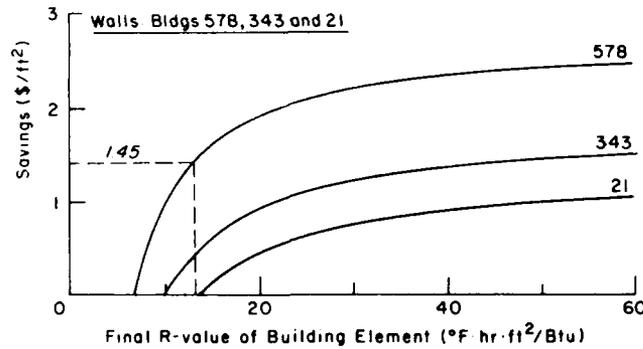
Figure 15. Fifteen-year present worth energy savings potential for adding insulation to three MCA buildings as a function of the final R-value. The dashed line is the estimated cost of installing a stucco-beadboard polystyrene insulation system on building 578.

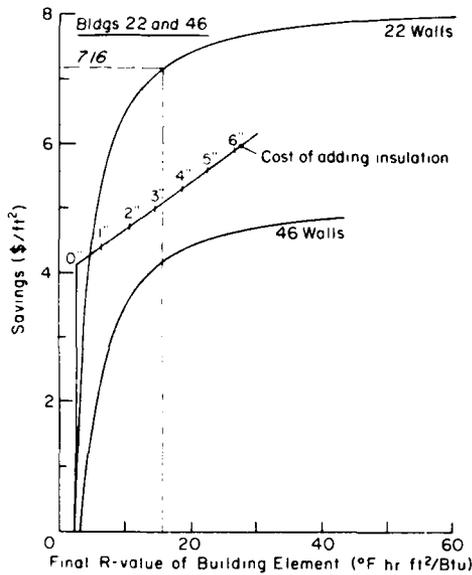
Figure 16. Fifteen-year present worth energy savings potential for adding insulation to two masonry buildings as a function of the final R-value. The dashed line is the estimated cost of installing a stucco-beadboard polystyrene insulation system on building 22.

The measurement results for the two masonry buildings show significant potential for thermal improvement (Fig. 16). The estimated insulation costs are based on data obtained from manufacturer's representatives for a plastic foam exterior insulation system with a reinforced stucco finish. They represent \$4.10/ft² for installation of the stucco-finish system and \$0.30/ft² for each inch of expanded polystyrene at R-3.6 per inch. Where the building "budget" curve is higher than the insulation cost line at a vertical slice through the graph, a cost savings occurs for each final R-value on the horizontal axis. The ratio between the cost and the savings shown at each vertical slice through the

Building 46 (Fig. 16) has a significant energy conservation budget, but it is not high enough to justify the exterior insulation system. With no cavities to fill, it is architecturally difficult to devise an insulation system that would be economical and meet code. A layer of foam insulation covered with gypsum wallboard applied to the interior might be feasible.

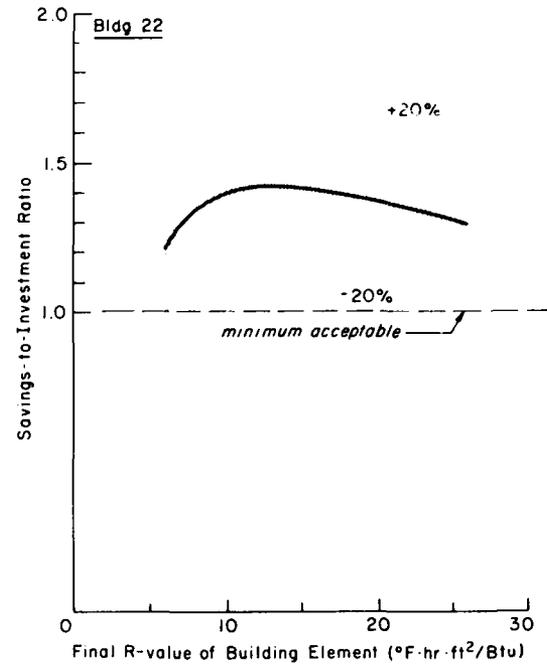
Figure 17. SIR for employing stucco-beadboard polystyrene exterior insulation on building 22 as a function of the resulting R-value. The shading depicts how the SIRs would change with a 20% variation in the assumed savings.

graph is the SIR; when $SIR \geq 1$, the project saves money.

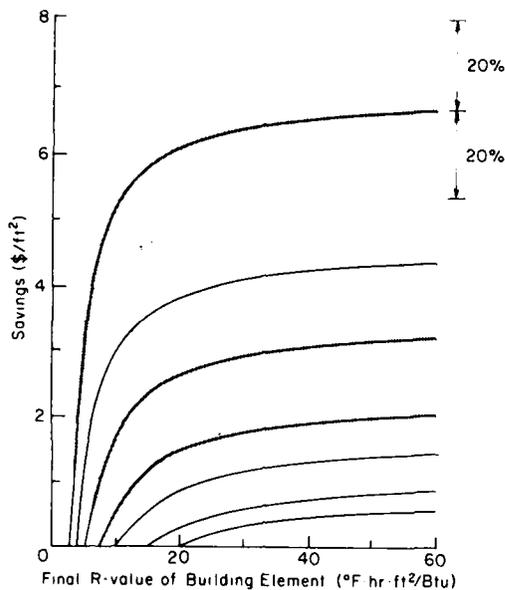
Figure 18. Fifteen-year energy savings potential for any building at Ft. Devens. The initial R-value is where a line intercepts the horizontal axis.

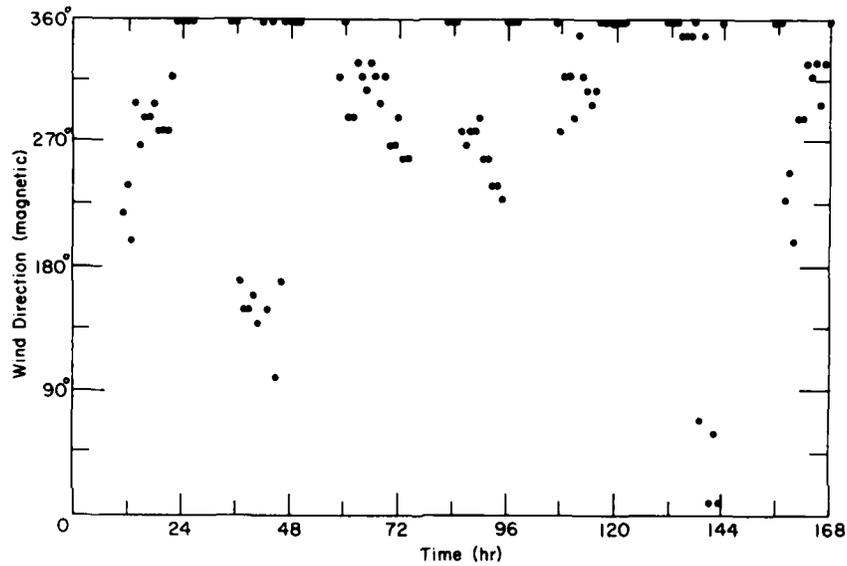
Figure B1. Hourly wind direction at Ft. Devens airfield during the thermal measurement period for building 933.

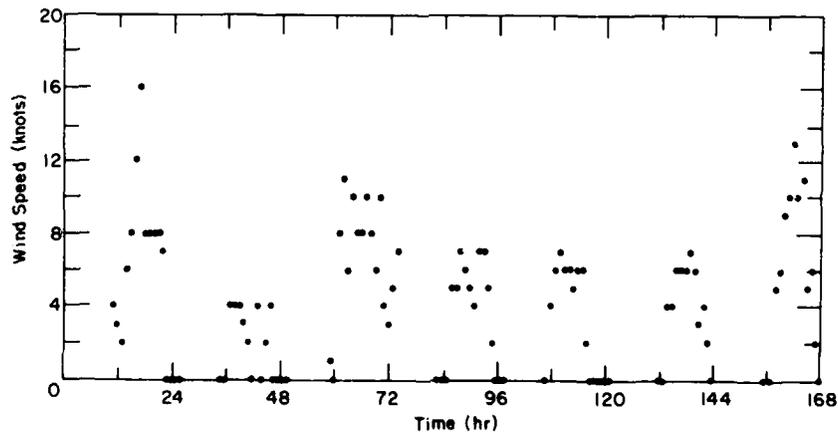
Figure B2. Hourly average wind speed at Ft. Devens airfield during the thermal measurement period for building 933.

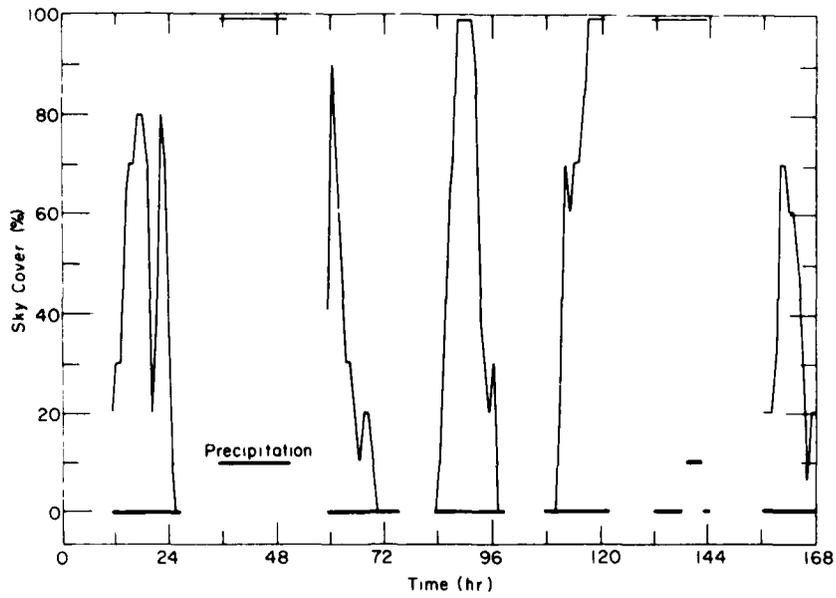
Figure B3. Sky cover and presence of precipitation during the thermal measurement period for building 933. Data were not obtained for night hours.

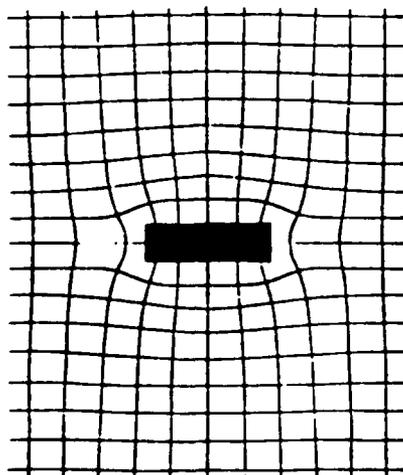
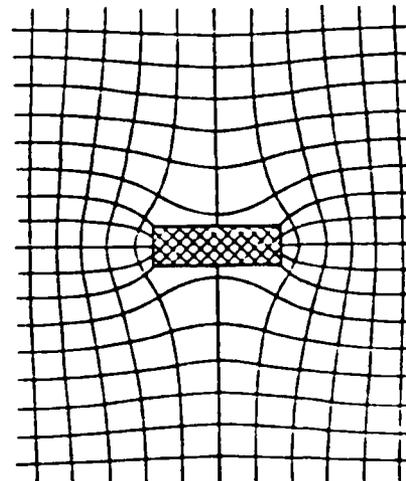
a. $K_s/K_m = \infty$.

b. $K_s/K_m = 0$.

Figure C1. Simulated isotherms and lines of equal heat flow density. (From Schwerdtfeger 1970.)

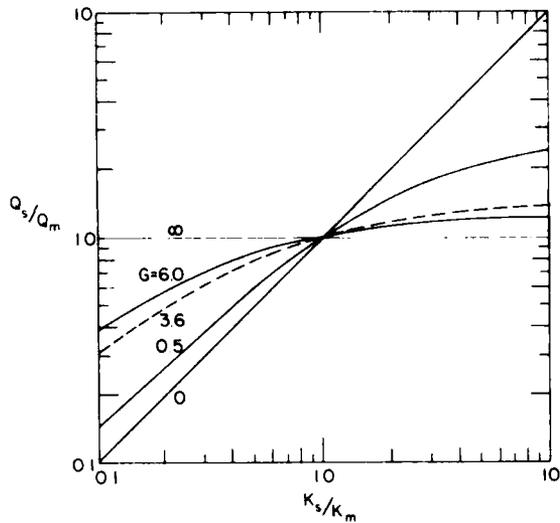
Figure C2. Normalized heat flux as a function of the conductivity ratio K_s/K_m for several values of the geometric parameter G . (After Schwerdtfeger 1970.)

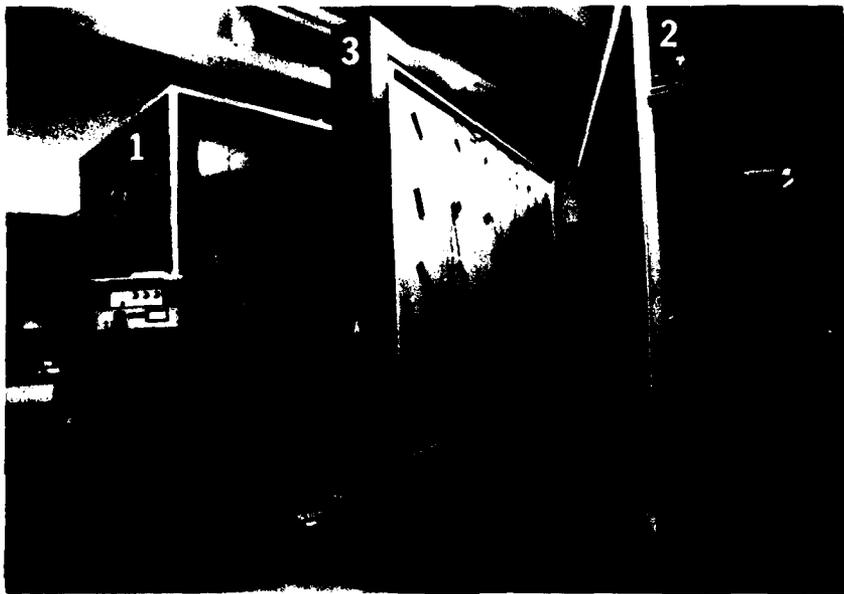
Figure D1. Calibrated hot box and moisture test facility used to calibrate the HFSs. A refrigerated chamber (1) and a heated chamber (2) maintain a constant temperature drop across a test wall held in a frame (3).

To simulate the conditions of measurement in the field, the calibration apparatus was a calibrated hot box. The box accommodates wall test sections up to 8 by 12 ft. The wall section employed for the calibration of the sensors was made of 2-in. tongue-and-groove extruded polystyrene taped at the joints with a layer of 0.5-in. gypsum wallboard held against the insulation with springboards.

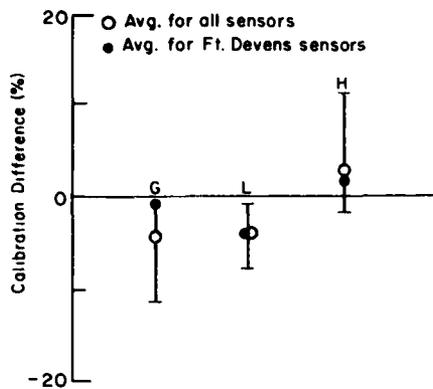
Figure D2. Average difference in sensitivity for each sensor and wall condition compared to an independent calibration, either from the large-scale calibrated hot box or from an ASTM C518 heat flow meter apparatus.

Analysis of the results revealed no bias as a function of sequence of experiments. Averaging all sensor treatments (Fig. D2) revealed little change in sensor calibration as a function of surface type. More change was apparent with the introduction of higher-thermal-resistance material (treatment H had only $\frac{1}{3}$ as much heat flow through the HFS as treatment L). However, this may be due to the increased difficulty in reading the HFS output when the signal was affected more by convection currents and less by conduction through the thicker material. Plywood or gypsum covers eliminated the effect of convection and caused steady sensor readings.

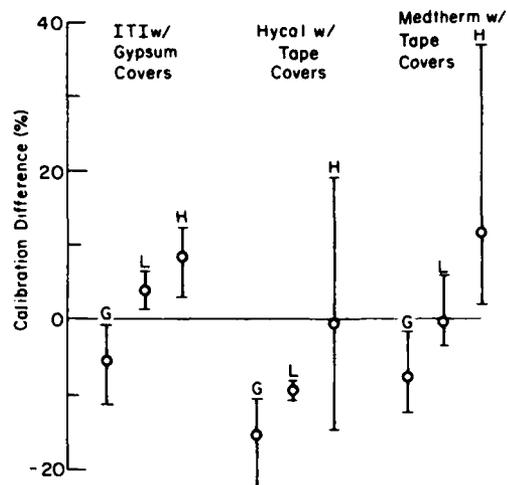
Figure D3. Effects of ITI sensors with gypsum wallboard covers relative to calibrated hot box calibration, Hycal sensors with tape covers relative to heat flow meter (HFM) calibration, and Medtherm sensors with tape covers relative to HFM.

A summary of selected sensor and treatment conditions (Fig. D3) echoes this apparent tendency for high R-value (H) to have a higher *Cal.* Looking at just the taped ITI sensors that simulate the method used at Ft. Devens (Fig. D4), we see that the average apparent calibration for *G*, according to eq 2, should fall on the horizontal axis because such results have been normalized to the wallboard calibration obtained in the earlier calibration runs. However, it is displaced below where we should expect it. The L condition results are displaced an equivalent distance in the sensitivity tests, when compared with the calibration test. For these sensors, the H condition is slightly lower than the other two.

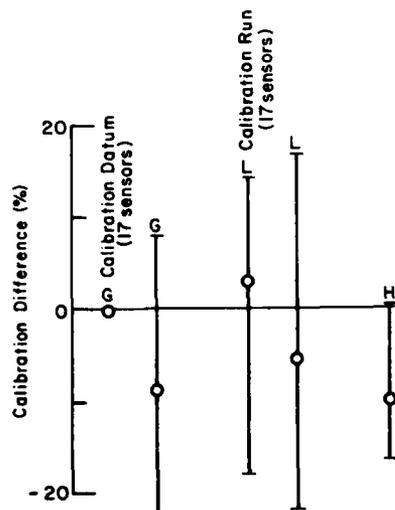
Figure D4. Difference in sensitivity of ITI sensors with tape covers for three wall conditions compared to an independent calibration. The calibration runs employed the DAS, whereas the sensitivity tests were recorded by hand; this is a probable source of bias between the two sets of data.

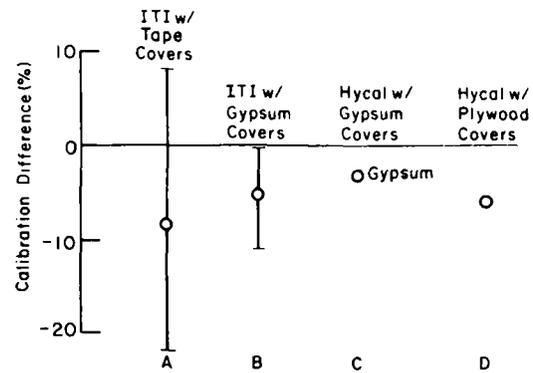
Figure D5. Difference in calibration between a value obtained to test sensitivity of the sensor to different thermal surroundings and a previously obtained reference calibration value. For A and B the reference calibrations were in the large calibrated hot box. For C and D the reference calibrations were in an ASTM C518 heat flow meter apparatus.

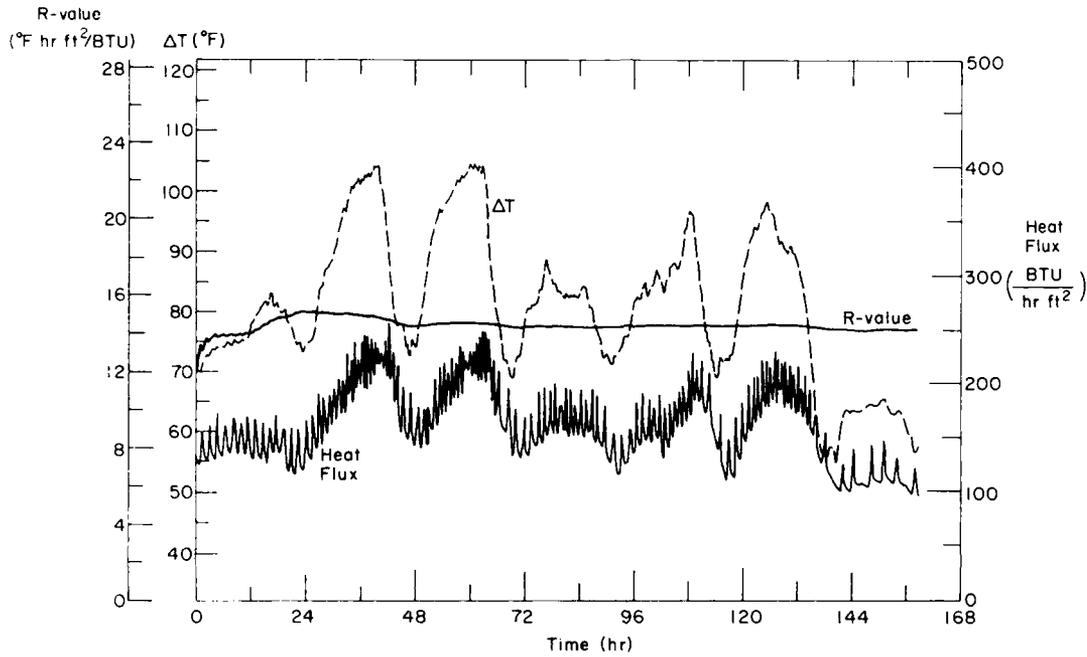
Figure E1. Temperature difference, heat flux and R_e for a frame wall of building 933. The ΔT data show a 24-hour variation attributable to daily change in outdoor temperature and a more frequent (about 40 min) cycle of the heating plant. The heat flux data lag slightly behind the ΔT data, but reflect the shape of the diurnal variation. The line depicting R_e quickly becomes stable for this light construction and this strong average ΔT .

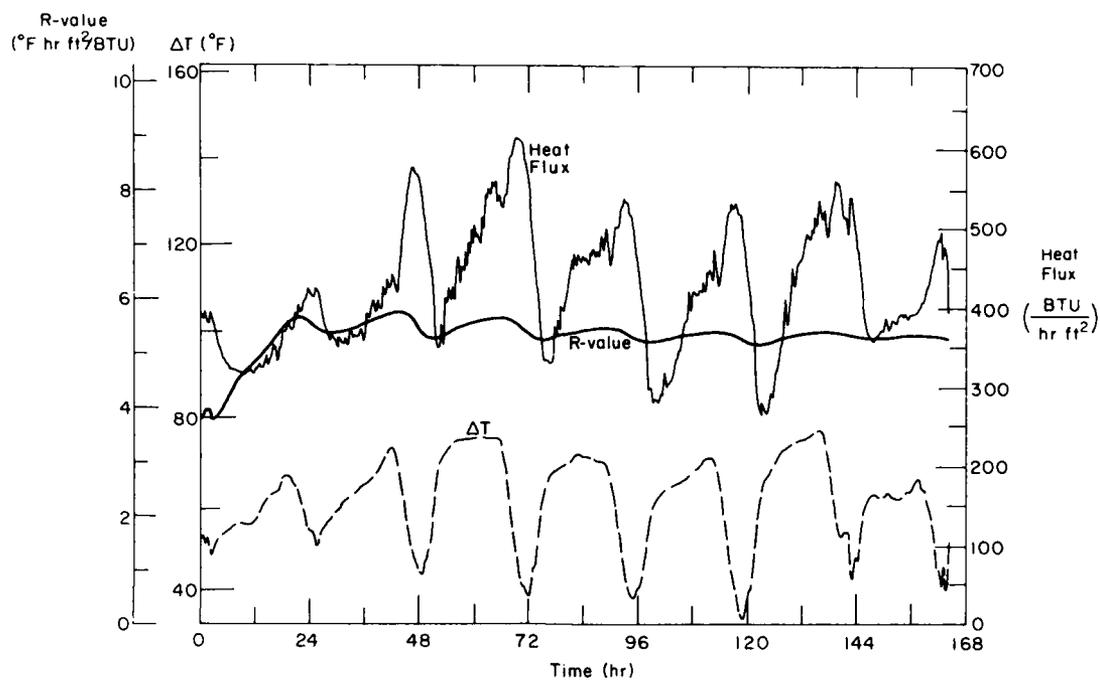
Figure E2. Temperature difference, heat flux and R_e for a concrete masonry wall of building 22. The massiveness of the construction causes heat flux to lag behind ΔT much more than for building 933 (Fig. E1). This fact and the lower average ΔT cause R_e to stabilize on a value more slowly.
