NAVAL POSTGRADUATE SCHOOL

THESIS

DETERMINATION OF THE DUCTILE TO BRITTLE
TRANSITION TEMPERATURE OF
PLATINUM-ALUMINIDE GAS
TURBINE BLADE COATINGS

MASTER OF SCIENCE IN MECHANICAL ENGINEERING

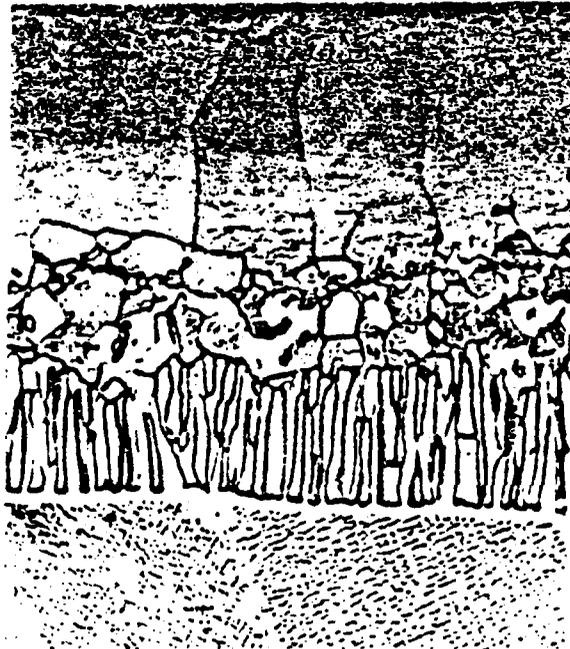
Figure 2. Outward Nickel-Aluminide Coating (1000x)

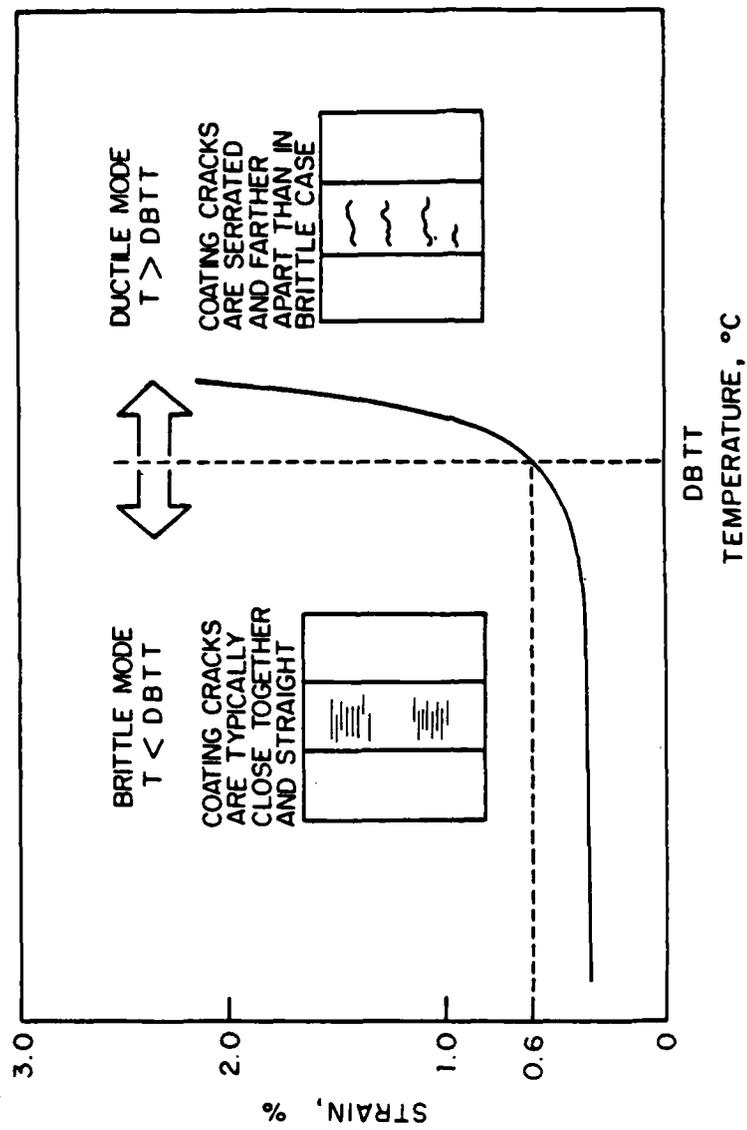
Figure 3. Typical Ductile to Brittle Transition Temperature Graph for a Given Coating-Substrate System

While the temperature range in which the system is in transition from brittle to ductile behavior is often used as above, the industry standard definition of DBTT was set forth by Lowrie and Boone in 1977 as that temperature which corresponds to a fracture strain of 0.6% [Ref. 25]. At temperatures above the DBTT, strains greater than 0.6% can be accommodated and at temperatures below the DBTT strains up to 0.6% can be accommodated. The most important point to observe in the definition is that testing is done to coating fracture so that the strains recorded in any experiment are actually beyond the maxima that can be tolerated at their given temperatures. In a typical DBTT tension test this involves coating fracture only at temperatures below the DBTT while at temperatures above the DBTT substrate failure may occur with or without coating fracture [Ref. 26]. In the brittle region cracks are straight and close together while in the ductile region cracks are more separated and bifurcated. See Figure 3.

a load was applied to the specimen. A chart speed of 5 inches per minute and a crosshead speed of 0.01 inches per minute were used giving a magnification factor of 500. The strain rate was 0.007 per minute and this was maintained throughout the testing in order to achieve consistent results due to the dependence of the DBTT upon strain rate [Ref. 35]. Once 0.8% strain was imparted, if no cracking was observed on the oscilloscope, it would be assumed that the upswing of the DBTT curve had been located. The load would then be removed from the specimen and the lower pin removed. Then the furnace would be reduced in temperature by 50°C and the test would be resumed as described. If cracking resulted in this specimen and if it were in the ductile region (above 0.6% strain) the cracks would likely be few and far apart. This same specimen could be used later at room temperature to establish the low end of the brittle region, since cracking in this area is short and dense and easily distinguished from the cracking initiated in the ductile region. See Figure 3.

after the test revealed that the coating cracks on the gage length were clearly visible and characteristic of a brittle coating failure (see Table III and Figure 3).

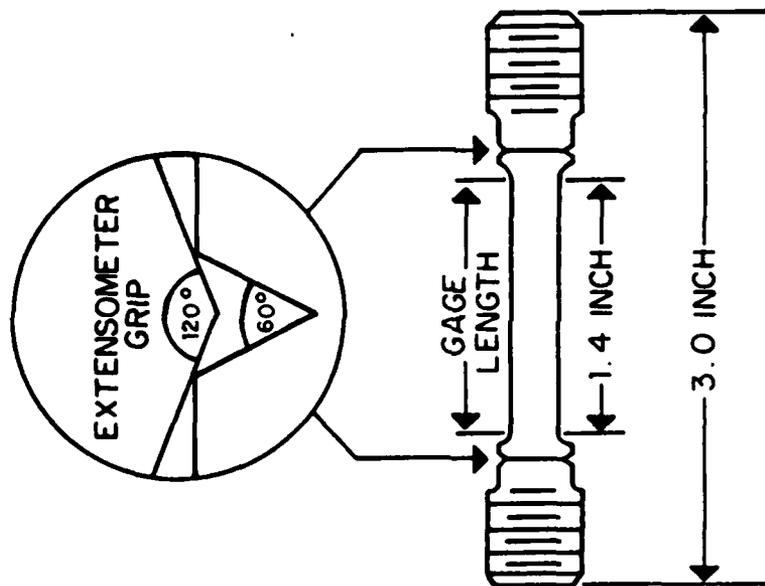
Figure 4. Coated Tensile Specimen

The gage length of each coated specimen was measured to 0.001 inch, the standard being 1.400 inch. The measured portion was only the portion of consistent diametrical dimension (Figure 4) as specified by ASTM standards and the maximum runout on any one specimen was 0.005 inch through the entire gage length. In all testing cases cracking was observed around the entire sample indicating good specimen alignment and sufficient specimen trueness (no bends on gage length).

portion and not on the gage length itself to prevent extensometer induced cracking. It was assumed that the elongation in areas of increasing thickness above and below the gage length but inside the extensometer grips would be insignificant compared to elongation on the gage length itself. The grooves on the specimens were cut at a 60 degree angle so that the 120 degree circular wedge grips on the extensometer would have a two surface grip as illustrated in Figure 4.

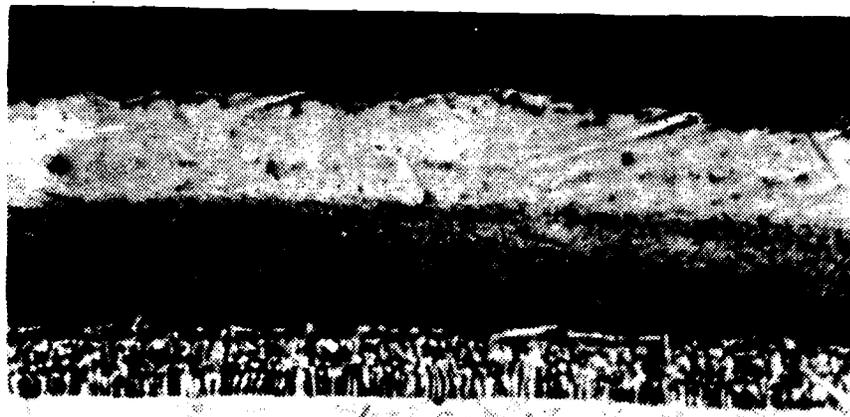
Figure 5. Coating No. 1 - Low Pt Diffusion, Inward Al, Etched (425x)

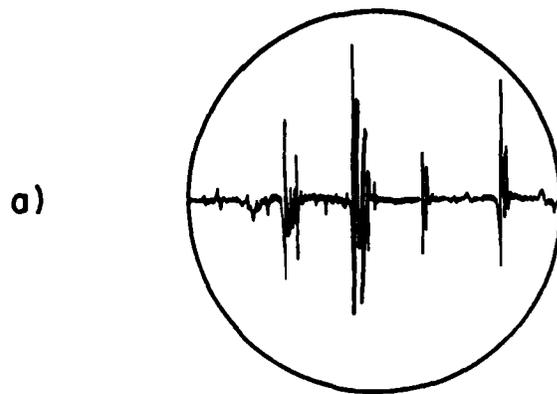
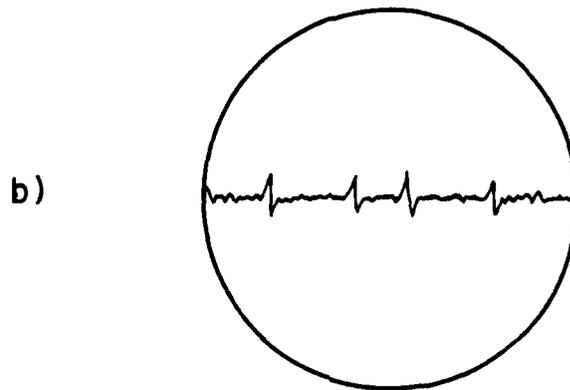
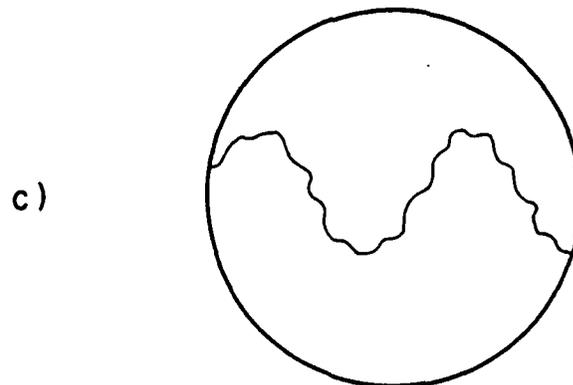
Figure 10. Typical Oscilloscope Signatures During Tensile Testing

STRAINING EMBRITTLED SUBSTRATE

EXHIBITS COATING CRACKING

THERMAL EXPANSION AND INSTRON MACHINE NOISE

Once several specimens were tested, it became very clear what the signature of a coating crack looked like on the

oscilloscope (see Figure 10b). Whenever this sharply defined characteristic was exhibited on the oscilloscope, there were cracks which could be observed on the specimen gage length at 425x under an optical microscope, and whenever this signature did not appear there were no cracks, regardless of how much strain the specimen had undergone and no matter what other patterns appeared on the oscilloscope. This is considered reasonable proof that the oscilloscope signature shown in Figure 10b was coating cracking observed during tensile straining of the specimens. Further confirmation of the cracking signature was provided by testing done above 800°C. The specimens deformed very quietly at these temperatures, they registered minimal noise on the oscilloscope, and so the cracking signature was even more distinguishable than at lower test temperatures where other noise was present on the scope. For instance, the test of coating No. 2 specimen No. 1 conducted at 860°C showed practically a clear scope, even though it was strained to 1.71%. Optical microscopy revealed no cracking of the specimen. Coating No. 3 specimen No. 1 on the other hand, which was also tested above 800°C, displayed the distinctive signature shown in Figure 10b beginning at 0.25% strain and continuing until approximately 0.65% strain with a clear scope showing beyond that point until the specimens fractured at 2.20% strain. Examination of this specimen

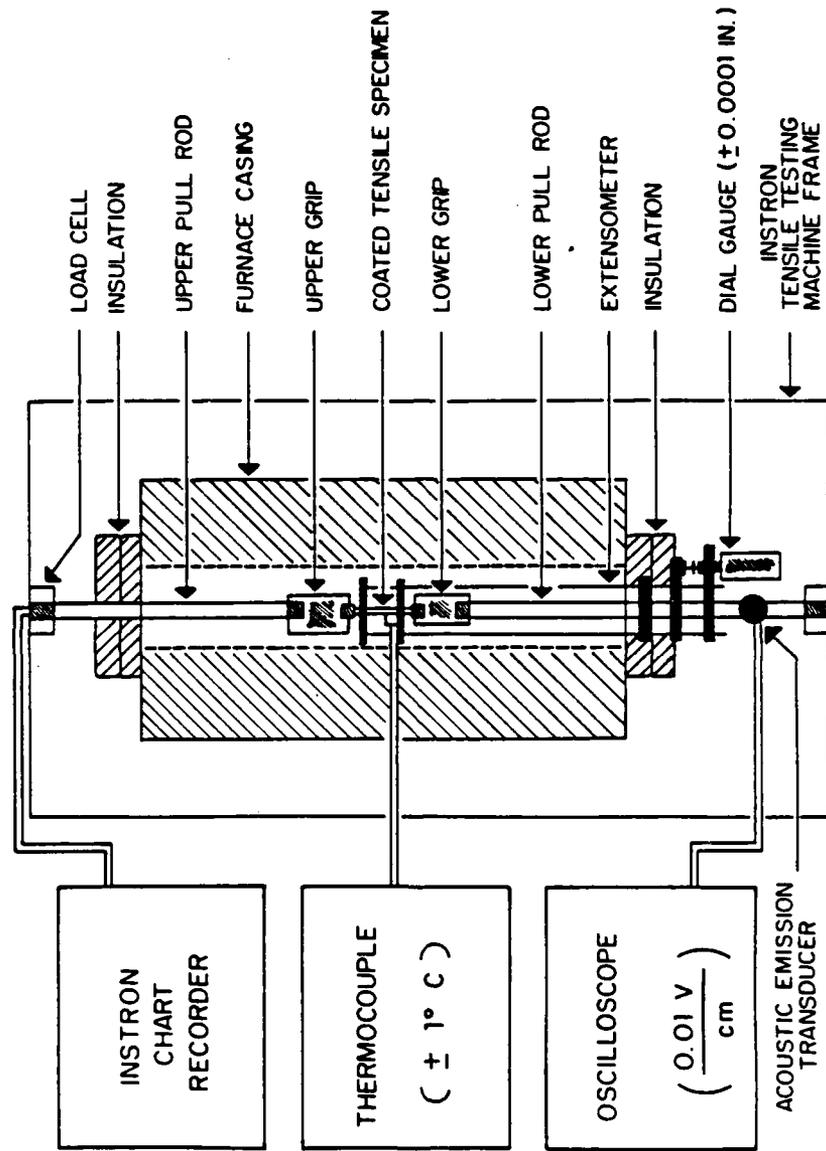
Figure 11. Experimental Set-Up for Coating-Substrate Ductility Testing

In this instance, the audio approach was employed in which a sound transducer, the Dunegan model S-140B, was used in conjunction with the Tektronix Type 551 Dual Beam Oscilloscope to give a visual signature of the coating failure. This method was considered feasible due to evidence that coating cracking on the surface of a coated alloy yielded a distinct acoustic signature in toughness tests reported by Lehnert and Schmidt on platinum-aluminide coatings [Ref. 34]. Surrounding noise which includes gear noise in the Instron machine and even thermal expansion of the tensile specimen appears sinusoidally, and is easily distinguished from coating crack generated noise. See Figure 10. The sensing element was attached directly to the lower pullrod in order to pick up the transmission of the cracking sound as directly as possible. See Figure 11.

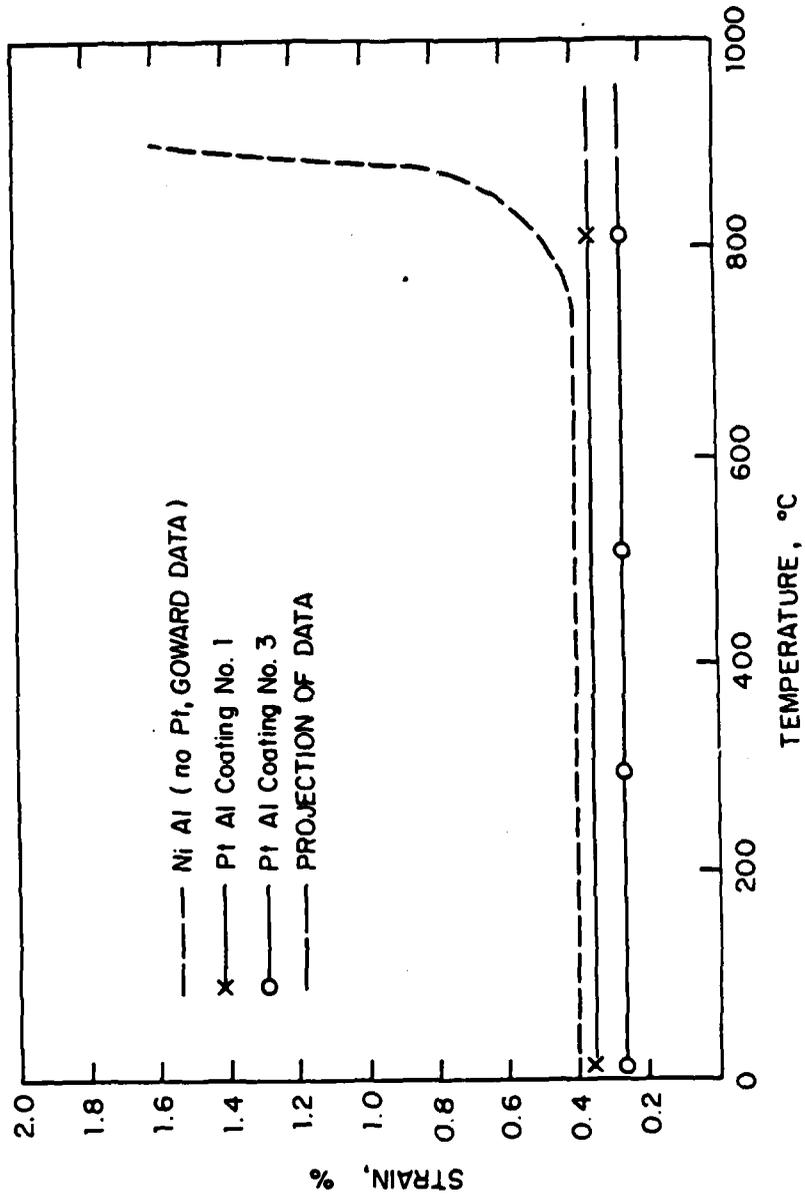
Figure 12. Ductility Graph of Inward Aluminum, High Activity Coatings (LTHA)

Using the curves generated in Figures 12 and 13 the ductile to brittle transition temperatures for the five coatings tested are presented in Table IV. The data is self consistent and it allows some tentative observations to be made concerning the influence of platinum on diffusion aluminide coatings applied to nickel-base superalloy substrates in regard to the DBTT. Both the inward and outward type diffusion aluminide coatings were embrittled to varying degrees with the addition of platinum, so the claim that platinum-aluminides are relatively brittle is well founded. However, all the outward (HTLA) nickel coatings with platinum were more ductile than the inward (LTHA) aluminum coating even without platinum which is somewhat surprising, since the platinum containing coatings all

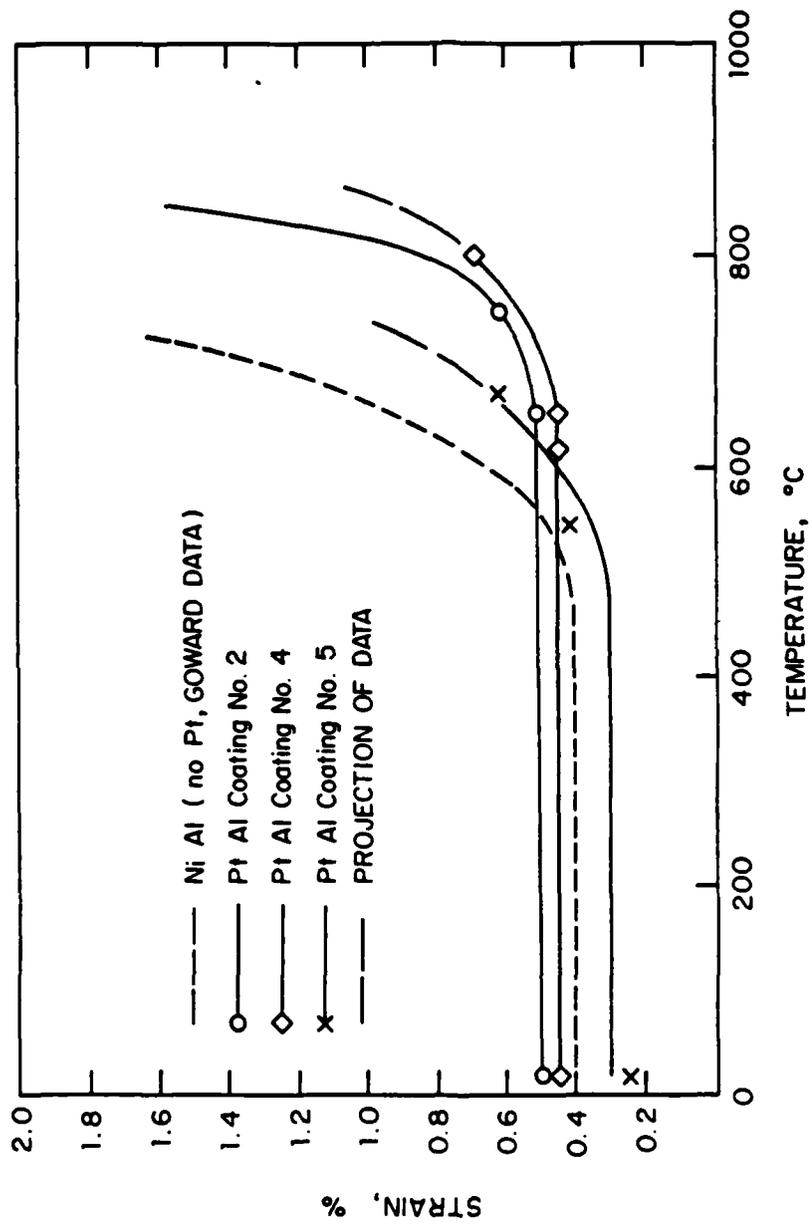
Figure 13. Ductility Graph of Outward Nickel, Low Activity Coatings (HTLA)
