SALVAGE AND DEMOLITION
OF
TWO NAVY OFFSHORE PLATFORMS

WILLIAM N. SEELIG

FPO-1-84(32) OCTOBER, 1984

CHESAPEAKE DIVISION
NAVAL FACILITIES ENGINEERING COMMAND
WASHINGTON NAVY YARD
WASHINGTON, DC 20374

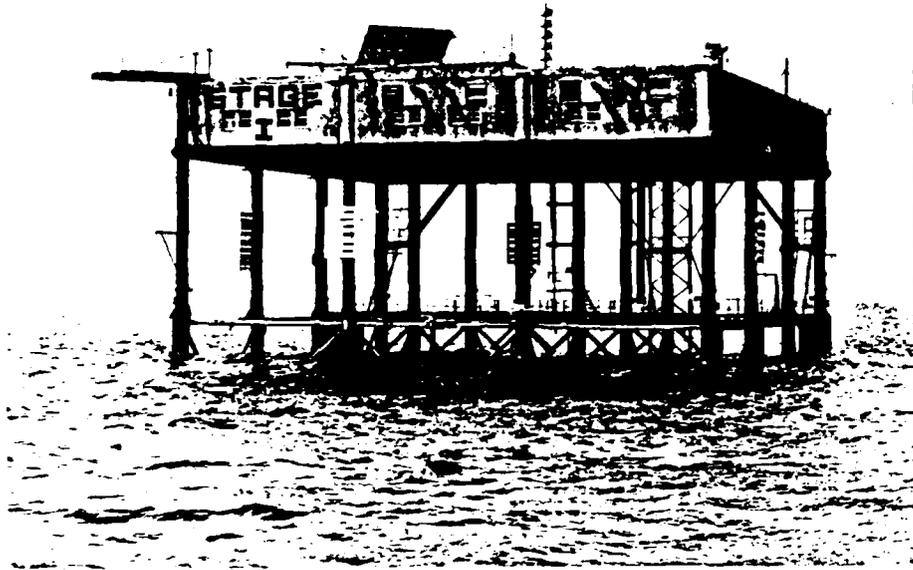
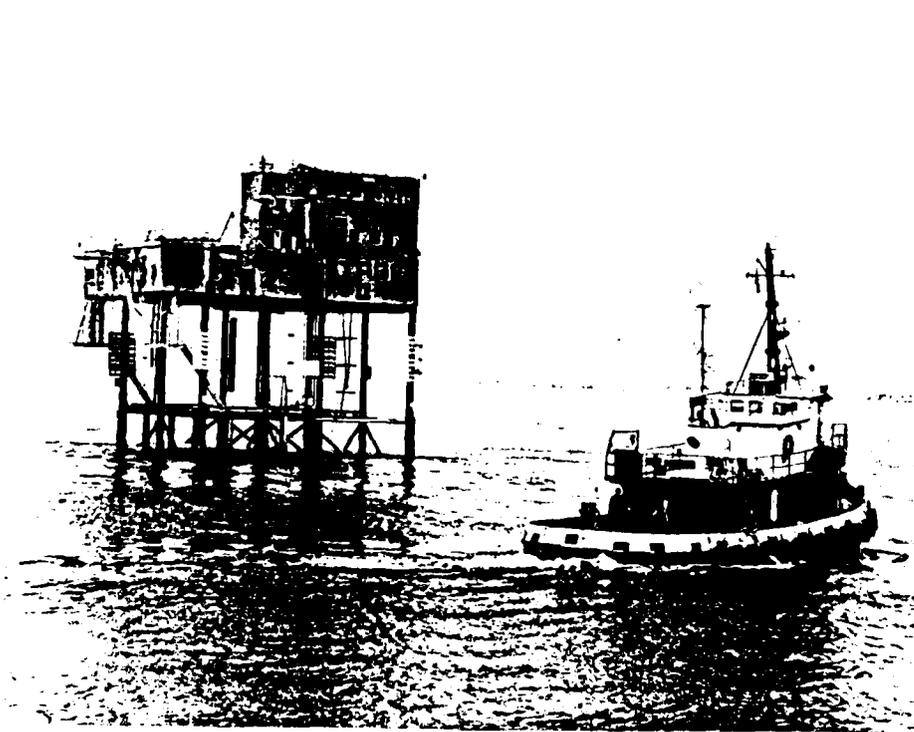
Figure 1. Offshore Platforms Salvaged/Demolished

a) STAGE I (3 July 1984)

b) STAGE II (3 August 1984)

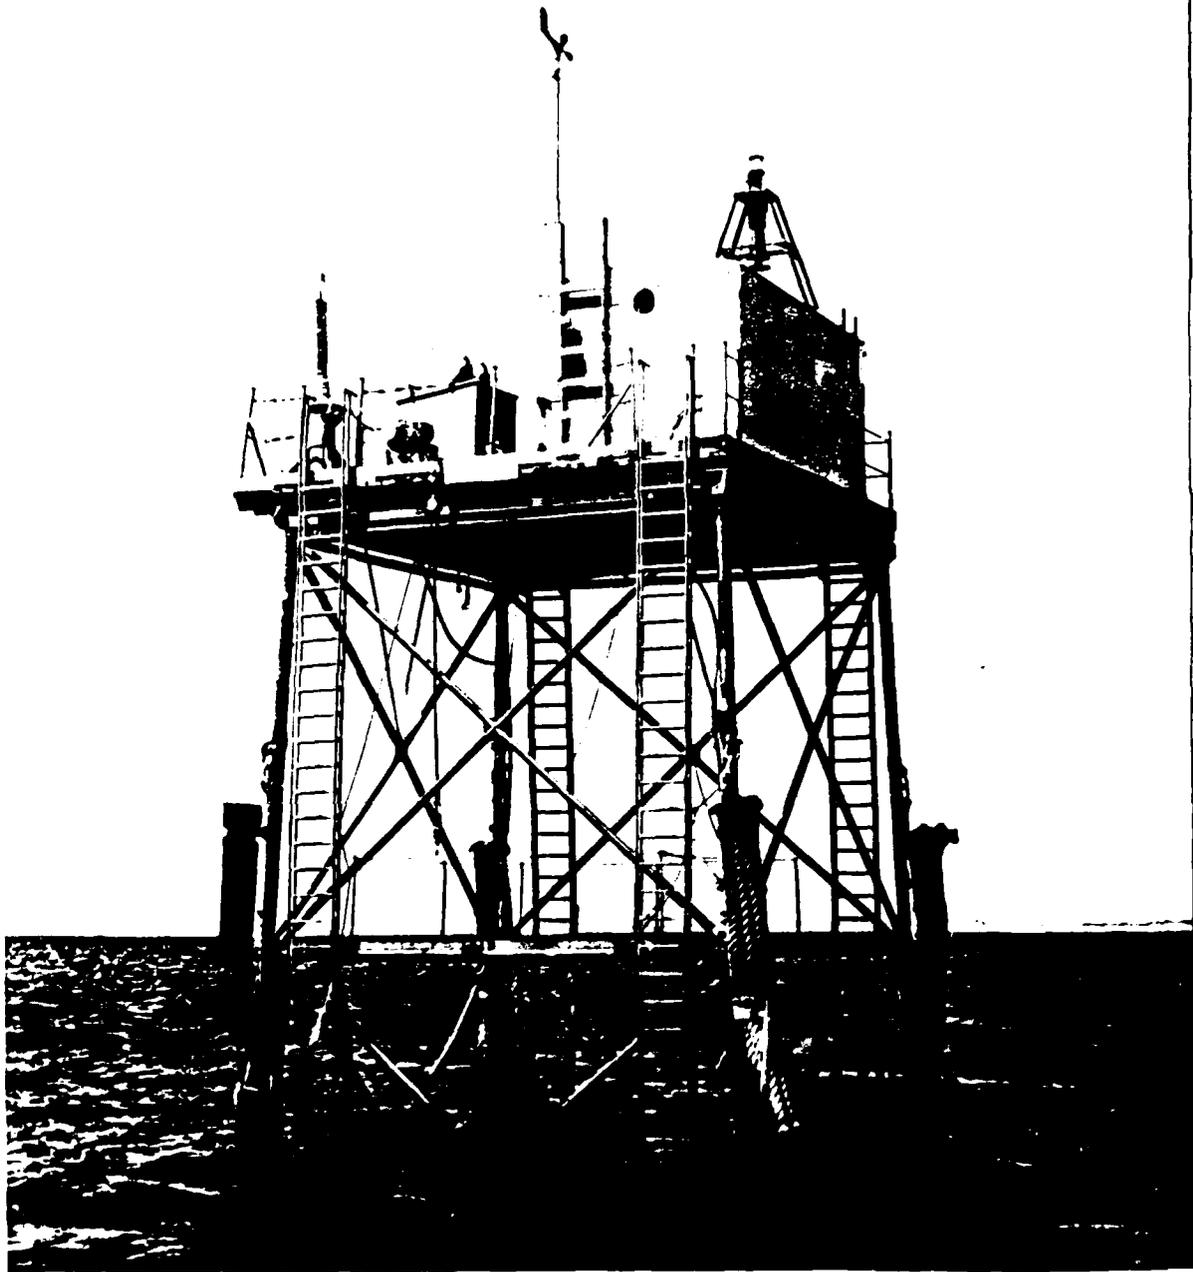
Figure 3. Photo of Platform At NCSC in the Early 1950's
(This platform was struck and destroyed by a barge
during a storm. The platform was later retrieved
for salvage.)

The Naval Coastal Systems Center (NCSC) first built a small four-pile platform (Figure 3) offshore of Panama City, Florida in the early 1950's. This platform proved to be a highly valuable facility at NCSC, but unfortunately a barge struck and destroyed the platform during hurricane Flossy in September 1956. This toppled structure was located soon after the storm and retrieved for salvage.

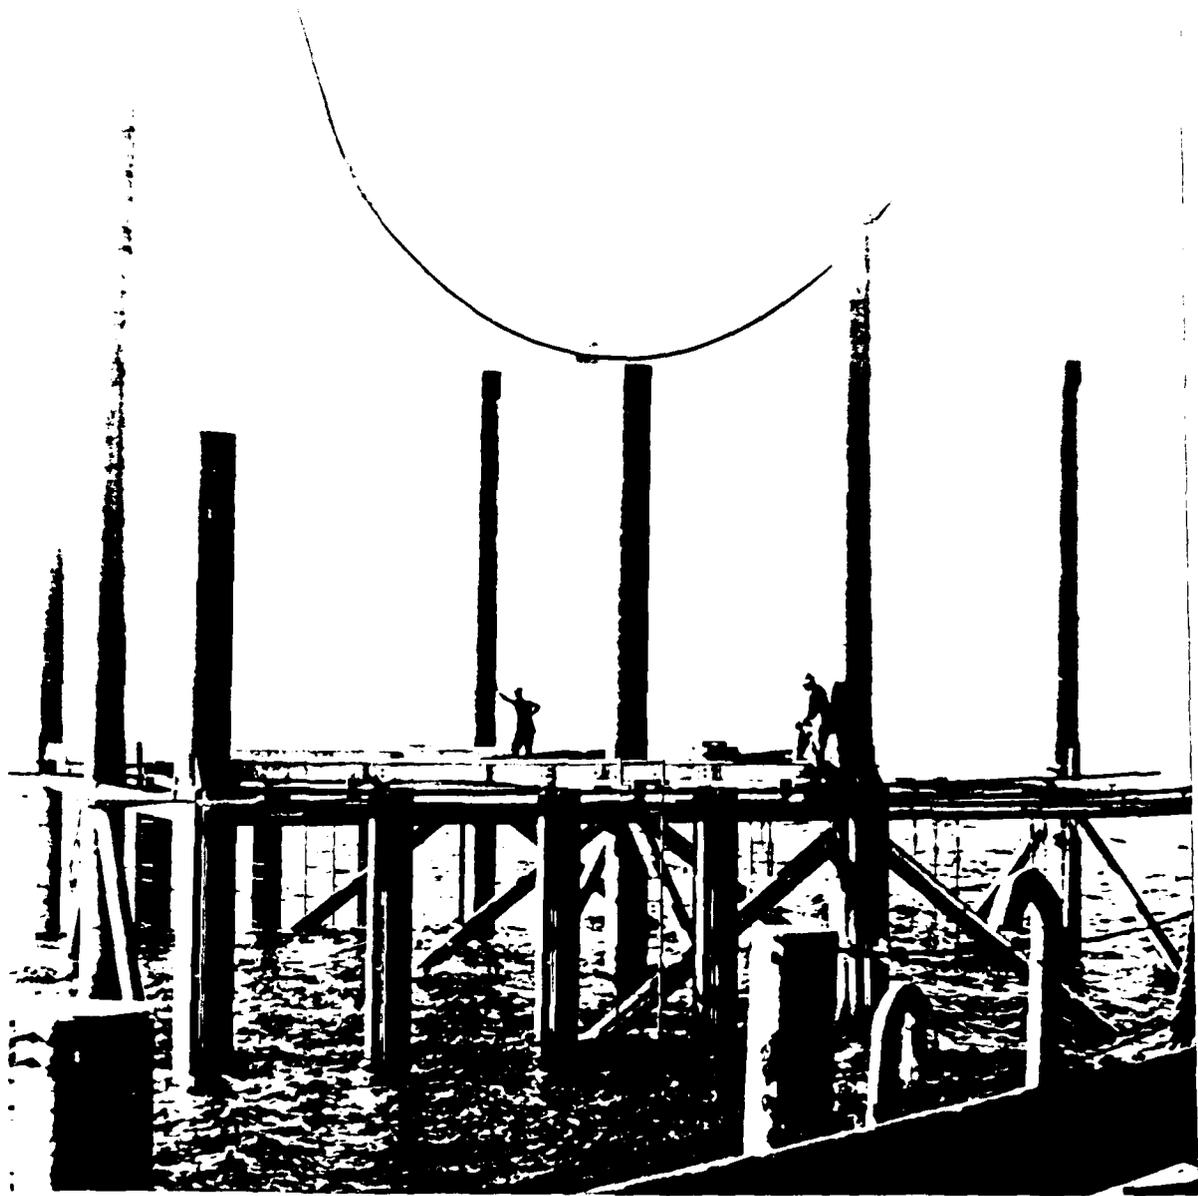
Figure 4b. Construction Photo of Stage II
(A Hurricane Delayed Installation of the Decks)

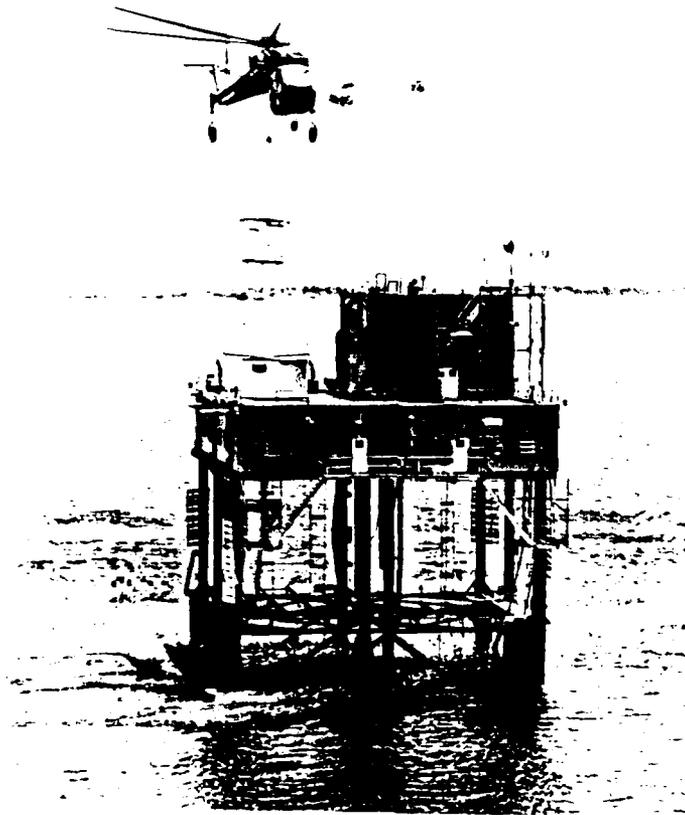
Figure 5. Military Helicopter Lifting Scientific Equipment on Stage II
(Date Unknown)

Major storms occasionally damaged the stairways and catwalks, so they were periodically repaired. Another problem was to find safe ways to get personnel and equipment to and from the stages. Boat transport was used during mild wave conditions and helicopter support was provided for heavier equipment (Figure 5).

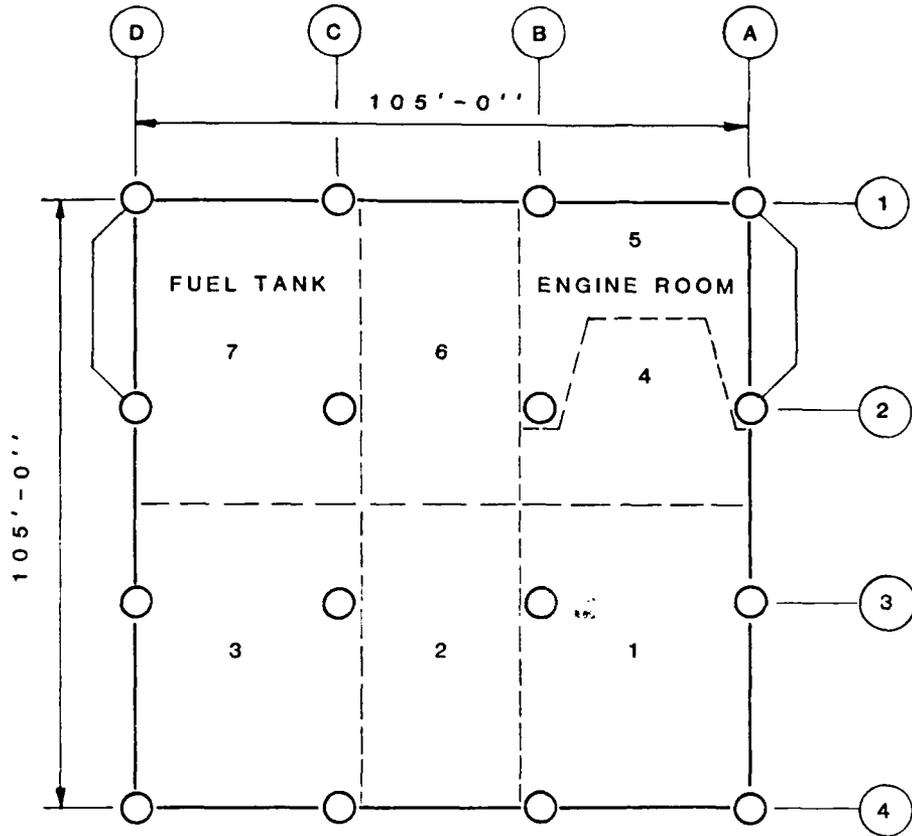
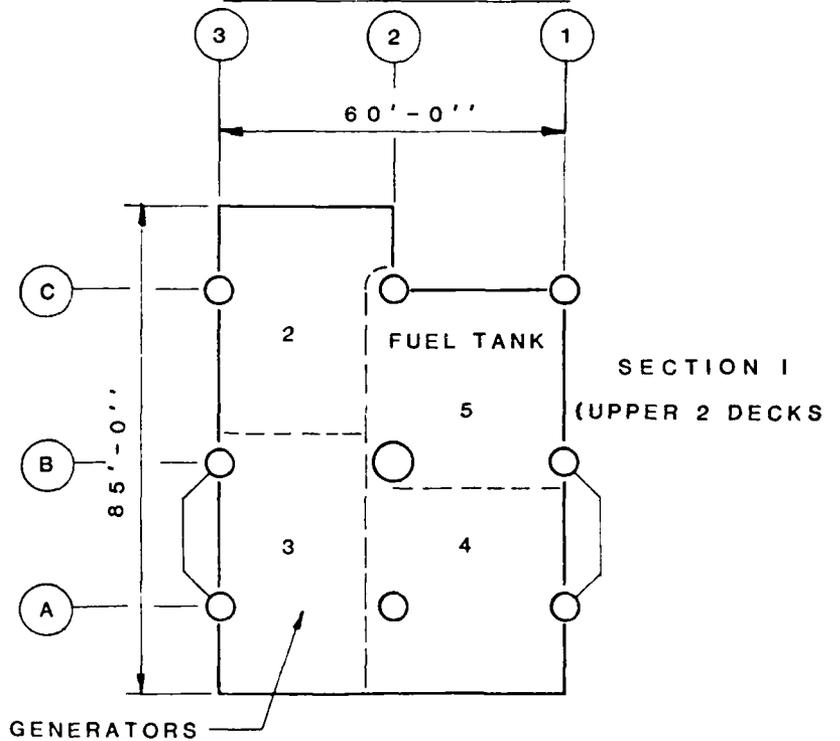
TOTAL WEIGHT = 755 TONS

TOTAL WEIGHT = 420 TONS

PLAN VIEWS OF THE STAGES ILLUSTRATING THE CUTTING PATTERN USED BY THE CONTRACTOR TO SECTION DECKS

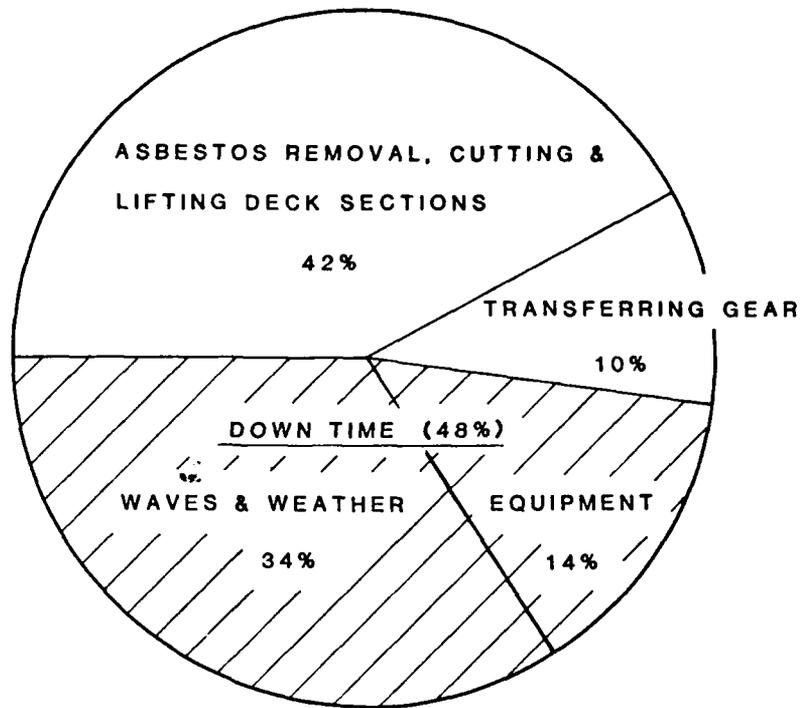
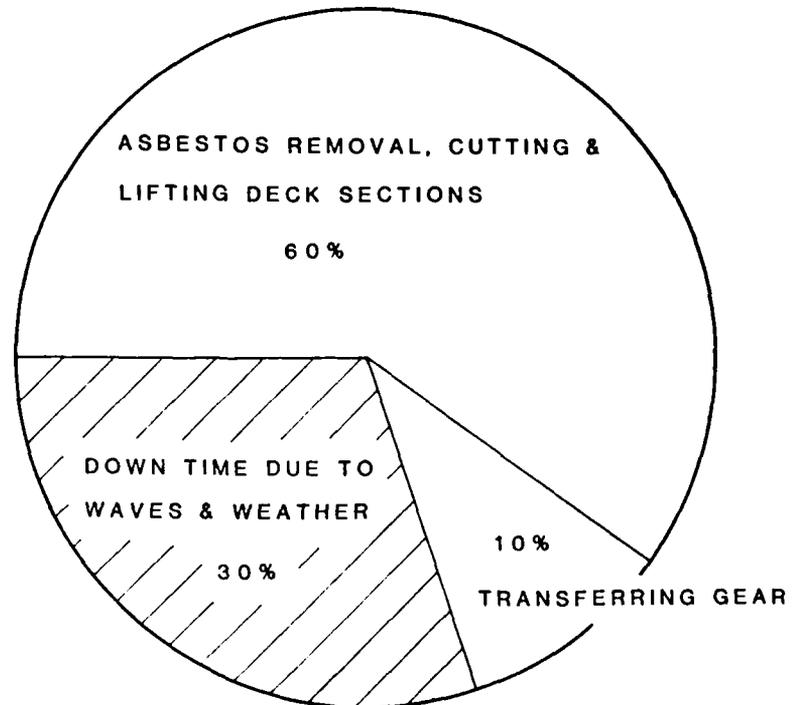
FIGURE 10. BREAKDOWN OF CONTRACTOR'S TIME ON SITE

a) STAGE I
(32 DAYS)

b) STAGE II
(16 DAYS)

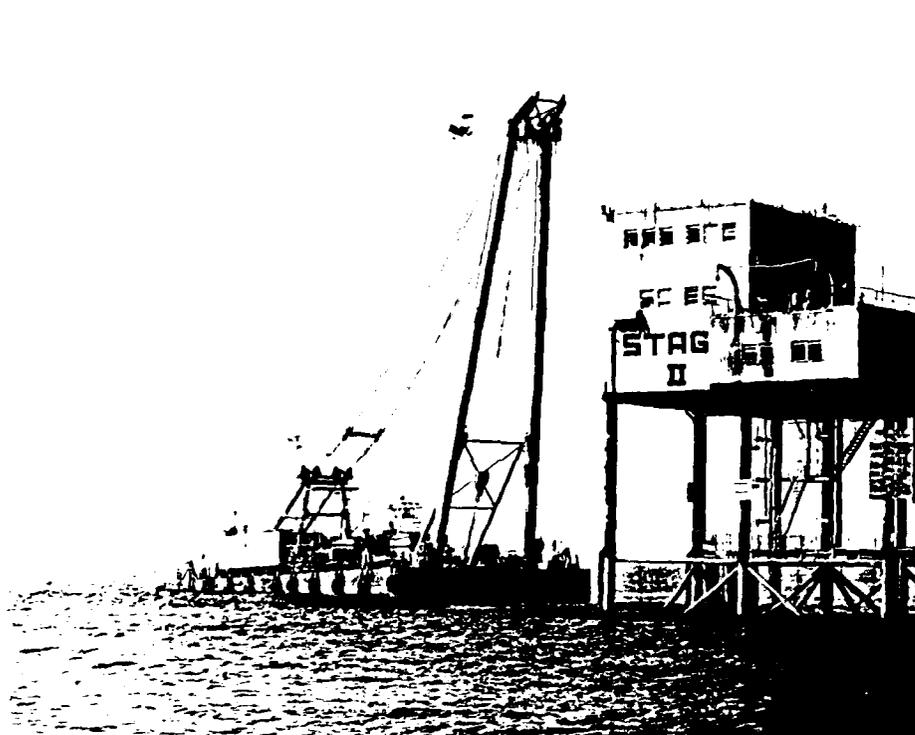
Figure 11. Photo of the Contractor's Barge (the "Sea Salvor")
(Two additional material barges were used to transport
equipment and sections of the stages)

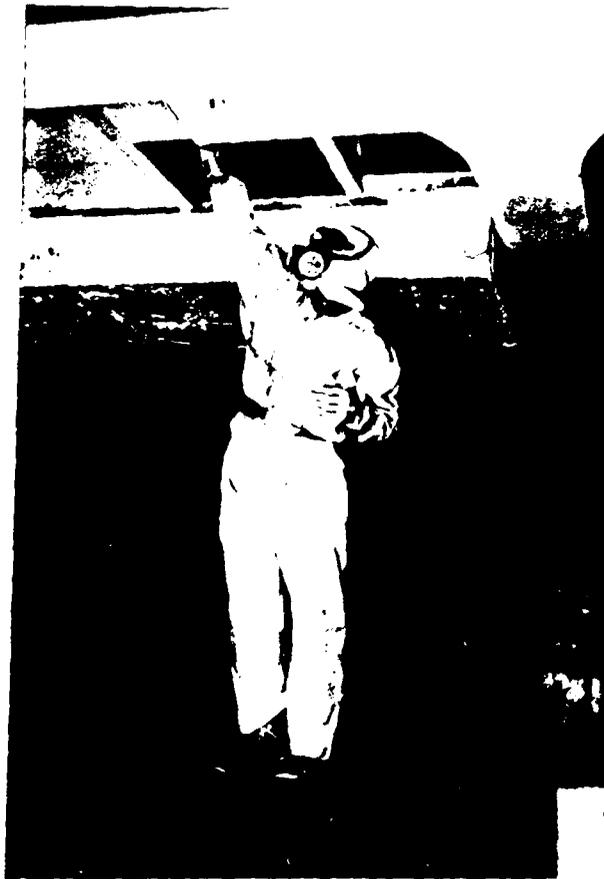
Figure 13. Photos Showing Asbestos Removal

a) Removing Non-Friable
Ceiling Tiles

b) Sampling Friable Asbestos
Covering Mufflers
(friable material was removed
using the glove-bag method)

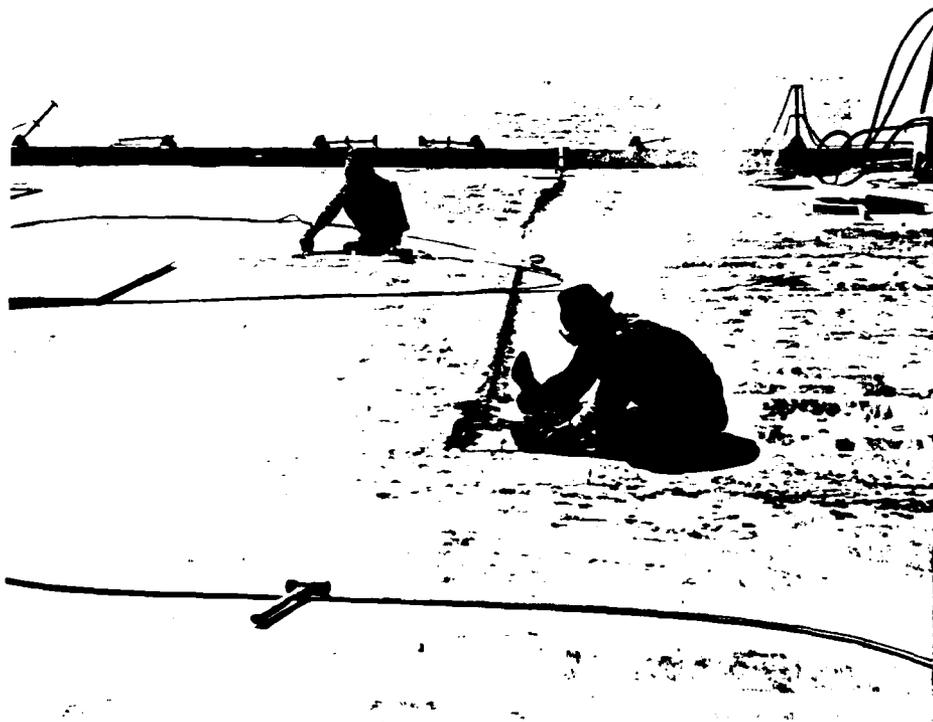
Figure 15. Precutting the Decks of Stage I
(all but several key beams were cut)

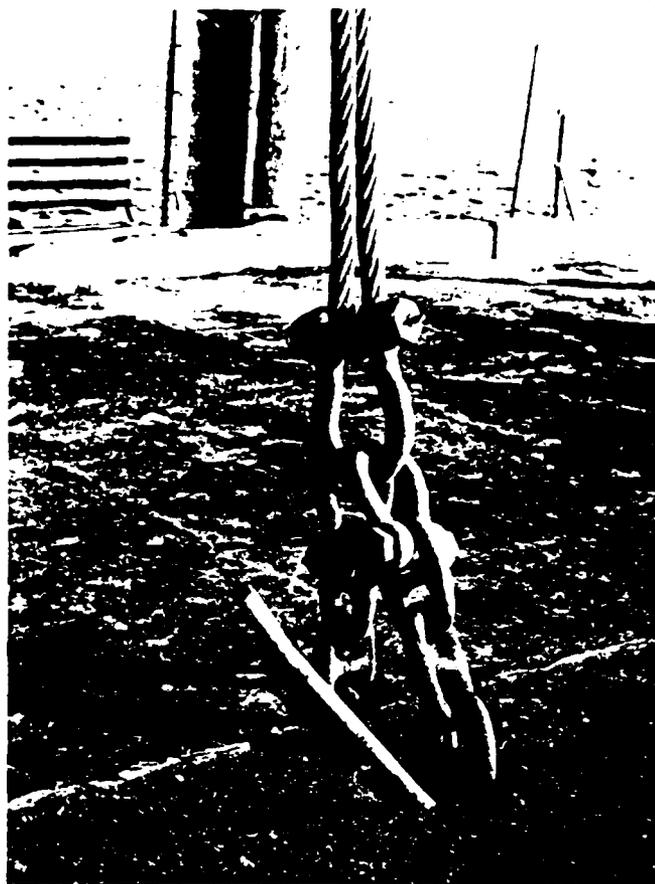
Figure 16. Rigging Chain and Wire Rope Bridals
(2" chain put around key beams with
the aid of air tuggers; wire rope
slings then shackled to chain)

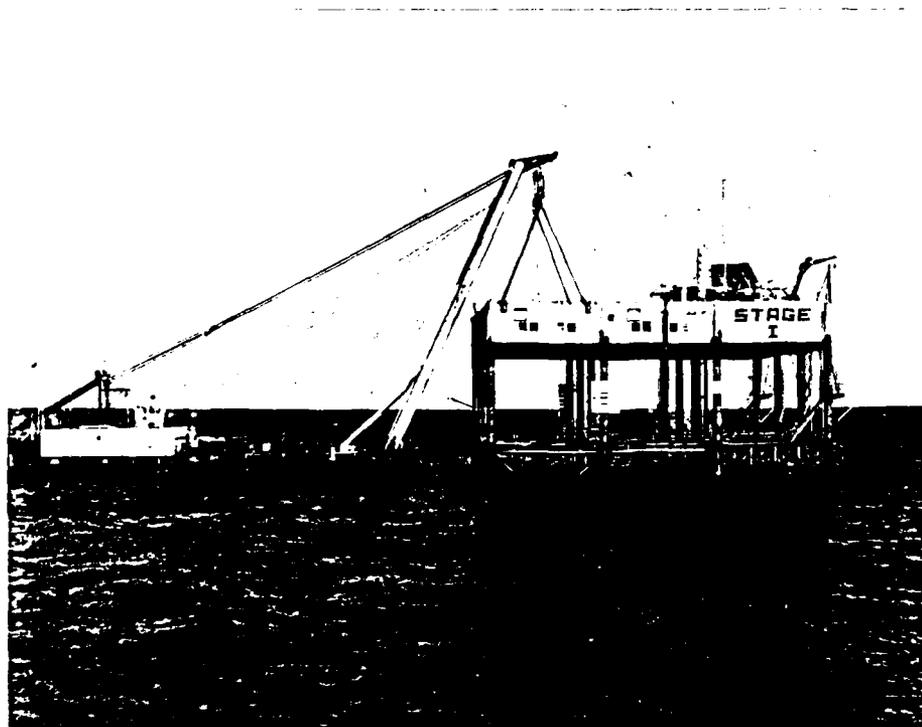
Figure 17. Contractor's Crane Provides Pretension to the
Section Before Final Cuts and a Lift is Made

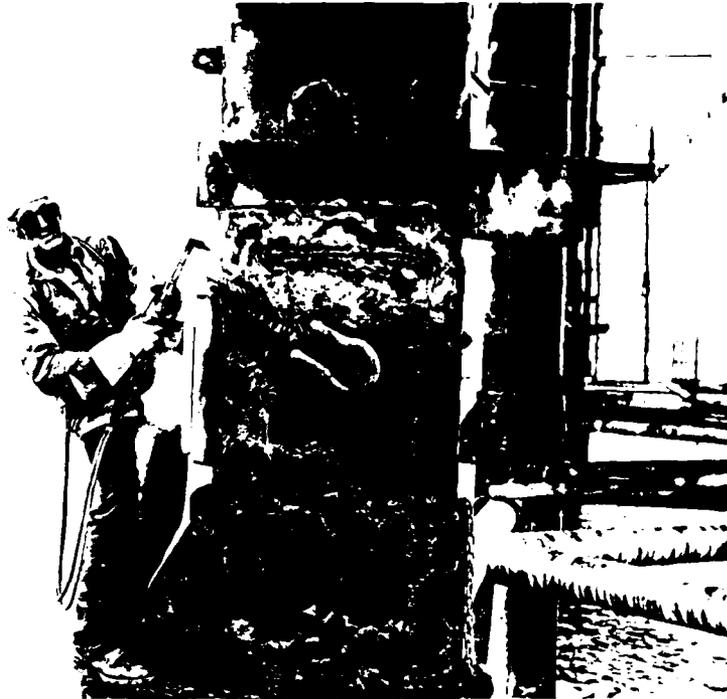
Figure 18. Supporting Legs are Last Items Cut Before a Lift is Made
(A 6" long section of circumference is not cut by the welders
on one pile; this "hangover" is torn off during lifting)

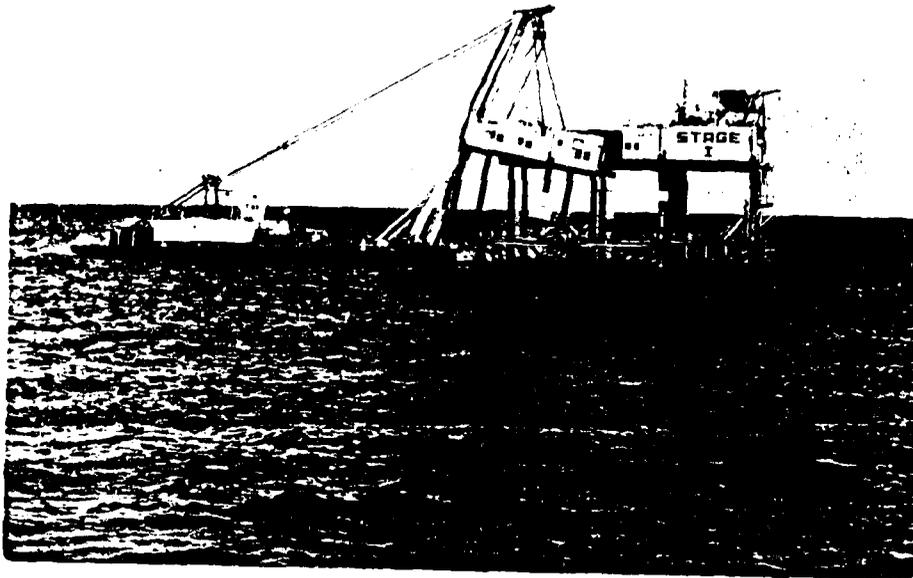
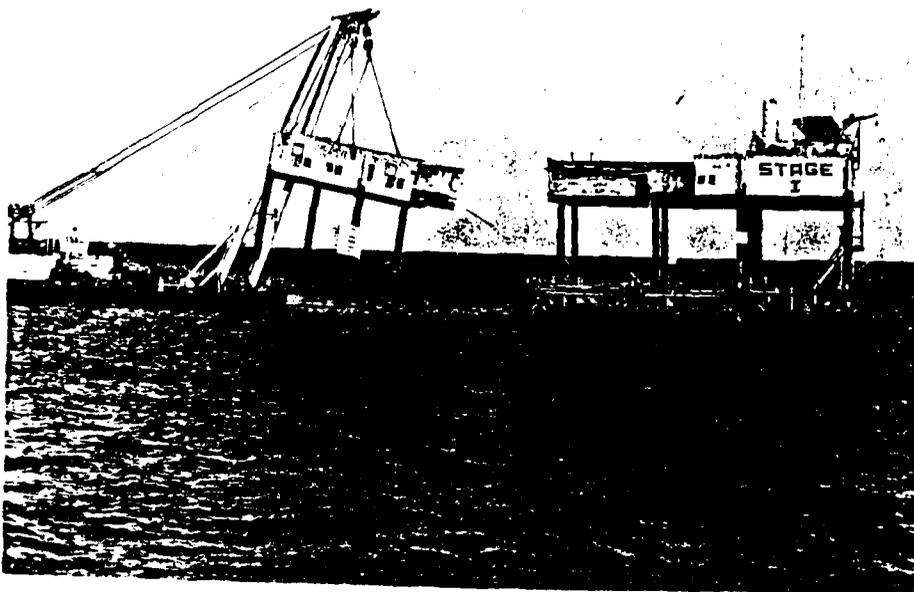
Figure 19. Lift of Section I Off Stage I
(9 July 1984, Section Weight = 105 tons)

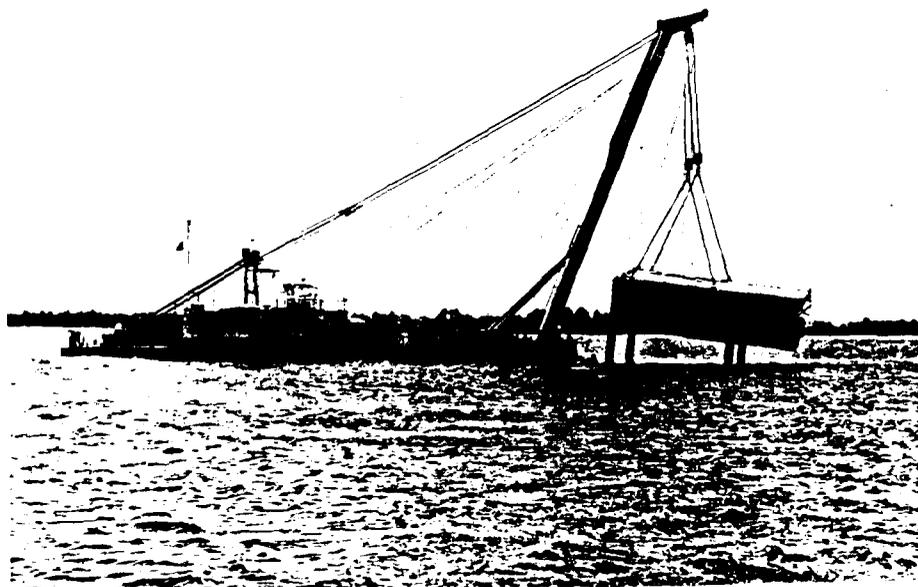
Figure 21. Photo of Section 1 Being Transported to the Bay
(Note that sections were lowered with legs in the water
during towing to reduce dynamic loads in the bridals)

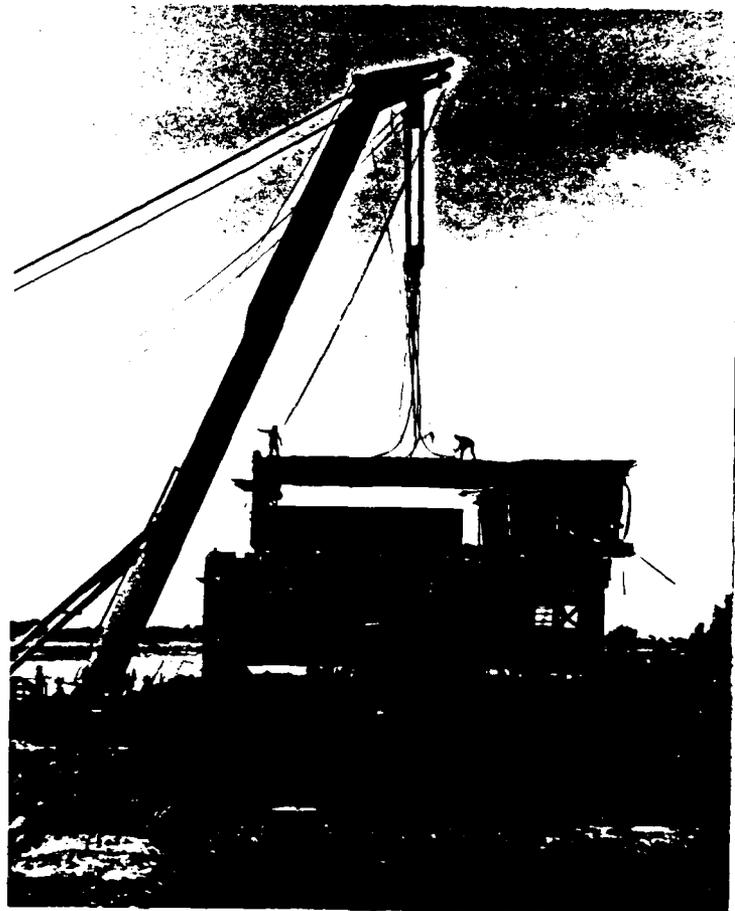
Figure 23. Unloading Section 2 (Stage I)
on Materials Barge
(Note that some sections were
stacked double-decker and then
welded together to save space)

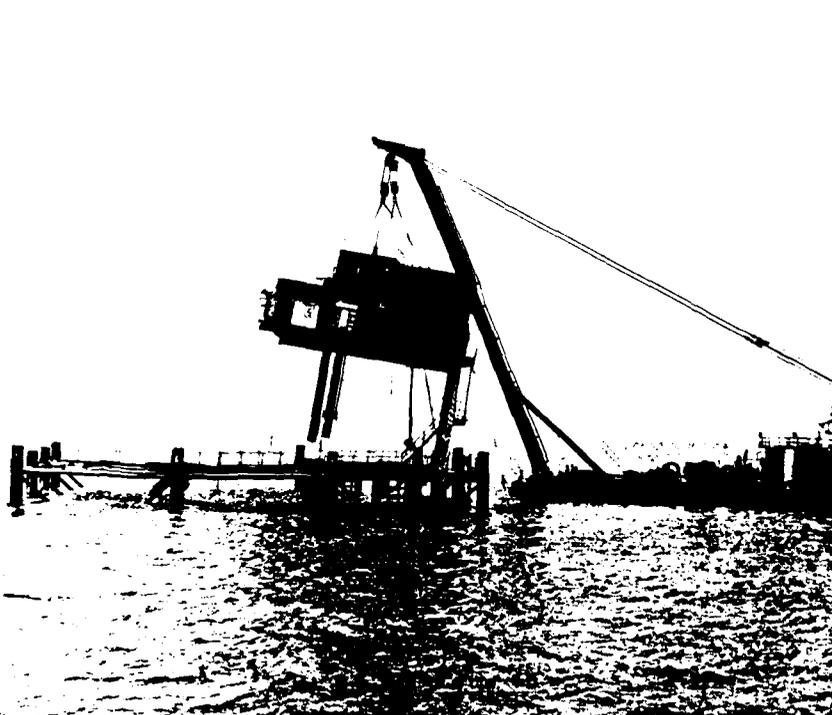
Figure 25. Lifting Section 7 Off Stage I
(28 July 1984, this was the
fuel tank, weight = 200 tons)

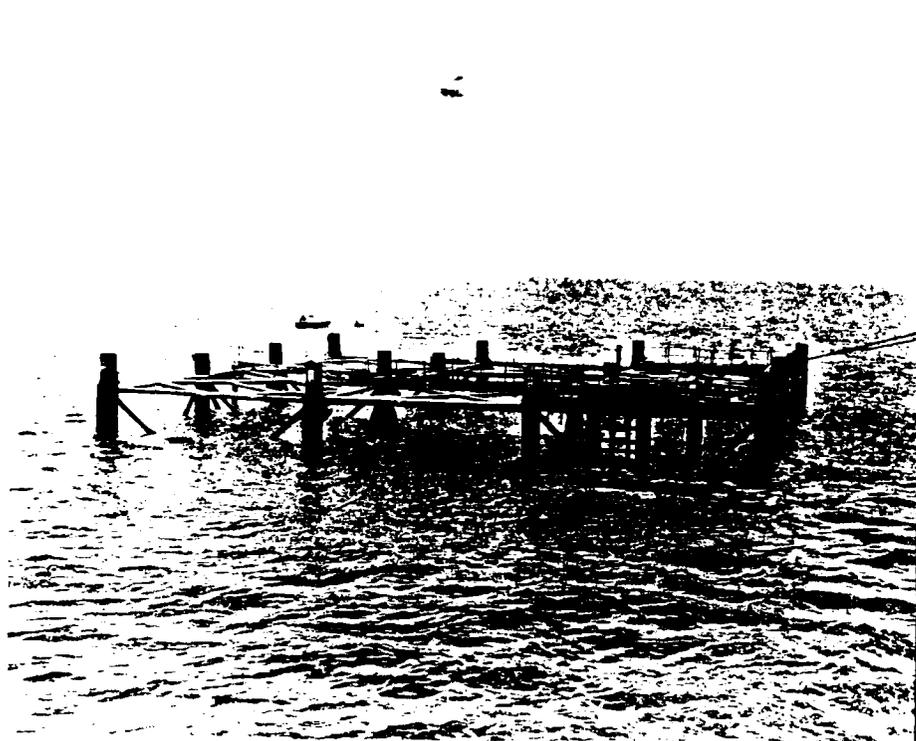
Figure 26. Stage I Jacket with Deck Removed
(A temporary navigation light was
installed soon after this photo
was taken. This completed the
Contractor's work on Stage I.)

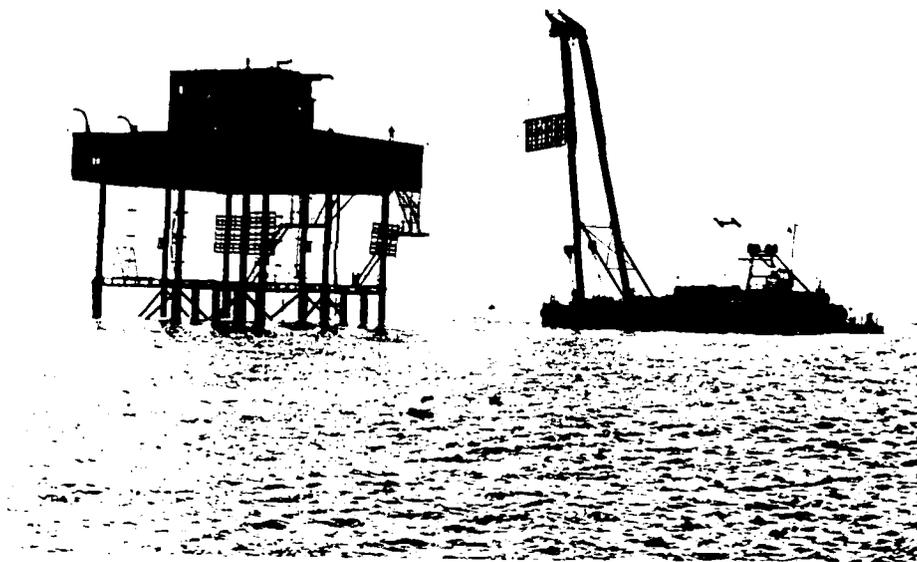
Figure 27. Solar Panel Being Removed from Stage II)
(5 August 1984)

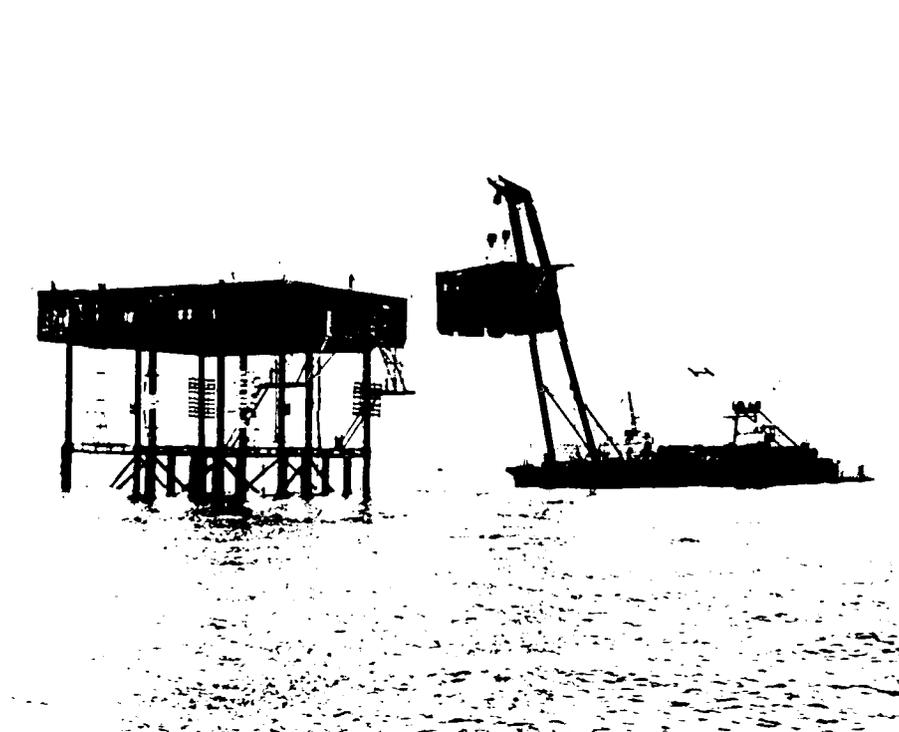
Figure 28. Section I (Upper Two Decks) Being Removed from
Stage II (5 August 1984, weight = 60 tons)

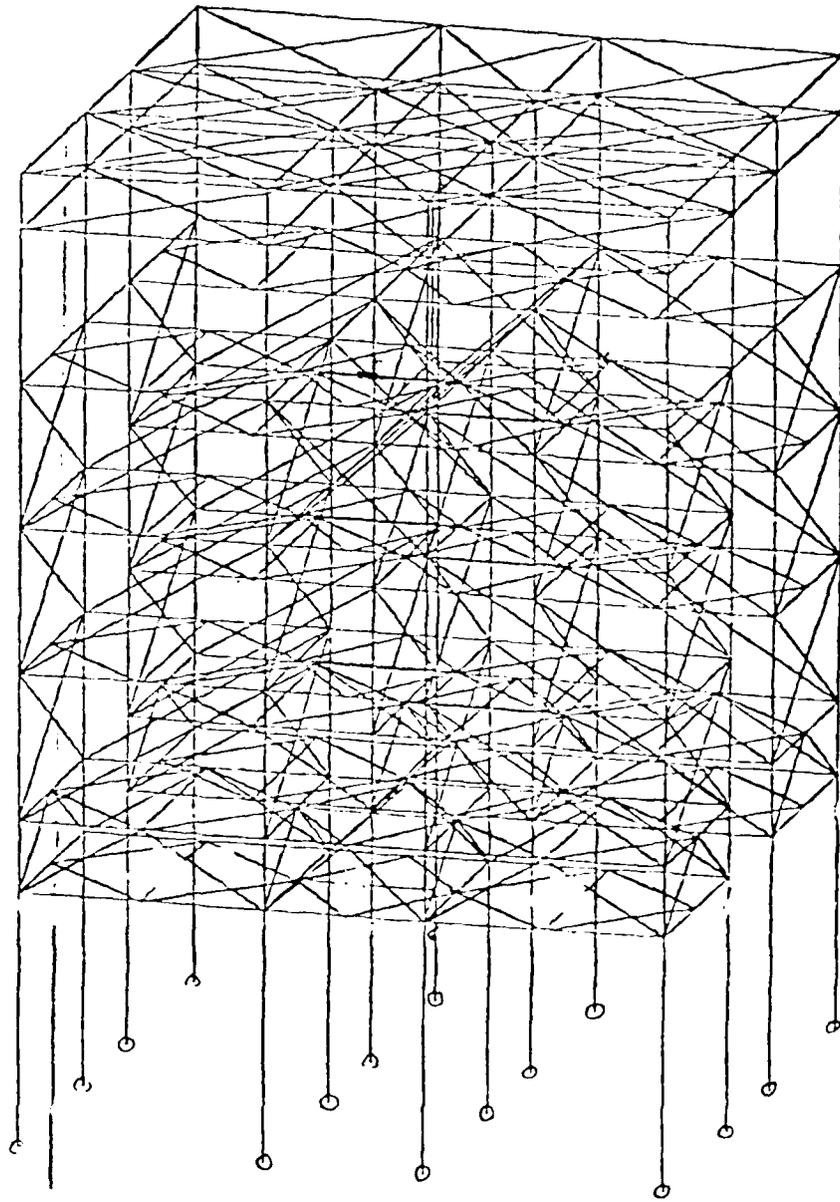
Figure 31. Computer Plot of Stage I

The stage jackets make excellent fishing reefs because the large exposed surface area (Figure 31 and 32) form a habitat and attract marine life. Artificial reefs are especially valuable to Florida waters because the sea bottom consists largely of a plain sand capable of supporting only modest amounts of sea life. It was impractical to leave the jackets intact due to the navigational hazards, so a decision was made to topple them in place to form underwater artificial reefs. Necessary permits were obtained to form these reefs and Bay County, Florida agreed to accept the reefs, once formed.

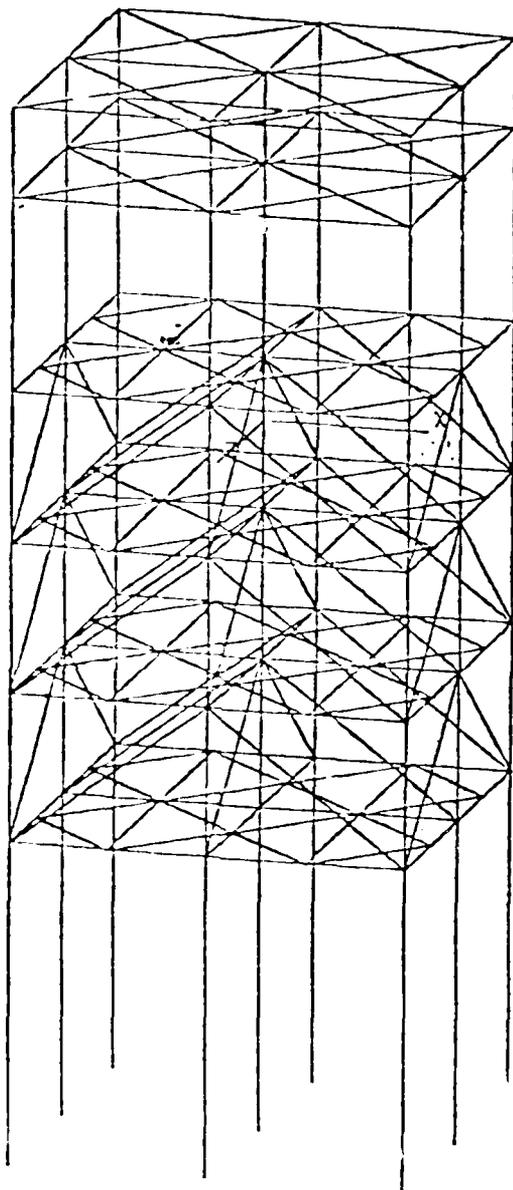
Figure 32. Computer Plot of Stage II

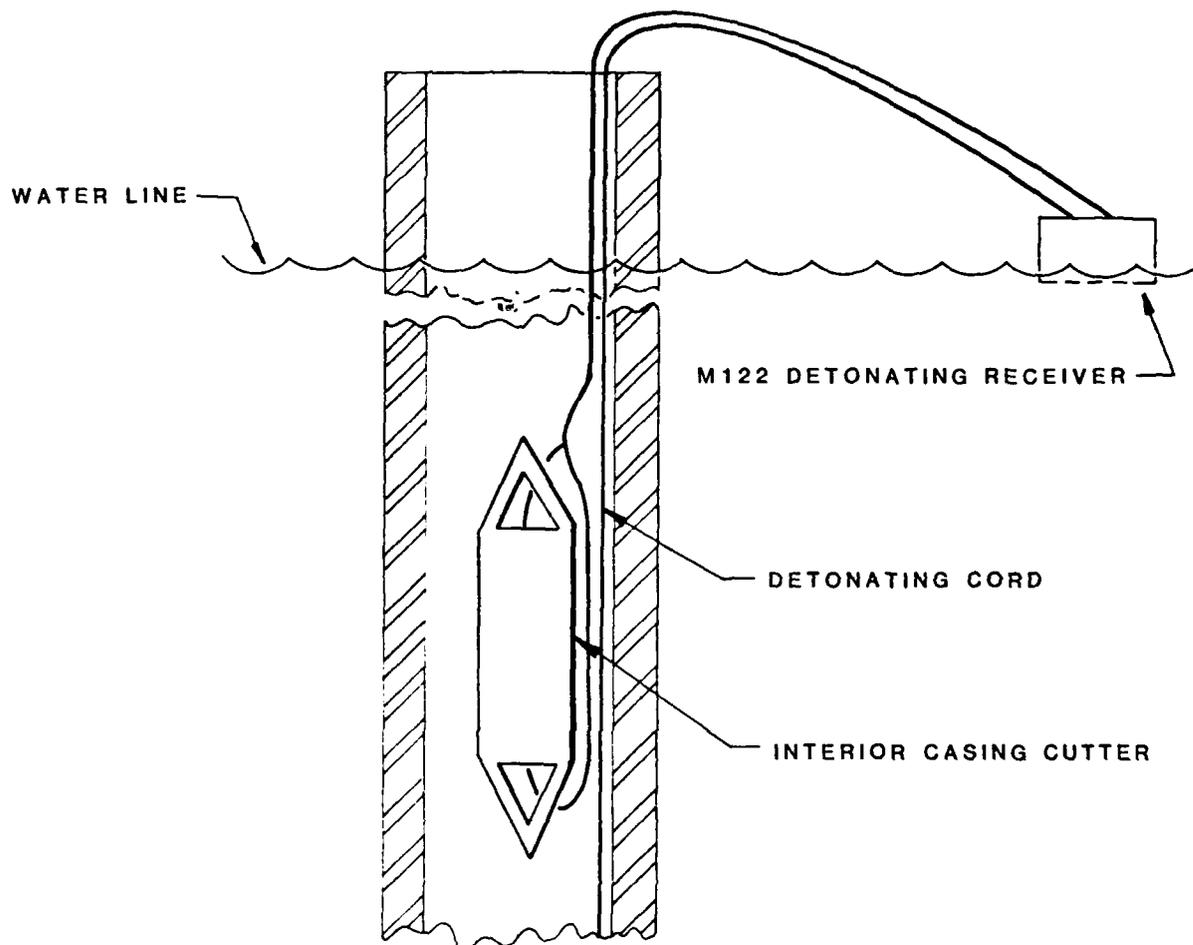
SAMPLE PLACEMENT OF A CONTAINER OF NM/DETA

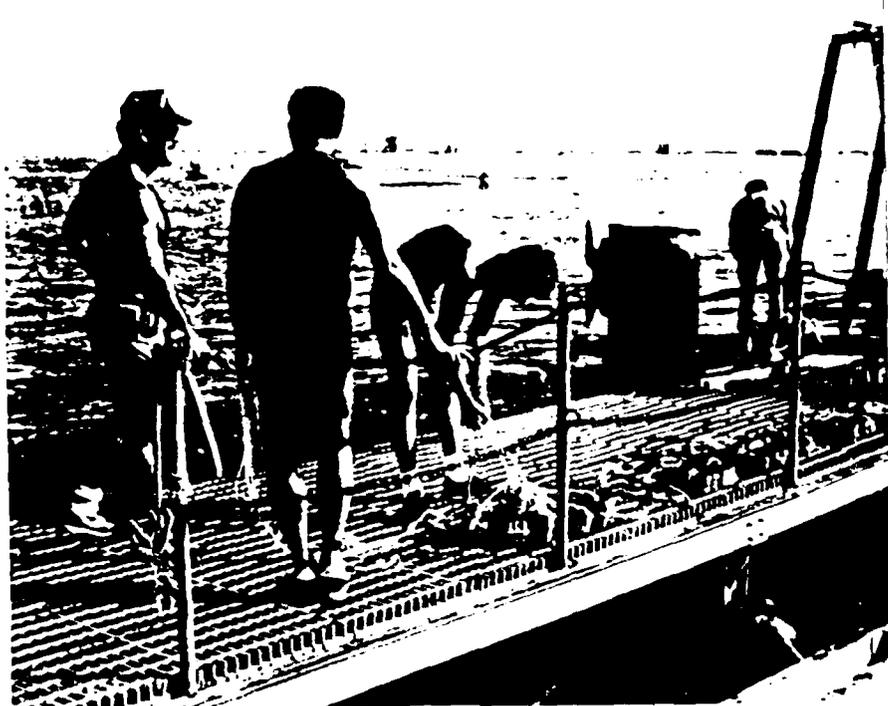
Figure 35. C-4 (RDK) Plastic Charges Being Hoisted)

- (1) Composition C-4 (RDK). This is a plastic charge easily molded and was made up in 40 lbs. blocks as kicker charges and in 4 lbs. blocks used to sever cross braces. (Figure 35).

- (1) Severed connecting braces with a combination of small charges consisting of Jet Research circular shaped charges, flexible linear shaped charges, and C-4 plastic in 4 lbs. blocks. (Figures 34, 35, and 36).
- (2) The two jackets were then toppled with the explosive placement and sequence shown in Figures 39 and 40. Liquid explosive of Nitromethane and Diethyenetriamine (NM/DETA) was mixed into 43 lbs. shaped charge canisters. These charges were lowered down the inside of the jacket leg/piles to a predetermined depth. Kicker charges of 40 lbs. were lowered on the outside of the piles to ensure toppling in the determined direction (Figures 39 and 40). A spherical white buoy was attached with wire rope to the Northern section prior to firing and now marks the reefs' general location. Figure 41 illustrates a typical shot.

- (1) The braces connecting the nine jacket piles together below and above the water were cut with a combination of small charges, consisting of, Jet Research circular shaped charges, flexible linear shaped charges and C-4 plastic in 4 lbs. blocks. (Figures 34, 35, and 36).

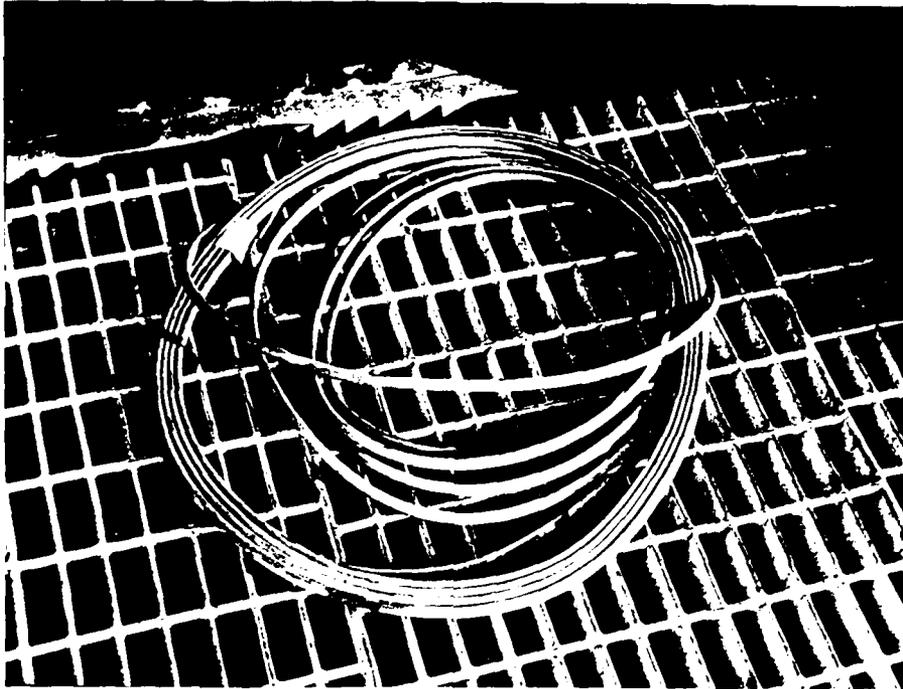
Figure 36. Flexible Linear Shaped Charges

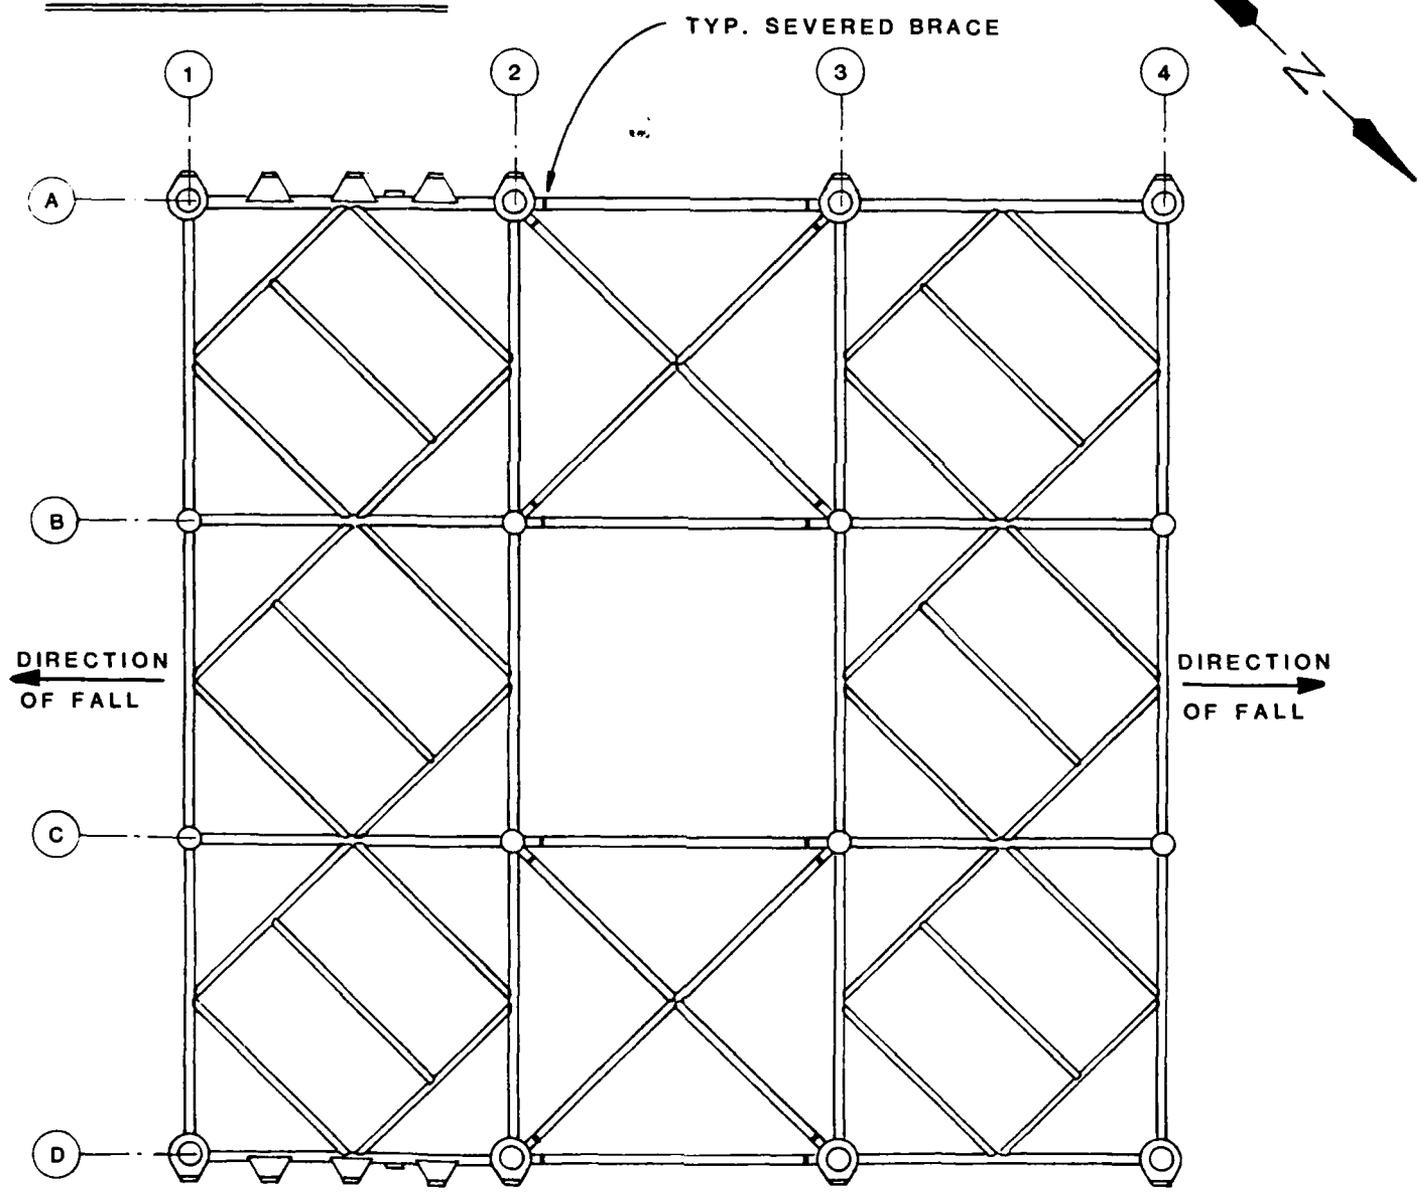
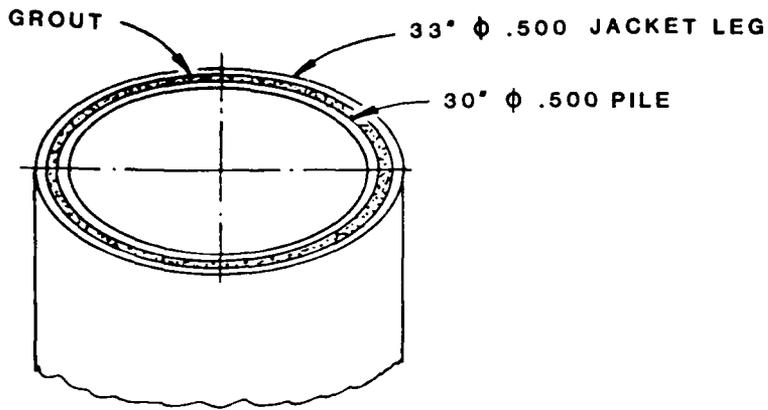
TYPICAL LEG DETAIL

DEMOLITION SEQUENCE

- 1) SEVERED CONNECTING BRACES
- 2) TOPPLED ROWS 1 & 2
- 3) TOPPLED ROWS 3 & 4

TYPICAL HORIZONTAL FRAMING PLAN
STAGE I - LOCATION OF CHARGES
