SALVAGE AND DEMOLITION
OF
TWO NAVY OFFSHORE PLATFORMS

WILLIAM N. SEELIG

FPO-1-84(32) OCTOBER, 1984

CHESAPEAKE DIVISION
NAVAL FACILITIES ENGINEERING COMMAND
WASHINGTON NAVY YARD
WASHINGTON, DC 20374

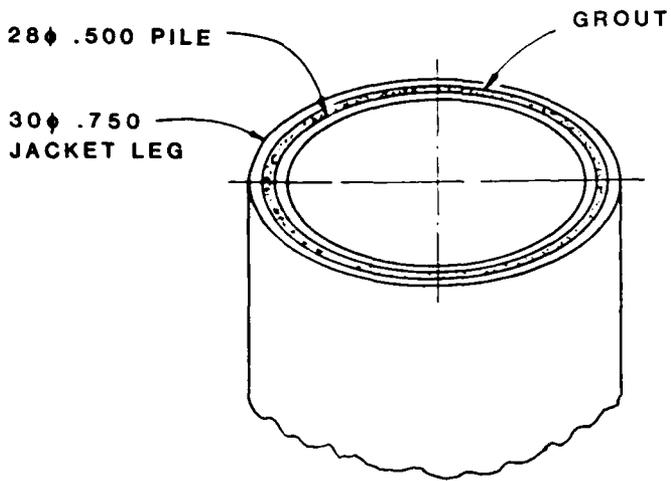
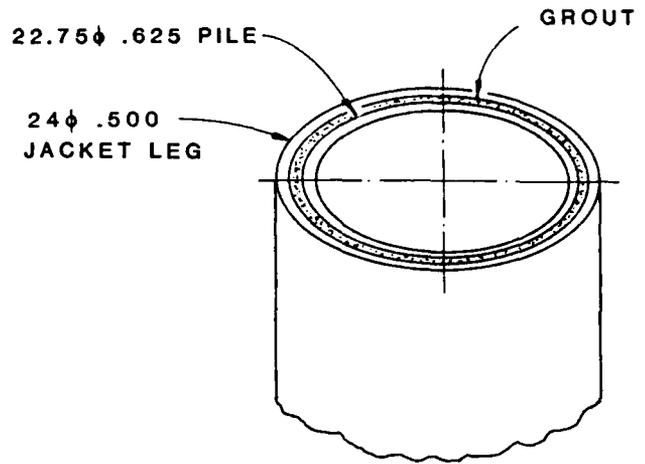
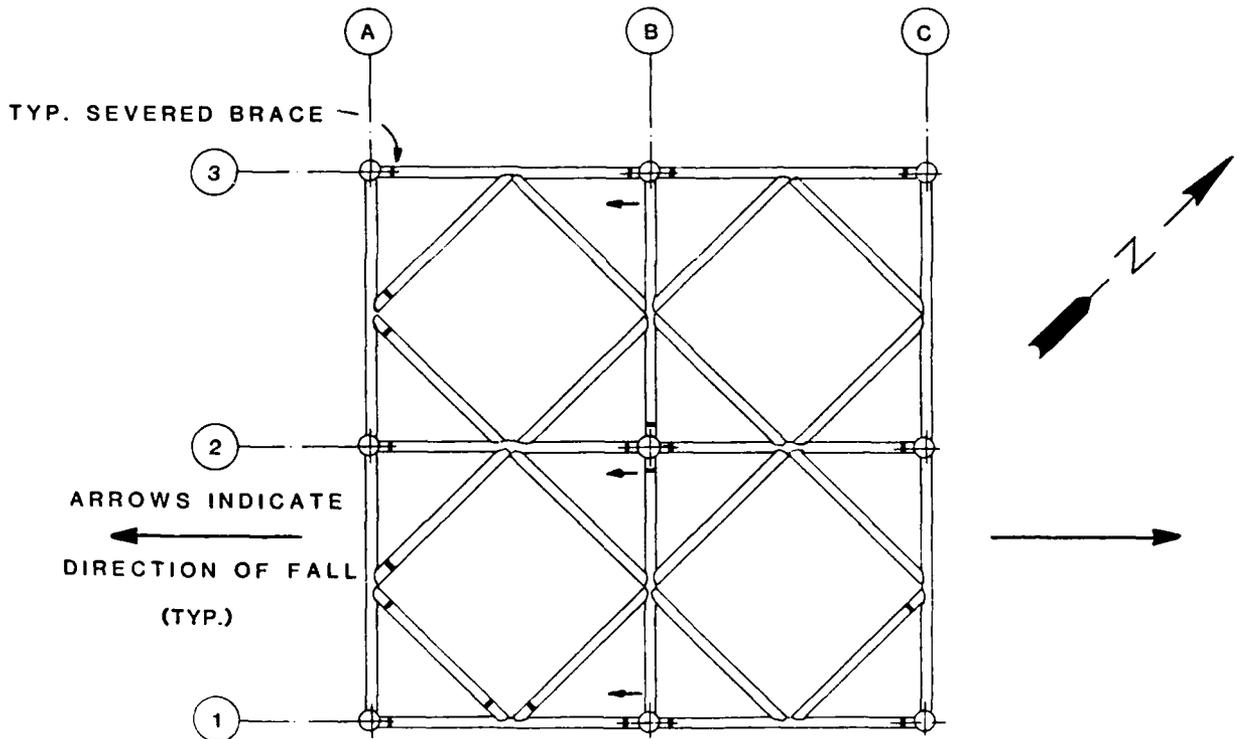
TYPICAL LEG DETAILS

STAGE II - LOCATION OF CHARGES

- 1) SEVERED CONNECTING BRACES
- 2) TOPPLED ROW C, PULLED WITH LCM-8
- 3) TOPPLED ROWS A & B, PULLED WITH LCM-8

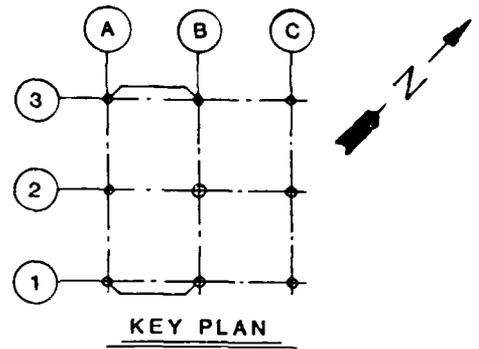
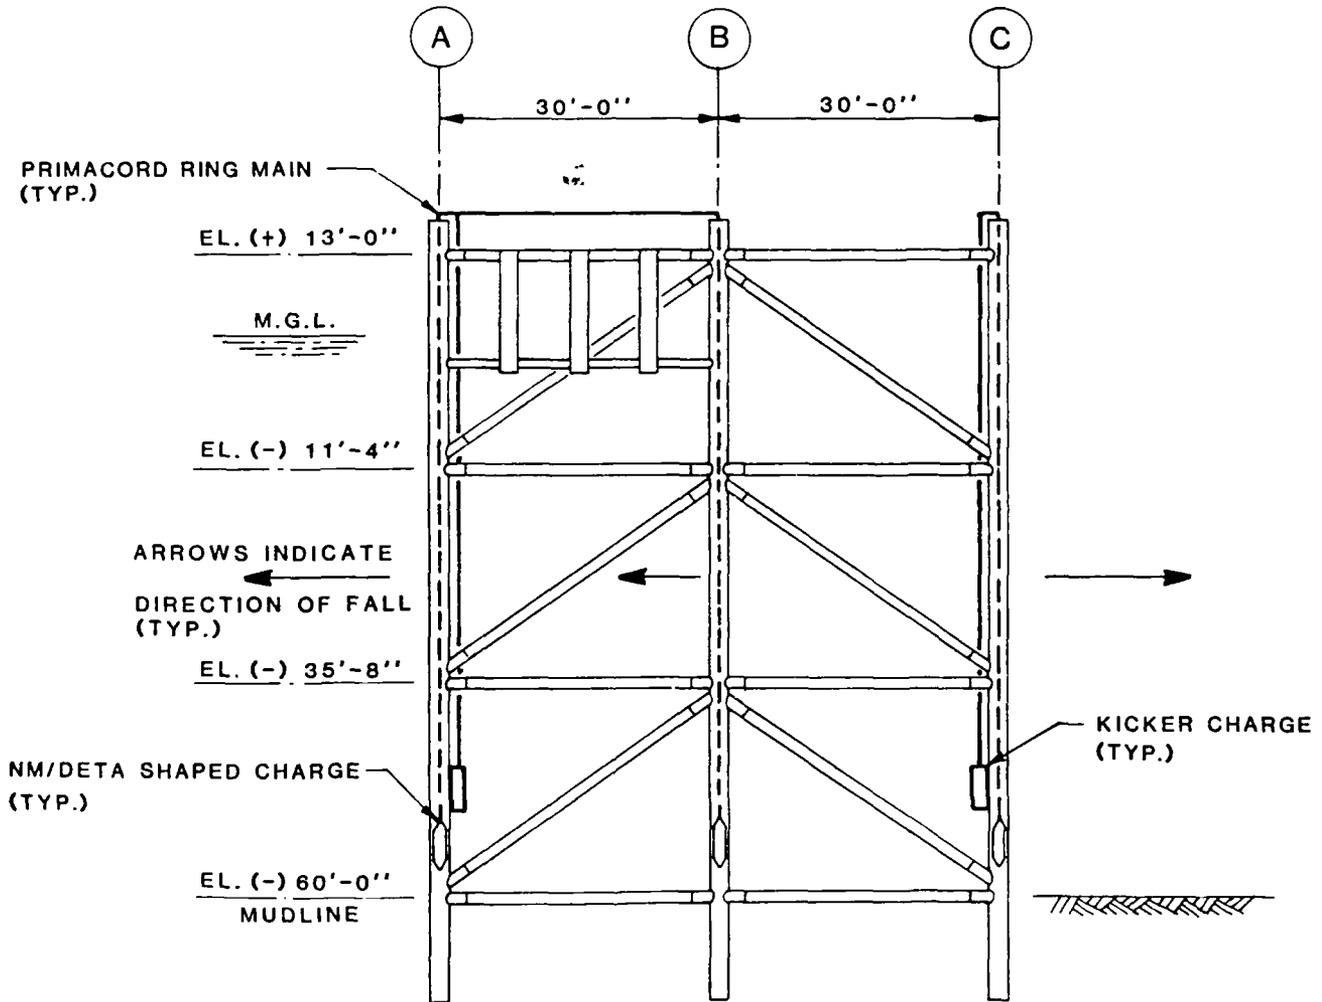
TYPICAL ELEVATION ROWS 1, 2 & 3

STAGE II LOCATION OF CHARGES

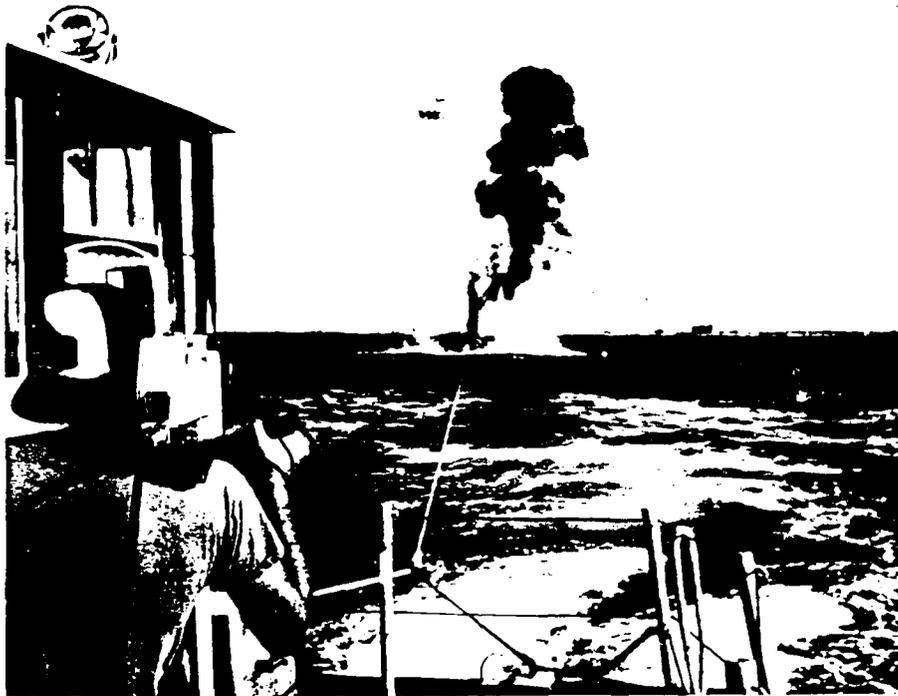
Figure 44. Demolition Shot on Stage II

- (2) The piles were then toppled in bents of three separate piles in a manner similar to the sequence used on Stage I. The only exception at Stage II was that a Navy vessel, LCM 8, secured a line to the three outer piles when the three east and west piles were toppled. The strain from the vessel, in addition to the careful placement of the kicker charges, ensured that the piles fell in the desired direction (Figures 42 and 43). Figure 44 illustrates one of the shots.

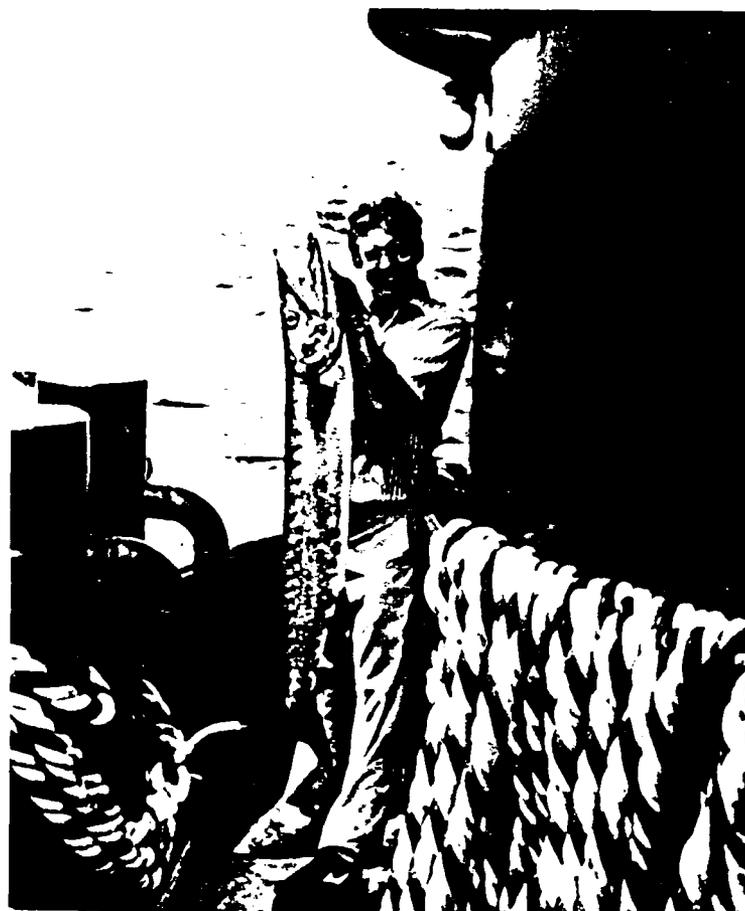
Figure 46. A Barracuda Picked Up After a Shot at Stage I

(1) The large charges were placed inside the piles to dissipate the pressure wave and (2) small "scare charges" were detonated just before larger charges were exploded. Fish that were killed did not go to waste (birds ate the smaller fish and the work crews collected the large fish, Figure 46).

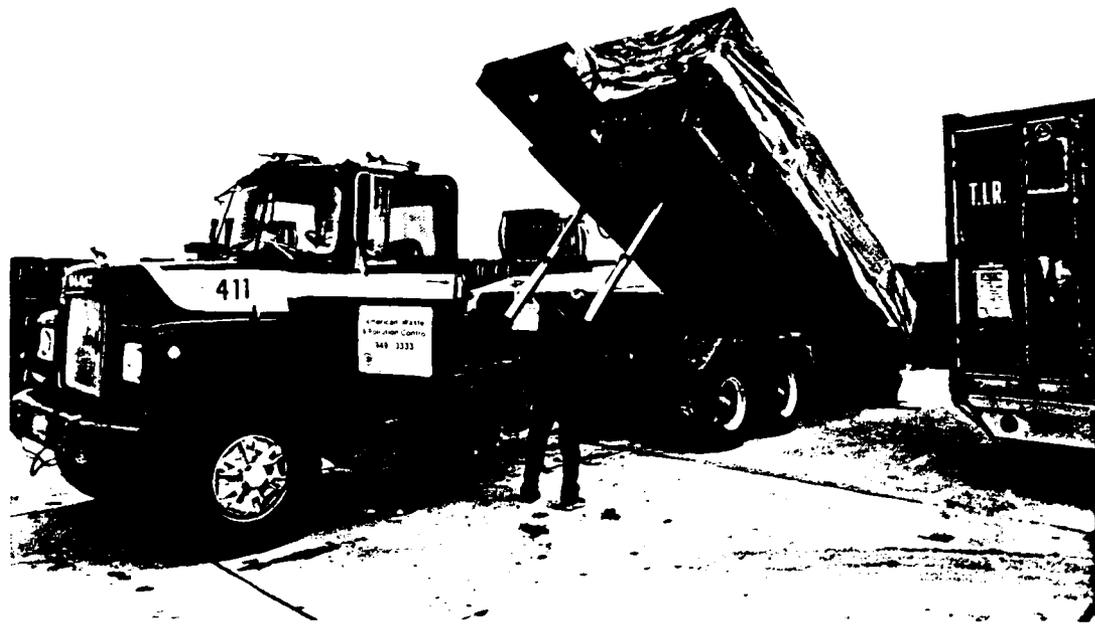
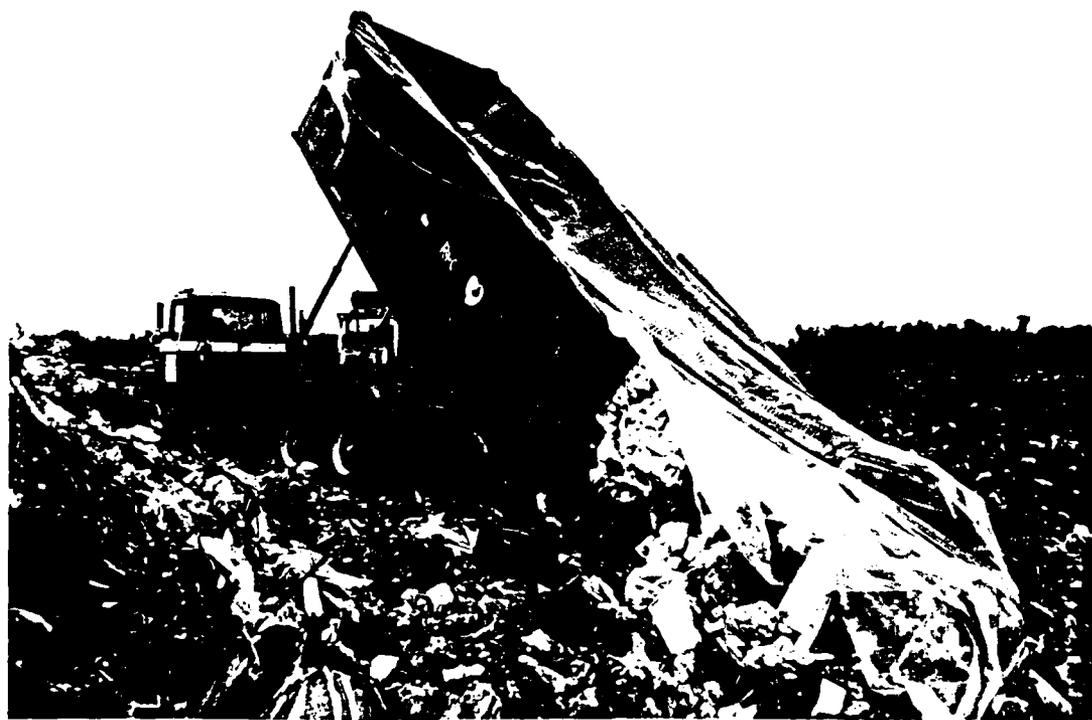
Figure 47. Disposal of Asbestos Waste

The project was effectively completed on 30 August 1984 when the asbestos waste was disposed in an approved landfill site (Figure 47). Details on this material are given in Appendix E.

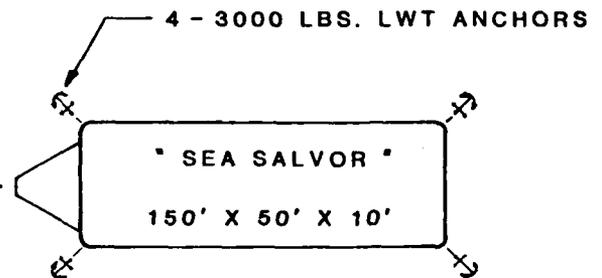
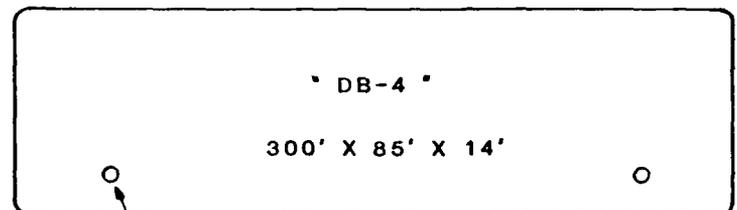
CONTRACTORS EQUIPMENT

A - FRAME
200 TONS LIFT CAPACITY

ELEVATION = 100 FEET OFF OF DECK

MATERIALS BARGE TO TRANSPORT
PLATFORM DECK SECTIONS

SPUDS FOR HOLDING BARGE IN PLACE
