11. TITLE (Including Security Classification)
AUTEC Ocean Hauldown Dive Survey Site 1 & Site 2

Final Report
AUTEC Ocean Hauldown Dive Survey
Site 1 & Site 2

DIVE SURVEY FOR OCEAN HAULDOWN

Site 1 & Site 2

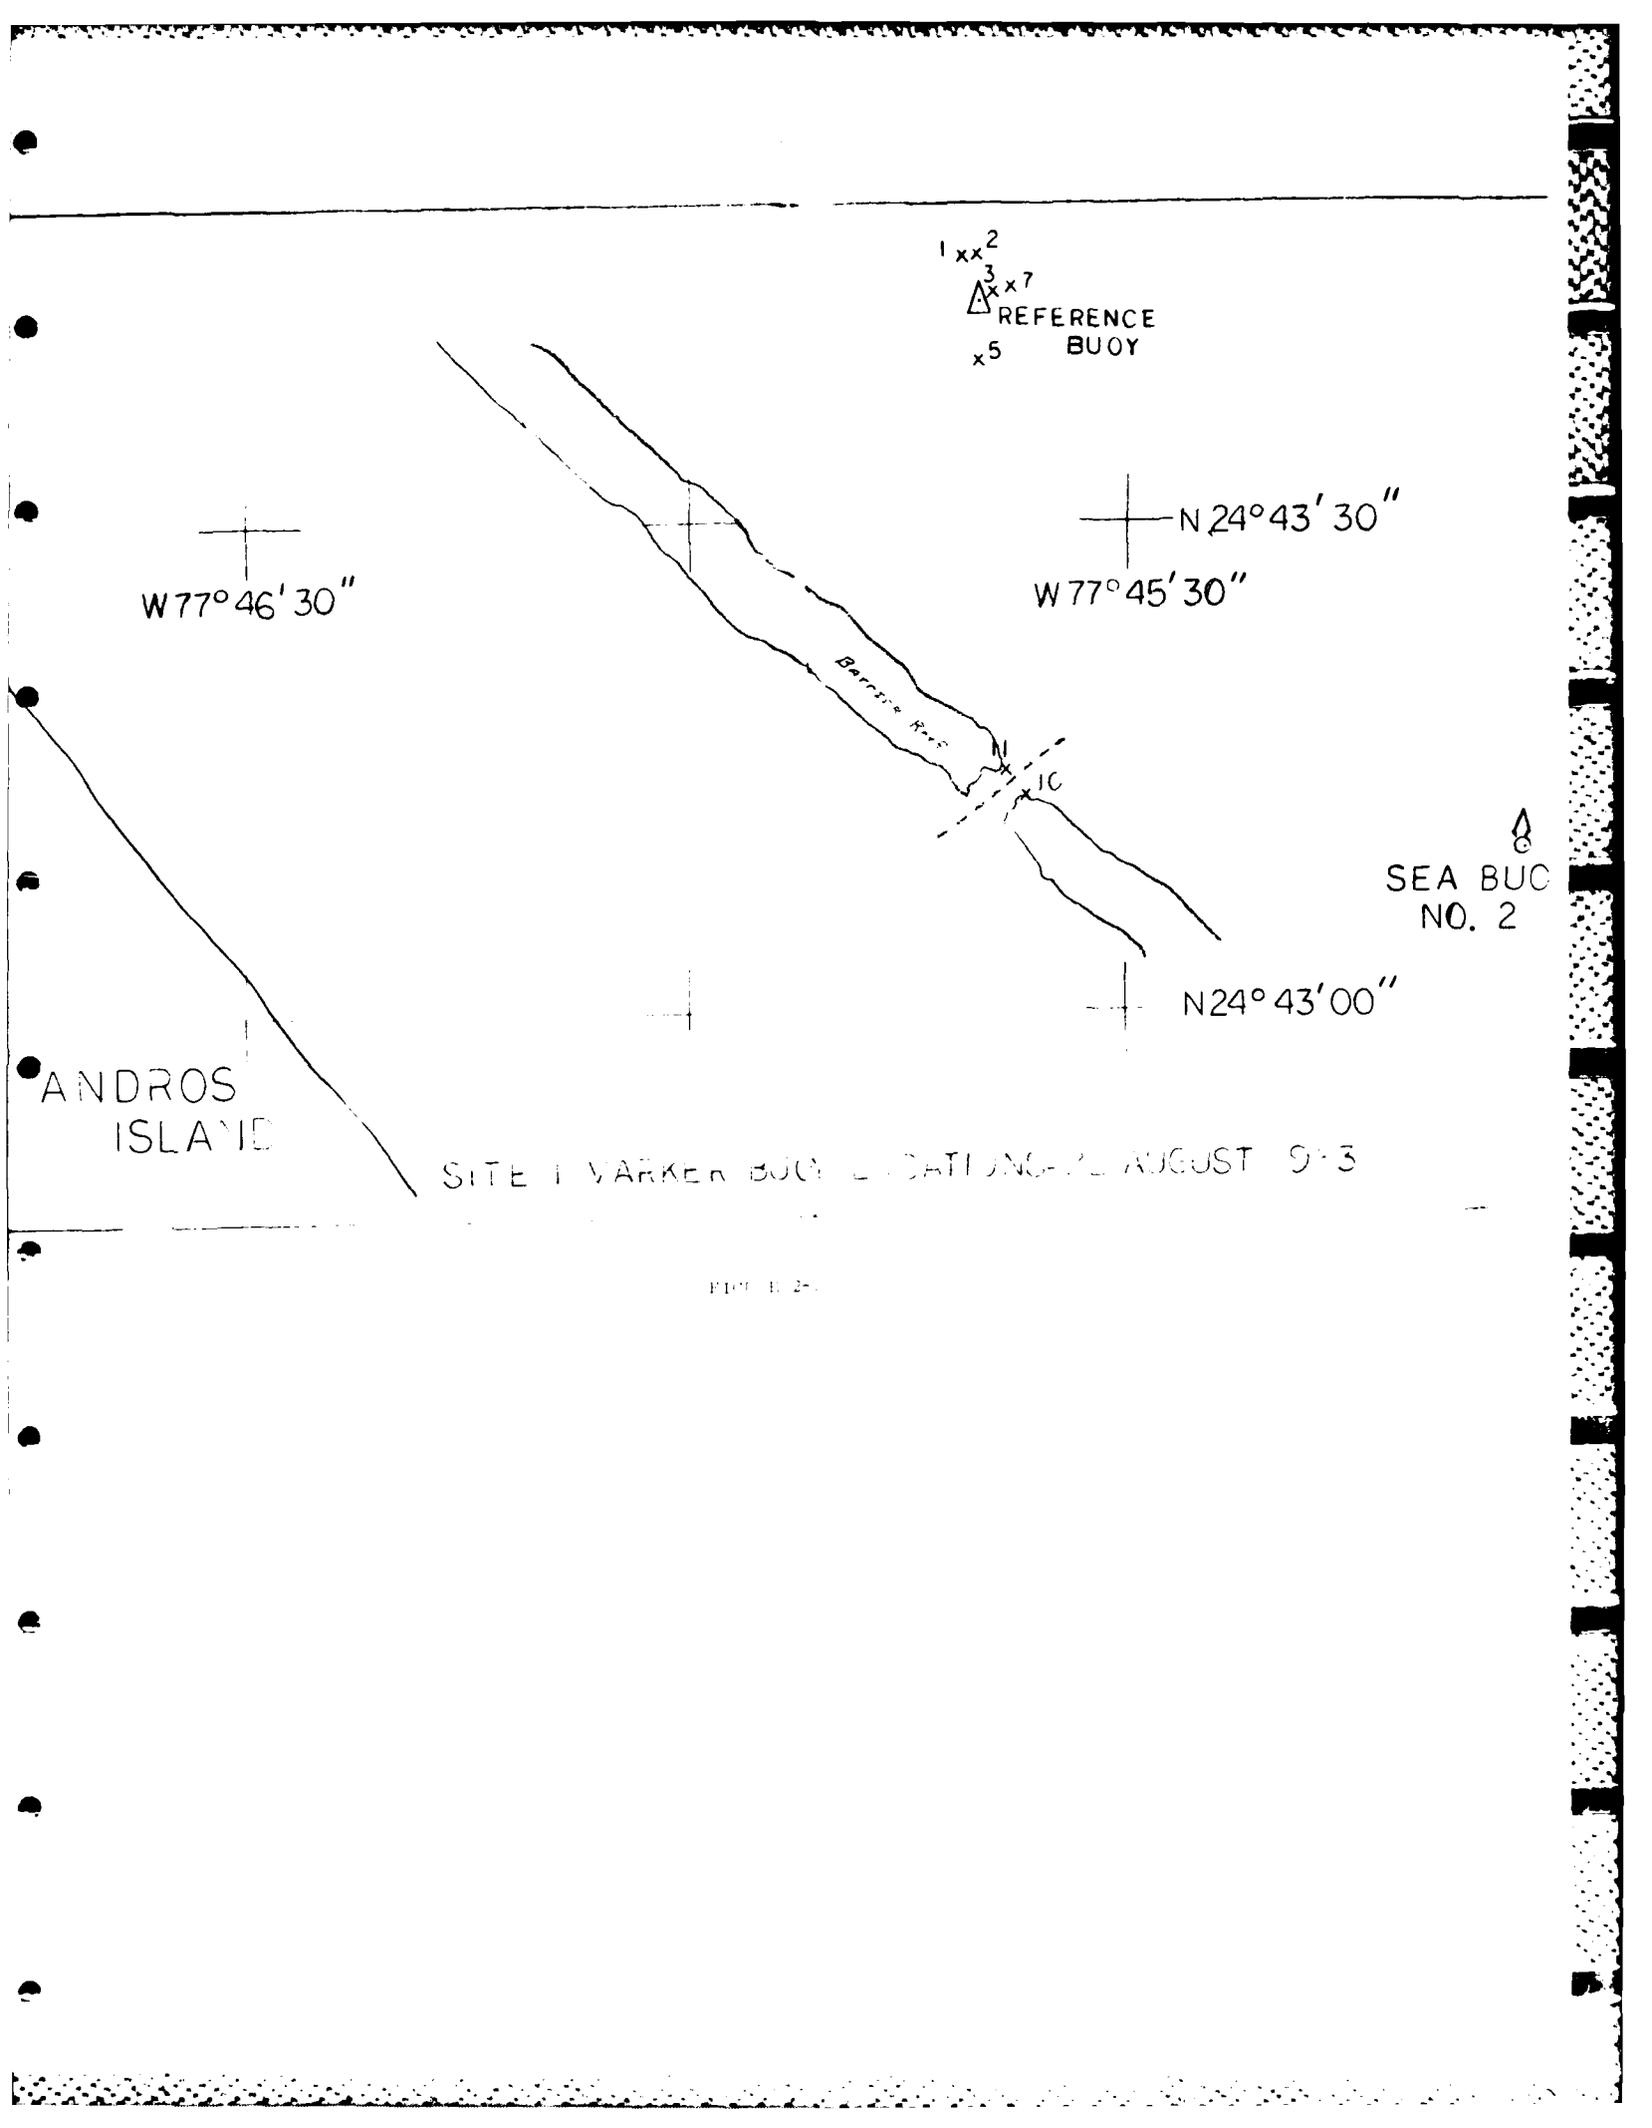
FIG. 1-2

is shown in Figure 2-1. (Reference buoy anchor chain was wrapped around coral head). The survey in the vicinity of the buoy indicated several areas of interest and small marker buoys numbered 3, 7, 2, 1, and 5 were placed to delineate these areas.

Buoys #10 and 11 were placed in a shallow reef cut to define a possible cable route to shore which is shown as a dashed line on Figure 2-1. They are located in approximately 10 feet of water with coral and sand bottom. The relief is approximately 2-3 feet and clear of obstructions to shore.

SITE 1 MARKER BUOY LOCATION - 22 AUGUST 9-3

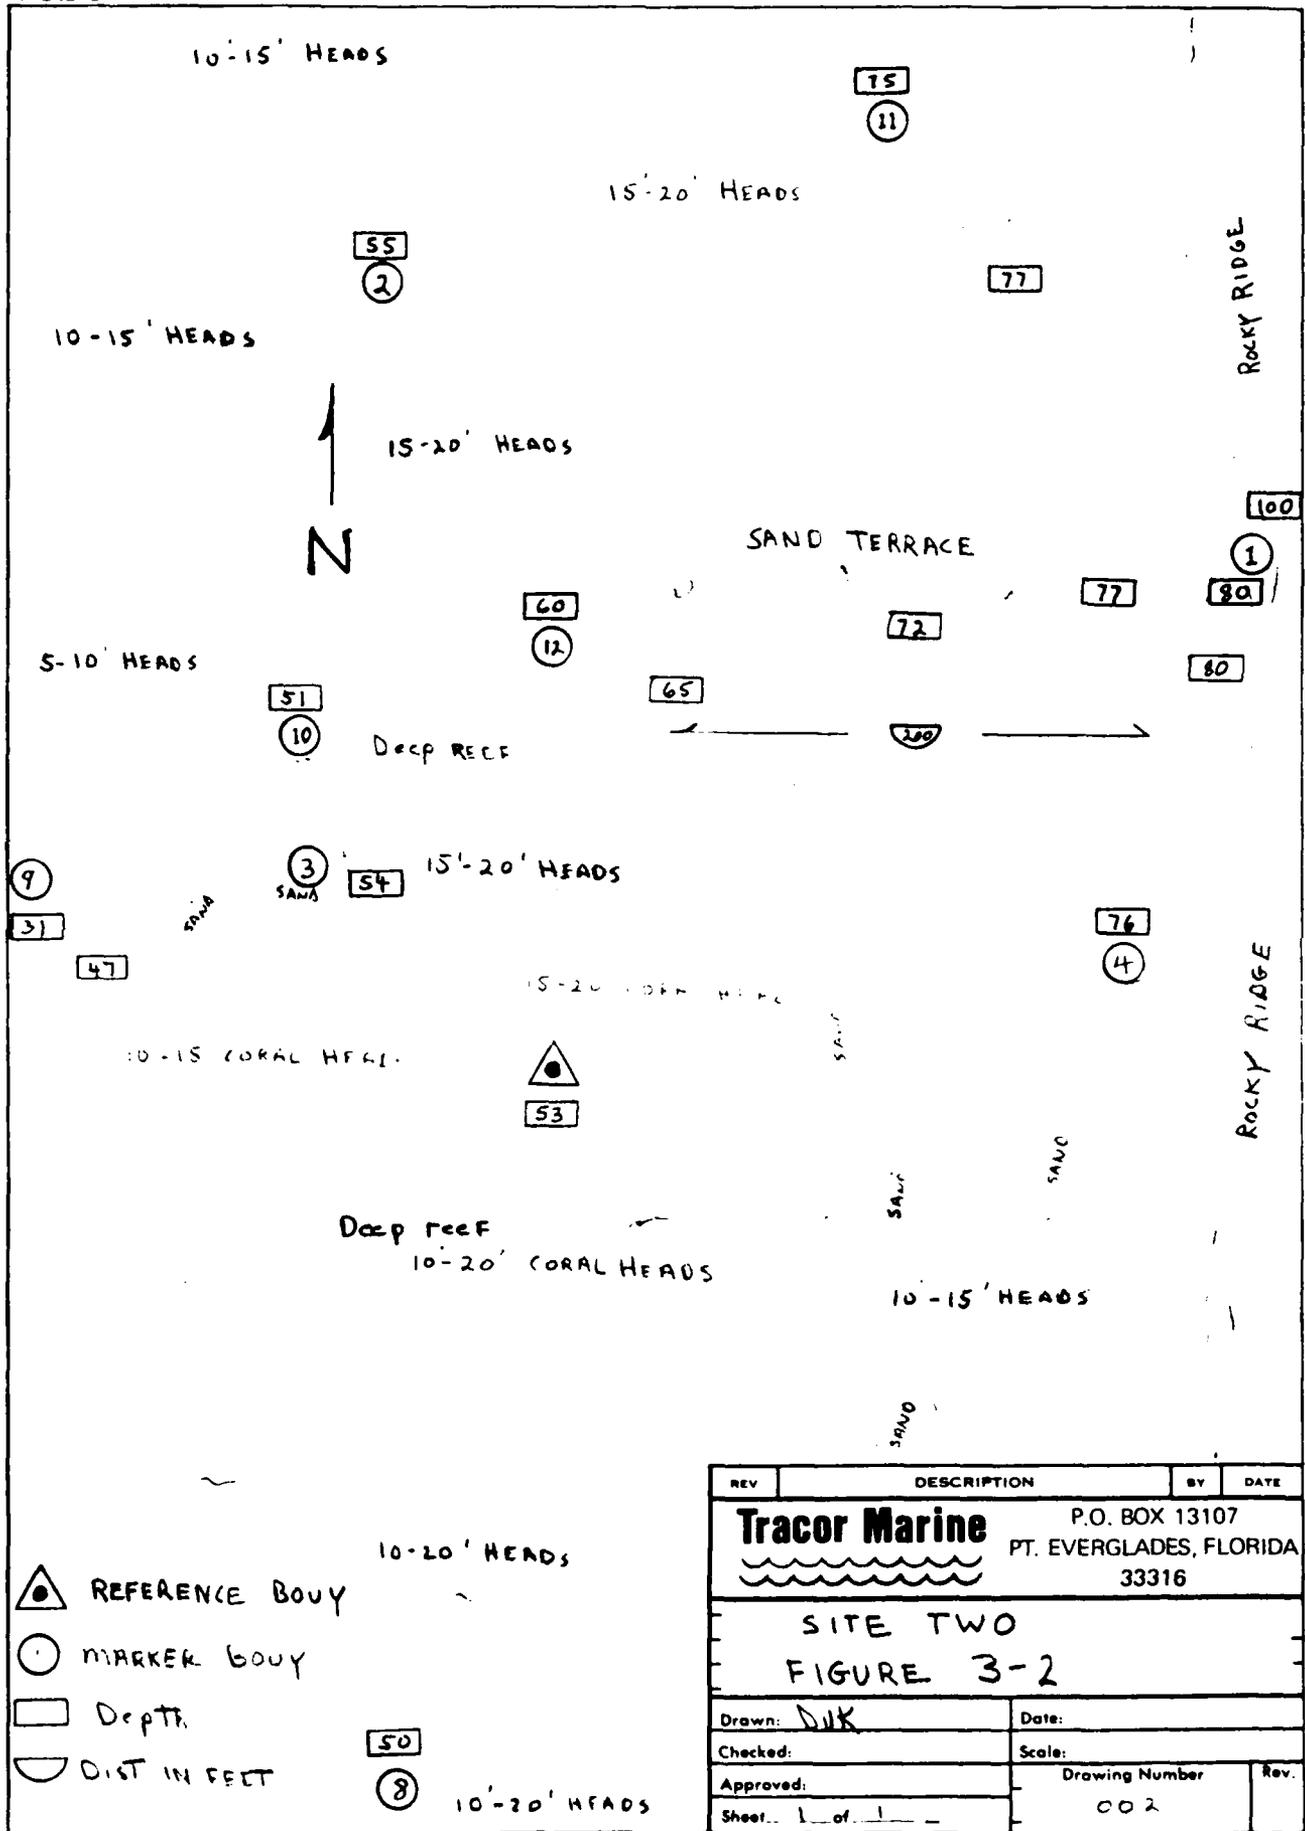
SITE 2 MARKER BUOY LOCATIONS - 15 AUGUST 1957

The Site 2 survey was conducted in an area approximately $\frac{1}{2}$ mile south of the Site 2 sea buoy. The general area was marked with a surface reference buoy at Latitude $24^{\circ} 29' 24.2049$ N, Longitude $77^{\circ} 41' 53.0062$ W as shown in Figure 3-1. The location of the reference buoy was determined from Trisponder information obtained during a bathymetric survey of the Site 2 area on 8 August, 1983.

50 yards to the north and north east, sand terraces were found. These sand terraces occurred between water depths of 65 and 90 ft. and were most common at 70 ft. Boundaries of the largest and most suitable sand terrace was marked with buoys as shown in Figure 3-2.

Upon completion of the deep water survey, a tentative cable route was surveyed. A small cut in the barrier reef was found and is noted on the Site 2 marked buoy locations shown in Figure 3-2. This is the shortest possible route from the reference buoy area to Site 2. The reef cut was located during an aerial survey using the Autec Helicopter and subsequently confirmed by diver observation.

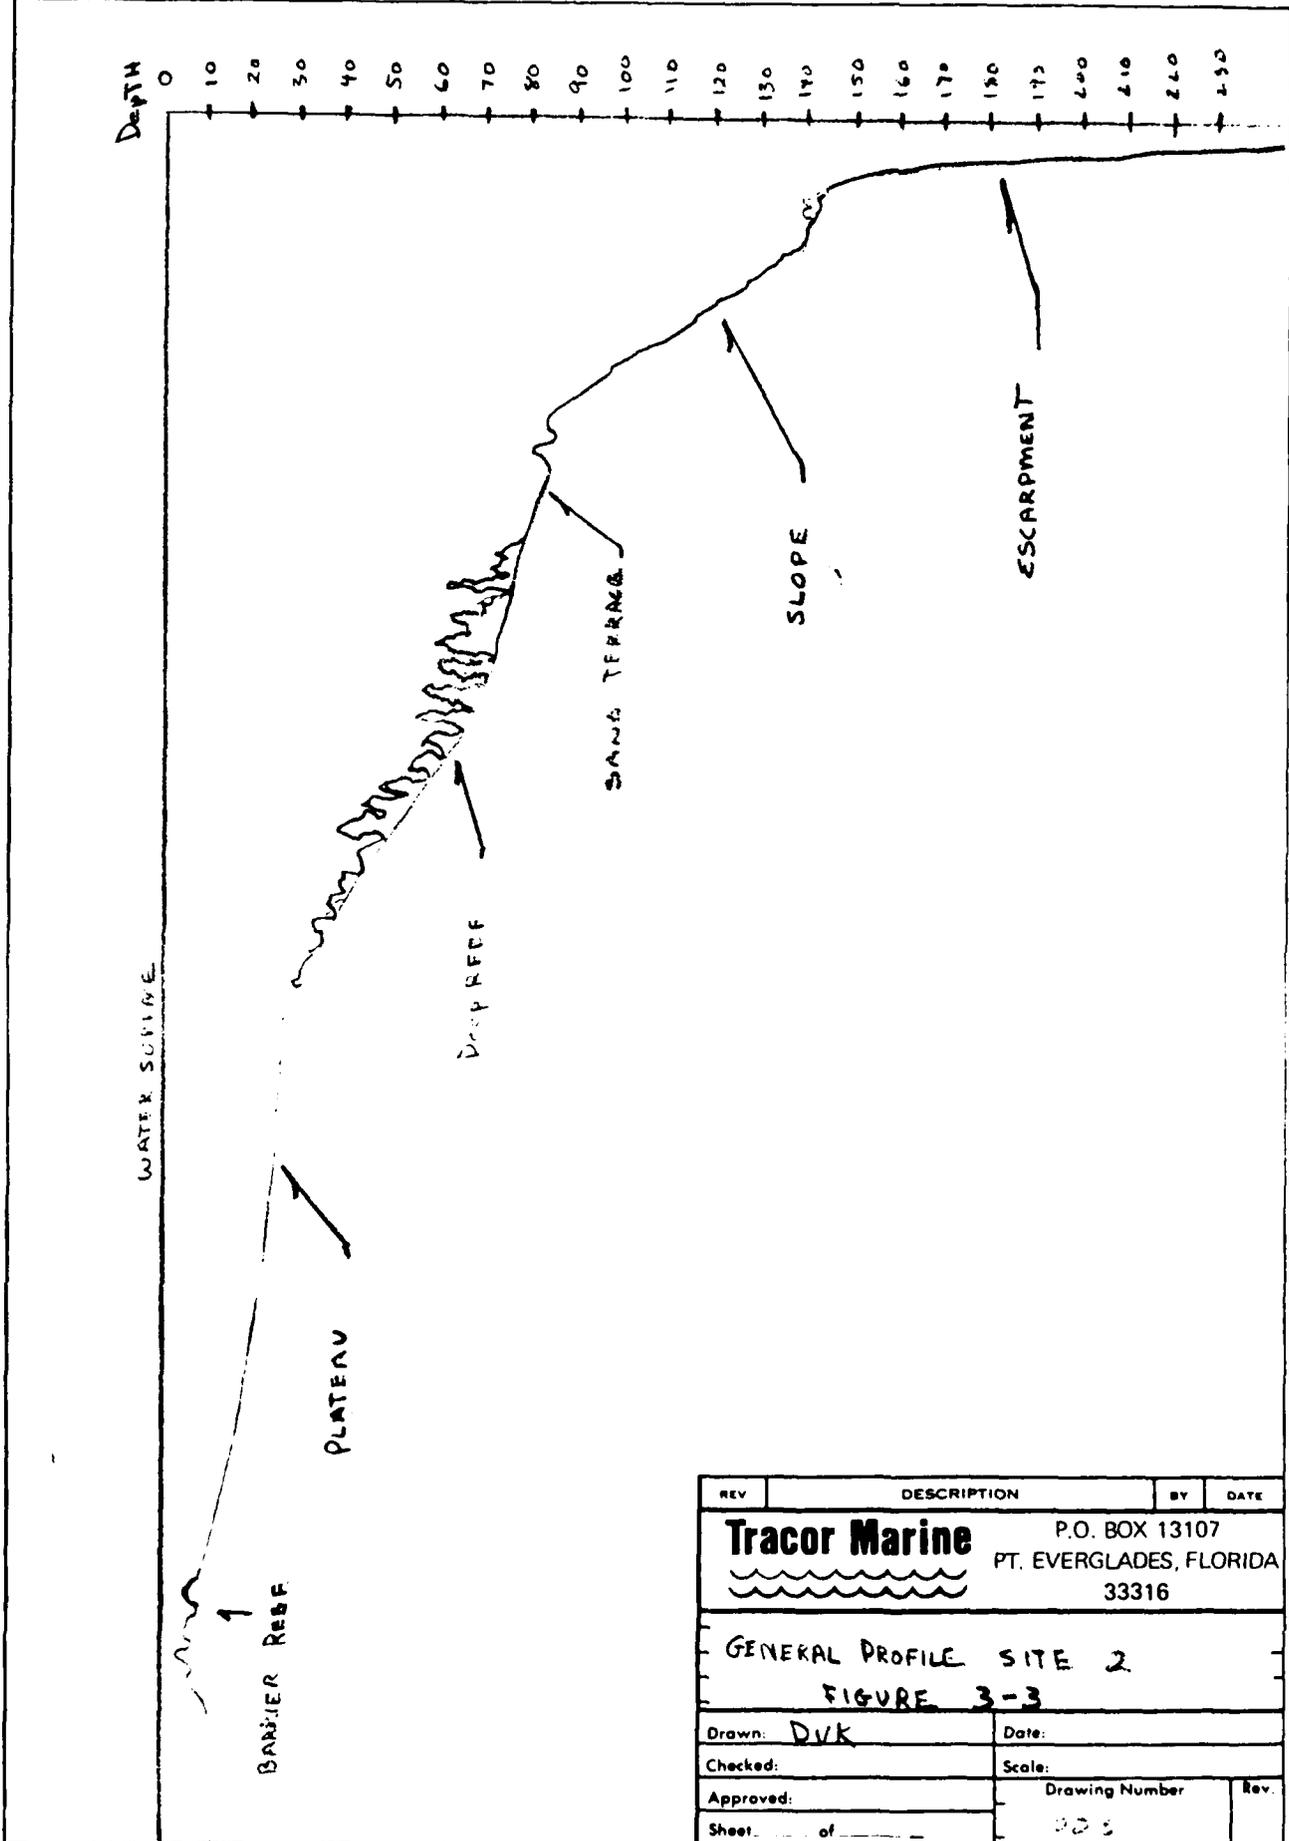
REV	DESCRIPTION	BY	DATE
Tracor Marine 		P.O. BOX 13107 PT. EVERGLADES, FLORIDA 33316	
GENERAL PROFILE SITE 2 FIGURE 3-3			
Drawn: DVK		Date:	
Checked:		Scale:	
Approved:		Drawing Number	Rev.
Sheet: _____ of _____		005

The general profile (Figure 3-3) of the surveyed area from west to east consists of a hard coral rock plateau with small heads from the barrier reef to 100 yards west of the reference buoy. The depth of the plateau before the drop off to the deep reef is 25 feet. The deep reef begins after the drop at 45 to 50 feet and continues gradually to 70 feet where the sand terraces begin. The terraces extend from 70 to 90 ft. to the rock ridge or sill. The ridge has a slight rise of coral rock before the start of the 45° slope which extends to 140 feet. At the 140 foot level, the escarpment begins with a very sharp drop off 80° .
