ADVANCED ELECTRIC PROPULSION MPD (MAGNETOPLASMA DYNAMIC)  
(U) PRINCETON UNIV NJ DEPT OF MECHANICAL AND AEROSPACE  
ENGINEERING A J KELLEY ET AL. MAY 86 AFRPL-TR-86-044  
F04611-79-C-0039

Final Report  
for the period  
15 August 1979 to  
31 May 1986

# Advanced Electric Propulsion MPD

Princeton University  
Department of Mechanical and  
Aerospace Engineering  
Princeton, NJ 08544

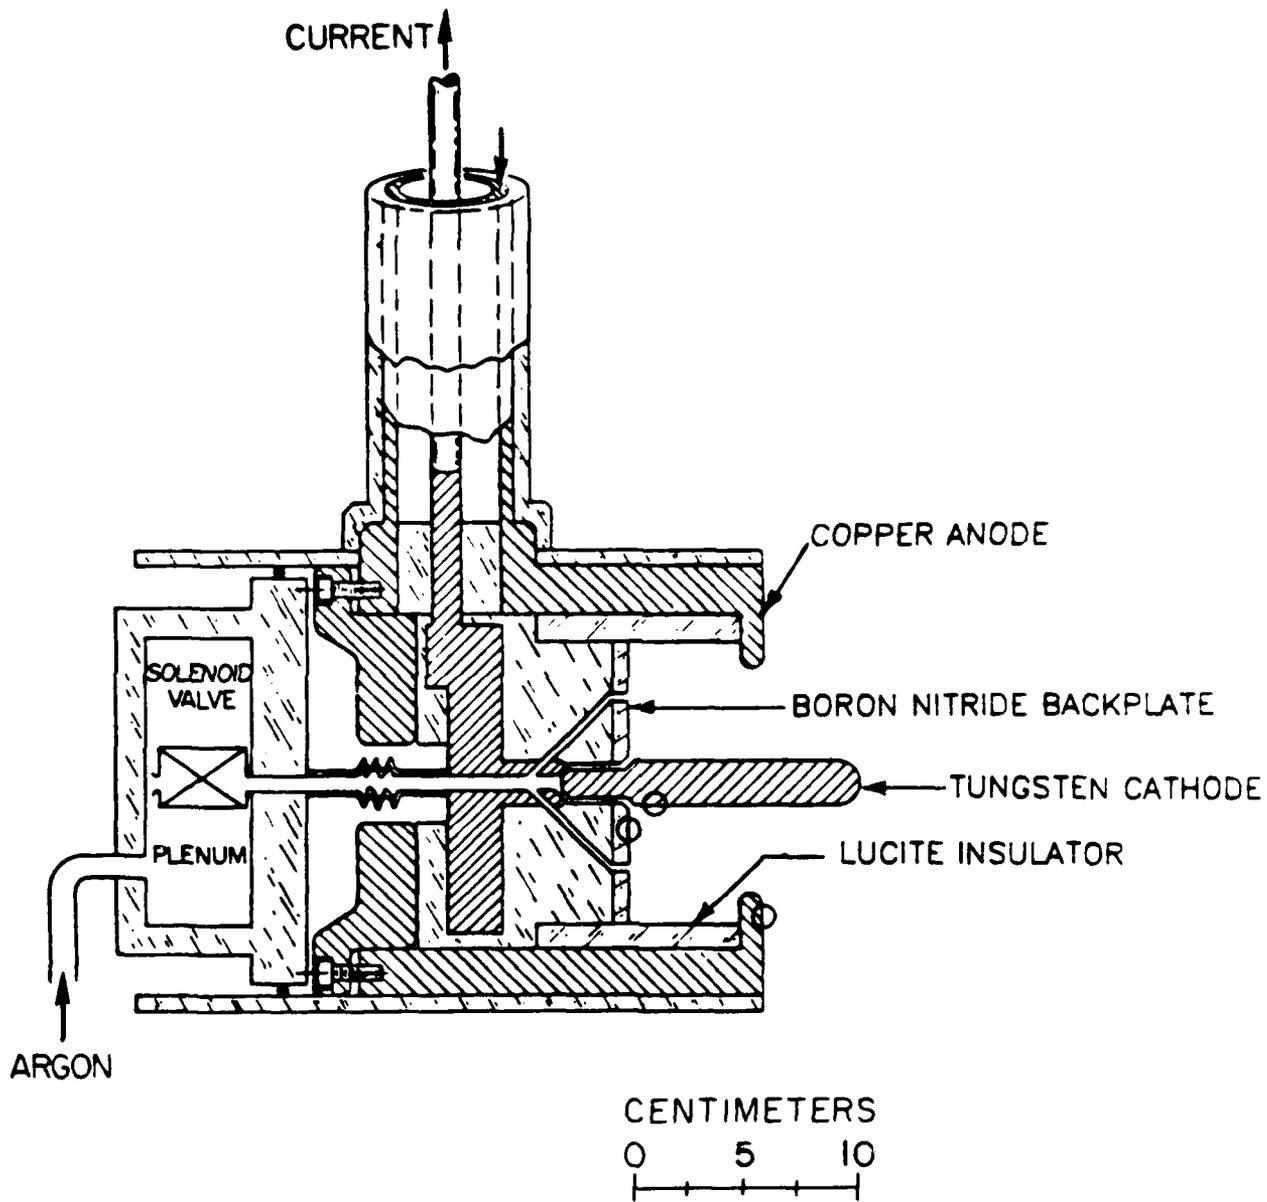
FIGURE 1: BENCHMARK THRUSTER

○ - IRRADIATED POSITIONS

The reference or "full-scale" coaxial thruster configuration shown in Figure 1 was used for all tests in this study. This configuration was chosen for several reasons. Not only is there a large experimental data base for this design, but, of equal importance, the QCM measurements of insulator erosion<sup>2</sup> were performed with this geometry. Consequently, a basis for direct comparison of the two measurement techniques is available.

As depicted in the figure, a 10 cm long by 1.9 cm diameter thoriated tungsten cathode, mounted on the centerline of the thruster, is separated from the 18.7 cm outer diameter, 10.2 cm inner diameter copper anode by boron nitride and lucite insulators which form the backplate and sidewalls of the 12.7 cm diameter by 5.1 cm deep thrust chamber. Argon propellant, injected through a high speed solenoid valve, is distributed by an annulus in the boron-nitride backplate surrounding the cathode and enters the interelectrode zone via twelve equispaced 3mm holes circularly arrayed at a radius of 3.8 cm.

As indicated in Figure 1 and the photos of Figure 3, one 0.5 cm diameter "spot" on the tungsten cathode, copper anode, and boron nitride backplate was activated by bombardment with a high energy alpha or proton beam. The cathode and backplate spot positions were chosen on the basis of spectroscopic data and the QCM experiment results which showed erosion to be most severe in these regions, that is, at the base of the cathode and close to the cathode on the backplate. The anode was irradiated on the downstream plane face radially outward and in the proximity to the lip radius.

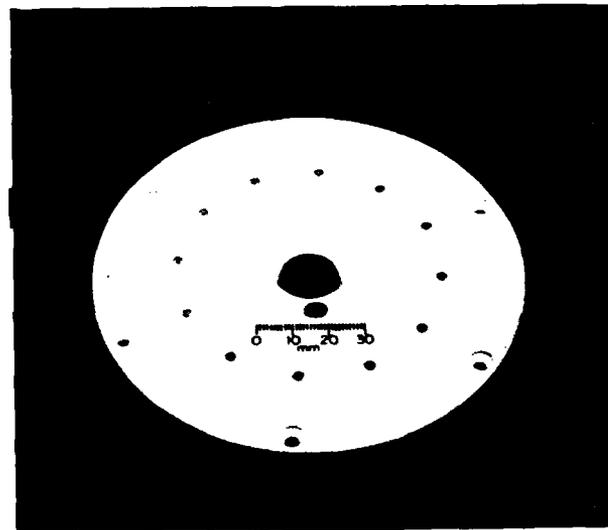
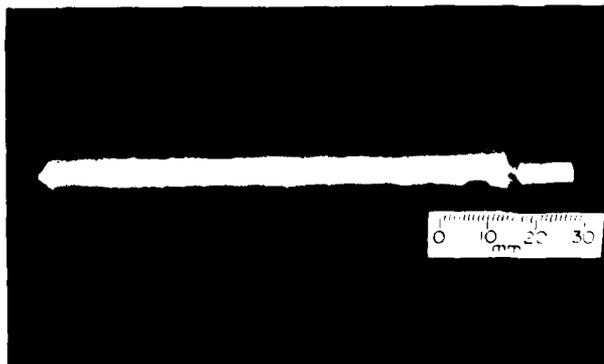
FIGURE 3: IRRADIATED COMPONENTS

IRRADIATED COPPER ANODE

IRRADIATED BORON NITRIDE  
BACKPLATE

IRRADIATED TUNGSTEN CATHODE

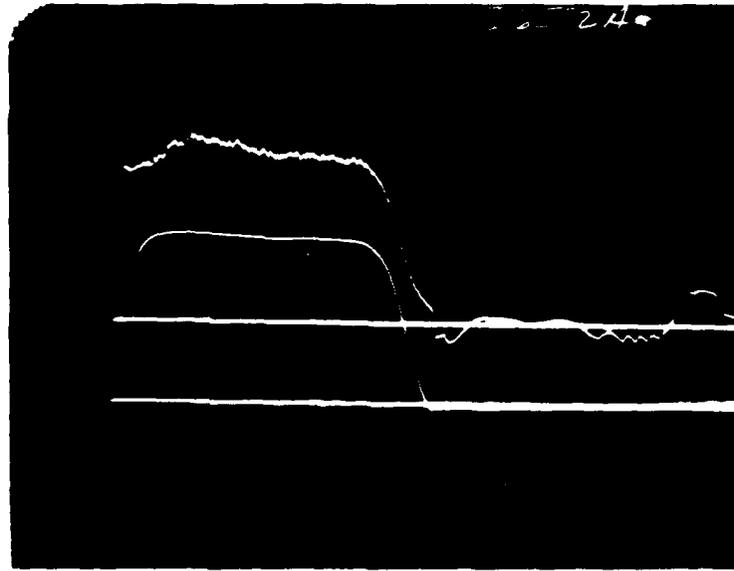
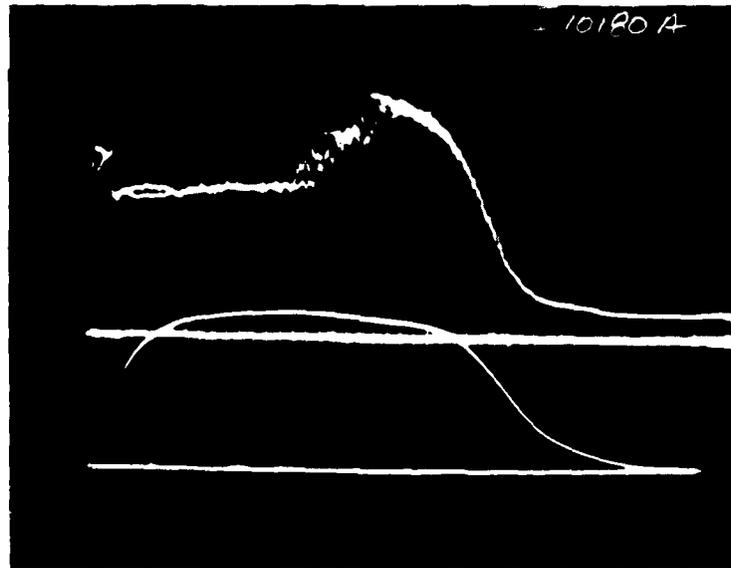
FIGURE 10: OSCILLOSCOPE CURRENT AND VOLTAGE TRACES

TYPICAL VOLTAGE TRACE

IRREGULAR "STEPPED" VOLTAGE TRACE

In addition, a number of the 15 kA, voltage traces exhibited an unusual stepped behavior. During normal operation, the voltage starts at some high value, drops to a quasi-steady value during breakdown, remains at this level until the end of the current pulse, whereupon it decays rapidly to zero, cf. Figure 10. In contrast to this, for the first two test run sequence at 15 kA, approximately 40% of the voltage traces were similar to the one shown in Figure 10, where the voltage steps up to a second quasi-steady level in the middle of the current pulse. In the final run sequence at 15 kA, approximately 70% of the traces were of this form. The voltage mean of the lower half of the stepped traces is plotted as squares in Figure 9 and the upper plateau voltages are displayed as triangles. As can be noted, the observed voltages for the first half of the current pulse correspond more closely with previous test data than do those of the latter portion. It is doubtful that this can be attributed to additional mass flow into the thruster, but more likely is due to a transition from one mode of arc behavior to another, such as from a diffuse discharge to a spoked discharge attaching preferentially in one location.

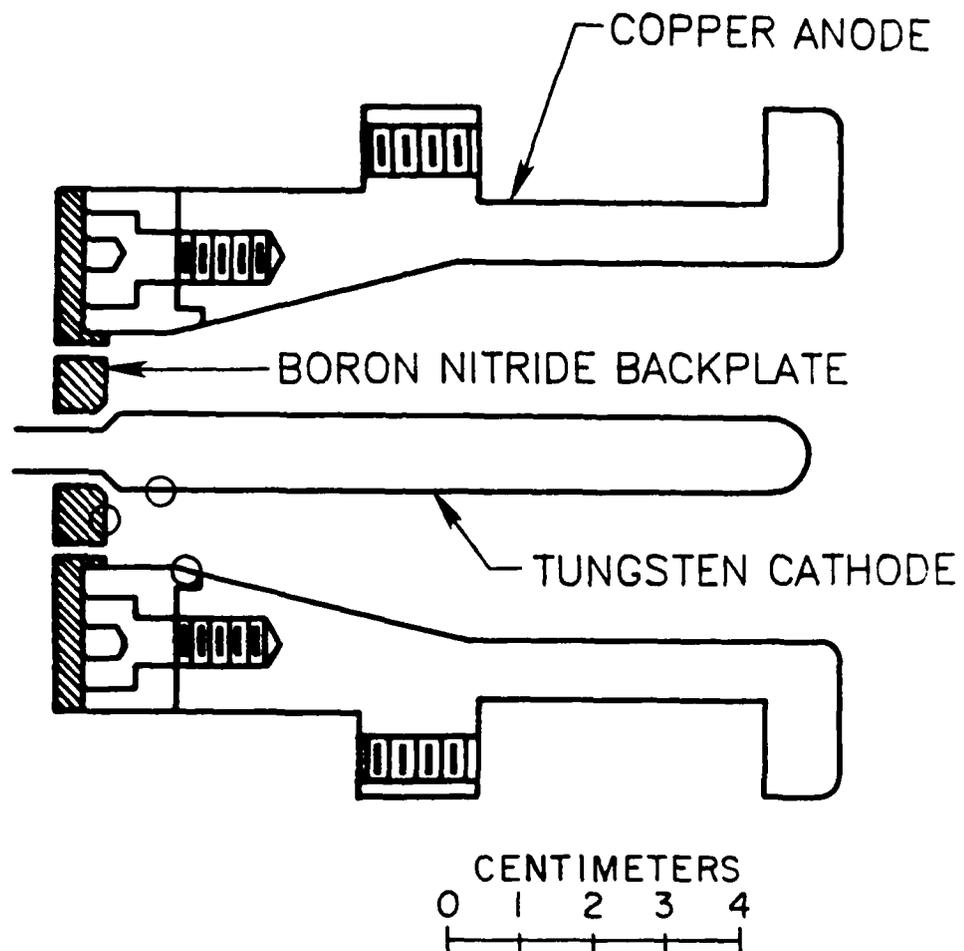
FIGURE 17: HALF-SCALE  
FLARED ANODE THRUSTER

○ - IRRADIATED POSITIONS

The flared anode thruster configuration shown in Figure 13 will be tested using the SLA technique with activated spots in the indicated positions. This design is a half-scale version of a thruster tested recently at Princeton. The planned test sequence involves continued variation of current level and mass flow in an attempt to explain the scatter of erosion rate with current observed with the full-scale reference thruster. In addition, use of refractory materials in the mass injection system will permit operation of this thruster at a higher pulse rate than has been heretofore possible. This will allow investigation of the effect of higher steady state temperatures on erosion rate. Operation of this half-scale thruster at mass flow rates will make it possible to explore the post onset current region in some depth, where evidence of insulator ablation should be manifest. Irradiation of a spot on the copper anode corresponding to the point of maximum current attachment should also make anode erosion detectable. Simultaneous diagnostic probing of an identical thruster mounted in another test facility will provide information on interelectrode current profiles at different operating conditions, and permit correlation with the erosion data. The effect of radiation damage on the mechanical properties of the irradiated spots will also be investigated in a continuing effort to determine the validity of the Surface Layer Activation technique.
