PLASTIC STRAIN LOCALIZATION IN SUPERALLOY SINGLE CRYSTALS

Prepared by
D.L. Anton
A.F. Giamei

FINAL REPORT

JULY 31, 1986

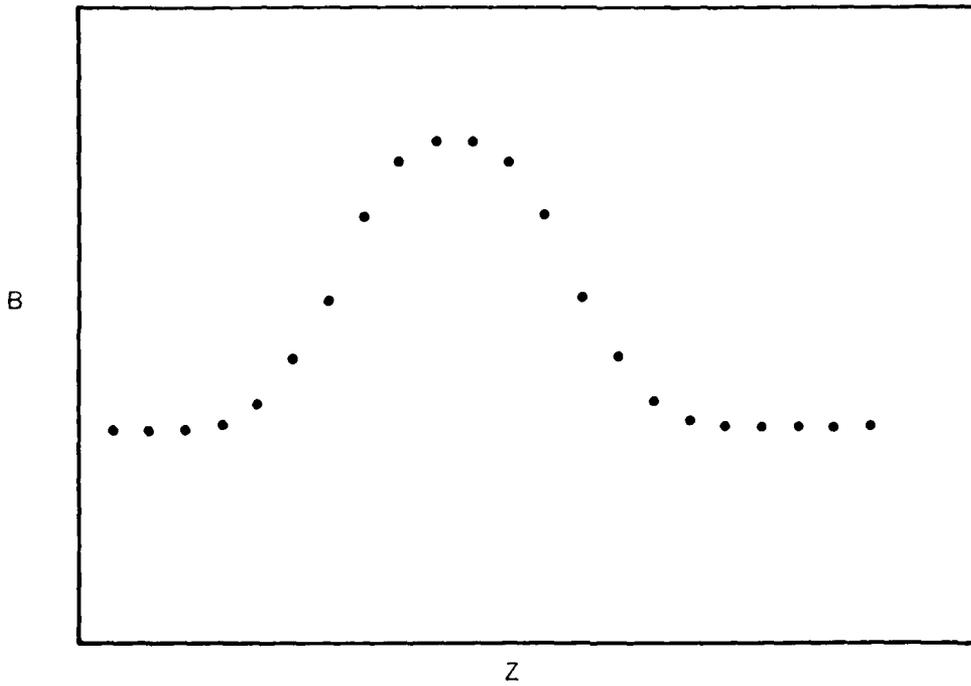
FIG. 3

SUMMATION OF SLIP IN THE SLIP BAND DEPICTED IN FIG. 2

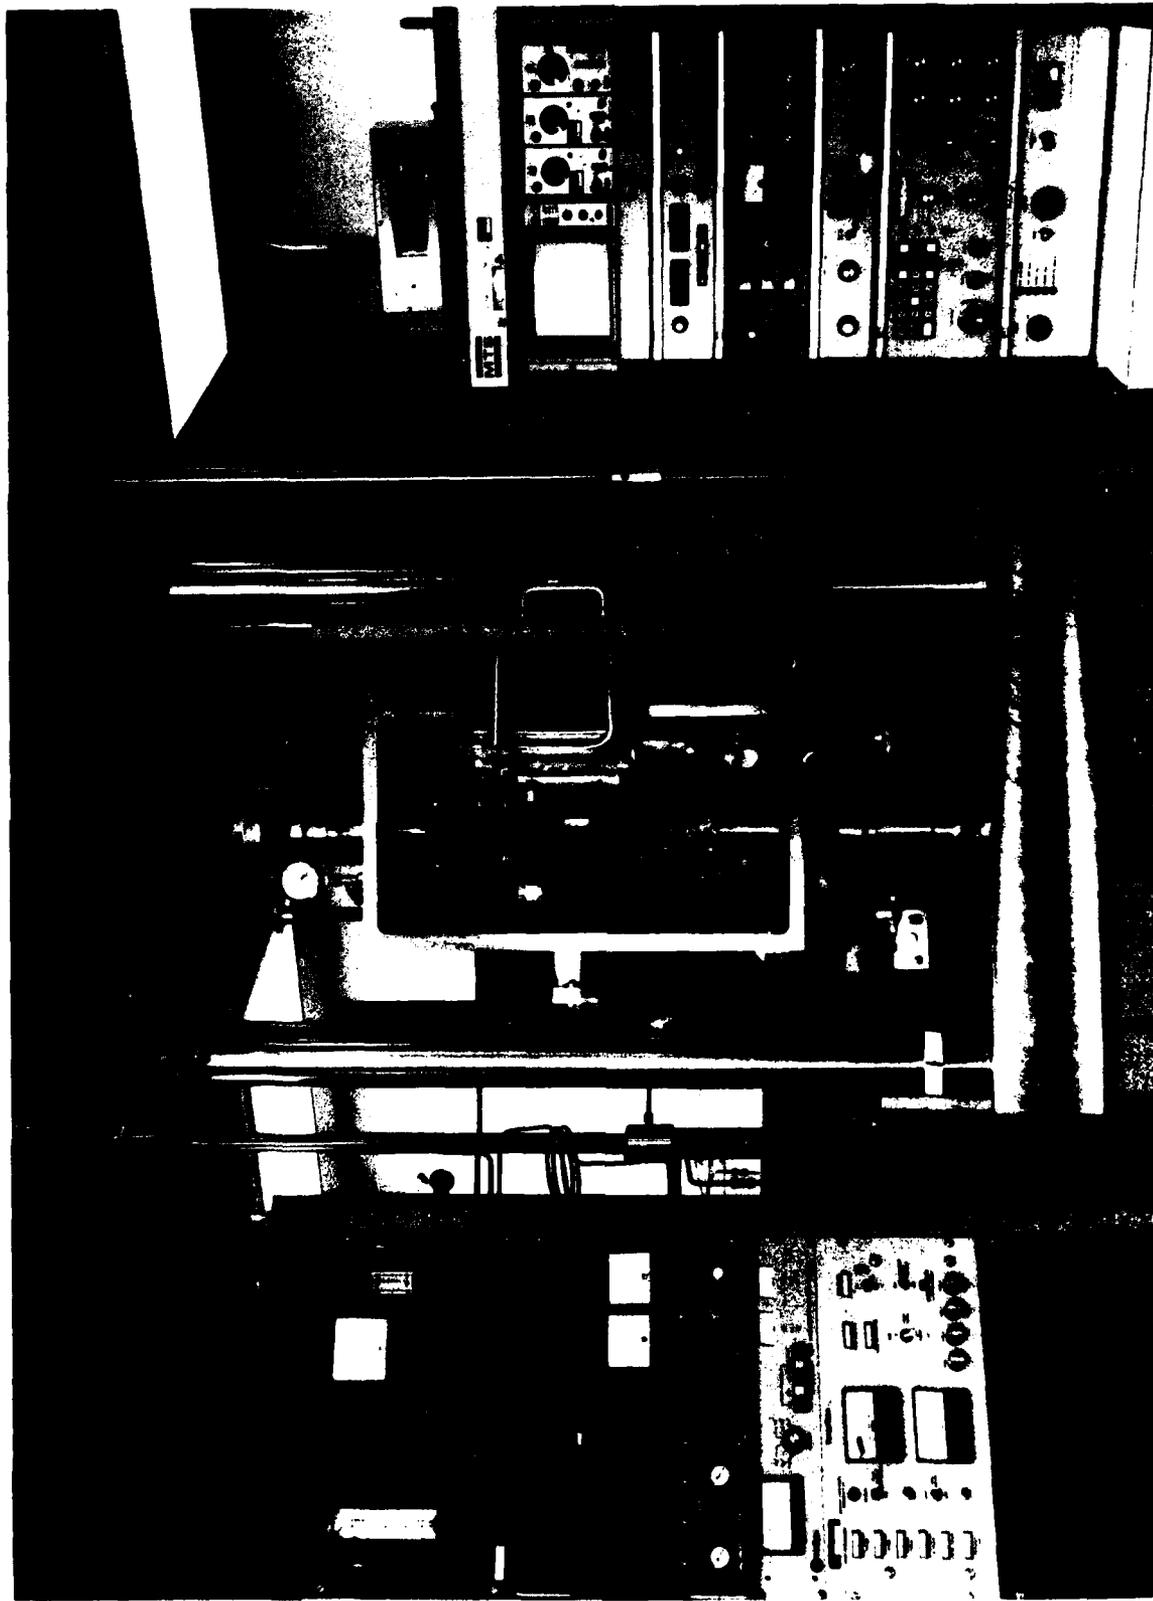
SERVO HYDRAULIC TEST SYSTEM WITH VACUUM CHAMBER OPEN

Compression at elevated temperatures, 466°C (870°F), was conducted in a high purity all metal testing furnace specifically designed for use in servo-hydraulic testing machines. This furnace is shown in Fig. 4. This system includes a high vacuum capability of 10^{-6} torr at temperatures as well as a Ti-gettered argon atmosphere which has been measured at an oxygen partial pressure of better than 10^{-10} ppm by use of a fast ion conductor Ca-stabilized zirconia cell. It has been found that by using purified Ar, a much lower oxygen partial pressure can be maintained in the furnace than under the available vacuum system. Specimens were methodically cleaned ultrasonically in trichloro-ethylene followed by a rinsing in pure ethanol. These stringent measures were found to be required to clean films that adhere to the electropolished surfaces during storage and test setup.

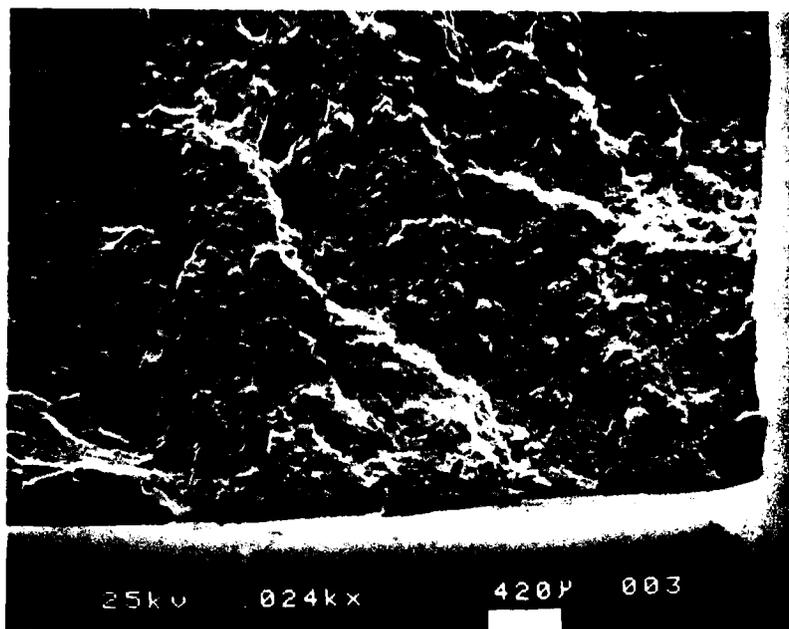
FATIGUE FAILURE INITIATION SITE IN SINGLE CRYSTAL U-700

Failure was initiated at surface slip traces after 6945 cycles. The initiation site is given in the SEM micrograph of Fig. 43. Cracks were seen to cover the surface of the gage section, all starting from surface slip traces. The fracture surface contained many faceted regions at the surface, indicative of surface related crack initiation. Multiple initiation led to crack linking resulting in a circumferential crack leading to failure.

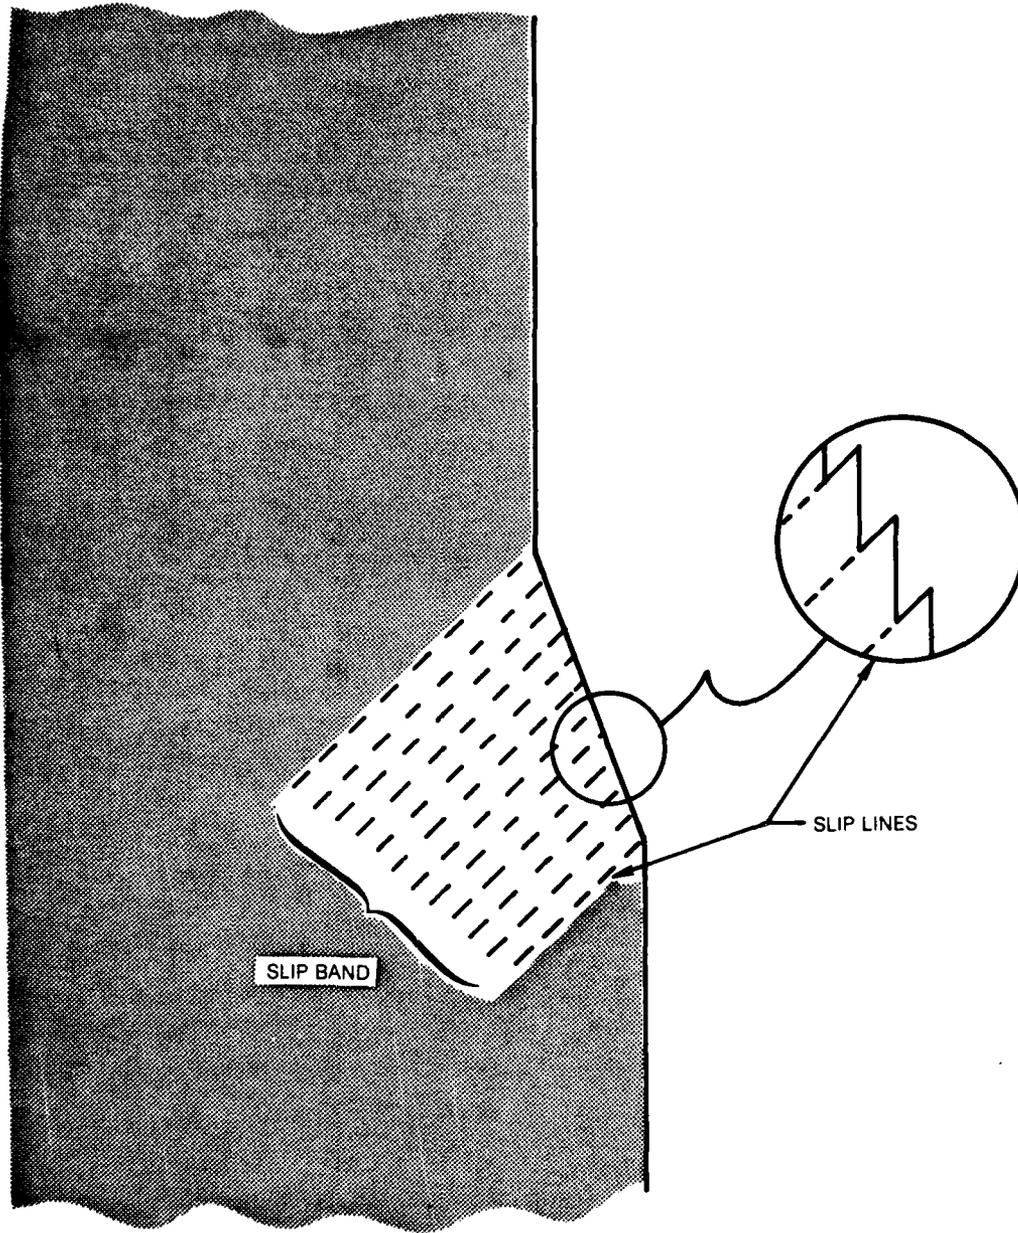
PROFILE OF SPECIMEN SURFACE SHOWING HOW SLIP LINES EMERGING AT SURFACE WILL PRODUCE MACROSCOPIC SLIP BANDS

The most striking feature which has been observed here, in all of the specimens tested, is the extreme uniformity of slip deformation throughout an individual slip band. Figure 48 graphically displays how these large slip bands are composed of many individual slip lines with a uniform spacing of approximately 50 nm. Each of these slip lines is composed of an integral number of Burger's vectors corresponding to the number of dislocations that have passed on each individual slip plane.

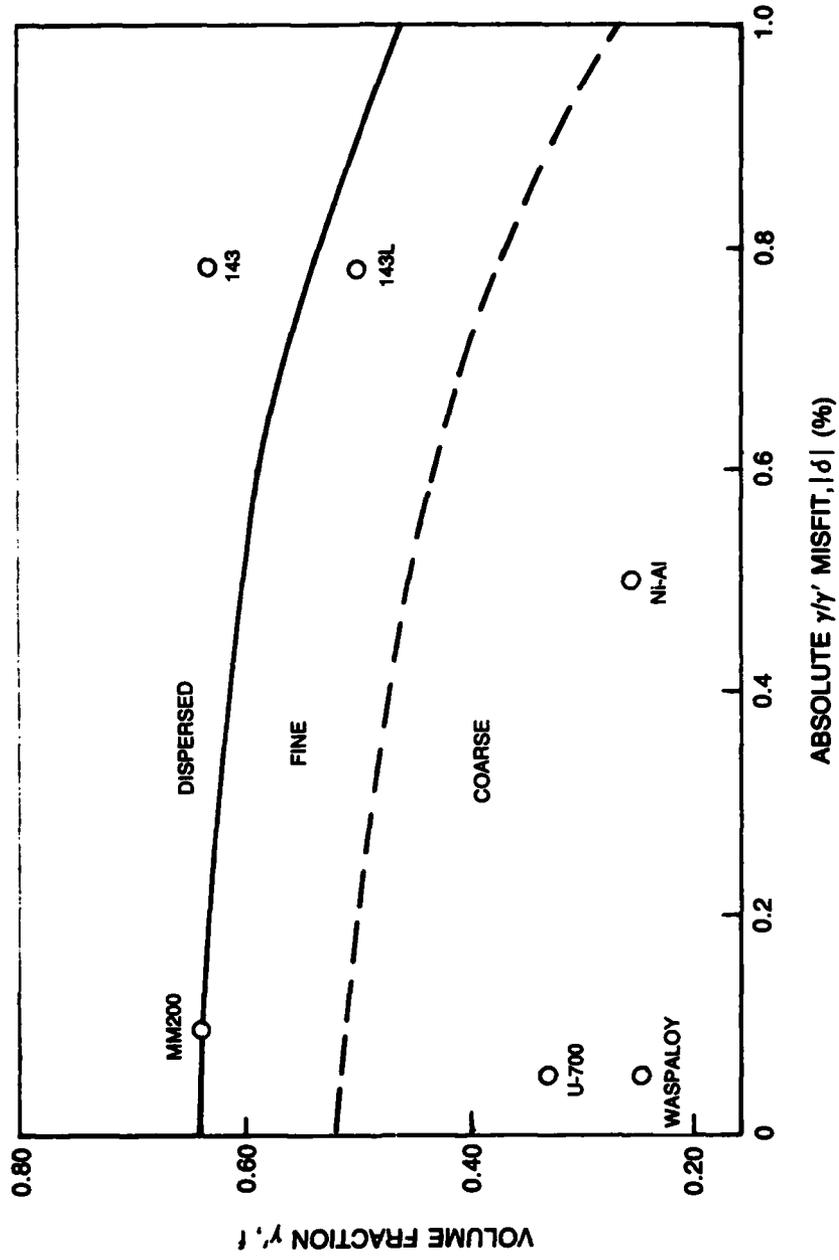
LOCAL PLASTIC STRAIN MAP FOR VARIOUS SUPERALLOYS

At this time a semi-quantitative graphical representation of plastic strain localization in superalloys can be made as functions of both misfit, $|\beta|$ and γ' volume fraction, f , (see Fig. 50). A number of features are shown here which summarize the work reported thus far. Slip can be loosely categorized into three modes, coarse, fine and dispersed. Coarse slip, typical of that found in U-700 and other lean alloys, is characterized by narrow slip bands and sharp offsets composed of few slip lines which have been formed by the passage of many dislocations. In cases when the dislocations are forced to cross slip onto many adjacent slip planes dispersed slip occurs. Here, very few if any dislocations pass on exactly the same slip plane. The slip bands are thus quite wide with evidence of slip lines within. In between these two extreme cases is what is referred to here as fine slip. Some of the features of both the above-mentioned types are present in this case. Broad slip bands composed of many fine and discrete slip lines characterize this form of strain localization. Our experiments, and those noted in the literature cover a wide range of misfit, γ' volume fraction and γ' size. Figure 50 depicts the placement of these alloys on a misfit-volume fraction-slip map to the best of our knowledge at this time.

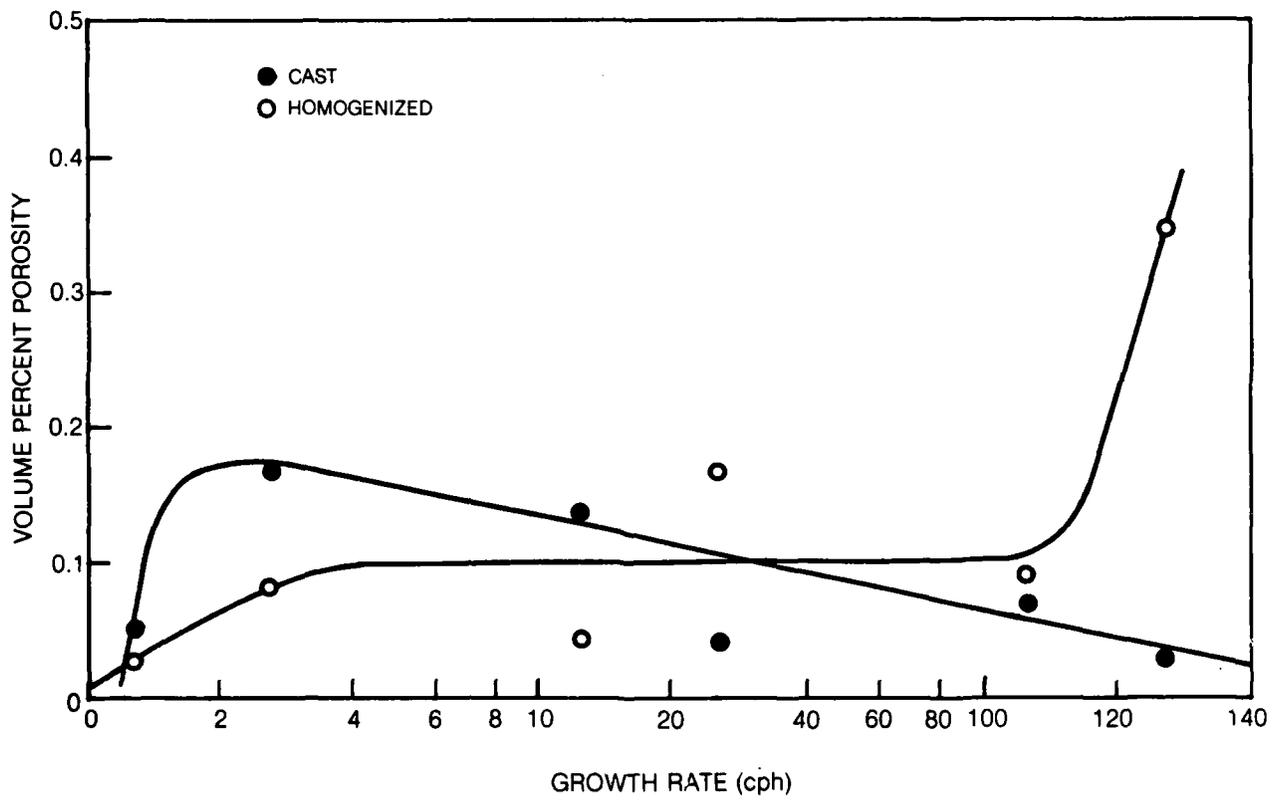
CHANGE IN VOLUME PER CENT POROSITY WITH GROWTH VELOCITY

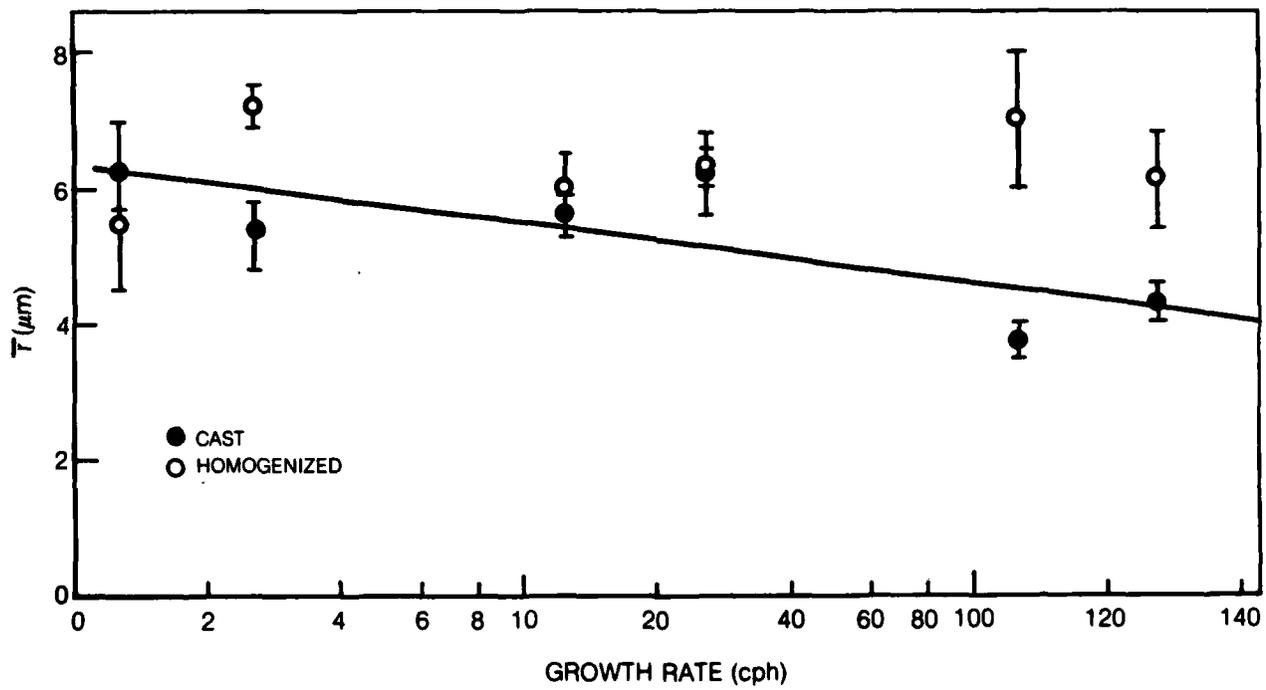
CHANGE IN MEAN PORE DIAMETER WITH GROWTH VELOCITY

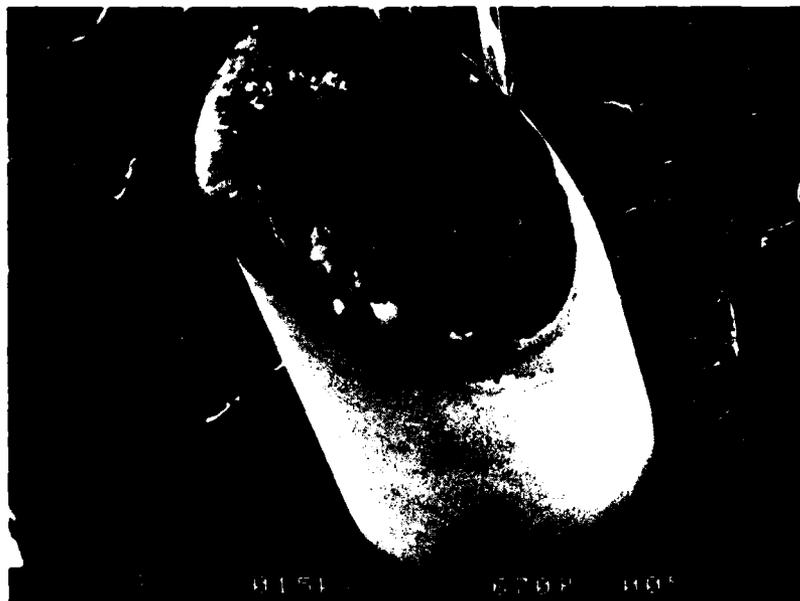
**FRACTURE SURFACE ILLUSTRATING SURFACE SLIP INITIATED
FATIGUE FAILURES**

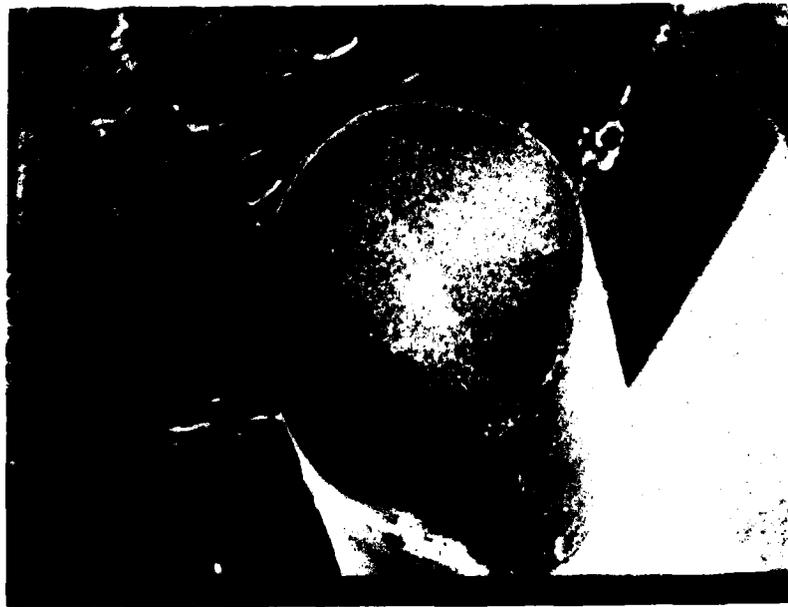
**FRACTURE SURFACE ILLUSTRATING SUB-GRAIN BOUNDARY INITIATED
FATIGUE FAILURES**

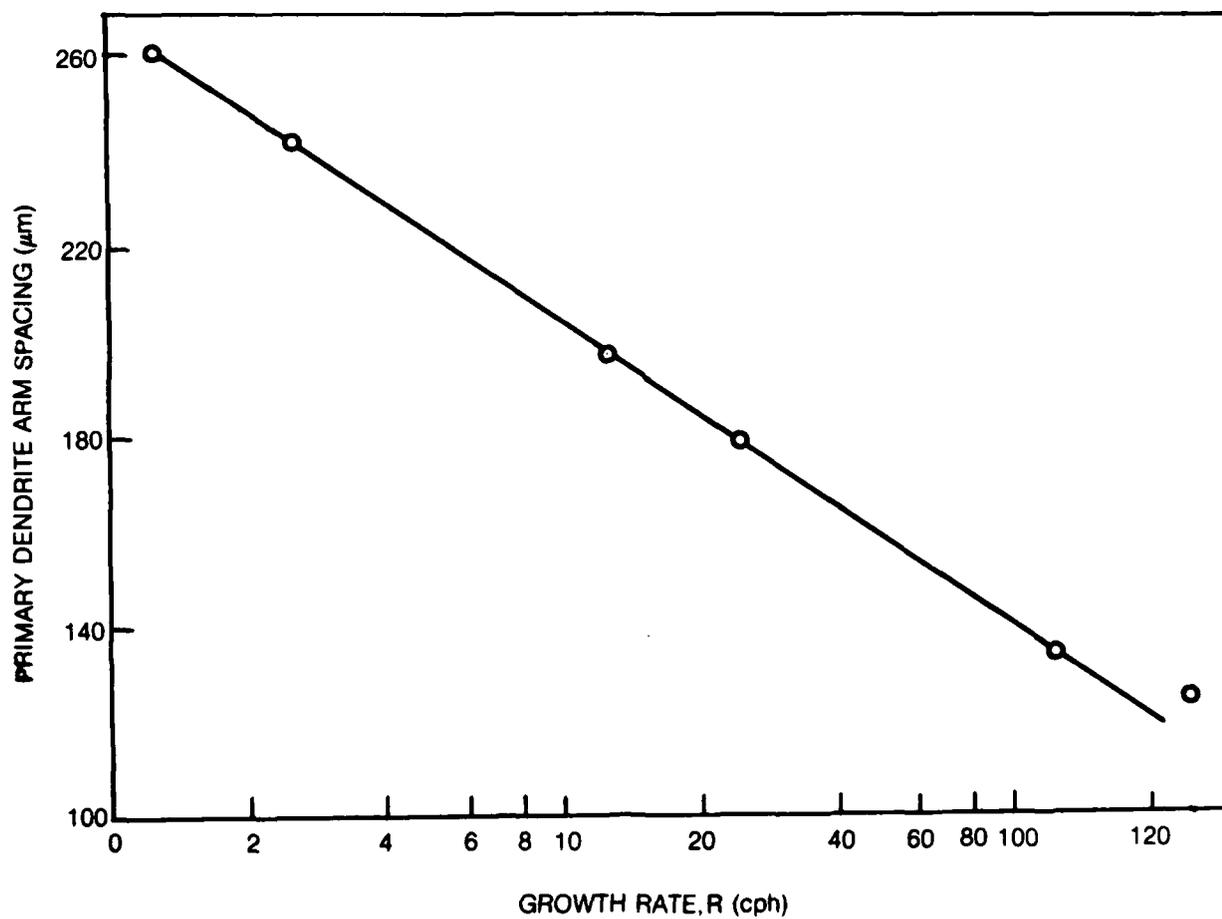
THE VARIATION IN PRIMARY DENDRITE ARM SPACING WITH GROWTH RATE
