Cold Regions Research &
Engineering Laboratory

Special Report 86-28

Engineering surveys along the Trans-Alaska Pipeline

Randy N. Godfrey and Robert A. Eaton

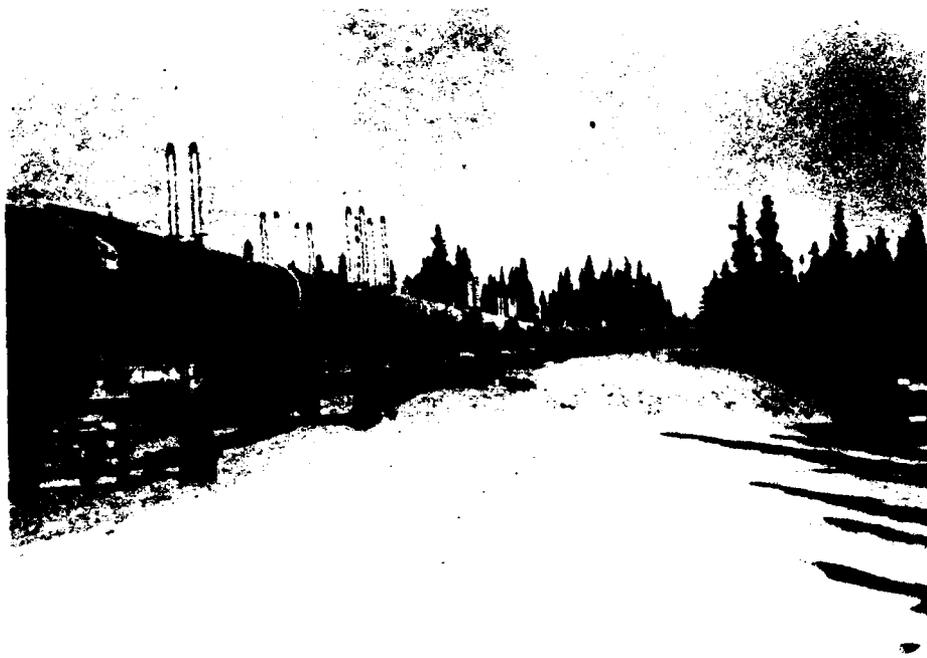
a. Looking north along the east side of the workpad from the centerline at VSM #49. Note the stones left on the surface after grading.

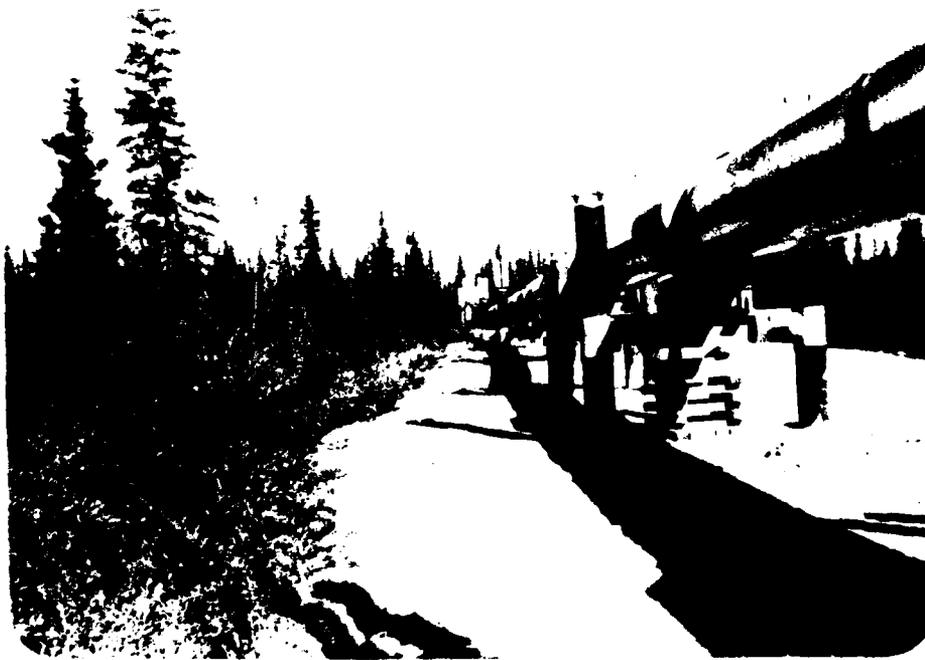
b. Looking north along the west shoulder of the workpad from VSM #49. Note the wood planking used to support the horizontal strut of the VSM.

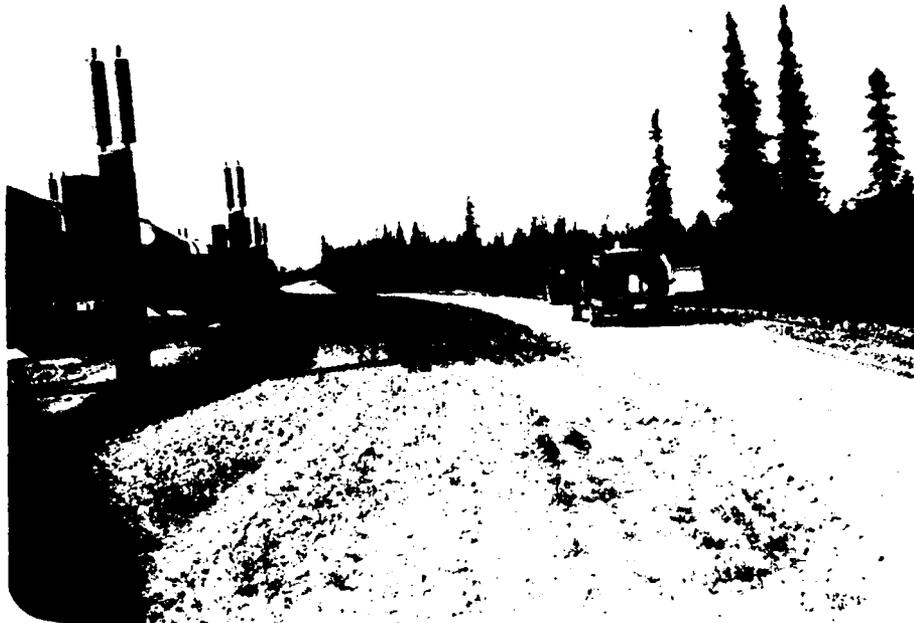
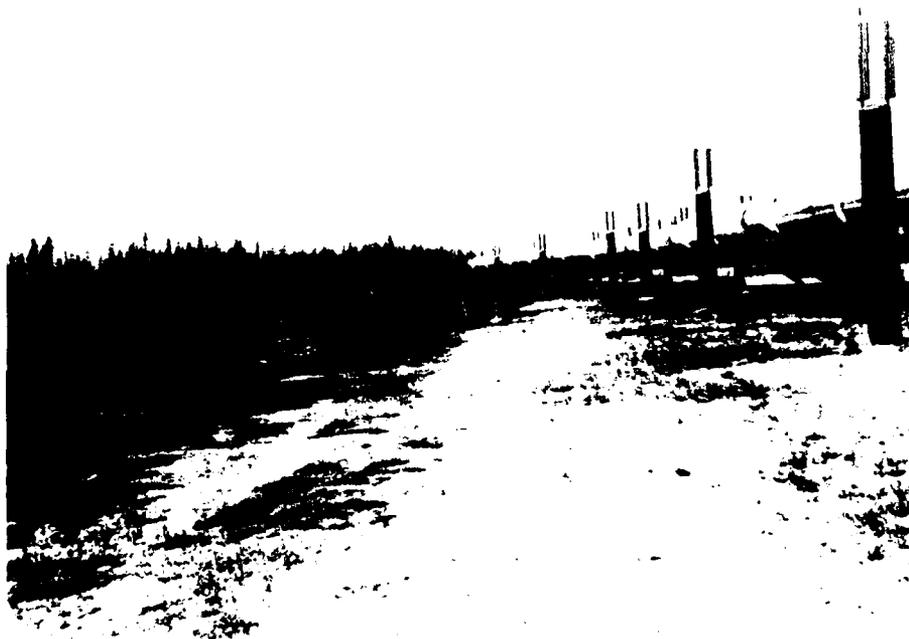
Figure 14. Quartz Lake test site, September 1977.

a. Looking north from VSM Bent #62 along the east side of the workpad.

b. Looking north from VSM Bent #62 along the west side of the workpad.

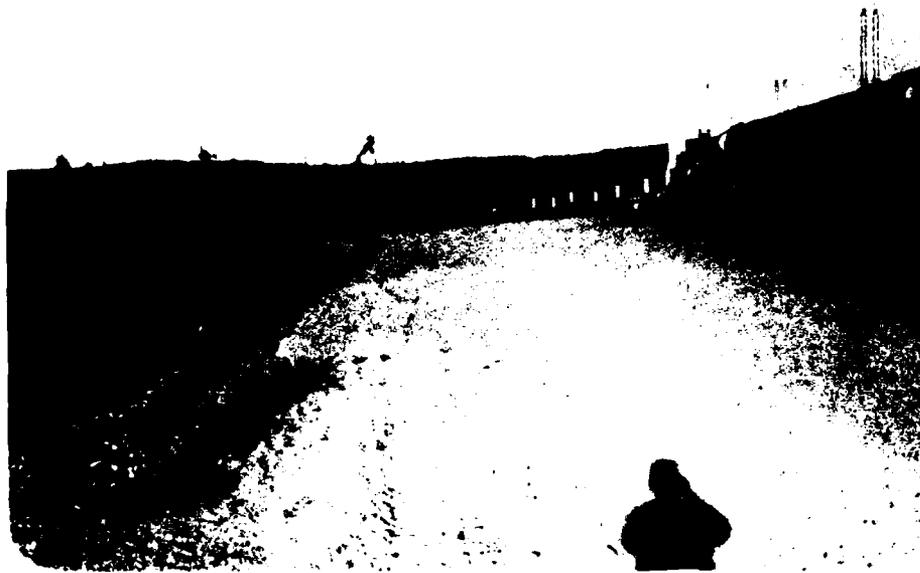
Figure 23. Engineer Creek site, 5 September 1977.

a. Looking east along the north side of the workpad from near VSM #48.

b. Looking east from near VSM #48 on the north side of the pipe.

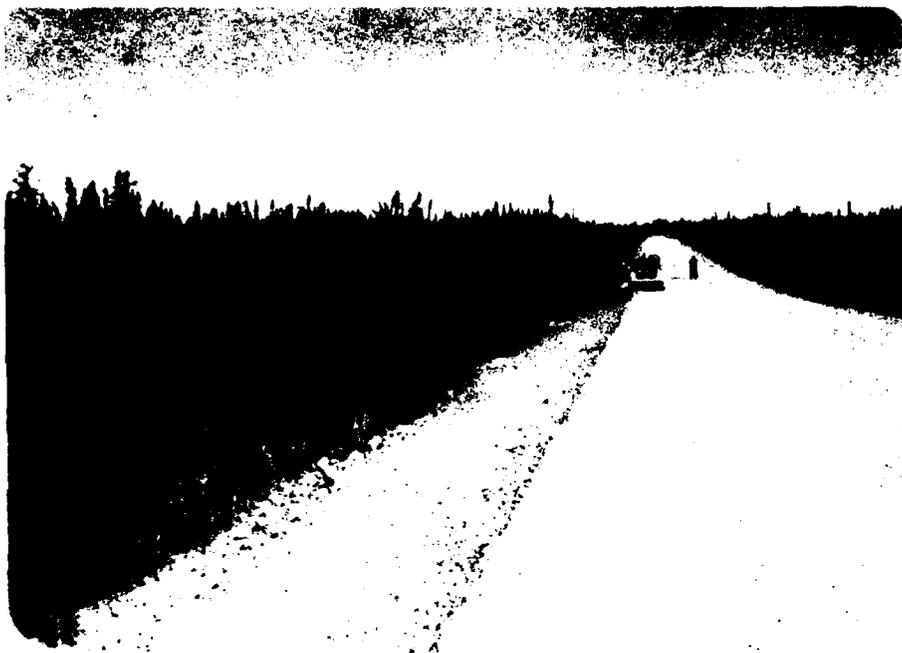
a. Looking north along the west side of the road. Note the shallow berm along the roadside created during grading.

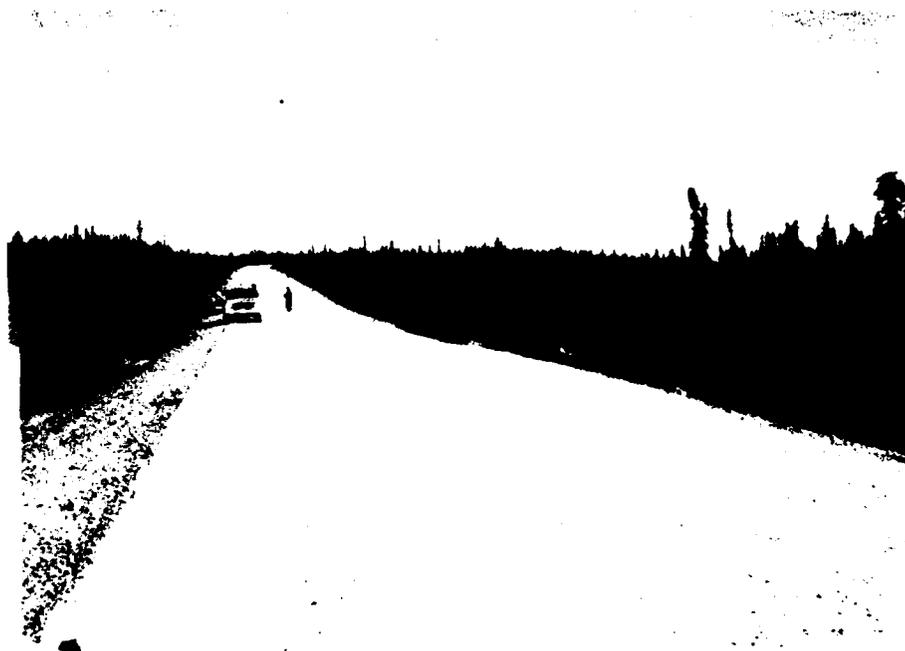
Figure 28. TAPS Road mile 16.3 site, 3 September 1977.

The gravel surface roadway (Fig. 28) was frequently regraded to maintain a relatively smooth surface, creating berms on both sides of the roadway. These berms inhibit water runoff to the roadside slopes and edges and allow excess water to enter the subgrade vertically or produce potholes in the roadway surface.

b. Looking northeast along the west shoulder of the road.

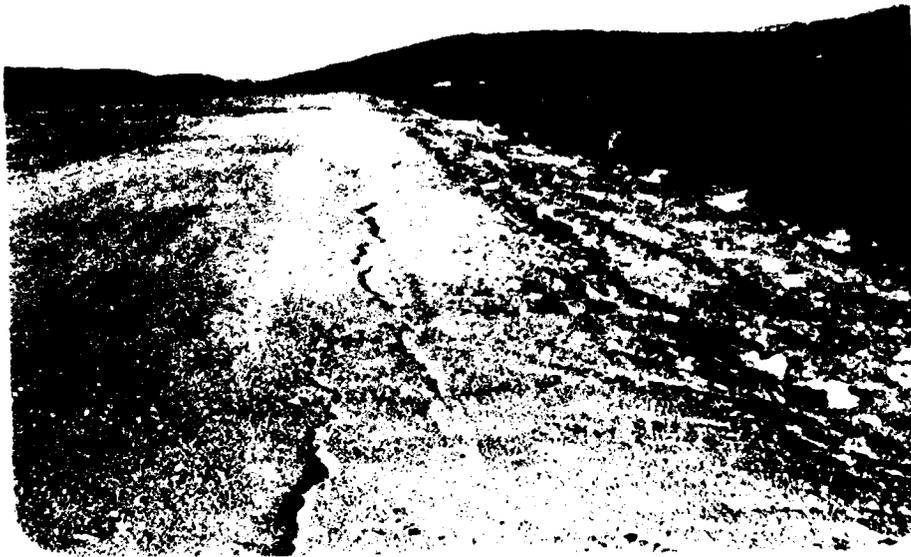
b. East site, looking west from the cross section along the north side of the runway. Note the cracks along the runway edge, probably caused by the settlement at the toe area. Also note the surface water along the toe.

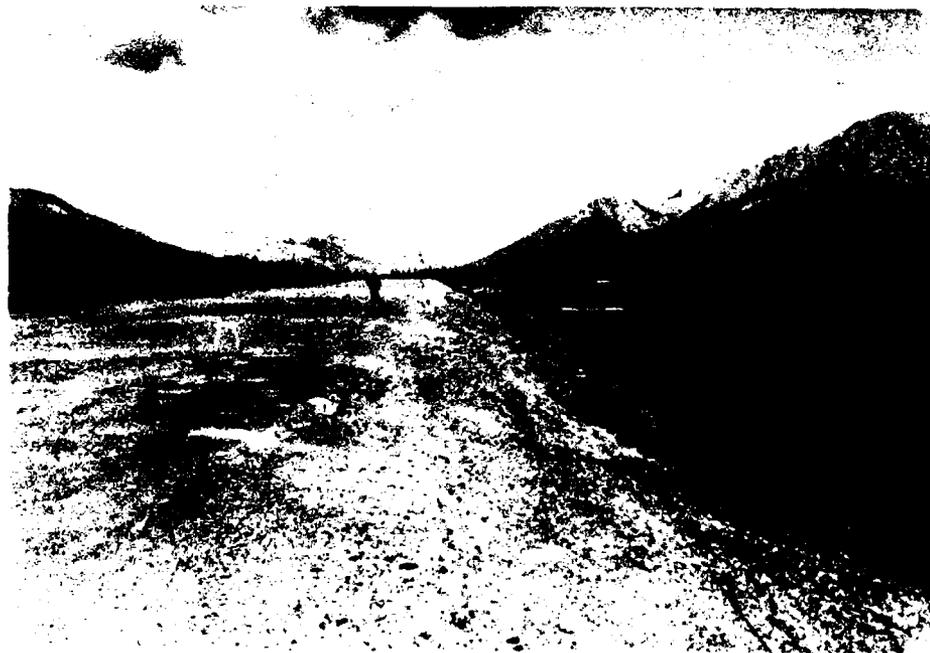
a. North site, looking north along the east shoulder of the runway. Note the shoulder cracks.

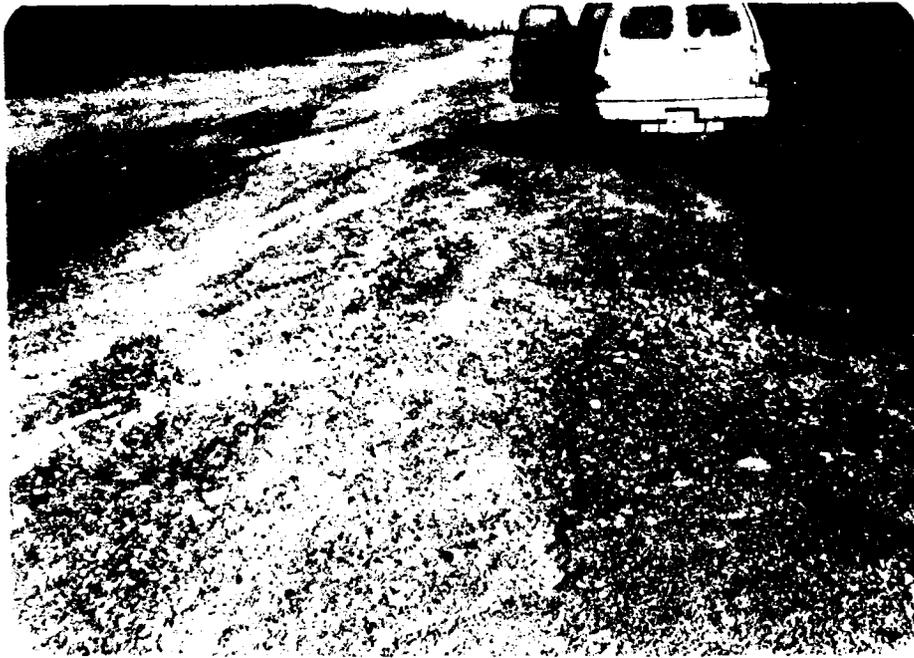
b. North site, looking north along the west shoulder. Note the shoulder cracking and the service road adjacent to the runway.

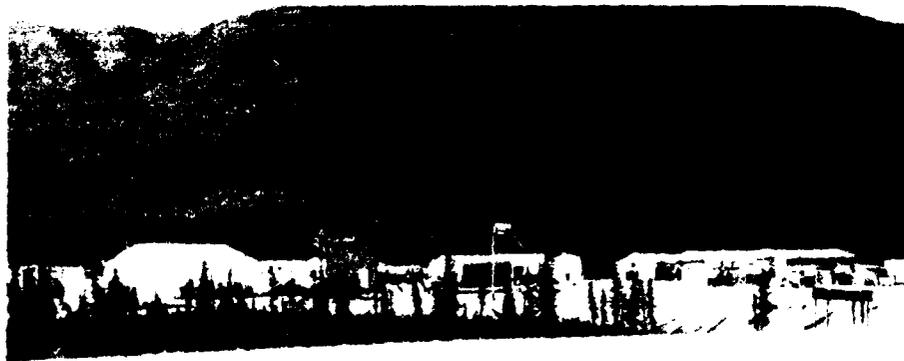
Figure 49 (cont'd). Dietrich Airfield north and south sites.

c. North site, looking north along the runway centerline from the southernmost point of the centerline profile.

d. South site, looking east from the runway centerline along the cross section. Note the pipeline (about 170 m from the runway edge) and the Haul Road visible beneath the pipe (about 250 m from the runway edge).

e. South site, looking west from the runway centerline along the cross section.

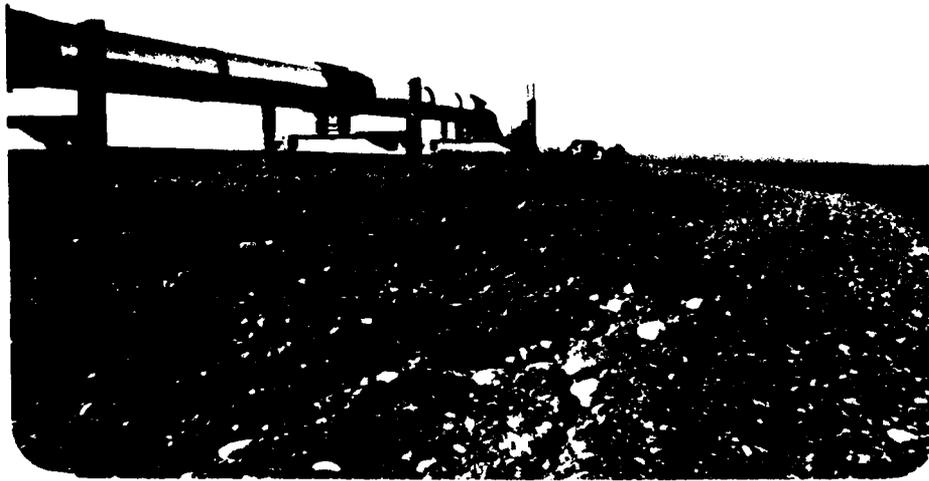
a. Looking north along the centerline of the workpad.
Note the wheel ruts in the gravel surface.
