TECHNICAL NOTE

MRL-TN-503

**TECHNIQUES FOR THE FIELD REPAIR OF
ARMOUR BATTLE DAMAGE**

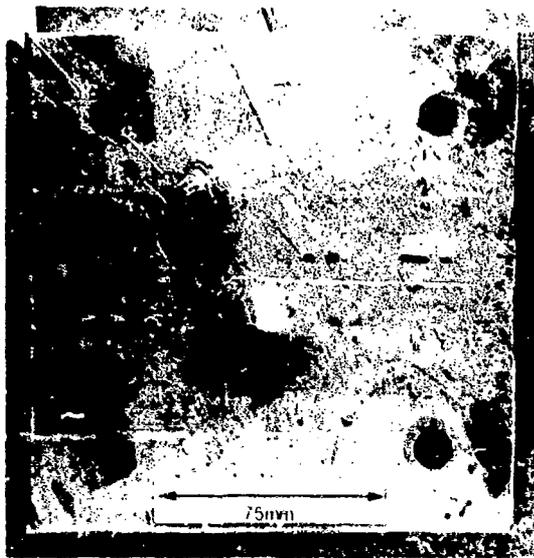
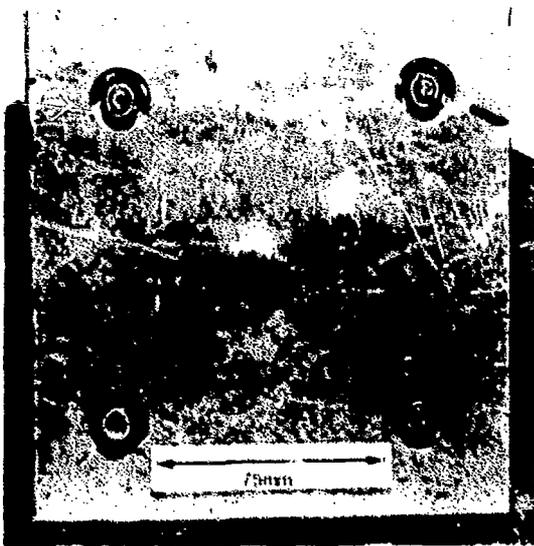
FIGURE 9 Aluminium and steel ballistic test patches showing .30 and .50 calibre AP round penetration.

The results of the .30 and .50 calibre armour piercing trials on the Ramset patch repair system are shown in Figure 9. Both AP rounds penetrated the steel and aluminium patches, however, the integrity of the patch fastening system was not diminished.
