TECHNICAL REPORT SL-87-10

# VULNERABILITY EVALUATION OF THE KEYWORKER BLAST SHELTER

April 1987

Prepared for Federal Emergency Management Agency  
Washington, DC 20472

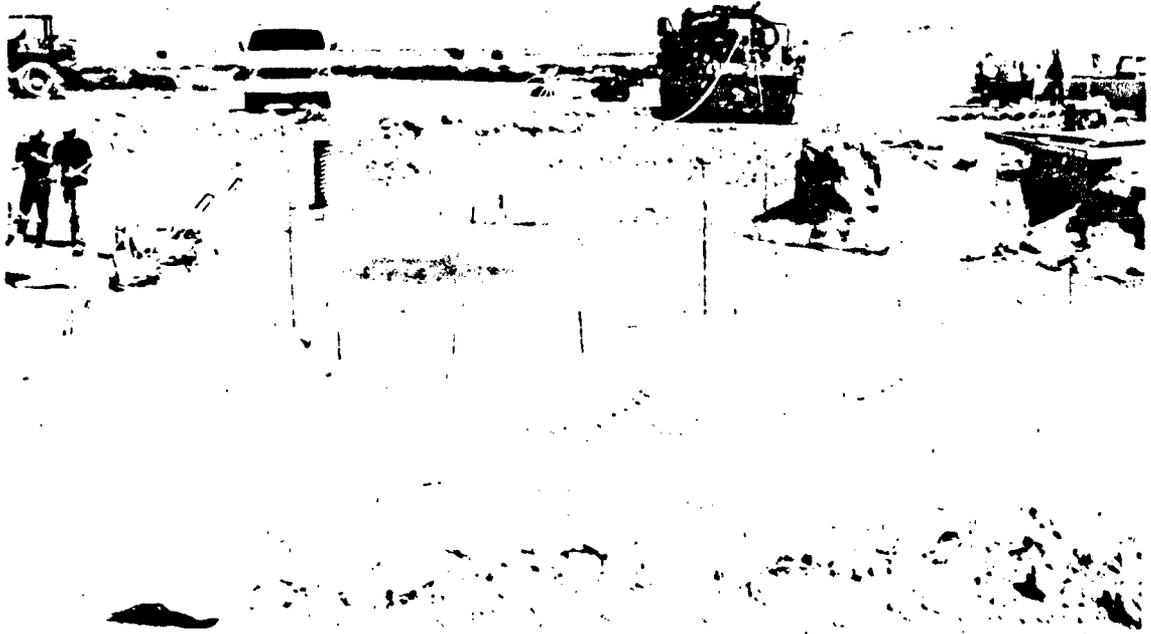
Figure 2.7. Backfilling at the roof level of the structure.

The test configuration is shown in Figure 2.6. The test procedure included instrumentation of the structure and free-field, backfilling to a depth of 4 feet above the shelter roof, constructing the charge cavity, covering the charge cavity with sand overburden, and detonation of the charge. Figures 2.7 through 2.9 document test preparation.

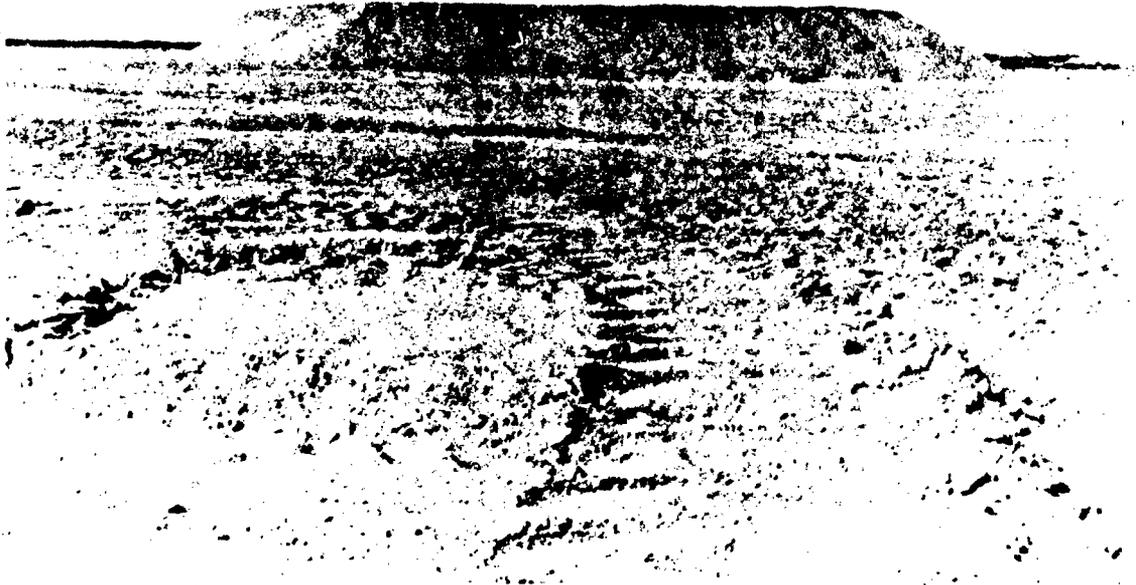
a. Pretest.

b. Detonation.

Figure 2.9. Detonation of the HEST charge cavity.

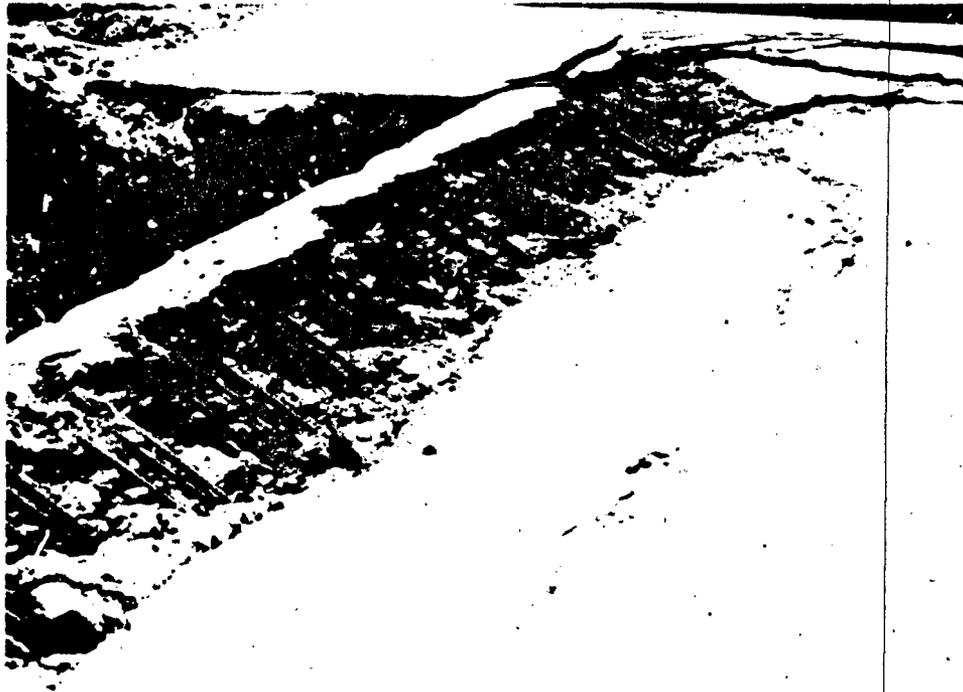
Figure 3.8. Exposed top of roof reinforcement, bay 3.

permanent midspan deflection. An interior view of bay 3 is shown in Figure 3.7, and a view of the exposed top roof reinforcement at the exterior wall of bay 3 is shown in Figure 3.8.
