AFATL-TR-87-14 **AD-A183 101**

Investigation of the Use of a Stereo Cranz-Schardin Camera Having Video Image Sensors to Behind-Panel Fragmentation Studies

SPECIAL ILLUMINATION SYSTEMS, INC
P O BOX 501
DAYTON, OHIO 45409-0501

FINAL REPORT FOR PERIOD AUGUST 1986 - FEBRUARY 1987

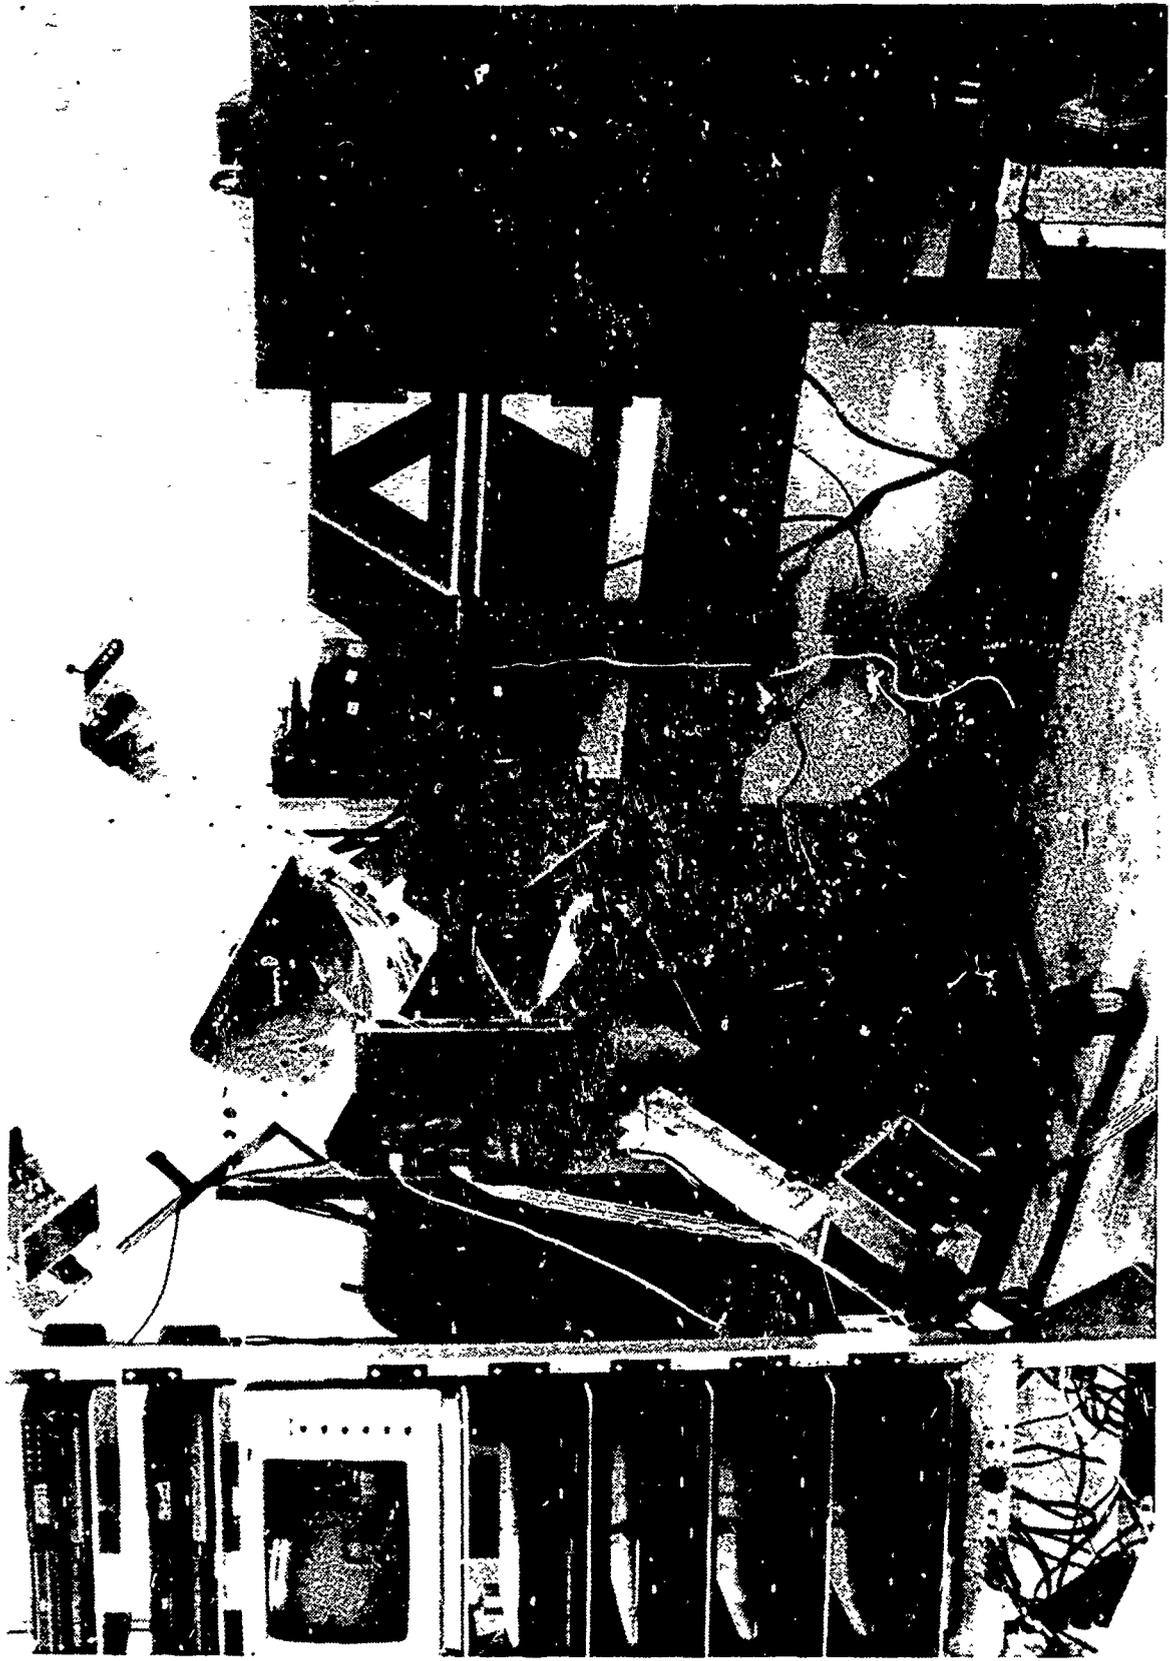
Figure 3. Target Tank and C-S Camera System, Camera Pulled Upstage to Reveal Target Tank .

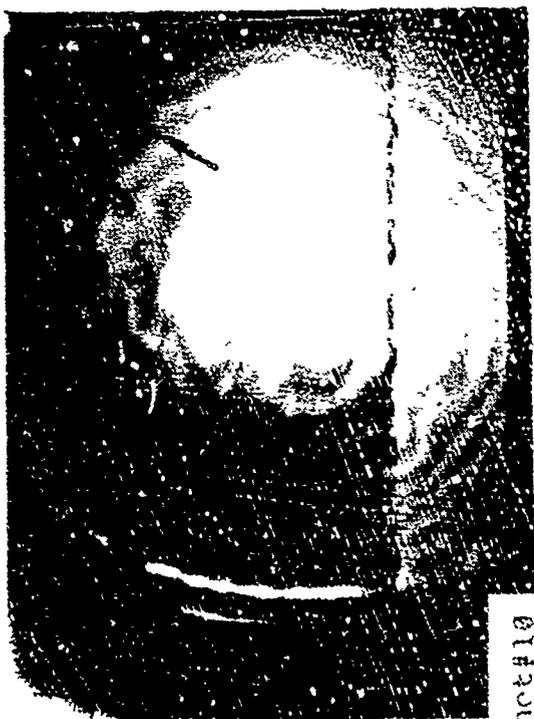
Two types of Polaroid film, type 667 (high contrast) and type 612 (low contrast) were used to record the images from the video tape. It was found in some instances that the detectability of particles was a strong function of the display intensity of the monitor screen and the type of Polaroid film employed. Figure 7 illustrates a case in which fragments are visible in one Polaroid print, but not in another. Since this was the case, several Polaroid prints of many video images were made using both types of film in order to ensure that no important results were overlooked.

Shot#18
Tape#3

Shot#19
Tape#3

Figure 7. Video tape images recorded using different Polaroid Films

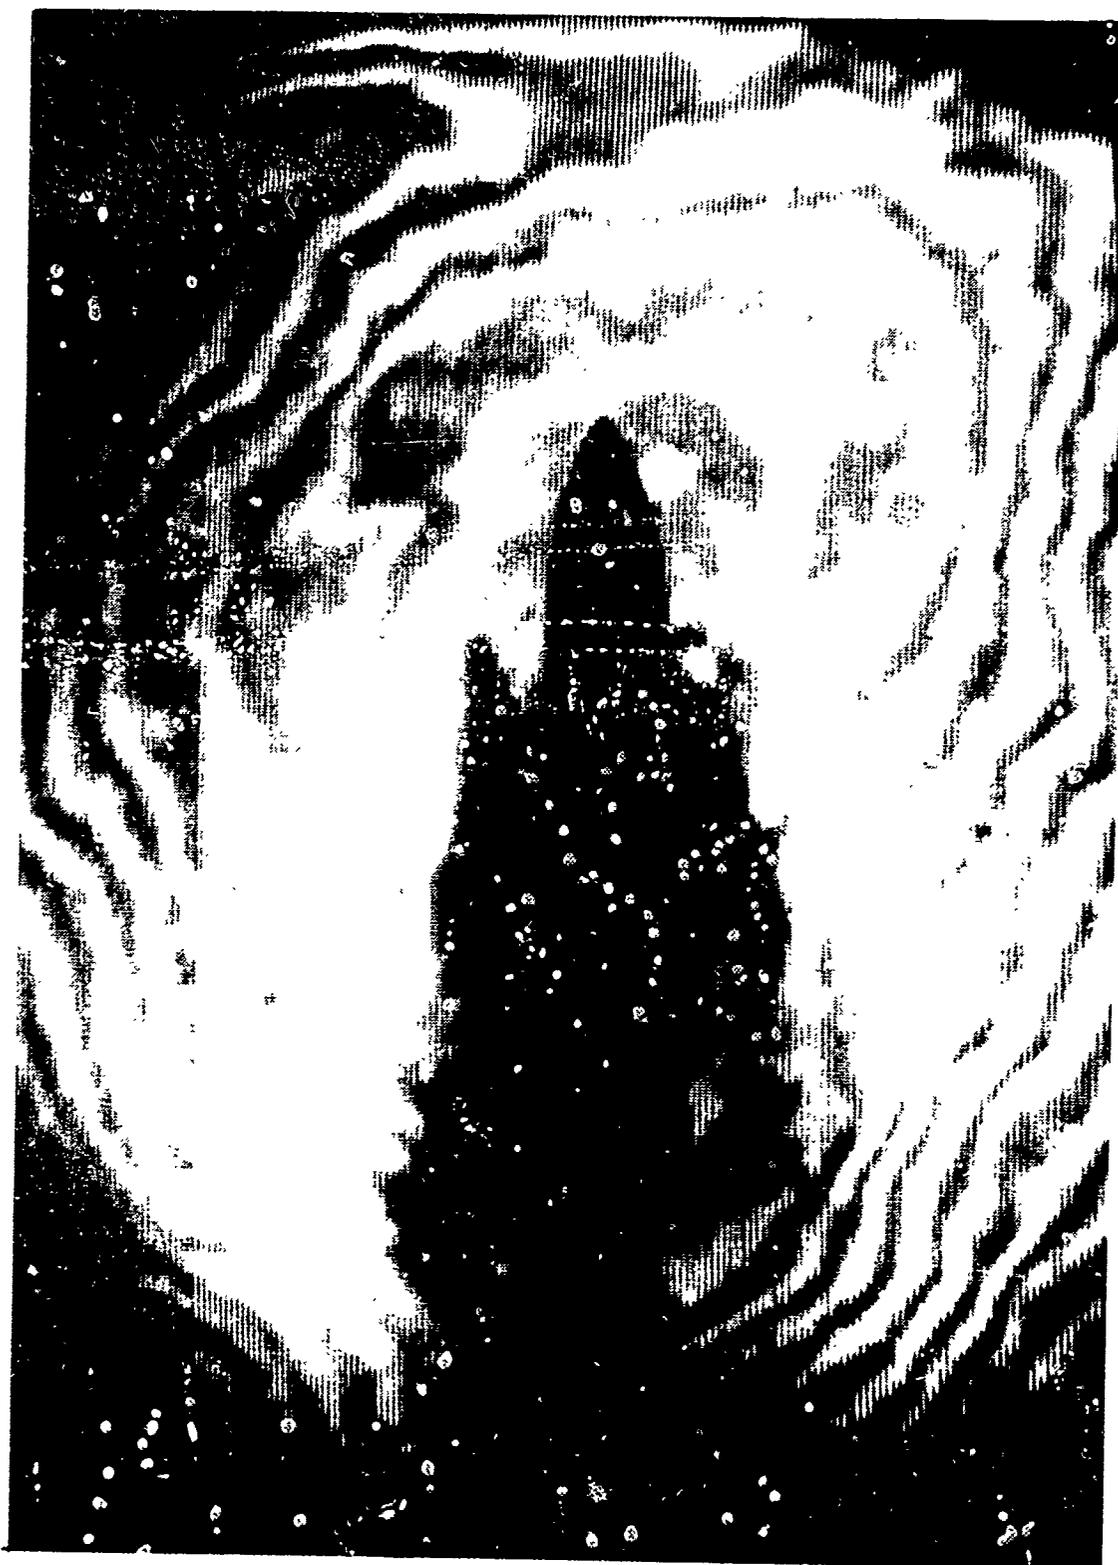
Figure 8. 35-mm SLR Camera Reconstruction of Video Image, Shot #1, Tape #2

One anomaly which had been observed, but not fully appreciated, was the fact that one of the first images recorded (Figure 8) showed an image of the projectile remnant and the debris cloud in which the cloud behind the projectile

was penetrated by the laser light. The anomaly lies in the fact that all the other images of the cloud indicate that it is exceedingly dense (as conventional wisdom dictates that it must be). Nonetheless, there is no reason to expect that the cloud in Figure 8 is really any different than the clouds in the other figures, only that our perception of it is different. Nearly all the experimental conditions of all the shots were the same: projectile type, target panel composition and thickness, impact velocity, and so on were the same when the image illustrated in Figure 8 was recorded as they were in the other images which indicated that the cloud was impenetrable.

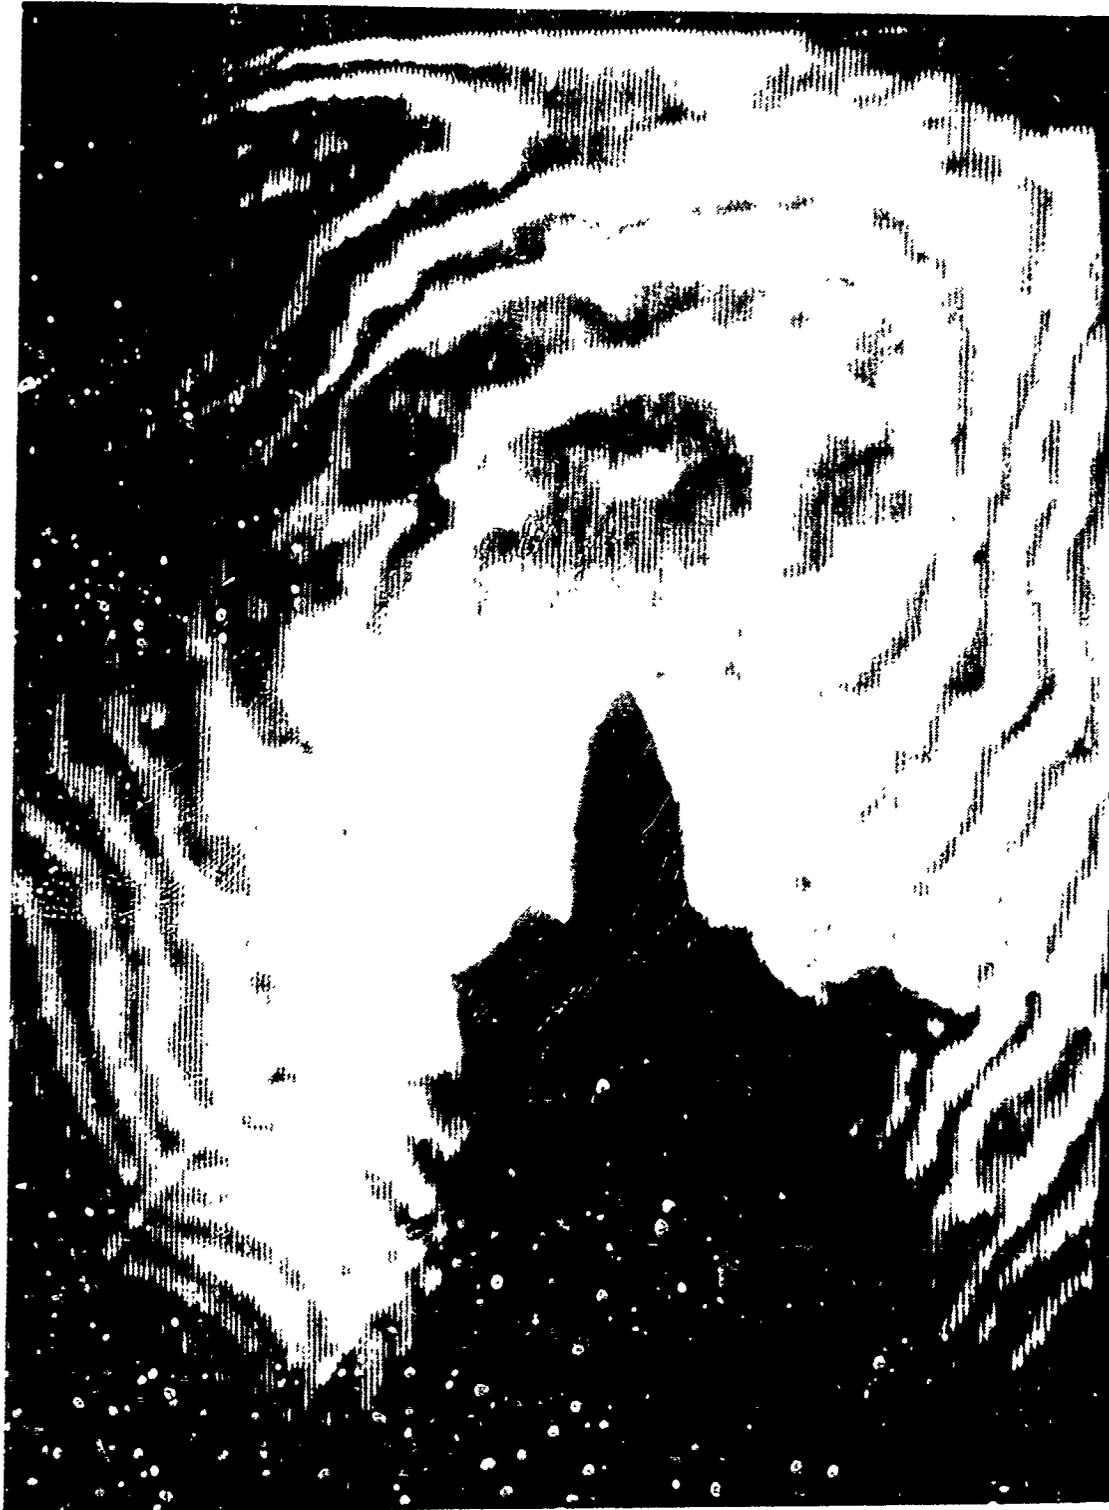
Figure 9. 35-mm SLR Camera Reconstruction of Video Image, Shot #4, Tape #2

The cloud here appears to be very impenetrable. This is believed to be an artifact since the camera saw through the cloud immediately after the laser fired. This is verified by the sharp difference in the image above and below the position of the scanning beam when the laser fired. Above this line the cloud appears dense since the image on the camera tube had time to decay before it was read. The projectile is seen to be pulling ahead of the dense cloud of debris as compared to the images recorded at earlier times. (Figures 9, 10, and 11.)

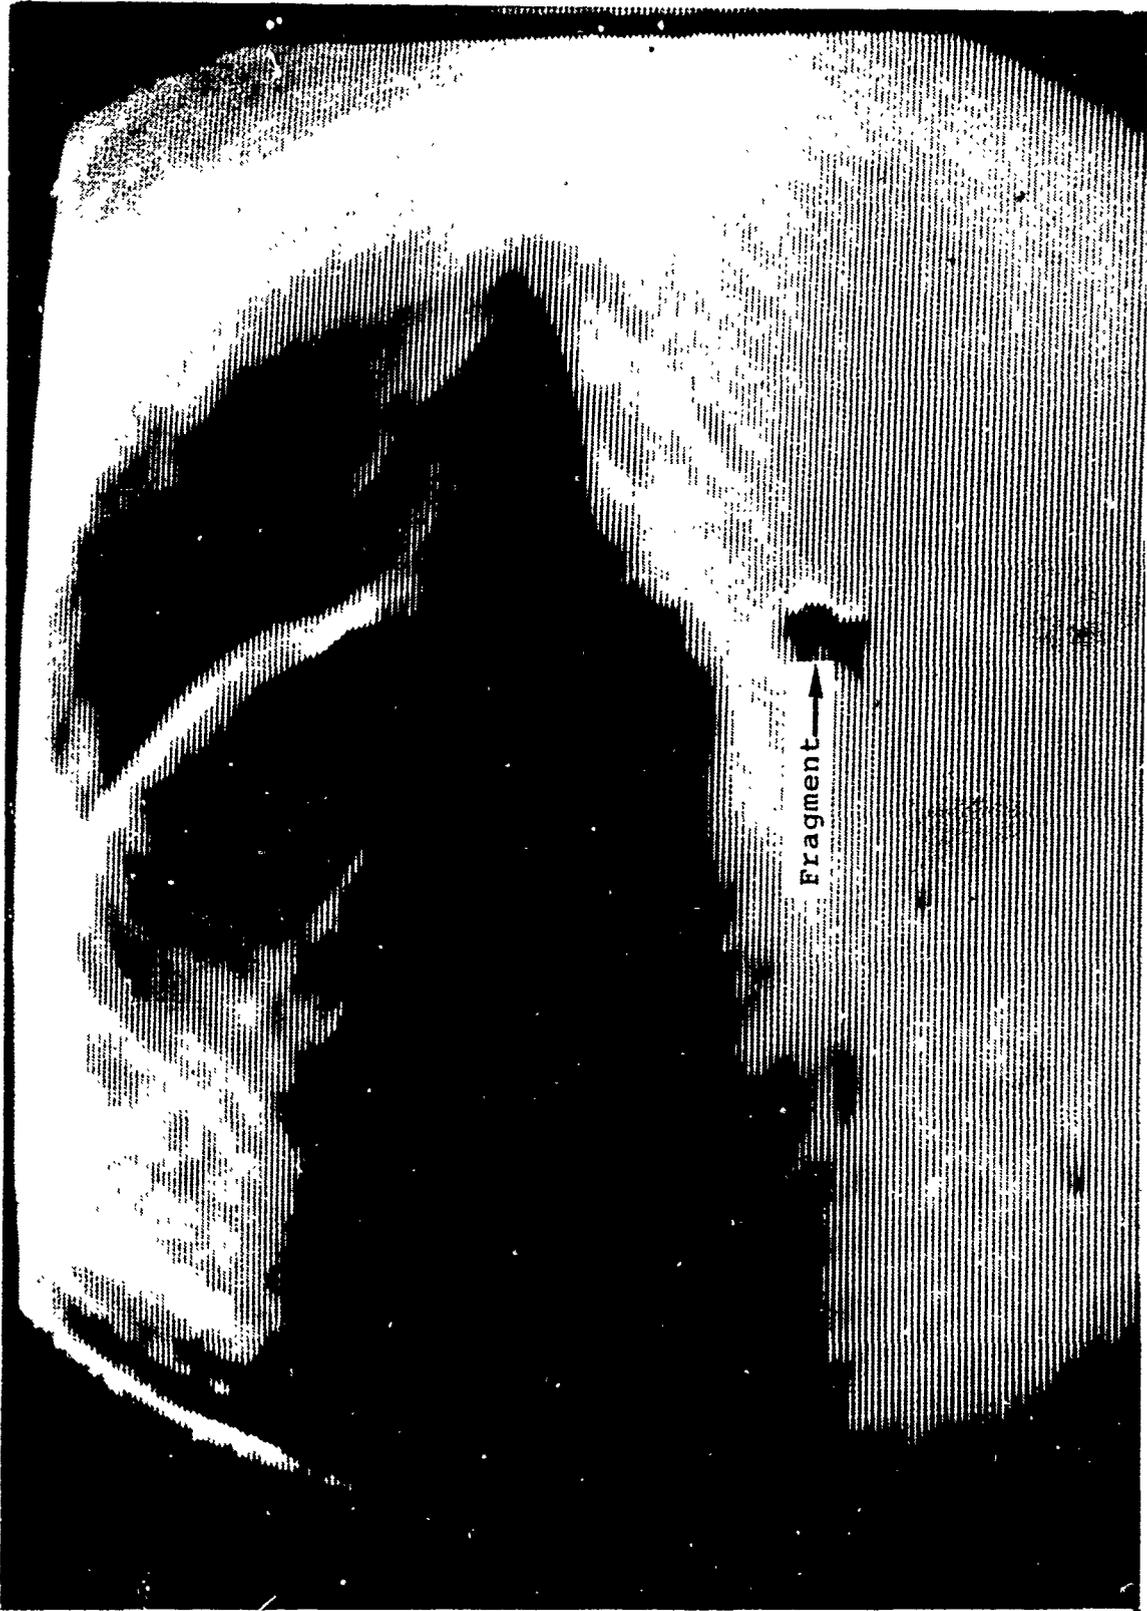
The interference pattern is missing in this image. The cause for this is unknown, but the brightness of this print indicates that the film (or print paper) is completely saturated. No evidence for cloud penetration is detectable.

Figure 10. 35-mm SLR Camera Reconstruction of Video Image, Shot #4, Tape #3

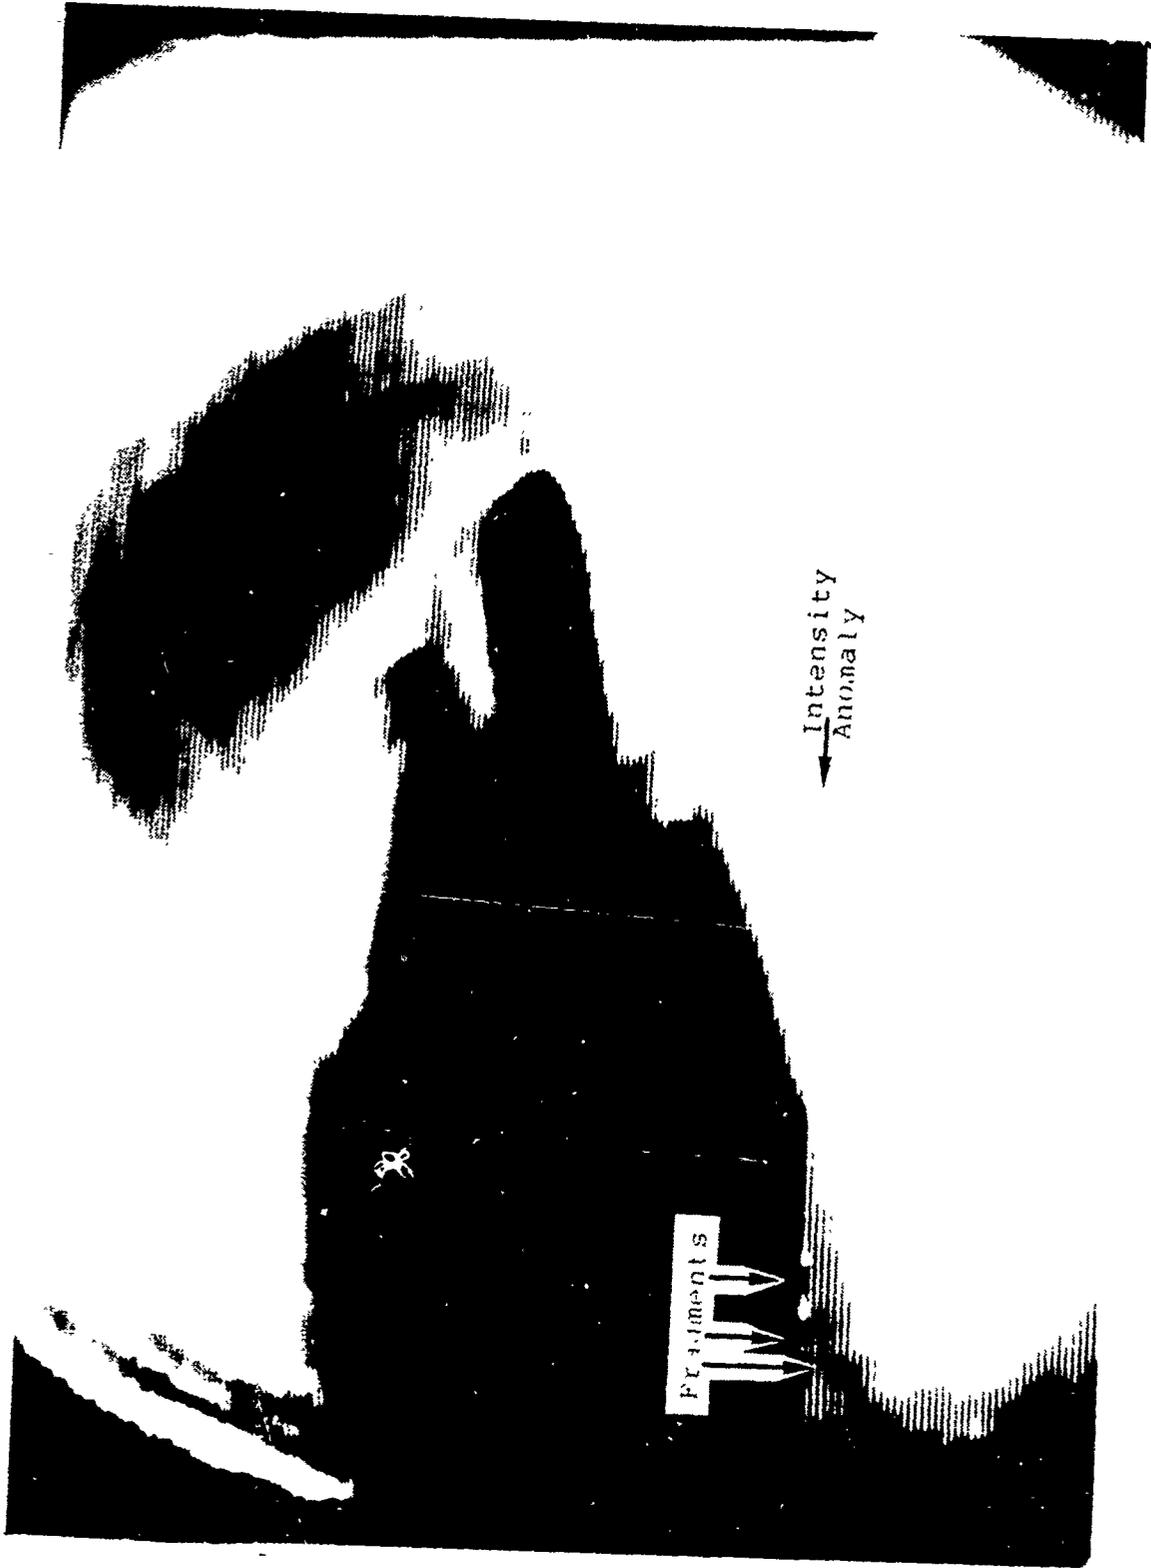
d. Figure 11, Shot #6, Tape #3. (270 microseconds after impact.)

The position of the scanning beam is clearly visible in this print. Below the line indicated on the figure, where the photocathode of the vidicon was scanned immediately after the

Figure 11. 35-mm SLR Camera Reconstruction of Video Image, Shot #6, Tape #3

laser fired, a good penetration of the cloud was achieved and some fragments are observable. Above this line (scanned later) the cloud appears to be much more dense. This is taken to indicate that the image on the vidicon face may decay much more rapidly than we were lead to expect--apparently even a short delay in reading the vidicon photocathode makes the cloud appear to be more dense than it really is.

displaying an anomalous behavior was given when the image illustrated in Figure 11 was examined closely. It will be noted that in the lower left-hand corner, there is a sharp line of demarcation (indicated by an arrow in the figure). Above this sharp line, the cloud of fine debris appears to be completely black; but, below the line it can be seen that an appreciable amount of light actually penetrated the debris cloud at some distance from the trajectory. This does not appear (at first) to be very significant, but the examination of other images illustrated that a strange phenomenon was occurring.

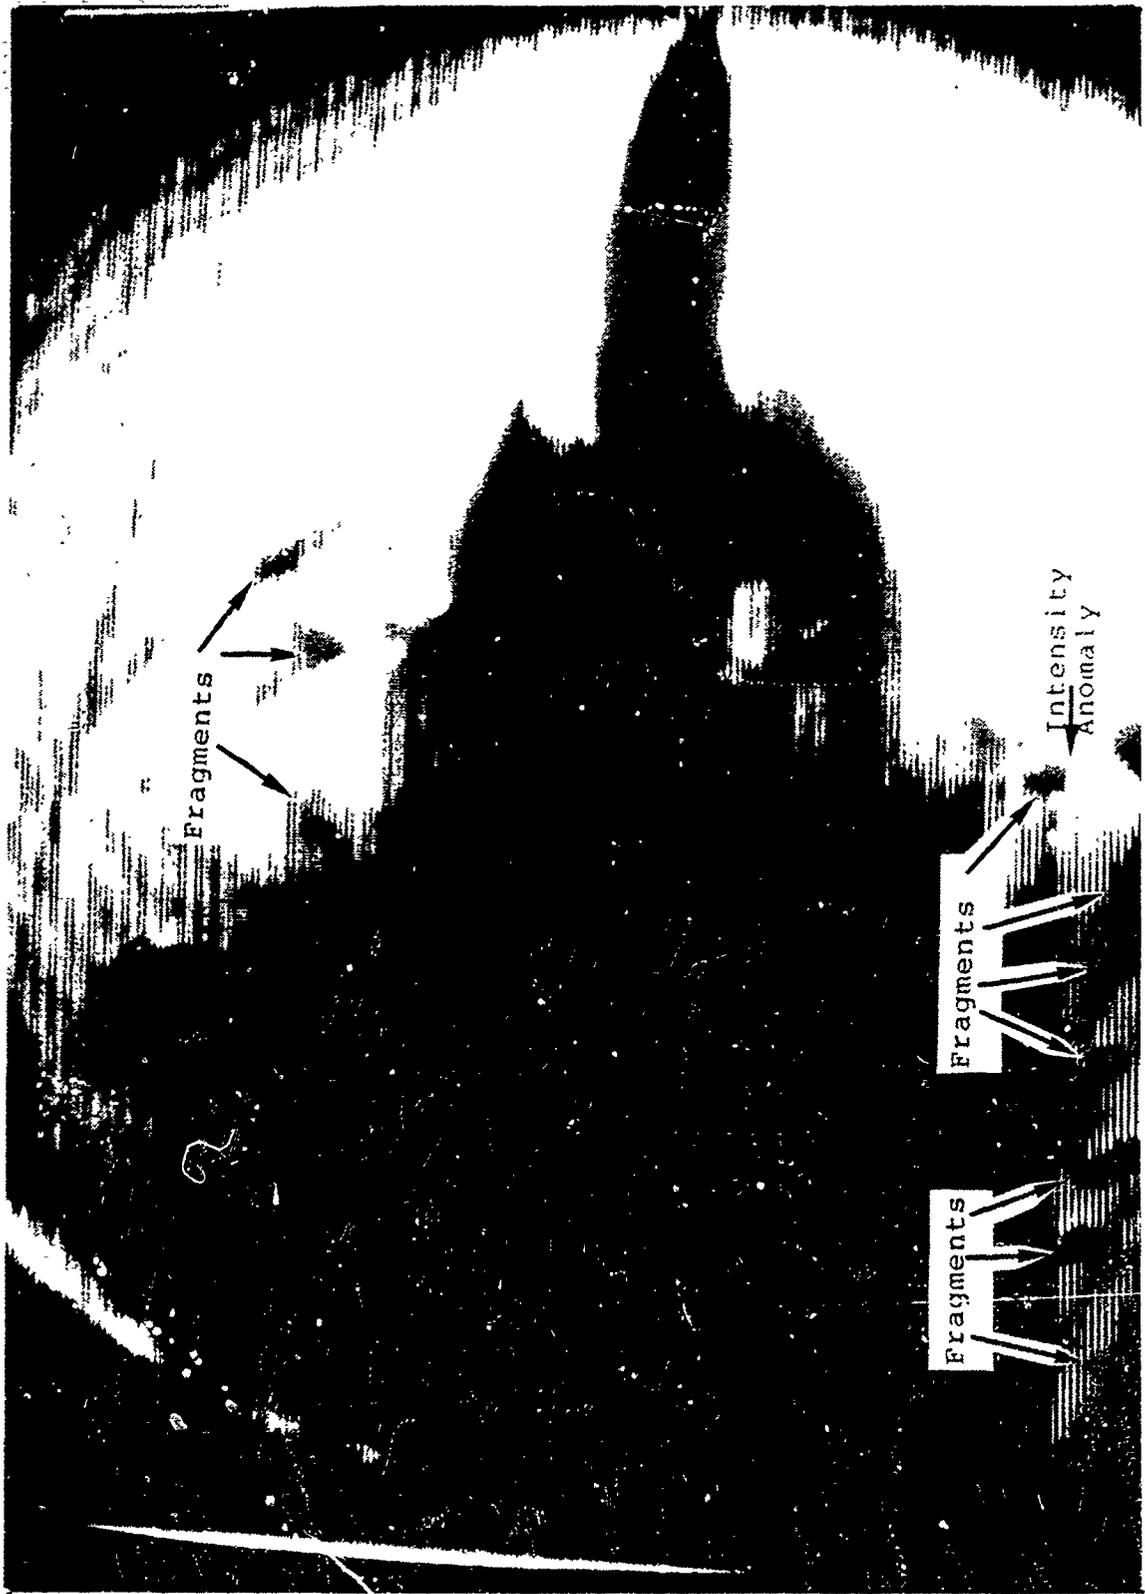
g. Figure 14, Shot #9, Tape #3. (320 microseconds after impact.)

The projectile has pulled even further ahead of the dense

Figure 14. 35-mm SLR Camera Reconstruction of Video Image, Shot #9, Tape #3

debris cloud. The effect of the image decay is very evident in the lower portion of this image. Below the sharp line of demarcation, the cloud is clearly penetrated (as in Figure 11). Above this line, the cloud appears to be extremely dense, but this is not real, the image on the vidicon has simply decayed so much that it appears to be much more dense than it really is.
