TECHNICAL REPORT GL-87-18

# COST-EFFECTIVE SURFACING FOR TRACKED-VEHICLE TRAFFIC

James E. Shoenberger

Geotechnical Laboratory

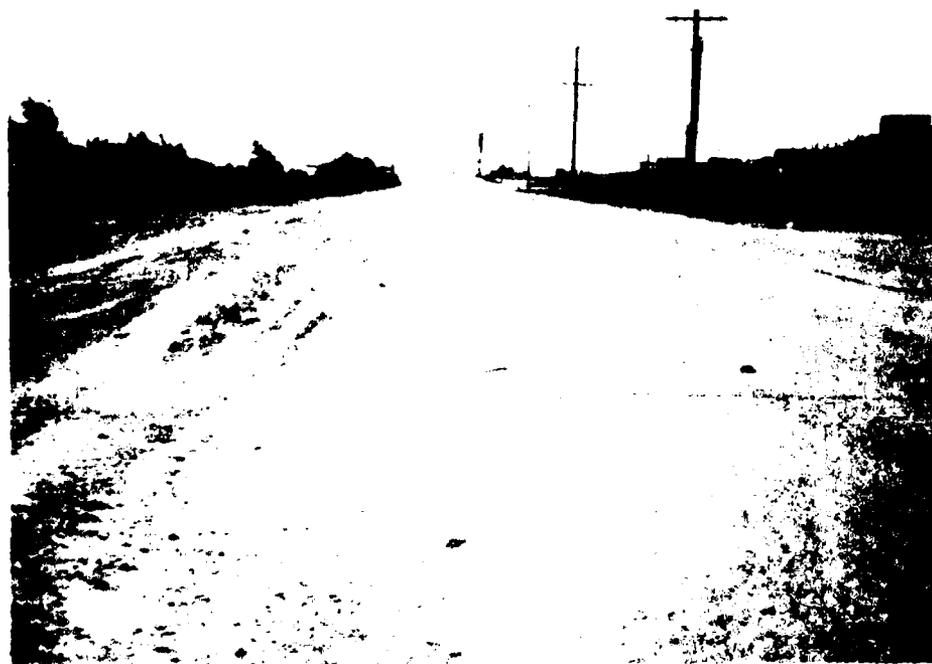
6. Intersections and along pavement edges were the problem areas for tracked vehicles on pavements. Wherever a tracked vehicle had turned, problems with scuffing or shoving occurred. Tracked vehicles, because of their width and speed, normally travel with their inside track on the middle of the traffic lane and the outside track on the shoulder or gutter causing distress to these structures (Photo 1). This traffic caused the outer edge of the pavement to wear faster than other areas, resulting over a period of time in the edge rounding (Photo 2).

12. Fort Hood had many PCC and asphalt concrete pavements that appeared to be in good condition except for the edges rounding off (Photo 2). This was

caused by the tracked vehicles running on the shoulder and the edge of the pavement. The PCC pavements are more difficult to repair and Fort Hood is currently seeking to replace the pavements with asphalt pavements to simplify repairs when they become necessary. Fort Hood also had many PCC pavement sections at tank crossings on asphalt roads. A problem had been encountered over the years as the asphalt pavement was overlaid, resulting in the formation of a dip at the PCC crossing (Photo 9). These dips had become severe. To alleviate this situation, concrete ramps were built up to these crossings and asphalt pavement was placed continuously throughout the road. These concrete ramps solved the major problem in crossing asphalt pavements--edge cracking. Fort Hood was increasing the use of asphalt concrete, which should have increased the amount of maintenance required while simplifying the repairs. Fort Hood had several parking and loading areas overlaid with asphalt pavement. These areas had received repeated fuel spills and had experienced damage from traffic (Photo 10).

Photo 2. Rounded pavement edge caused by tracked-vehicle traffic, Fort Hood

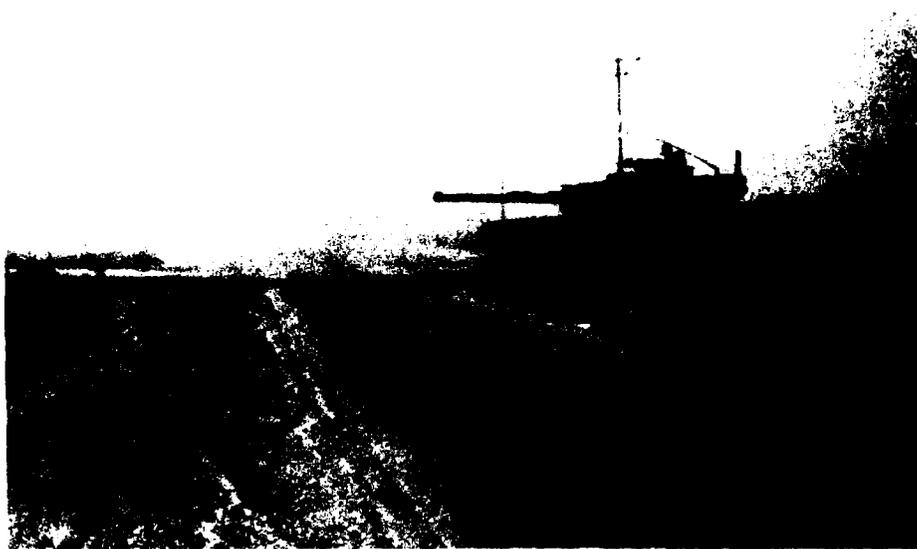
7. Tank-crossing areas also caused problems. When the crossing was from a dirt road, in addition to the wear on the pavement, there were problems with dirt being dumped from the tank tracks onto the pavement. A dust hazard also occurred at dirt road crossings (Photo 3). With enough cross traffic with tracked vehicles, differential wear will result to these pavement areas.

Photo 3. M-1 tank crossing paved road. (Note heavy dust resulting in obscured vision)

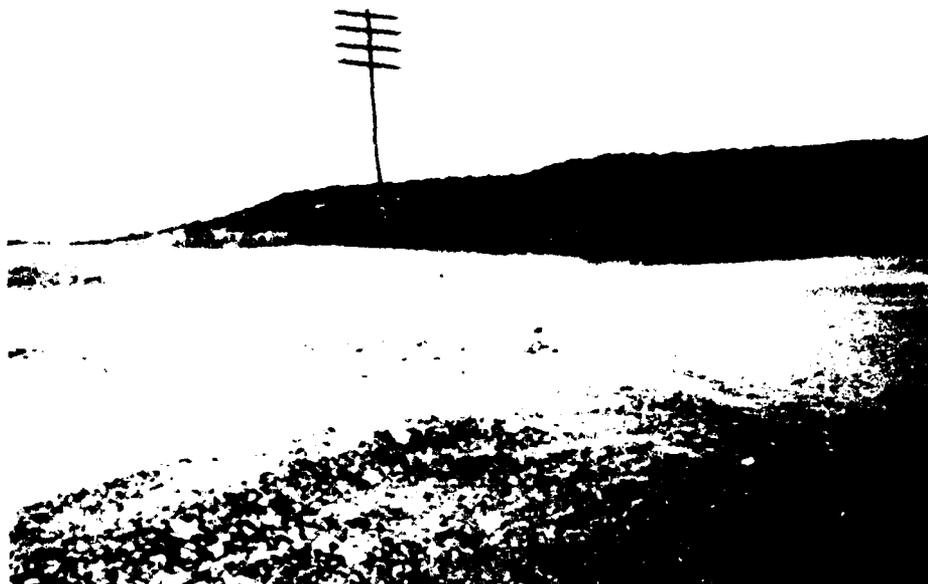
Photo 9. Dip on road at Fort Hood where PCC section intercepts asphalt cement road

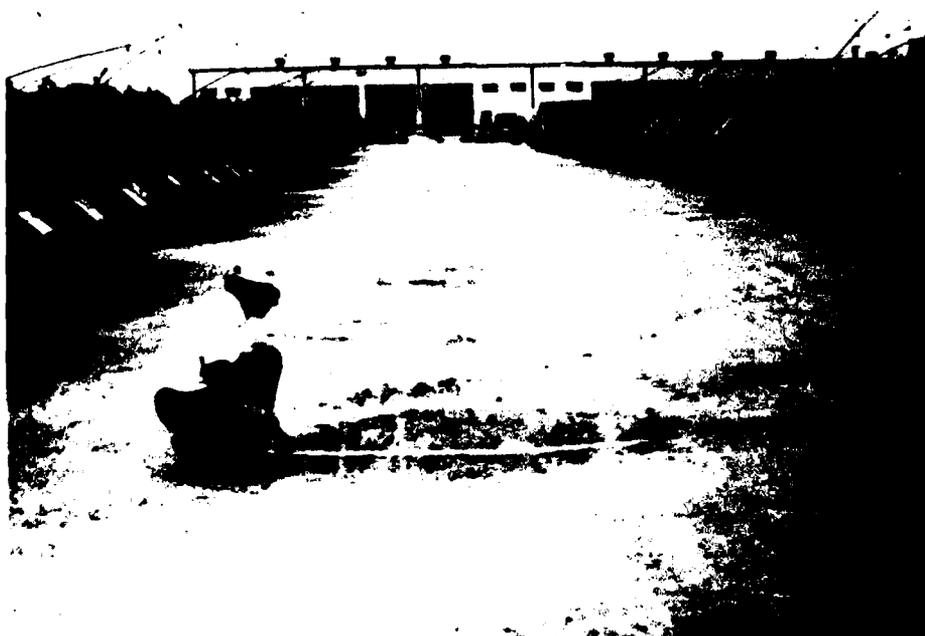
Photo 10. Parking area damaged by fuel spills

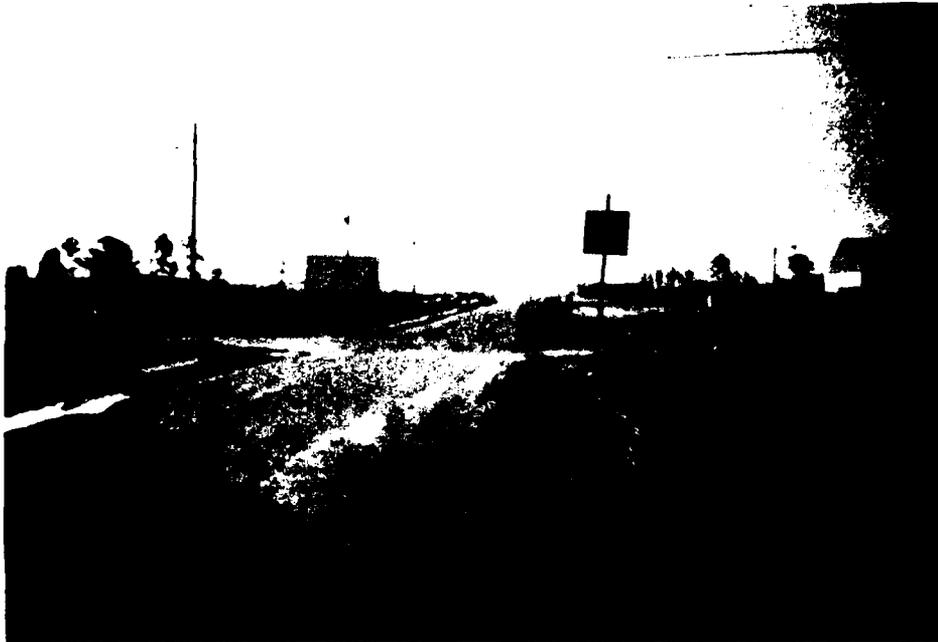
14. The survey of the pavements at Fort Stewart revealed distress similar to that observed at the other locations visited. Damage had occurred most frequently at intersections or wherever turns were made. Also, damage had occurred at the road edge, shoulders or gutters, or where there was heavy tank traffic (Photo 11).

Photo 11. Damage to road and shoulders caused by tracked-vehicle traffic

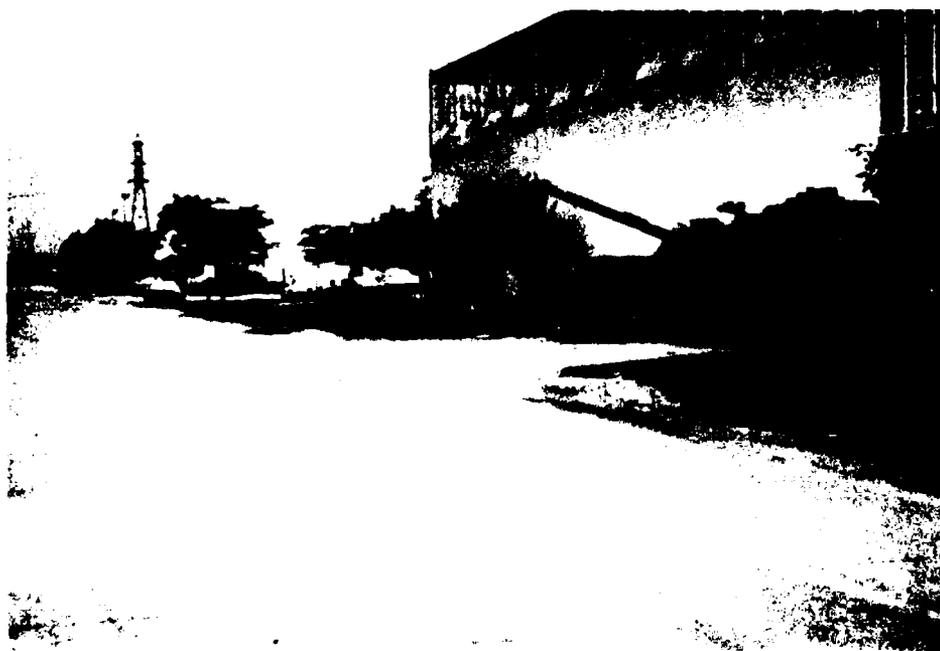
16. The pavement was in good condition with only a few surface defects (Photo 13). There was some surface scuffing where tracked vehicles had turned (Photo 14). This asphalt pavement was placed over PCC pavement and the underlying contraction joints had reflected through (Photo 15). These cracks were small and had not raveled. During construction, a problem was encountered with the slag aggregate in that the specific gravity of the slag varied so much that it was difficult to maintain the proper void content in the mix.

Photo 14. Surface scuffing from turning tracked vehicles

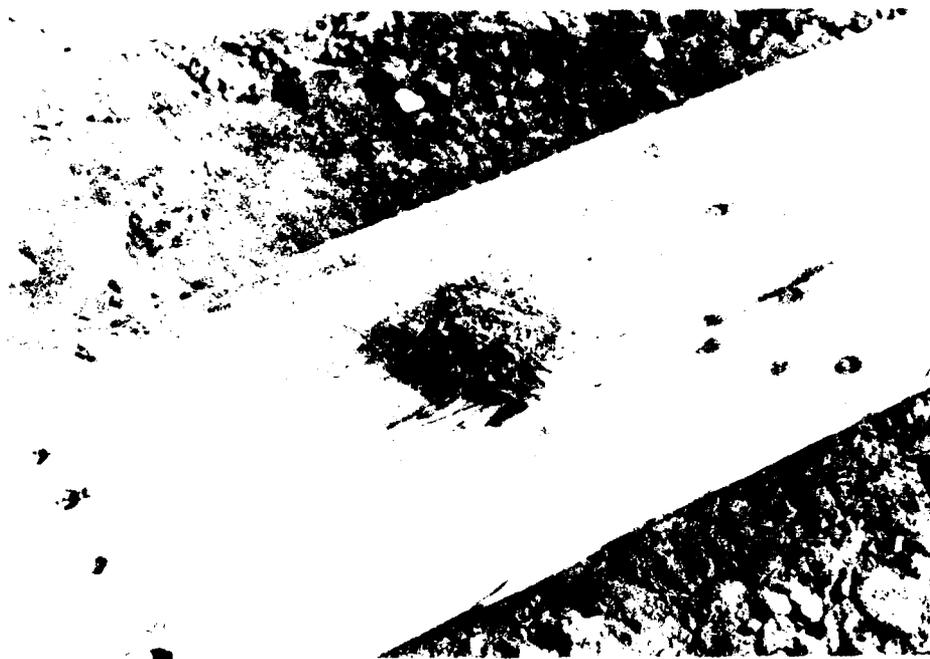
Photo 17. Steel fiber clumps (about 2 in. in diameter) that formed in the concrete

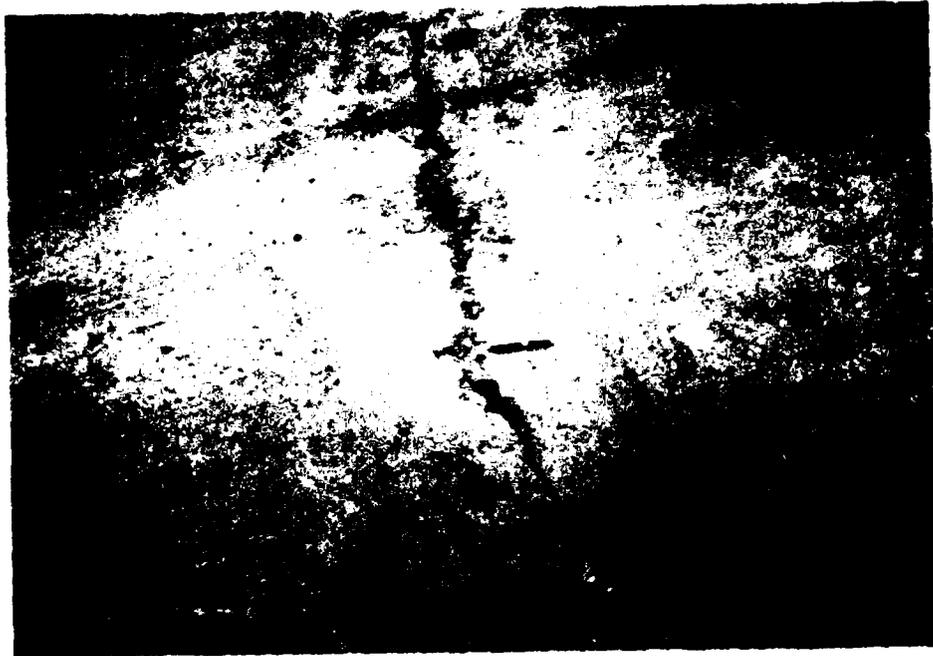
41. Performance. This 8-in.-thick RCCP was in good condition after an estimated 1,300 tracked-vehicle passes. Locked-track turns by an M-88 tank retriever caused no distress to this item. At the time of inspection, a shrinkage crack approximately 3/16 in. wide ran through the middle of the item and was lightly spalled (Photo 41). The remainder of Item I exhibited no distress. Beam samples were cut from this item (Figure 5). Table 11 gives the results of the flexural strength tests performed on the samples. Test results indicate that the RCCP exceeds the flexural design strength requirements of 650 psi.

Photo 41. Shrinkage crack, Item I

83. Use RCCP for tracked-vehicle traffic. The optimum thickness will depend on the amount of traffic and the strength of the underlying surface. In many cases, RCCP can be placed directly on the existing grade surface. Shrinkage cracks forming in the RCCP surface may require periodic maintenance. This maintenance should be no more severe than that normally associated with conventional concrete pavements.

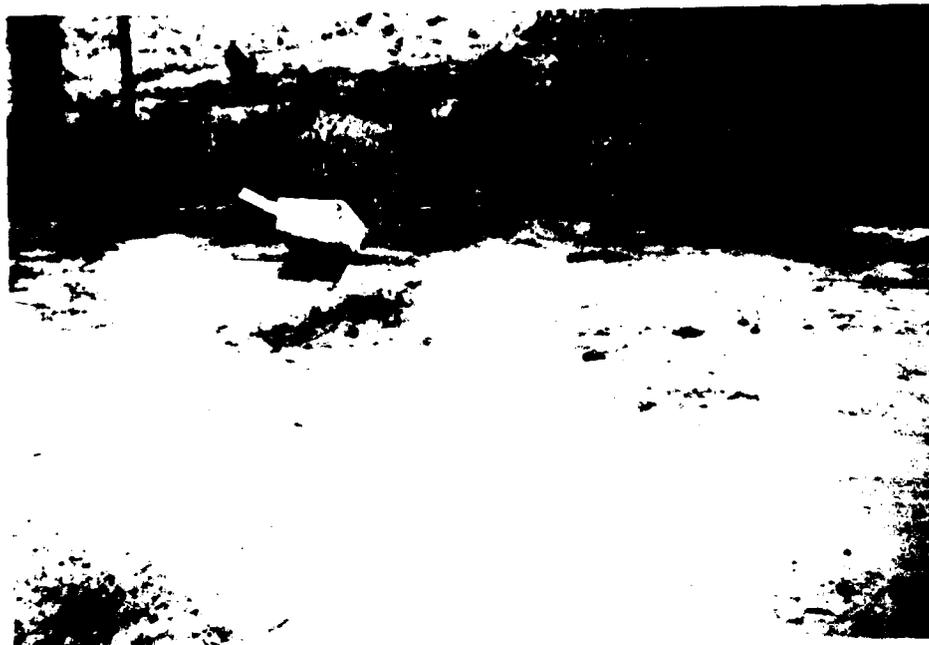
43. Performance. This 6-in.-thick RCCP was in good condition after an estimated 1,300 tracked-vehicle passes. Locked-track turns by an M-88 tank retriever caused no distress to this item. A shrinkage crack approximately 1/8 in. wide ran through the northern end of the item and was spalled lightly (Photo 42). The remainder of the item exhibited no distress. Two beam samples were cut from the item (Figure 5). The results of flexural strength tests performed on these samples are given in Table 11. Test results indicate that the RCCP exceeds the average flexural design strength requirement of 650 psi. The lower flexural strengths found in the bottom half of several of the pavement samples for Item J were from voids caused by either segregation during placement or inadequate compaction (rolling). These void areas were not widespread, but this type of deficiency may cause localized failure under traffic.

Photo 42. Shrinkage crack, Item J

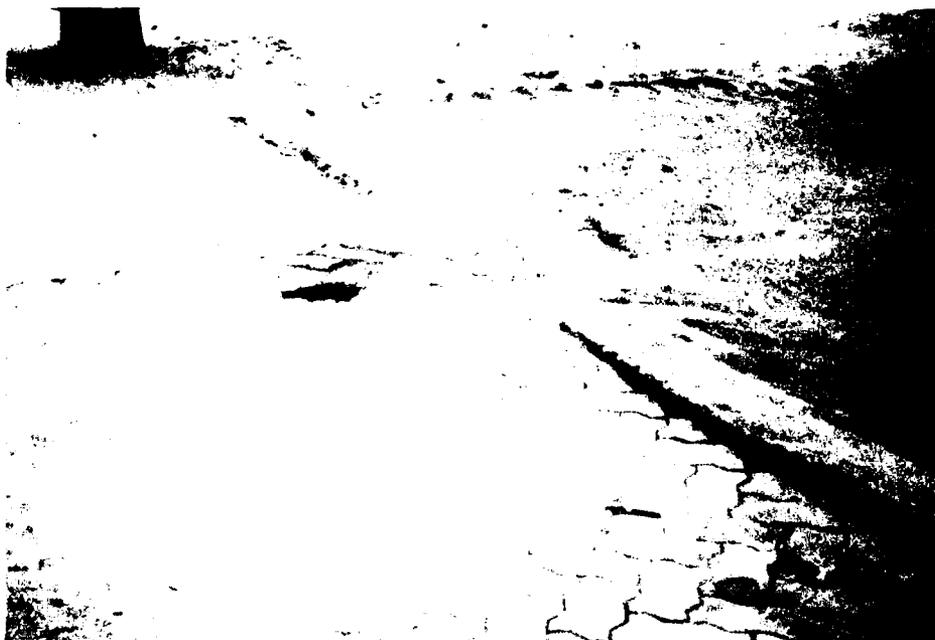
54. The paving blocks were in good condition and showed only minor distress after an estimated 2,100 tracked-vehicled passes. The locked-track turns made by an M-88 tank retriever caused no distress to this item (Photo 54). There was approximately 1/2 in. of settlement across the entire item, with additional rutting approximately 1/2 in. deep in the traffic lanes as a result of traffic (Photo 55).

Photo 54. After turns of the retriever, Item D (foreground) and Item E (background)

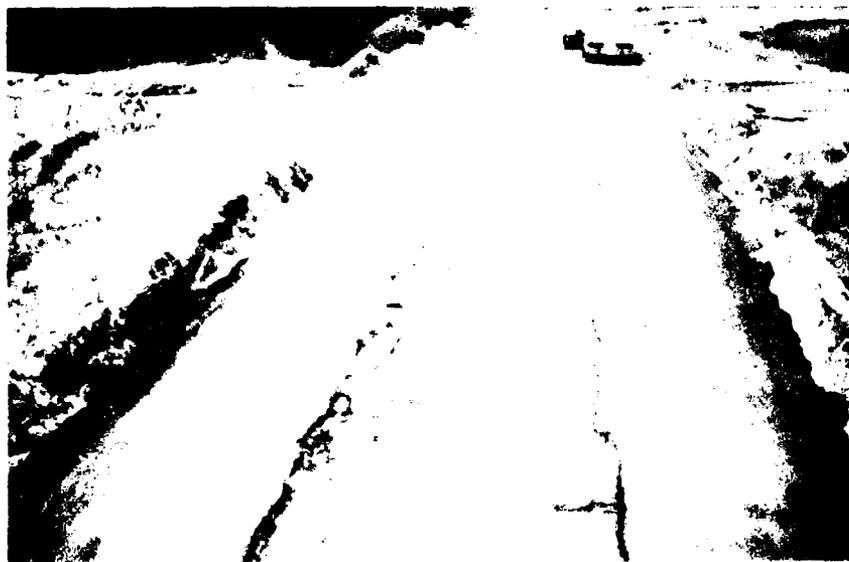
61. A total of 4 in. of asphalt in two equal lifts was to be placed in this item. However, mechanical problems encountered with the original paver caused uneven lift thicknesses resulting in final thickness variations of 4 to 5 in. over the entire item (Photo 62). A second paver was obtained the next day and used to complete this item and the two other asphalt items. The base course was primed prior to paving. The surface of the intermediate lift, after the first day, showed about 12 ft<sup>2</sup> of cracking on each edge of the pavement. The cracking did not appear to be a problem related directly to the asphalt; instead, it appeared to be alligator cracking. The asphalt was compacted with approximately four passes each of a dual-drum vibratory roller and a 20-ton rubber-tired roller. The cracks that developed at the intermediate lift showed up in the surface lift (Photo 63). The final densities obtained in the pavement averaged 94.4 percent of the laboratory density (Table 15). Figure 6 gives locations of the cores that were taken.

Photo 62. First-day construction, Item G (paver breakdown caused uneven lift thicknesses)

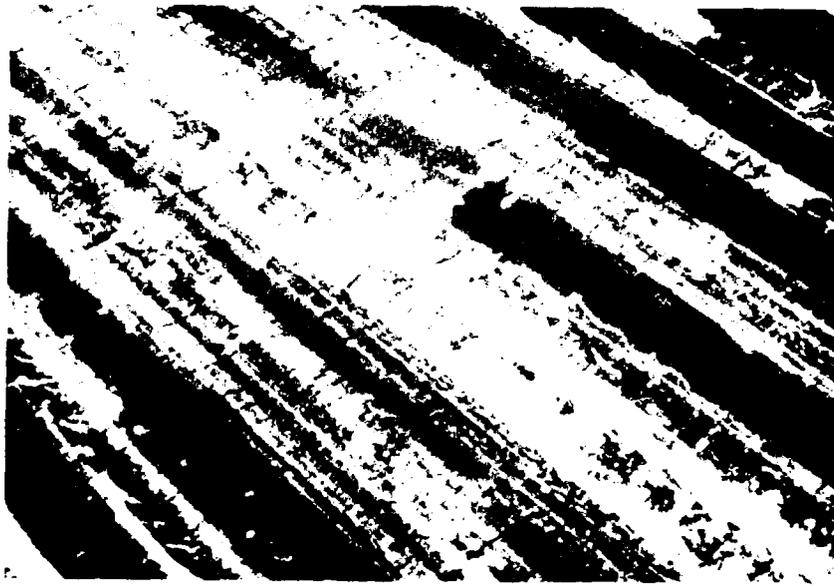
80. The asphalt concrete in Items E, G, and L has performed well in all. The cracks developing in these items during construction (compaction of the asphalt mix) were caused by localized base failures because of excessive moisture in the underlying base course. The low densities obtained were caused by the combination of equipment problems, maneuverability restraints throughout all asphalt concrete items, and the small volume of material placed (Table 14 and 15). The scuffing of Item E occurring during locked-track tests

Photo 63. Cracks that formed after rolling, attributed to base failure

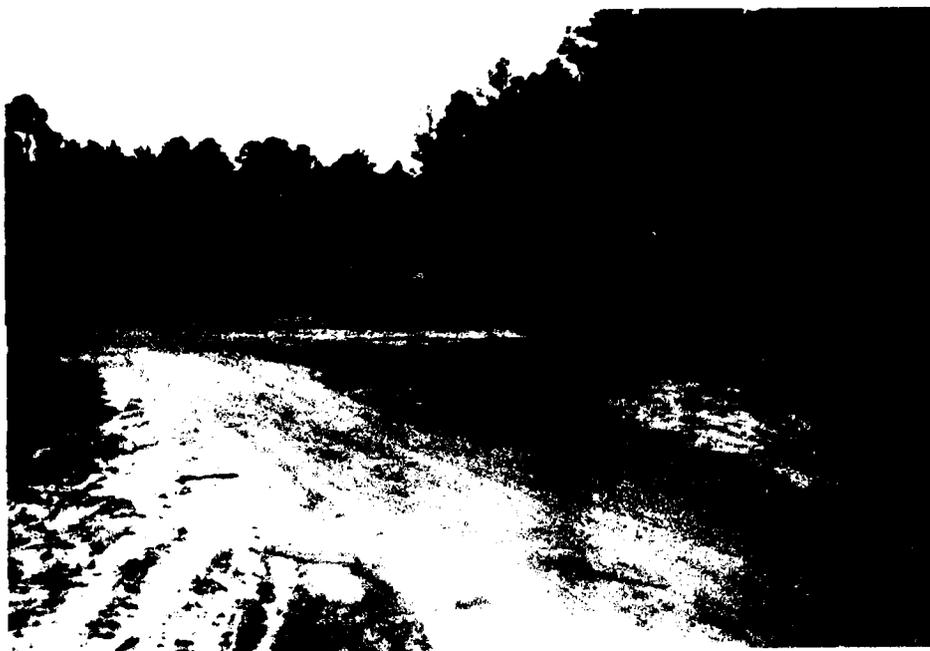
75. The effects of traffic on the test section, especially Items F, G, H, and L, have been tempered because of the amount of soil that has been dumped and washed onto these items. Because of the improper grading of the shoulders, an average of 2 to 3 in. of soil covers most of these items (Photo 67). Although this soil protects the pavement surface, it also allows the soil to be carried onto maintenance areas, requiring additional cleaning.

Photo 67. Dirt covering, from foreground to background  
(2 to 3 in.), Items L, H, G, and F
