AEFA PROJECT NO. 86-20

PRELIMINARY AIRWORTHINESS EVALUATION  
OF A UH-1 EQUIPPED WITH A TERRAIN MAPPING  
RECEIVER ANTENNA

FEBRUARY 1987

FINAL REPORT

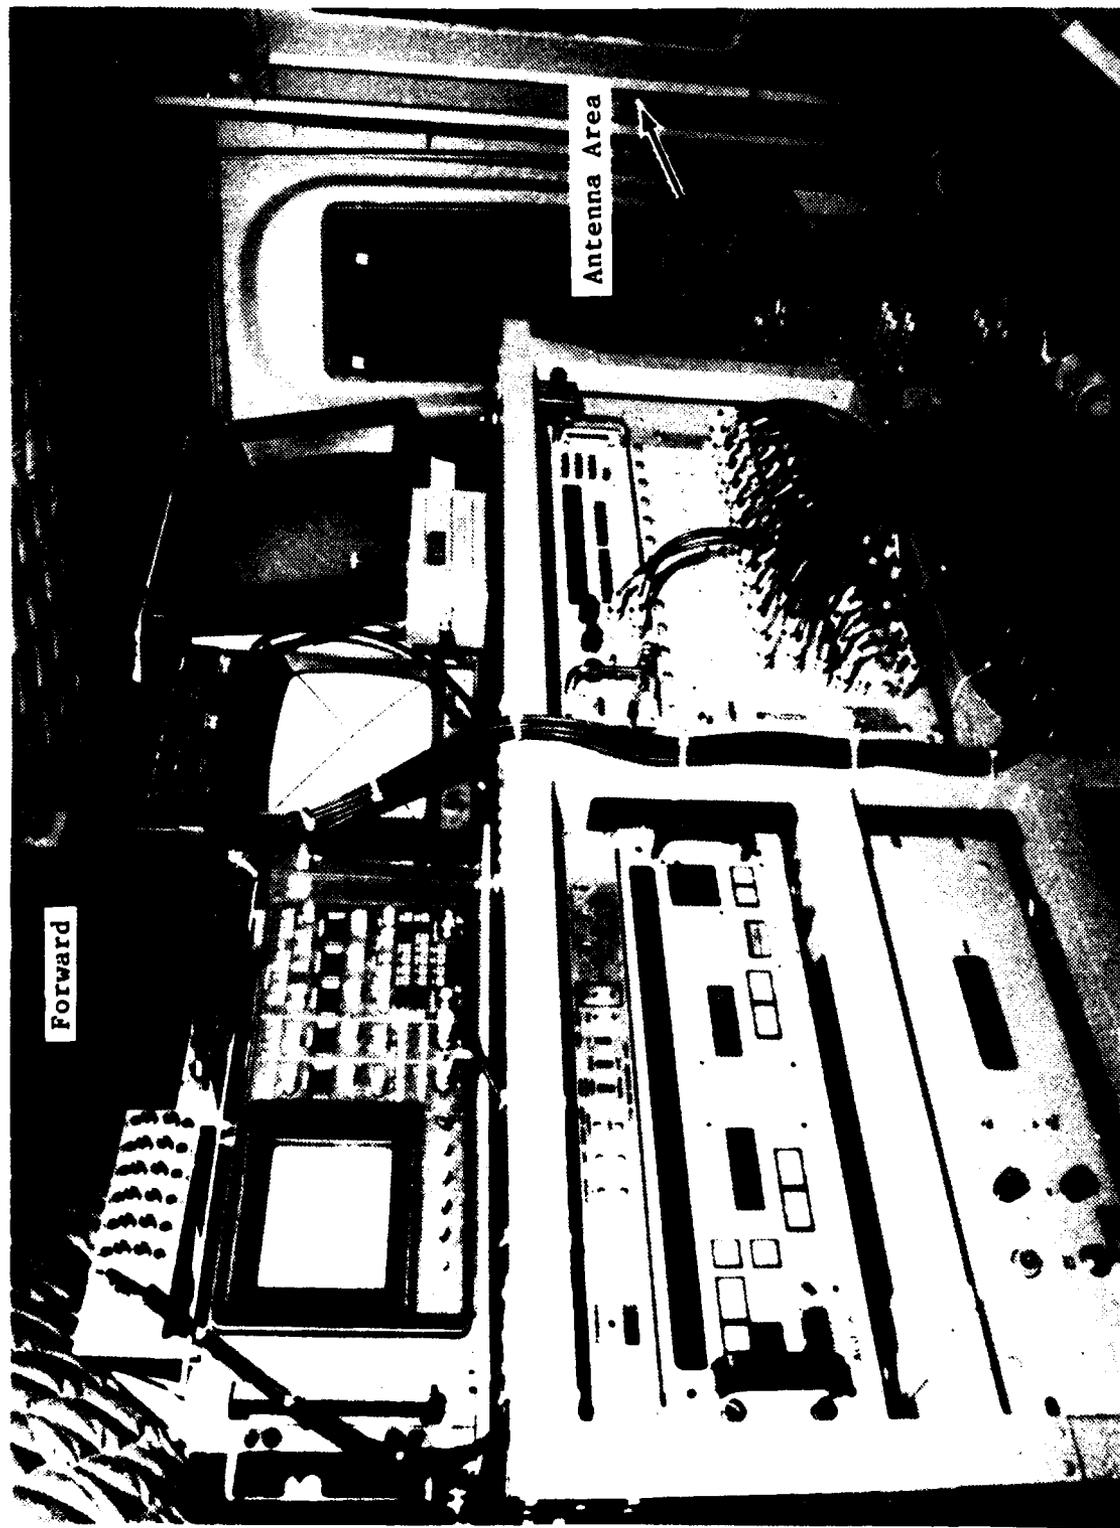
Photo 2. Electronic Equipment at the Operator's Station

19. The crew and cargo compartments were qualitatively evaluated throughout the test program. Electrical mission equipment was installed in the cabin area (photo 2). The only onboard fire extinguisher was located on the floor to the right of the pilot's seat. The mission equipment operator did not have immediate access to this fire extinguisher. Due to the great extent of electrical mission equipment located in the cabin area, a greater electrical fire hazard existed than in a standard UH-1H helicopter. A portable fire extinguisher should be installed in the cabin area and be accessible to the mission equipment operator in flight.

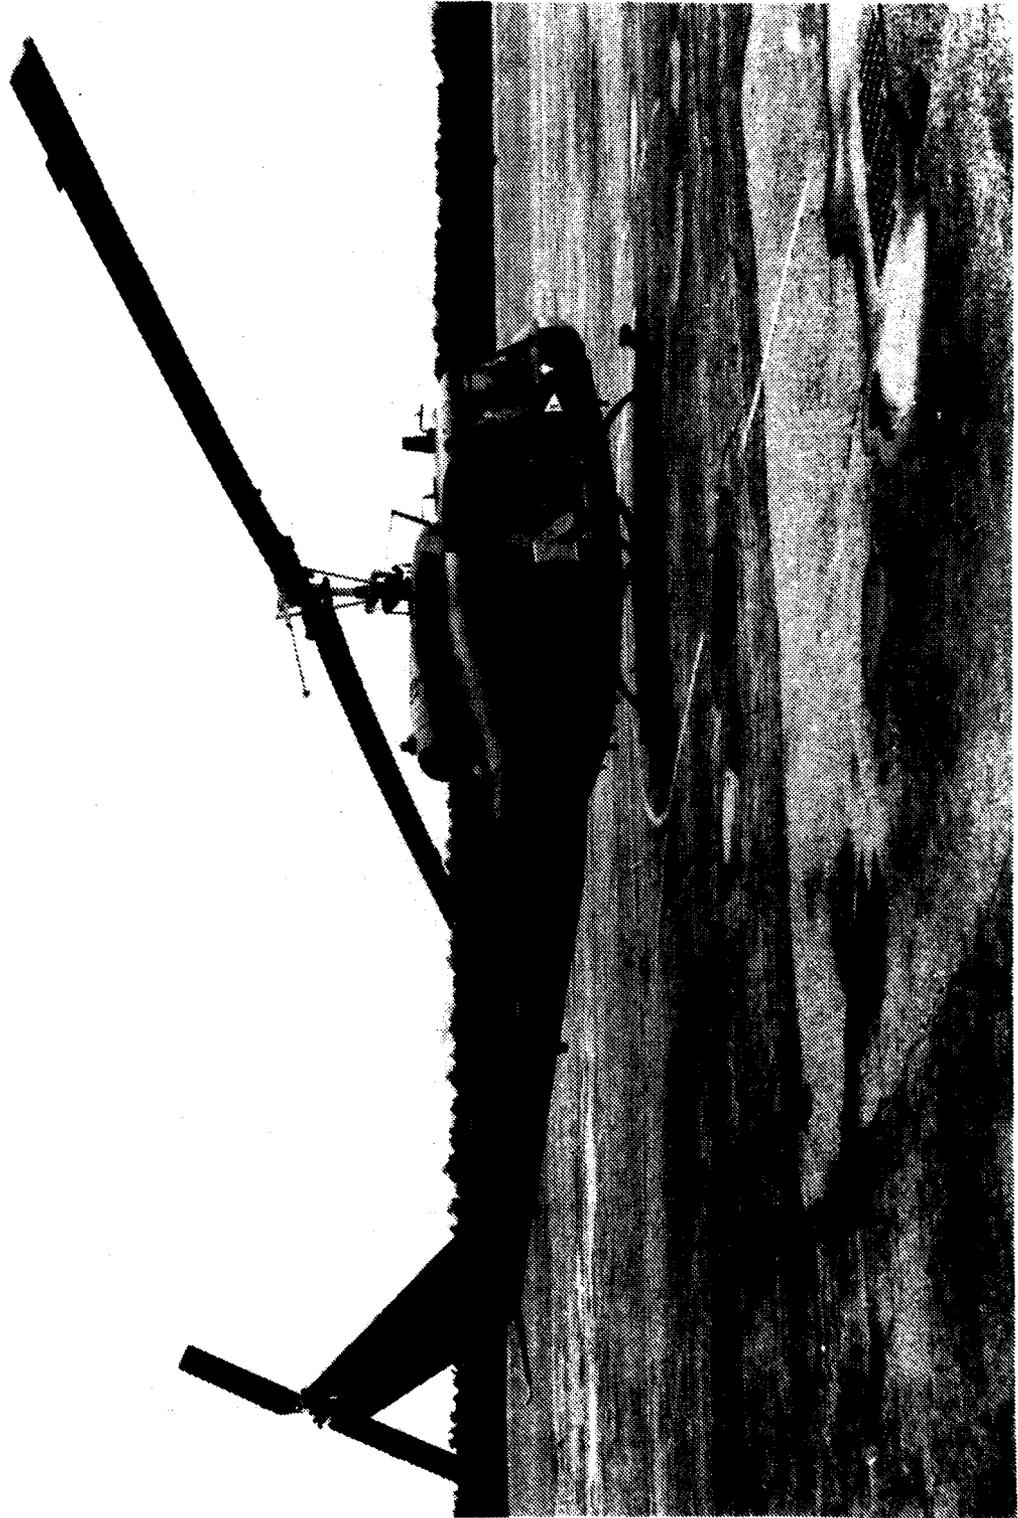
Photo 7. Modified UH-1H Helicopter (Ferry Configuration)

servo motors which positioned the antenna within the full range of motion (+10 deg to -18 deg elevation and +26 deg azimuth) while at a hover. When electrical power is removed from the servo motors, the antenna is free to rotate about any axis. Consequently, the receiver antenna was designed to be mechanically secured to the helicopter with four support tubes when in transit to and from the operational area. A full description of the terrain mapping radar system is contained in the pamphlet "Four Axis Gimbal System Transmitting Model 5550-85 Receiving Model 5050-85" (ref 4). The receiver antenna, yoke assembly, and cantilever beam may be removed for ferry flights, leaving only the vertical support structure and antenna electrical components mounted in the antenna area (photos 6 and 7).
