DYNAMIC TEST OF A CORRUGATED STEEL KEYWORKER BLAST SHELTER MISTY PICTURE

Structures Laboratory

DEPARTMENT OF THE ARMY
Waterways Experiment Station, Corps of Engineers
PO Box 631, Vicksburg, Mississippi 39180-0631

Final Report

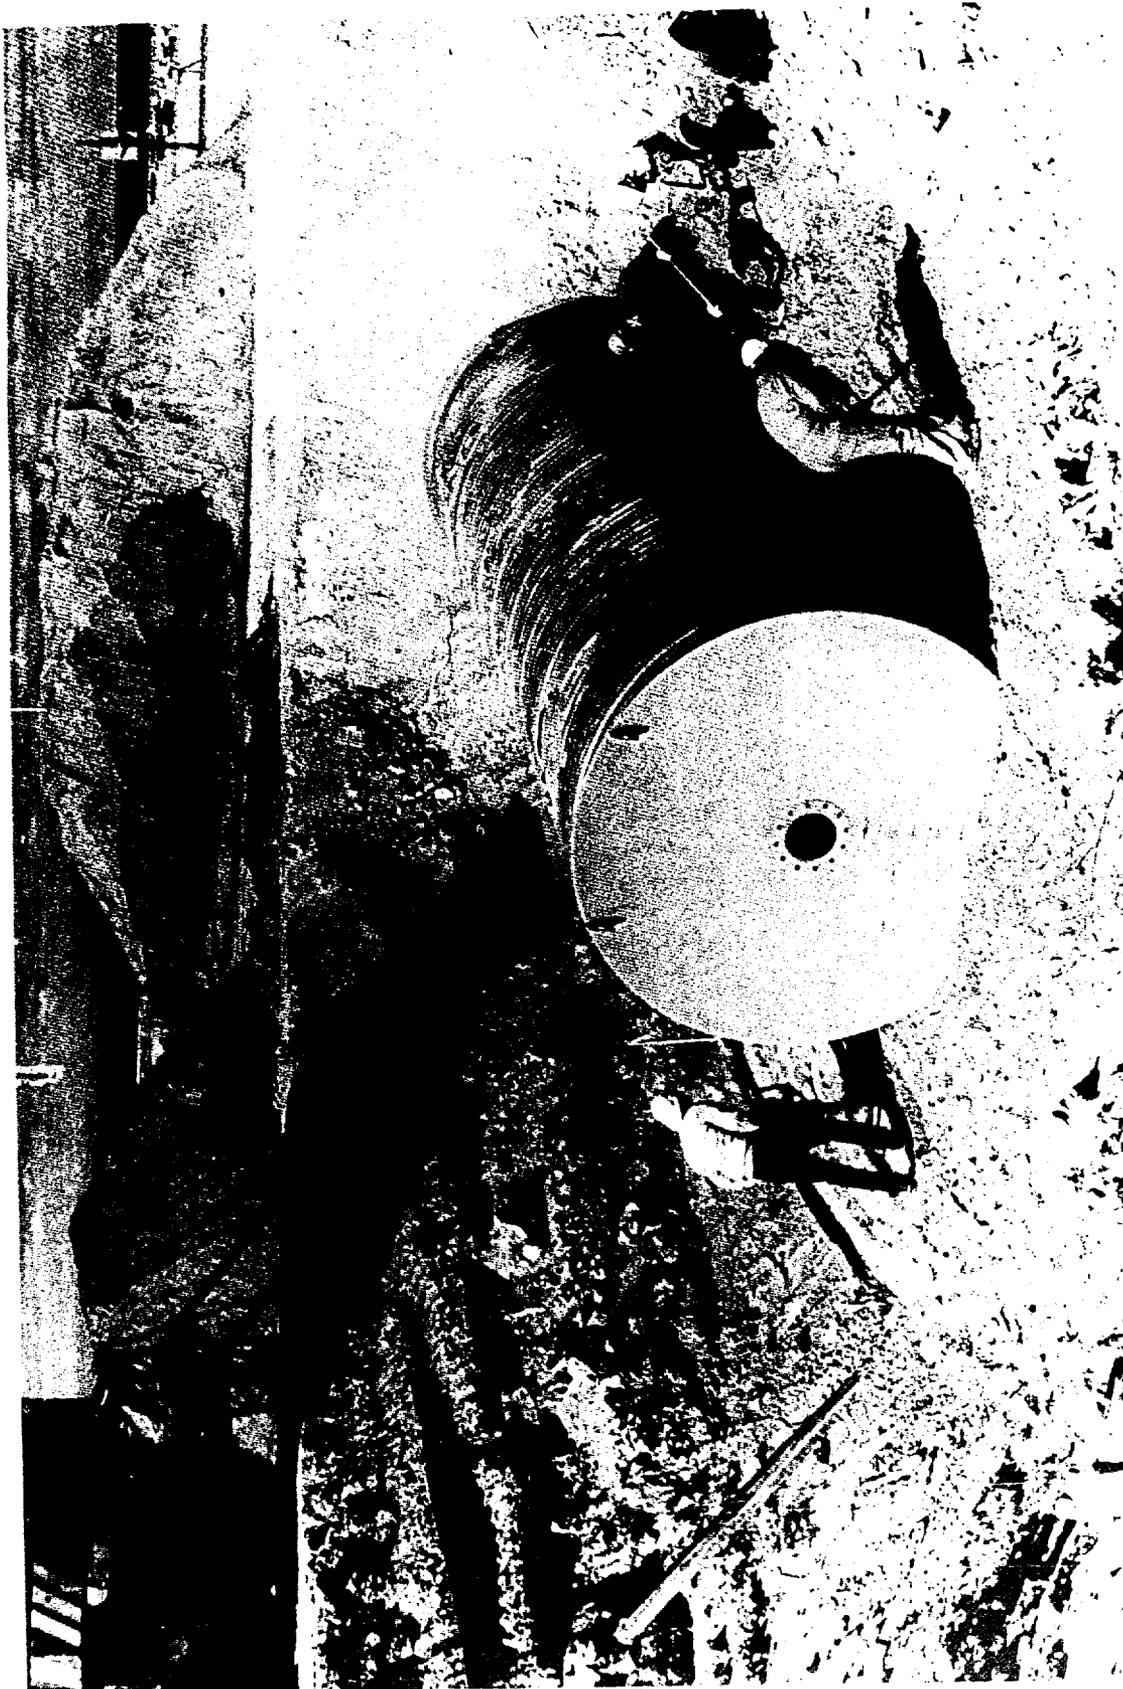
Figure 2.1. The 18-man shelter without the entryway and ventilation system attached.

The blast shelter shown in Figure 2.1 was furnished by HND. It was constructed by a private contractor in accordance with the plans and specifications provided by HND. Detail drawings of the shelter are presented in Appendix A.

The main section of the shelter was fabricated from a 9-foot-diameter, 27.5-foot-long section of 10-gage, galvanized, corrugated steel culvert. The entryway shaft and ventilation stacks were constructed from 14 gage, 36- and 12-inch-diameter culvert sections, respectively. The entry hatch was constructed from a 1/8-inch-thick dished plate that was filled with vermiculite and covered with fiberglass as shown in Appendix A, Detail 1. The endwalls were constructed from ASTM A36, 3/16-inch-thick steel plates. All structural connections, splices, and joint connections were waterproofed. Steel blind flanges were provided for the air intake and exhaust stacks. These flanges were used to prevent the blast pressure from entering the shelter during the test since blast valves were not included.

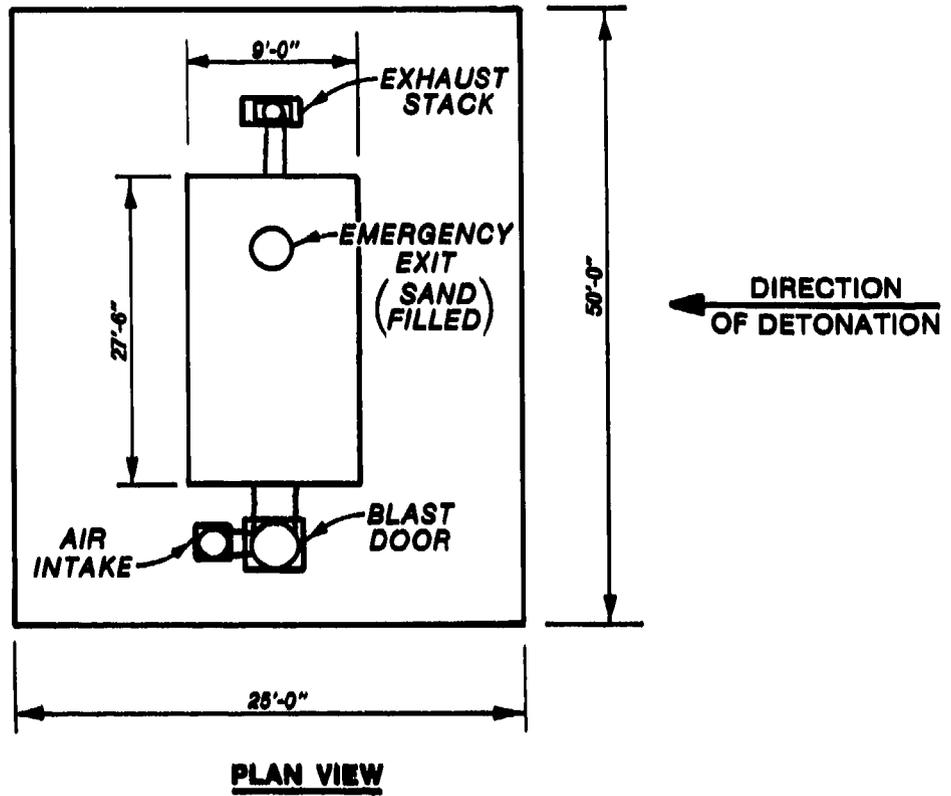
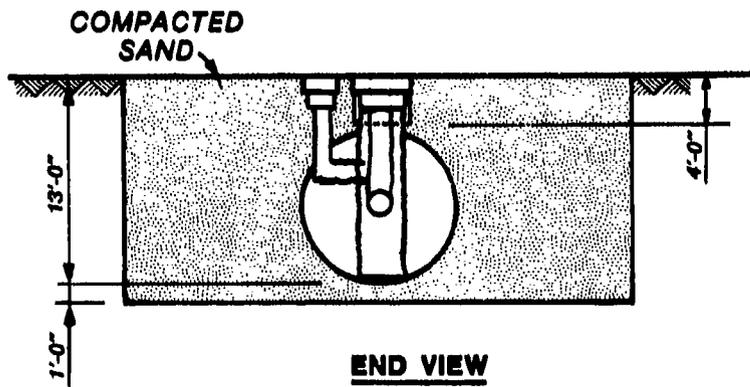
Figure 2.2. Test bed configuration.

The test bed configuration is shown in Figure 2.2. The test bed was approximately 50-feet-long, 25-feet-wide, and 14-feet-deep. The backfill material used during this test was a locally available material referred to as

blow sand. A 1-foot layer of blow sand was placed in the test bed prior to placement of the main section of the shelter. Based on the backfill densities obtained using blow sand in similar tests conducted on the WSMR, the initial backfill layer was placed in the test bed with a thickness of 6 inches. Using this layer thickness, the average dry and wet densities were 98.9 lb/cu ft. and 103.6 lb/cu ft., respectively, at an average moisture content of 4.5 percent.

To achieve the desired compaction, all remaining backfill layers were placed in the test bed in 4-inch-thick layers. These layers were compacted using three passes of a Ditch Witch, model DP-190, crawler vibrator, and with two passes of a hand compactor. Where necessary, the area along the sides of the shelter was compacted with a Wacker Rammer, model GVR 200, compactor. Backfill densities and moisture contents were not monitored for each layer but were monitored at various depths throughout the test bed using a Troxler model 3400-B series surface moisture-density gage. The average dry density, average wet density, and average moisture content at midheight of the shelter were 100.9 lb/cu ft., 108.0 lb/cu ft. and 6.6 percent, respectively. After approximately 8-ft. of blow sand had been placed in the testbed, backfill properties were again monitored. The average dry density, average wet density, and average moisture content were 101.5 lb/cu ft., 106.2 lb/cu ft. and 4.4 percent, respectively.

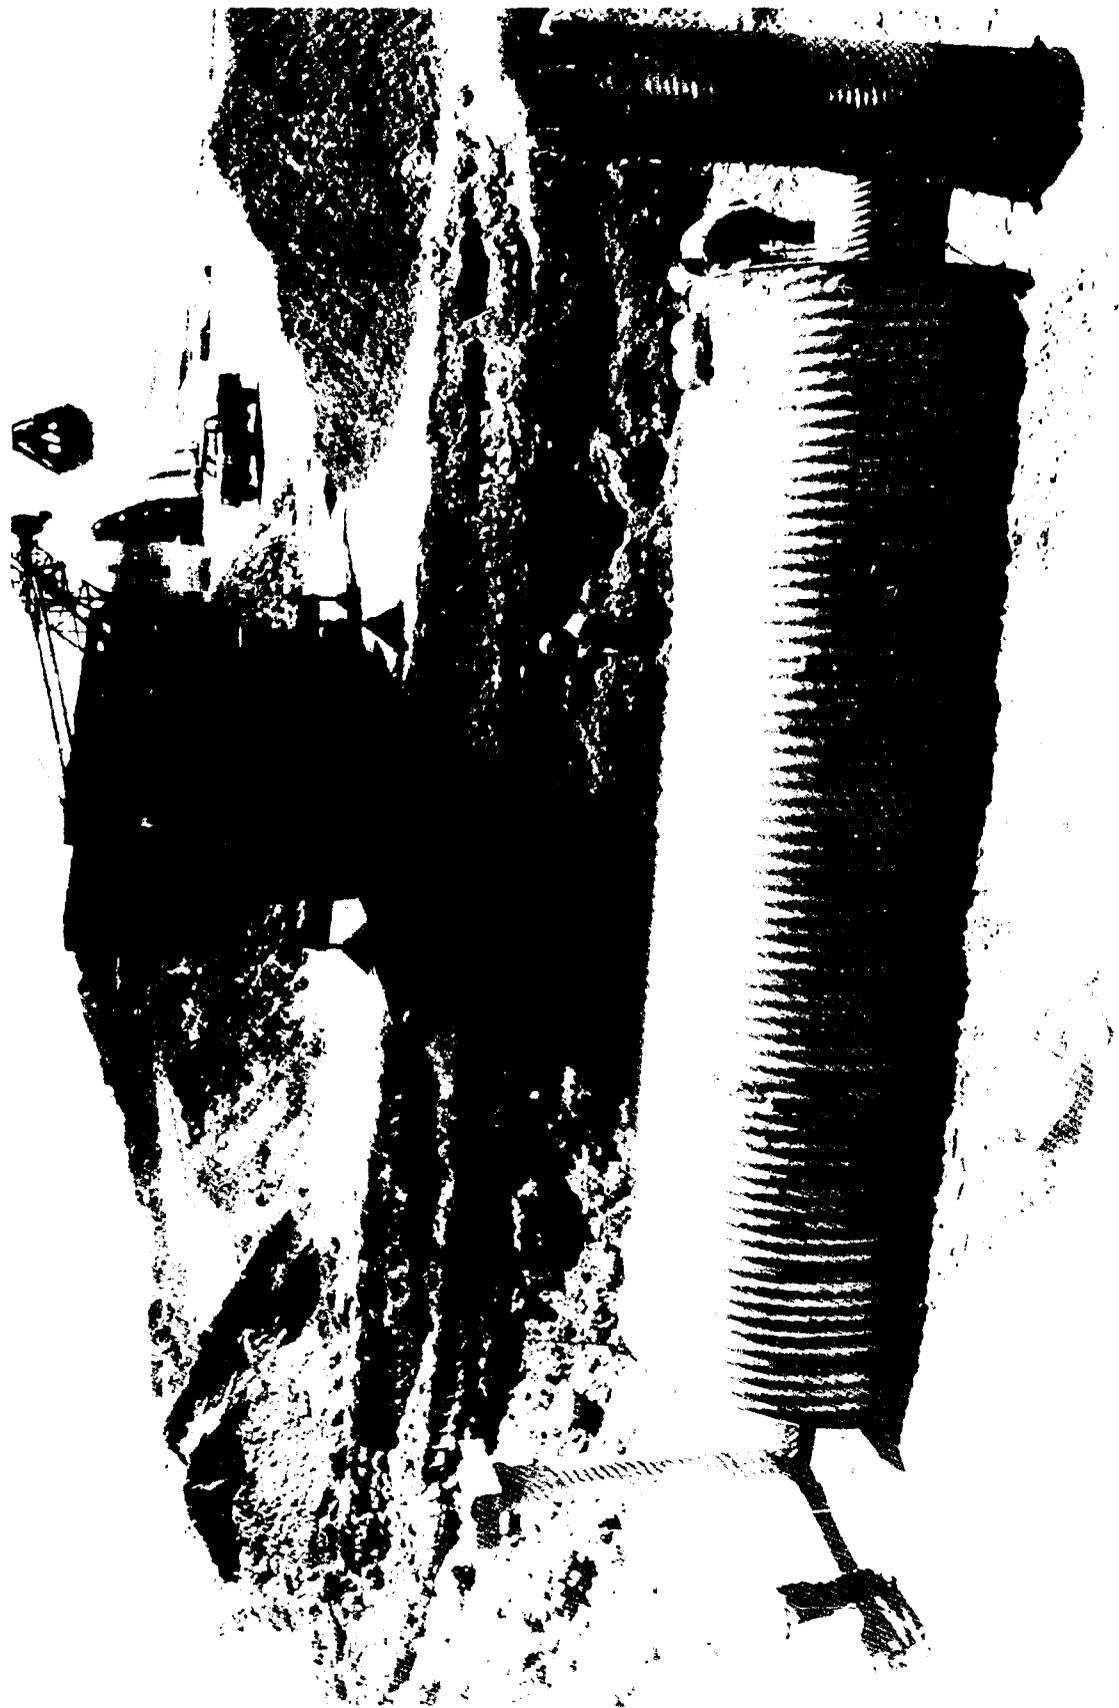
Figure 2.3. The 18-man shelter with the entryway and air exhaust stack attached.

After approximately 3 feet of blow sand had been placed into the test bed, the entryway was bolted to the front endwall as shown in Figure 2.3. The air exhaust stack was bolted to the rear endwall after approximate 4 feet of blow sand had been placed into the test bed. The air intake stack was bolted to the entry shaft after approximately 7 feet of blow sand had been placed into the test bed. After approximately 11 feet of backfill material had been placed in the test bed, the emergency exit shaft was installed. It was placed over the shelter such that approximately 2 inches of blow sand separated the bottom of the emergency exit shaft and the top of the shelter. A total of 4 feet of backfill material was placed over the top of the shelter. The surface of the test bed was leveled and the airblast gage mounts were installed flush with the ground surface at the locations shown in Figure 2.4.

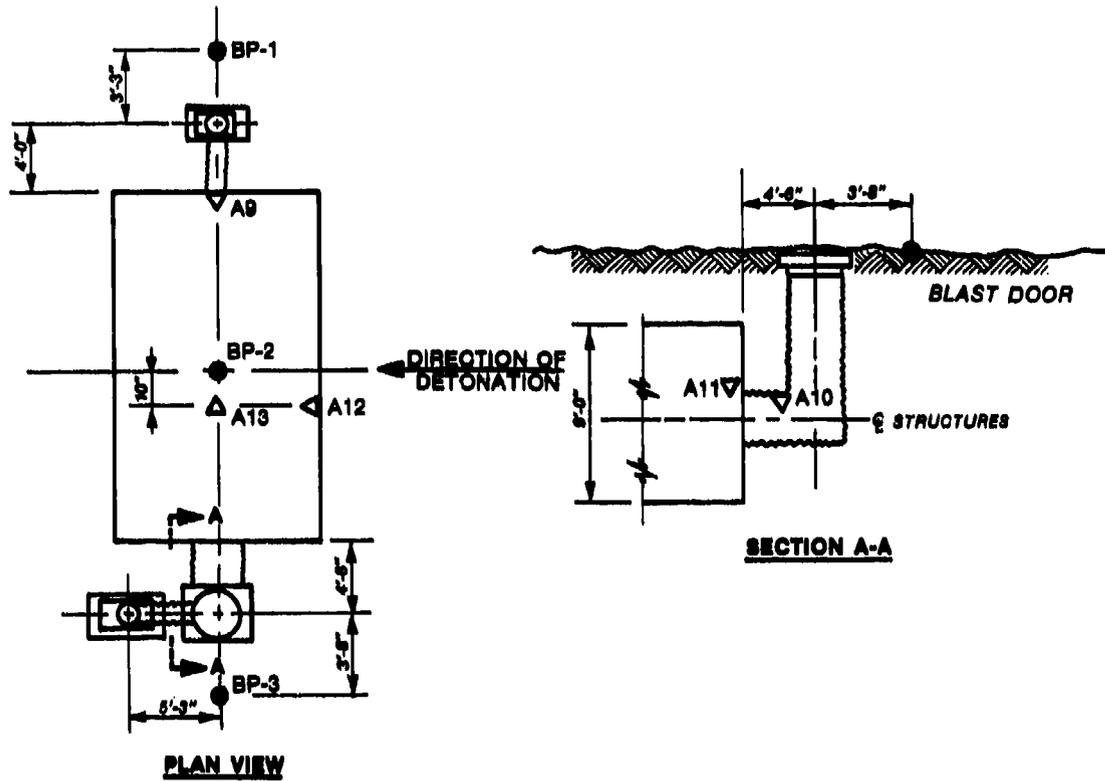
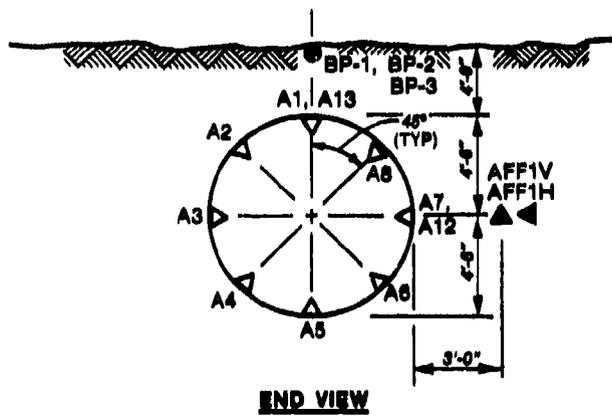
NOTE: ALL ACCELEROMETERS AT MID LENGTH OF STRUCTURE UNLESS DENOTED.

Figure 2.4. Instrumentation locations.

A total of 18 data channels were used during this test. Locations of the gages are presented in Figure 2.4. The data collected during the test were digitally recorded at various sampling rates on a Pacific Model 9833-064-I recorder. The recording of the test data started approximately 45 msec after detonation of the charge, and the total duration of data recording was 1.12 sec. The total memory used for recording each data channel was 64 Kbytes which was divided into 16, 4 Kbyte segments. The sampling rate during each memory segment was varied as shown in Table 2.1 to recover the initial high frequency response and still provide a recording duration long enough to recover the relatively late-time response. The recorded data are presented in Appendix B, and an instrumentation summary is presented in Table 2.2.

Fifteen Endevco accelerometers, Model 2262C, were used to monitor the structural and free-field accelerations. Thirteen accelerometers (A) were installed to measure structural accelerations at locations shown in Figure 2.4. Two accelerometers were located in the free field to measure vertical (AFF-1V) and horizontal (AFF-1H) accelerations as shown in Figure 2.4.

Three Kulite Model XT-190 airblast-pressure (AB) gages with ranges of 500 psi were used to monitor the airblast overpressure at the ground surface above the shelter. These gages were positioned at three locations along center line of the shelter at the ground surface as shown in Figure 2.4.

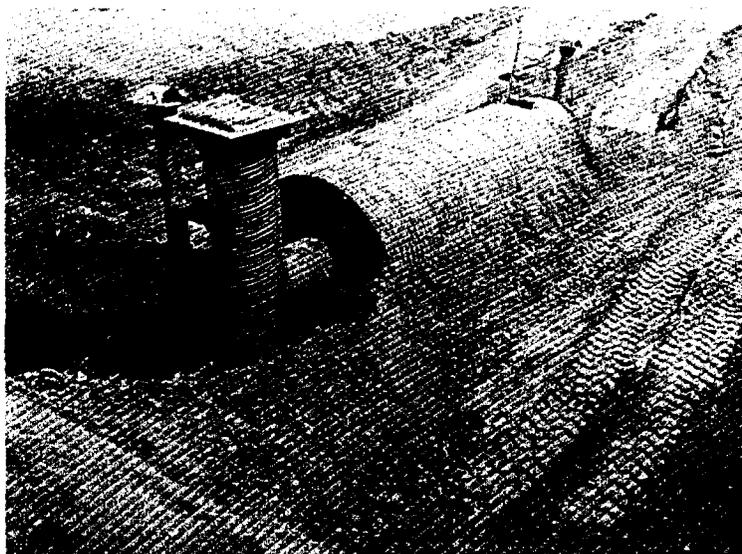
Figure 3.1. Posttest view of the shelter.

Figure 3.1 shows a posttest over view of the 18-Man Shelter. The damage sustained by the entryway hatch and the air intake stack is shown in Figure 3.2. The fiberglass cover on the entryway hatch had a maximum deflection at the center of 3.2 inches. Although the entryway frame was deformed at various locations and the top of the hatch was damaged, the entryway hatch was operational. The damage sustained by the intake stack (Figure 3.2) and the exhaust stack (Figure 3.3) was minor. Posttest inspection revealed that the ventilation system remained structurally sound.

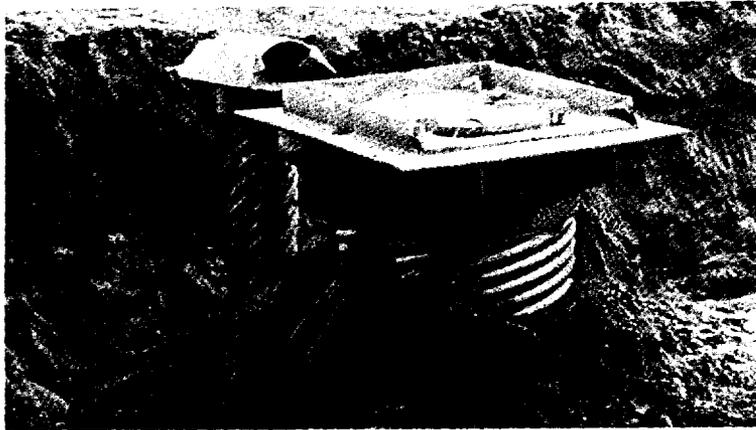
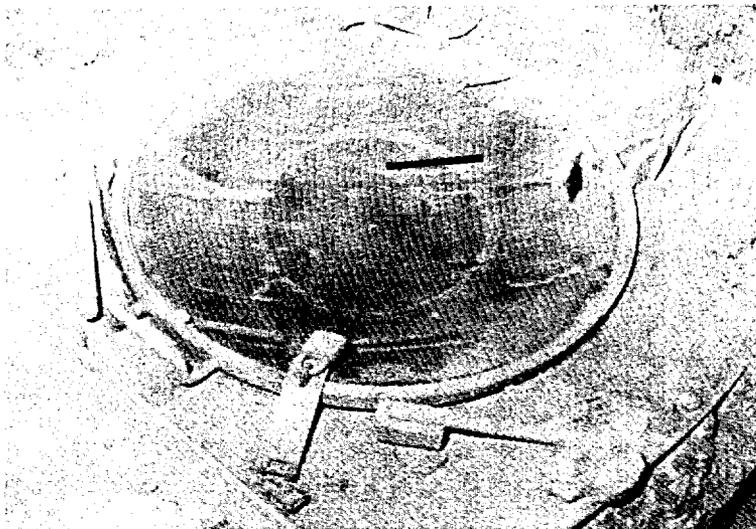
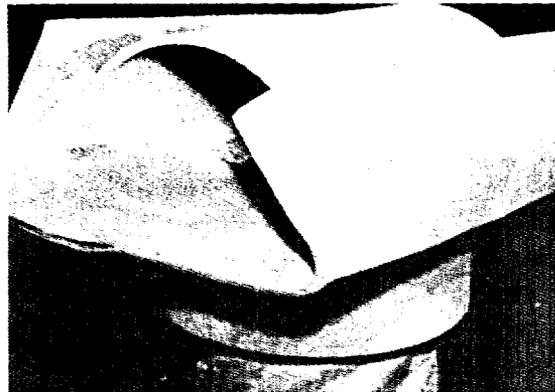
a. Entryway hatch and air intake stack.

b. Close-up view of the entryway hatch.

c. Close-up view of the air intake stack.

Figure 3.2. Damage sustained by the entryway and the air intake stack.

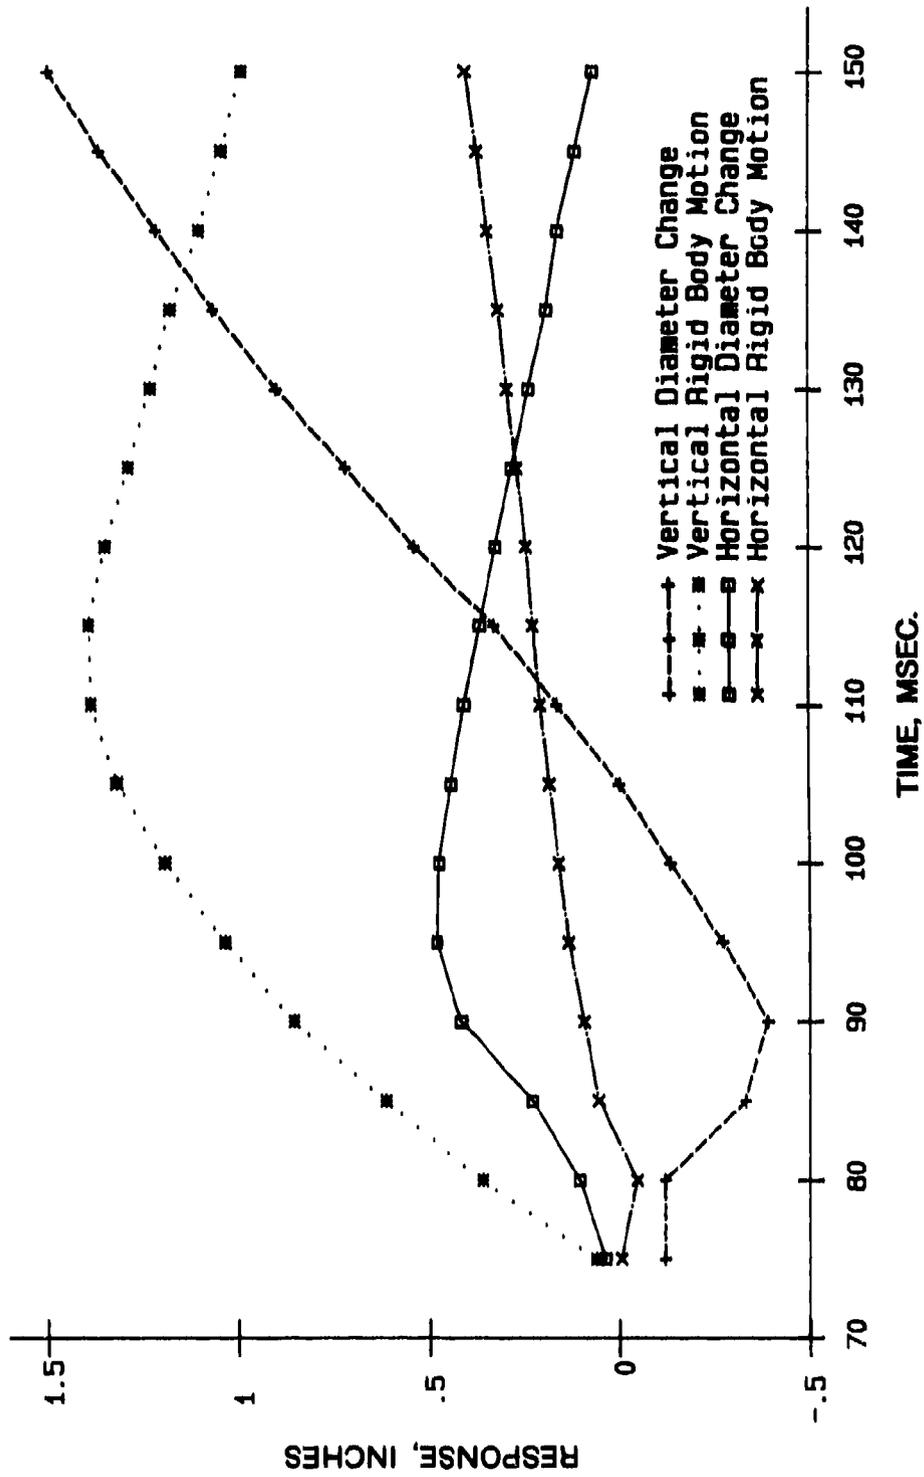
Figure 3.4. Structural diameter changes and rigid-body motion occurring at mid-length of the shelter.

The data presented in Figure 3.4 revealed that the predominant structural response and rigid-body motion occurred during the first 75 msec after the blast wave arrived at the shelter. Overall, the permanent structural deformations were small. The main section of the shelter was slightly ovalized during the test with the midlength vertical diameter increasing approximately 1.4 inches and the horizontal diameter decreasing approximately 1.4 inches. Rigid-body vertical displacement was 3.7 inches downward.

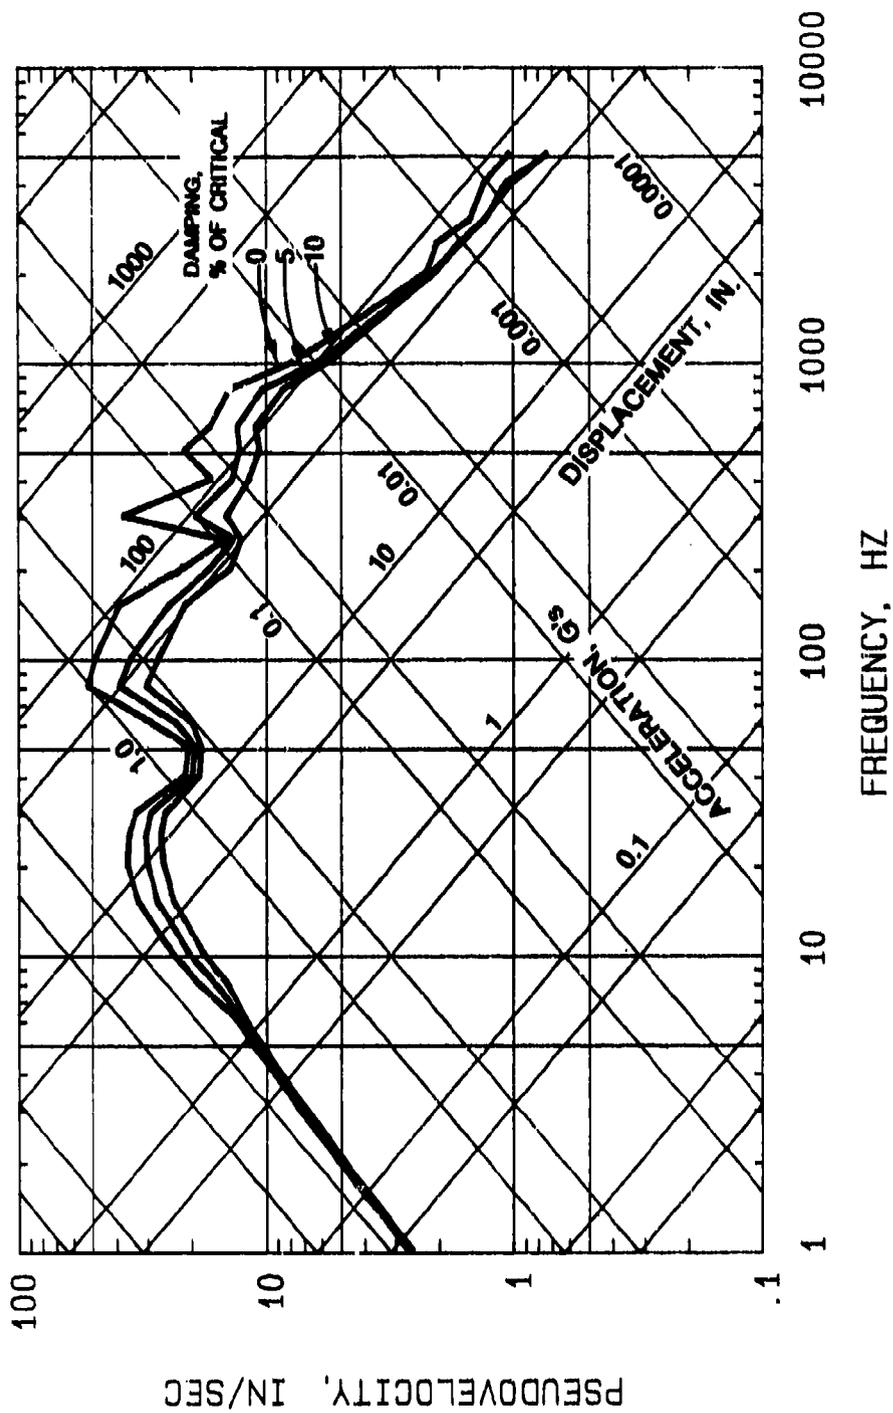
Figure 4.1.1. Shock spectra using accelerometer A3.

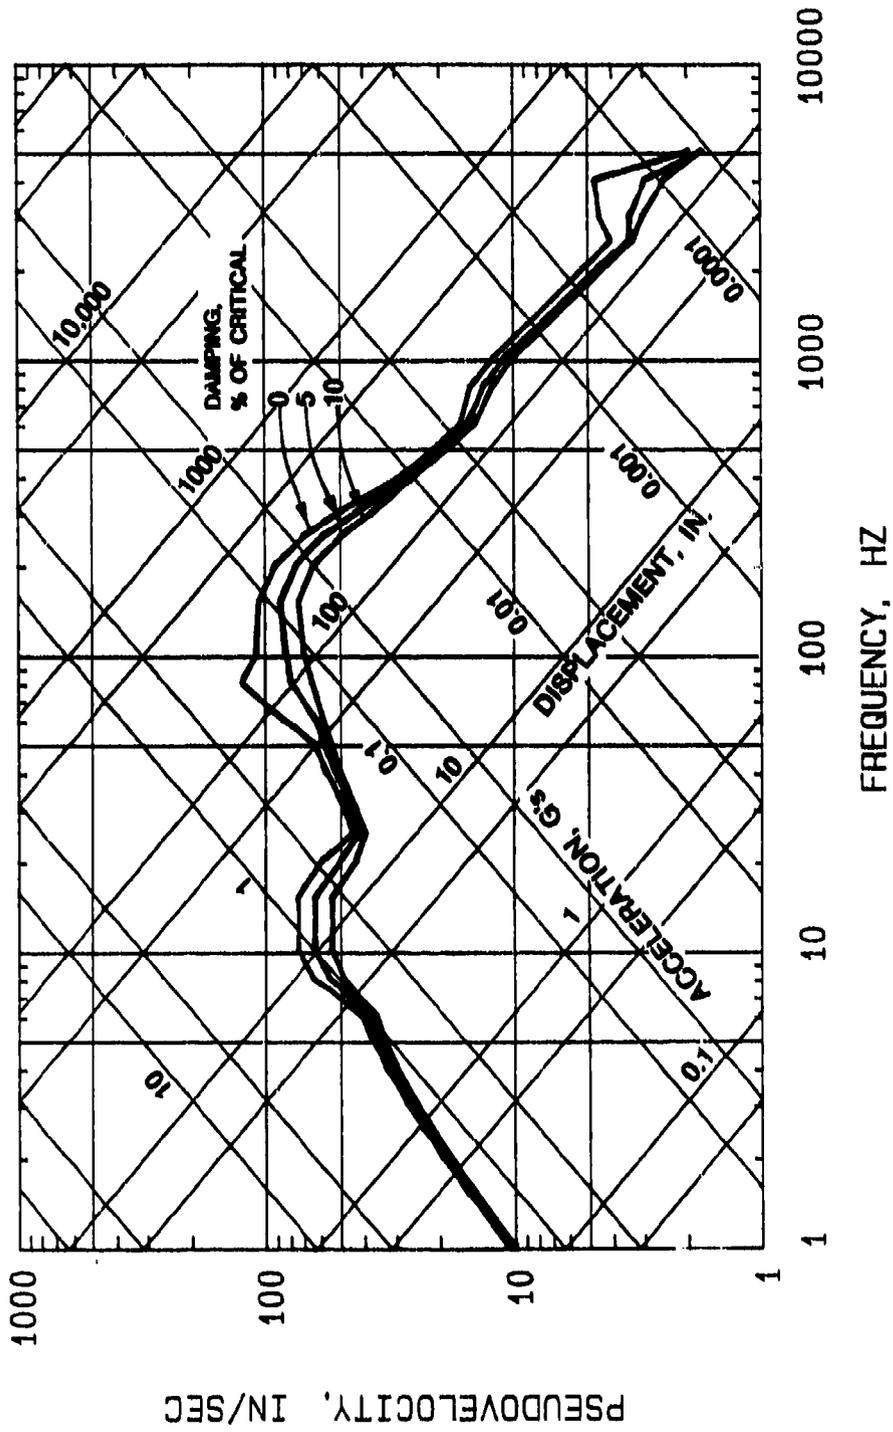
Figure 4.2. Shock spectra using accelerometer A5.

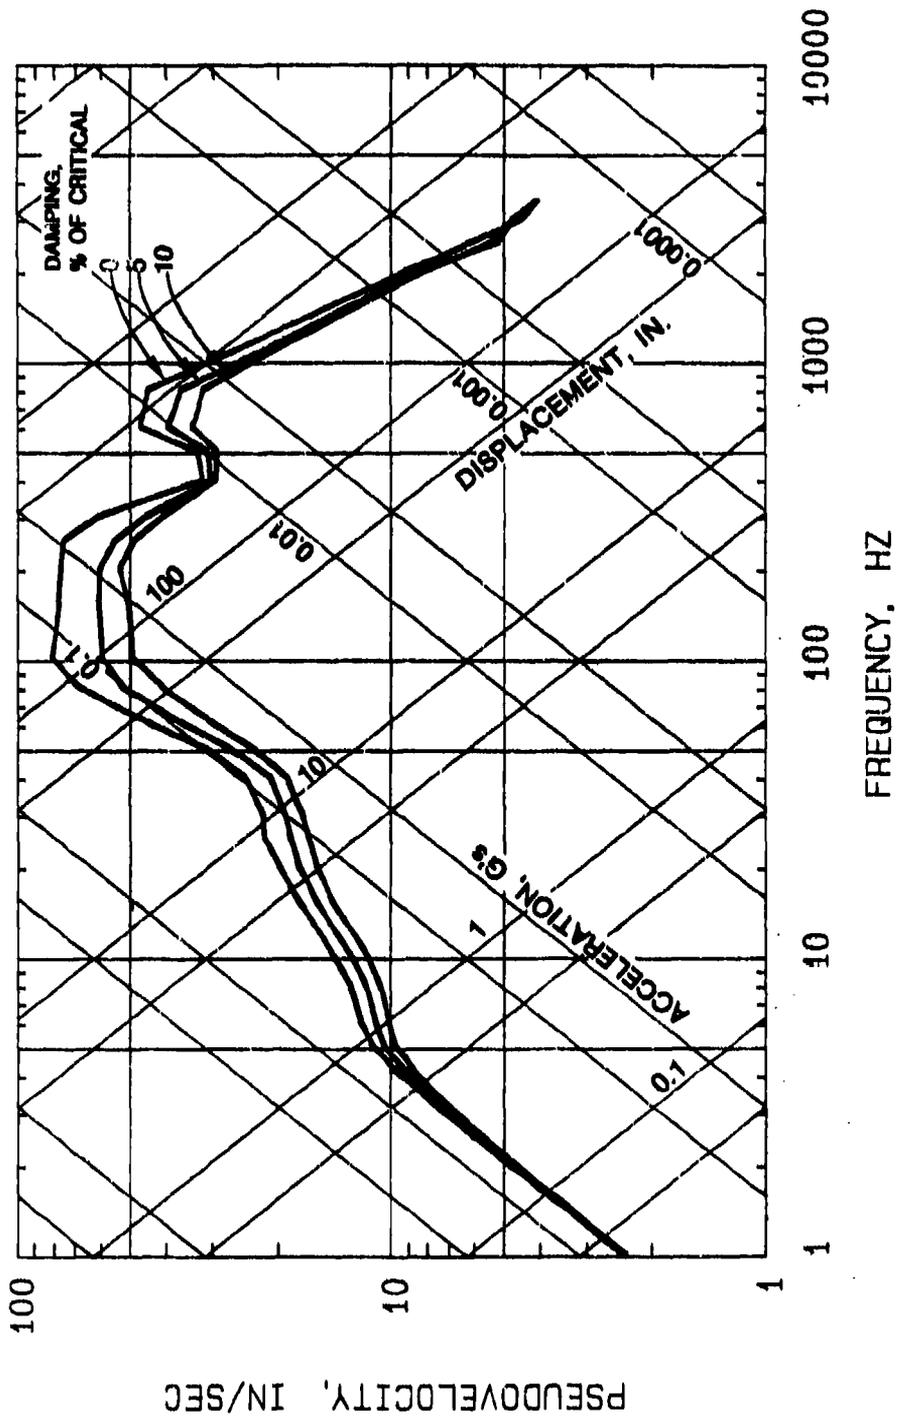
Figure 4.3. Shock spectra using accelerometer A7.

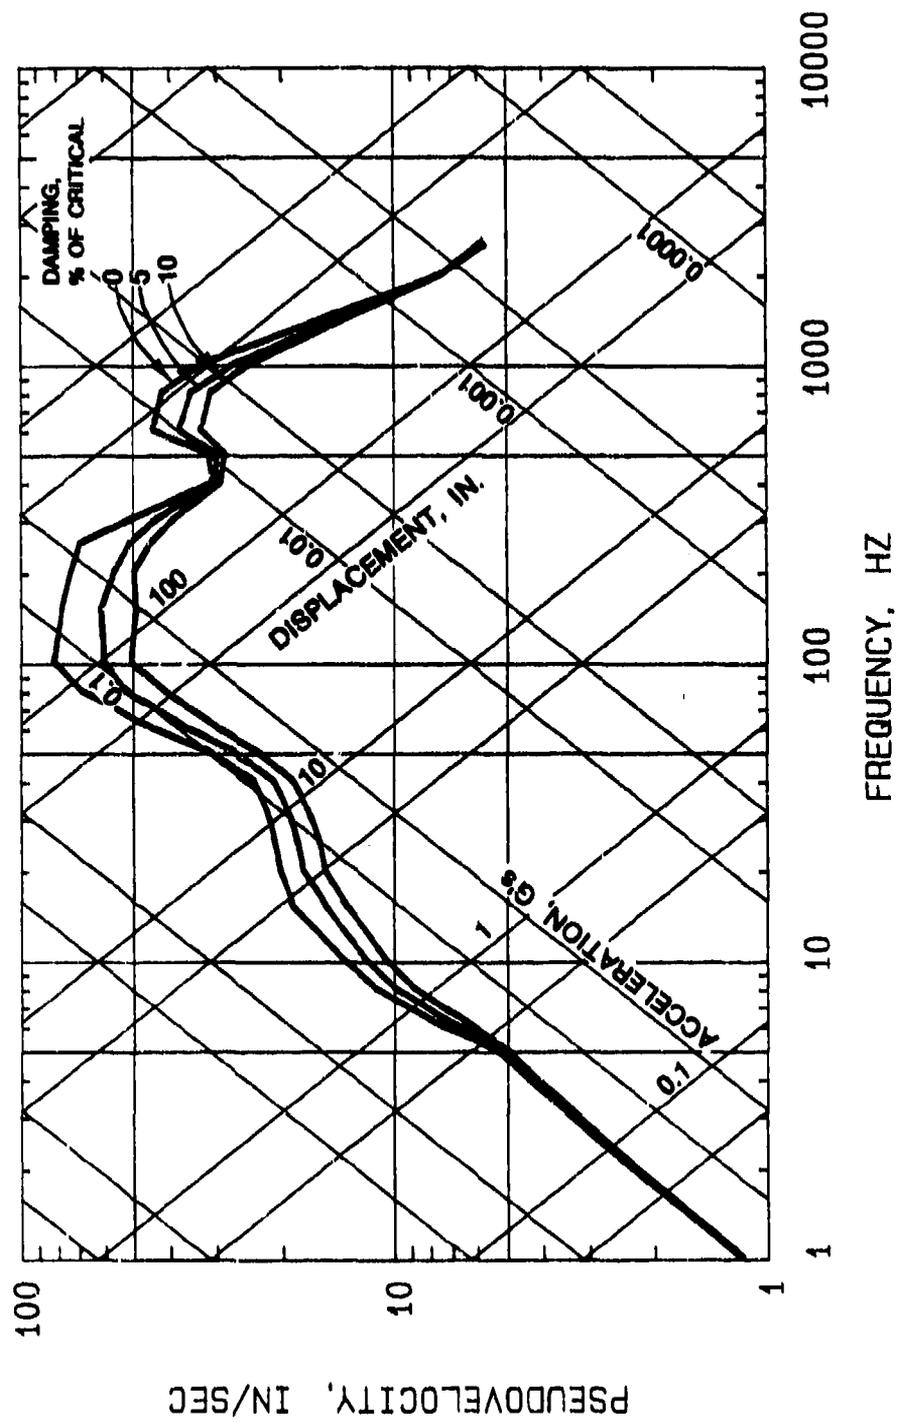
Figure 4.4. Shock spectra using accelerometer A12.

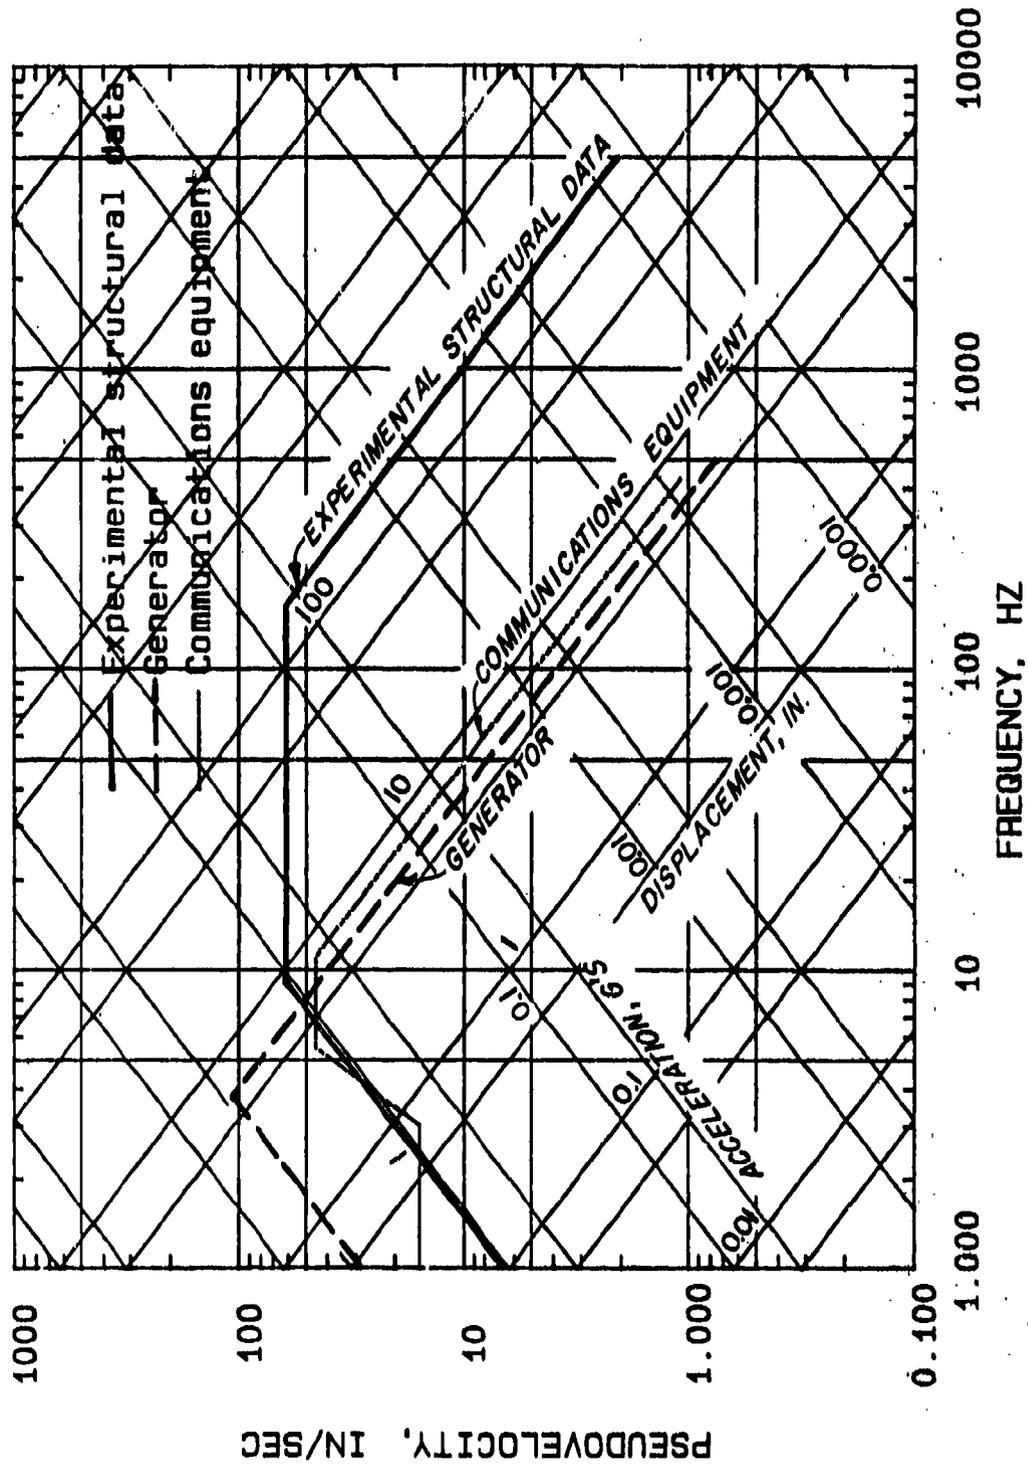
Figure 4.5. Comparison of the response spectra for the floor (10 percent damping) with fragility curves for typical floor-mounted equipment.

(Headquarters, Department of the Army, 1987). Floor-mounted equipment would include items such as generators and communication devices. This comparison indicates that typical floor-mounted equipment would not have survived at the overpressure level of this test. It should be noted that the experimental shock spectra were generated from data recovered from gages located on the shelter and not attached to any floor surface. Typical equipment would be mounted to a plywood floor in an actual shelter. The floor tends to reduce the amplitudes observed in the shock spectra and increases the chances of survival of equipment and occupants.

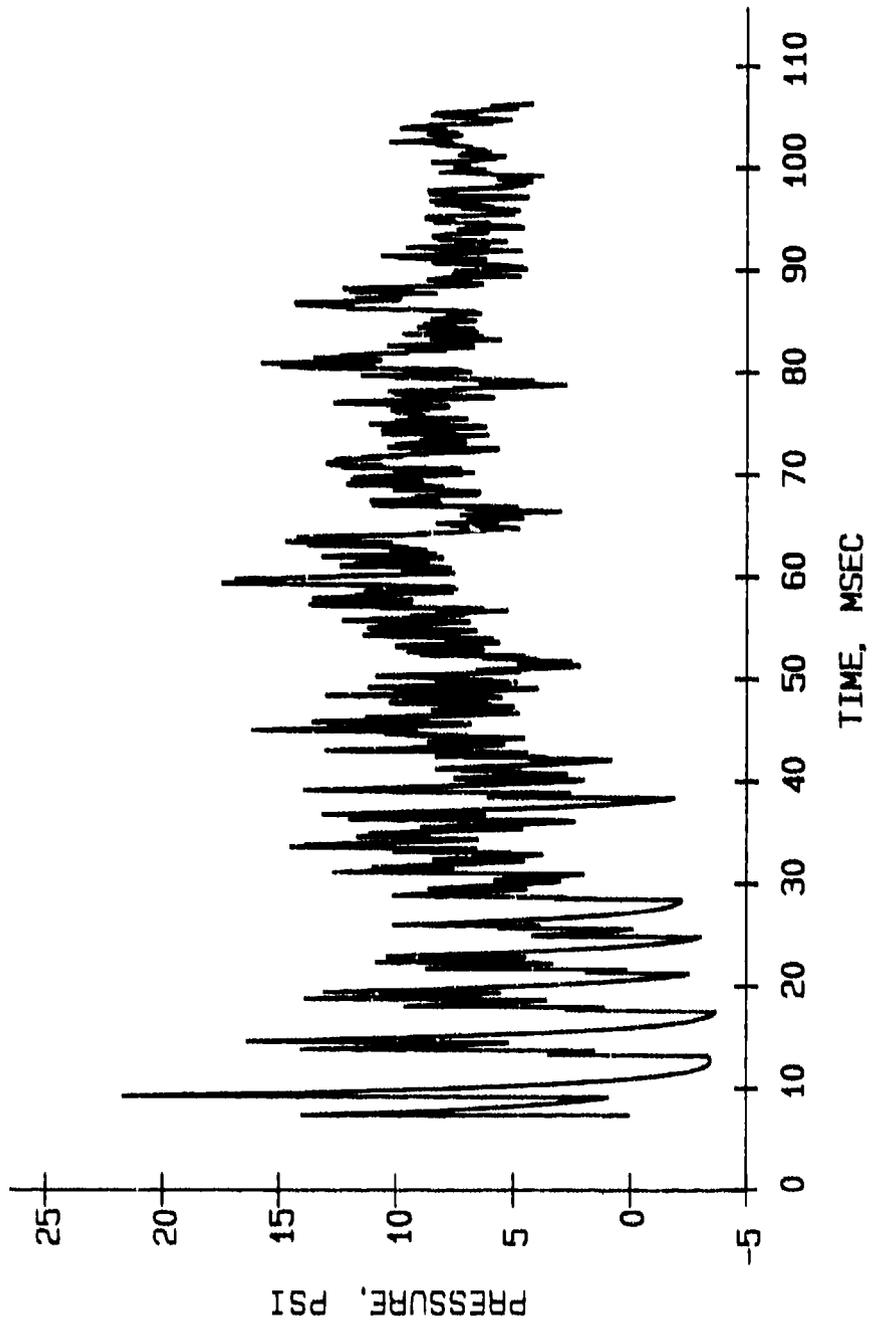
Figure 4.6. Pressure-time plot for target 1.

The failure of the emergency exit cover plate allowed blast pressure to fill the shelter. Since internal pressure reduces the effective external structural loading, it was necessary to determine if enough pressure entered the shelter to affect its structural response. Figures 4.6 and 4.7 present the predicted pressure inside the shelter at targets 1 and 2, respectively. Target 1 was located on the floor at midlength of the shelter while target 2 was located at the center of the endwall near the entryway. The Chamber computer program (Britt and Drake, 1986) was used to perform these calculations. The results indicated that a fill-pressure of 7.9 psi at 6.4 msec after the failure of the emergency exit cover plate was present inside the shelter. This predicted internal pressure is considered to be an upper bound since it was assumed that the emergency exit cover plate failed at the instant the airblast pressure wave arrived at the ground surface above the shelter.

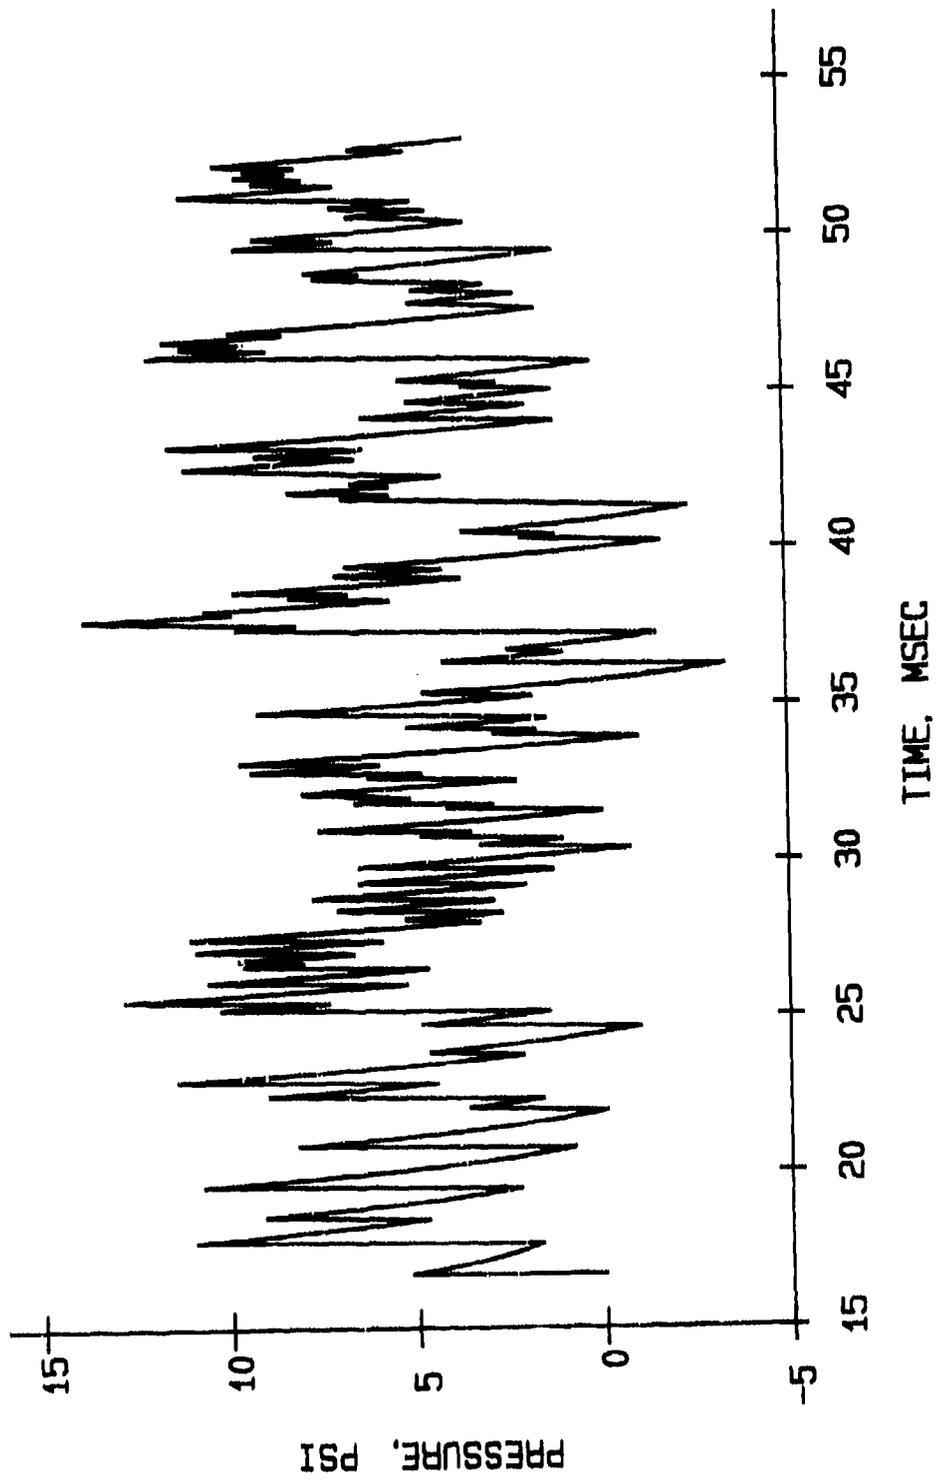
Figure 4.7. Pressure-time plot for target 2.

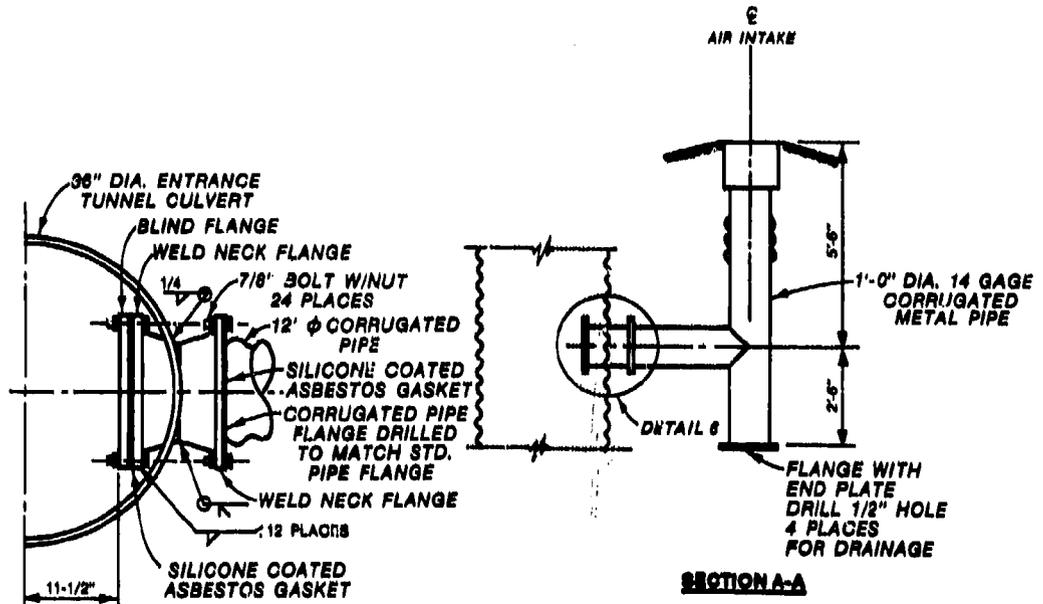
DETAIL-1

(INTAKE STACK TO ENTRYWAY)

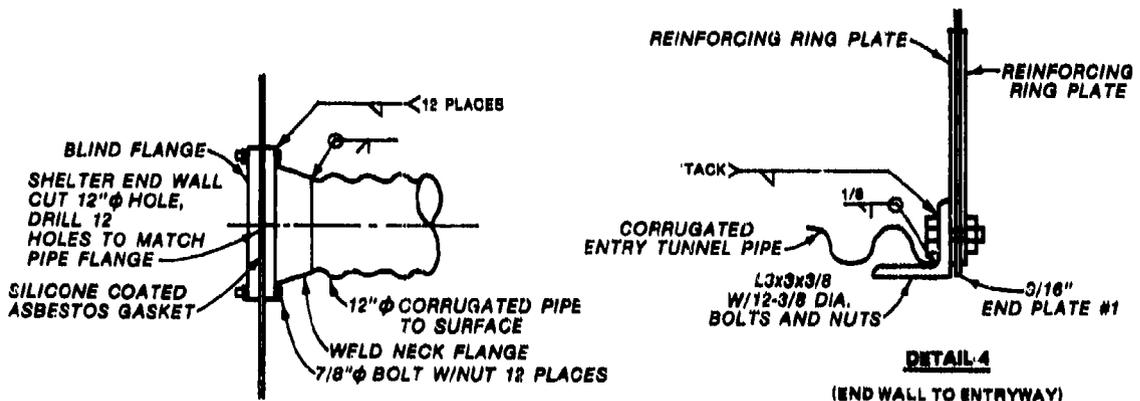
DETAIL-2

(EXHAUST STACK TO END WALL)
