**Report 2461**

## **Some Effects of Nitrates on the Tensile Properties of Al 7075-T7351**

Report Date: **March 1988**

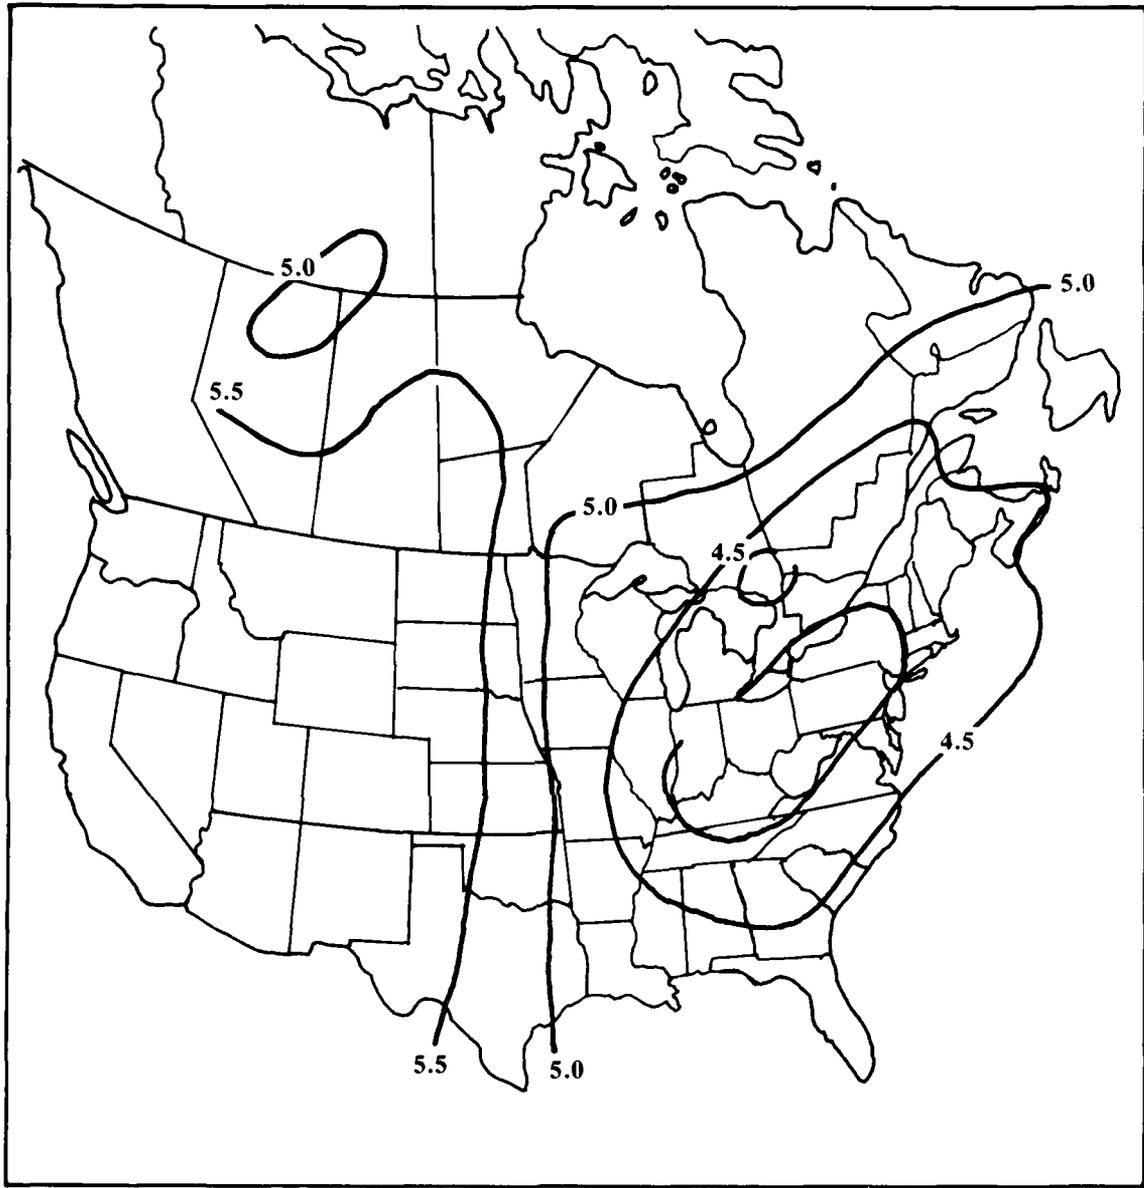
Figure 1. Remote monitoring pH rain values

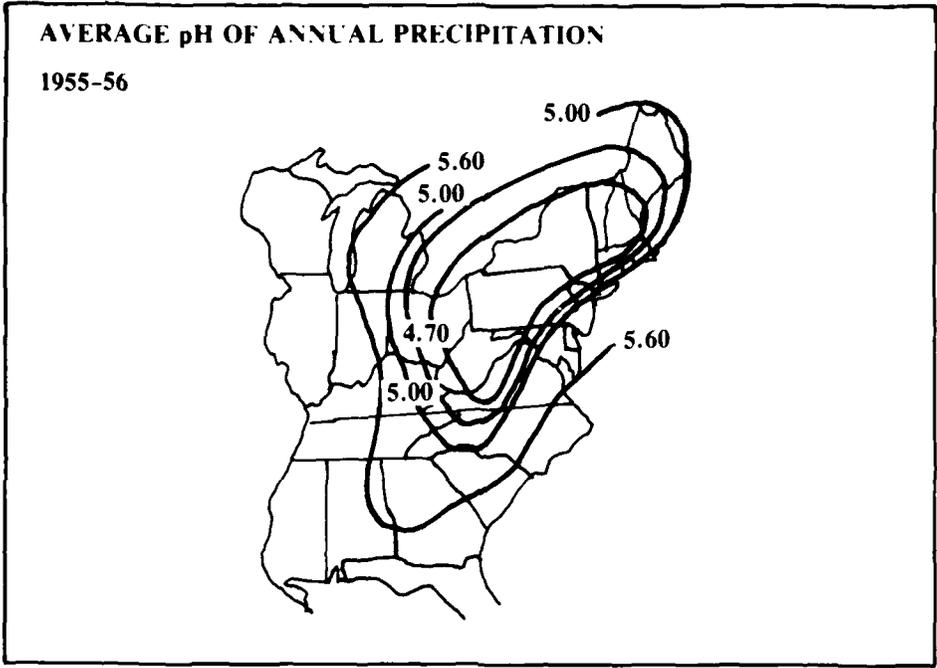
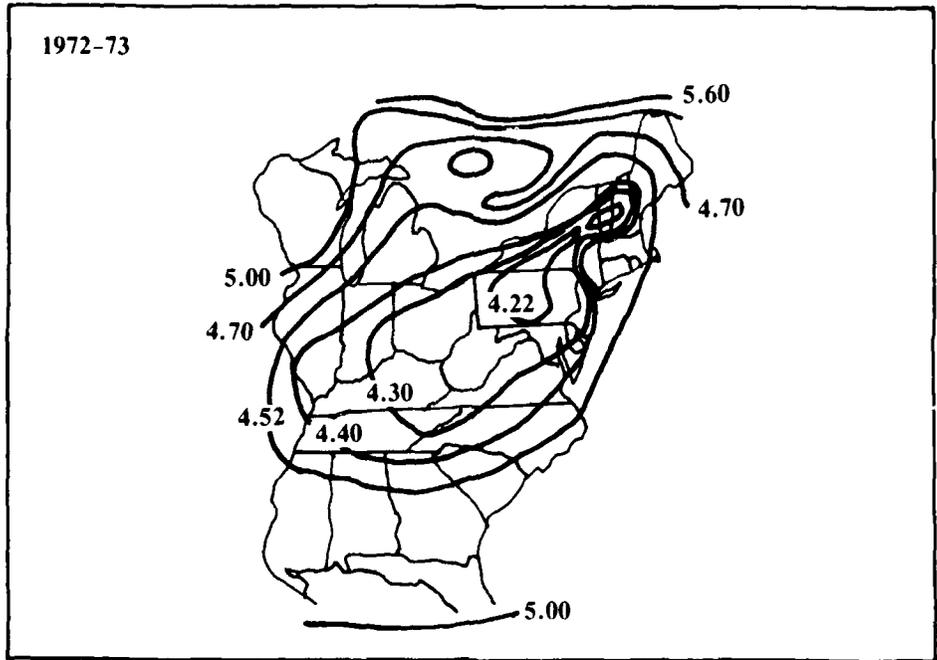
**Figure 2. Trends in precipitation acidity in eastern North America**  
(Adapted from *Chemical and Engineering News*, 1976)

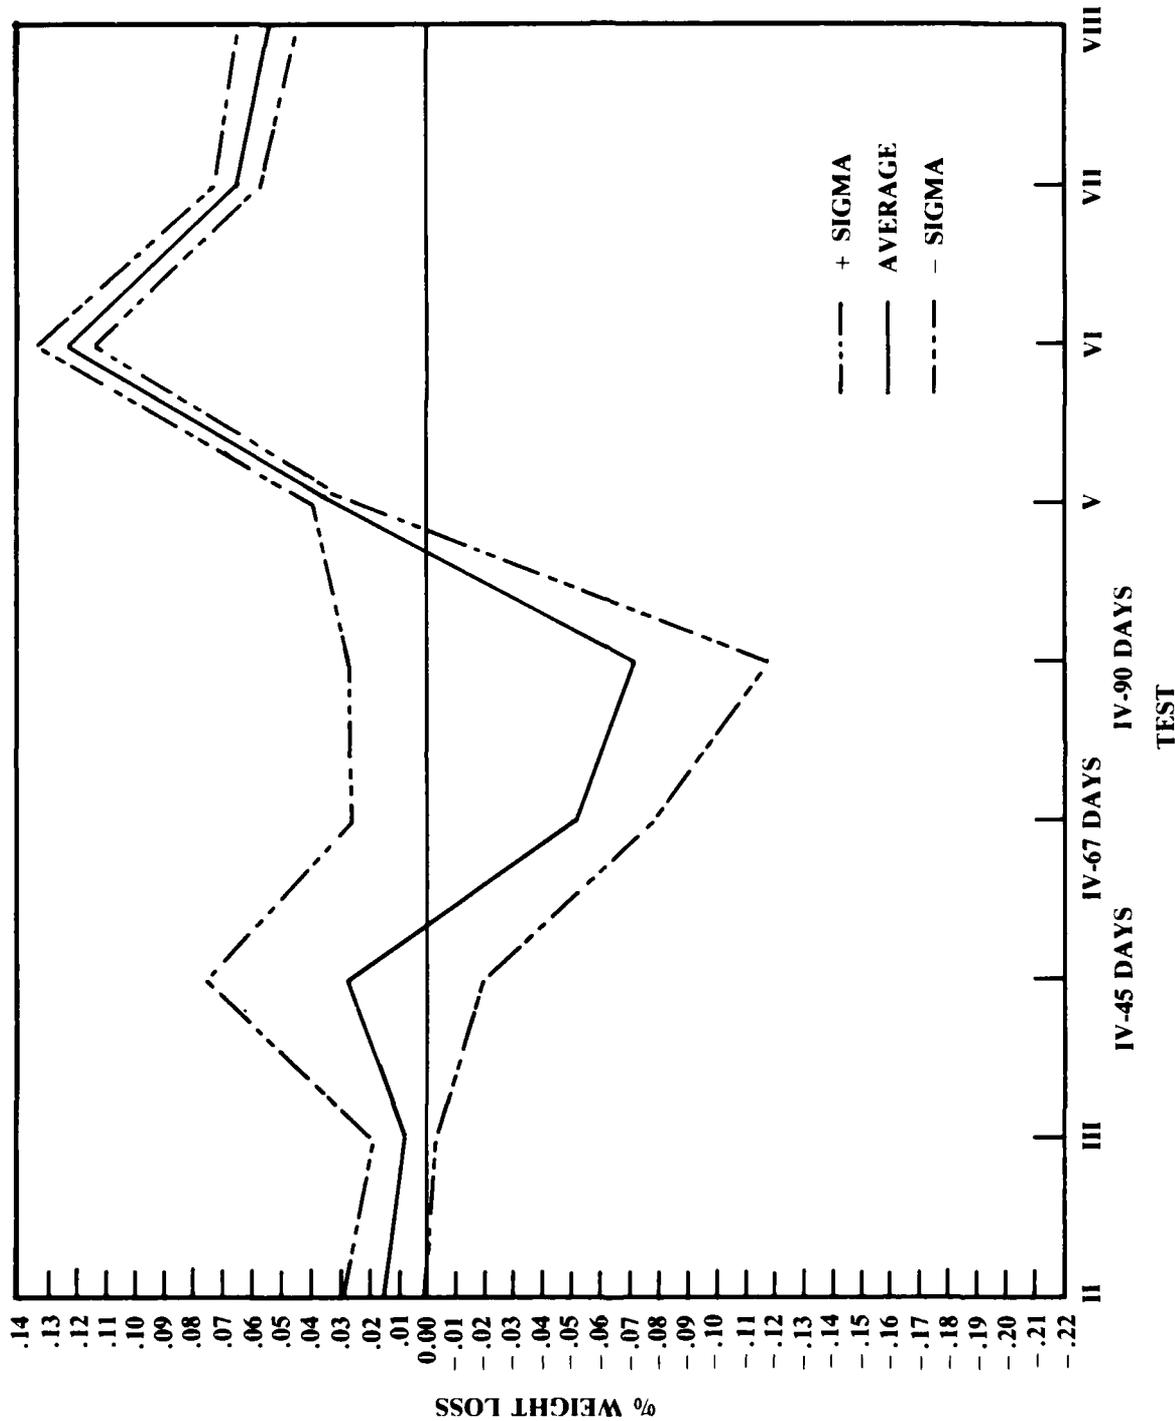
Figure 12. Percent weight loss, Tests II through VIII

For the L oriented samples, the weight data shows the most dramatic change in values, and with the exception of the 12.6 value for the % elongation of Control set IV/t, no other variable shows much of a deviation within its data set. The weight data in graphic form is given in Figure 12. In Figure 4, TUS averages, and Figure 5, TYS averages, the Test VI values appear to be lower than the rest of the values for Tests II through VIII. Similarly, the Test IV/90 values appear to be lower than the rest of the field in Figure 8, TUS averages, and Figure 9, TYS averages. For the TYS averages, the changes are 1.7% and 1.2%, respectively, less than half the value of the largest change seen in the L-T data set.

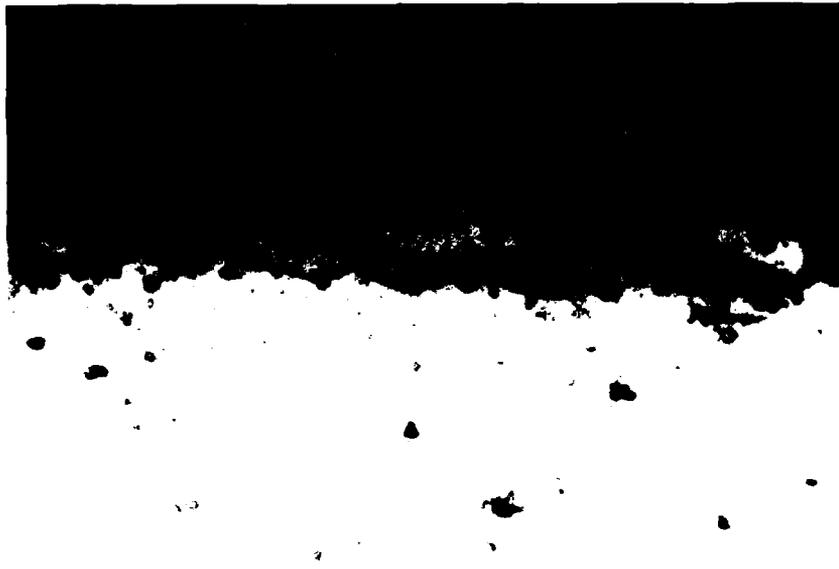
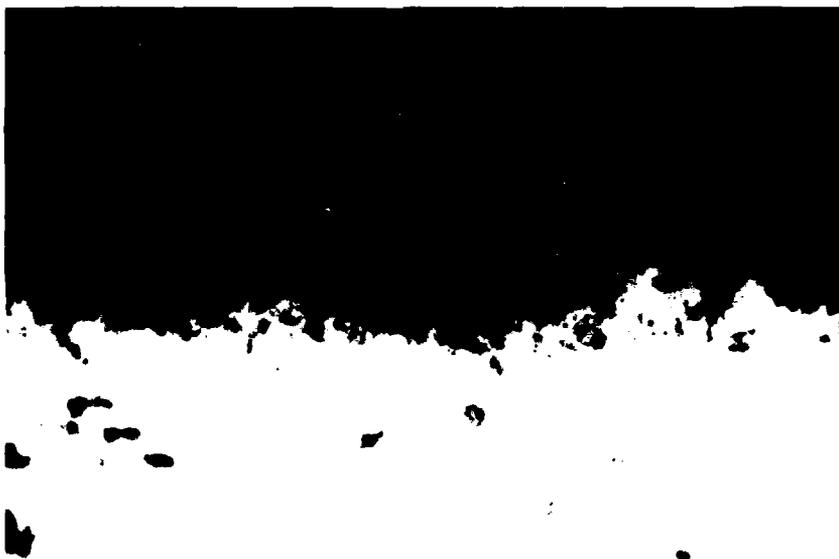
**Figure 22. A. Incipient grain removal which results in  
B. Shallow surface corrosion (removal) after exposure to baseline environment**

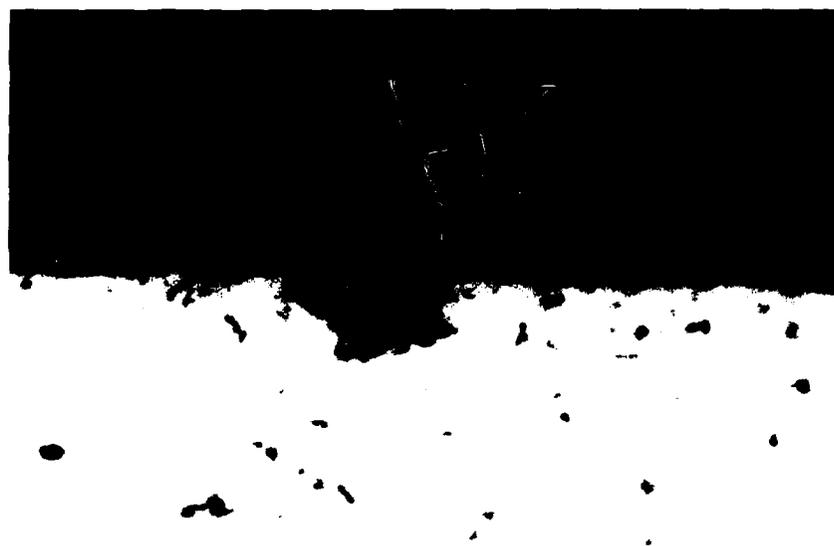
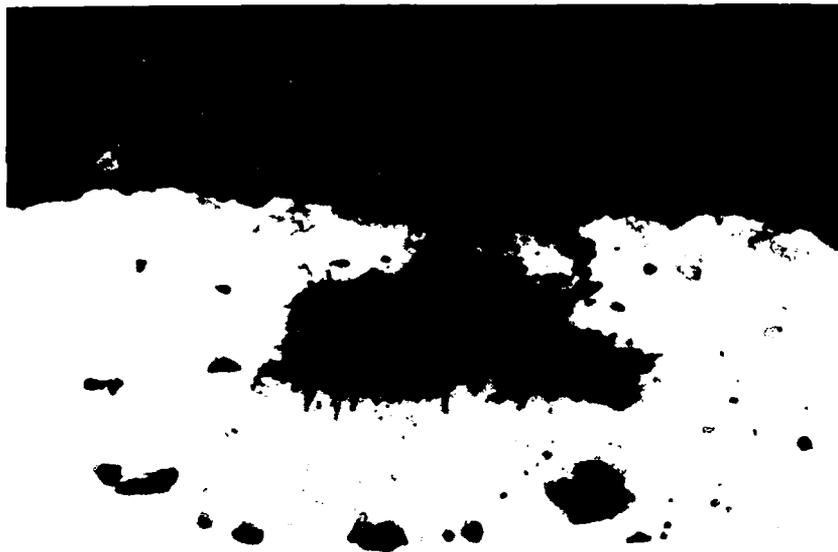
**Figure 23. Pitting on the flat specimens. A. Pit with a crack. B. Normal pit. C. Pit which has a small orifice with respect to its volume after exposure to baseline environment**
