Naval Weapons Development & Engineering Center  
Portsmouth, Rhode Island 02884-5000

Report 2489

## Stressed Fabric Abrasion Test Procedure for Urethane Coated Fabric Fuel Tanks

Report Date: June 1988

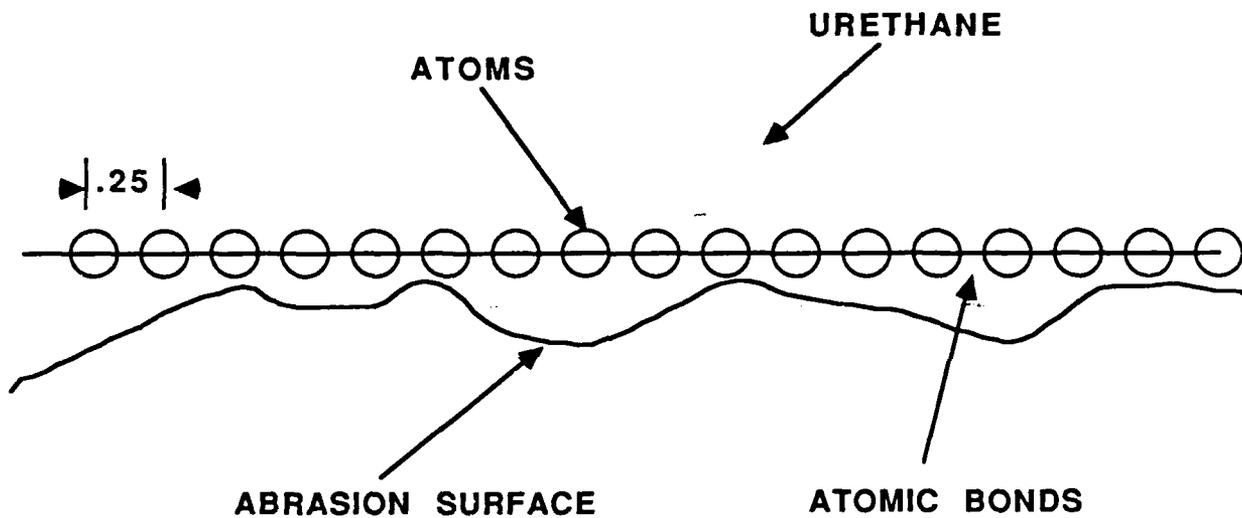
Figure 1. Urethane Unstressed

In urethanes, adhesive abrasion occurs when the adhesive force between adjoining materials is stronger than the chemical bond in the polymer chain. When an atom is removed through this process, the chain is weakened and wear occurs more rapidly. When a urethane is under a tensile stress, the chemical bonds are spread out and adhesive wear can occur with less of an atomic force applied (see Figures 1 and 2). For the same reason, mechanical friction occurs more readily when the urethane is under a tensile stress.

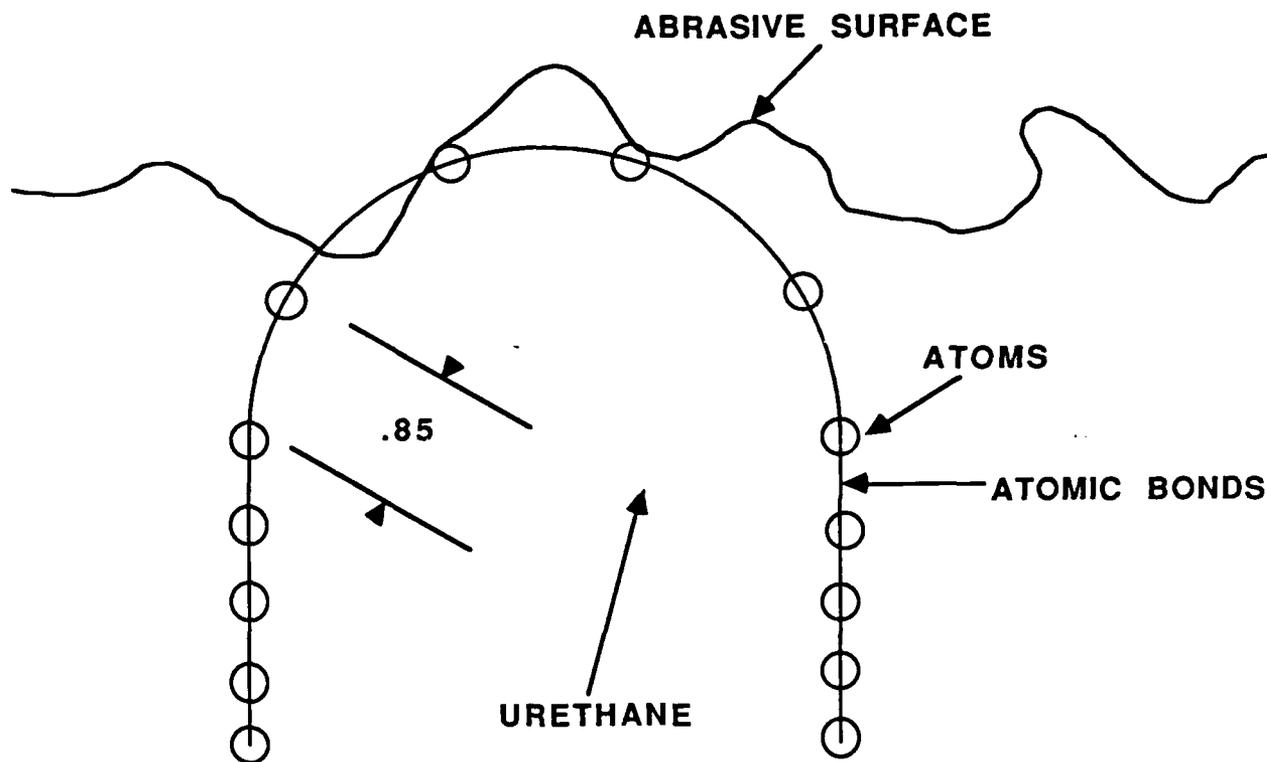
Figure 2. Urethane Stressed

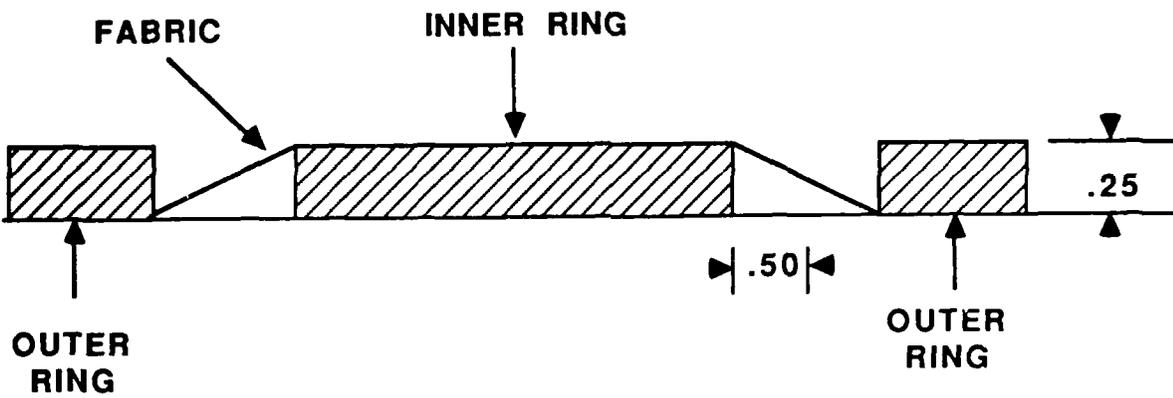
Figure 3. Stressed Abrasion Tester

For this test, an apparatus was designed and made that placed the urethane under a constant and reproducible stress. Because putting material into a compound fold configuration would make the test dependent on the thickness of the material, this solution was unacceptable. Instead, a Taber Abrader was modified to accept a platen that would be adjustable for height in the center with a ring on the outside edge to clamp the material down (Figure 3). In use, the material would be placed

on the platten with the center ring in the down position. After the material is secured to the outer ring, the center section would be raised to a height of  $\frac{1}{4}$  inch. The vertical distance between the edge of the center section and the outer ring is  $\frac{1}{2}$  inch, giving the material a bend of  $-30^\circ$  from the horizontal position (Figure 4). A ceramic abrader wheel (Figure 3) Calibrade H-18 manufactured by Taber Instruments was mounted onto a swivel arm so that the edge of the wheel would ride on the crease created by the platten at an angle of  $10^\circ$  from the horizontal plane. The sample was then subjected to a number of cycles sufficient to expose the base fabric. The ceramic wheel was resurfaced every 500 cycles to minimize error associated with clogging or a worn surface. A standard Taber Abrader was used to gather information about the abrasion characteristics of an unstressed sample from each material.
