AFWAL-TR-87-2089

OPTICAL FIRE DETECTOR TESTING IN THE AIRCRAFT  
ENGINE NACELLE FIRE TEST SIMULATOR

A. M. Johnson  
BOEING ADVANCED SYSTEMS  
P.O. Box 3707  
Seattle, WA 98124-2207

March 1988  
FINAL REPORT for period July 1985-October 1986

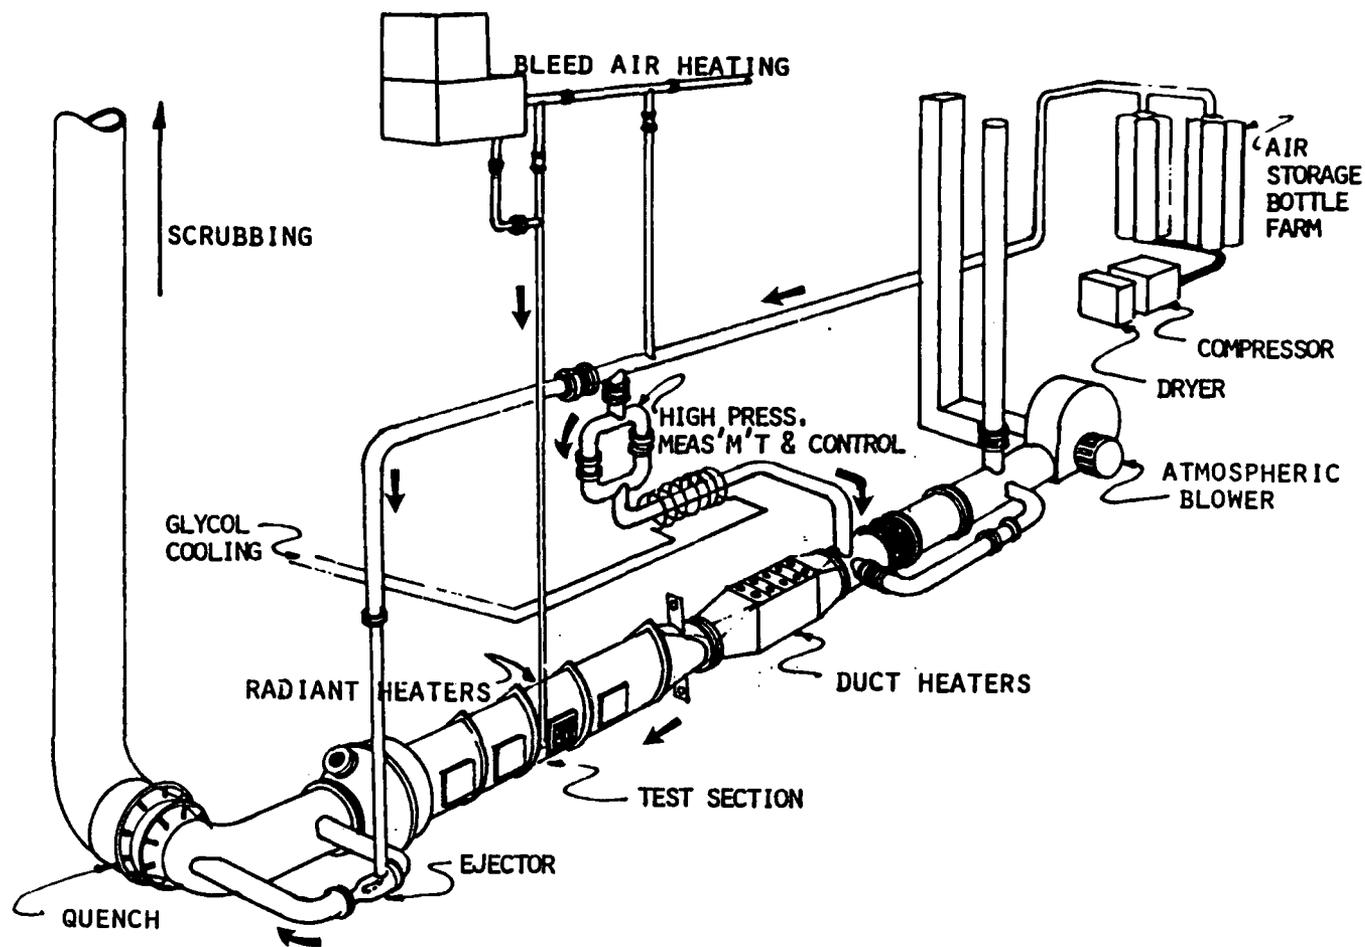
Figure 1. Components of the AENFTS

As shown in Figure 1, the AENFTS ventilation airflow conditioning systems include a blower which provides air at atmospheric pressure to simulate low speed sea level flight conditions, a high pressure compressor and air storage bottle farm which can provide ventilation airflow simulating ram pressure in low altitude supersonic flight conditions and an air driven ejector which can evacuate the test section to simulate high altitude flight conditions. The shorter curved test section wall, which simulates the case of a turbojet or turbofan engine, can be heated with radiant heaters. The test section can be rotated 360 degrees allowing simulation of any 114 degree segment of an aircraft engine compartment.

(ARROWS INDICATE AIRFLOW DIRECTION)

The Aircraft Engine Nacelle Fire Test Simulator (AENFTS) is a ground test facility designed to simulate potential fire hazards in the annular compartment around an aircraft engine. The facility is installed in I-Bay of Building 71-B in Area B of Wright-Patterson Air Force Base, Ohio. The facility includes air delivery and conditioning equipment designed to simulate engine compartment ventilation and bleed airflow, a test section within which fire testing can safely be conducted and an exhaust system which can cool the combustion products and scrub them sufficiently to allow their release into the atmosphere (Figure 1).

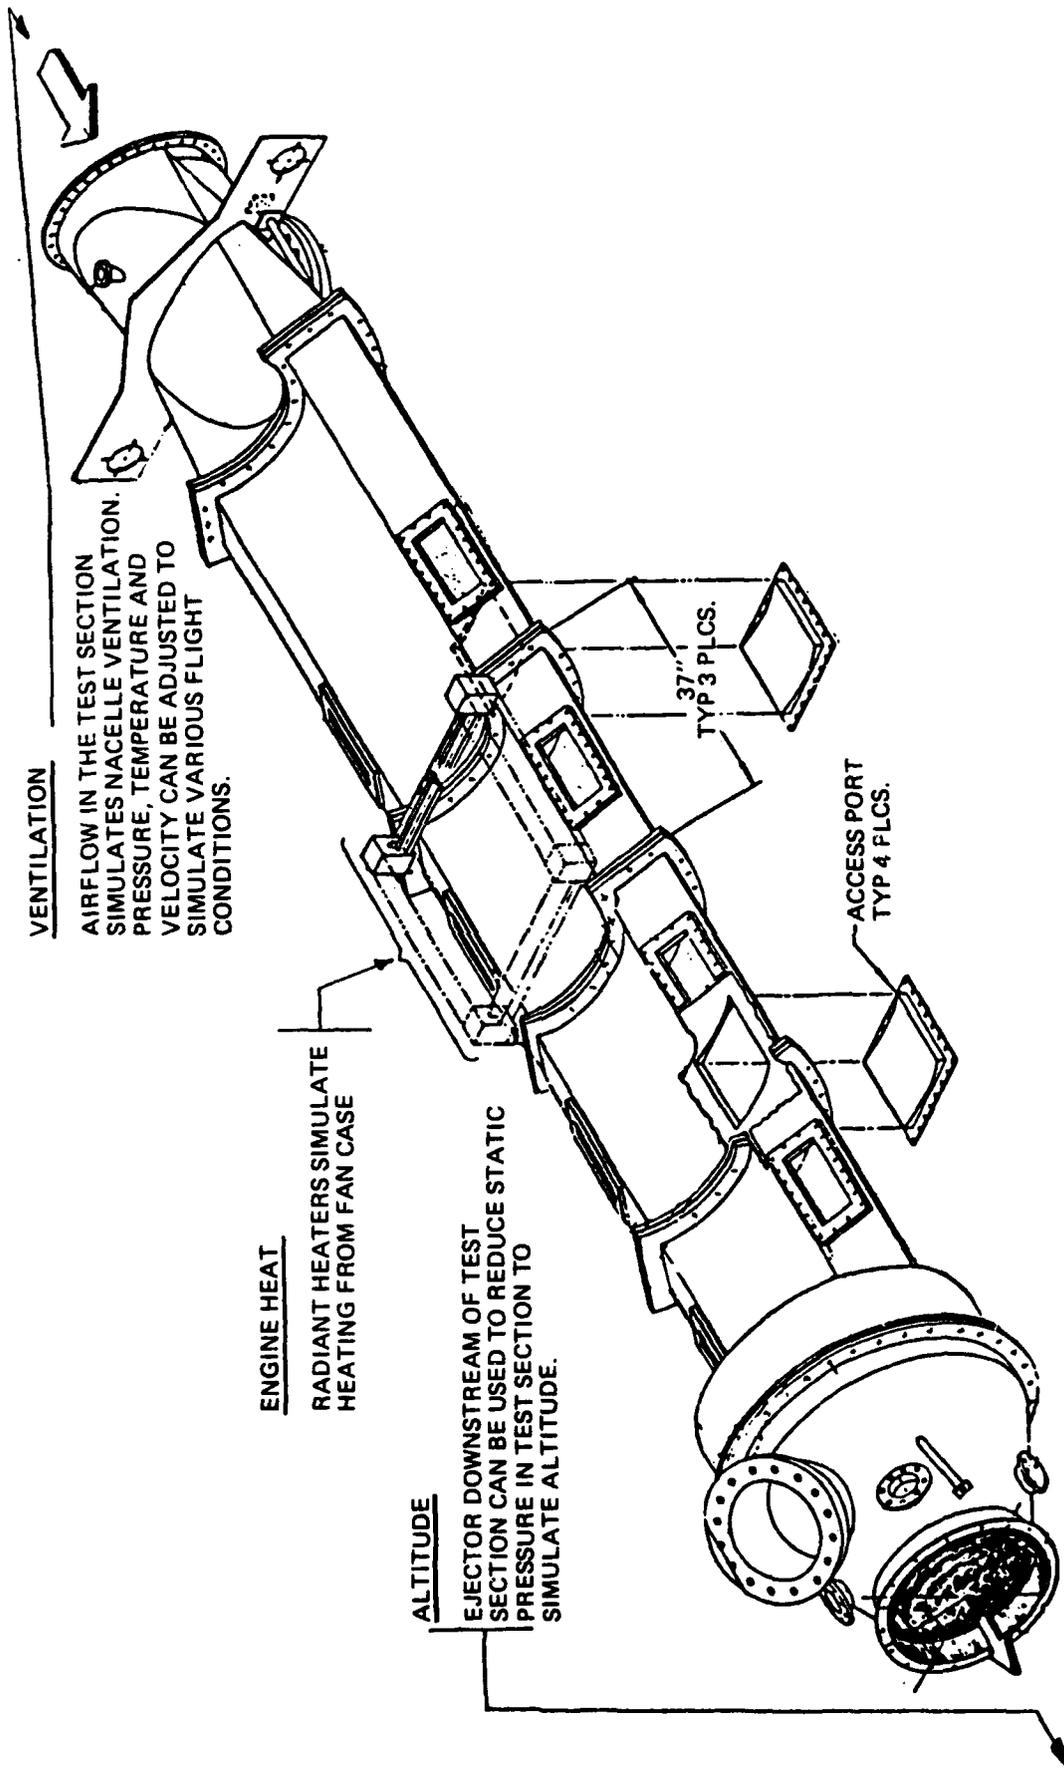
Figure . 2. AENFTS Test Section

The test section of the AENFTS (Figure 2) consists of a two radian (114 degree) segment of the annulus between a 15 inch radius duct, which simulated an engine case, and a 24 inch radius duct, which simulated the engine compartment outer wall. It is approximately 14 feet long and is constructed from 1/4 inch stainless steel. Various access ports and viewing windows are provided for access to test equipment and instrumentation and for observation of the test activities taking place within.

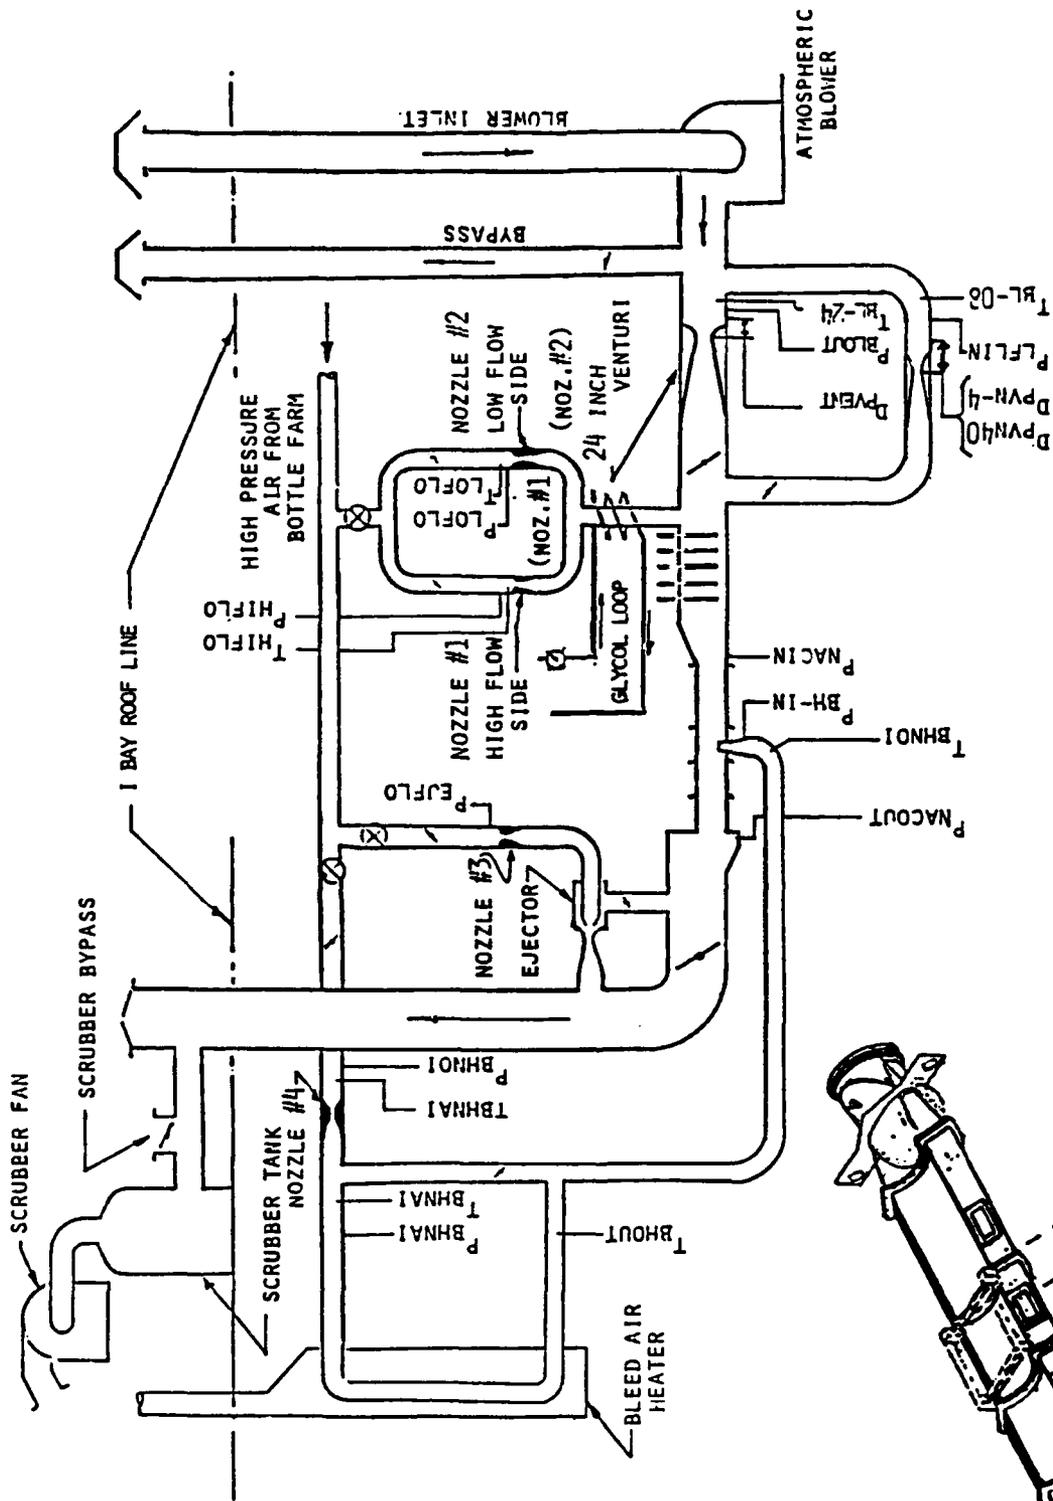
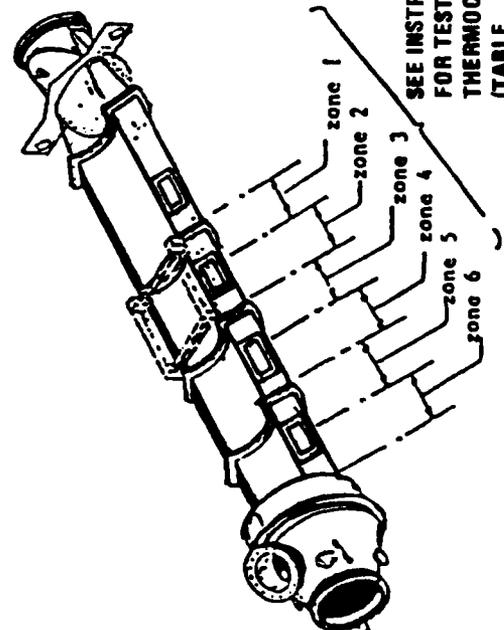
Figure 5. AENFTS Instrumentation Schematic

SEE INSTRUMENTATION LIST  
FOR TEST SECTION  
THERMOCOUPLE DETAILS  
(TABLE 2)

Seventeen pressure transducers were used to acquire pressure data during these tests. These transducers were standard commercial products manufactured by Sensotec and Setra. They were precalibrated by their manufacturers with standards traceable to the National Bureau of Standards. Their calibration had been periodically checked during the last several years using a dead weight tester. Details of the transducer ranges, sensitivities and accuracies are included in Table 1.

Type J, K and T thermocouples were used to measure the simulated ventilation airflow temperature at the flowmeters, the air temperature in the test section

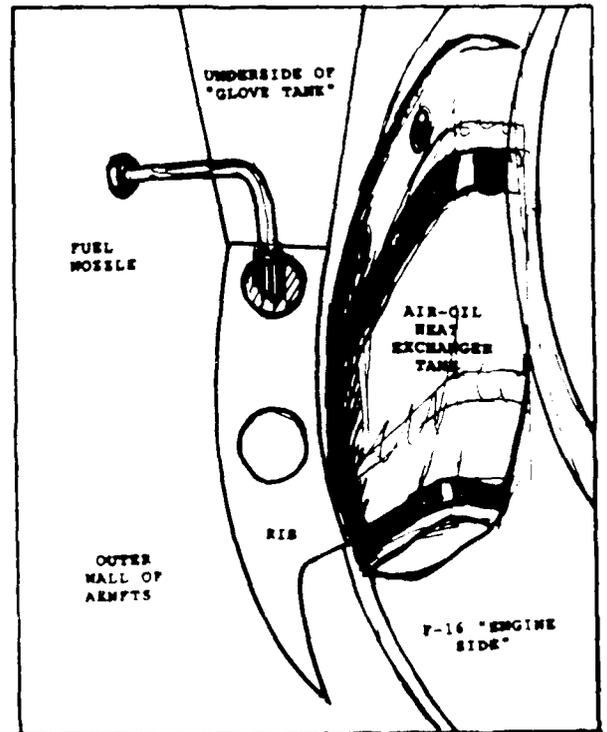
Figure 6 31.2 GPH Fires at Three  
Ventilation Flowrates

a) 1 lb/sec

c) 6 lbs/sec

b) 3.5 lbs/sec

THUMBNAIL DRAWING OF  
AREA OF F-16 SIMULATOR  
VIEWED BY VIDEO CAMERA

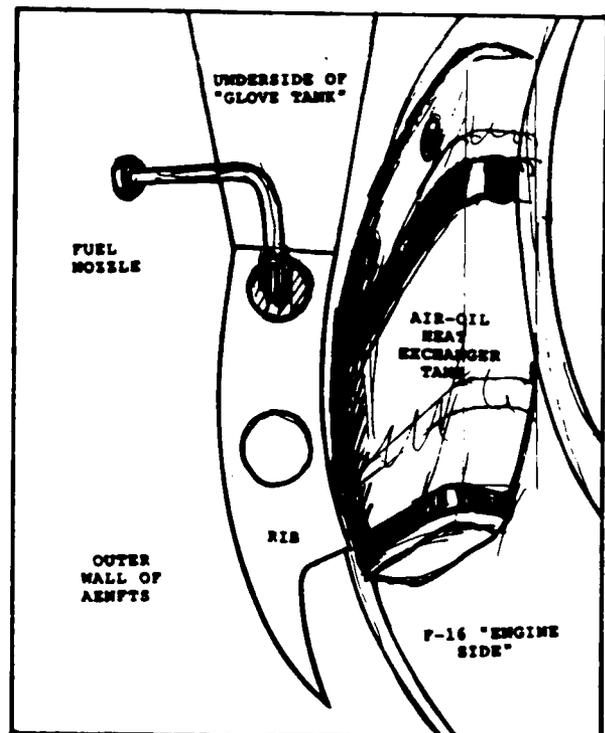
Figure 7. 1.0 GPH Fires at Three  
Ventilation Flowrates

a) 0.5 lbs/sec

c) 2.5 lbs/sec

b) 1.0 lbs/sec

THUMBAIL DRAWING OF  
AREA OF F-16 SIMULATOR  
VIEWED BY VIDEO CAMERA

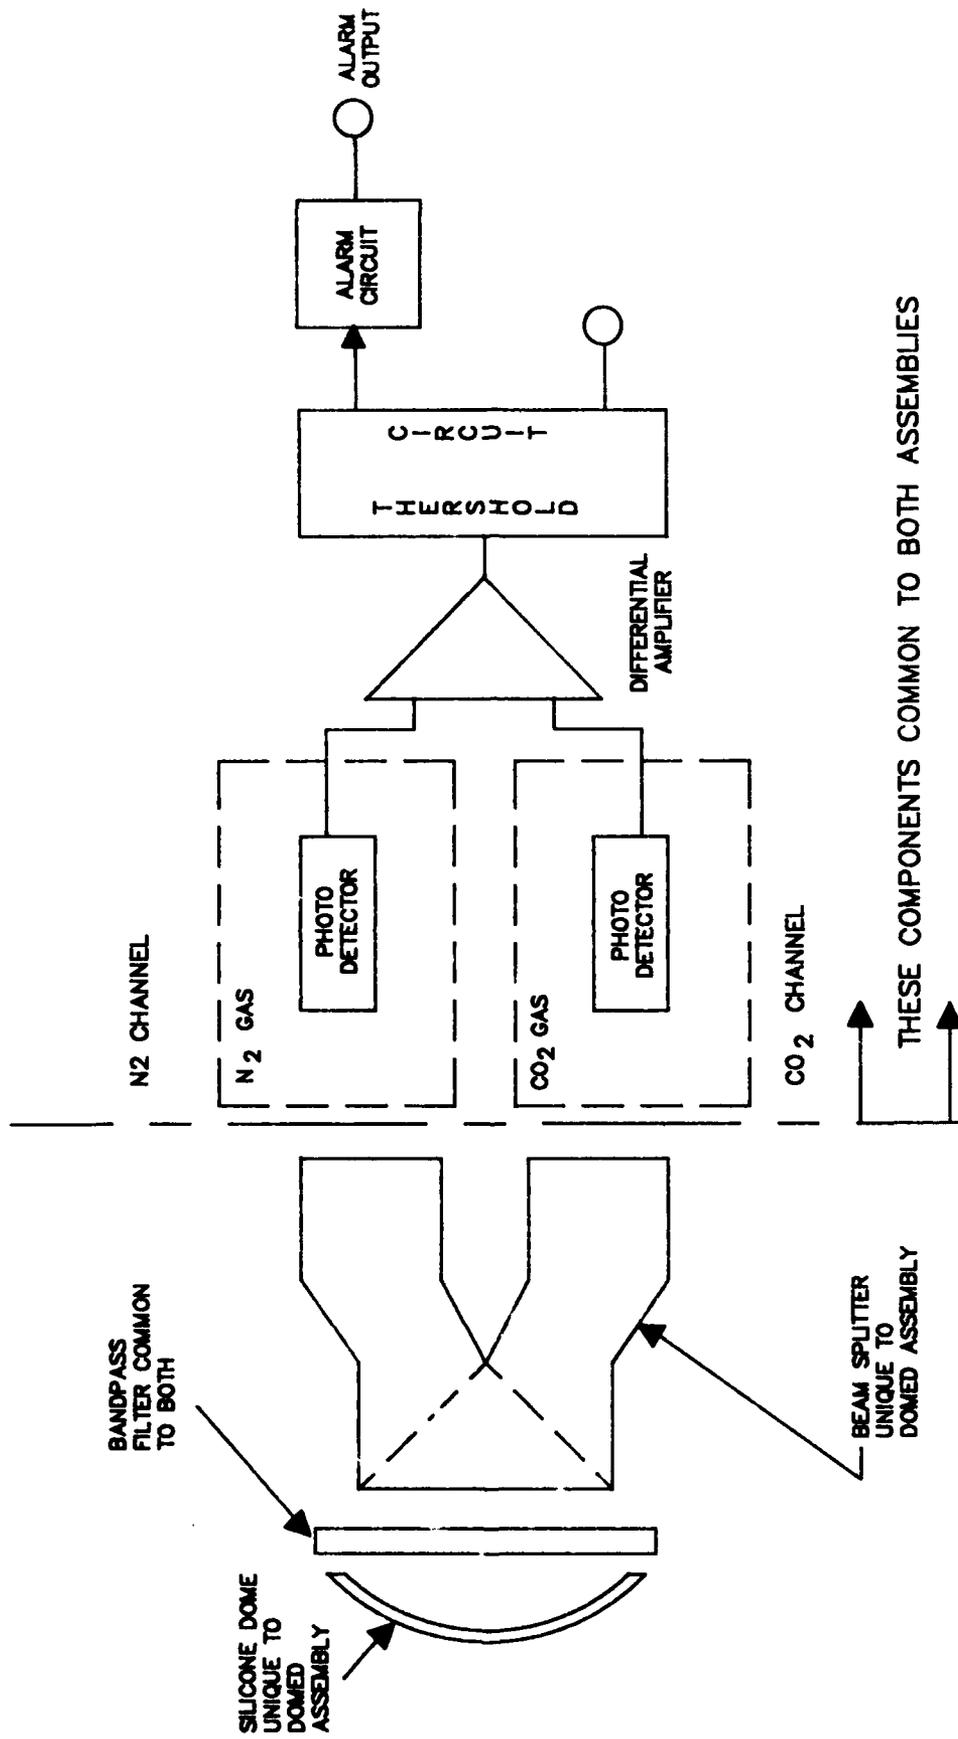
Figure 12. Typical Configuration of W. Kidde Optical Detector

Each version of the two detectors contained one nitrogen and one carbon dioxide filled photodetector. Each photodetector output its signal to an amplifier circuit. Amplification was necessary to provide an adequate signal to the differential amplifier. Upon "seeing" a flame from the combustion of various hydrocarbons the output of the nitrogen gas filled photodetector became much larger than the output of the carbon dioxide filled photodetector. This caused the differential amplifier to output a large negative signal. This signal, upon reaching a preset level (voltage) set within the threshold circuit, triggered an alarm circuit.

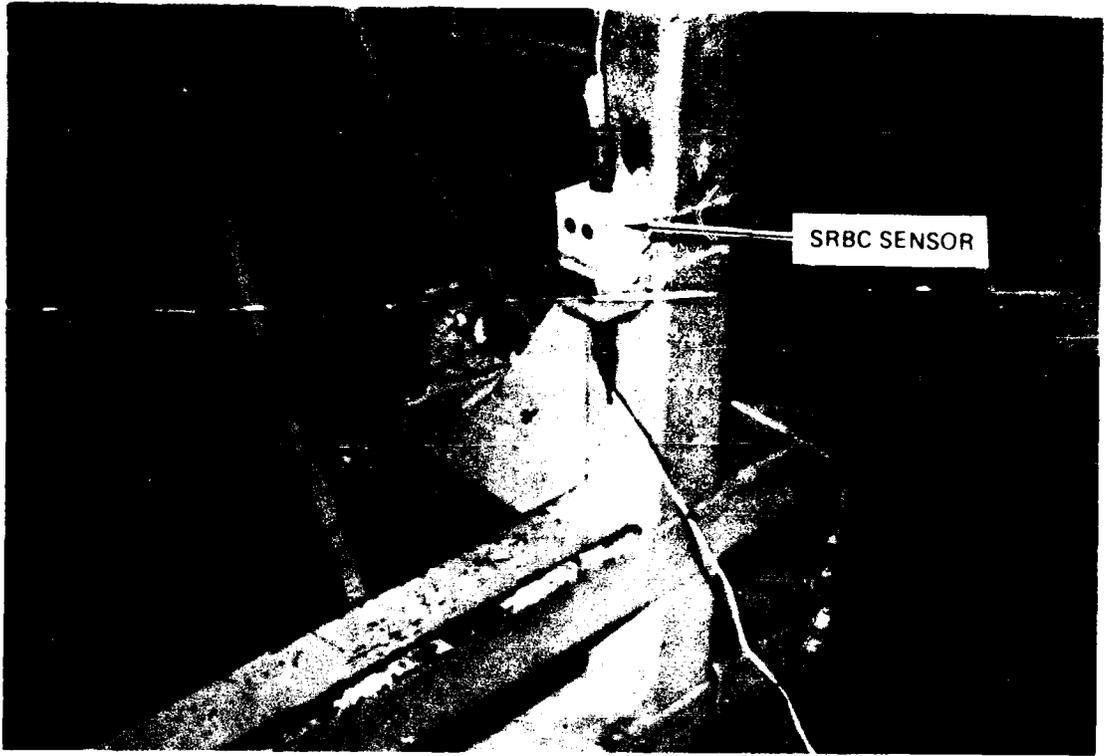
*Figure 16. Two SRBC Sensor Units*

Santa Barbara Research Centers' optical fire detection system consisted of a dual channel IR sensor unit and an enunciator box which indicated the presence of a fire with fire warning lights. The sensor unit was 2 x 2 x 1.5 inches (Figure 16), and had a 90 degree solid cone angle field of view.

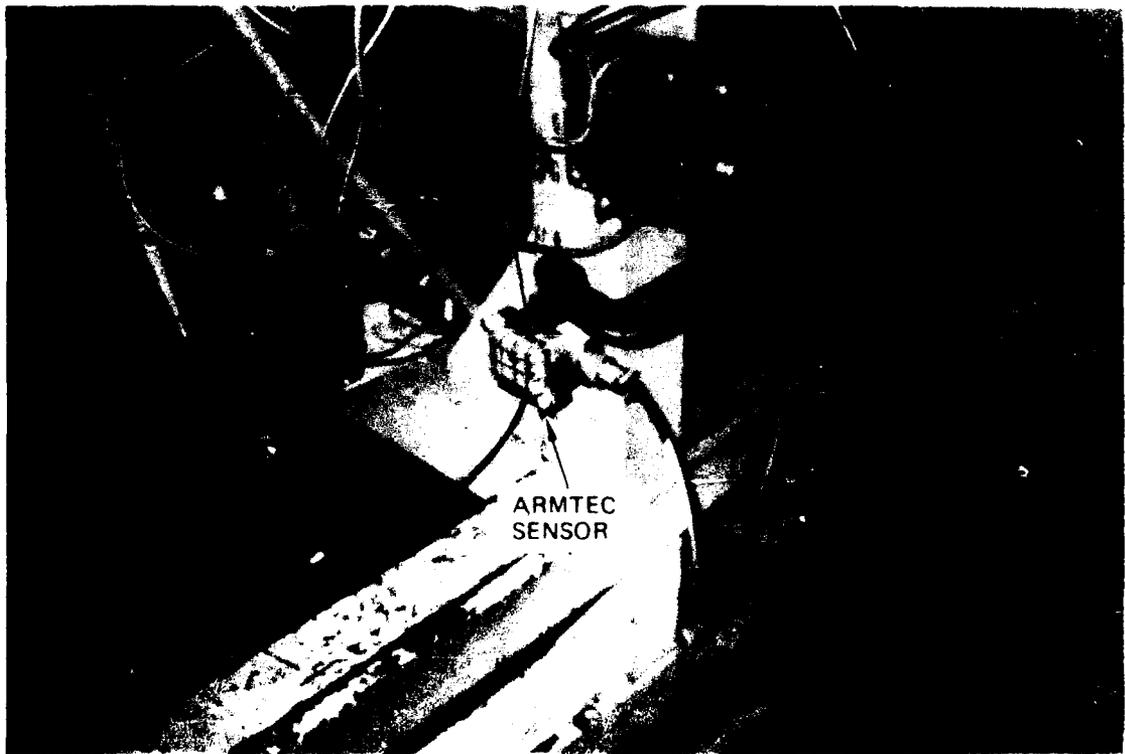
*Figure 19. ARMTEC Sensor and CWU*

The Armtec optical fire detection system consisted of a sensor unit and a control unit containing a microprocessor. The control unit was mounted on the AENFTS frame adjacent to the upstream end of the first test section. The sensor was about 2 x 2 x 1.5 inches and had three small domes covering the detectors (Figure 18), all protected by a metal screen. A terminal strip on the control box provided electrical connections for a cockpit crew warning unit with adjacent red fire, amber "fault" and green "system ready" lights and connection to a 28-volt power supply (Figure 19). Boeing provided a red and a green light on a mounting bracket above the main AENFTS viewing window so that the control box fire and "system ready" output signals could be included in the video tape data record.

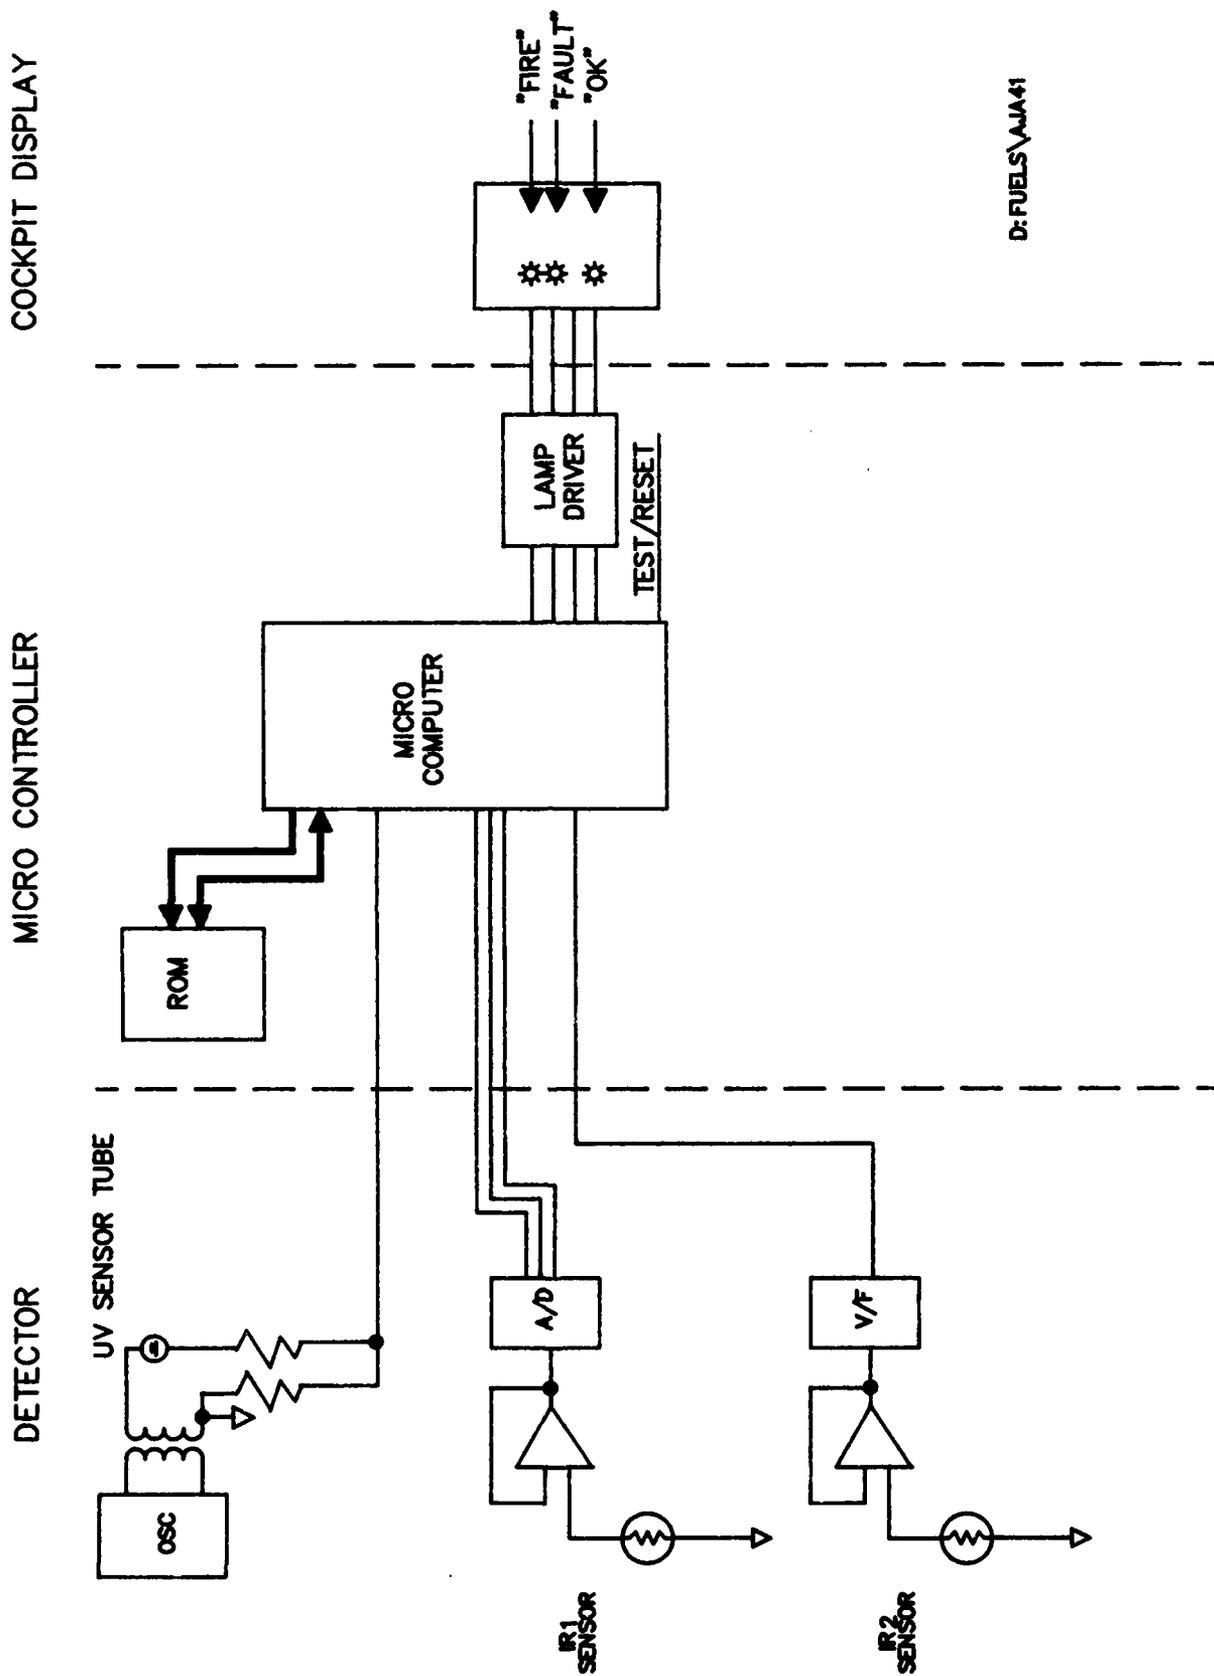
Figure 20. Block Diagram of Armtec Optical Detector

Referring to Figure 20, Armtec has described the detector unit as containing three optical detectors which monitored, respectively, broad band IR signal, narrow band IR signal centered on the CO<sub>2</sub> emission and the shorter UV wavelengths. Outputs from these three detectors were monitored by the microprocessor and its internal logic established combinations of signals that would allow for determination of a fire condition with maximum discrimination (i.e. actual fire versus false alarms).

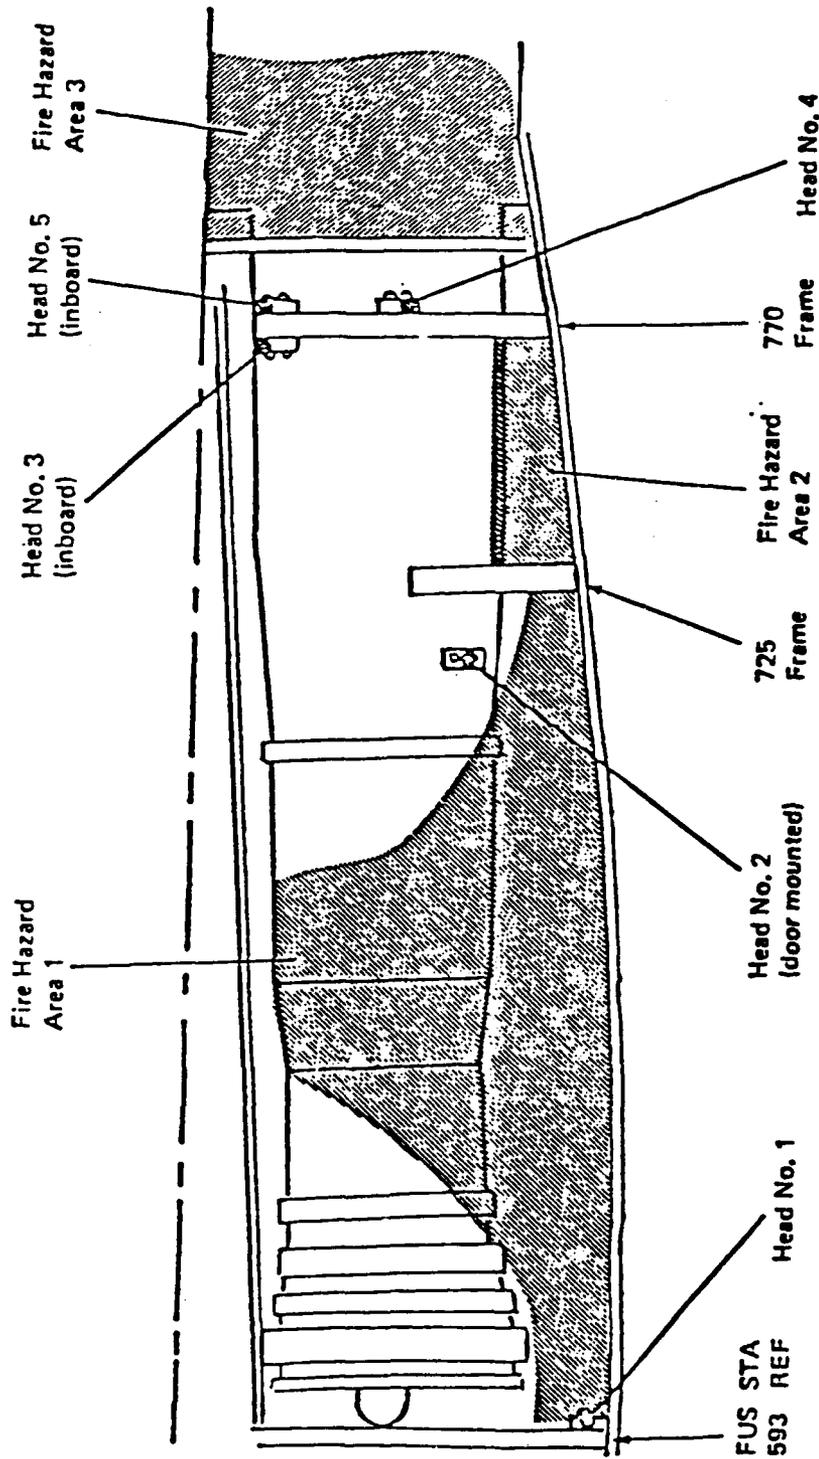
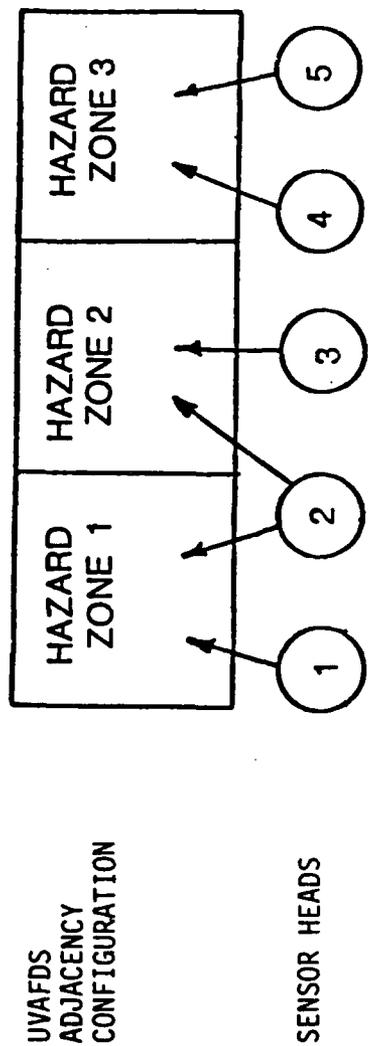
FIGURE 1. SENSOR HEAD LOCATIONS AND ADJACENCY CONFIGURATION.

One feature that both Systems A and B use is adjacency. Adjacency is defined as two sensors viewing the same area/volume. Figure 1 illustrates UVAFDS adjacency design and the location of each of the sensor housings. As can be seen, sensors one and two view one hazard zone, two and three view a second hazard zone, and sensors four and

five view a third hazard zone. This means that System A has four UV detectors viewing each hazard zone area, whereas System B only has two. Thus, System A can lose up to three of its four detectors without losing hazard zone coverage. System B, however, can only lose one detector and still provide hazard zone coverage. If hazard zone coverage is lost, a fault lamp is illuminated on the cockpit display (CWU). For example, in Hazard Zone 1 System A has head 1 (with UV detectors X1 and Y1) and head 2 (with detectors X2 and Y2) providing detection coverage. Any fire signals from X1 and Y1, or X1 and Y2, or X2 and Y1, or X2 and Y2 would illuminate a fire lamp on the CWU. If detector X1 was damaged, the system would ignore X1's output and wait for fire signal inputs from either Y1 and X2 or X2 and Y2. If detector Y1 is nonoperational, the system reconfigures to X2 and Y2 only. If the Y2 detector fails, then the system reconfigures so that the output from only detector X2 is capable of triggering a fire warning. Finally, if X2 fails, the fault lamp is illuminated on the CWU.
