CONTRACT REPORT CERC-88-2

# LONG-TERM SAND CAP STABILITY: NEW YORK DREDGED MATERIAL DISPOSAL SITE

Jeffrey H. Parker, Raymond M. Valente

July 1988  
Final Report

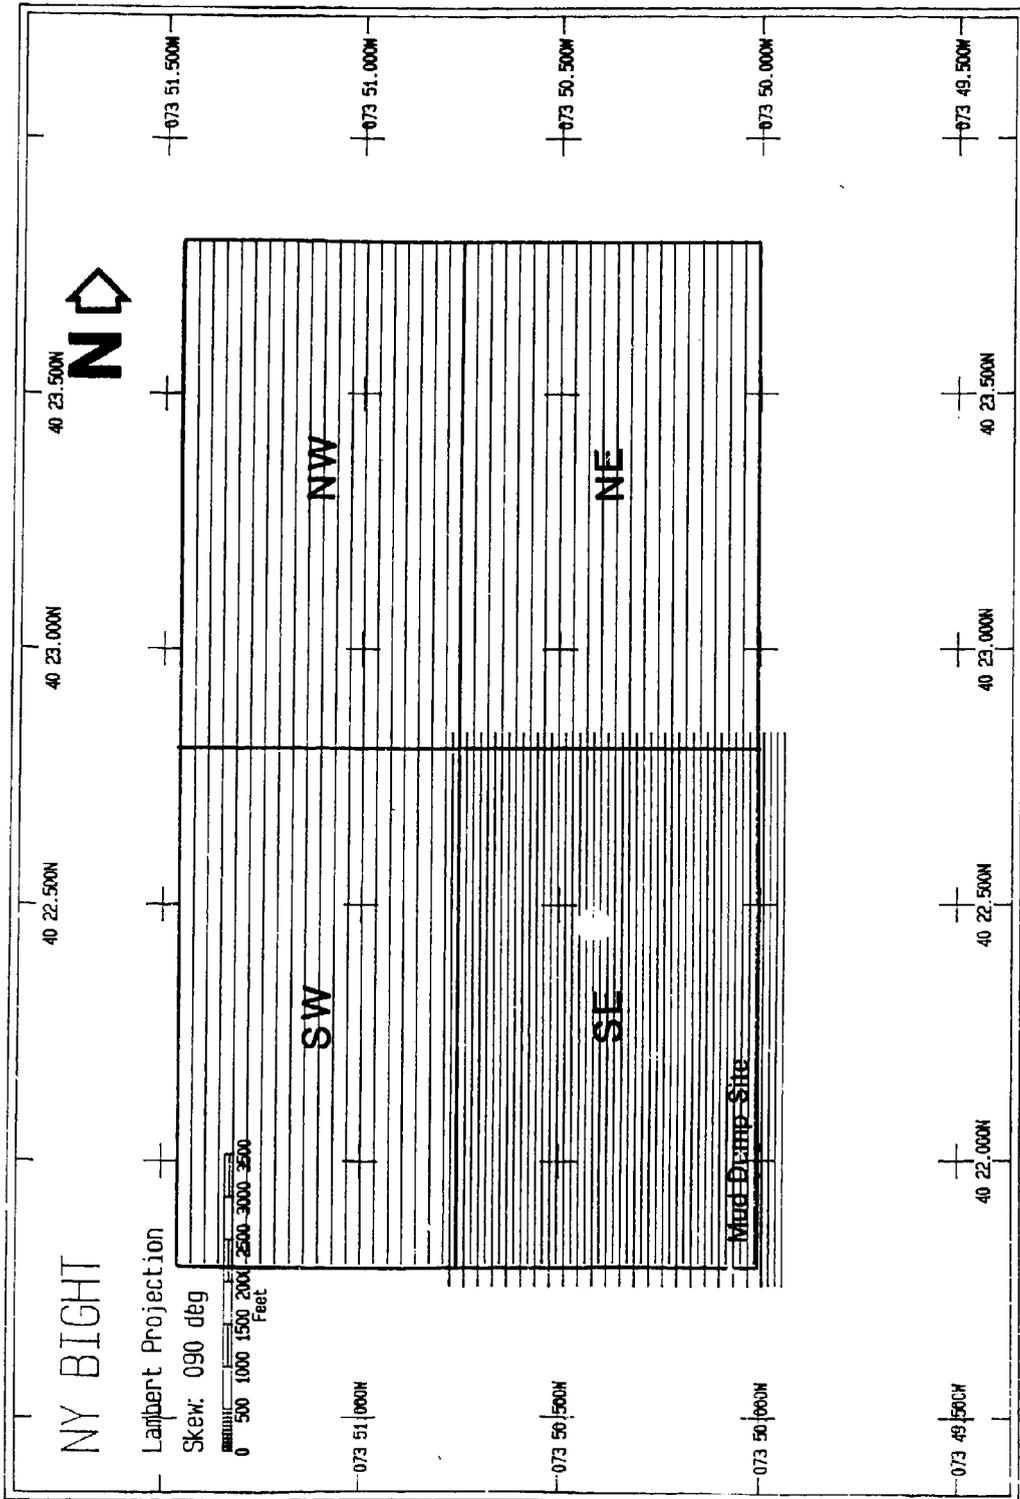
Figure 2. Survey lanes used for the precision bathymetric survey.

- a. A precision bathymetric survey was conducted over the entire Mud Dump site in an area of 2050 m by 3700 m at a lane spacing of 50 m (Figure 2). This configuration approximates that used by the Survey Branch of NY District during the August 1981 survey (objectives a and b).

- a. A precision bathymetric survey was conducted over the southeast quadrant at the EMD covering an area 1200 m by 2000 m at a lane spacing of 25 m (Figure 2). This approximates the procedures used during the June 1980 and August 1981 surveys performed by the Survey Branch of NY District (objective c).

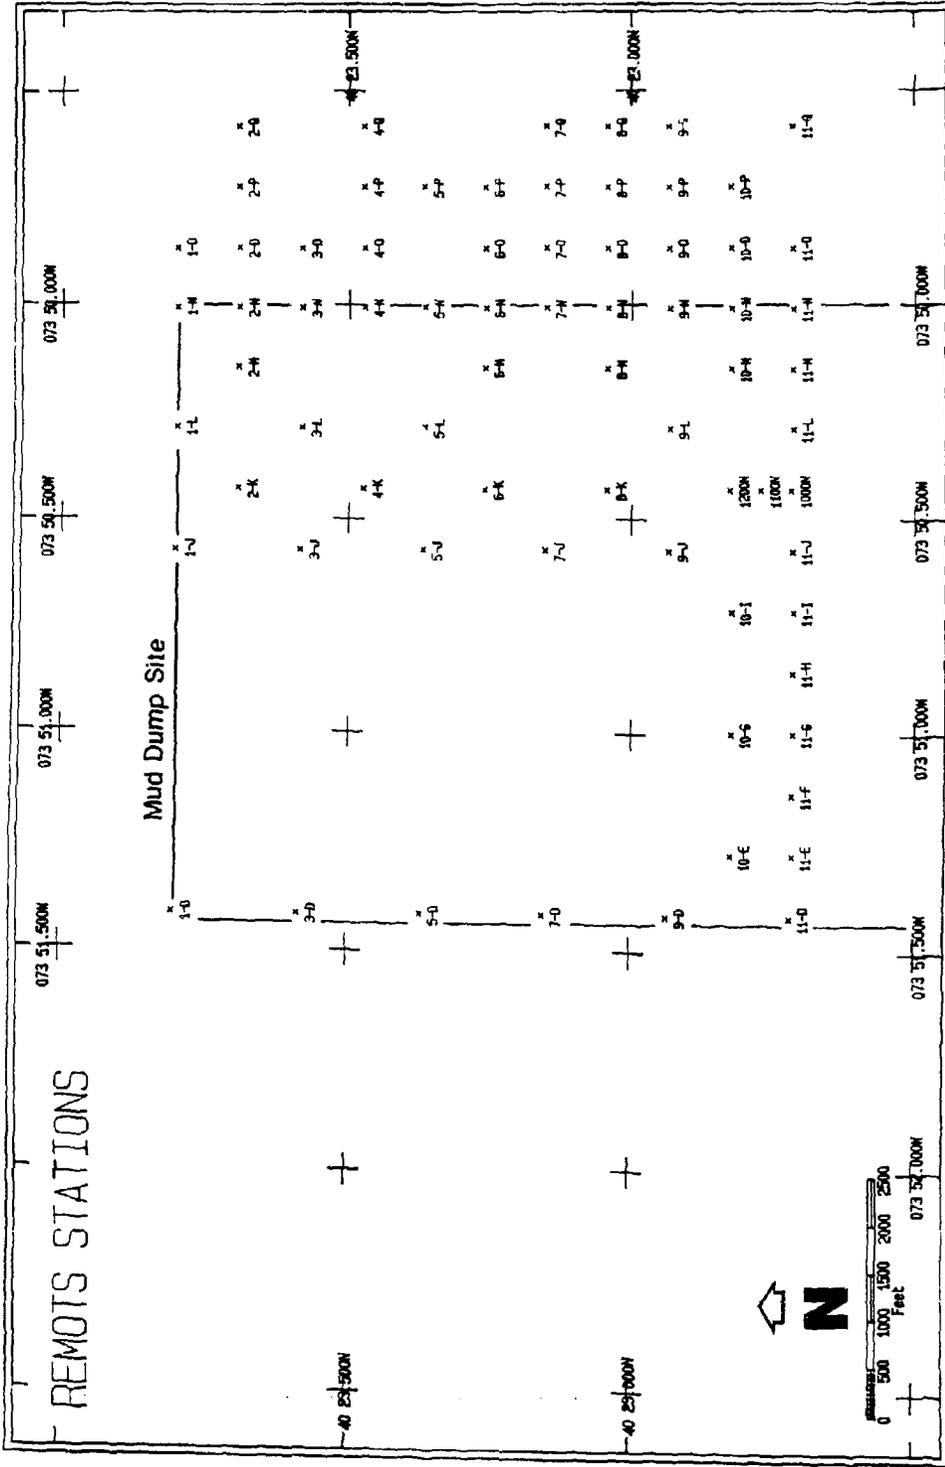
Figure 3a. Locations and designations of REMOTS® stations in the northern half of the New York Mud Dump site.

- b. To define the boundaries of the Mud Dump site, a grid of REMOTS® images were taken at a 400 m spacing over the northwest and northeast quadrants and at 200 m spacing over the southeast and southwest quadrants extending 600 meters beyond the south, east, and southwest boundaries of the Mud Dump site (Figure 3, objective b).

41. A single REMOTS® image was obtained and analyzed for each station shown in Figure 3. Out of a total of 330 stations, 287 stations were occupied. The remaining 43 could not be completed due to adverse weather conditions. Variability in sediment type and shear strength among different areas of the Mud Dump site affected the penetration of the REMOTS® prism. During the field

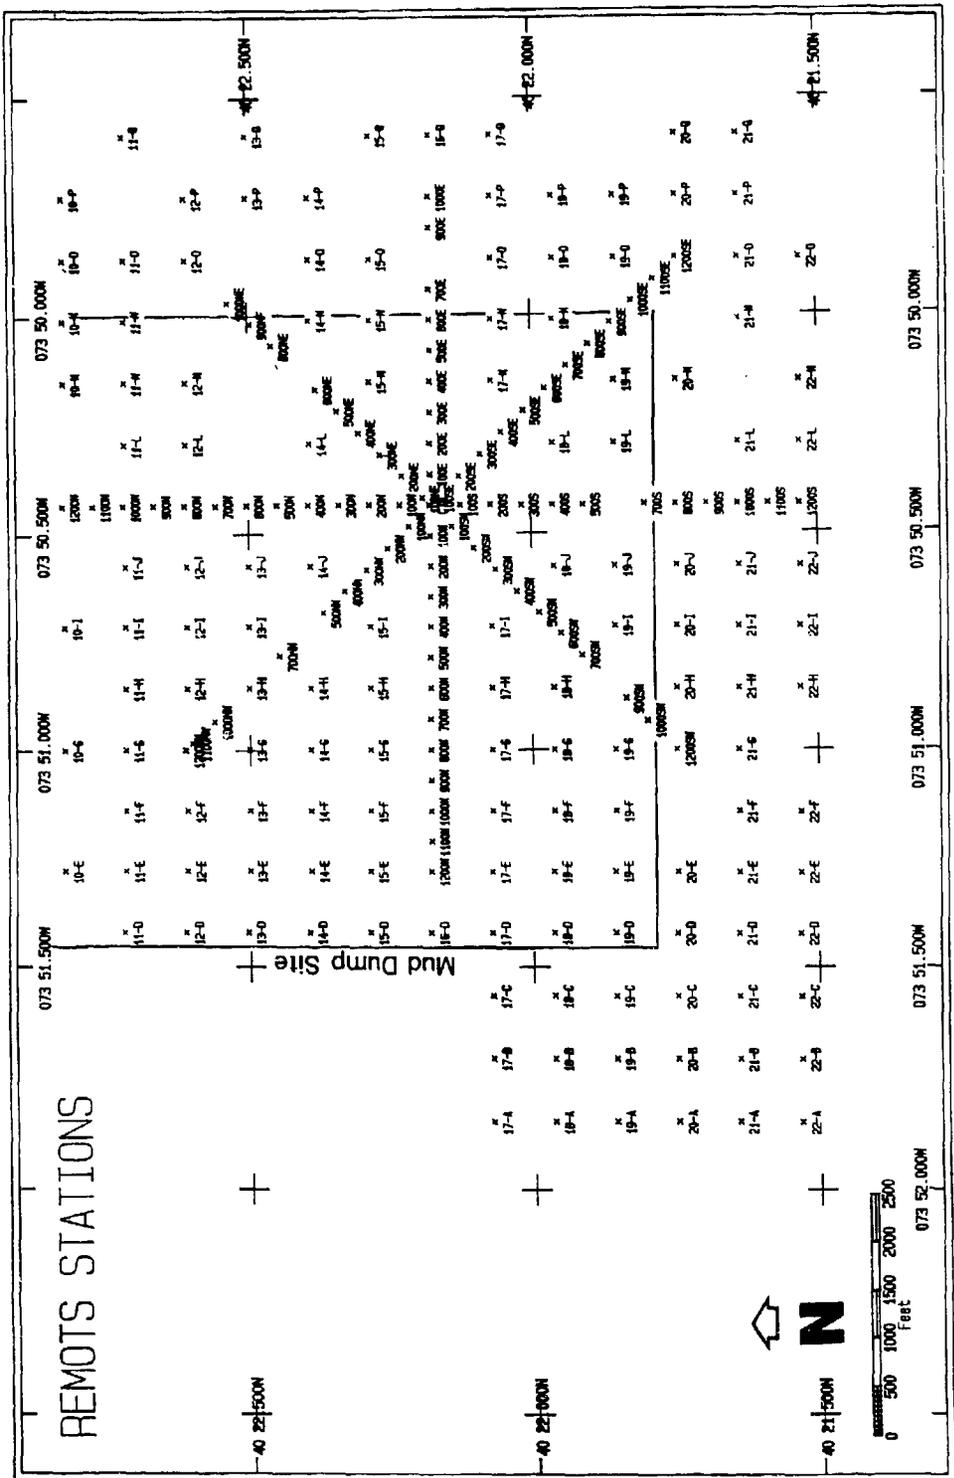
Figure 3b. Locations and designations of REMOTS® stations in the southern half of the New York Mud Dump site.

- c. The lateral extent of the sand cap and the dredged material was determined by REMOTS® images taken every 100 m on eight radial transects emanating out to a distance of 1200 m from the center of the dredged material mound as determined by previous bathymetric surveys and the "MD" buoy location (Figure 3, objective c and d).

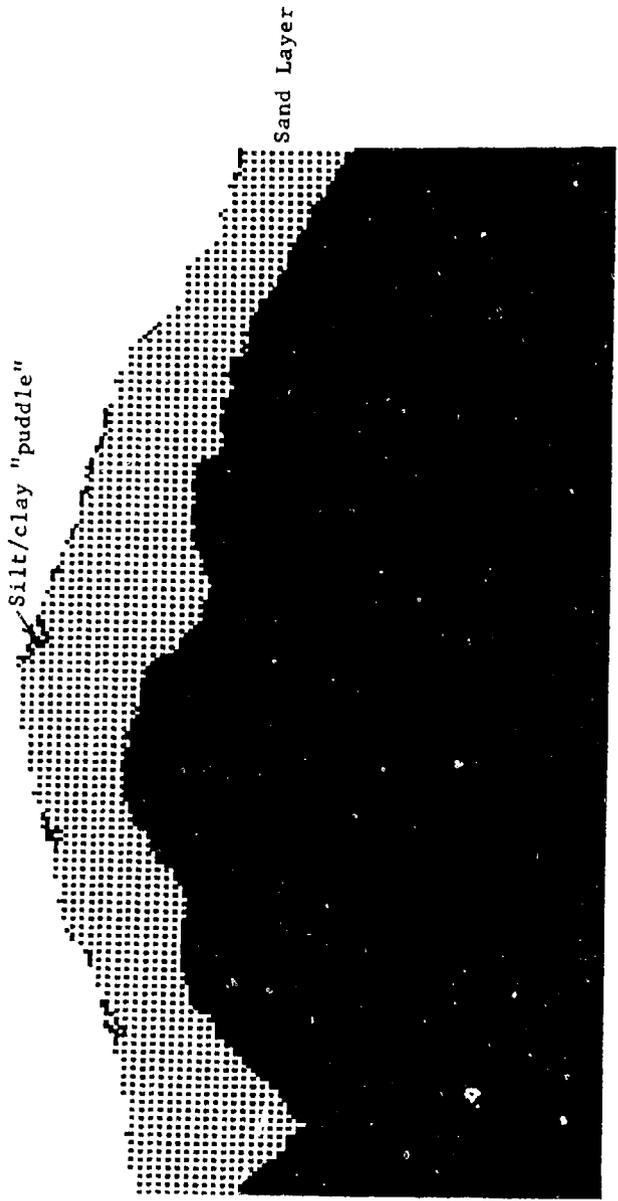
Figure 4. Representative trace of acoustic impedance at the EMD.

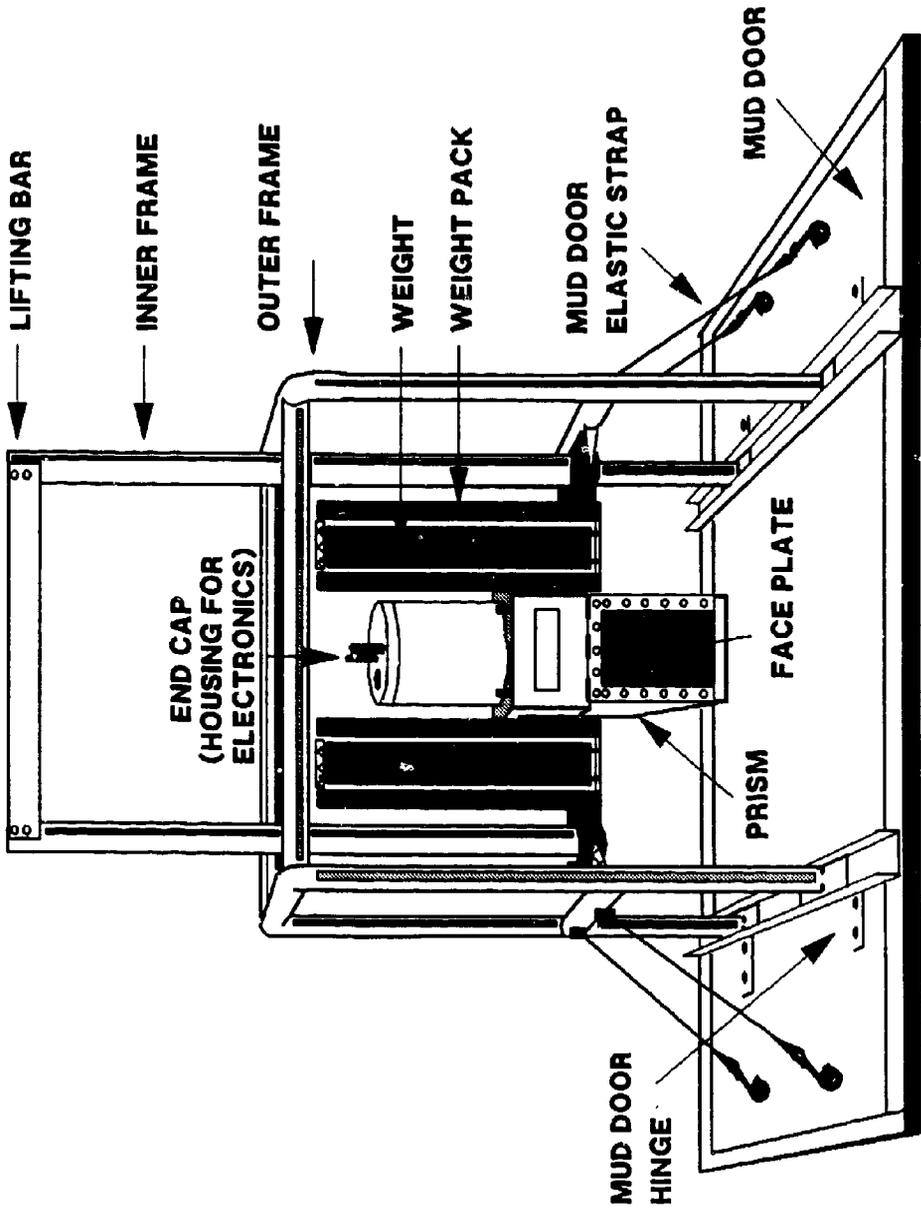
Figure 5. Benthos Model 3731 Sediment-Profile Camera.

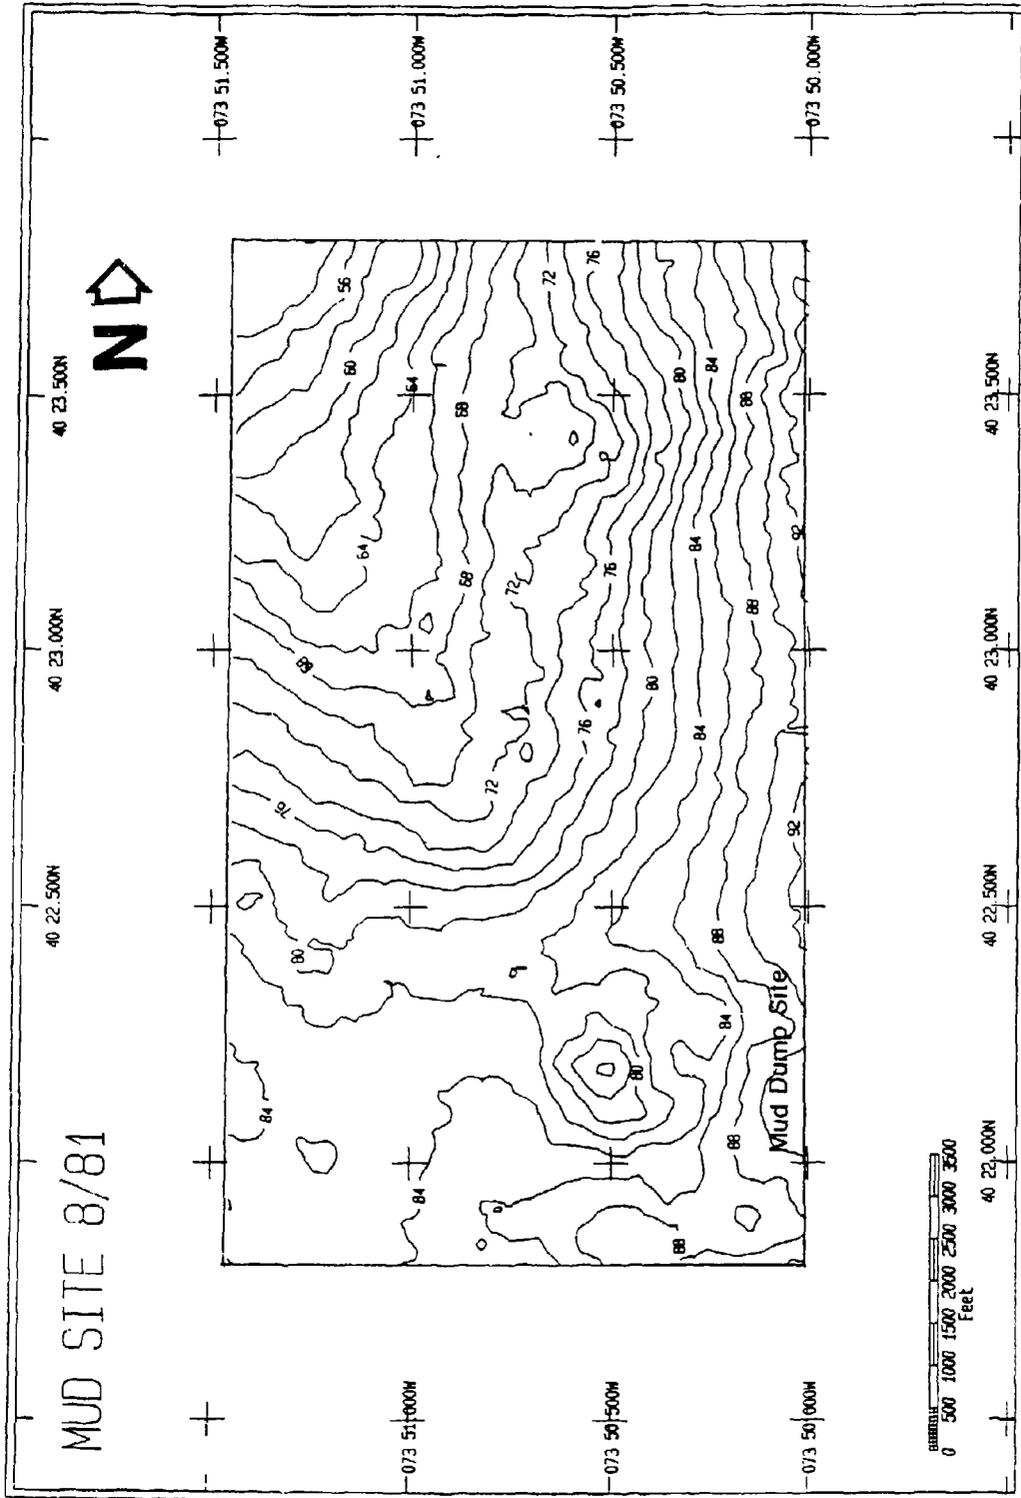
Figure 6. Contoured depth chart of the Mud Dump, August 1981. Depths are in feet.

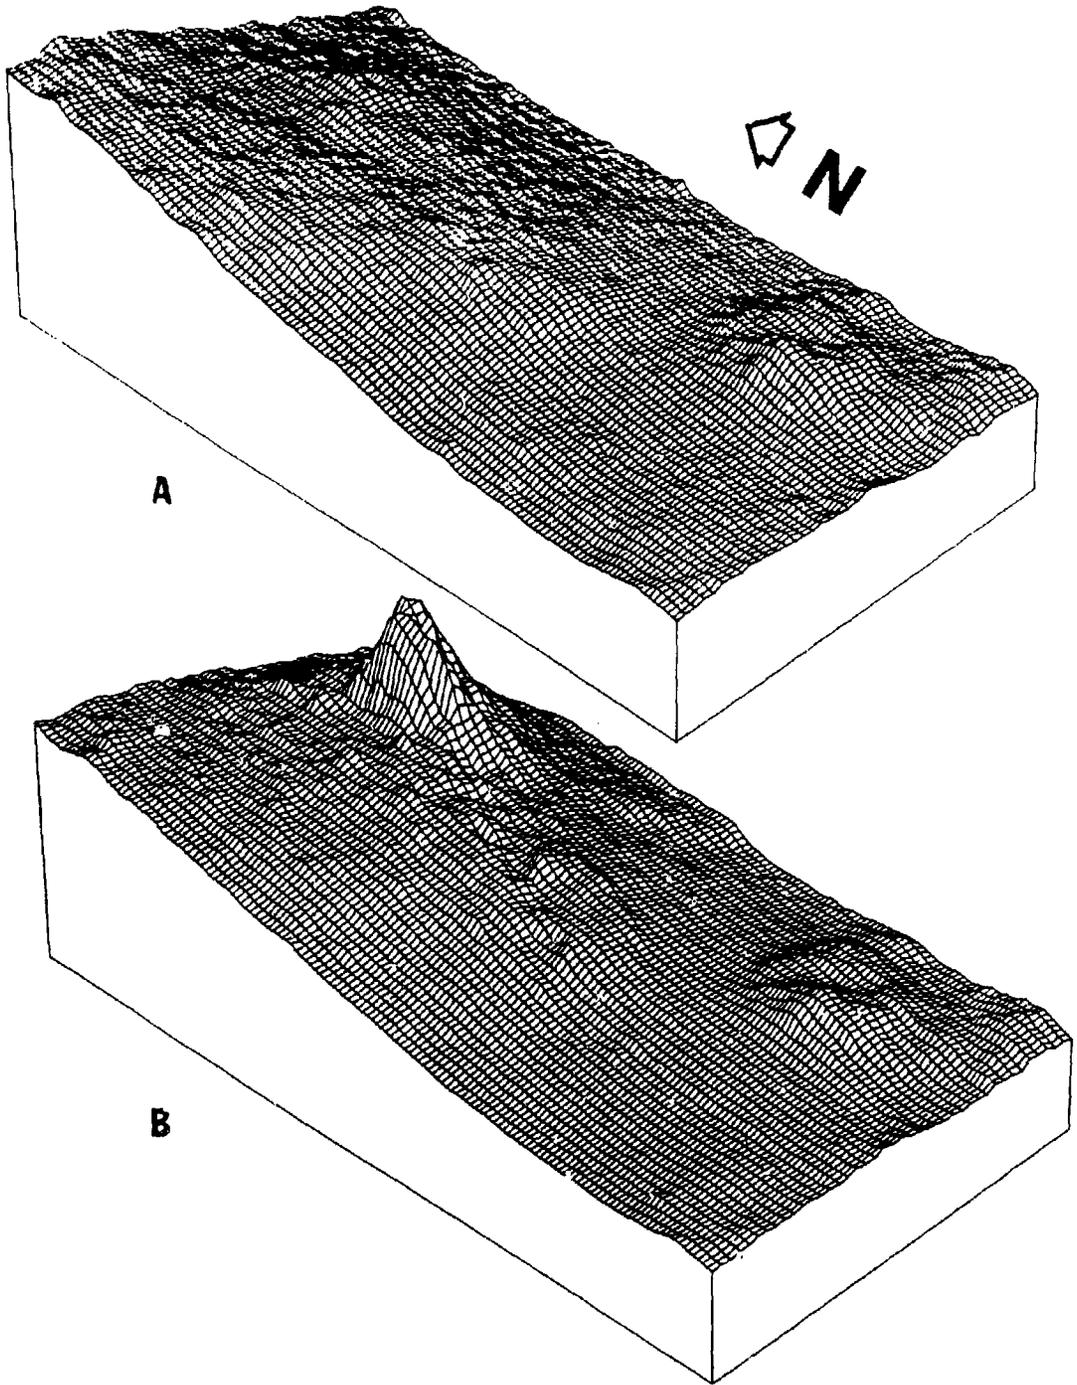
Figure 8. Three dimensional plot of the Mud Dump site in a) August 1981 and b) November 1986.

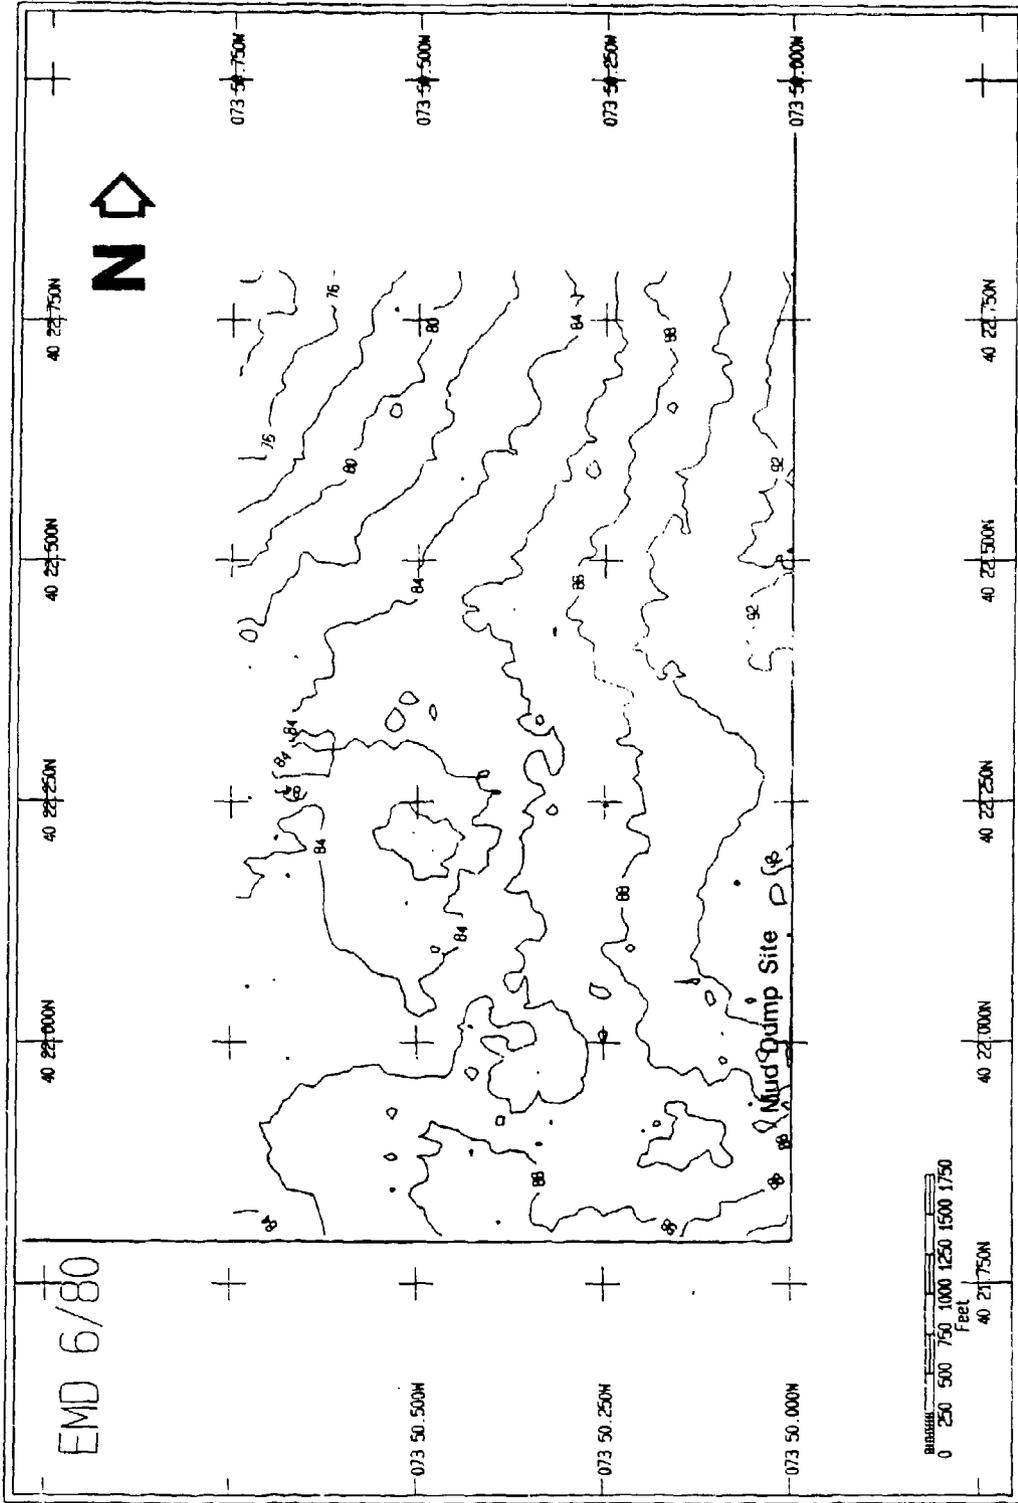
Figure 9. Contoured depth chart of the southeast quadrant, June 1980. Depths are in feet.

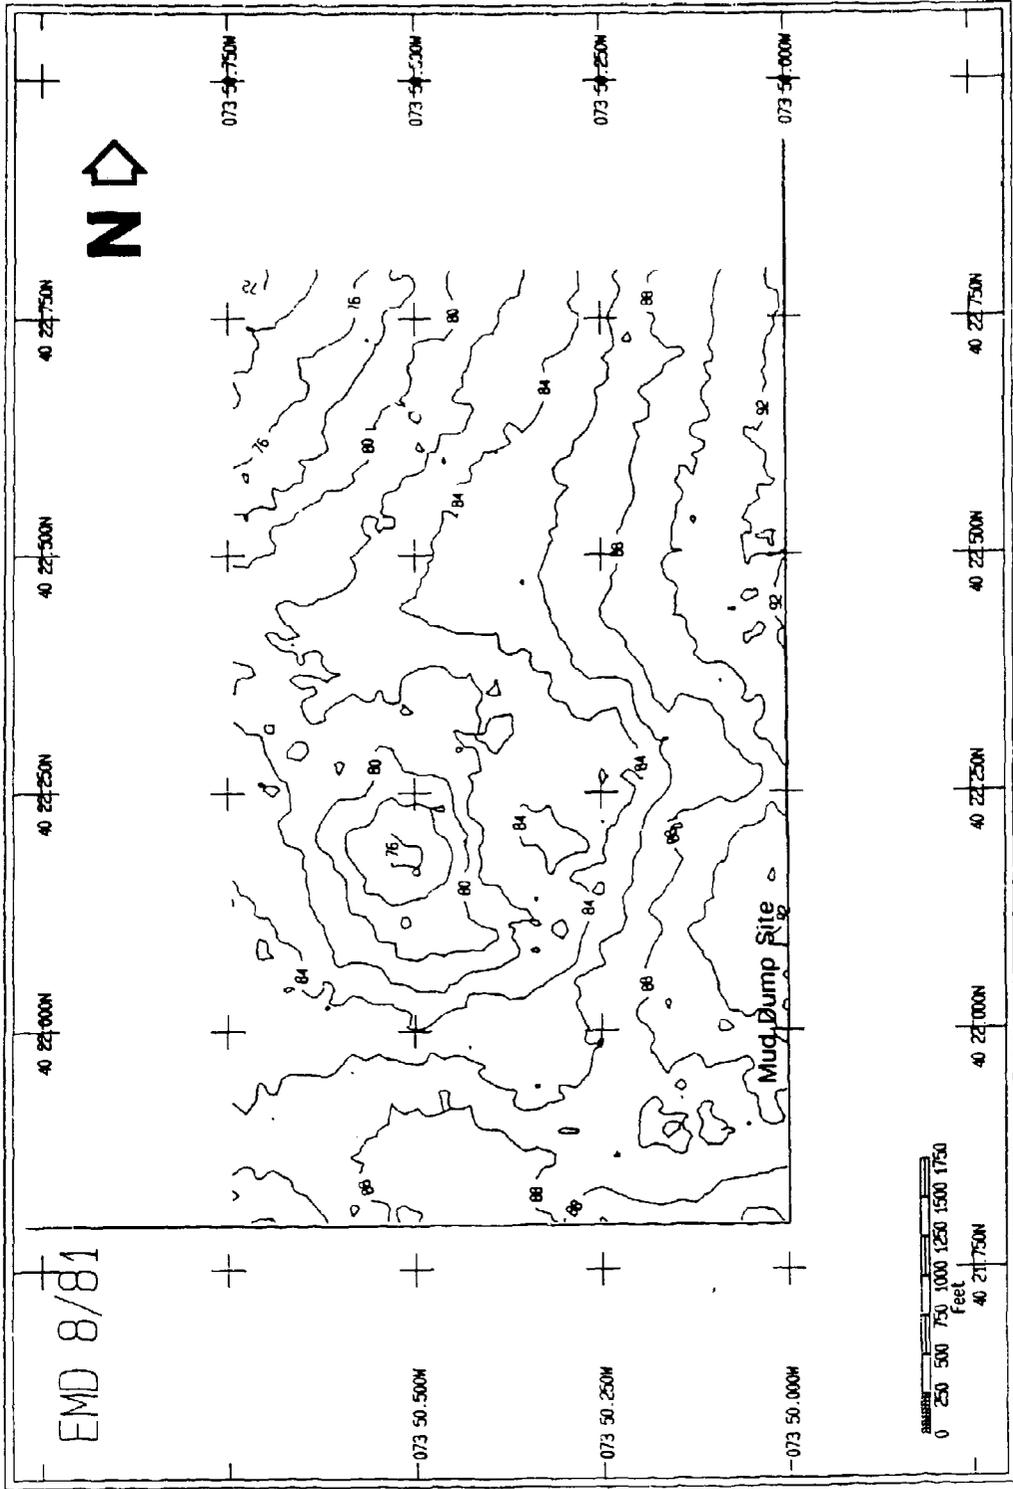
Figure 10. Contoured depth chart of the southeast quadrant, August 1981. Depths are in feet.

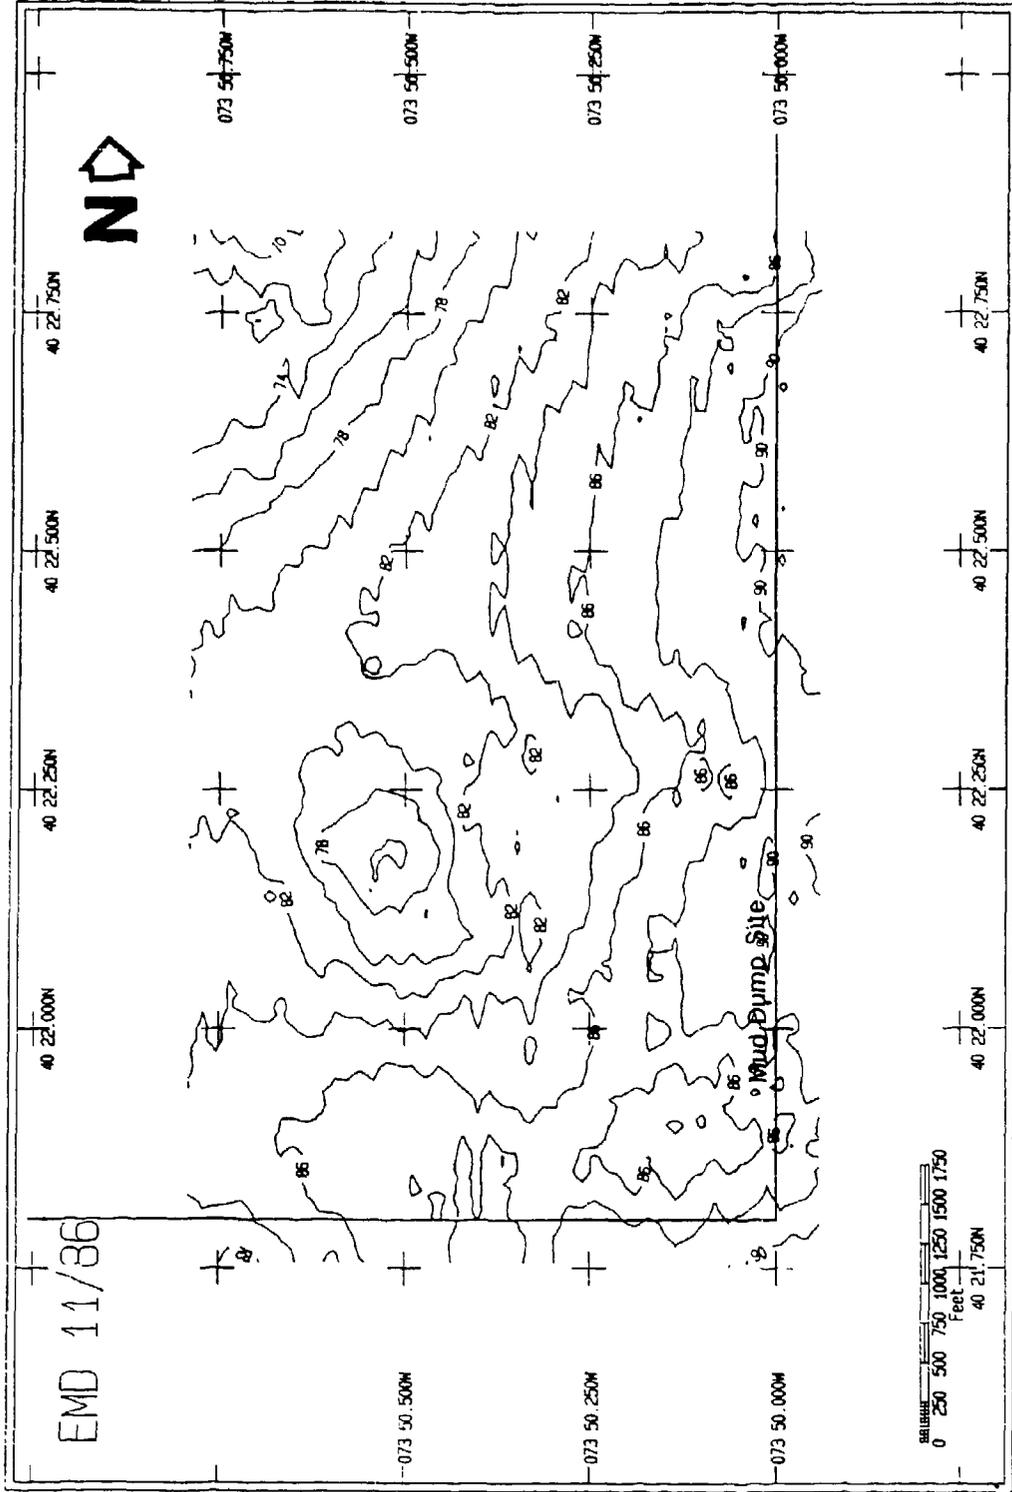
Figure 11. Contoured depth chart of the southeast quadrant, November 1986. Depths are in feet.

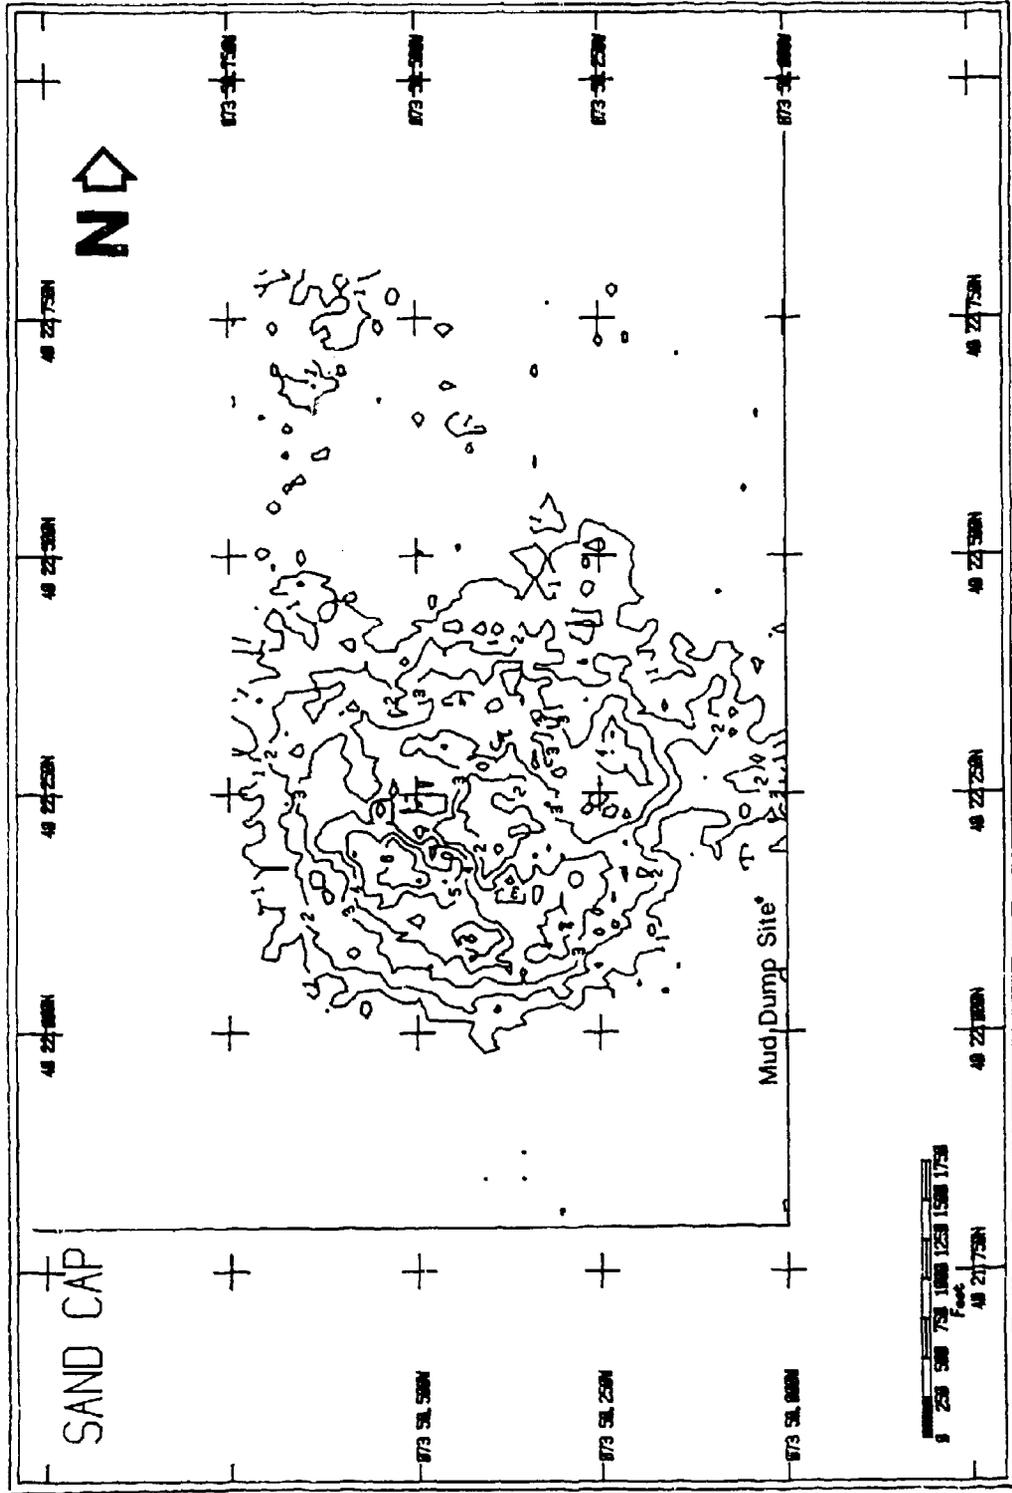
Figure 12. Contoured depth difference chart comparing the June 1980 and August 1981 surveys of the southeast quadrant. Depths are in feet.

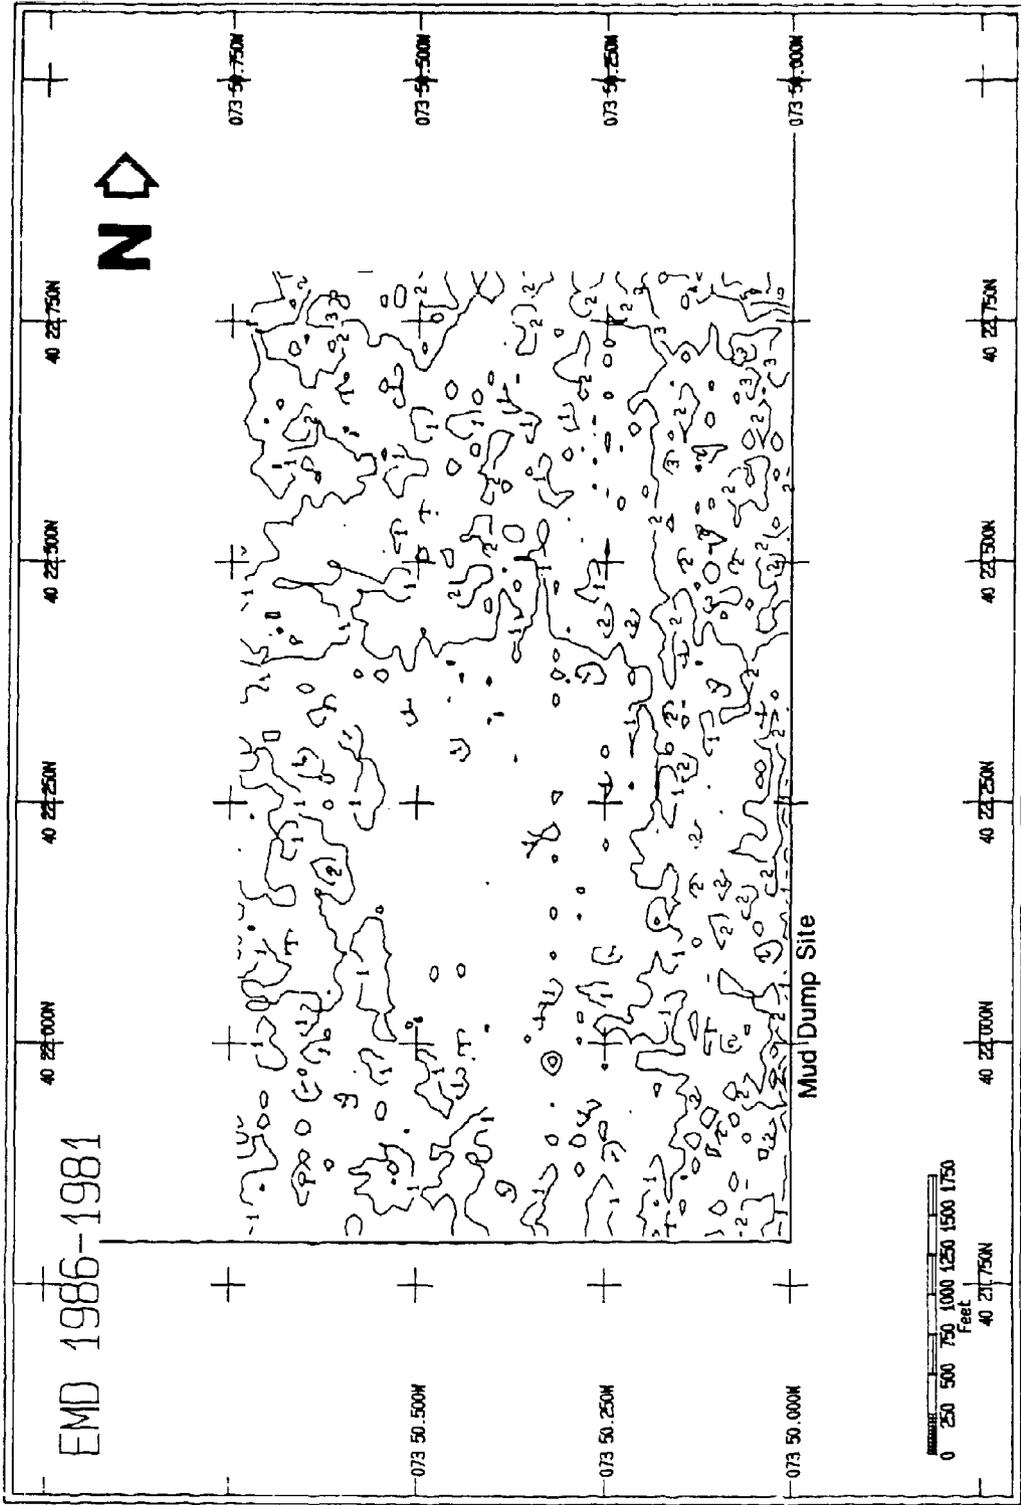
Figure 13. Contoured depth difference chart comparing the August 1981 and November 1986 surveys of the southeast quadrant. Depths are in feet.

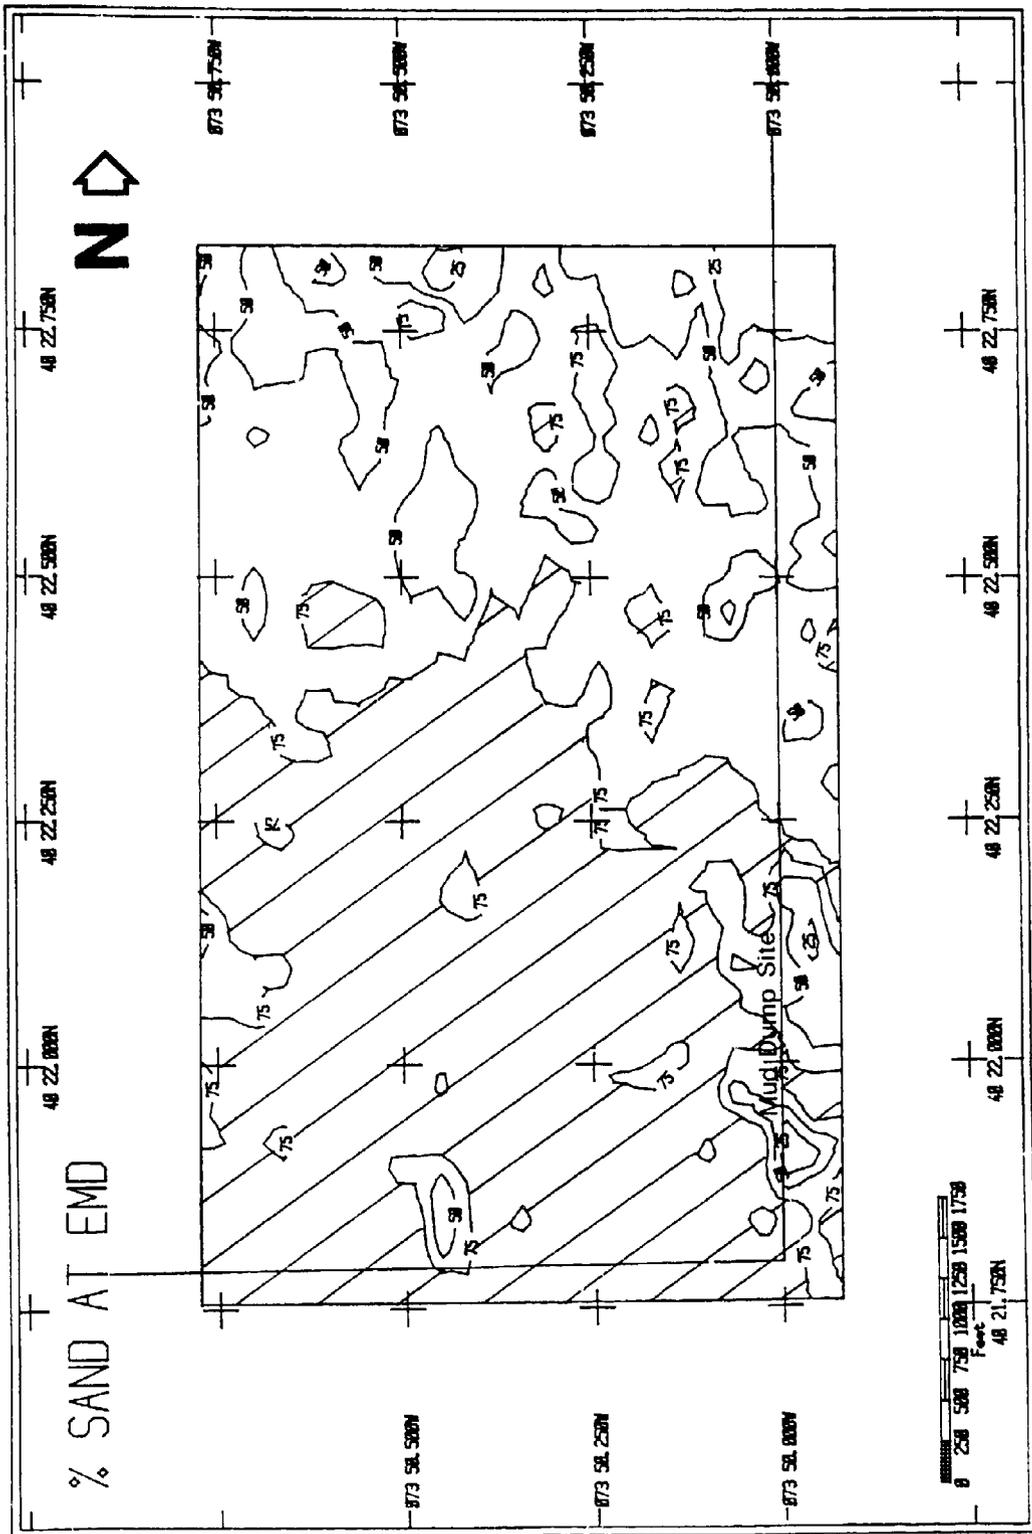
Figure 14. Percent-sand contour chart of the southeast quadrant.

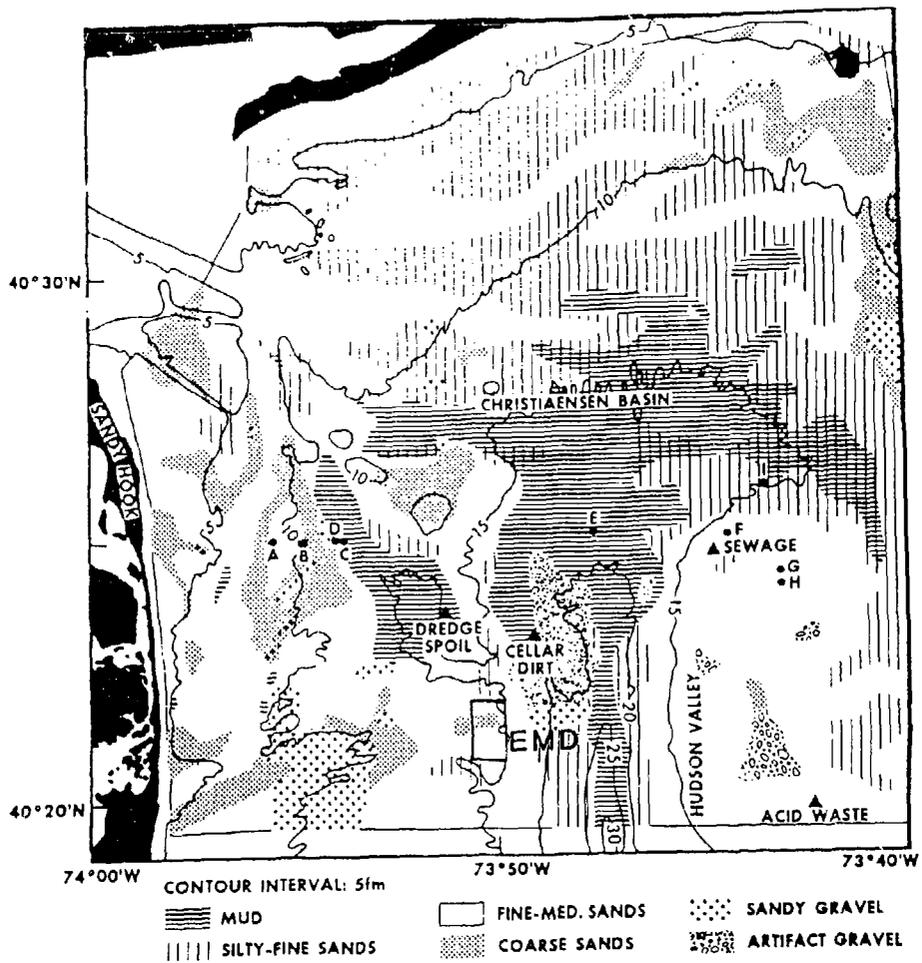
Figure 15. Distribution of surficial sediment in the New York Bight (from Freeland et al., 1976).

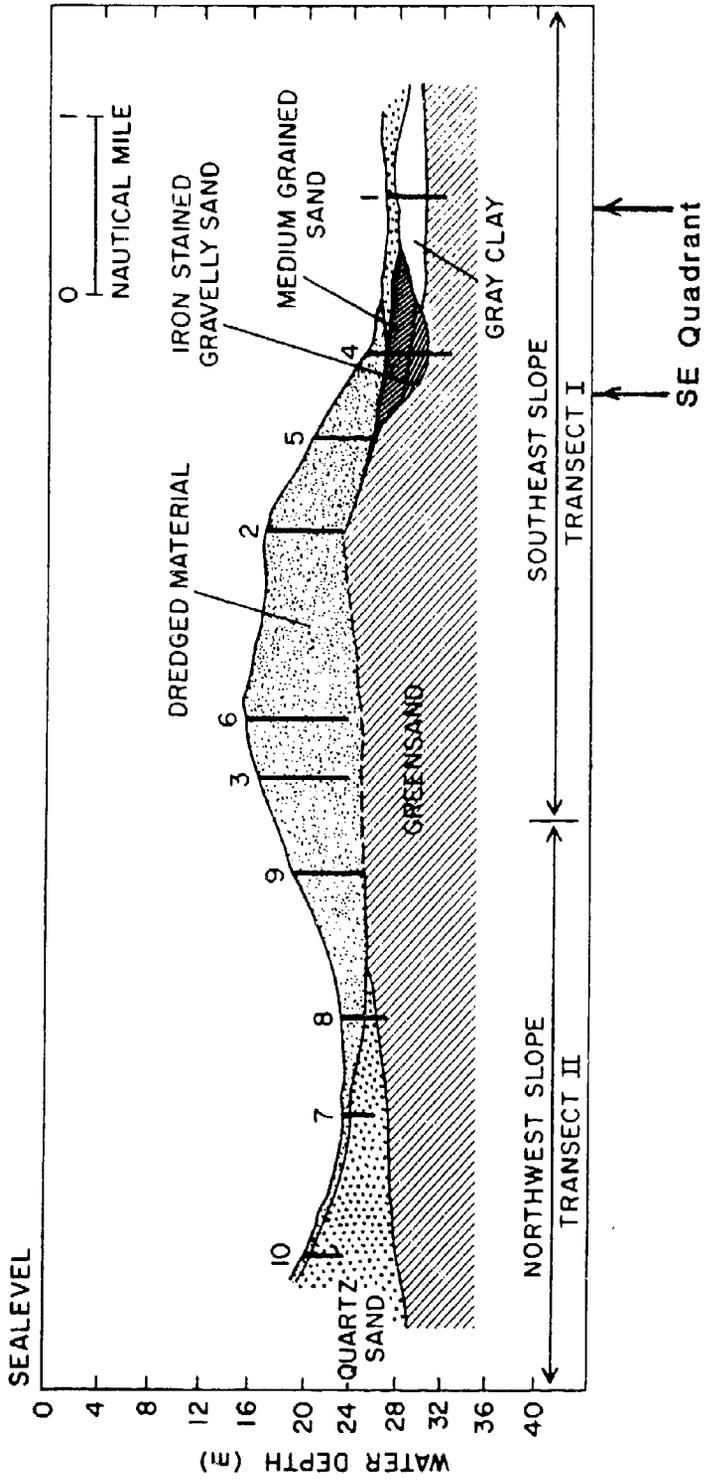
Figure 16. Cross-section of the general disposal area in the New York Bight (from Dayal et al., 1981).

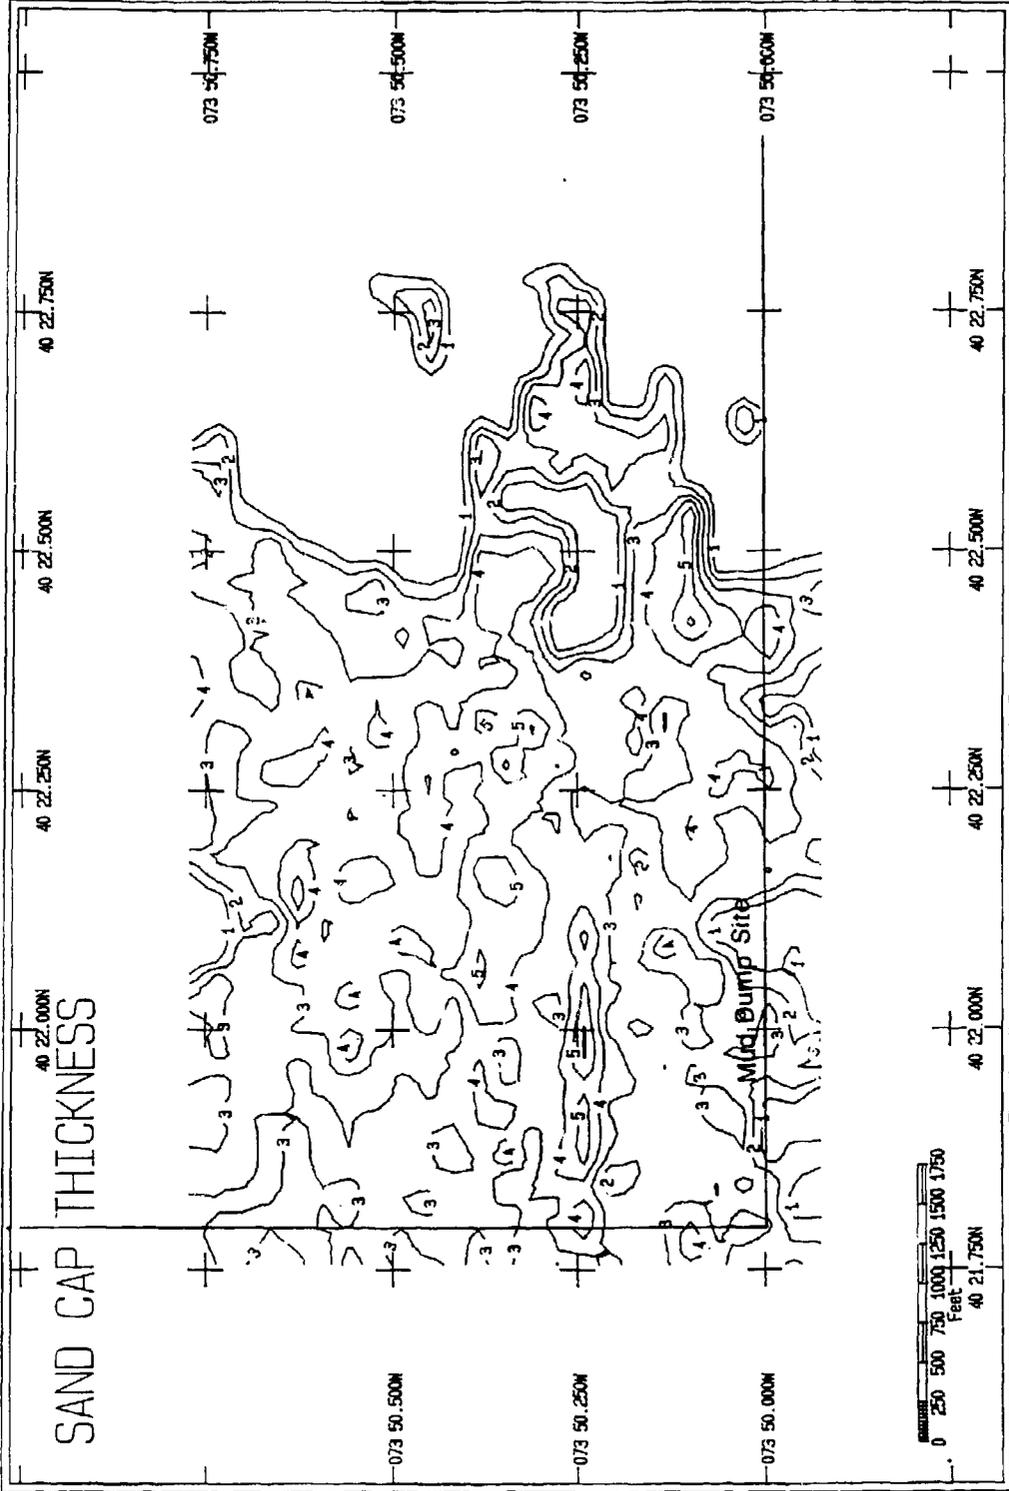
Figure 17. Sand layer thickness contour chart of the southeast quadrant. Values are in feet.
