CONTRACT REPORT CERC-88-2

# LONG-TERM SAND CAP STABILITY: NEW YORK DREDGED MATERIAL DISPOSAL SITE

Jeffrey H. Parker, Raymond M. Valente

July 1988  
Final Report

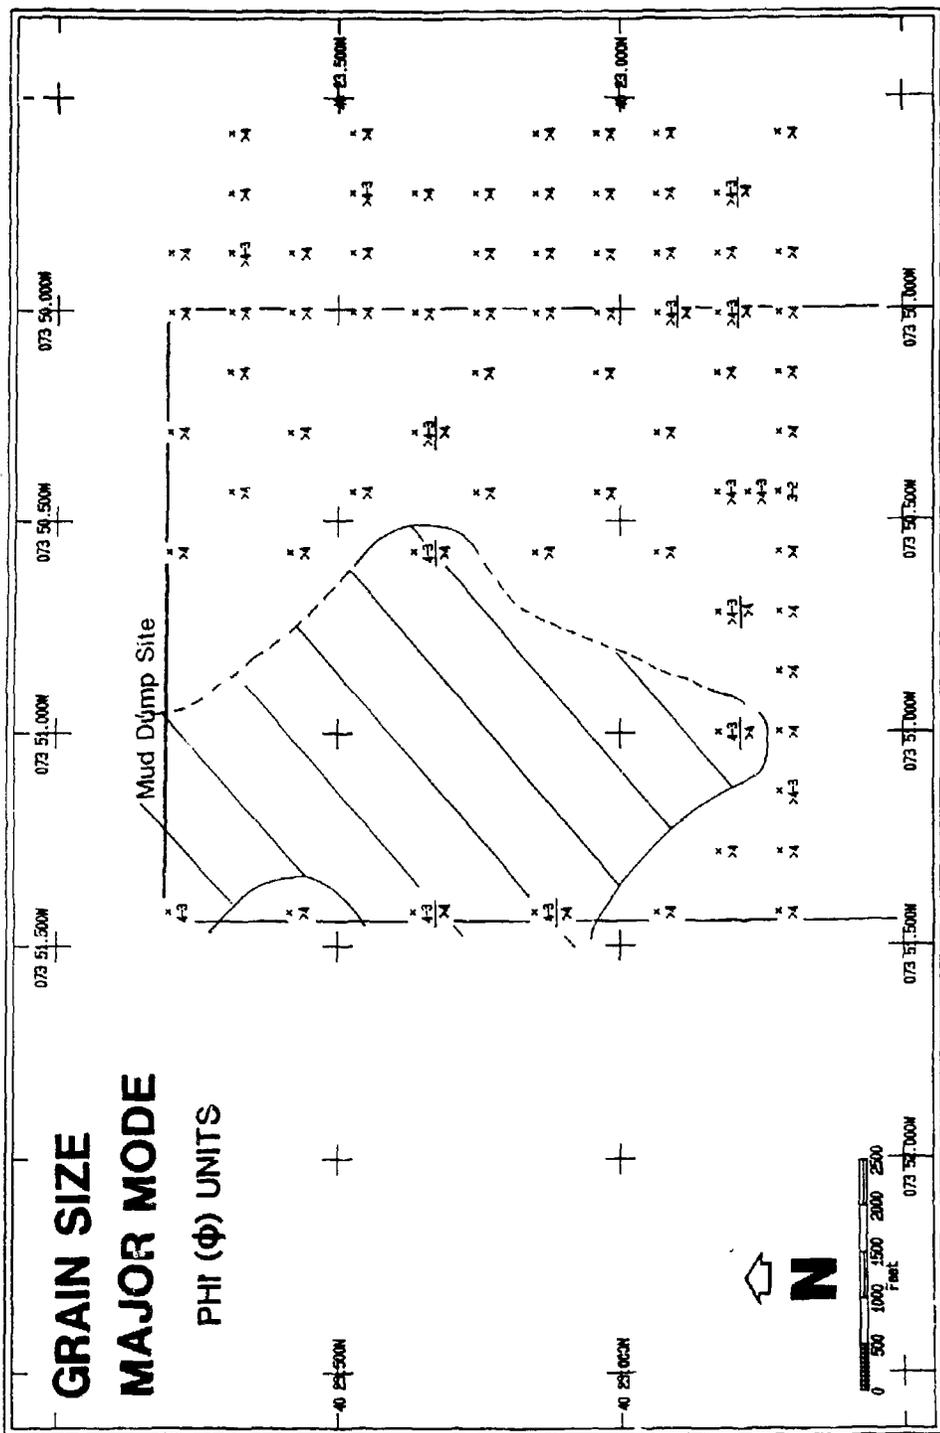
Figure 18a. The mapped distribution of apparent grain-size major mode (in phi units) in the northern half of the Mud Dump site. Hatched areas delimit stations where sand (4 to 1 phi) comprises the surface sediment. Unhatched areas are stations having surface sediments of silt/clay (>4 phi) or very fine sand/silt/clay (>4-3 phi). Both the top and bottom grain-size major modes are indicated at stations having two distinct sedimentary layers.

44. Figure 18 shows the distribution of sediment grain-size major mode at the Mud Dump site. The stations which fall outside the hatched areas in this figure predominantly have a major mode of silt/clay ( $\geq 4$  phi) or very fine sand - silt/clay ( $>4-3$  phi). Many images showed a distinct cross-sectional stratigraphy with abrupt transitions between sedimentary layers of different grain size (Figure 19). At such stations, very fine sand - silt/clay ( $>4-3$  phi) were found to overlay slightly finer-grained layers of silt/clay ( $\geq 4$  phi). These latter depositional intervals appear to be organic-rich, low reflectance mud (most likely dredged material) which occurs primarily in the northeast quadrant as well as in the northern halves of the southwest and southeast quadrants. In addition, an isolated patch of this sediment exists southwest of the center of the EMD.

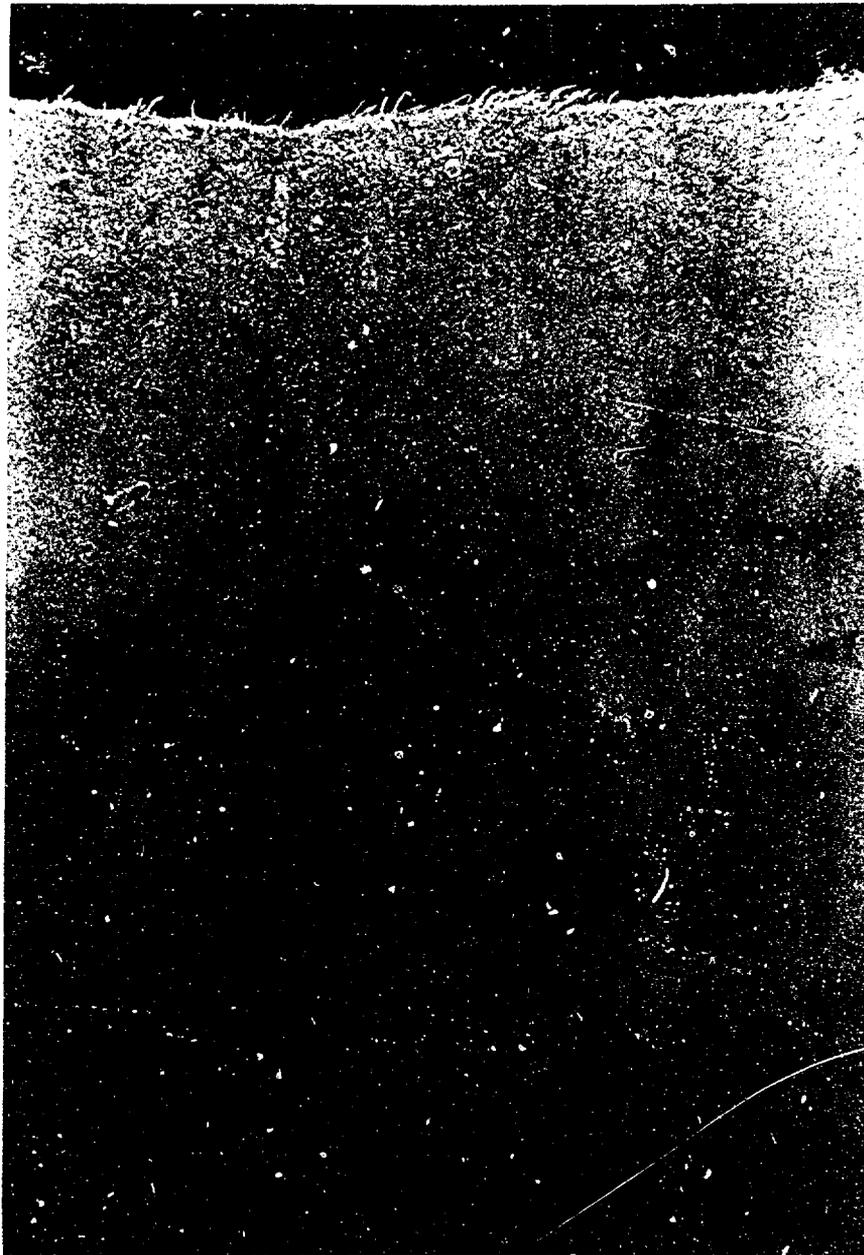
Figure 19. REMOTS® image from station 18-H showing sedimentary layers of different apparent grain-size major mode. In this case, sediment having an apparent grain-size major mode of  $>4-3$  phi (very fine sand/silt/clay) overlays a slightly finer-grained layer of silt/clay ( $>4$  phi). The point of contact of the two layers is indicated by an arrow. Scale = 1X.

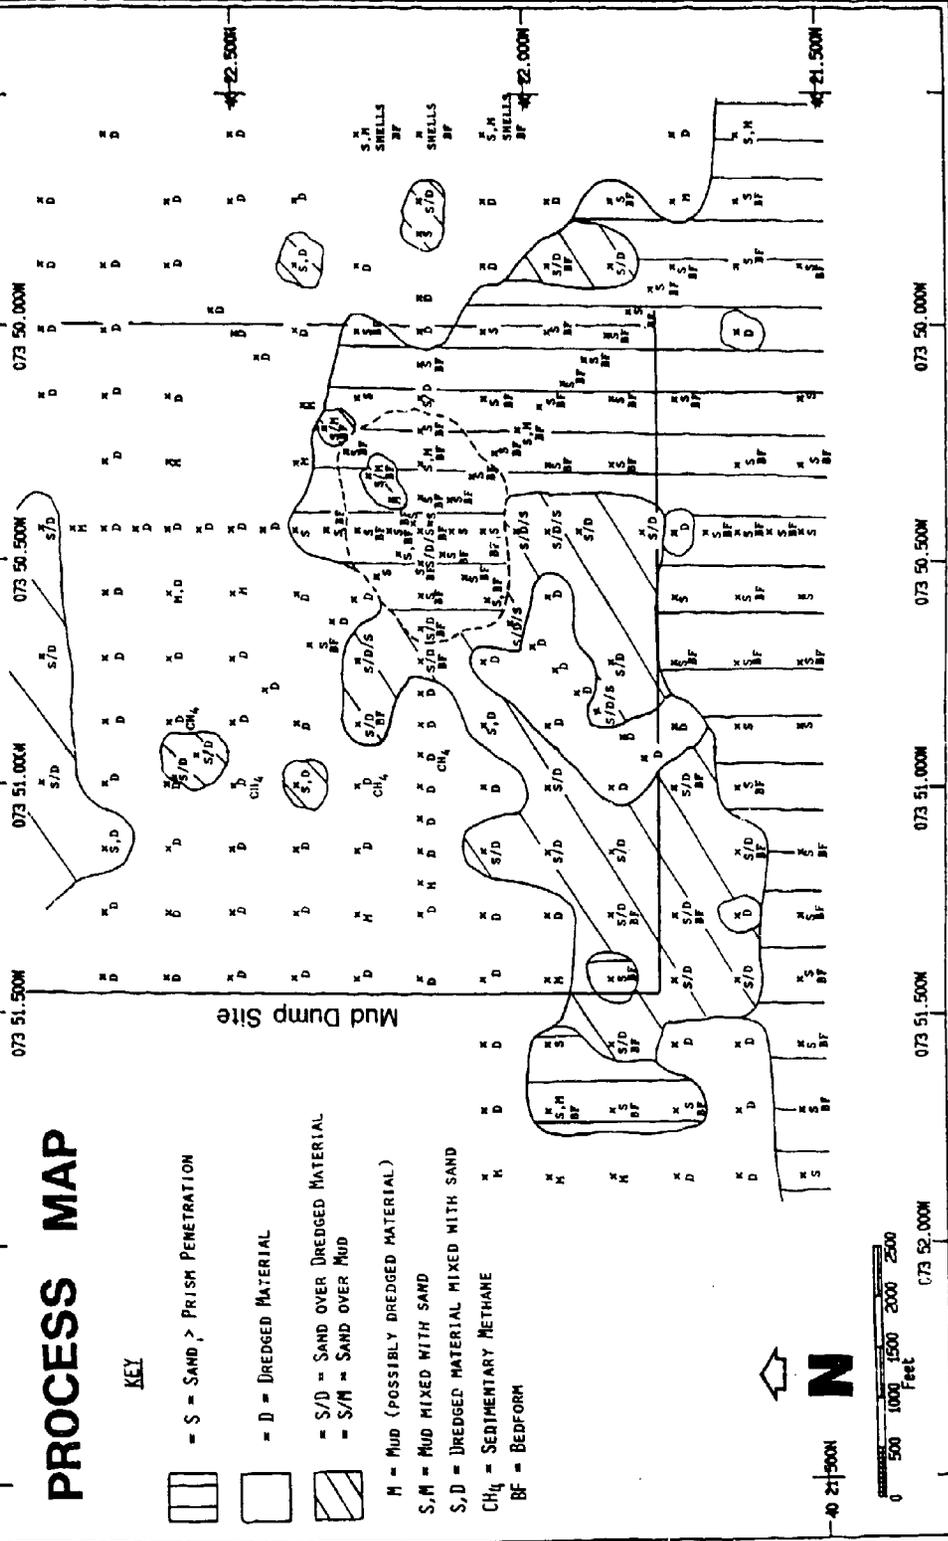
= S/D - SAND OVER DREDGED MATERIAL  
= S/M - SAND OVER MUD
- M - MUD (POSSIBLY DREDGED MATERIAL)
- S.M - MUD MIXED WITH SAND
- S,D - DREDGED MATERIAL MIXED WITH SAND
- CH<sub>4</sub> - SEDIMENTARY METHANE
- BF - BEDFORM

Figure 21b. "Process" map illustrating sediment surface characteristics and benthic features in the southern half of the Mud Dump site. The elliptical area outlined by the broken line in the center of the map is characterized by clean, fine-grained, high-reflectance sand at the sediment surface. This sand is presumed to represent the original sand cap material.

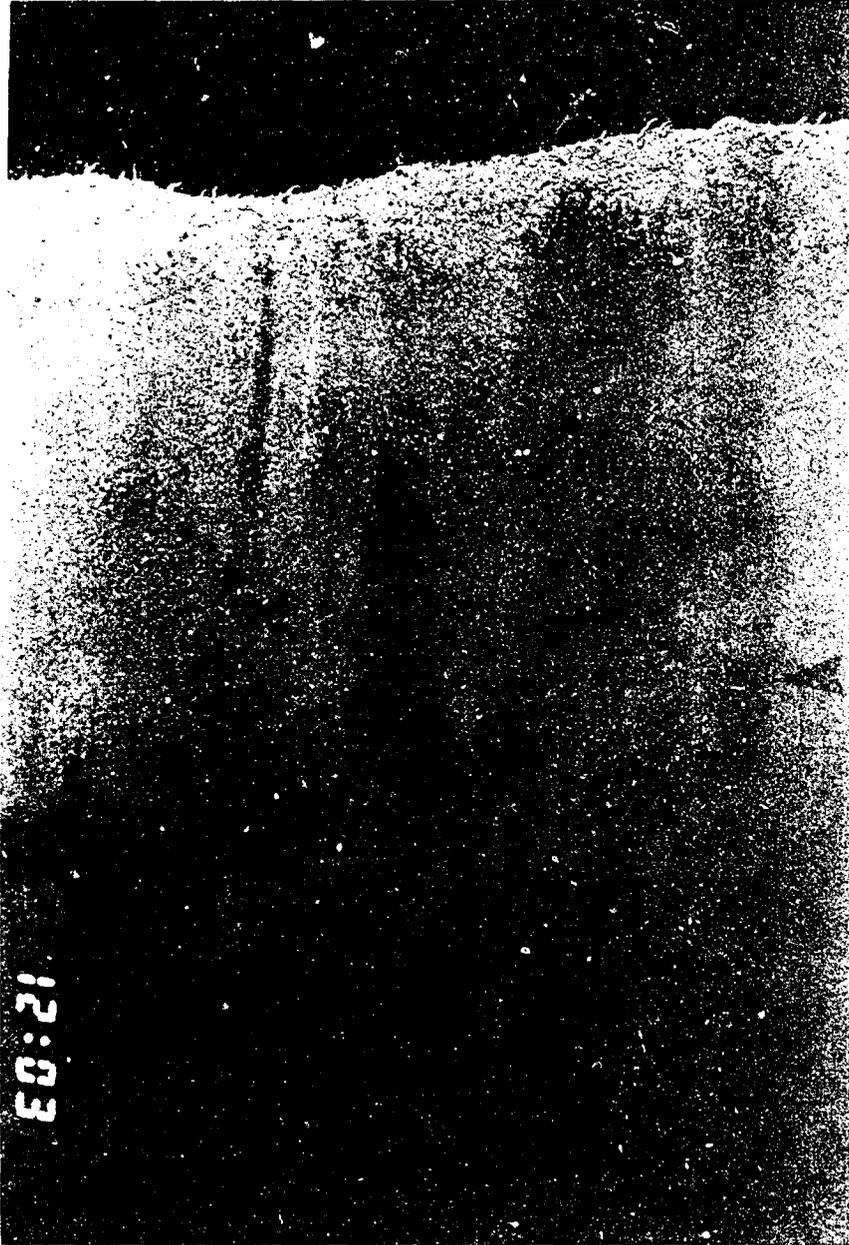
Figure 23. Methane gas bubbles (arrow) are visible in the sediment in this REMOTS® image from station 8-0. Scale = 1X.

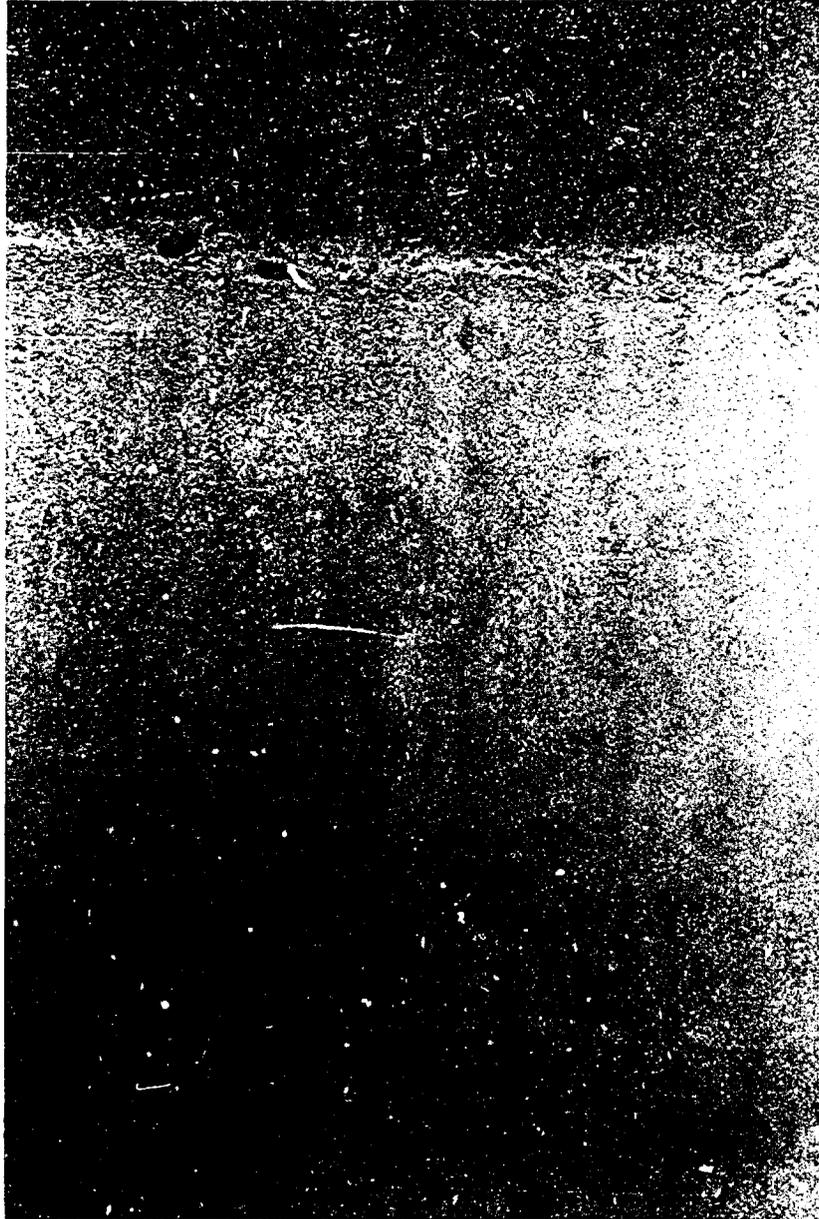
Figure 29. Low-reflectance mud, possibly dredged material, characterizes the sediment surface at station 200-NE. Scale = 1X.

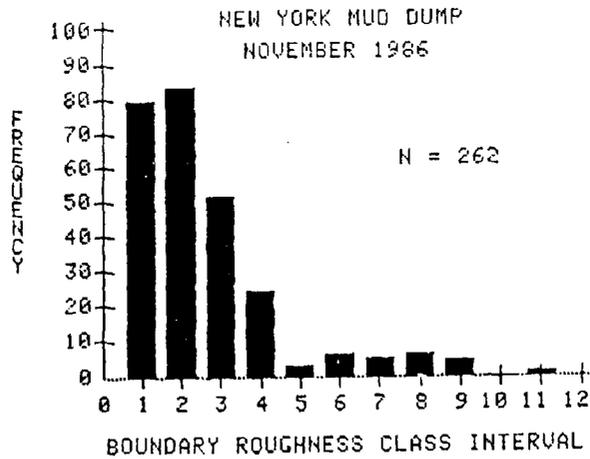
<u>Class Interval</u>	<u>Range of Boundary Roughness (cm)</u>
1	0.0 - 0.6
2	0.6 - 1.0
3	1.0 - 1.4
4	1.4 - 1.8
5	1.8 - 2.2
6	2.2 - 2.6
7	2.6 - 3.0
8	3.0 - 3.4
9	3.4 - 3.8
10	3.8 - 4.2
11	4.2 - 4.6
12	4.6 - 5.0

Figure 30. Frequency distribution of small-scale boundary roughness (in cm) for stations sampled in the REMOTS® survey.

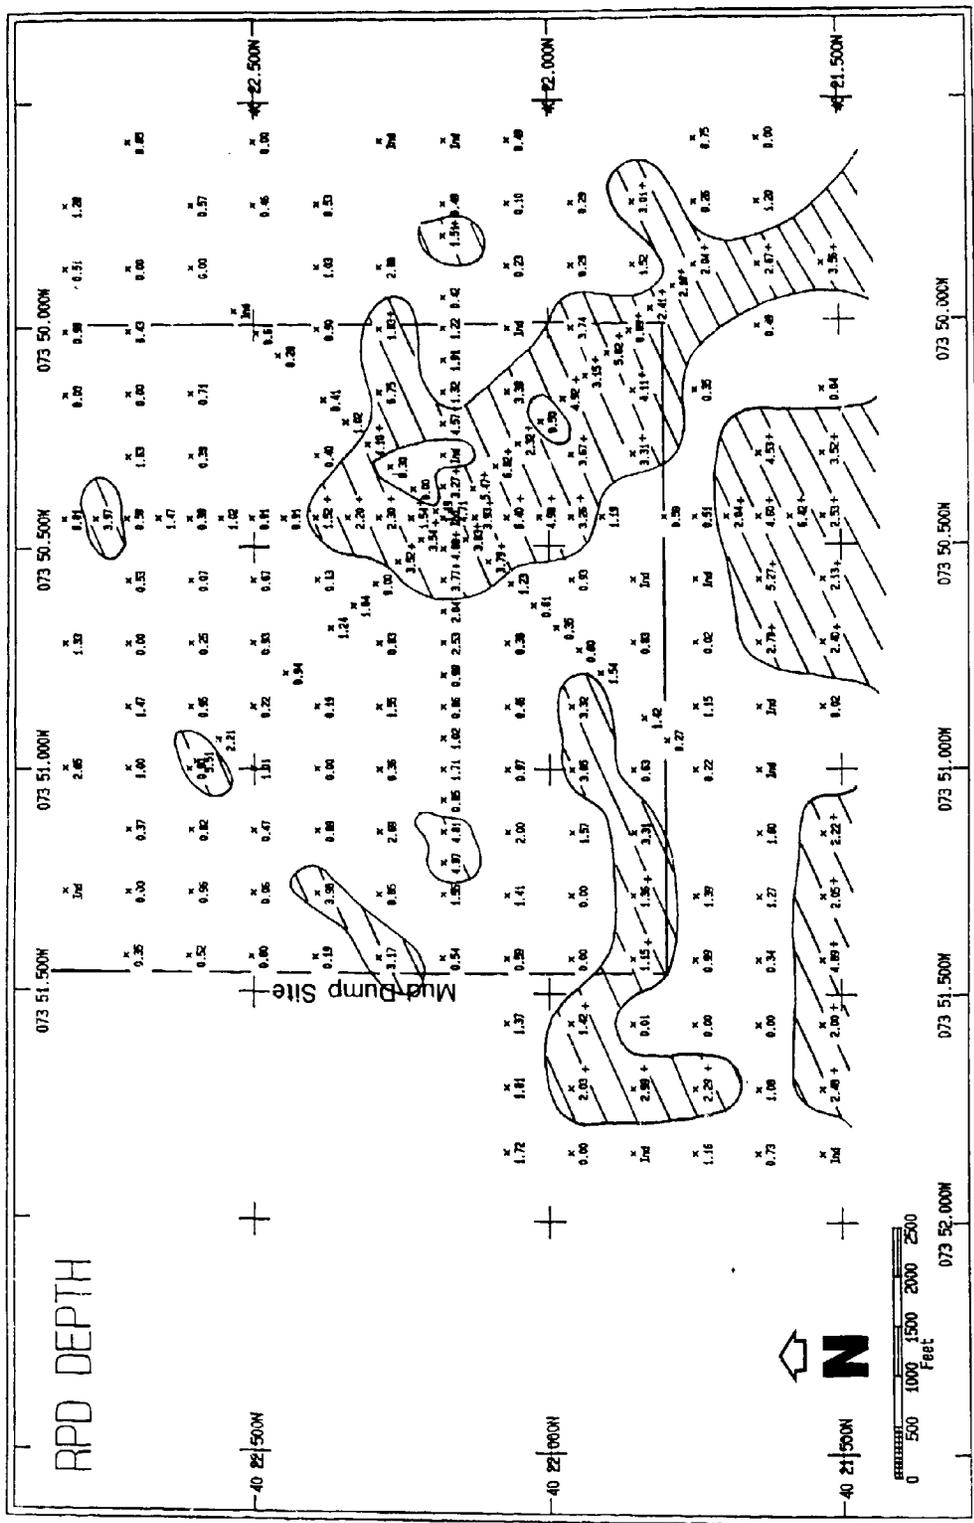
Figure 32b. The mapped distribution of mean apparent RPD depths (in cm) in the southern half of the Mud Pump site. A "+" indicates that the apparent RPD depth exceeded the prism penetration. Hatched areas are those where RPD depths exceeded the prism penetration and/or RPD depths were greater than 3cm.

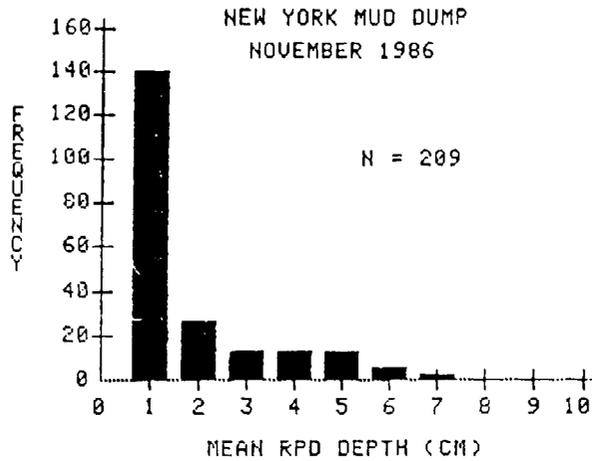
Figure 33. The frequency distribution of mean apparent RPD depths for stations sampled in the REMOTS® survey of the Mud Dump site. Scale - 1X.

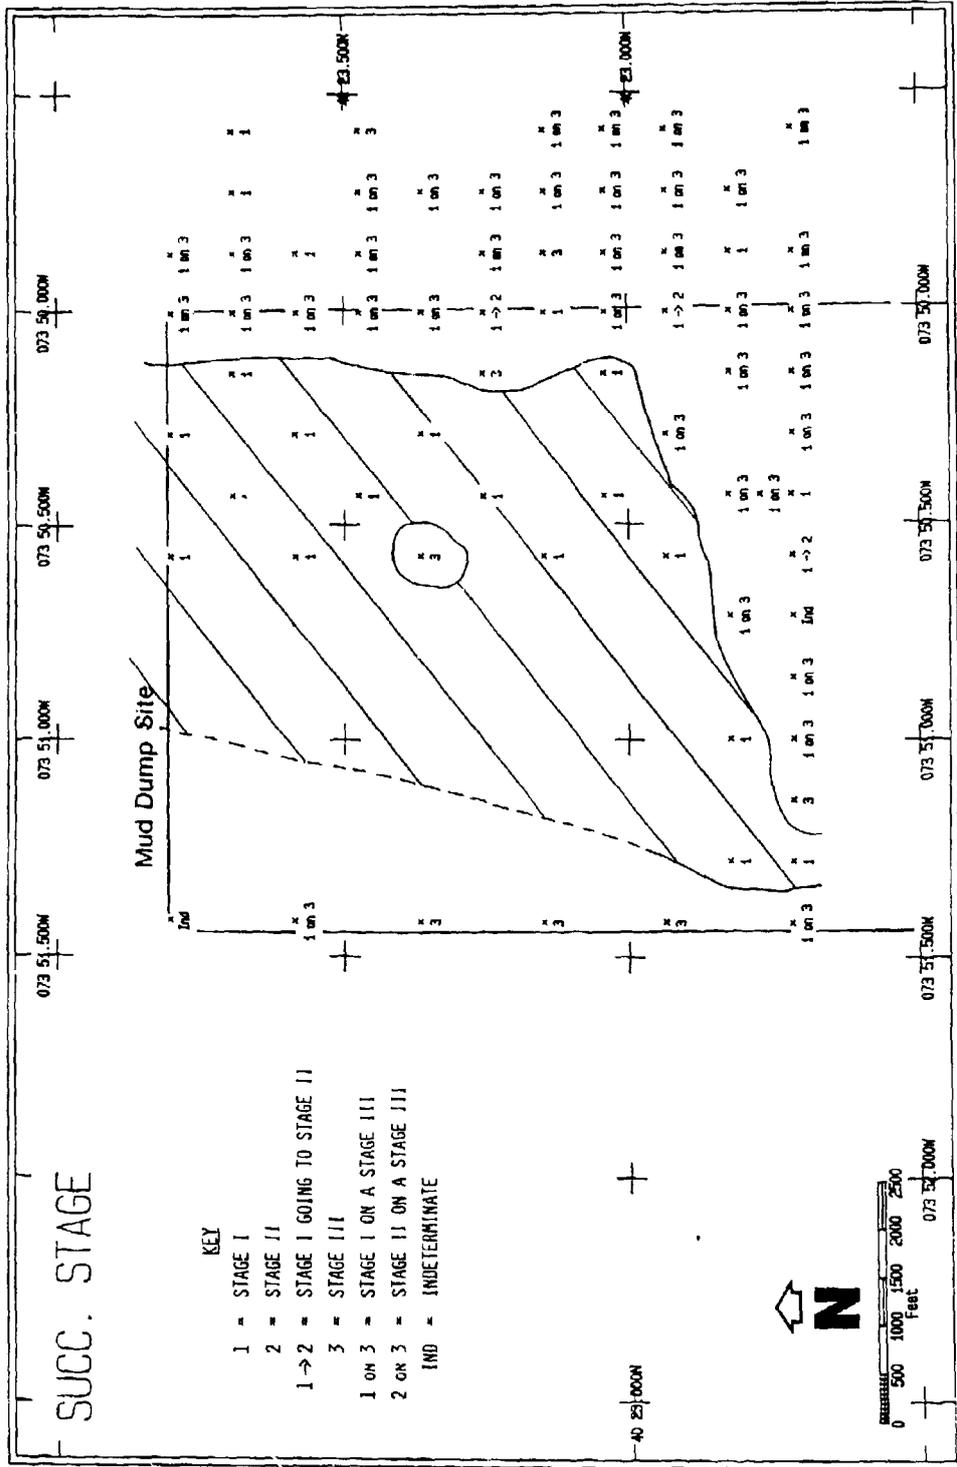
Figure 34a. The mapped distribution of infaunal successional stages in the northern half of the Mud Dump site. Hatched area denotes a Stage I successional stage.

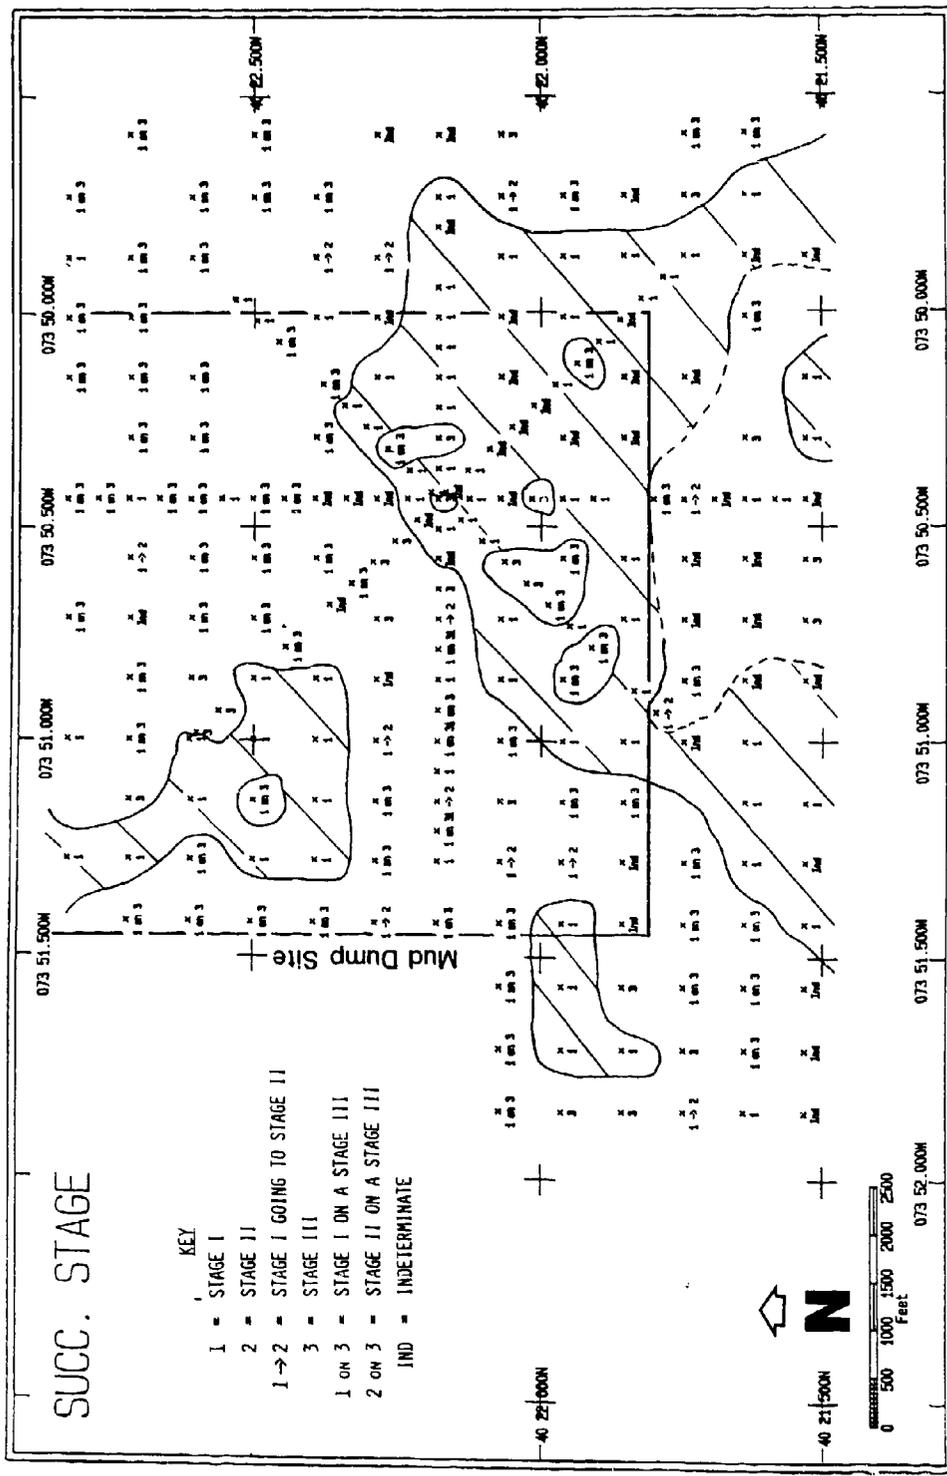
Figure 34b. The mapped distribution of infaunal successional stages in the southern half of the Mud Dump site. Hatched areas are those having a Stage I successional stage.

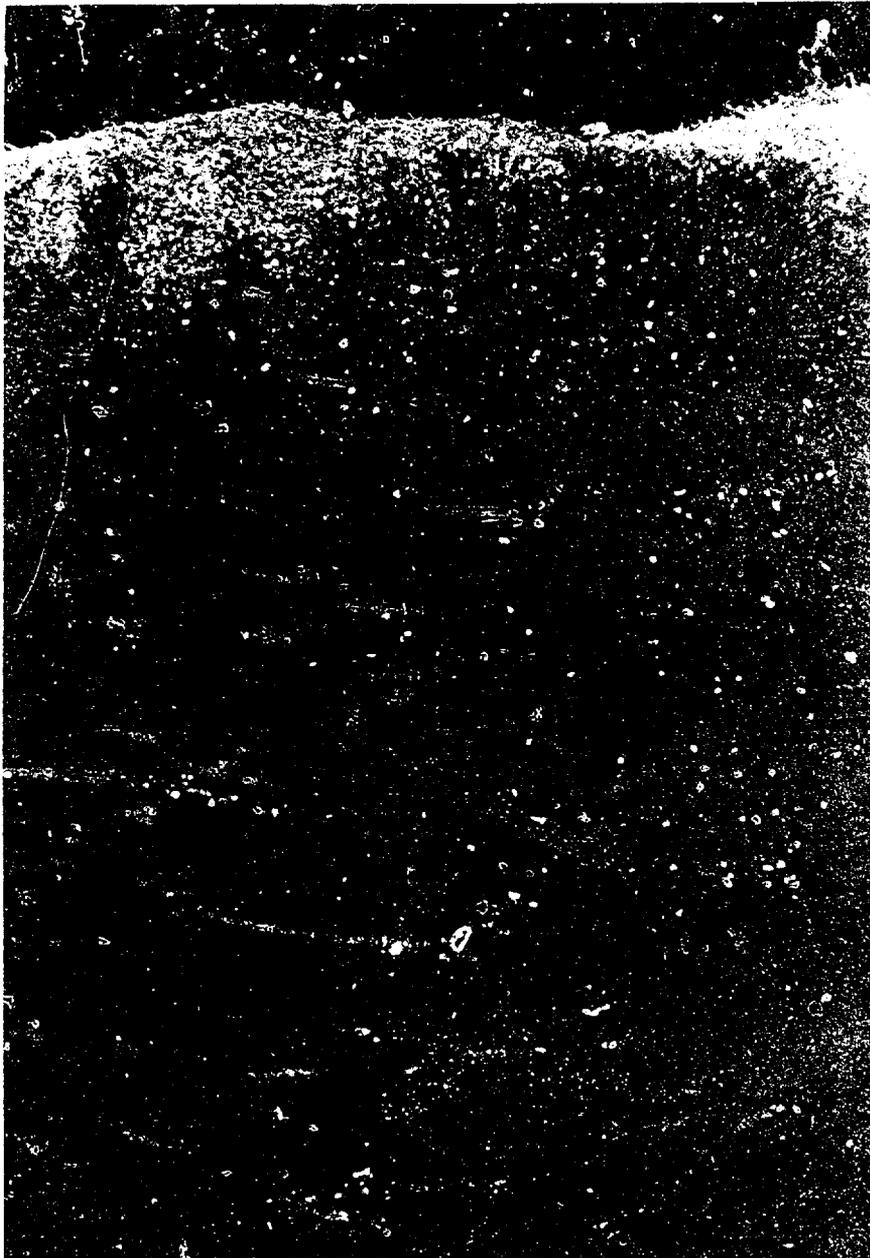
Figure 36. A typical feeding void (arrow) is visible at depth in this REMOTS® image from station 1200-N. Such feeding voids indicate the presence of head-down deposit-feeding Stage III infauna. This station is designated as a Stage I on a Stage III successional stage because of the aggregation of tubicolous polychaetes visible at the sediment surface. Scale = 1X.

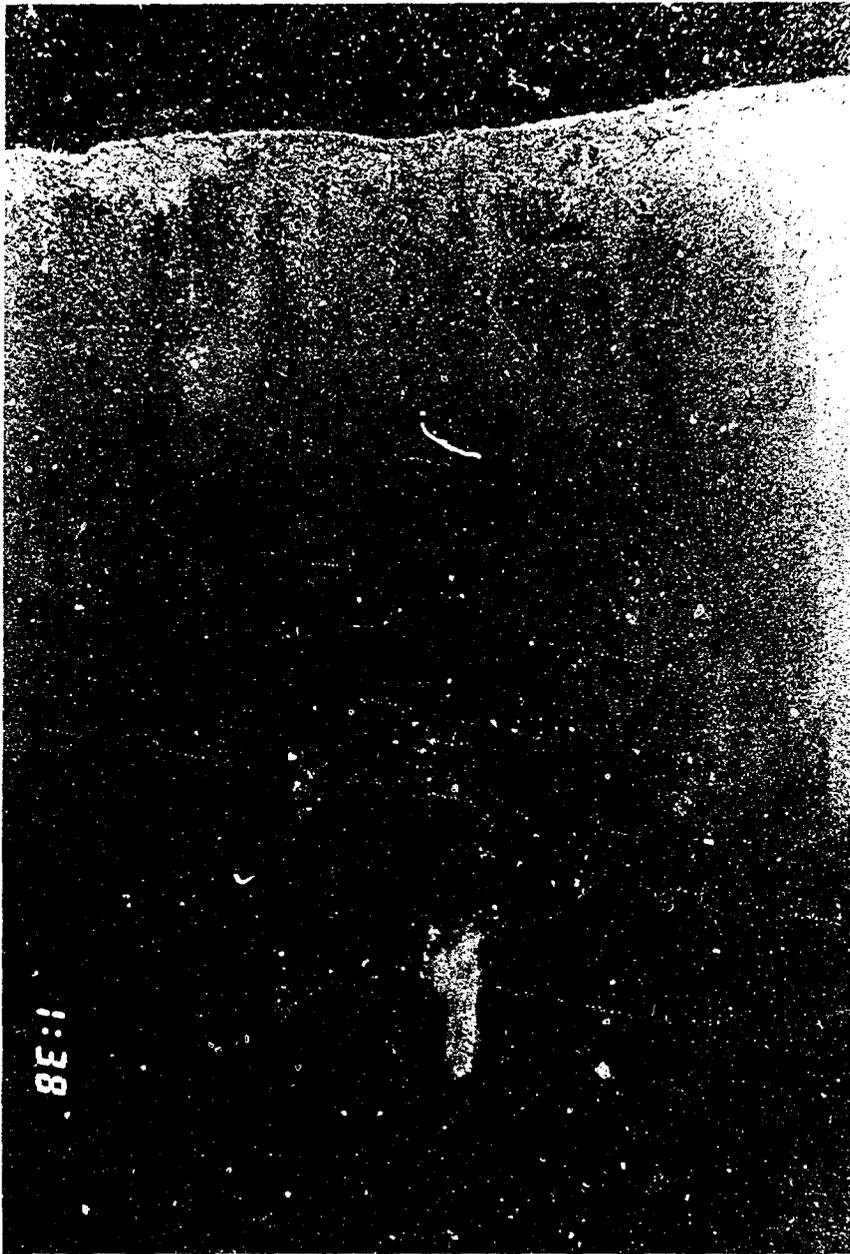
Figure 37. The organism indicated by the arrow is presumed to be the burrowing anemone Ceriantheopsis americanus in this REMOTS® image from station 5-P. The low-reflectance sediment at this station appears to have high sediment oxygen demand. Approximate scale = 0.78X.

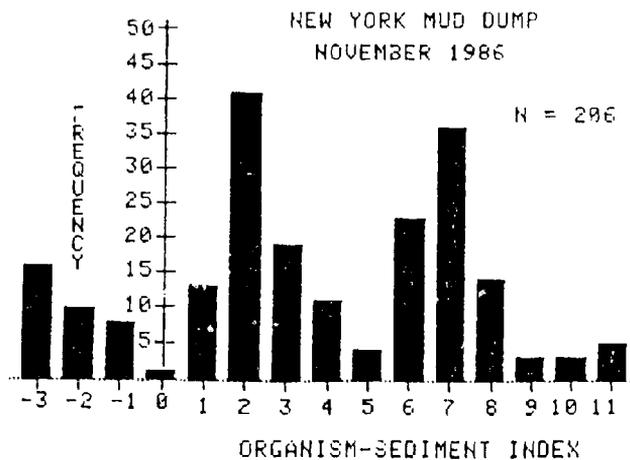
Figure 38. The frequency distribution of Organism-Sediment Index (OSI) values for stations sampled in the REMOTS® survey at the Mud Dump site.

33. A multi-parameter REMOTS® Organism-Sediment Index (OSI) has been constructed to characterize habitat quality in terms of disturbance frequency. Habitat quality is defined relative to two end-member standards. The lowest value is given to those bottom substrates which have low or no dissolved oxygen in the overlying bottom water, no apparent macrofaunal life, and methane gas present in the sediment. The REMOTS® Organism-Sediment Index for such a condition is minus 10. An aerobic bottom with a deeply depressed RPD, evidence of a mature macrofaunal assemblage, and no apparent methane gas bubbles at depth will have a REMOTS® Organism-Sediment Index value of plus 11. The REMOTS® Organism-Sediment Index is arrived at by summing the subset indices shown in Table 3. The Organism-Sediment Index is an excellent parameter for mapping disturbance gradients in an area and documenting ecosystem recovery after disturbance (see Germano and Rhoads, 1984). Because secondary succession can take place in the absence of a disturbance event, the presence of Stage I on Stage III or Stage II on Stage III assemblages will not affect the final index value.

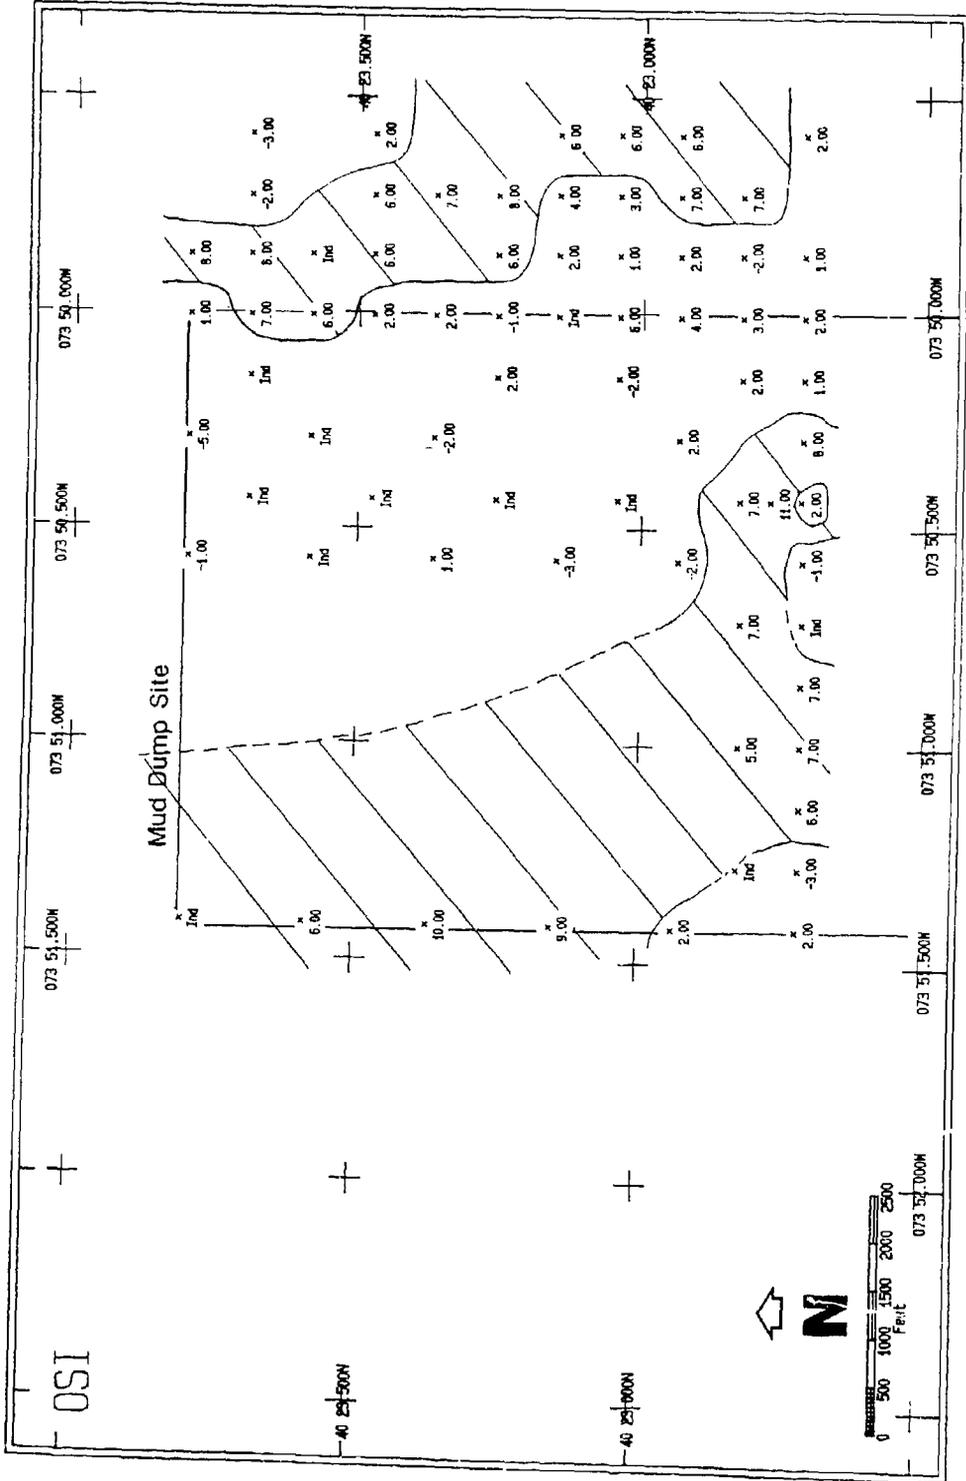
Figure 39a. The mapped distribution of OSI values in the northern half of the Mud Dump site. The hatched areas are those having OSI values greater than or equal to +5. "Ind" means the OSI was indeterminate at that station.

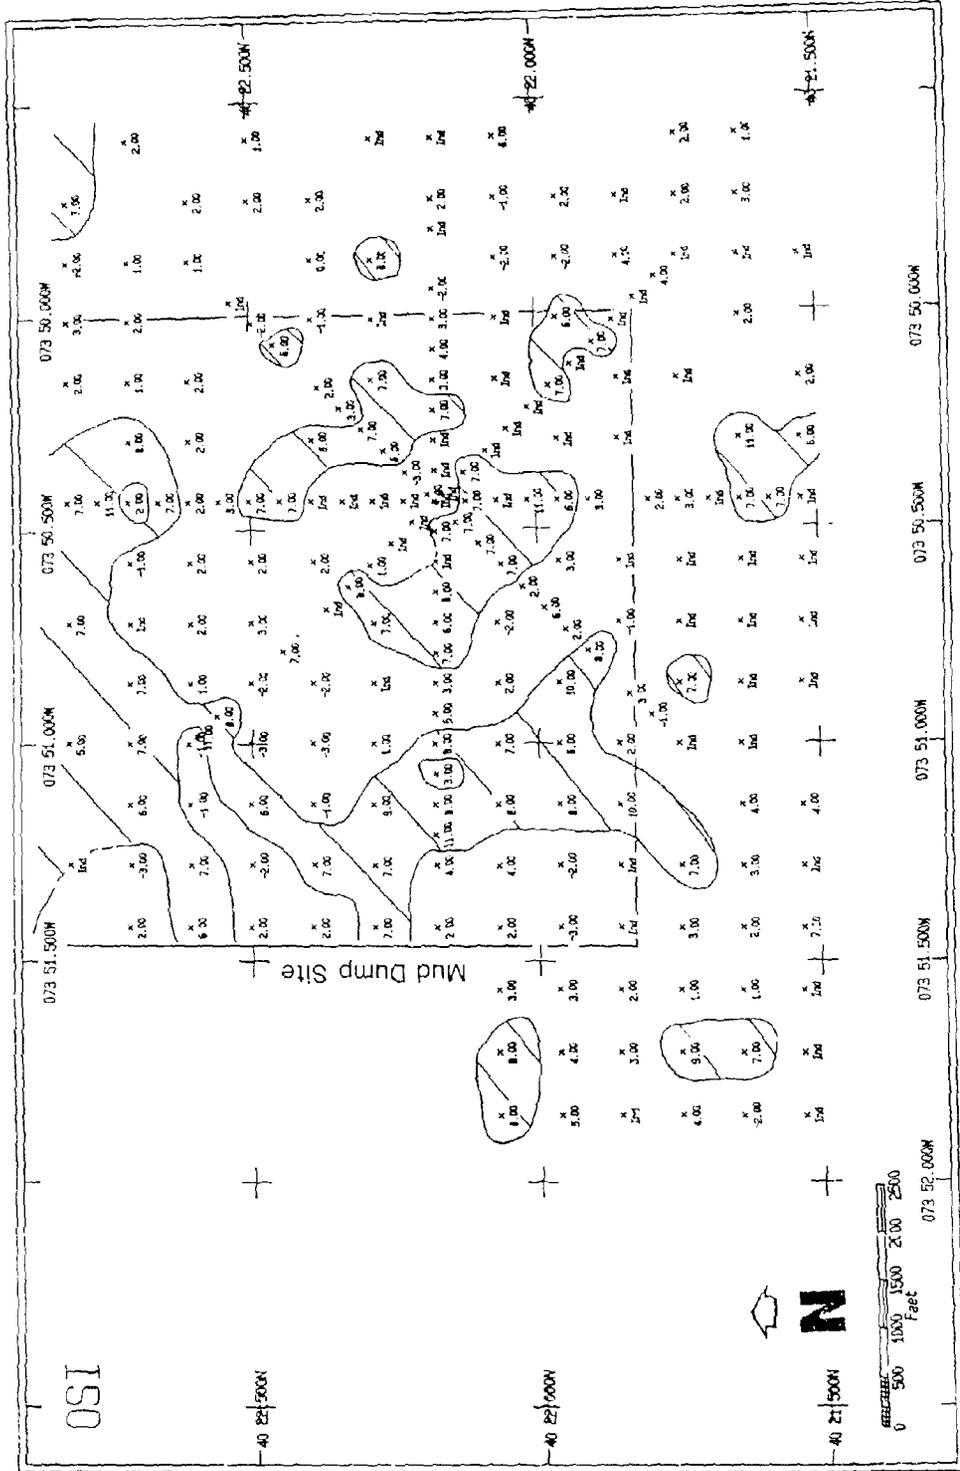
Figure 39b. The mapped distribution of OSI values in the southern half of the Mud Dump site. The hatched areas are those having OSI values greater than or equal to +5. "Ird" means the OSI was indeterminate at that station.
