AFWAL-TR-88-2095

## In-Line Wear Monitor

November 1988

Interim Technical Report  
for Period November 1985-June 1988

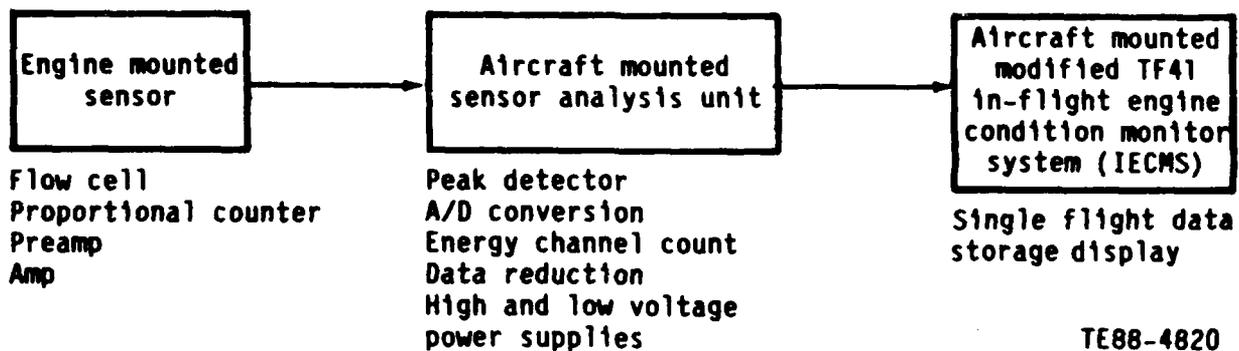
Figure 2. In-line wear monitor block diagram.

A block diagram of the system being developed is shown in Figure 2. The sensor is to be engine mounted and contains a radioactive X-ray source, a flow cell to direct the oil across an X-ray permeable window, a proportional counter X-ray detector and its associated analog circuitry, a preamplifier, and

amplifier electronics. The data acquisition electronics is mounted off engine on the airframe and includes a peak detector, A/D converter, a microprocessor based section for keeping track of energy band counts and data analysis, high and low voltage power supplies, and system interface electronics. The data storage section consists of existing engine monitor system electronics that are to be modified to accept the outputs of the data acquisition electronics and store debris concentration values on magnetic tape for long term trending.

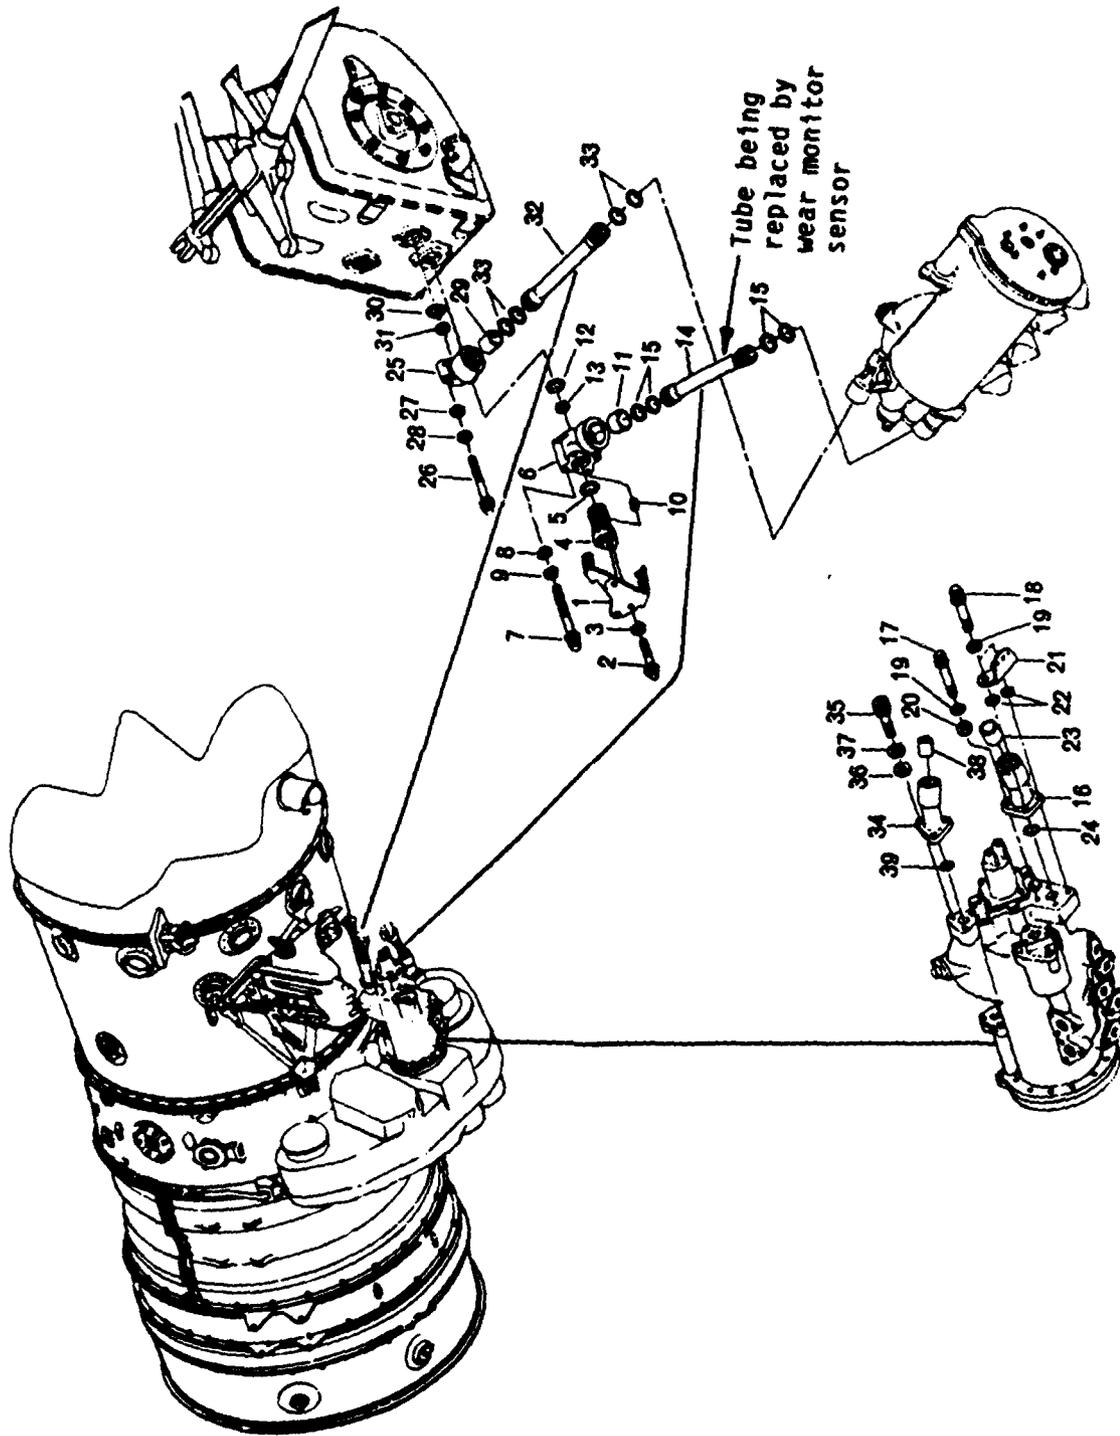
Figure 3. Oil tube location on TF41 engine.

The flow cell for the in-line wear monitor system was designed to fit in place of a tube going between the TF41 engine oil tank and the engine oil pump inlet. This location was selected because (1) it is easy to insert the flow cell at this point since the tube is easily removed, (2) the location sees the full oil flow of the system and is ahead of the oil filter, and (3) the oil pressure is low at this point--approximately 3 psi--which reduces the stress on the X-ray window. The tube being replaced is shown in the exploded view of the TF41 oil system in Figure 3 and the design of the flow cell is shown in Figures 4 and 5. The flow cell can be easily inserted in place of the original tube by removing four bolts that hold the mating connector assembly.

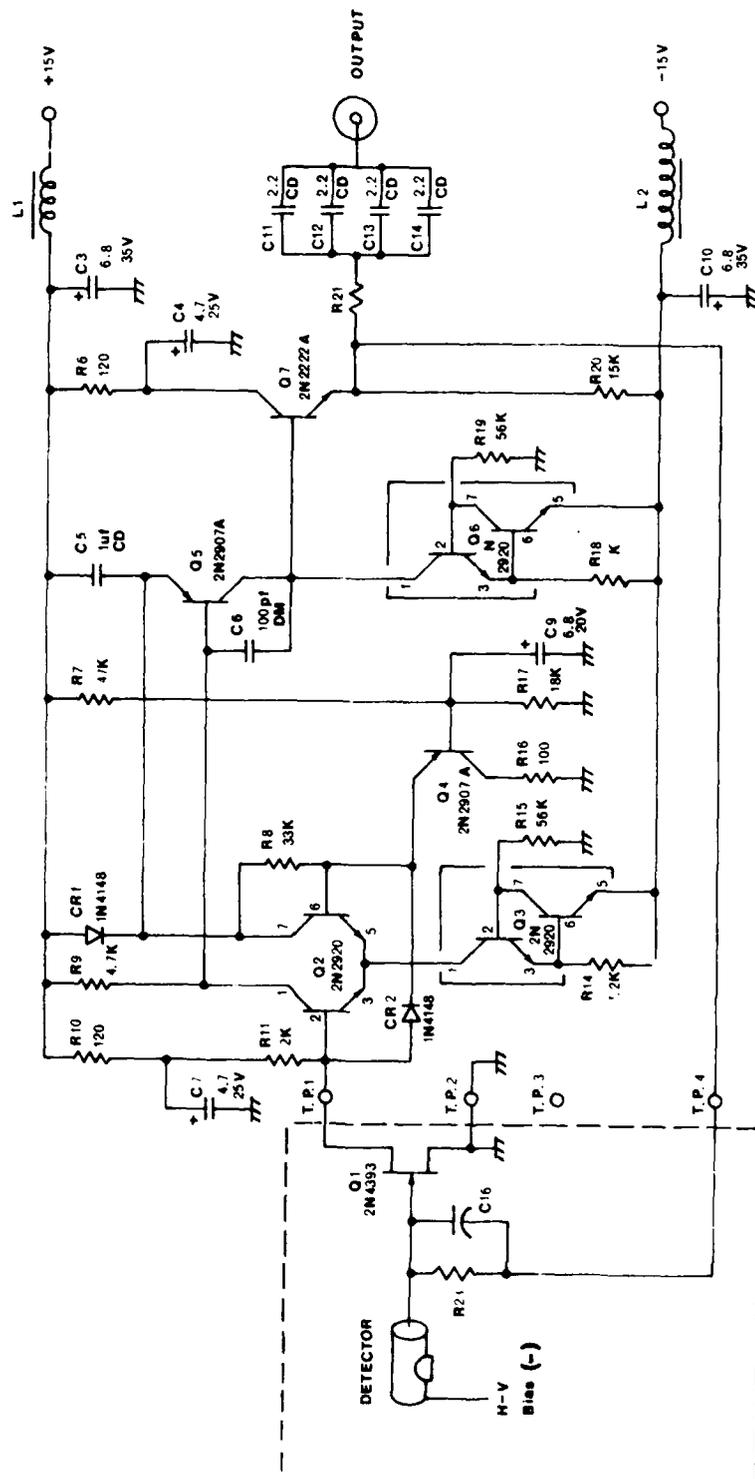
Figure 9. Preamplifier schematic.

1. All resistors in ohms, RMC, 1/4W, 1%
2. All capacitors in uf's
3. Q2, Q7 are flight approved transistors
4. All electrolytics replaced with similar value ceramic capacitors

- o A preamplifier circuit for conditioning and amplifying the signals from a proportional counter X-ray detector tube has been developed and shown to be stable at the high ambient temperatures present on a turbine engine.

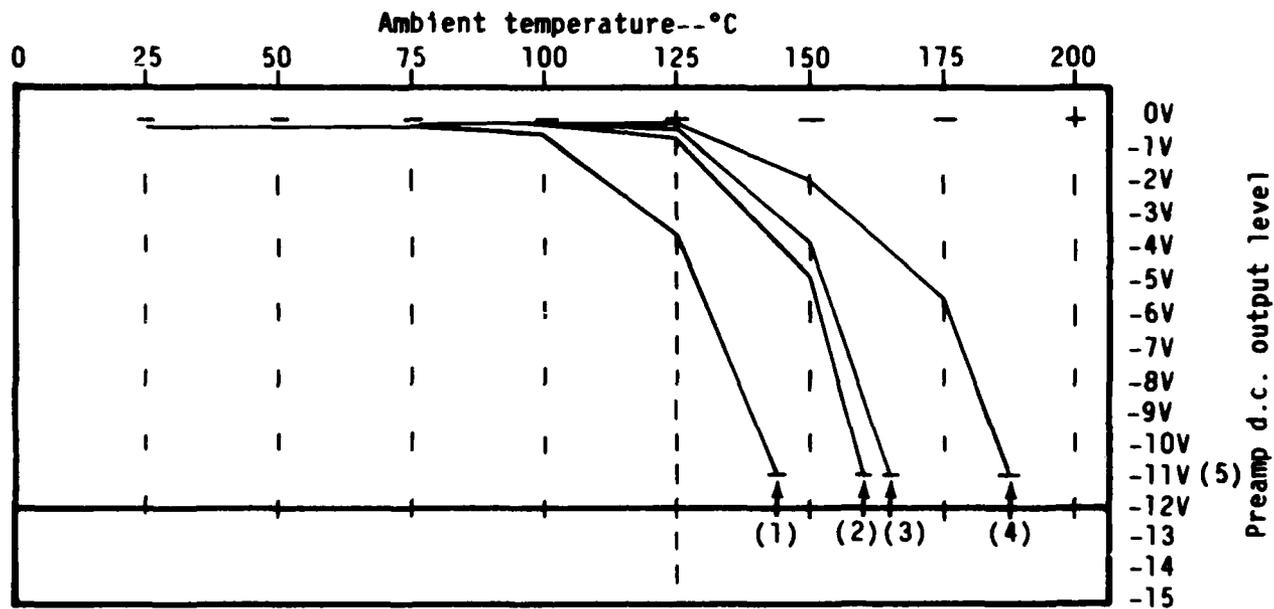
Figure 10. Preamplifier temperature effects.

1. 2 giga ohm feedback resistor--glass construction
2. 500 mega ohm carbon composition
3. 2 giga ohm feedback with leakage balancing scheme
4. 100 mega ohm carbon composition
5. -11 volts is the limit for output d.c. voltage with a  $\pm 12$  volt power supply

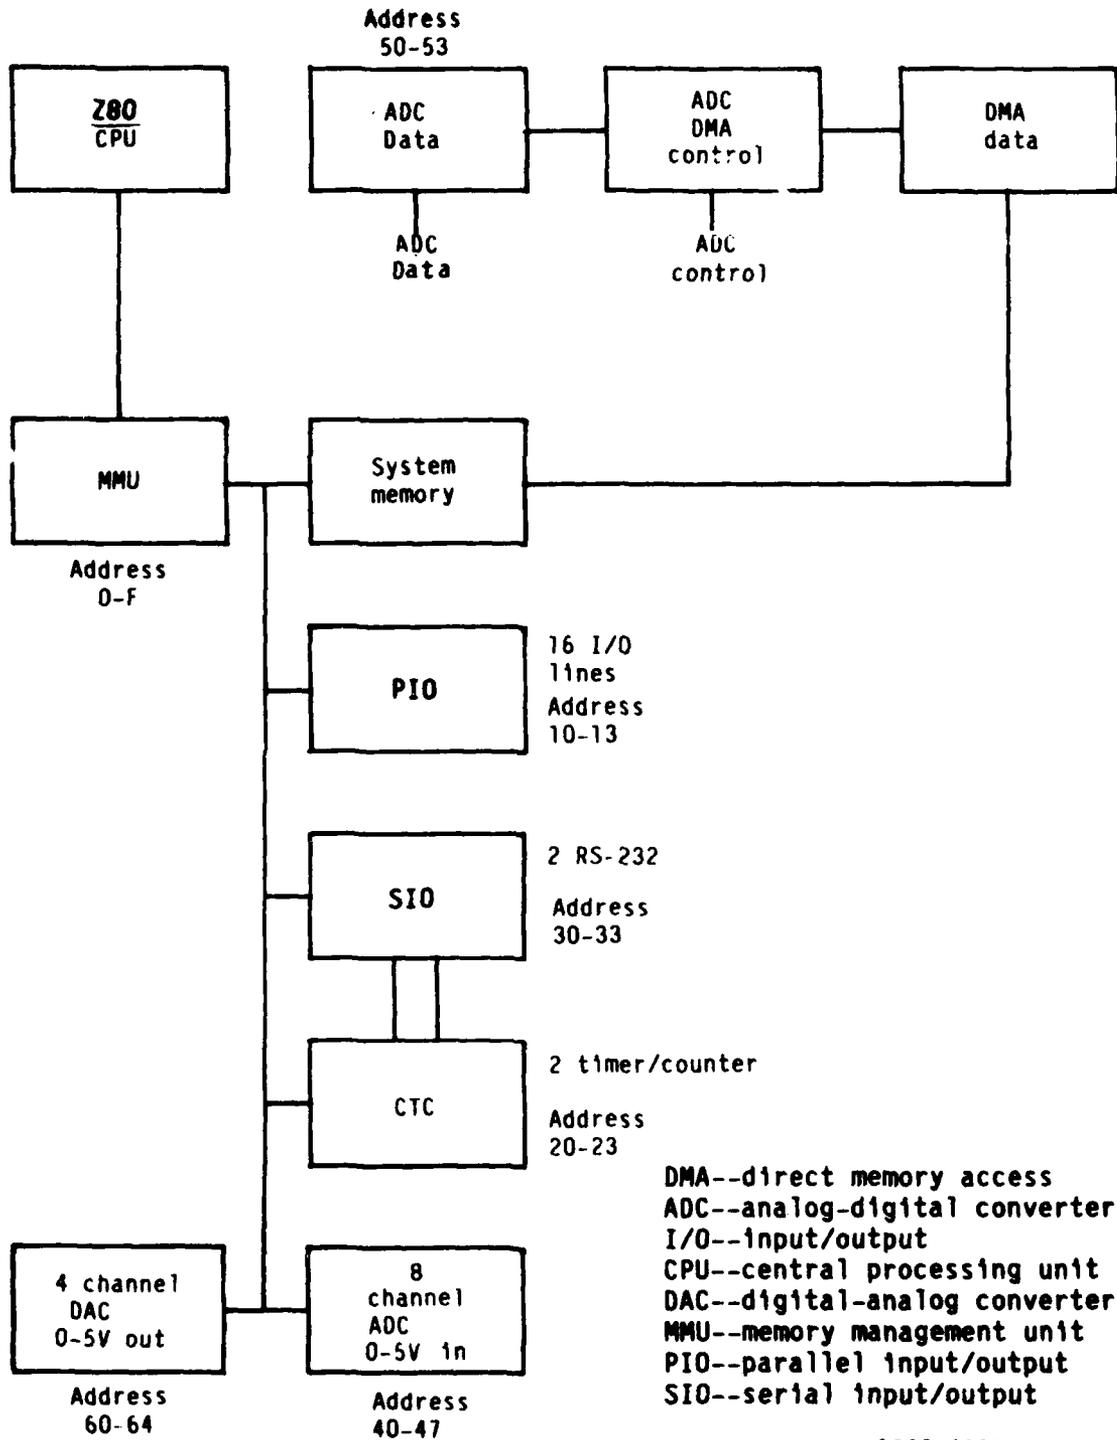
Figure 13. Data processing electronics block diagram.

A diagram of the electronics being developed to process the pulse signals from the engine mounted sensor is shown in Figure 13. A peak detector circuit is used to capture the peak value of the pulse from the sensor head amplifier. The peak value is digitized by a special A/D converter designed to avoid non-linear effects of normal successive approximation converters. The digitized pulse value is used to increment the pulse counts of the corresponding energy band counter. After accumulating counts for a period of time, the results can

be analyzed to separate out intermetal effects and background counts. The resulting concentration values can then be supplied to the aircraft mounted engine condition monitoring system through the D/A converter or through the serial data output.

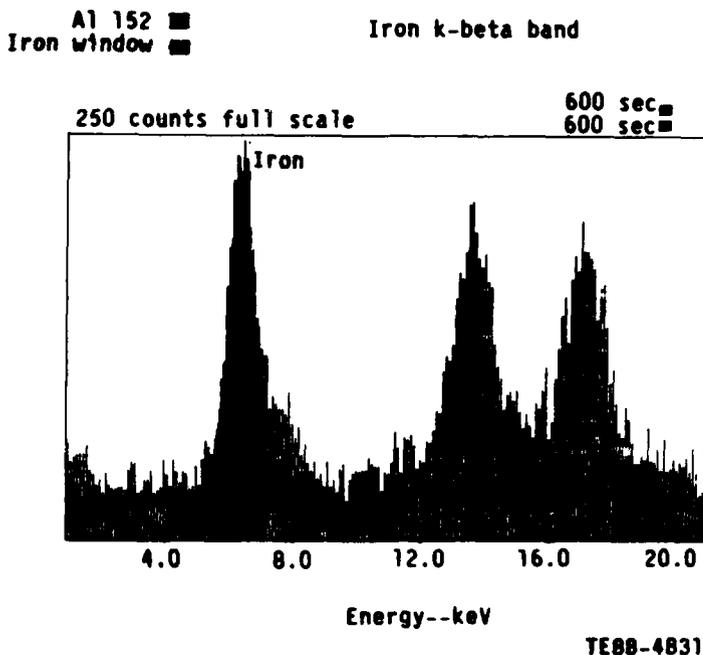
Figure 14. Background spectrum from beryllium foil window.

Figure 14 shows the background spectrum from the 0.010 Be window alone. This is the window that was pressure tested at Allison. The very significant iron background signal is clearly unsatisfactory, and can make low level detection of Fe from the oil sample virtually impossible.

The intensity of the iron signal is approximately that observed from a 500 ppm Fe standard sample of the type described later.

While rechecking the details of the beryllium window contamination (Figure 14) another 0.010 Be window extracted from an old cell in some other equipment was tested. This window showed a considerably cleaner spectrum and Figure 25 shows the overlaid background spectra obtained from the two foils.

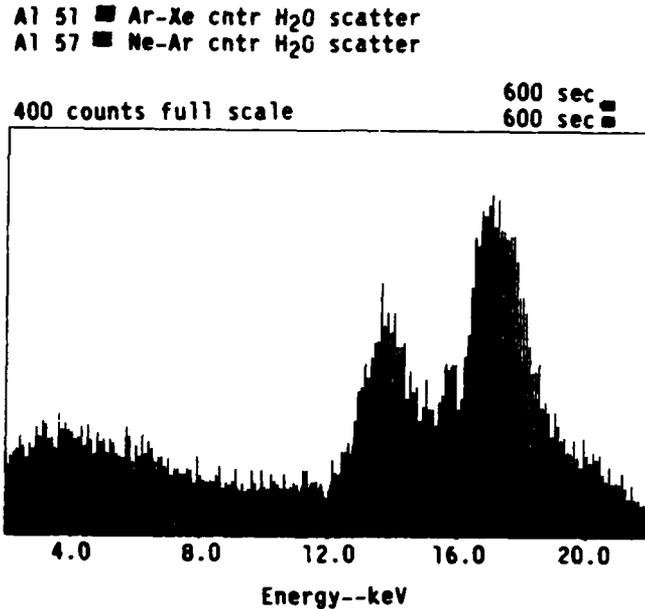
Figure 17. Background spectra argon-xenon and neon-argon detectors.

These effects are shown in Figure 17 for an analysis of a pure water sample where the (a) spectrum from an Ar-Xe tube is compared with the (b) spectrum from a Ne-Ar gas mixture, which shows almost 50 percent reduction of background level in the region of interest.

These results were only obtained after quite careful design of antiscattering baffles and source holders, and considerable ongoing help from Outokumpu Finland based on their experience in this area with their X-MET products.

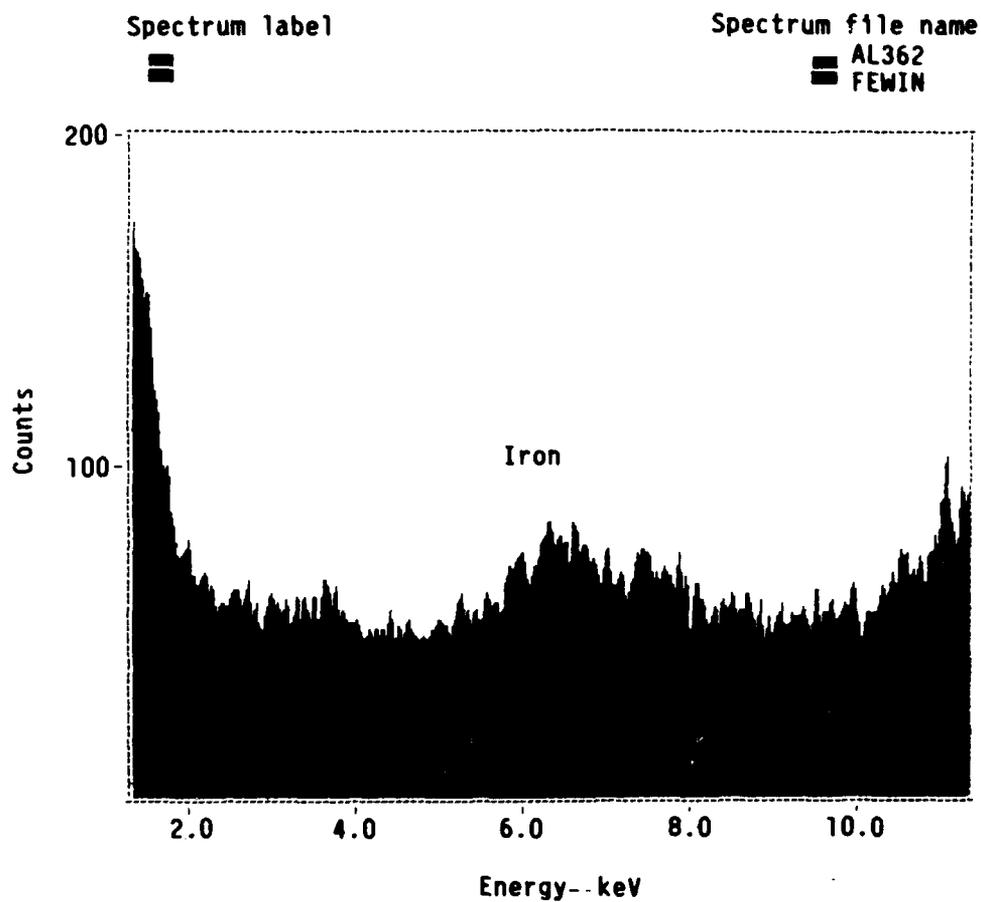
Figure 22. Spectra 10 ppm Fe sample.

Signal from the samples is being seen at the 10 ppm and 20 ppm levels as indicated in Figure 22 and Figure 23 spectra.

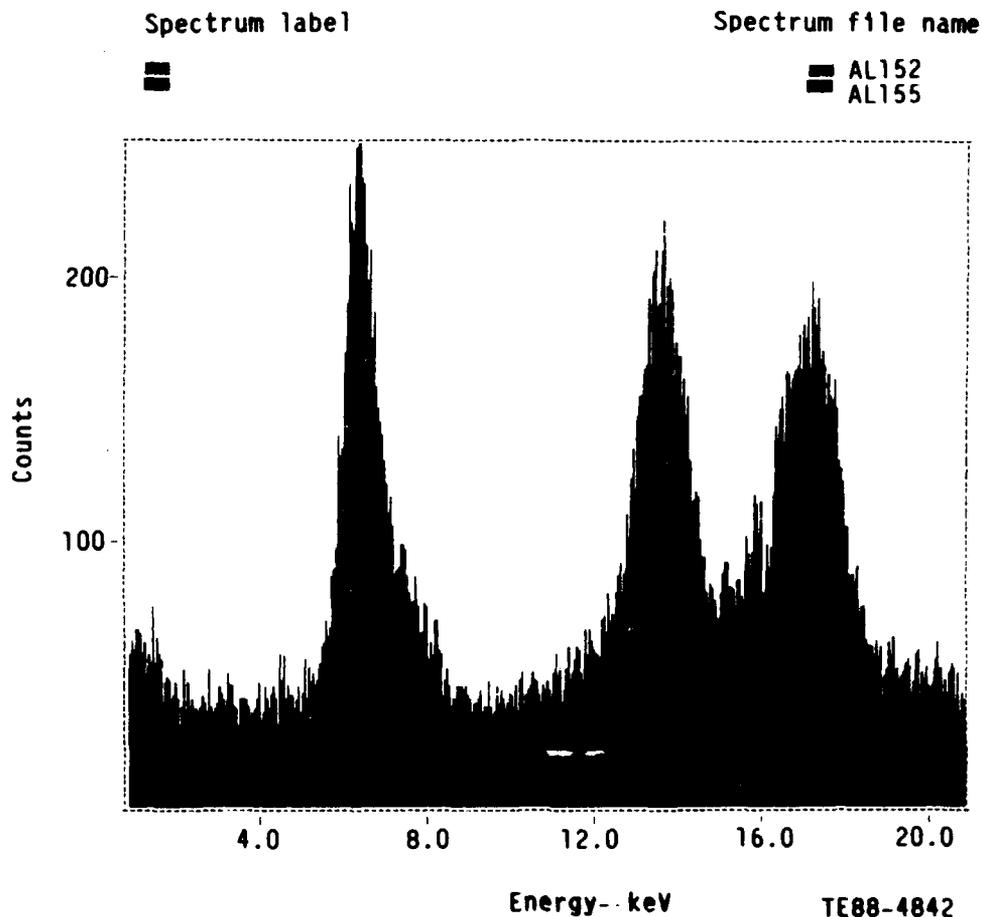
Figure 25. Backscatter spectra from beryllium foils.

Both foils were standard Be disks obtained from Brush Wellman. The difference is quite high and was totally unexpected.

Initial indications are that the original cell window was perhaps a very poor specimen of beryllium material and that effort in developing the polyimide window system was unnecessary.

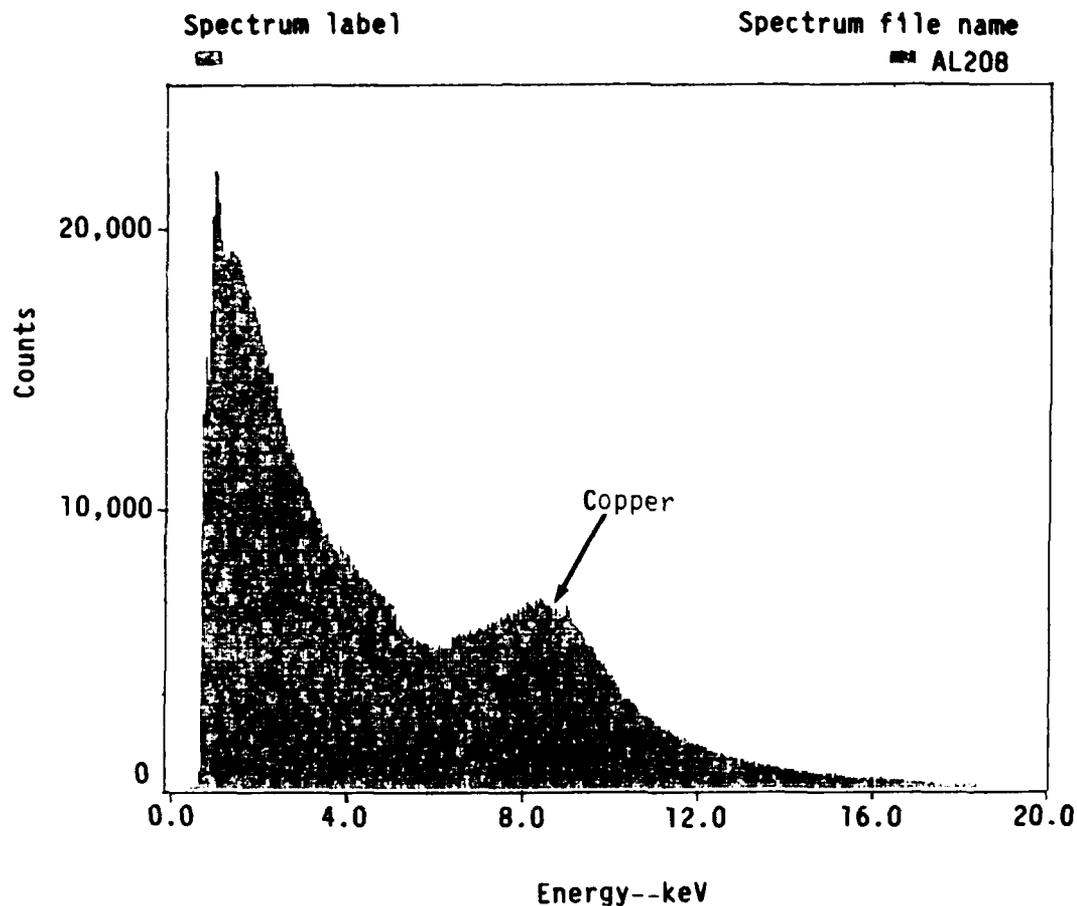
Figure 33. Spectrum at 732 Hz resonance.

Spectrum A1 208, Figure 33, at the 732-5 Hz resonance shows however that the sensor response is wiped out by the introduction of a substantial noise slope entering the spectrum from low energies. The location and analysis of the copper peak remained intact so the gain stability and operation of the sensor is not being affected; background noise pulses are being injected into the analysis.

This was the worst spectrum obtained in these results.

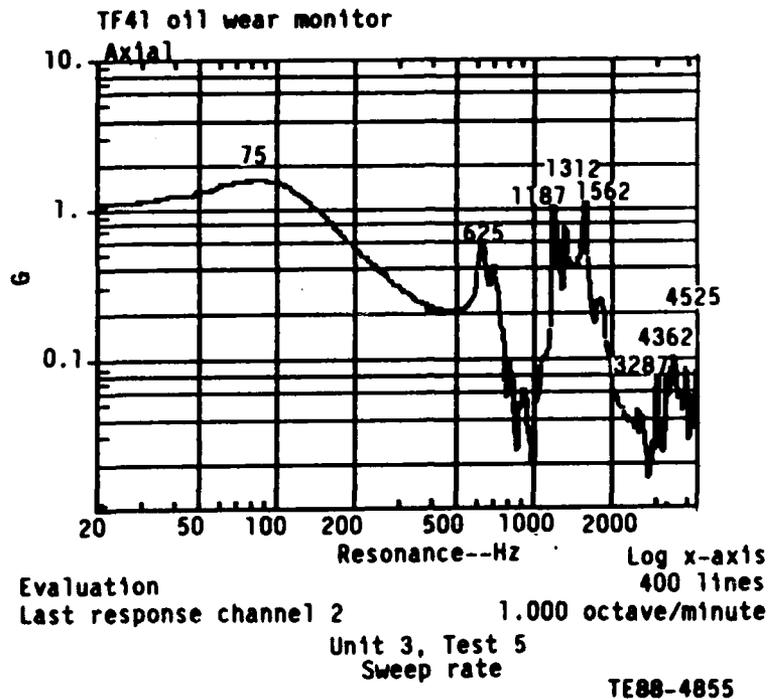
Figure 37. Resonance profile--axial vibration sweep.

The mechanical resonance profile is shown in Figure 37. Once again the profile is similar to the other axes in showing resonance peaks each side of 1 kHz, although the low frequency profile is different.

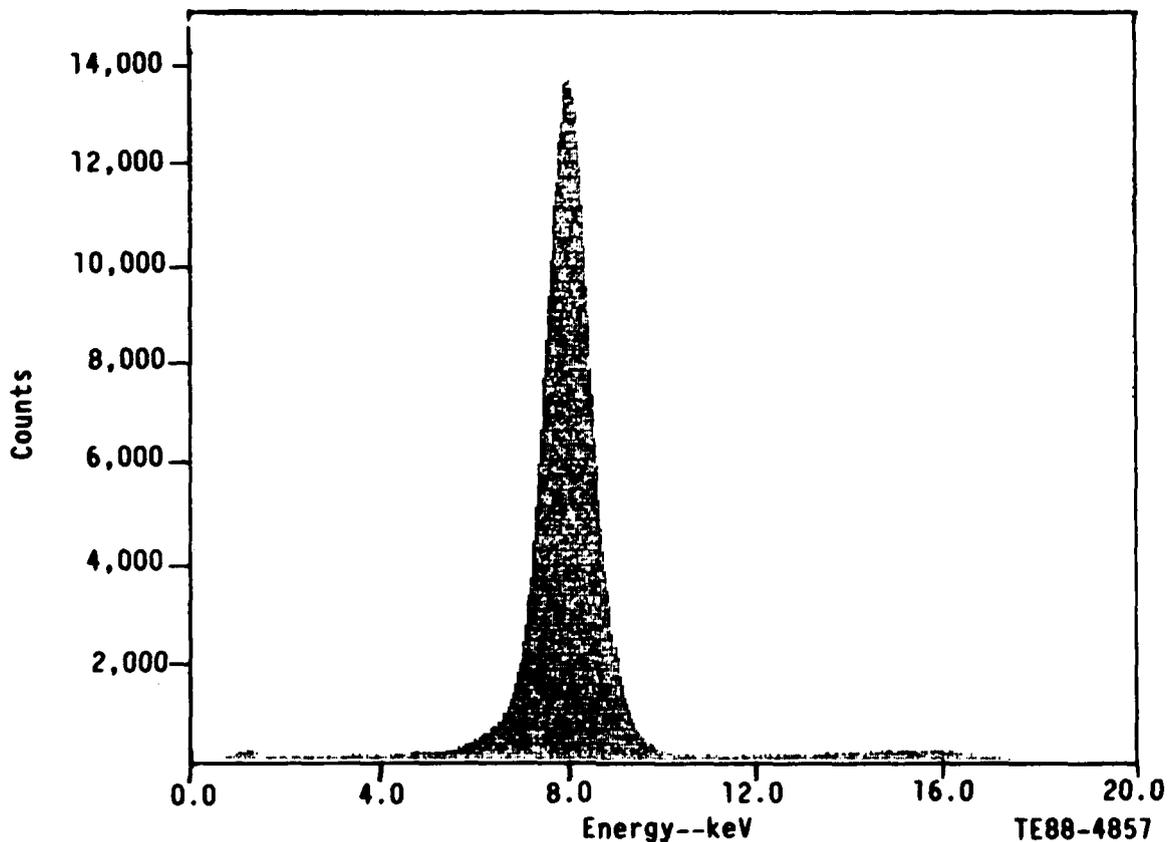
Figure 39. Spectrum at 1187 Hz resonance.

The voltage correction (from 548 V to 546 V) was made for the spectrum A1 215, Figure 39.

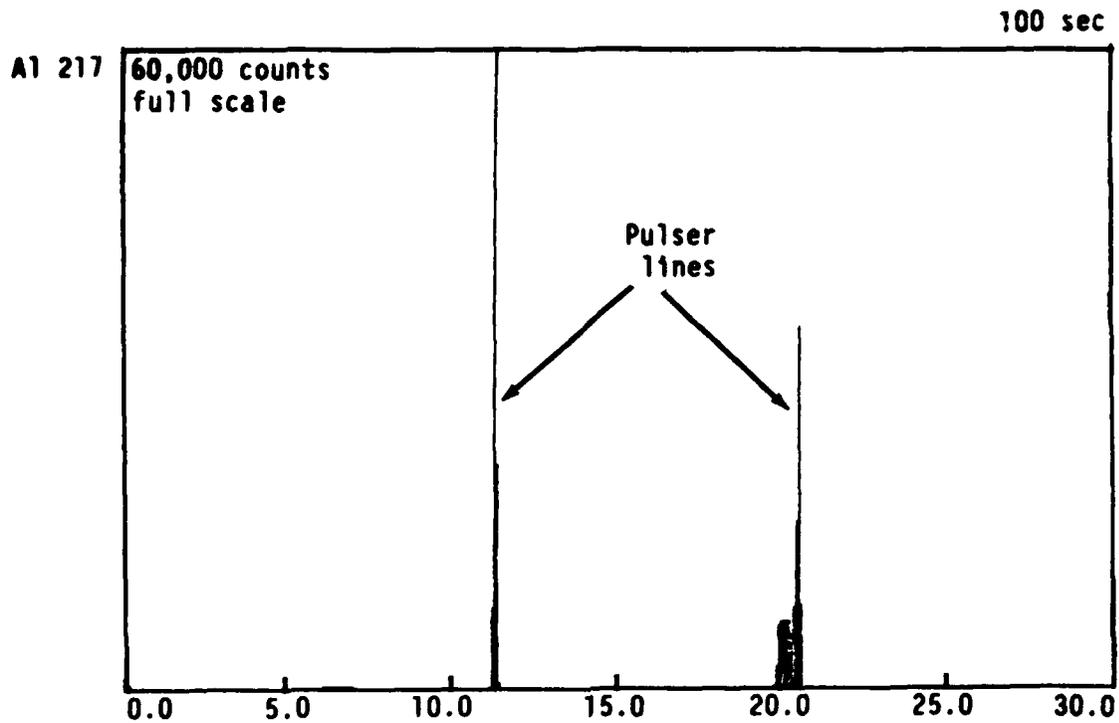
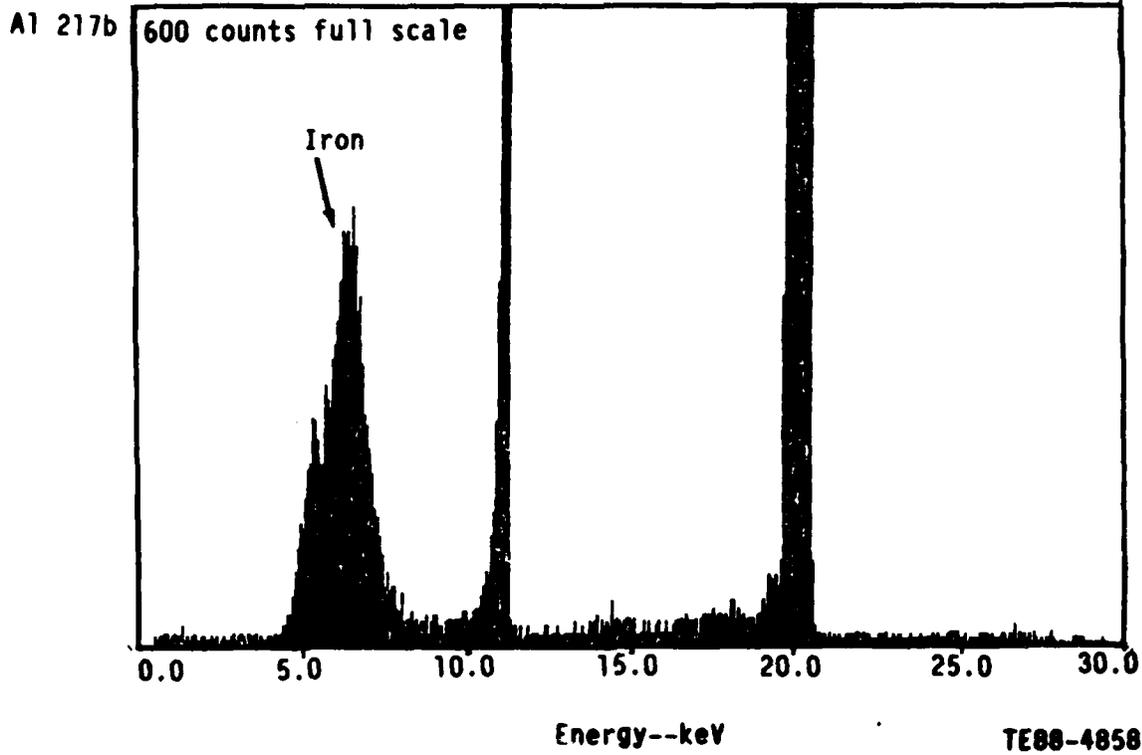
Figure 40. Spectrum with test pulses into sensor copper foil window removed.

The copper foil was removed from the cell. Since the analysis "sample" was now not present, a test pulser was connected to the system. Provision already existed in the design for test pulse injection through the counter.

Figure 40 shows the Al 217 spectrum for the pulser. There are two pulser lines due to electronic pulse shaping. The spectrum also shows iron background from deep scattering in the stainless steel cell as shown by the expanded spectrum Al 217b in Figure 40.

The sharp pulser resolution of Figure 40 is badly degraded and low energy background noise is entering the spectra.

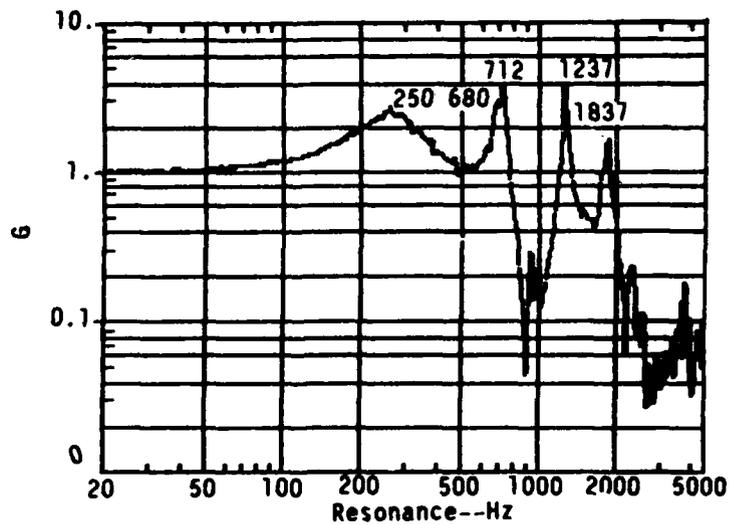
Figure 45. Resonance profile--vertical vibration sweep, copper foil cell window replaced, circuit boards conformally coated.

The resonance profile is shown in Figure 45.

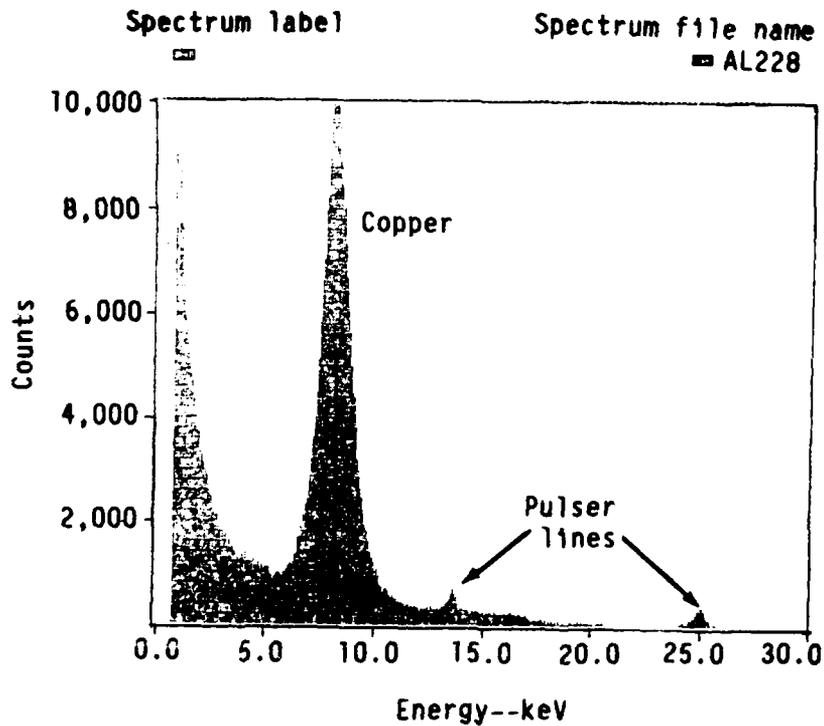
Figure 55. Spectrum taken during NAVMAT vibration.

A spectrum from the sensor working under these NAVMAT test conditions is shown in Figure 55.

It appears that the final instrument will probably need some background curve fitting routines in the data analysis, even after the background noise problem is significantly improved; and unless it can be very significantly improved the sensor would not be able to detect ppm levels under these conditions.

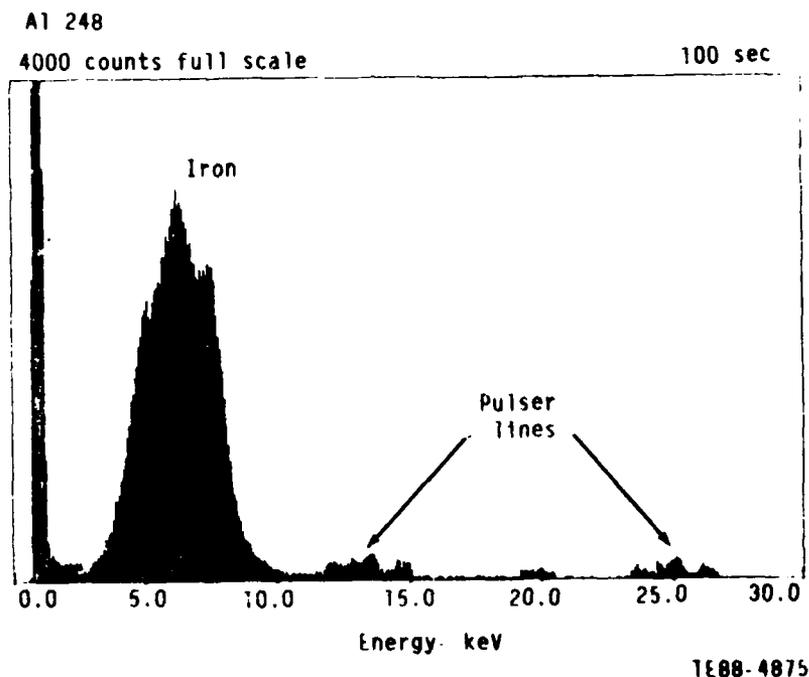
Figure 57. Spectrum at 2775 Hz (38 g) resonance.

Spectrum Al 248 was taken at the 2775 Hz (38 g) resonance, as is shown in Figure 57. It was surprising to see anything analyzed at all under these conditions. The peak in the spectrum corresponds to analysis of Fe in the shaker table baseplate to which the sensor was clamped. The pulser lines are reduced to multiple bumps around 14 keV and 25 keV in the spectrum.
