AIR FORCE INSTITUTE OF TECHNOLOGY

AFIT/GAE/AA/88D-28

INVESTIGATION OF FAILURE MODES
IN FIBER REINFORCED CERAMIC
MATRIX COMPOSITES

THESIS

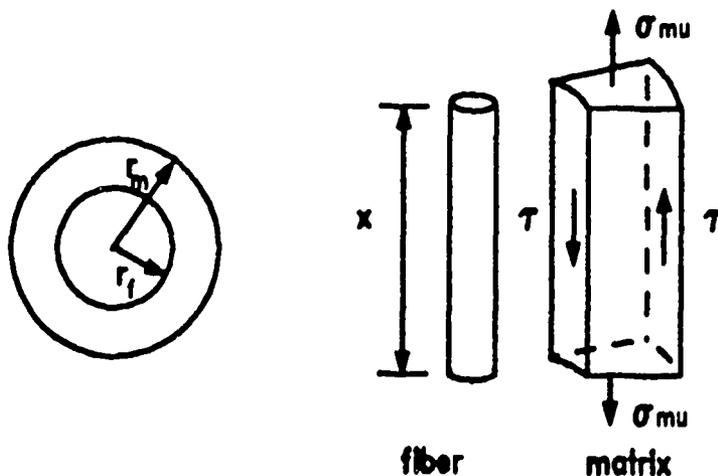
Figure 1. Fiber-matrix Shear Lag Model (3)

$$\sigma_{mu}[\pi(r_m^2 - r_f^2)] = \tau 2\pi r_f x \quad (1)$$

where σ_{mu} is the breaking stress of the matrix, r is radius, and the subscripts f and m refer to fiber and matrix respectively.

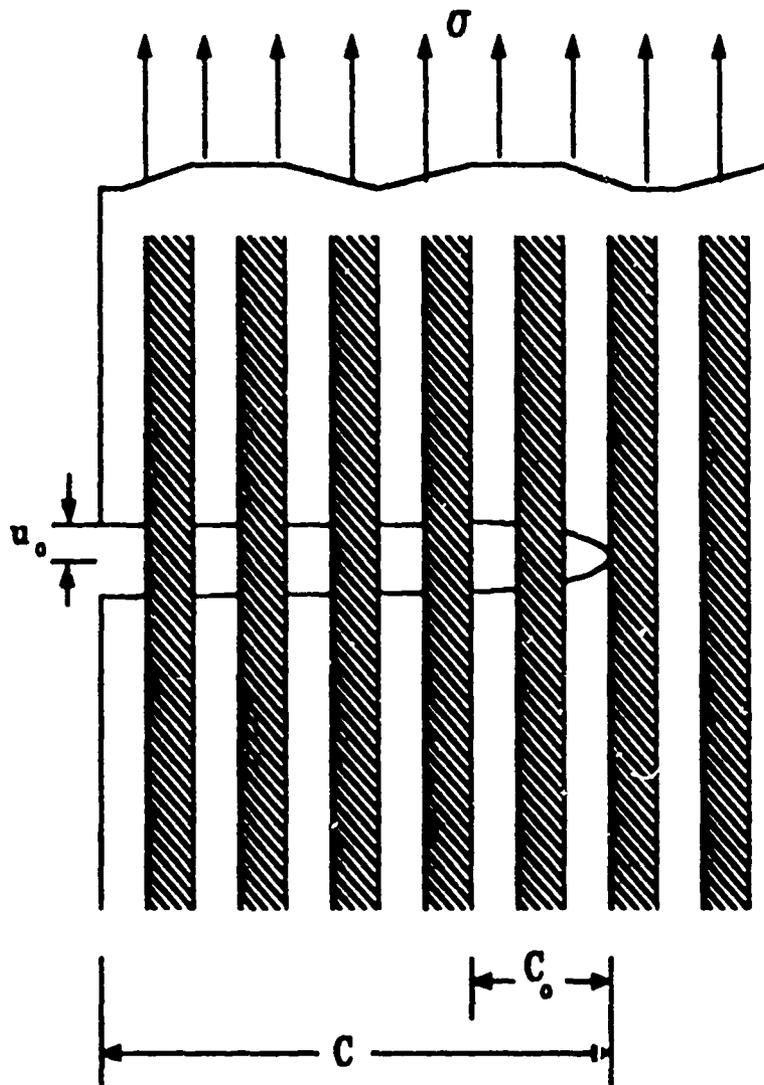
Figure 2. Steady-state Matrix Cracking in a Composite (13)

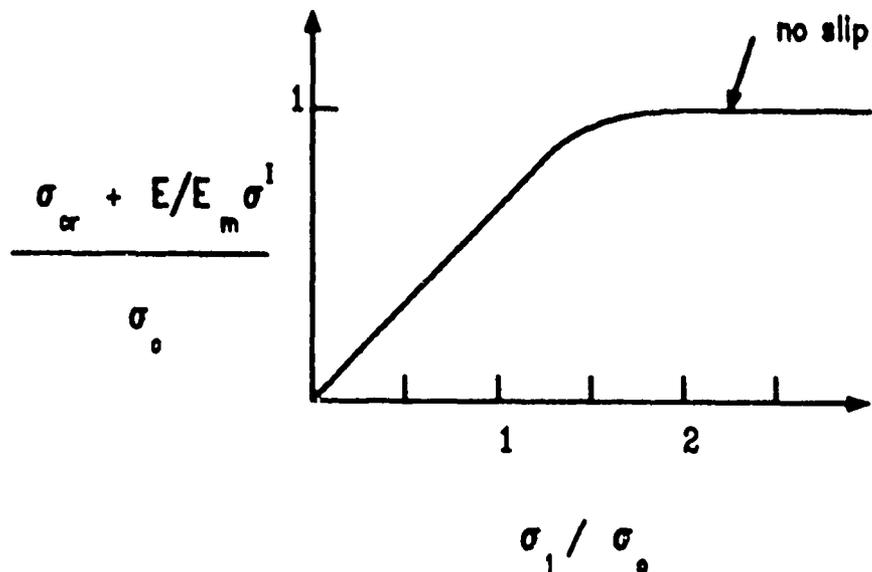
Figure 3. Matrix Cracking Stress for Frictionally Constrained Fibers (3)

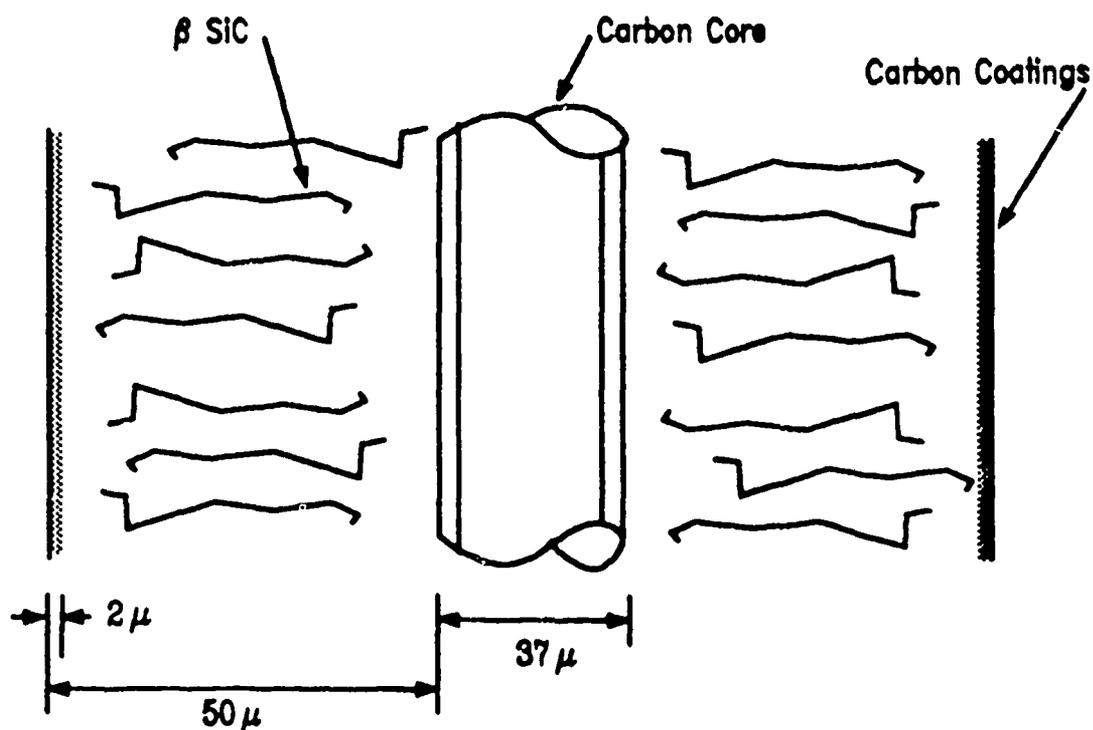
Figure 4. AVCO SCS-6 Fiber Core and Coatings (17)

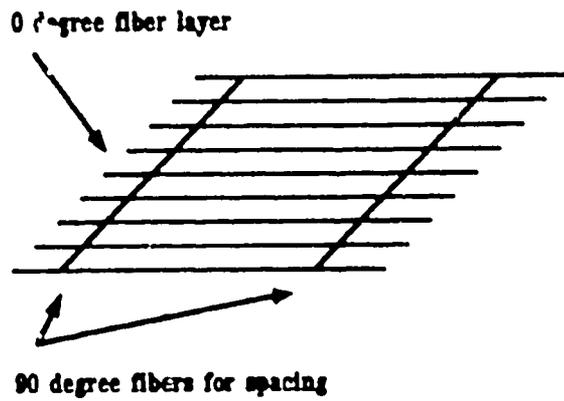
Figure 5. Fiber Layer Sequence for Fabrication

The composite specimens tested were all fabricated using a vacuum hot press. The AVCO fibers came in six inch (15.3 cm) wide rolls backed with aluminum. From this roll, two inch (5.1 cm) squares of the fibers were cut with the edges taped so that the aluminum backing could be removed. Next the squares were painted with glass slurry composed of glass powder, polyvinyl acetate, and acetone. The polyvinyl acetate serves as a binder for the fibers until hot pressing. The aluminum backing was removed from the squares and both sides were painted with the slurry. After the slurry dried, 12 squares were stacked unidirectionally to form a sample. Between each layer of fibers, two fibers were layed transversely across the fibers (one at each end) to improve the distribution of matrix between the fiber layers as shown in Figure 5. The 12 layer stack of plies was then heated to a temperature between 700-750°C to burn off the binder and partially sinter the glass. The sample was then loaded in a graphite die for hot pressing. The die was lined with molybdenum sheet on the four interior sides to prevent the glass from reacting with the graphite die parts. Ten grams of glass powder were packed above and below the stack of fiber layers and molybdenum sheets were again used to prevent reaction of glass with the graphite rams within the die

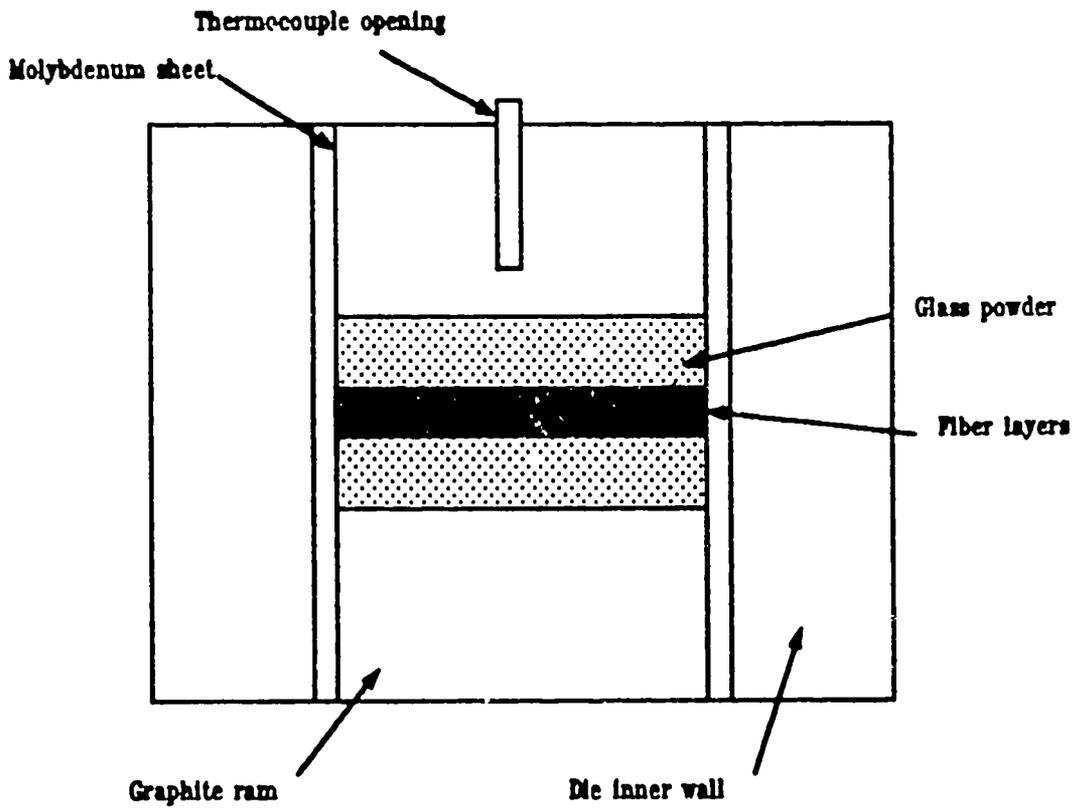
Figure 6. Sample Loaded in the Graphite Die

(Figure 6). The sample was heated by induction under vacuum until the glass powder slumped freely. This temperature was approximately 50°C to 100°C above the glass annealing point. The glass annealing point is defined as the temperature at which glass under tensile stress viscously elongates at specified rates and equates to a viscosity of 10^{13} poises (12:323). This temperature corresponded to a temperature of 850°C to 1150°C on the thermocouple inserted into the die. At the processing temperature, argon was added to the hot-press chamber and the ram pressure on the sample was increased to approximately 1000 psi (6.895 MPa). The sample was held in these conditions between 25 to 30 minutes.

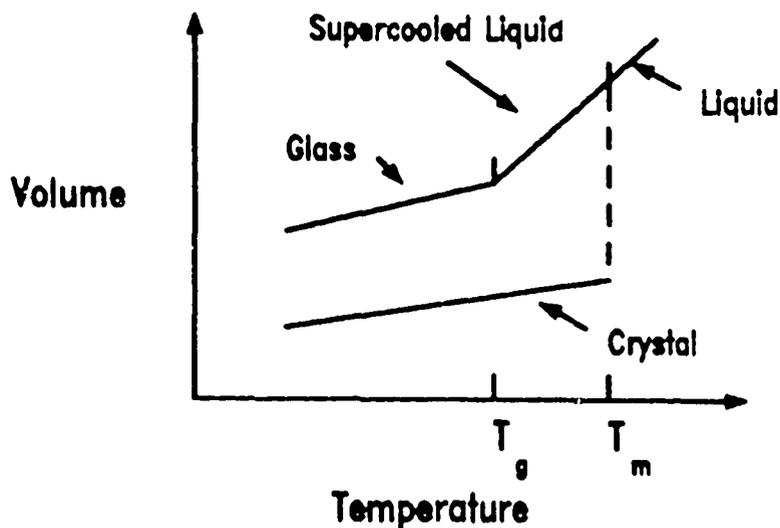
Figure 7. Glass-transition Temperature (18)

between a glass and a supercooled liquid as seen in Figure 7. Just above the glass transition temperature the supercooled, highly viscous liquid is semirigid, but it progressively reduces its viscosity and becomes a more fluid liquid as the temperature is raised. Below this temperature, the glass is a rigid solid (18:122).

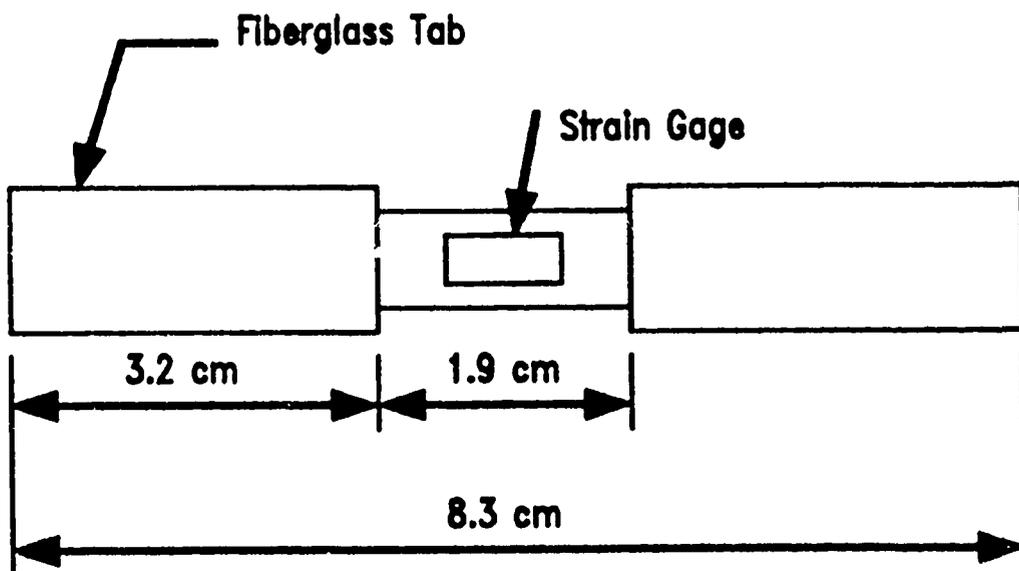
Figure 8. Tabbed Specimen for Testing

Each sample's thickness and width were carefully measured using a micrometer to determine the cross-sectional area. Then a 350 ohm strain gage (Type CEA-06-062VW-350) was attached longitudinally to one side of the sample to be tested in the straining stage. For the longitudinal samples tested on the MTS machine for mechanical properties, a stacked 0/90° strain gage (Type CEA-06-062WT-350) was used.

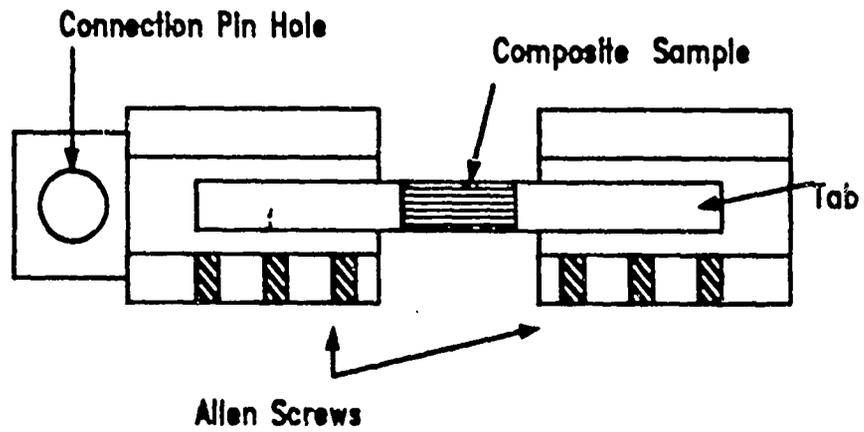
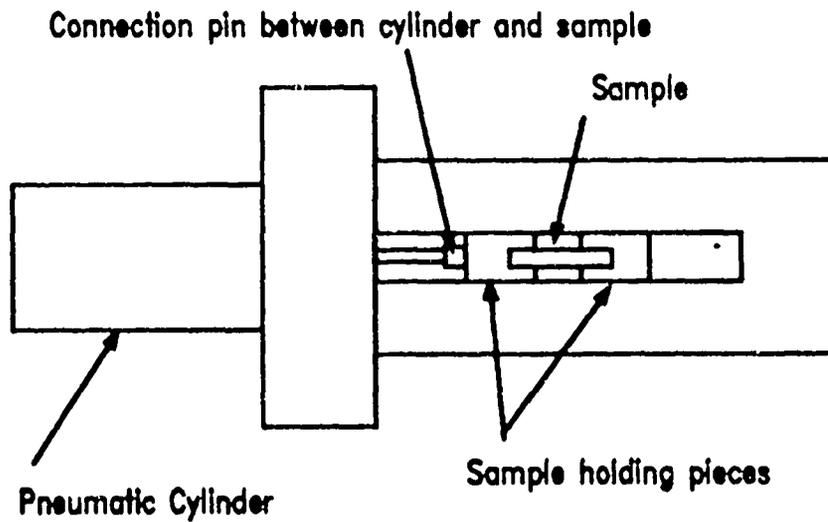
a. Sample holding pieces

b. Schematic of components of straining fixture

Figure 9. Straining Fixture

In order to observe damage formation and progression in the samples, a specially devised straining fixture was used which was developed by Dr. Ran Y. Kim of the University of Dayton Research Institute. The apparatus consists of a stainless steel pneumatic cylinder, a grooved steel block, two pieces that grip the specimen, and a strain indicator. The holding pieces grip the sides of the specimens with allen screws. A tensile or a compressive load may be applied to the specimen via a gas bottle through the pneumatic cylinder. Figure 9 illustrates the straining fixture schematically and Figures 10a and 10b are photographs of the apparatus. The device applies a constant load to the specimen controlled by the pressure regulator on the gas bottle. One psi of pressure on the bottle pressure indicator corresponds to a 2.65 lb load on

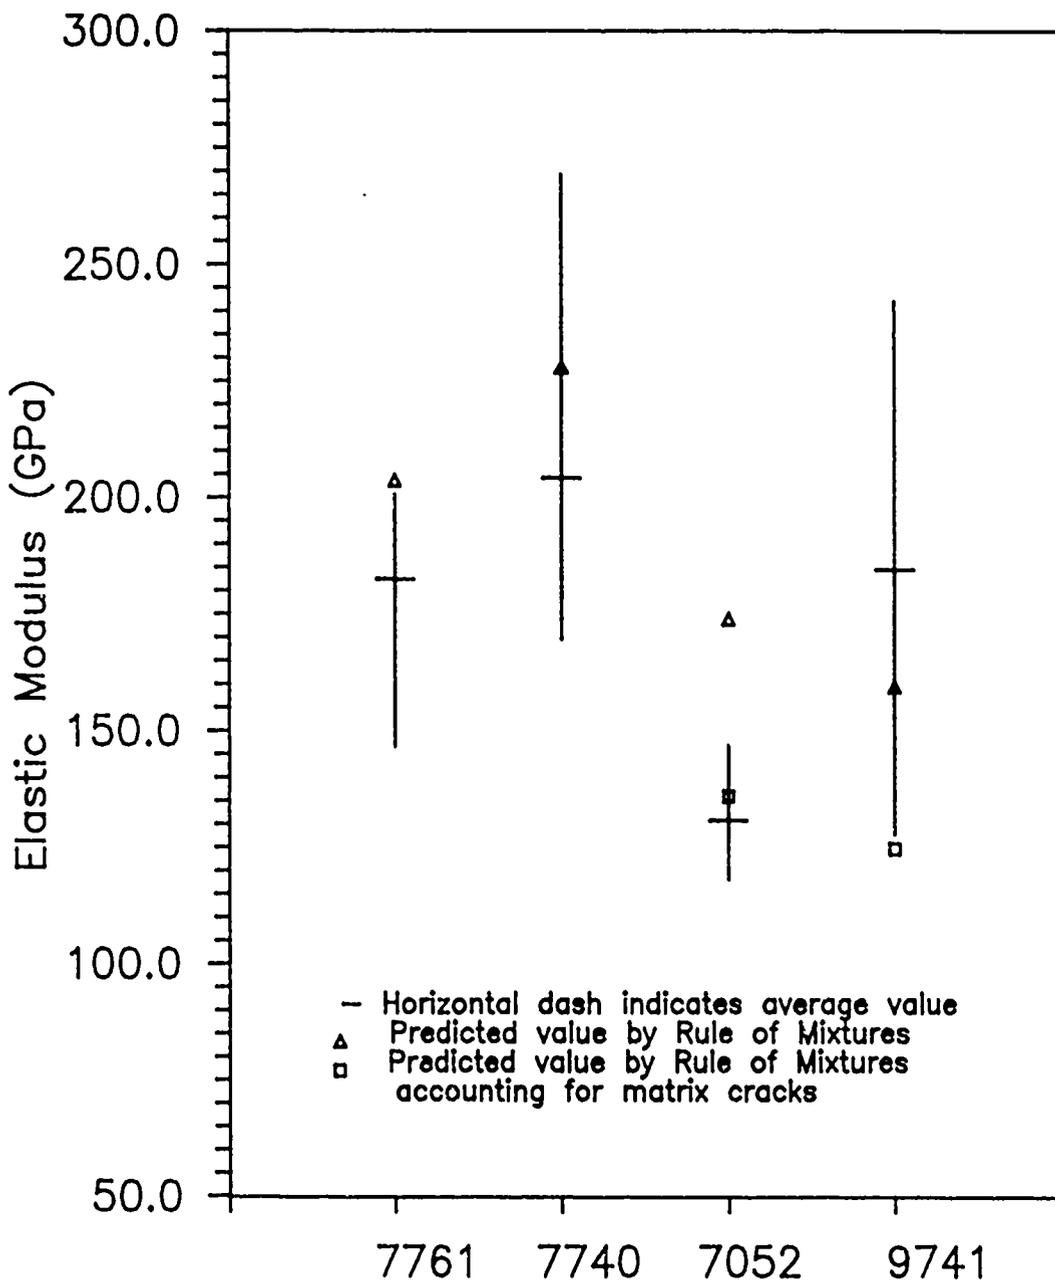
Figure 12. Elastic Modulus Values for Glass/AVCO Composites

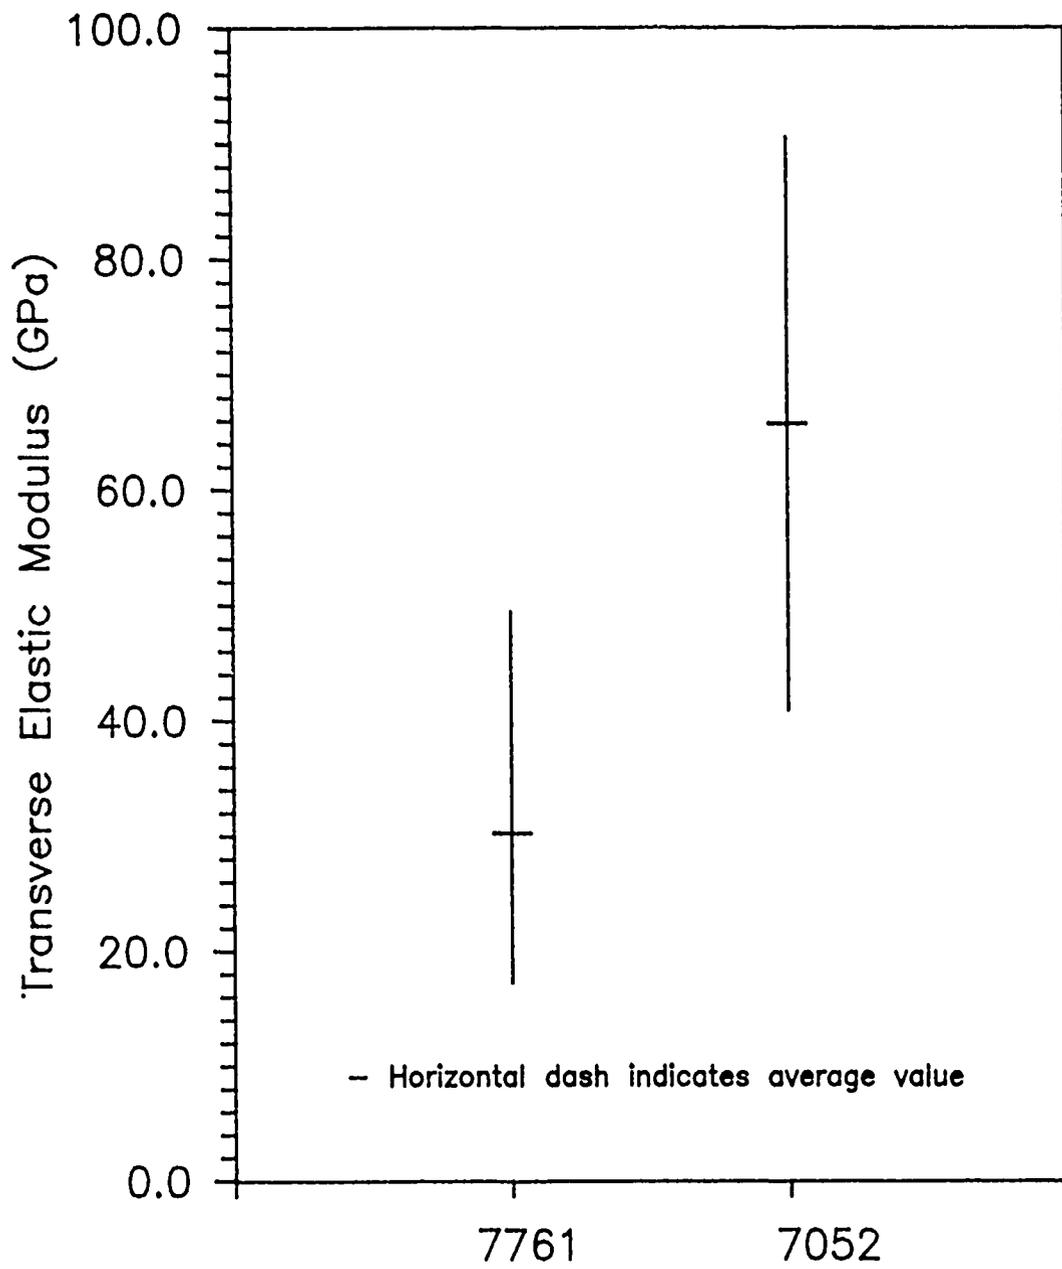
Figure 13. Transverse Elastic Modulus Values for Glass/AVCO Composites

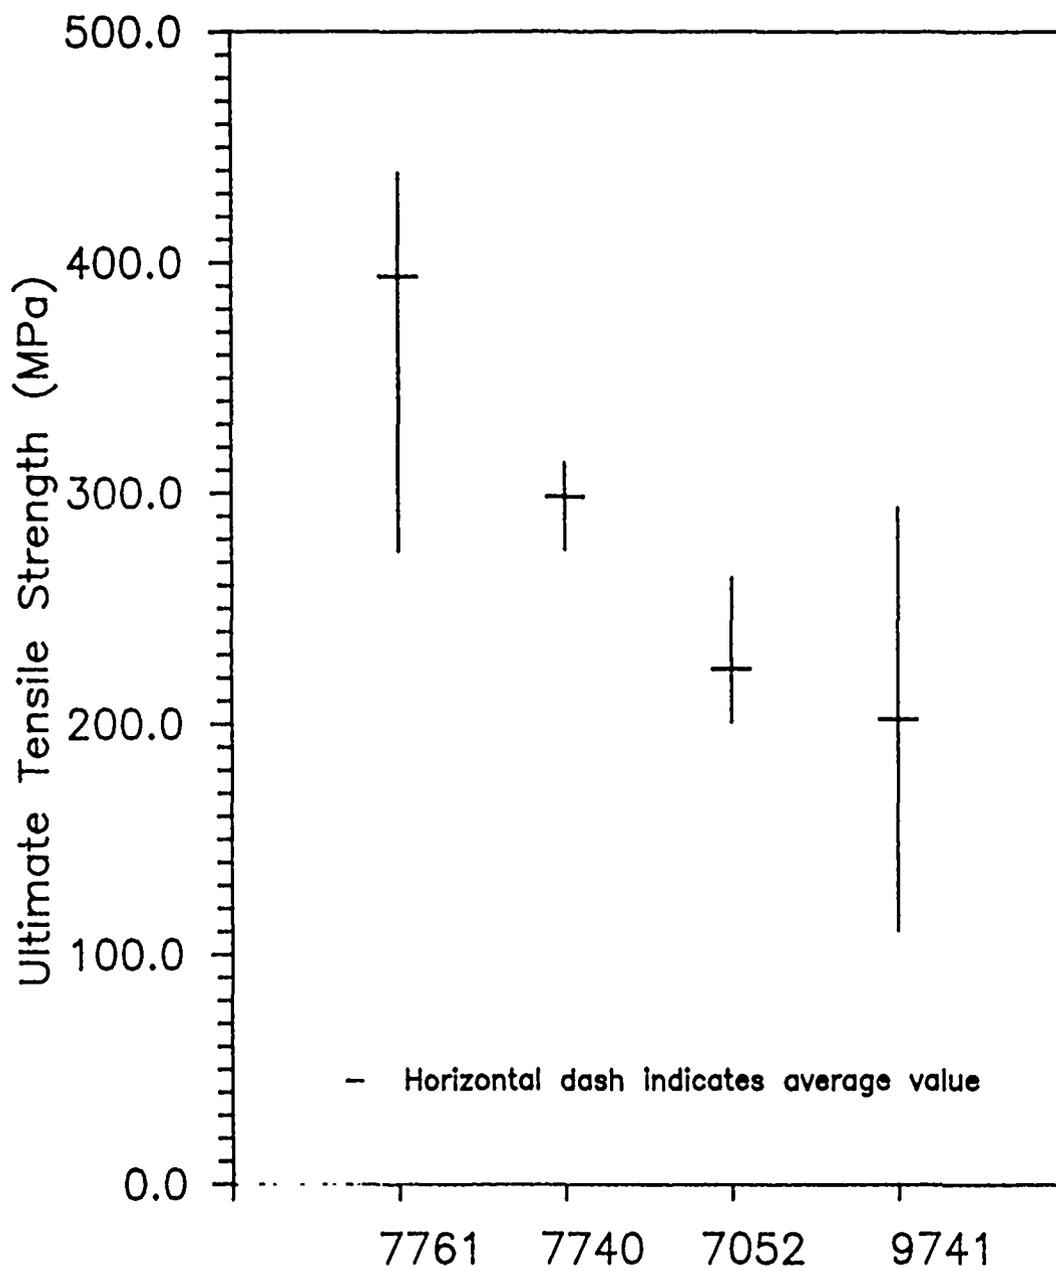
Figure 14. Ultimate Strength Values for Glass/AVCO Composites

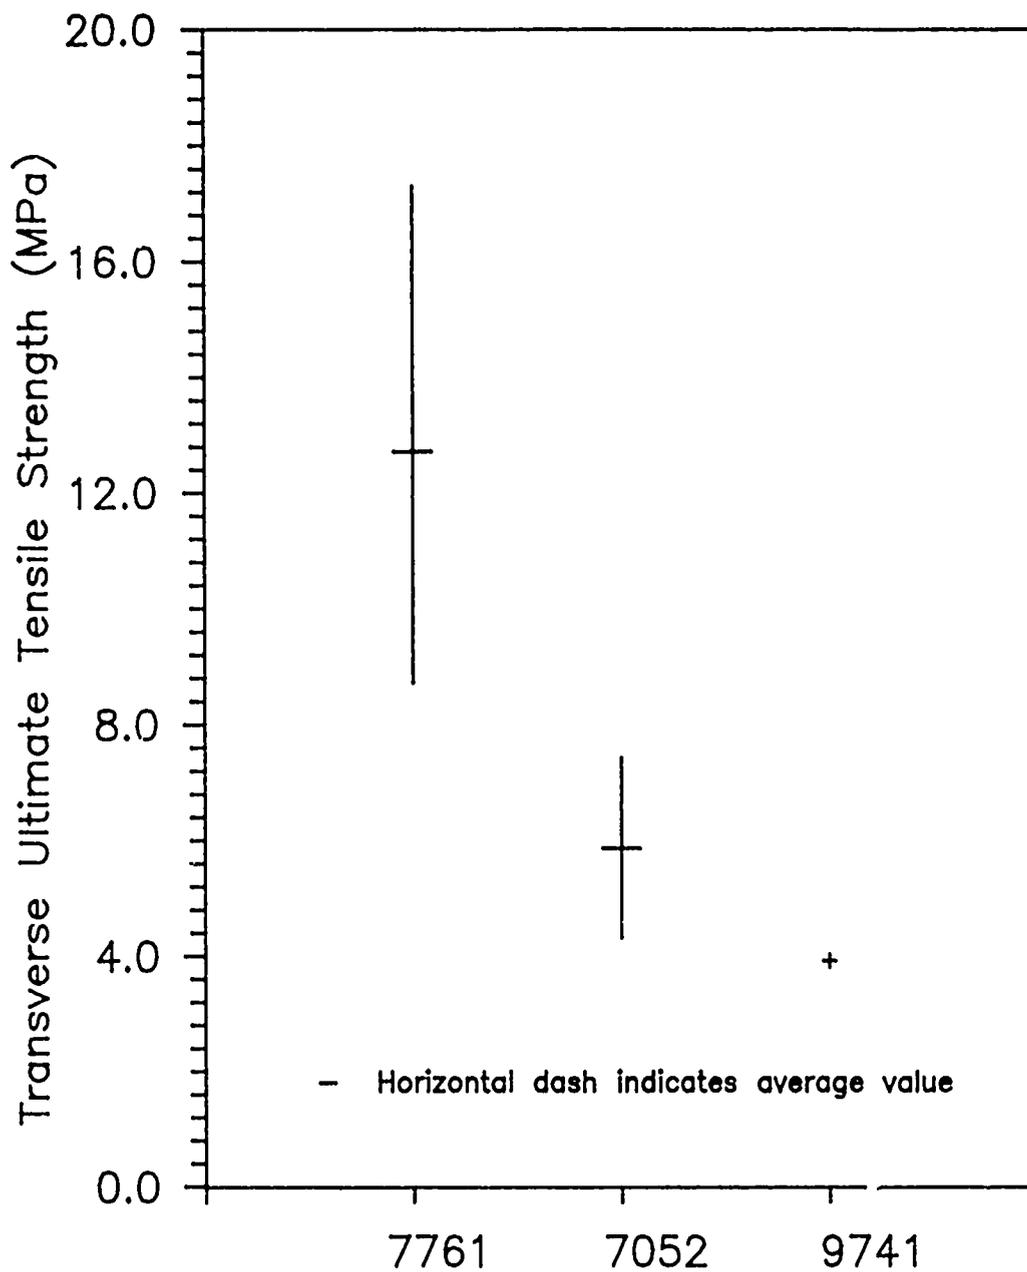
Figure 15. Transverse Ultimate Strength Values for Glass/AVCO Composites

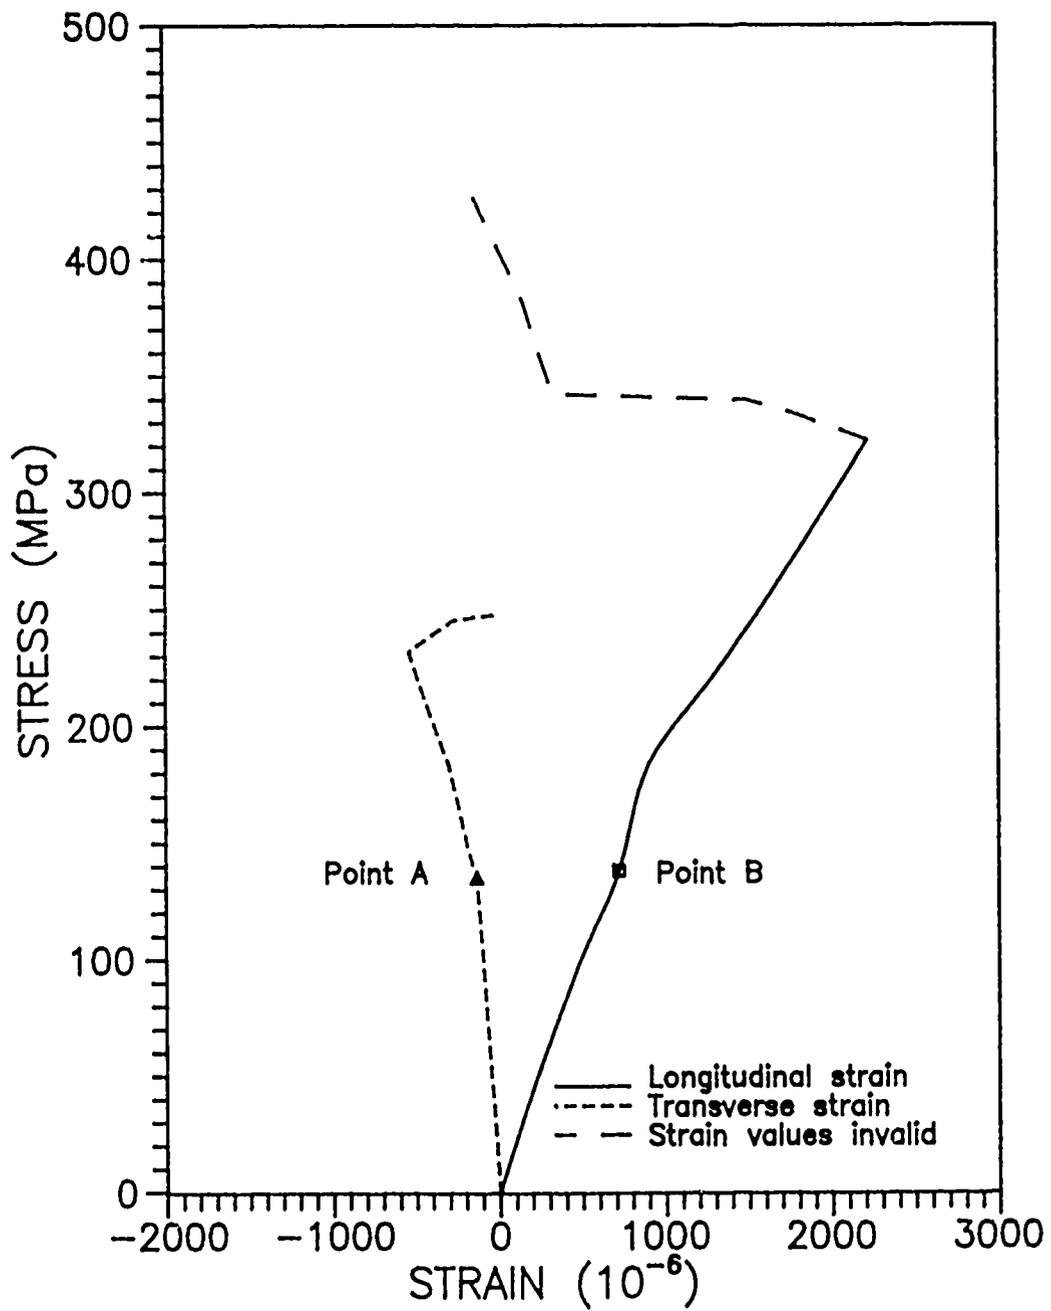
Figure 16. Stress-Strain Curve for AVCO/7761
Sample 28-Z

From the load-displacement curves produced by the MTS testing, apparent stress-strain curves were calculated using the initial cross-sectional area of the samples. Two examples of the stress-strain curves are shown in Figures 16 and 17. The curves for the other samples tested are shown in the Appendix in Figures 46 thru 52. An interesting aspect noted in the curve for the 7761/AVCO longitudinal specimen (Figure 16) is the reversal of transverse strain. This phenomena was first reported by Kim and Katz (9) in their study of failure processes of fiber reinforced ceramic matrix composites. In the stress-strain curves obtained from the tensile tests, both the axial and transverse stress-strain curves exhibit a proportional limit. The transverse stress-strain curve became nonlinear at .013 percent strain as indicated by Point A on Figure 16. The axial curve became nonlinear at .072 percent strain as shown by Point B in Figure 16.

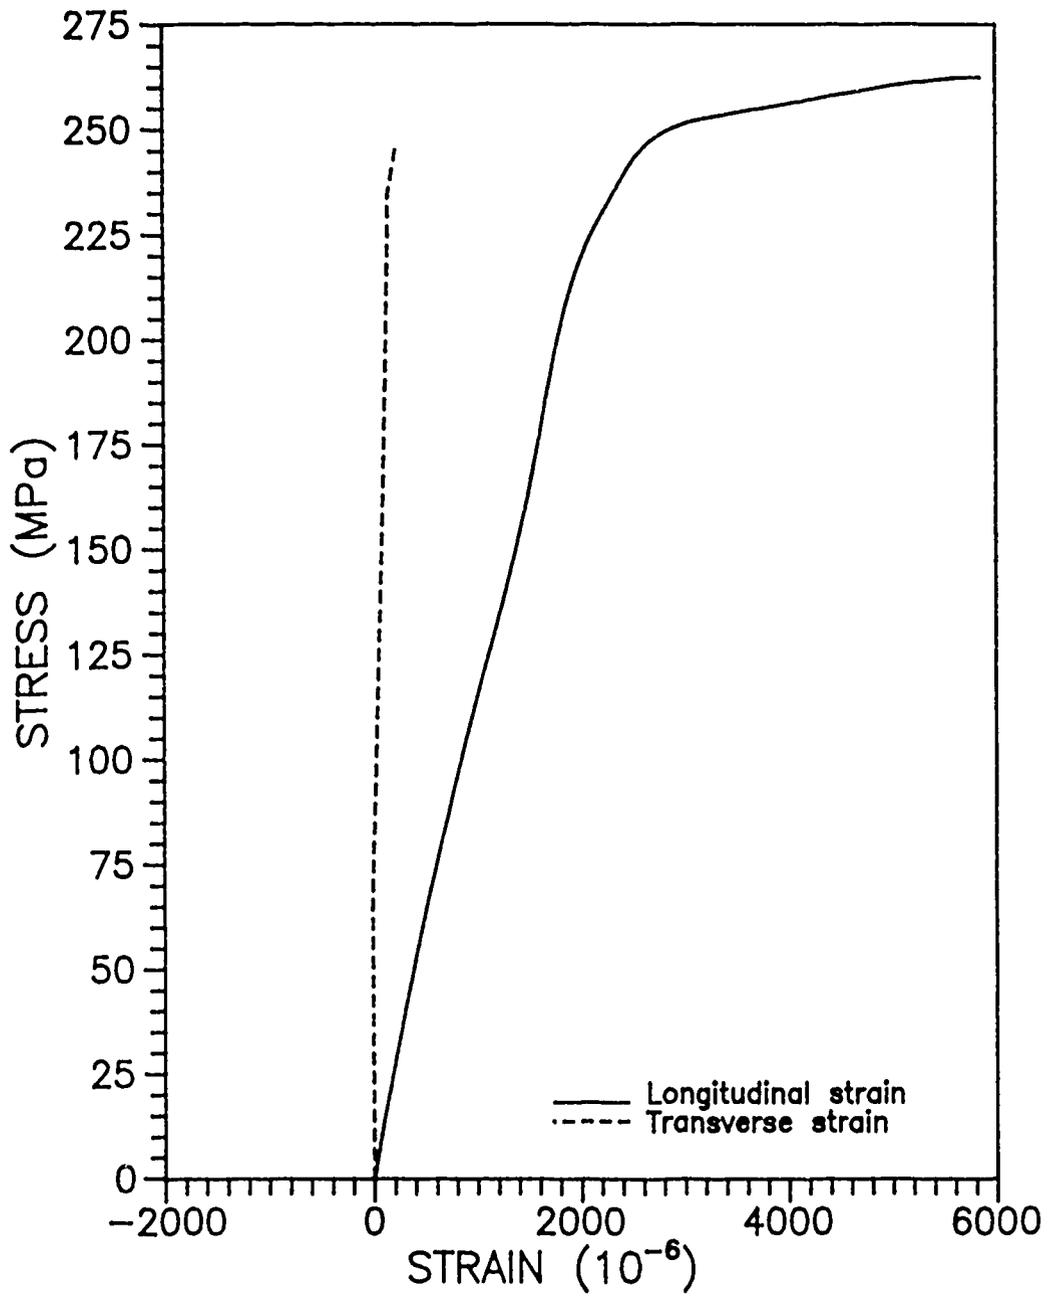
Figure 17. Stress-Strain Curve for AVCO/7052
Sample 39-B

Beyond their respective proportional limit, the curves behave nonlinearly. In this nonlinear region, the axial or longitudinal strain continues to increase while the transverse strain decreases. The transverse strain actually changes its direction. Physically this means that the composite stops contracting in the lateral direction and begins expanding. This transverse strain reversal is not well understood, but is believed to be caused by the formation of axial matrix cracks and to fiber-matrix debonding (9:1). Another observation during these tensile tests is that transverse matrix cracks appeared on the surface of some of the longitudinal specimens well before the onset of nonlinearity in the stress-strain curves. This was determined by noting the strain at which the first crack appeared on the sample surface and comparing this to the strain at which the stress-strain curve became nonlinear. For example, during the test of Sample 28-Z, a 7761/AVCO system sample, matrix cracking was observed at an axial strain of .05 percent while the onset of nonlinearity occurred at .072 percent strain (Point B on Figure 16). The number of cracks increased with increasing stress and are assumed to be partially responsible for the nonlinearity of the stress-strain curve. But because some cracks did appear before the proportional limit, it can be said that the onset of nonlinearity in the stress-strain curve is not a reliable indication of the initiation of

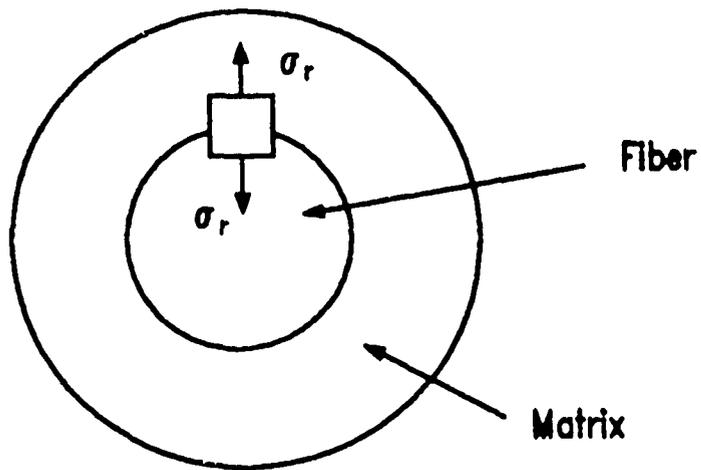
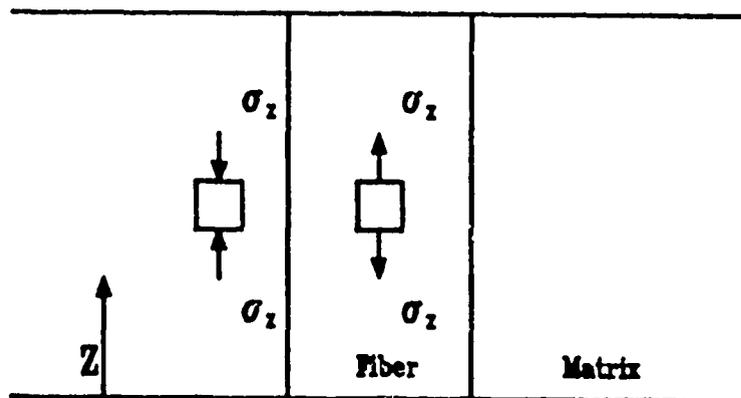
a. Radial stresses at fiber-matrix interface (tension-tension)

b. Axial stresses at fiber-matrix interface (matrix in compression, fibers in tension)

Figure 18. Stresses at fiber-matrix interface
7761/AVCO system

2. In the axial direction, the fibers will place the matrix in compression while the fibers themselves are in tension (Figure 18b). This matrix pre-stressing will increase the overall strain required to initiate failure and thus increase the overall strength of the composite. However this pre-stressing assumes the fiber and matrix are strongly bonded. If the interface cannot support the induced stresses, little or no matrix pre-stressing will occur (6:954). To obtain quantitative values for these stresses, the NDSANDS model developed by Pagano and Tandon (16) was used. This model assumes the fiber and matrix to be linearly elastic, homogeneous, and perfectly bonded. The predicted state of stress at the fiber-matrix interface for the composite systems tested is presented in Table IX and will be discussed later in this chapter. For the AVCO/7761 system, three samples were tested on the straining stage. The first sample tested exhibited matrix cracking at strains of .08 percent as shown in Figures 19a and 19b. In these figures, the gray area is the glass matrix and the white bands are fibers. In Figure 19a, the fibers are below the glass and appear as light colored horizontal bars. In Figure 19b two fibers are seen at the surface of the sample. In both figures the cracks run transversely across the sample width and appear as dark

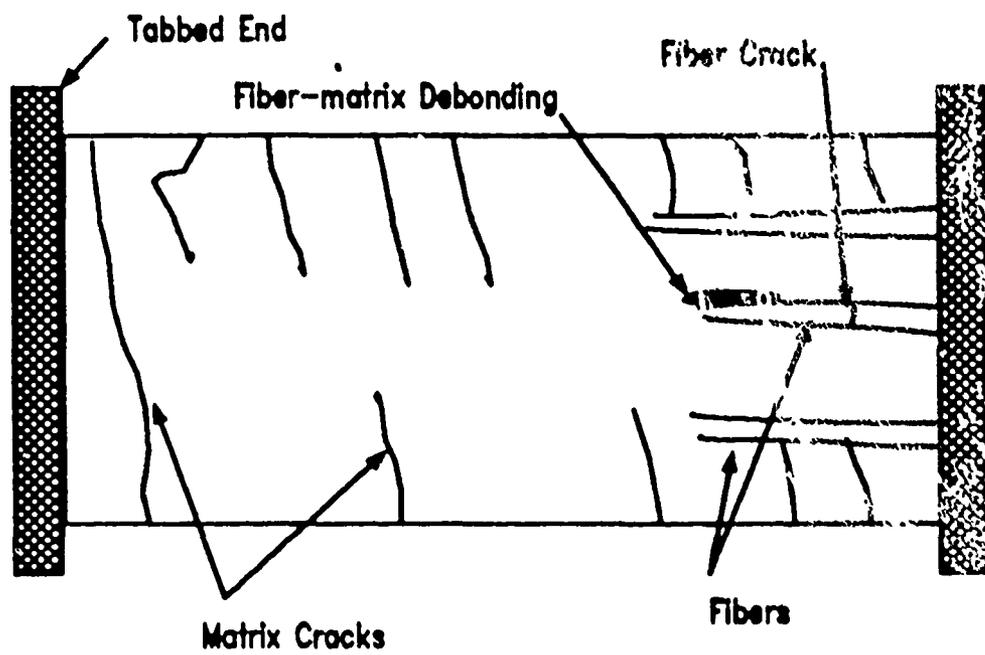
Figure 27. Schematic diagram of damage in 7761/AVCO sample at .14 percent strain

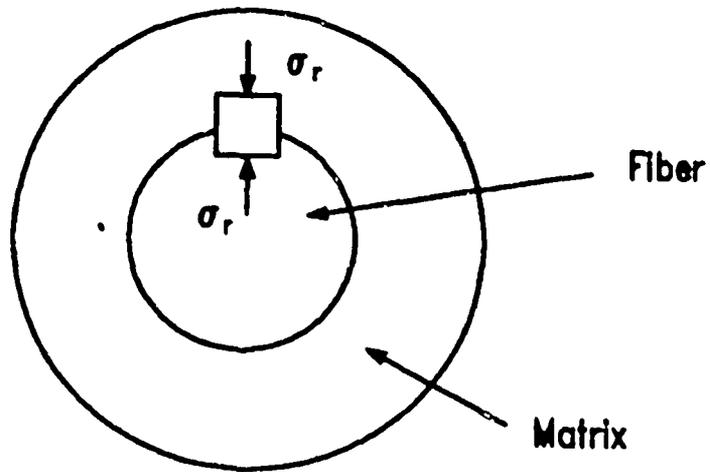
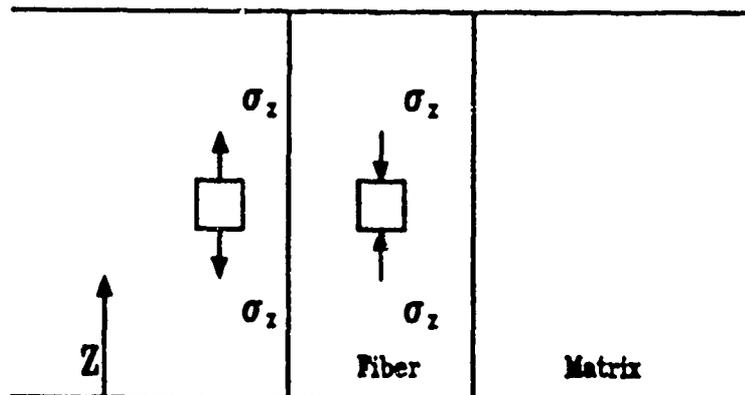
a. Radial stresses at fiber-matrix interface (compression, compression)

b. Axial stresses at fiber-matrix interface (matrix in tension, fiber in compression)

Figure 28. Stresses at fiber-matrix interface for 7052/AVCO and 9741/AVCO systems

2. Along the axial direction, the fibers will place the matrix in tension (Figure 28b). If the differential in CTE is large enough, the failure strain of the matrix may be exceeded and a network of microcracks may develop perpendicular to the fiber axis (6:954). As mentioned previously in the discussion of residual stress, when $\alpha_m > \alpha_f$, the matrix is in tension while the fibers are in compression. When the CTE mismatch is great enough, the residual tensile stress placed on the matrix may exceed the strength of the matrix. This proved to be the case for the 7052/AVCO system. All samples fabricated from this system exhibited uniformly spaced matrix cracking transverse to the fiber direction after processing. Figure 28 shows a schematic of the cracks in a 2 inch (5.1 cm) square plate. Two samples of the 7052/AVCO composite with the matrix cracking are shown in Figures 30a and 30b. To ensure the cracks were not a result of processing, the temperature and ram pressure applied during hot pressing were varied. Additionally, the samples were annealed to relieve any residual stresses. The cracks remained in all fabricated samples indicating the cracks were indeed a result of CTE

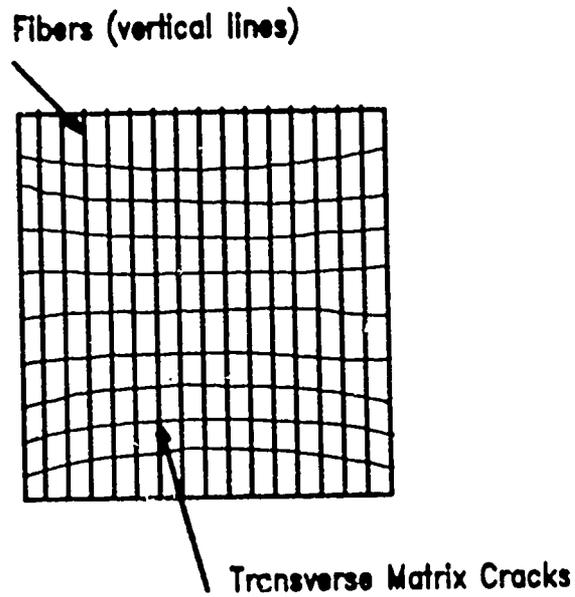
Figure 29. Matrix cracks in a 7052/AVCO composite plate after fabrication

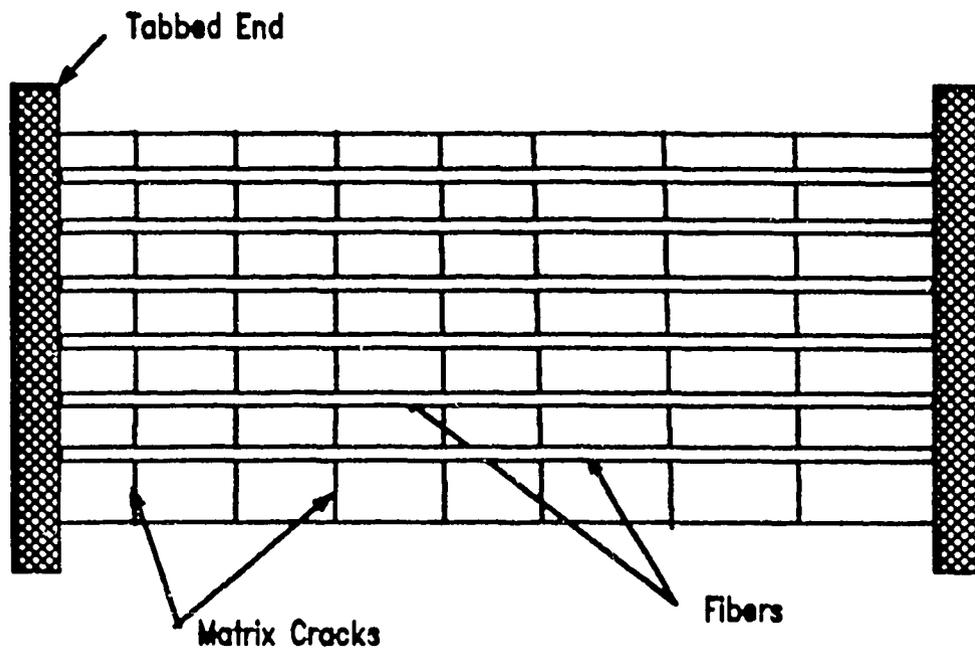
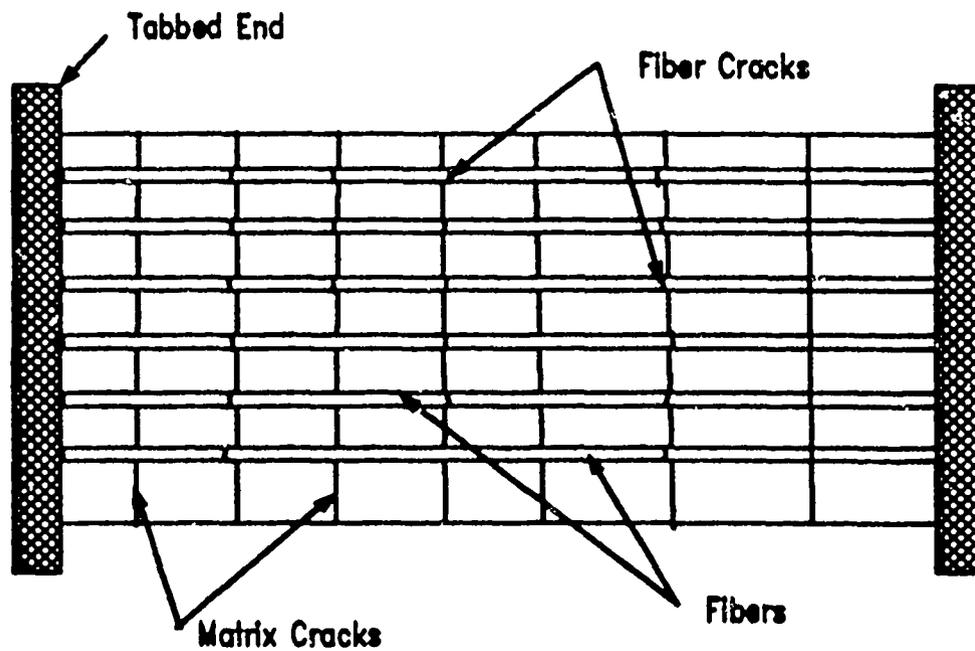
a. Evenly spaced matrix cracks in sample prior to testing

b. Fiber and matrix cracks at .06 percent strain

Figure 33. 7052/AVCO Sample before and after testing

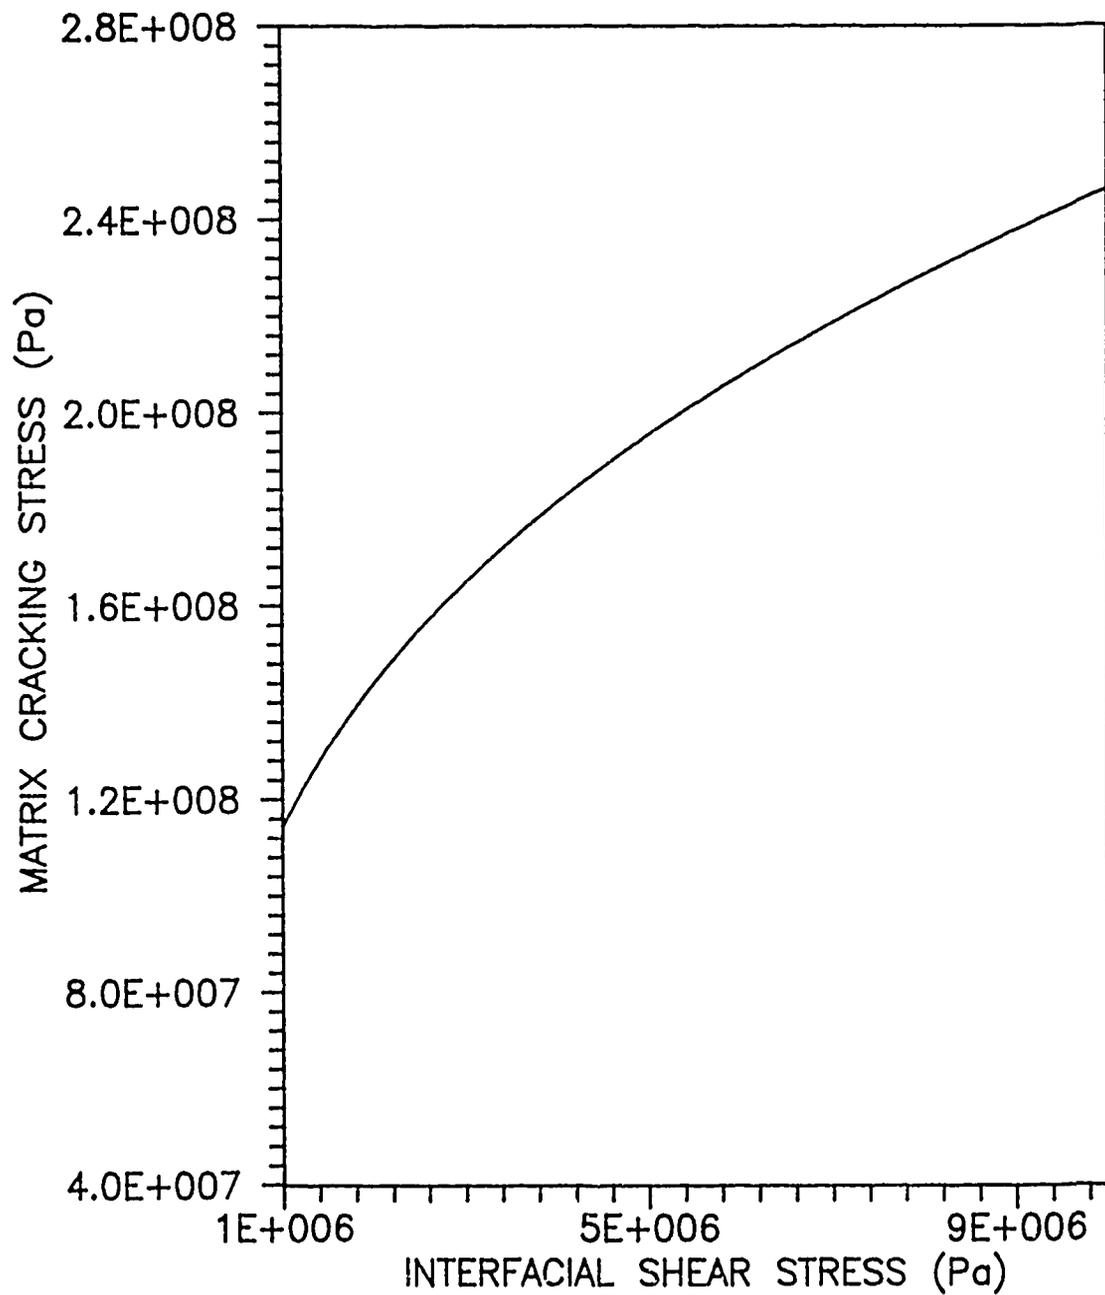
Figure 37. Matrix Cracking Stress Vs Interfacial Shear Stress
 Predicted Stress from MCE Model
 CGW 7761 Glass with AVCO Fibers

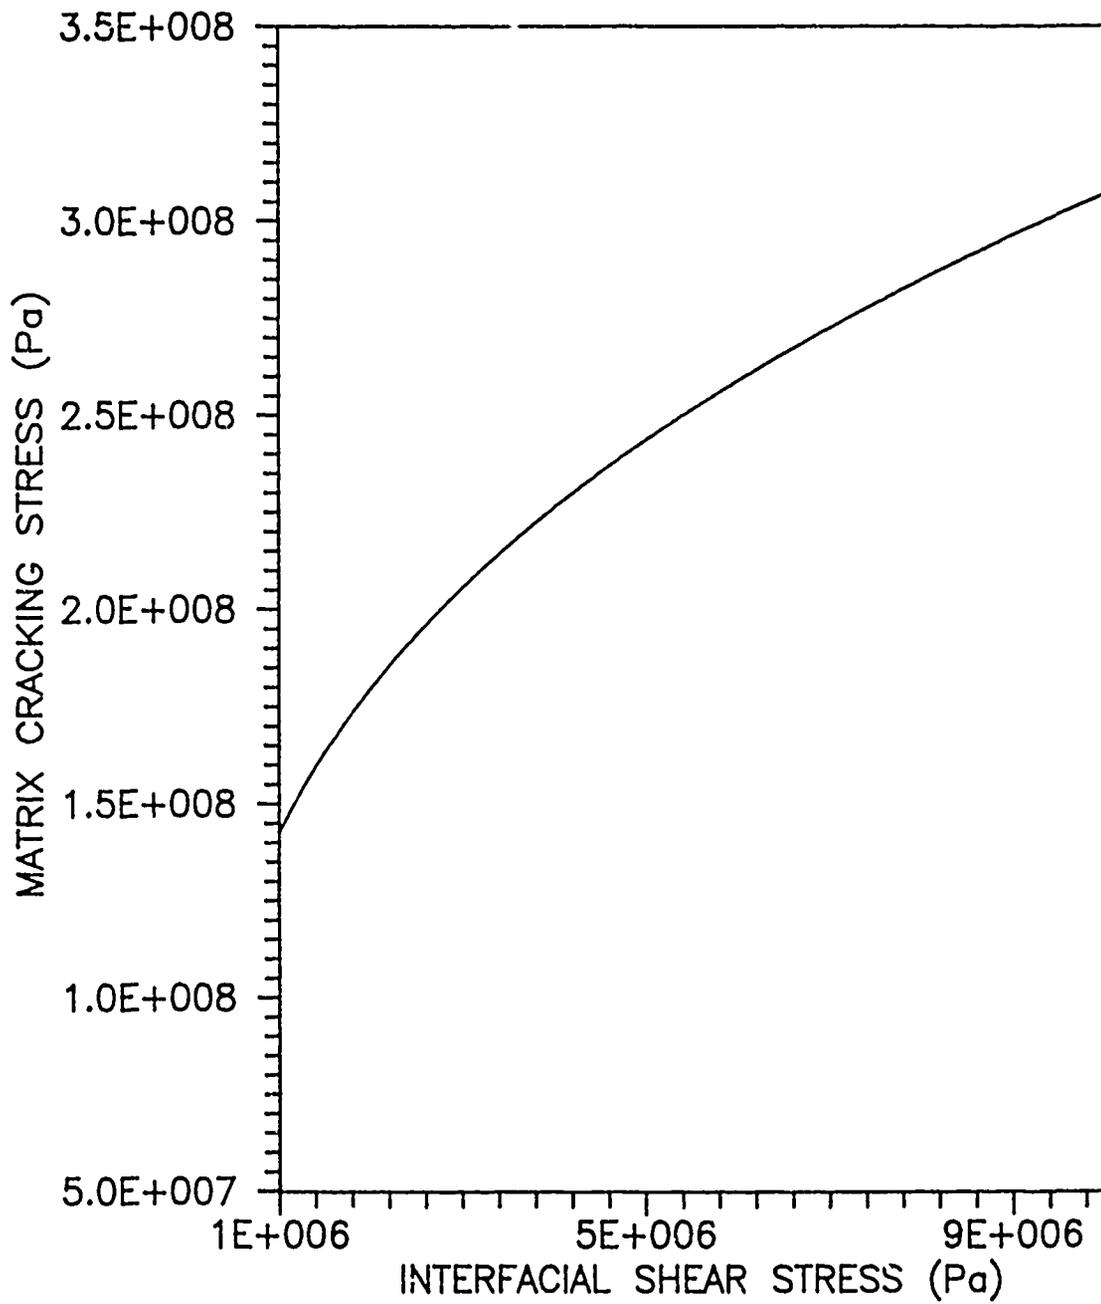
Figure 38. Matrix Cracking Stress Vs Interfacial Shear Stress
 Predicted Stress from MCE Model
 CGW 7740 Glass with AVCO Fibers
