AIR FORCE INSTITUTE OF TECHNOLOGY

AFIT/GAE/AA/88D-28

INVESTIGATION OF FAILURE MODES
IN FIBER REINFORCED CERAMIC
MATRIX COMPOSITES

THESIS

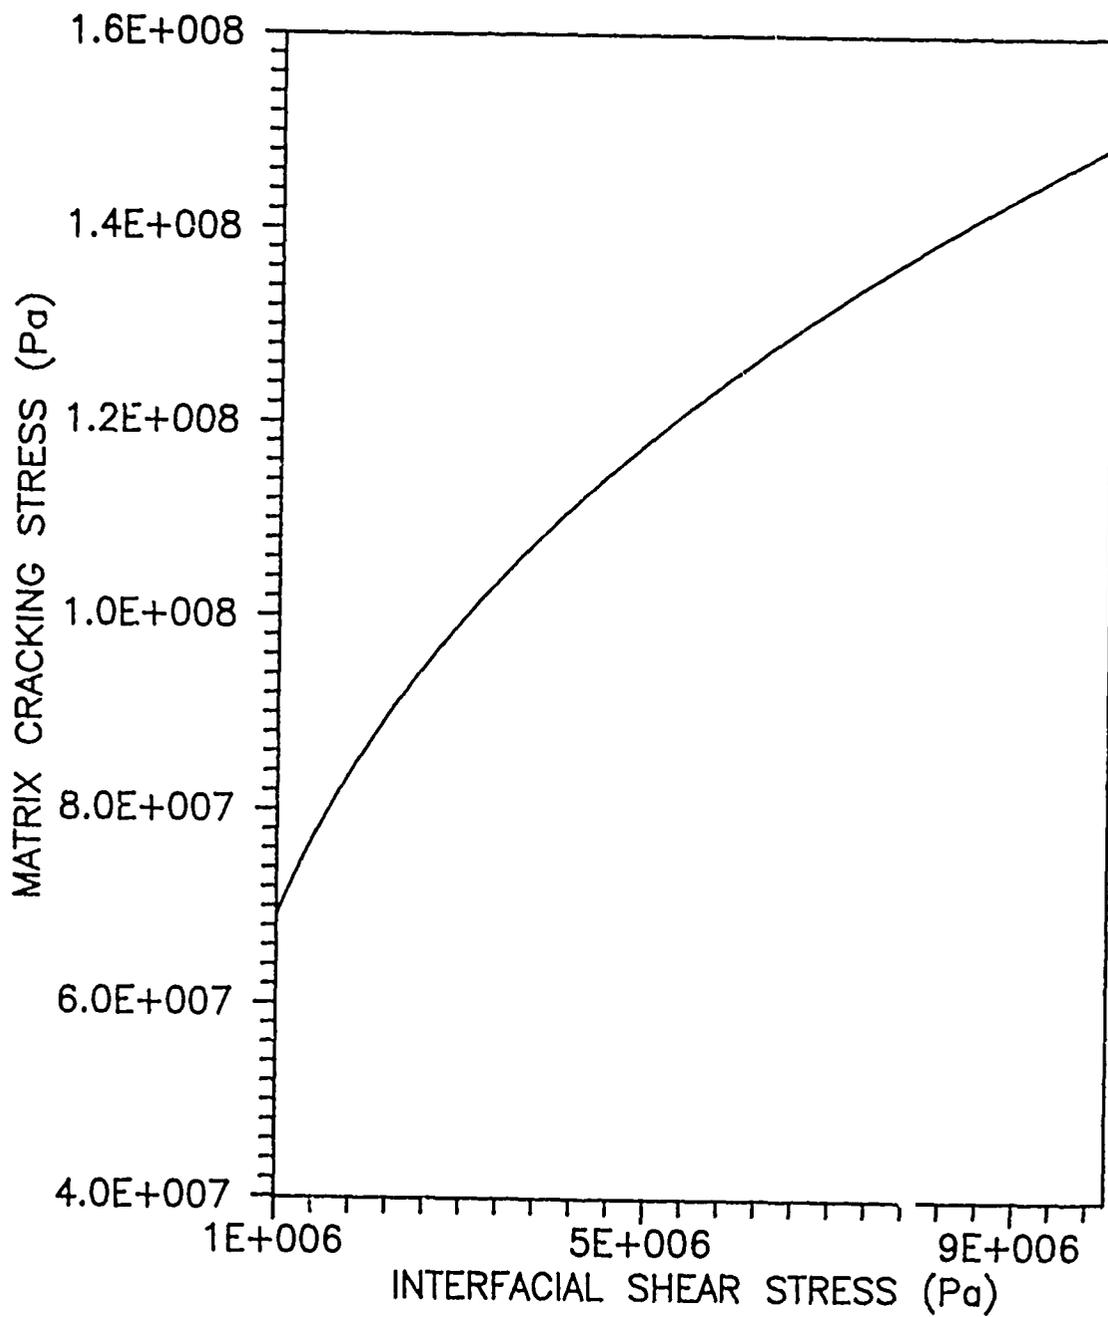
Figure 39. Matrix Cracking Stress Vs Interfacial Shear Stress
Predicted Stress from MCE Model
CGW 9741 Glass with AVCO Fibers

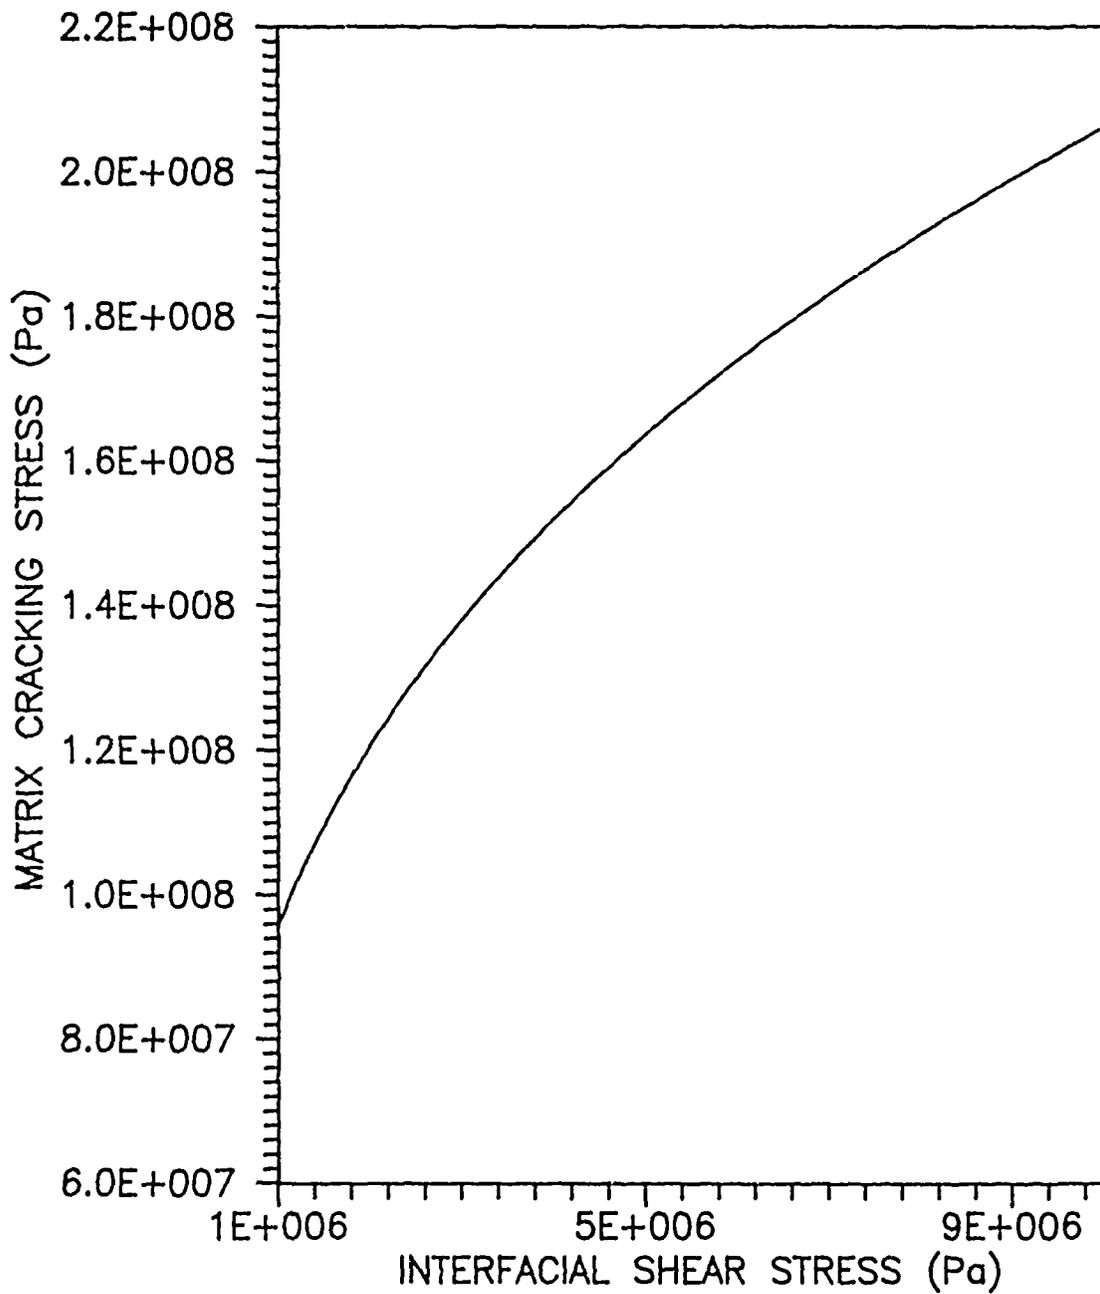
Figure 40. Matrix Cracking Stress Vs Interfacial Shear Stress
 Predicted Stress from MCE Model
 CGW 7052 Glass with AVCO Fibers

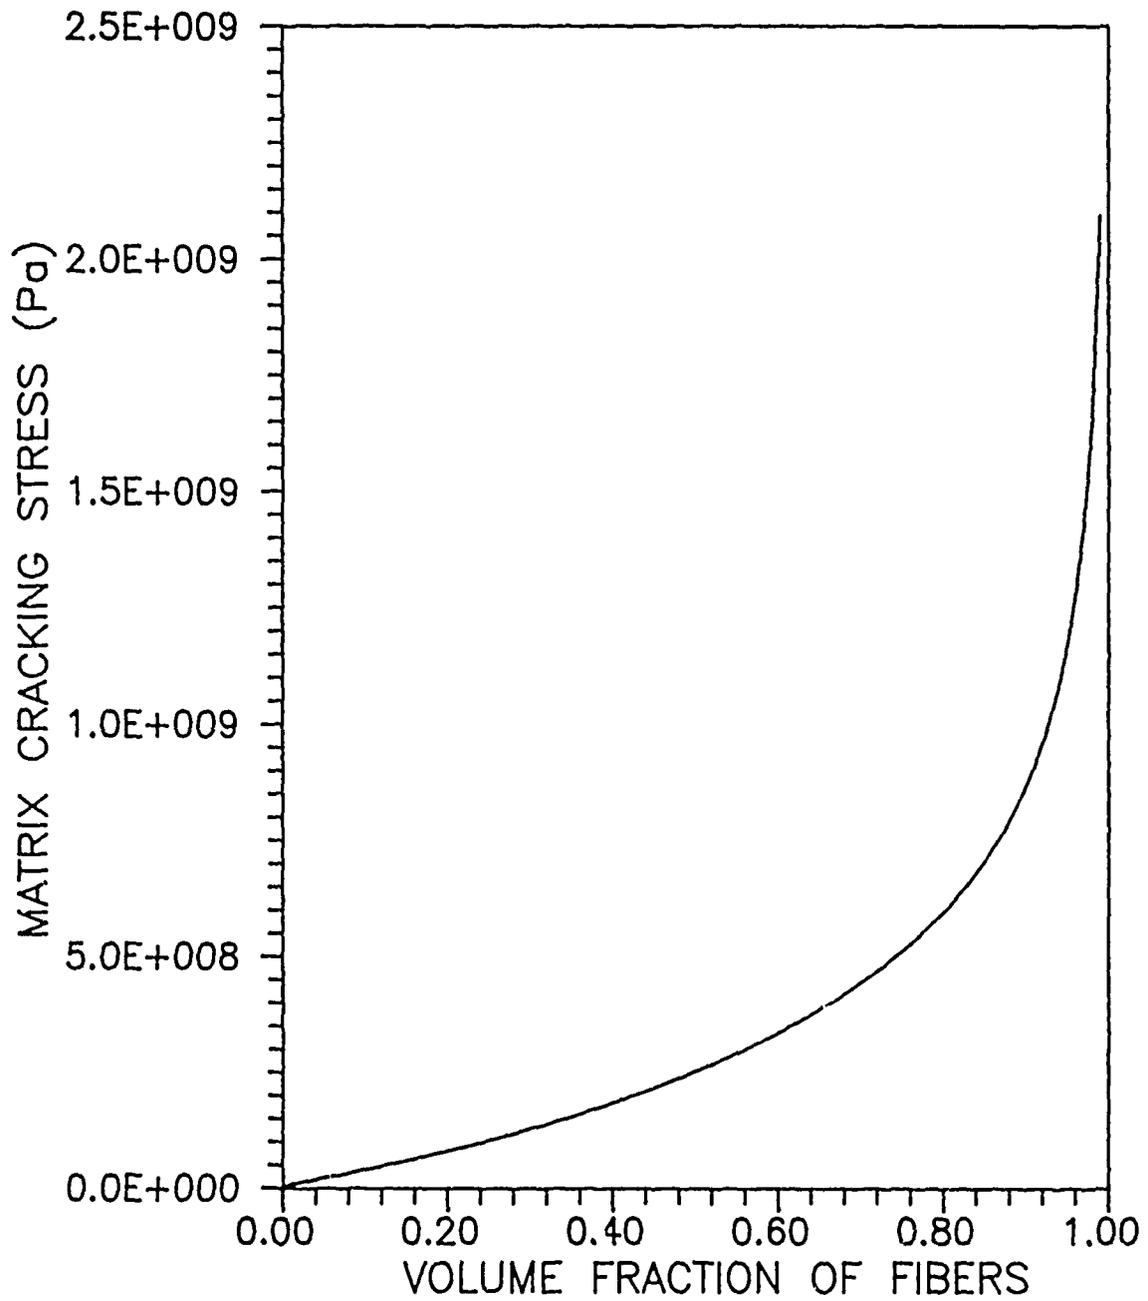
Figure 41. Matrix Cracking Stress Vs Volume Fraction Fibers
Predicted Stress from MCE Model
CGW 7761 Glass with AVCO Fibers

Figures 41 through 44 show the variation of matrix cracking stress with volume fraction of fibers. V_f in equation 18 was varied from 0.0 to 1.0 for the four composite systems. The matrix cracking stress increases dramatically with increasing V_f . However a limitation of the models becomes apparent from this parametric study. In the mid-range of values of V_f the predicted values of

matrix cracking stress appear valid. However as V_f approaches zero, the predicted matrix cracking stress also goes to zero. In reality for $V_f = 0$, the matrix cracking stress should be that of the monolithic matrix. At the other end of the scale where V_f approaches one, the model predicts the matrix cracking stress goes to infinity or a singular solution. For $V_f = 1$, the matrix cracking stress should be equal to that of the fibers. Thus for the cases of very small V_f and very large V_f , the models are not satisfactory.

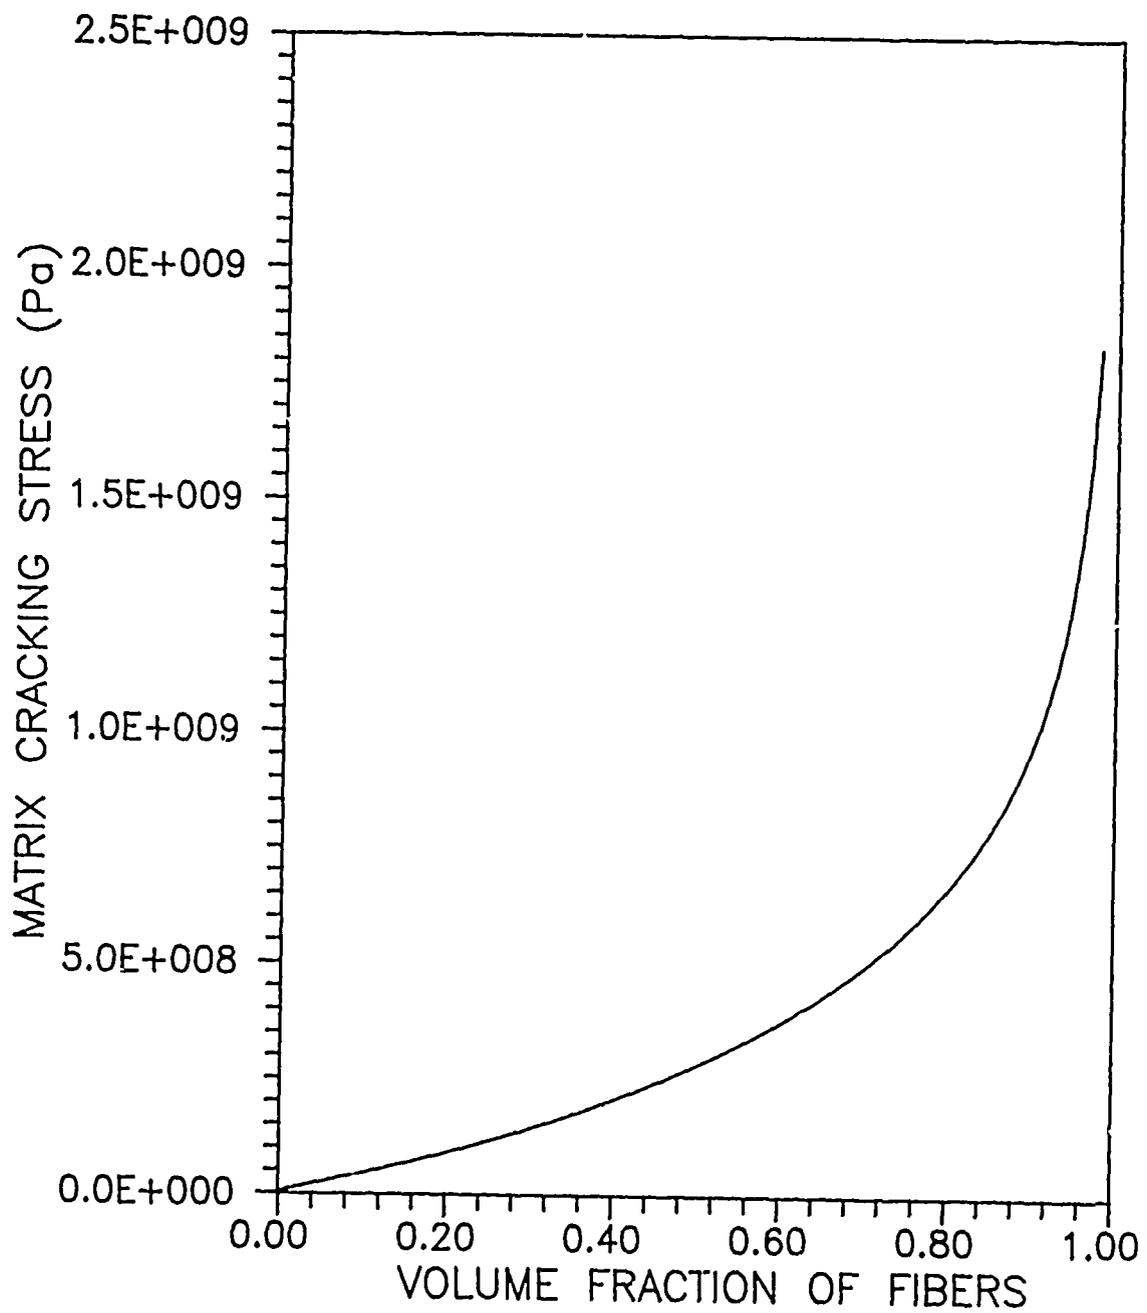
Figure 42. Matrix Cracking Stress Vs Volume Fraction Fibers
Predicted Stress from MCE Model
CGW 7740 Glass with AVCO Fibers

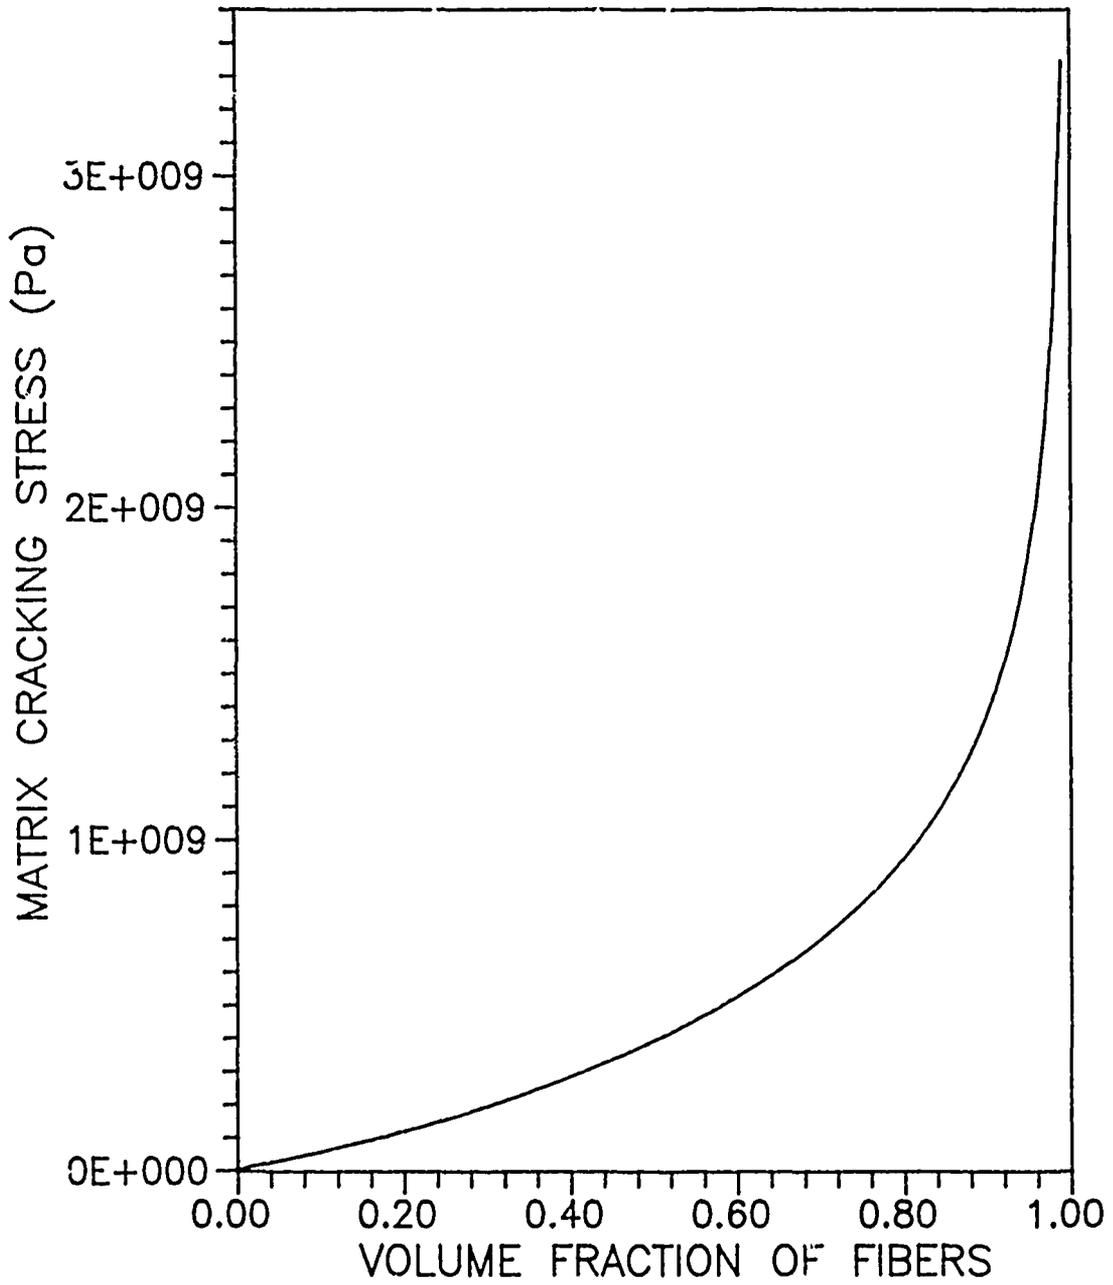
Figure 43. Matrix Cracking Stress Vs Volume Fraction Fibers
 Predicted Stress from MCE Model
 CGW 9741 Glass with AVCO Fibers

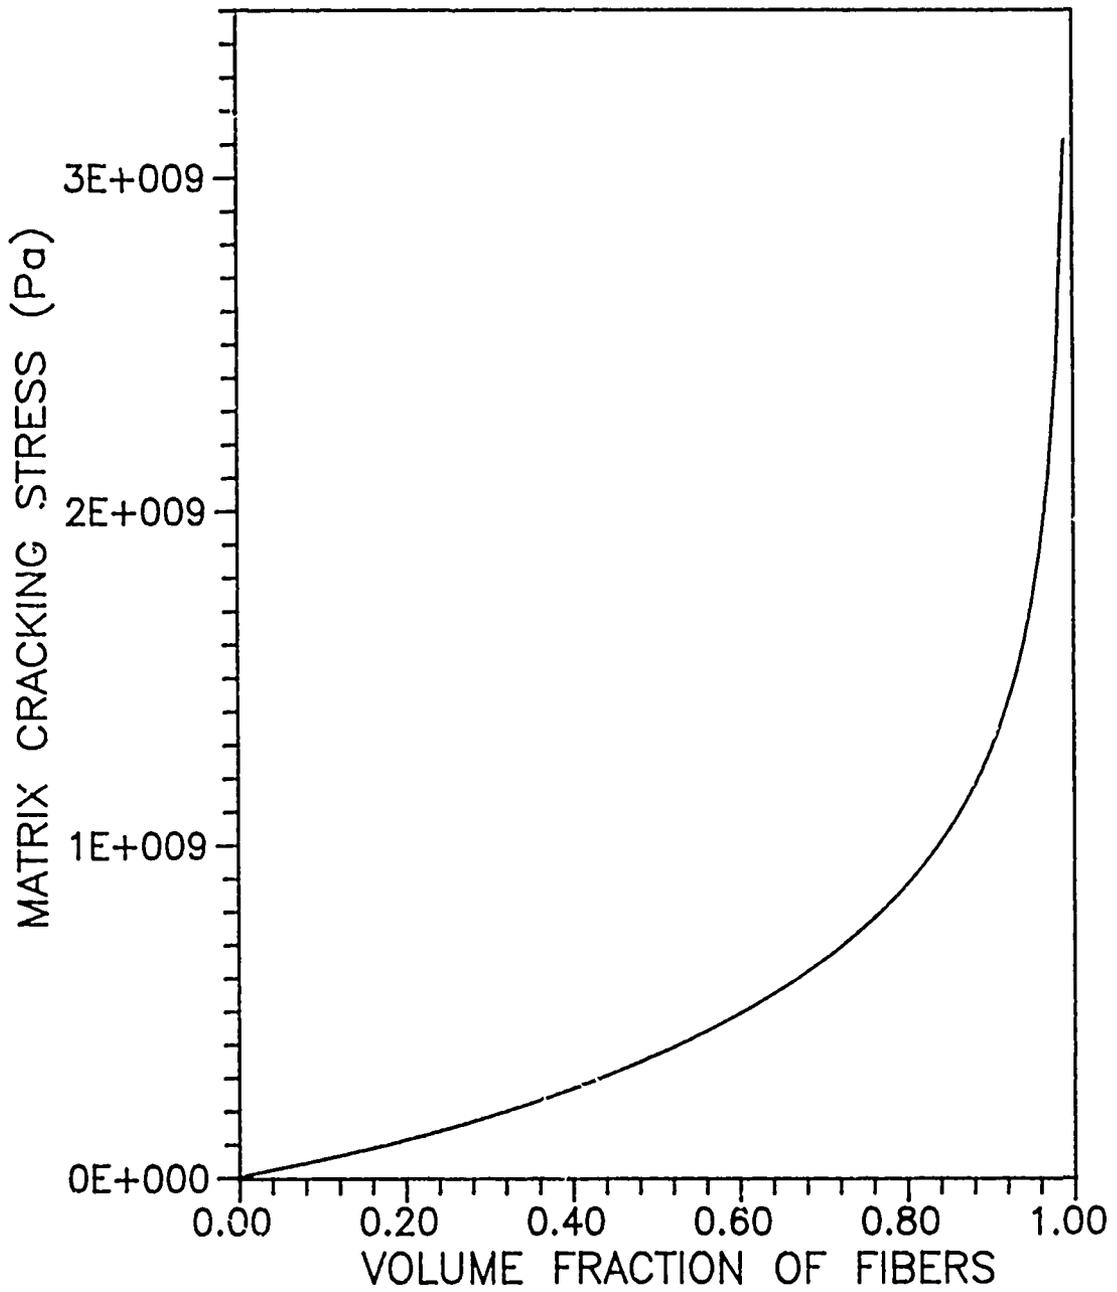
Figure 44. Matrix Cracking Stress Vs Volume Fraction Fibers
Predicted Stress from MCE Model
CGW 7052 Glass with AVCO Fibers

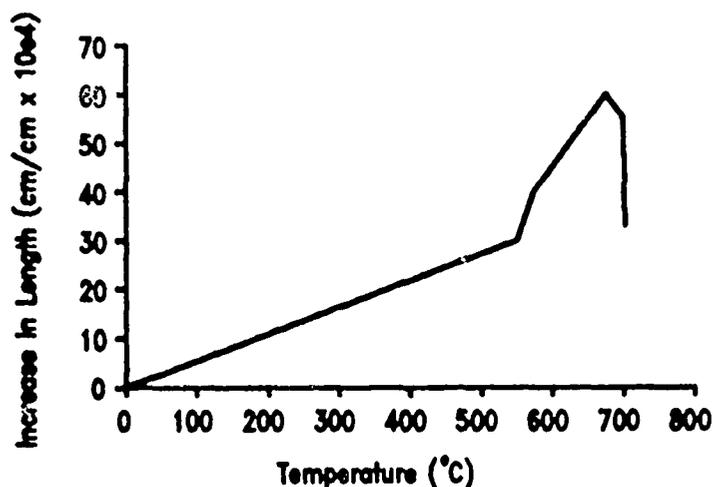
Figure 45. Example of Thermal Expansion Data for Glass from Ref. 11.

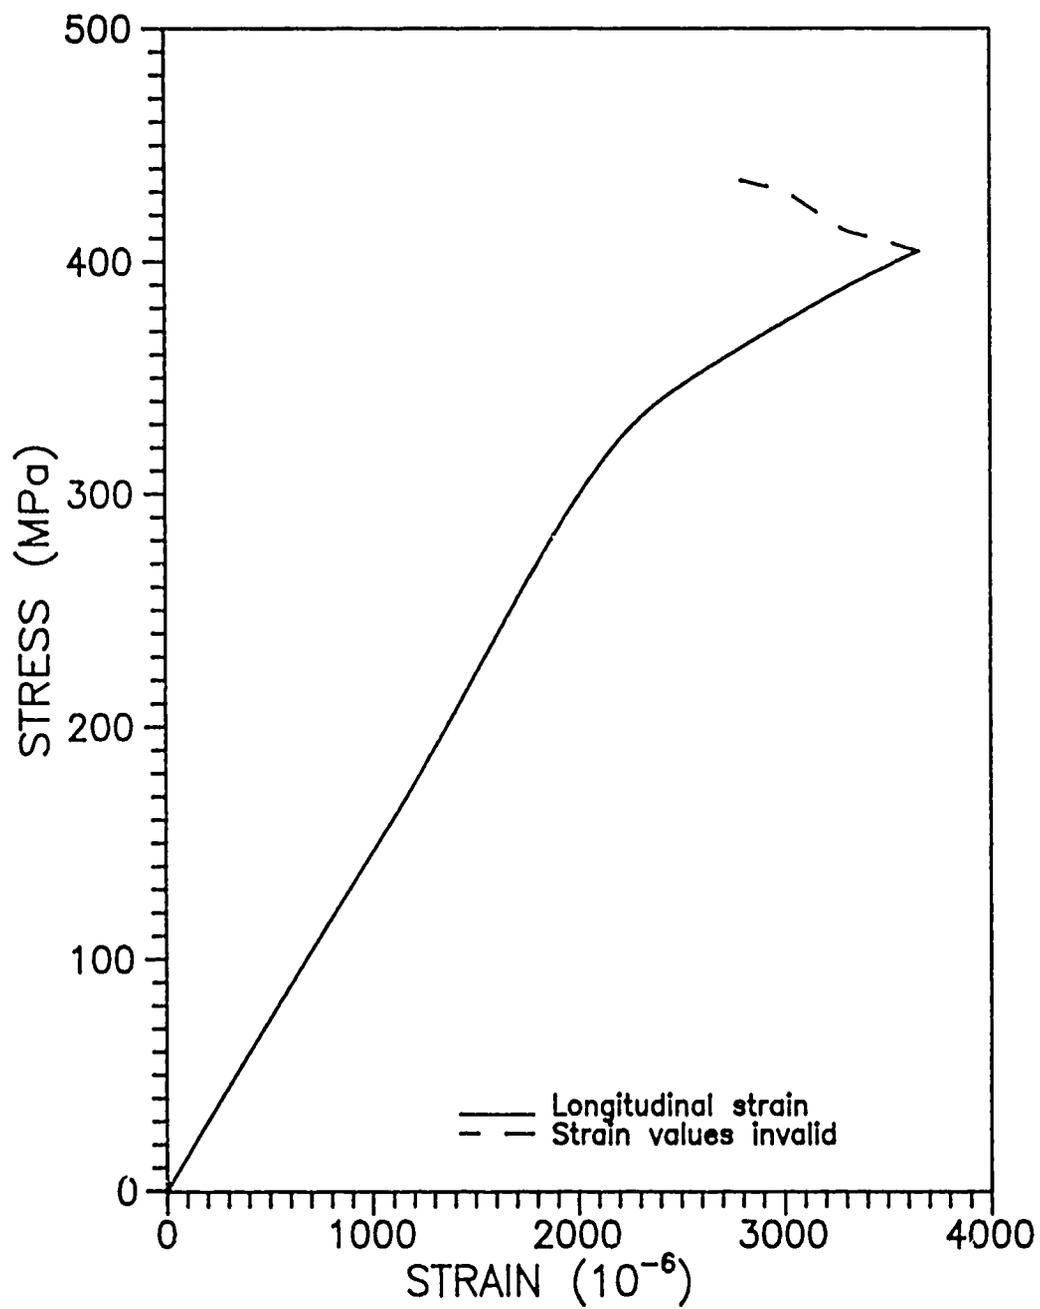
Figure 46. Stress-Strain Curve for AVCO/7761
Sample 28-X

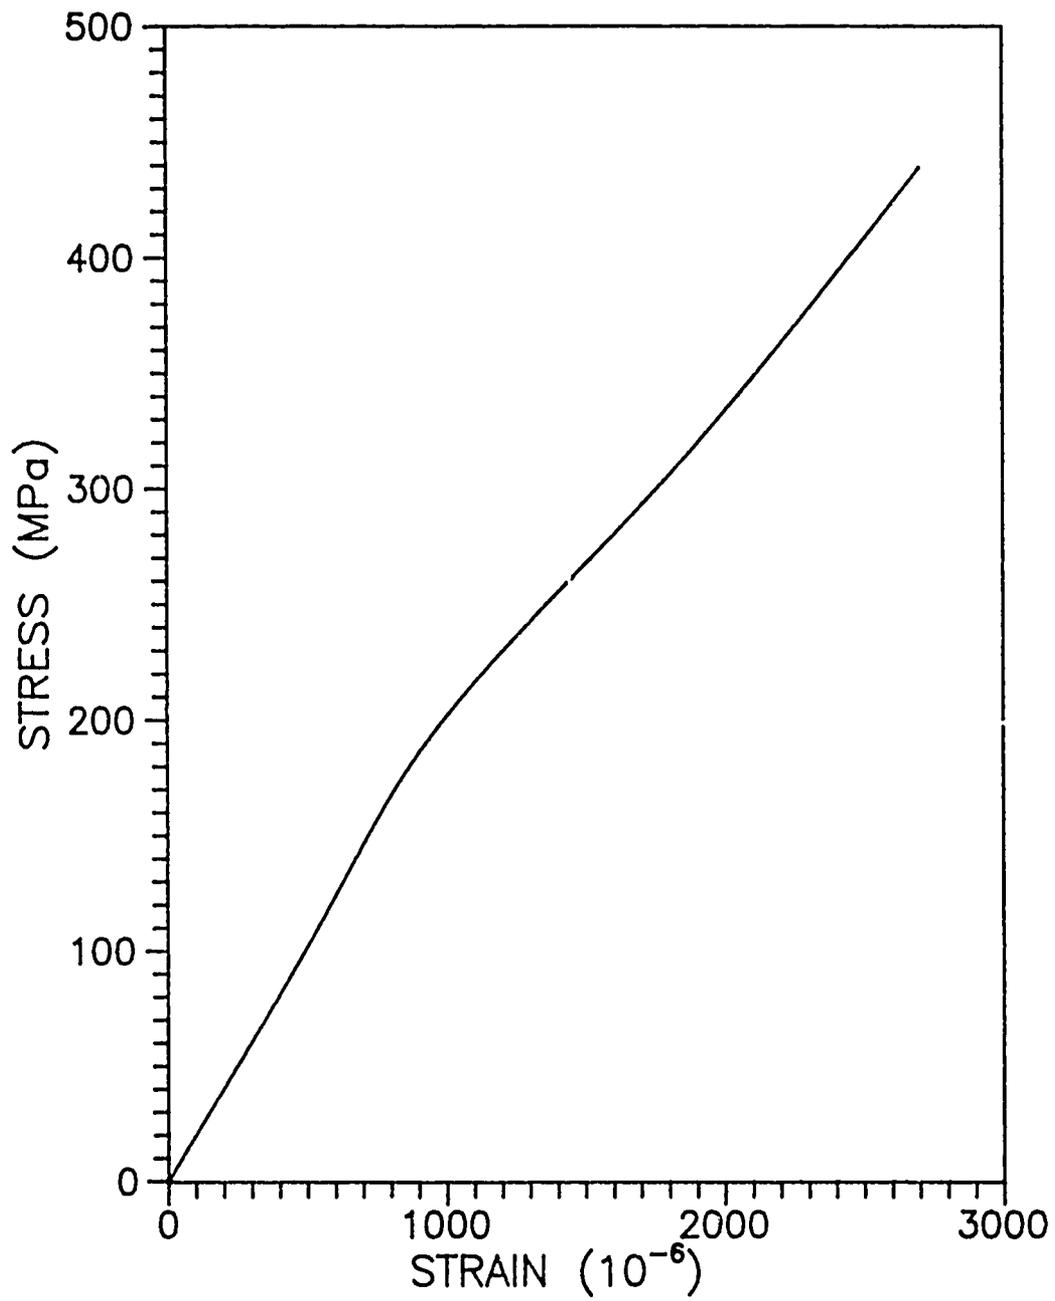
Figure 47. Stress-Strain Curve for AVCO/7761
Sample 24-B

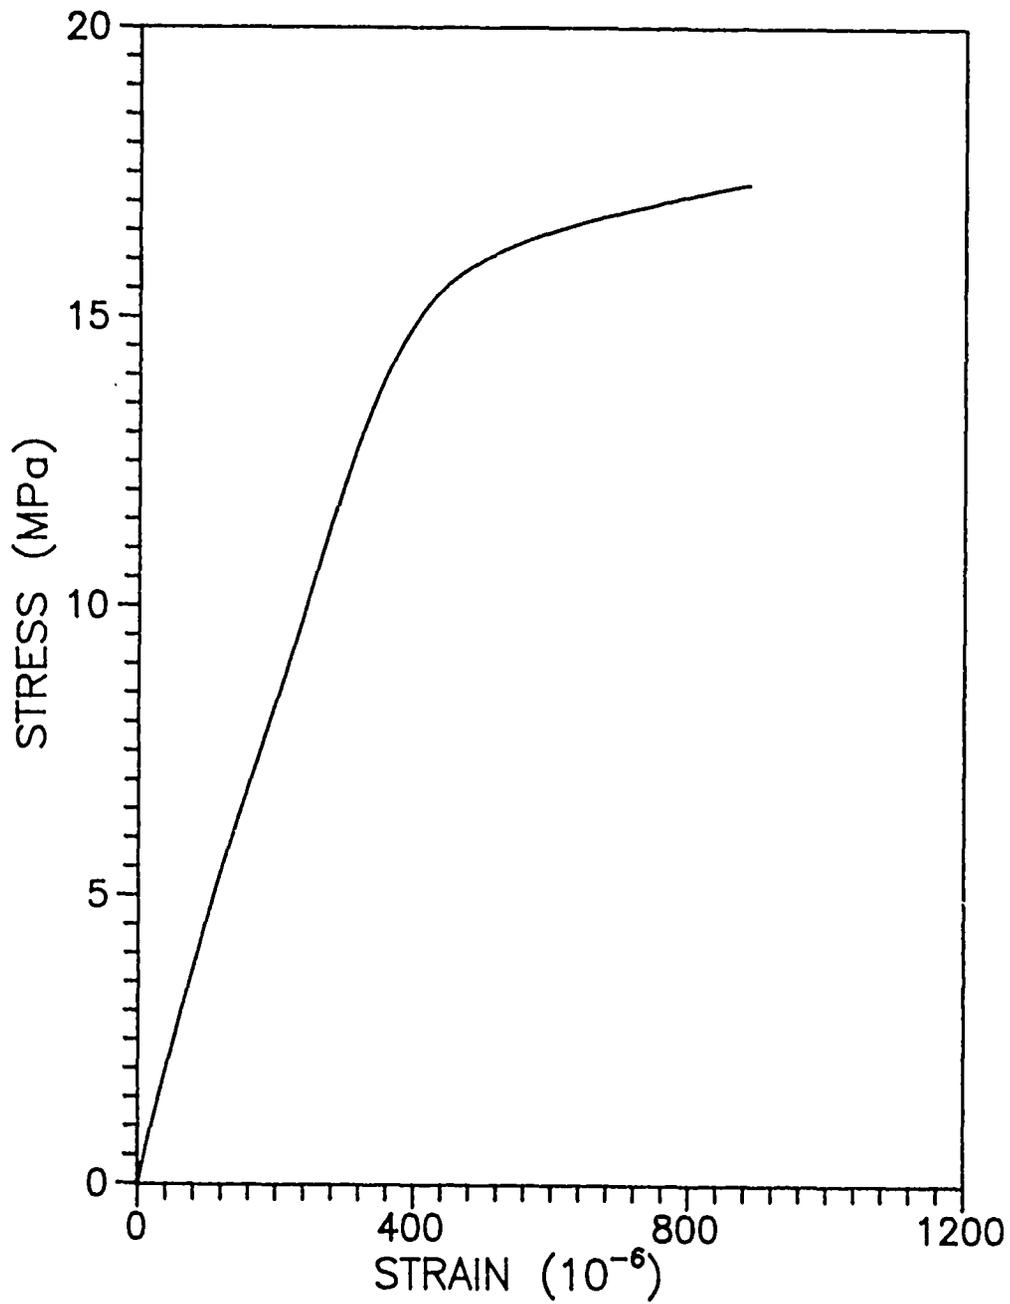
Figure 48. Stress-Strain Curve for AVCO/7761
Sample 27-C (Transverse)

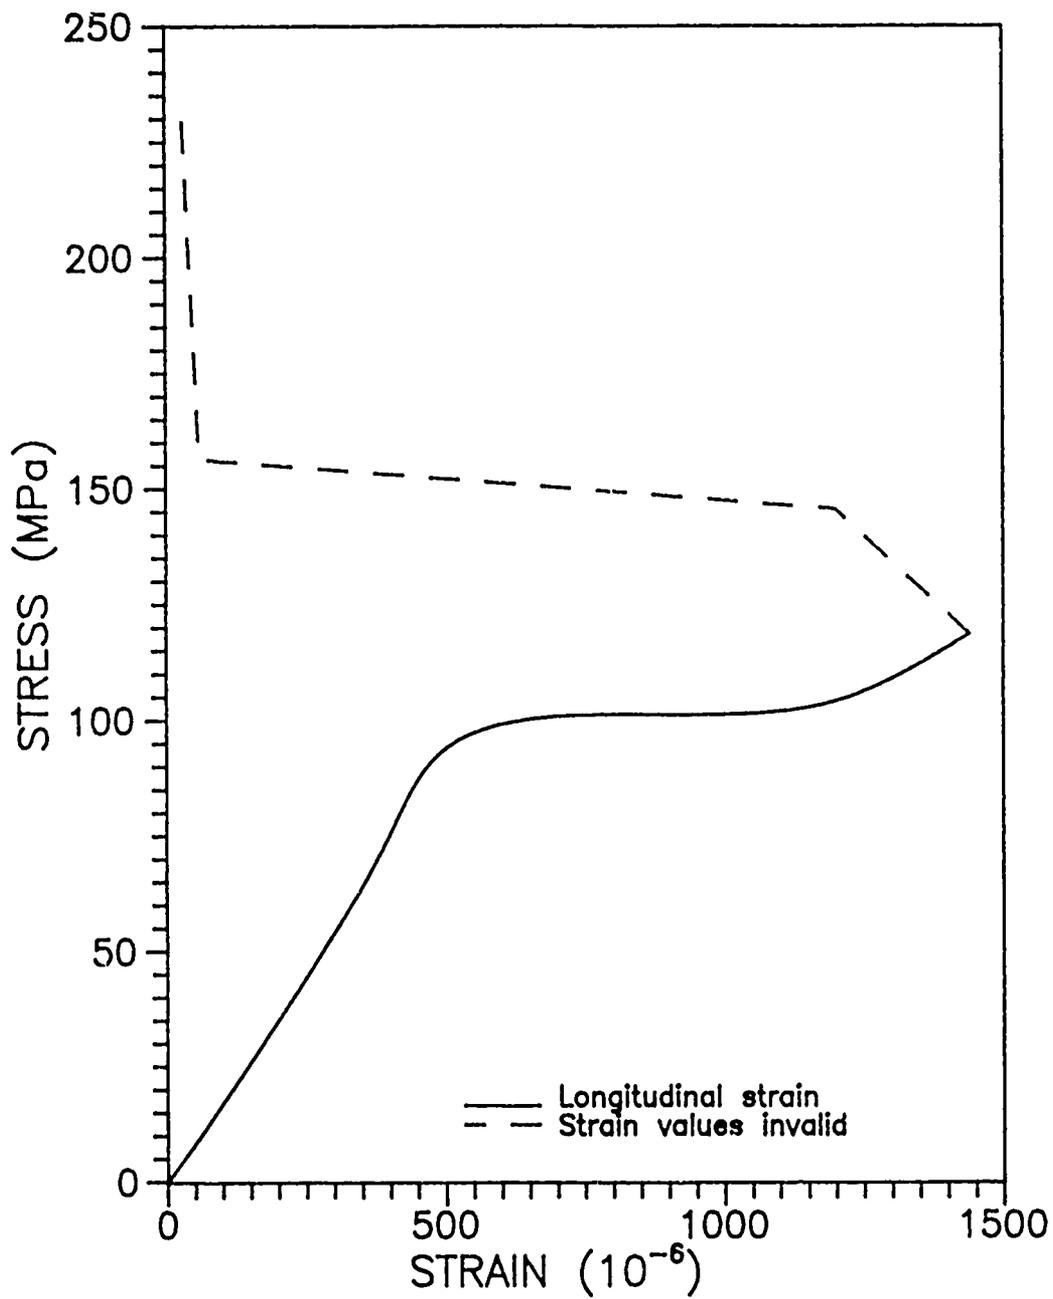
Figure 49. Stress-Strain Curve for AVCO/7740
Sample 32-A

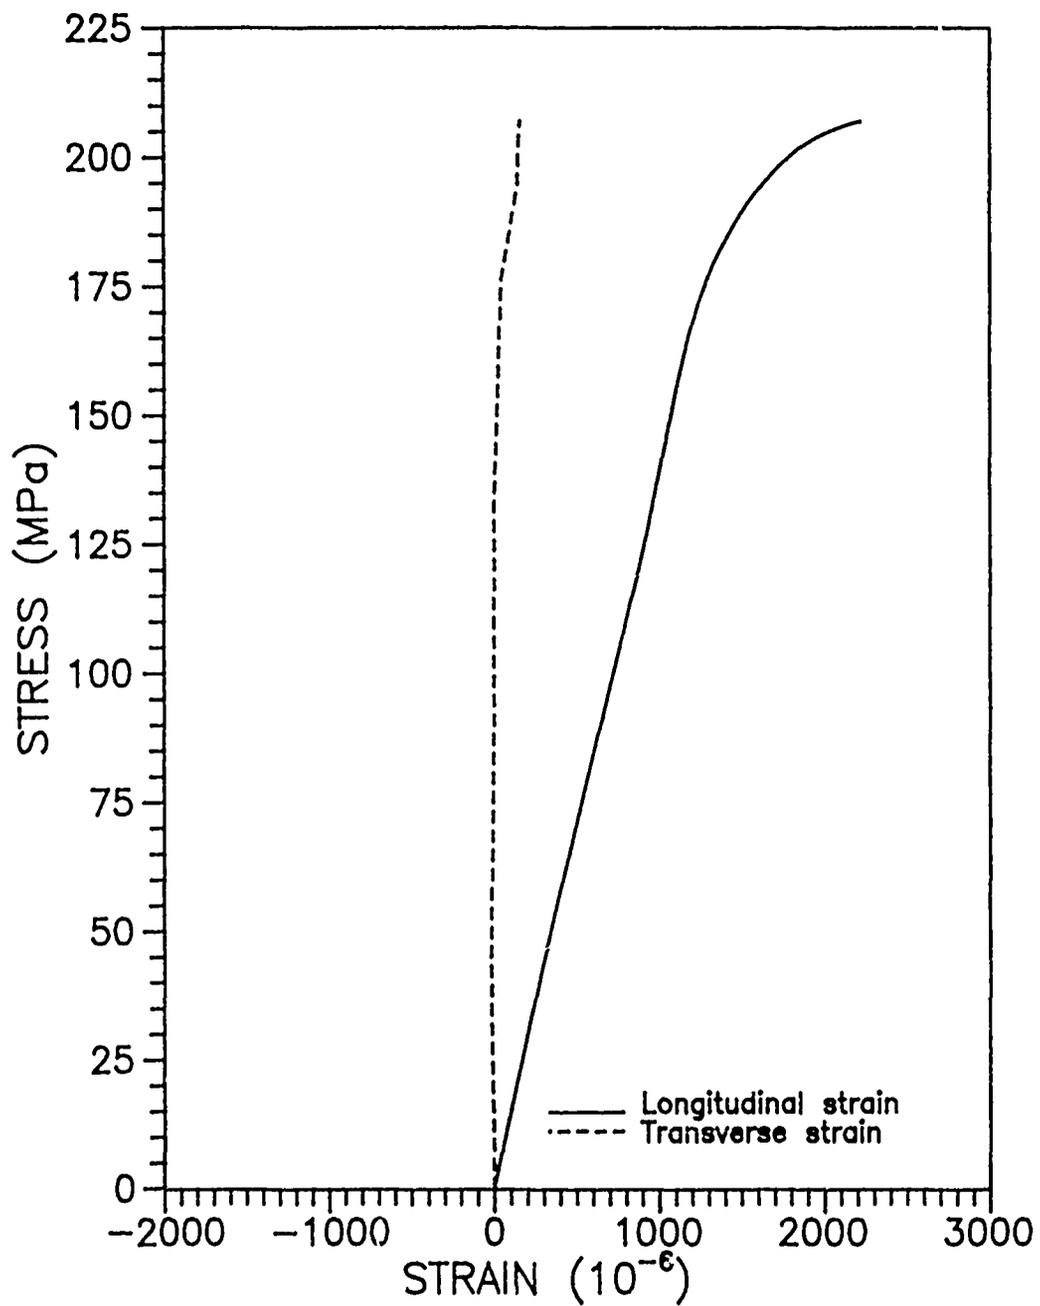
Figure 50. Stress-Strain Curve for AVCC/7052
Sample 39-C

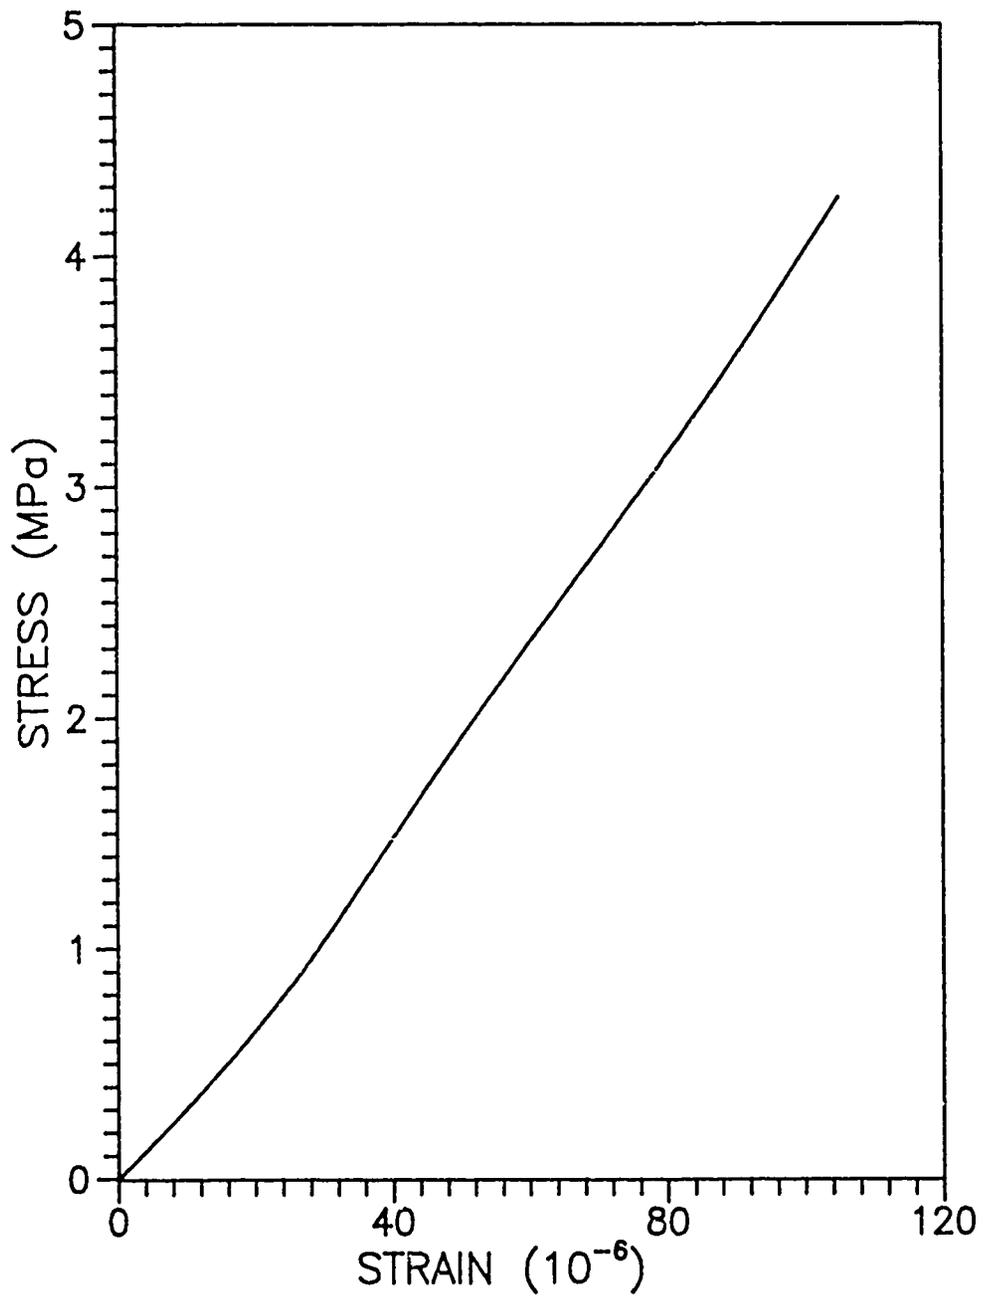
Figure 51. Stress-Strain Curve for AVCO/7052
Sample 40-B (Transverse)

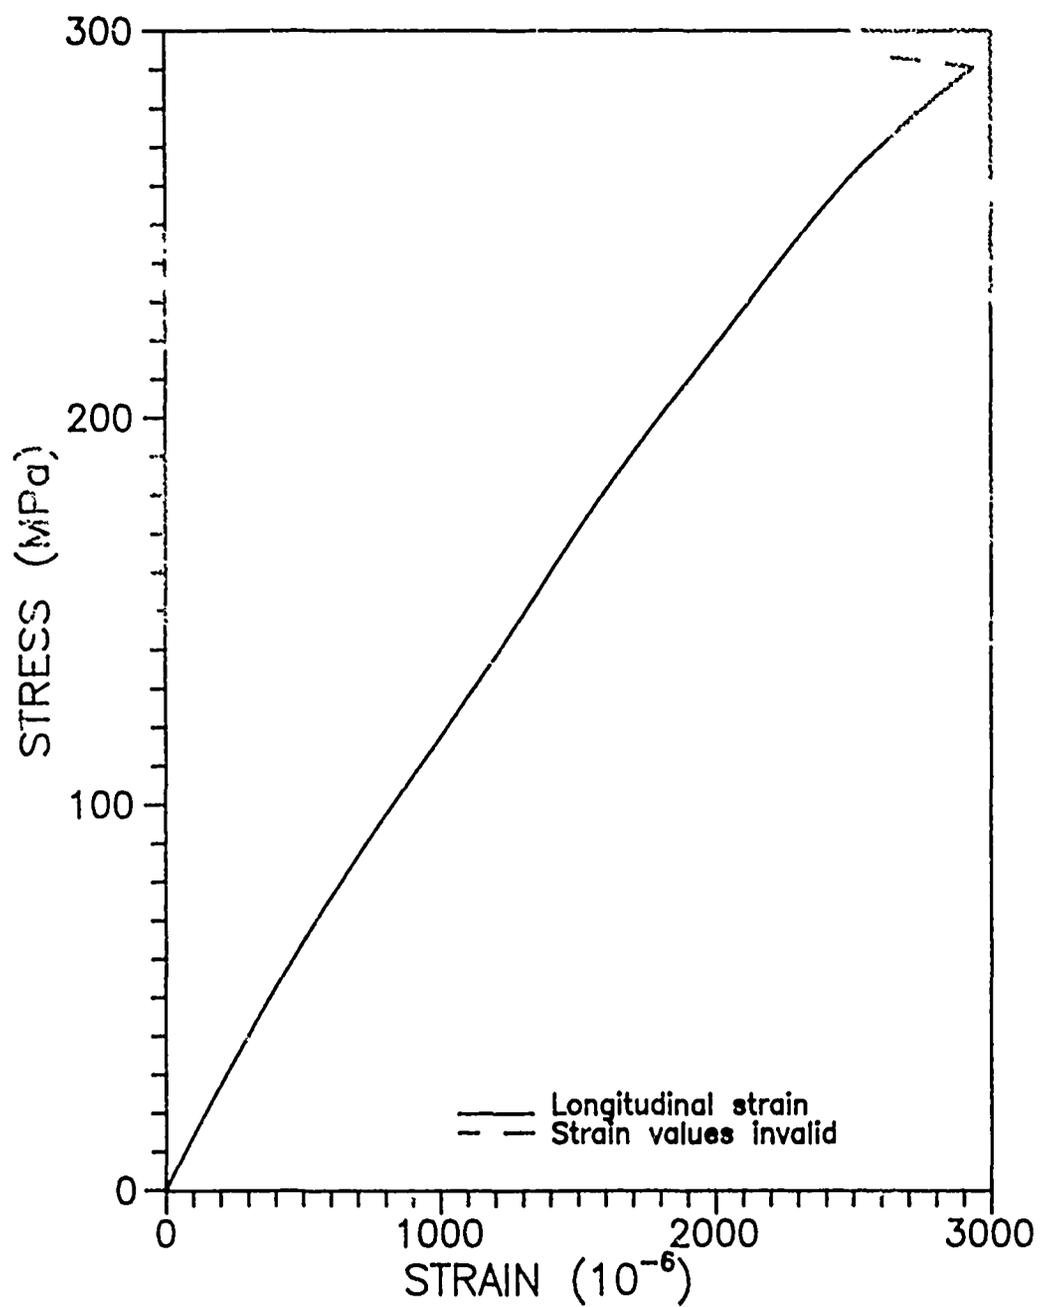
Figure 52. Stress-Strain Curve for AVCO/9741
Sample 42-C
