AFWAL-TR-88-3024

IN-FLIGHT LIGHTNING CHARACTERIZATION PROGRAM ON A  
CV-580 AIRCRAFT

June 1988

Final Report for Period October 1983 - September 1987

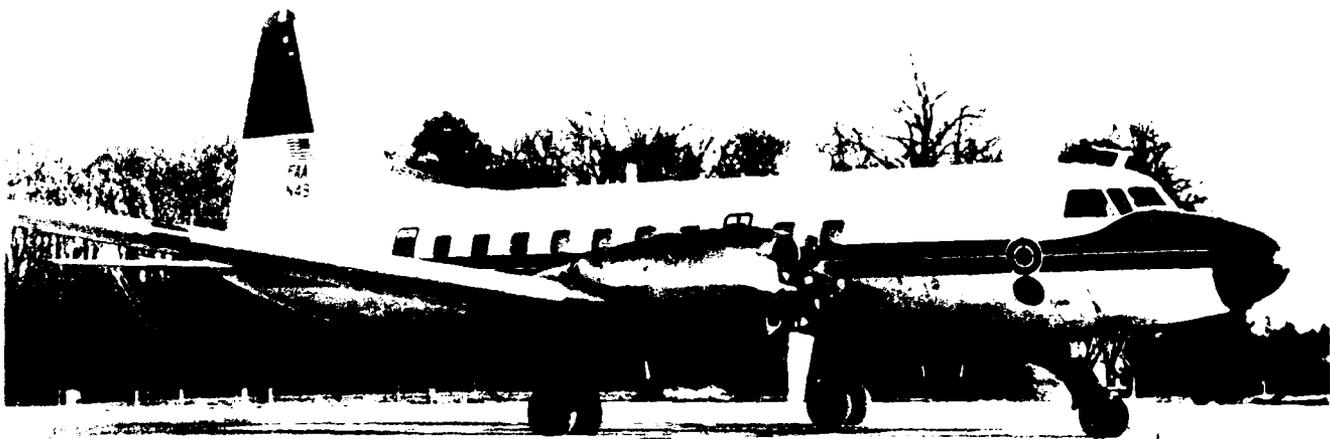
Figure 2. The CV-580 Aircraft

Prior to flights in 1985, the vertical fin cap was modified to include a boom with a current shunt and the vertical fin strobe light was relocated to the tail cone of the aircraft. The modified fin cap was also evaluated for safety purposes.

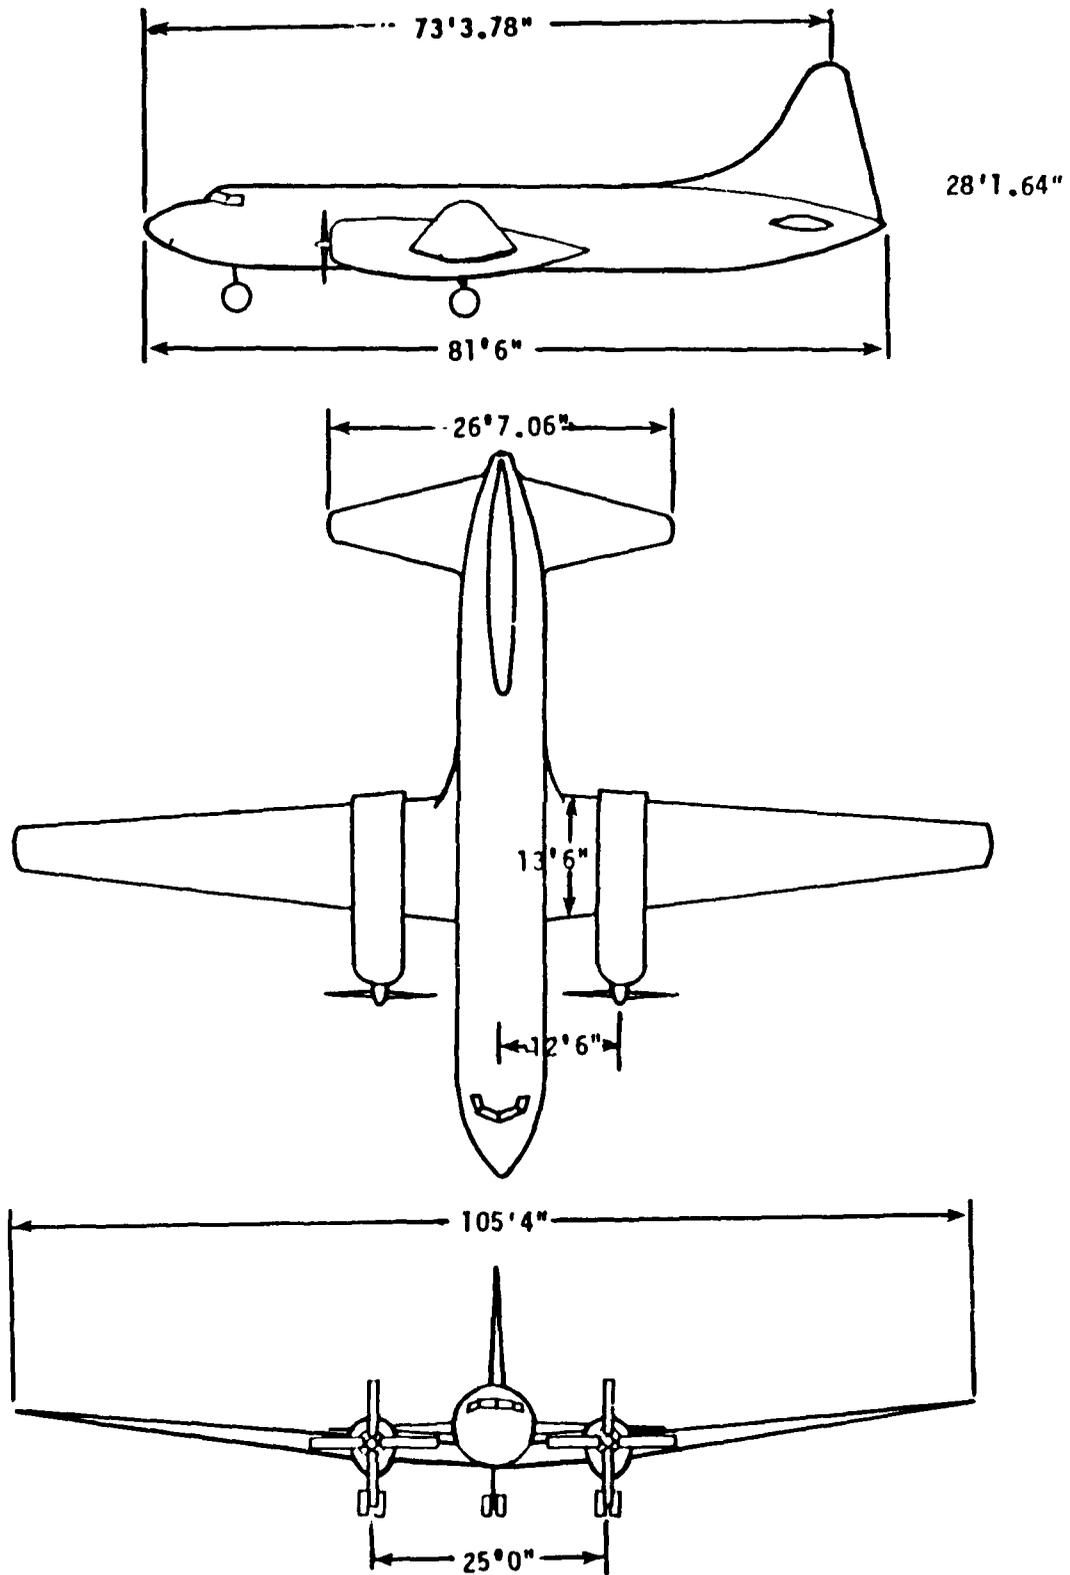
Figure 3. External Dimensions of the CV-580 Aircraft

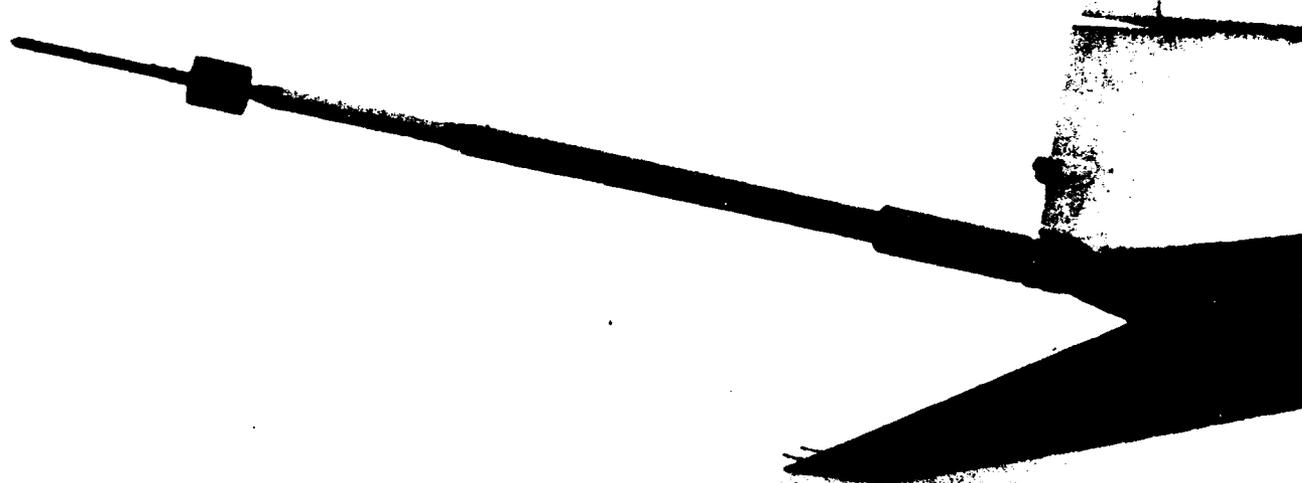
Figure 1. The Tail Boom Installed on the Aircraft in 1936

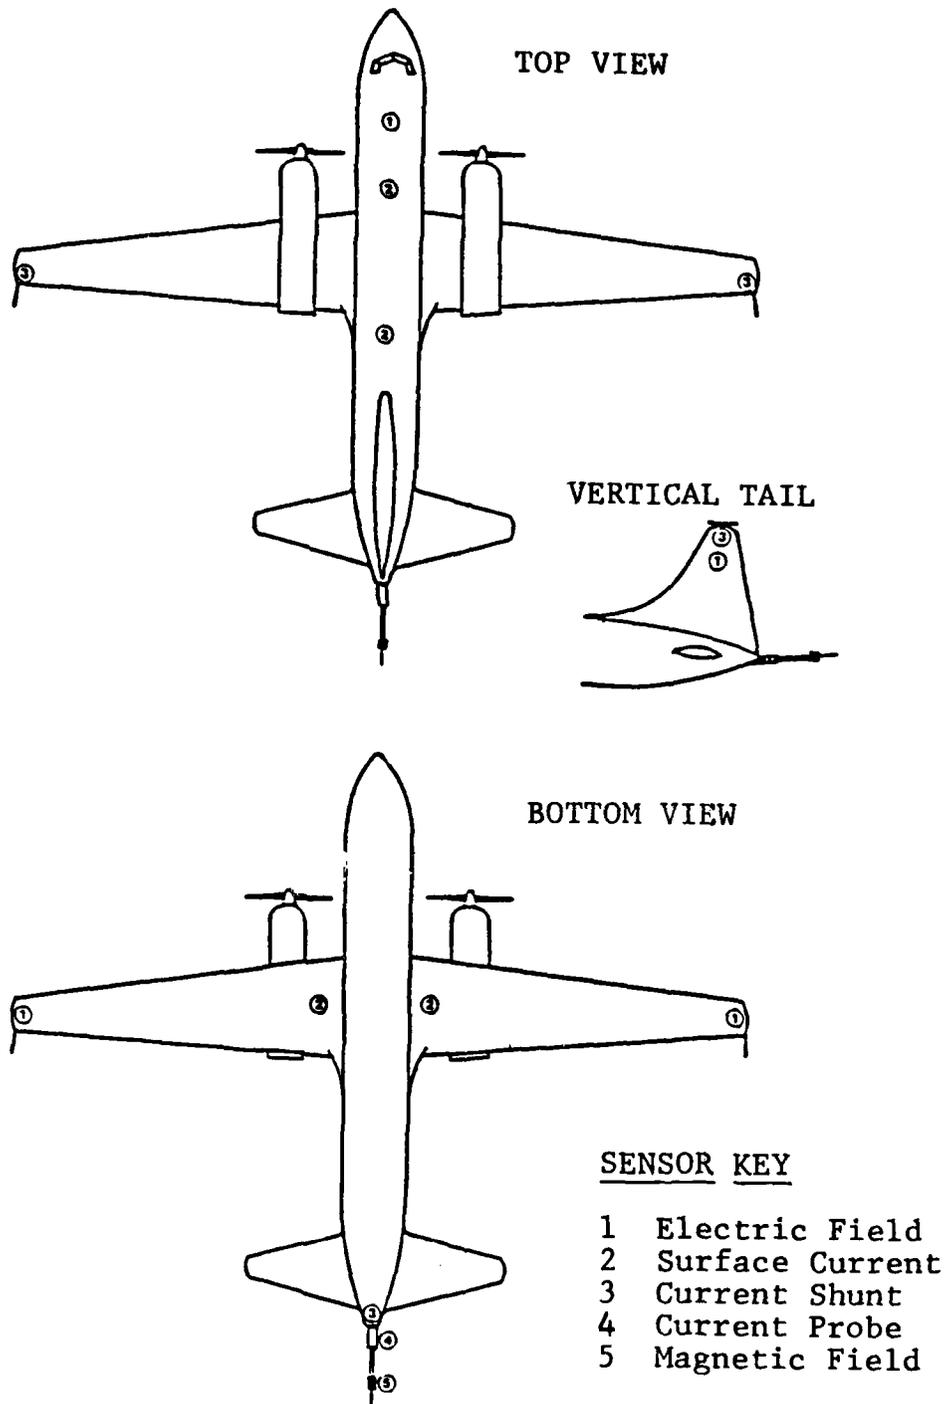
Figure 5. Locations of the Electric Field, Surface Current, Current Shunt, Current Probe, and Magnetic Field Sensors on the Aircraft

The four surface current sensors were a multigap loop (MGL) design by EG&G with an equivalent area of 0.001 m<sup>2</sup>, a frequency response greater than 700 MHz, and a rise time of 0.5 ns. Derivative outputs from these sensors were recorded digitally in 10-μs windows. Integrated data from these sensors was recorded on analog tape. However, due to signal conditioning problems, cable shield currents, and signal-to-noise problems, the integrated data could not be processed by conventional methods.

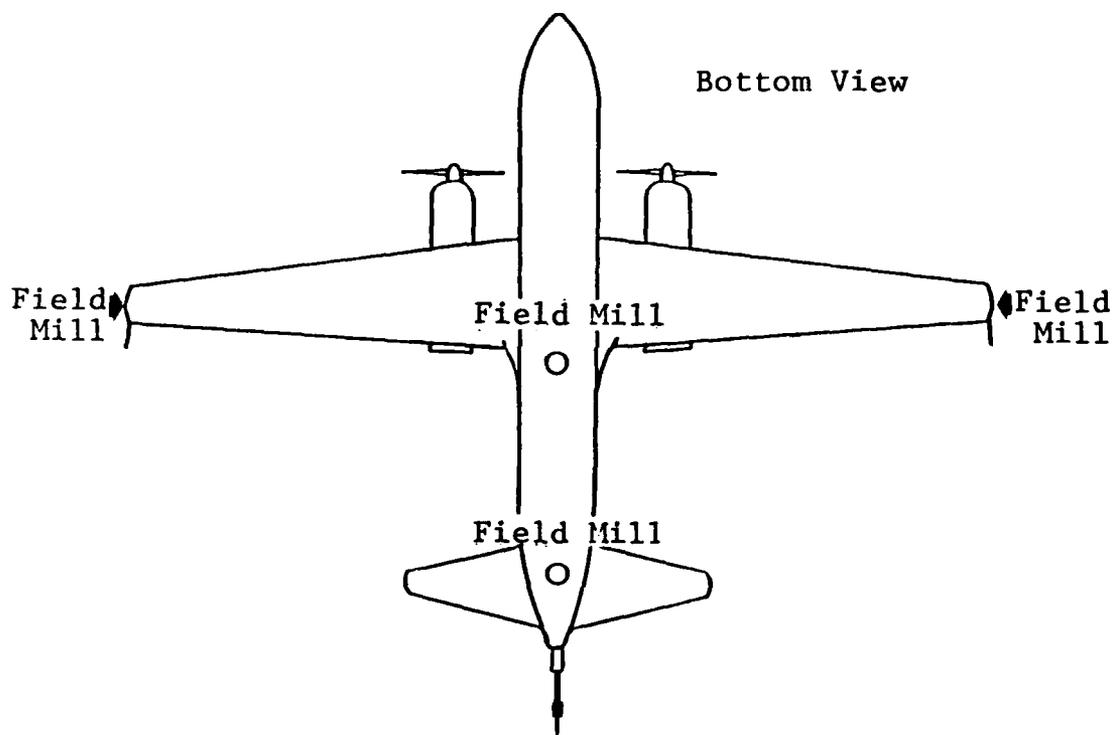
Figure 7. Locations of NRL Field Mills for Quasi-static Measurements on the Aircraft

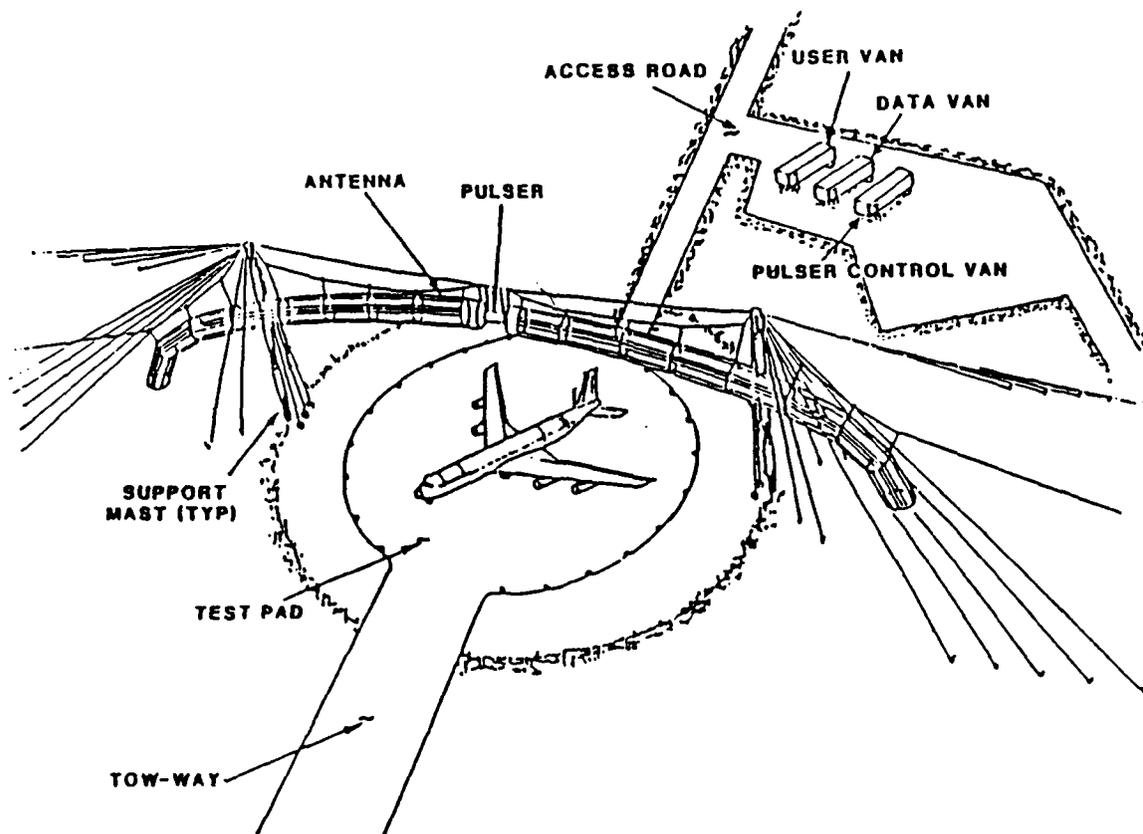
Figure 8. The Naval Air Test Center's Electromagnetic Pulse Facility at Patuxent River, Maryland

In addition to lightning characterization, the program objectives called for comparing the aircraft response to a simulated nuclear electromagnetic pulse (EMP) and to a lightning strike. Ground EMP simulation facilities at the Naval Air Test Center in Patuxent River, Maryland were used for these tests. The EMP simulator consisted of a 5-MV pulse generator suspended above the aircraft in a horizontally polarized dipole configuration. The generator produced a 60- to 65-kV/m electric field with a 7- to 8-ns rise time at a point corresponding to the top of the fuselage. Figure 8 is a diagram of the facility. The aircraft was pulsed with the fuselage parallel or perpendicular to the incident electric field.

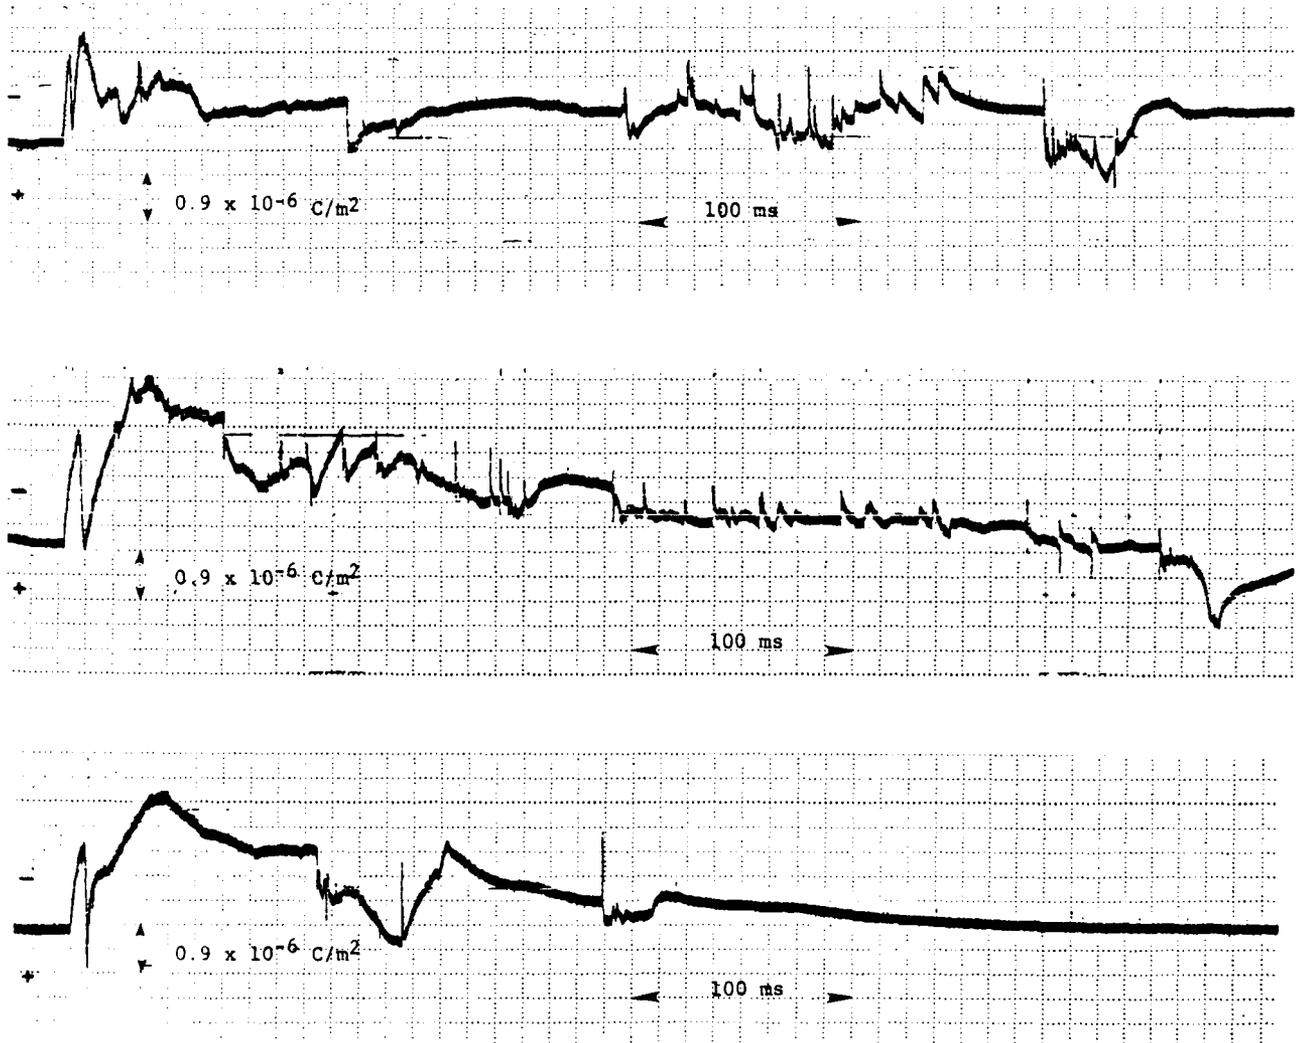
- Figure 12. Three Category 1 Waveforms Typical of the 32 Waveforms Recorded in This Category at Altitudes Greater Than 14,000 ft.

Typical Category 1 waveforms were shown in Figs. 9 and 12. An electric field record measured on the ground from one of these events and the electric field record recorded simultaneously on the aircraft 100 km away are compared in Fig. 30. The initial process on the aircraft record is absent from the ground record and appeared to occur before any activity was detected at the ground. This suggests that the initial field change on the aircraft was a result of charge differences on the aircraft itself rather than of an atmospheric raising or lowering of charge, which would be detectable at both locations. Although one waveform must be inverted due to a polarity difference between the aircraft and ground sensors, the waveforms are similar in shape with many common peaks, valleys and spikes. Some of the dissimilarities are due to the distance and altitude differences between the two

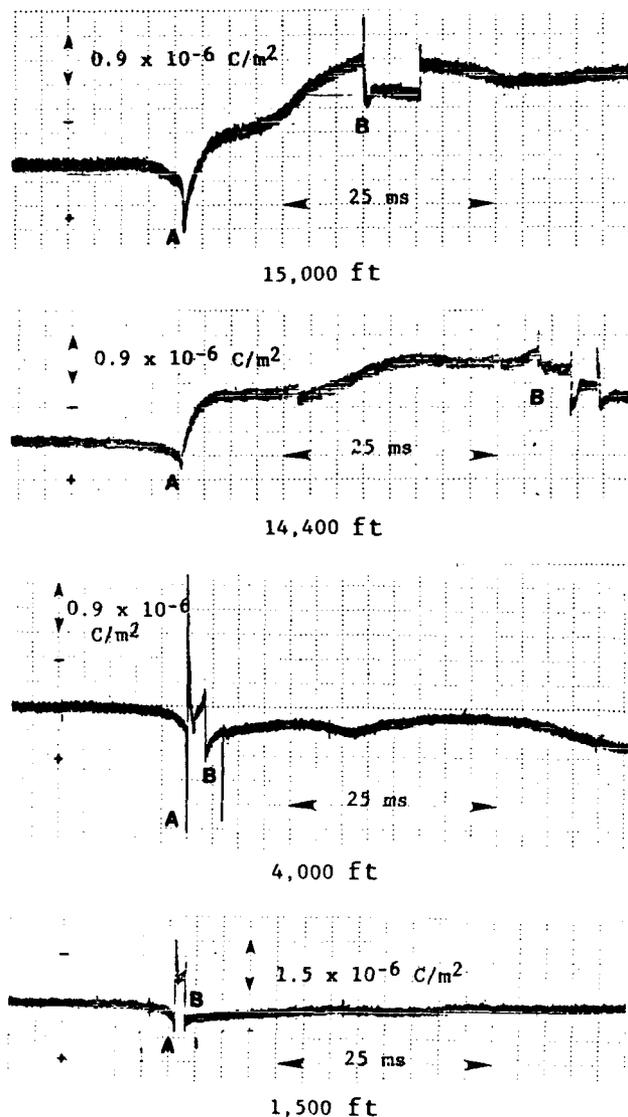
Figure 13. The Four Category 2 Events Recorded in 1984 and 1985 With Altitudes at Which They Occurred

The initial portions of the electric field records for the four events in this category were shown in Fig. 13. In all four cases, there was an initial slow positive charge increase, followed by a sharp negative charge increase, which occurred very quickly for the two attachments at low altitude. A slow negative charge increase interrupted many milliseconds later by a sharp negative pulse was observed on the two attachments at high altitude. Figure 15 presents electric field, magnetic field and current measurements corresponding to Point A for the waveform in Fig. 13 obtained at 1,500 ft. It shows relatively fast field changes with a small amount of current flow on the left wing. Figure 16 shows current flow also occurred at this point in the flash for the waveform obtained at 15,000 ft. Small current pulses were observed at this time on the other Category 2 waveforms as well.

In Fig. 13, the time from the initial leader attachment to the first subsequent pulse (Point A to Point B) is 20.8 ms for the event at 15,000 ft and 41.9 ms for the event at 14,000 ft. Assuming the leader contacted ground at Point B, these times correspond to leader velocities of  $2.2 \times 10^5$  and  $1.0 \times 10^5$  m/s, respectively, in good agreement with the average velocities given by Uman for a stepped leader (Reference 9). For the events at lower altitudes, the time between initial leader contact at Point A and Point B was 2.1 ms for the event at 4,000 ft

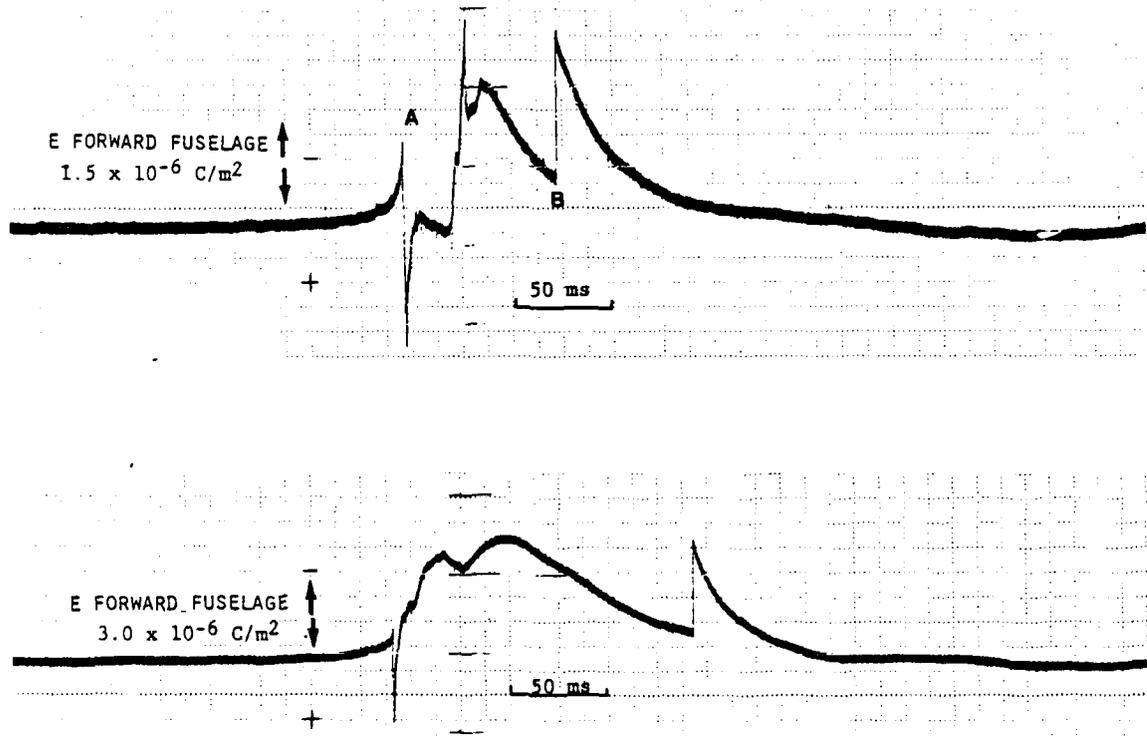
Figure 14. Two of the Three Category 3 Events Recorded at Altitudes Above 14,000 ft

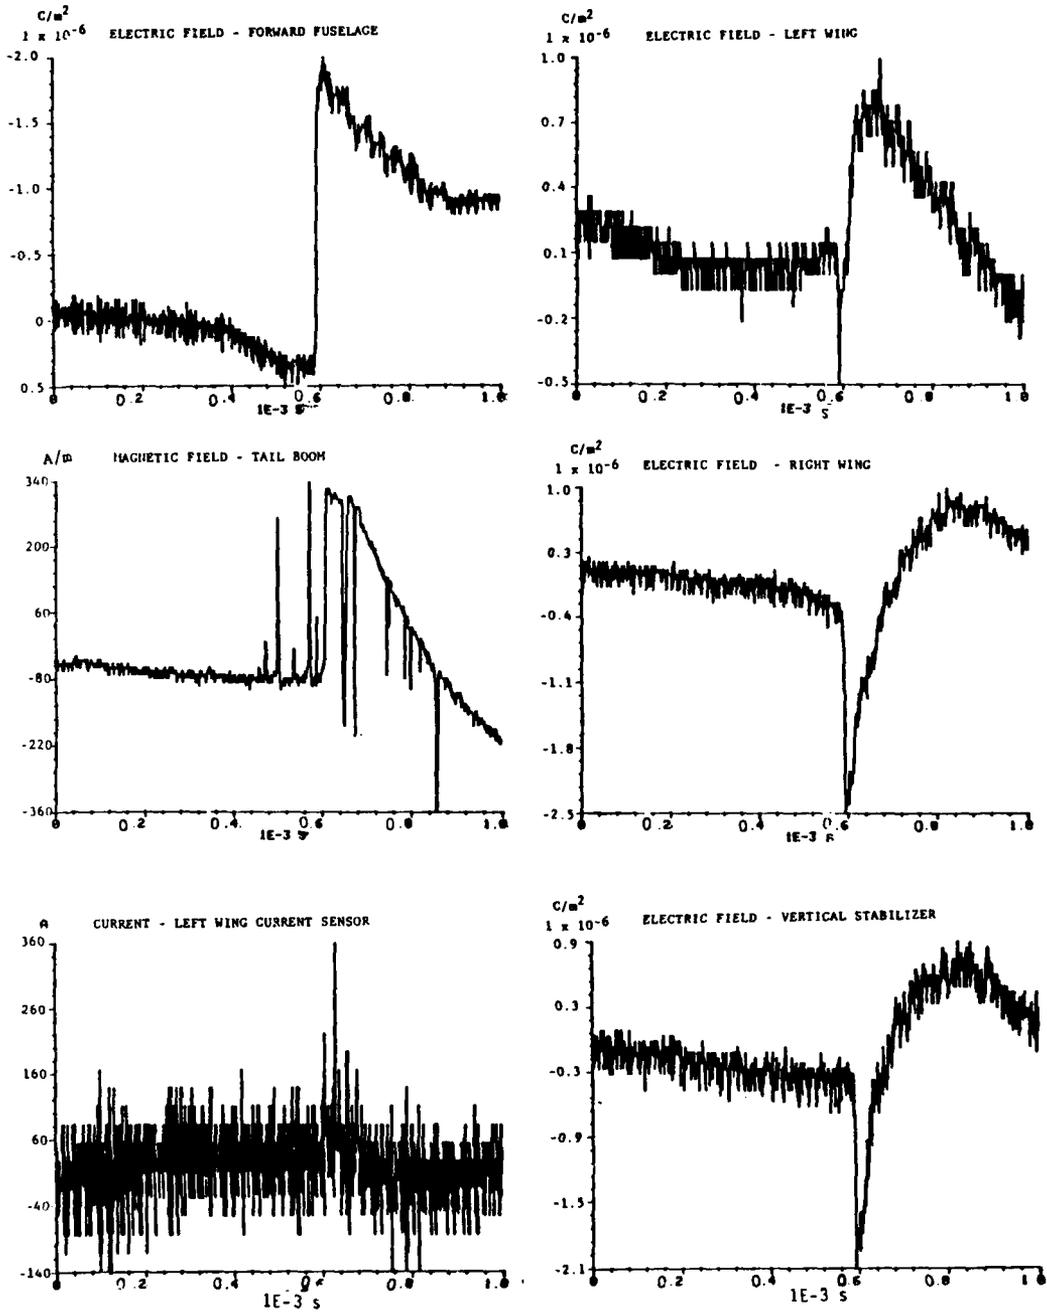
Figure 15. Electromagnetic Field and Current Records at Point A for the Event at 1,500 ft in Figure 13

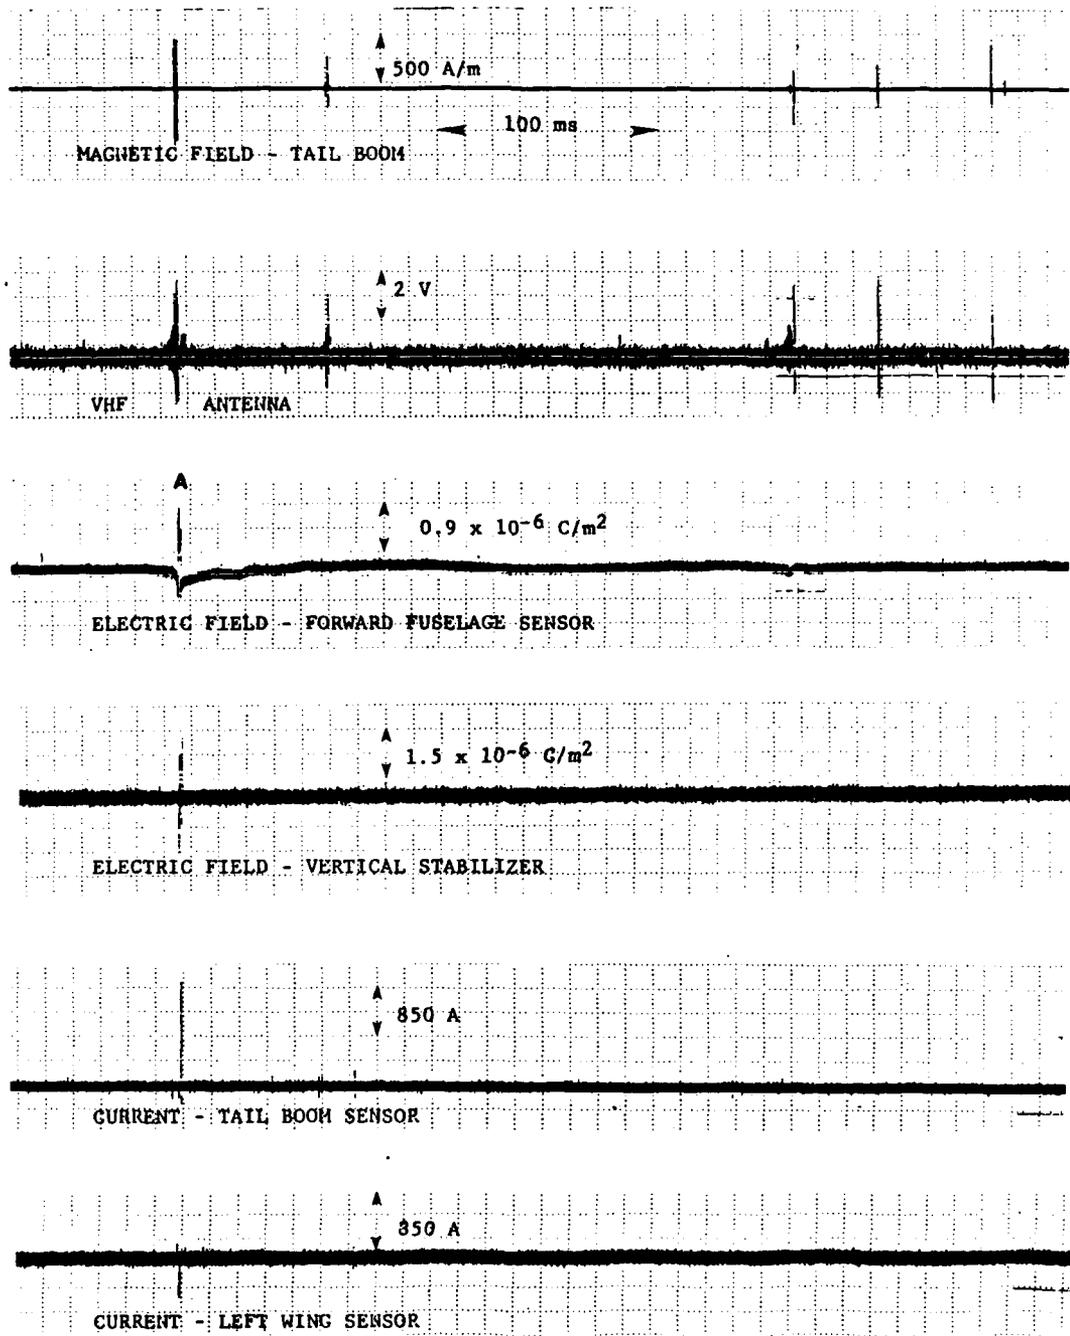
Figure 17. Electromagnetic Field and Current Data During and After Lightning Attachment at 1,500 ft

An explanation of this event is presented by means of Figs. 17, 19, and 20. Figure 19 is an expansion at Point A in Fig. 17 and the lightning attachment scenario is illustrated in Fig. 20. The approach of the lightning leader, in this

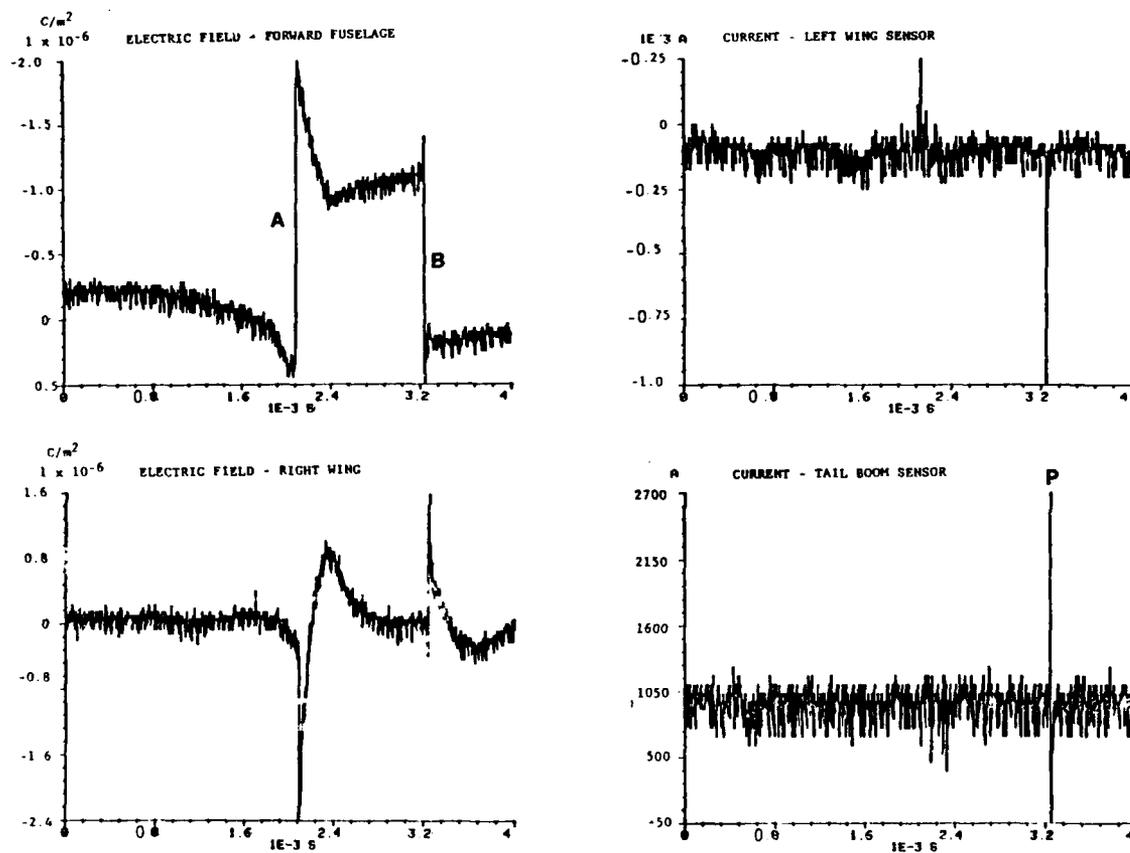
Figure 19. Simultaneous Electric Field and Current Records From a Lightning Attachment in Which the Aircraft Was in a Branch of a Cloud-to-Ground Event

In Section IV on instrumentation, we found it possible to obtain one set of digital data for each event. A 10- $\mu$ s window of data was obtained at Point P in Fig. 19 and, although limited, this data confirmed the positive field change shown on the analog data. Note the response on the left-wing electric field sensor in Fig. 22, showing decreased negative charge on the aircraft. The tail boom measured 3.2 kA of current as negative charge moved back onto the aircraft. The surface current on the aft fuselage sensor agreed with the tail boom value and was of the correct polarity for negative charge moving from tail to nose. The amplitude and polarity of the surface current on the right wing suggest that a significant quantity of negative charge was also moving from outboard of that sensor toward the fuselage. Although a complete set of digital data is not available, information combined from analog and digital data sets suggests that the attachment occurred somewhere near the nose or top of the fuselage with exit points at the left wing current shunt, tail boom shunt and edge of the right wing.

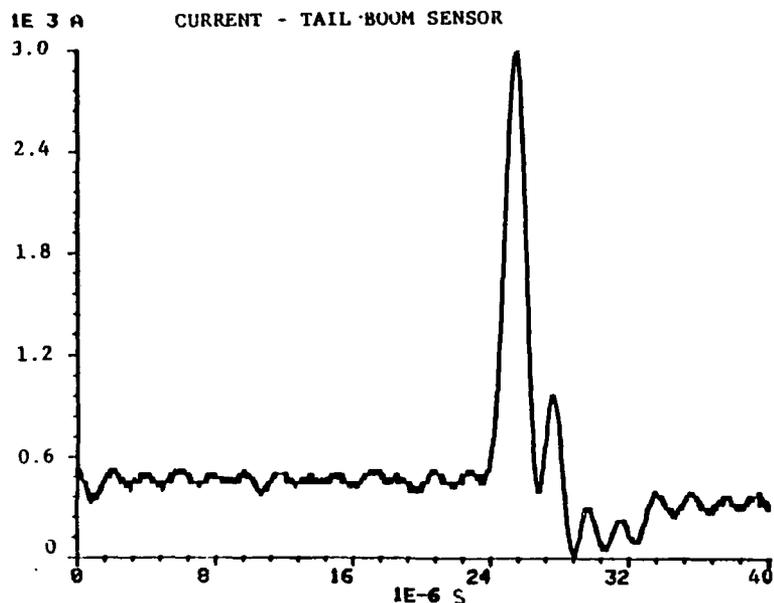
Figure 21. A Window of 40  $\mu$ s Taken at P in Figure 19 to Show the Absence of Return Stroke Characteristics

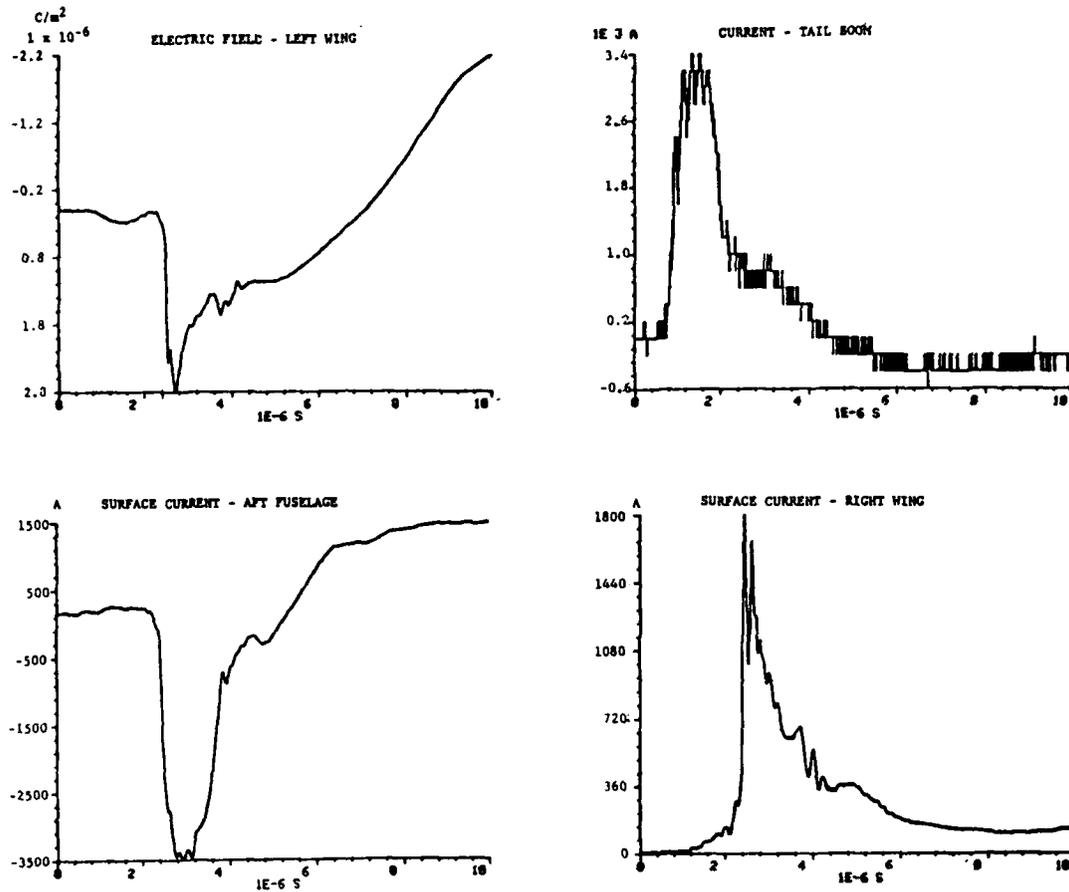
Figure 22. Electric Field and Current Pulses Recorded Digitally as the Branch Attached to the Aircraft Collapses During a Cloud-to-Ground Event.

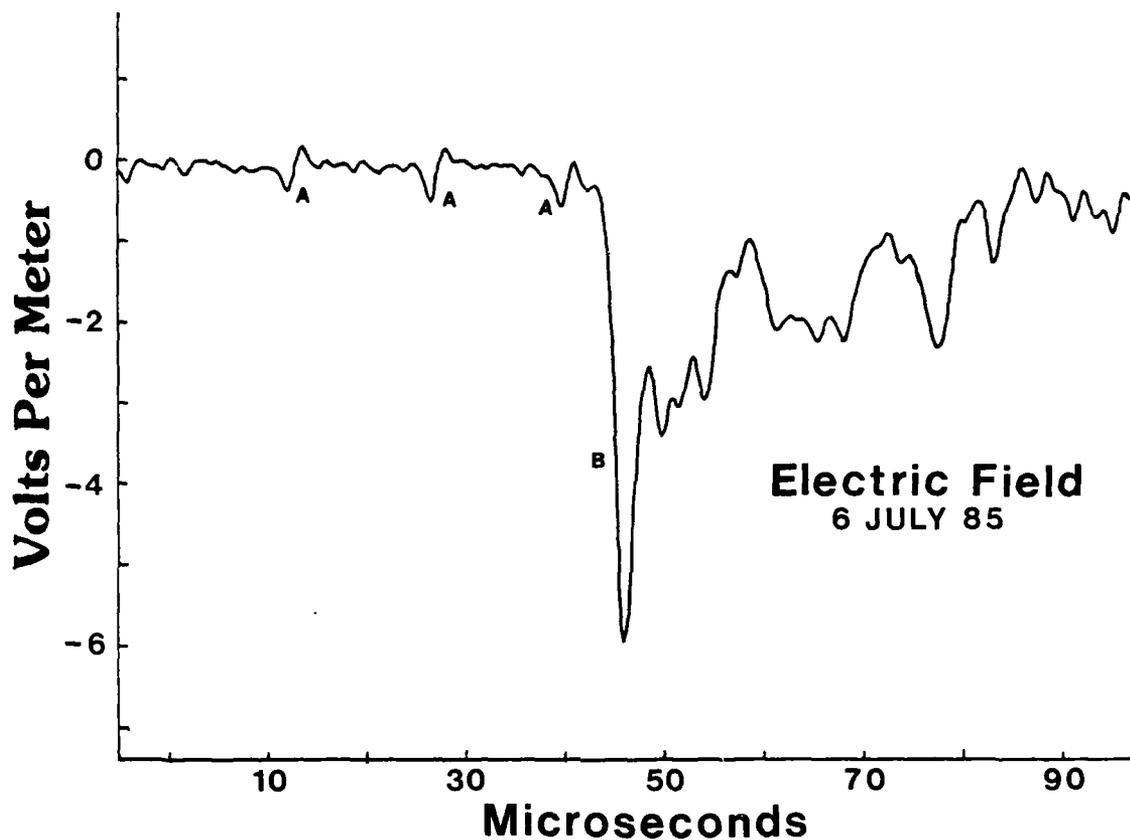
Figure 23. Stepped Leaders (A) and First Return Stroke (B) Recorded at the Ground Station Simultaneously With the Event in Figure 19

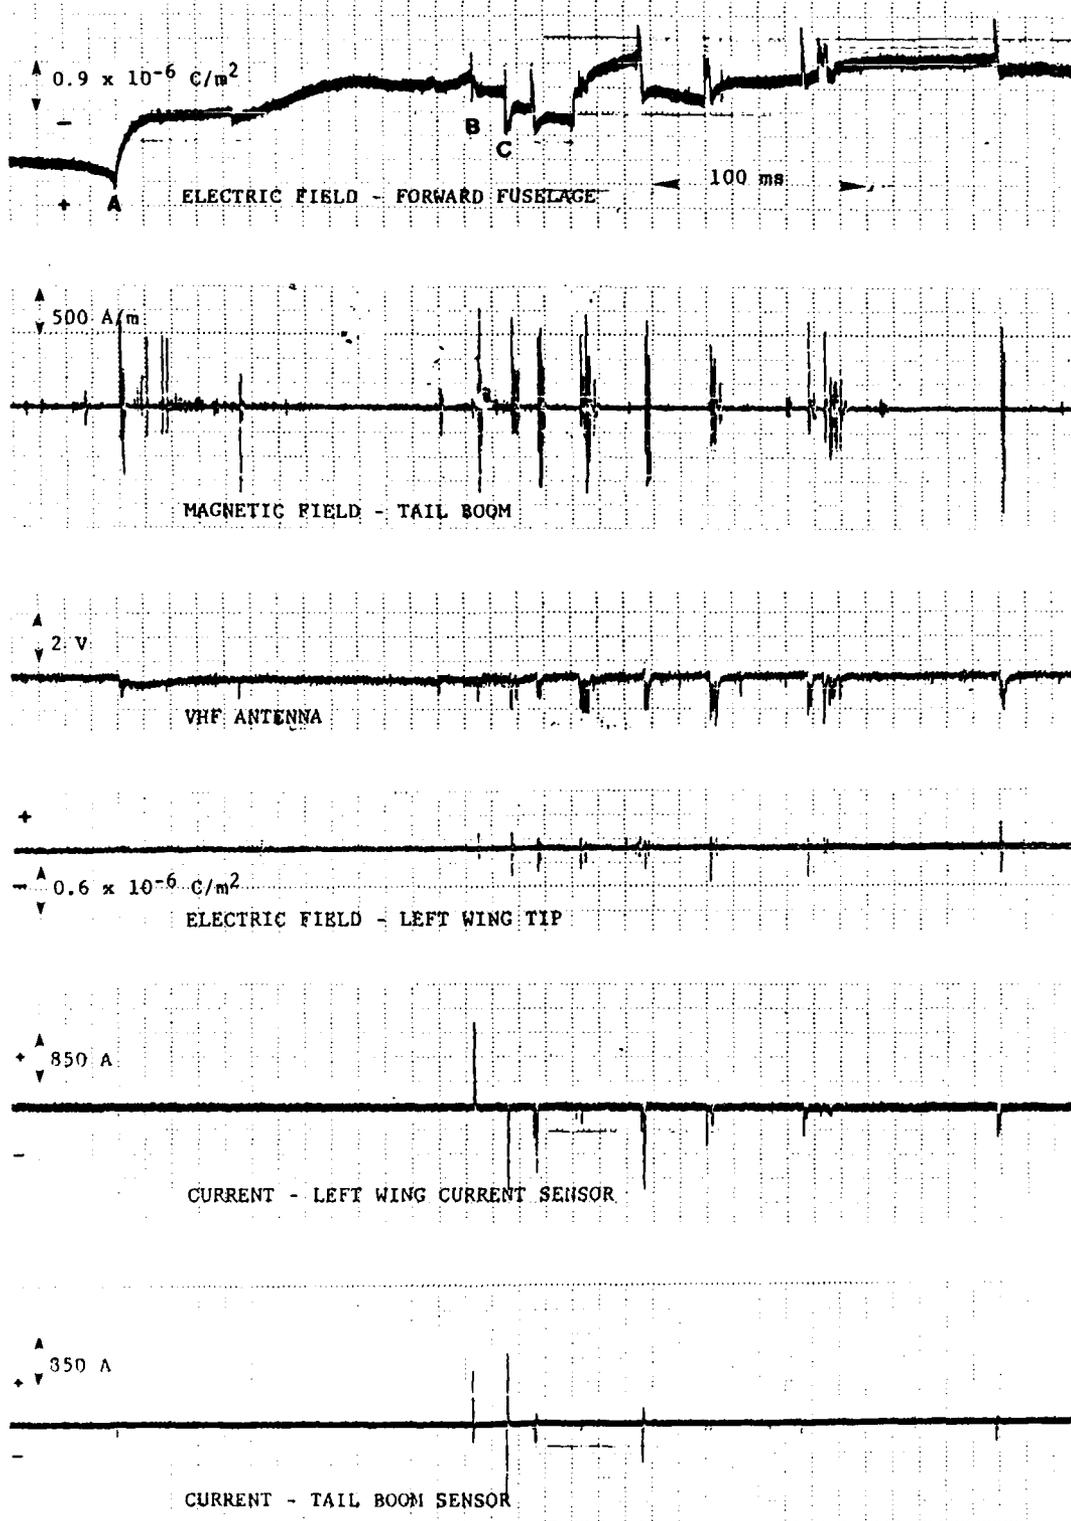
Figure 24. Electromagnetic Field and Current Data During a Lightning Attachment at 14,400 ft Where the Aircraft Was Part of the Main Channel

Analog records from the strike at 14,400 ft are shown in Fig. 24. As was the case with the waveforms for the previous event (Fig. 17), there was an initial positive charge increase at the forward fuselage sensor as a negative leader approached, passed through the aircraft and proceeded toward the ground. Pulses were then observed on the magnetic field sensor and VHF antenna, corresponding with current pulses and electric field changes on the aircraft throughout the event. We see that this event was a nine stroke cloud-to-ground discharge in which the aircraft was part of the main channel.

Reference to Figs. 24 and 27 shows once again that there had been a reversal in polarity on the current sensors. Again, we assume that the attachment point changed, returning to the left wingtip boom and remaining there for the rest of the flash. Supporting evidence for this supposition is provided by the electric field changes on the aircraft coincident with these current pulses. They are negative for all subsequent pulses, indicating negative charge flowing onto the aircraft in each case. The only way for the current sensors to show a change in

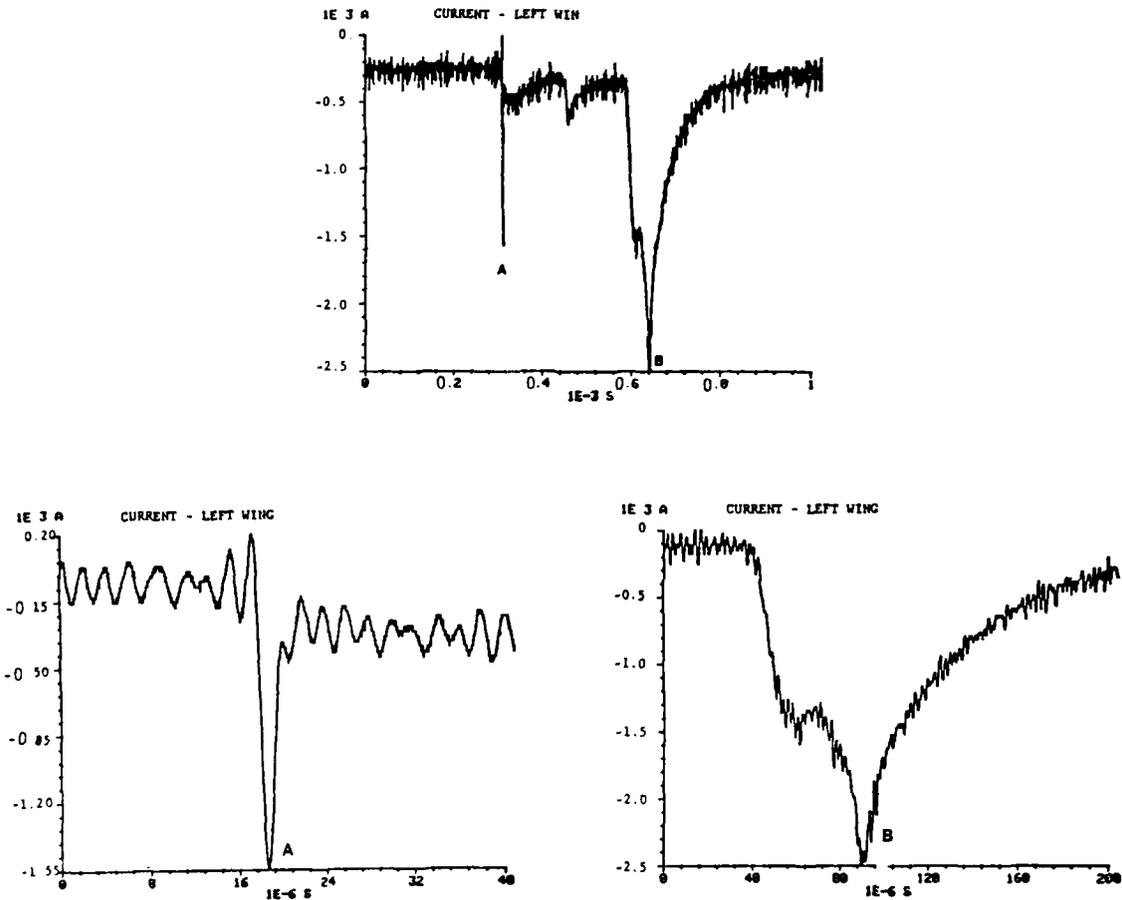
Figure 27. Current Pulses on the Aircraft as a Dart Leader (A) and Subsequent Return Stroke (B) Pass Through the Aircraft During the Cloud-to-Ground Event in Figure 24—Expansion at Point C

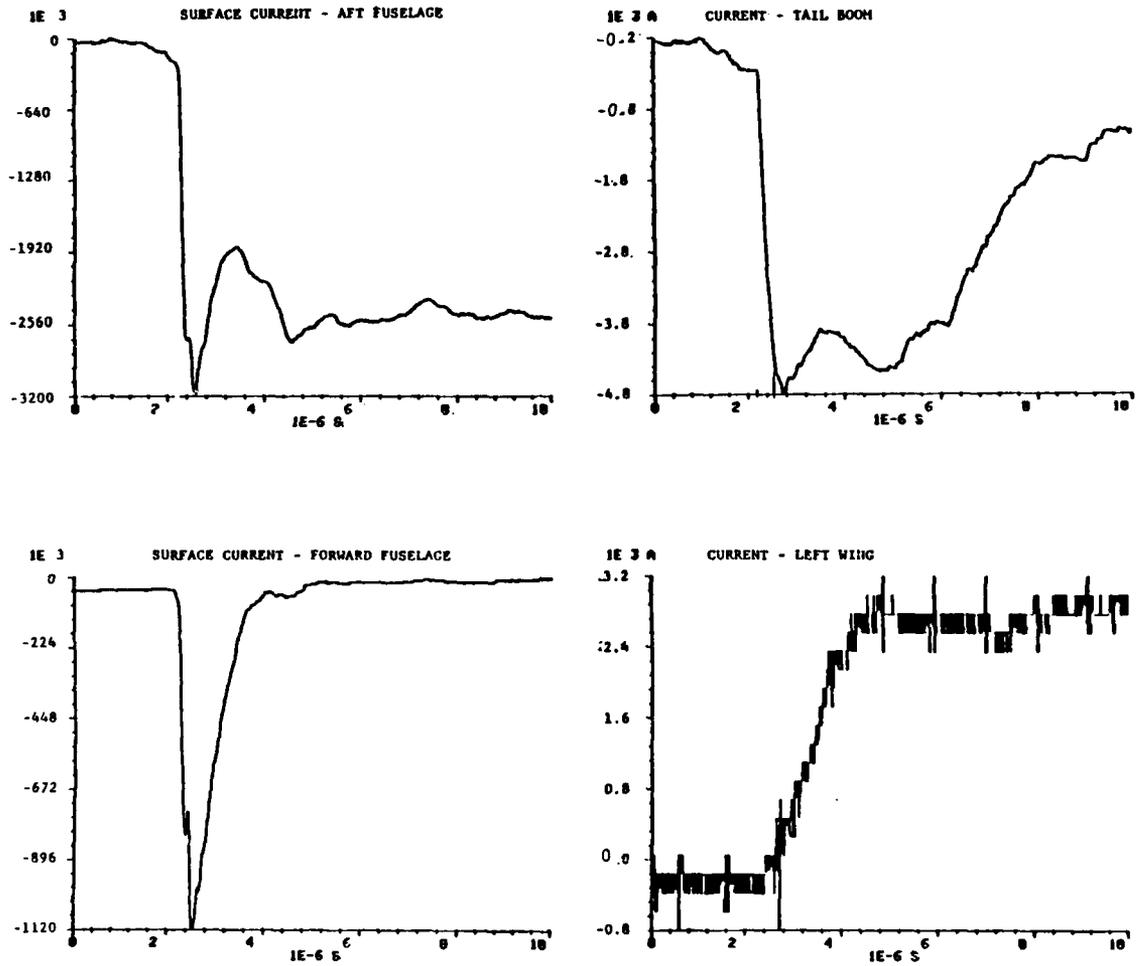
Figure 28. Current Pulses Recorded Digitally During a First Return Stroke of a Cloud-to-Ground Event

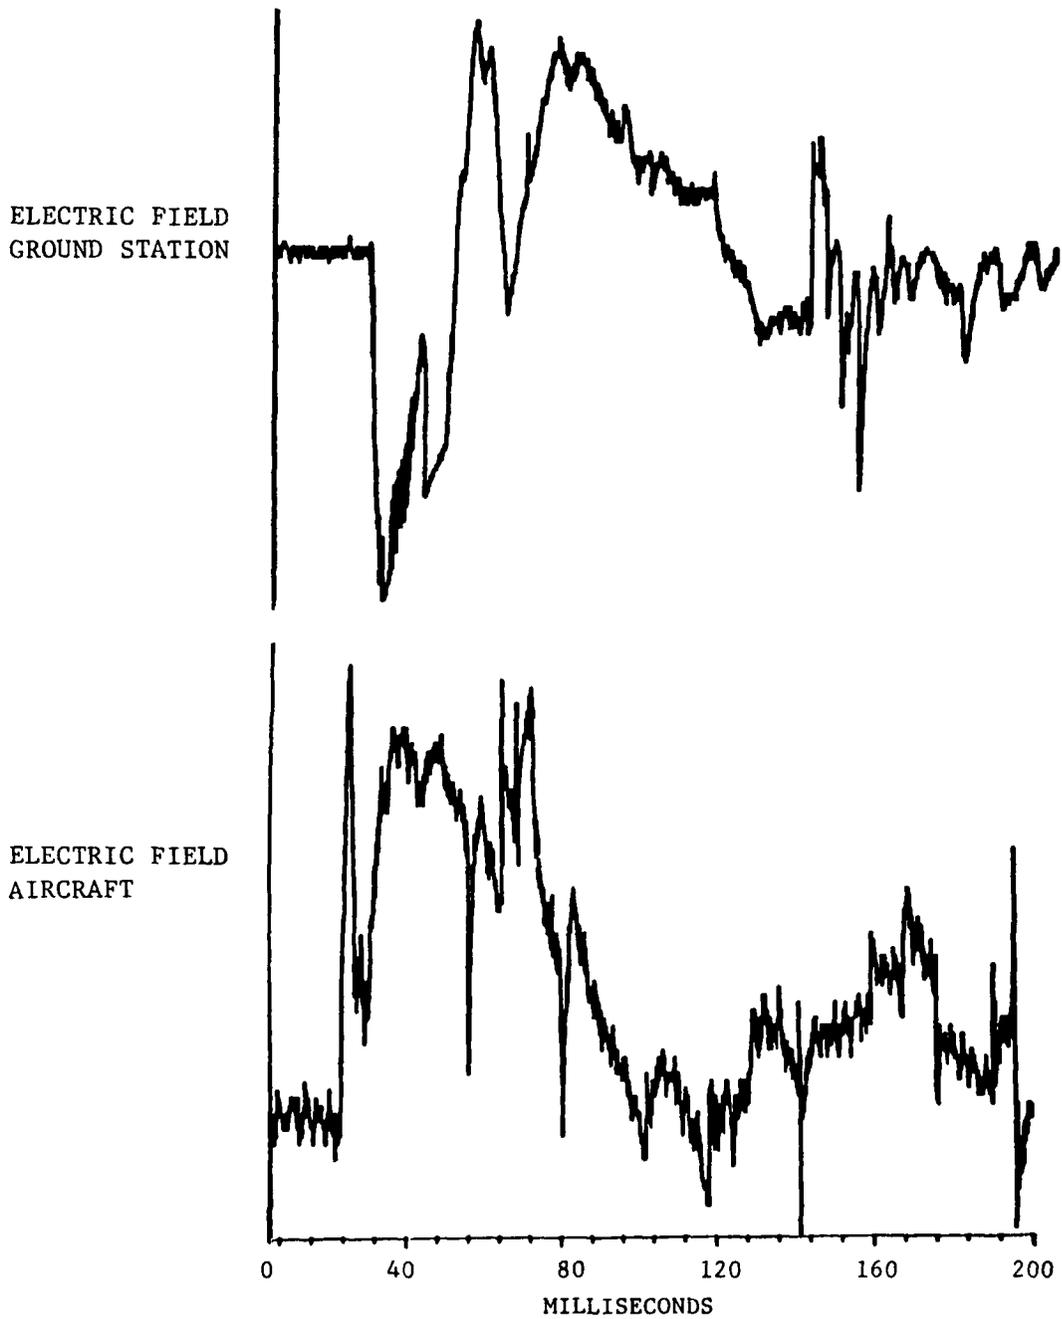
Figure 30. Initial Portions of Unscaled Electric Field Records Recorded Simultaneously at the Ground Station (Top) and Aircraft (Bottom) During a Strike Triggered by the Aircraft
