AFWAL-TR-88-3024

IN-FLIGHT LIGHTNING CHARACTERIZATION PROGRAM ON A  
CV-580 AIRCRAFT

June 1988

Final Report for Period October 1983 - September 1987

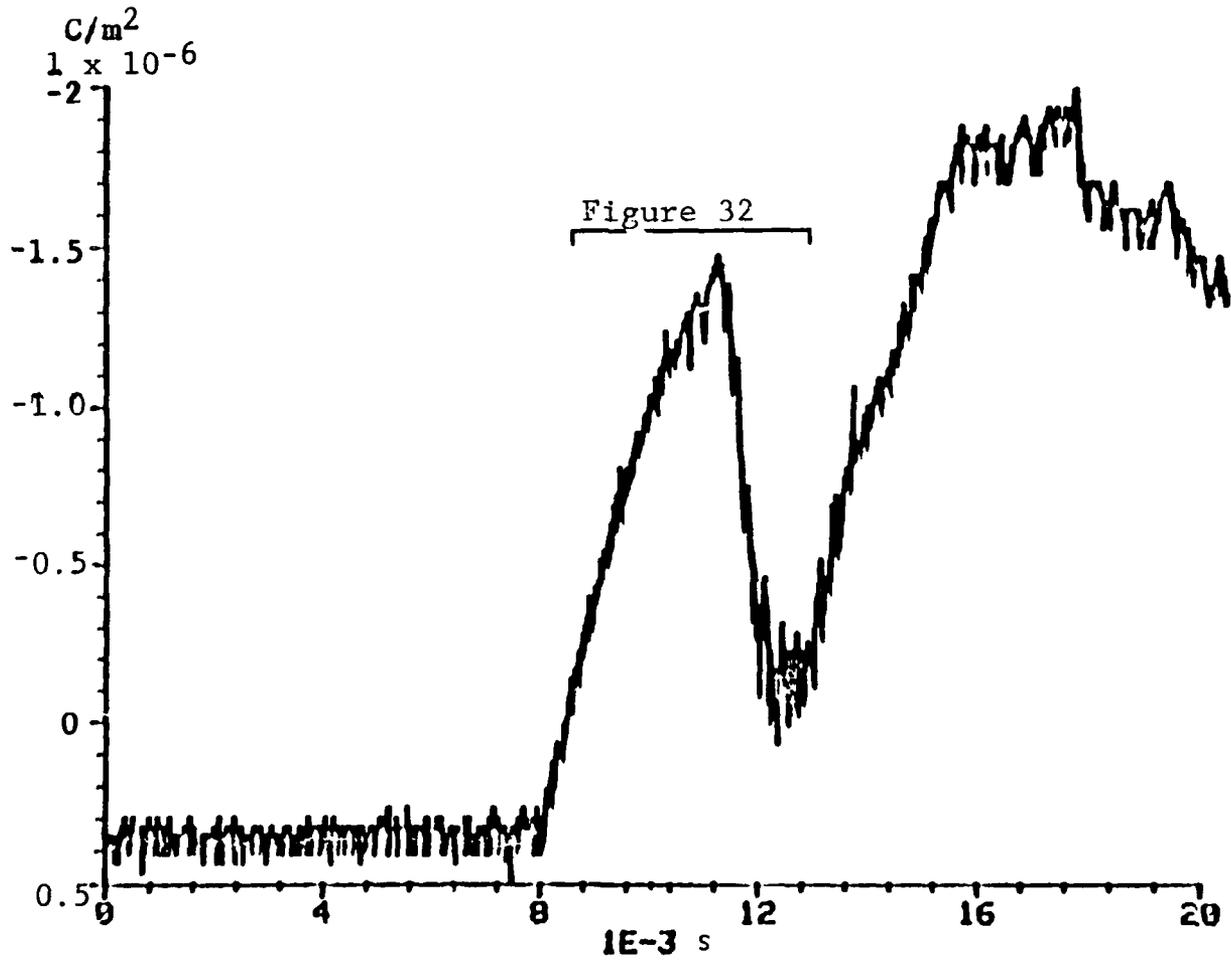
Figure 31. Expansion of First Part of Typical Category 1 Electric Field Waveform Shown in Figure 9

Analysis of all the records in Category 1 showed that the slow, initial, negative charge increase averaged  $2.0 \times 10^{-6}$  C/m<sup>2</sup> and lasted between 1 and 10 ms. The more rapid decay in charge occurred within 0.1 to 2 ms to a level more or less than the charge increase in the initial ramp. Individual fast pulses were often observed during both charge changes on electric field records from the fuselage, wingtips, and vertical stabilizer. The expansion of the first part of the electric field waveform from Fig. 9 is shown in Fig. 31, denoting a section of the waveform that is expanded even further in Fig. 32.

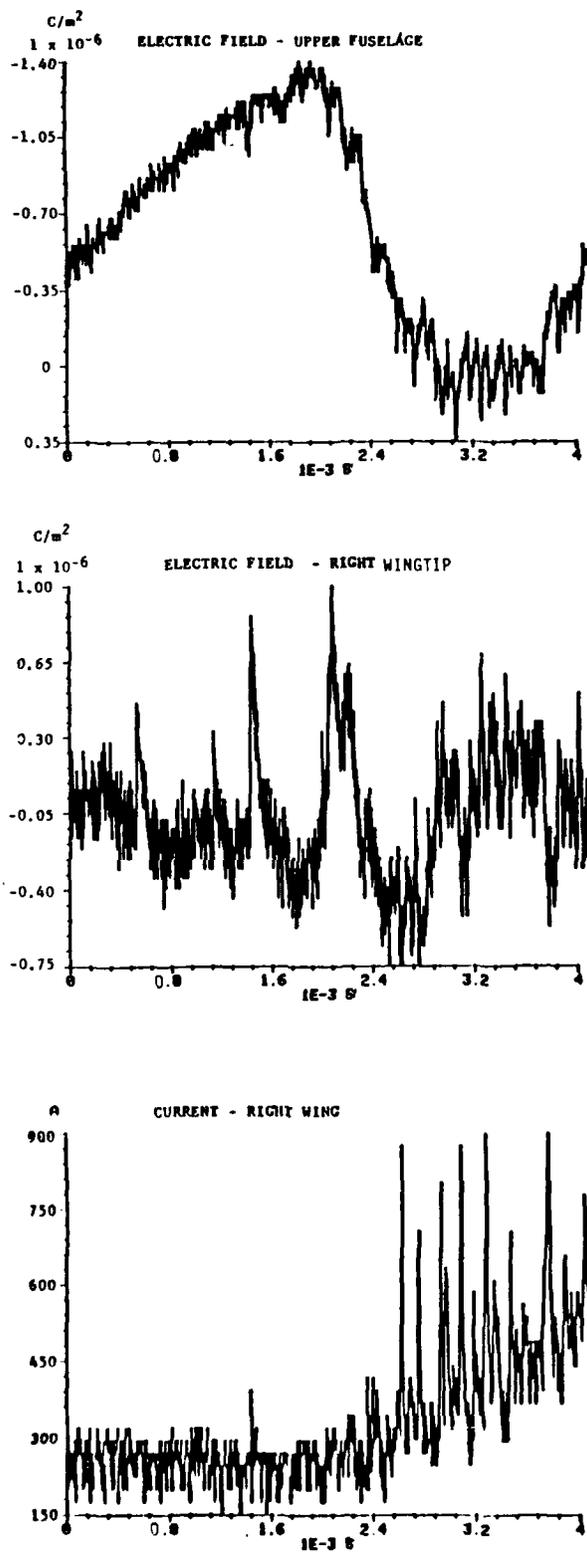
Figure 32. Electric Field and Current Waveforms During the Initial Milliseconds of a Lightning Attachment in Category I—Expansion From Figure 31

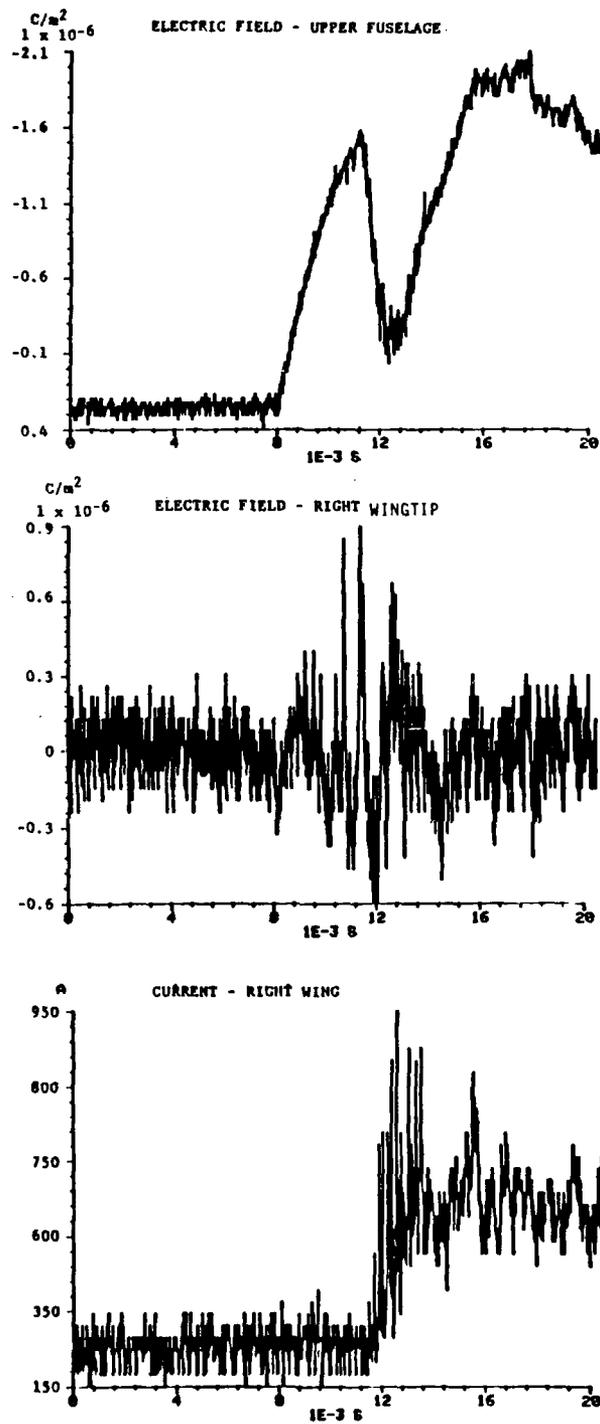
Figure 33. Electric Field and Current Waveforms During the First 12 ms of a Lightning Attachment in Category 1

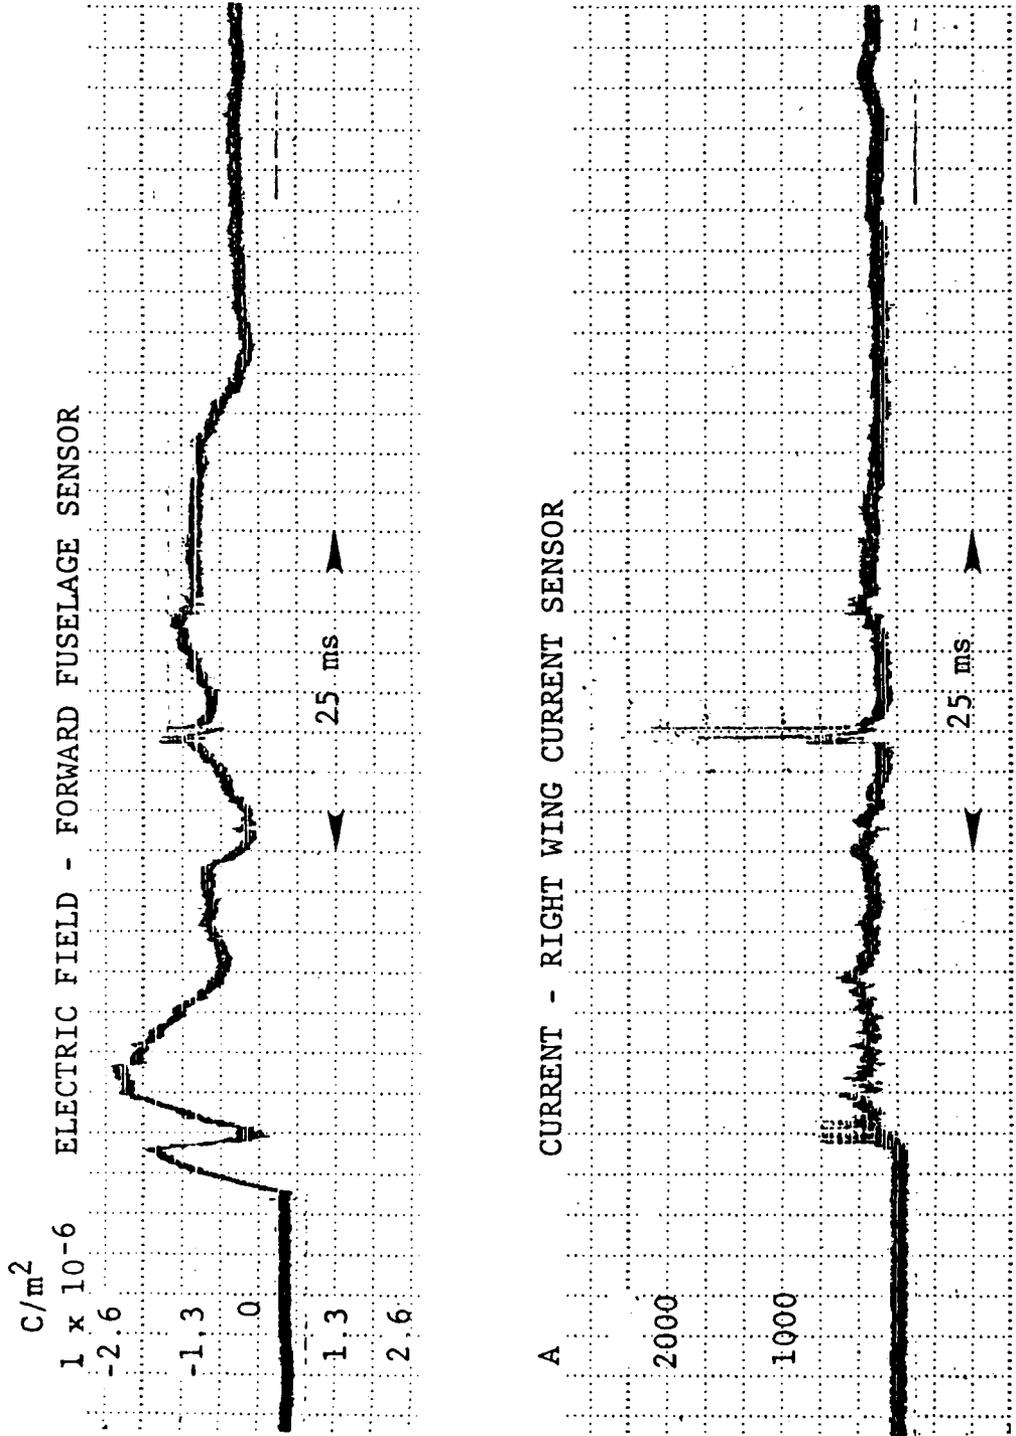
Figure 34. Electric Field and Current Waveforms During the First 100 ms of the Lightning Attachment in Figure 9

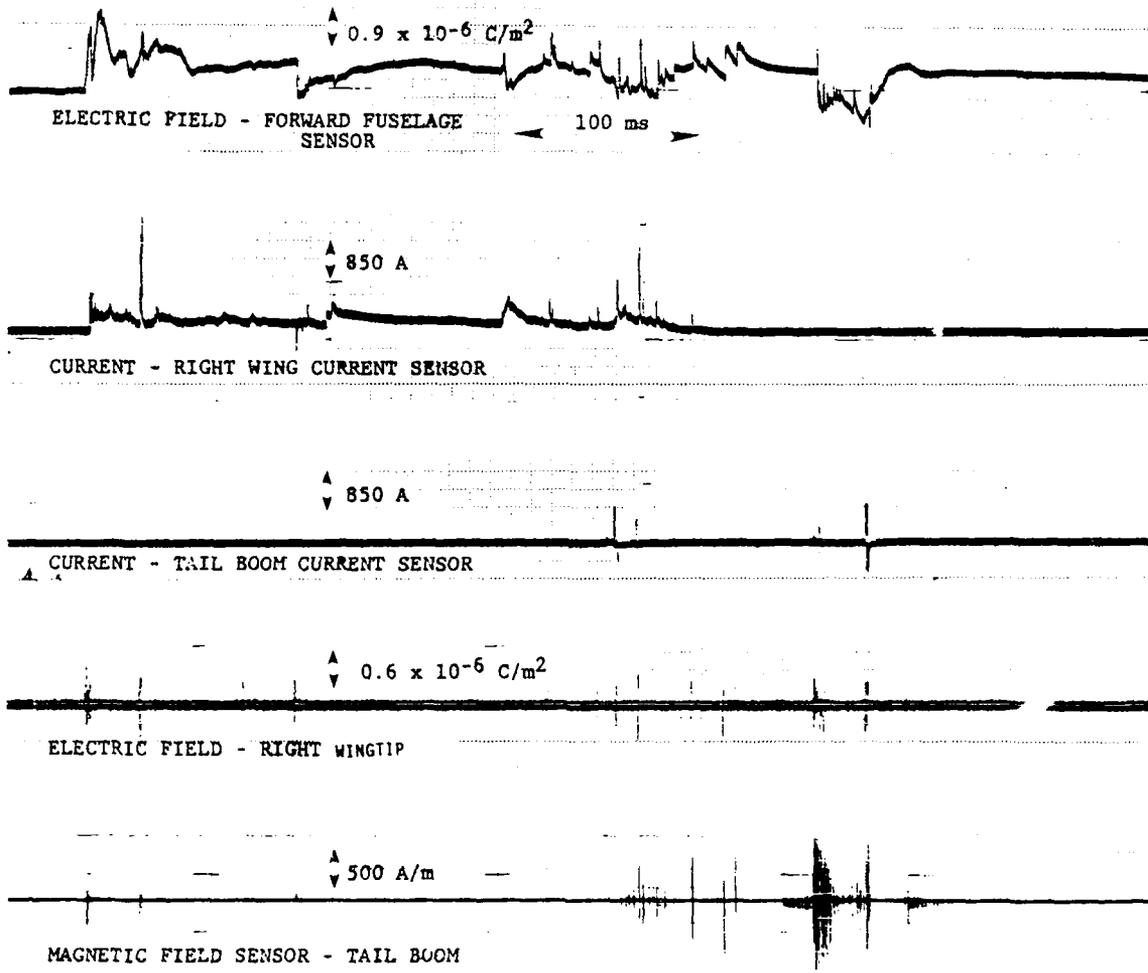
Figure 35. Electromagnetic Field and Current Waveforms During a Lightning Attachment in Category I

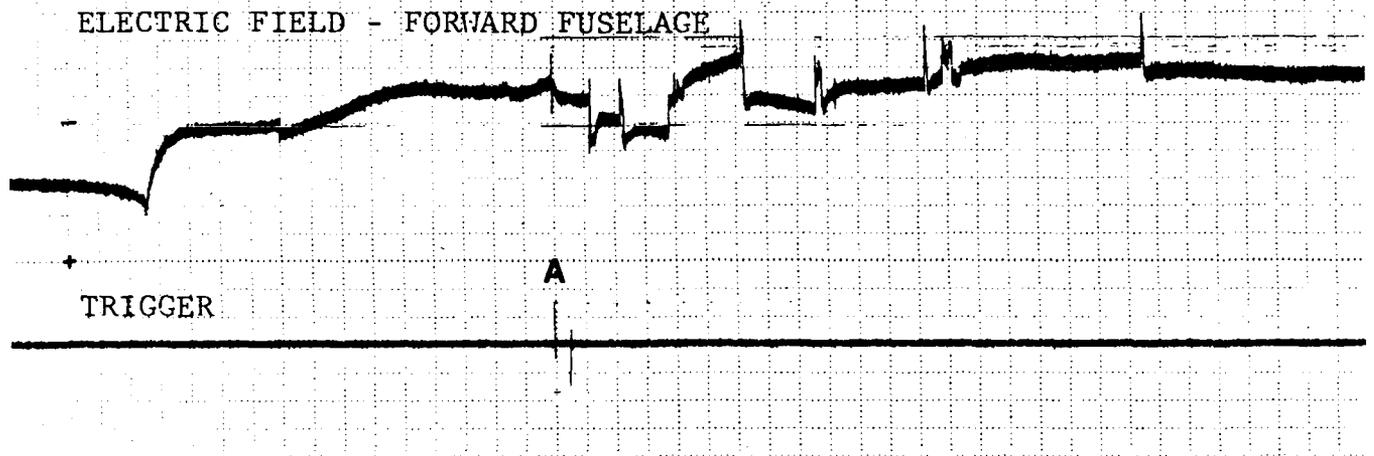
Figure 37. Analog Record for 27 June 1985 Lightning Event Showing Trigger Pulse (A) Which Corresponds to the Time at Which the Data Shown in Figure 36 Was Recorded

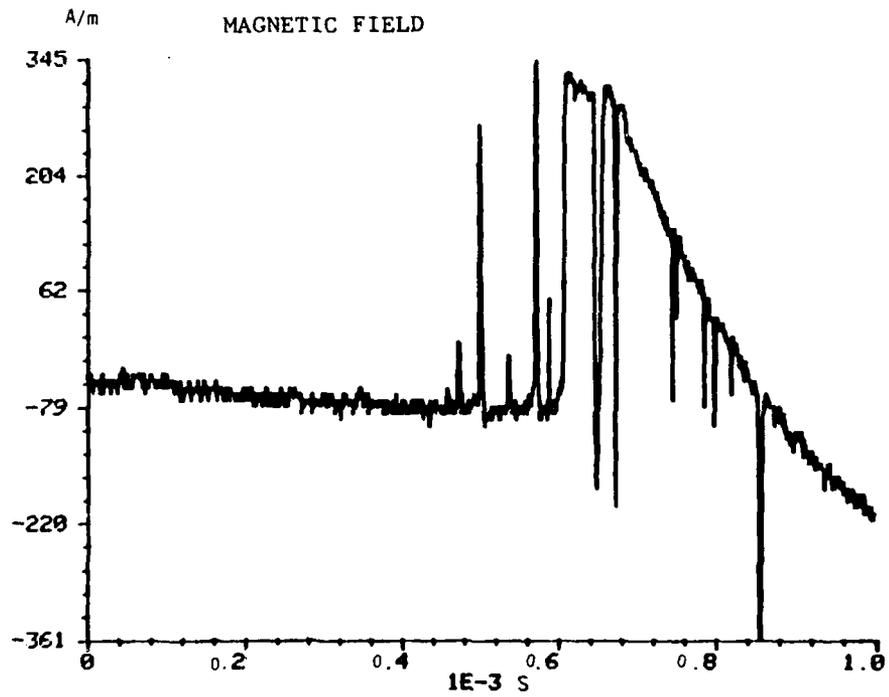
Figure 40. Magnetic Field Data Showing Approach of a Stepped Leader, Attachment to the Aircraft and Departure of the Leader

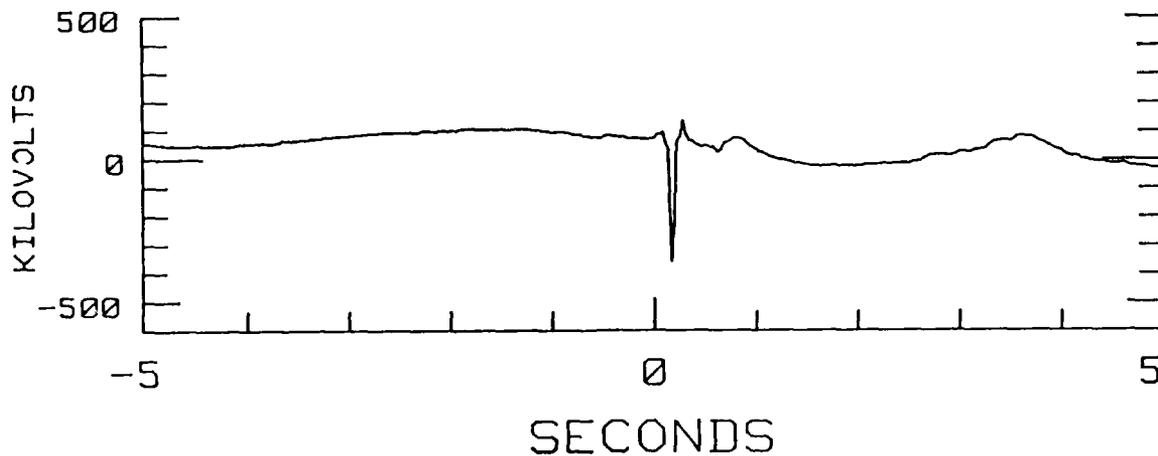
Figure 45. Aircraft Potential as Determined From the Quasi-static Electric Fields for an Event Where the Aircraft Was in the Main Channel of a Cloud-to-Ground Discharge

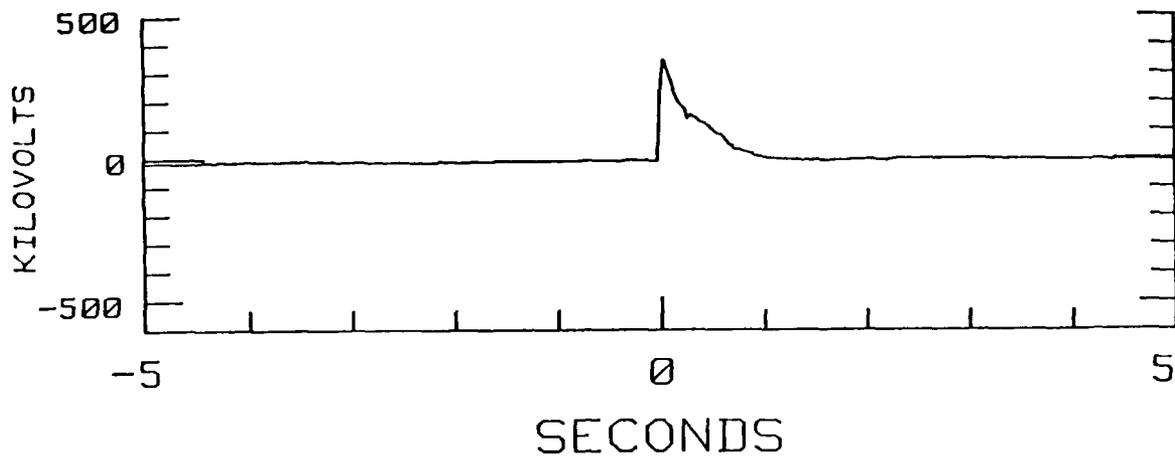
Figure 46. Aircraft Potential as Determined From the Quasi-static Electric Fields for an Event Where the Aircraft Was in a Branch of a Cloud-to-Ground Discharge

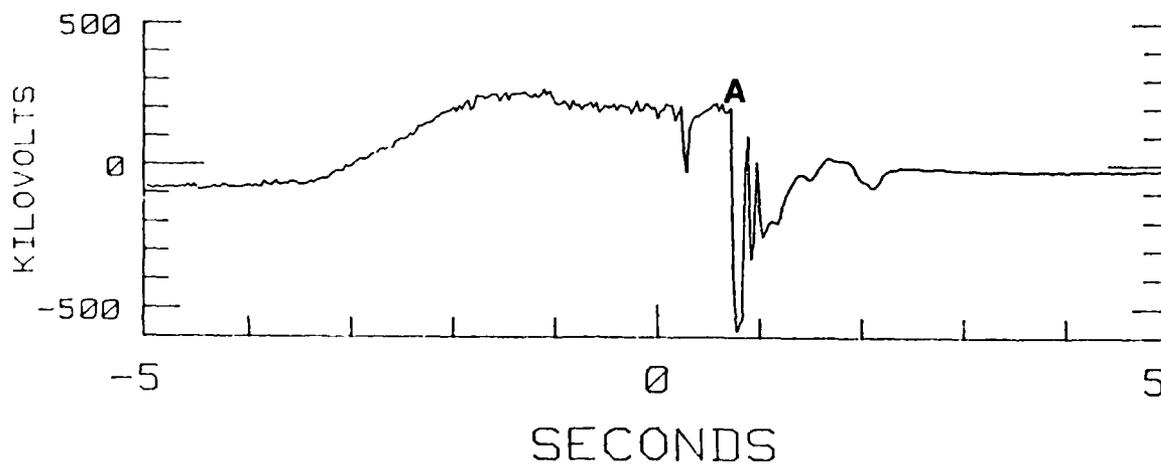
Figure 47. Aircraft Potential as Determined From the Quasi-static Electric Fields for an Event Triggered by the Aircraft

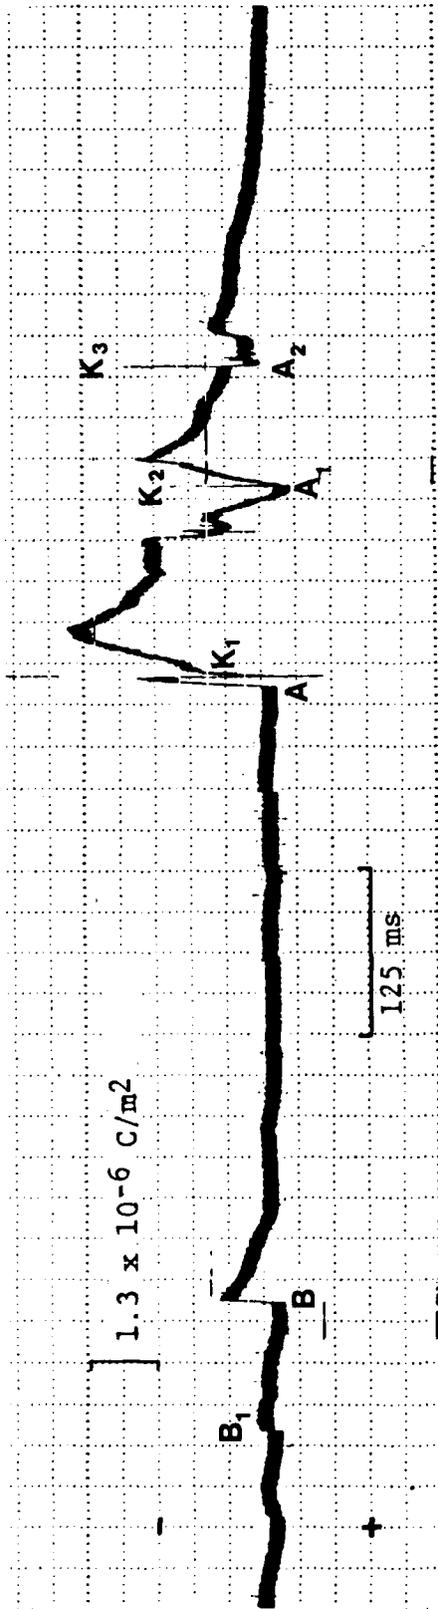
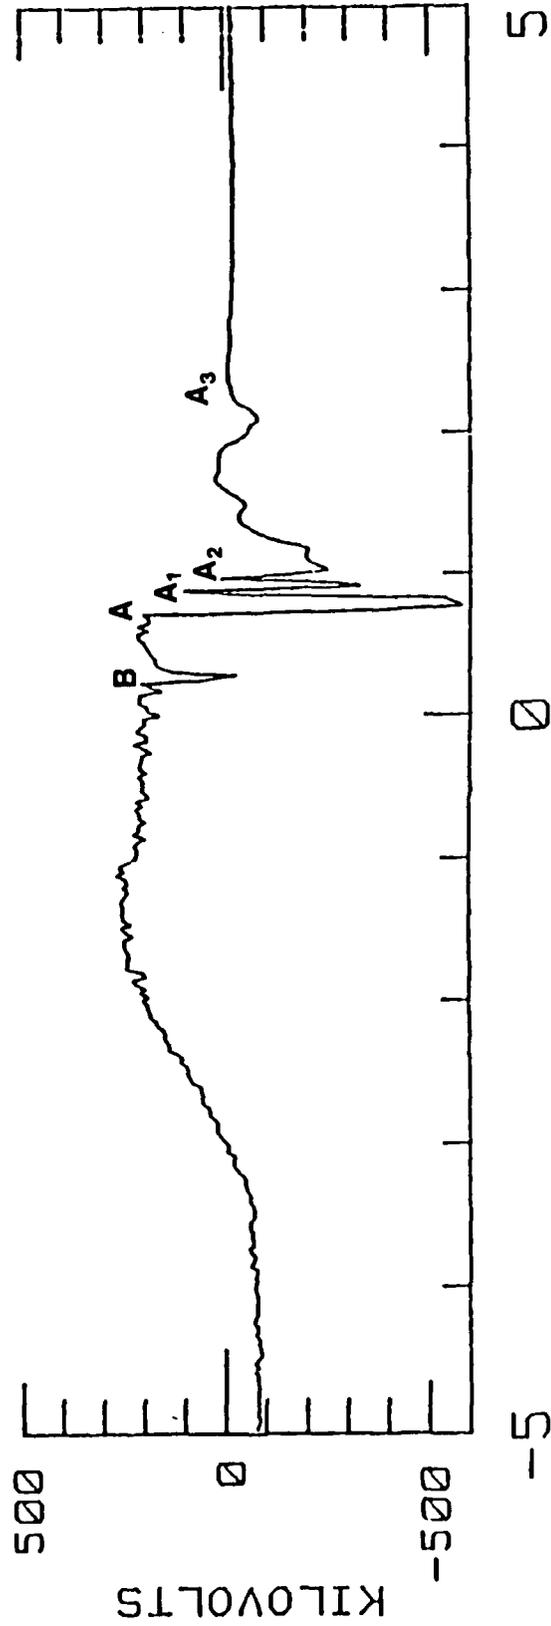
Figure 48. Comparison of the Electric Field Record From the Forward Fuselage Sensor With the Field Mill Record Showing Aircraft Potential for an Event Triggered by the Aircraft

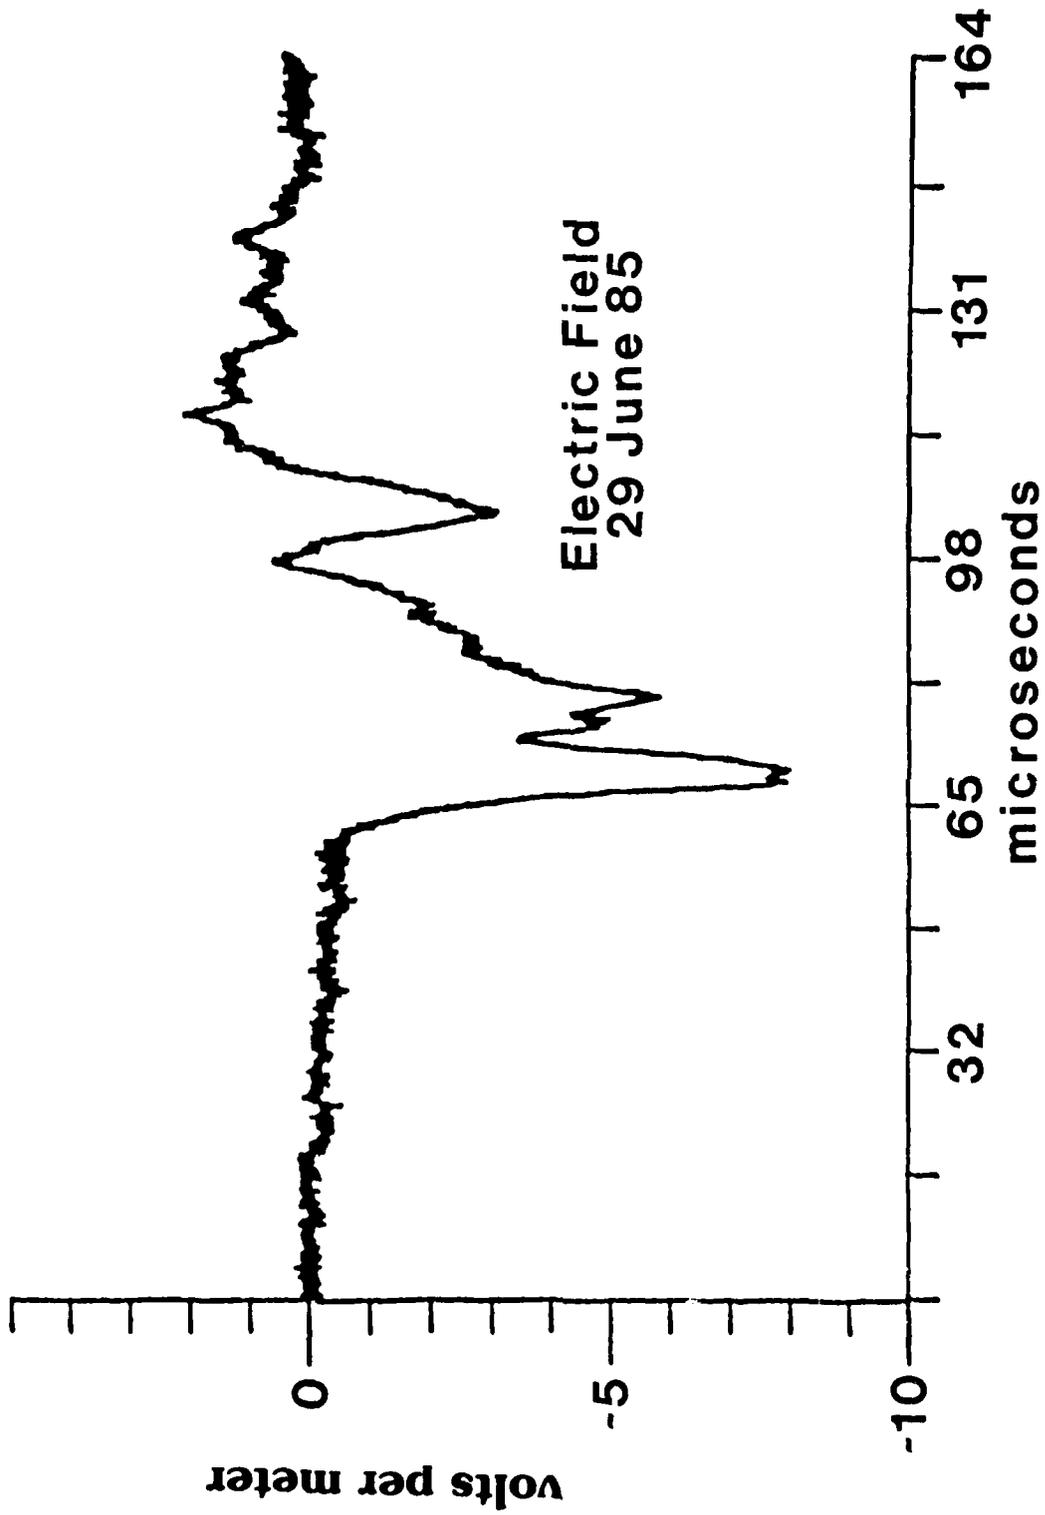
Figure 51. Electric Field Produced by a First Return Stroke Recorded at the Ground Station for an Event Where the Aircraft Was in a Branch of a Cloud-to-Ground Discharge

With the measured value of  $E = 9$  V/m, equation 8 provided a peak current of 33.75 kA at sea level. Assuming an exponential decay of current with height, z, of form

The much higher level of current measured at the ground during the first return stroke indicates that, as in the event on 6 July 1985, the aircraft was in a branch rather than the main channel. This explains the short length of the electric field record on the aircraft since the aircraft would not see field changes once the branch collapsed. Since the data showed negative charge flow onto the aircraft, in

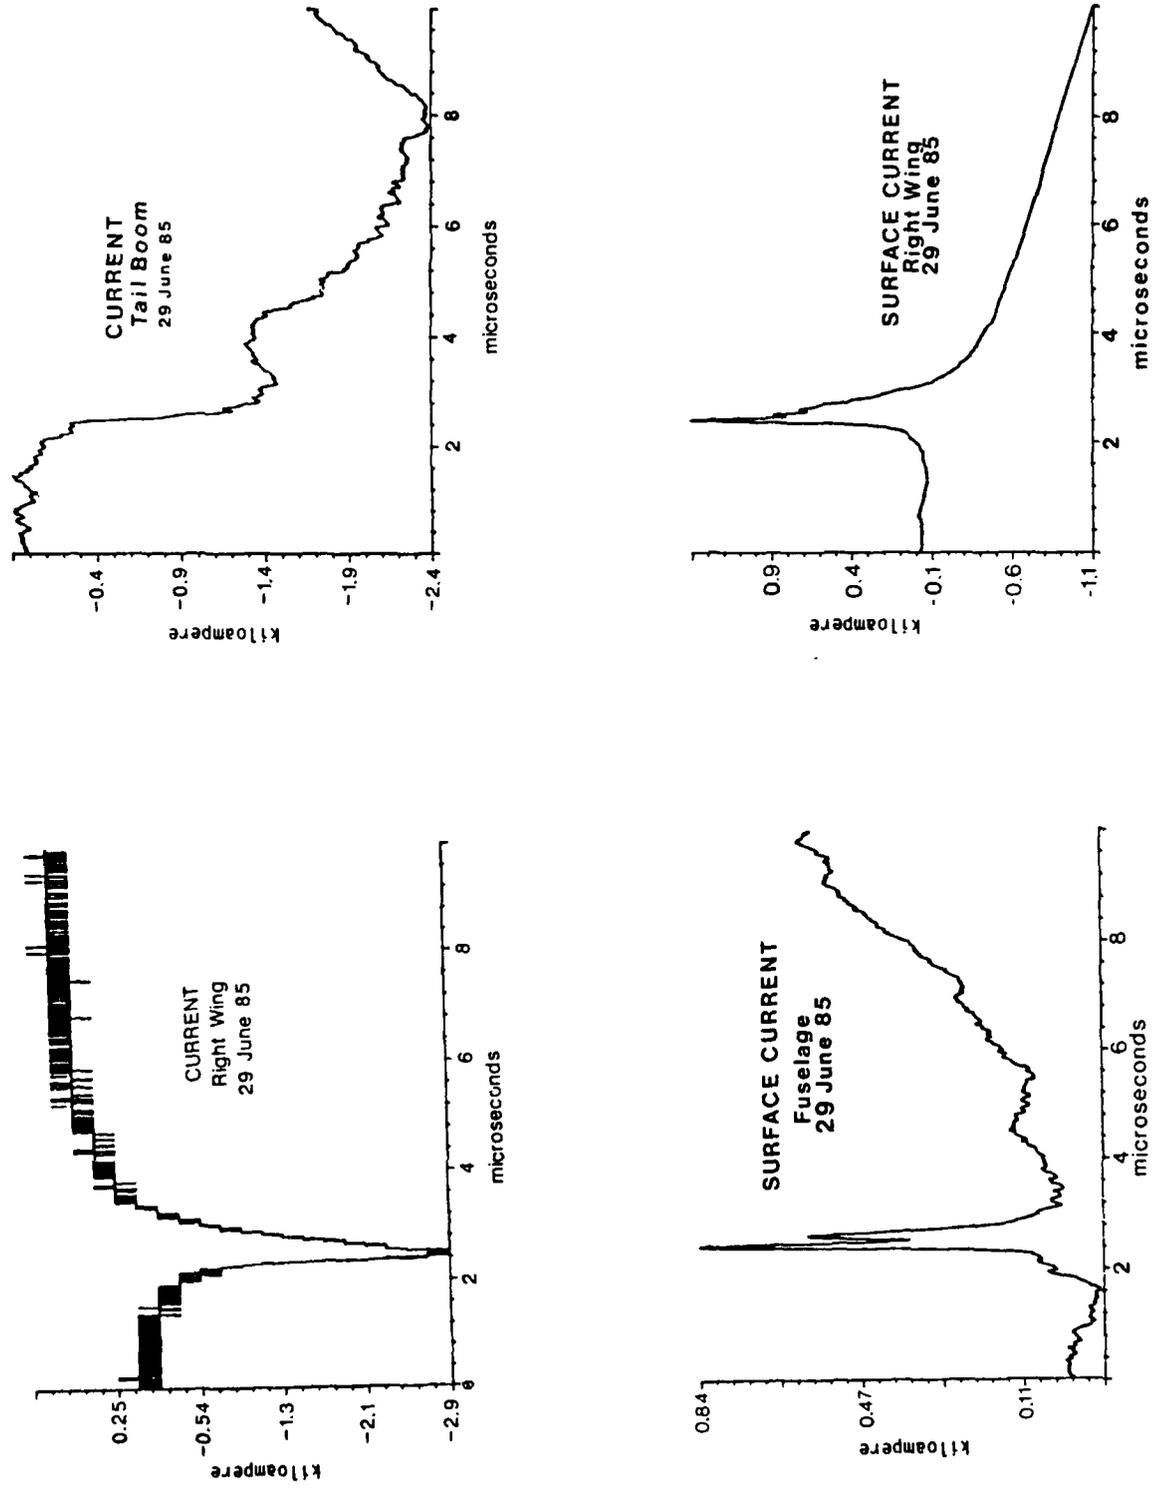
Figure 52. Digital Data Recorded on the Aircraft at the Time of the Cloud-to-Ground Event Shown in Figure 51.

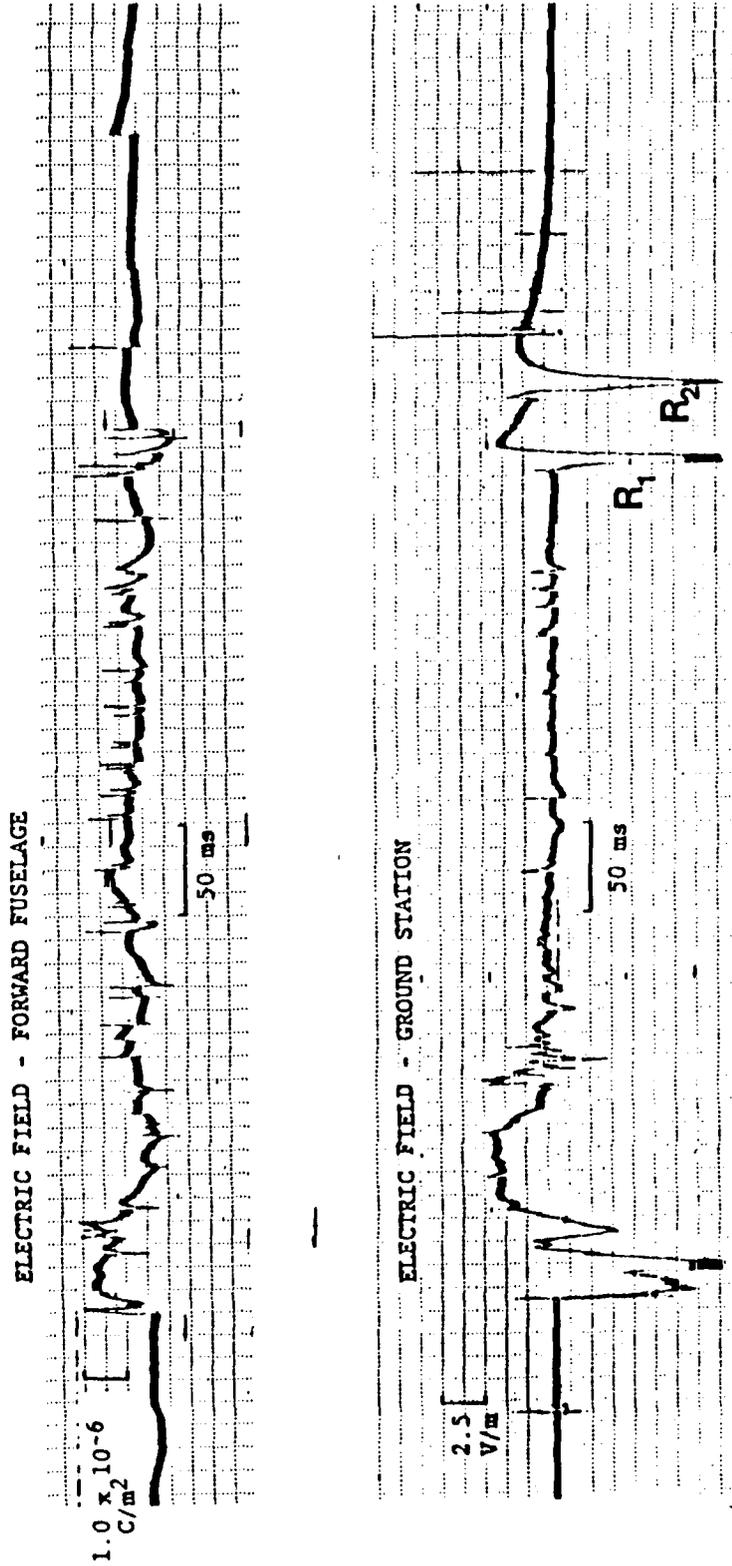
Figure 53. Simultaneous Recordings of the Electric Field on the Aircraft and at the Ground Station During an Event Triggered by the Aircraft

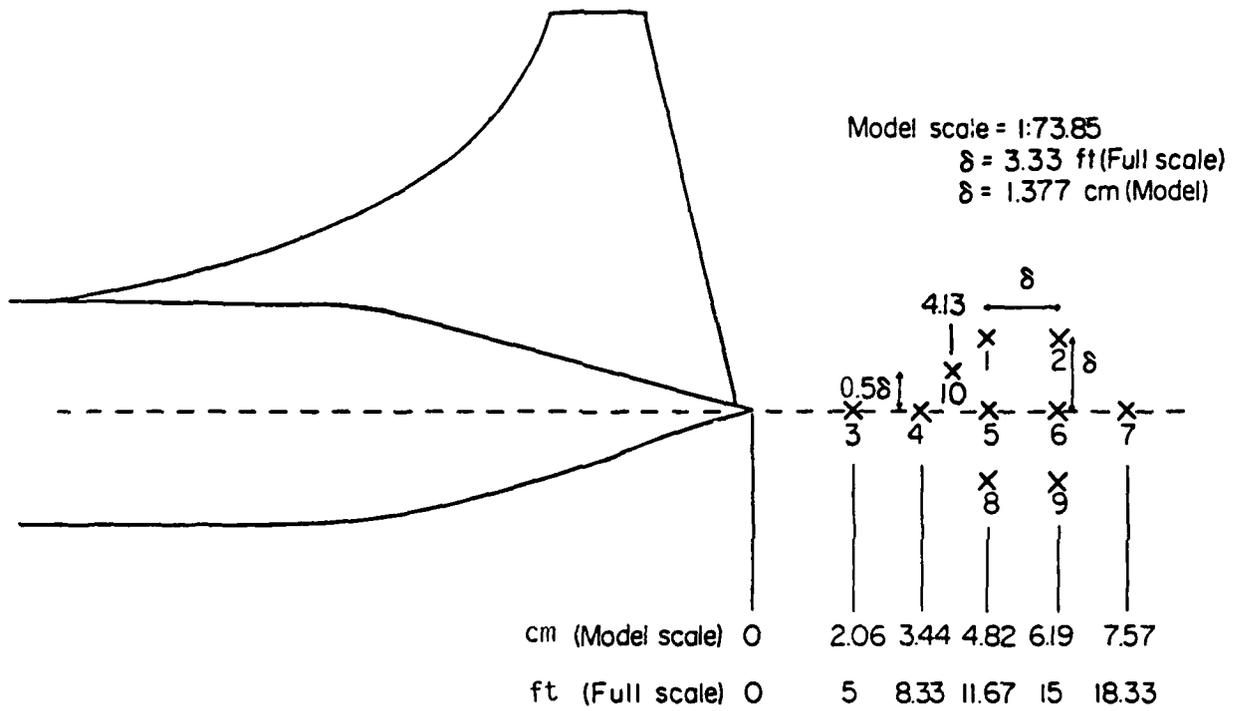
Figure 55. Scale Model Study Measurement Locations (Not to Scale)

To attain some of the objectives of the program, we needed to measure some characteristics of the lightning channel prior to attachment to the aircraft. To make this measurement, a magnetic field sensor was selected, but a suitable location on the aircraft had to be determined to avoid field distortion and measurement inaccuracy caused by the geometry of the aircraft. The aircraft would produce scattering within the bandwidth of interest if a suitable location was not selected. Theoretical considerations suggested that the best location would be in the plane of symmetry either fore or aft of the aircraft and near the axis of the fuselage. Thus, scale model tests were conducted to determine a suitable sensor location (Reference 33). At the University of Michigan Radiation Laboratory facility described in Reference 34, a 1:74-scale model of the CV-580 was used to determine the error at positions 1 to 9 in the plane of symmetry, shown in Fig. 55. Analysis

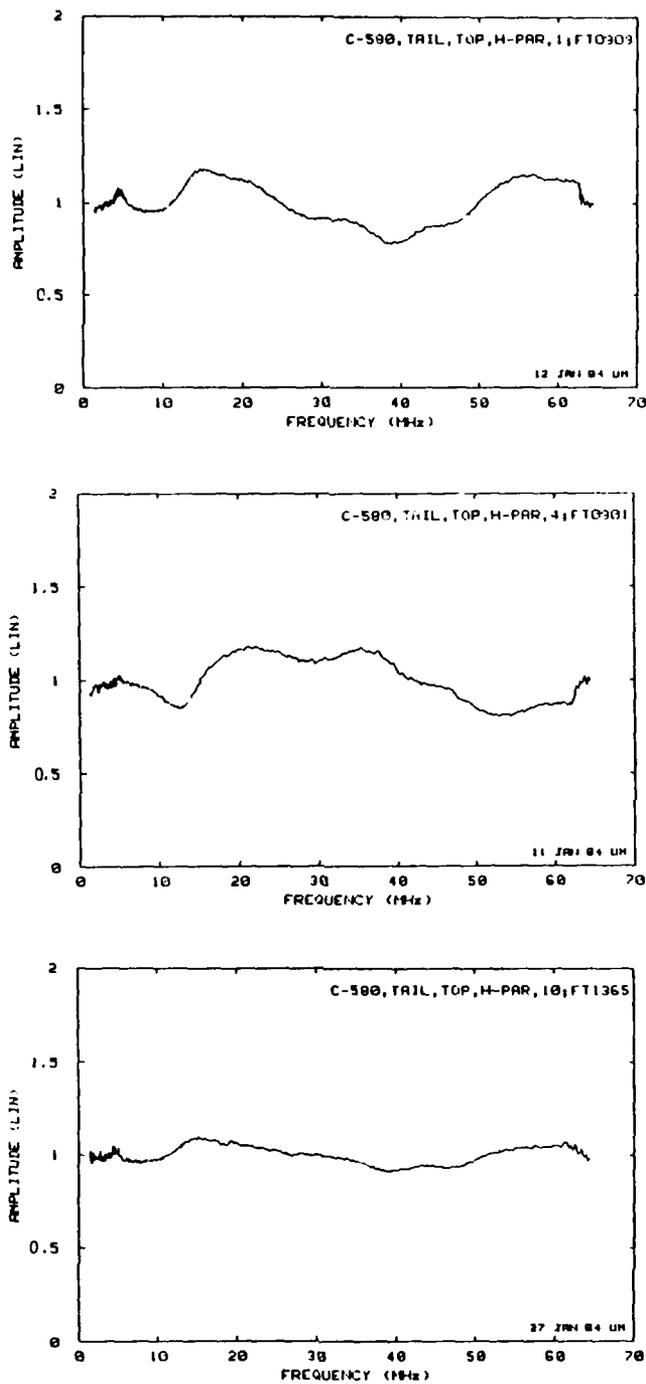
Figure 56. Comparison of Scale Model Measurements at Three Positions in the Plane of Symmetry Aft of the Aircraft

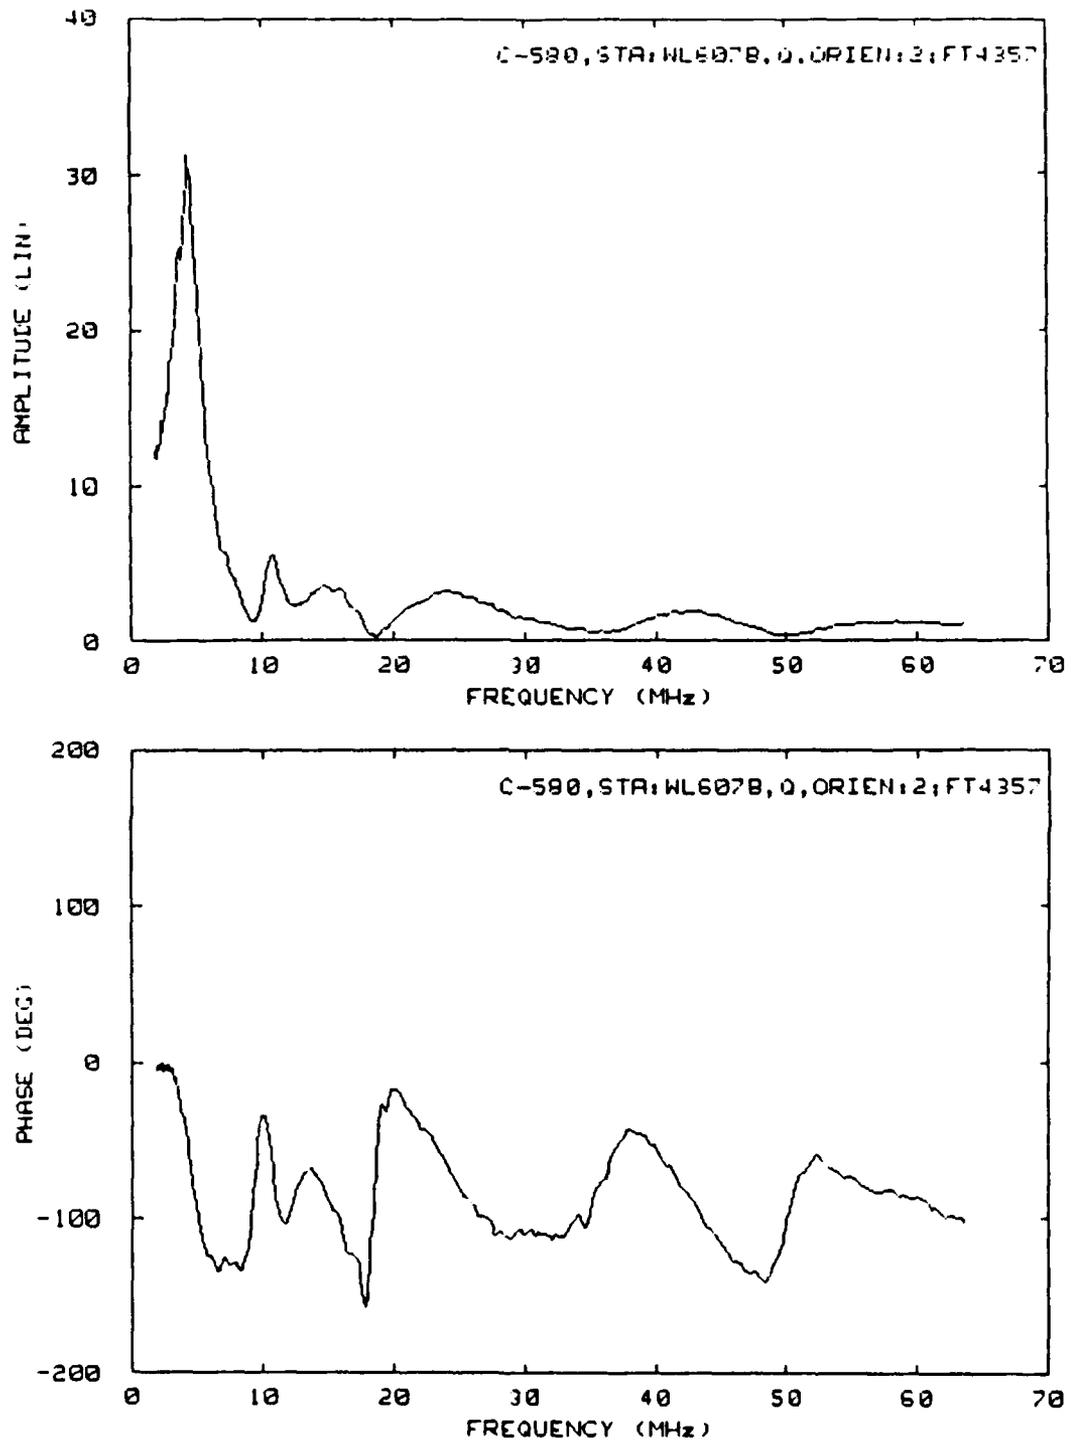
Figure 57. Typical CV-580 Response (Taken From Reference 35)

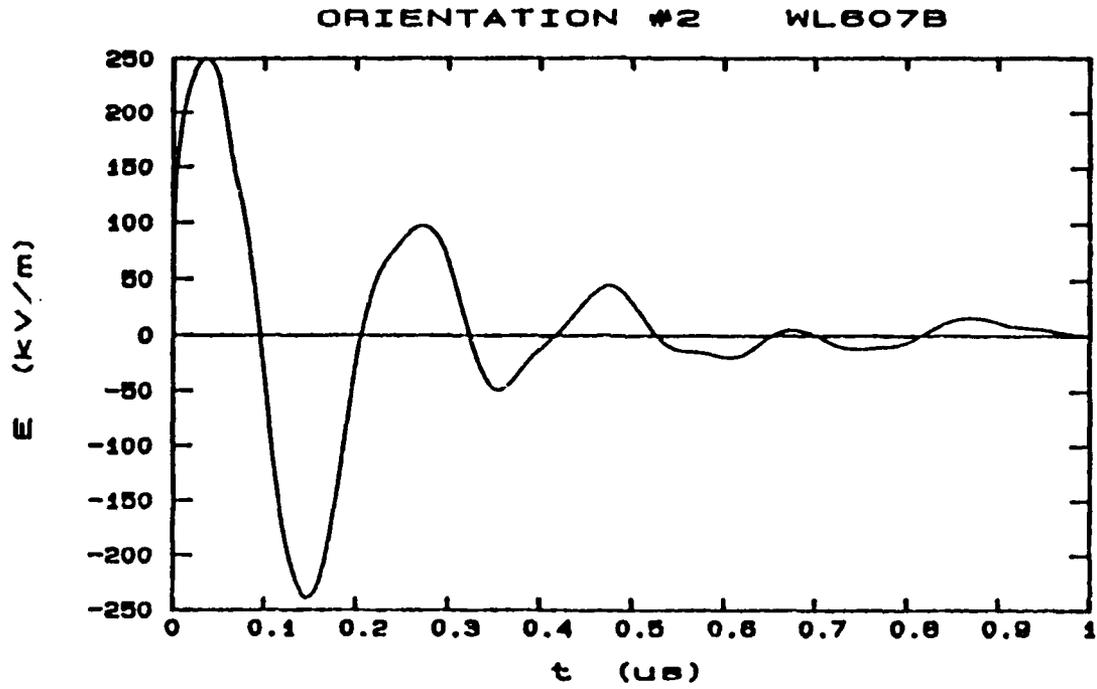
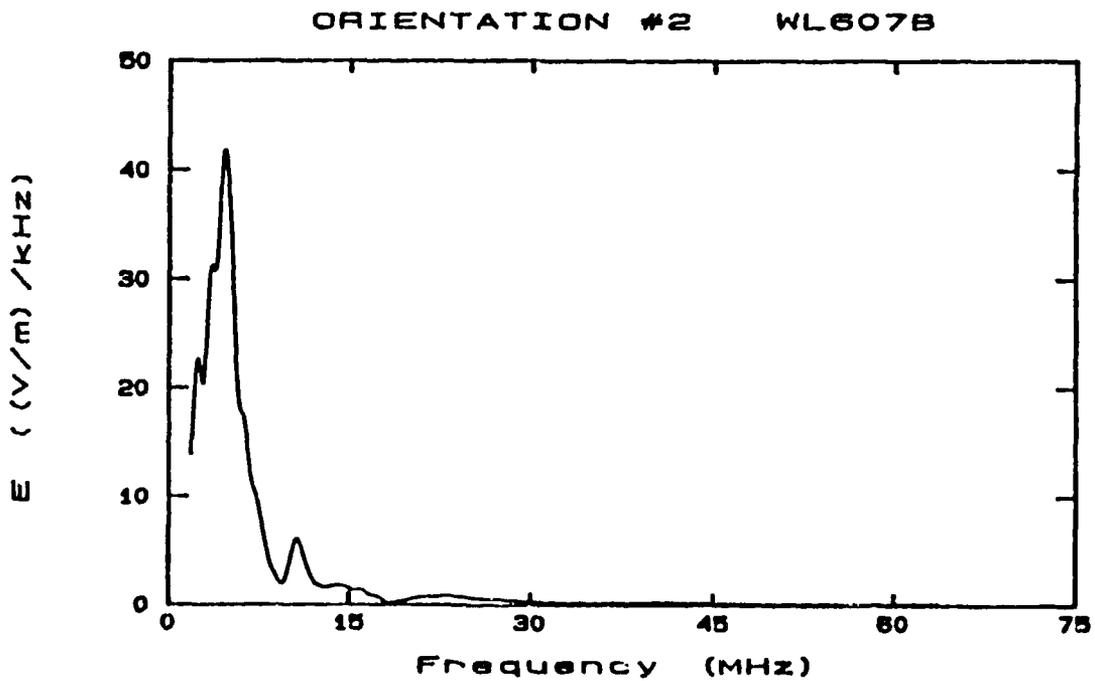
Figure 58. Predicted Response to the Reciprocal Double Exponential Waveform for the Sensor Location of Figure 57

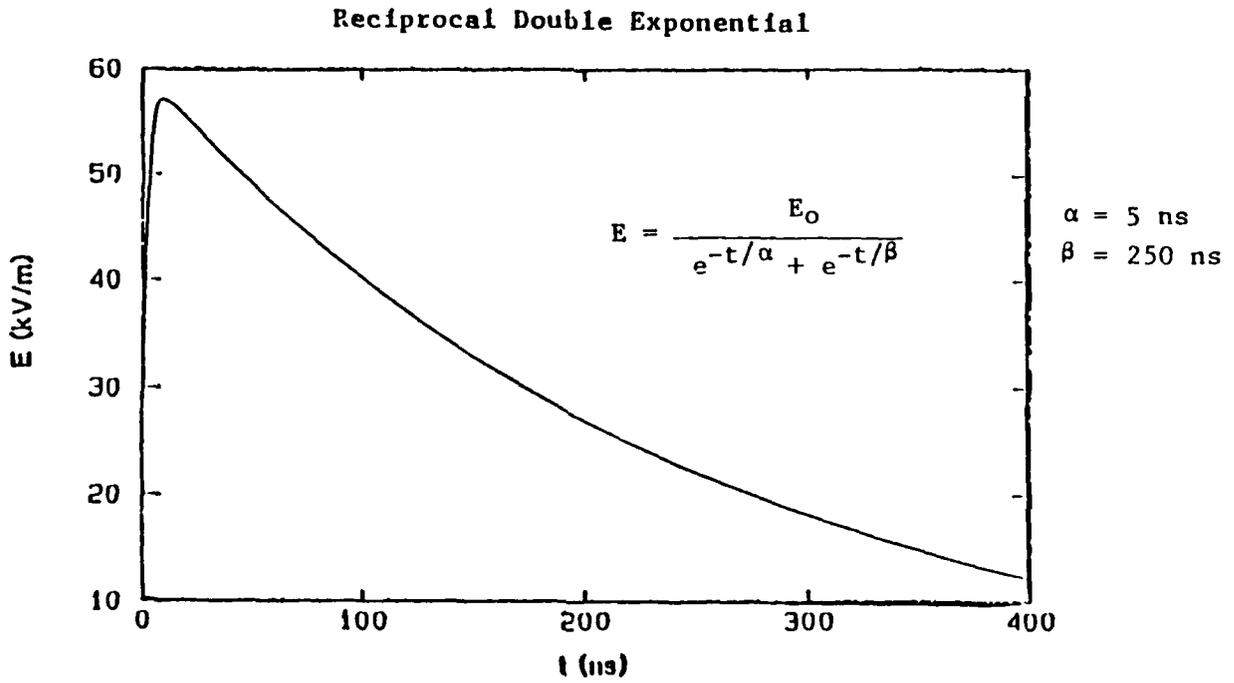
Figure 59. Reciprocal Double Exponential and Simulated NEMP Input Waveforms

Figure 59 shows a typical reciprocal double exponential waveform used to predict aircraft responses and a representative excitation received during simulated NEMP tests. The reciprocal double exponential input assumed a 60-kV/m peak field strength with a 5-ns time constant and a 250-ns decay time to 50 percent of peak value. Typical simulated NEMP excitations had comparable peak magnitudes with 7 to 8-ns rise and decay times. Extrapolated scale model and measured responses for the forward fuselage surface current sensor are shown in Fig. 60. In this case, the applied field was oriented in a direction parallel to the aircraft fuselage. Figure
