AFWAL-TR-88-3024

IN-FLIGHT LIGHTNING CHARACTERIZATION PROGRAM ON A  
CV-580 AIRCRAFT

June 1988

Final Report for Period October 1983 - September 1987

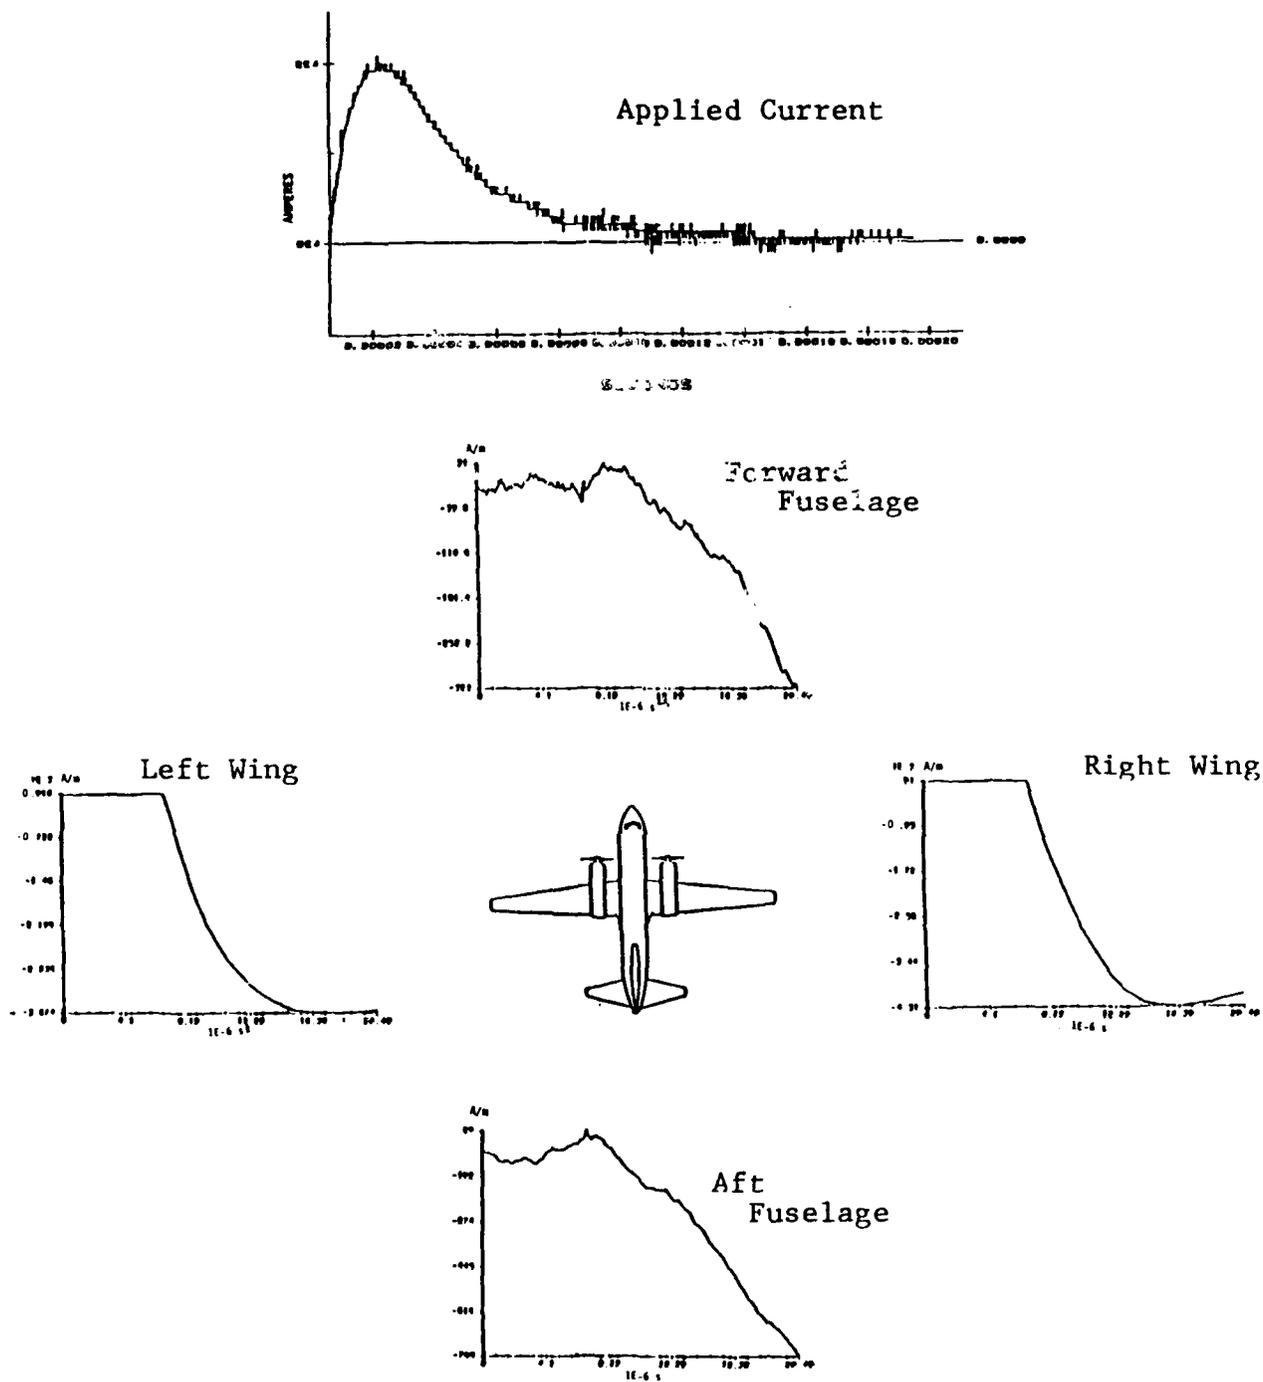
Figure 62. Response of the Surface Current Sensors to a Unipolar Current From the 4 μf, 200-kV Generator Applied to the Left Wing of the Aircraft

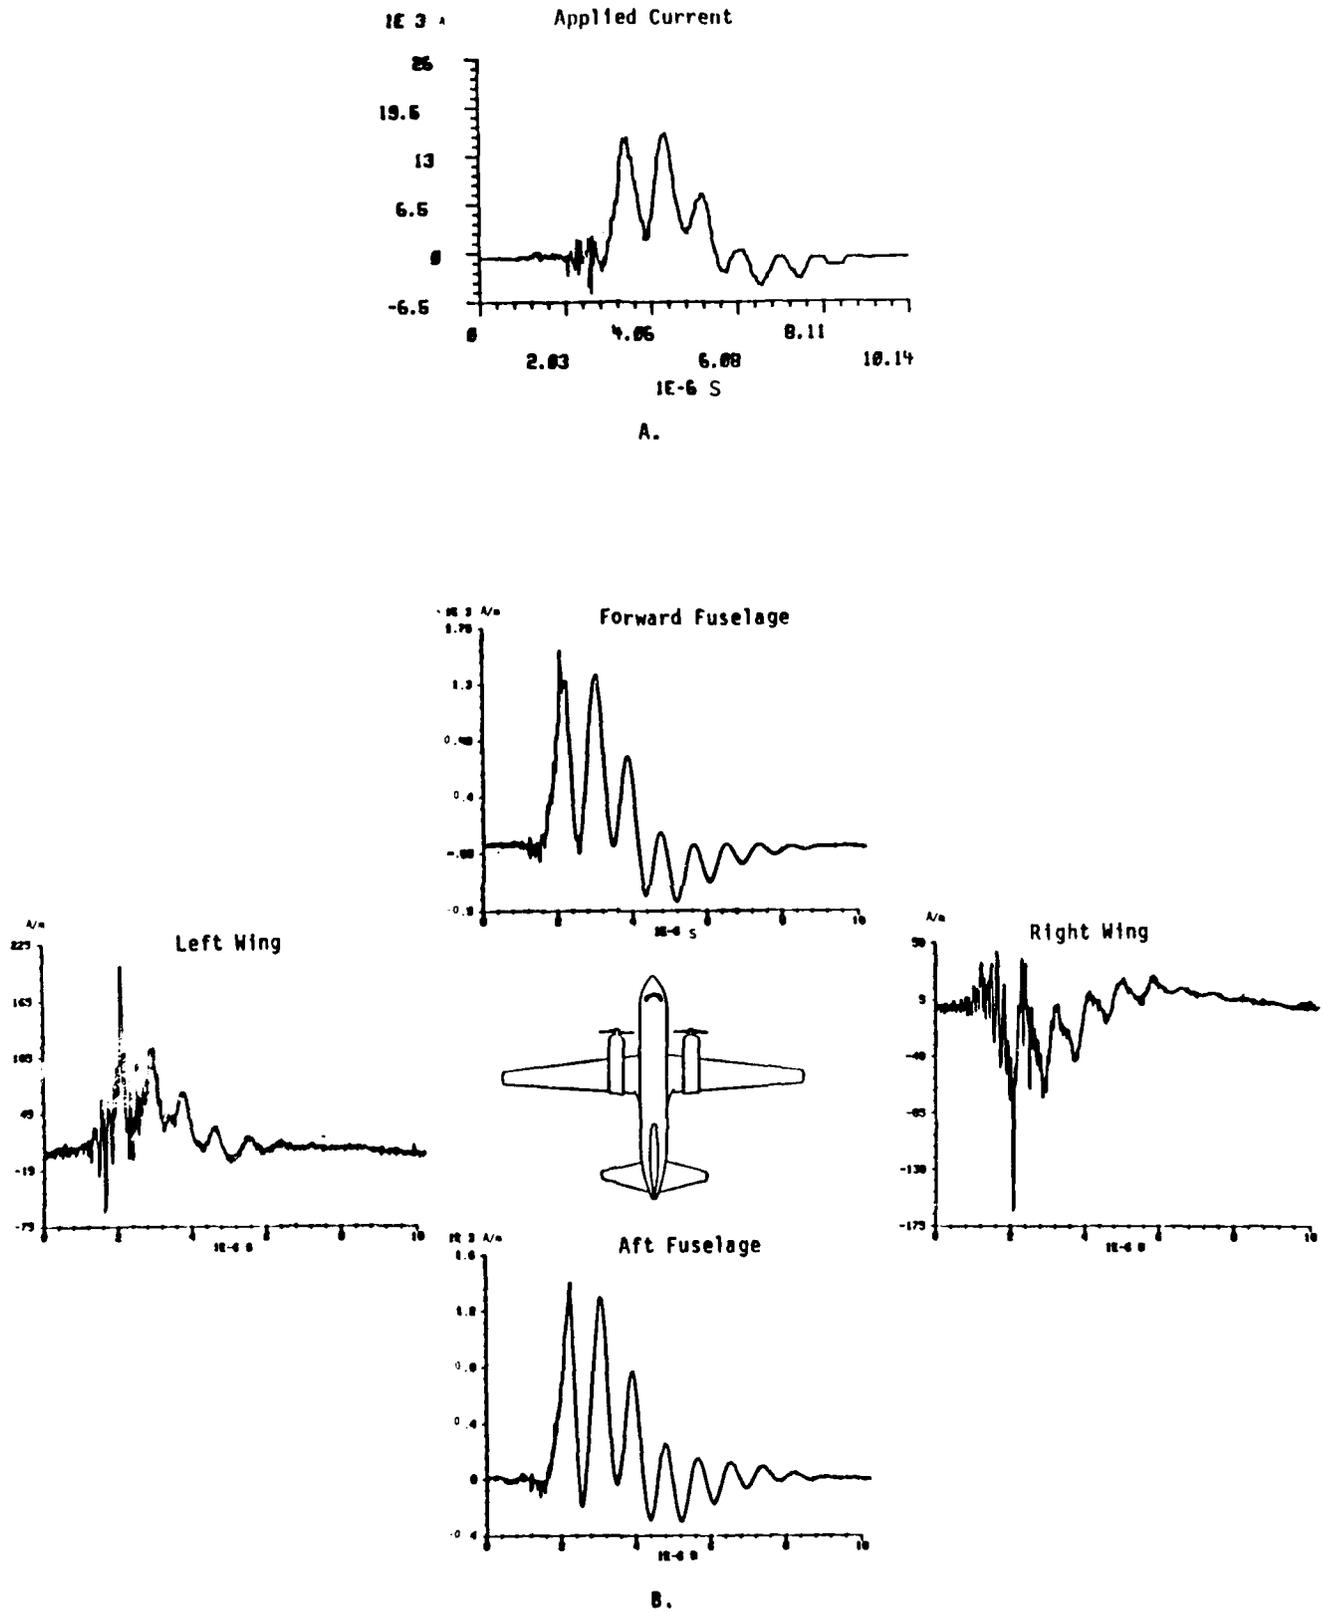
Figure 63. Response of the Surface Current Sensors to a Unipolar Current From the Fast Rise Time Generator Applied to the Nose of the Aircraft.
