ARCHAEOLOGICAL SURVEY AT
THE PROPOSED TUSKAHOMA LAKE
1987

Report to
U.S. Army Corps of Engineers
Tulsa District

Report to the U. S. Army Corps of Engineers
Tulsa District
Contract # DACW56-Q-0115

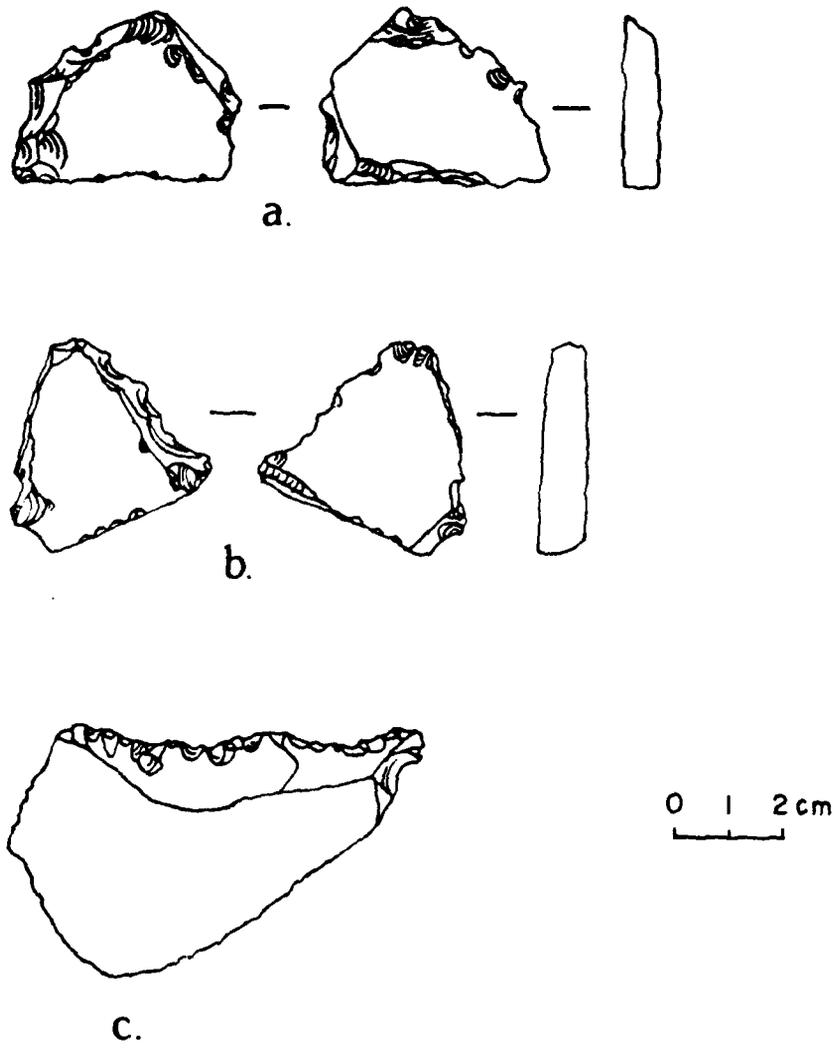
Figure 3. Artifacts from X-02. a,b) Glass scrapers, c) Bigfork chert scraper

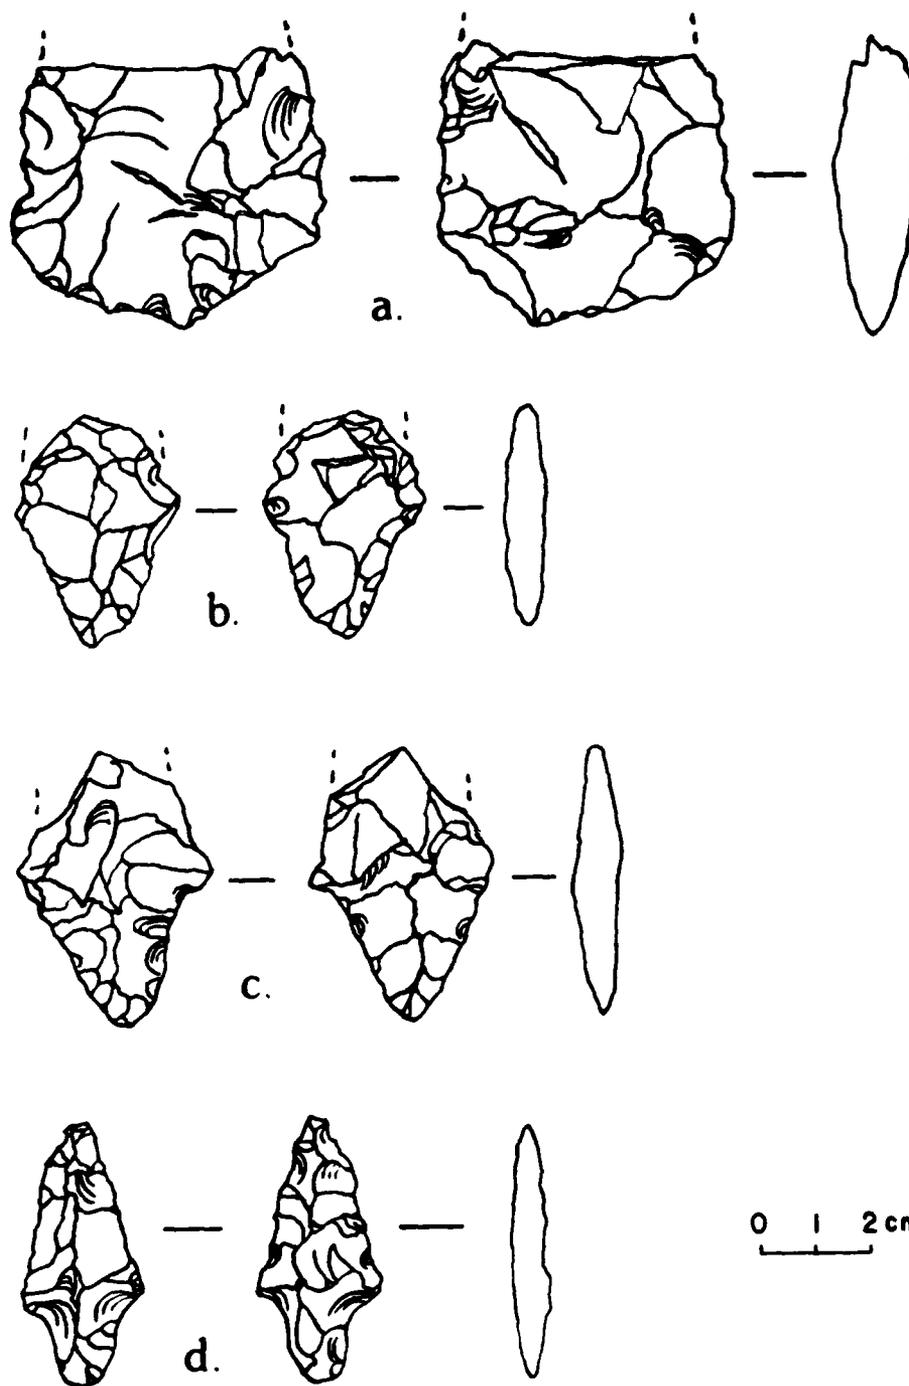
Figure 4. Lithic Artifacts. a) Large biface from X-06; b,c) Gary bases from X-06, d) Gary point from X-04A.

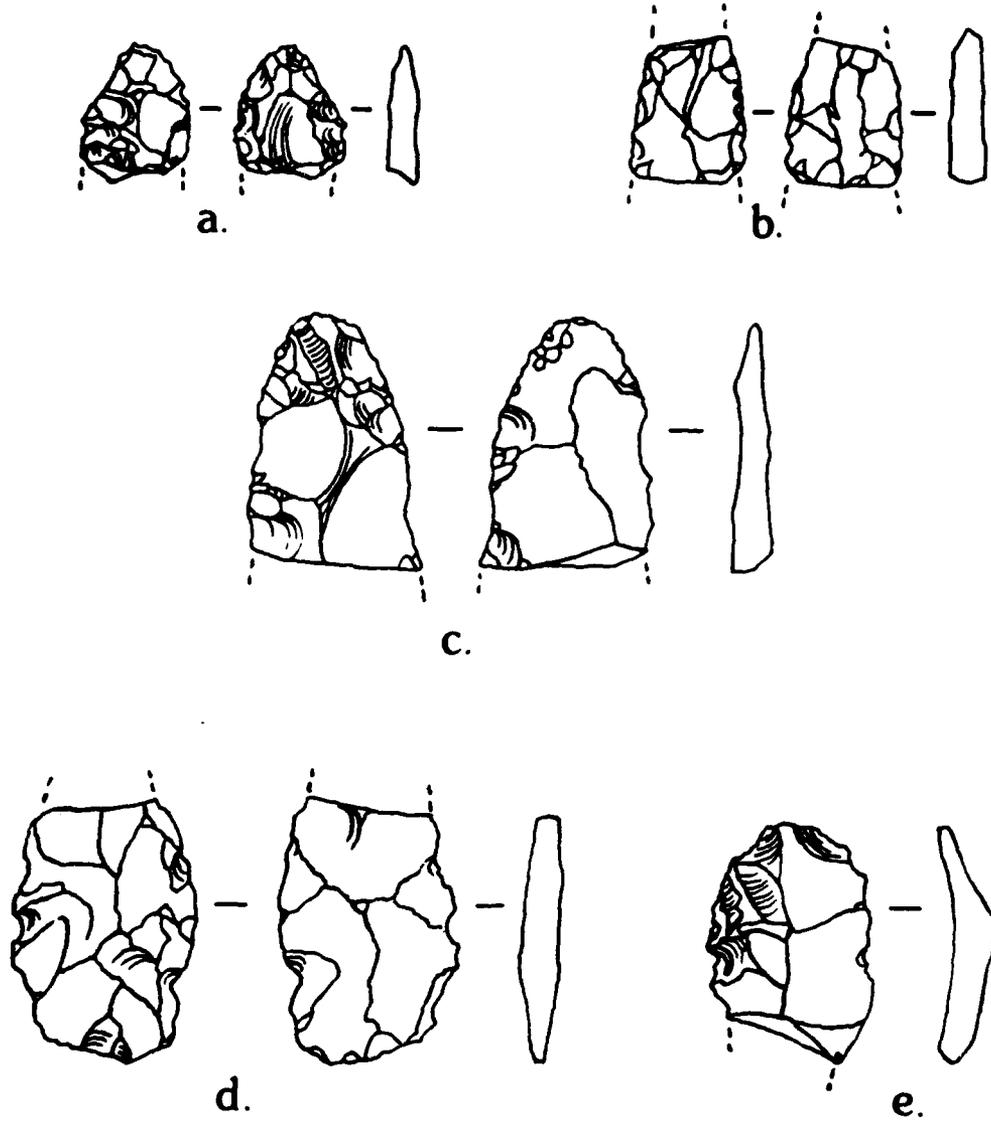
Figure 5. Lithic Artifacts from X-08. a) Biface tip; b) Biface medial fragment; c) Large biface tip; d,e) Scrapers.

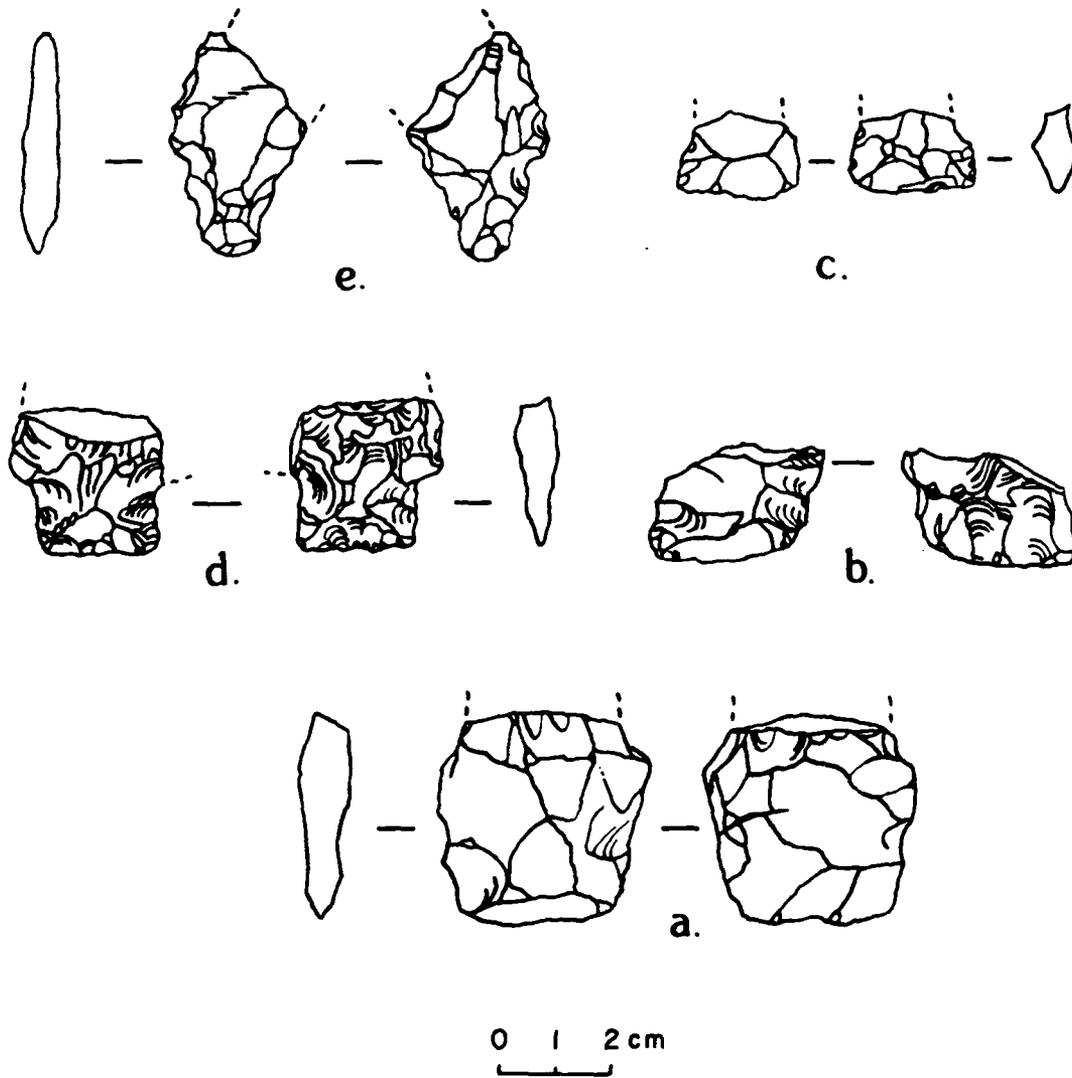
Figure 6. Lithic Artifacts from X-08. a) Large biface base; b,c,d) Large, flat point bases.
