NAVAL POSTGRADUATE SCHOOL

THESIS

**THE EFFECT OF AGING TREATMENT
ON THE MICROSTRUCTURE AND PROPERTIES
OF COPPER-PRECIPITATION
STRENGTHENED HSLA STEEL**

December 1988

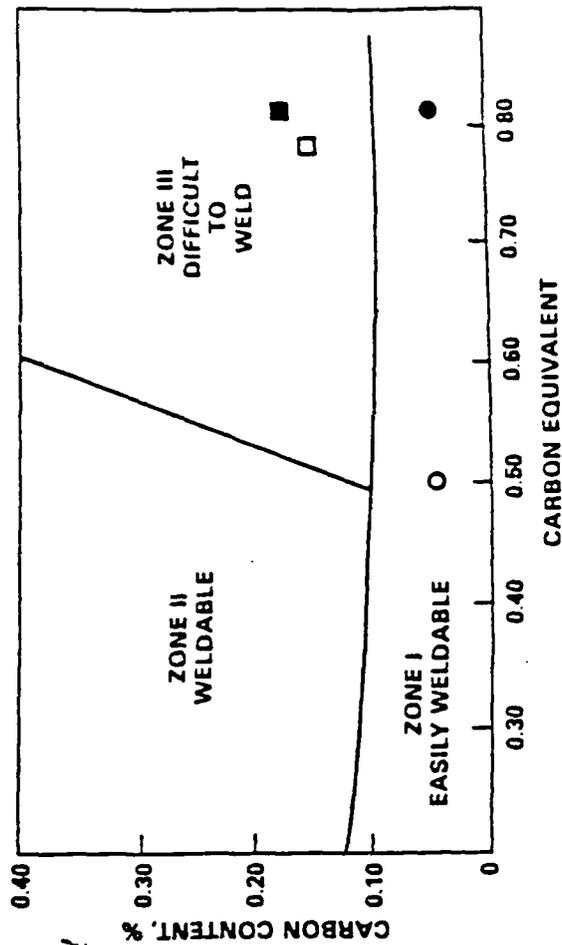
Figure 1. Graville Diagram—Weldability as a Function of Carbon Content and Carbon Equivalent for Some Shipbuilding Materials

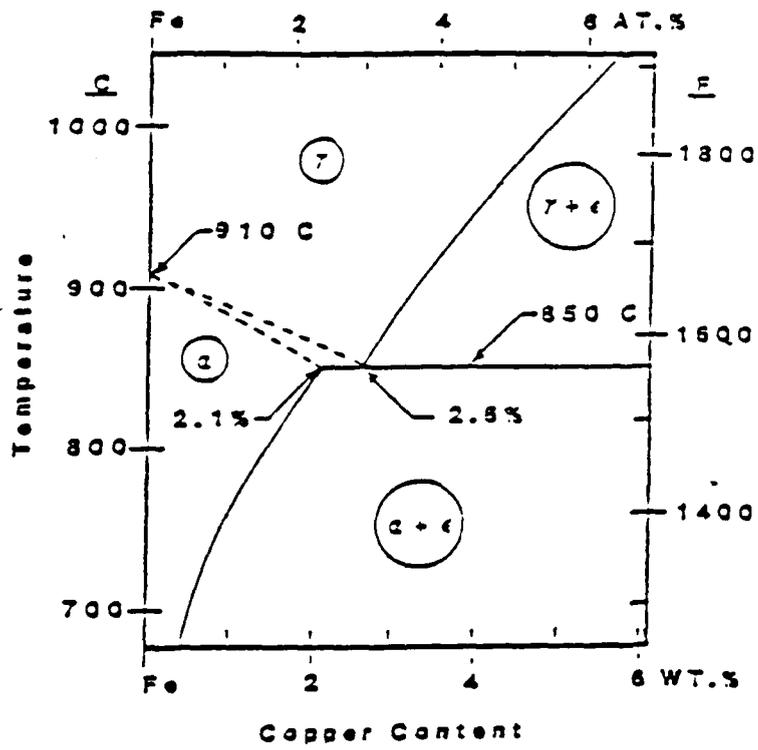
Figure 2. Iron-Rich Portion of Fe-Cu Phase Diagram

From Figure 2, it can be seen that upon cooling alloys of iron and copper, the products of the eutectoid reaction are epsilon phase FCC copper and alpha phase iron. The maximum solubility of copper in iron is 2.1 percent at approximately 850 C. Precipitation strengthening is possible because the solubility of copper in iron decreases as temperature decreases. Although very little information has been reported about the effect of copper on the transformation kinetics and hardenability of steels, it has been reported that copper lowers the M_s temperature slightly and delays the decomposition of austenite. [Ref. 14]

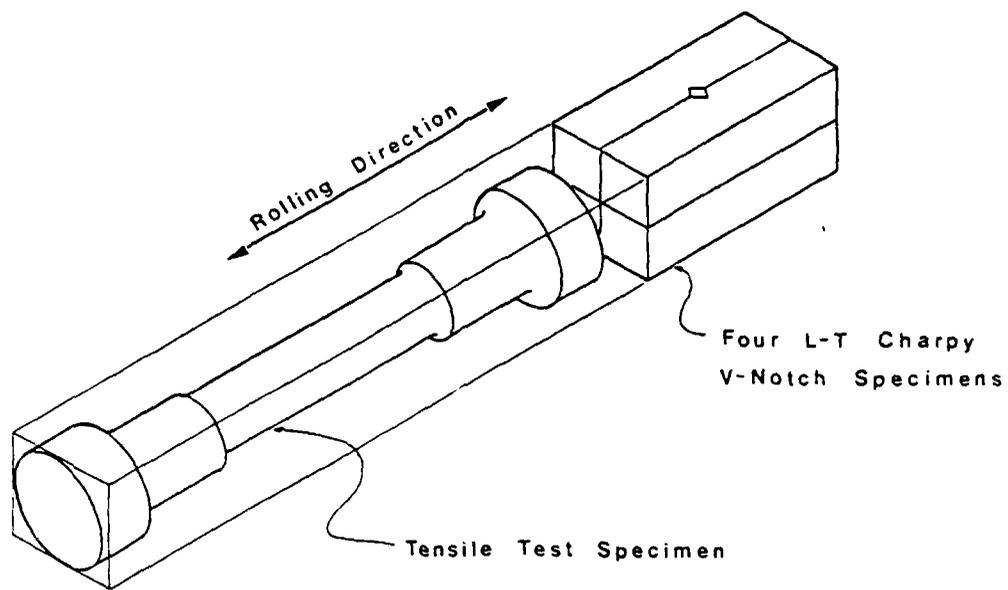
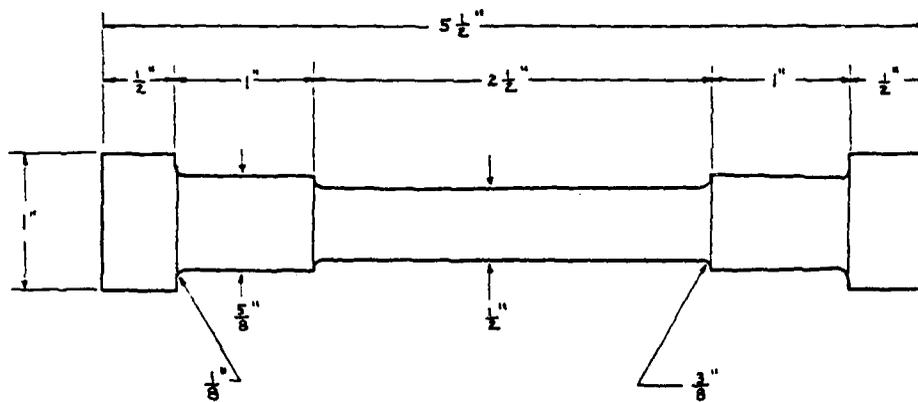
After heat treatment, the blanks were machined into round 12.7 mm diameter x 60 mm gage length tensile test specimens and 10 x 10 x 50 mm Charpy V-notch specimens (Figure 3). The blanks were cut in the rolling direction, as explained before, so that the tensile specimens were tested in that direction. The Charpy specimens were cut from the blanks such that they were fractured in the L-T orientation. Tensile testing was carried out at room temperature (20 C) at a strain rate of 7.41×10^{-4} per second on an Instron Model 6027 test apparatus with a Hewlett-Packard 3852A data acquisition control unit and a Hewlett-Packard 7475A plotter to determine strength and

Figure 3. (a) Schematic of Tensile and Charpy Specimens Cut from the Blanks; (b) Tensile Test Specimen

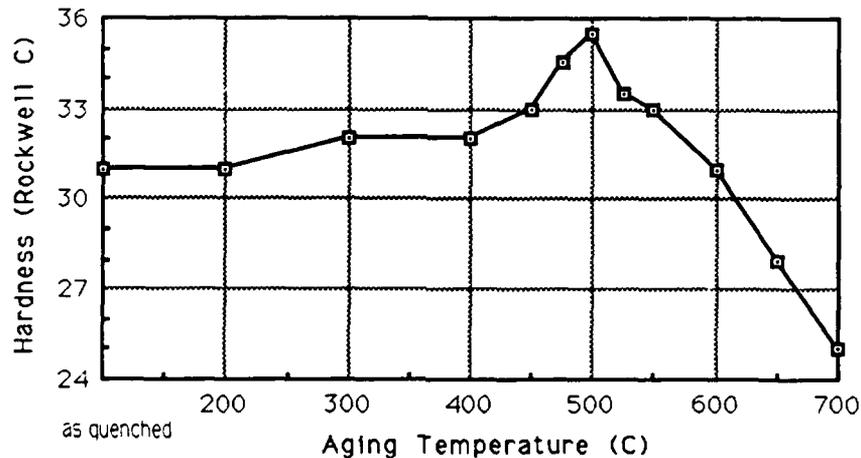
The variation of the Rockwell C hardness as a function of aging temperature is presented in Figure 4. The maximum hardness occurs near 500 C and the hardness decreases as the aging temperature is increased to 700 C. Goodman and coworkers observed [Ref. 8] that the peak strength is reached well before precipitation is complete. This encouraged the examination of overaged conditions of this steel. The subsequent aging was performed at temperatures from 500 C to 700 C in order to investigate HSLA-100 at its peak strength and in various overaged conditions.

Figure 4. The Effect of Aging Temperature on Hardness

In this research, a maximum hardness and strength was reached at the 500 C aging temperature (Figures 4, 5). Although aging of the matrix reduced the number of dislocations as recovery took place (Figures 20, 24), dislocation density still provided a portion of the strengthening of HSLA-100 after this aging condition. The observations of Goodman [Ref. 9] indicate that fine (24 Å) copper provides significant strengthening at this temperature. The high hardness and strength values of this investigation support Goodman's work.

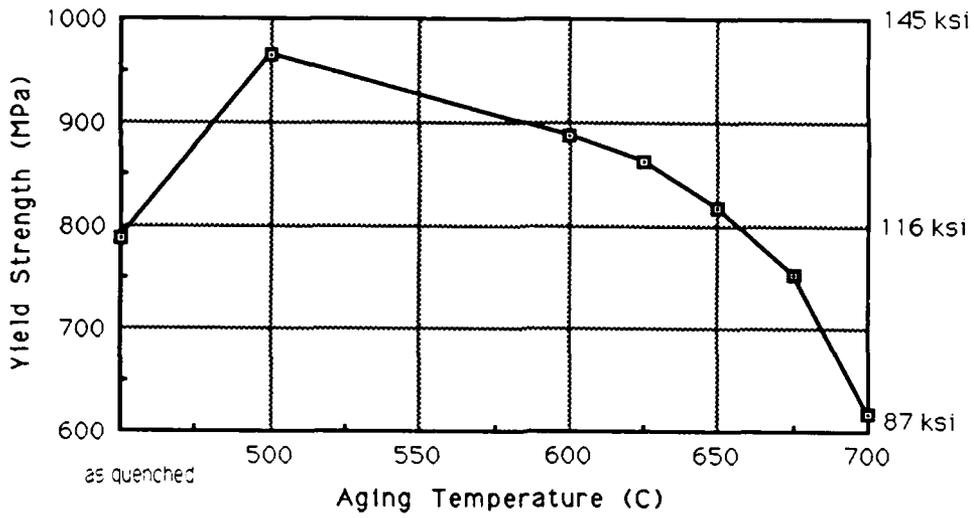
Figure 5. The Effect of Aging Temperature on Yield Strength

Two major factors contribute to the lower strength after the 650 C aging temperature (Figures 5, 6). After 650 C aging, the copper precipitates were coarser (100–600 Å), providing less strengthening effect than did the fine (24 Å) copper precipitates [Ref. 9]. Dislocations provided less strengthening than after 500 C aging because dislocation recovery was more advanced. A rod-like growth in the coarser copper particles, as was found by Hornbogen [Ref. 6] and Speich [Ref.7], can be seen at this temperature (Figure 22).

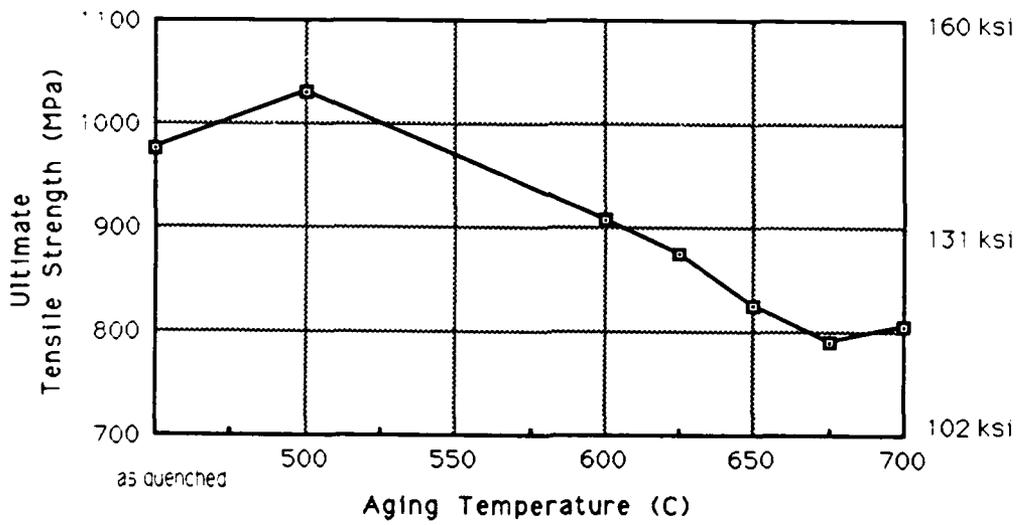
Figure 6. The Effect of Aging on Ultimate Tensile Strength

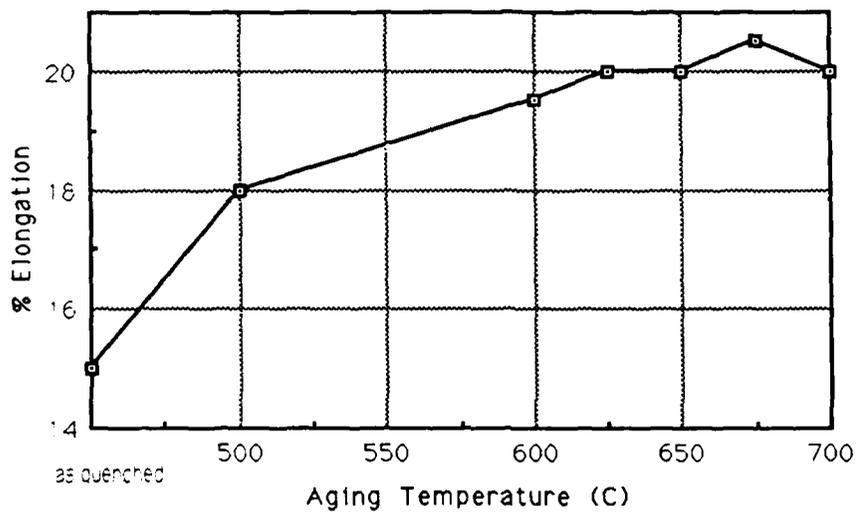
The effects of aging temperature on ductility can be seen in Figure 7. As this figure shows, the ductility of HSLA-100 increases as the aging temperature is increased, reaching a maximum value near an aging temperature of 675 C. Above the 675 C aging temperature, the ductility begins to decline. The variation of ductility and strength from the 675 C to 700 C aging temperatures implies a significant microstructural change in this temperature range. The results of the Charpy impact tests are summarized in Table 3. For better clarity, Figure 8 displays the variation of impact energy with aging temperature for each of the three fracture temperatures. As the testing temperature is lowered, the impact energy decreases. At all aging temperatures, with the exception of the 500 C temperature, HSLA-100 exhibits a

Figure 7. The Effect of Aging Temperature on Ductility

The occurrence of the eutectoid temperature near 680 C may explain the alteration in the mechanical properties which occurred at this point. Figure 7 shows that HSLA-100 is most ductile after the 675 C aging temperature, but the ductility decreases after 700 C aging. This may be attributed to the formation of a significant number of martensite/austenite particles formed during the 700 C aging. The martensite/austenite microconstituent can be more brittle than the ferrite matrix, which caused a reduction in ductility.

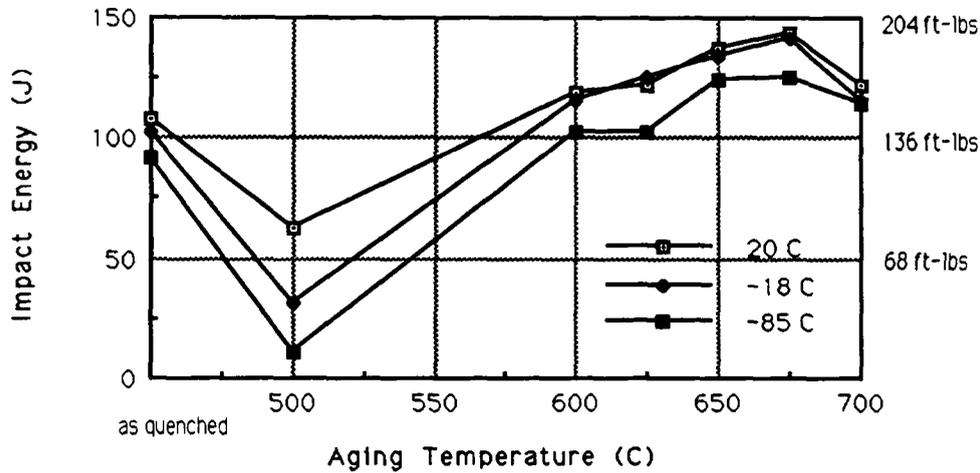
Figure 8. The Effect of Aging Temperature on Notch Toughness

high-impact energy. Impact energies for all of the samples except the 500 C aging temperature exceed the Navy requirements of 26 J (35 ft-lbs) at -85 C (-120 F) and 44 J (60 ft-lbs) at -18 C (0 F).

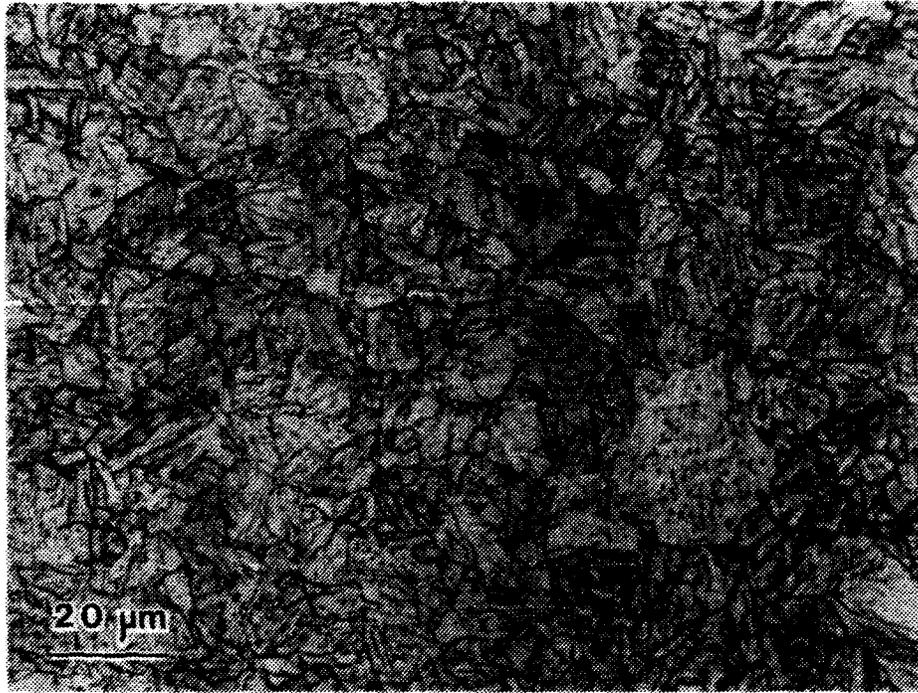
A light micrograph of the 500 C aged material is shown in Figure 15. The individual laths are not readily resolved by the etching technique in this micrograph, but the particles appear similar to the as-quenched material. Figure 16 shows a transmission electron micrograph of the lath structure. The high dislocation density is apparent by

Figure 15. Light Micrograph of 500 C Aged Material, Nital Etch

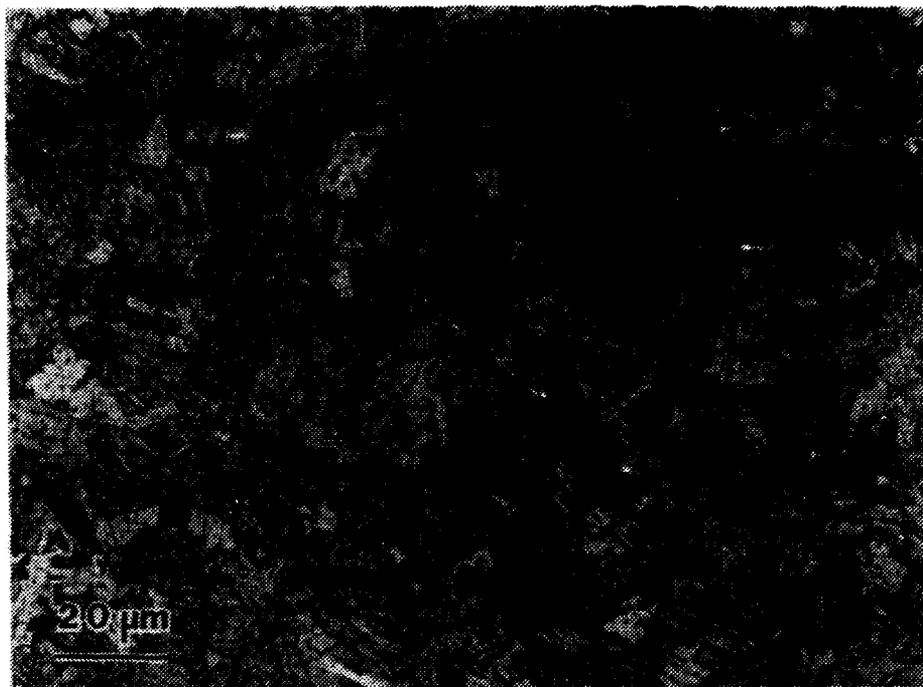
The light micrograph of 650 C aged material does not reveal any significant differences when compared with the previous conditions (Figure 19). A closer examination of the lath structure in Figure 20 again shows a high density of dislocations. In the area between the laths (A), microconstituents are visible which are probably martensite/austenite. Figure 21 illustrates a large ferrite area with the surrounding lath structure. A uniform distribution of copper particles is visible throughout the ferrite matrix in this figure. These copper particles have diameters from 100 to 300 Å, although many small copper particles are not observable. Coarse copper precipitates are found in localized regions and are prominent in Figure 22. Measurement of these precipitates shows diameters ranging from 200 to 600 Å.

Figure 19. Light Micrograph of 650 C Aged Material, Picral Etch

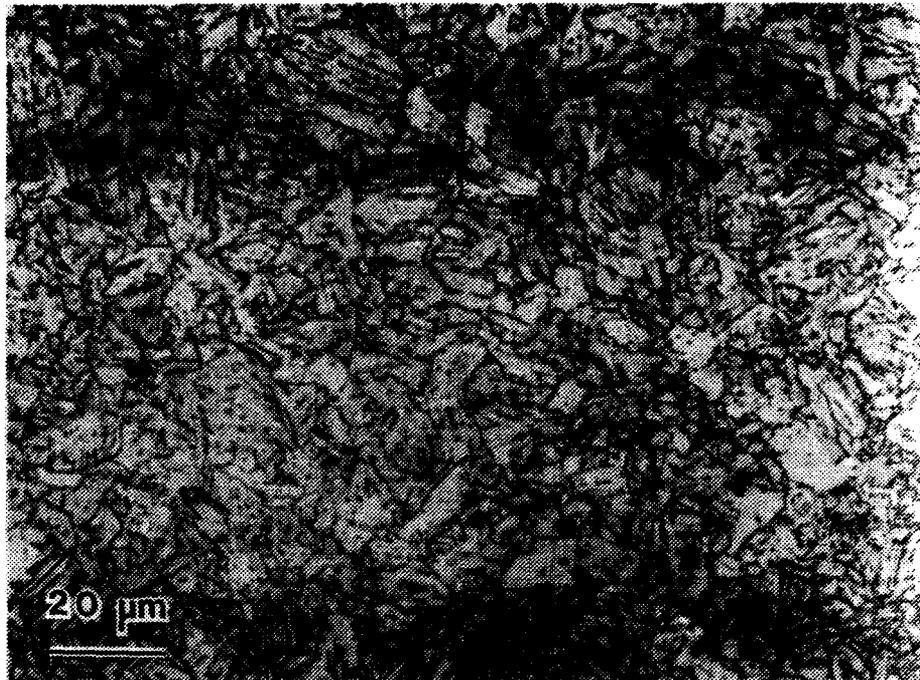
Figure 23, a light micrograph of the material aged at 700 C, shows that more precipitate particles are visible than were seen at the lower aging temperatures. The dark area at the bottom of Figure 23 indicates some banding effect, possibly caused by manganese segregation [Ref. 2]. An examination of the lath structure in Figure 24 shows a low dislocation density, copper precipitates, and the presence of large amounts of a microconstituent. The microconstituent, which is also visible in Figure 25, was identified as martensite/austenite, which is distributed along the ferrite laths and the grain boundaries. The diffraction patterns for the martensite/austenite particles indicate that the majority of them contain microtwins. These microtwins are visible at T in Figure 26. Figure 27 is a bright field and dark field micrograph which shows a group of coarse copper particles that are as large as 1,000 Å in diameter.

Figure 23. Light Micrograph of 700 C Aged Material, Nital Etch

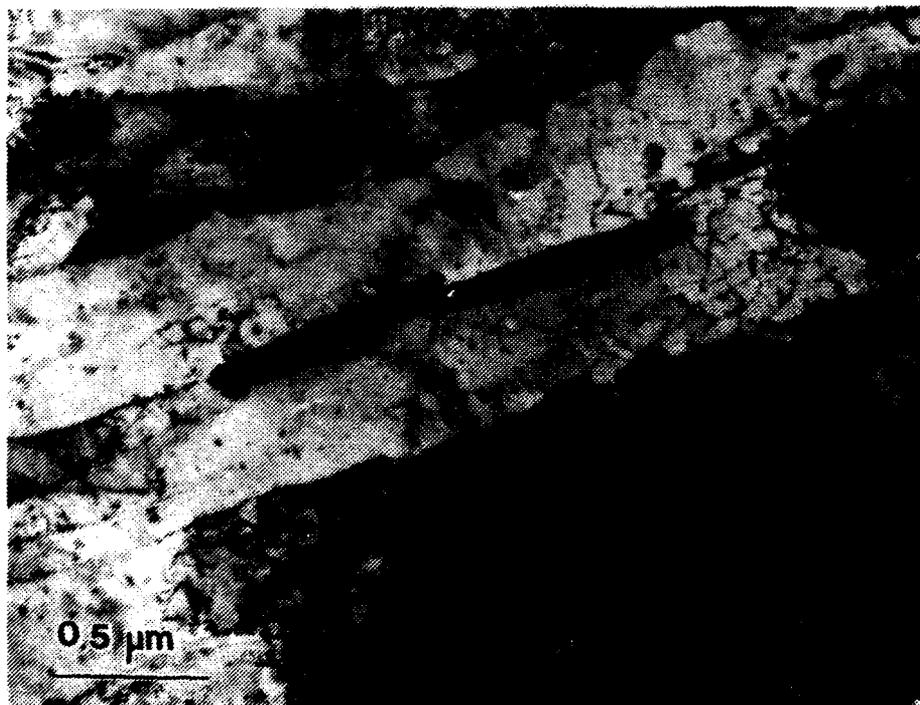
Figure 24. TEM Micrograph of Martensite/Austenite Particles, 700 C Aged Material

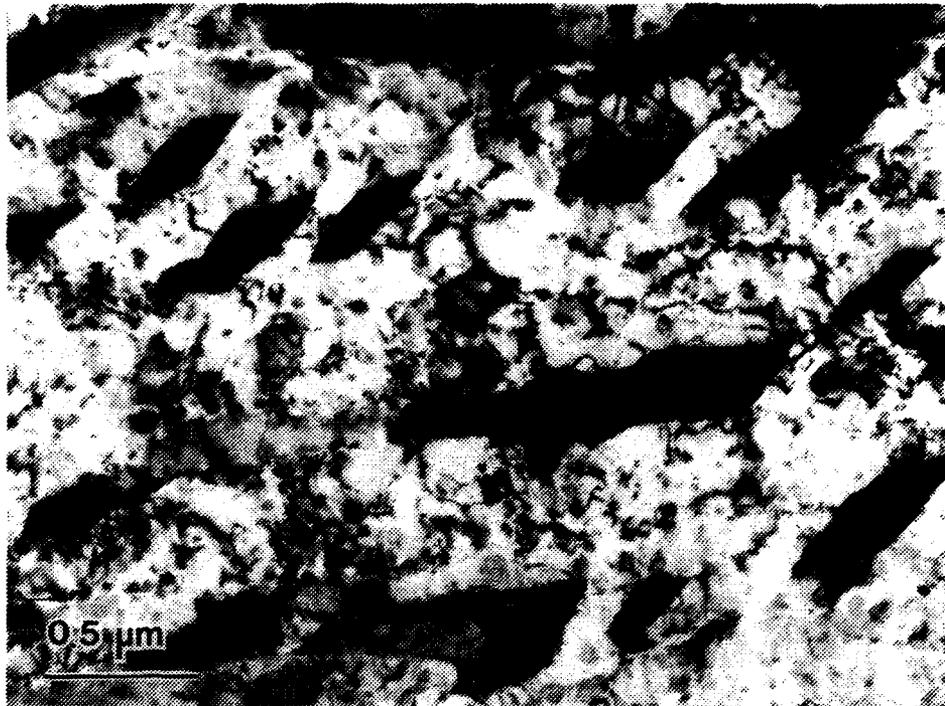
Figure 25. TEM Micrograph of Martensite/Austenite Particles, 700 C Aged Material

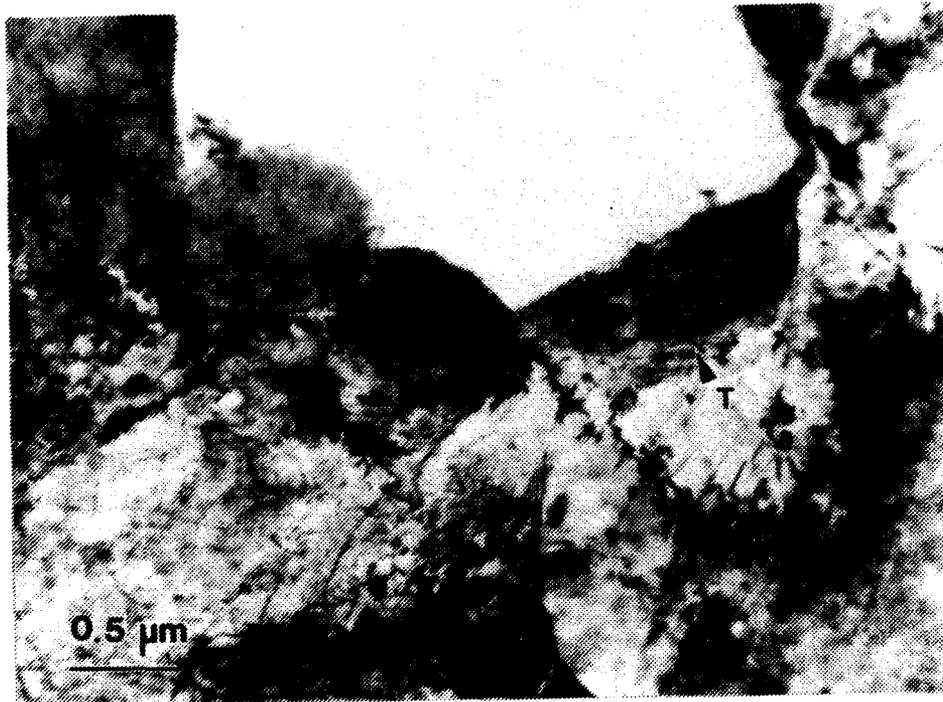
Figure 26. TEM Micrograph Showing Twins (T), 700 C Aged Material

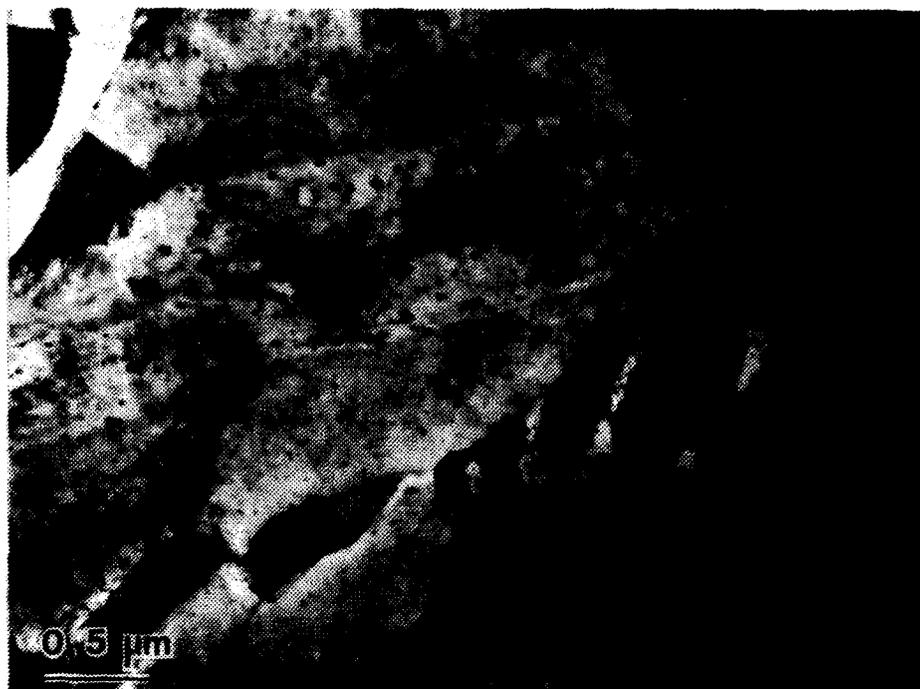
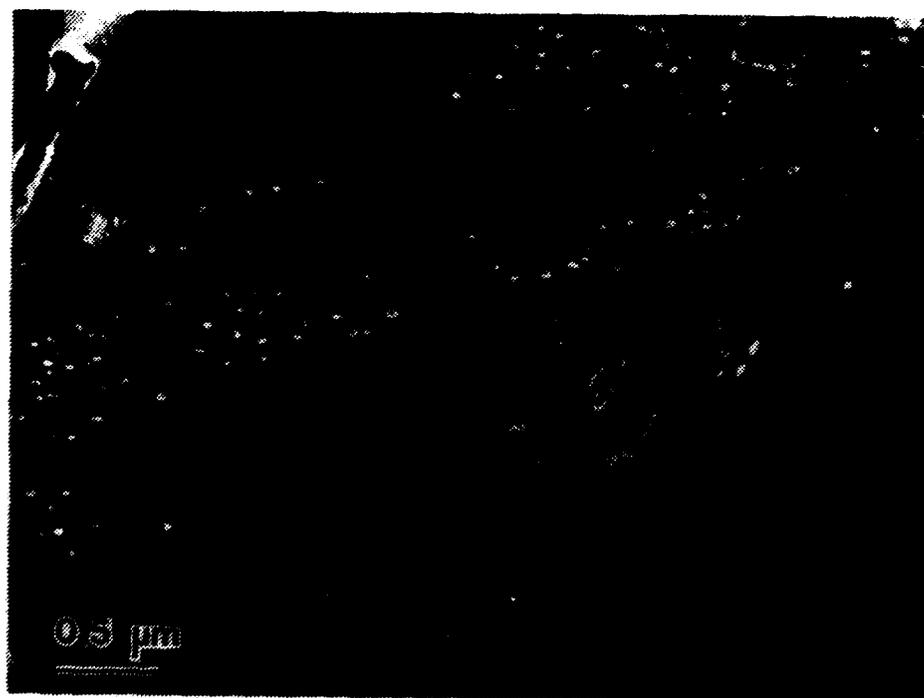
Figure 27. TEM Bright Field/Dark Field Micrographs Showing Coarse Copper Particles

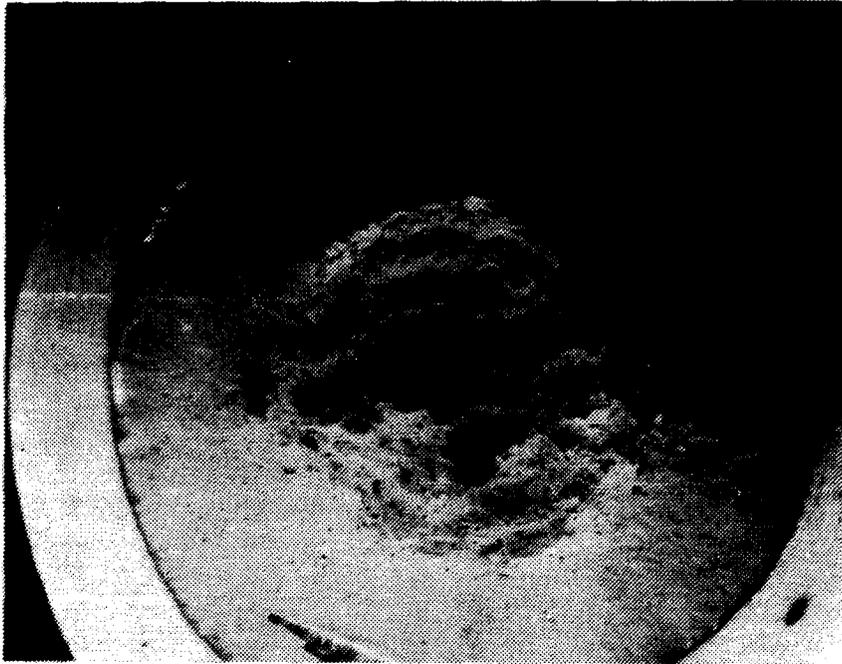
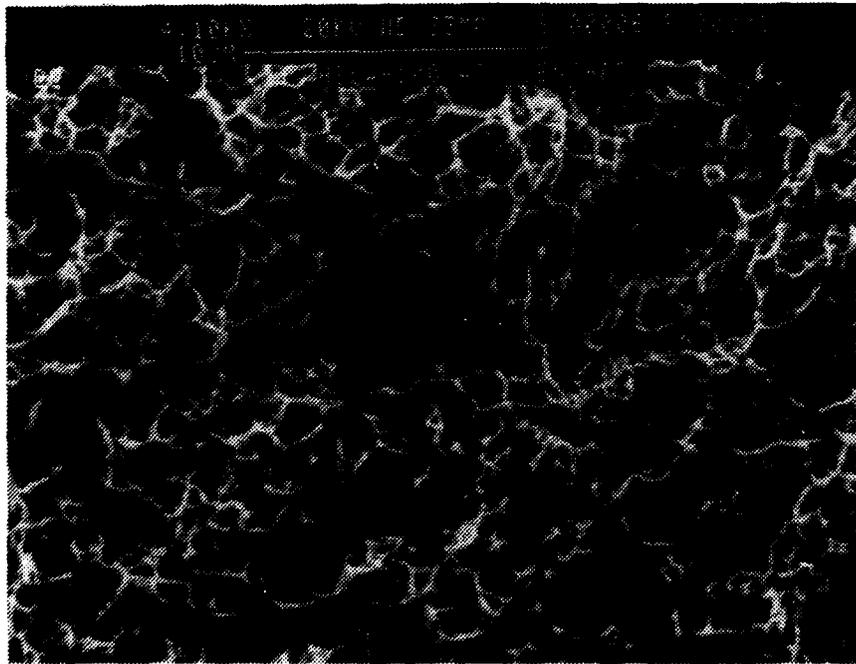
Tensile tests showed that all samples failed in a ductile manner. Figure 28, which shows the tensile fracture surface of HSLA-100 in the as-quenched condition, indicates failure by microvoid coalescence. The classic cup and cone fracture is indicative of a highly ductile condition for this material. The 500 C aged material (Figure 29) exhibits multiple splits in the rolling direction. Although the reasons for this behavior are not precisely understood, various possible causes

Figure 28. SEM Micrograph of As-Quenched Tensile Fracture Surface

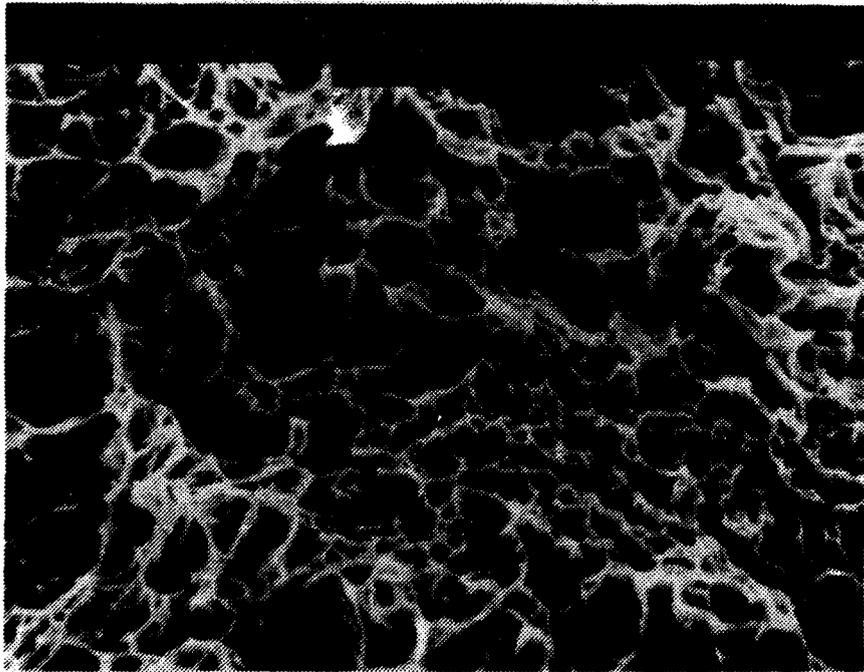
**Figure 29. SEM Micrograph of 500 C Aging Temperature
Tensile Fracture Surface**

occurs at the aging temperatures from 500 C to 675 C (Figures 29, 30). Although previous work [Refs. 21, 22] has associated the splitting with cementite precipitates on the ferrite boundaries, cementite is not present in significant amounts in this steel. The actual causes of splitting are the subject of some controversy. Apparently, the elongation of grains in the rolling direction, segregation of impurities along the grain boundaries, and the development of an unfavorable crystallographic texture all have an influence on splitting. The presence of splitting did not seem to have an adverse effect on this material's mechanical properties but is an area that needs further investigation.

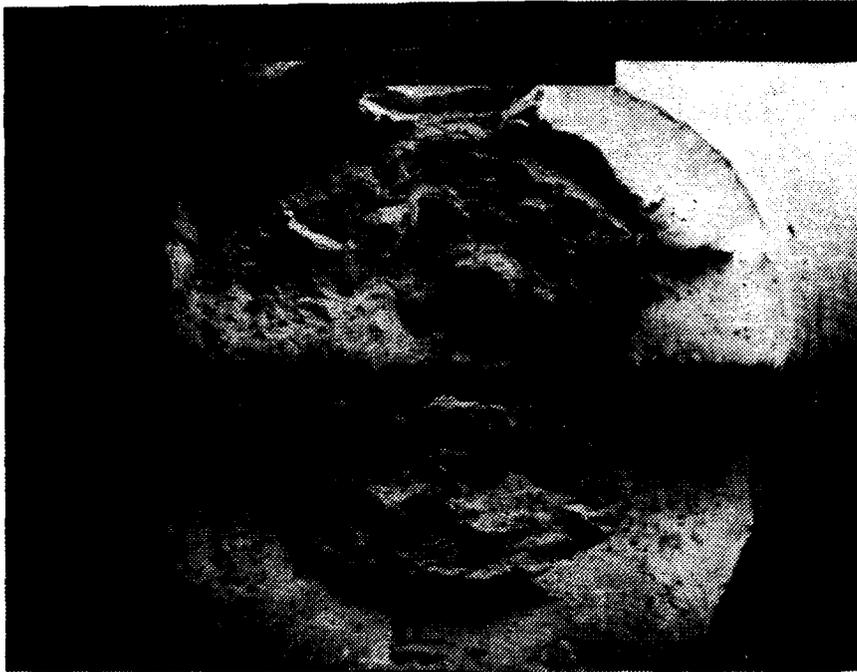
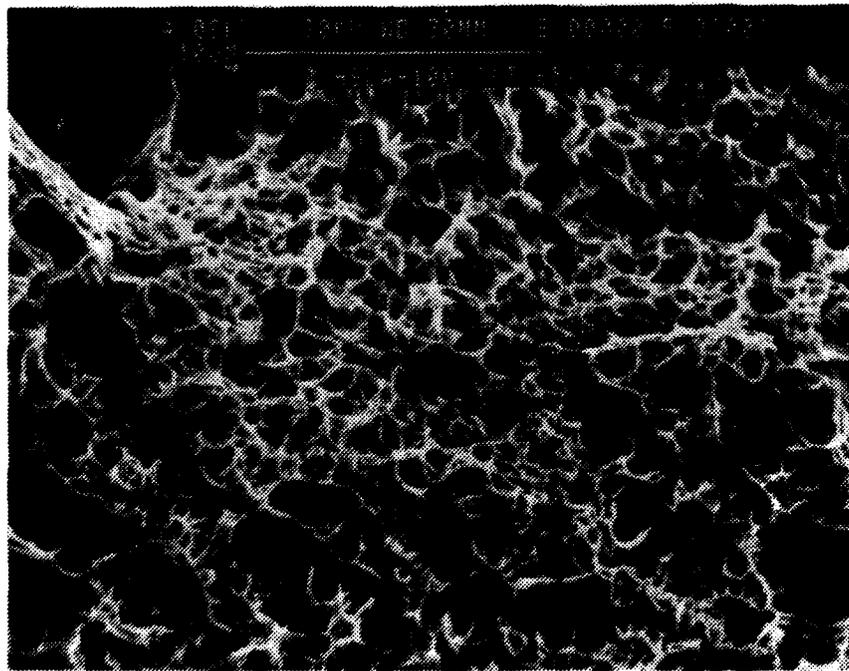
**Figure 30. SEM Micrograph of 650 C Aging Temperature
Tensile Fracture Surface**

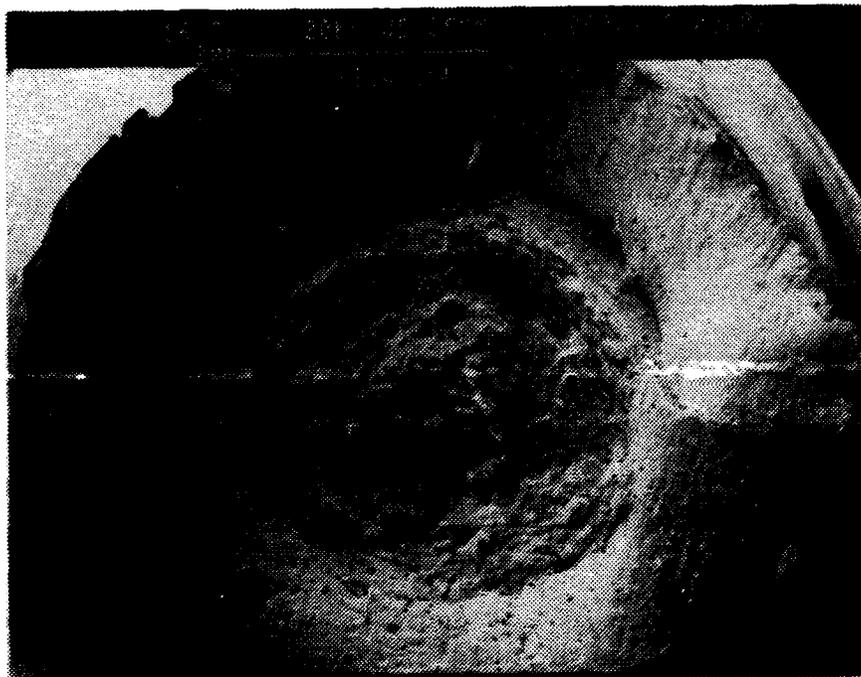
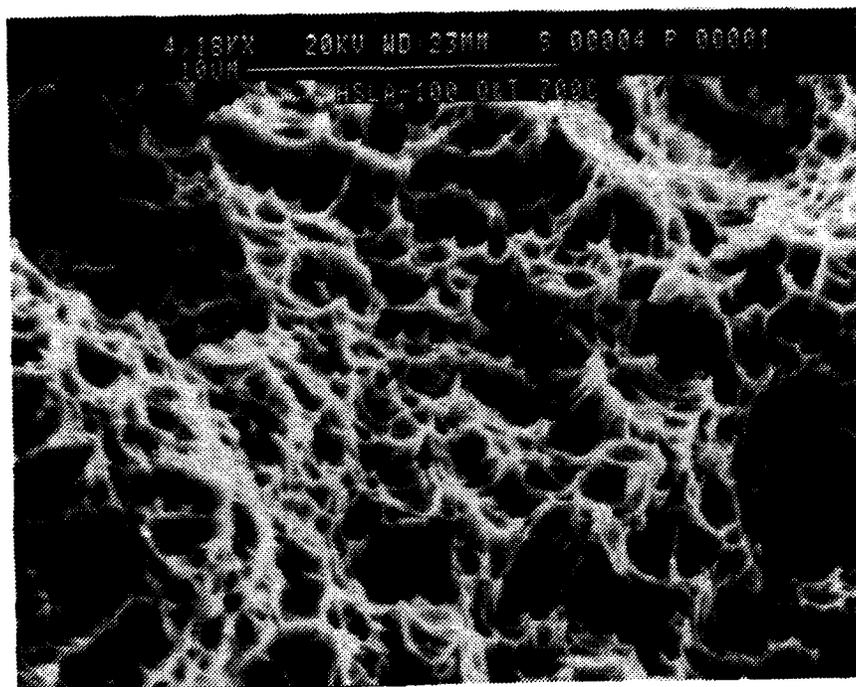
Figure 31. SEM Micrograph of 700 C Aging Temperature Tensile Fracture Surface

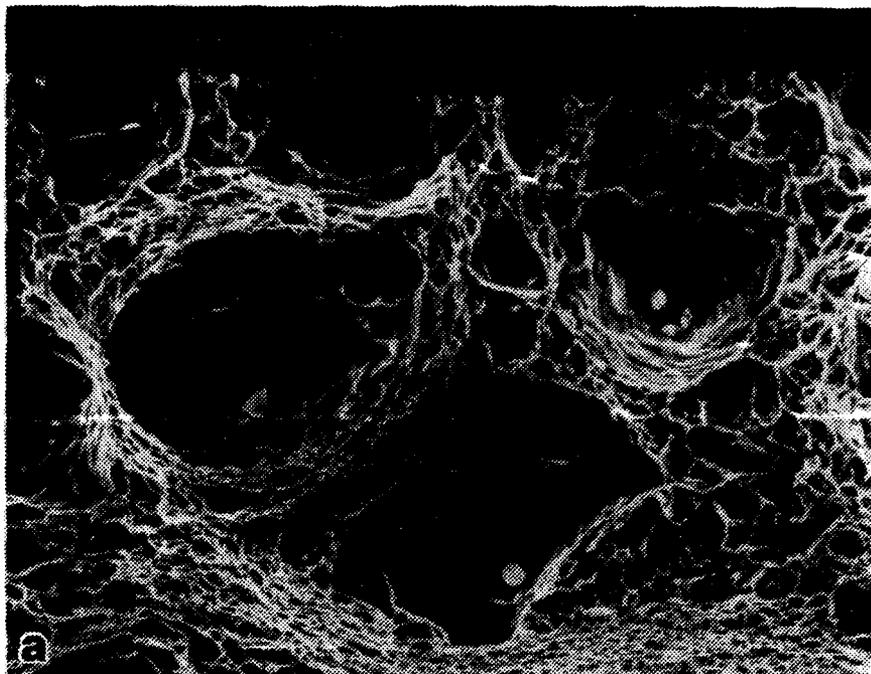
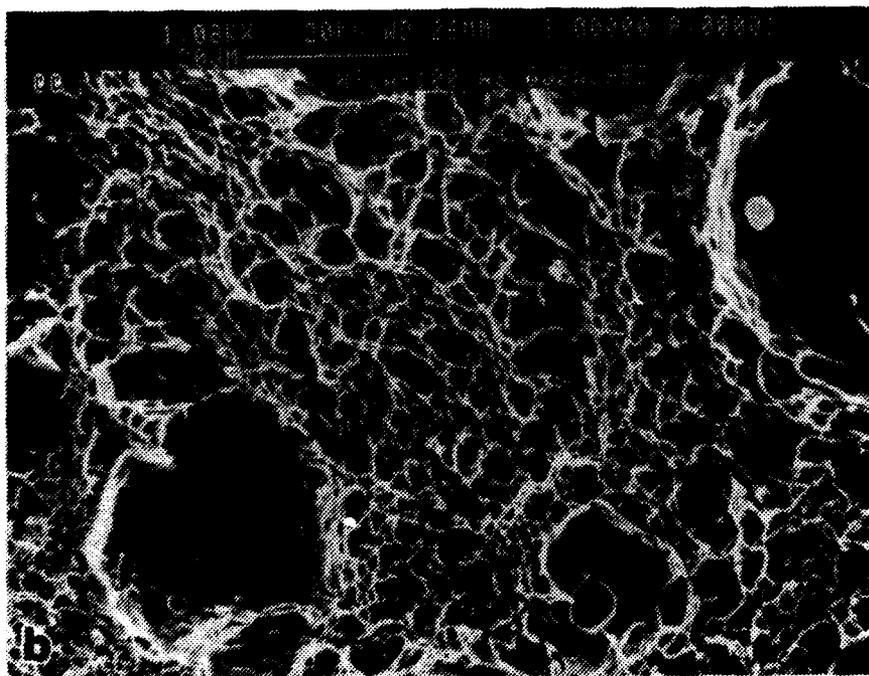
The Charpy fracture surfaces in Figure 32 for the as-quenched material at 20 C and -85 C temperatures show inclusions which act as microvoid nucleation sites. Both temperatures show the dimples of a ductile fracture and are quite similar. The 500 C aged material (Figure 33) is the only condition which exhibits quasicleavage fracture characteristics in this Charpy testing. The room temperature (20 C) specimen shows both cleavage and small amounts of ductile tearing. The specimen fractured at -85 C is essentially a brittle fracture, although it has some very small areas where ductile tearing has taken place. The 650 C aged material (Figure 34) shows numerous inclusions and ductile tearing at both temperatures. The 700 C aged material (Figure 35) also indicates ductile tearing with large dimples

**Figure 32. Charpy V-Notch Fracture Surface,
As-Quenched Material
(a) Fractured at -85 C; (b) Fractured at 20 C**

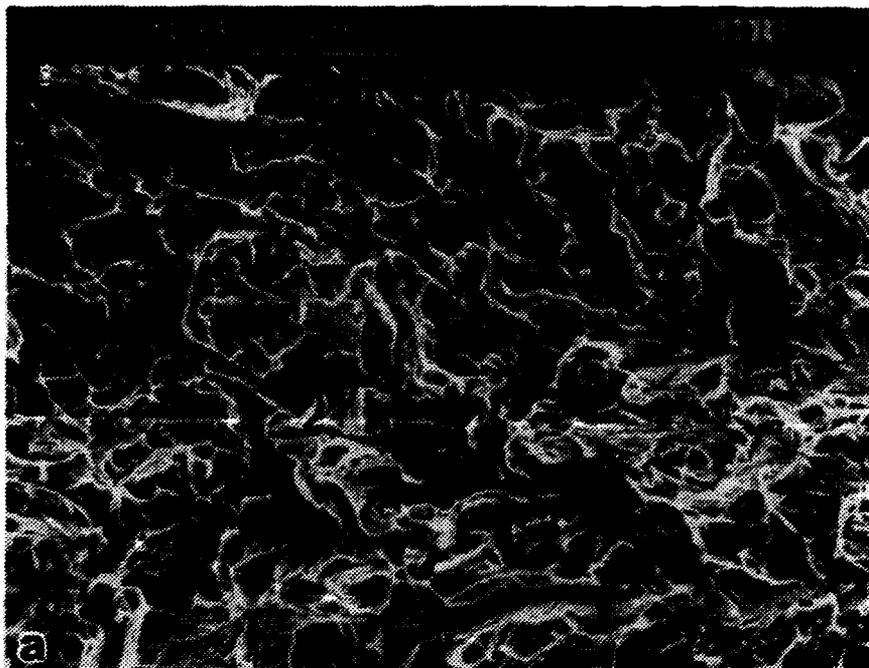
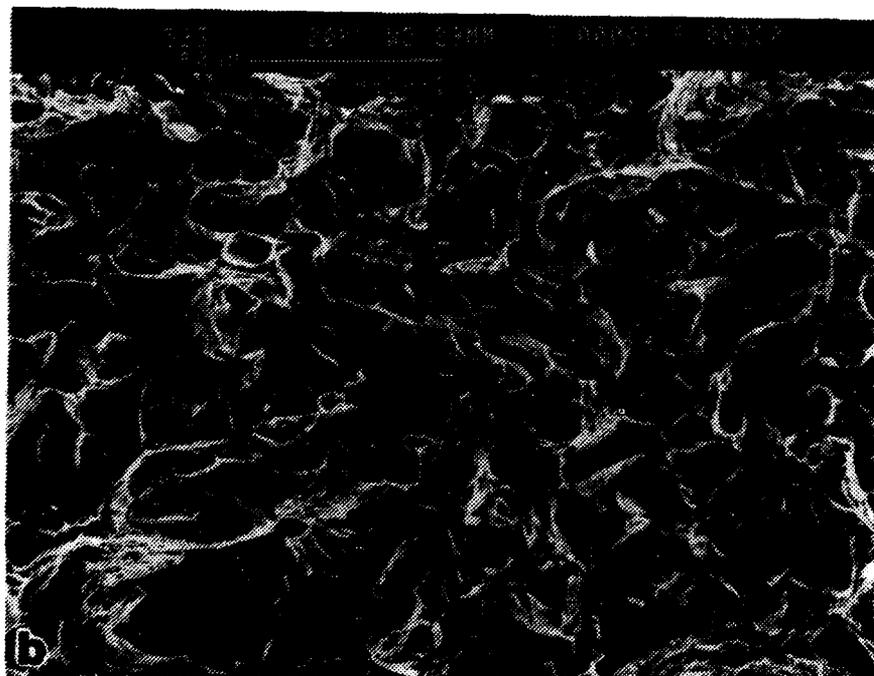
**Figure 33. Charpy V-Notch Fracture Surface,
500 C Aged Material
(a) Fractured at -85 C; (b) Fractured at 20 C**

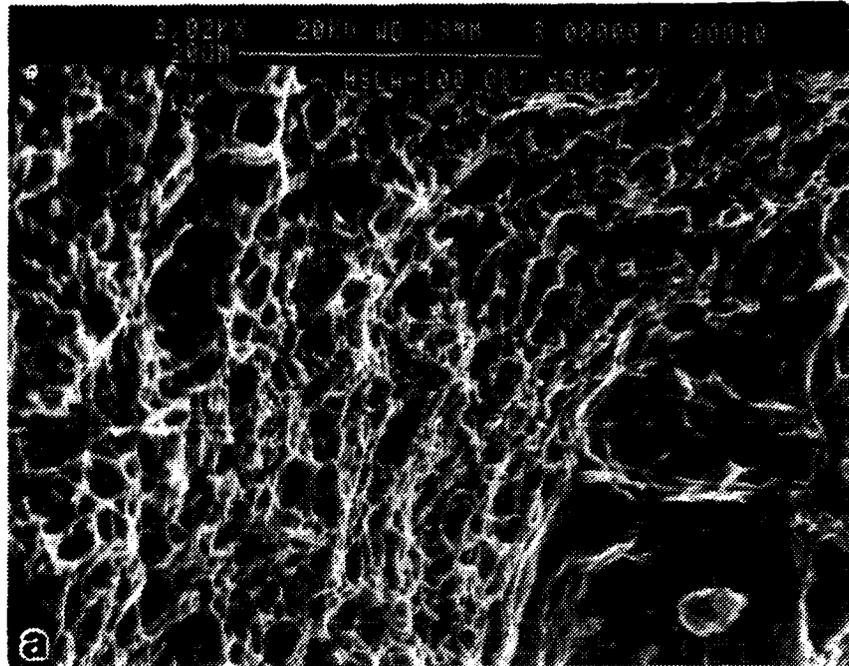
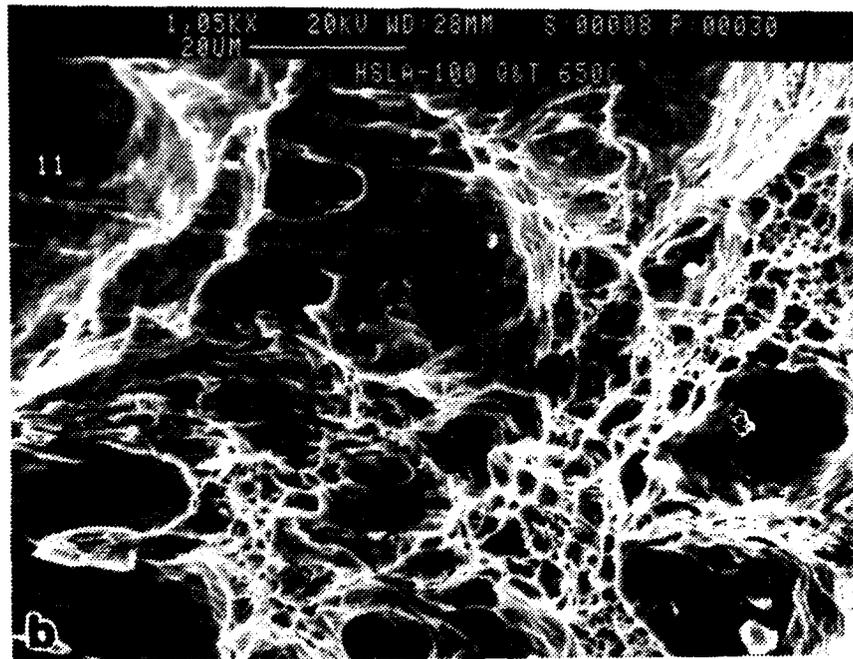
**Figure 34. Charpy V-Notch Fracture Surface,
650 C Aged Material
(a) Fractured at -85 C; (b) Fractured at 20 C**

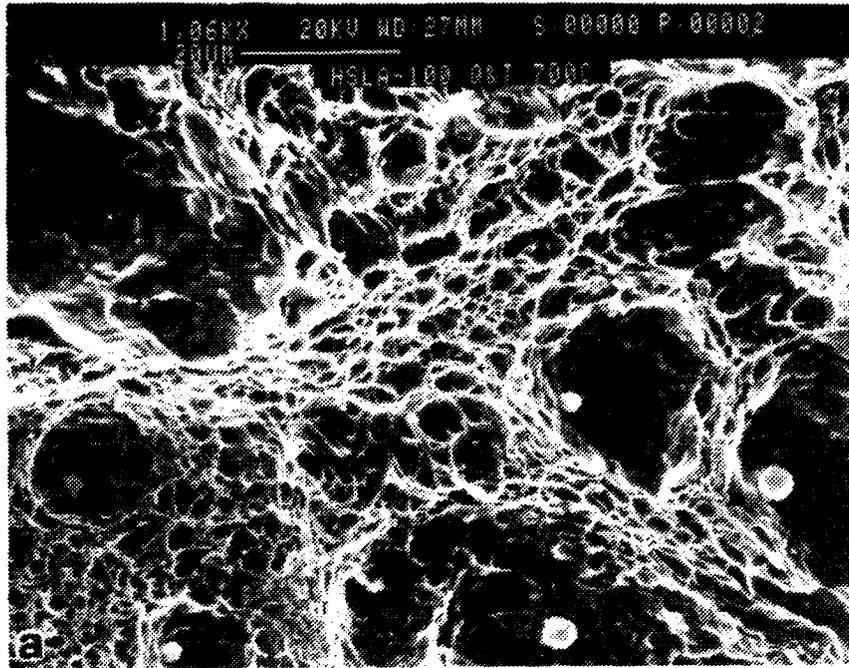
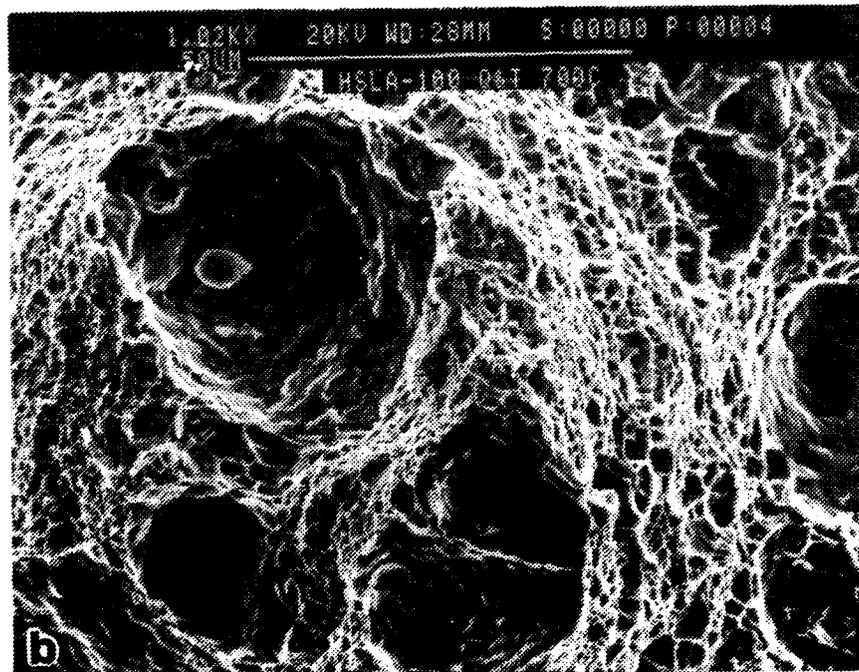
**Figure 35. Charpy V-Notch Fracture Surface,
700 C Aged Material
(a) Fractured at -85 C; (b) Fractured at 20 C**

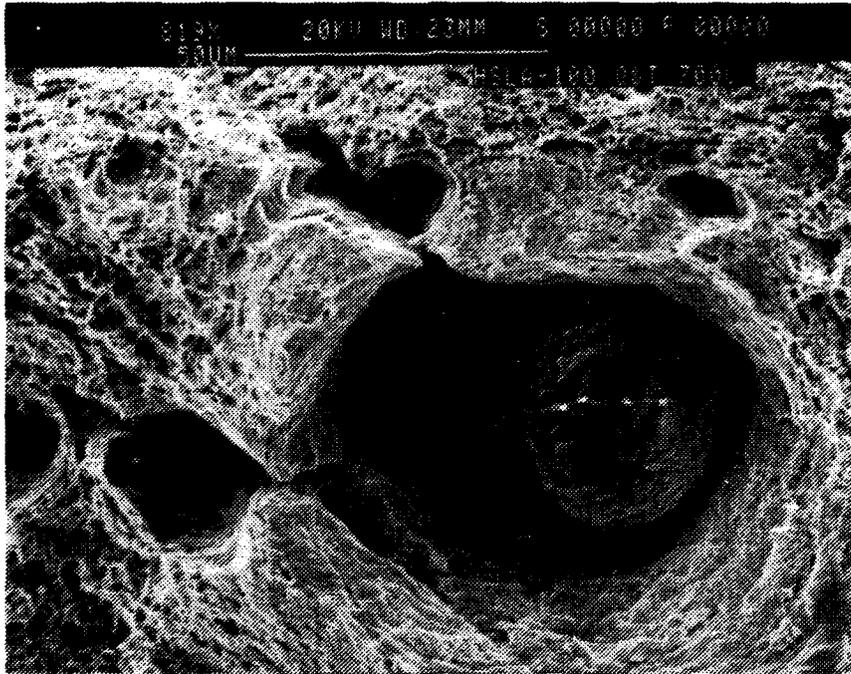
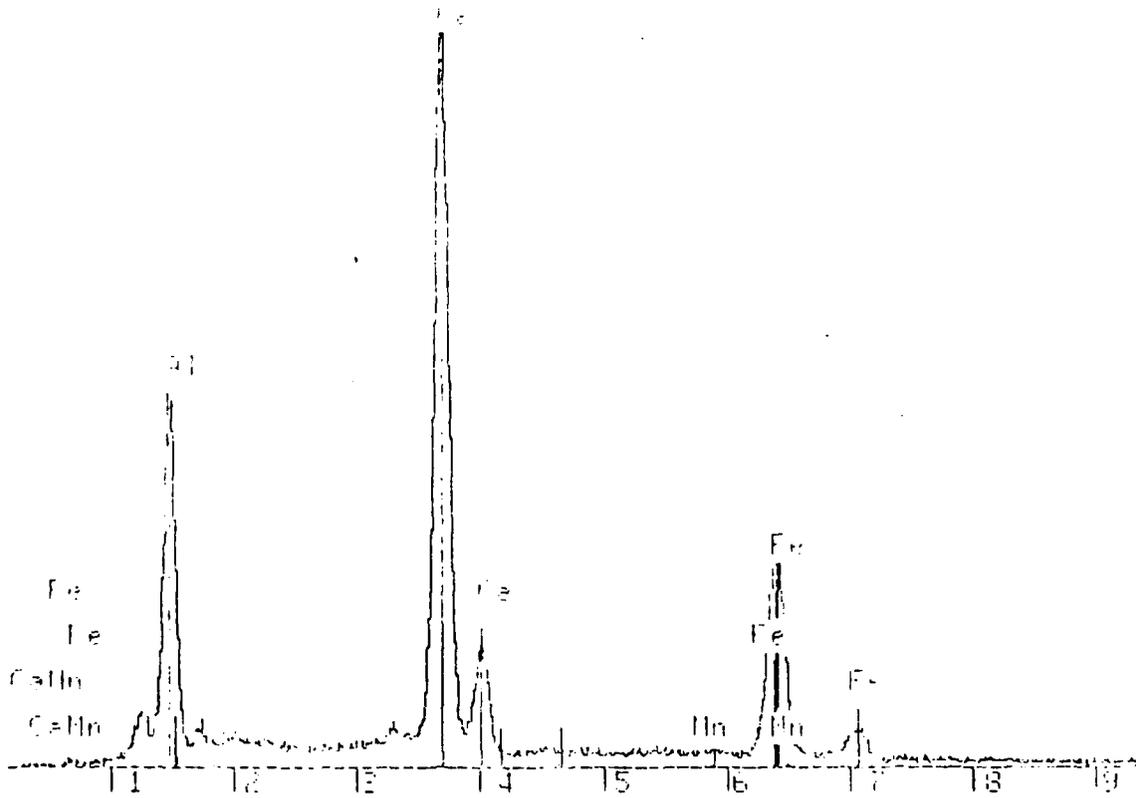
A number of inclusion particles was selected for chemical analysis. The analysis of one particle is shown in Figure 36. This indicates that the inclusion particles are likely to be calcium sulfide. Calcium sulfide inclusions may be caused by the addition of calcium in the manufacturing process.

Figure 36. KEVEX Analysis of Chemical Composition of Inclusion, 700 C Aged Material
