NAVAL POSTGRADUATE SCHOOL

THESIS

**THE EFFECT OF AGING TREATMENT
ON THE MICROSTRUCTURE AND PROPERTIES
OF COPPER-PRECIPITATION
STRENGTHENED HSLA STEEL**

December 1988

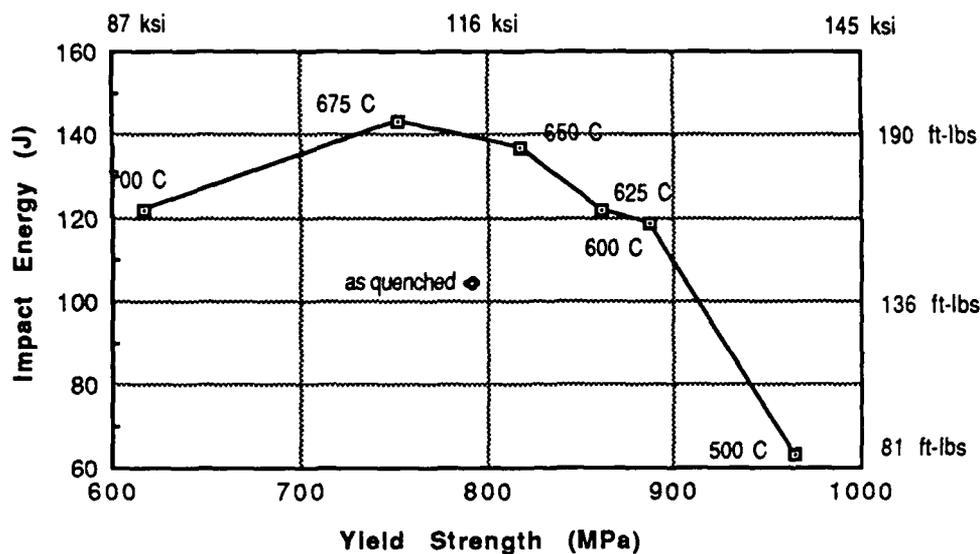
Figure 37. **The Relationship of Notch Toughness and Yield Strength**

illustrates the relationship of the impact energy and the yield strength for various aging temperatures. The 675 C aging temperature provided the greatest ductility while meeting the Navy strength requirements (see Appendix). If, however, the HSLA-100 eutectoid temperature is in fact near 680 C, the use of 675 C as an optimum aging temperature for processing would not be advisable. Variations in temperature could easily allow the steel to move into the two-phase region above the eutectoid temperature and mechanical properties would become much less predictable.

As indicated in previous work [Refs. 3, 8, 9], the most desirable strength and ductility properties for low carbon copper precipitation strengthened steels are reached in an overaged condition. Figure 37
