NATIONAL COMMUNICATIONS SYSTEM

TECHNICAL INFORMATION BULLETIN

THE EFFECTS OF HIGH-ALTITUDE
ELECTROMAGNETIC PULSE (HEMP) ON THE
NORTHERN TELECOM INC.
DMS-100™ SWITCH

TEST PROGRAM

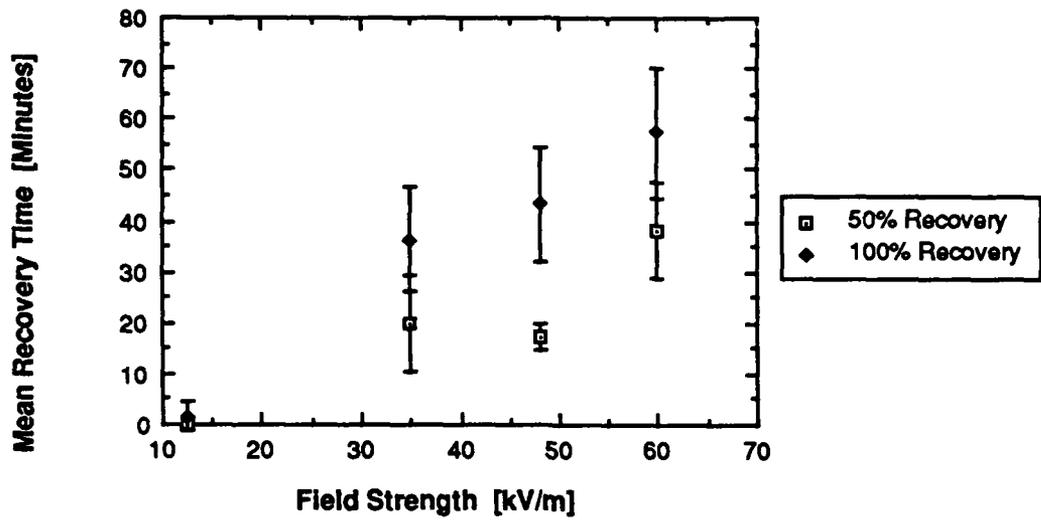
Figure 2-1. Summary of Mean Recovery Times Under HDL Simulators

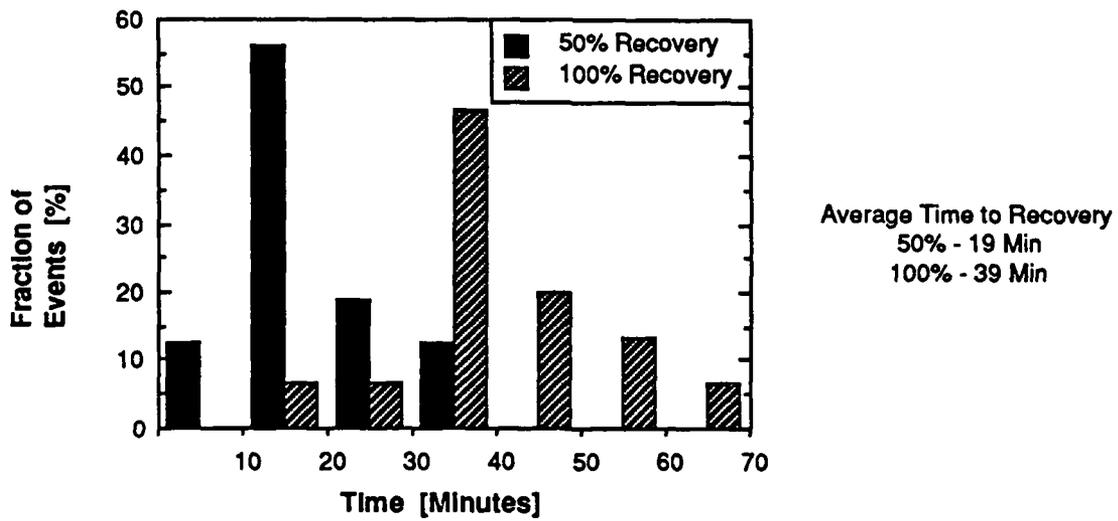
Figure 2-2. Recovery Time Distribution for Medium HEMP Stresses (30-50 kV/m)

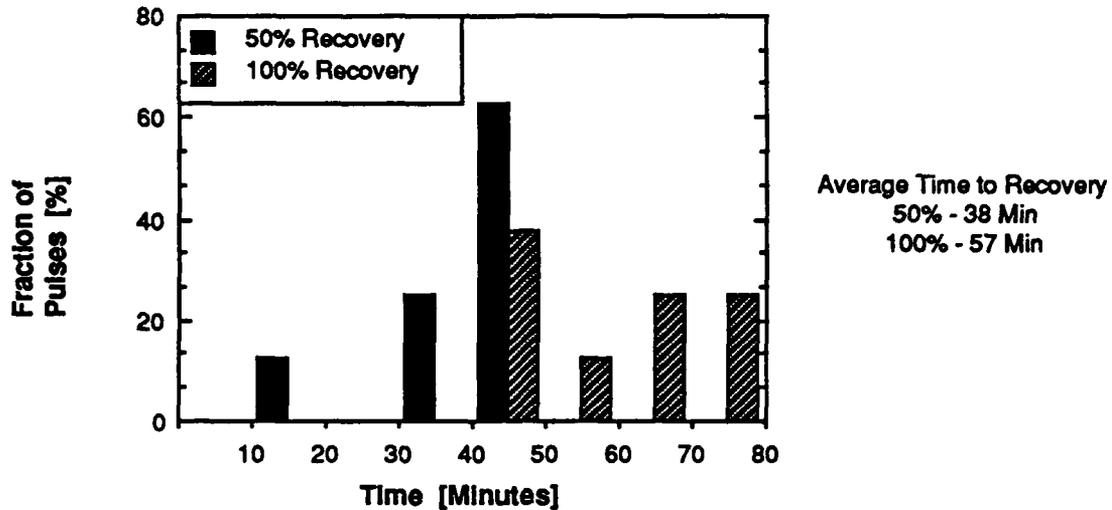
Figure 2-3. Recovery Time Distribution for High HEMP Stresses (50-70 kV/m)

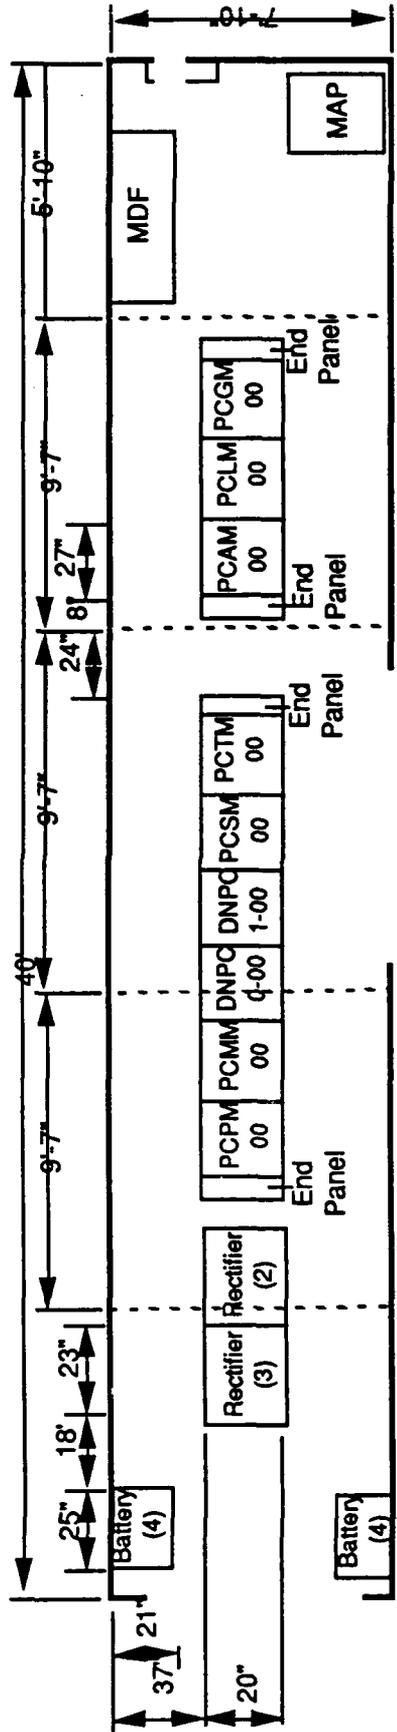
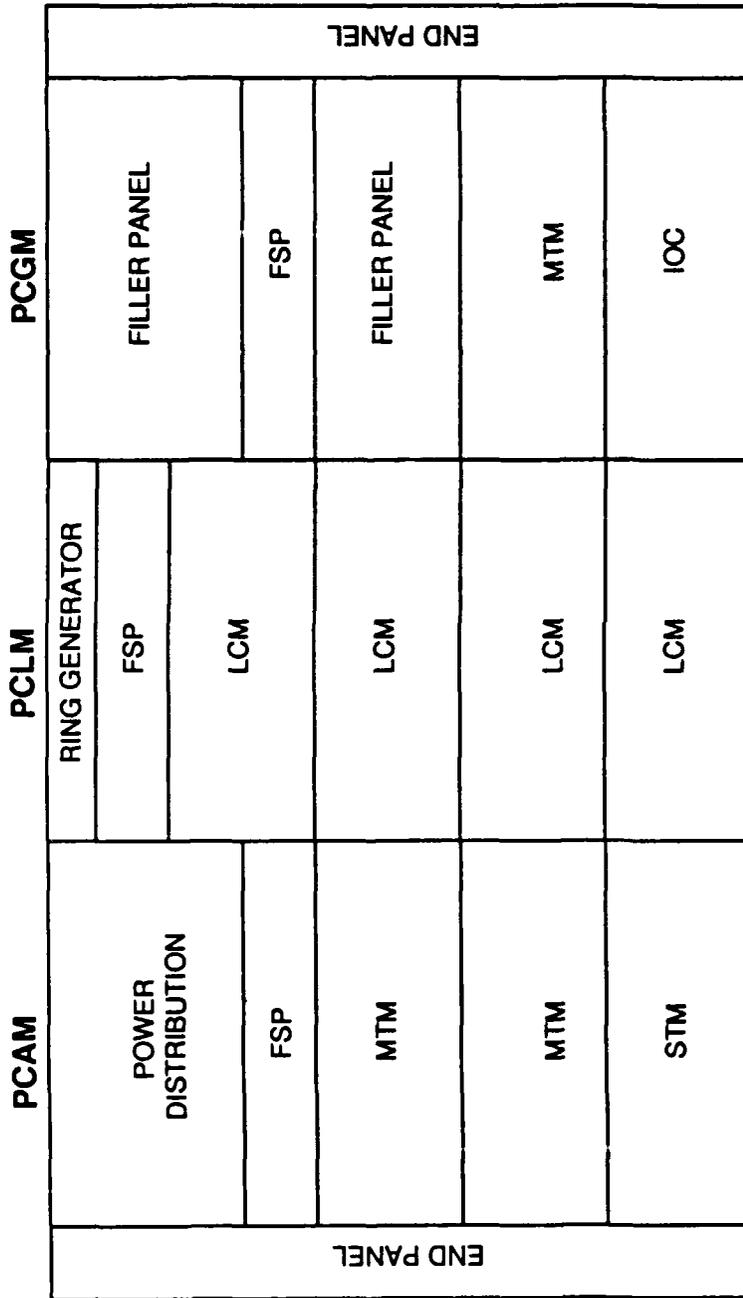
Figure 3-2. Switch Frame Configuration (Front View)

Figure 3-2 (Cont.). Switch Frame Configuration (Front View)

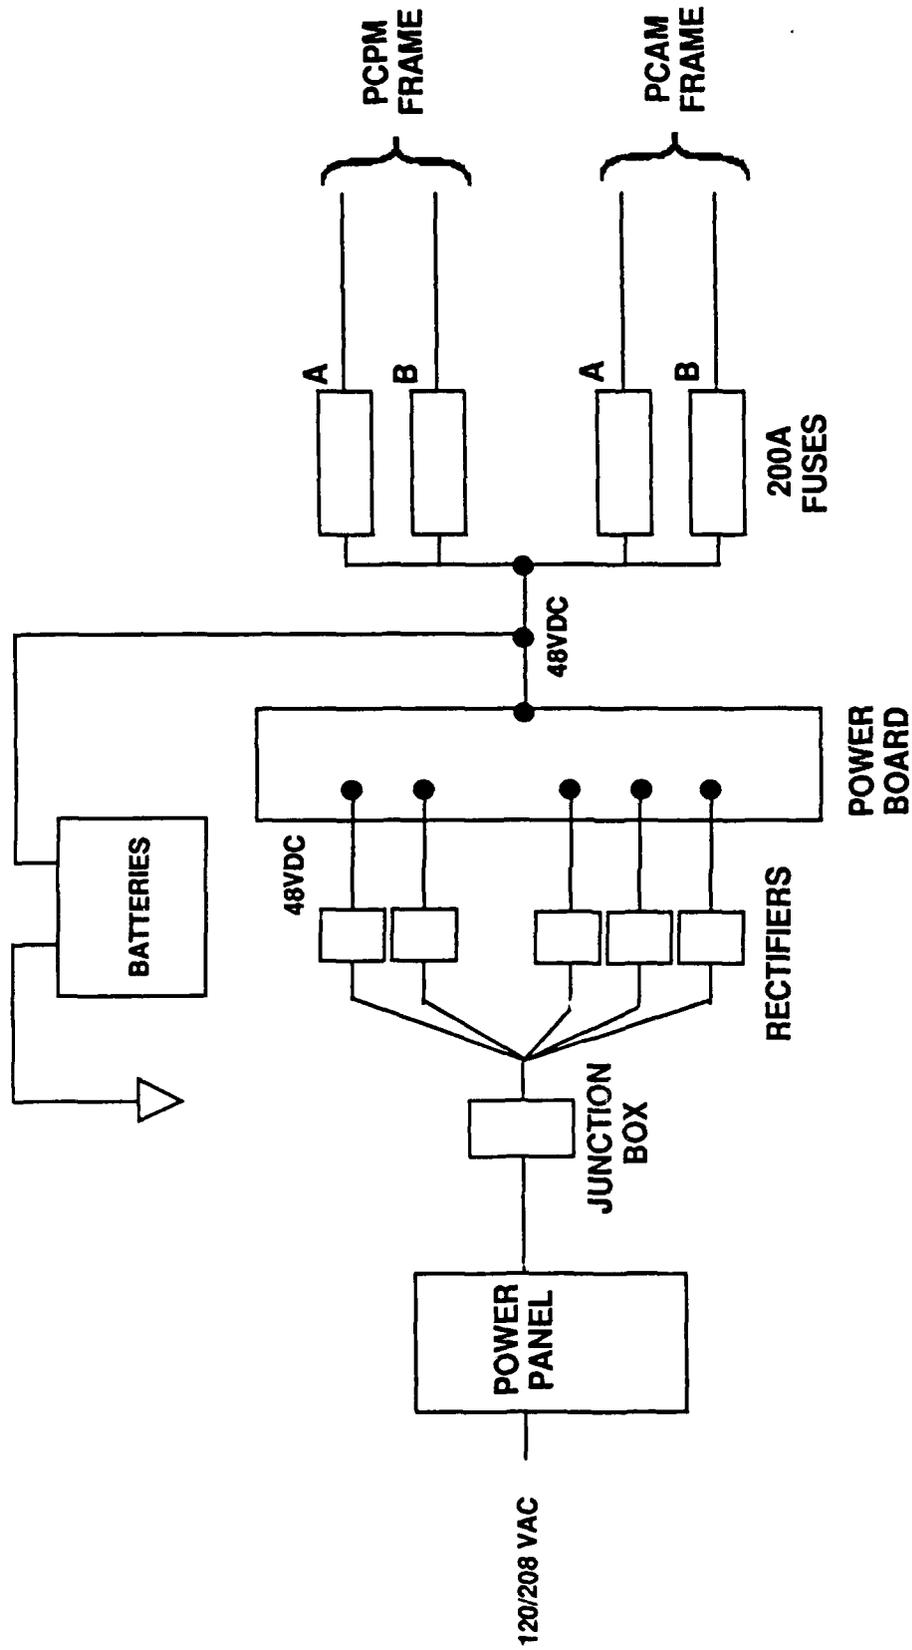
Figure 3-3. Power Subsystem Configuration

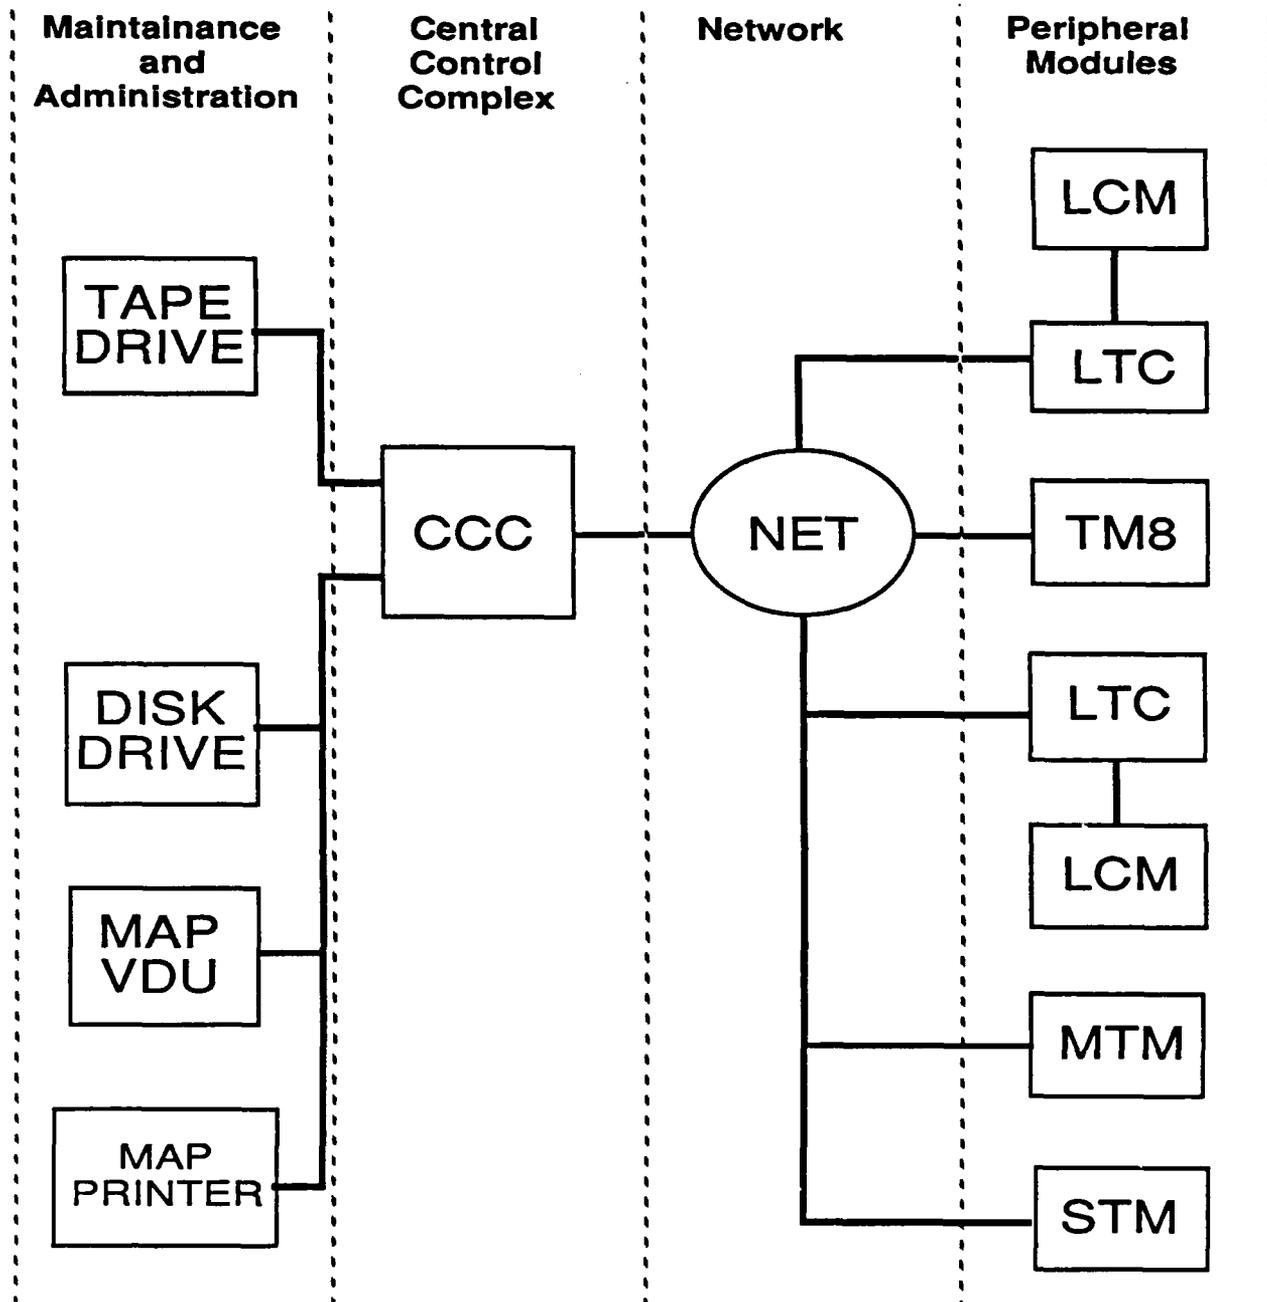
The DMS-100/200 consists of four major subsystems which are illustrated in **Figure 3-4** and are described below:

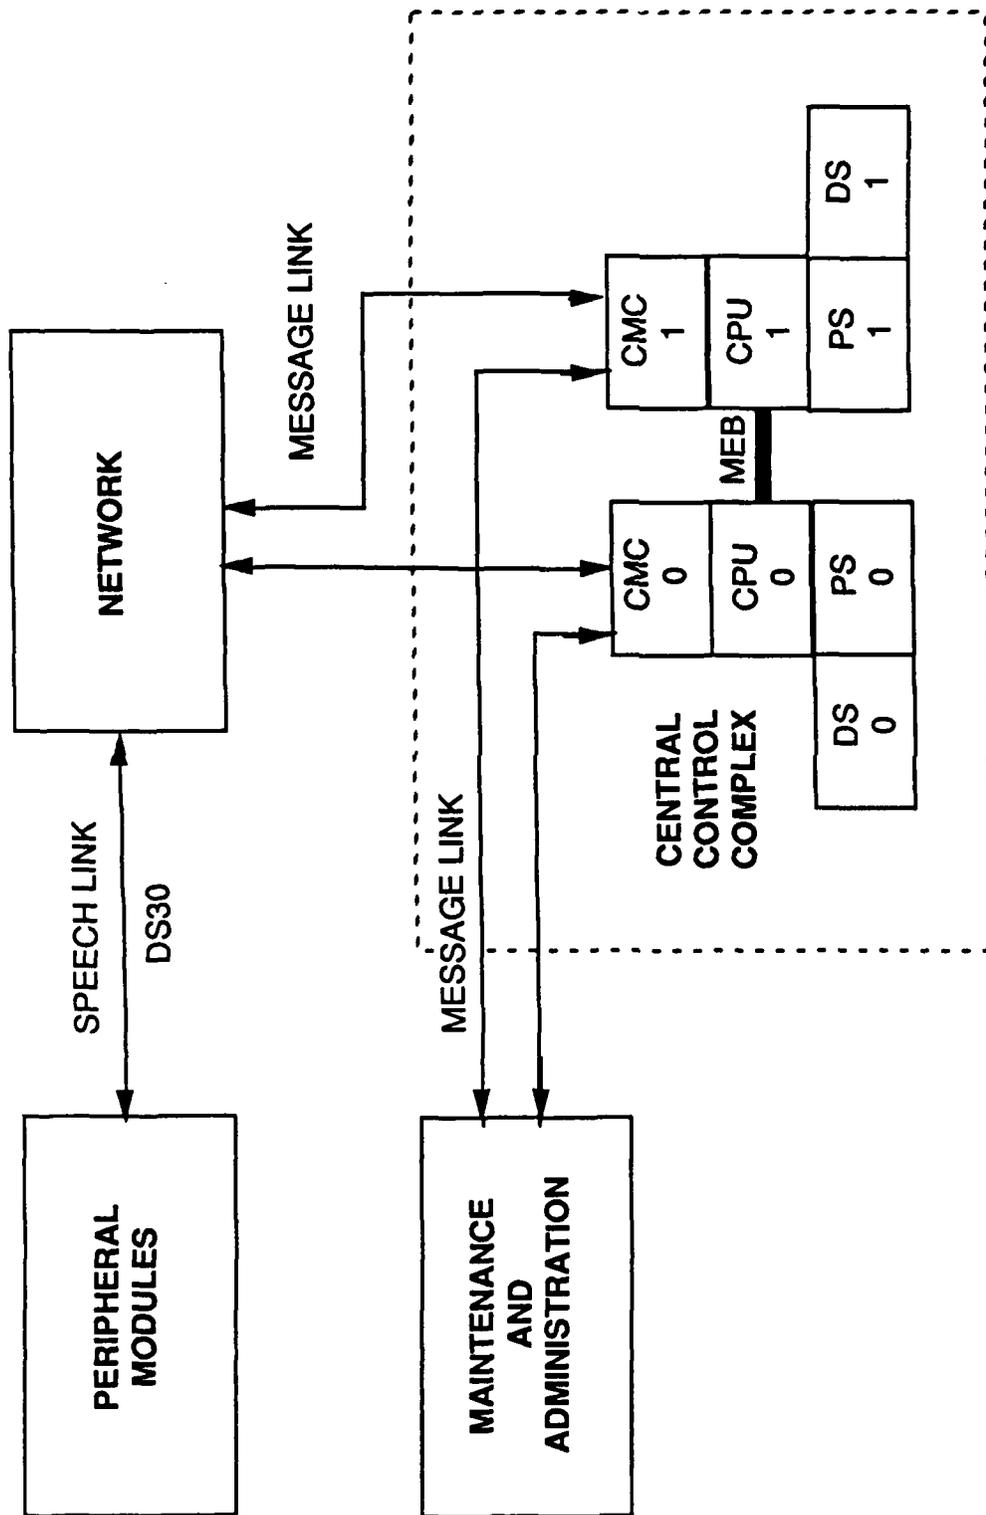
Figure 3-5. Central Control Complex Modules

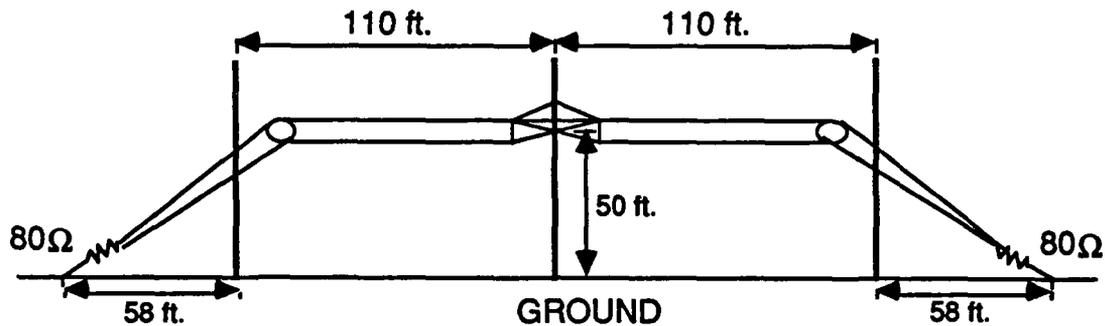
The simulator that was used for the Ottawa test was the HDL-built, transportable 250 kV pulser. The pulser and the antenna cables were transported to the Ottawa test site where they were installed onto three 70-foot poles as shown in Figure 3-6.

Figure 3-6. EMP Simulator At Ottawa

The 250 kV pulser consisted of a 250 kV pulse generator and a horizontal dipole antenna extending horizontally from the pulser for 110 feet and then terminated to ground. The pulser provided an equivalent radiated free field of 2.5 kV/m at 25 meters (centerline distance) from the pulser. The output pulse is an exponential damped wave with less than a 20% undershoot. The first crossover occurs between 7 and 200 ns, depending on the risetime. The nominal risetime can be set between 0.7 and 2.0 ns. The pulser can be fired as frequently as once per 20 seconds. Coverage and angle of incidence will depend upon the test setup. The majority of the tests were conducted with the pulser antenna parallel to the longest cables connected to the equipment. Figure 3-7 shows one electric field waveform, which includes the ground interactive field, measured at 25 meters.

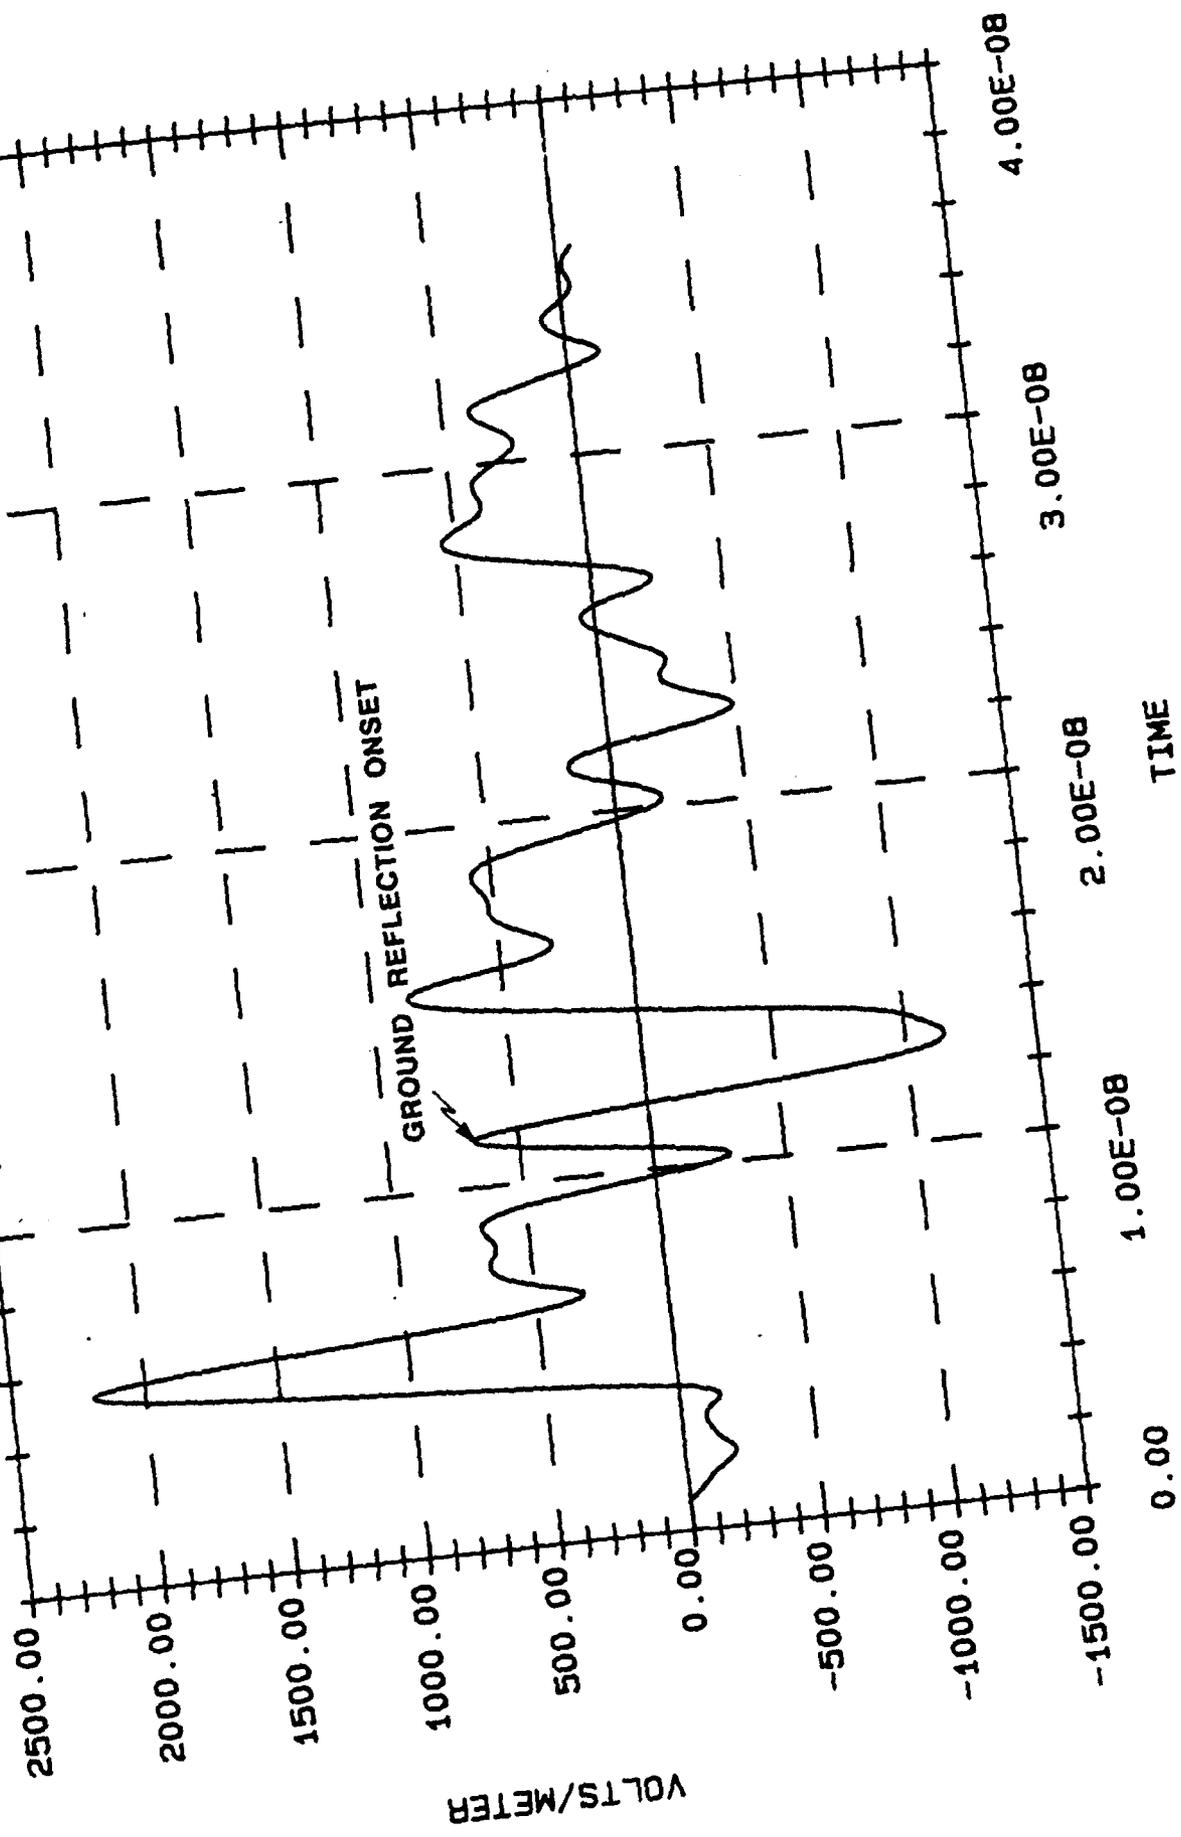
Figure 3-7. Field Measurement at Ottawa

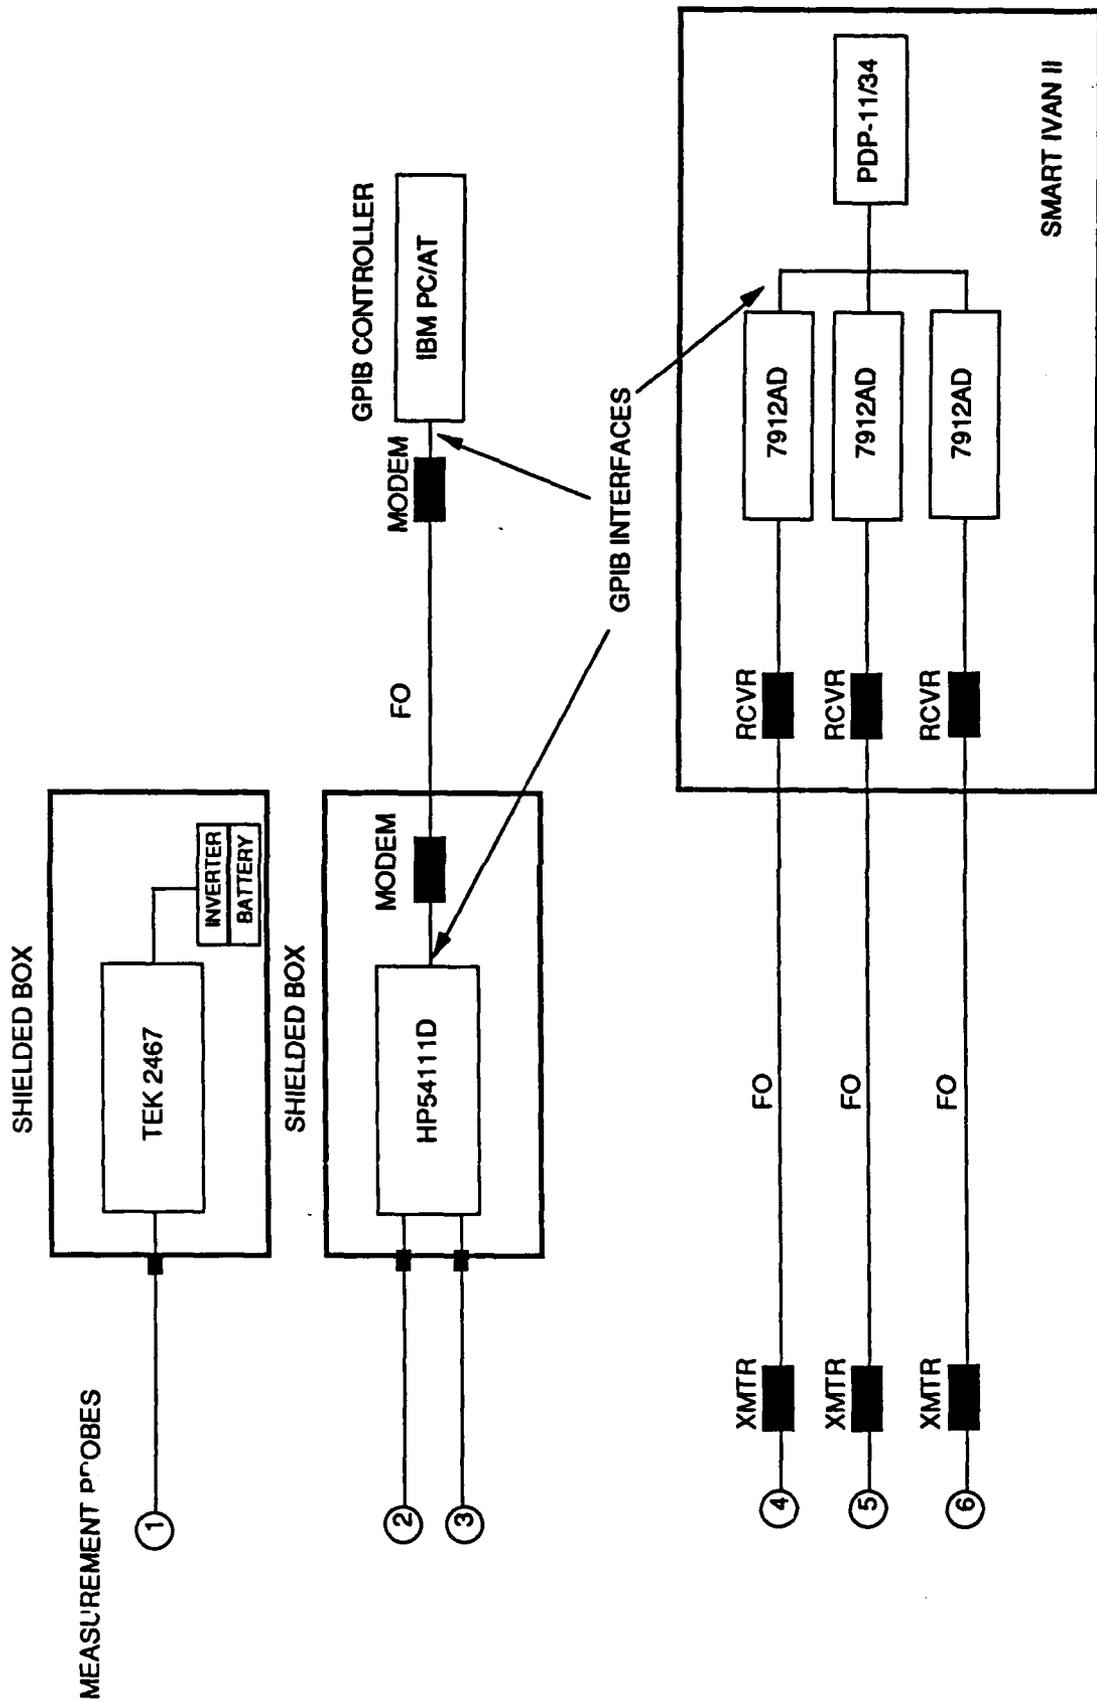
Figure 3-8. Transient Measurement Configuration

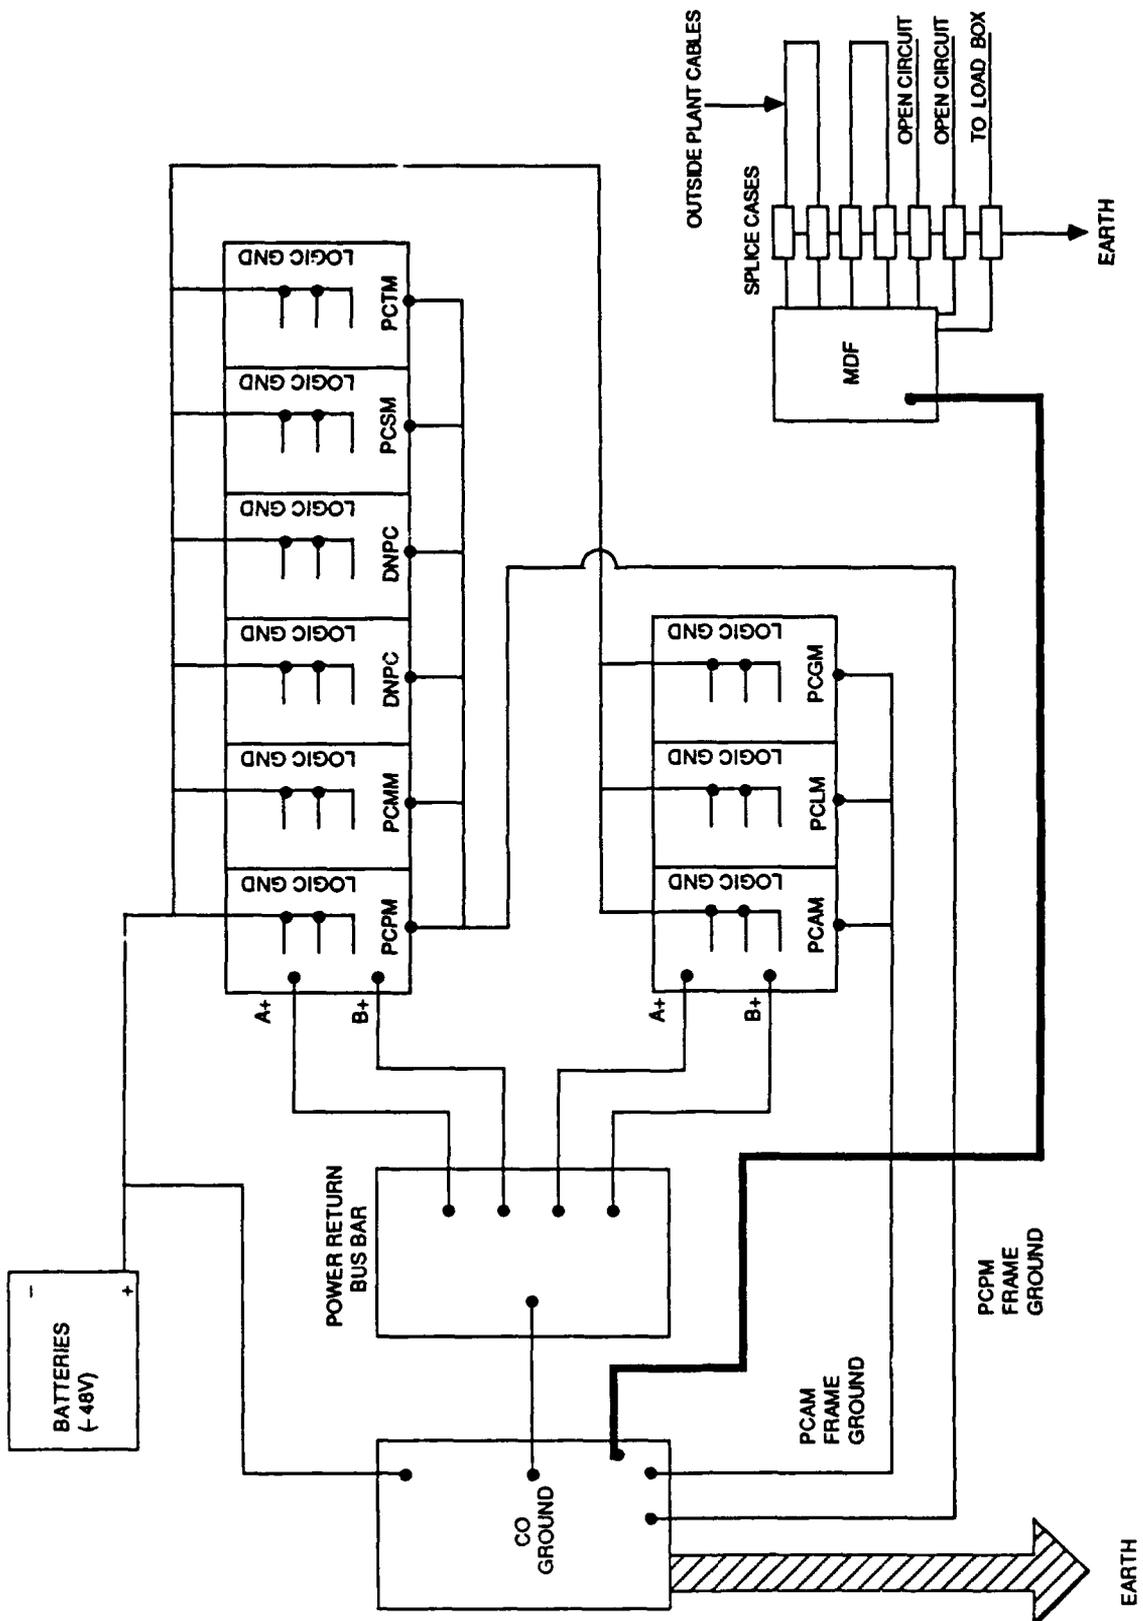
Figure 4-1. Grounding Configuration for Ottawa and REPS Tests

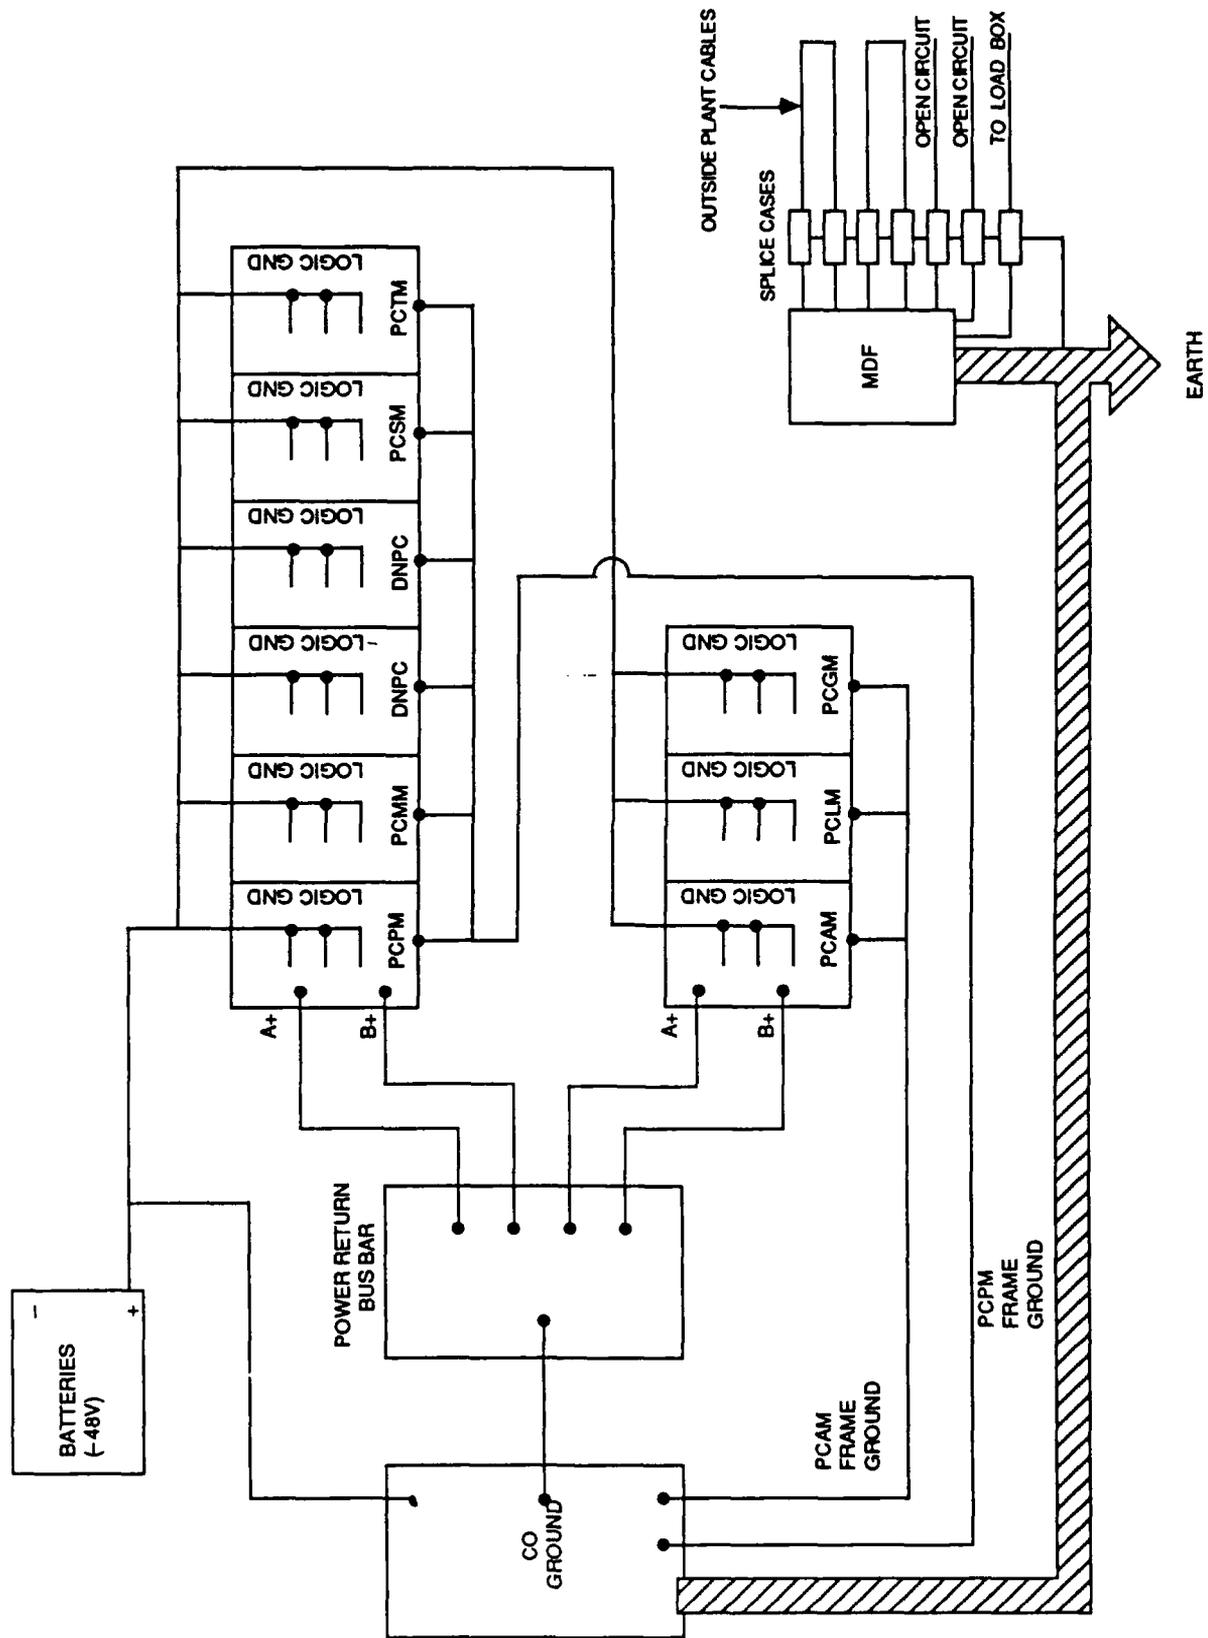
Figure 4-2. Grounding Configuration for AESOP Test

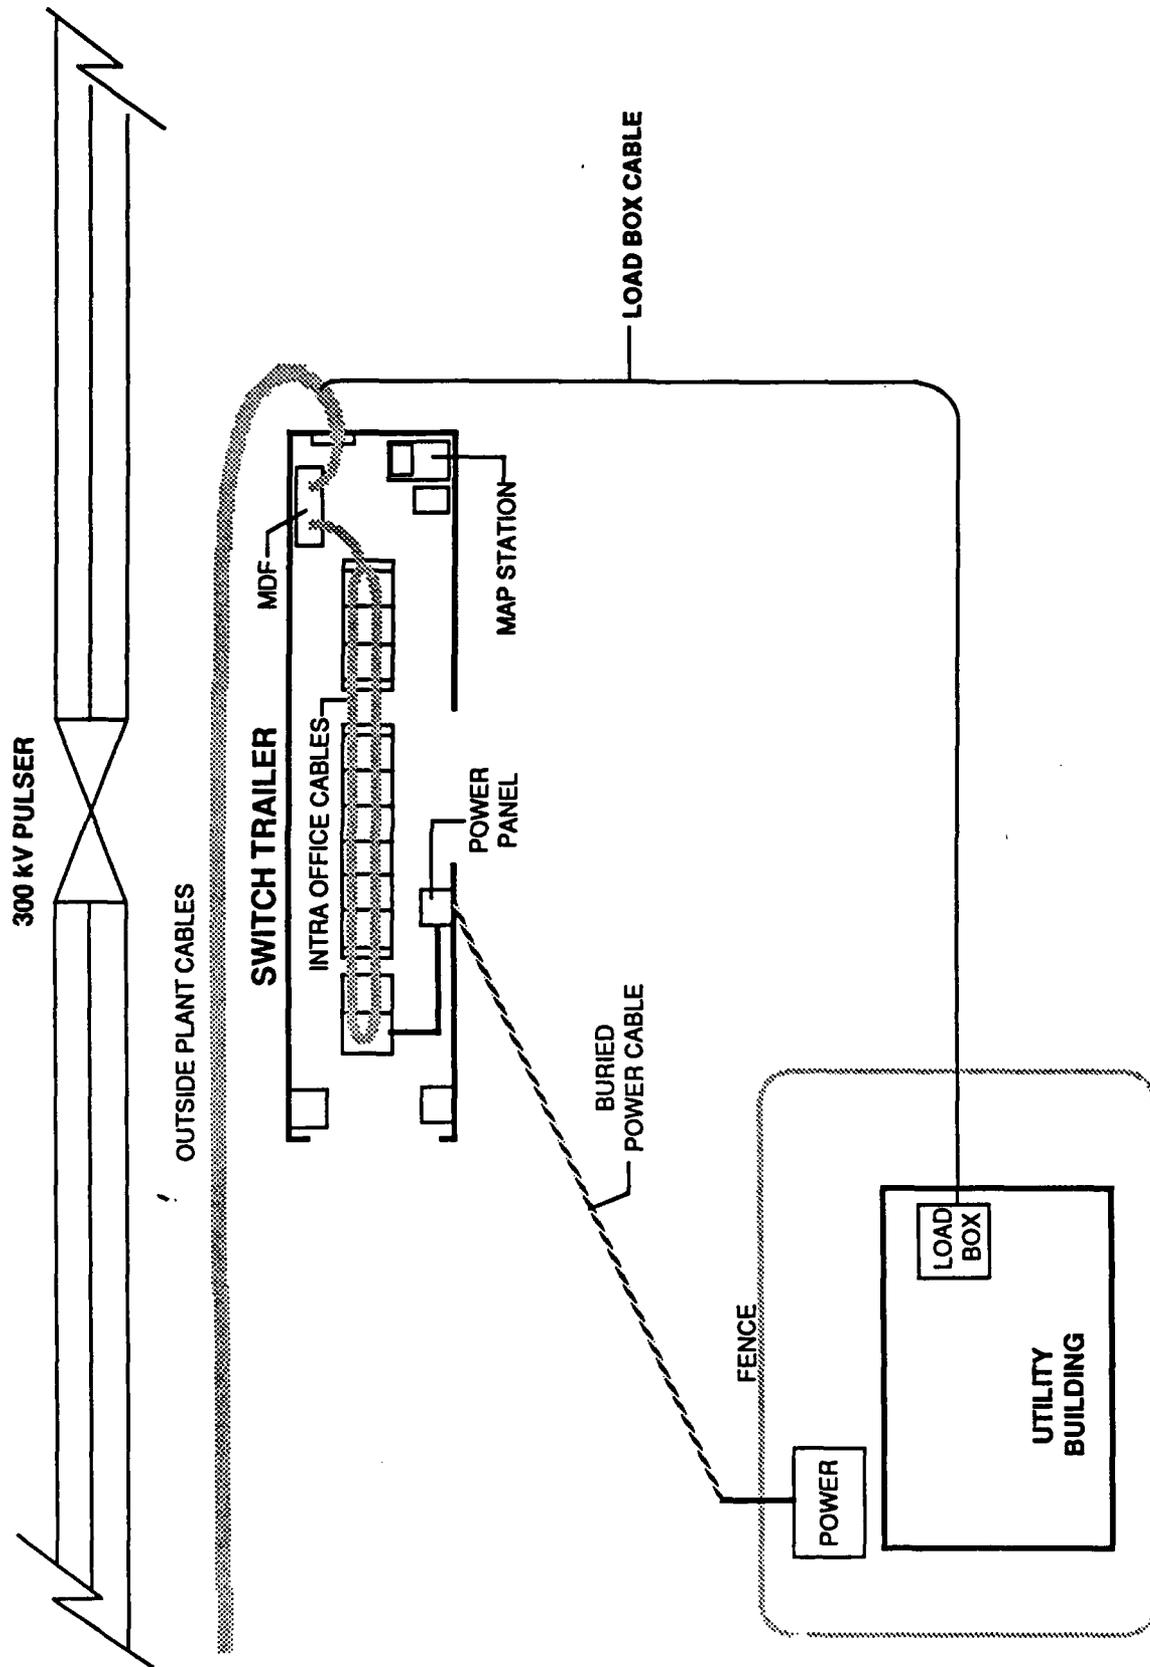
Figure 4-3. Test Setup (Ottawa)

Outside Plant Cables. These cables were suspended 8 feet above the ground and extended to approximately 500 feet parallel to the pulser antenna.

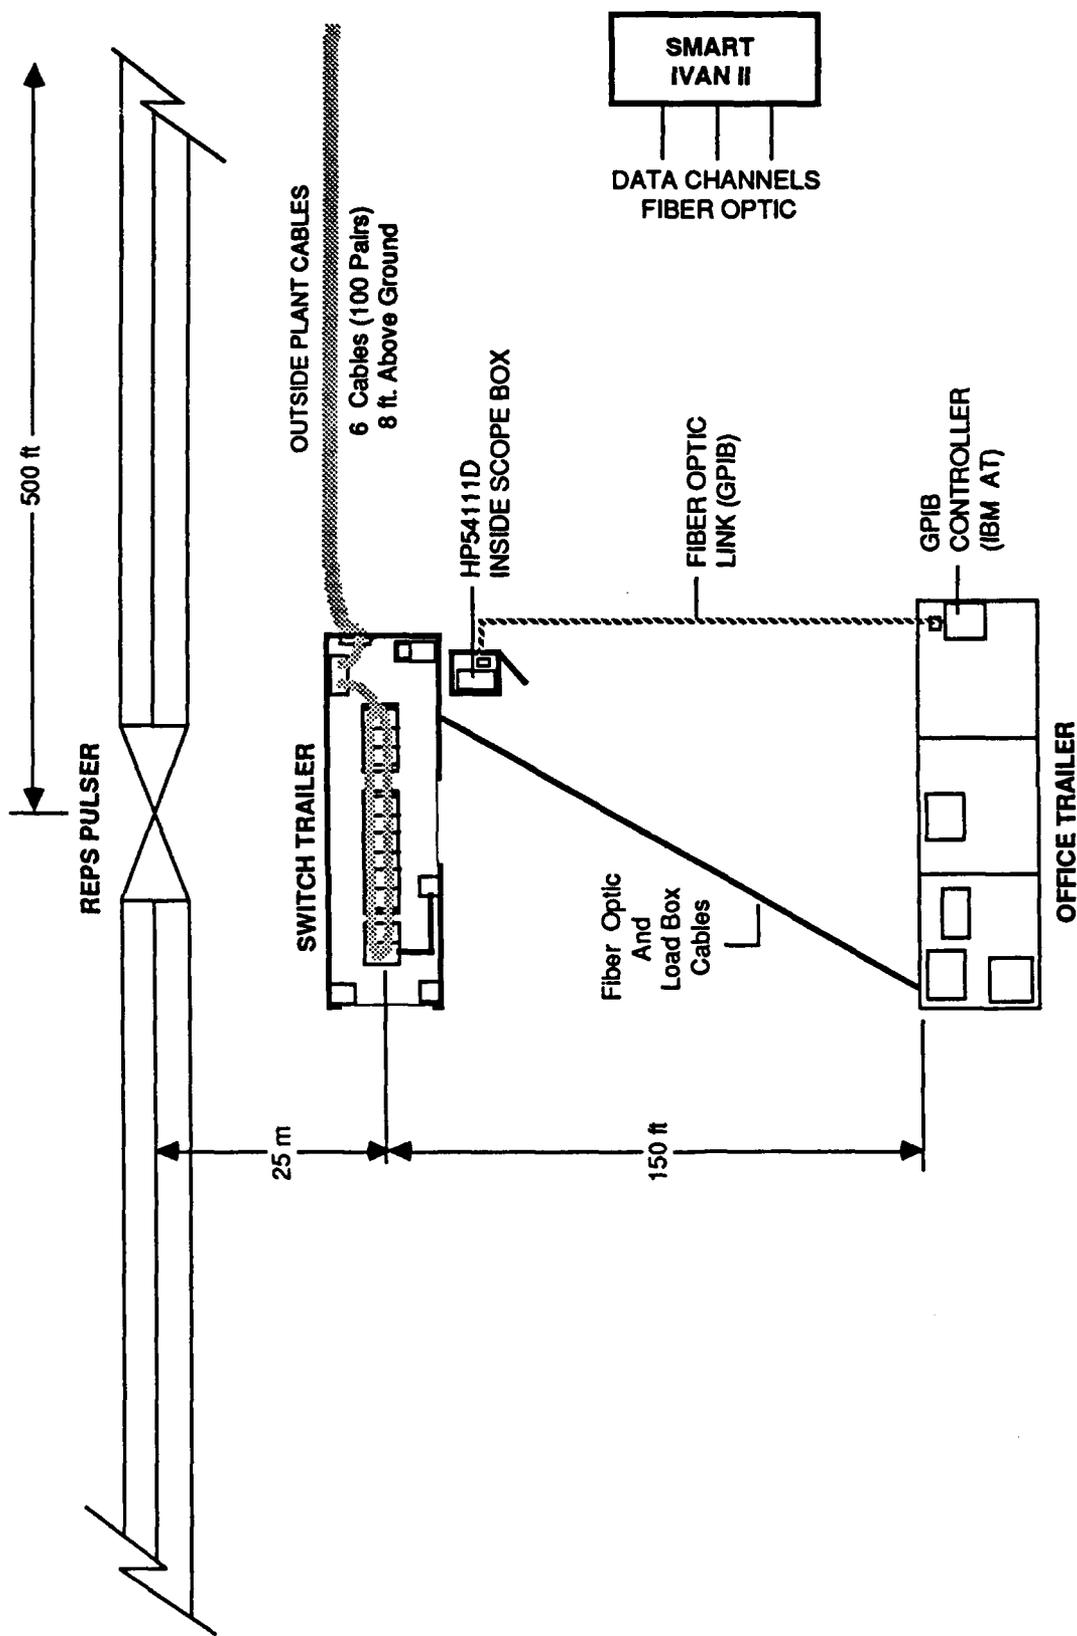
Figure 4-4. Test Setup (REPS)

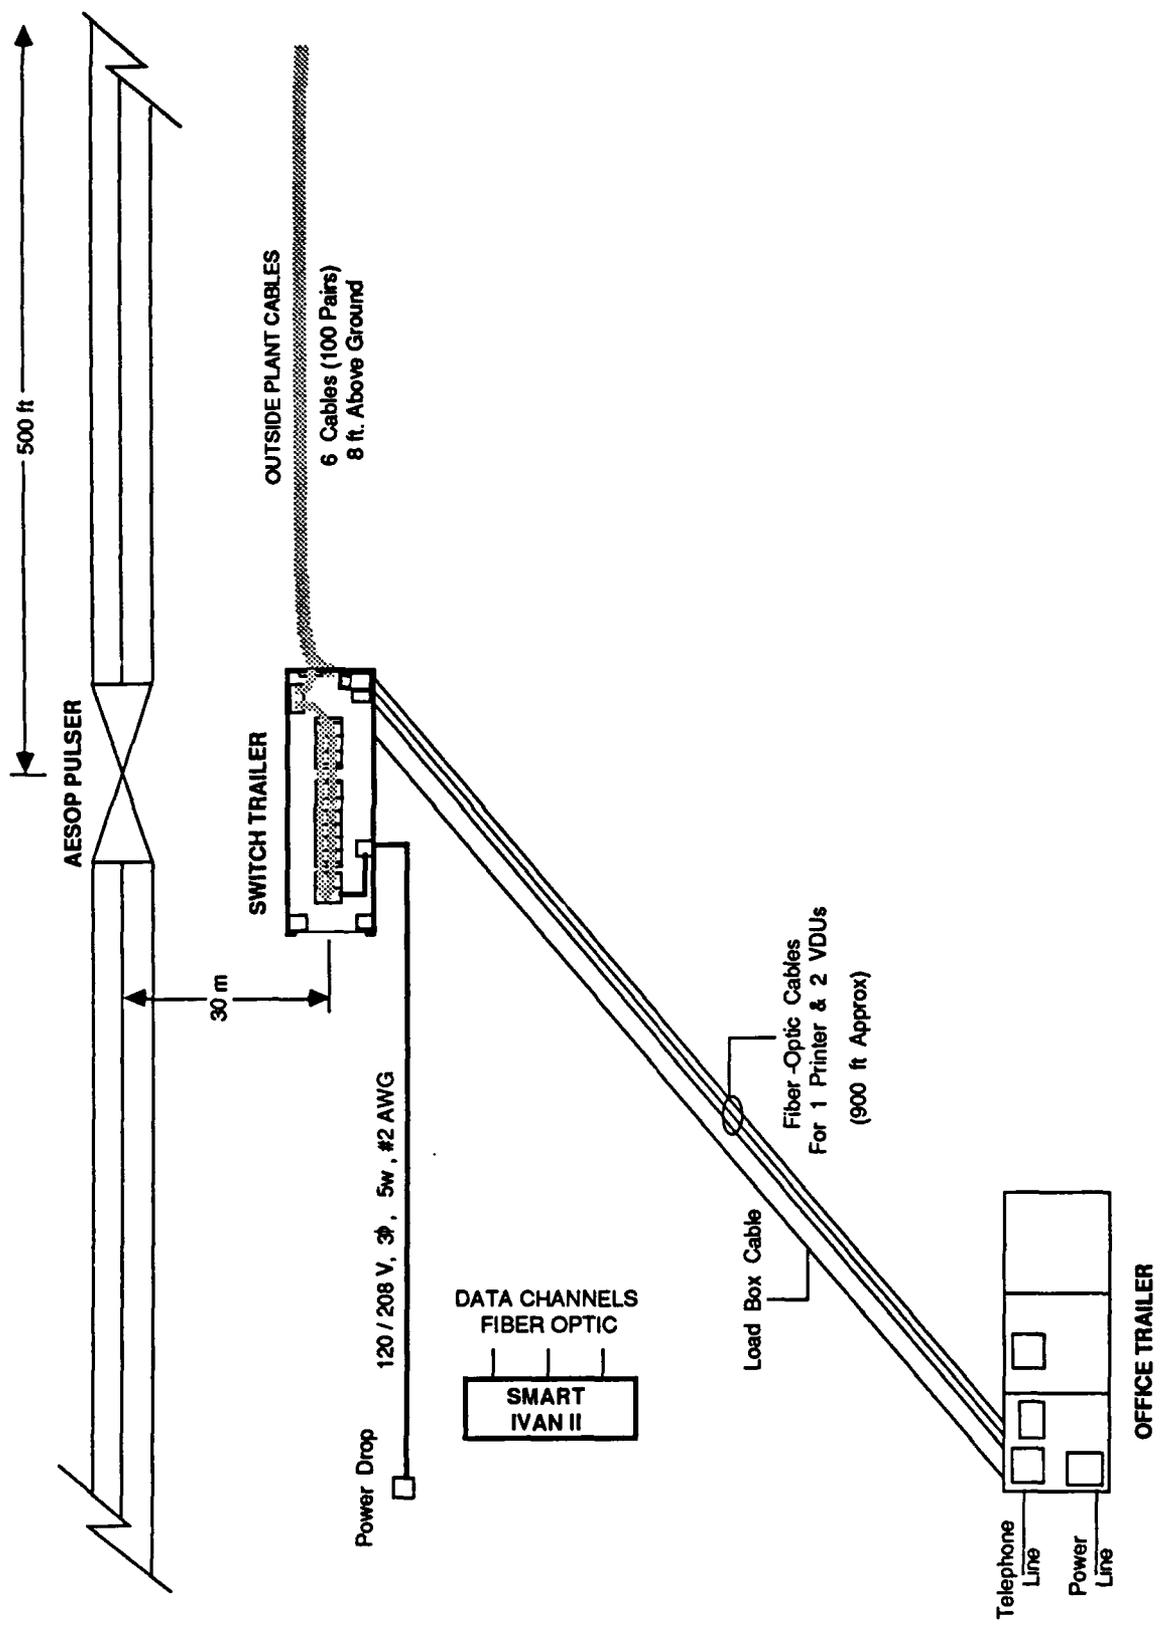
Figure 4-5. Test Setup (AESOP)
