NATIONAL COMMUNICATIONS SYSTEM

TECHNICAL INFORMATION BULLETIN

THE EFFECTS OF HIGH-ALTITUDE
ELECTROMAGNETIC PULSE (HEMP) ON THE
NORTHERN TELECOM INC.
DMS-100™ SWITCH

TEST PROGRAM

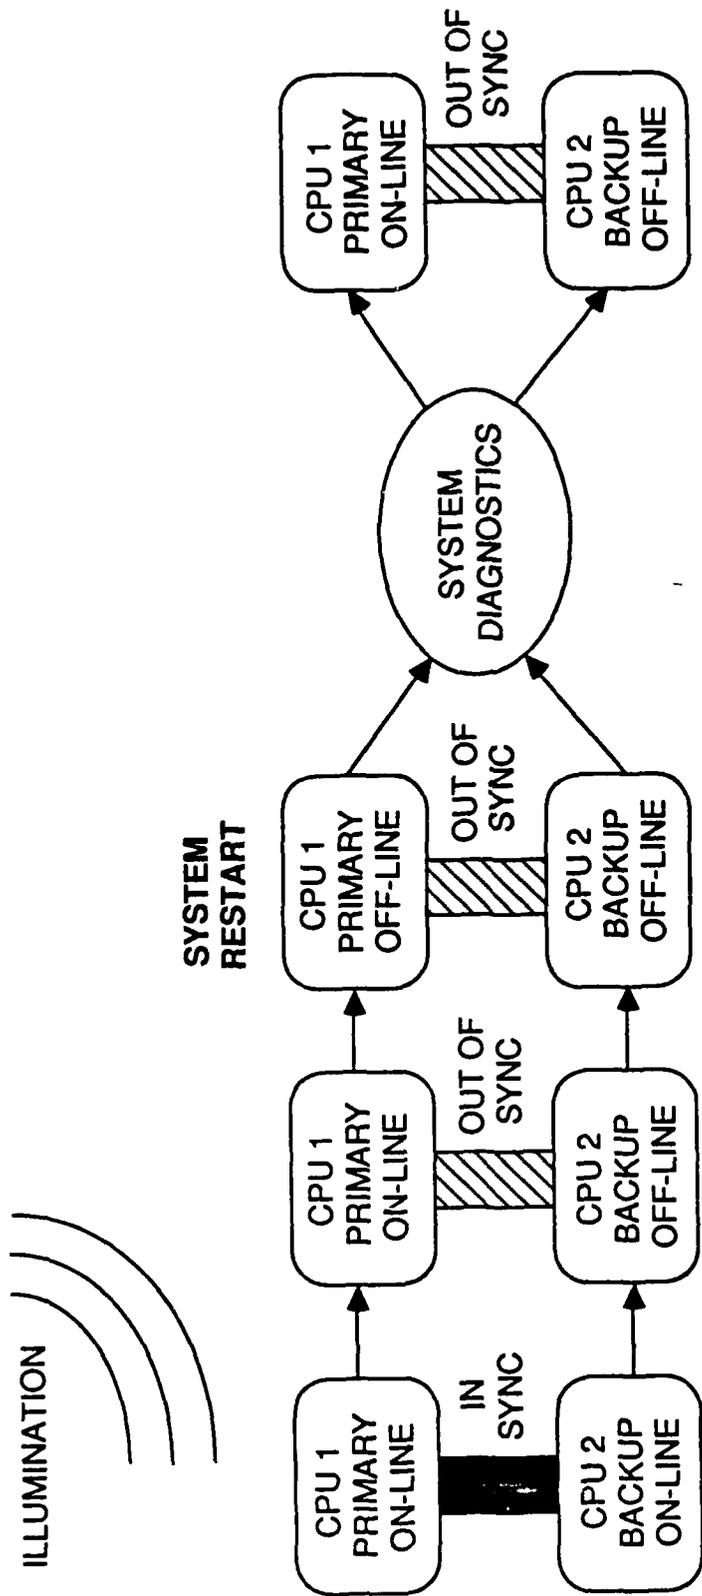
Figure 4-6. System Restart Scenario

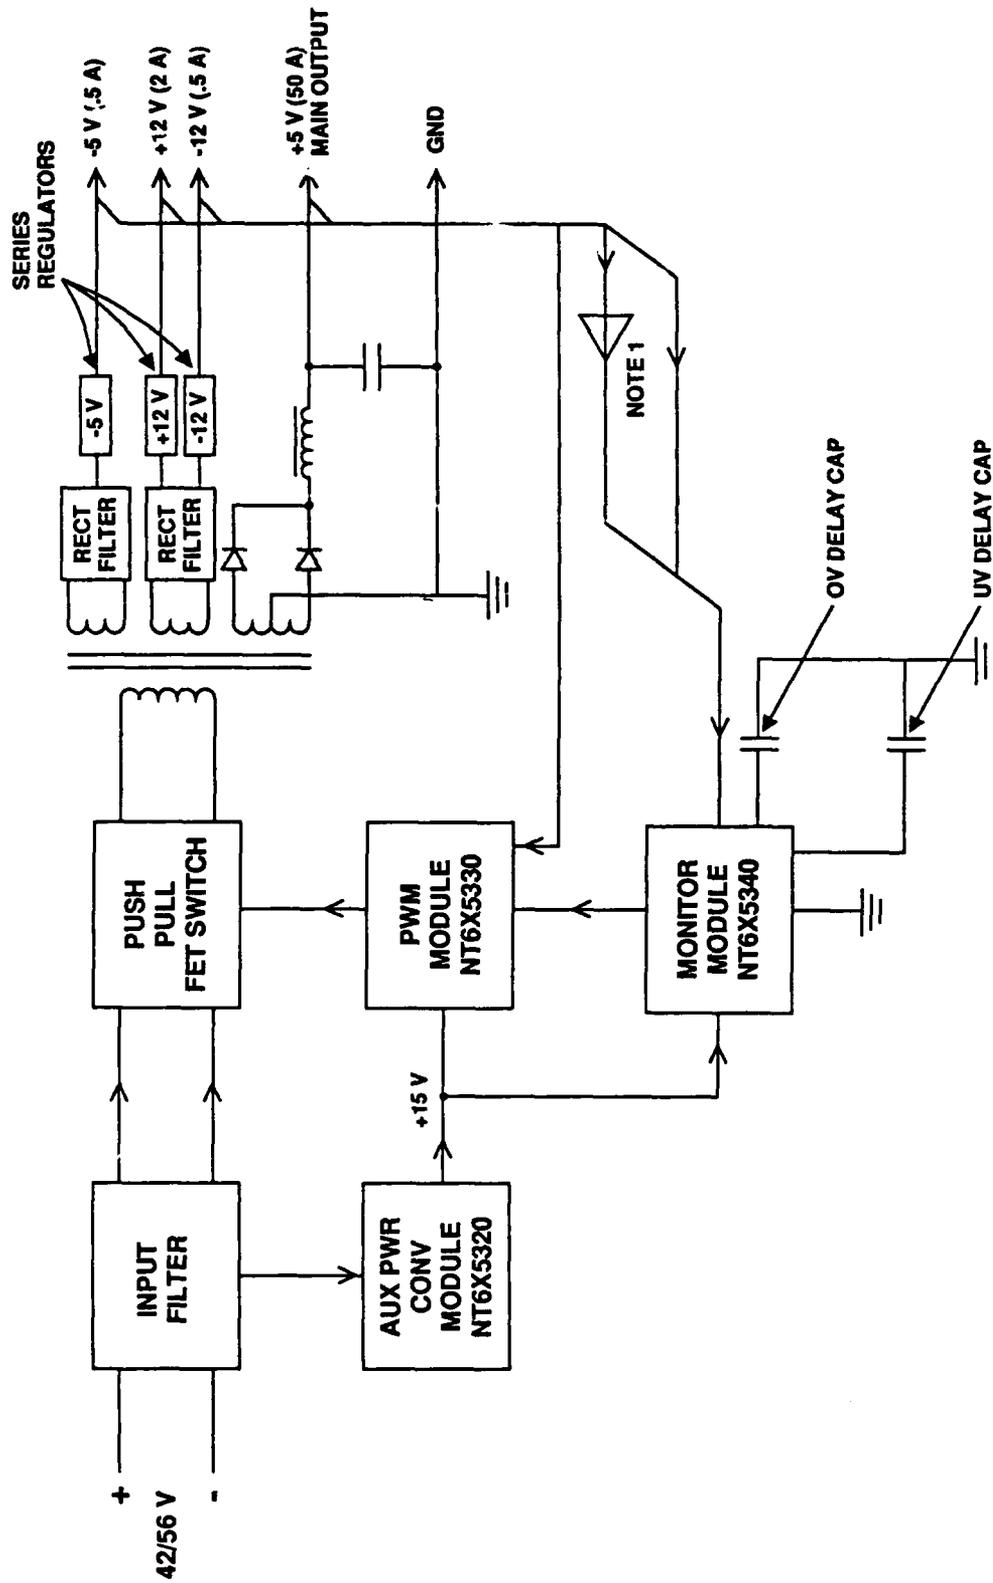
NOTE 1: 4 OUTPUTS ARE MONITORED WITH RESISTOR VOLTAGE DIVIDERS AND FED INTO COMPARATORS IN THE NT6X5340 MODULE. THE ± 5 V USES EXTERNAL COMPARATORS. THE ± 12 V USE THE INTERNAL COMPARATORS IN THE NT6X5340 MODULE.

Figure 4-7. NT2X70AD Configuration

One, or rarely two, of the four LTC power convertors (NTZX70AD) occasionally tripped. Figure 4-7 shows a configuration diagram of NTZX70AD. The unit was affected due to transient coupling into the monitor module (NT6X5340) inside the NT2X70AD. The module contained a supervisory chip to detect an overvoltage condition and cause power converter shutdown for self protection. An HEMP event caused transients in the circuit that were interpreted as an overvoltage condition that then "turned off" the converter unit. Figure 4-8 shows the circuit diagram of the NT6X5340 monitor module. The first modification was to install filter capacitors in the sensitive module. The result was a decrease in the occurrences of upsets. The supervisory chip was eventually replaced with a pin-compatible chip from another manufacturer during the AESOP testing, and this upset problem never occurred again.

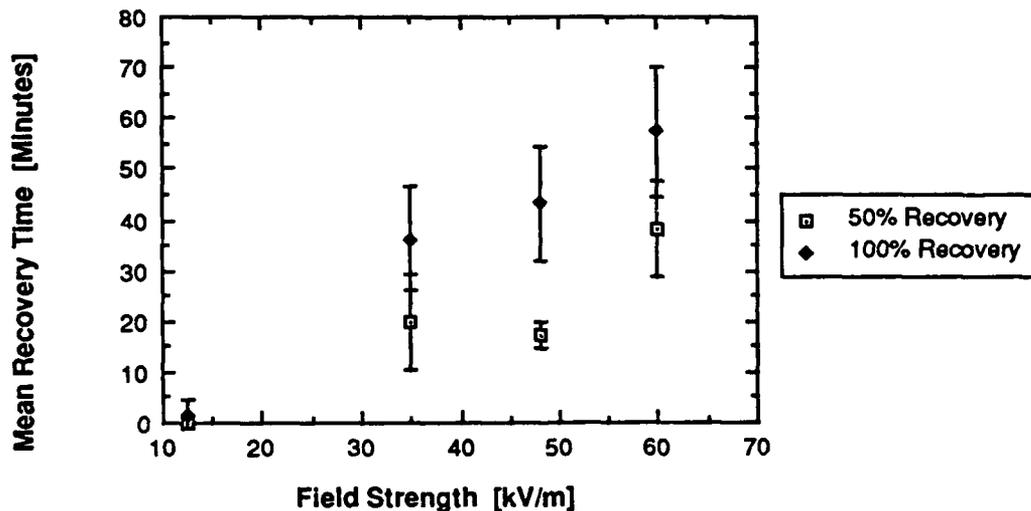
Figure 4-9. Summary of Mean Recovery Times Under HDL Simulators

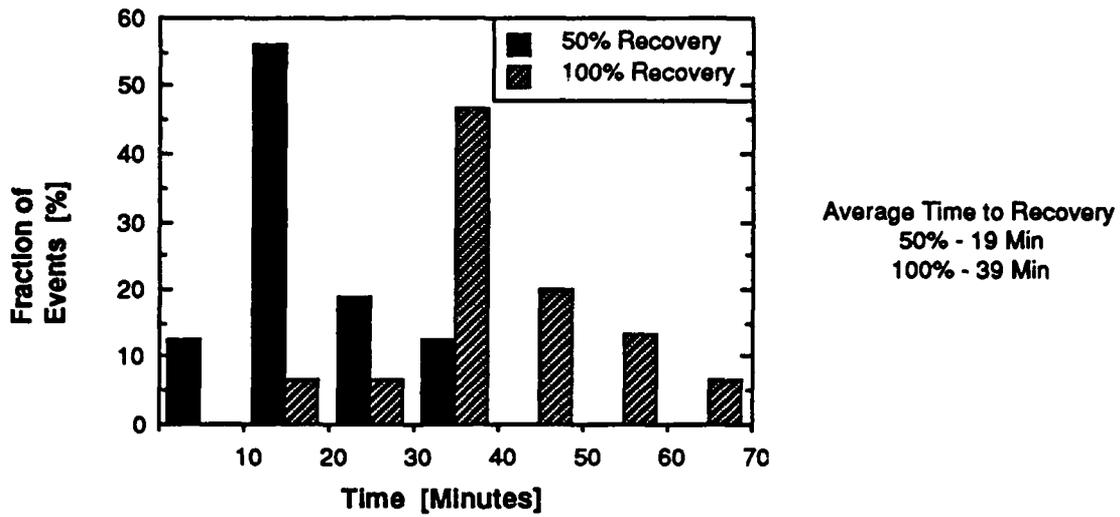
Figure 4-10. Recovery Time Distribution for Medium HEMP Stresses (30-50 kV/m)

Figures 4-10 and 4-11 show the recovery time results for the upsets for low (10-30 kV/m) and high 30-50 kV/m) field levels, respectively. Two call processing recovery times, 50% and 100%, were recorded for each pulse. The 50% recovery time was recorded when one LCM was returned into operation, and 100% recovery time was recorded when both LCMs were returned into operation as indicated by the MAP outputs.

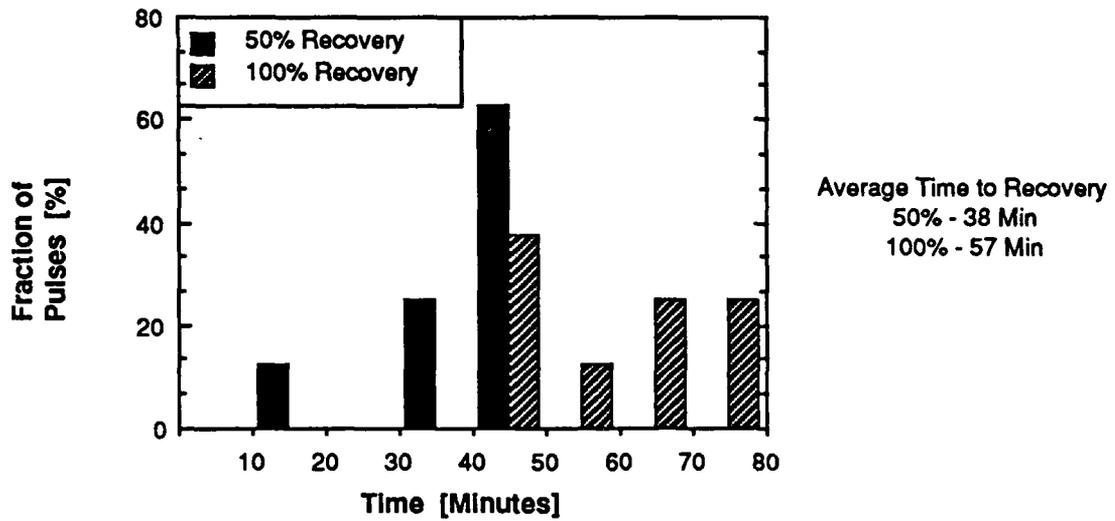
Figure 4-11. Recovery Time Distribution for High HEMP Stresses (50-70 kV/m)

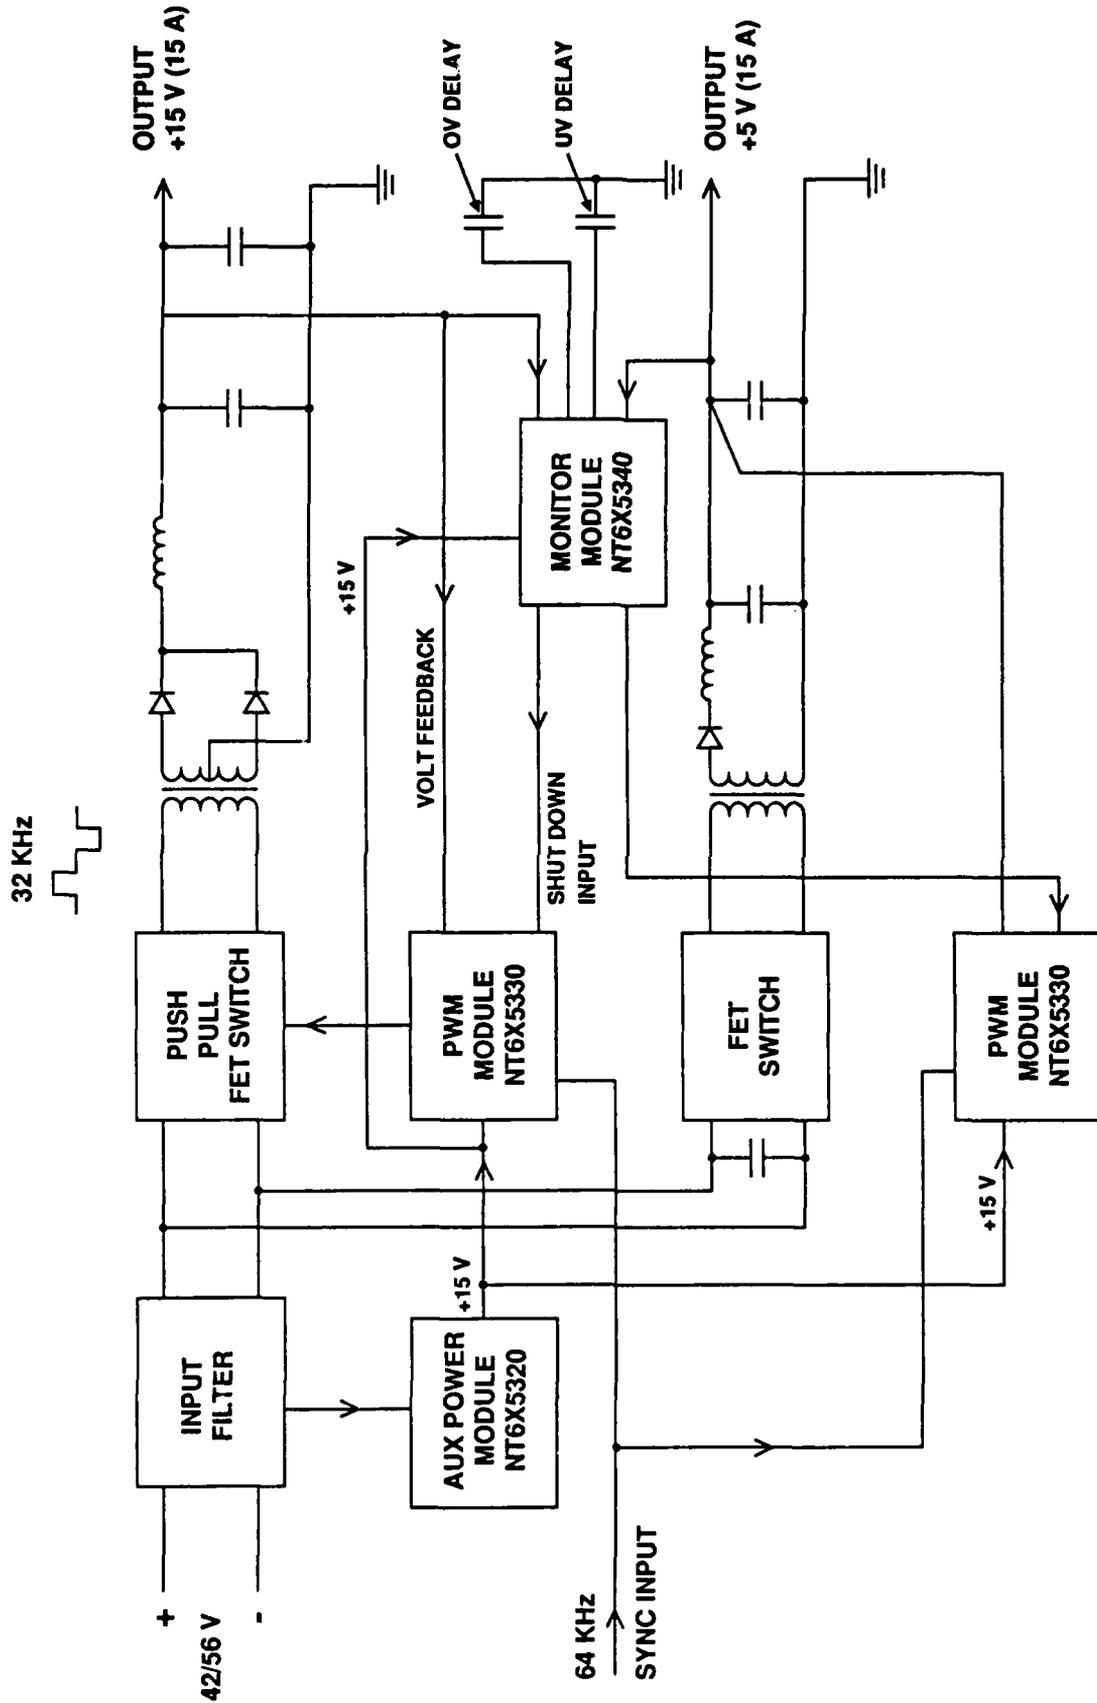
Figure 4-12. NT6X53AA Configuration

Power Converter Shutdown and Modification. This upset problem is similar to the occurrence of the power shutdown in the LTCs. Figure 4-12 illustrates the component configuration of the NT6X53AA, the power converter unit inside the LCMs. The monitor module (NT6X5340), which is identical to the monitor module in the LTC power converter, detected an overvoltage condition and transmitted a "shutdown" signal to the PWM module, which disabled the operation. Power was restored when a manual reset at the unit was performed. This upset problem was eventually cured when the supervisory chip in the monitor module was replaced with a pin-compatible chip from Unitrode manufacturer.

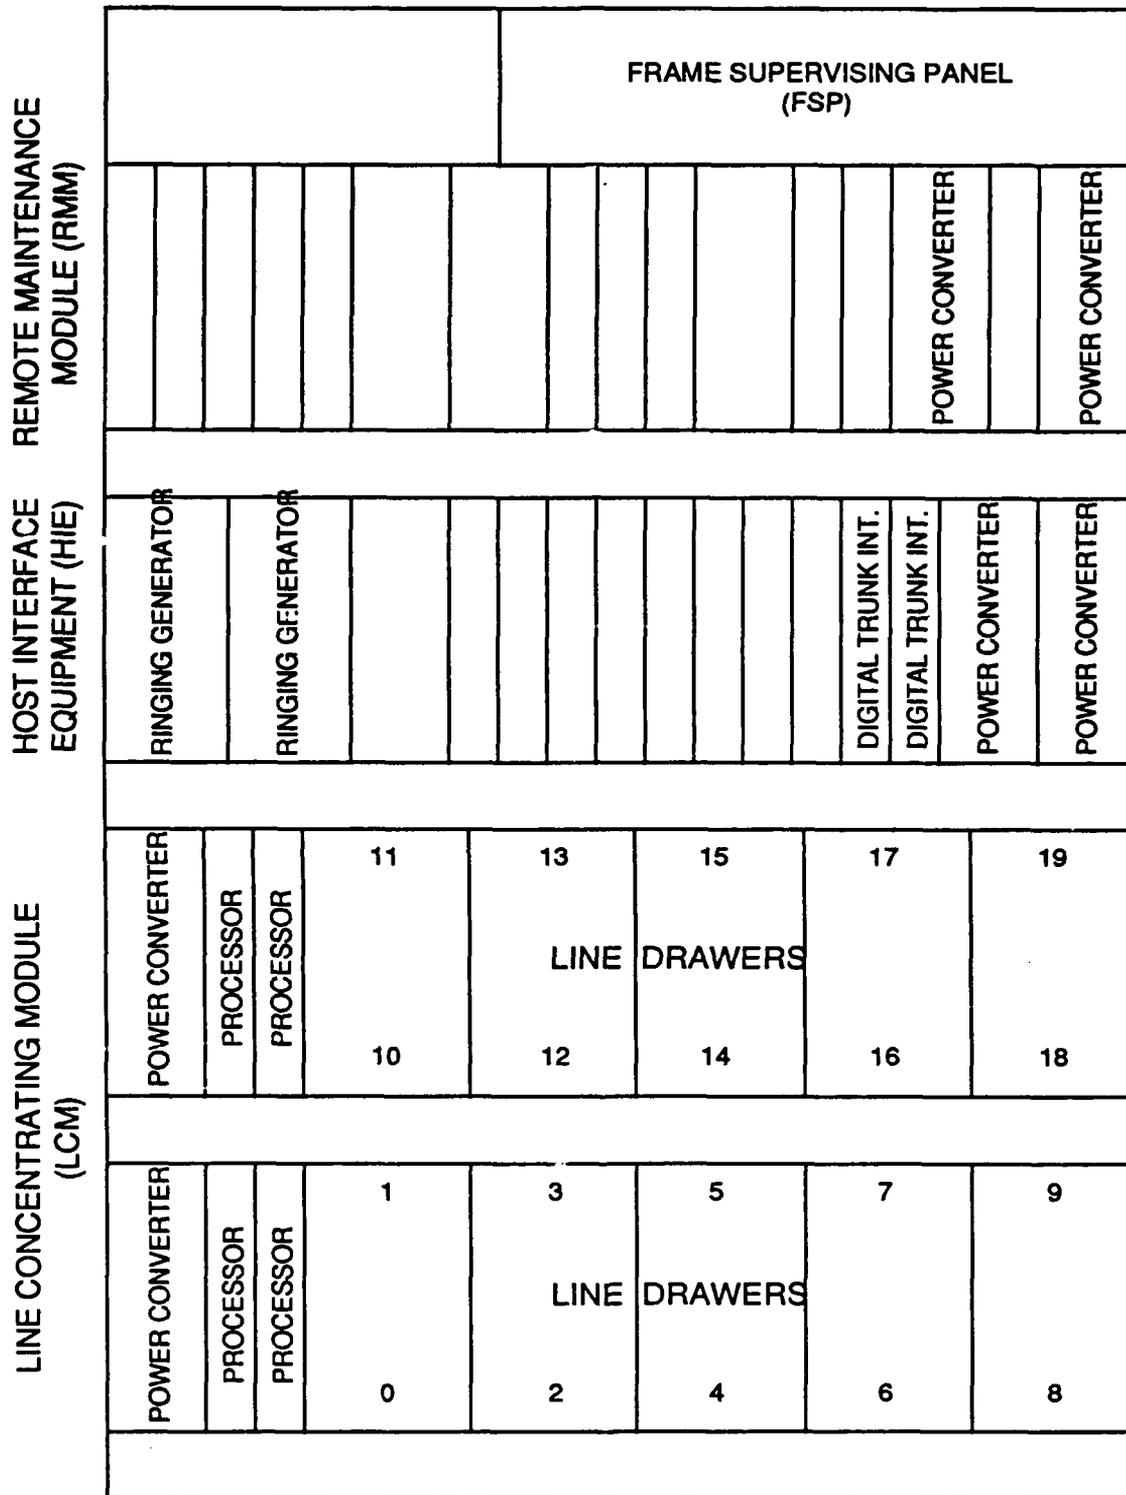
Figure B-1. Remote Line Concentrating Module (RLCM)

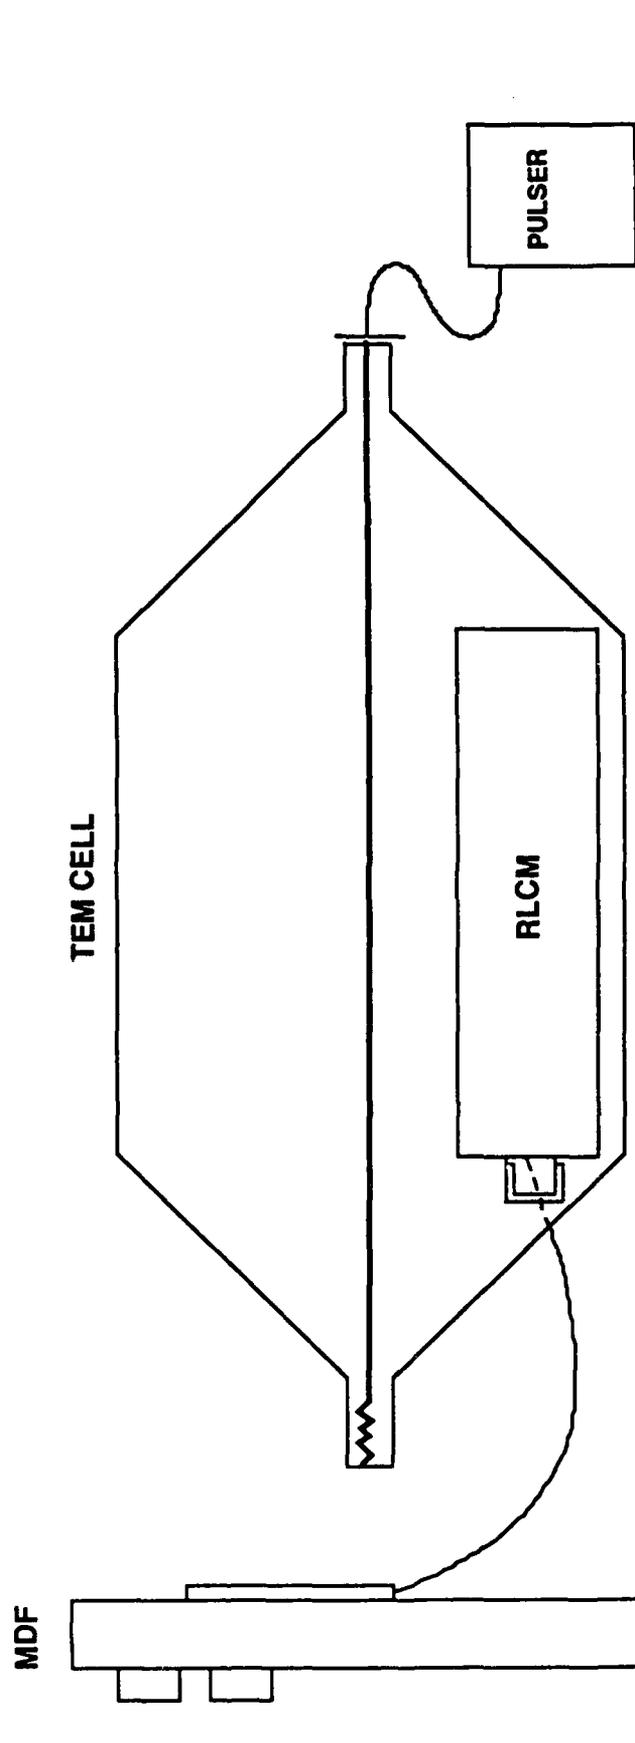
Figure B-2. TEM Cell Setup

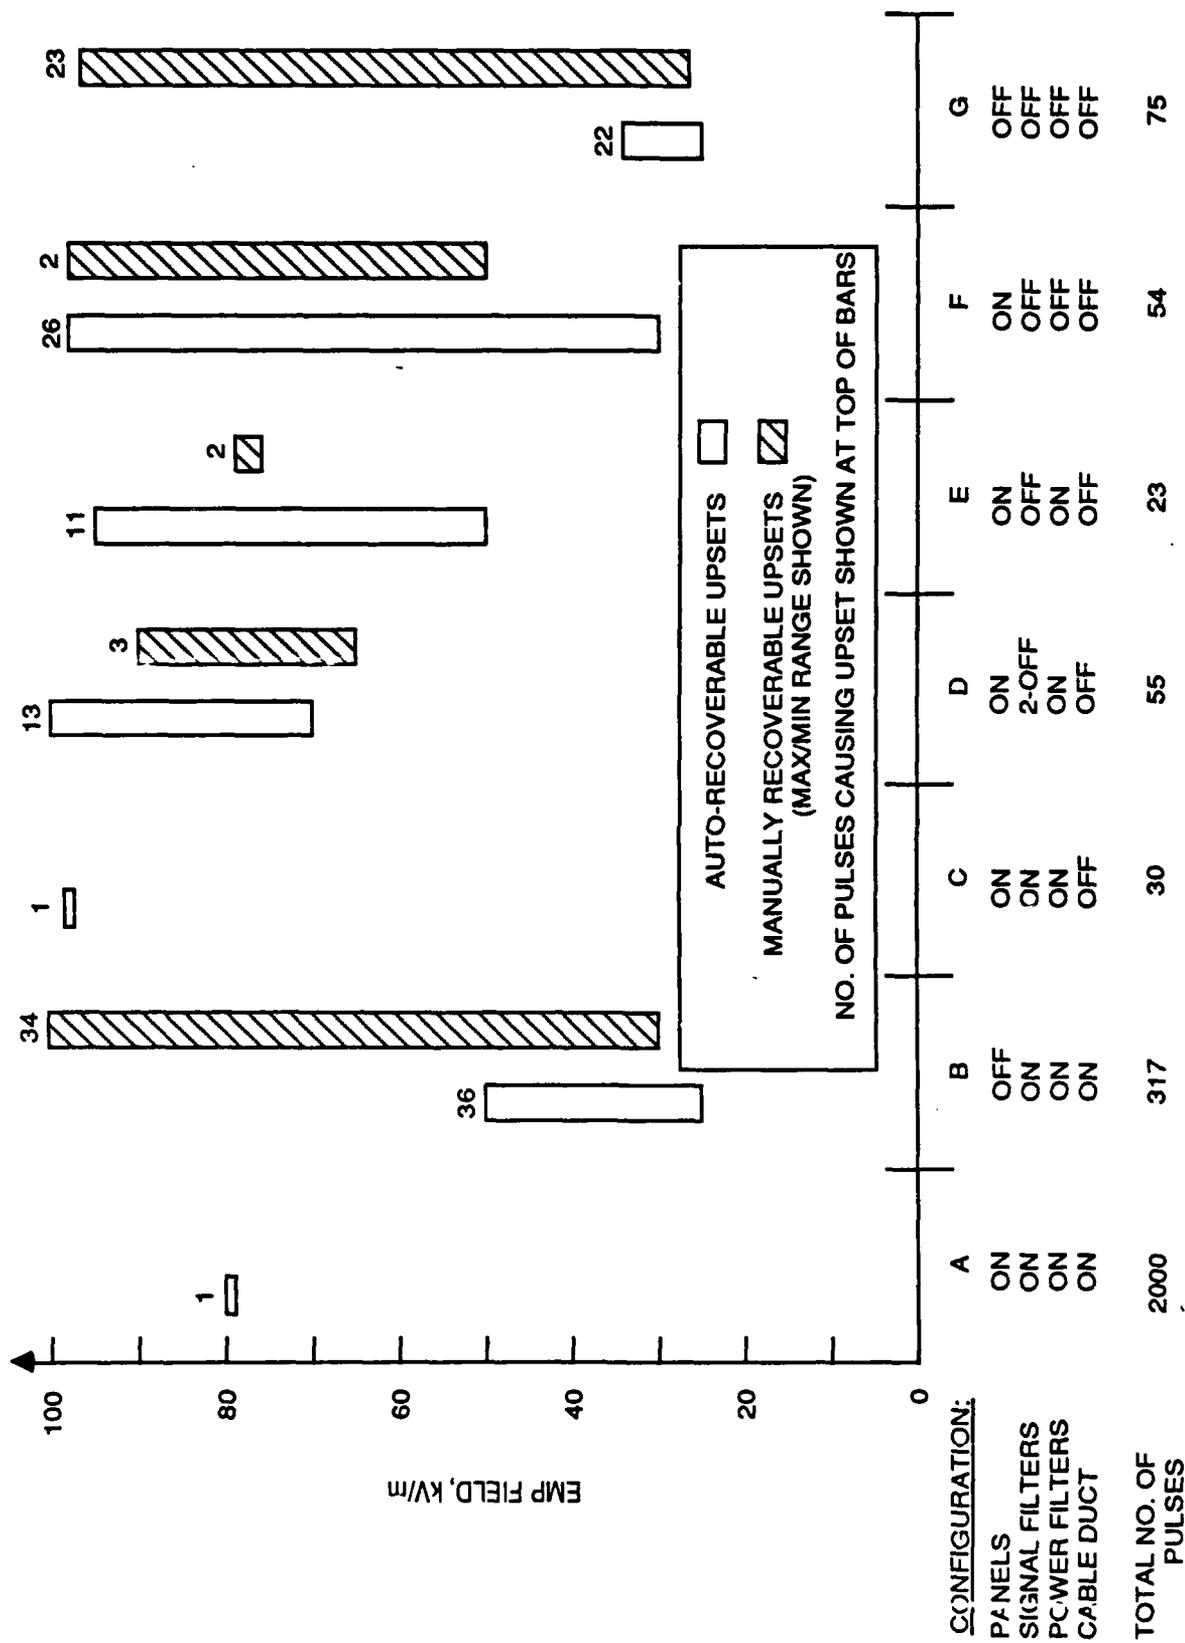
Figure B-3. RLCM Upset Distribution (Radiated TEM Cell Experiment)

In Configuration B, shielding panels are removed. Figures B-3 and B-4 demonstrate the significant shielding effectiveness of the frame panels. At 50 kV/m field level and above the percentage of pulses causing upset reaches 100%. As the EMP field exceeds 80 kV/m the probability of tripping both power converter units of the Remote Maintenance Module (RMM) increases.

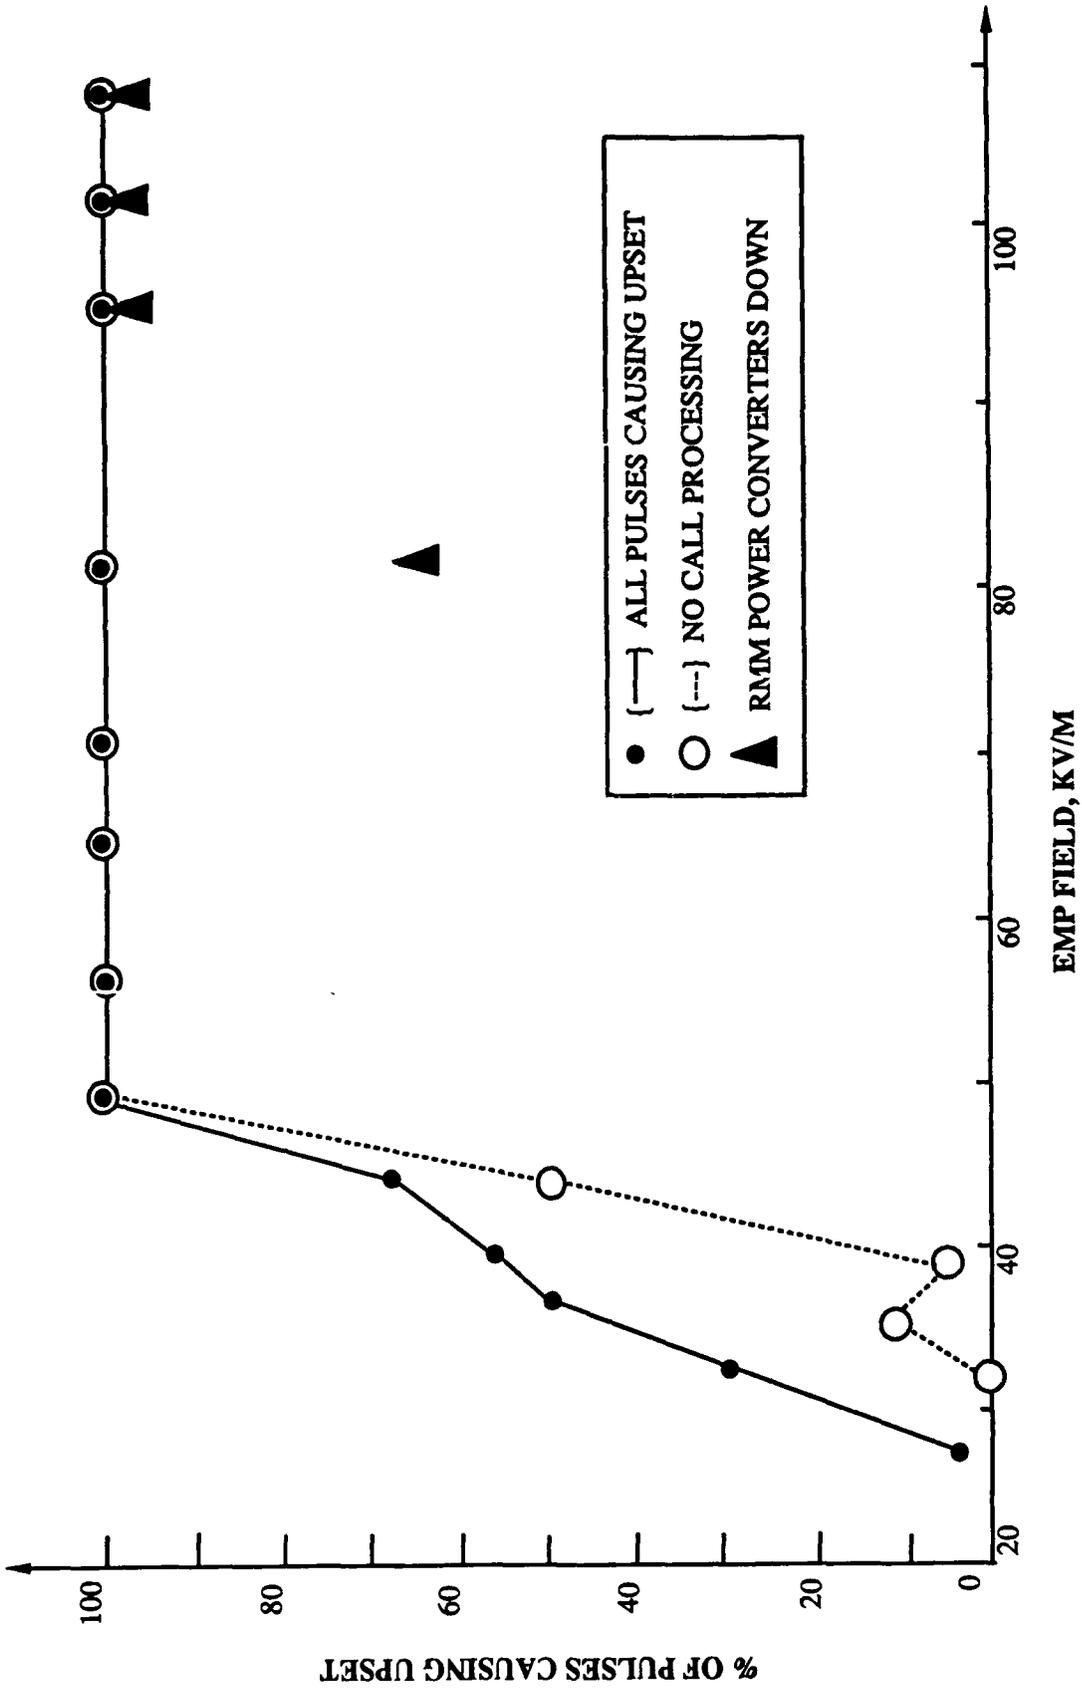
B-7

Figure B-4. Radlated Experiment Result (Configuration B)

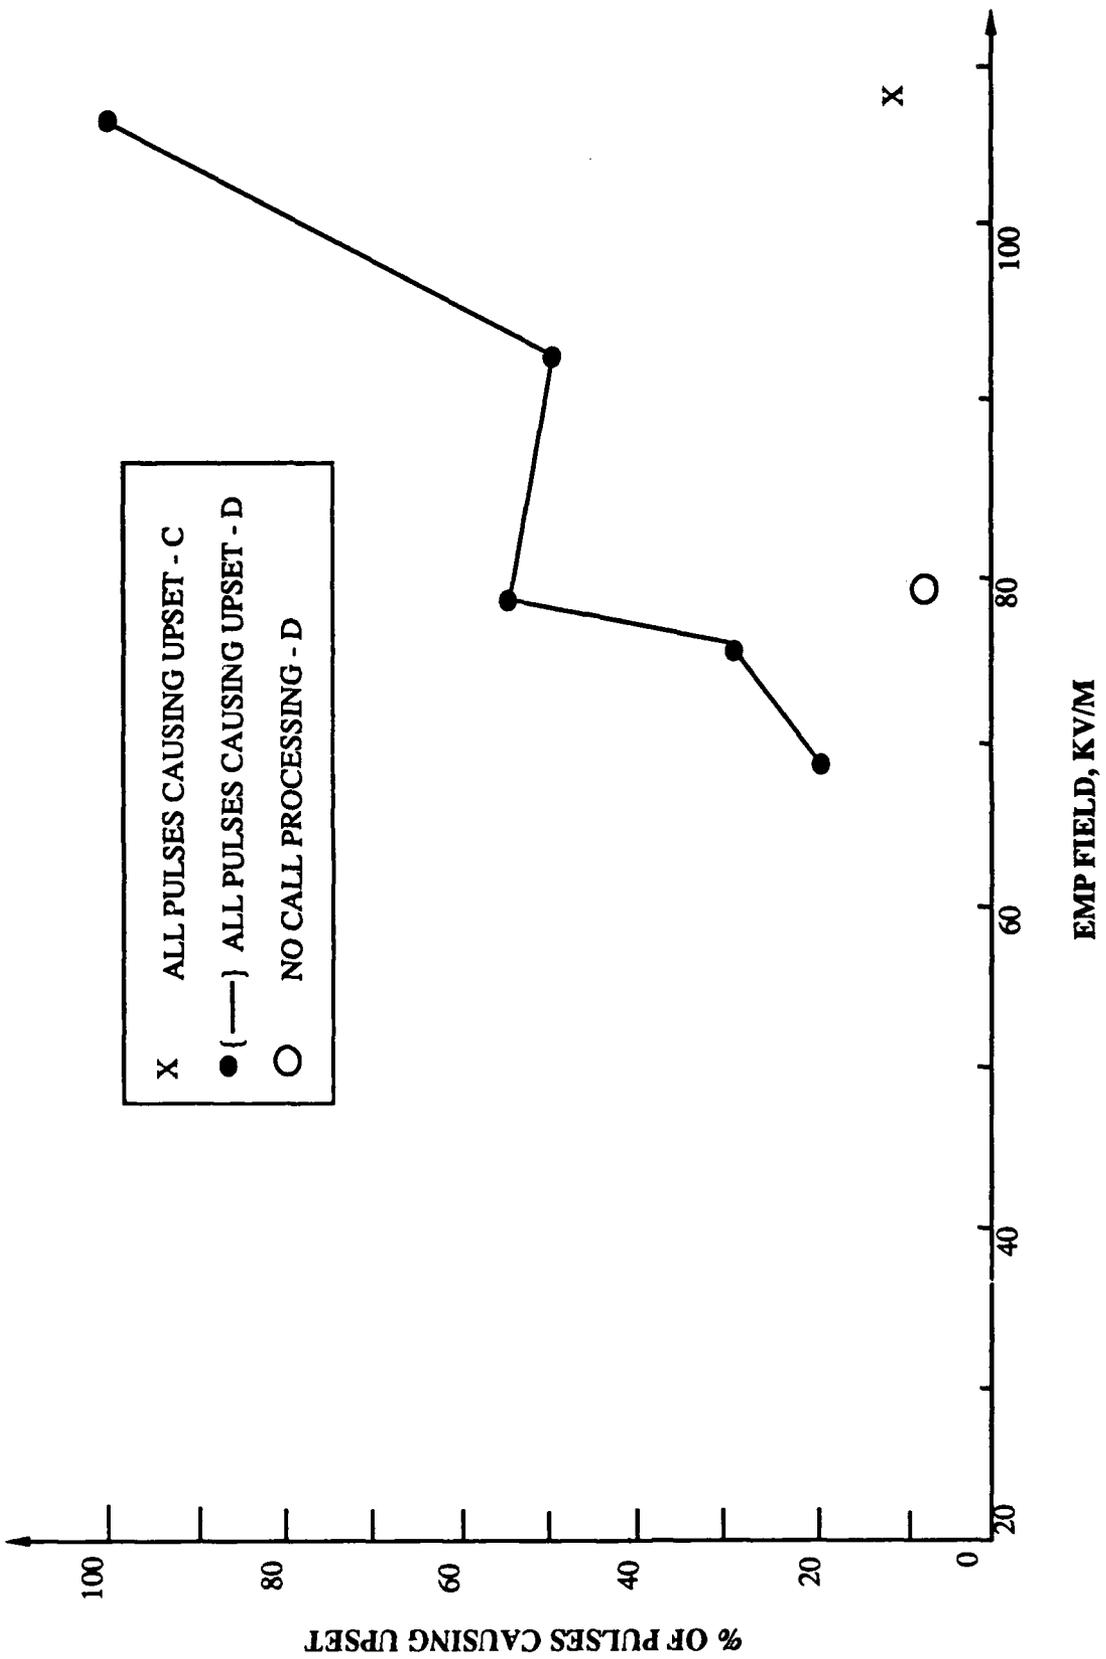
X ALL PULSES CAUSING UPSET - C
 ● (—) ALL PULSES CAUSING UPSET - D
 ○ NO CALL PROCESSING - D

Figure B-5. EMP Field Upset Distribution (Configurations C and D)

In Configuration C, panels are on, but the cable duct is removed to expose system cables. Applying 30 pulses caused only one auto-recoverable upset that did not affect call processing (Exhibits B-3 and B-5). The effect of bypassing two signal filters in Configuration D is shown in Figure B-5. The results of bypassing all signal filters in Configuration E are shown in Figure B-6. In Configuration F, the power filters, which are standard on all switches, are also bypassed and this result is shown in Figure B-7.

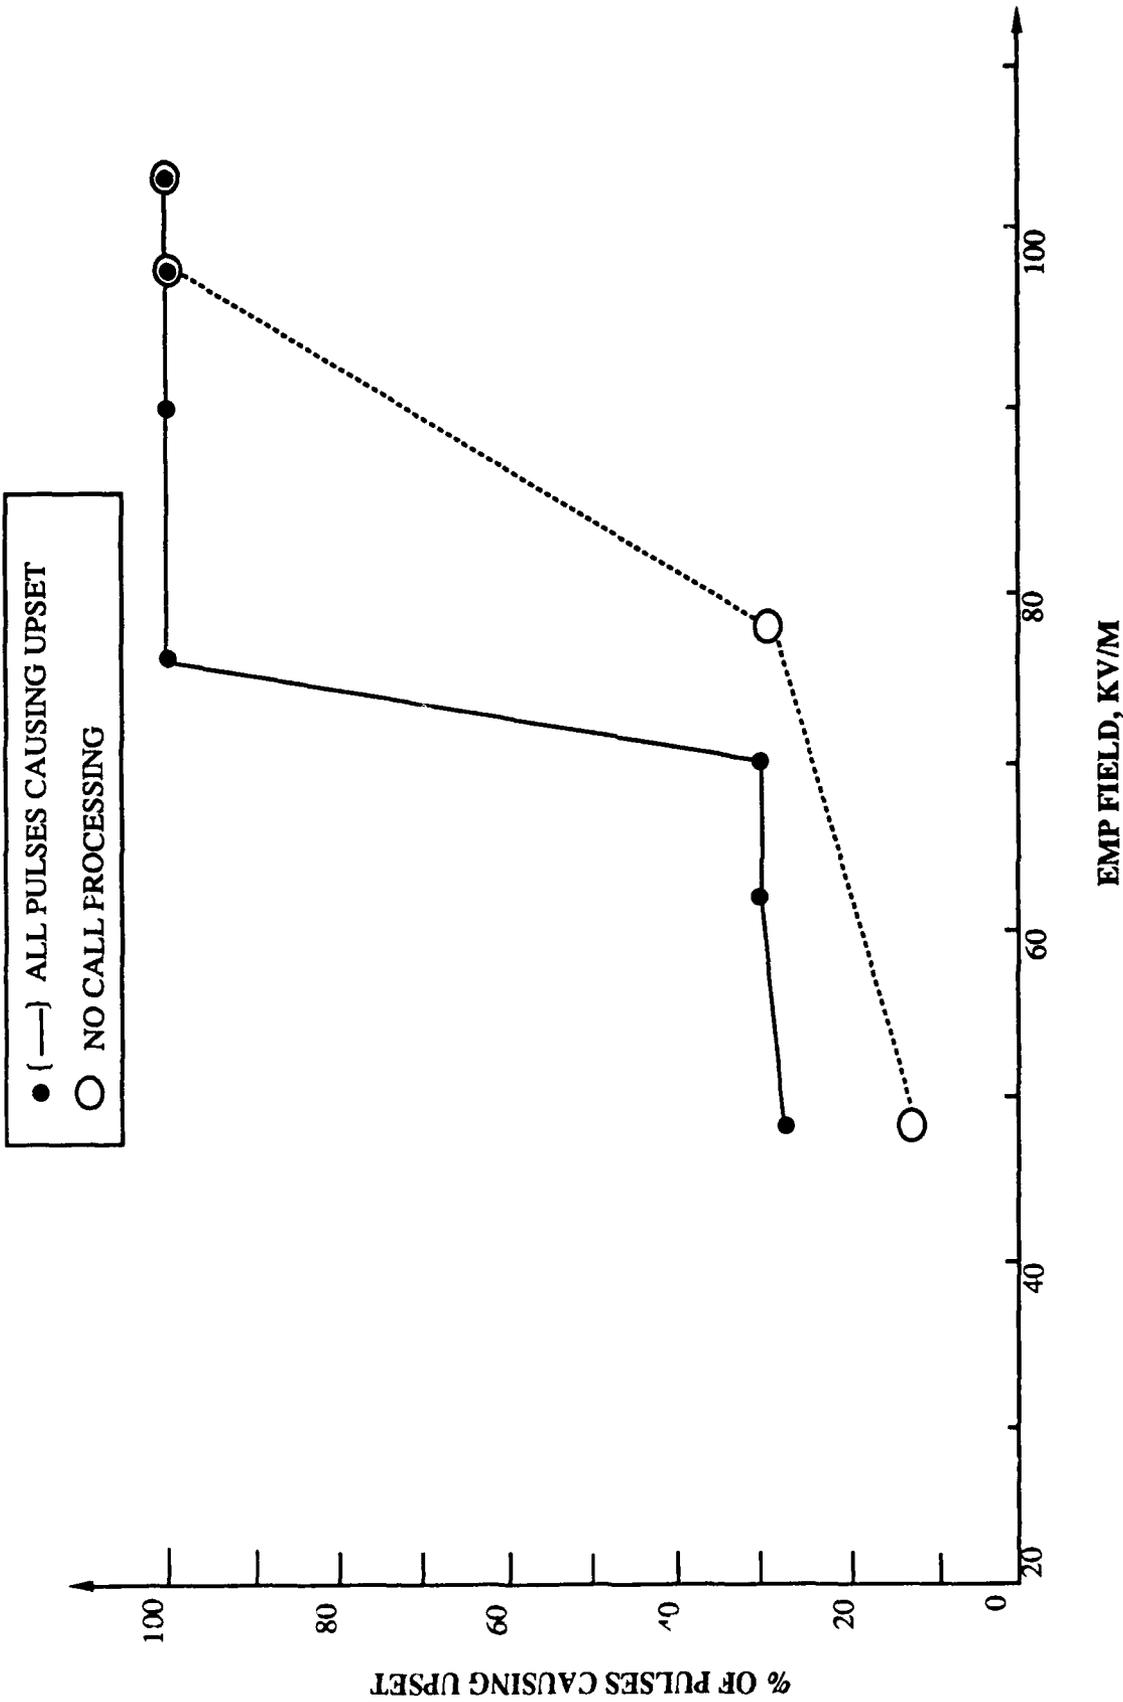
Figure B-6. EMP Field Upset Distribution (Configuration E)

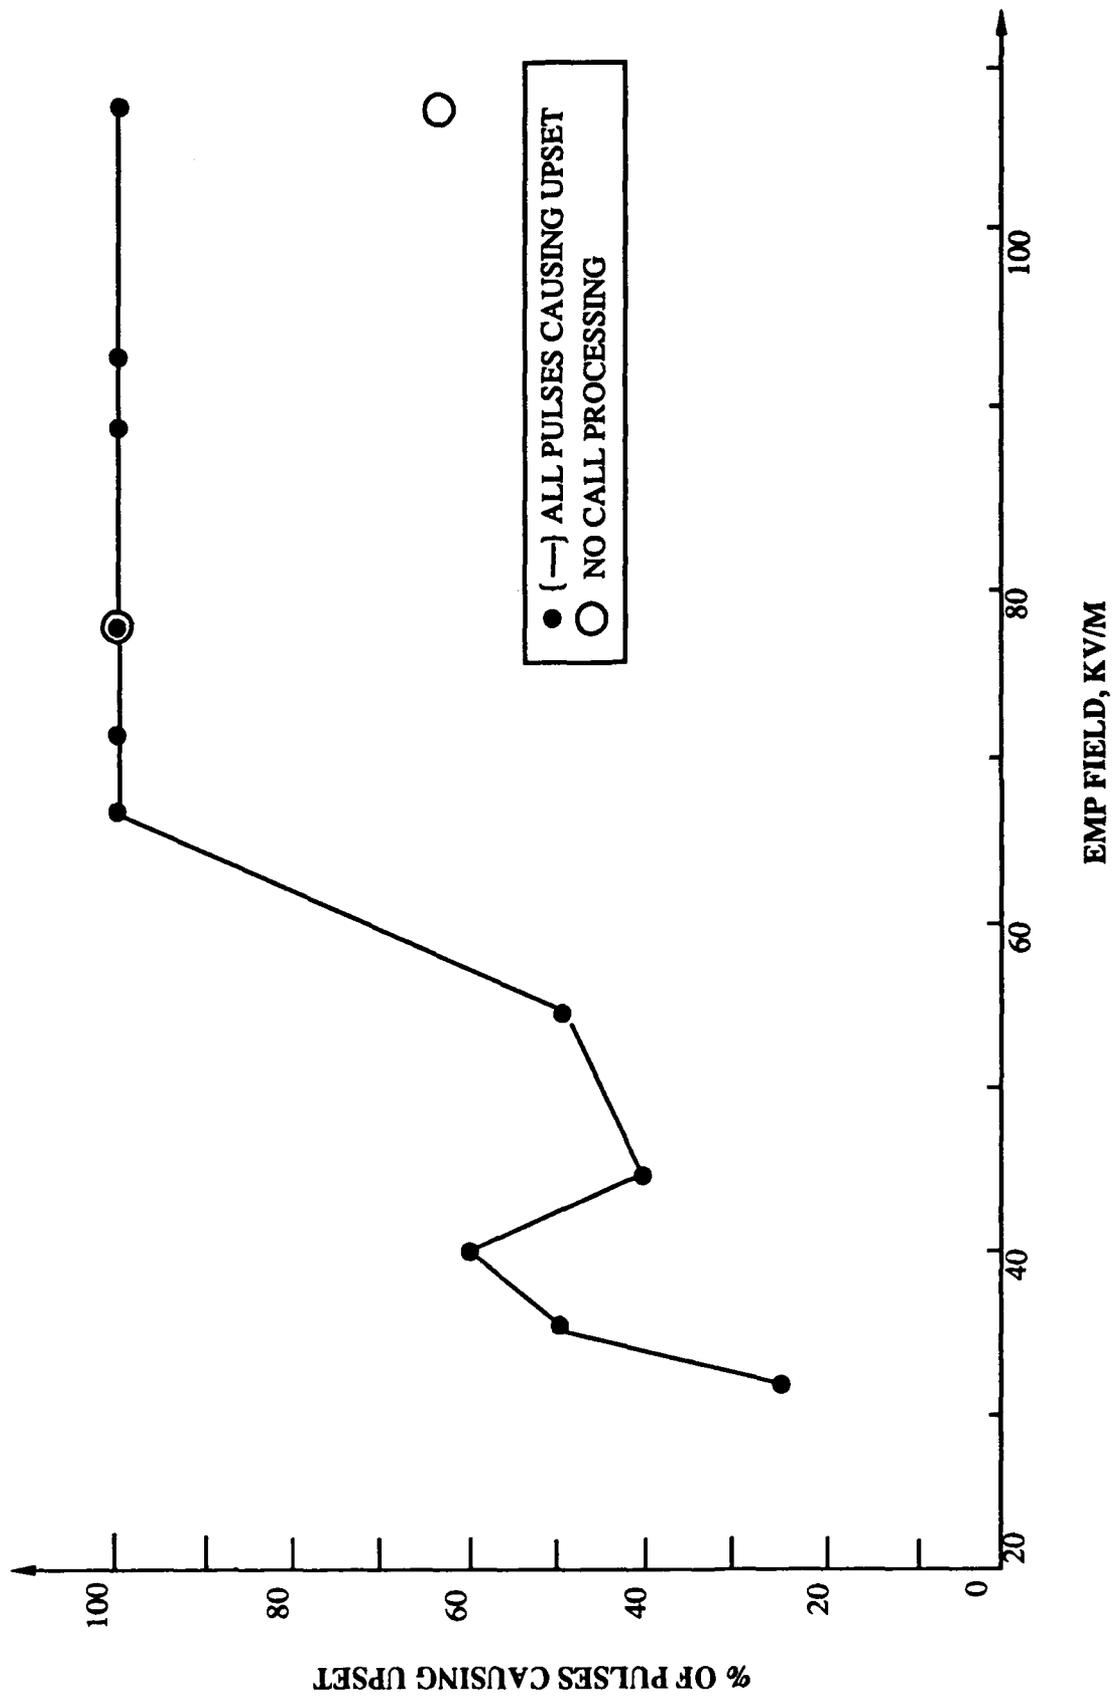
B-10

Figure B-7. EMP Field Upset Distribution (Configuration F)

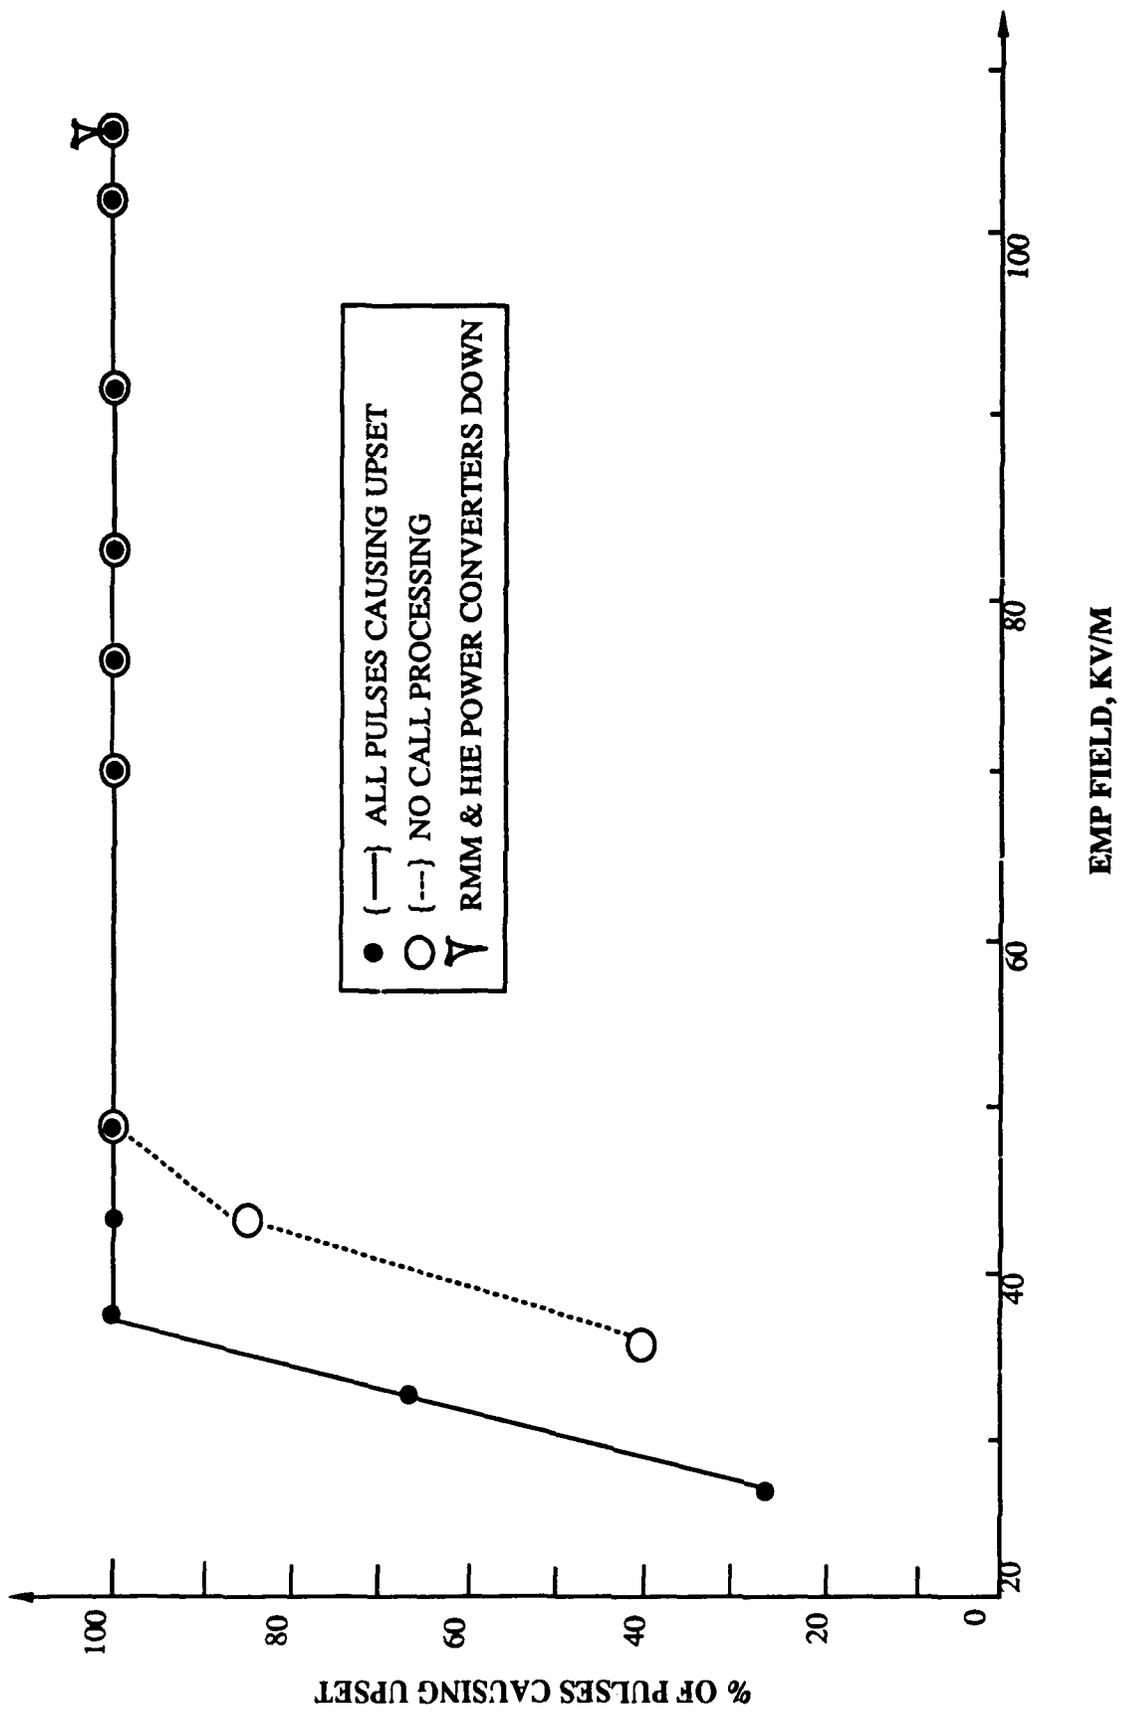
Figure B-8. EMP Field Upset Distribution (Configuration G)
