NATIONAL COMMUNICATIONS SYSTEM

TECHNICAL INFORMATION BULLETIN

THE EFFECTS OF HIGH-ALTITUDE
ELECTROMAGNETIC PULSE (HEMP) ON THE
NORTHERN TELECOM INC.
DMS-100™ SWITCH

TEST PROGRAM

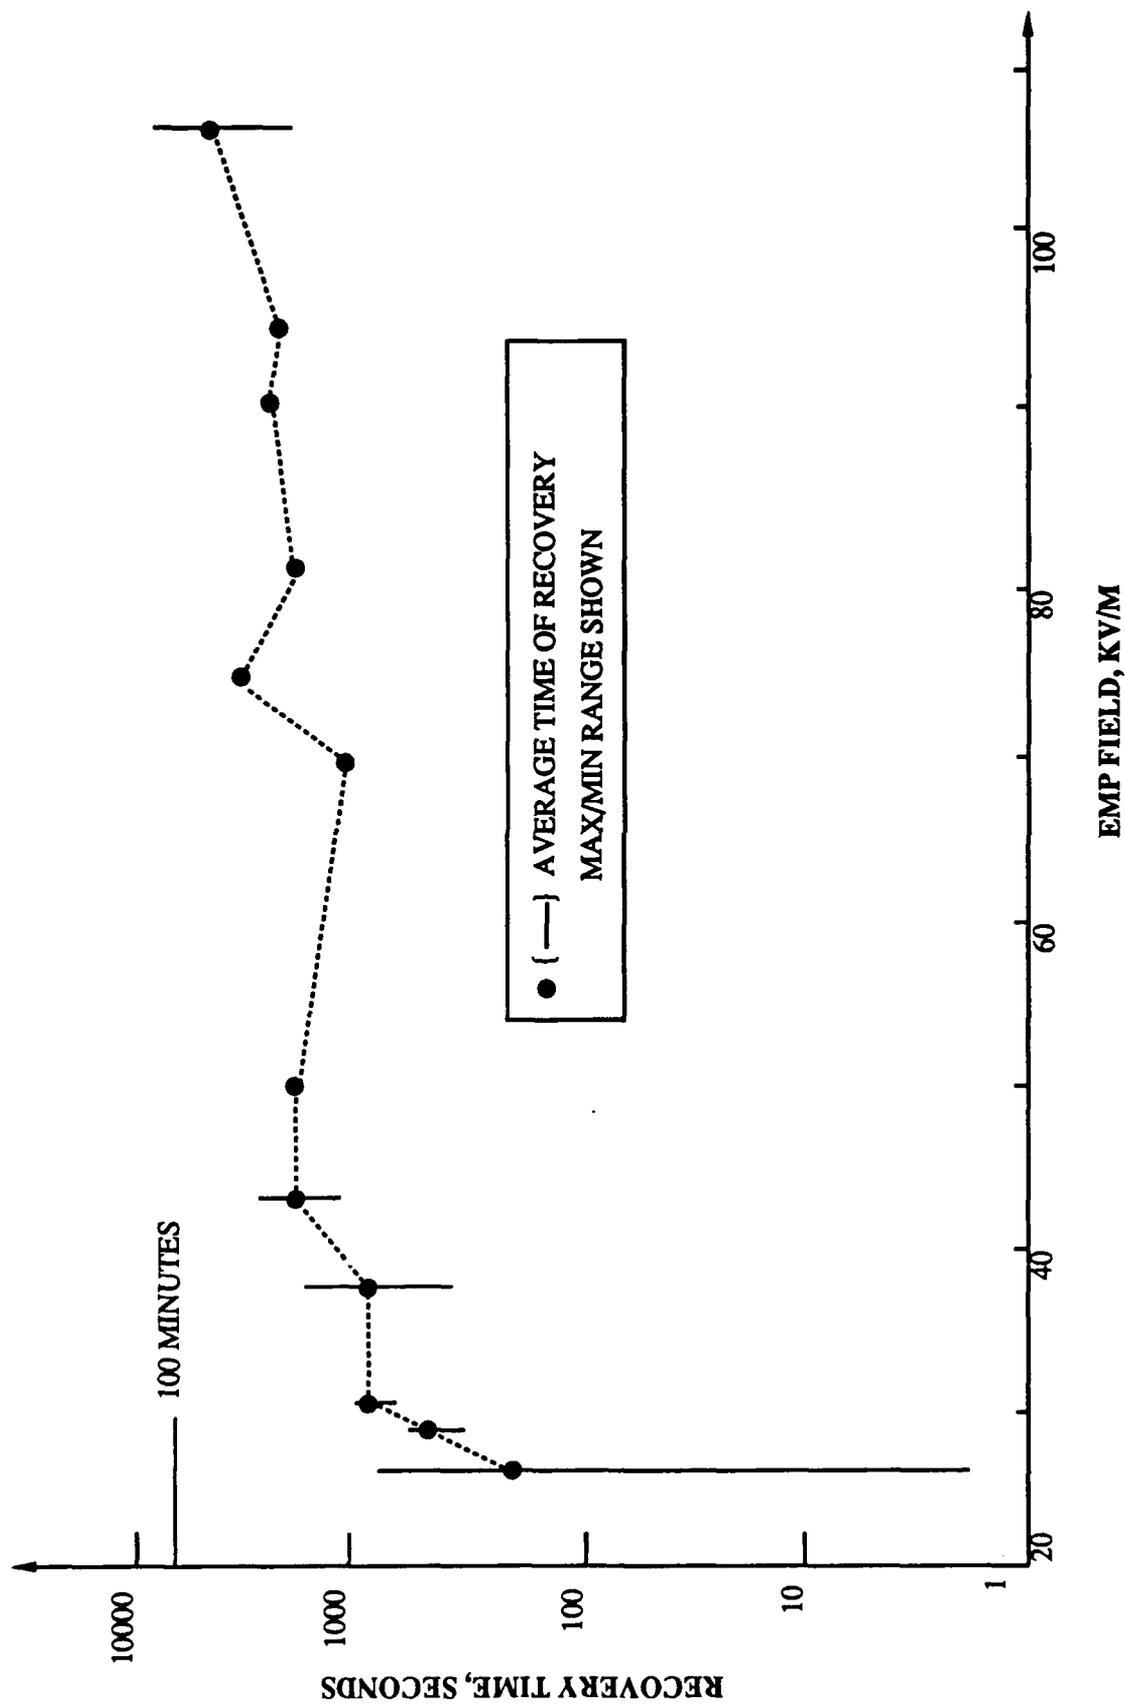
Figure B-9. Time of Recovery to Full System Operation (Configuration G)

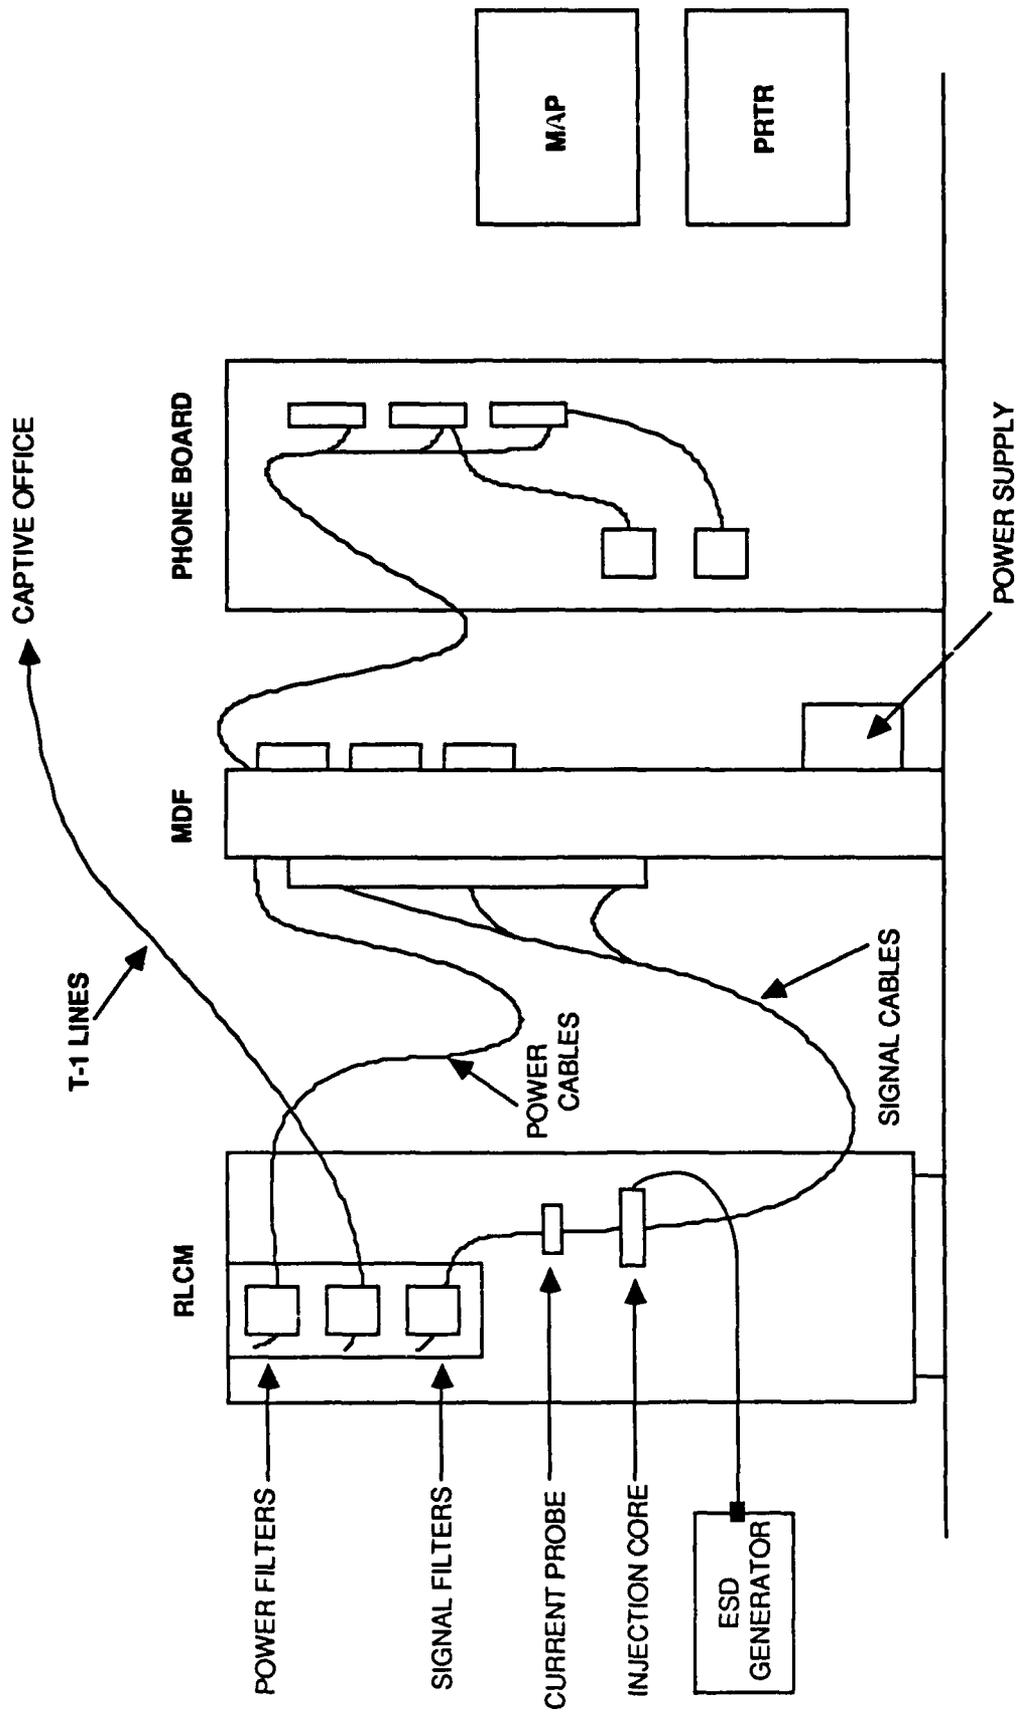
Figure B-10. Current Injection Setup

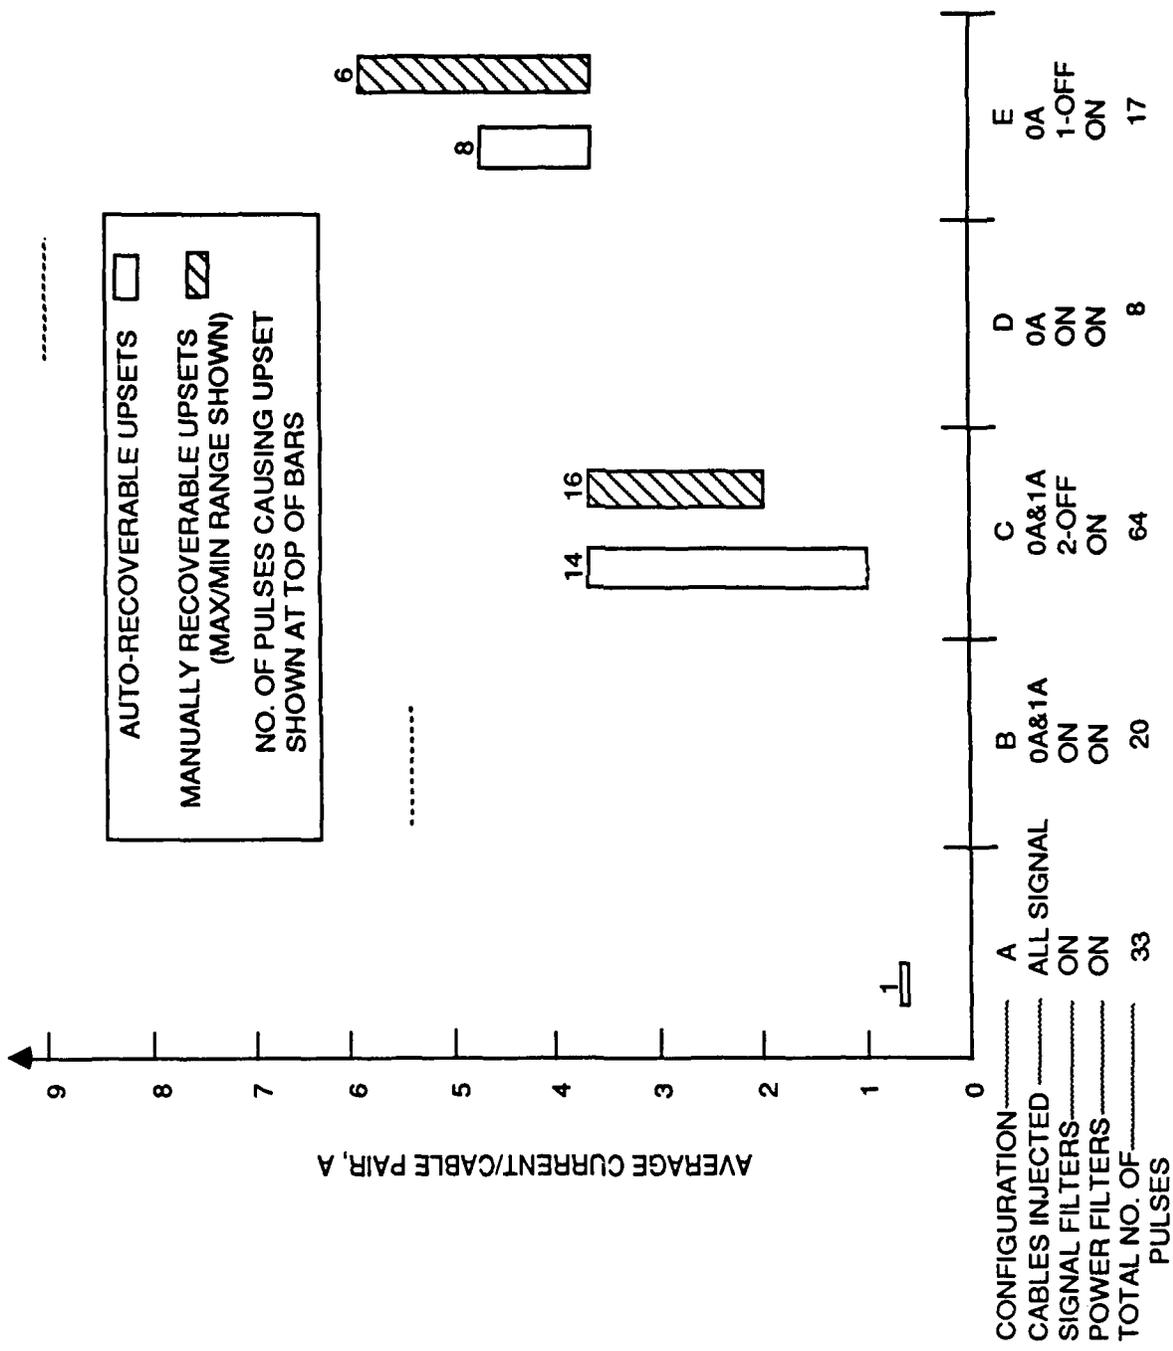
Figure B-11. RLCM Upset Distribution (Current Injection Experiment)

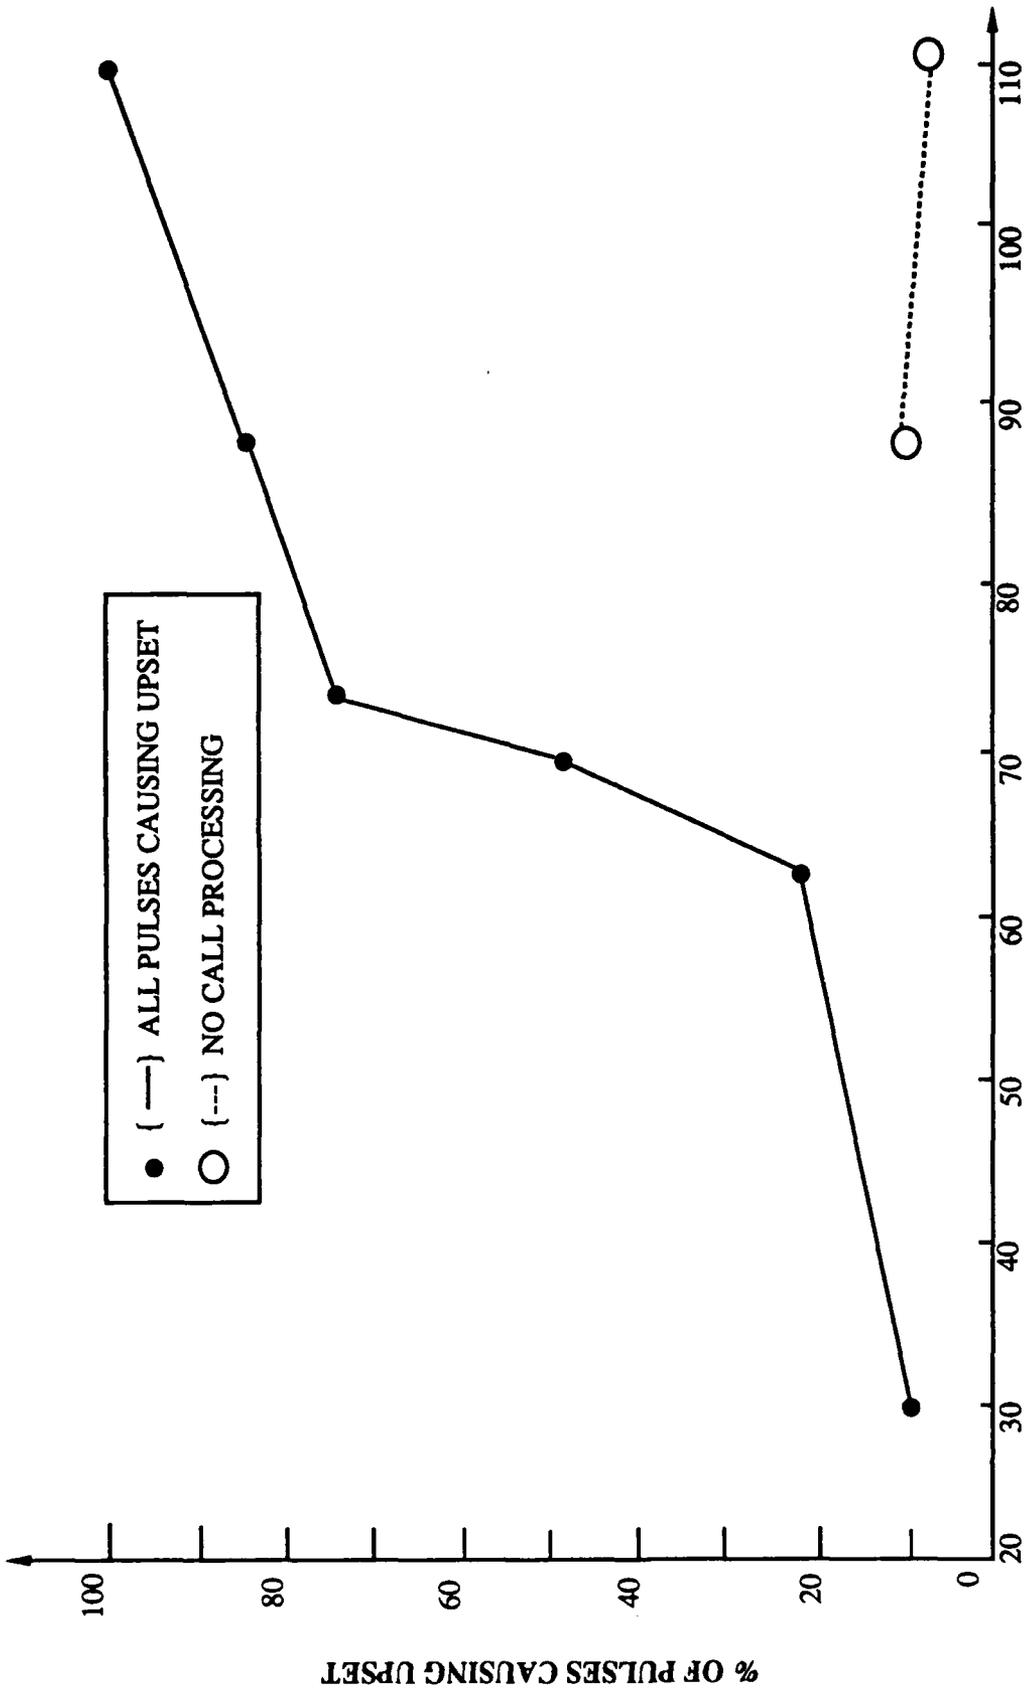
Figure B-12. Current Injection Upset Distribution (Configuration C)

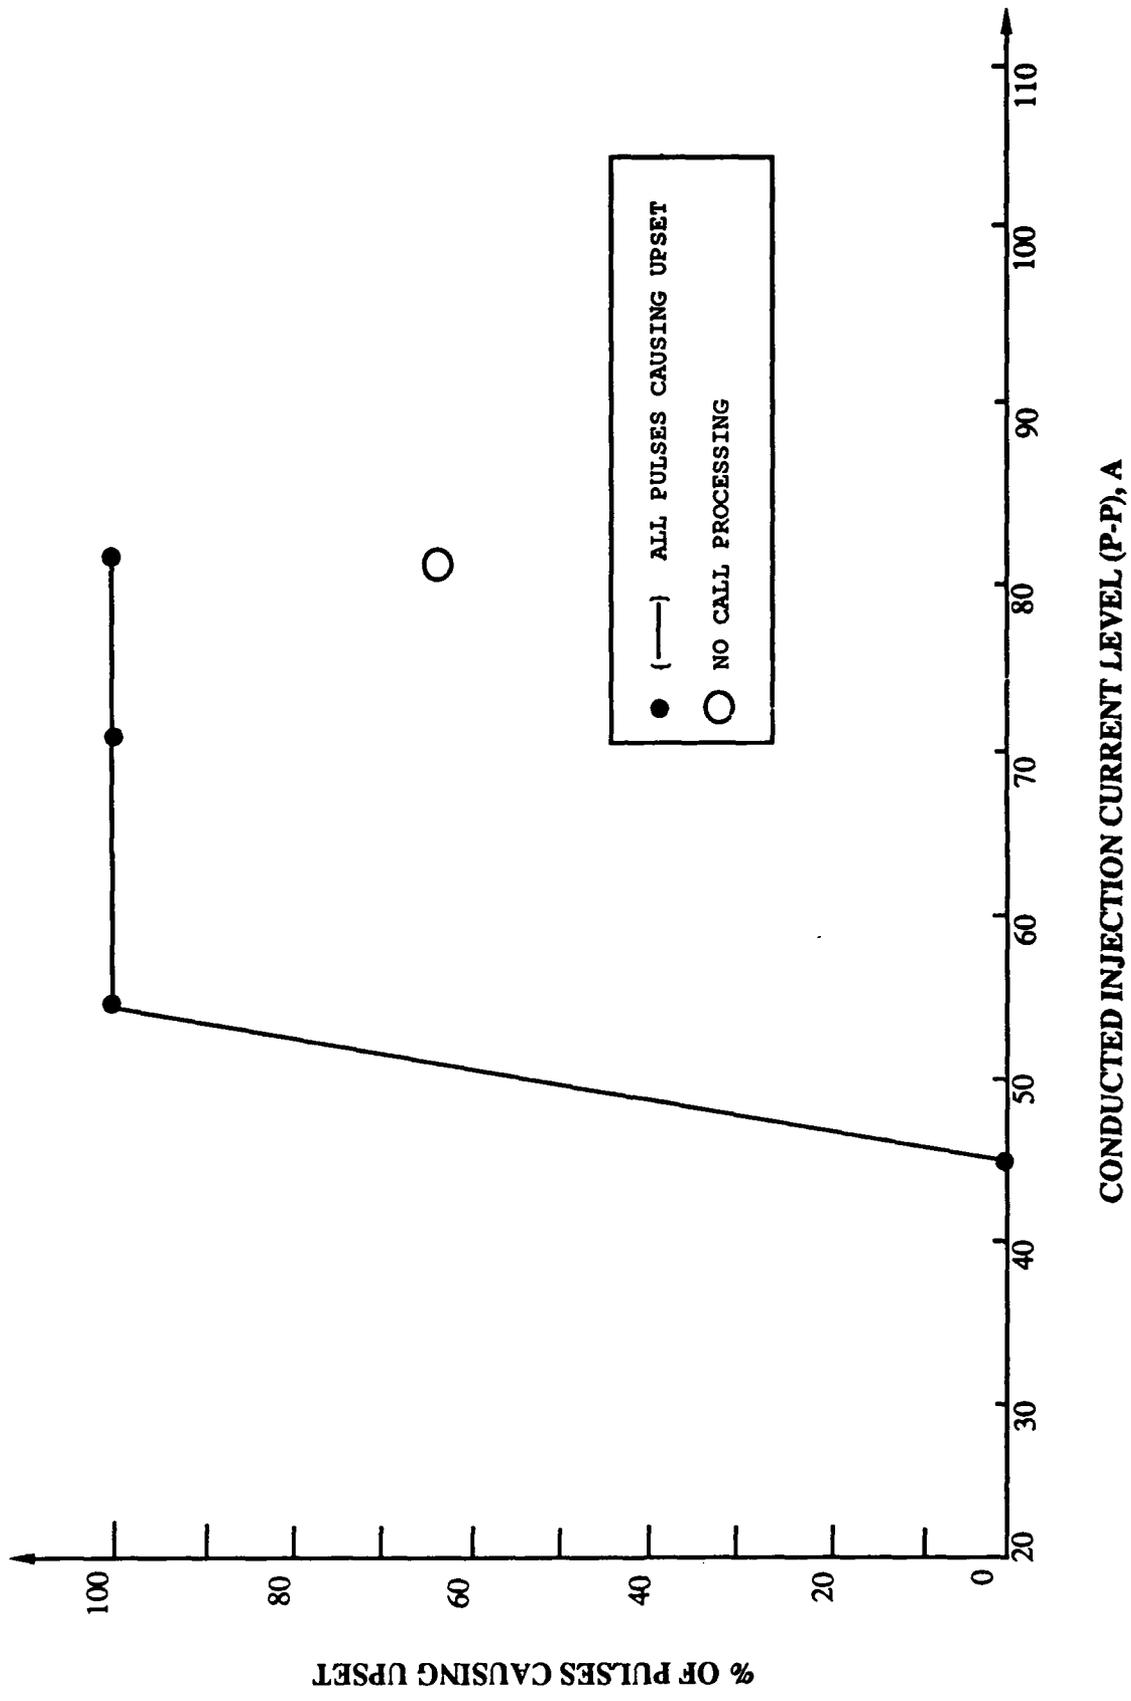
Figure B-13. Current Injection Upset Distribution (Configuration E)
