MISCELLANEOUS PAPER EL-89-5

PHYSICAL CHANGES IN CUTOFF BENDS ALONG THE TENNESSEE-TOMBIGBEE WATERWAY

Environmental Laboratory

June 1989

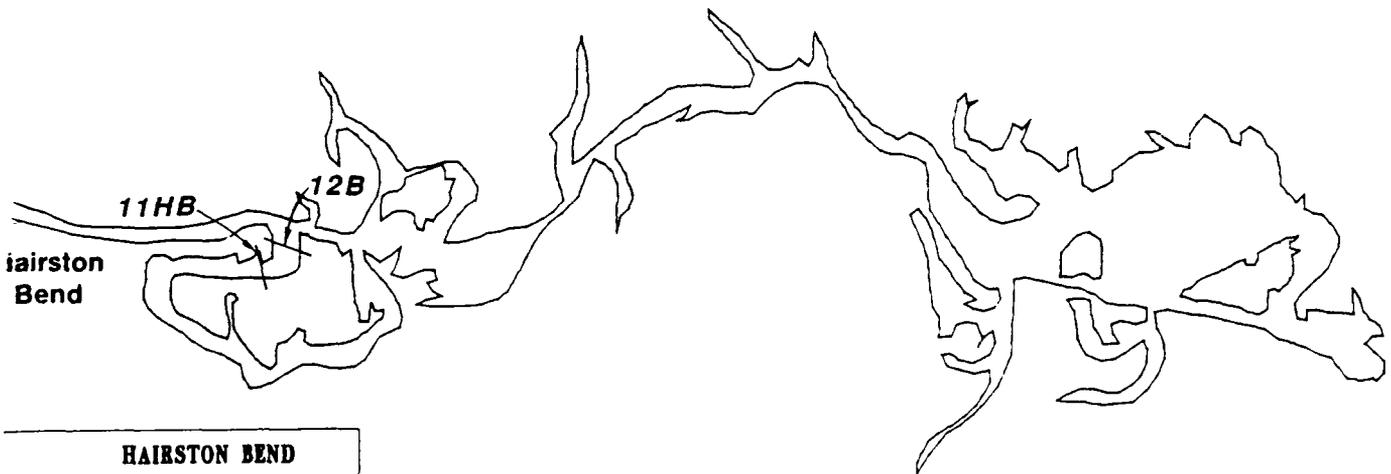
Figure 11. Bendway sedimentation, Alabama. Cross-section plots are at :

ation, Aliceville Lake (horizontal line
ts is at normal pool elevation)

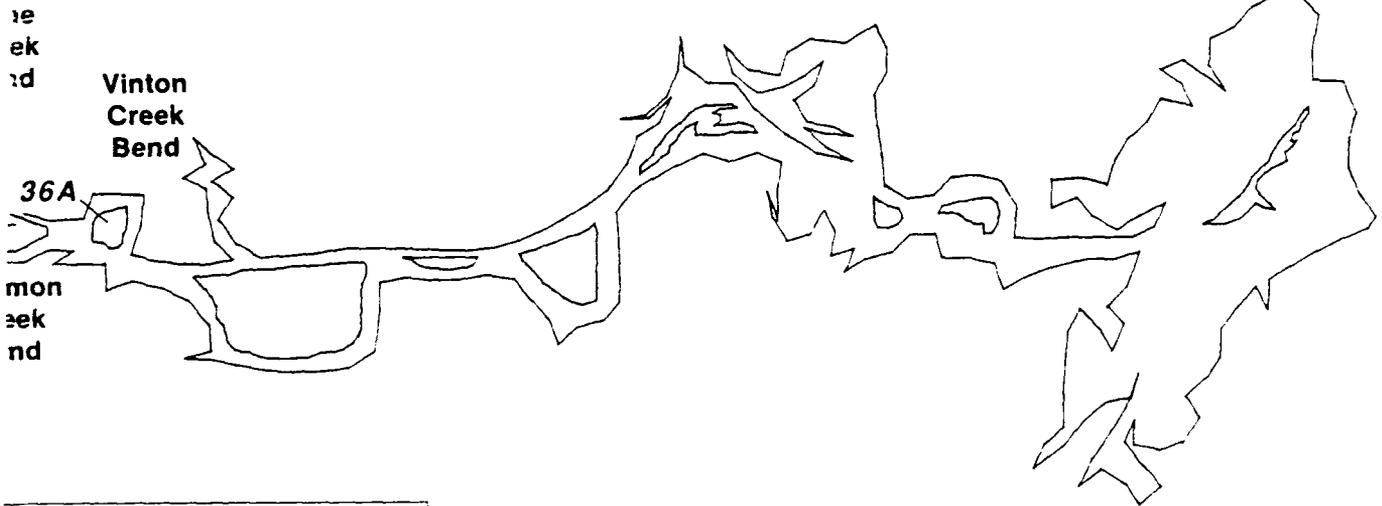
Figure 13. Bendway sedimentation, Cold Cane Creeks). Horizontal line on cross elevation

ation, Columbus Lake (Vinton, Denmon, and
ne on cross-section plots is at normal pool
elevation

64. Figure 13 shows results of surveys of Vinton, Denmon, and Cane Creek bendways. Deposition occurred most rapidly between 1981 and 1983, immediately after cutoff and during a period of high streamflow. All three of the survey ranges in Denmon Creek show significant scour between the initial survey in April 1981 and the first resurvey in December 1982. The reason for this scour is not known with certainty, but it could have been caused by flow acceleration due to completion of the cut channels just downstream prior to completion of the Denmon Creek cut. Blockage structures were constructed in the upstream bend entrances of each of these bendways shortly before the 1987 survey. Plots of the 1987 survey of the range nearest the upstream entrance for each of the bendways show the blocks in place in 1987. Survey ranges 41A and 36A coincide with sloping portions rather than the crest of the block.

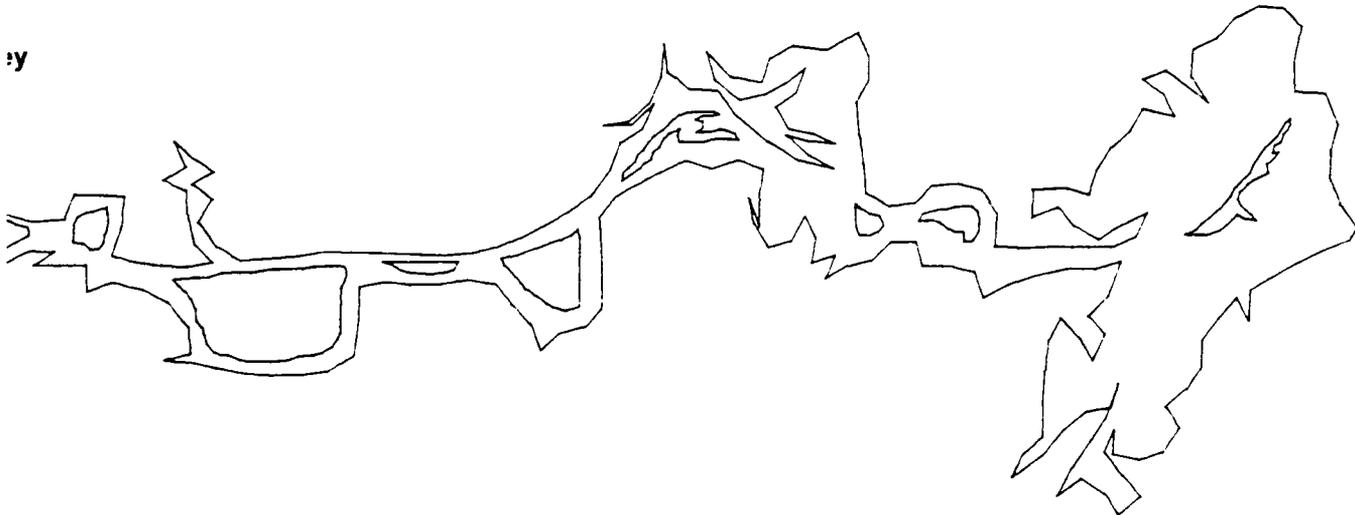
Figure 14. Bendway sedimentation, (Hickleson Lake, and James Creek). plots is at normal

ation, Columbus Lake (McKinley Creek, eek). Horizontal line on cross-section normal pool elevation
