Heliport Surface Maneuvering Test Results

June 1989

DOT/FAA/CT-TN88/30

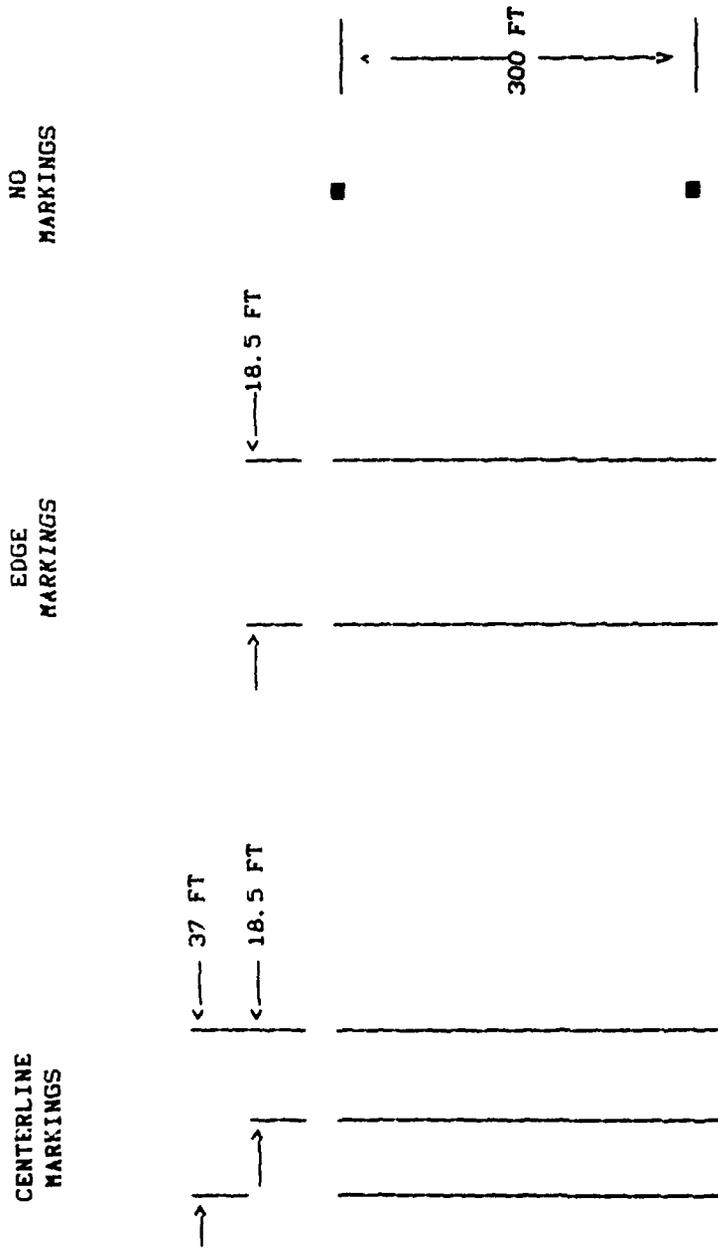
FIGURE 1. SCENARIOS FOR TAXIWAY TESTS

Note: The taxiway tests were conducted on taxiway Alpha at Atlantic City International Airport. This taxiway is 37 feet wide with a centerline marking. The scenarios with only side markings were conducted using half of taxiway A, thus giving a width of 18.5 feet. Both the 37.0- and 18.5-foot widths are larger than the taxiway widths required in the Heliport Design Advisory Circular for UH-1H maneuvers.

The taxiing tests measured hover taxi performance under various taxi route marking conditions with headwinds, tailwinds, and crosswinds. Three situations were tested: when the taxi route had a centerline; when it had only edge markings; and over a grass area with no markings available. During this test the pilot was instructed to hover a distance of 300 feet longitudinally, reverse course and hover back to the start point. Figure 1 depicts these three taxiing scenarios. One-half of the taxiing tests were performed at a hover height selected by the pilot. For the second half of the taxiing tests, the pilot was directed to maintain a 3-foot skid height during hover. Throughout the hover the pilot was asked to maintain a constant altitude, ground track, and rate of movement.

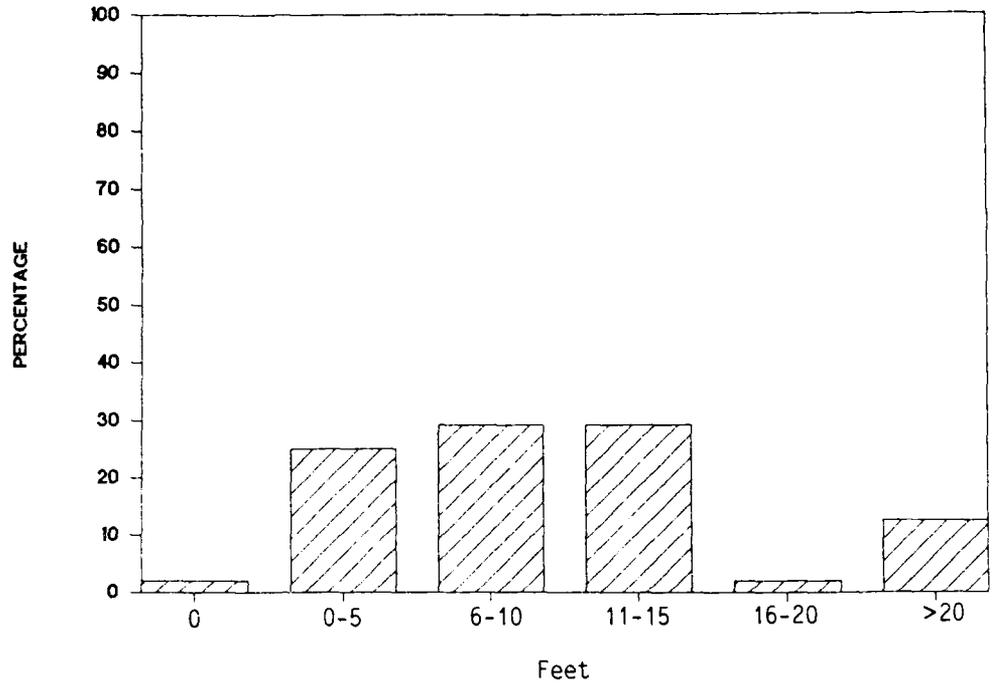
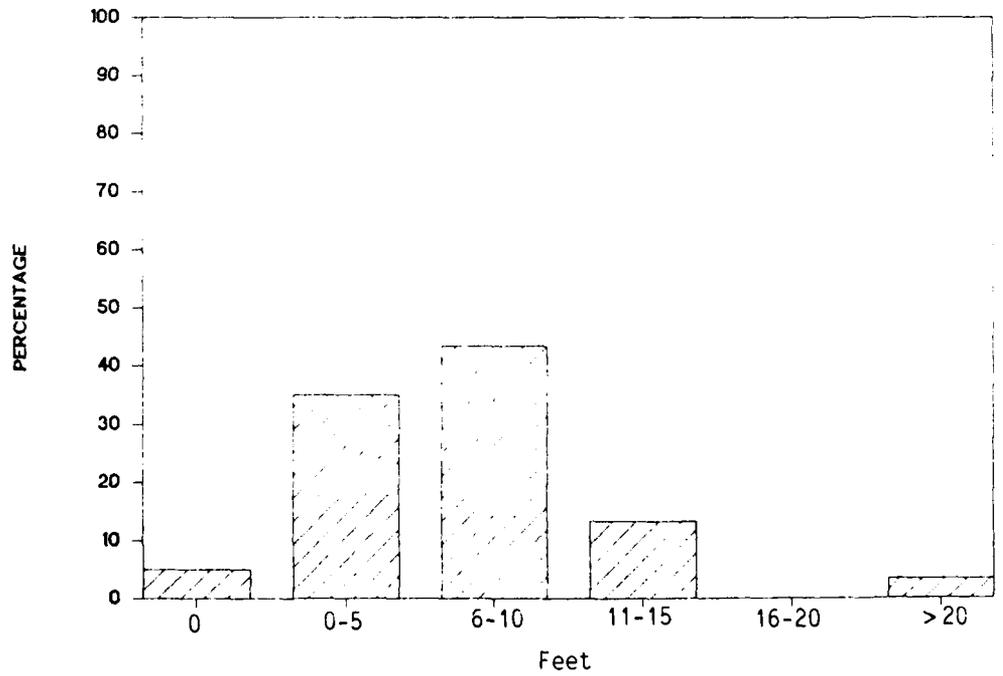
FIGURE 3. ACTUAL TIP CLEARANCES FOR PILOT CHOICE PARKING MANEUVERS REGARDLESS OF WINDS

REGARDLESS OF WIND (WITH OBJECT)

REGARDLESS OF WIND (NO OBJECT)

With an obstacle under tailwind condition, 97.5 percent of the responses were less than 15.43 feet. This was the largest for all tested conditions. Figure 3 shows plots of the actual clearances regardless of wind conditions for the pilot choice maneuvers. Greater than 85 percent of the observations with an obstacle present were less than or equal to 1/3 rotor diameter of the UH-1H. The remaining 15 percent of the observations ranged from 21 to 39 feet. Without the object, more than 95 percent of the observations were less than or equal to the 1/3 rotor diameter criteria, with the remaining observations ranging from 1.5 to 2.5 times the criteria. These clearances, broken down by wind conditions, are plotted in figure 4.

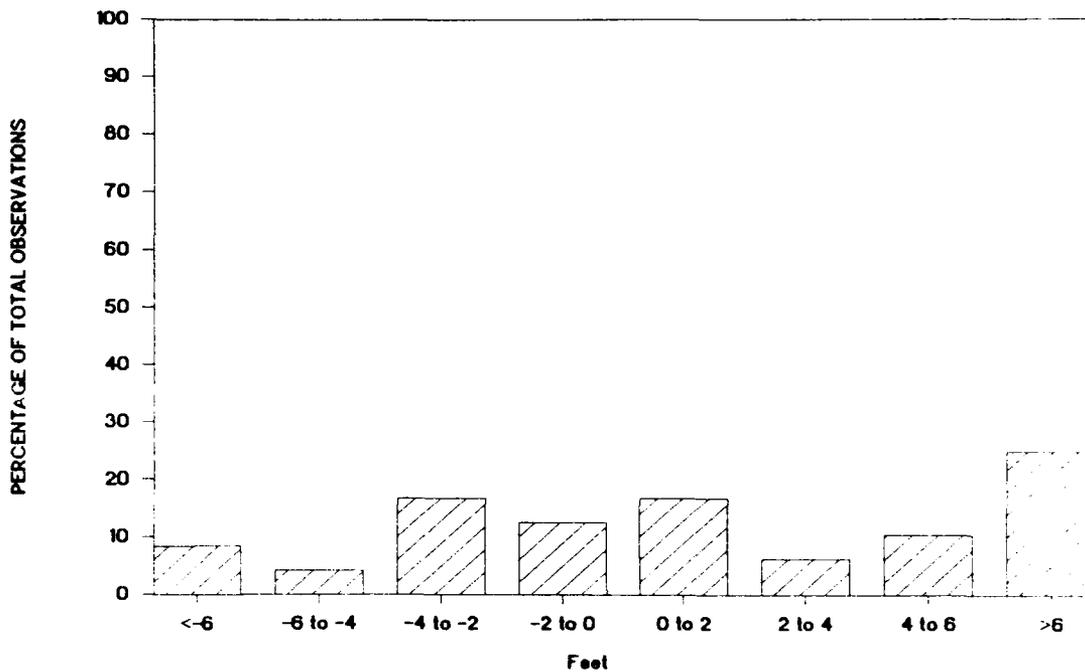
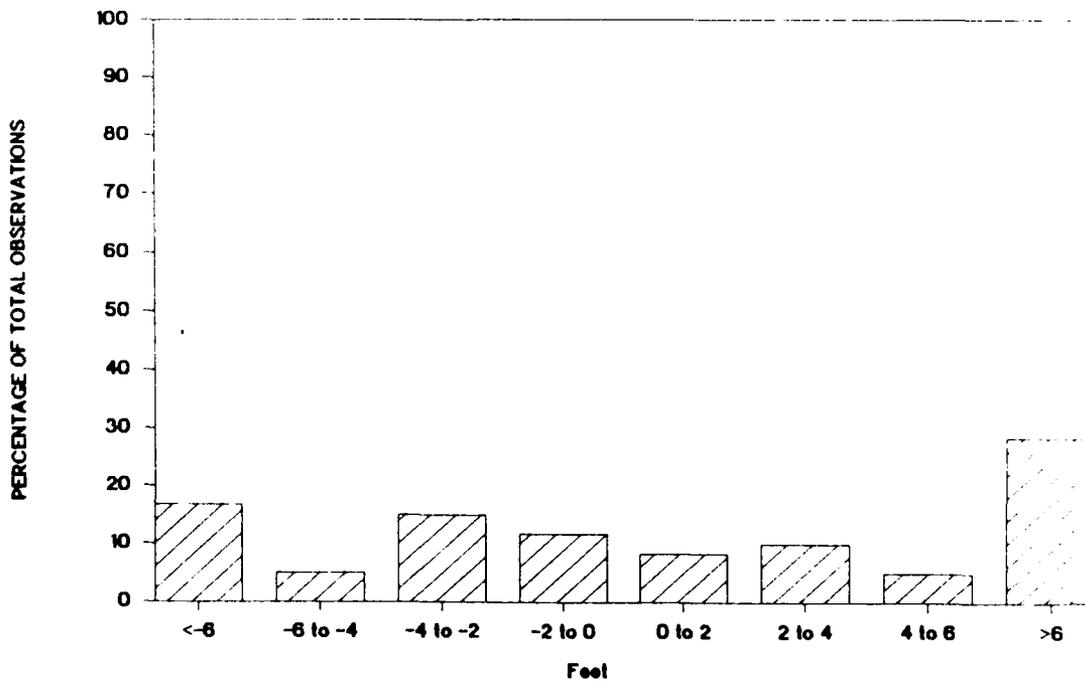
FIGURE 7. REQUESTED 12-FOOT PARKING CLEARANCES; PERFORMANCE ERRORS REGARDLESS OF WIND DIRECTION

REGARDLESS OF WIND- WITH OBJECT

REGARDLESS OF WIND- WITHOUT OBJECT

Performance errors were generated by subtracting the 12-foot requested clearance from the actual clearance. Histograms of these errors are found in figures 7 and 8. Examination of the performance errors, regardless of wind conditions, revealed that the pilots parked the helicopter 12 feet or more from the obstacle 58 percent of the time. This indicates they tended to underestimate their clearances and were conservative in their performance. In addition, 25 percent of the pilots overestimated the clearances by 3 feet or less. Similarly, when there was no obstacle, the actual clearances, regardless of winds, were underestimated approximately 52 percent of the time, with 18 percent overestimated by 3 feet or less. Again, their performance was conservative. When the data were broken down by wind conditions, the best performance was seen with headwinds. The percentage (69 percent) of clearances 12 feet or more from the obstacle with headwinds was 13-19 percent larger than either of the other two conditions. Without the obstacle, the performance was 15-20 percent larger for headwind conditions.

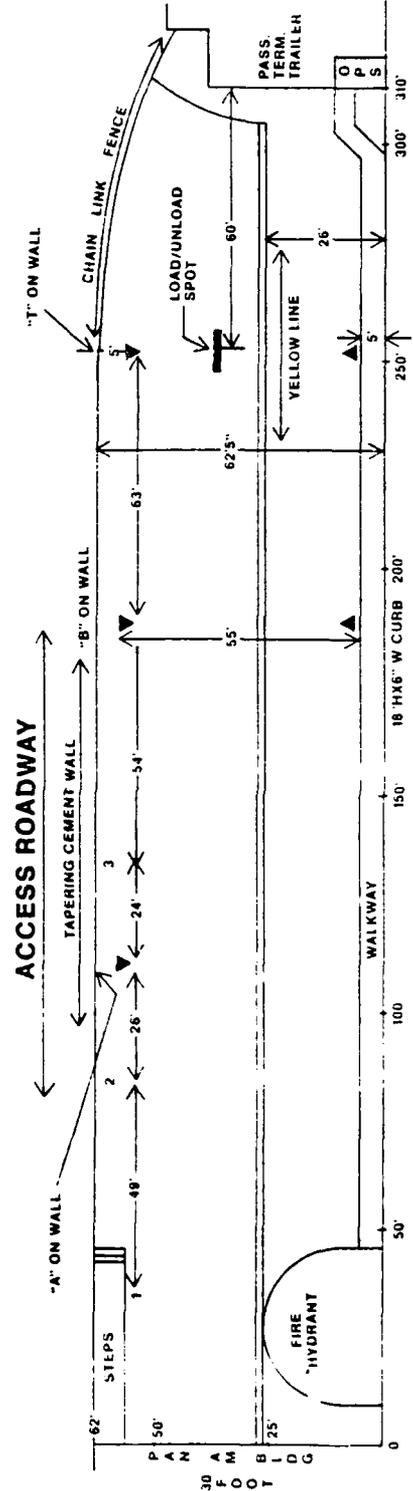
FIGURE C-1. LAYOUT OF 60TH STREET HELIPORT, NEW YORK CITY

"A" & "B" ON WALL FOR LARGE HELICOPTERS
12.3 MARKED ON WALL

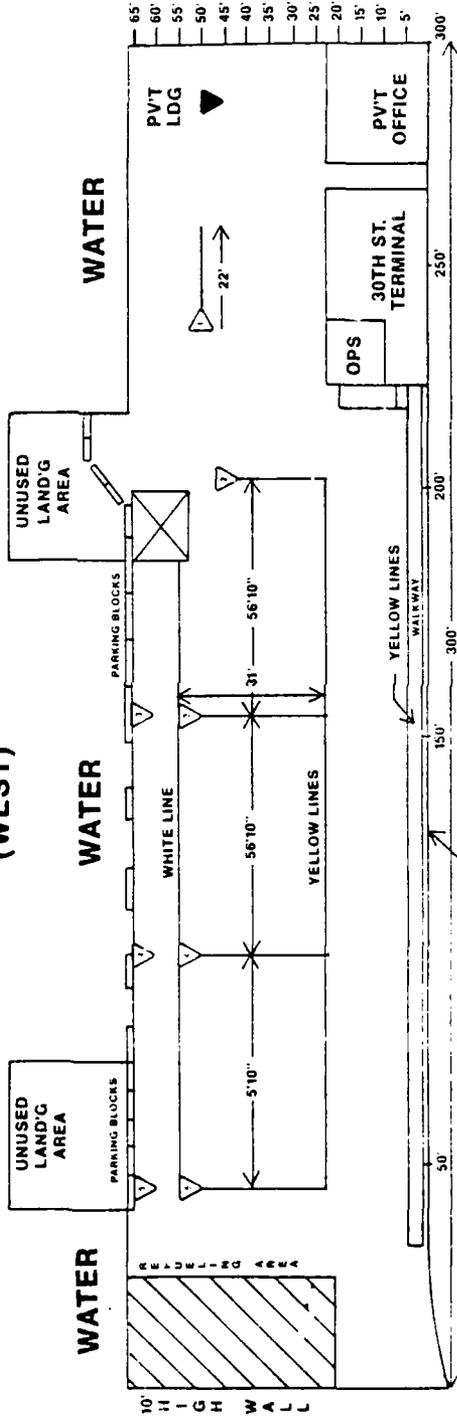
NOTE:
A/C PARK WITH TAIL ROTOR
CLOSE TO WALKWAY

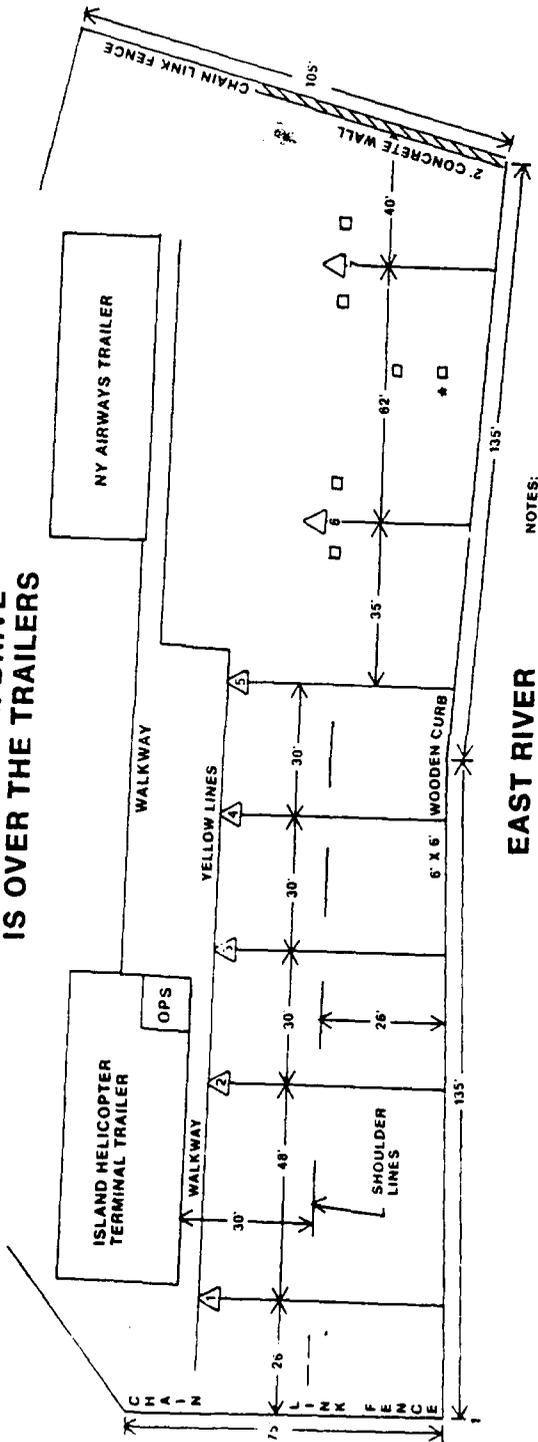
FIGURE C-5. LAYOUT OF 34TH STREET HELIPORT, NEW YORK CITY

- JAN '88**
- NOTES:
 1) SPOTS 6 & 7 FOR S-58
 2) A/C/PARK WITH TAILROTOR
 TOWARDS RIVER
 3) 61,000 OPERATIONS IN 1987
 4) * FOR WHEELS S-58 N-S LANDING
