Enhanced Preliminary Assessment Report:

East Windsor Army Housing Units East Windsor, Connecticut

October 1989

Environmental Research Division
Argonne National Laboratory
Argonne, Illinois 60439

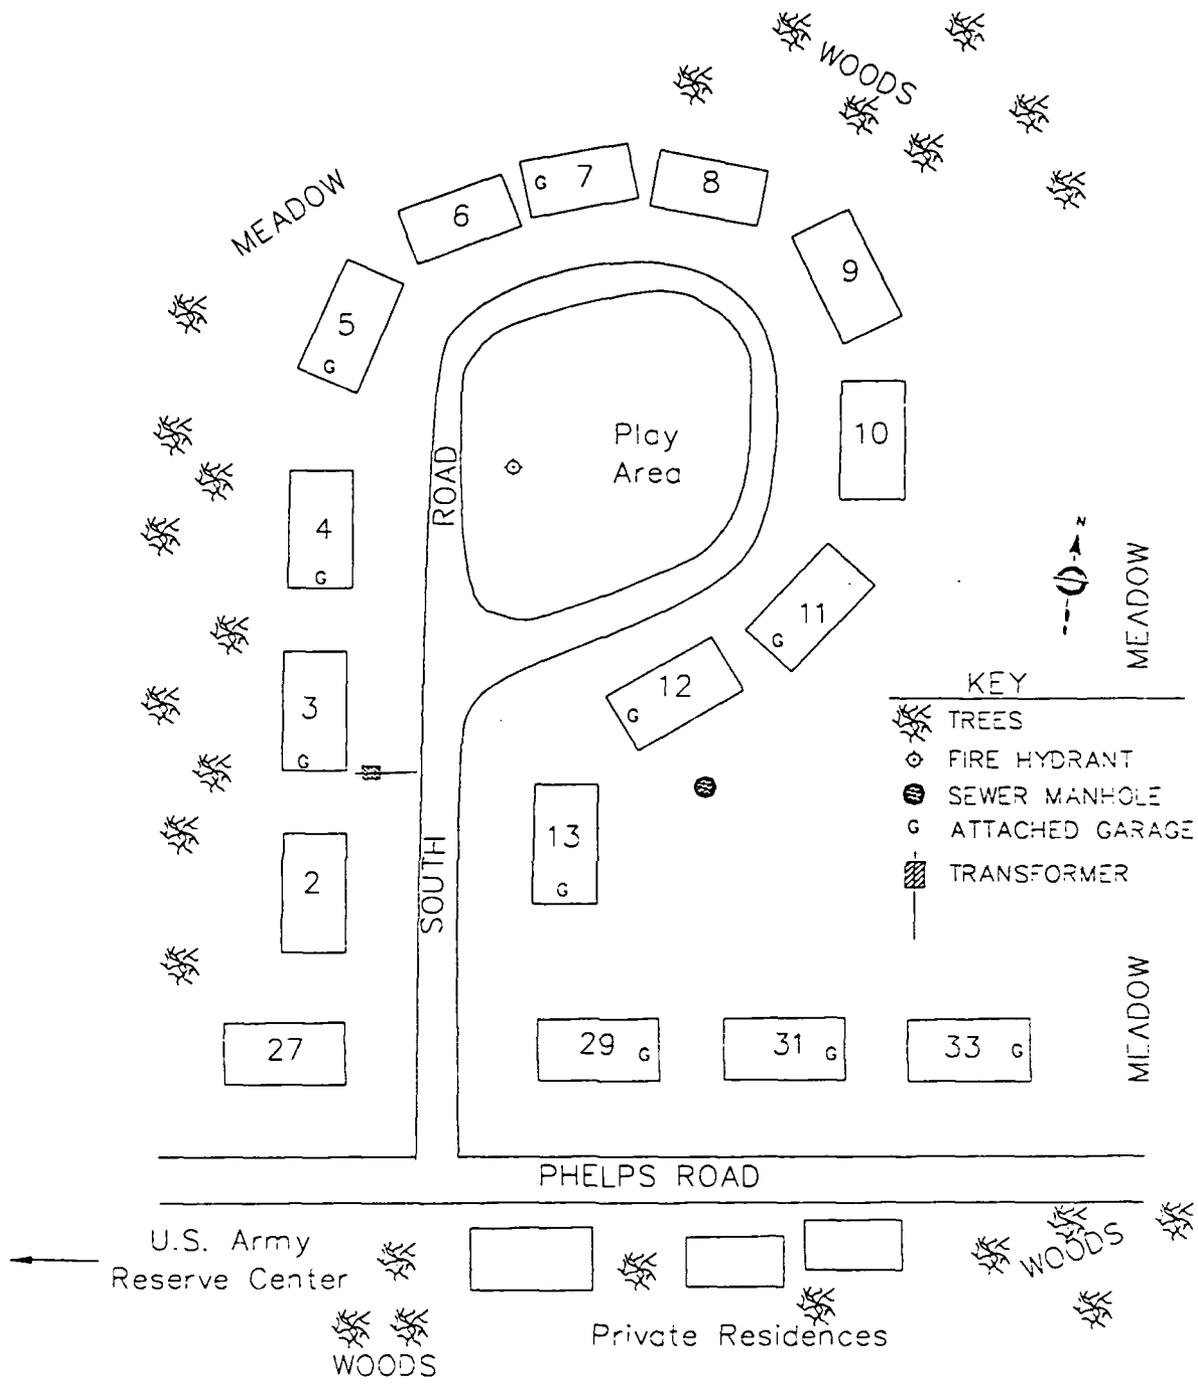
FIGURE 3 Site Plan Map of East Windsor Army Housing Units

Figure 3 shows the site plan of the housing property.

The East Windsor military housing facility comprises 16 wood-frame, one-story, single-family houses built on concrete slabs. Capehart is the model name assigned to these houses by the builder, National Homes. Nine of the housing units have three bedrooms and seven have two bedrooms. Twelve of the 16 housing units have attached garages, equally divided among the two- and three-bedroom units.
